## JOURNEY RISK MANAGEMENT (JRM) STUDY

### Salem Terminal TO YADHAVAN AGENCIES

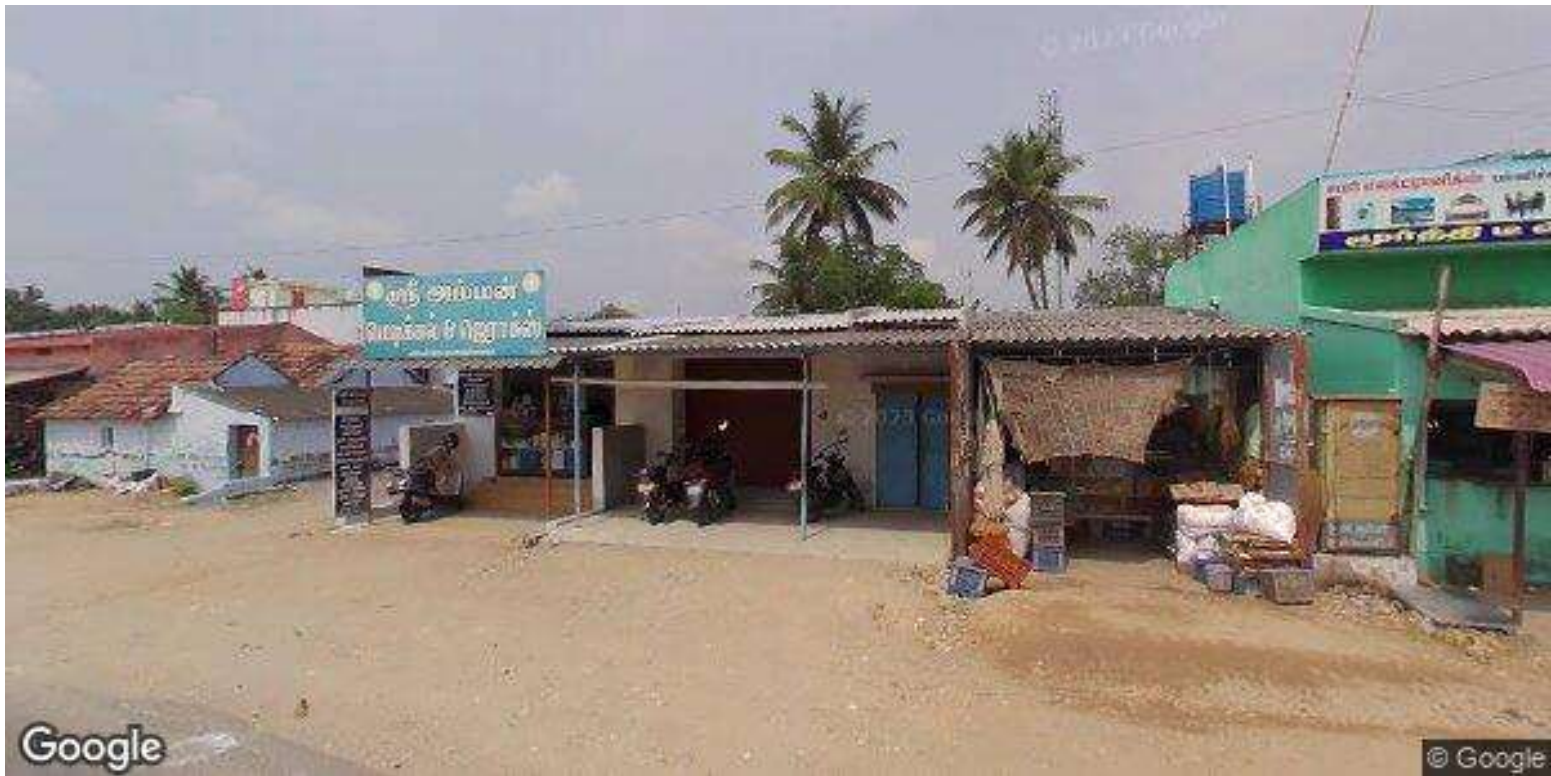
**Risk Type:** Turn  
**Risk Level:** Medium  
**Speed Limit:** 30 KM/Hr  
**Coordinates:** 11.20776, 77.70916

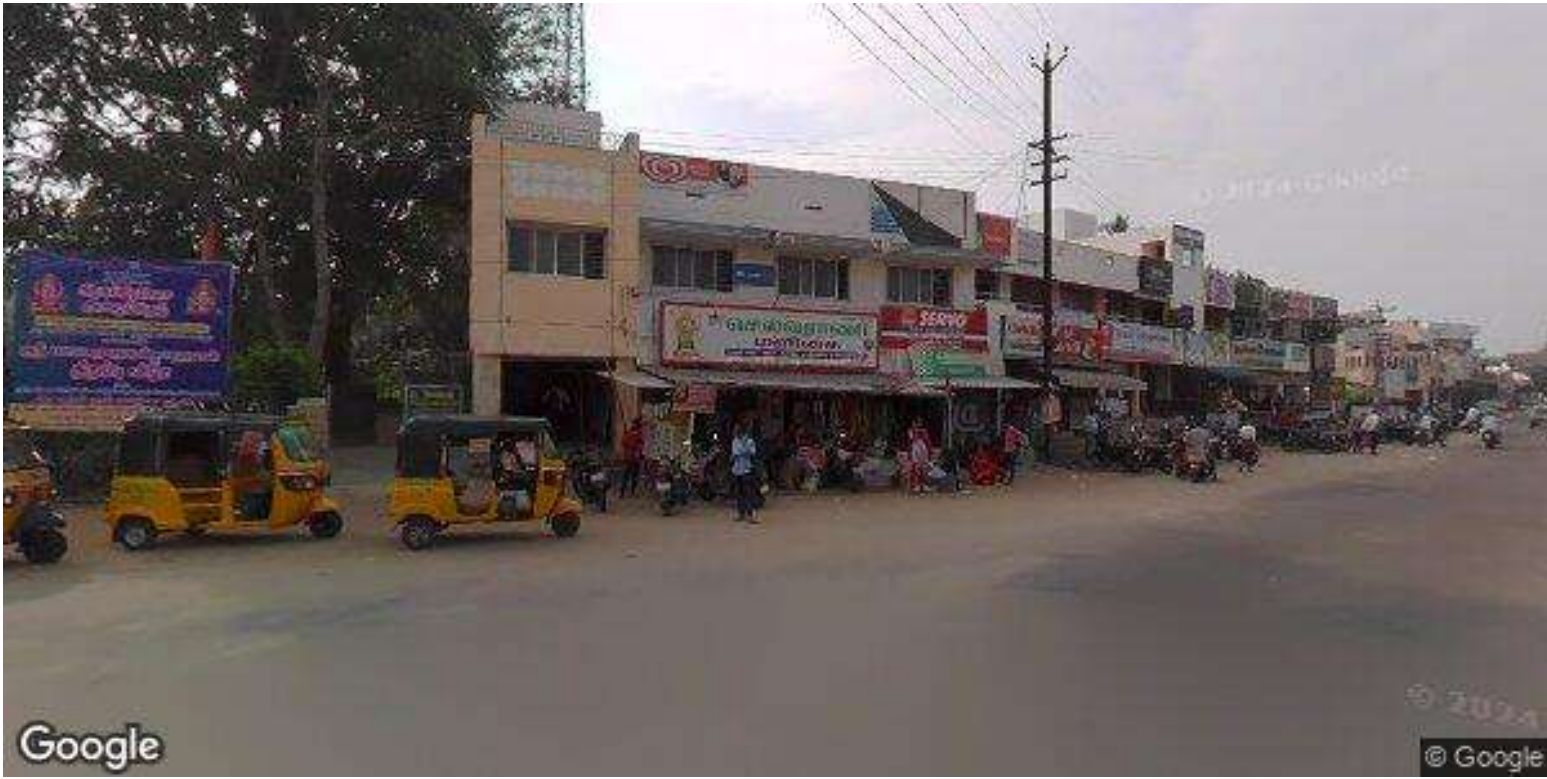
**Risk Type:** Turn  
**Risk Level:** Medium  
**Speed Limit:** 30 KM/Hr  
**Coordinates:** 11.15942, 77.70068

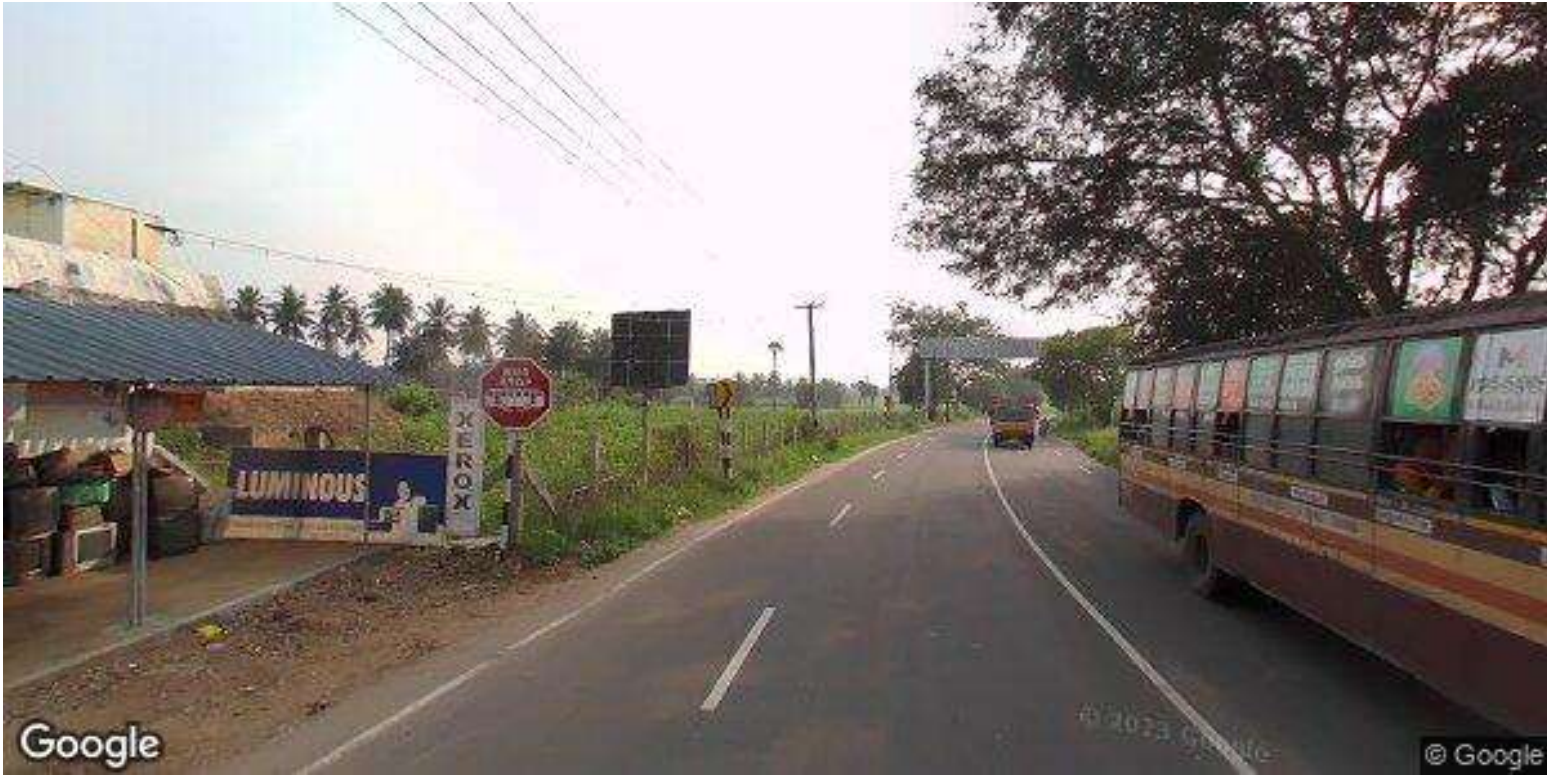
**Risk Type:** Turn  
**Risk Level:** Medium  
**Speed Limit:** 30 KM/Hr  
**Coordinates:** 11.12102, 77.67919

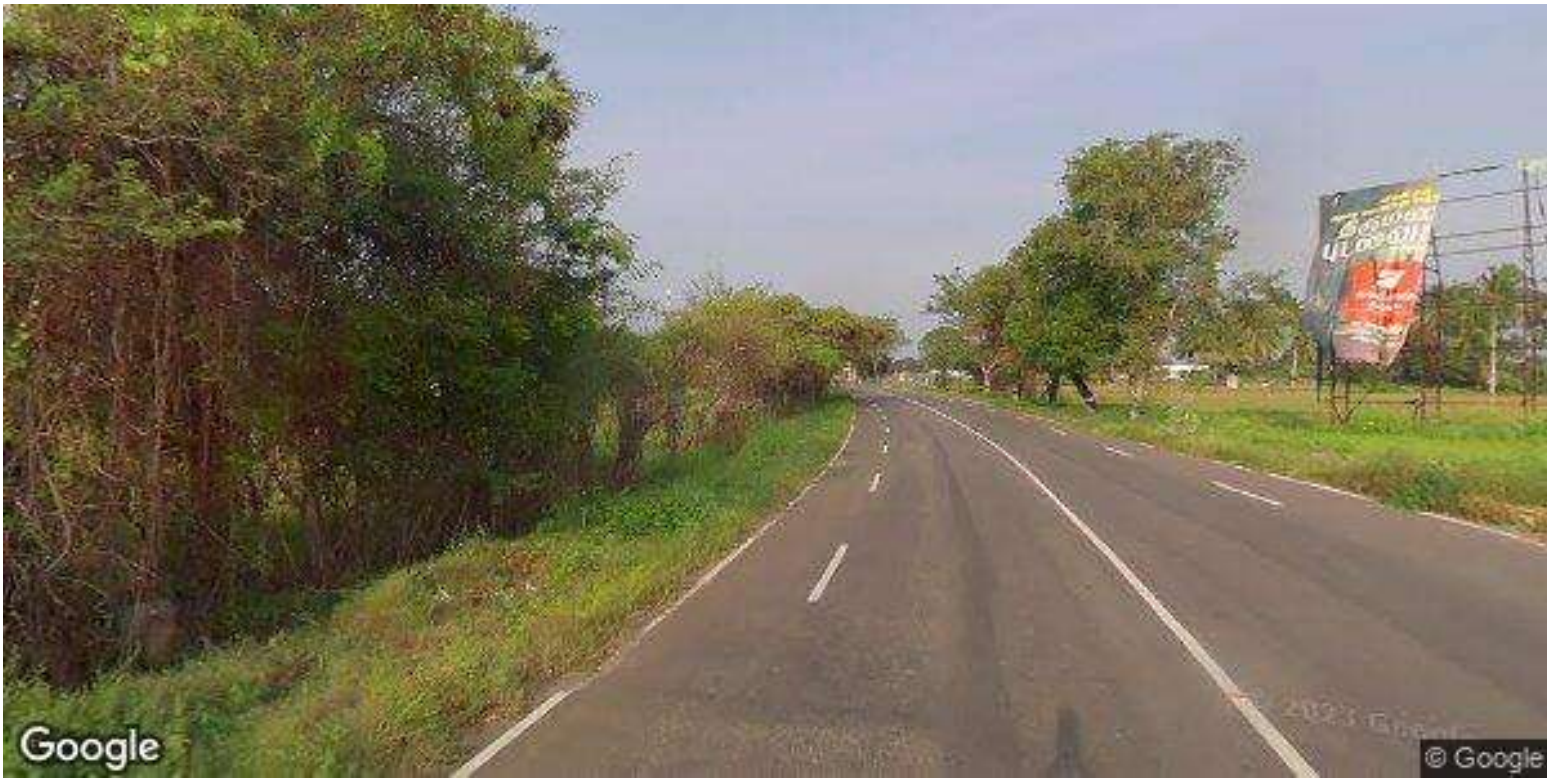
**Risk Type:** Turn  
**Risk Level:** Medium  
**Speed Limit:** 30 KM/Hr  
**Coordinates:** 11.11932, 77.67786

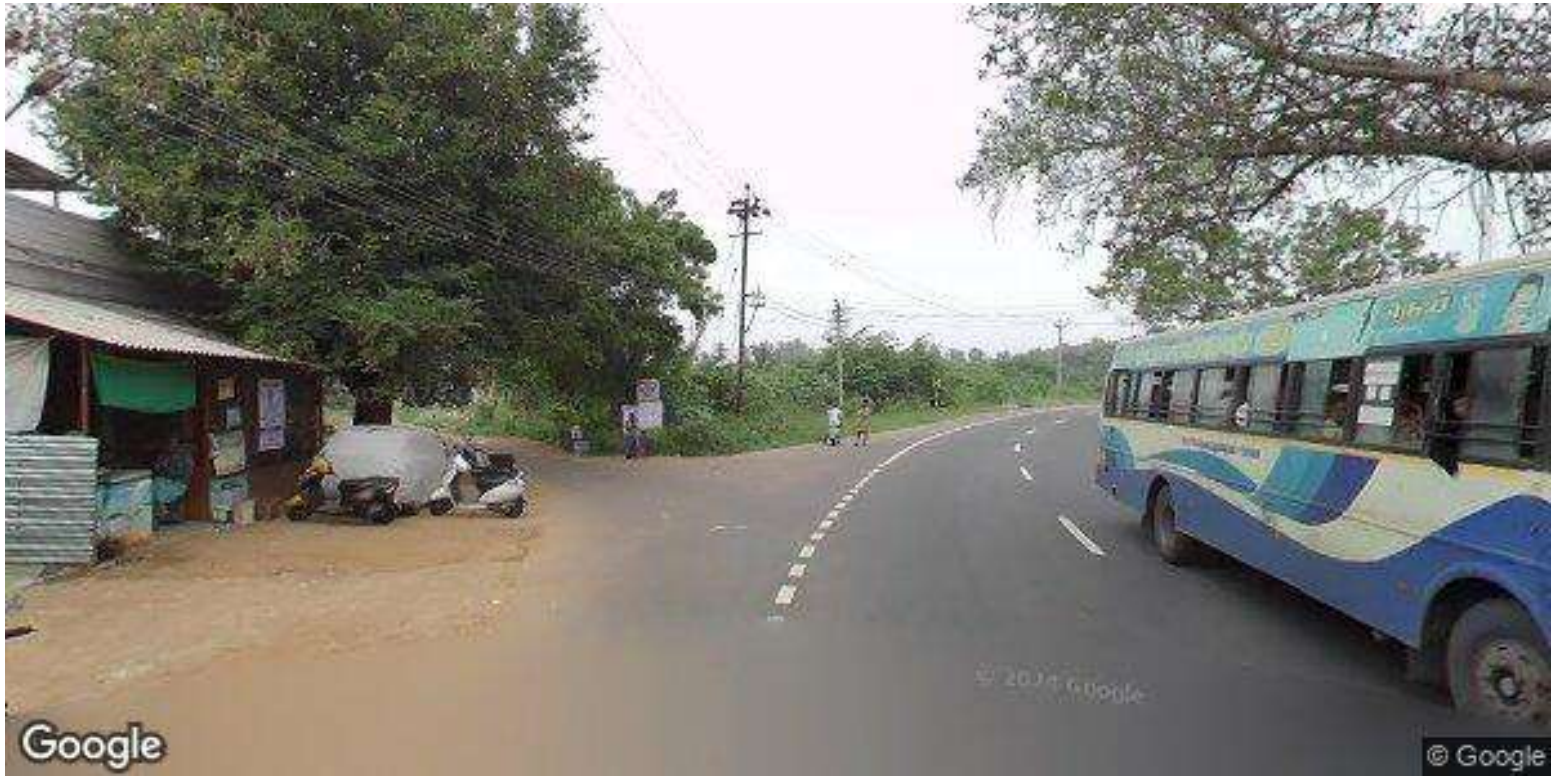
**Risk Type:** Turn  
**Risk Level:** Medium  
**Speed Limit:** 30 KM/Hr  
**Coordinates:** 11.11710, 77.67175

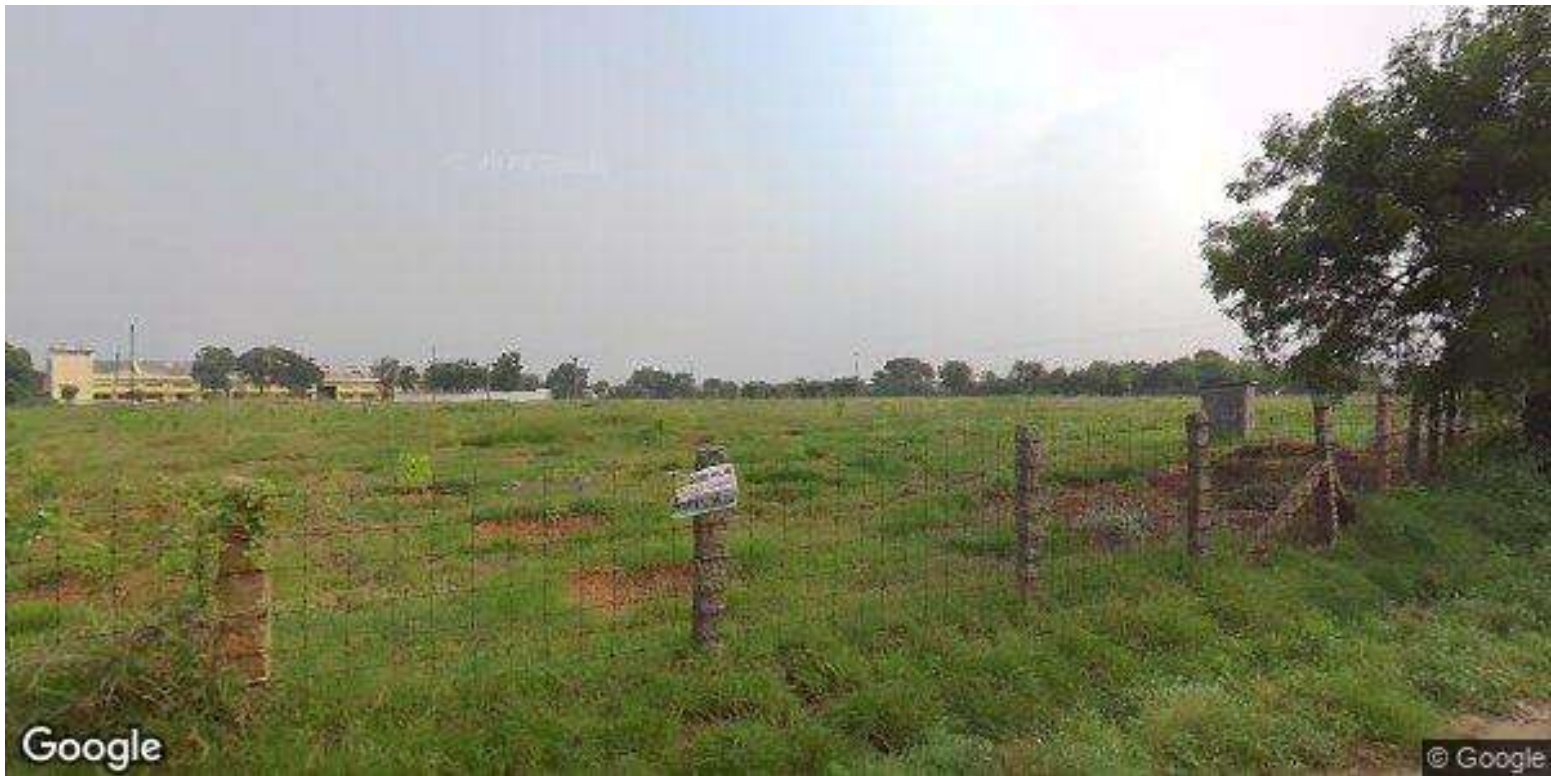
**Risk Type:** Turn  
**Risk Level:** Medium  
**Speed Limit:** 30 KM/Hr  
**Coordinates:** 11.09491, 77.66603

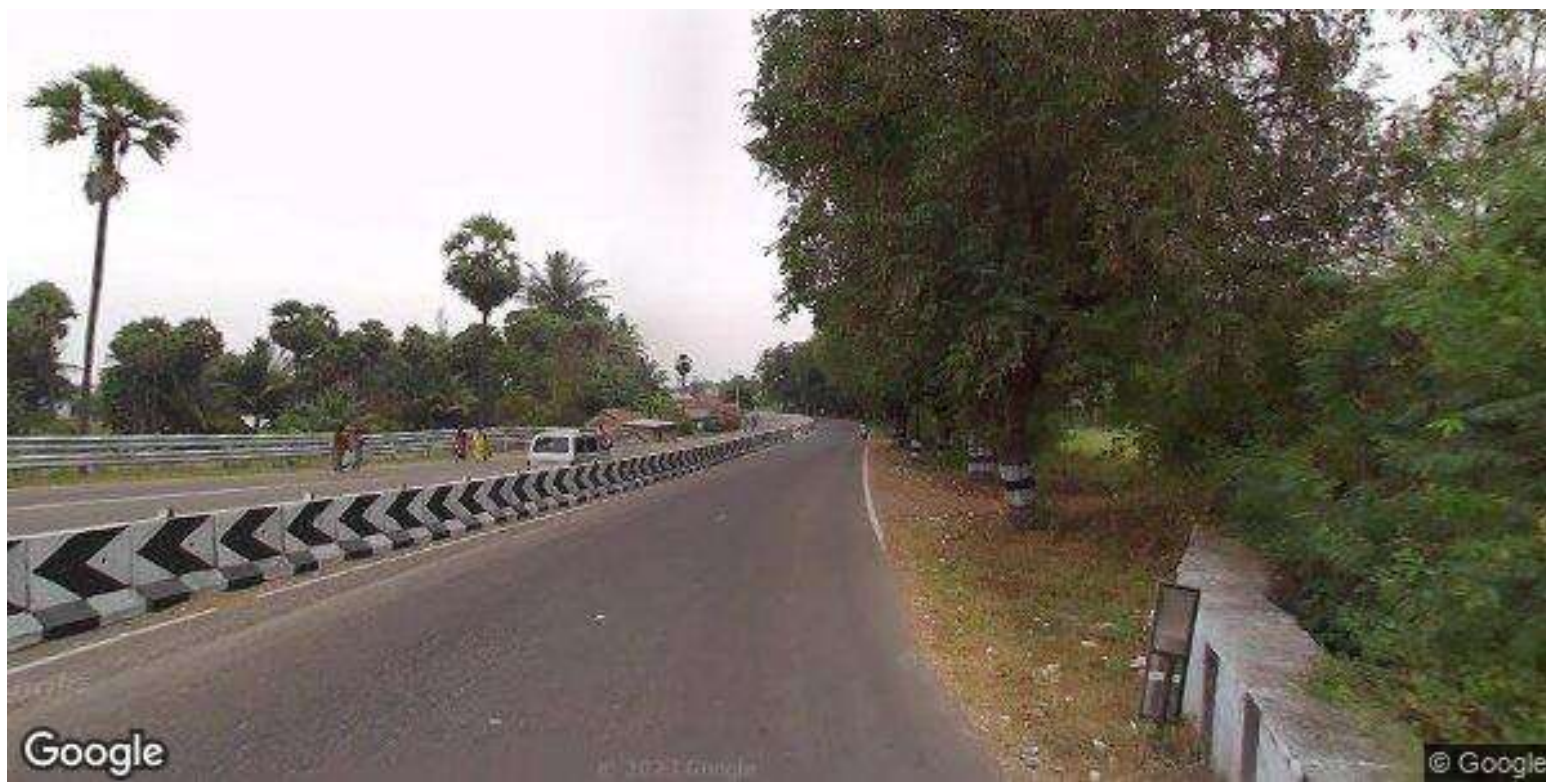
**Coordinates:** 11.08296, 77.65857

**Risk Type:** Turn

**Risk Level:** Medium

**Speed Limit:** 30 KM/Hr

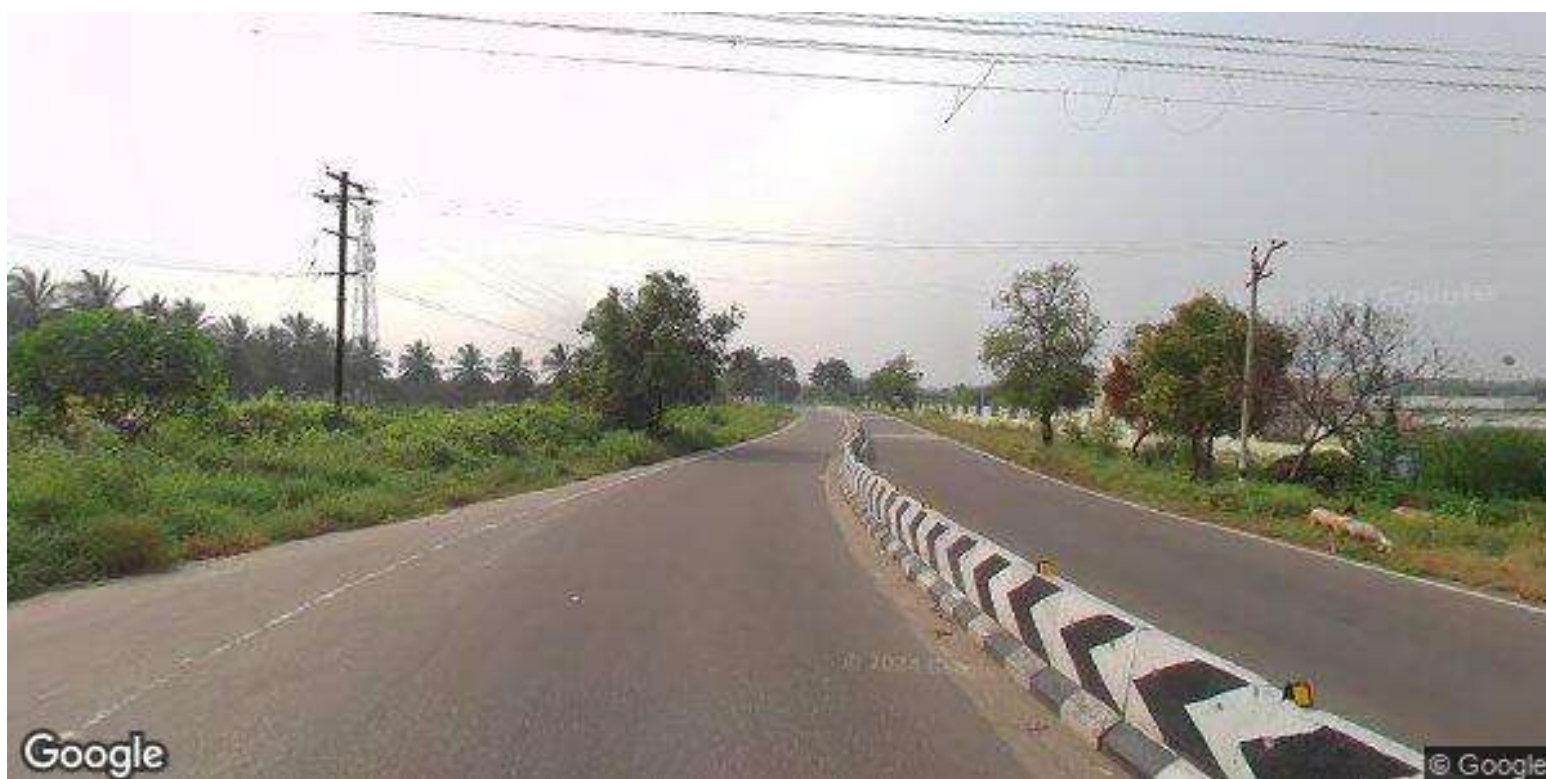
**Coordinates:** 11.06183, 77.63924

**Risk Type:** Turn

**Risk Level:** Medium

**Speed Limit:** 30 KM/Hr

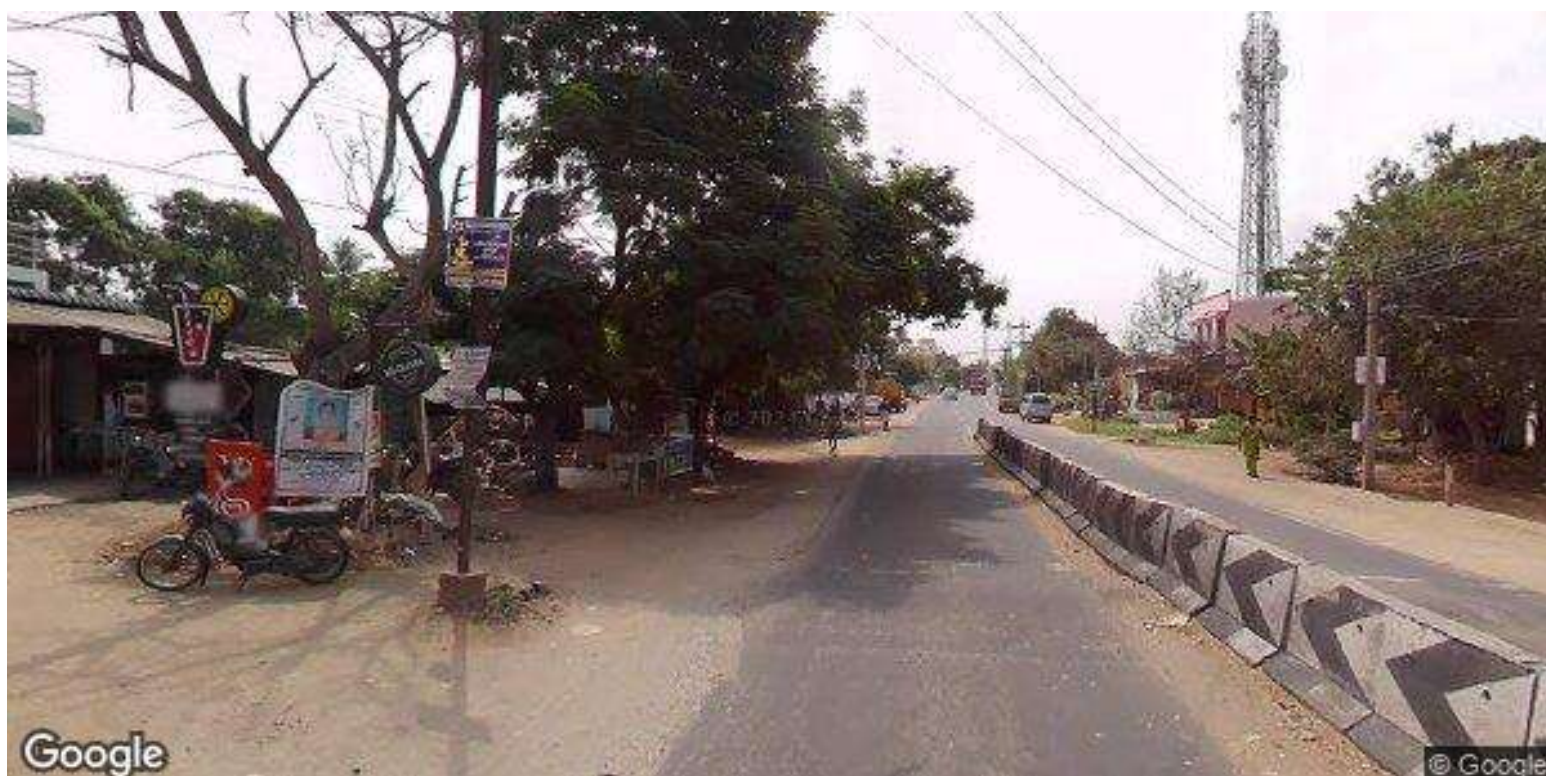
**Risk Type:** Turn  
**Risk Level:** High  
**Speed Limit:** 15 KM/Hr  
**Coordinates:** 11.00826, 77.56962

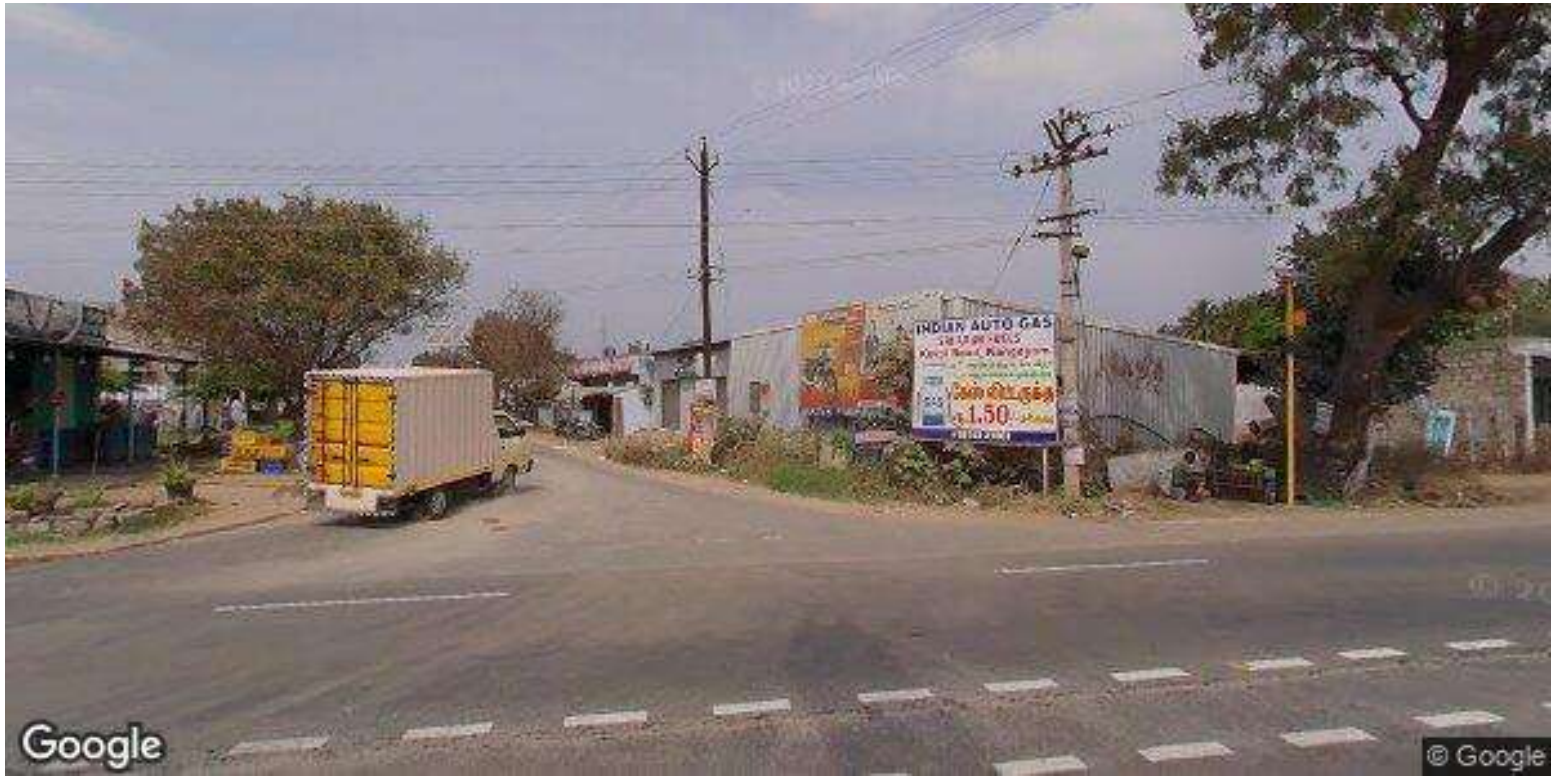
**Risk Type:** Blind Spot  
**Risk Level:** Blind Spot  
**Speed Limit:** 10 KM/Hr  
**Coordinates:** 11.00058, 77.56882

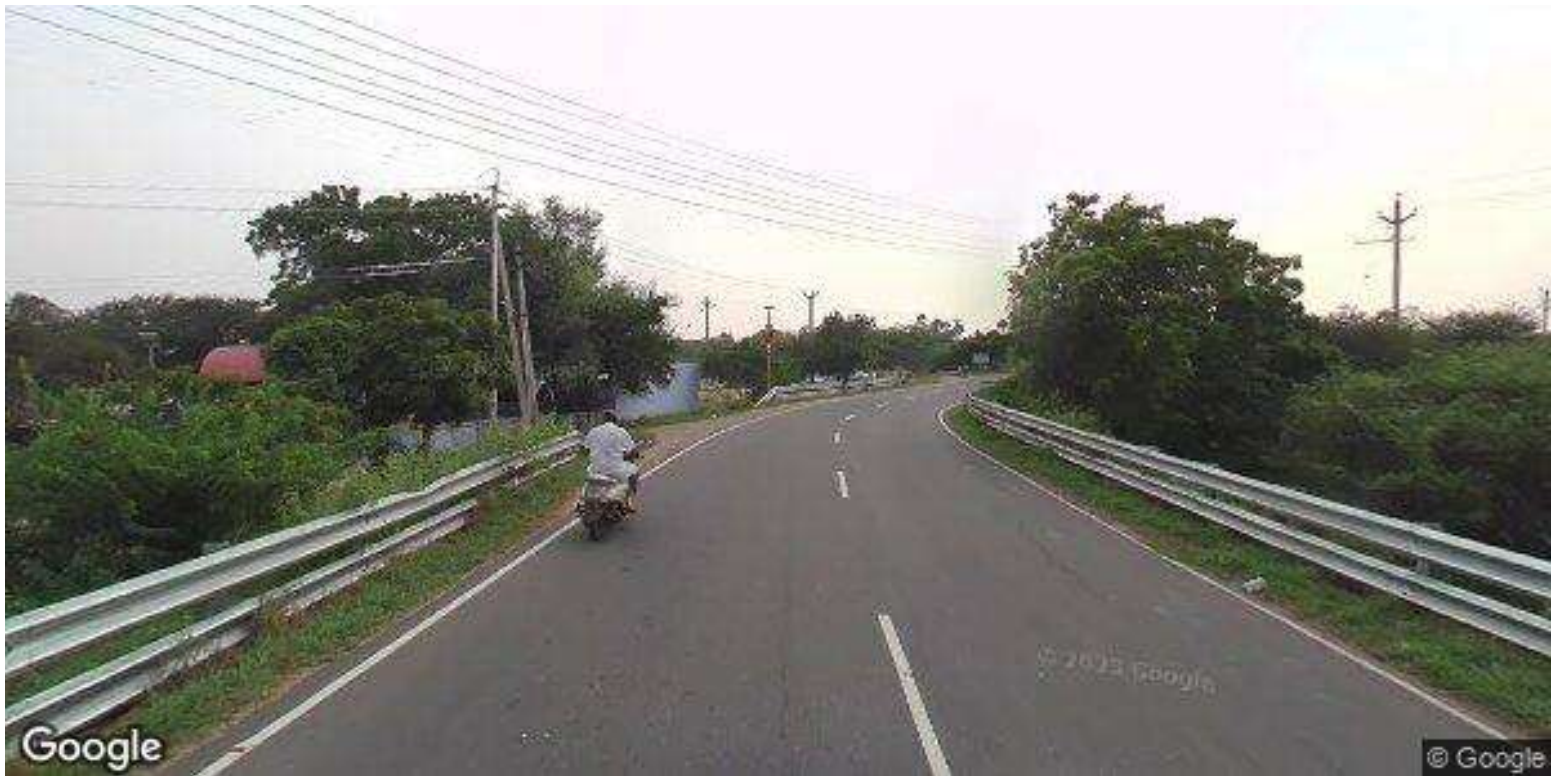
**Risk Type:** Turn  
**Risk Level:** Medium  
**Speed Limit:** 30 KM/Hr  
**Coordinates:** 10.94722, 77.54709

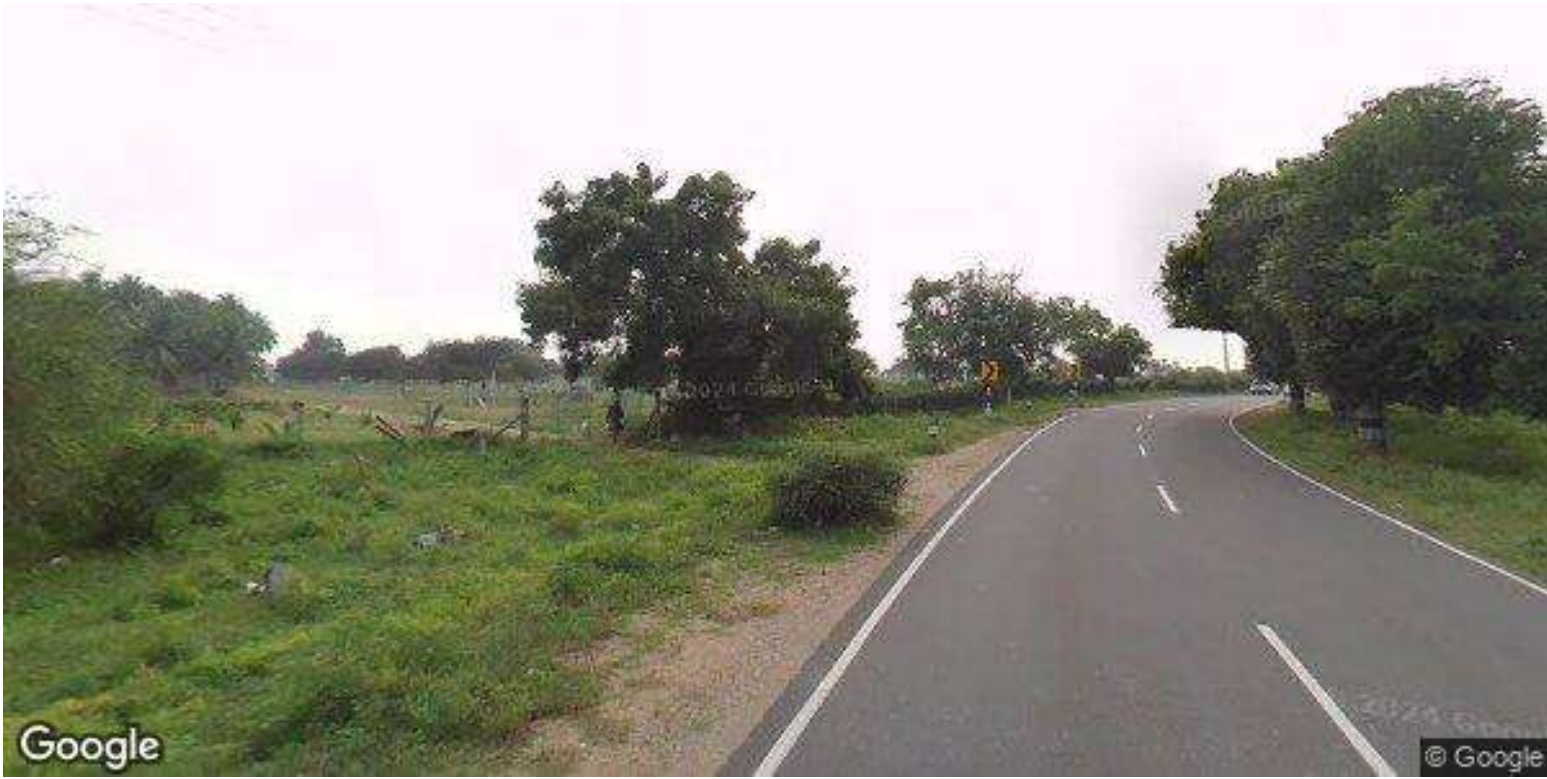
**Risk Type:** Turn  
**Risk Level:** Medium  
**Speed Limit:** 30 KM/Hr  
**Coordinates:** 10.93895, 77.53976

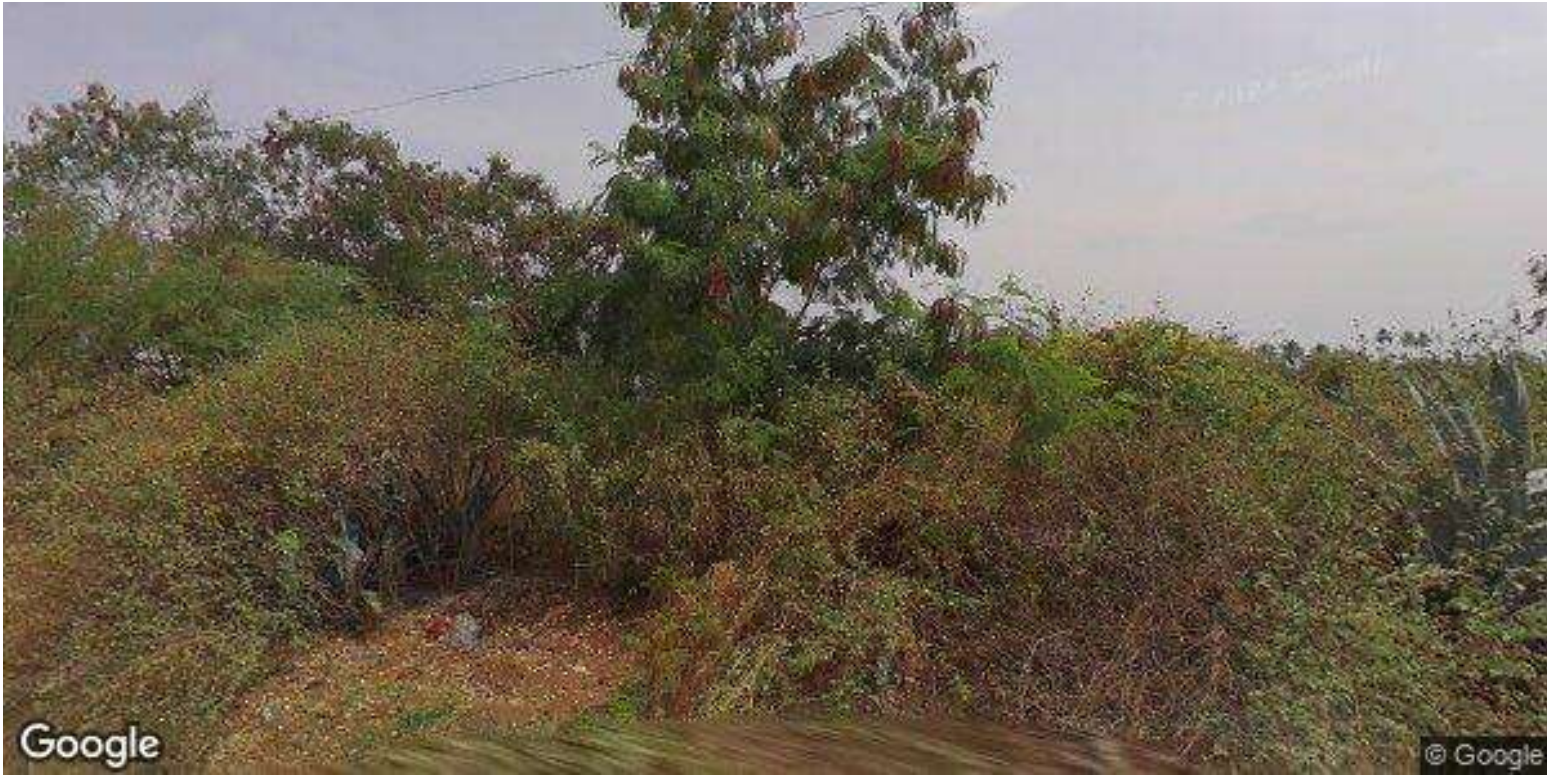
**Risk Type:** Turn  
**Risk Level:** Medium  
**Speed Limit:** 30 KM/Hr  
**Coordinates:** 10.93054, 77.53265

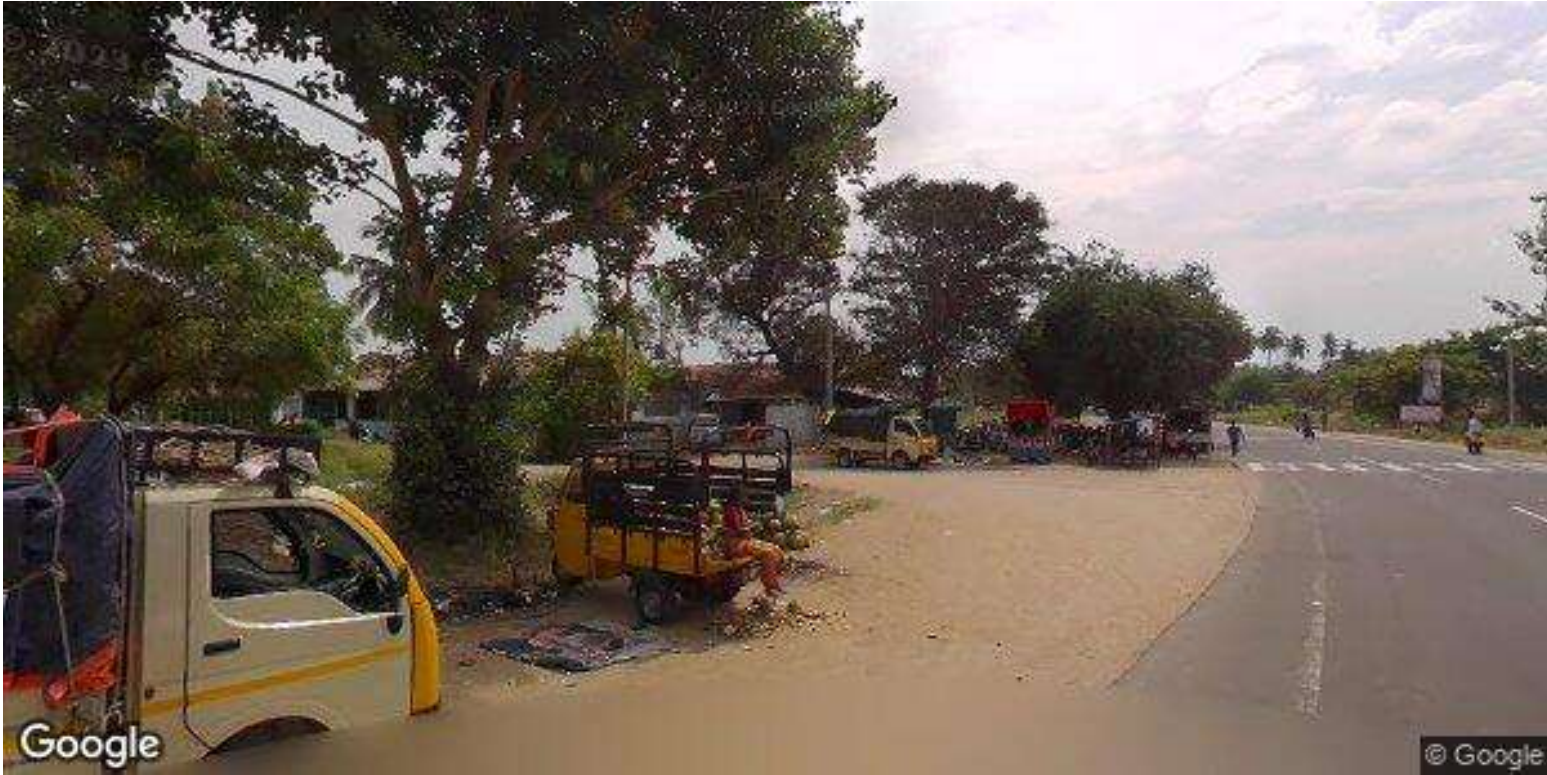
**Risk Type:** Turn  
**Risk Level:** Medium  
**Speed Limit:** 30 KM/Hr  
**Coordinates:** 10.89213, 77.52646

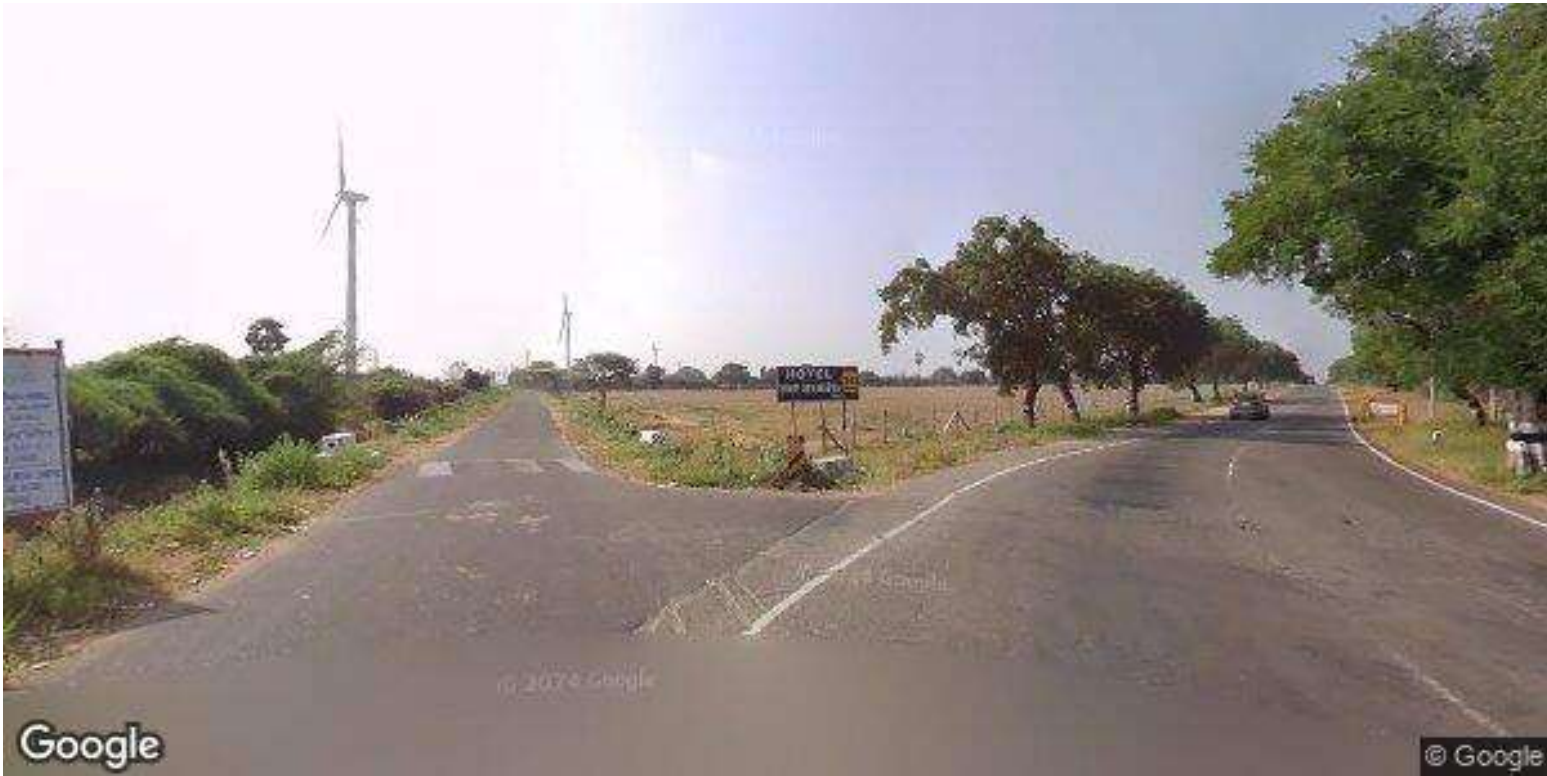
**Risk Type:** Turn  
**Risk Level:** Medium  
**Speed Limit:** 30 KM/Hr  
**Coordinates:** 10.83409, 77.52932

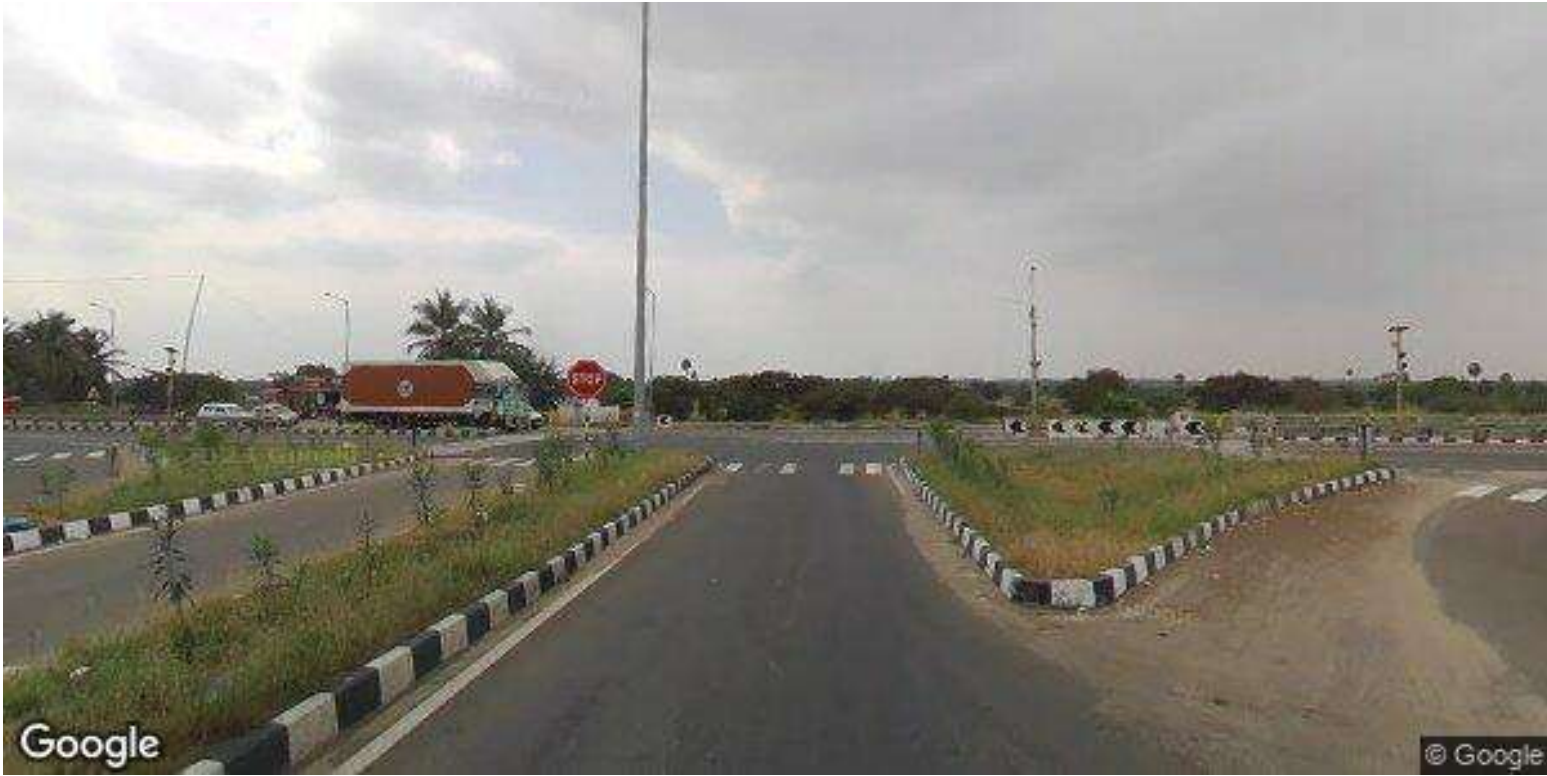
**Risk Type:** Turn  
**Risk Level:** Medium  
**Speed Limit:** 30 KM/Hr  
**Coordinates:** 10.77642, 77.50712

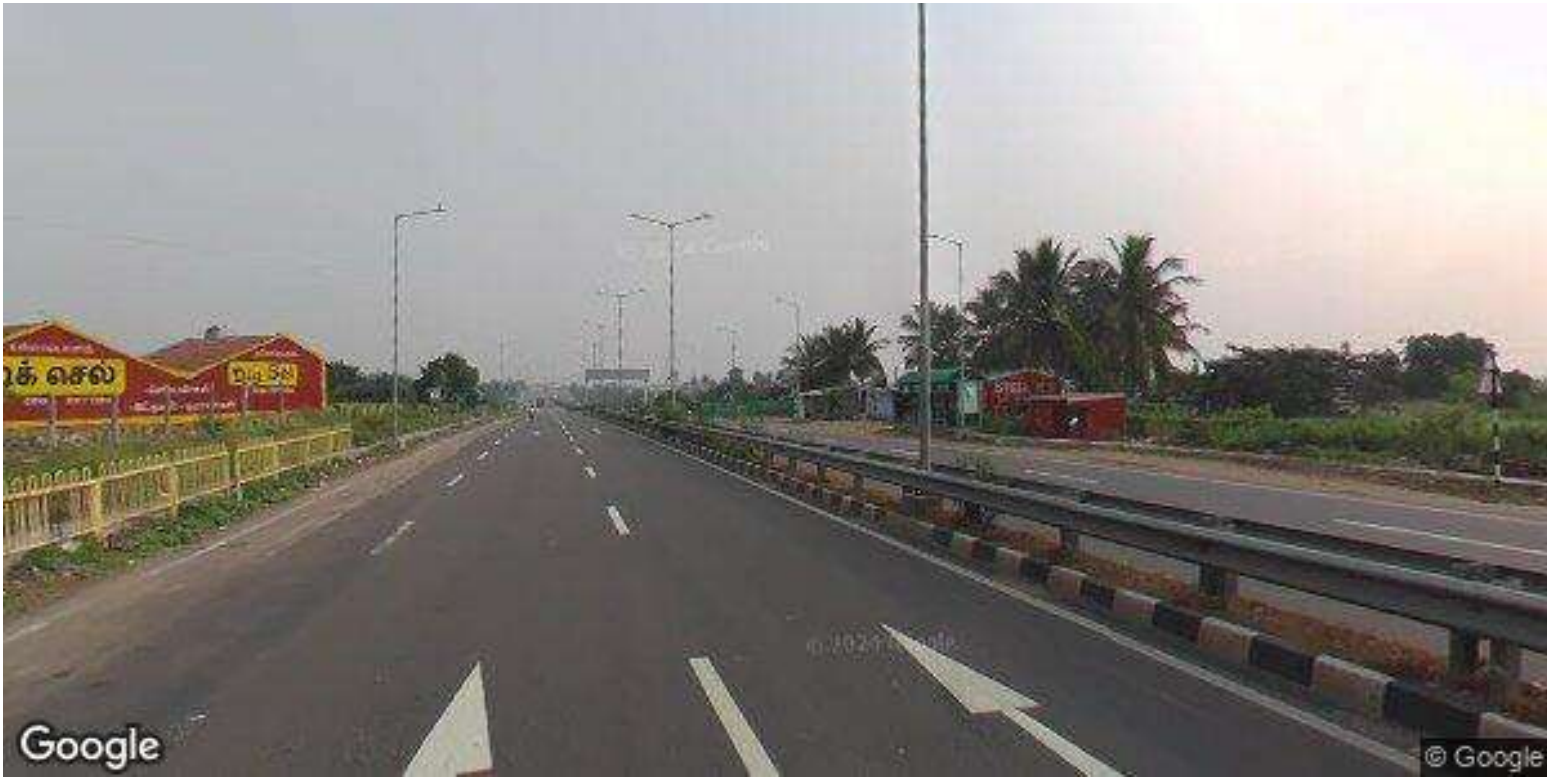
**Risk Type:** Turn  
**Risk Level:** Medium  
**Speed Limit:** 30 KM/Hr  
**Coordinates:** 10.77580, 77.50724

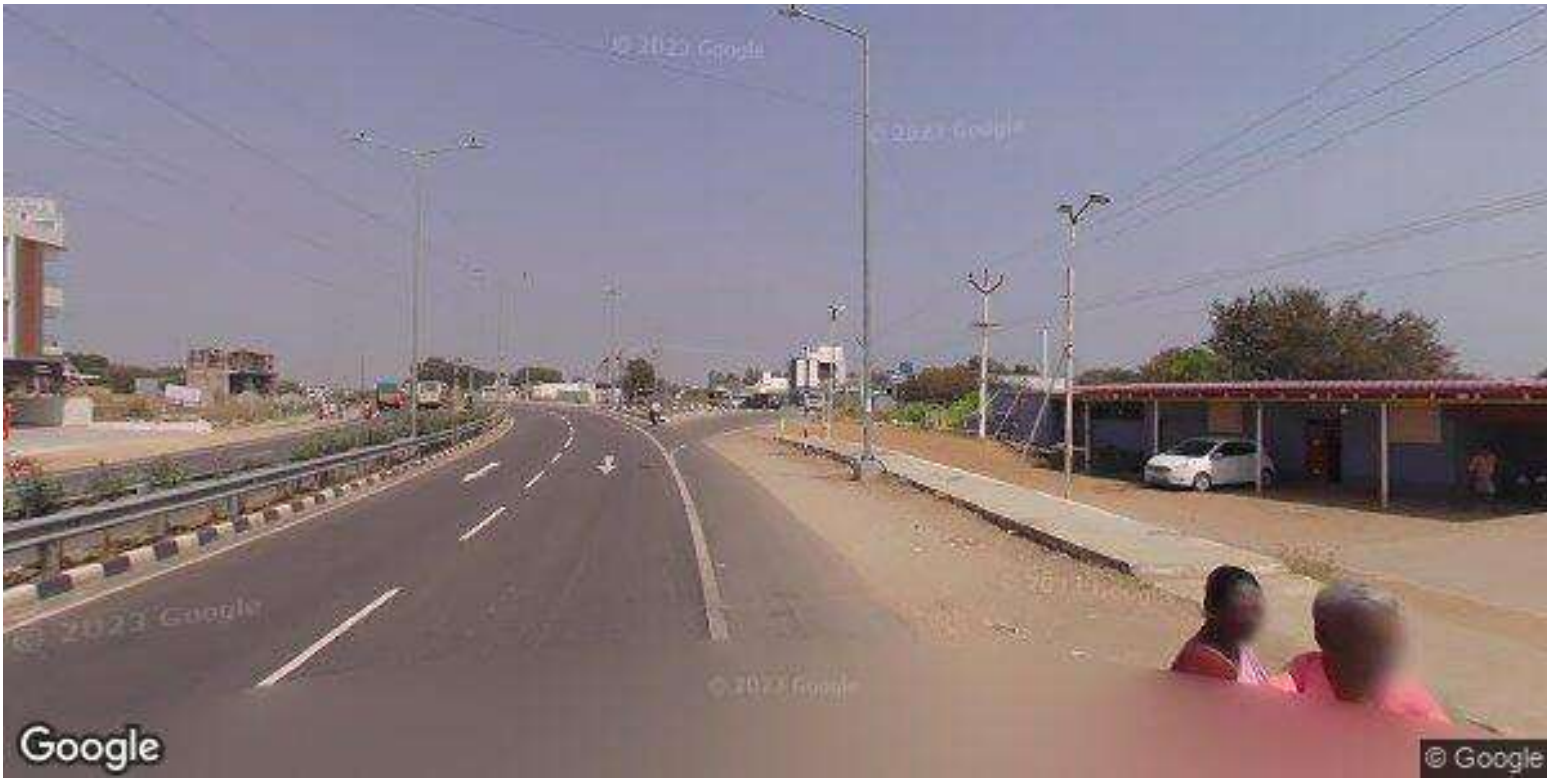
Coordinates: 10.75722, 77.51935

Risk Type: Turn

Risk Level: Medium

Speed Limit: 30 KM/Hr
