## JOURNEY RISK MANAGEMENT (JRM) STUDY

### Salem Terminal TO YADHAVAN AGENCIES

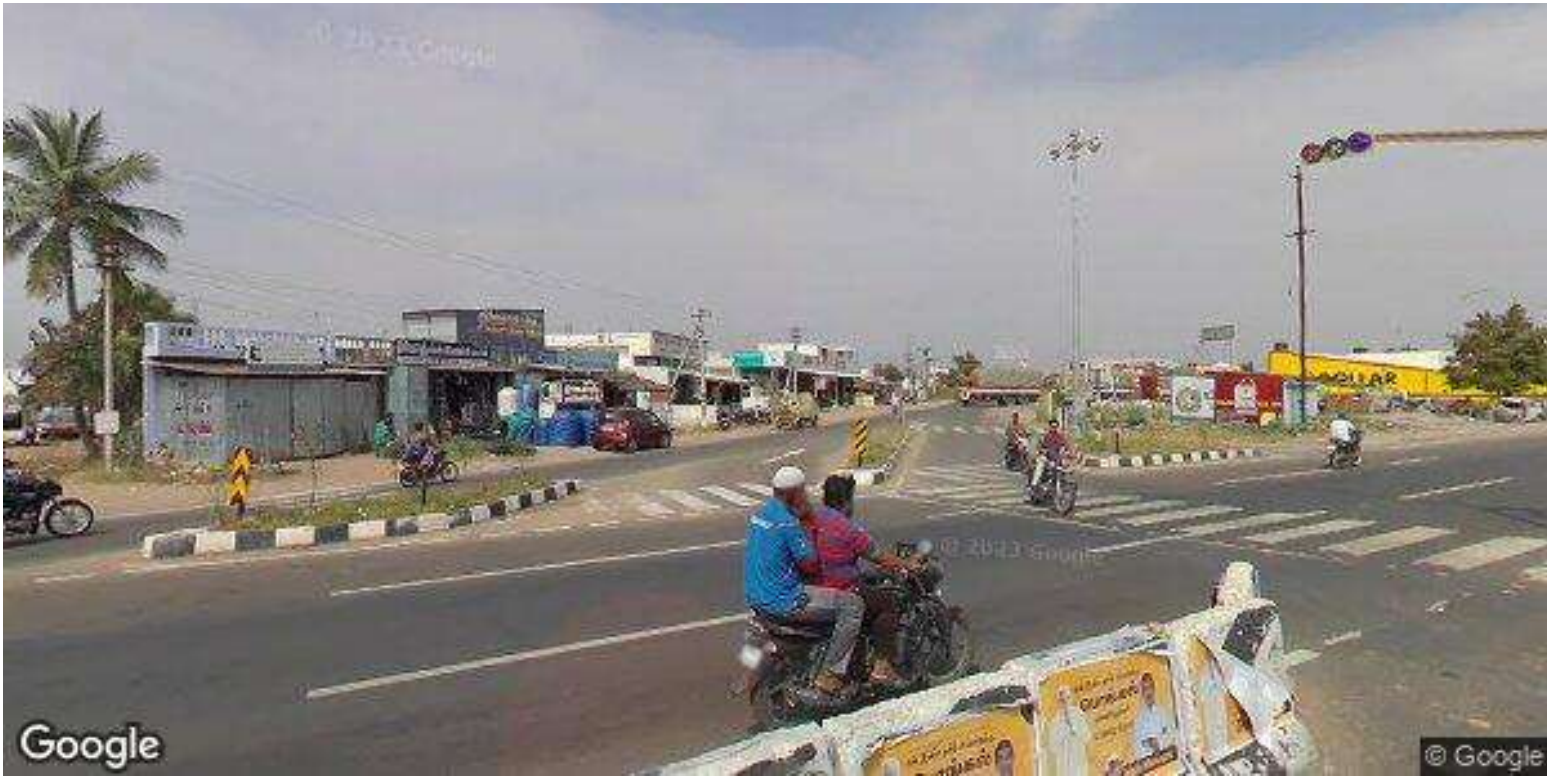
Coordinates: 10.74756, 77.51879

Risk Type: Blind Spot

Risk Level: Blind Spot

Speed Limit: 10 KM/Hr
