# IndianOil

## JOURNEY RISK MANAGEMENT (JRM) STUDY

### Salem Terminal TO CIBI PANDIYAN AGENCIES

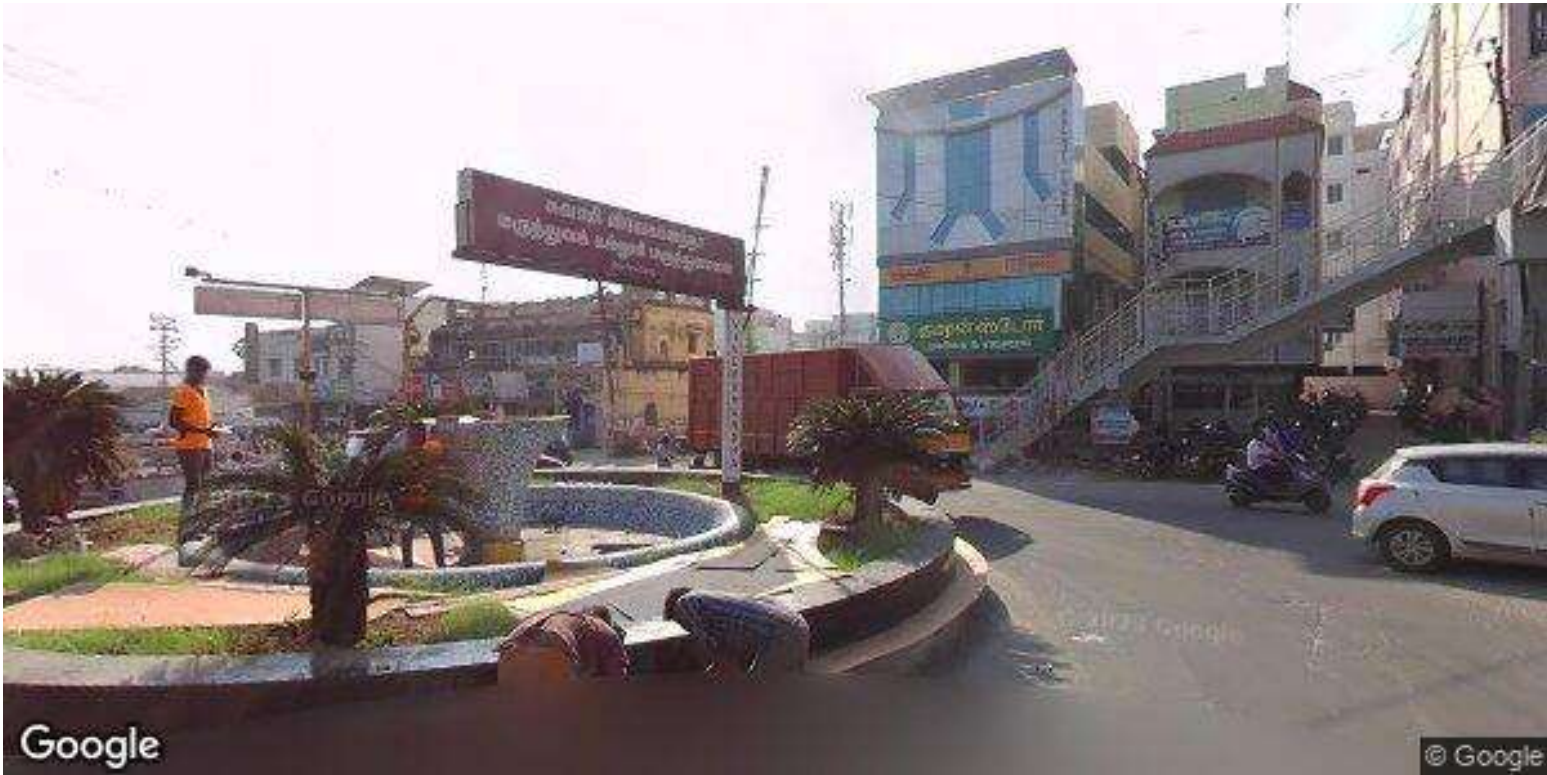
Coordinates: 11.38395, 77.89480

Risk Type: Roundabout

Risk Level: High

Speed Limit: 15 KM/Hr

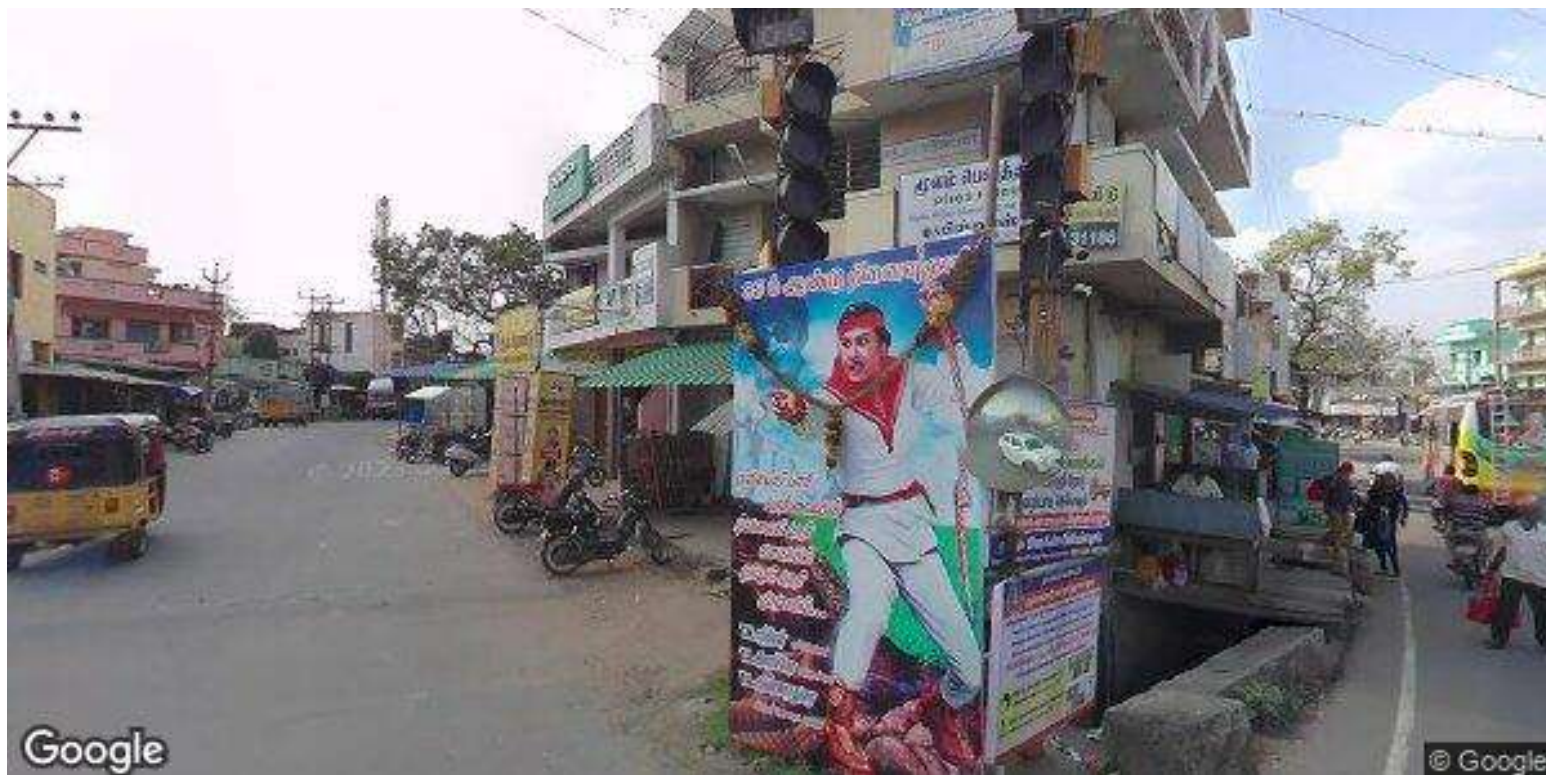
**Coordinates:** 11.38342, 77.89975

**Risk Type:** Turn

**Risk Level:** Medium

**Speed Limit:** 30 KM/Hr

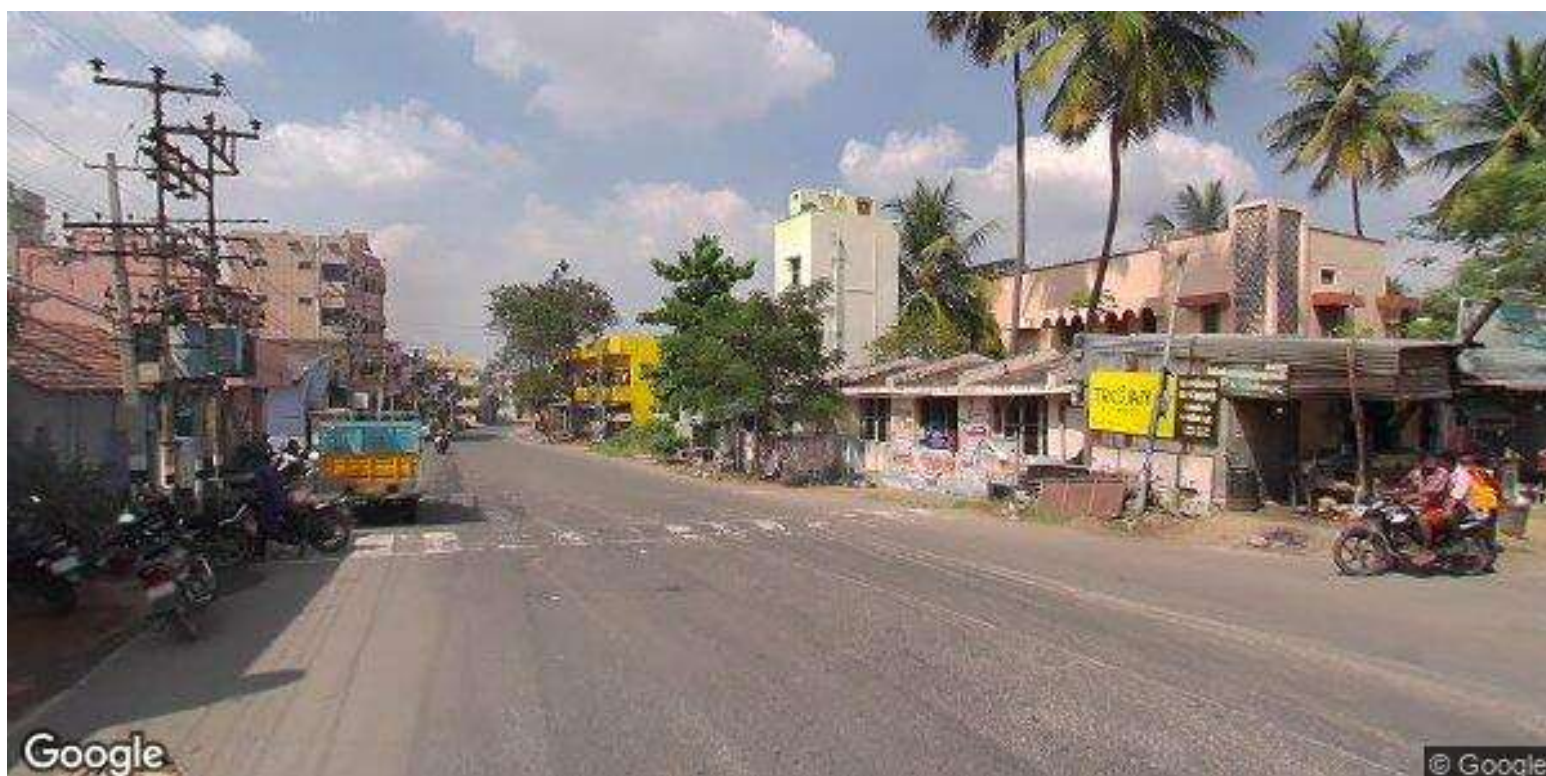
**Coordinates: 11.38190, 77.90254**

**Risk Type: Turn**

**Risk Level: Medium**

**Speed Limit: 30 KM/Hr**

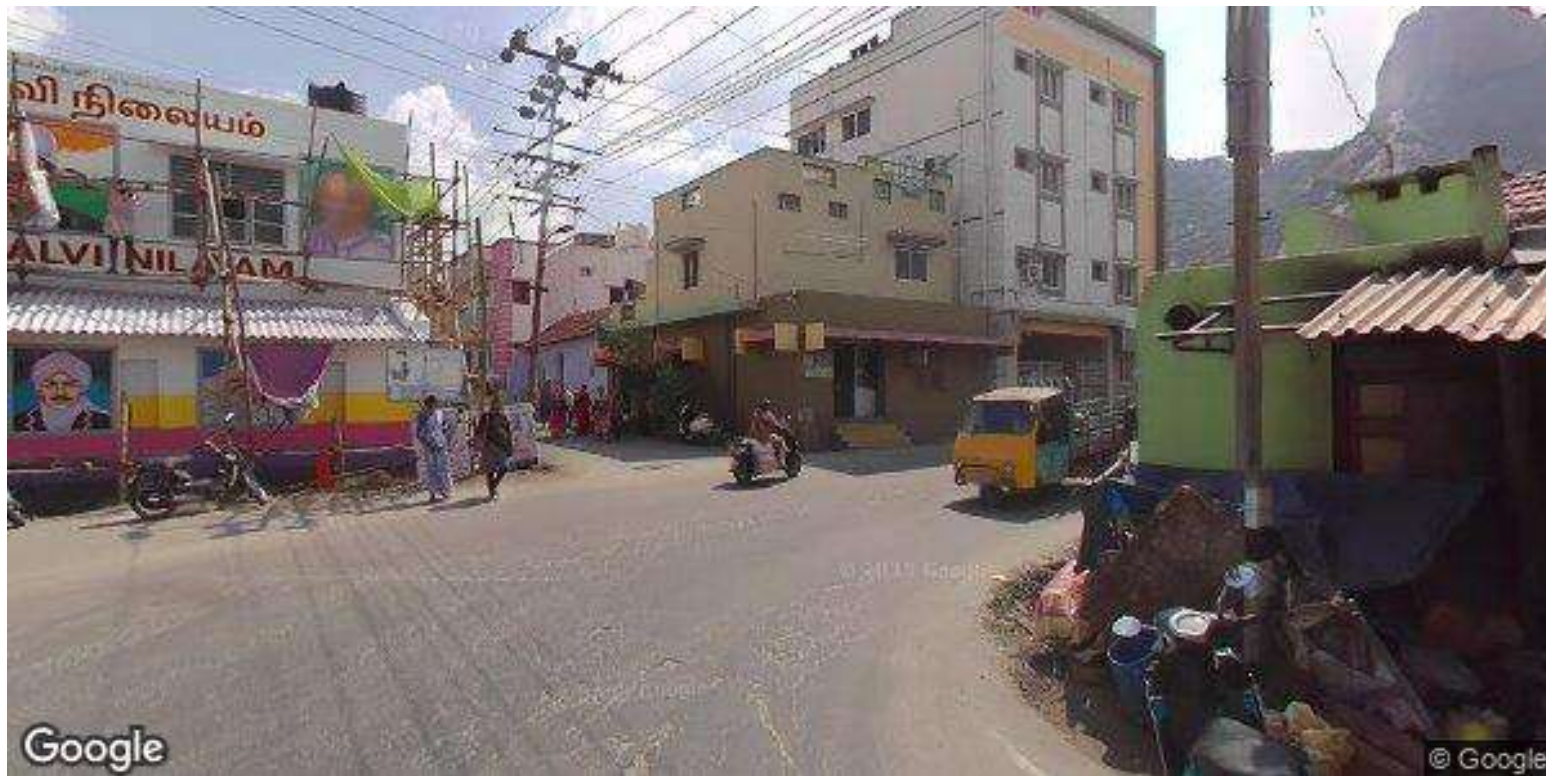
**Coordinates: 11.38186, 77.90258**

**Risk Type: Turn**

**Risk Level: High**

**Speed Limit: 15 KM/Hr**

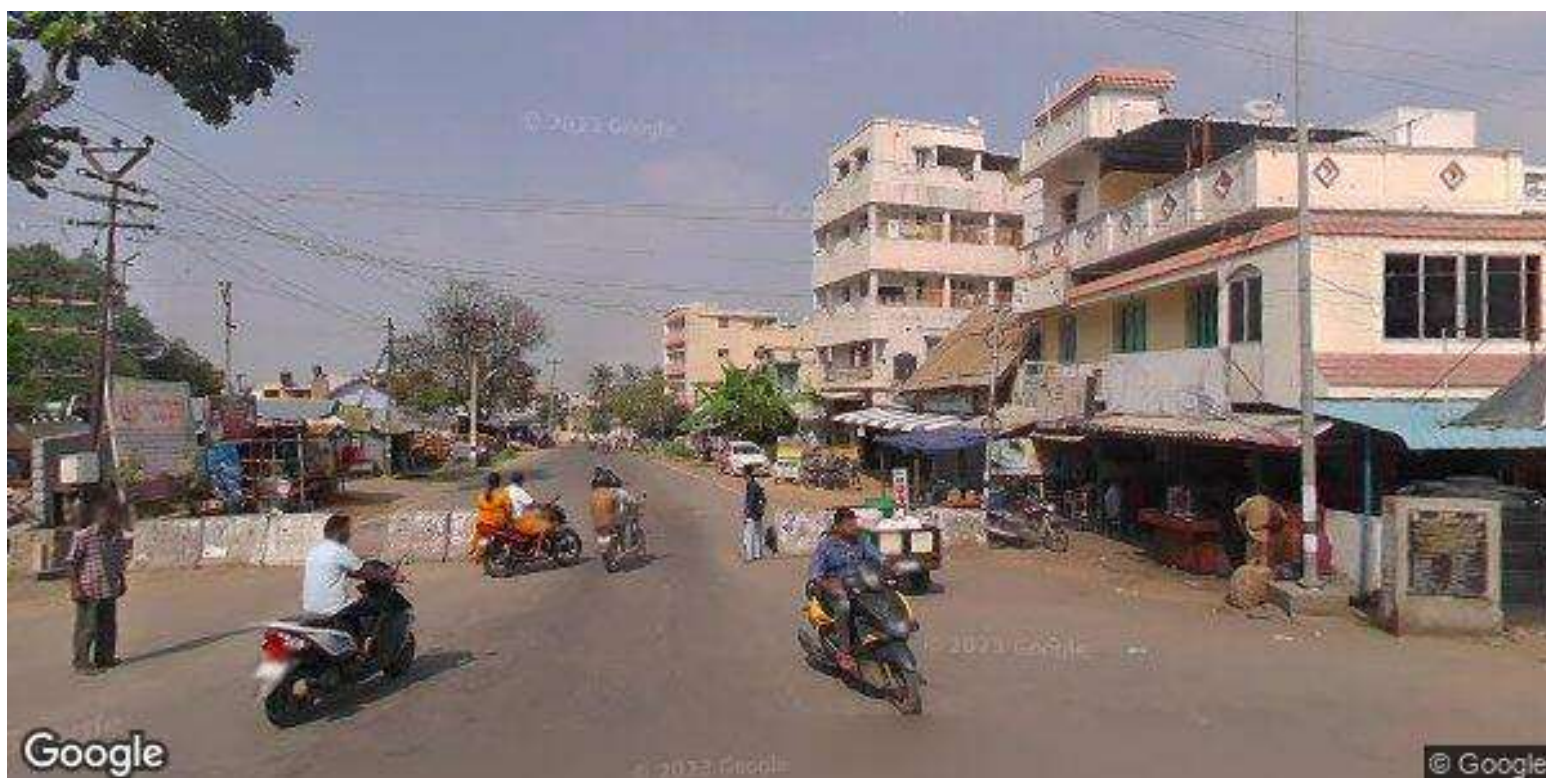
**Coordinates: 11.37841, 77.90140**

**Risk Type: Blind Spot**

**Risk Level: Blind Spot**

**Speed Limit: 10 KM/Hr**

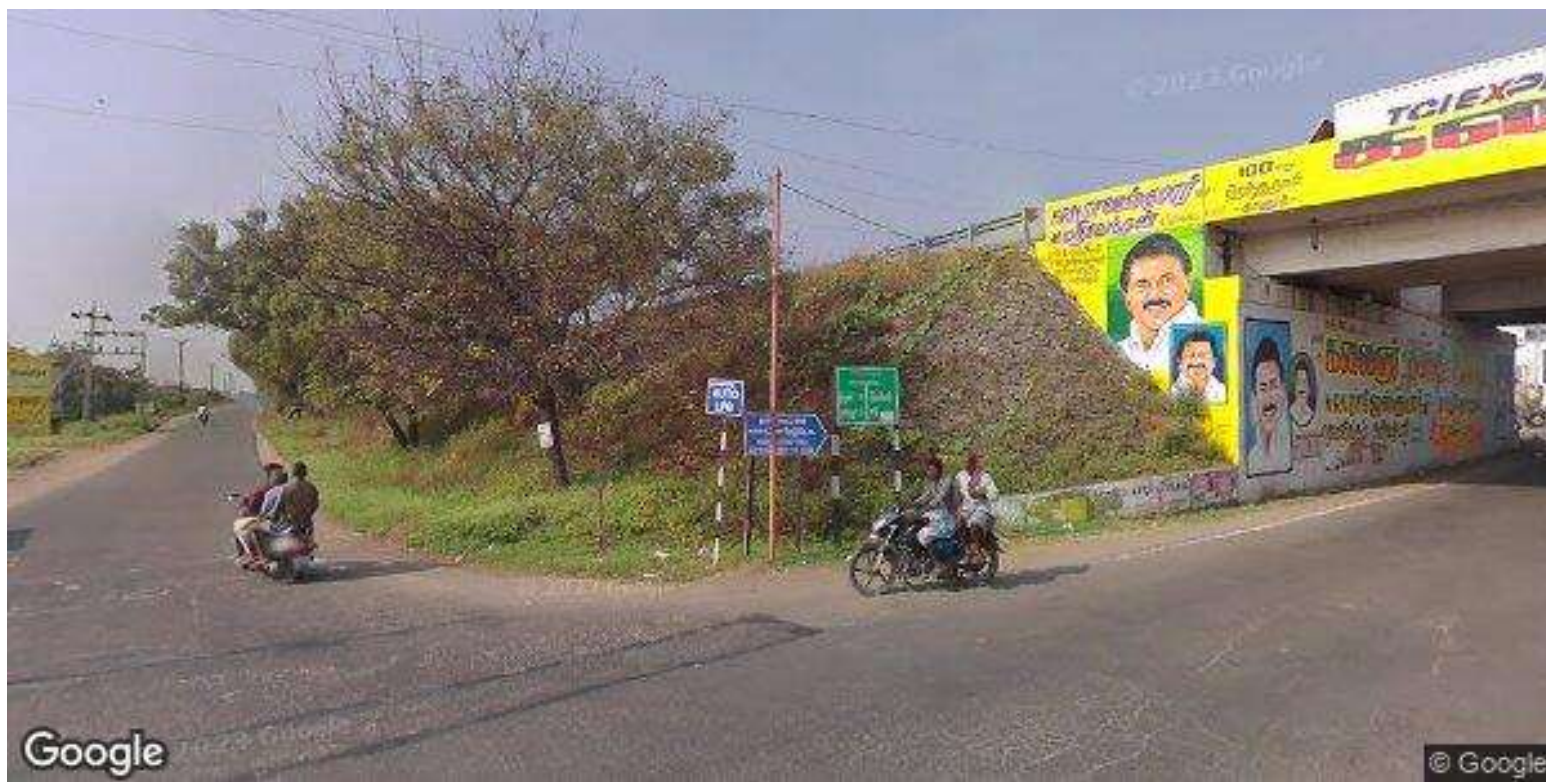
**Coordinates:** 11.23936, 78.14267

**Risk Type:** Blind Spot

**Risk Level:** Blind Spot

**Speed Limit:** 10 KM/Hr

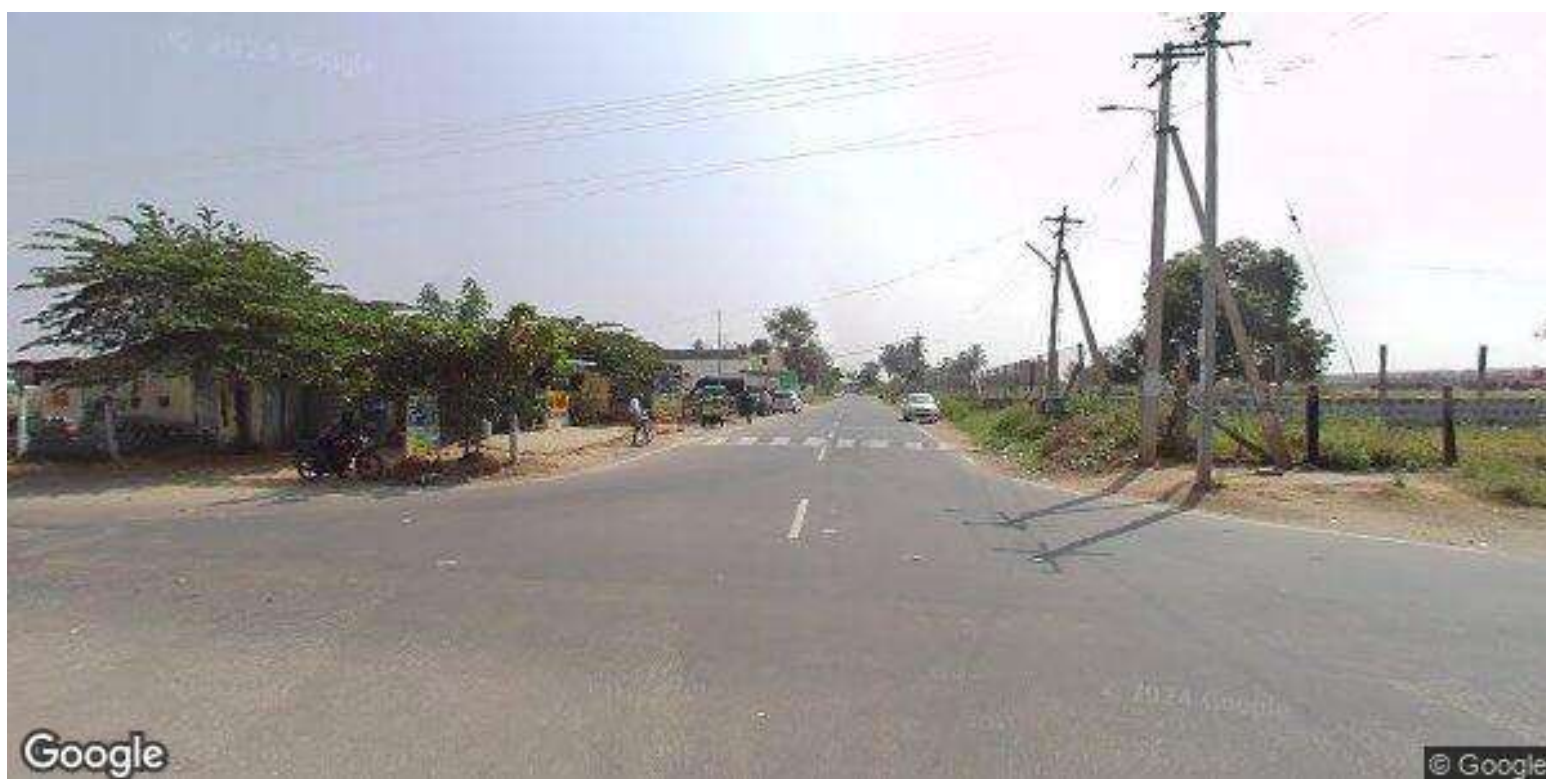
**Coordinates:** 11.23027, 78.13705

**Risk Type:** Turn

**Risk Level:** High

**Speed Limit:** 15 KM/Hr

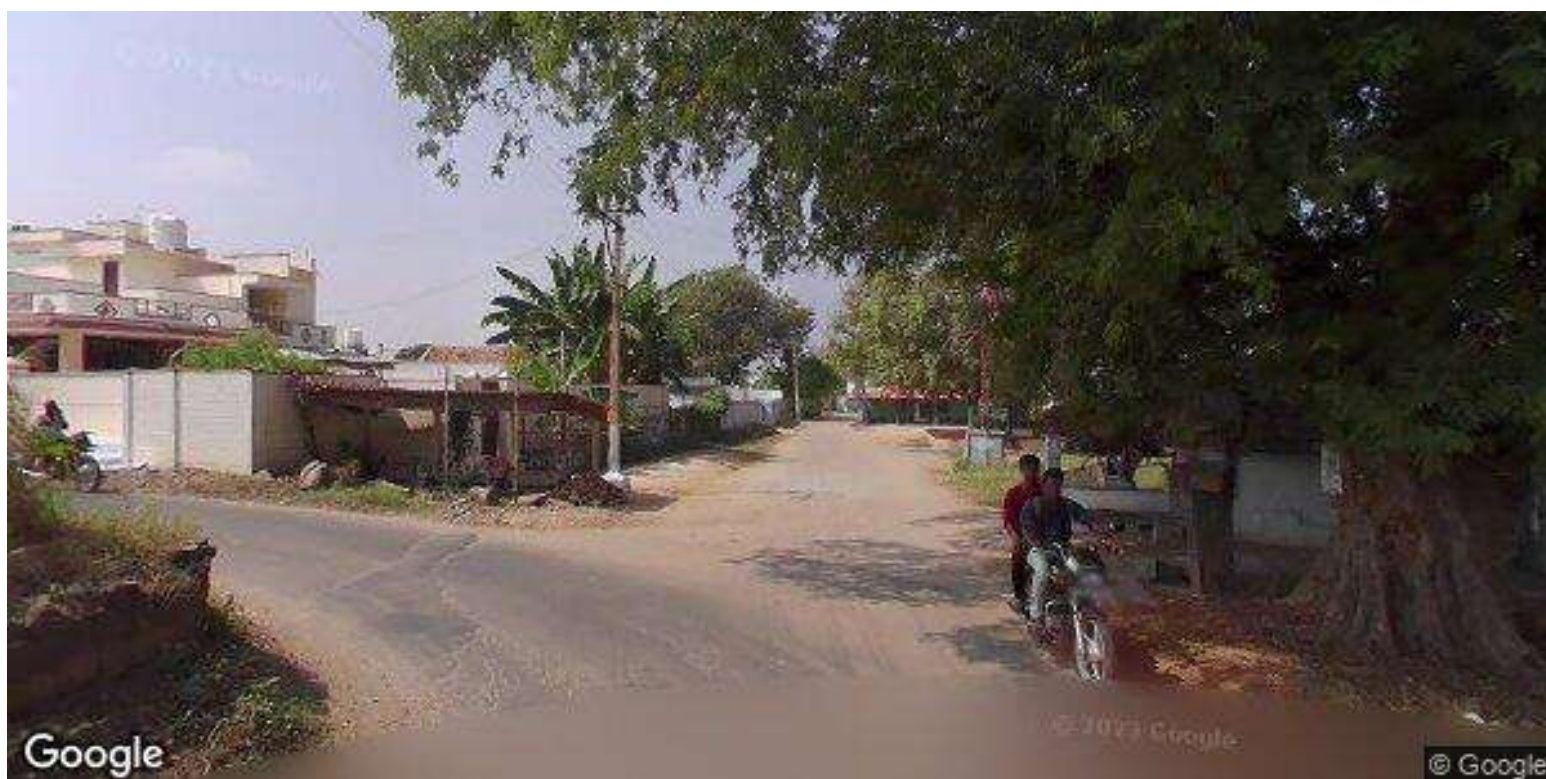
**Risk Type:** Turn  
**Risk Level:** High  
**Speed Limit:** 15 KM/Hr  
**Coordinates:** 11.23078, 78.13298

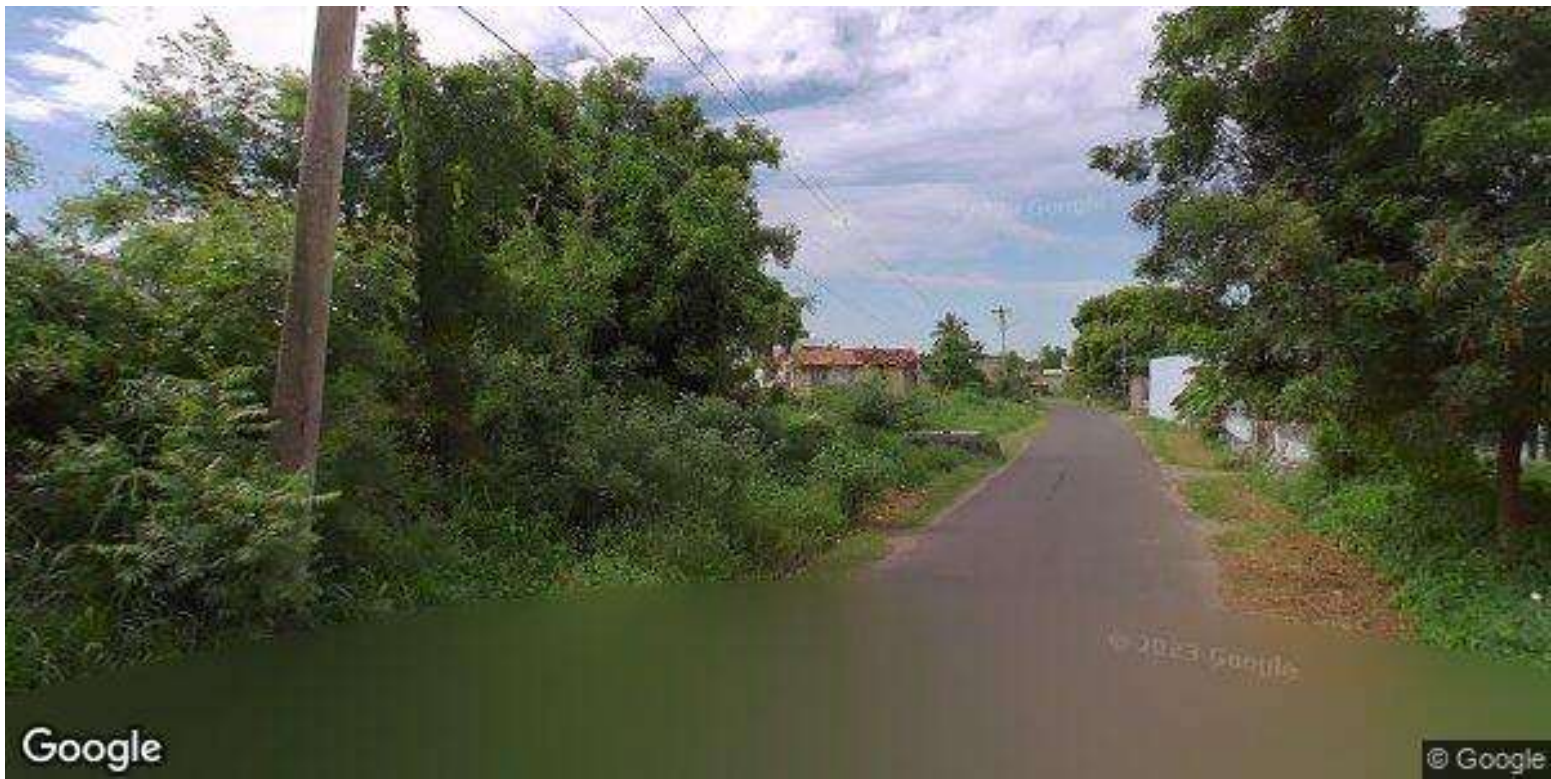
**Risk Type:** Turn  
**Risk Level:** Medium  
**Speed Limit:** 30 KM/Hr  
**Coordinates:** 11.22970, 78.13291

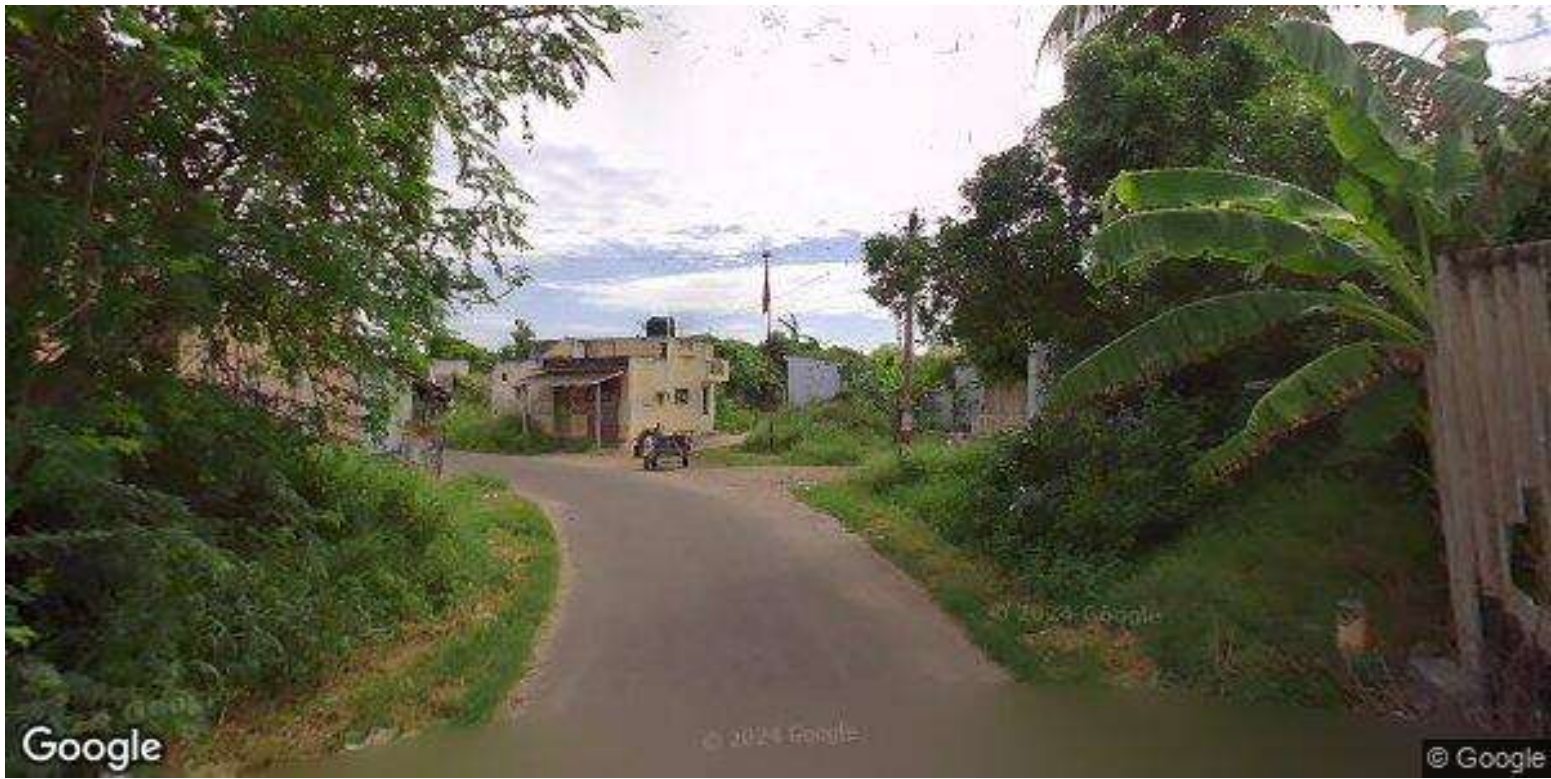
**Risk Type:** Turn  
**Risk Level:** Medium  
**Speed Limit:** 30 KM/Hr  
**Coordinates:** 11.22883, 78.13229

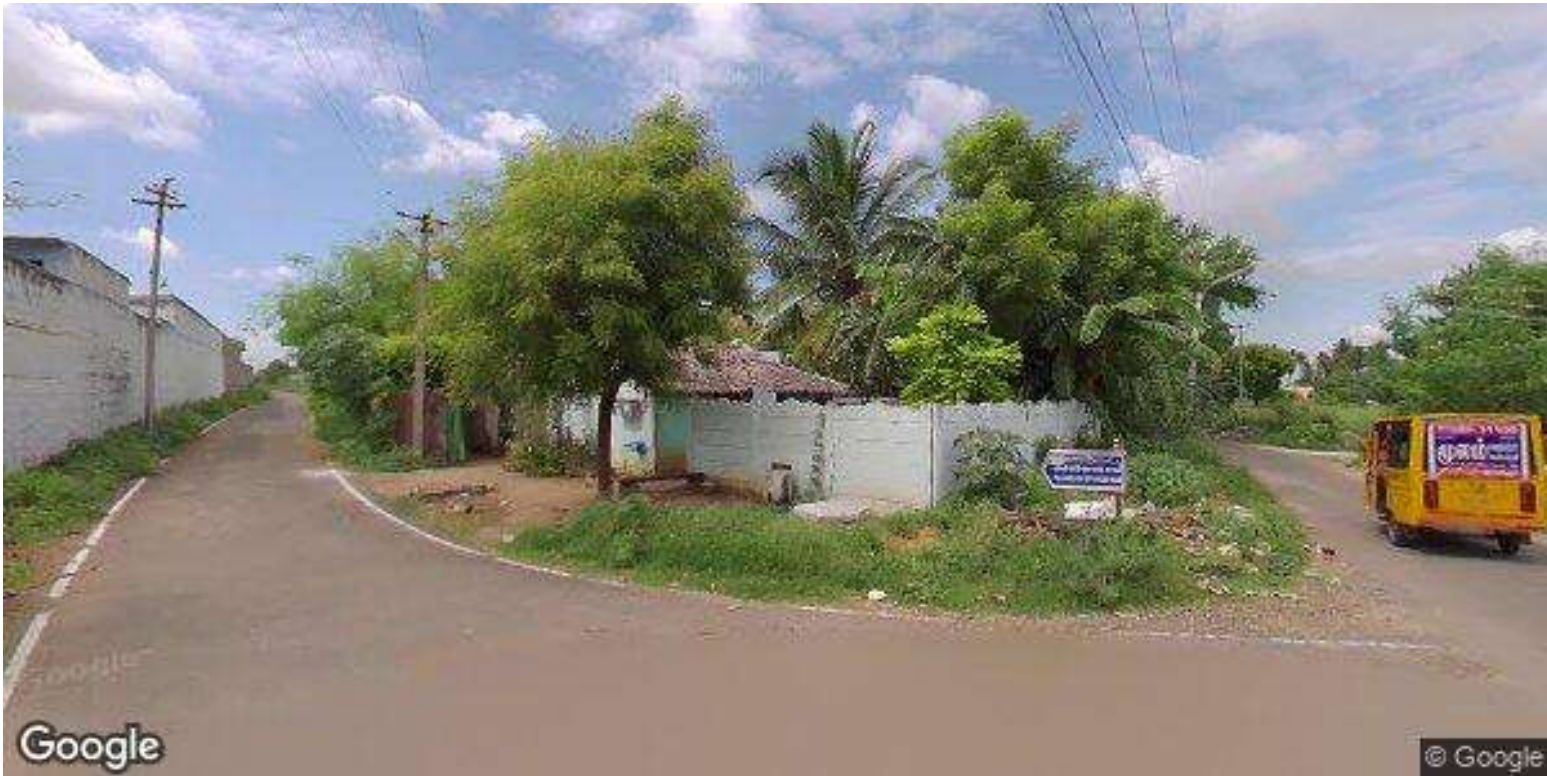
**Risk Type:** Turn  
**Risk Level:** High  
**Speed Limit:** 15 KM/Hr  
**Coordinates:** 11.22868, 78.13200

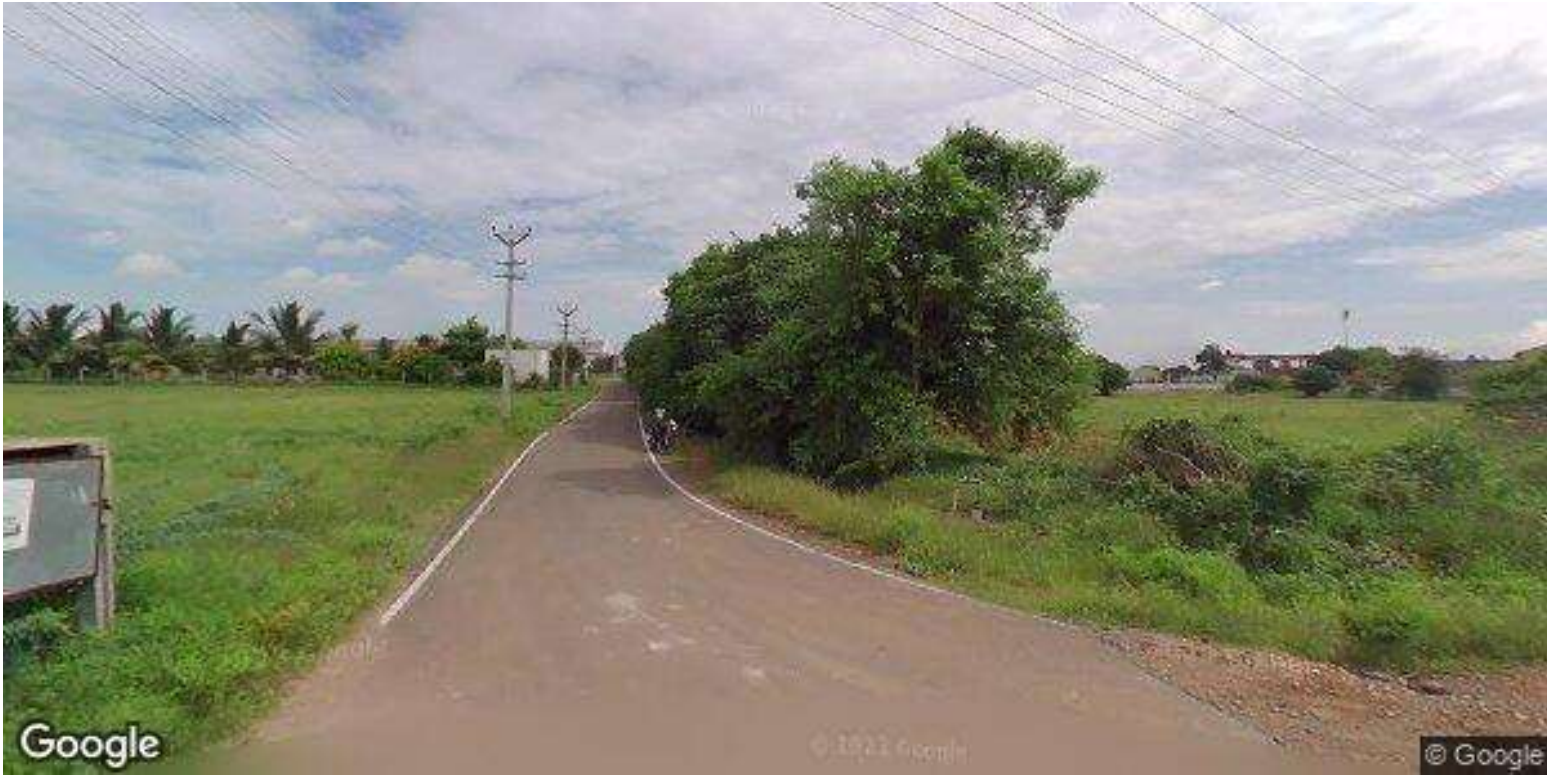
**Risk Type:** Turn  
**Risk Level:** High  
**Speed Limit:** 15 KM/Hr  
**Coordinates:** 11.22332, 78.13129

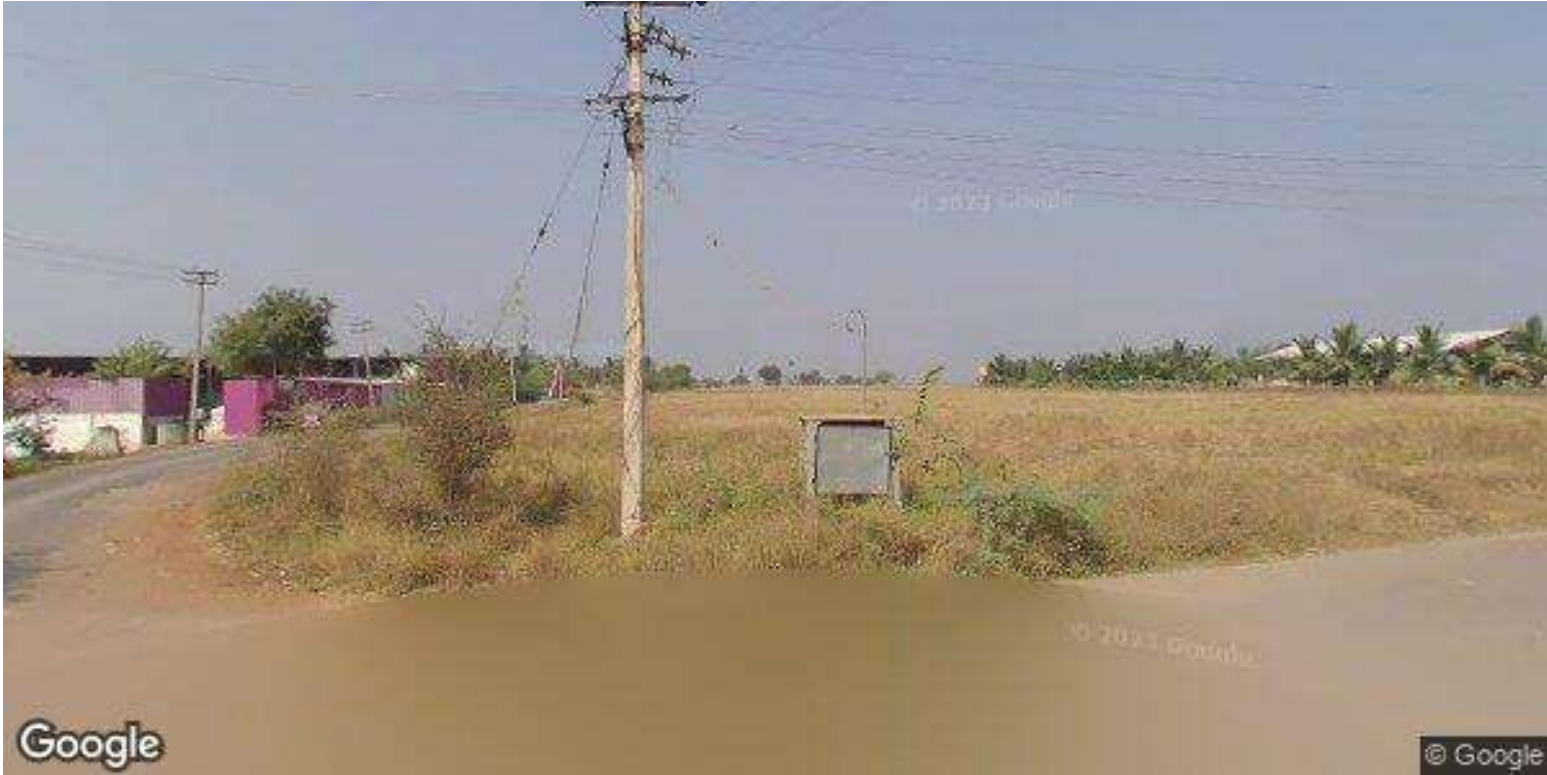
Coordinates: 11.22332, 78.13131

Risk Type: Turn

Risk Level: Medium

Speed Limit: 30 KM/Hr

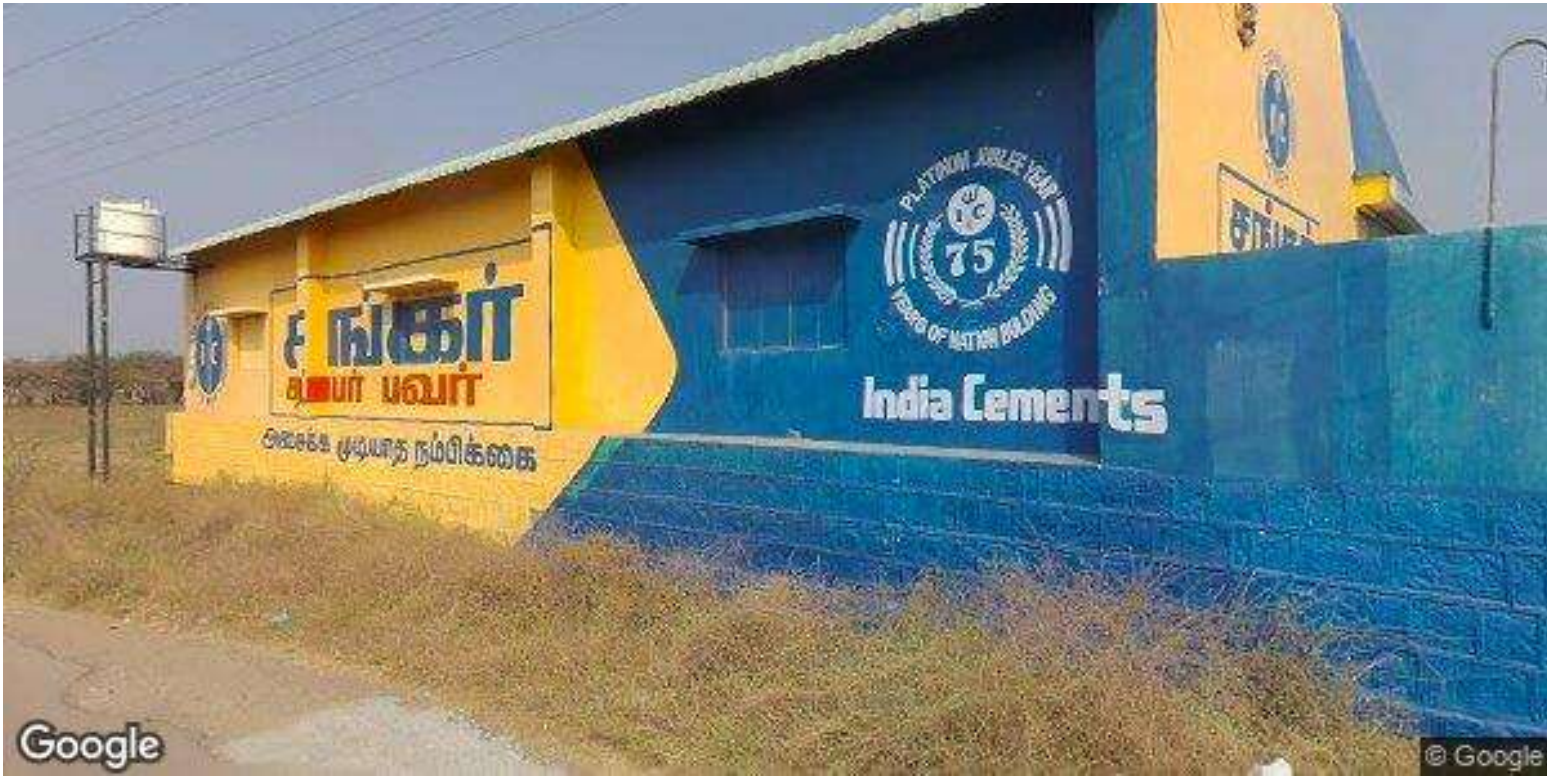
Coordinates: 11.22385, 78.13244

Risk Type: Turn

Risk Level: Medium

Speed Limit: 30 KM/Hr

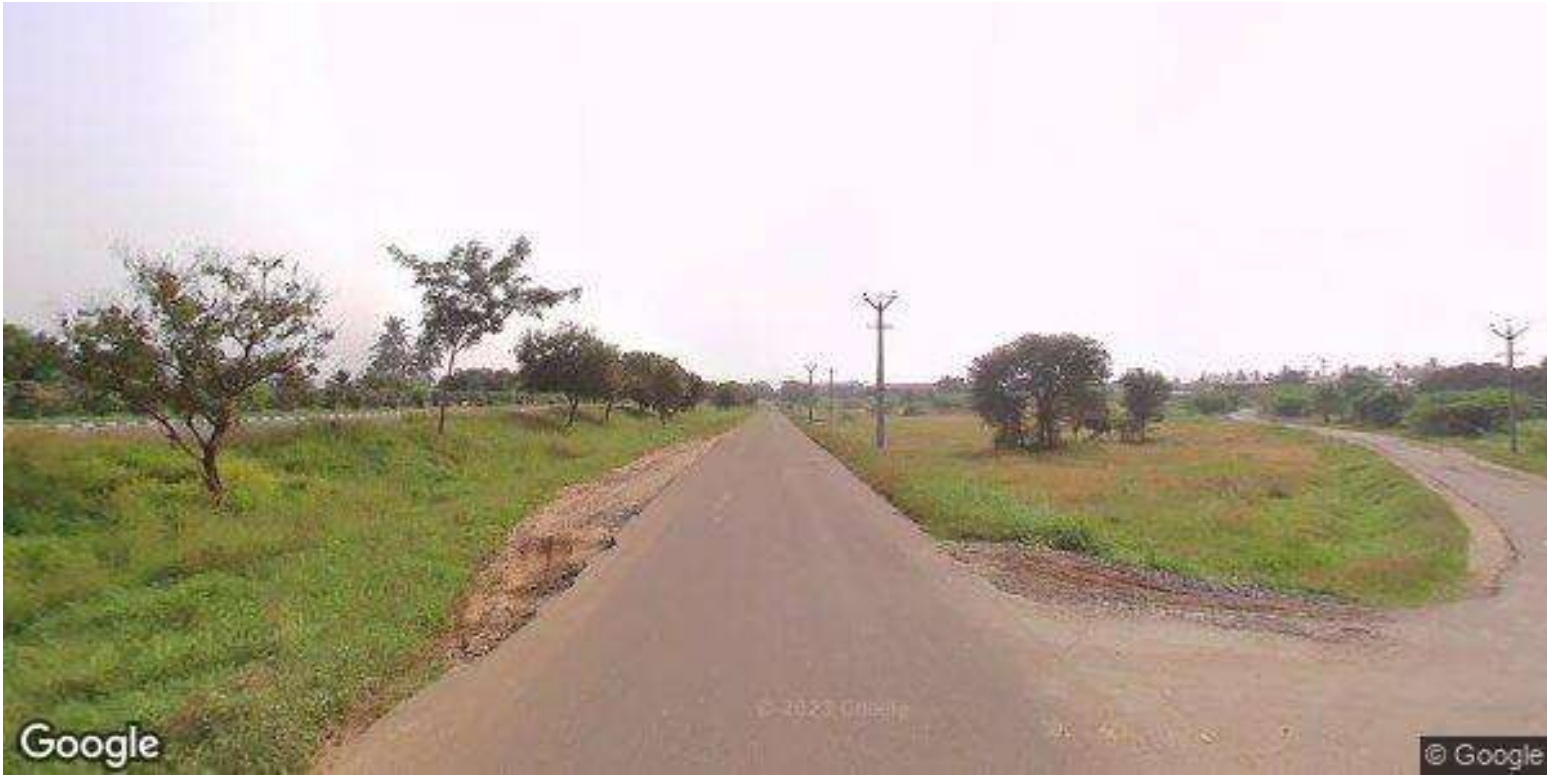
Coordinates: 11.22384, 78.13250

Risk Type: Turn

Risk Level: High

Speed Limit: 15 KM/Hr

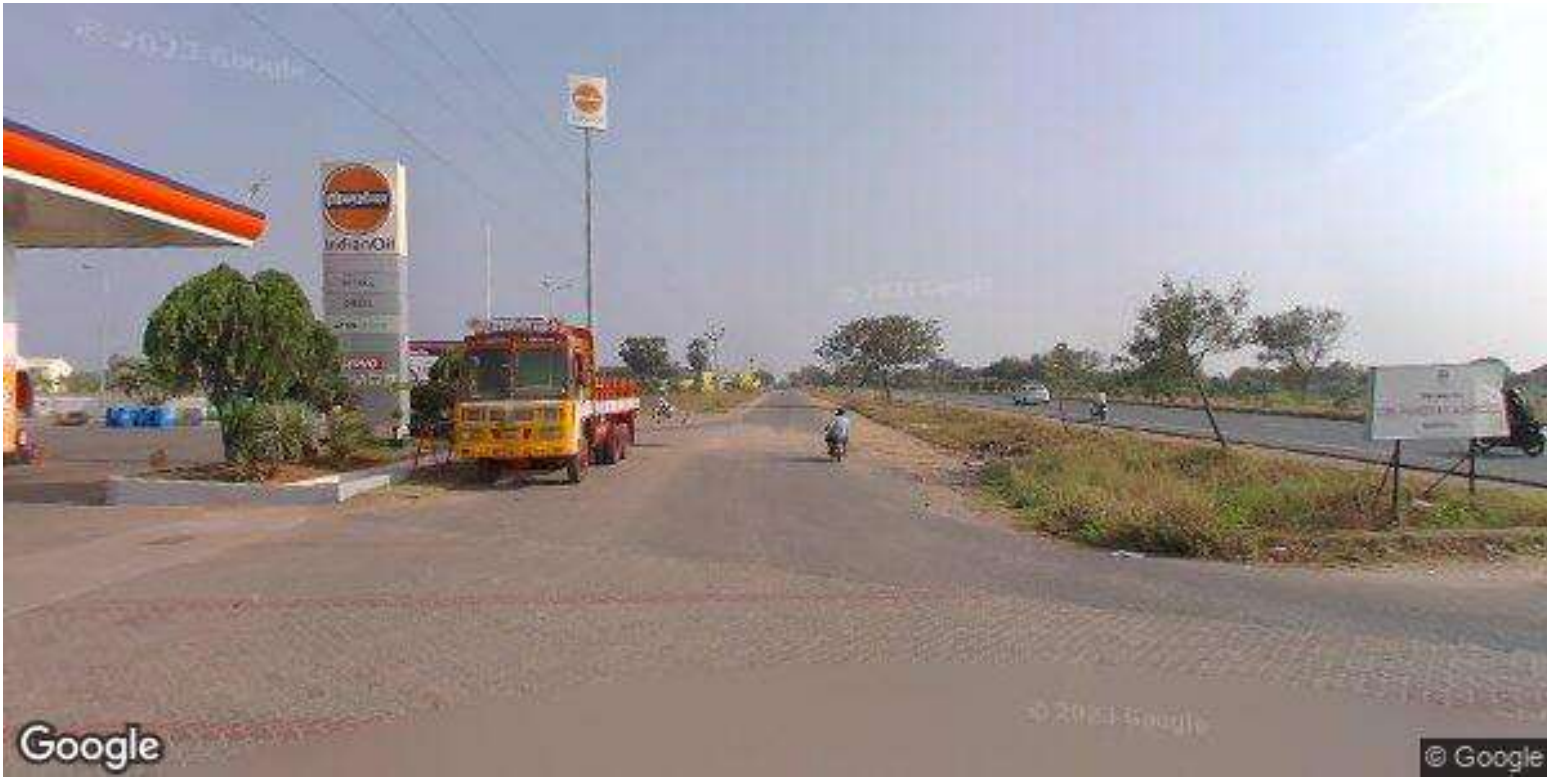
**Coordinates:** 11.22469, 78.13303

**Risk Type:** Turn

**Risk Level:** High

**Speed Limit:** 15 KM/Hr
