## JOURNEY RISK MANAGEMENT (JRM) STUDY

### Salem Terminal TO SRI RAMAKRISHNAA AGENCIES

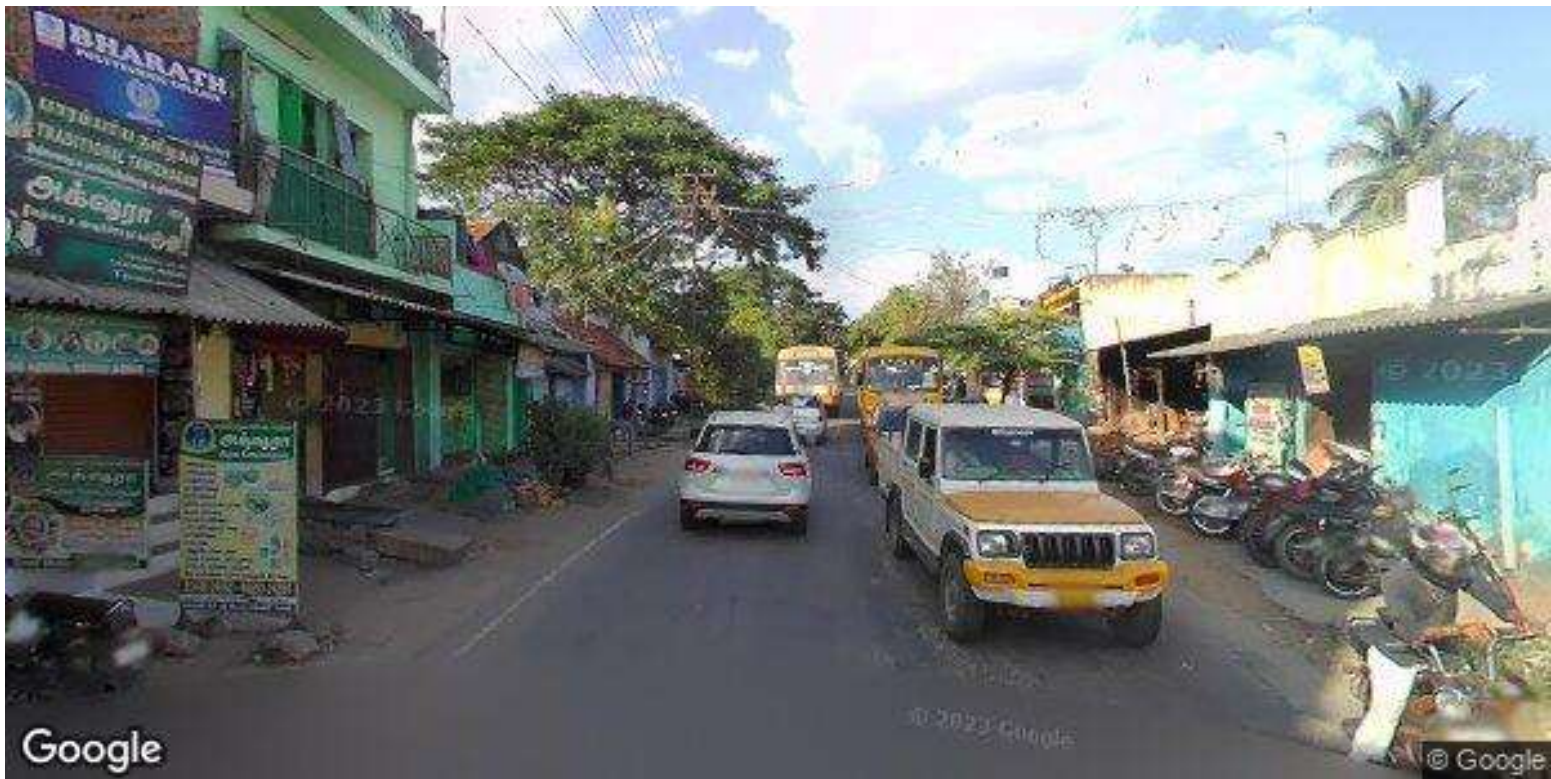
Risk Type: Turn

Risk Level: High

Speed Limit: 15 KM/Hr

Coordinates: 11.45028, 77.87202

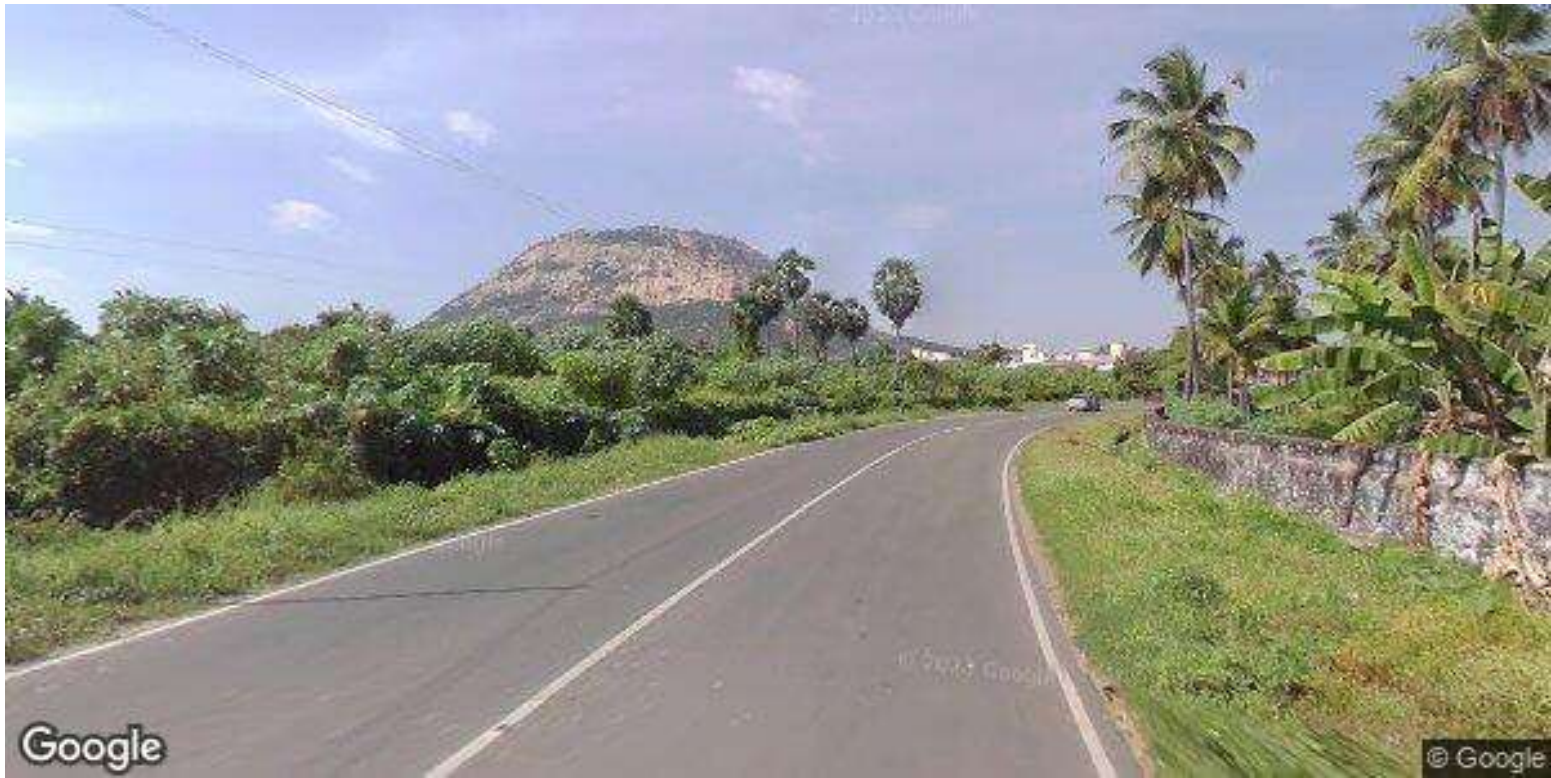
**Risk Type:** Turn  
**Risk Level:** Medium  
**Speed Limit:** 30 KM/Hr  
**Coordinates:** 11.46765, 77.87037

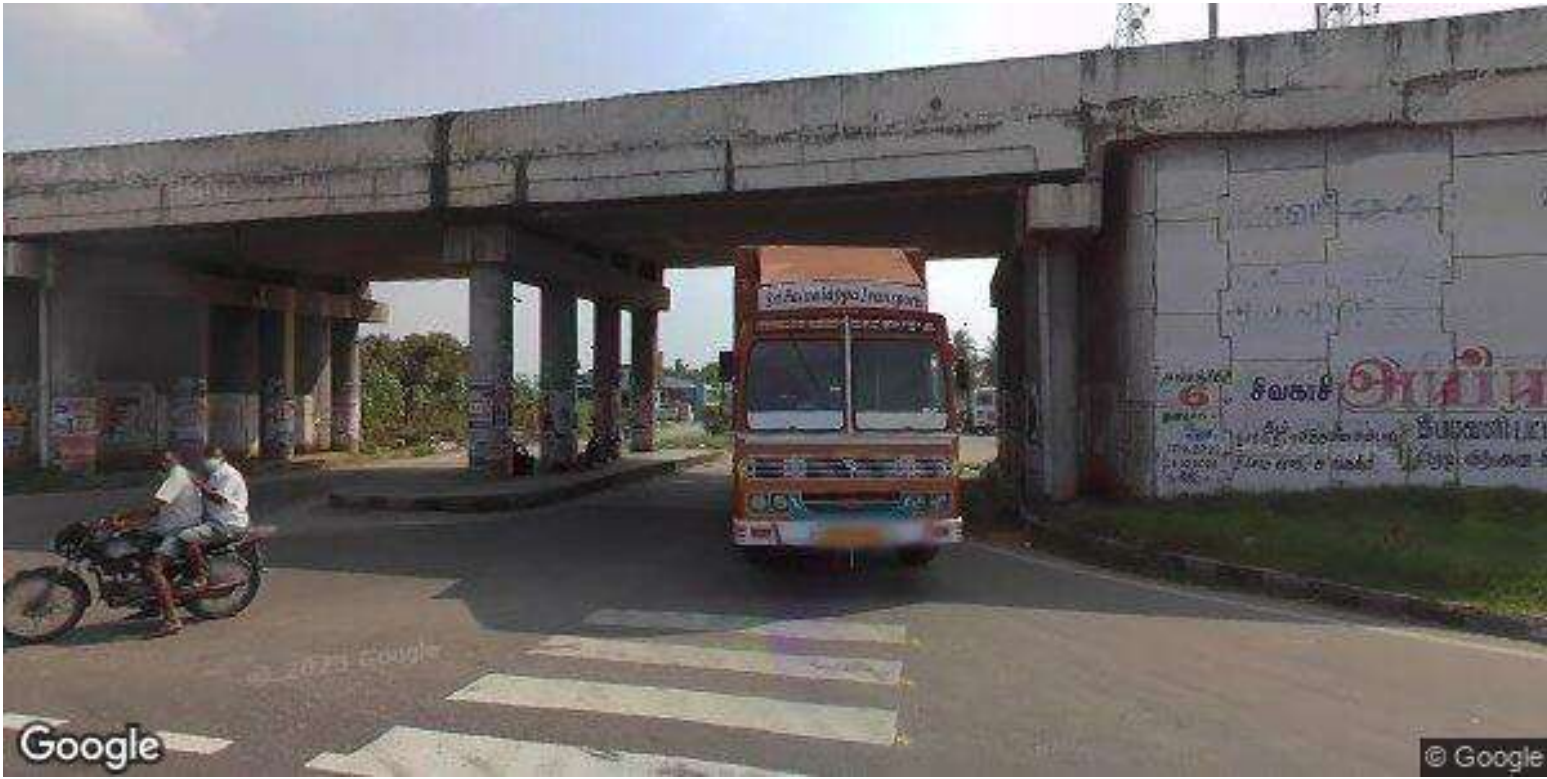
**Risk Type:** Turn  
**Risk Level:** High  
**Speed Limit:** 15 KM/Hr  
**Coordinates:** 11.49224, 77.89601

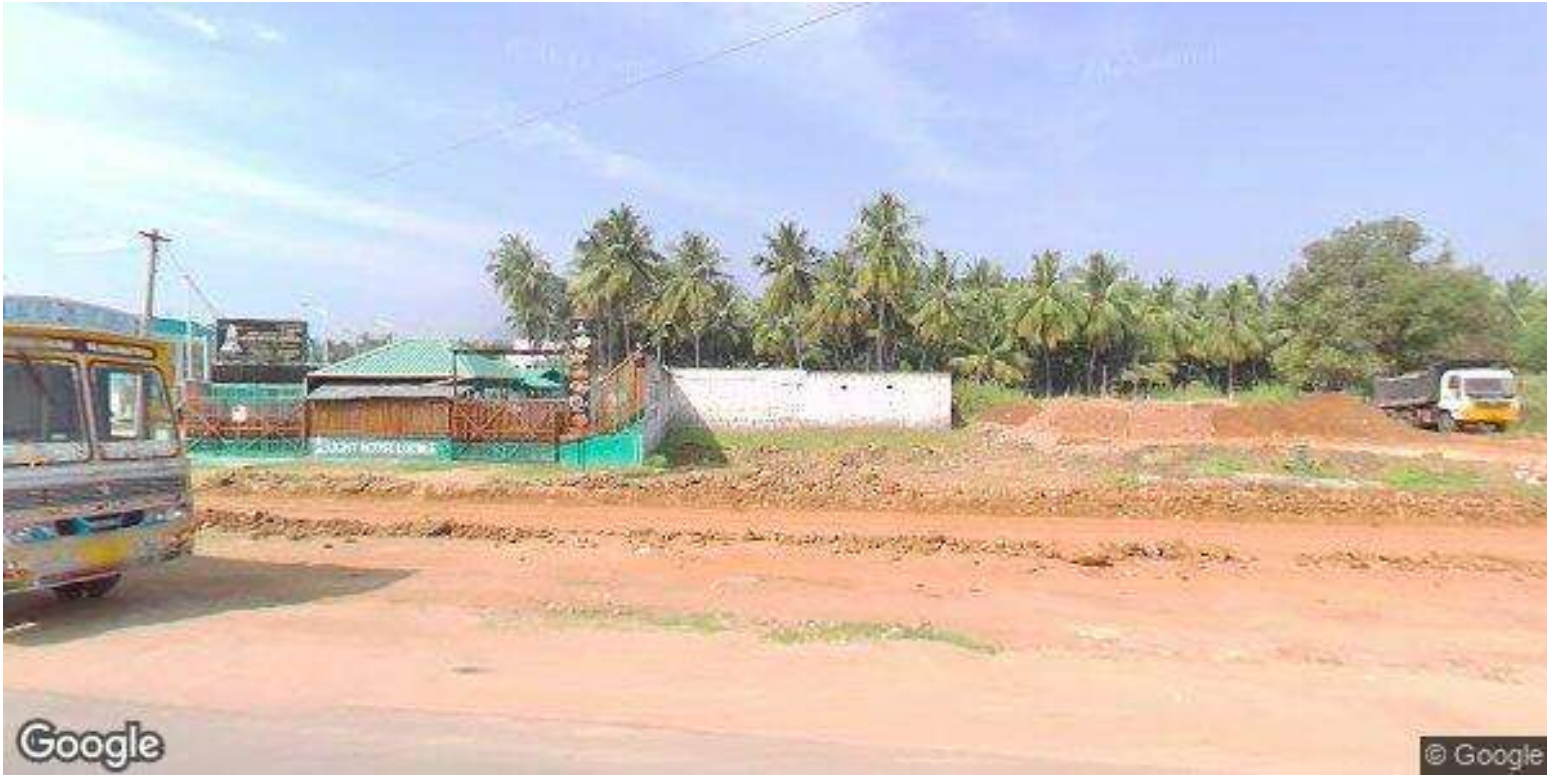
**Risk Type:** Turn  
**Risk Level:** Medium  
**Speed Limit:** 30 KM/Hr  
**Coordinates:** 11.61736, 78.10588

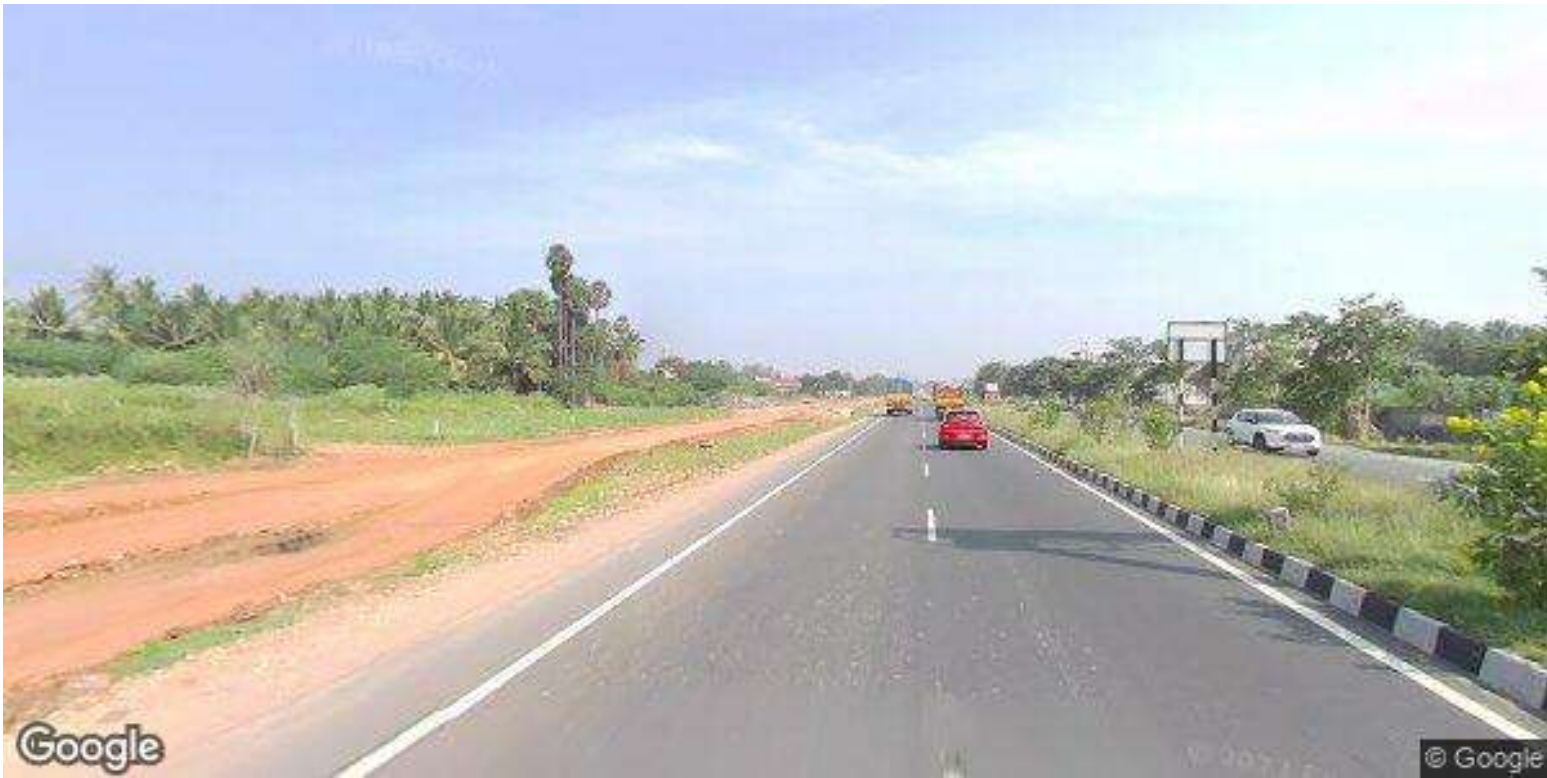
**Risk Type:** Turn  
**Risk Level:** Medium  
**Speed Limit:** 30 KM/Hr  
**Coordinates:** 11.61753, 78.10608

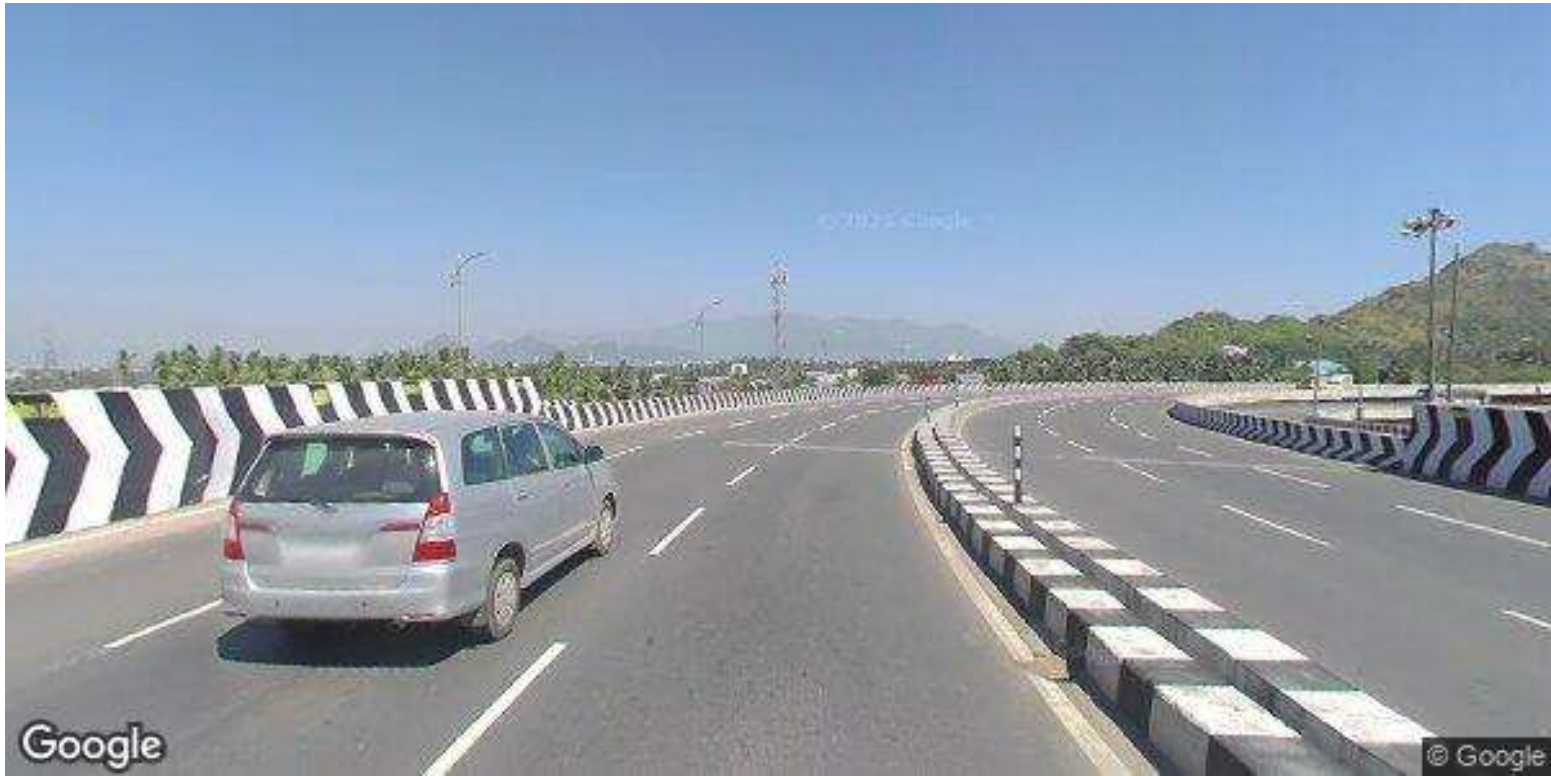
**Risk Type:** Turn  
**Risk Level:** Medium  
**Speed Limit:** 30 KM/Hr  
**Coordinates:** 11.64172, 78.11817

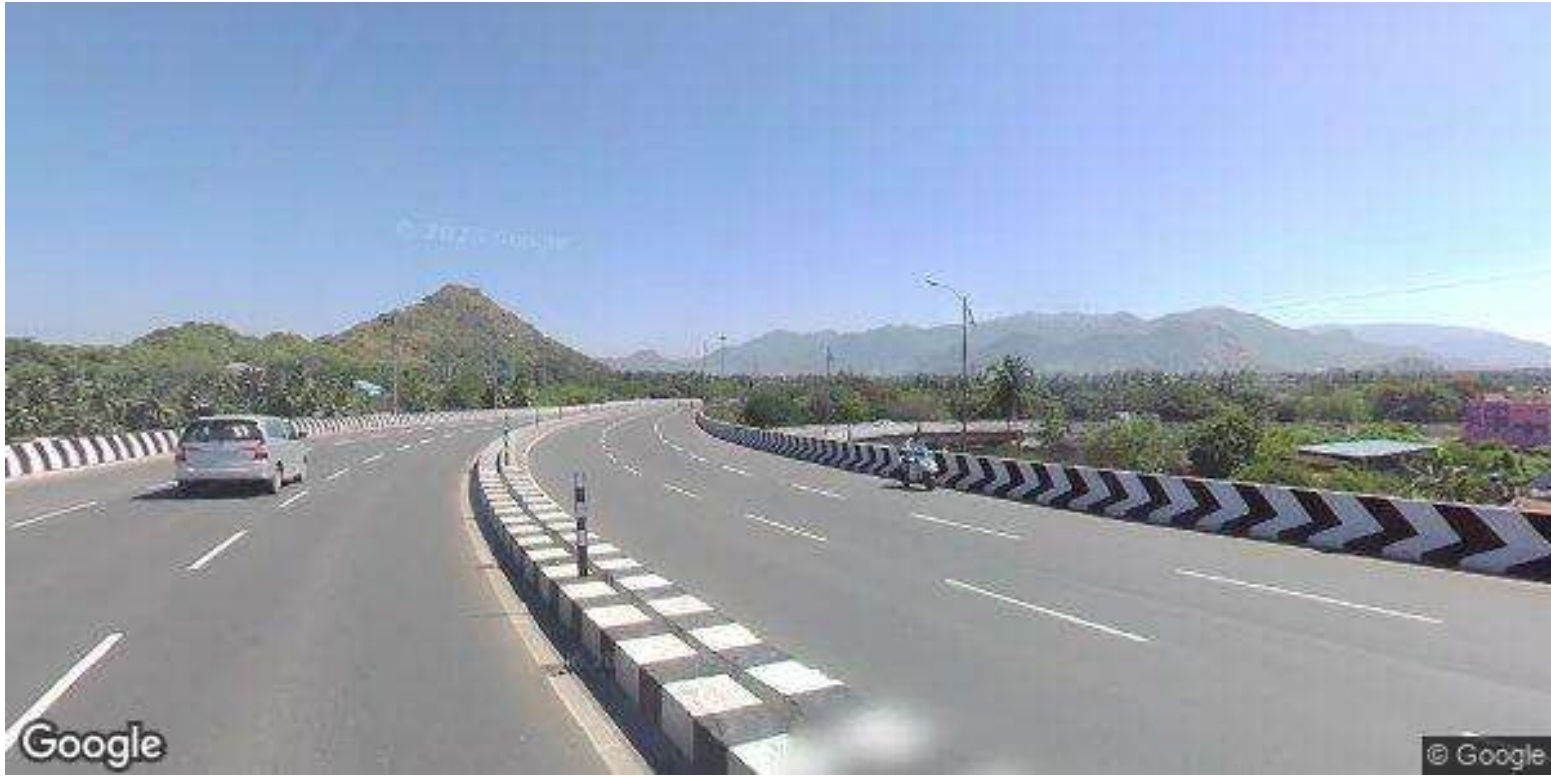
**Risk Type:** Turn  
**Risk Level:** Medium  
**Speed Limit:** 30 KM/Hr  
**Coordinates:** 11.64216, 78.11875

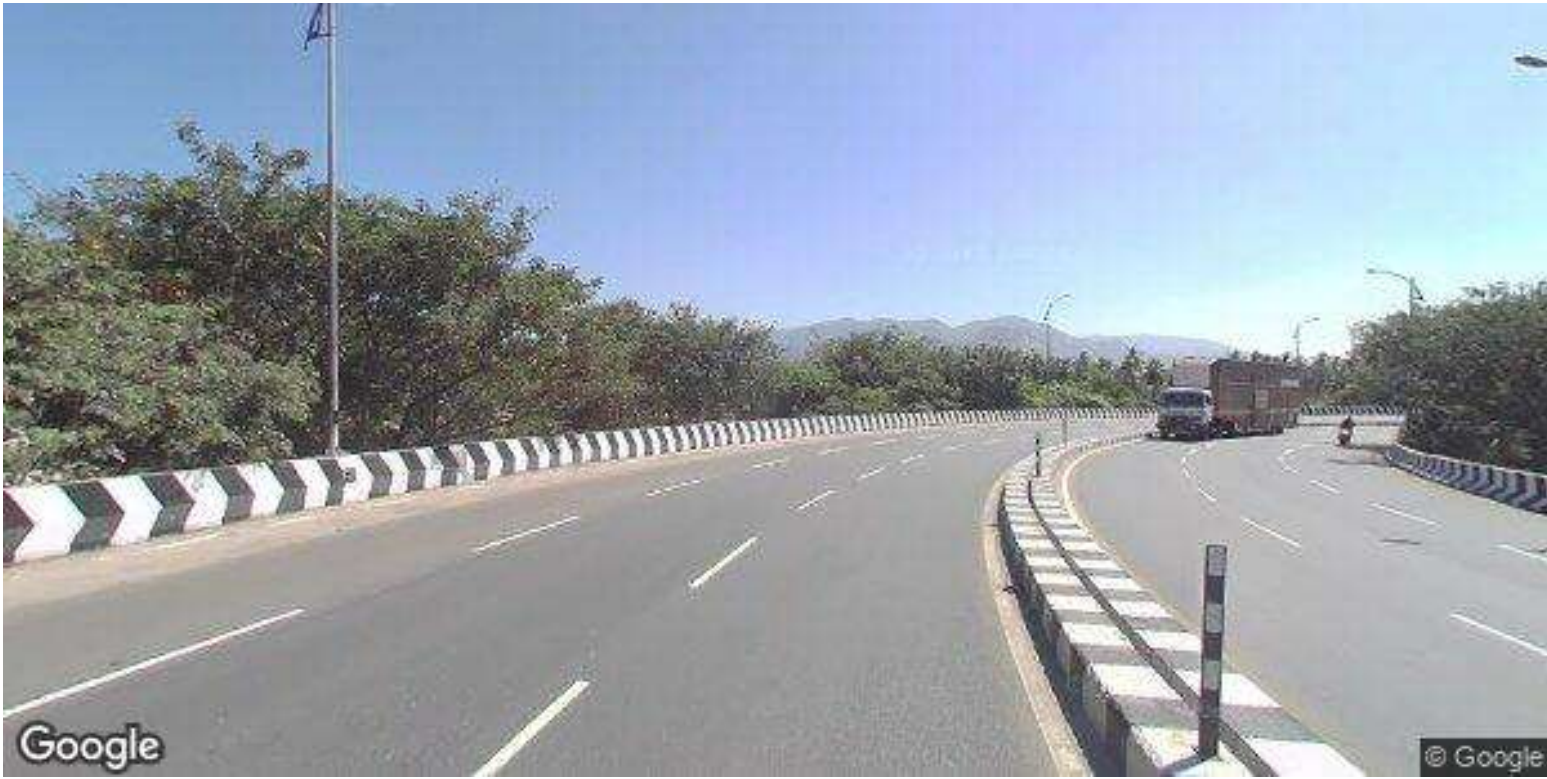
**Risk Type:** Turn  
**Risk Level:** Medium  
**Speed Limit:** 30 KM/Hr  
**Coordinates:** 11.64195, 78.12129

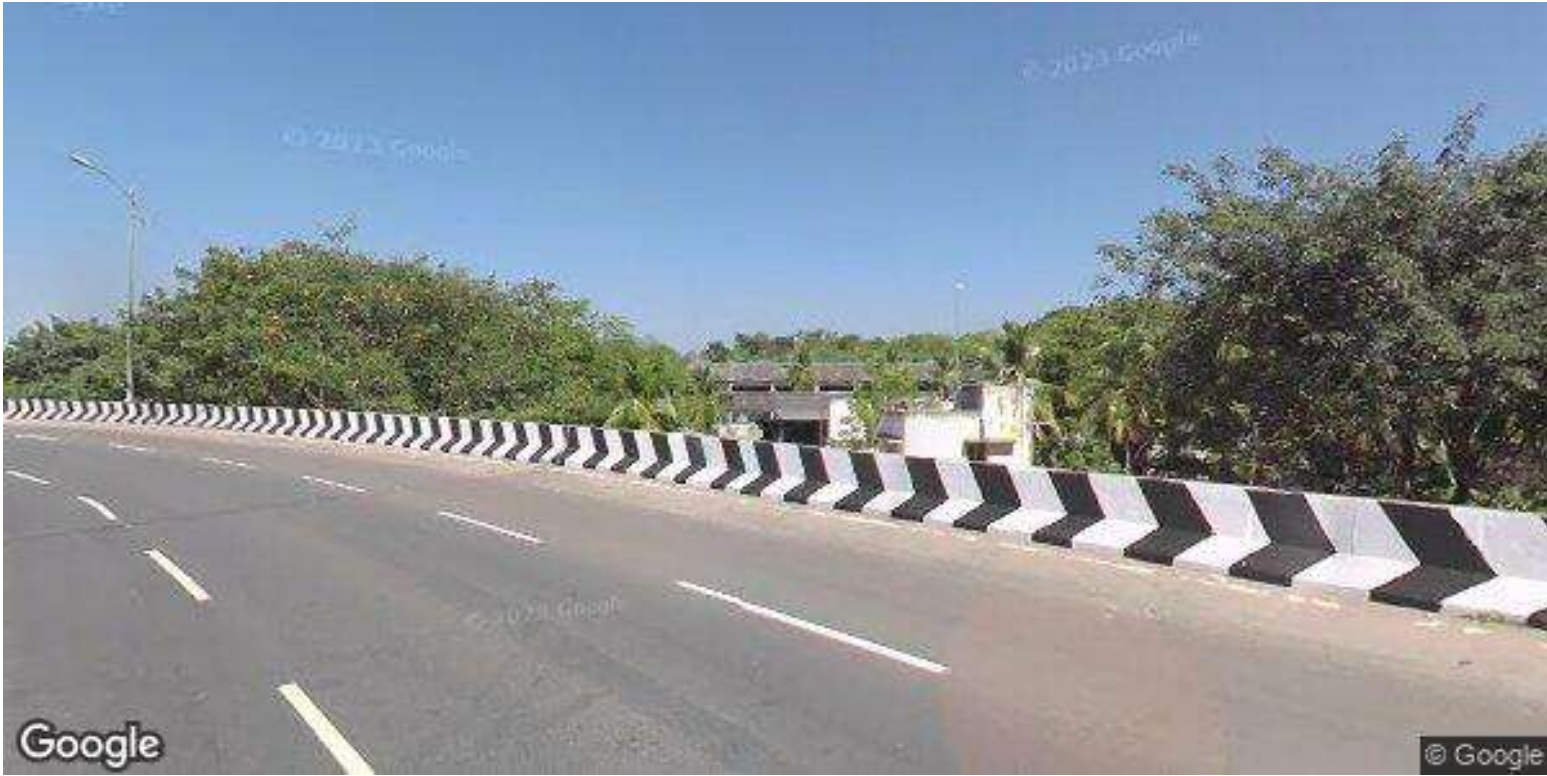
**Risk Type:** Turn  
**Risk Level:** Medium  
**Speed Limit:** 30 KM/Hr  
**Coordinates:** 11.64162, 78.12160

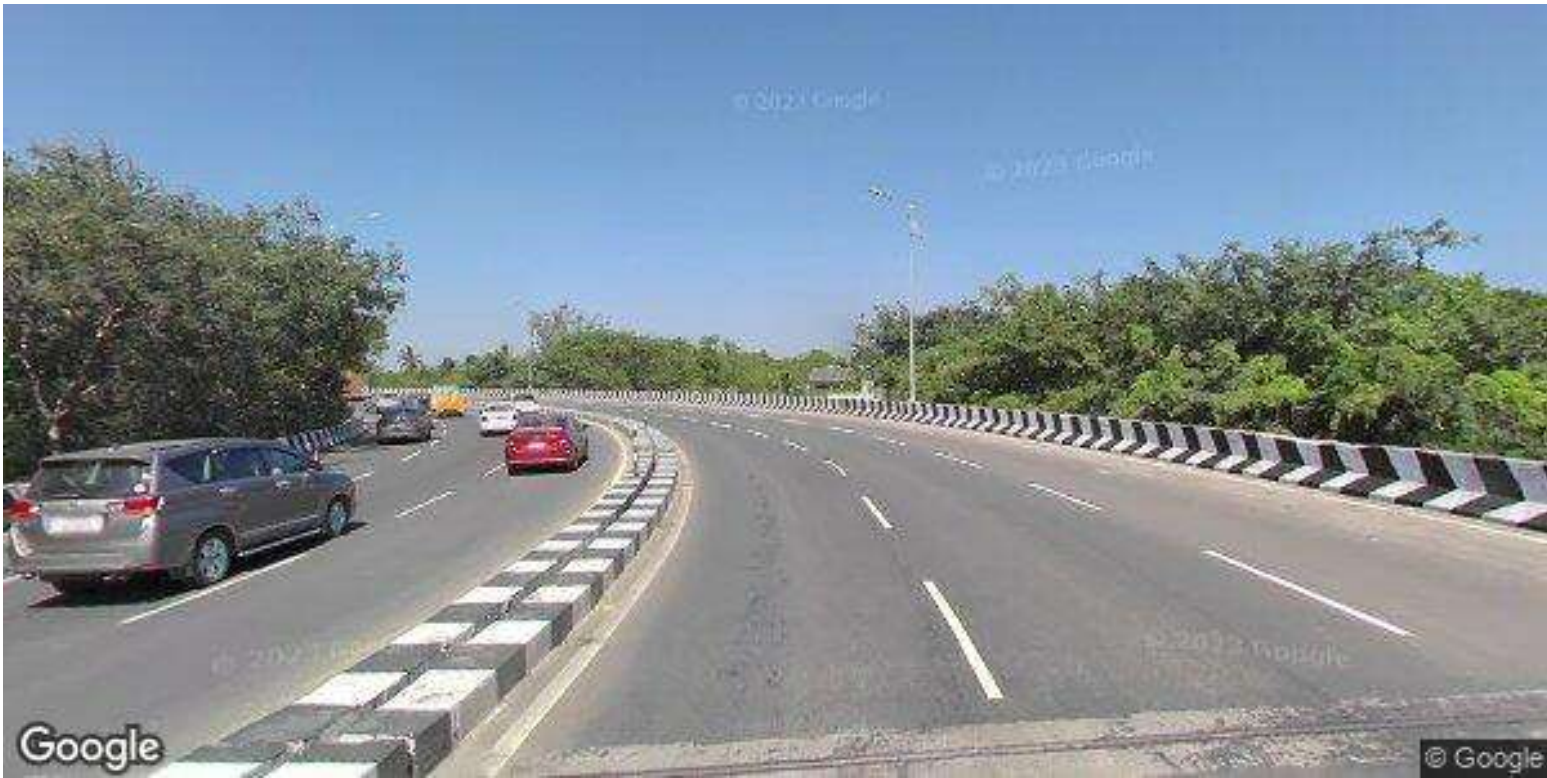
**Risk Type:** Turn  
**Risk Level:** Medium  
**Speed Limit:** 30 KM/Hr  
**Coordinates:** 11.64120, 78.12168

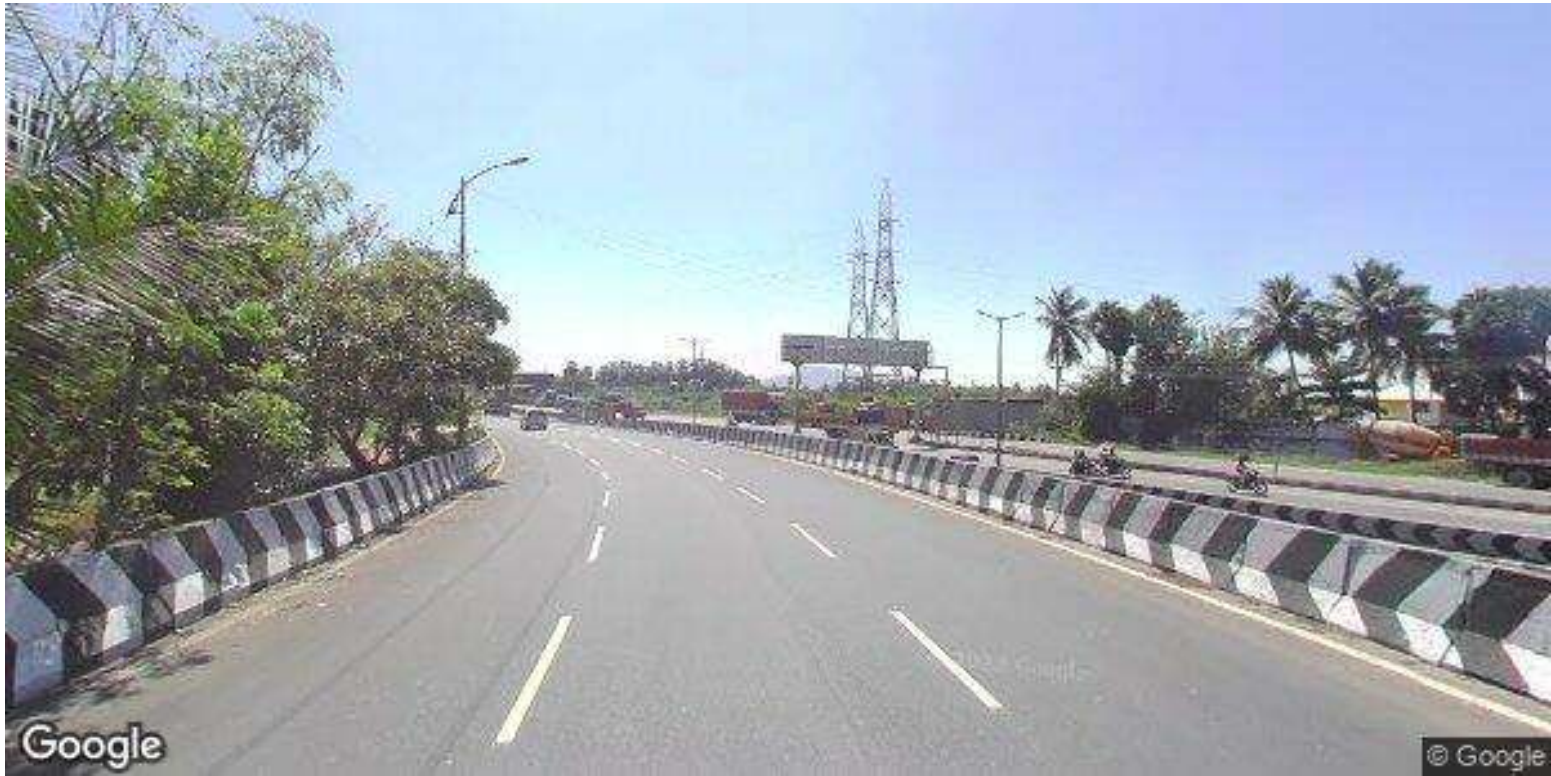
**Risk Type:** Turn  
**Risk Level:** Medium  
**Speed Limit:** 30 KM/Hr  
**Coordinates:** 11.63948, 78.12081

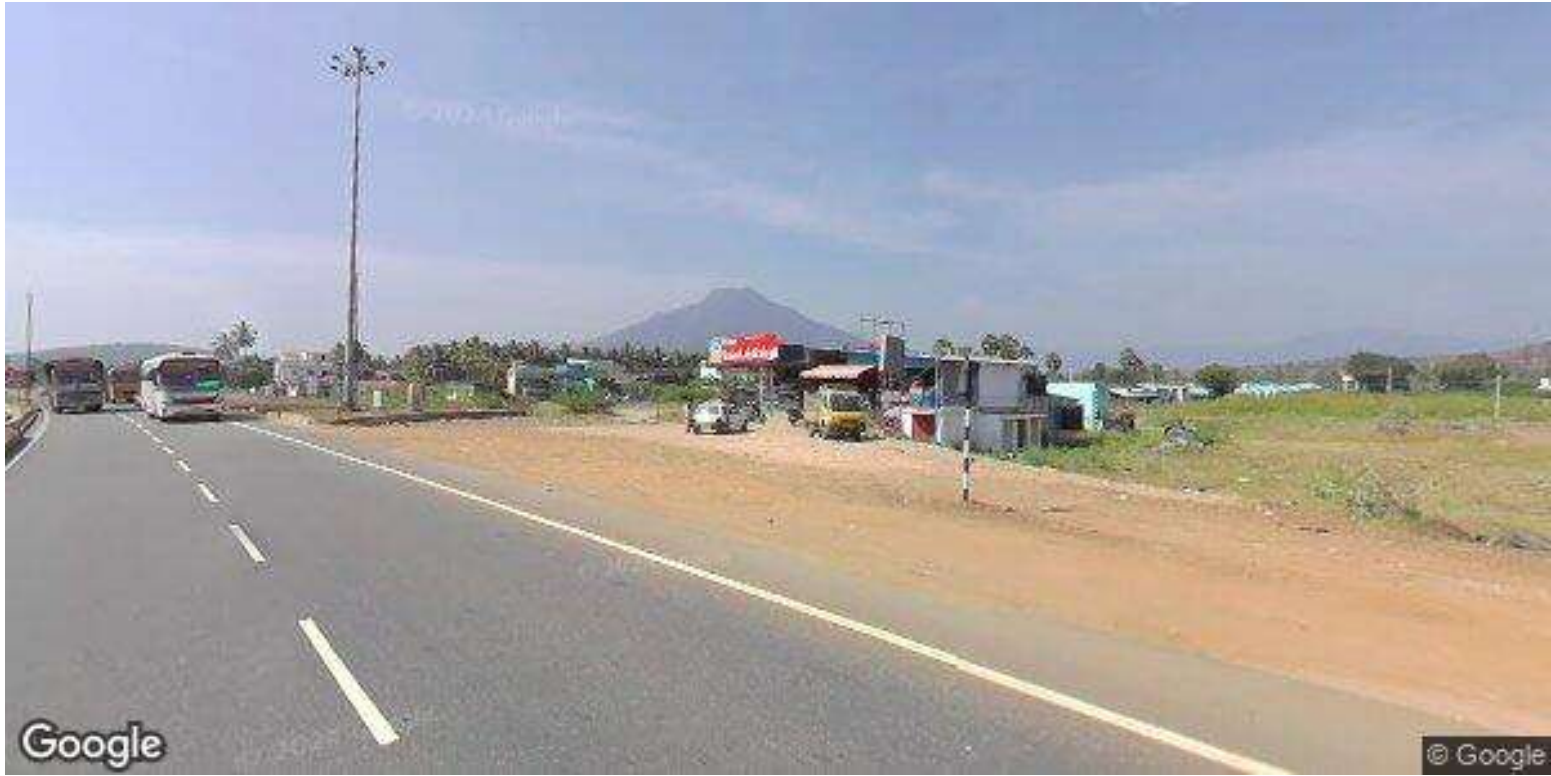
**Risk Type:** Turn  
**Risk Level:** Medium  
**Speed Limit:** 30 KM/Hr  
**Coordinates:** 11.65441, 78.38090

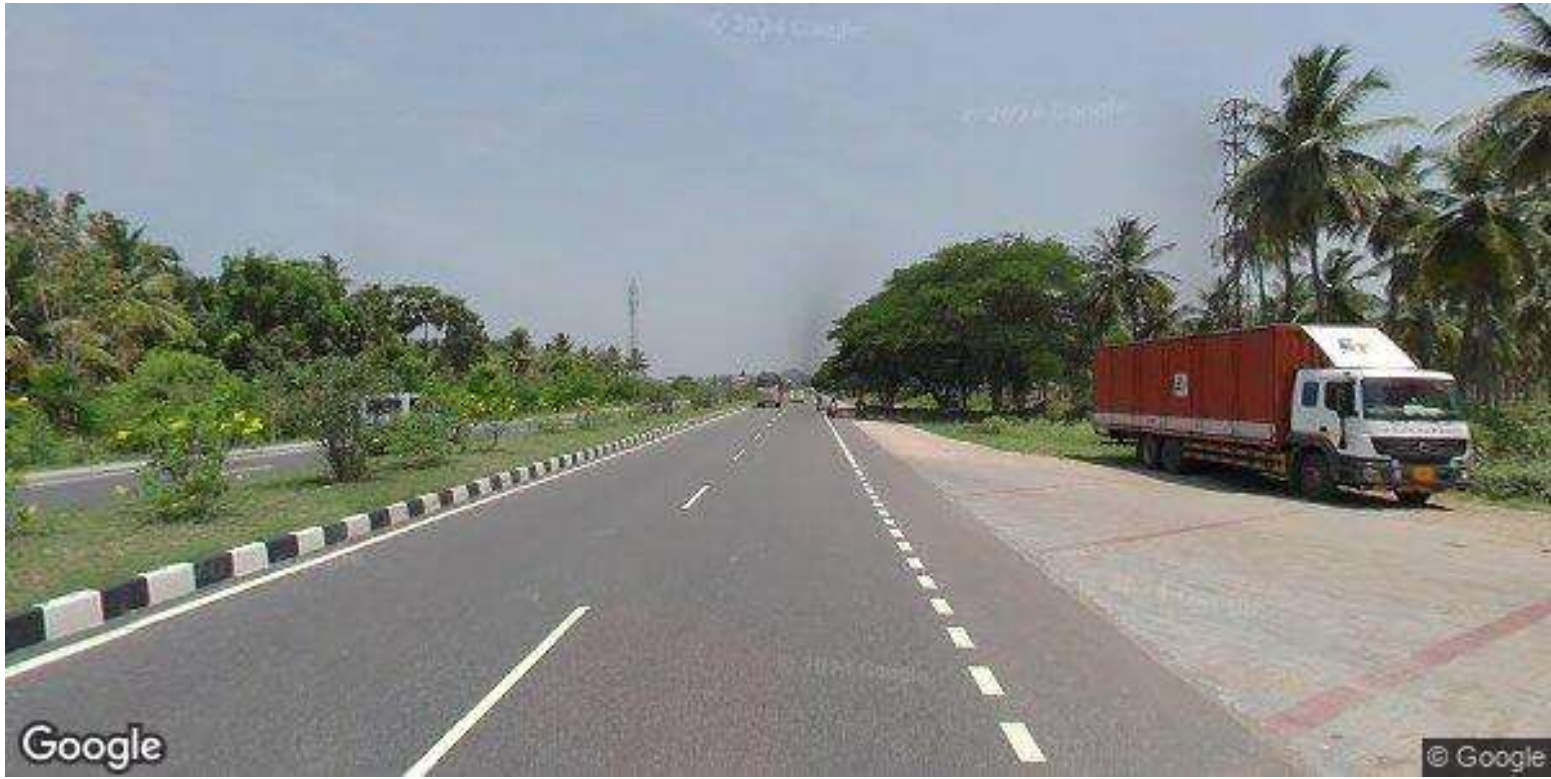
**Risk Type:** Turn

**Risk Level:** High

**Speed Limit:** 15 KM/Hr

**Coordinates:** 11.64216, 78.51921
