# IndianOil

## JOURNEY RISK MANAGEMENT (JRM) STUDY

### Salem Terminal to SUDHARSAN TRADERS

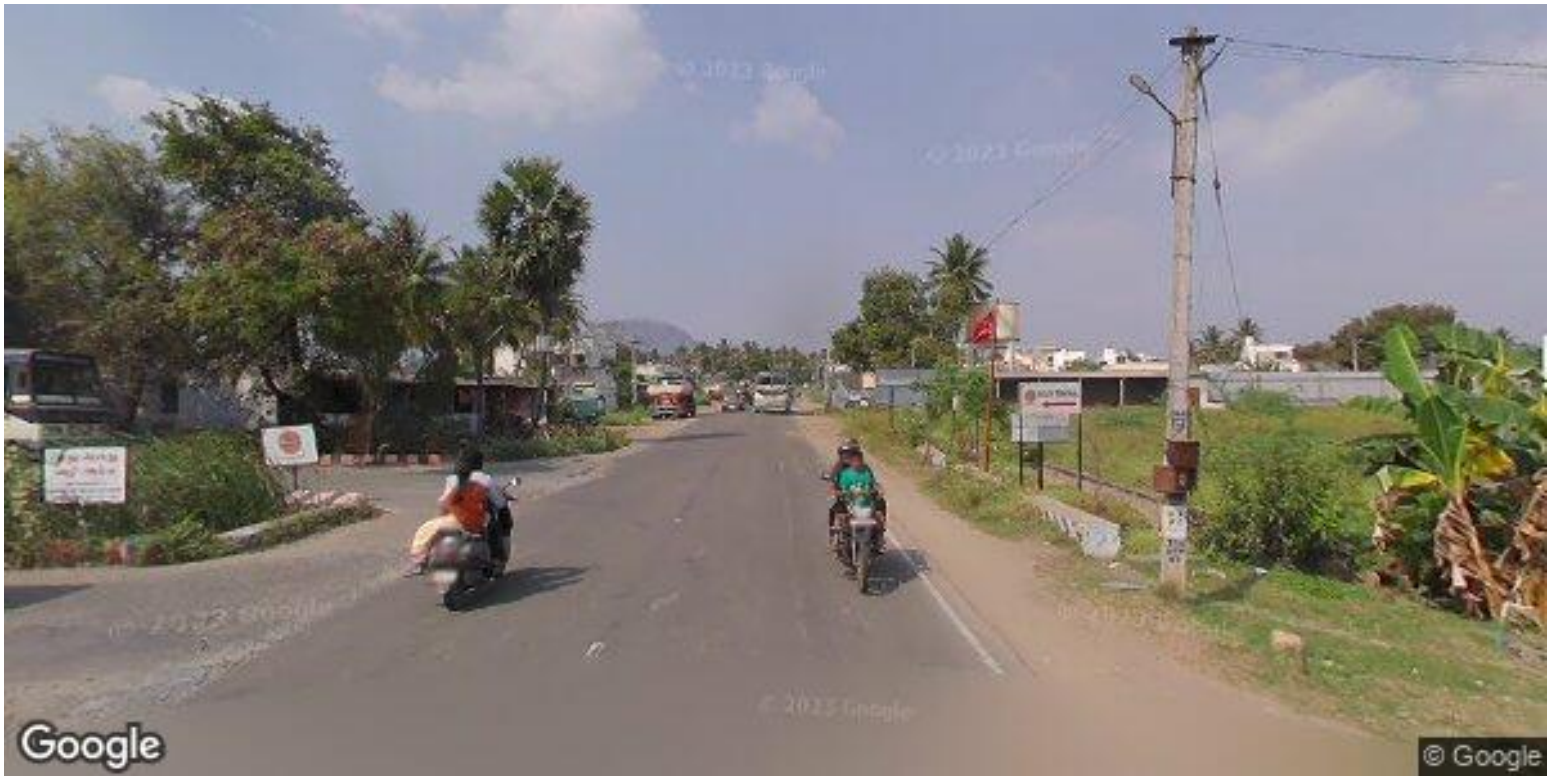
| | Risk Type | Risk Level | Coordinates | Speed Limit |
|---|---|---|---|---|
| 2 | Turn | High | 11.44019, 77.87547 | 15 KM/Hr |

**Risk Type:** Turn  
**Risk Level:** High  
**Speed Limit:** 15 KM/Hr  
**Coordinates:** 11.44019, 77.87547

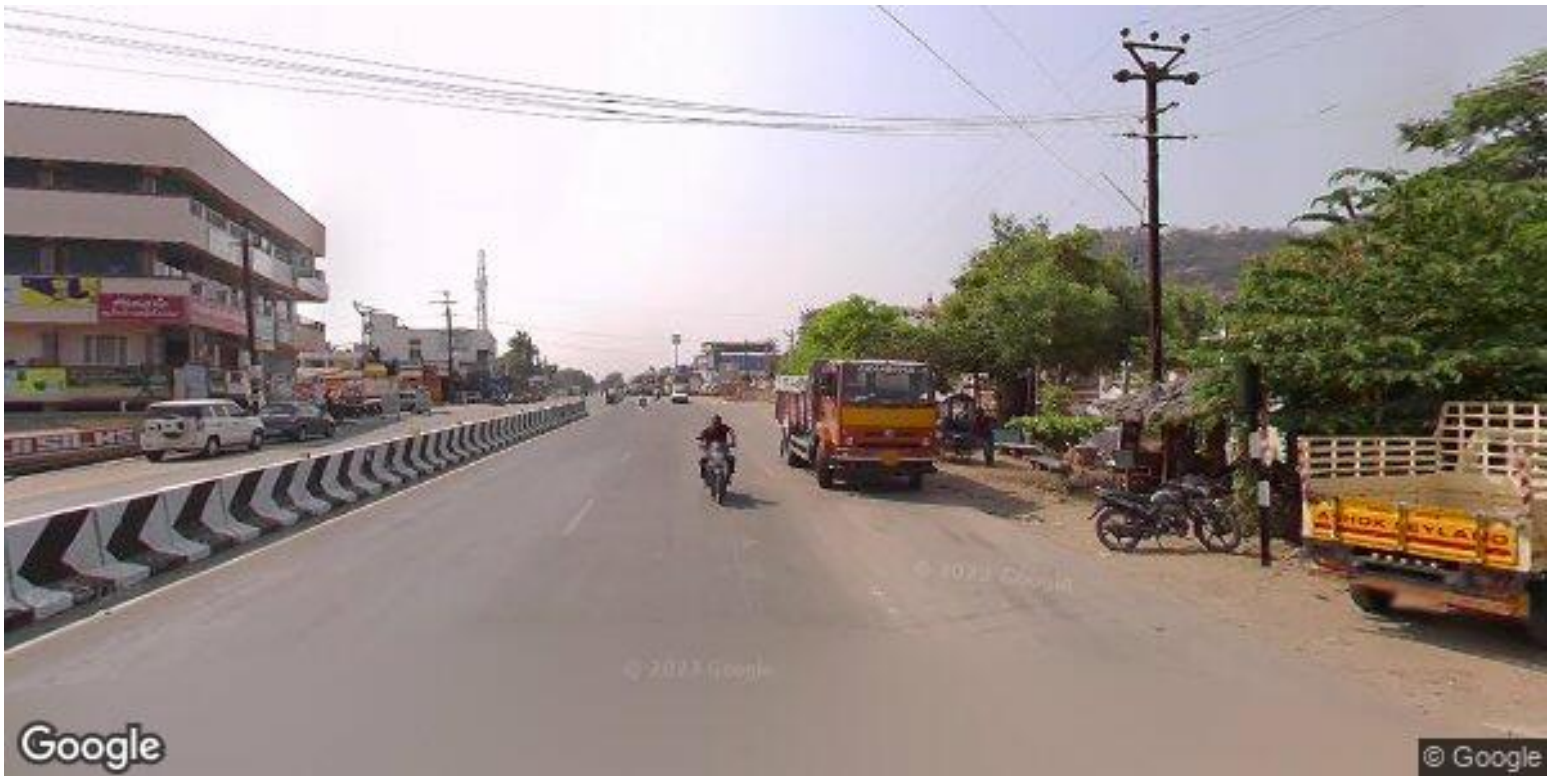
| | Risk Type | Risk Level | Coordinates | Speed Limit |
|---|---|---|---|---|
| 3 | Turn | Medium | 11.39685, 77.88861 | 30 KM/Hr |

**Risk Type:** Turn  
**Risk Level:** Medium  
**Speed Limit:** 30 KM/Hr  
**Coordinates:** 11.39685, 77.88861

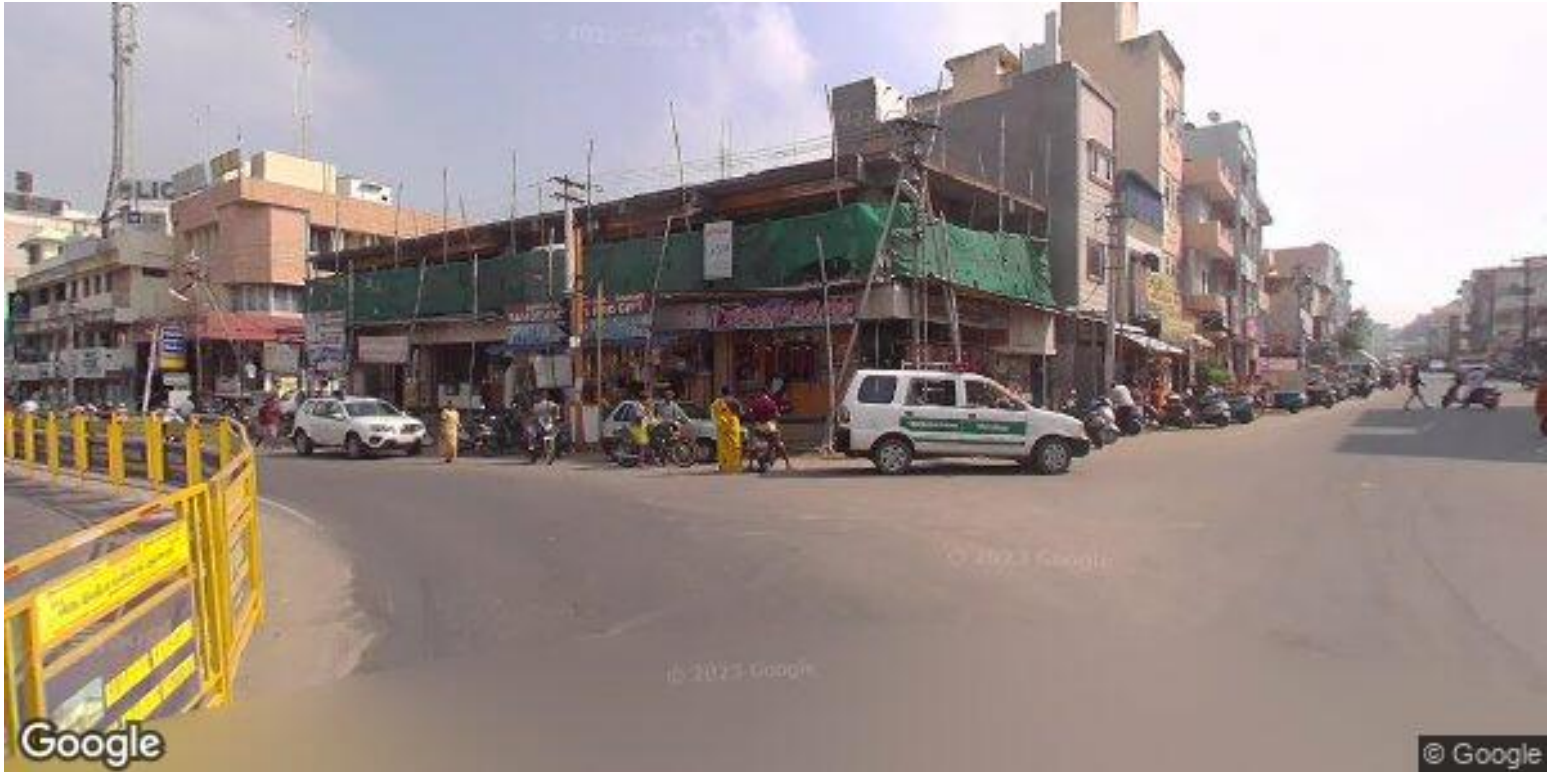
| | Risk Type | Risk Level | Coordinates | Speed Limit |
|---|---|---|---|---|
| 4 | Turn | High | 11.37868, 77.89498 | 15 KM/Hr |

**Risk Type:** Turn  
**Risk Level:** High  
**Speed Limit:** 15 KM/Hr  
**Coordinates:** 11.37868, 77.89498

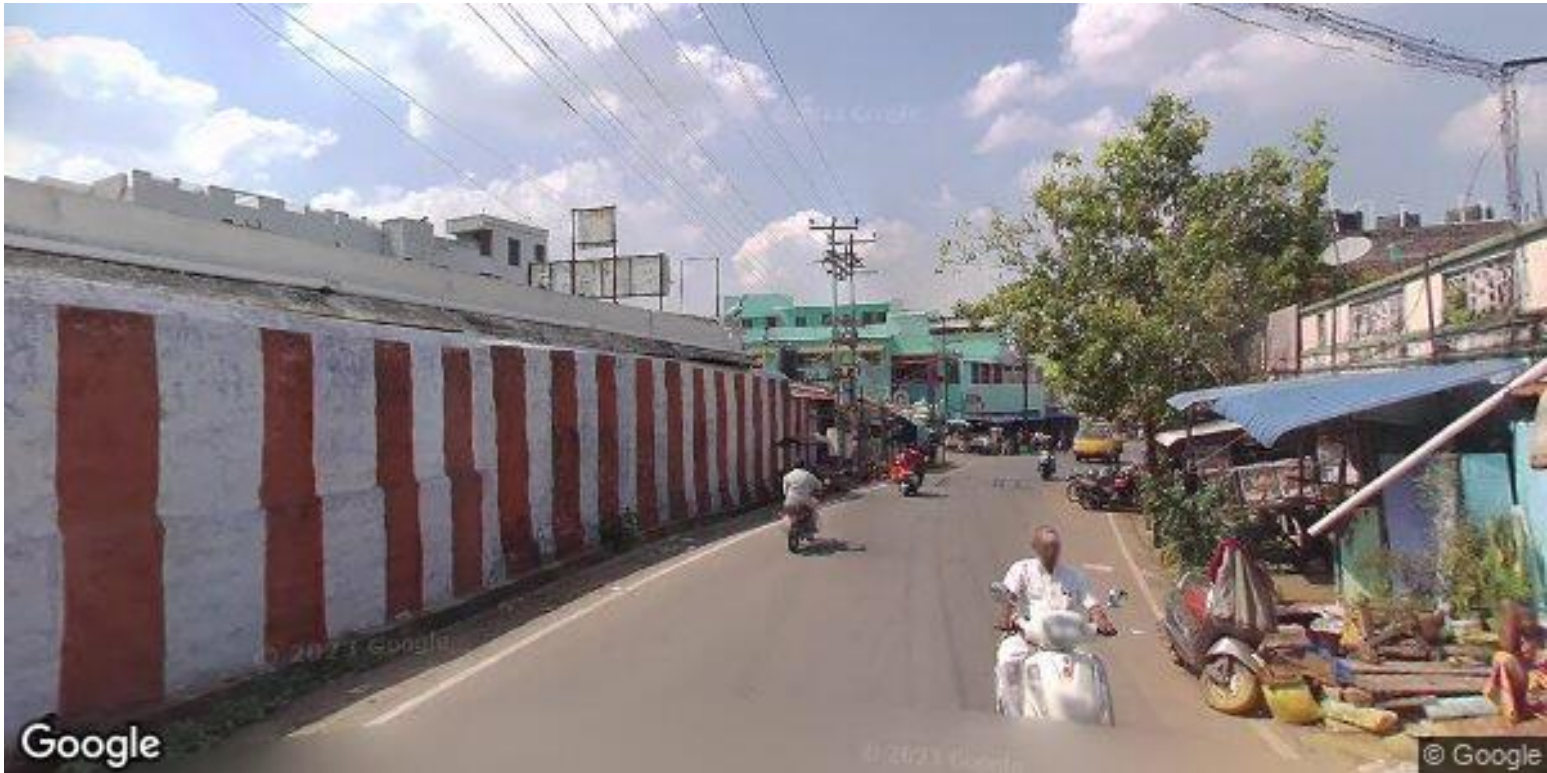
| | Risk Type | Risk Level | Coordinates | Speed Limit |
|---|---|---|---|---|
| 5 | Turn | Medium | 11.37809, 77.89834 | 30 KM/Hr |

**Risk Type:** Turn  
**Risk Level:** Medium  
**Speed Limit:** 30 KM/Hr  
**Coordinates:** 11.37809, 77.89834

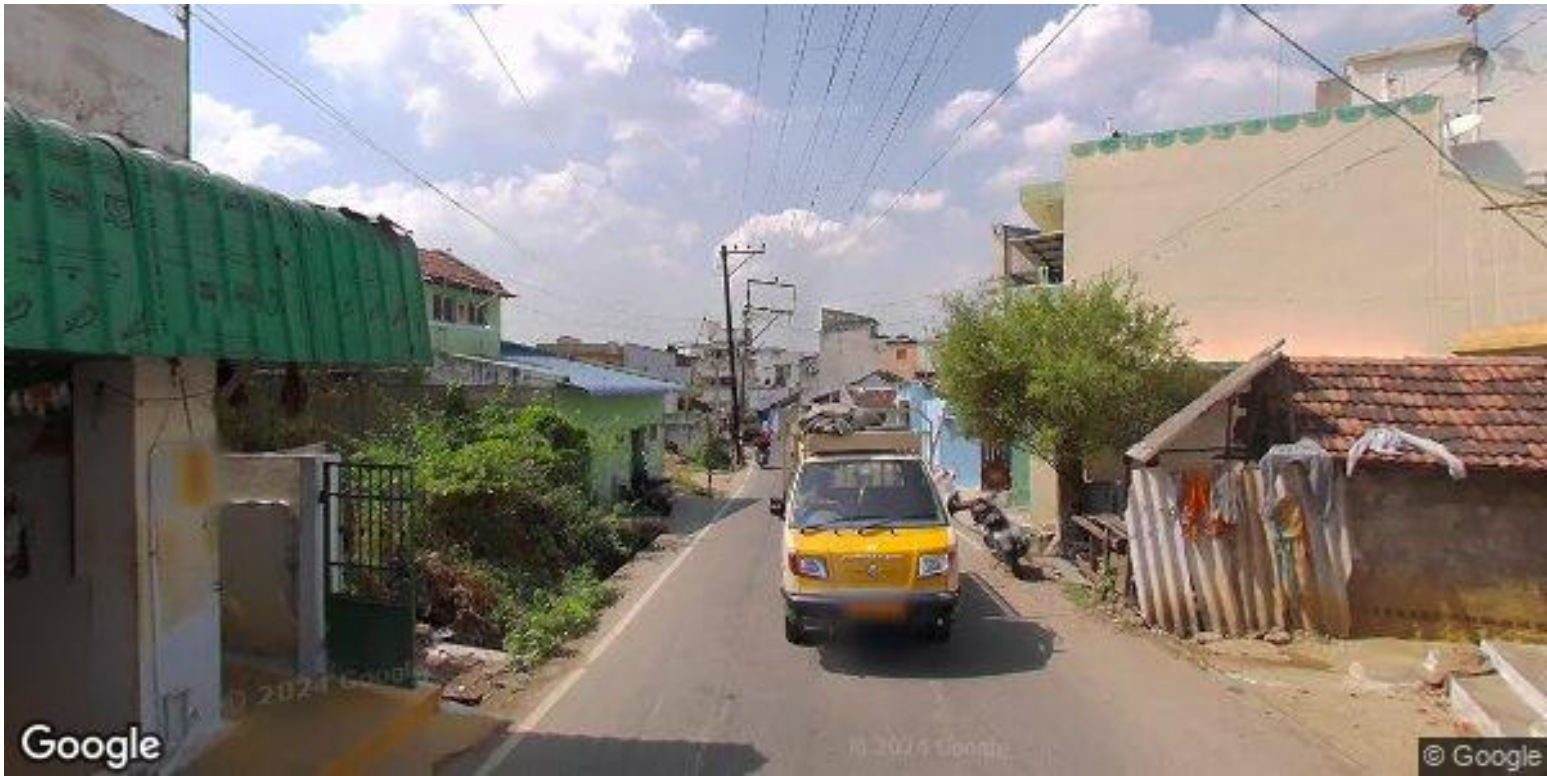
| | Risk Type | Risk Level | Coordinates | Speed Limit |
|---|---|---|---|---|
| 6 | Turn | Medium | 11.37885, 77.89989 | 30 KM/Hr |

**Risk Type:** Turn  
**Risk Level:** Medium  
**Speed Limit:** 30 KM/Hr  
**Coordinates:** 11.37885, 77.89989

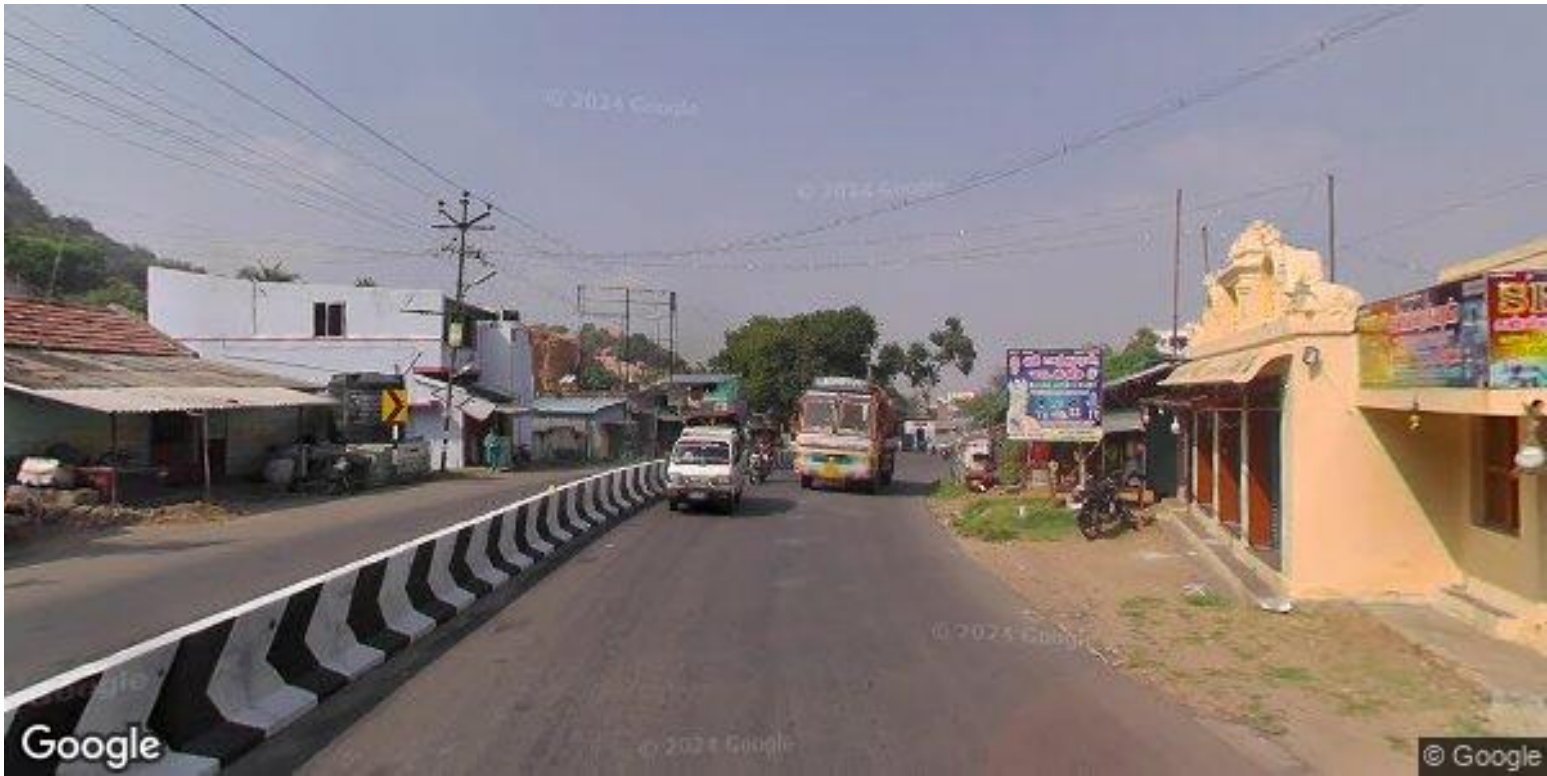
| | Risk Type | Risk Level | Coordinates | Speed Limit |
|---|---|---|---|---|
| 7 | Turn | Medium | 11.37820, 77.90220 | 30 KM/Hr |

**Risk Type:** Turn  
**Risk Level:** Medium  
**Speed Limit:** 30 KM/Hr  
**Coordinates:** 11.37820, 77.90220

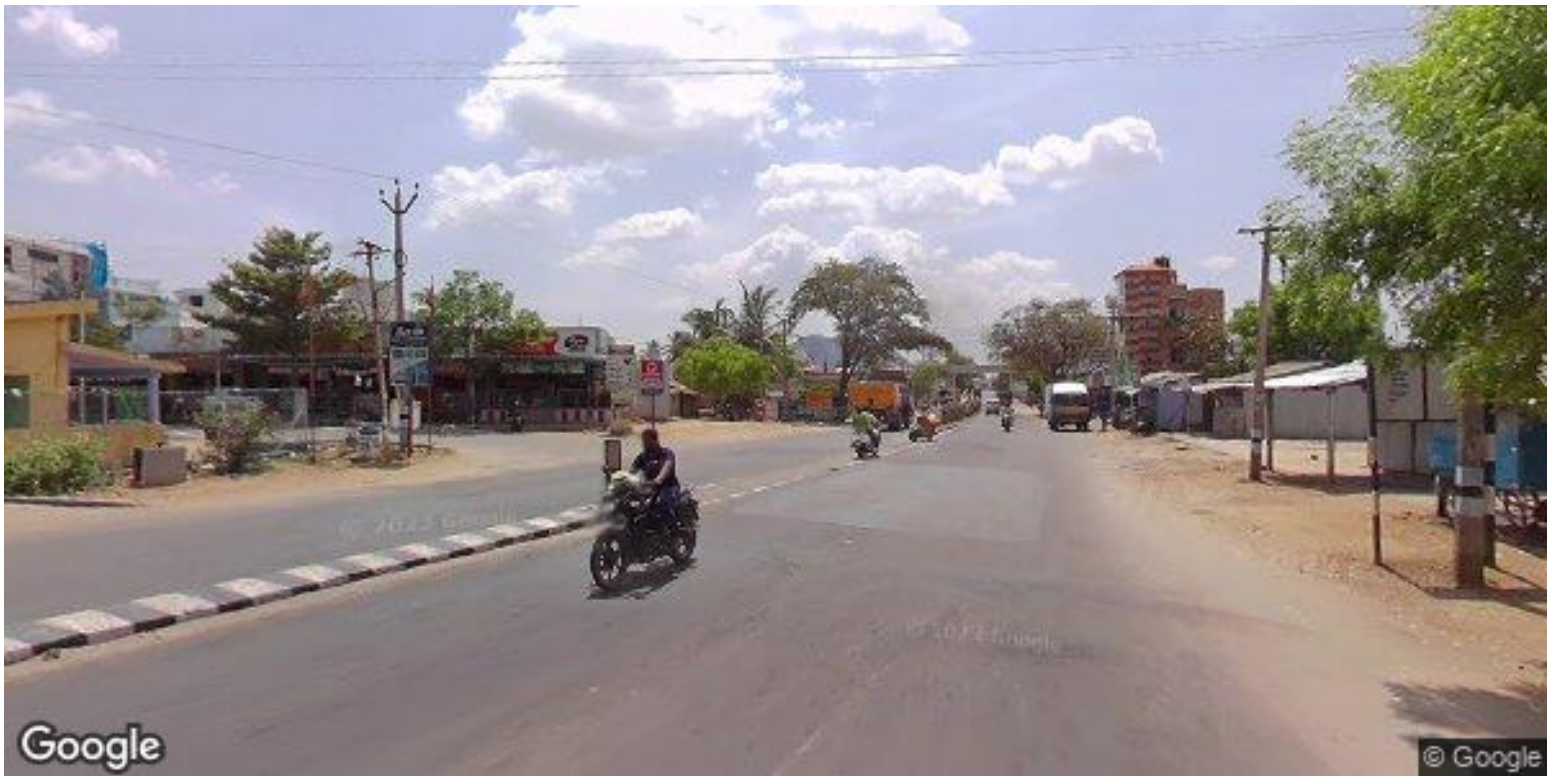
| | Risk Type | Risk Level | Coordinates | Speed Limit |
|---|---|---|---|---|
| 8 | Turn | Medium | 11.36748, 77.93938 | 30 KM/Hr |

**Risk Type:** Turn  
**Risk Level:** Medium  
**Speed Limit:** 30 KM/Hr  
**Coordinates:** 11.36748, 77.93938

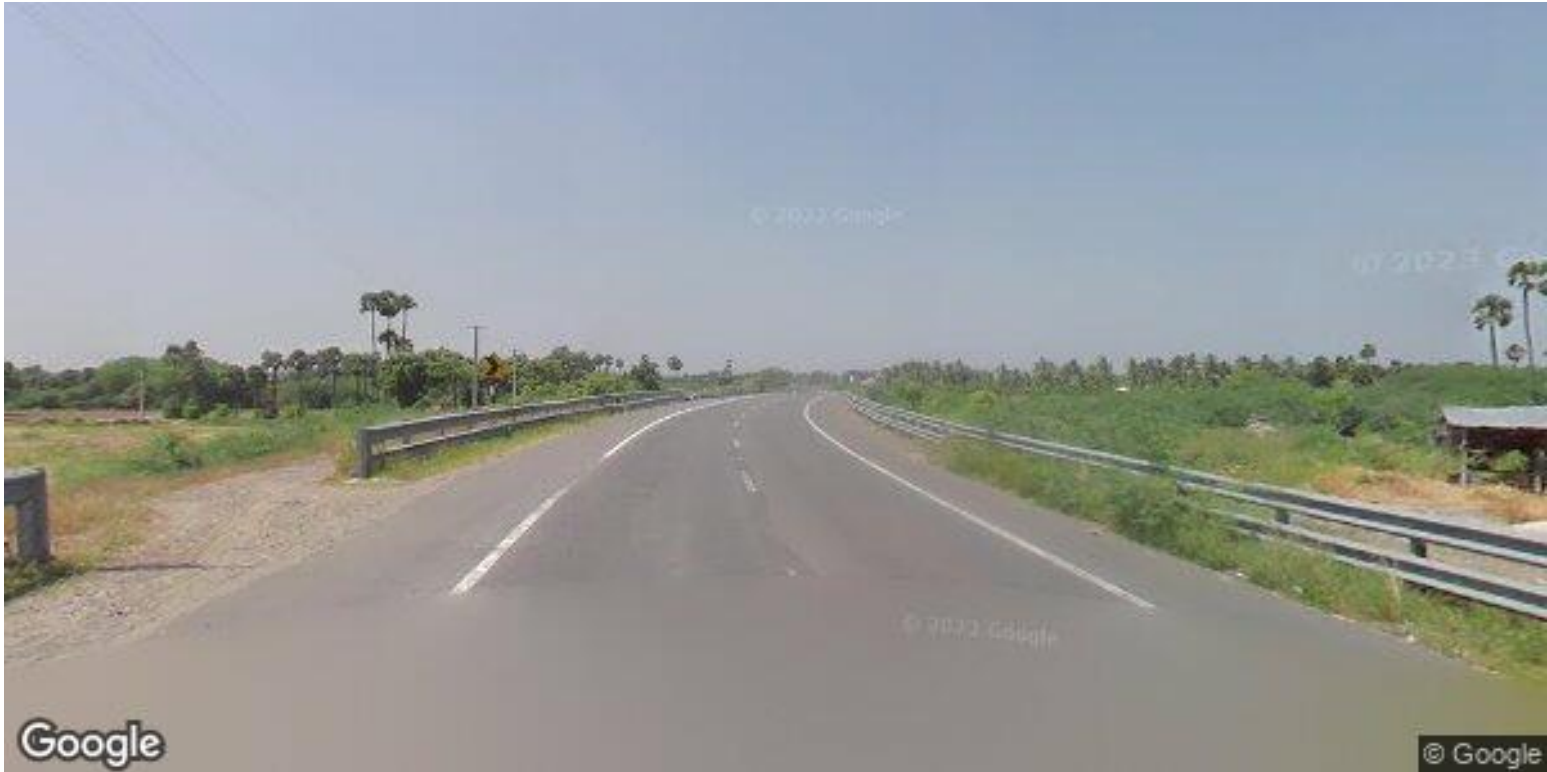
| | Risk Type | Risk Level | Coordinates | Speed Limit |
|---|---|---|---|---|
| 9 | Turn | Medium | 11.38968, 78.02925 | 30 KM/Hr |

**Risk Type:** Turn  
**Risk Level:** Medium  
**Speed Limit:** 30 KM/Hr  
**Coordinates:** 11.38968, 78.02925

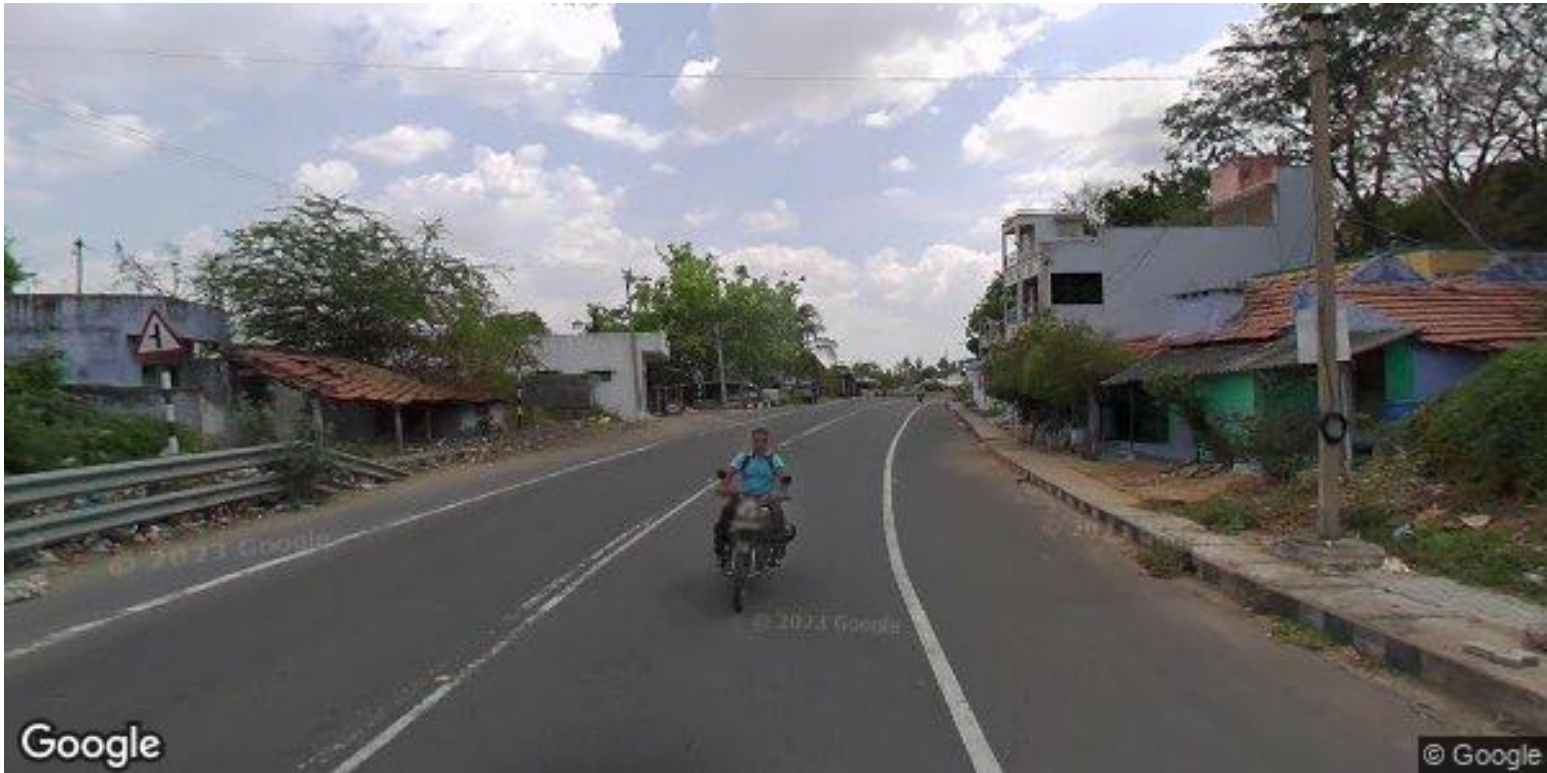
| | Risk Type | Risk Level | Coordinates | Speed Limit |
|---|---|---|---|---|
| 10 | Turn | Medium | 11.41310, 78.08062 | 30 KM/Hr |

**Risk Type:** Turn  
**Risk Level:** Medium  
**Speed Limit:** 30 KM/Hr  
**Coordinates:** 11.41310, 78.08062

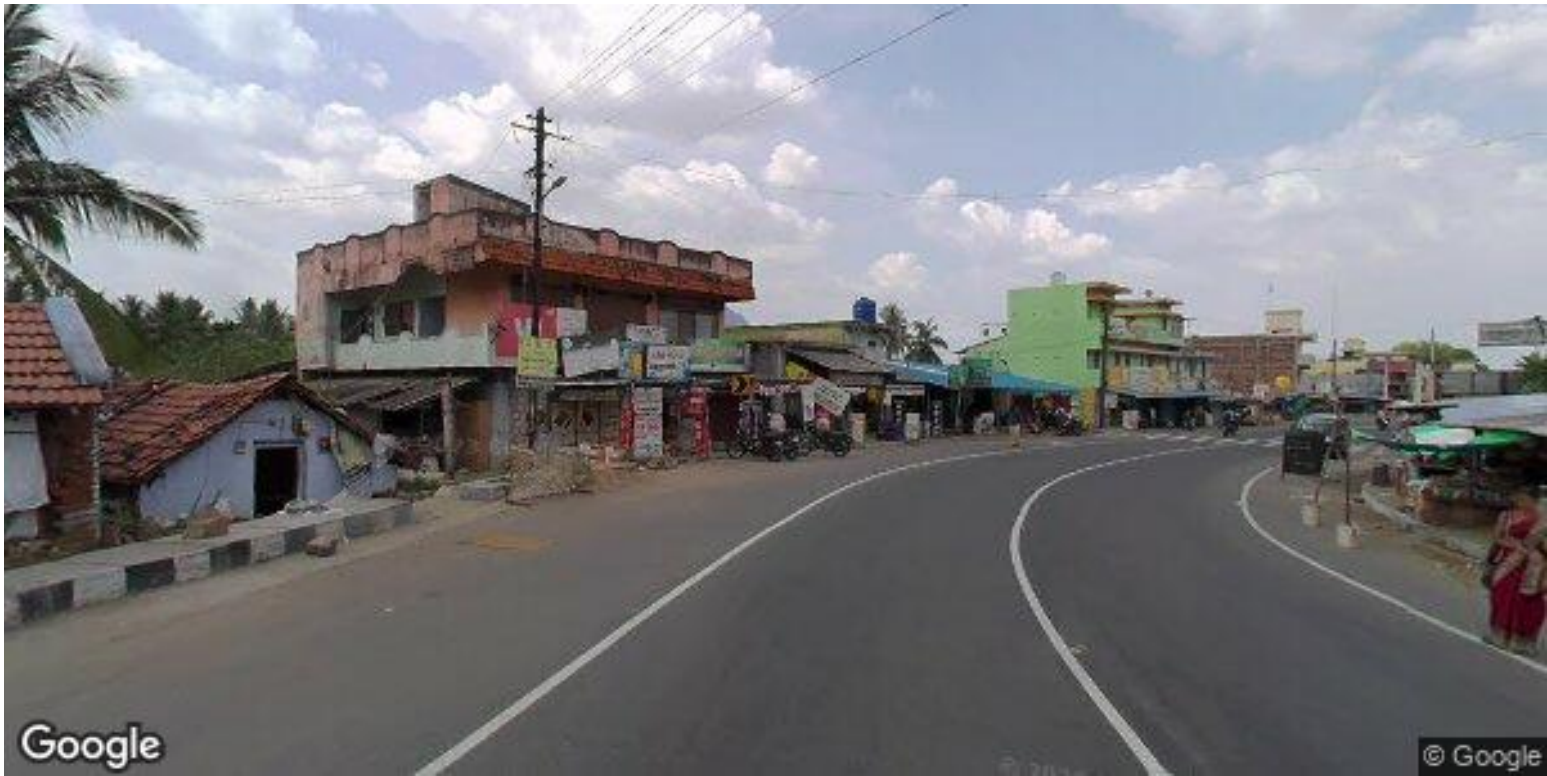
| | Risk Type | Risk Level | Coordinates | Speed Limit |
|---|---|---|---|---|
| 11 | Turn | High | 11.41468, 78.08072 | 15 KM/Hr |

**Risk Type:** Turn  
**Risk Level:** High  
**Speed Limit:** 15 KM/Hr  
**Coordinates:** 11.41468, 78.08072

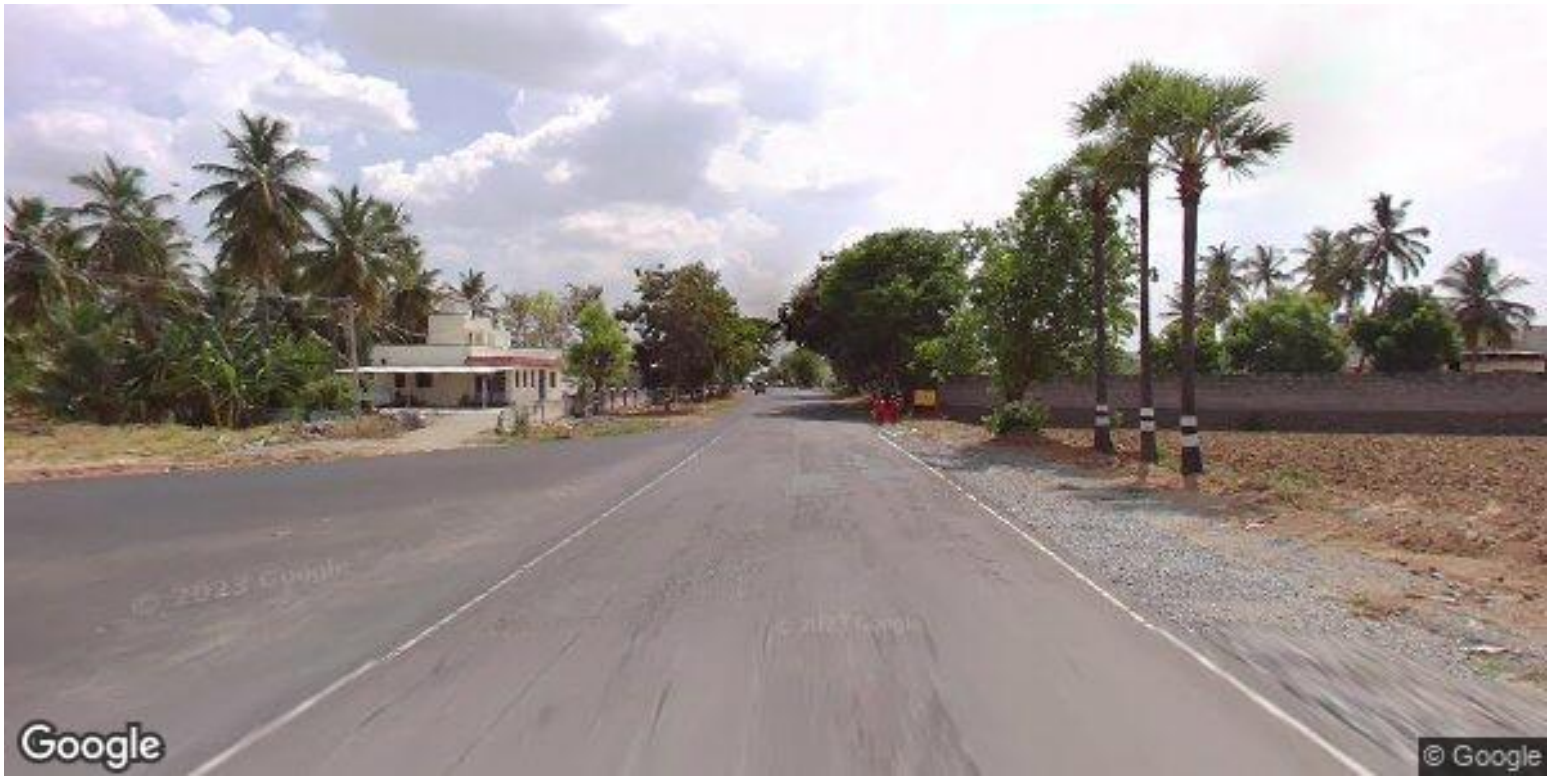
| | Risk Type | Risk Level | Coordinates | Speed Limit |
|---|---|---|---|---|
| 12 | Turn | High | 11.42964, 78.11587 | 15 KM/Hr |

**Risk Type:** Turn  
**Risk Level:** High  
**Speed Limit:** 15 KM/Hr  
**Coordinates:** 11.42964, 78.11587

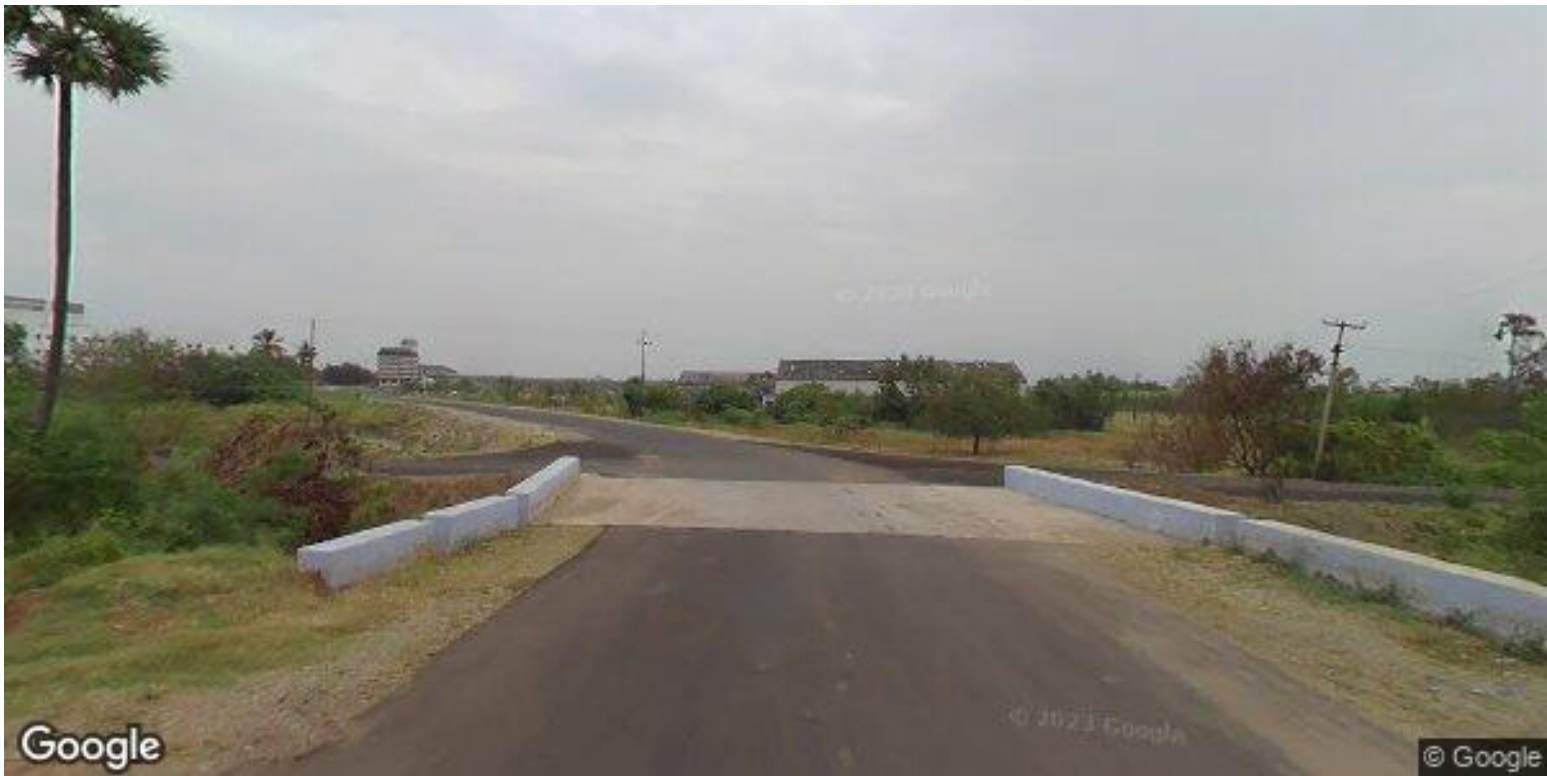
| | Risk Type | Risk Level | Coordinates | Speed Limit |
|---|---|---|---|---|
| 13 | Turn | Medium | 11.42447, 78.15264 | 30 KM/Hr |

**Risk Type:** Turn  
**Risk Level:** Medium  
**Speed Limit:** 30 KM/Hr  
**Coordinates:** 11.42447, 78.15264

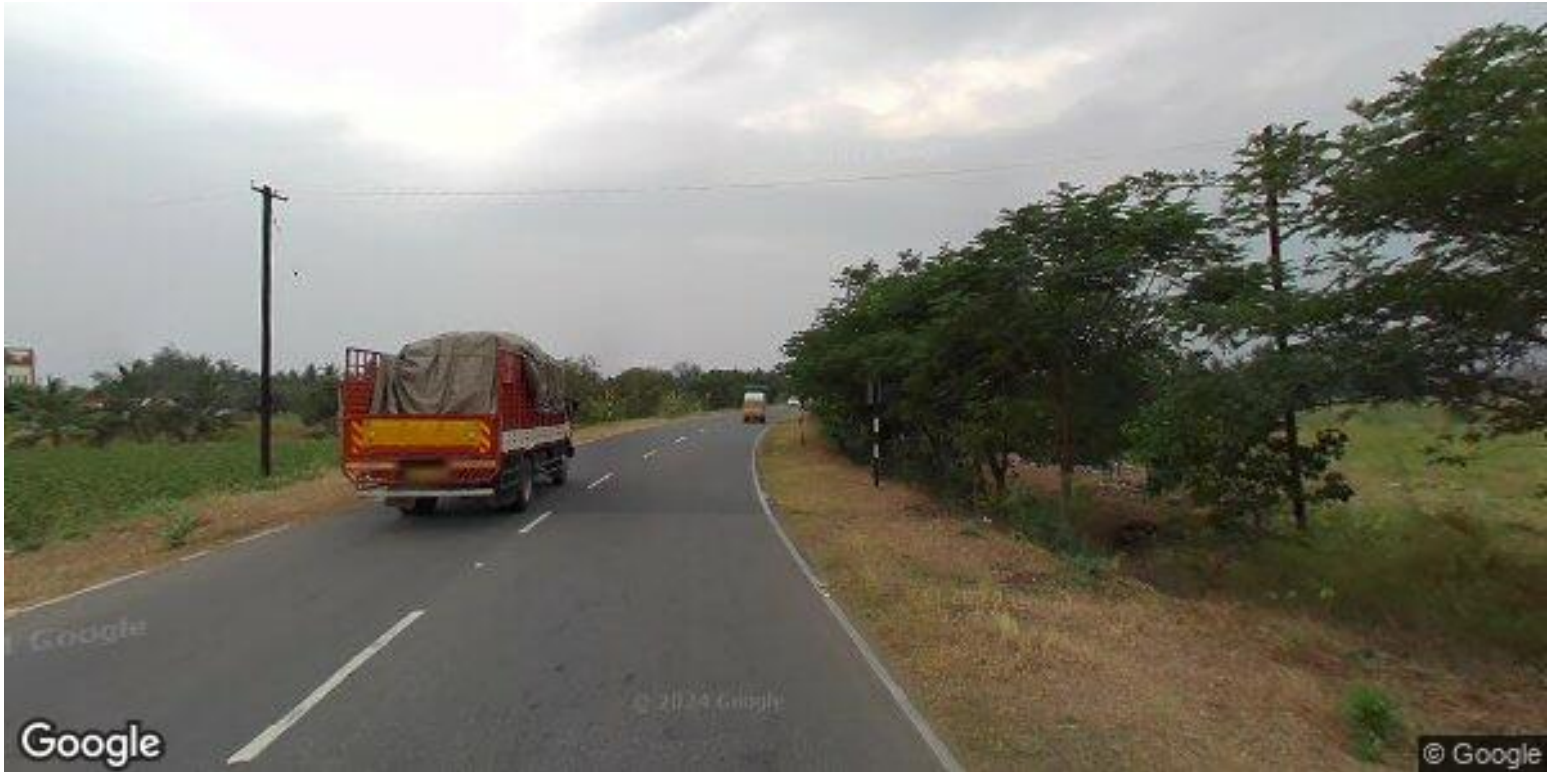
| | Risk Type | Risk Level | Coordinates | Speed Limit |
|---|---|---|---|---|
| 14 | Turn | Medium | 11.42962, 78.16871 | 30 KM/Hr |

**Risk Type:** Turn  
**Risk Level:** Medium  
**Speed Limit:** 30 KM/Hr  
**Coordinates:** 11.42962, 78.16871

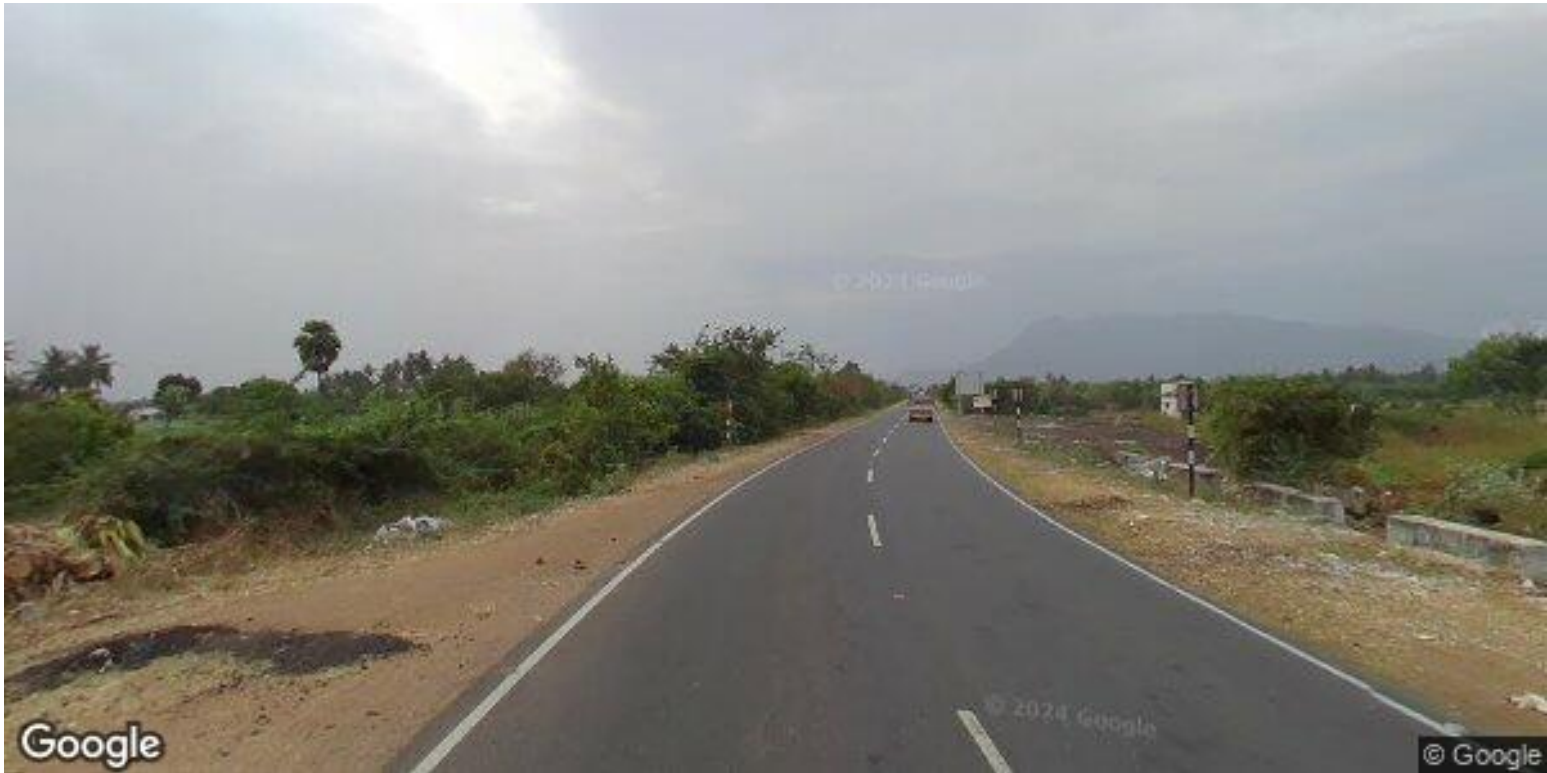
| | Risk Type | Risk Level | Coordinates | Speed Limit |
|---|---|---|---|---|
| 15 | Turn | Medium | 11.43142, 78.18781 | 30 KM/Hr |

**Risk Type:** Turn  
**Risk Level:** Medium  
**Speed Limit:** 30 KM/Hr  
**Coordinates:** 11.43142, 78.18781

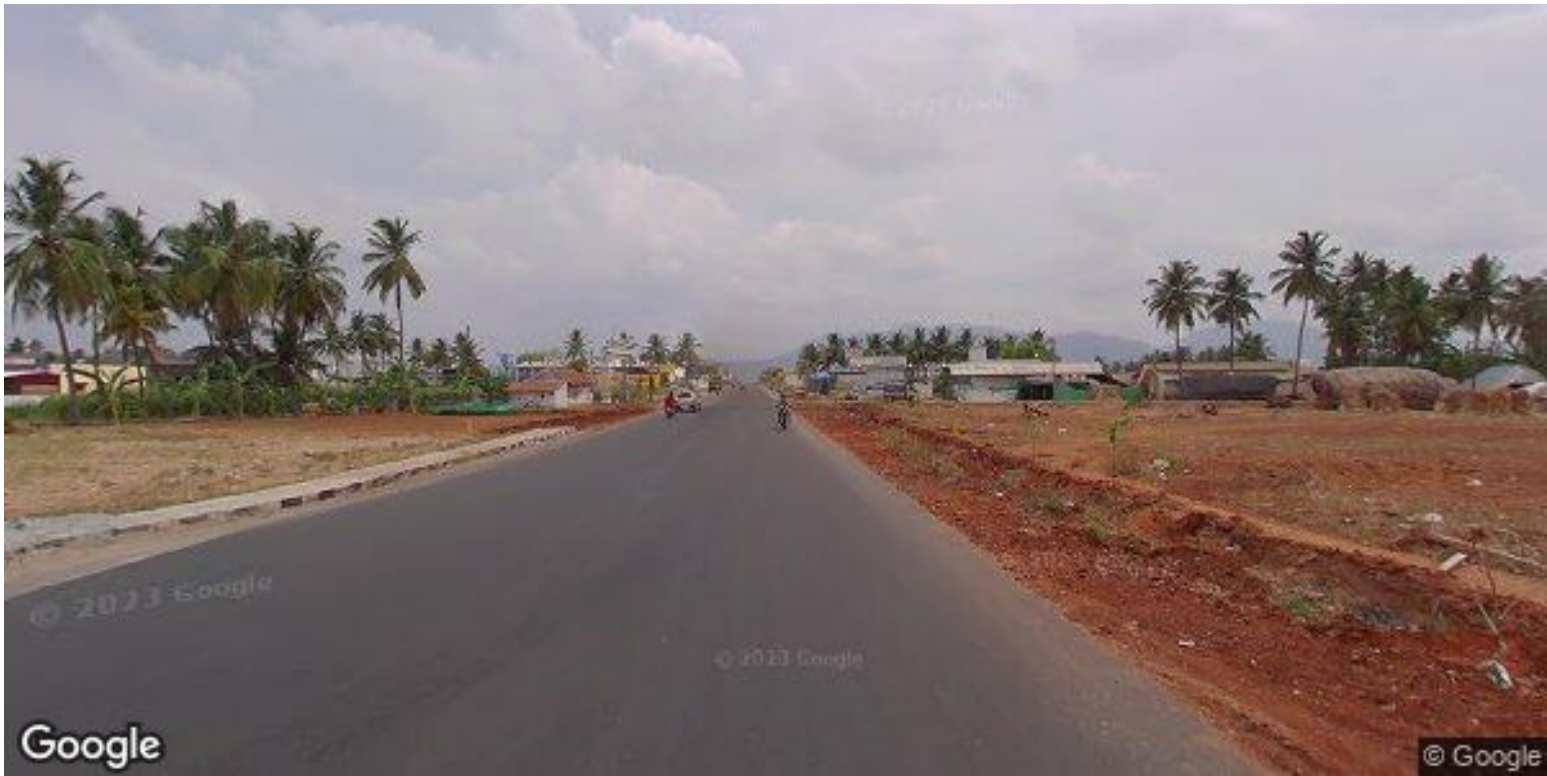
| | Risk Type | Risk Level | Coordinates | Speed Limit |
|---|---|---|---|---|
| 16 | Turn | High | 11.43542, 78.20754 | 15 KM/Hr |

**Risk Type:** Turn  
**Risk Level:** High  
**Speed Limit:** 15 KM/Hr  
**Coordinates:** 11.43542, 78.20754

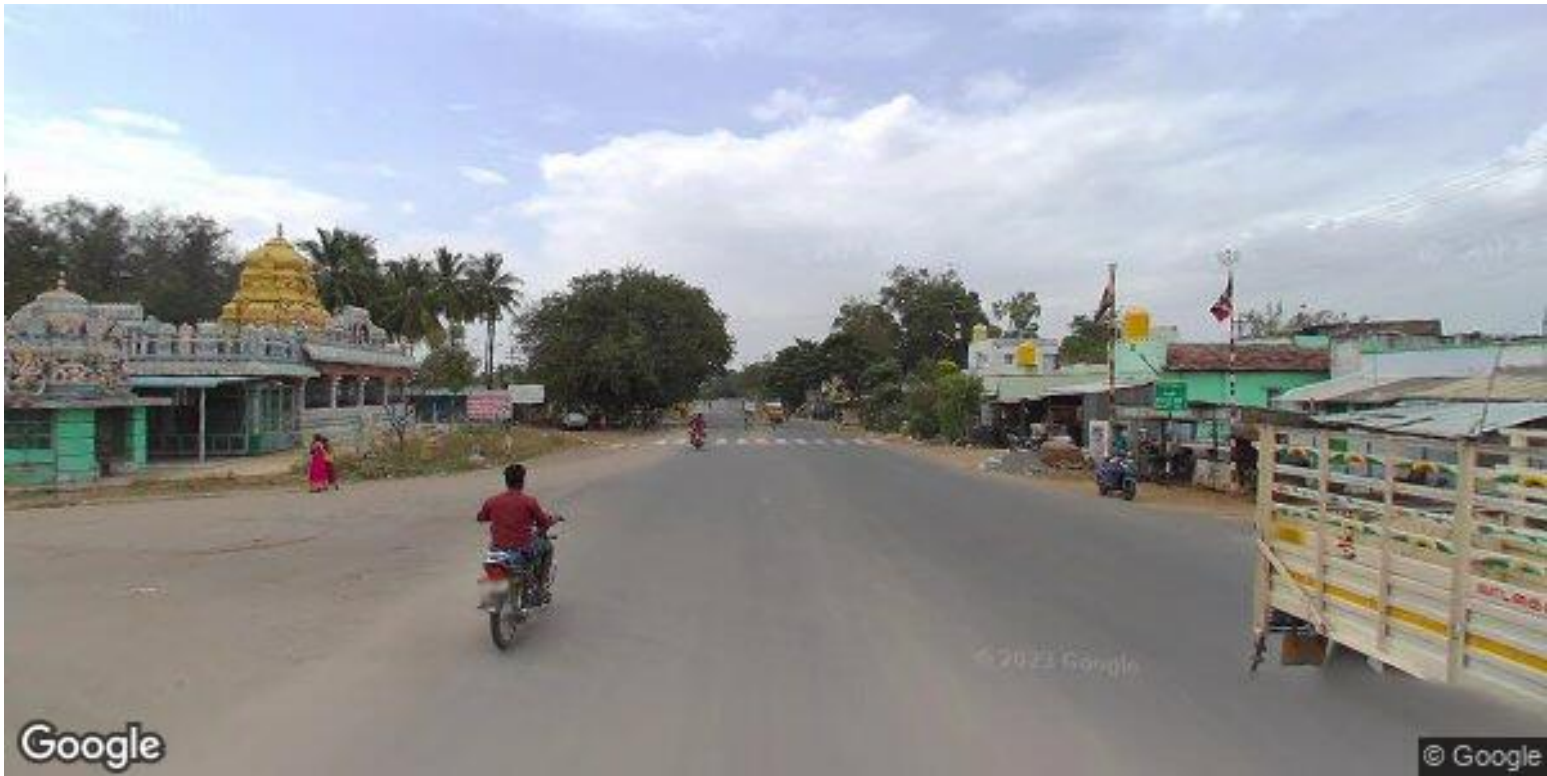
| | Risk Type | Risk Level | Coordinates | Speed Limit |
|---|---|---|---|---|
| 17 | Blind Spot | Blind Spot | 11.45099, 78.20397 | 10 KM/Hr |

**Risk Type:** Blind Spot  
**Risk Level:** Blind Spot  
**Speed Limit:** 10 KM/Hr  
**Coordinates:** 11.45099, 78.20397

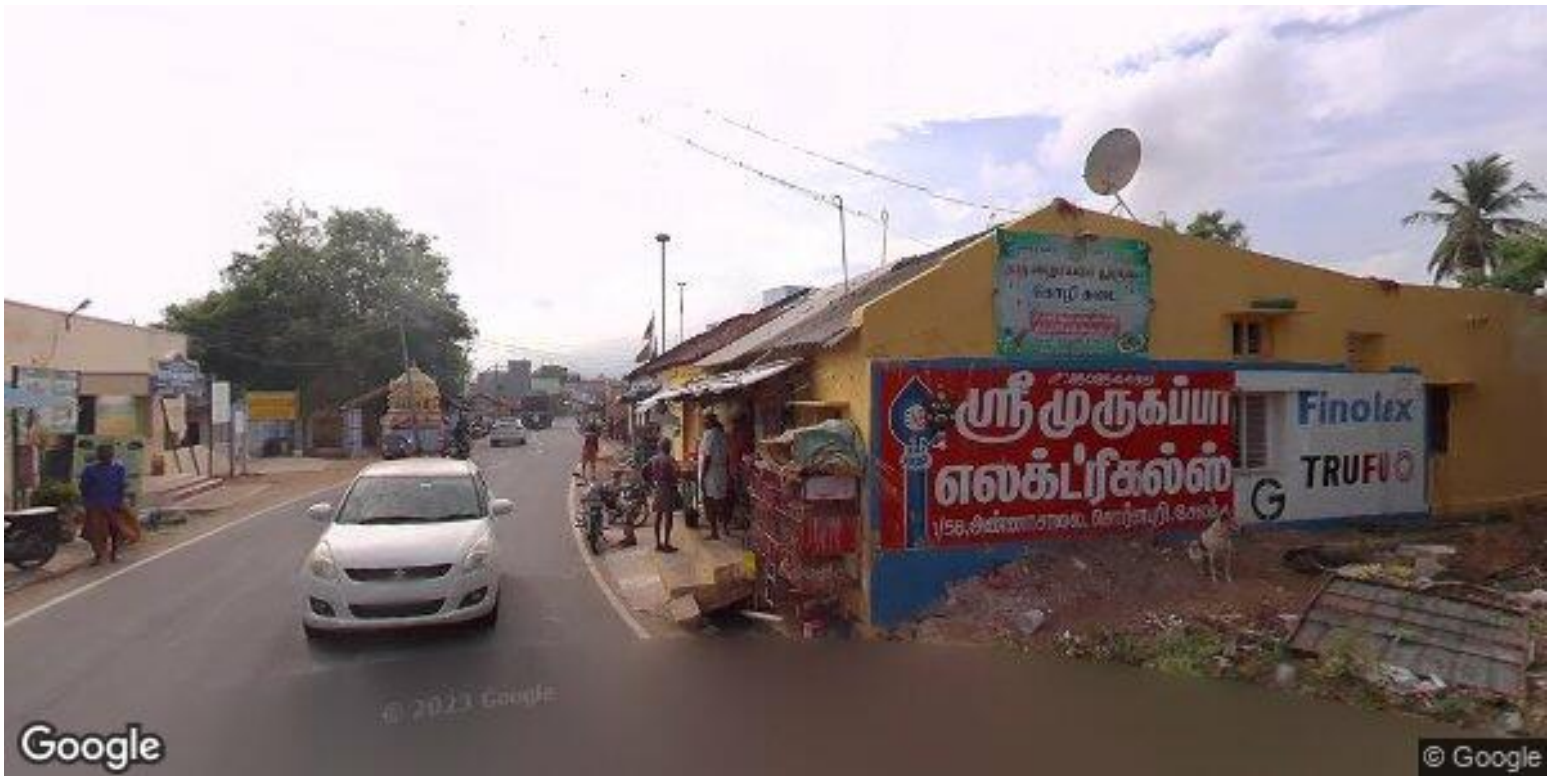
| | Risk Type | Risk Level | Coordinates | Speed Limit |
|---|---|---|---|---|
| 18 | Turn | Medium | 11.44993, 78.22146 | 30 KM/Hr |

**Risk Type:** Turn  
**Risk Level:** Medium  
**Speed Limit:** 30 KM/Hr  
**Coordinates:** 11.44993, 78.22146

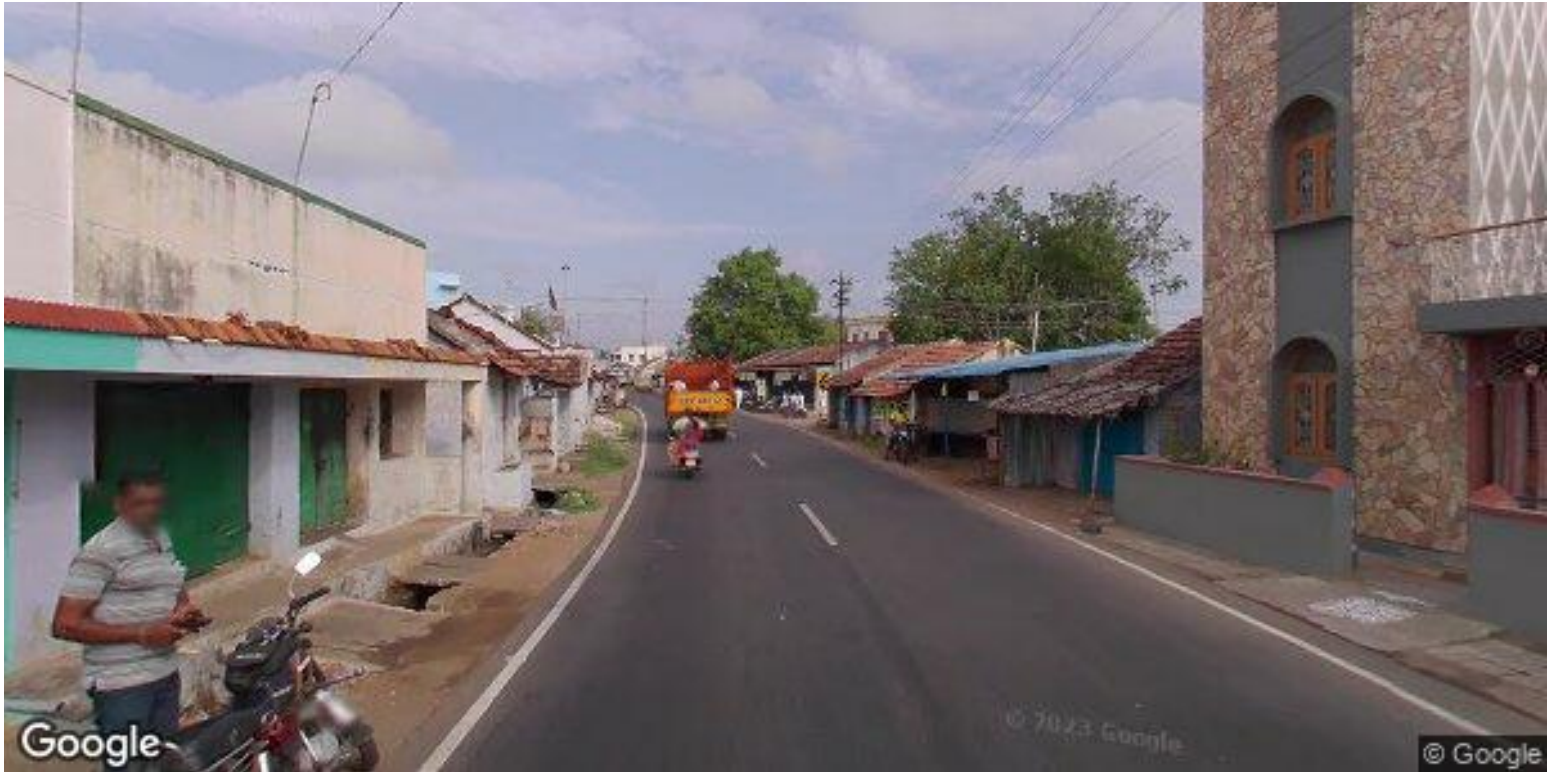
| | Risk Type | Risk Level | Coordinates | Speed Limit |
|---|---|---|---|---|
| 19 | Turn | Medium | 11.44956, 78.22253 | 30 KM/Hr |

**Risk Type:** Turn  
**Risk Level:** Medium  
**Speed Limit:** 30 KM/Hr  
**Coordinates:** 11.44956, 78.22253
