# IndianOil

## JOURNEY RISK MANAGEMENT (JRM) STUDY

### Salem Terminal to SUDHARSAN TRADERS

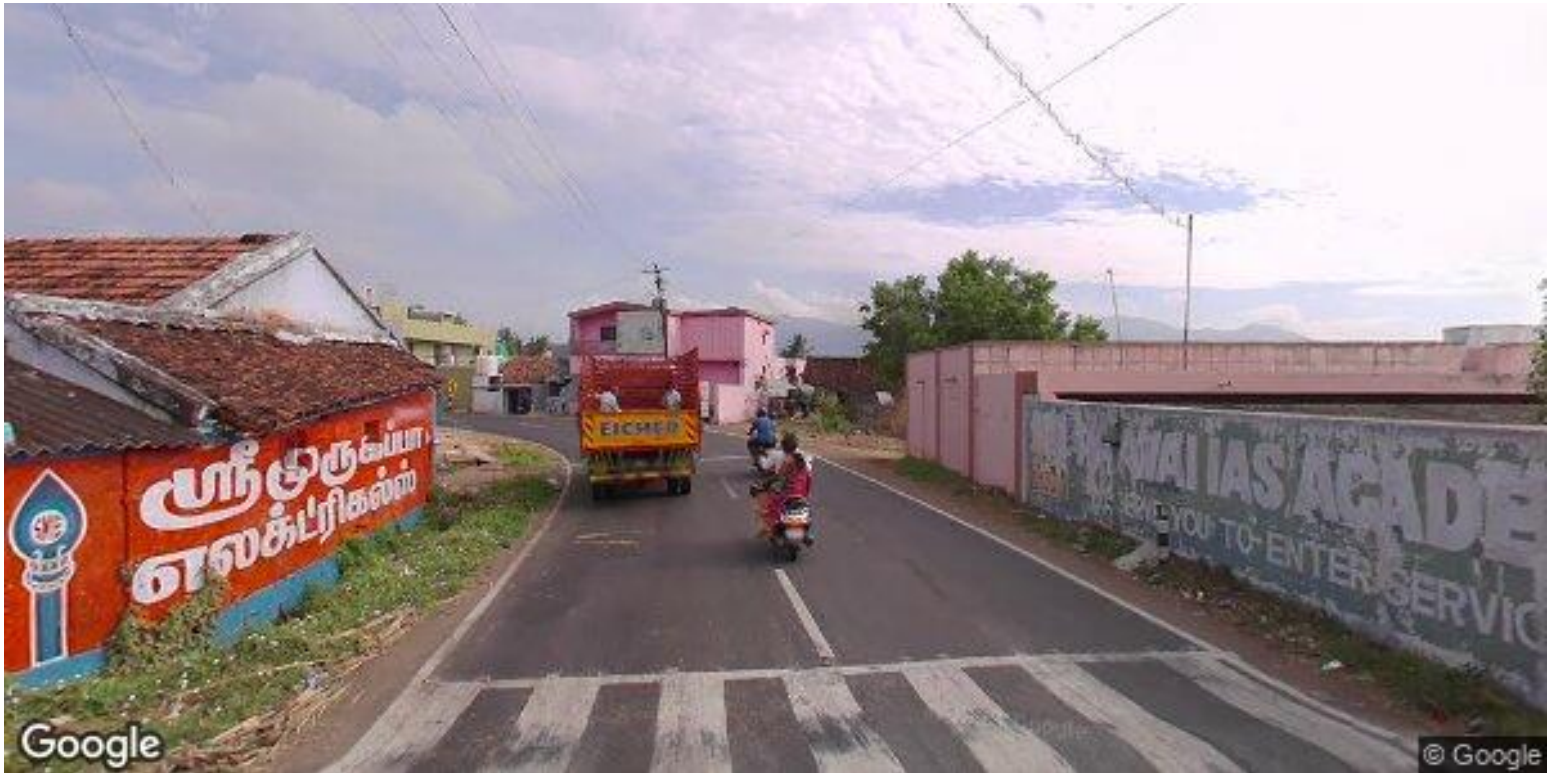
| | Risk Type | Risk Level | Coordinates | Speed Limit |
|---|---|---|---|---|
| 20 | Turn | Medium | 11.44909, 78.22293 | 30 KM/Hr |

**Risk Type:** Turn  
**Risk Level:** Medium  
**Speed Limit:** 30 KM/Hr  
**Coordinates:** 11.44909, 78.22293

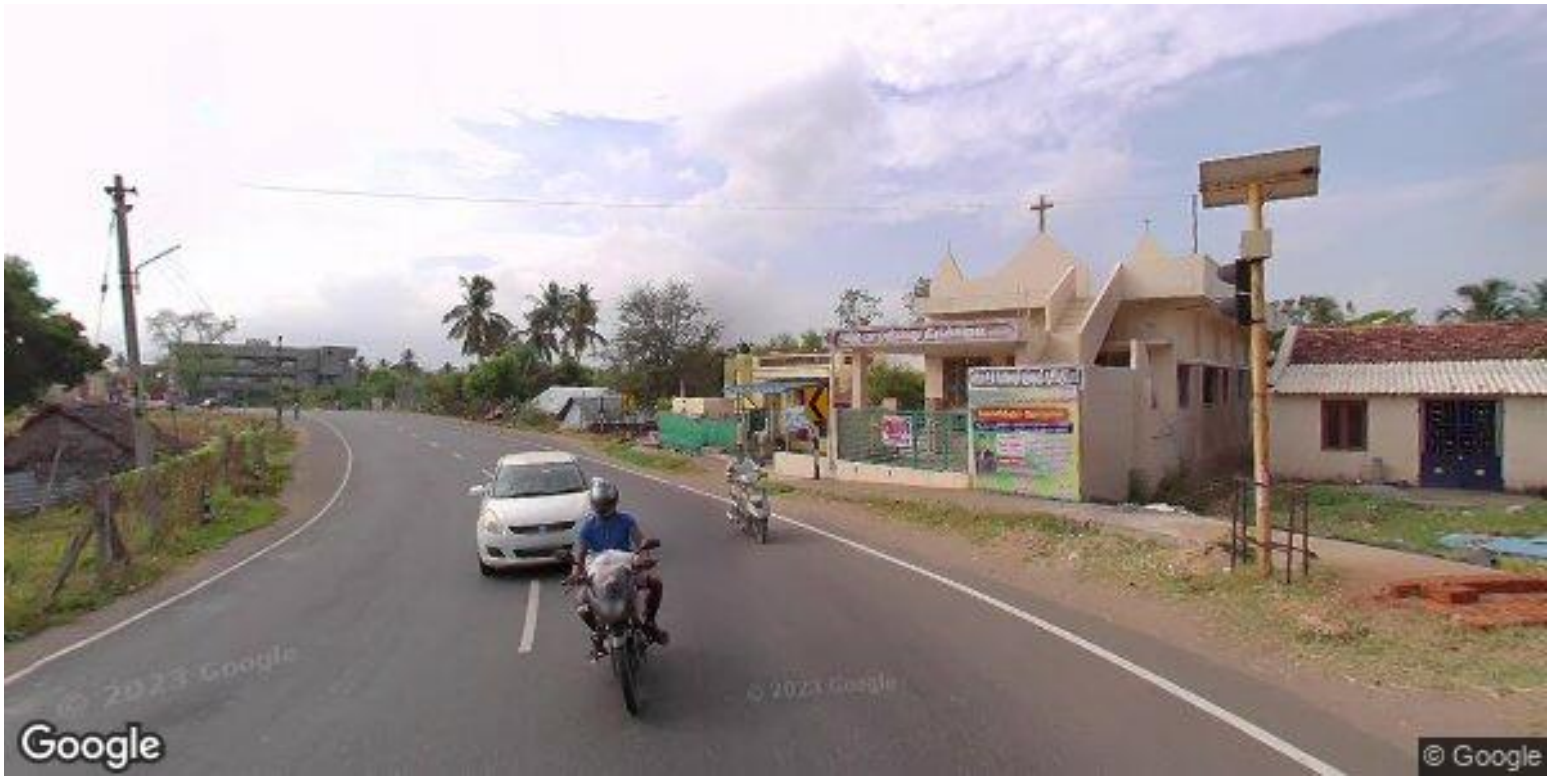
| | Risk Type | Risk Level | Coordinates | Speed Limit |
|---|---|---|---|---|
| 21 | Turn | High | 11.44800, 78.22312 | 15 KM/Hr |

Risk Type: Turn

Risk Level: High

Speed Limit: 15 KM/Hr

Coordinates: 11.44800, 78.22312

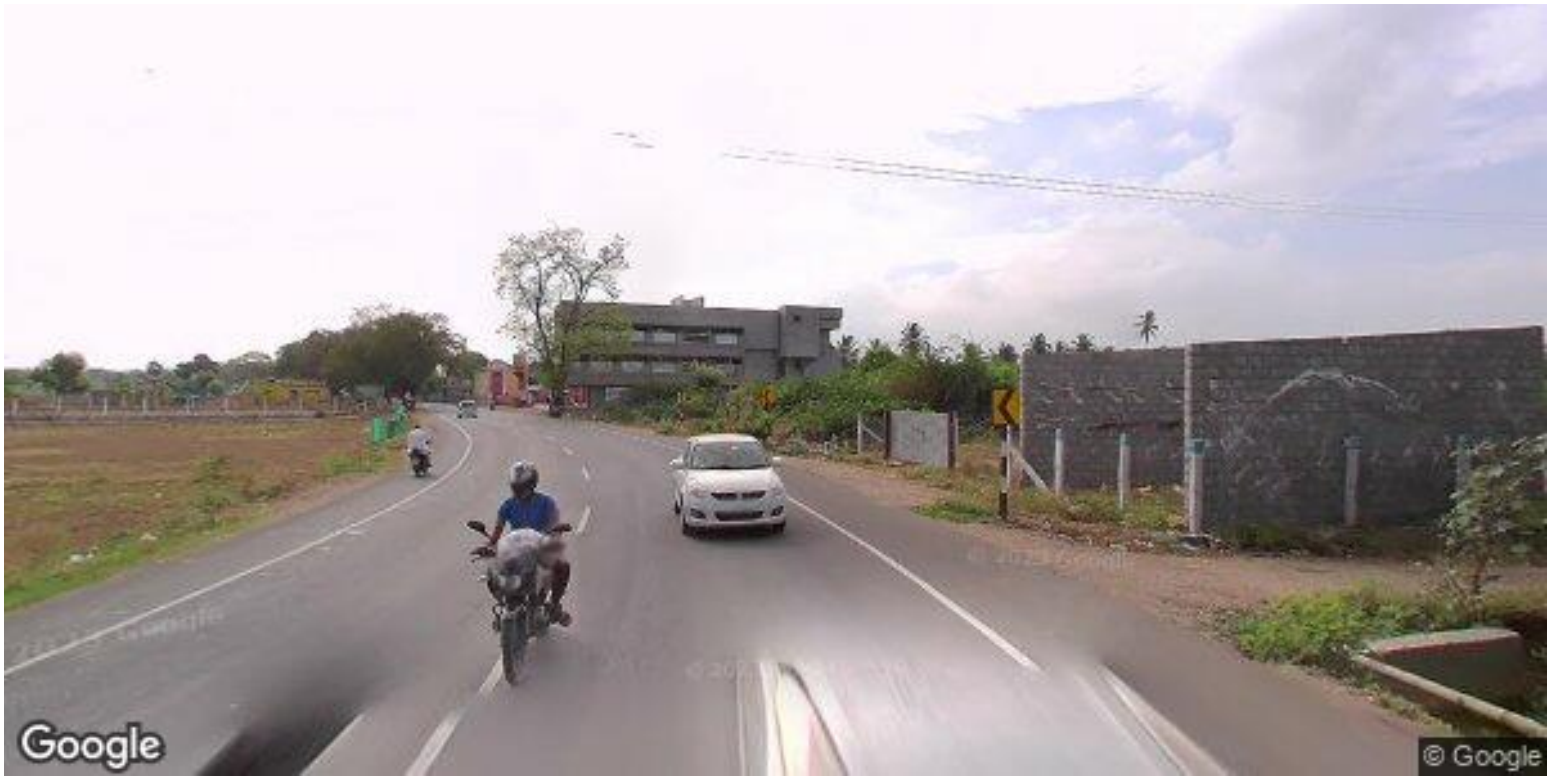
| | Risk Type | Risk Level | Coordinates | Speed Limit |
|---|---|---|---|---|
| 22 | Turn | Medium | 11.44758, 78.22397 | 30 KM/Hr |

Risk Type: Turn

Risk Level: Medium

Speed Limit: 30 KM/Hr

Coordinates: 11.44758, 78.22397

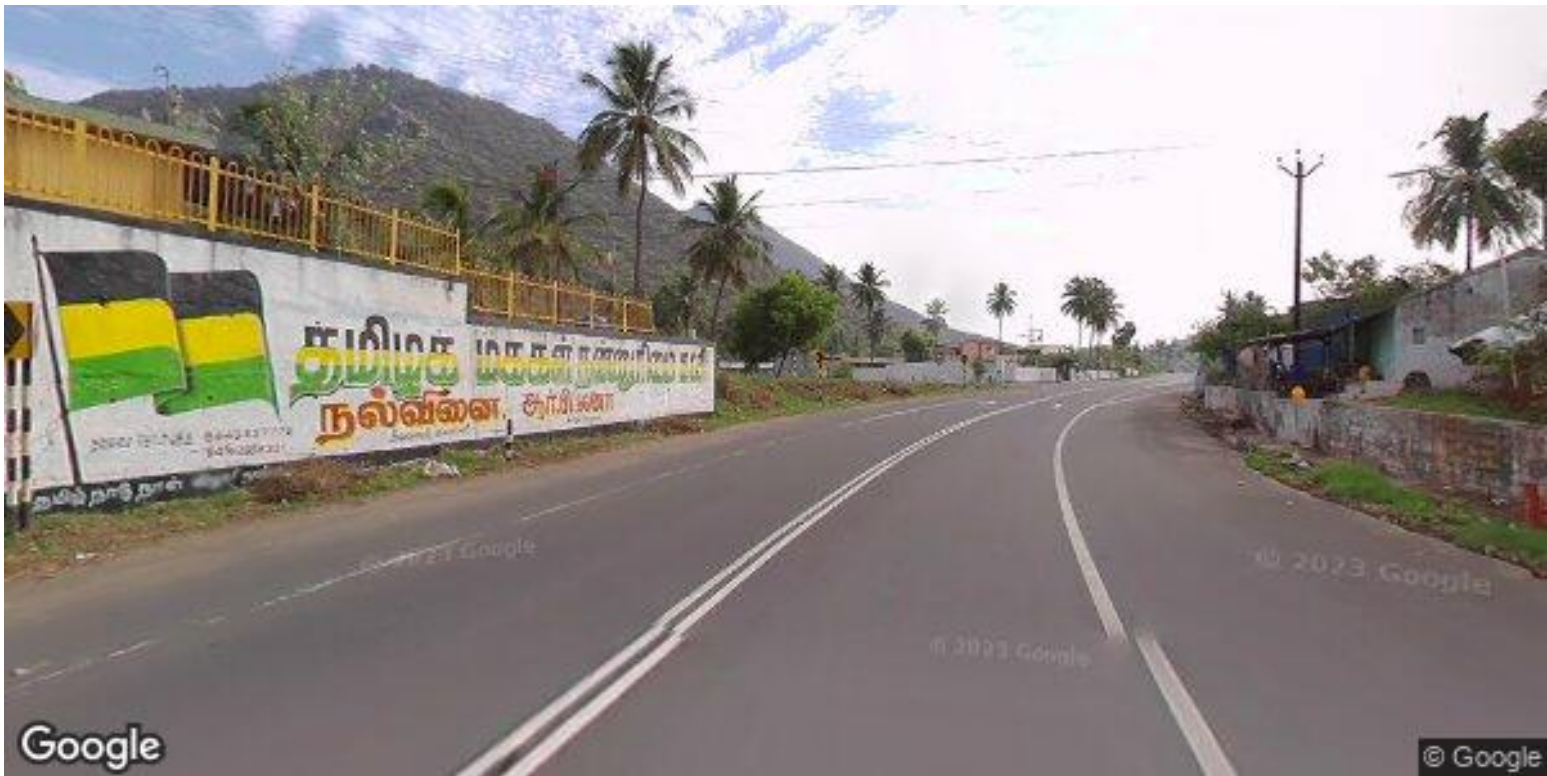
| | Risk Type | Risk Level | Coordinates | Speed Limit |
|---|---|---|---|---|
| 23 | Turn | Medium | 11.49825, 78.32406 | 30 KM/Hr |

**Risk Type:** Turn  
**Risk Level:** Medium  
**Speed Limit:** 30 KM/Hr  
**Coordinates:** 11.49825, 78.32406

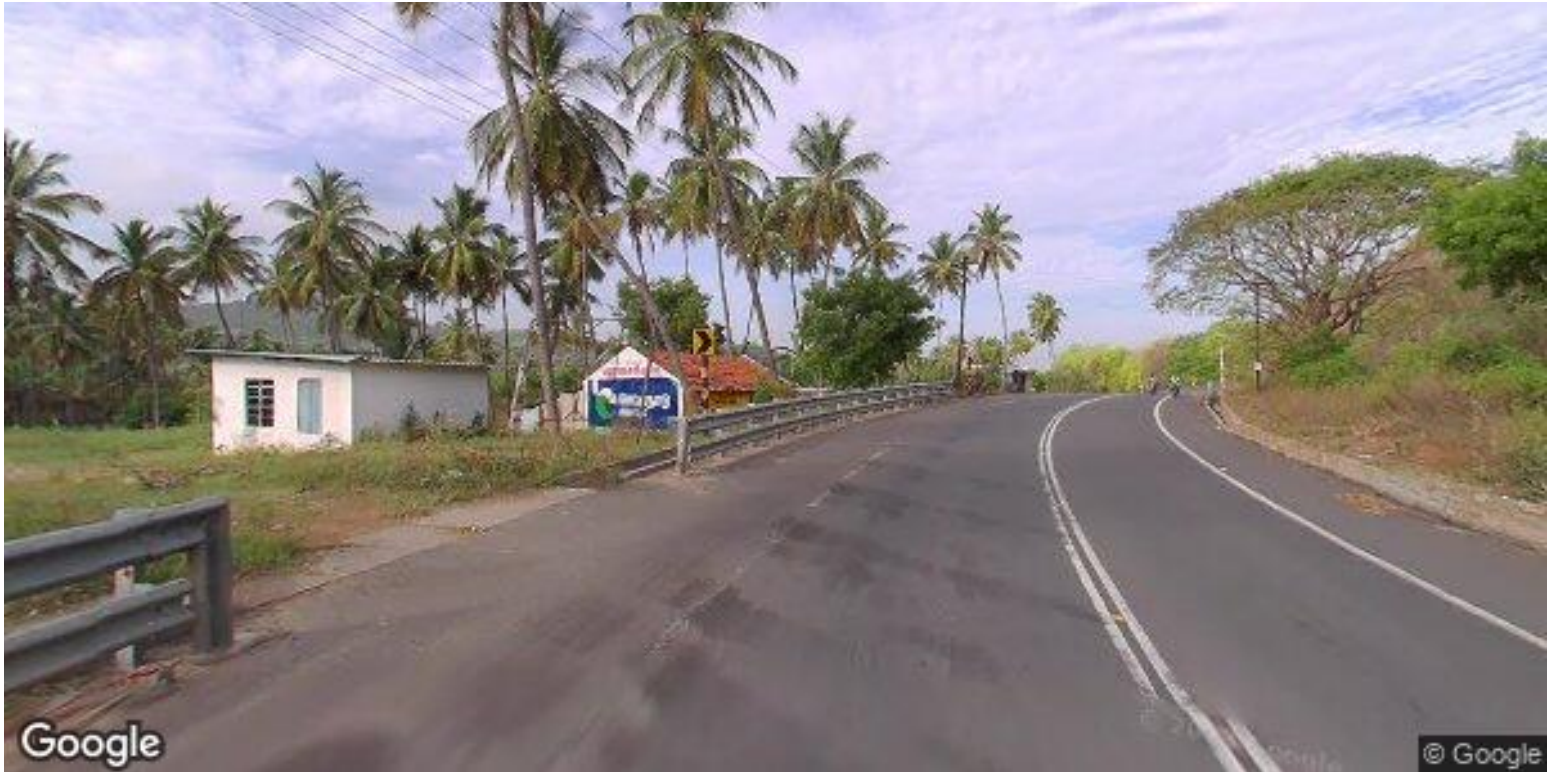
| | Risk Type | Risk Level | Coordinates | Speed Limit |
|---|---|---|---|---|
| 24 | Turn | Medium | 11.50502, 78.33084 | 30 KM/Hr |

**Risk Type:** Turn  
**Risk Level:** Medium  
**Speed Limit:** 30 KM/Hr  
**Coordinates:** 11.50502, 78.33084

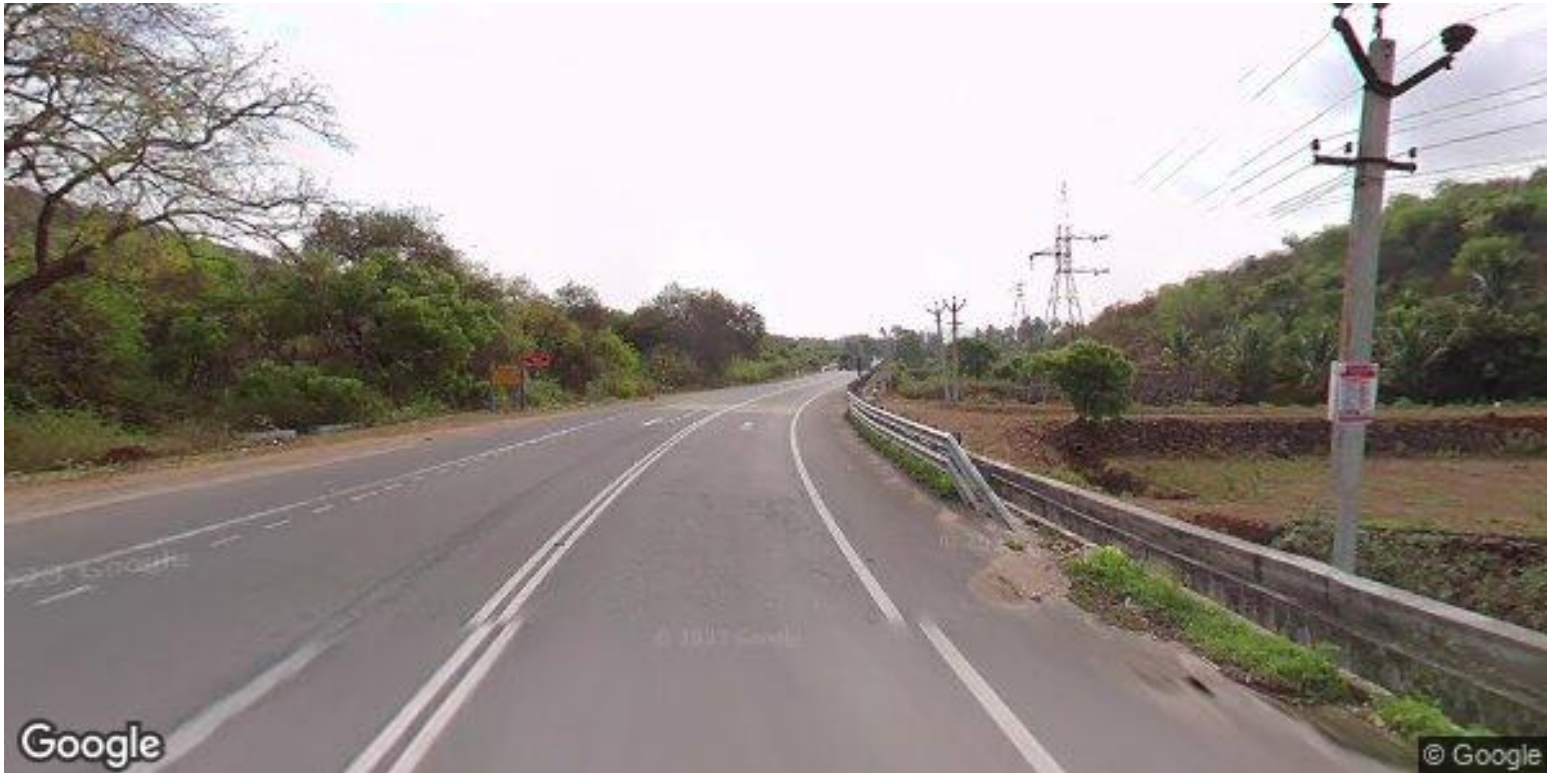
| | Risk Type | Risk Level | Coordinates | Speed Limit |
|---|---|---|---|---|
| 25 | Turn | Medium | 11.50779, 78.33309 | 30 KM/Hr |

**Risk Type:** Turn  
**Risk Level:** Medium  
**Speed Limit:** 30 KM/Hr  
**Coordinates:** 11.50779, 78.33309

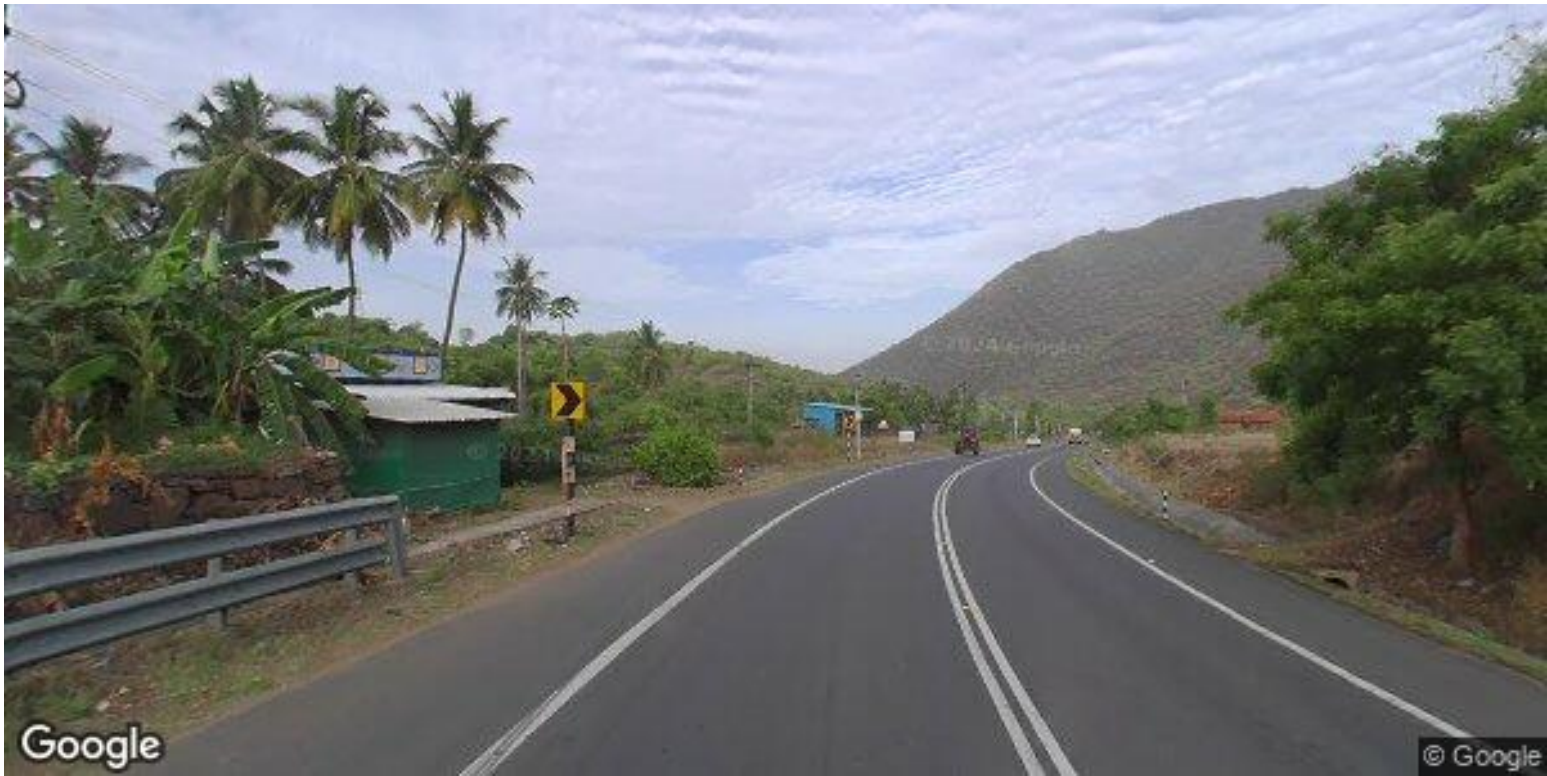
| | Risk Type | Risk Level | Coordinates | Speed Limit |
|---|---|---|---|---|
| 26 | Turn | Medium | 11.50863, 78.33962 | 30 KM/Hr |

**Risk Type:** Turn  
**Risk Level:** Medium  
**Speed Limit:** 30 KM/Hr  
**Coordinates:** 11.50863, 78.33962

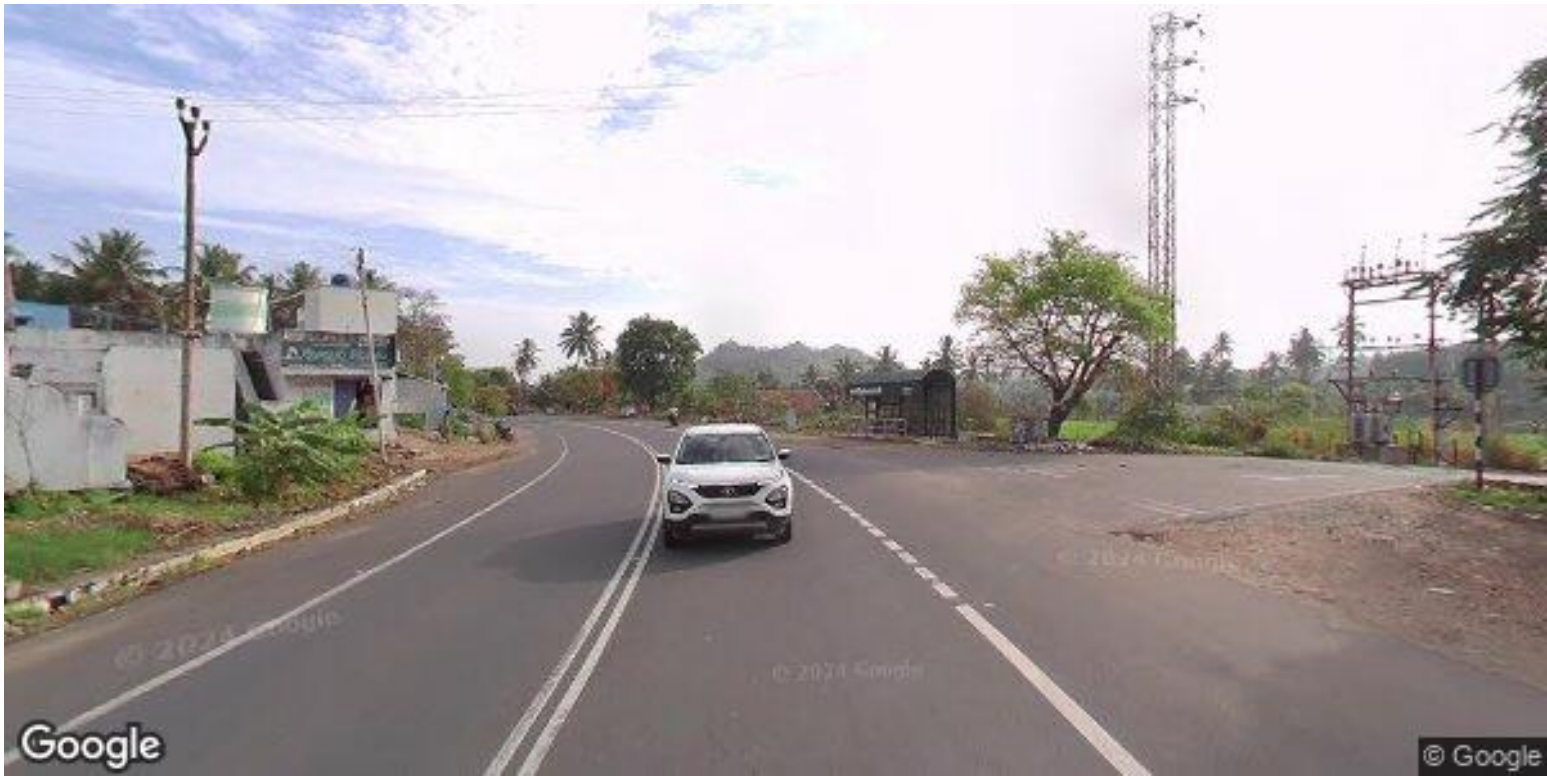
| | Risk Type | Risk Level | Coordinates | Speed Limit |
|---|---|---|---|---|
| 27 | Turn | Medium | 11.51862, 78.34812 | 30 KM/Hr |

**Risk Type:** Turn  
**Risk Level:** Medium  
**Speed Limit:** 30 KM/Hr  
**Coordinates:** 11.51862, 78.34812

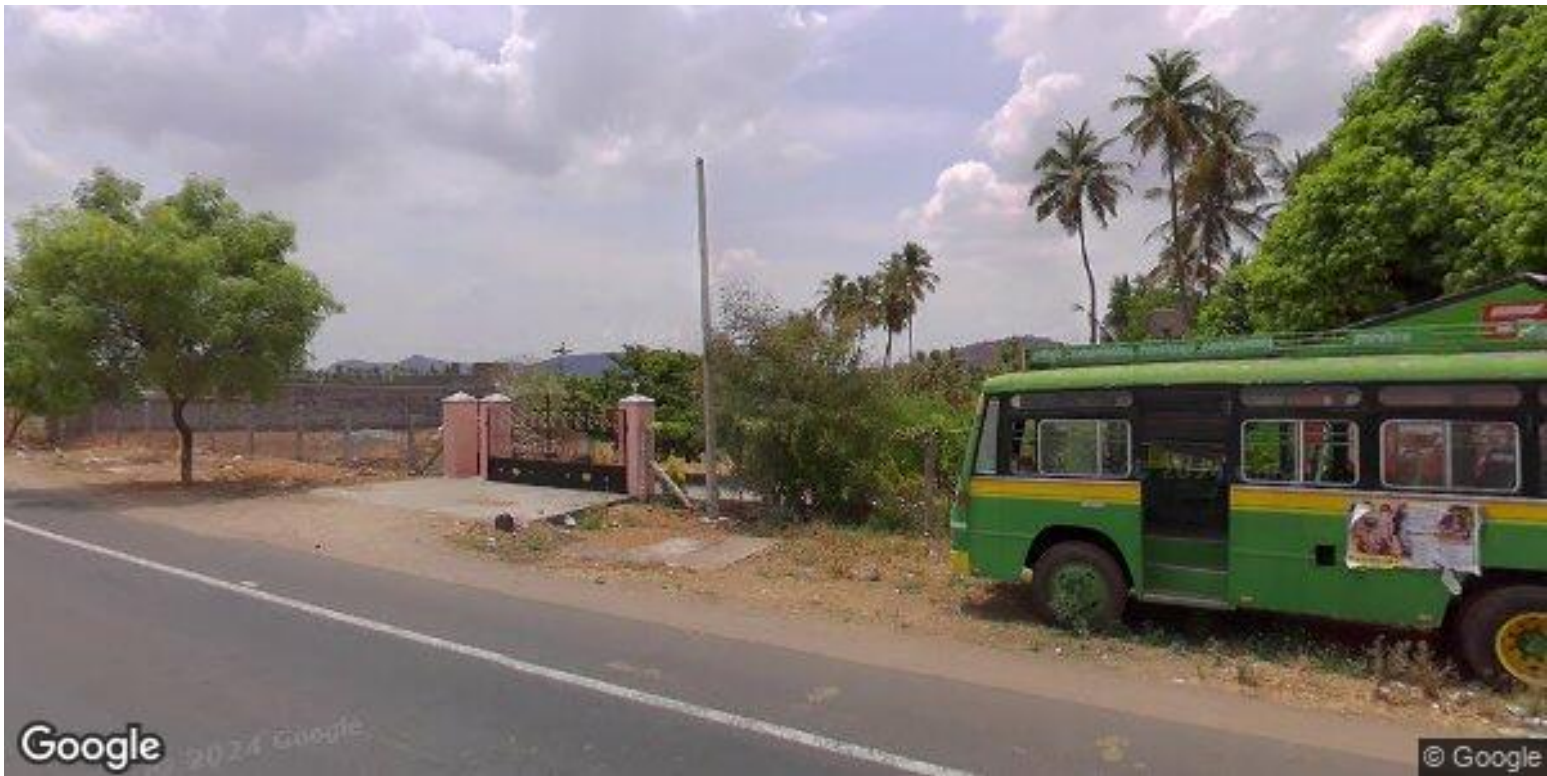
| | Risk Type | Risk Level | Coordinates | Speed Limit |
|---|---|---|---|---|
| 28 | Turn | Medium | 11.54826, 78.35614 | 30 KM/Hr |

**Risk Type:** Turn  
**Risk Level:** Medium  
**Speed Limit:** 30 KM/Hr  
**Coordinates:** 11.54826, 78.35614

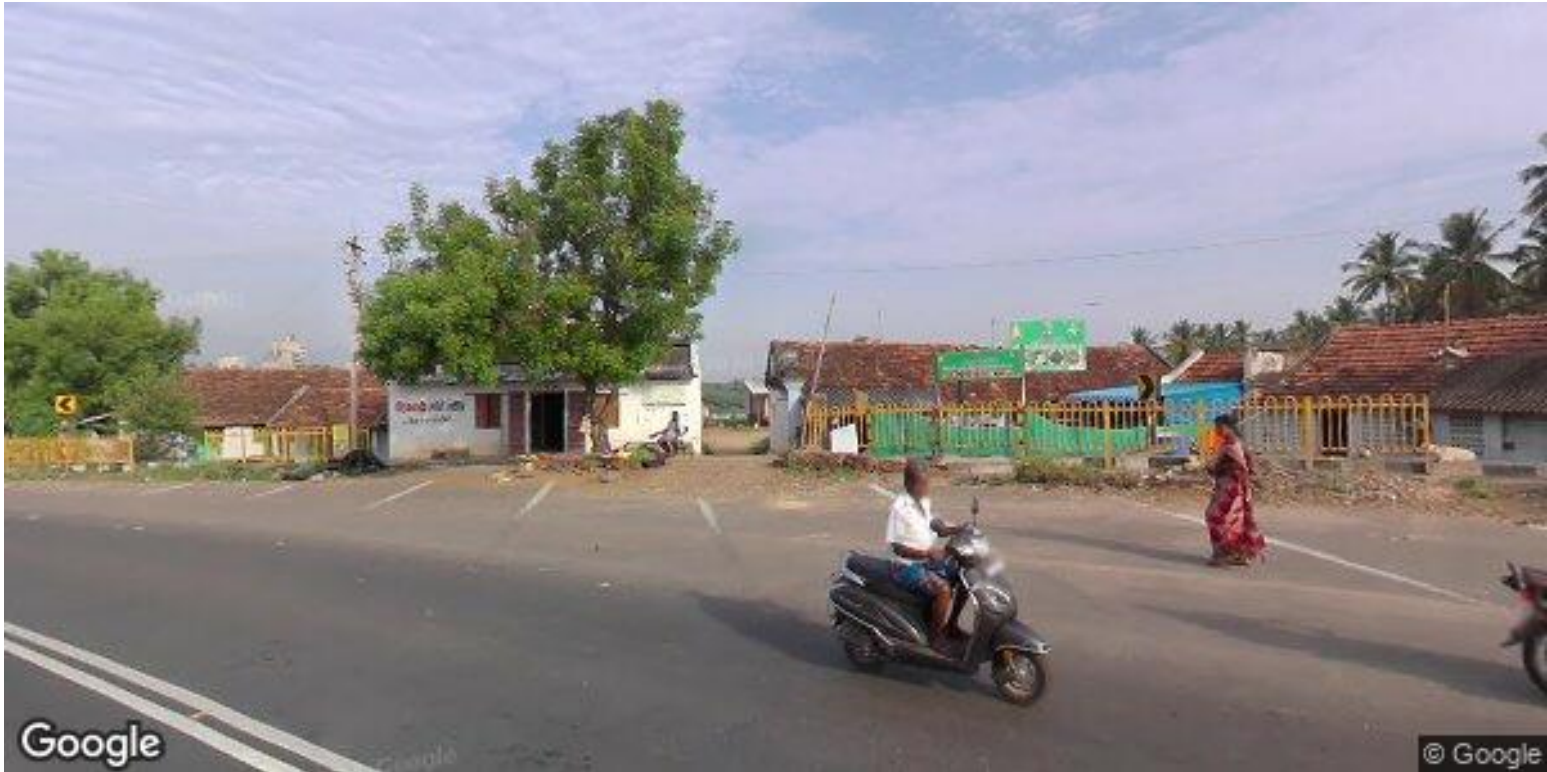
| | Risk Type | Risk Level | Coordinates | Speed Limit |
|---|---|---|---|---|
| 29 | Turn | Medium | 11.56714, 78.37807 | 30 KM/Hr |

**Risk Type:** Turn  
**Risk Level:** Medium  
**Speed Limit:** 30 KM/Hr  
**Coordinates:** 11.56714, 78.37807

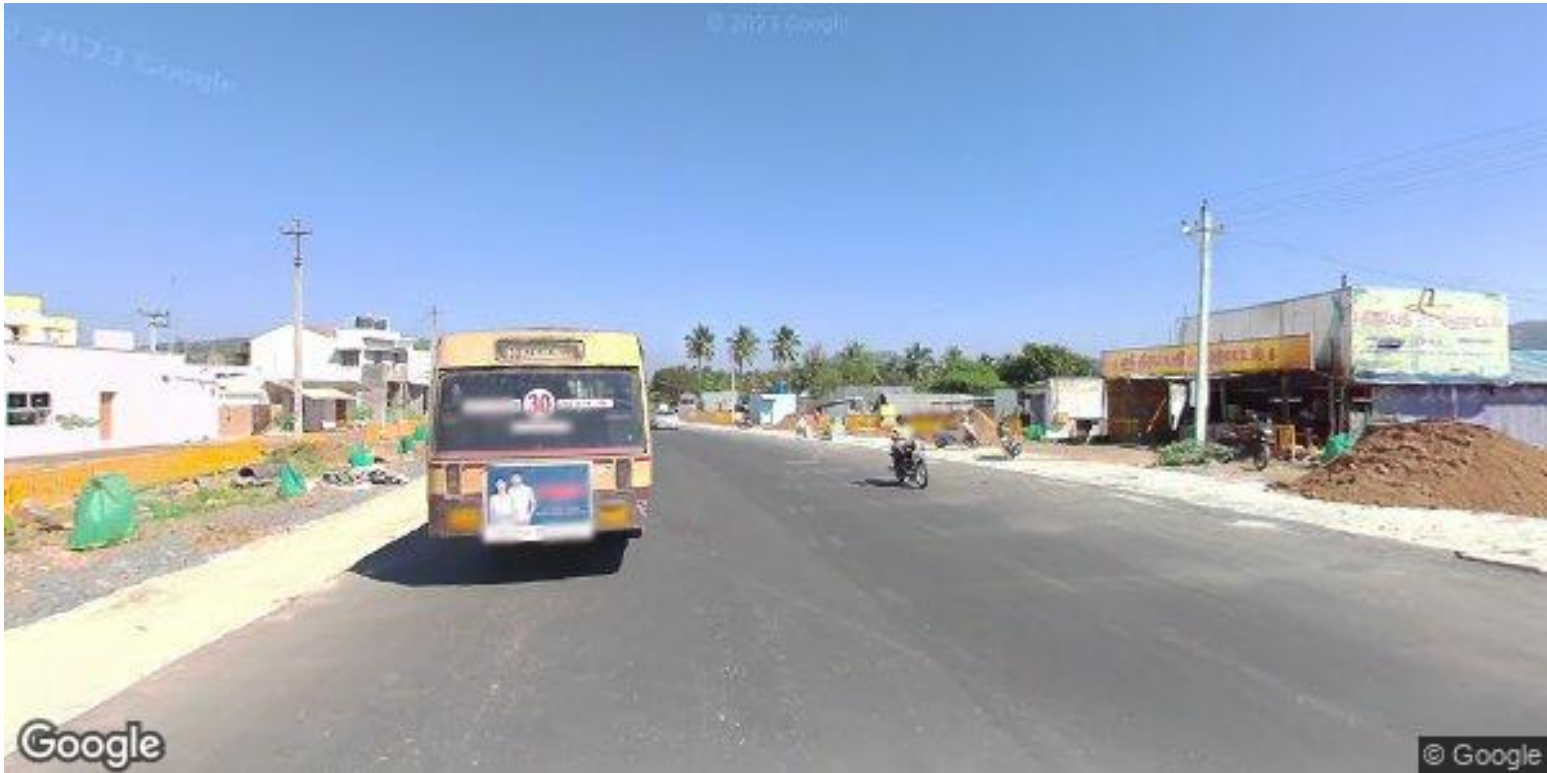
| | Risk Type | Risk Level | Coordinates | Speed Limit |
|---|---|---|---|---|
| 30 | Turn | Medium | 11.57102, 78.50078 | 30 KM/Hr |

**Risk Type:** Turn  
**Risk Level:** Medium  
**Speed Limit:** 30 KM/Hr  
**Coordinates:** 11.57102, 78.50078

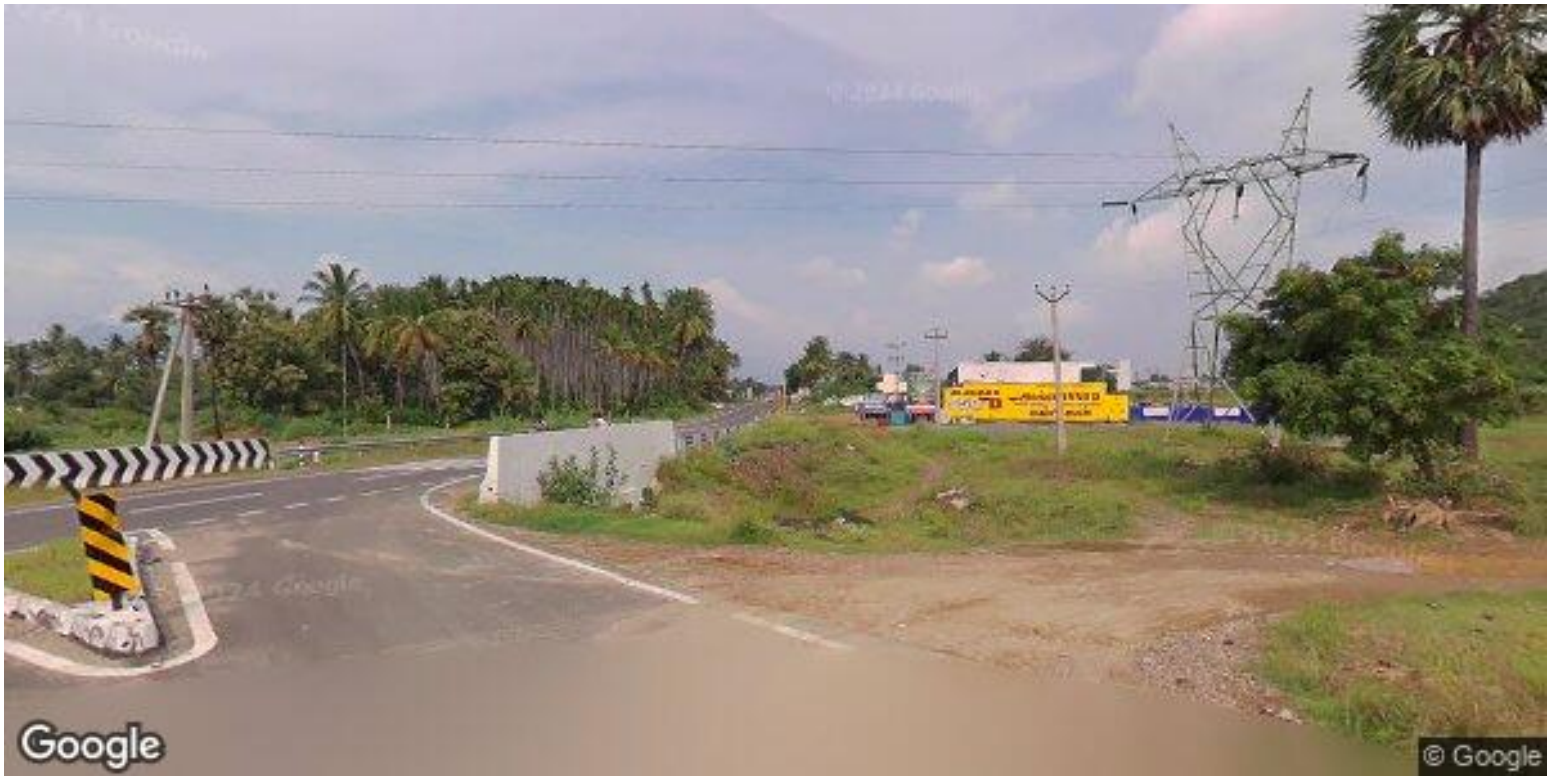
| | Risk Type | Risk Level | Coordinates | Speed Limit |
|---|---|---|---|---|
| 31 | Turn | Medium | 11.58683, 78.54570 | 30 KM/Hr |

**Risk Type:** Turn

**Risk Level:** Medium

**Speed Limit:** 30 KM/Hr

**Coordinates:** 11.58683, 78.54570
