## JOURNEY RISK MANAGEMENT (JRM) STUDY

### Salem Terminal TO SRI PALANI MURUGAN PETROLEUM

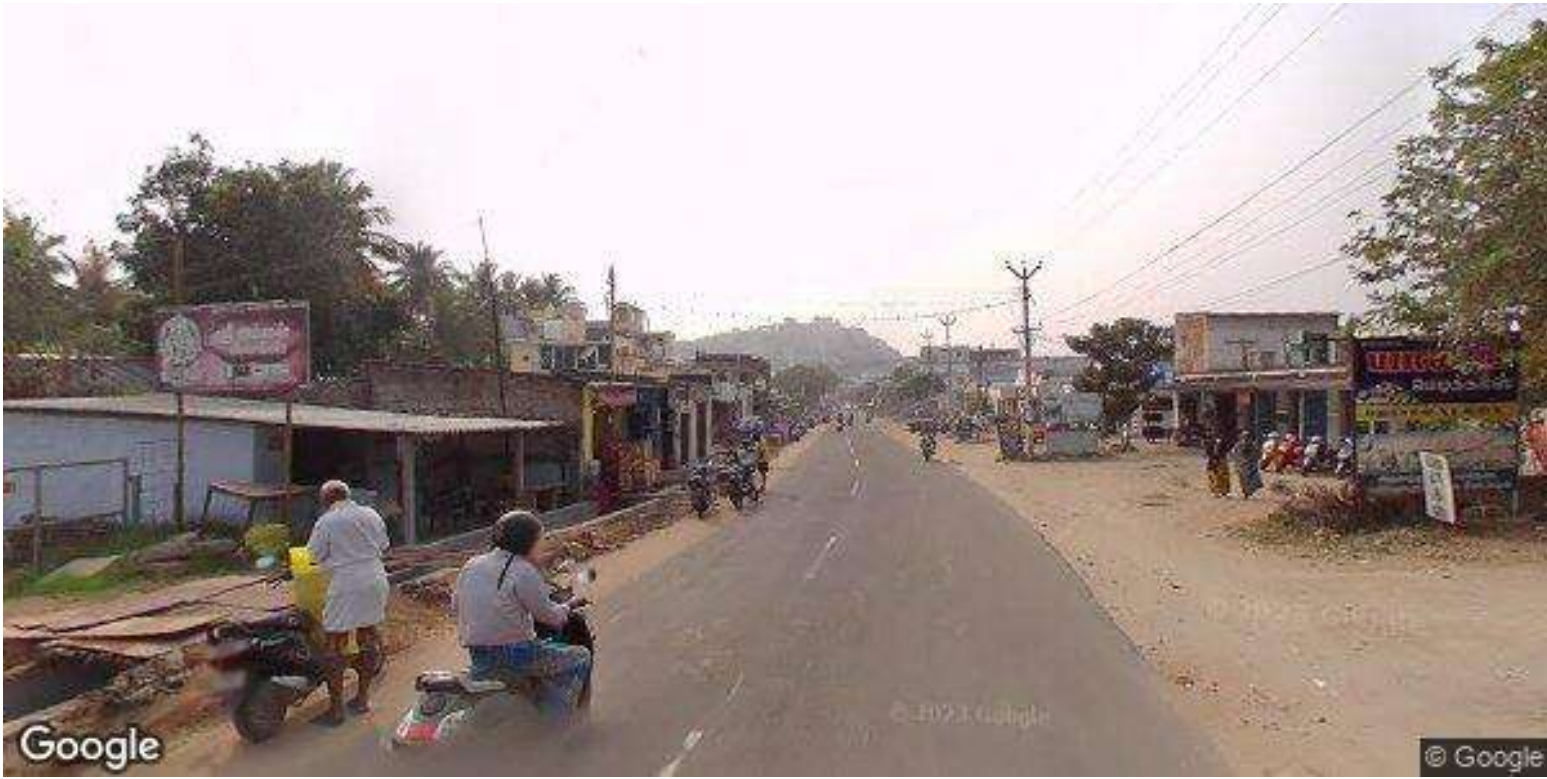
Coordinates: 11.07462, 78.00608

Risk Type: Roundabout

Risk Level: High

Speed Limit: 15 KM/Hr

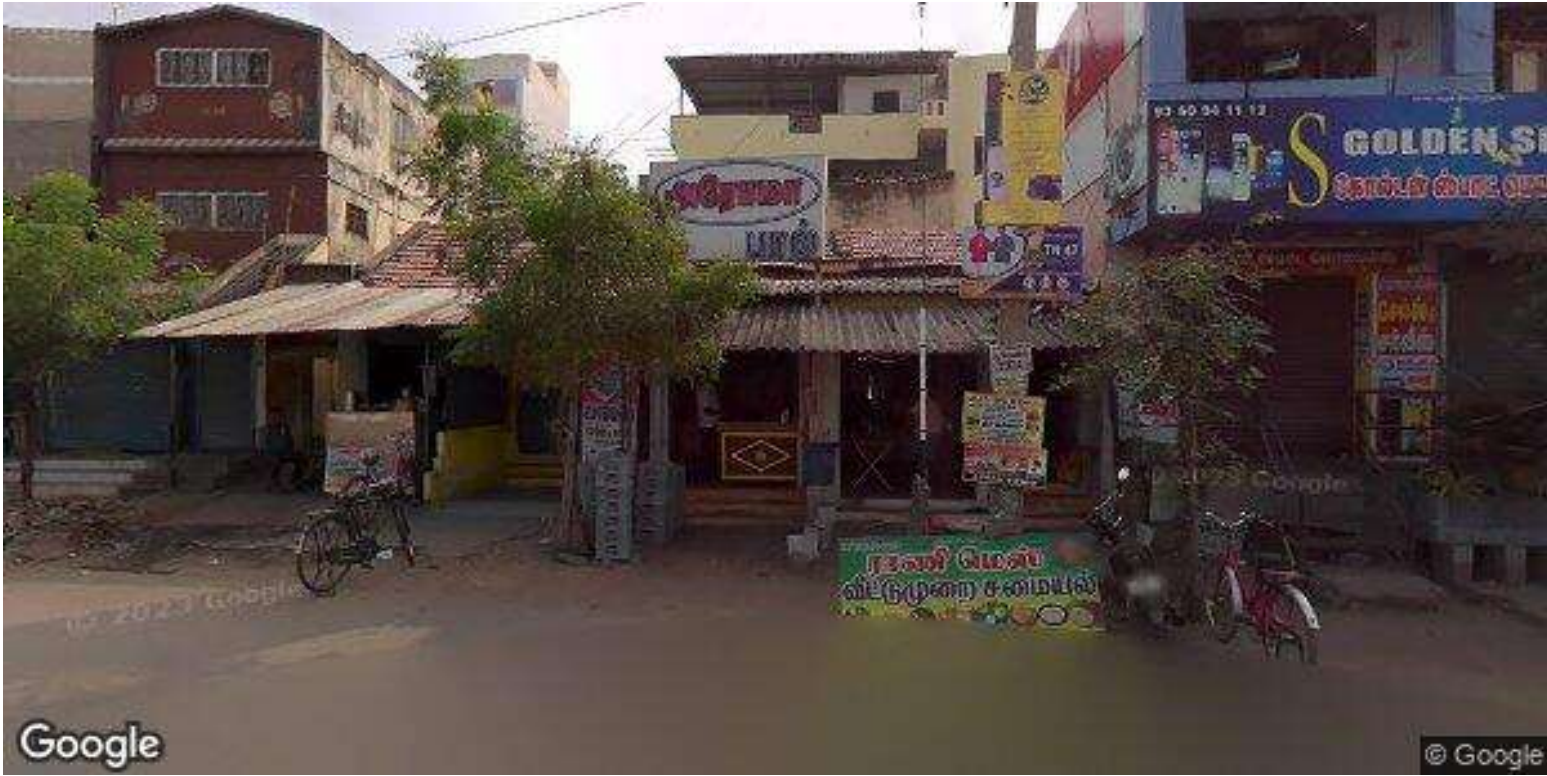
Coordinates: 11.07485, 78.00156

Risk Type: Roundabout

Risk Level: High

Speed Limit: 15 KM/Hr

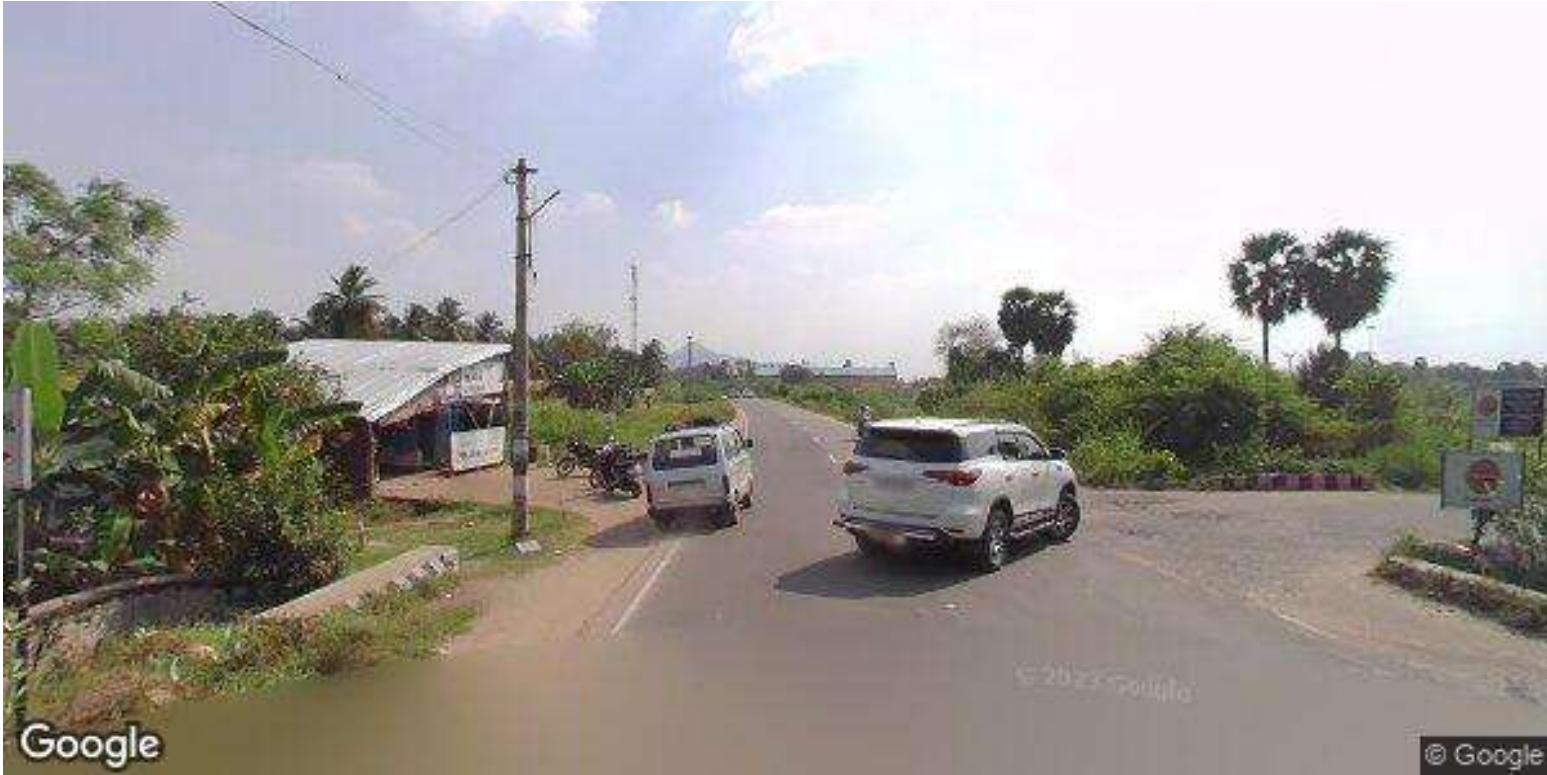
**Coordinates: 11.44029, 77.87544**

**Risk Type: Blind Spot**

**Risk Level: Blind Spot**

**Speed Limit: 10 KM/Hr**

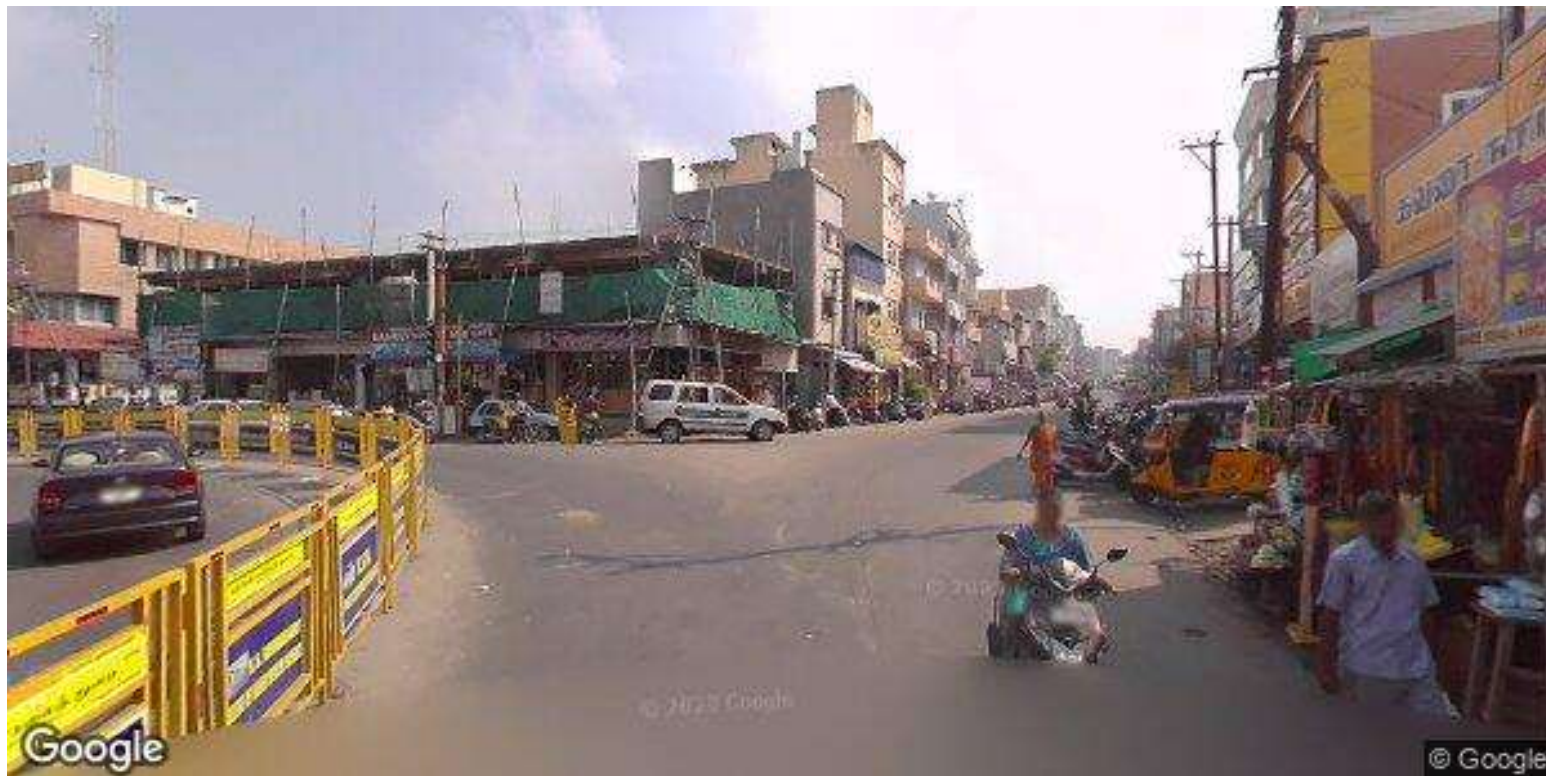
**Coordinates: 11.37862, 77.89488**

**Risk Type: Turn**

**Risk Level: High**

**Speed Limit: 15 KM/Hr**

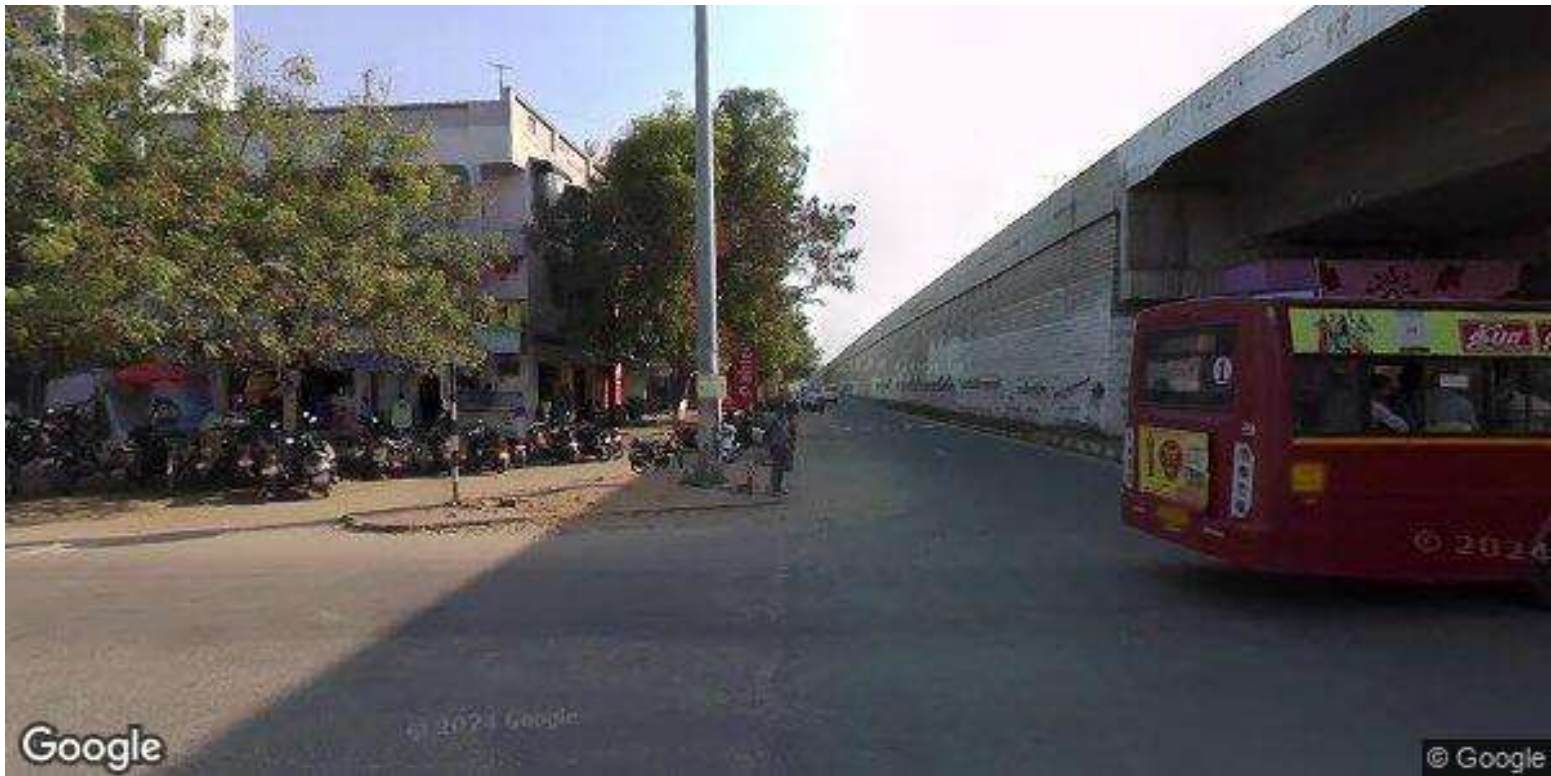
**Risk Type:** Turn  
**Risk Level:** High  
**Speed Limit:** 15 KM/Hr  
**Coordinates:** 11.07467, 78.00842

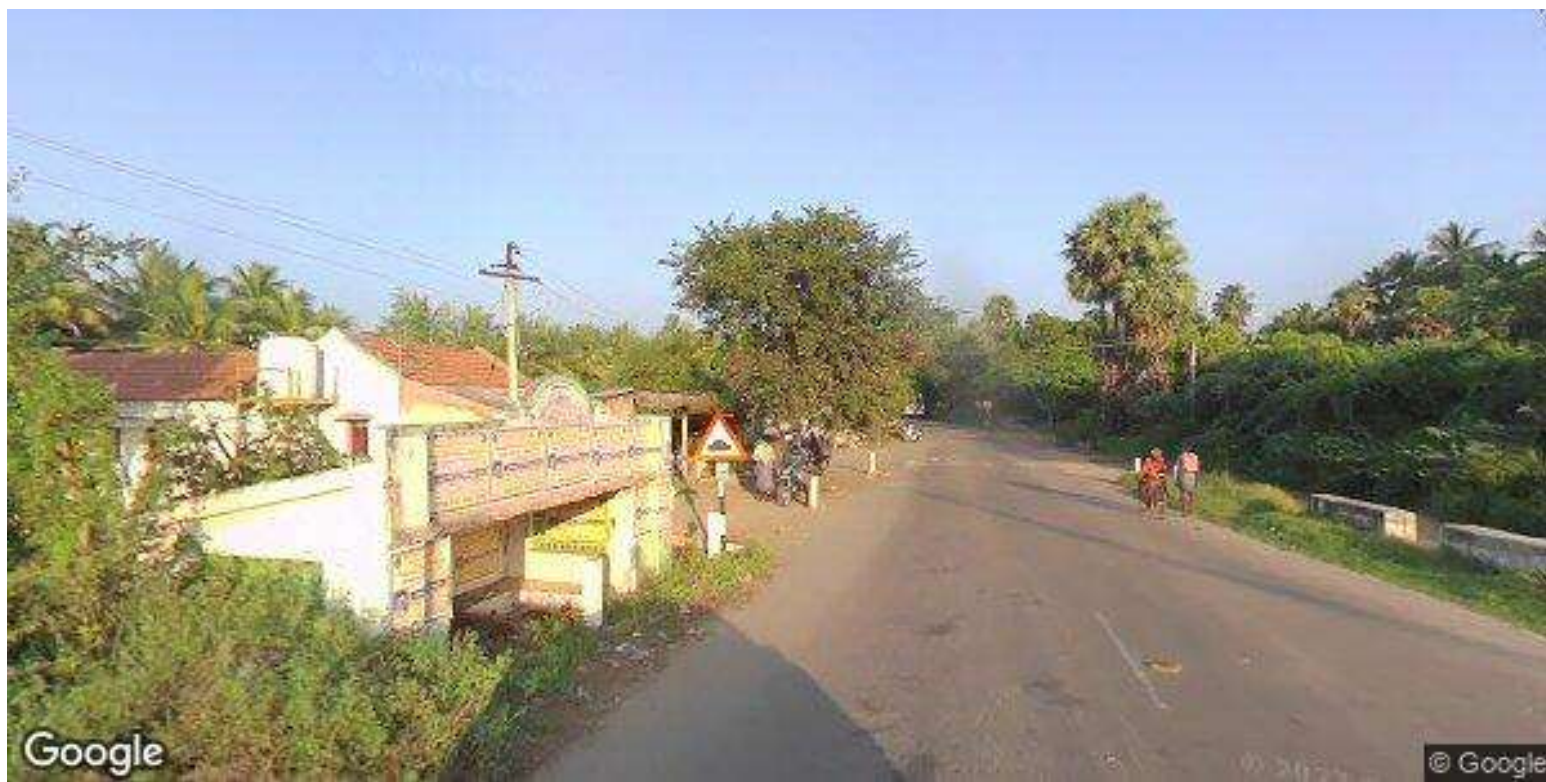
**Coordinates: 11.05900, 77.95376**

**Risk Type: Turn**

**Risk Level: High**

**Speed Limit: 15 KM/Hr**

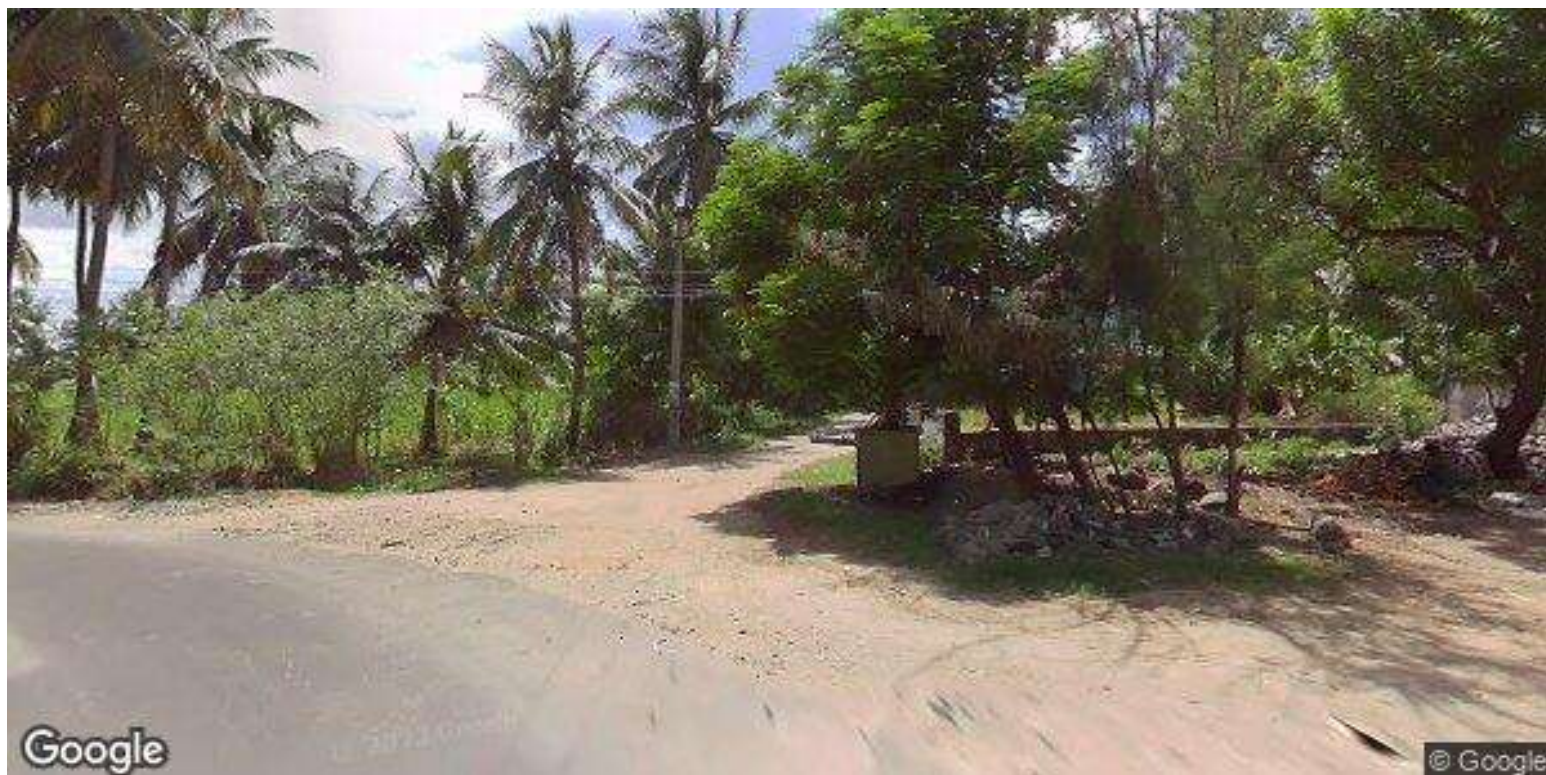
**Coordinates: 11.04807, 77.94800**

**Risk Type: Turn**

**Risk Level: High**

**Speed Limit: 15 KM/Hr**

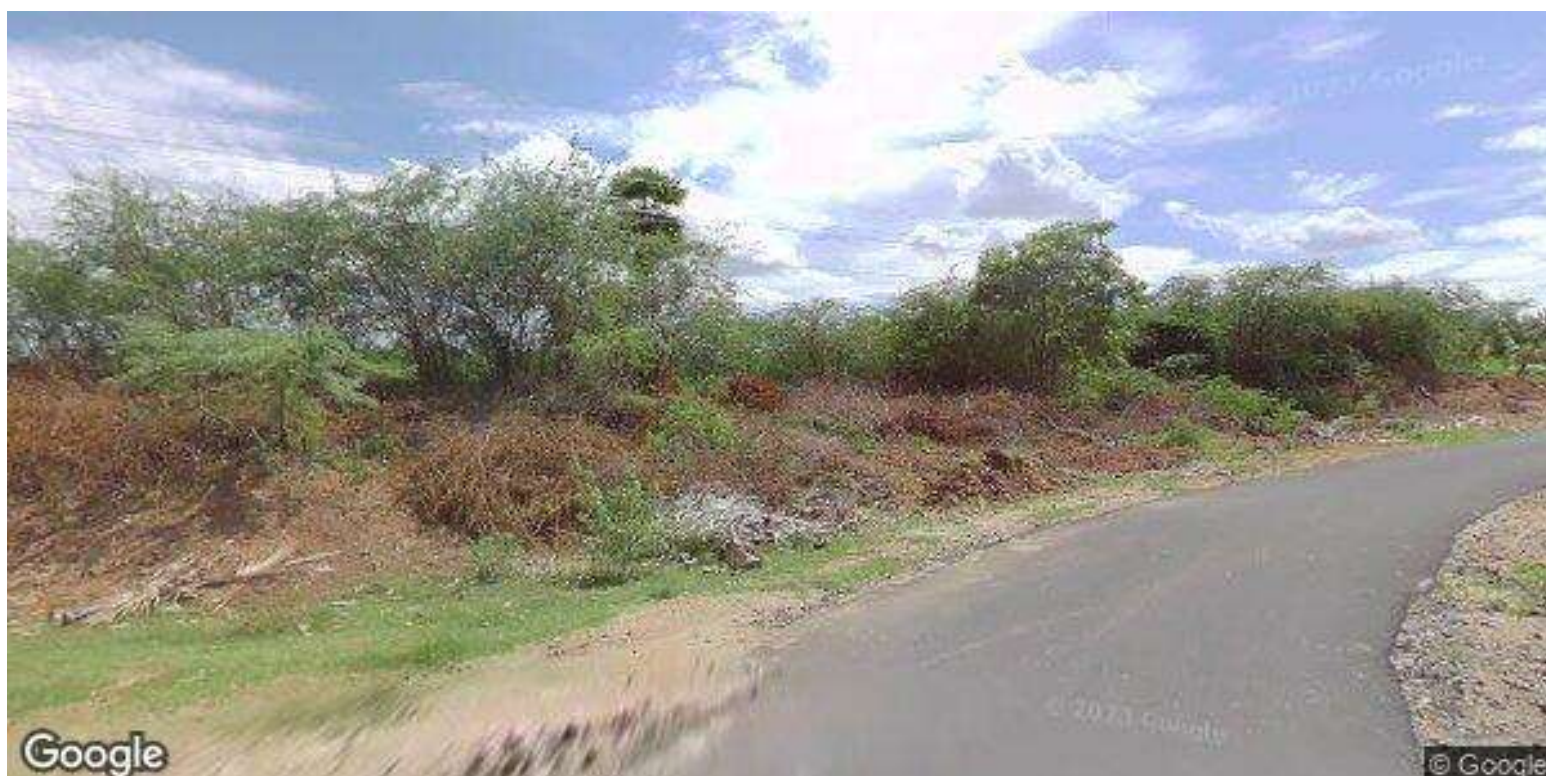
Coordinates: 11.04661, 77.94755

Risk Type: Turn

Risk Level: High

Speed Limit: 15 KM/Hr

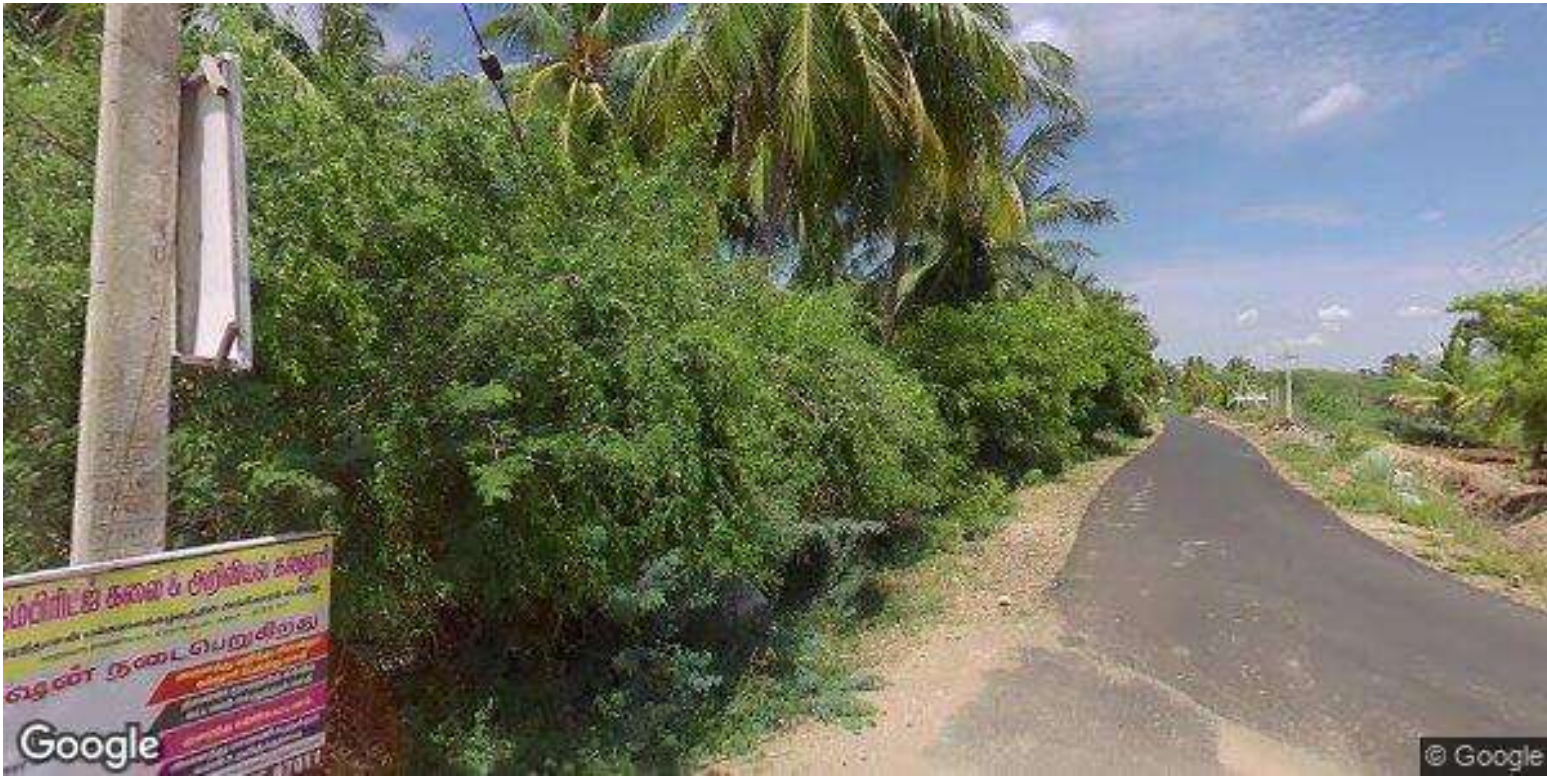
Coordinates: 11.04677, 77.94601

Risk Type: Turn

Risk Level: High

Speed Limit: 15 KM/Hr

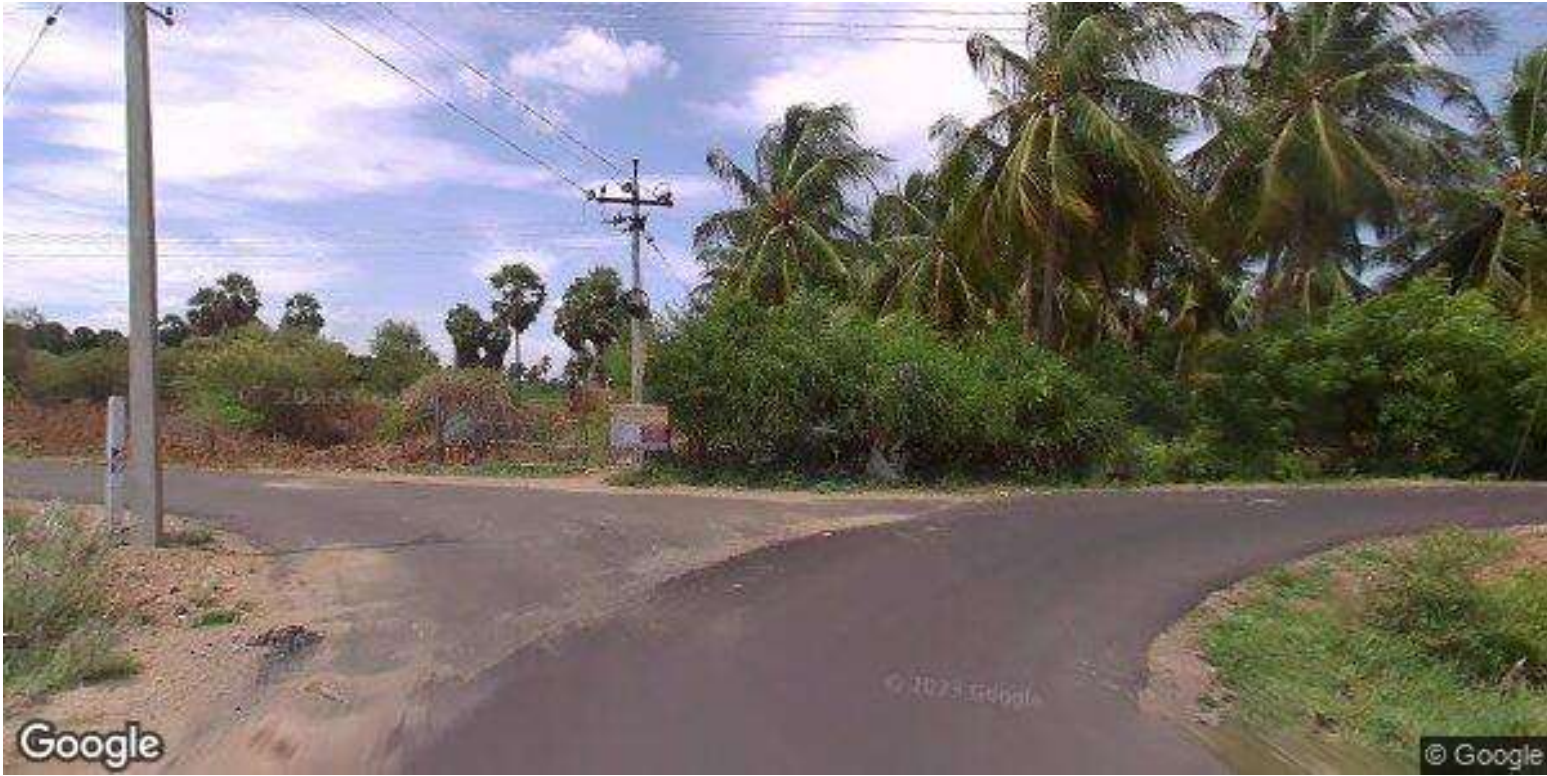
Coordinates: 11.04670, 77.94593

Risk Type: Turn

Risk Level: High

Speed Limit: 15 KM/Hr

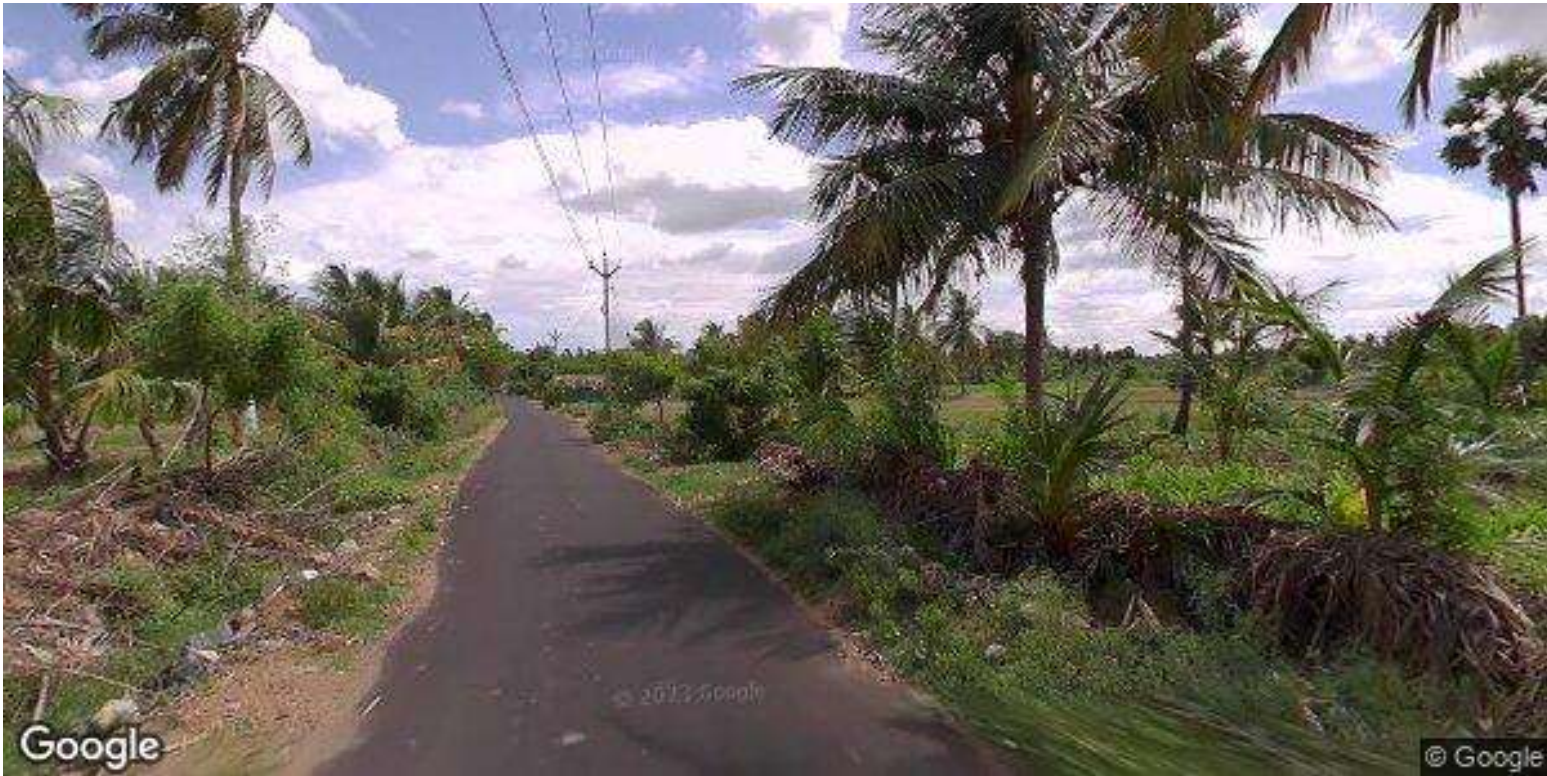
**Risk Type:** Turn  
**Risk Level:** Medium  
**Speed Limit:** 30 KM/Hr  
**Coordinates:** 11.04190, 77.94682

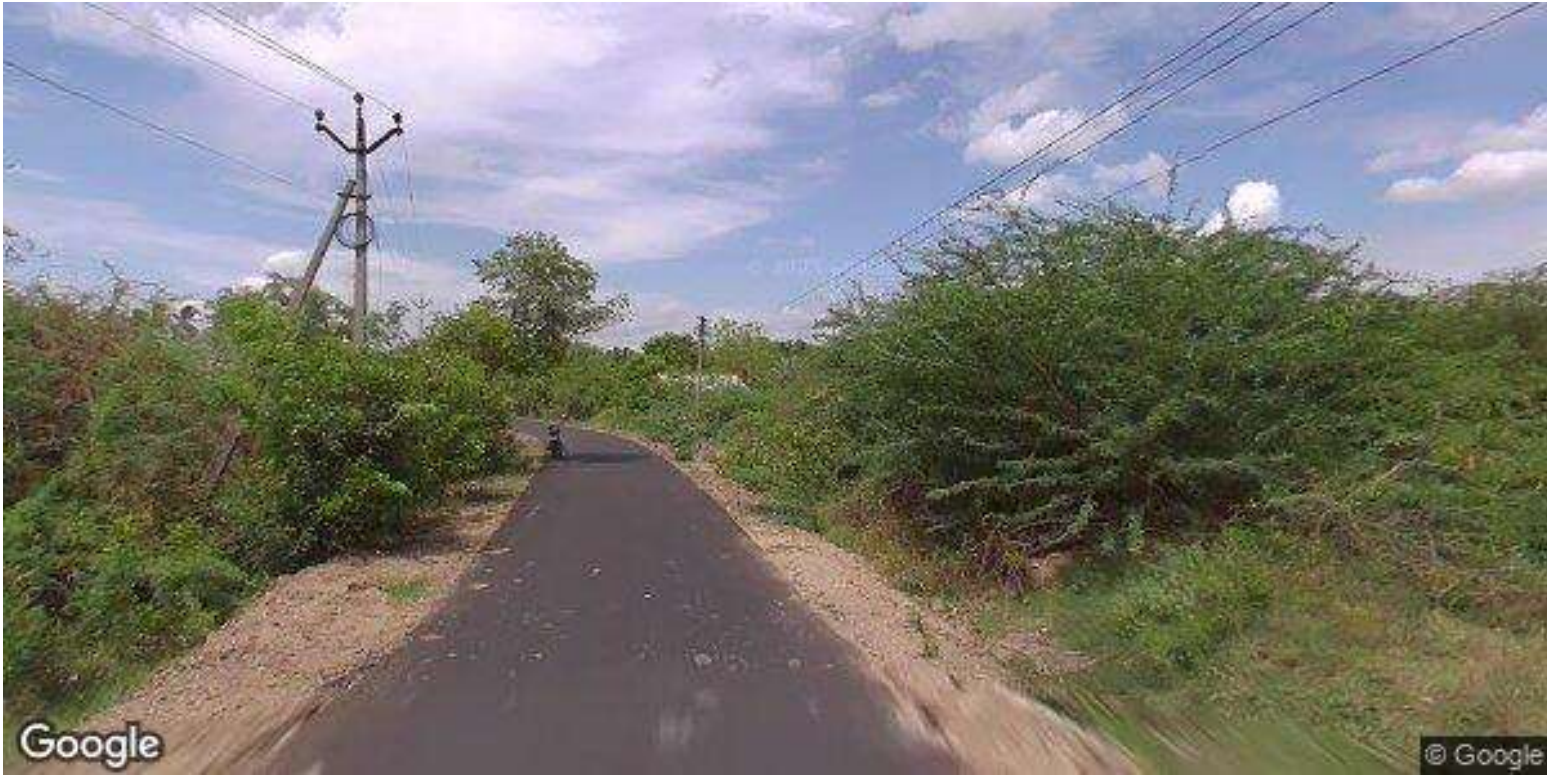
**Risk Type:** Turn  
**Risk Level:** Medium  
**Speed Limit:** 30 KM/Hr  
**Coordinates:** 11.03753, 77.94595

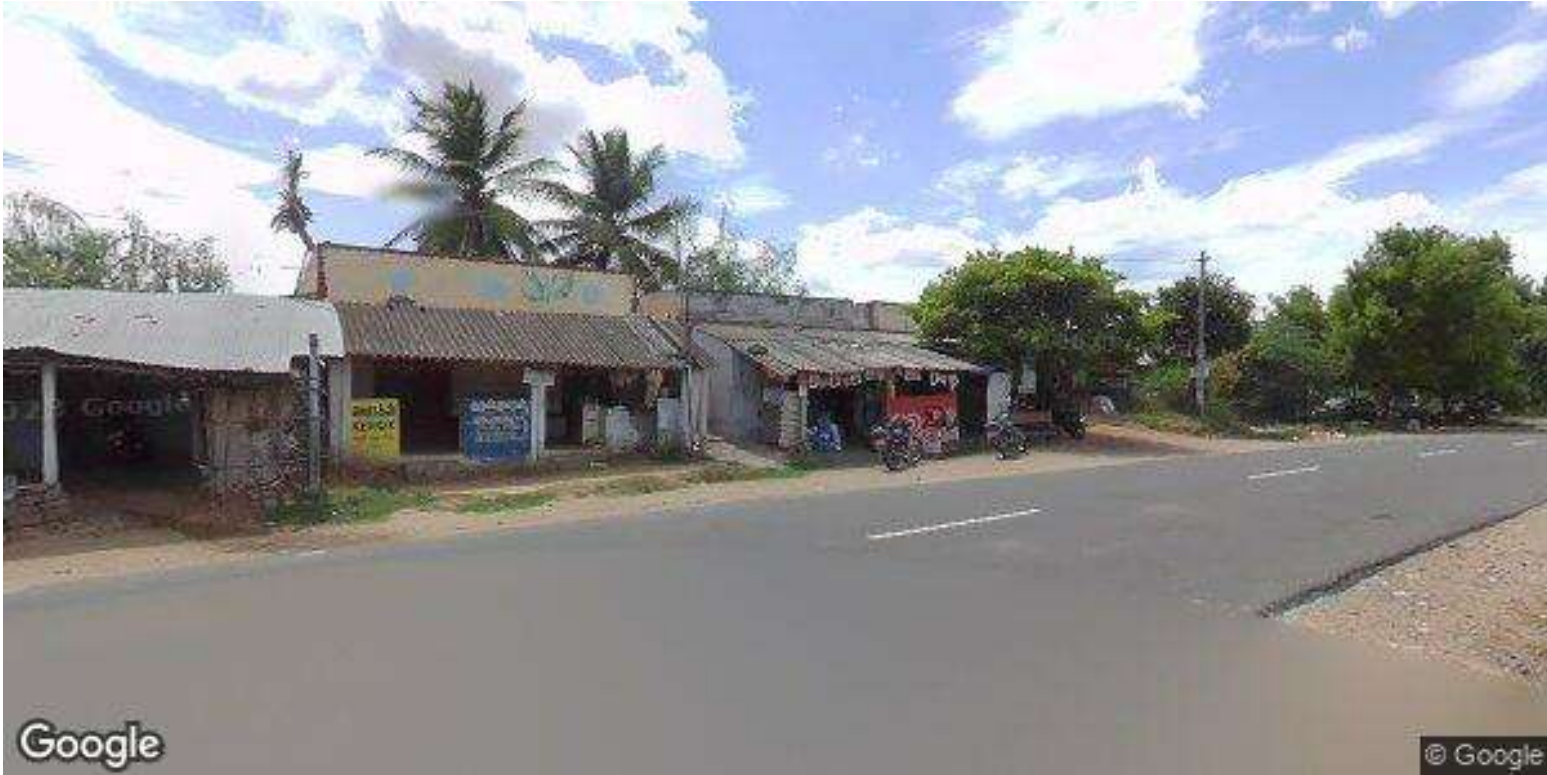
**Coordinates:** 11.03547, 77.94388

**Risk Type:** Blind Spot

**Risk Level:** Blind Spot

**Speed Limit:** 10 KM/Hr
