## JOURNEY RISK MANAGEMENT (JRM) STUDY

### Salem Terminal TO SRI DEVI FUELS

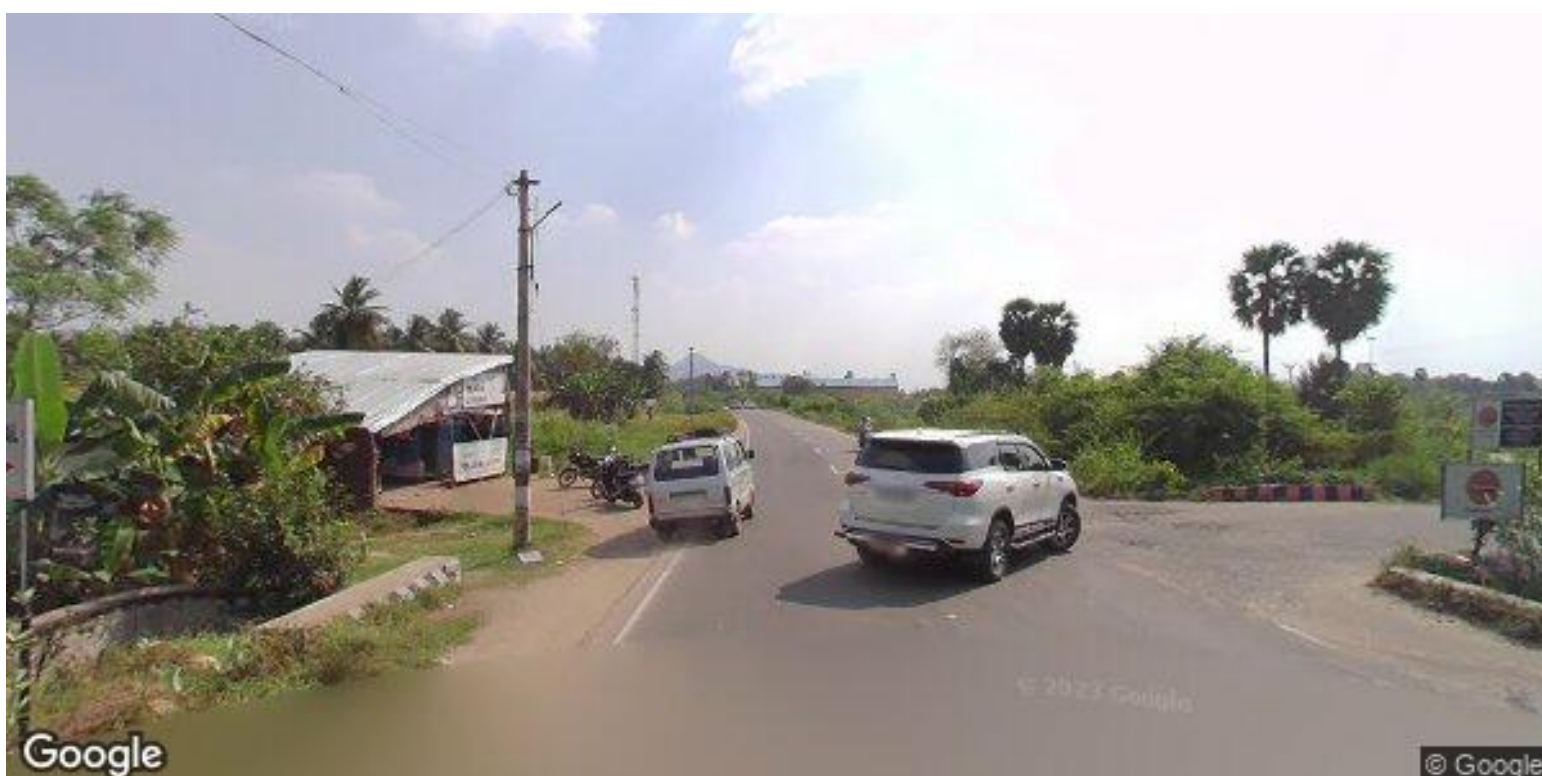
**Risk Type:** Turn

**Risk Level:** High

**Speed Limit: 15 KM/Hr**  
**Coordinates: 11.44029, 77.87544**

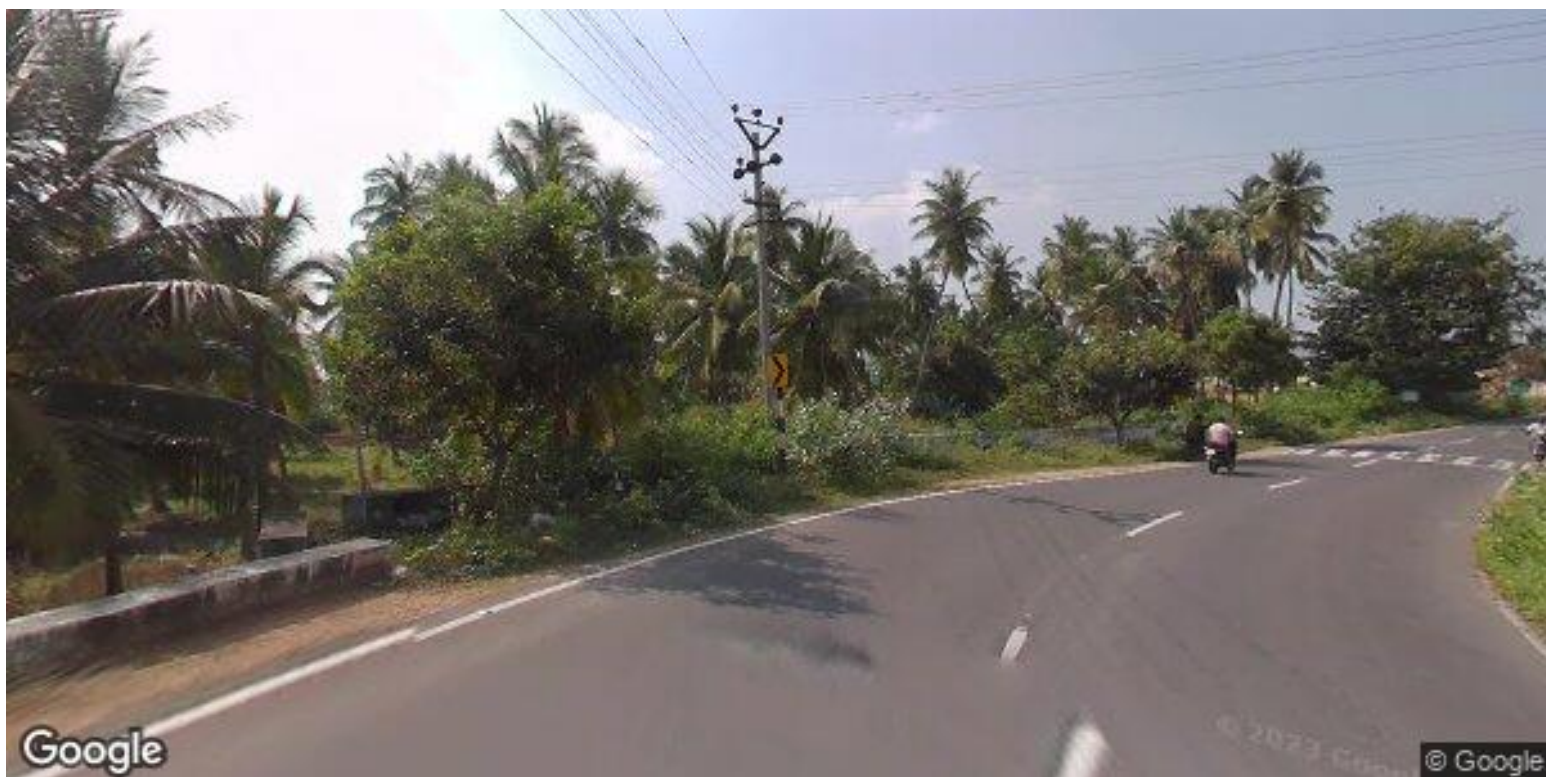
**Risk Type: Turn**  
**Risk Level: Medium**  
**Speed Limit: 30 KM/Hr**  
**Coordinates: 11.45348, 77.85706**

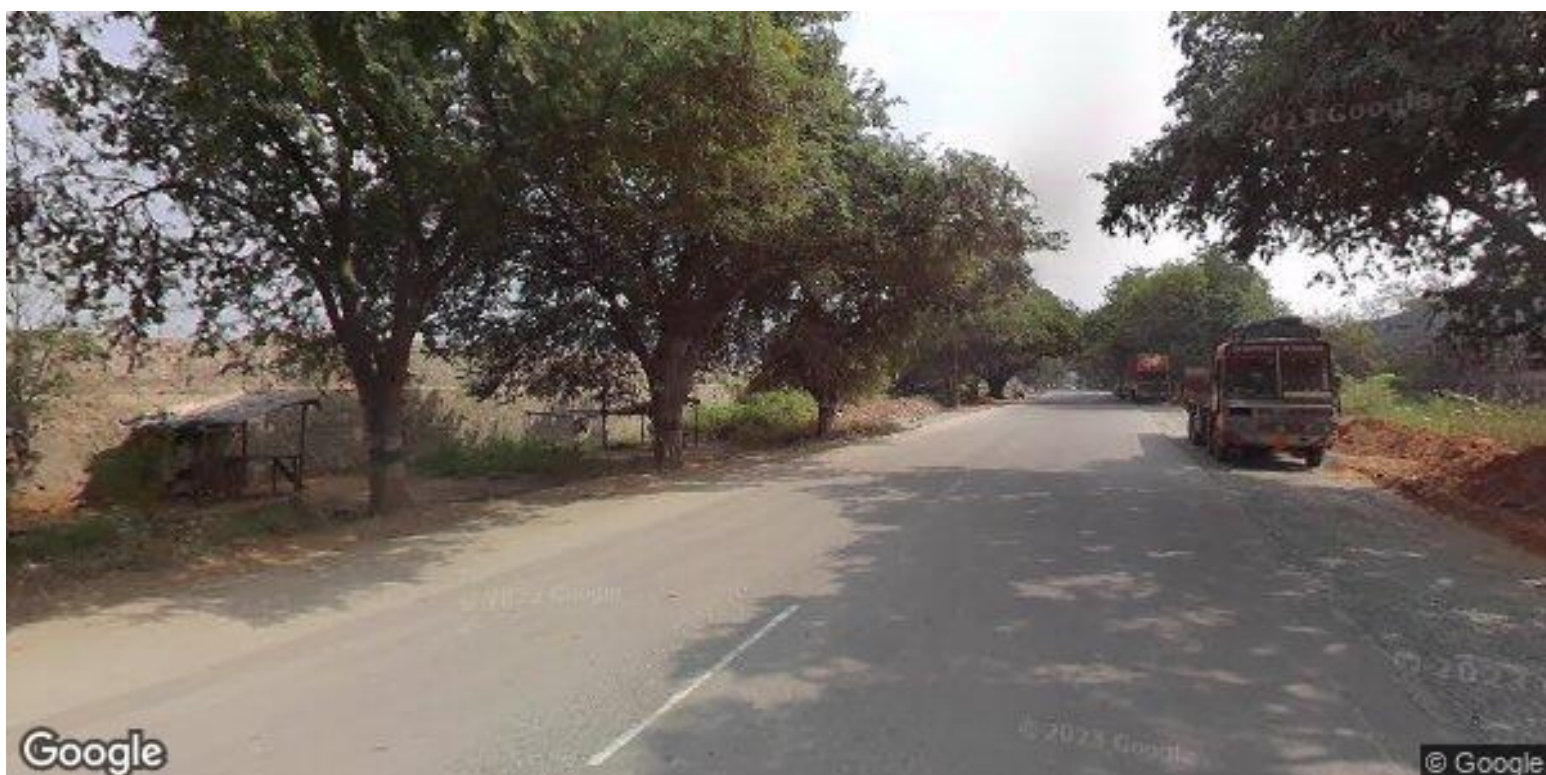
**Risk Type: Turn**

**Risk Level: Medium**

**Speed Limit: 30 KM/Hr**

**Coordinates: 11.45697, 77.82719**

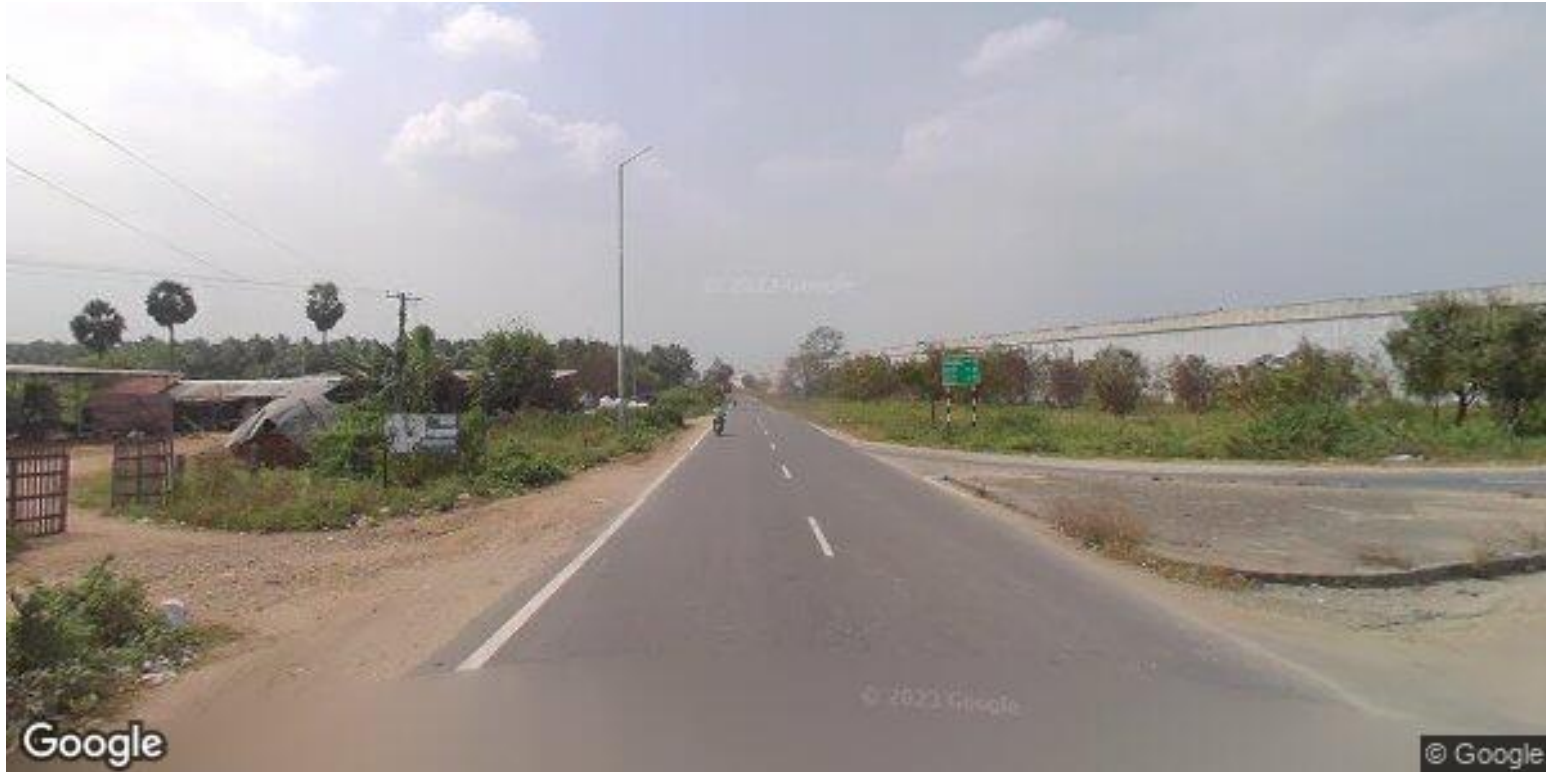
**Risk Type: Turn**

**Risk Level: High**

**Speed Limit: 15 KM/Hr**

**Coordinates: 11.45542, 77.81725**

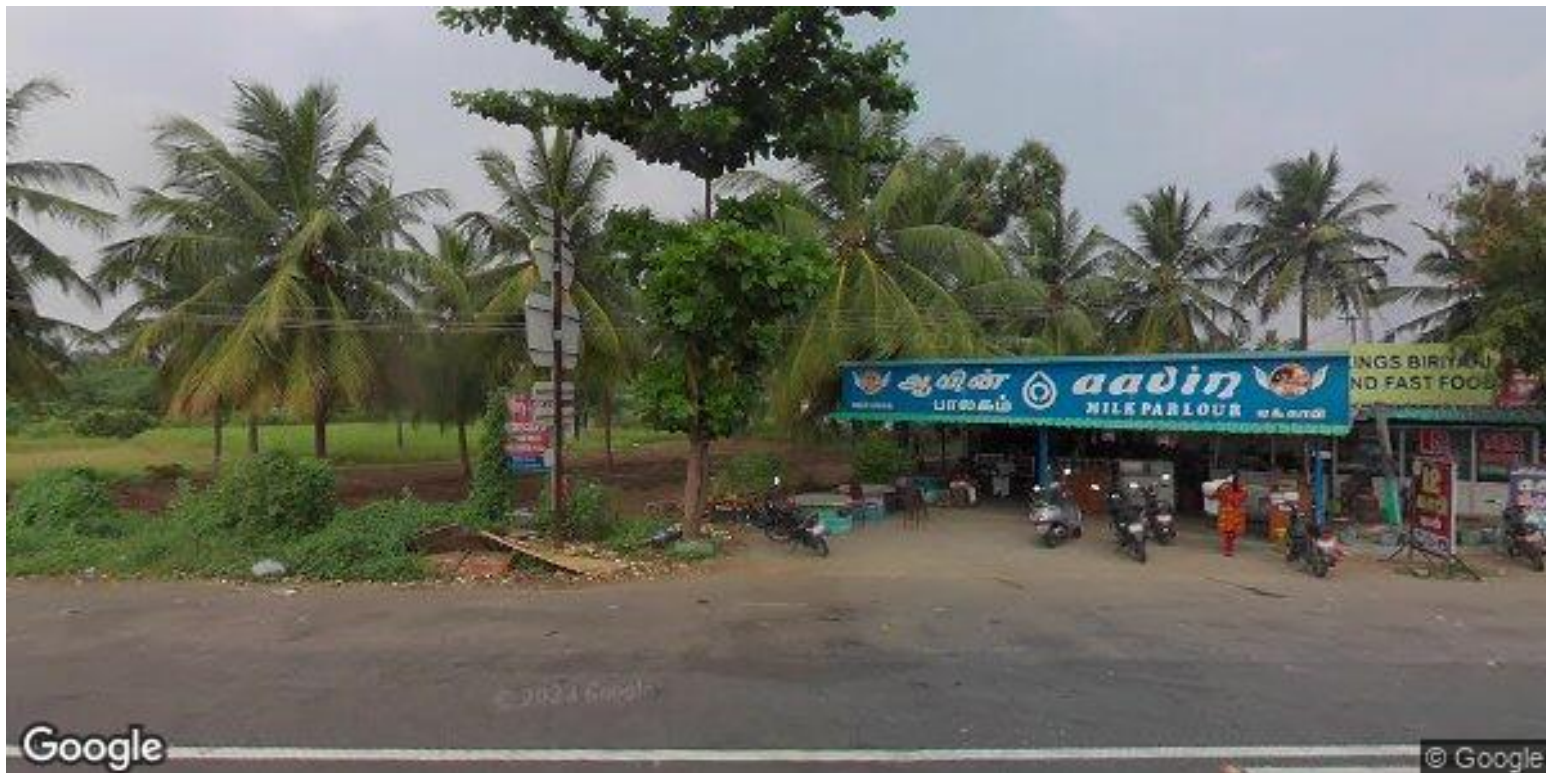
**Risk Type: Turn**

**Risk Level: High**

**Speed Limit: 15 KM/Hr**

**Coordinates: 11.45631, 77.81668**

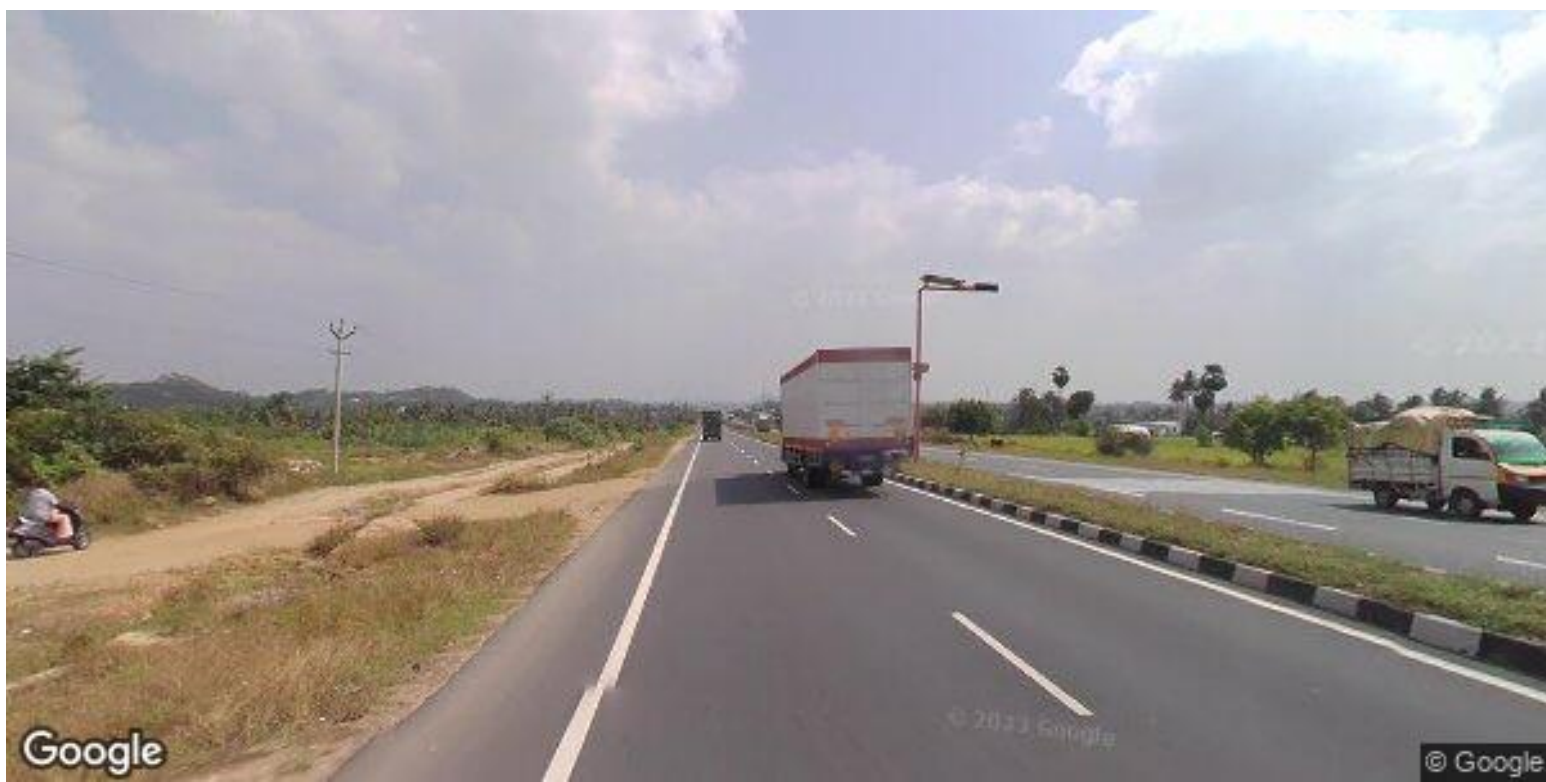
**Risk Type:** Turn

**Risk Level:** High

**Speed Limit:** 15 KM/Hr

**Coordinates:** 11.49409, 77.88004

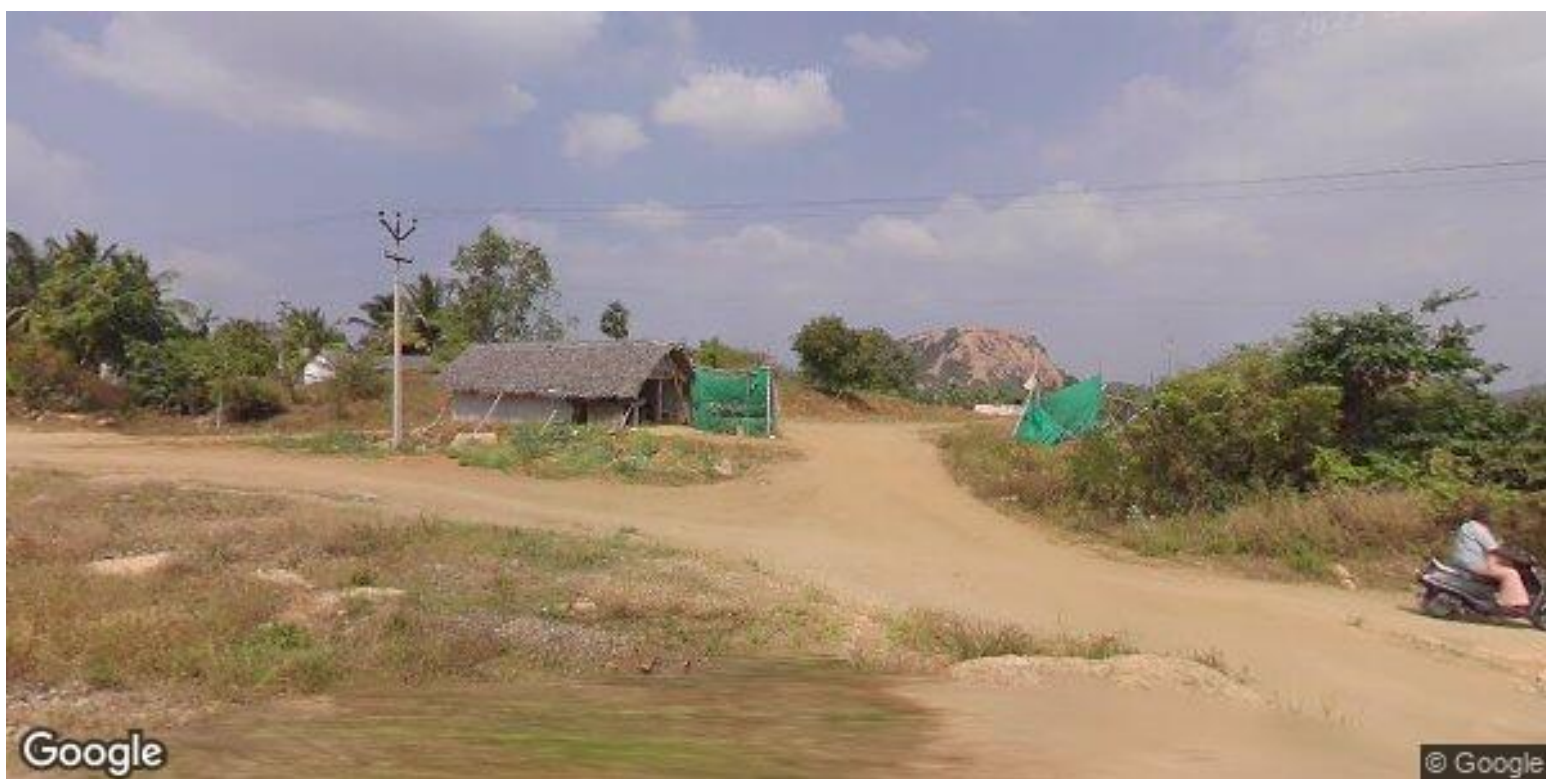
**Risk Type:** Turn

**Risk Level:** Medium

**Speed Limit:** 30 KM/Hr

**Coordinates:** 11.49419, 77.88015

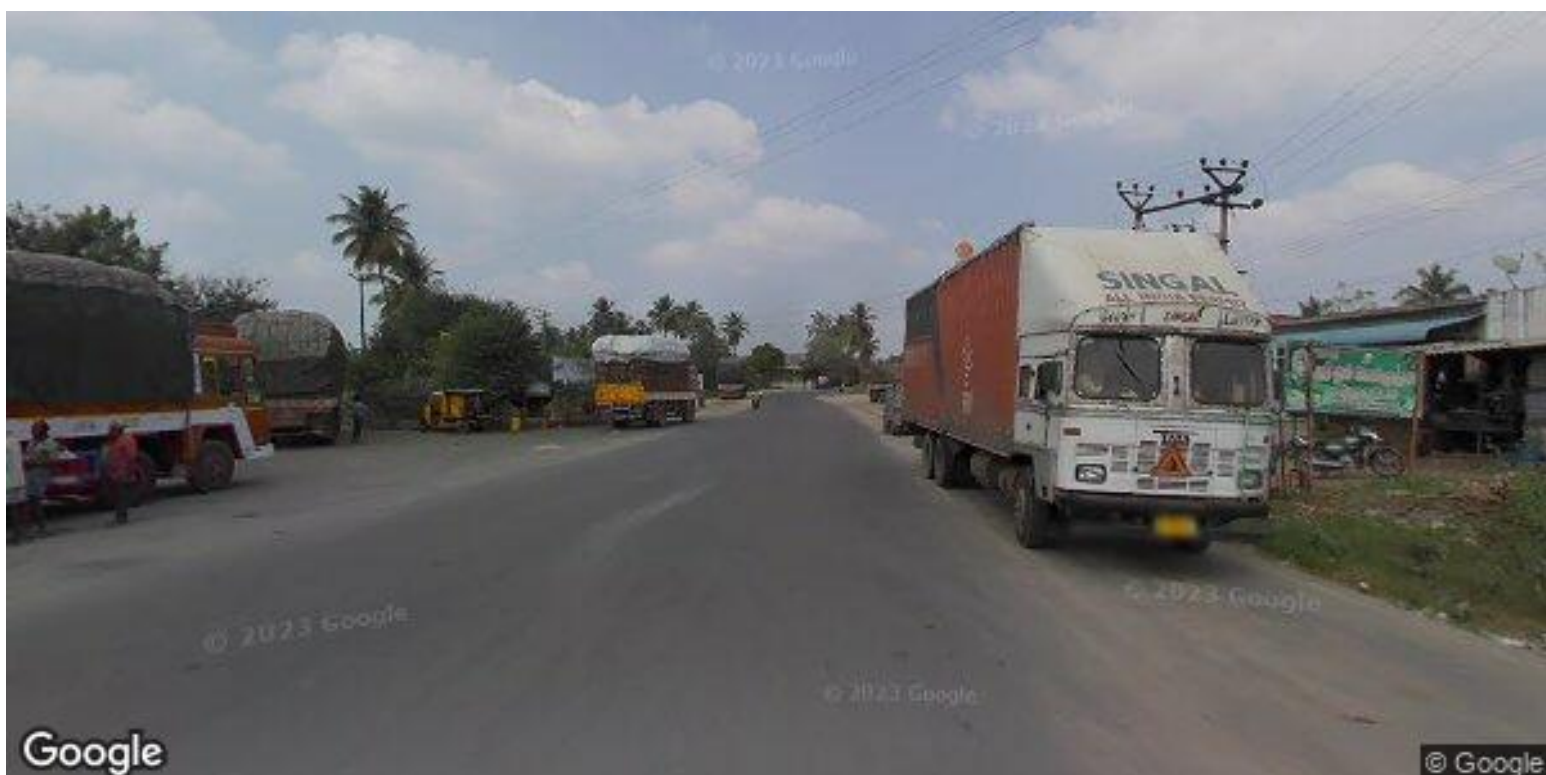
**Risk Type:** Turn

**Risk Level:** Medium

**Speed Limit:** 30 KM/Hr

**Coordinates:** 11.49377, 77.88573

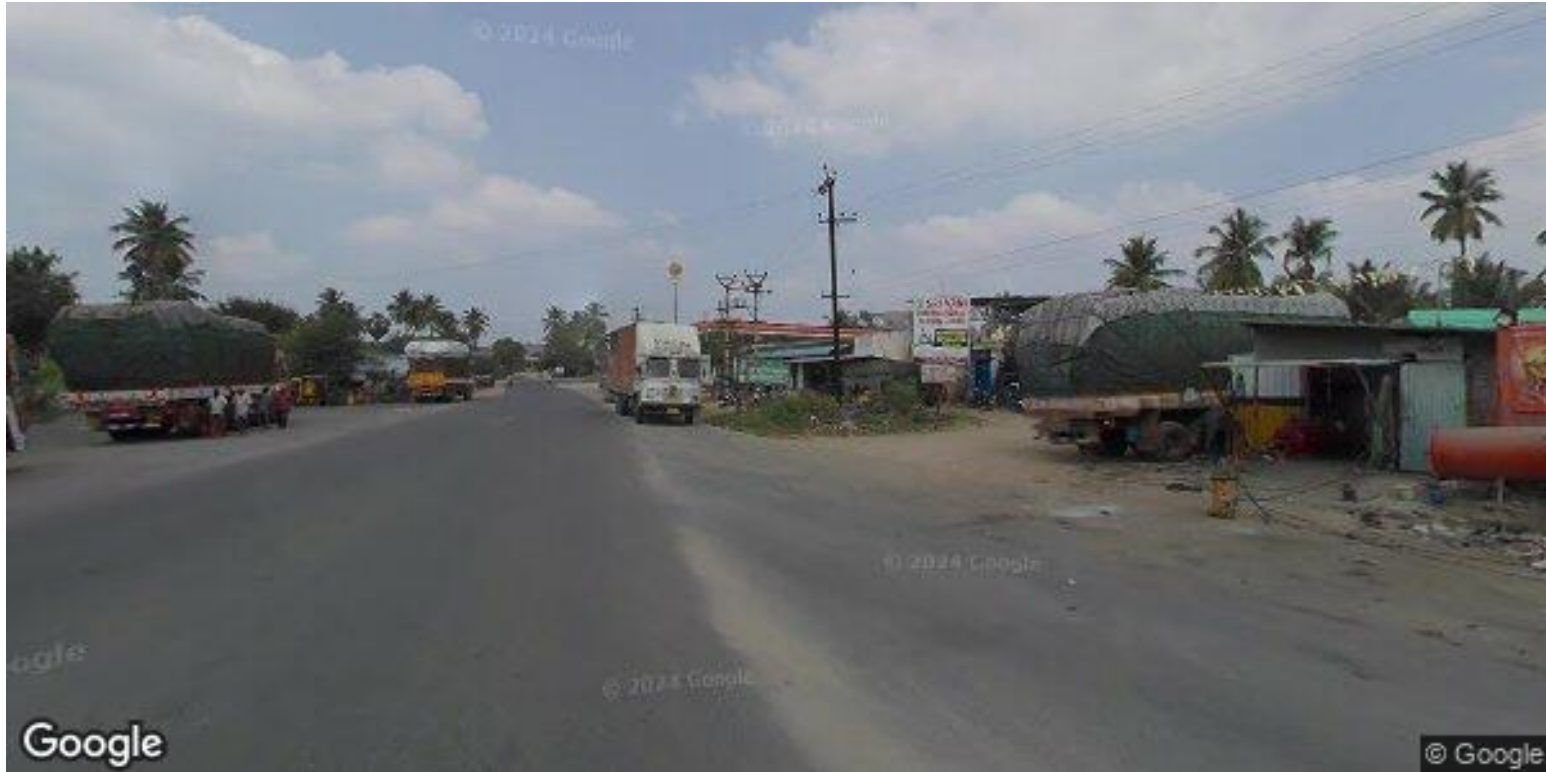
**Risk Type:** Turn

**Risk Level:** High

**Speed Limit:** 15 KM/Hr

**Coordinates:** 11.49363, 77.88590

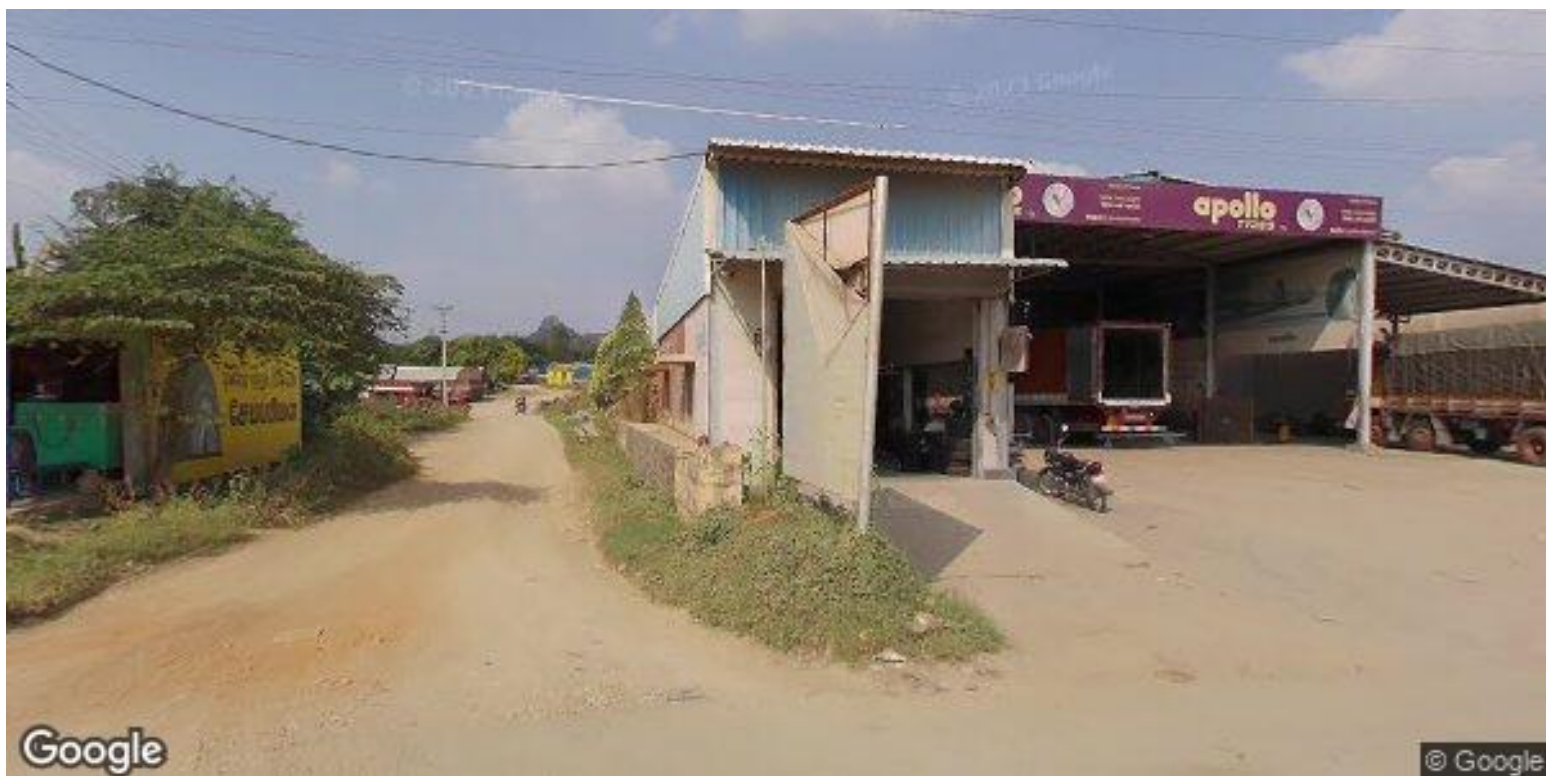
**Risk Type:** Turn

**Risk Level:** High

**Speed Limit:** 15 KM/Hr

**Coordinates:** 11.49235, 77.89561

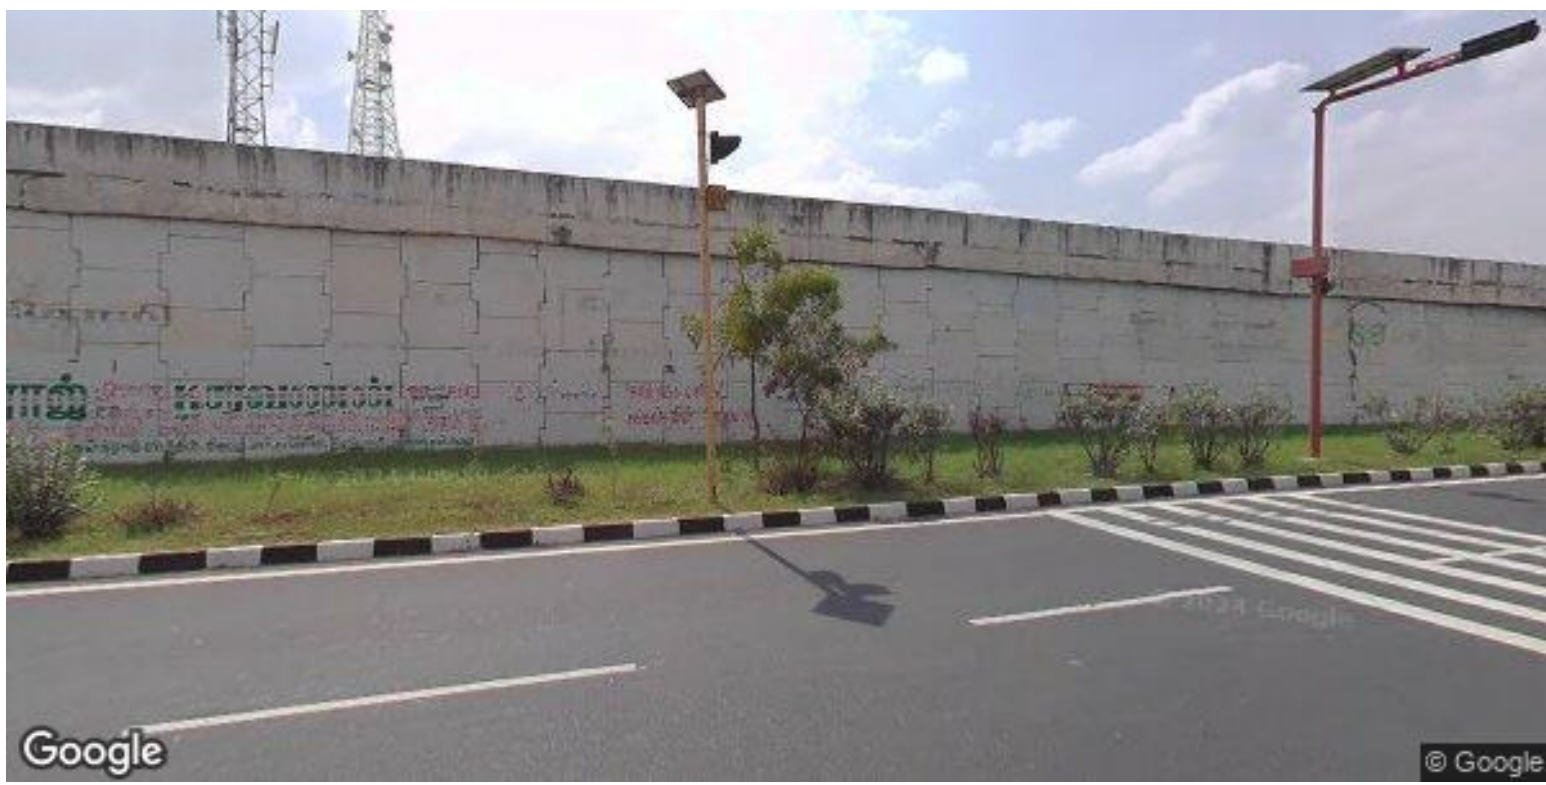
**Risk Type:** Blind Spot

**Risk Level:** Blind Spot

**Speed Limit:** 10 KM/Hr

**Coordinates:** 11.49225, 77.89560

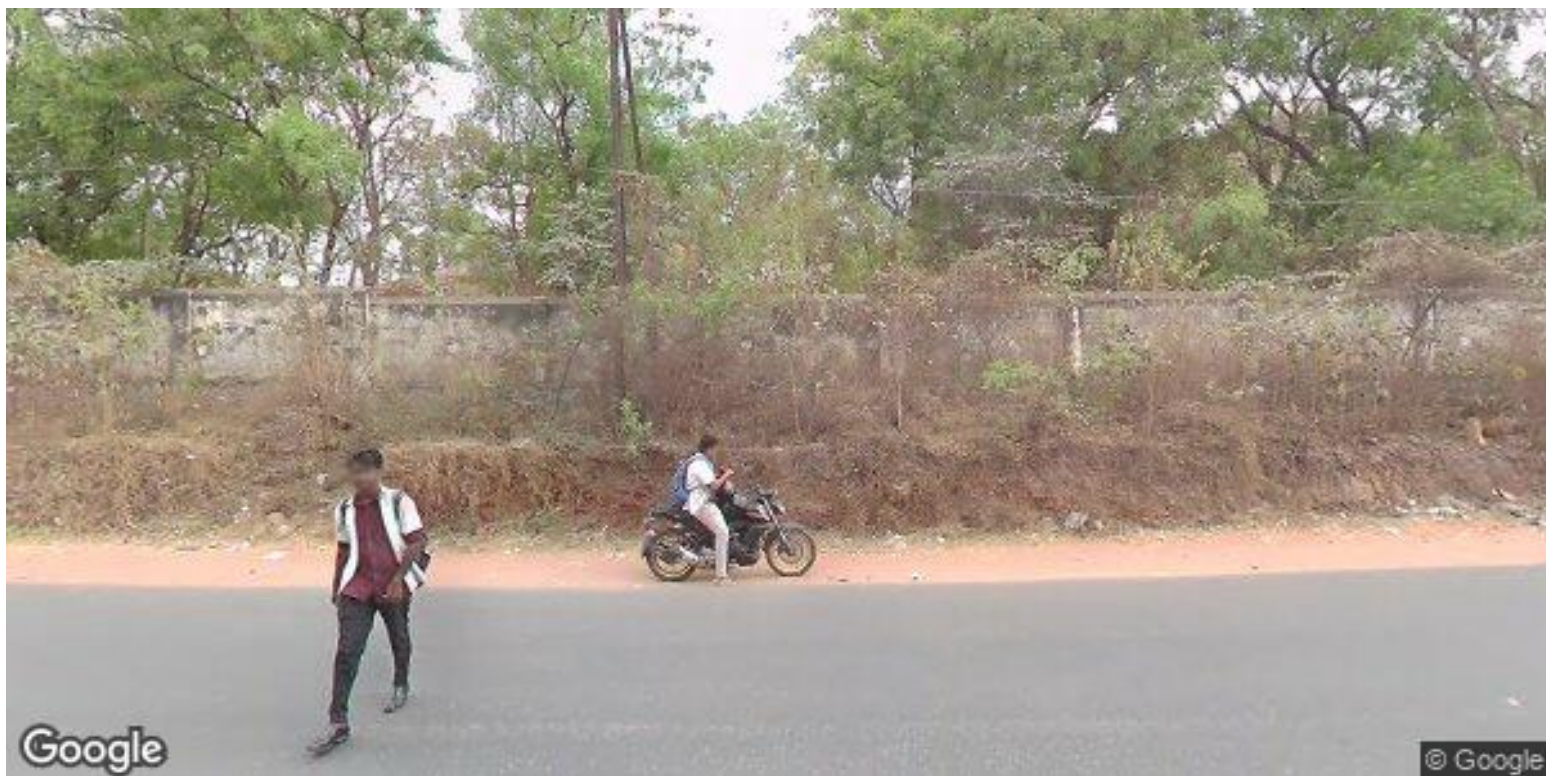
**Risk Type:** Blind Spot

**Risk Level:** Blind Spot

**Speed Limit:** 10 KM/Hr

**Coordinates:** 11.55800, 78.01305

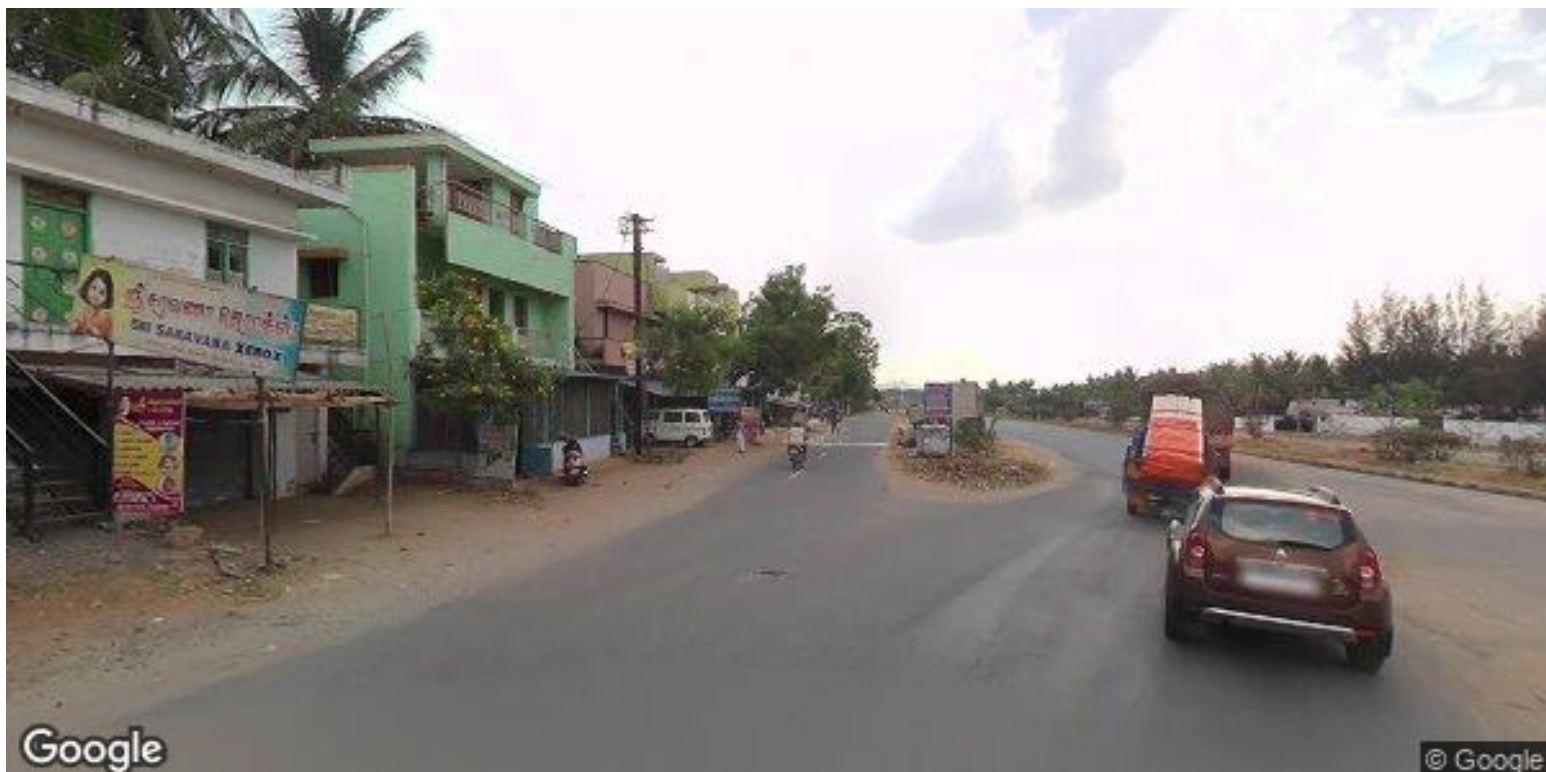
**Risk Type:** Turn  
**Risk Level:** Medium  
**Speed Limit:** 30 KM/Hr  
**Coordinates:** 11.55679, 78.01024

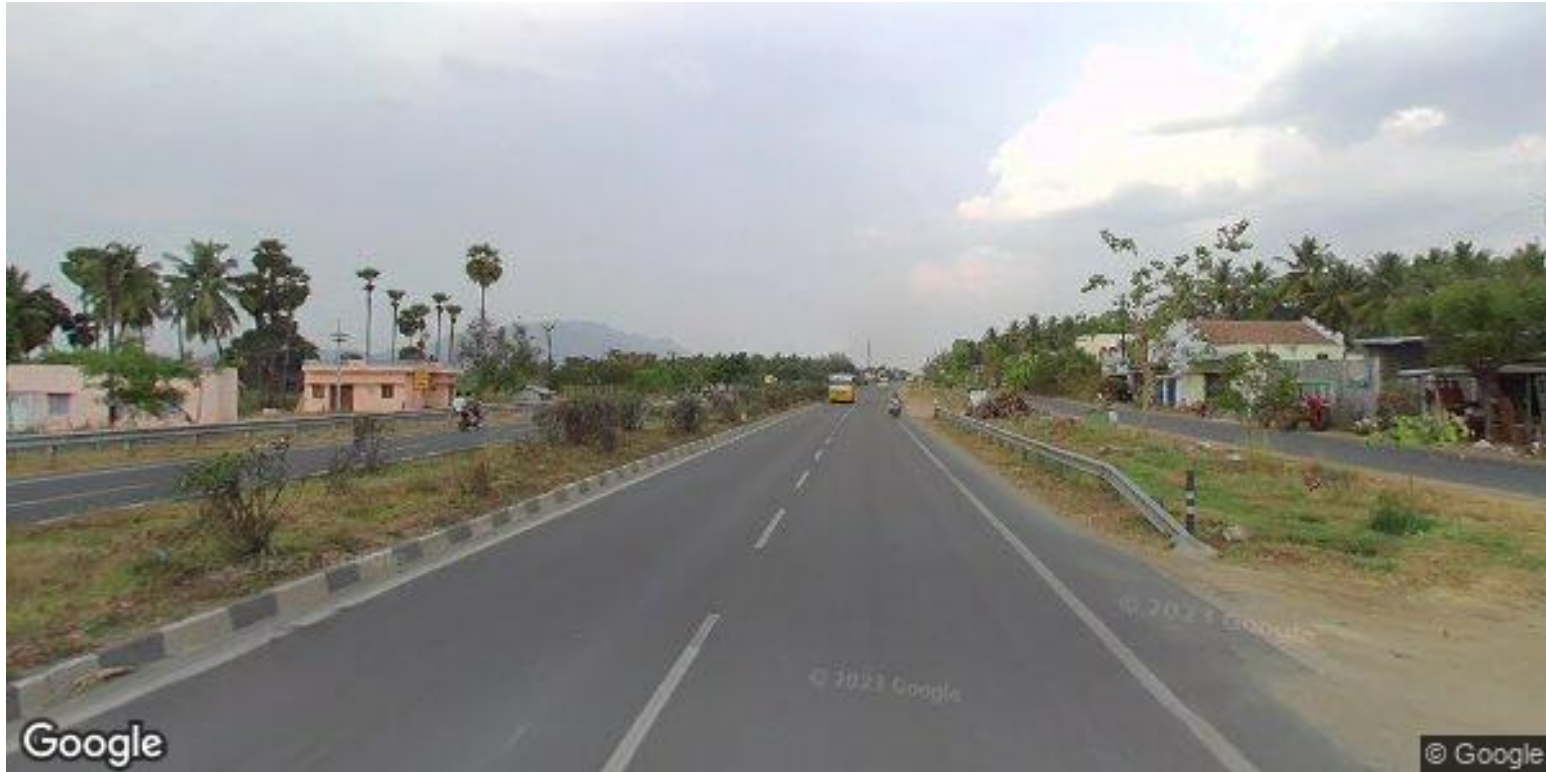
**Risk Type:** Blind Spot  
**Risk Level:** Blind Spot  
**Speed Limit:** 10 KM/Hr  
**Coordinates:** 11.55501, 78.00596
