# IndianOil

## JOURNEY RISK MANAGEMENT (JRM) STUDY

### Salem Terminal TO SWARNAMBIGAI FUEL SERVICE

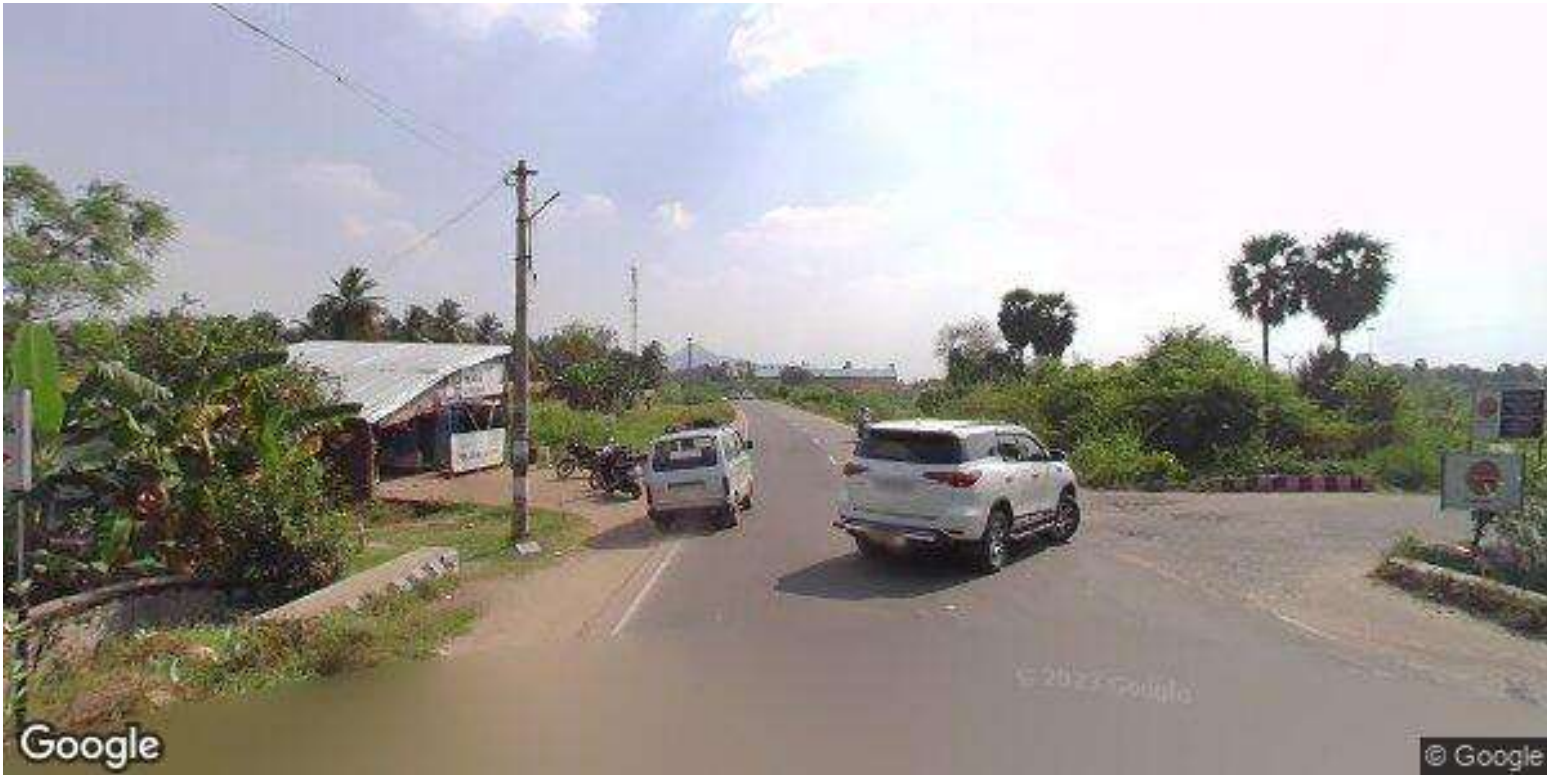
Coordinates: 11.44029, 77.87544

Risk Type: Turn

Risk Level: High

Speed Limit: 15 KM/Hr

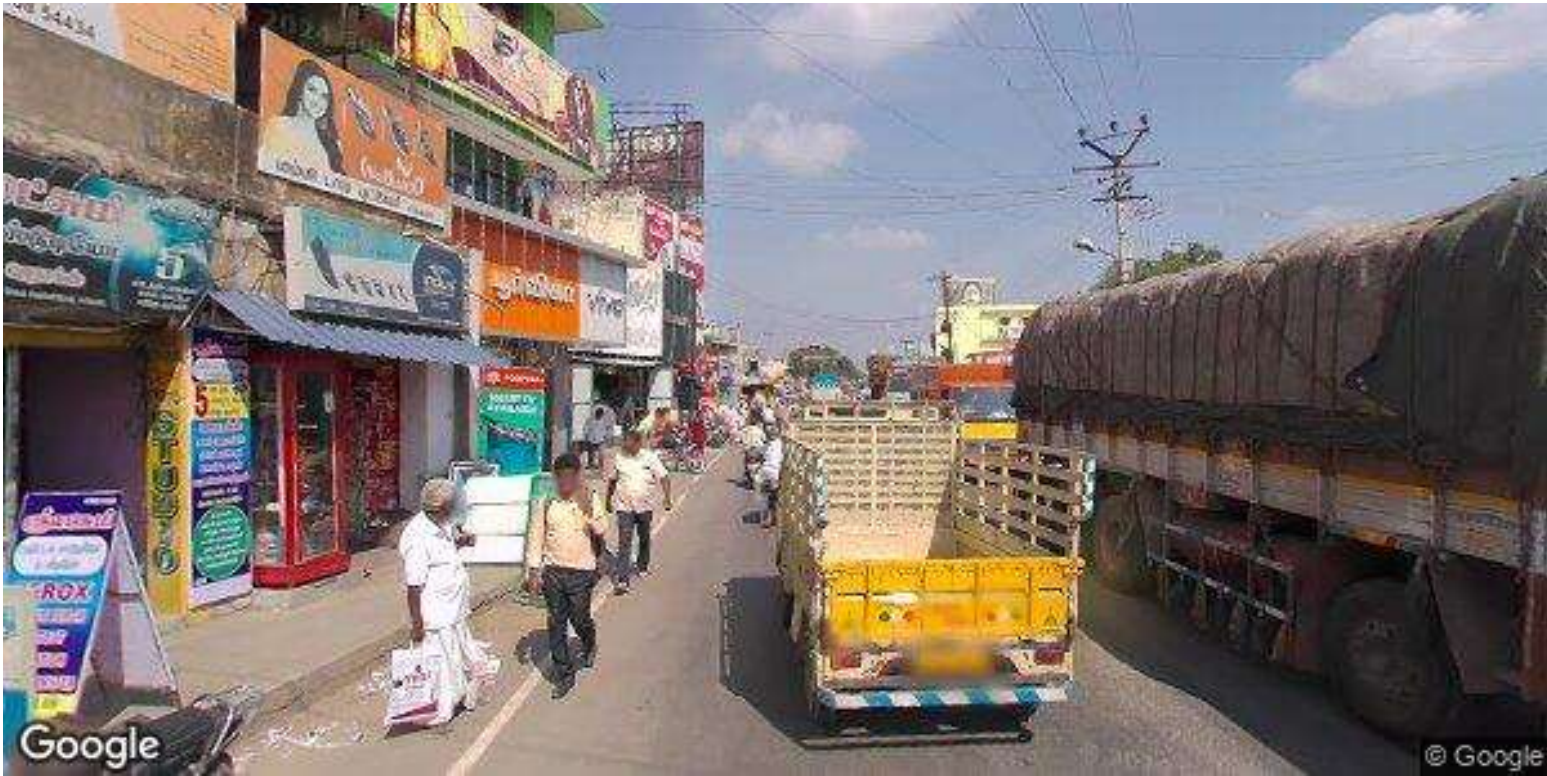
Coordinates: 11.47410, 77.86845

Risk Type: Turn

Risk Level: Medium

Speed Limit: 30 KM/Hr

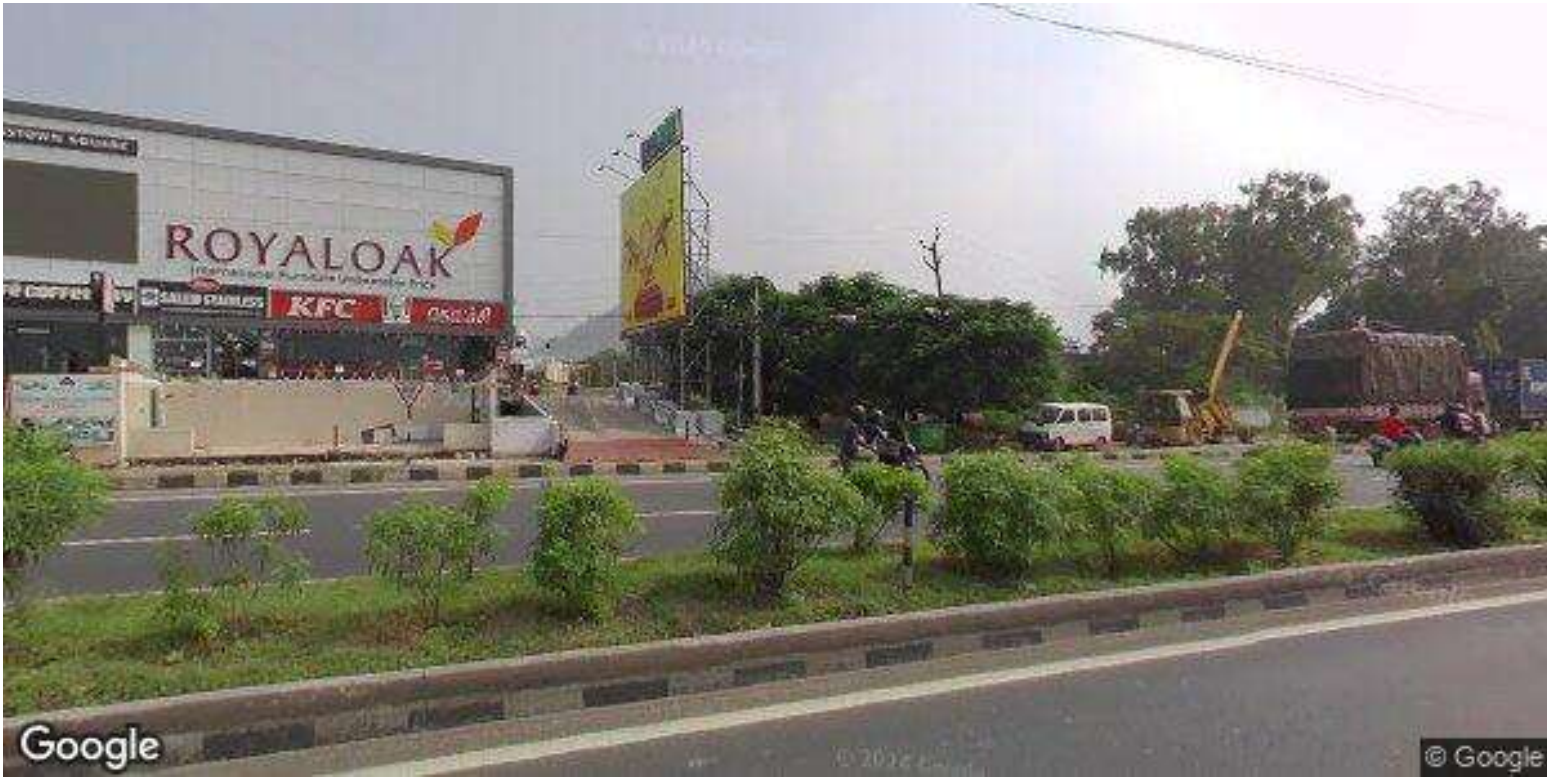
**Risk Type:** Turn  
**Risk Level:** Medium  
**Speed Limit:** 30 KM/Hr  
**Coordinates:** 11.68921, 78.11798

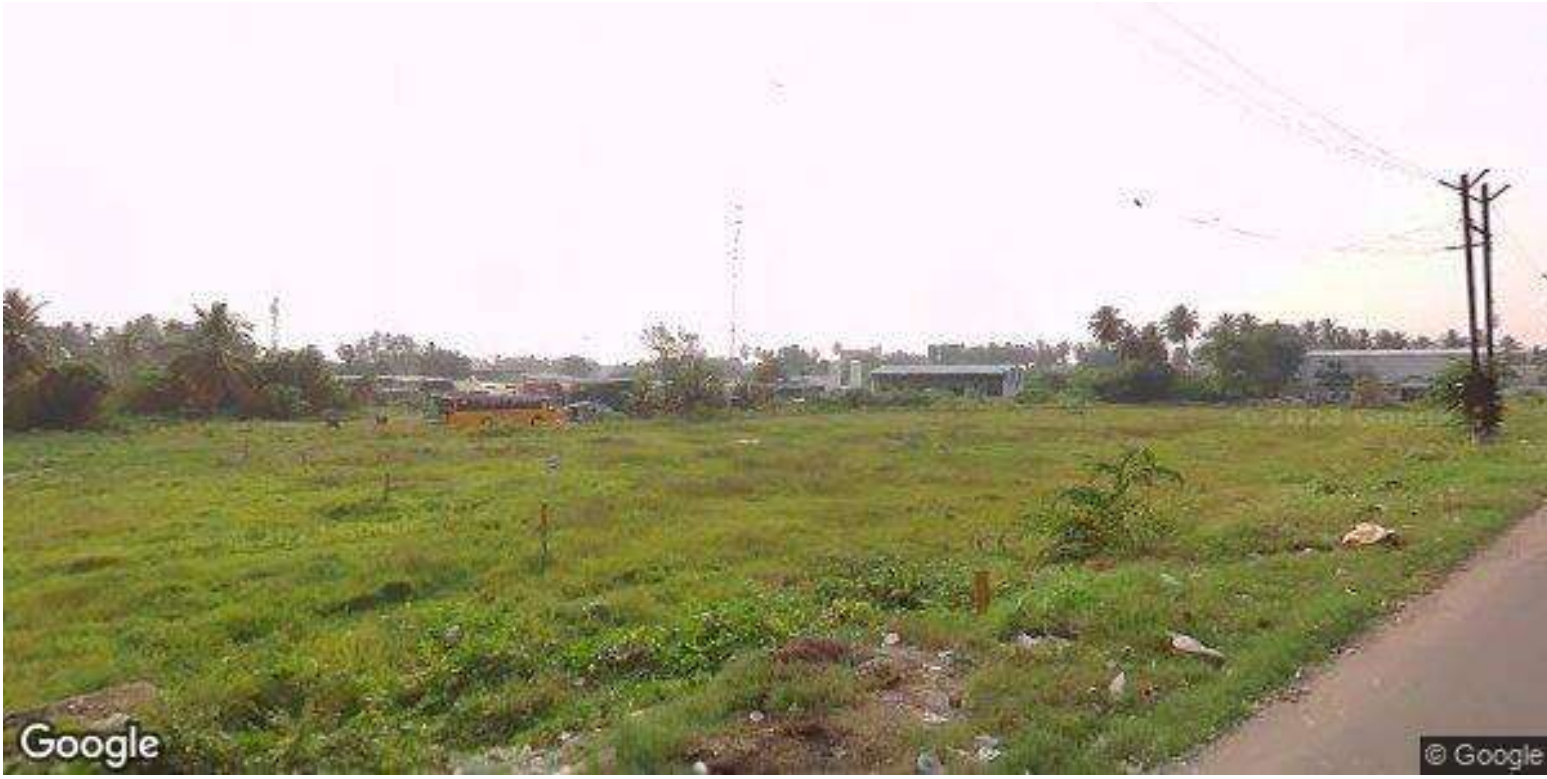
**Risk Type:** Turn  
**Risk Level:** Medium  
**Speed Limit:** 30 KM/Hr  
**Coordinates:** 11.68926, 78.11777

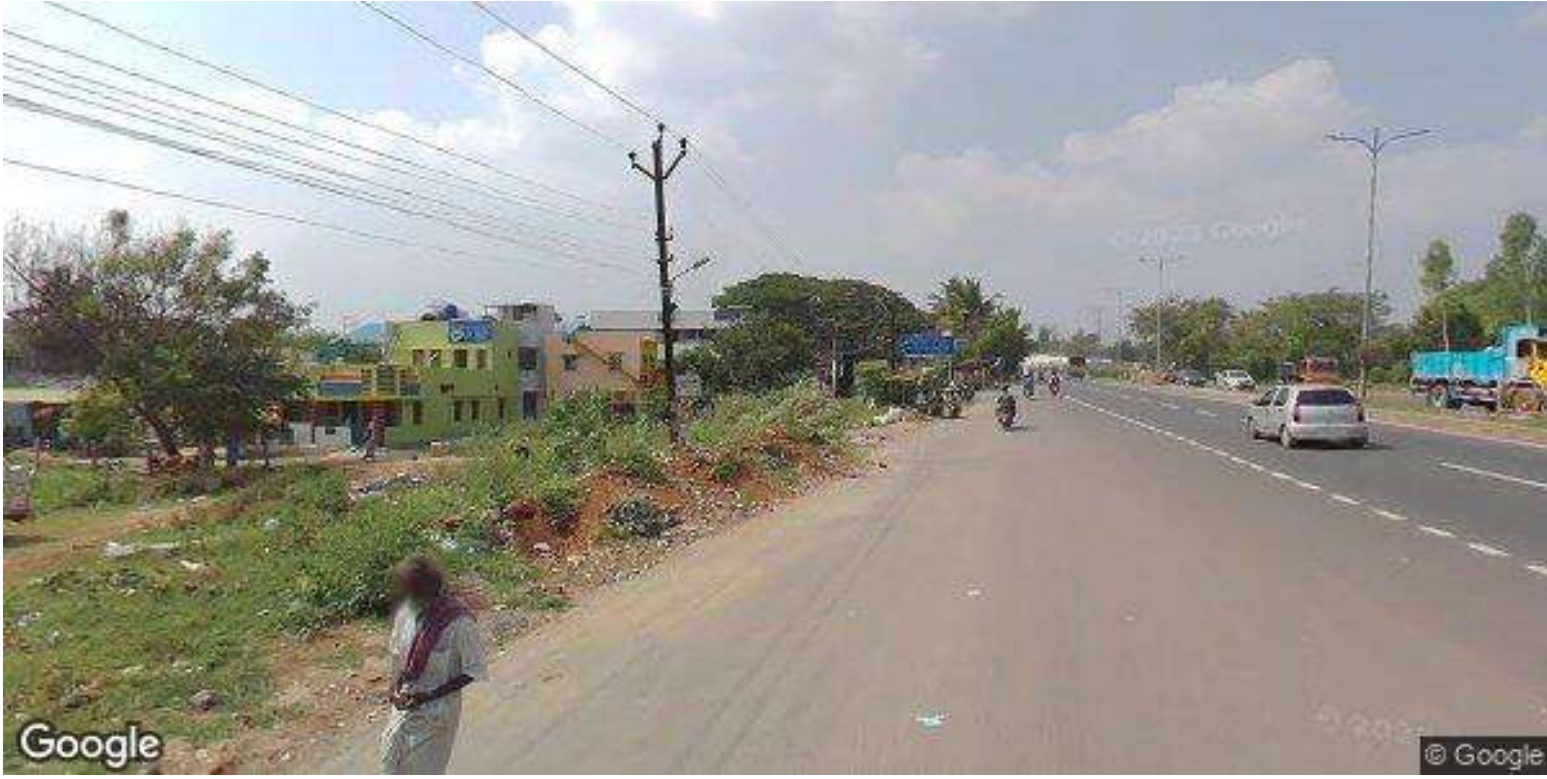
**Risk Type:** Turn  
**Risk Level:** High  
**Speed Limit:** 15 KM/Hr  
**Coordinates:** 11.69390, 78.10964

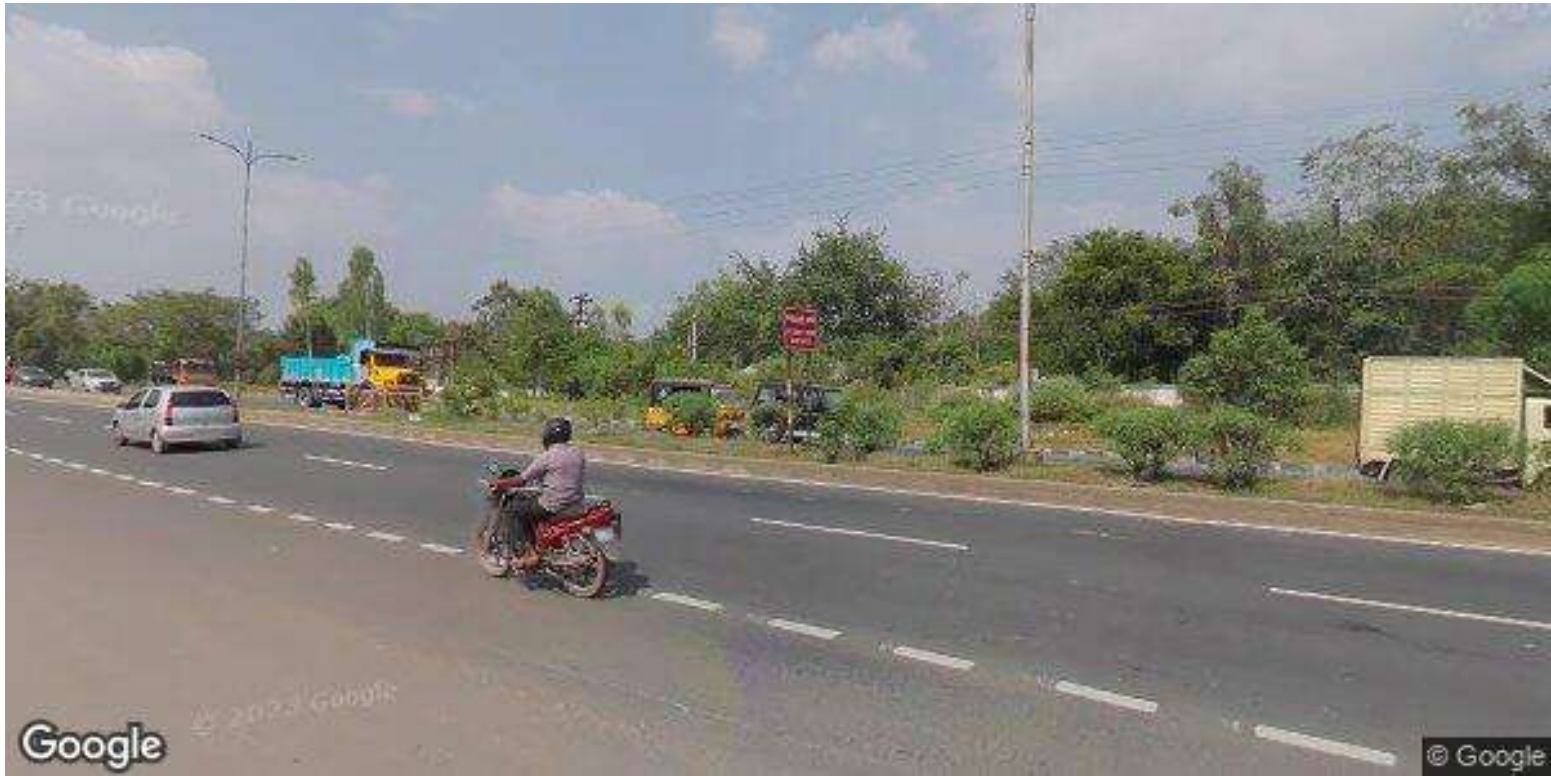
**Risk Type:** Turn  
**Risk Level:** High  
**Speed Limit:** 15 KM/Hr  
**Coordinates:** 11.69394, 78.10964

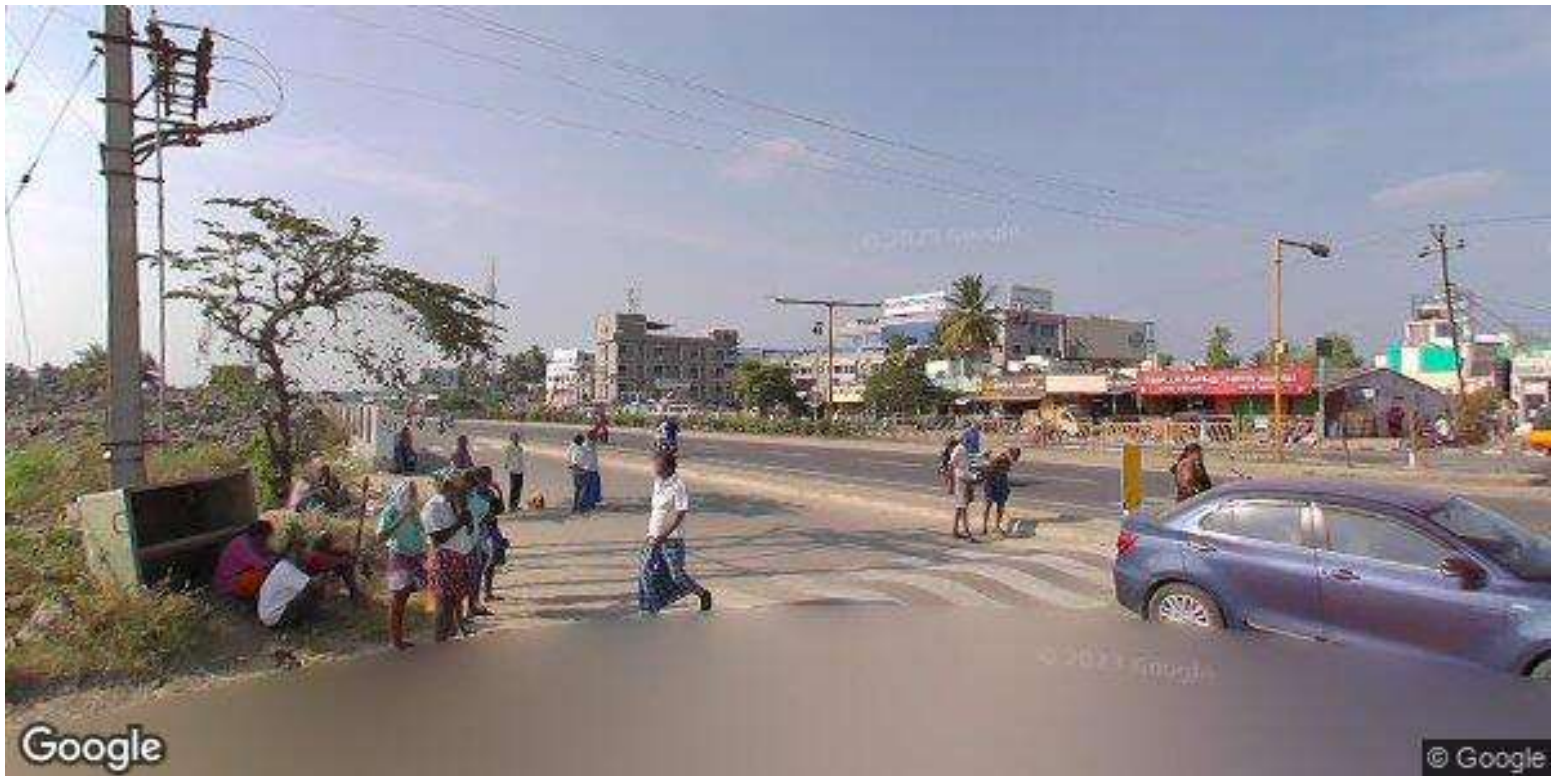
**Risk Type:** Blind Spot  
**Risk Level:** Blind Spot  
**Speed Limit:** 10 KM/Hr  
**Coordinates:** 11.70185, 78.10306

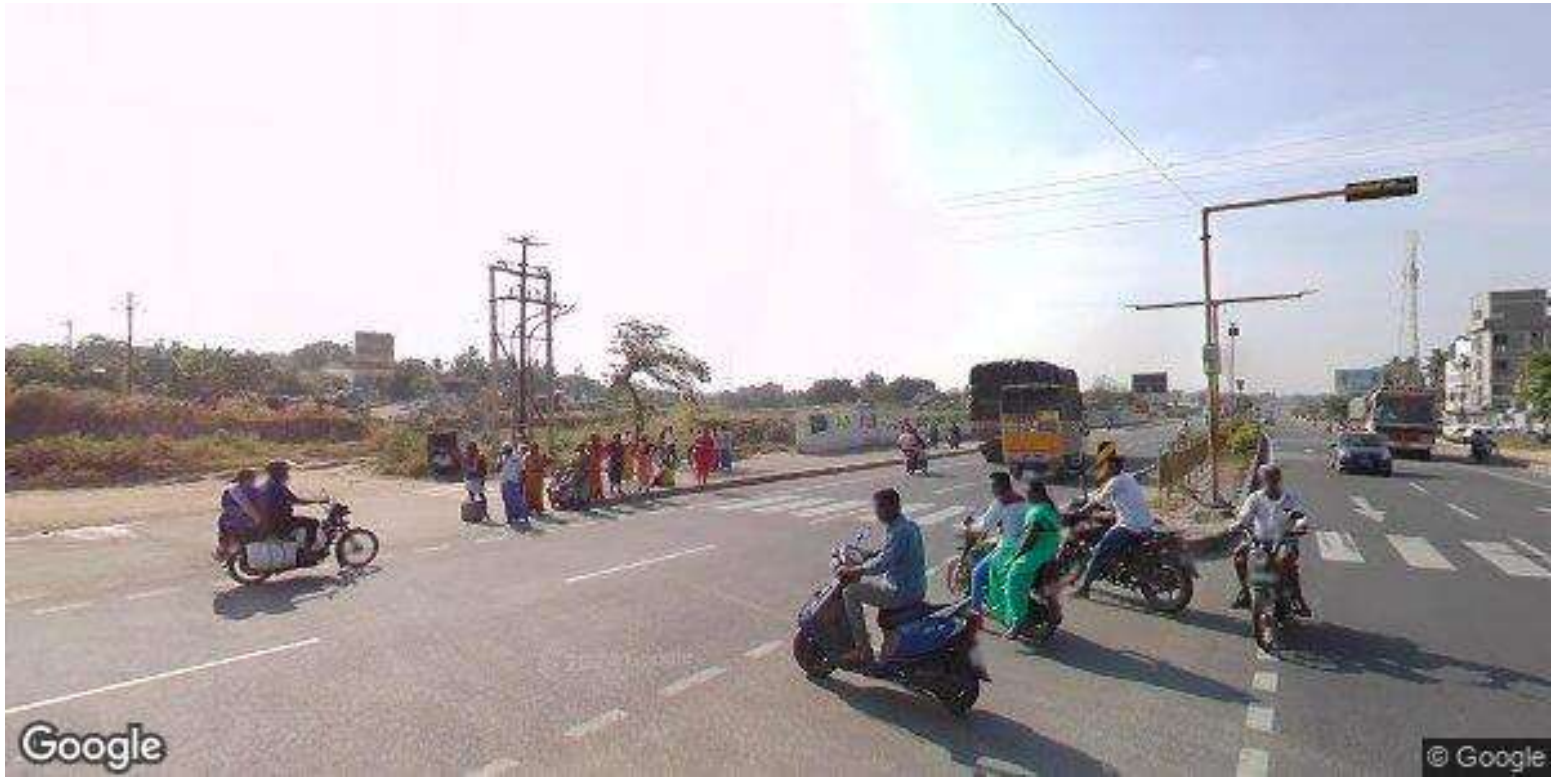
**Risk Type:** Turn  
**Risk Level:** High  
**Speed Limit:** 15 KM/Hr  
**Coordinates:** 11.70200, 78.10318

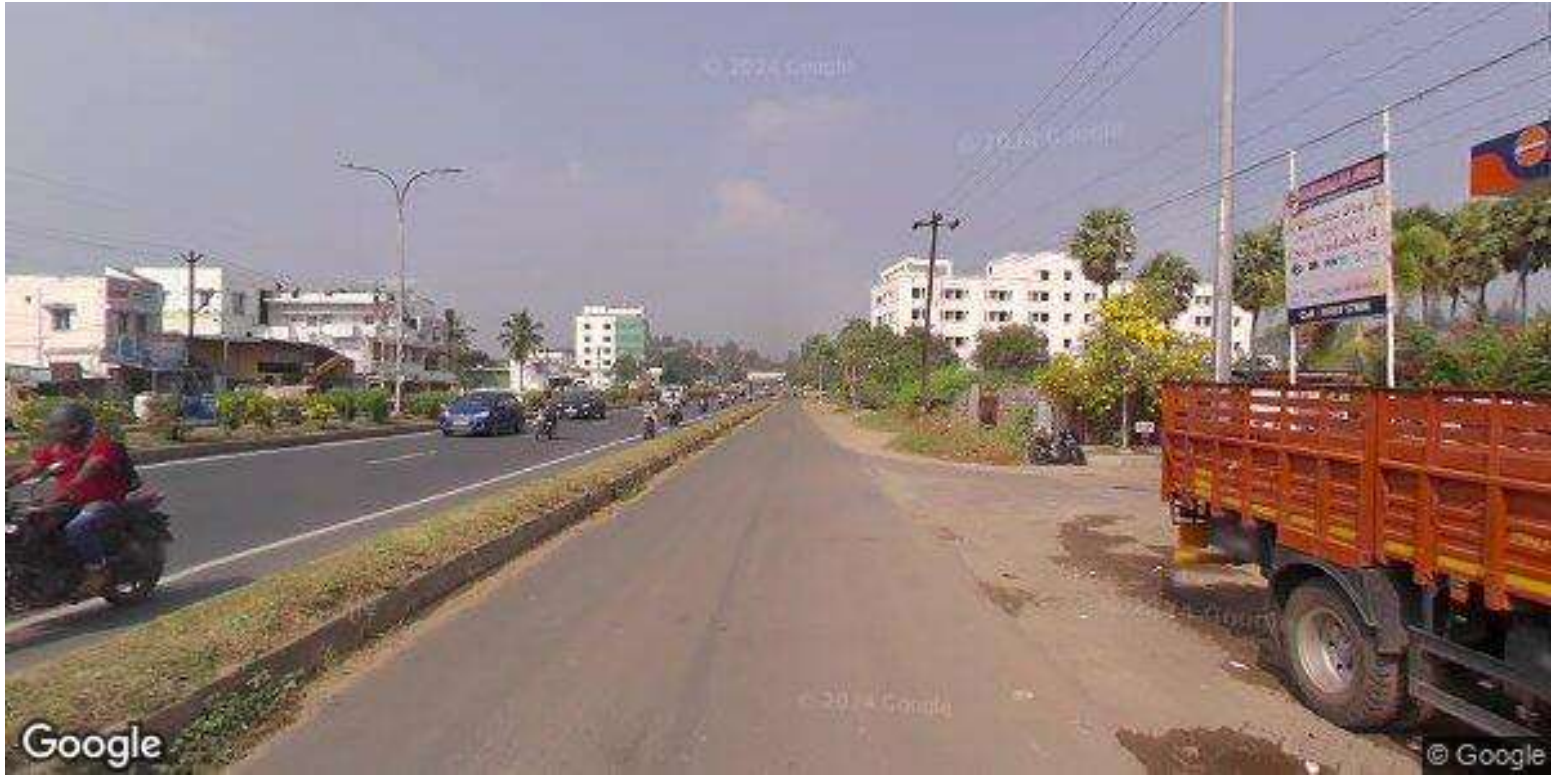
**Risk Type:** Blind Spot  
**Risk Level:** Blind Spot  
**Speed Limit:** 10 KM/Hr  
**Coordinates:** 11.69310, 78.11182
