## **JOURNEY RISK MANAGEMENT (JRM) STUDY**

### **Salem Terminal To SIVA SAKTHI AGENCY**

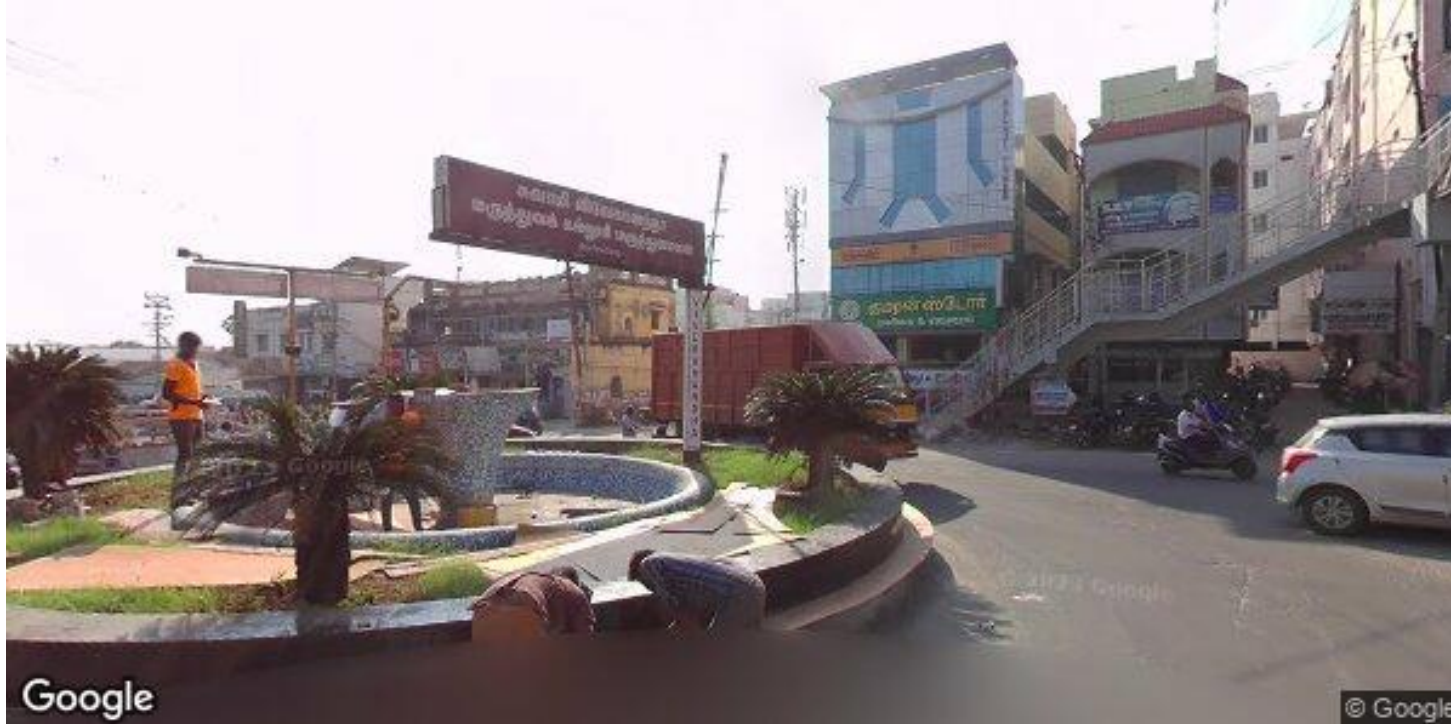
**Risk Type:** Roundabout  
**Risk Level:** High  
**Speed Limit:** 15 KM/Hr  
**Coordinates:** 11.38395, 77.89480

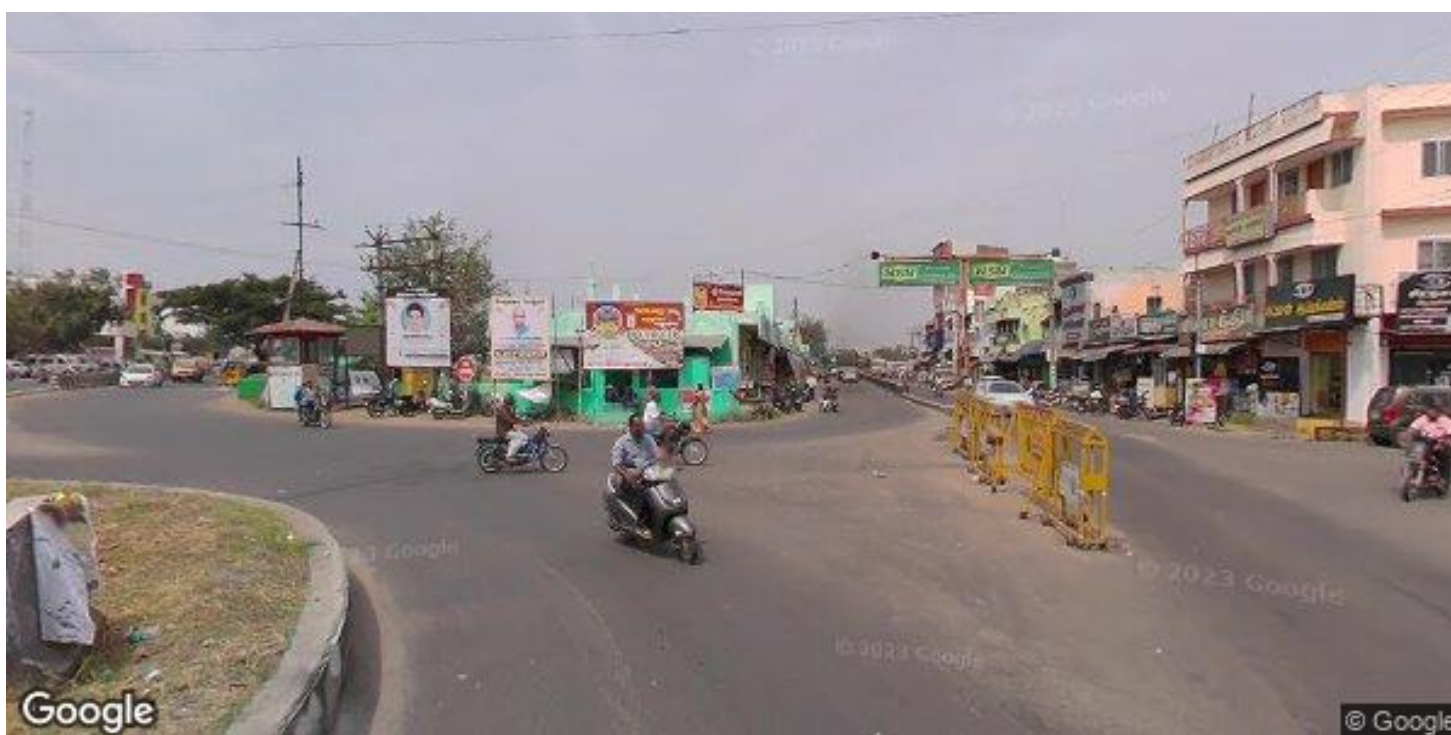
**Risk Type:** Roundabout  
**Risk Level:** High  
**Speed Limit:** 15 KM/Hr  
**Coordinates:** 11.00535, 77.56114

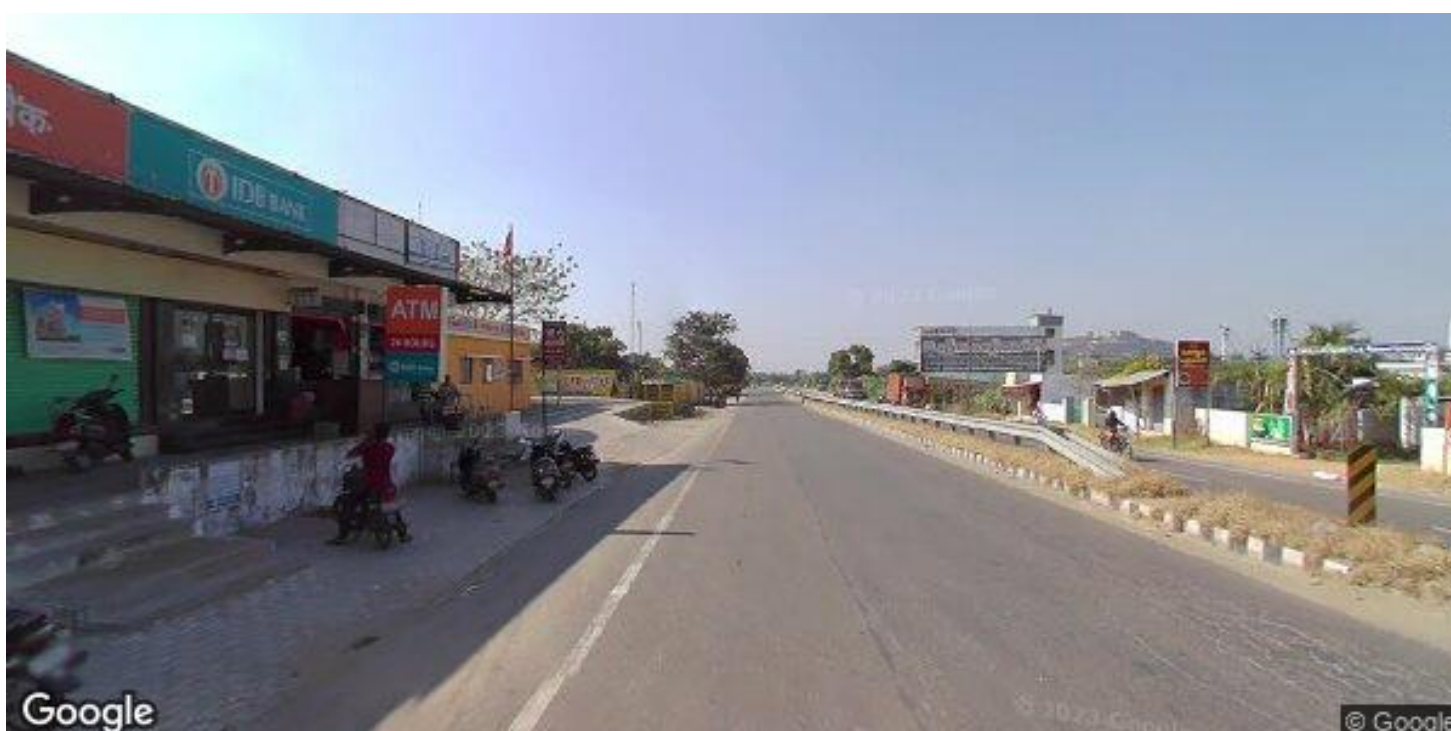
**Coordinates: 11.0185643, 77.5453777**

**Risk Type:** U-Turn  
**Risk Level:** High

**Speed Limit: 10 KM/Hr**

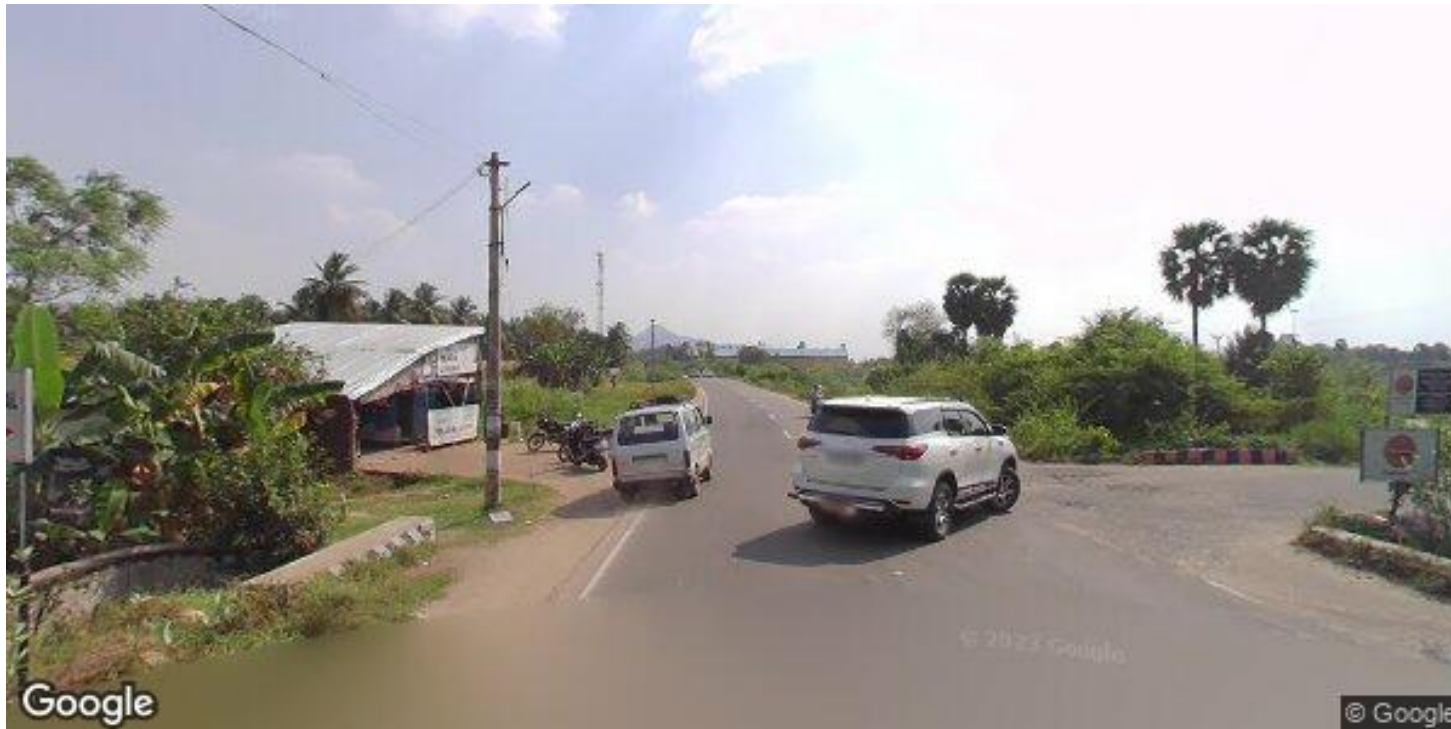
**Coordinates: 11.44029, 77.87544**

**Risk Type: Turn**

**Risk Level: High**

**Speed Limit: 15 KM/Hr**

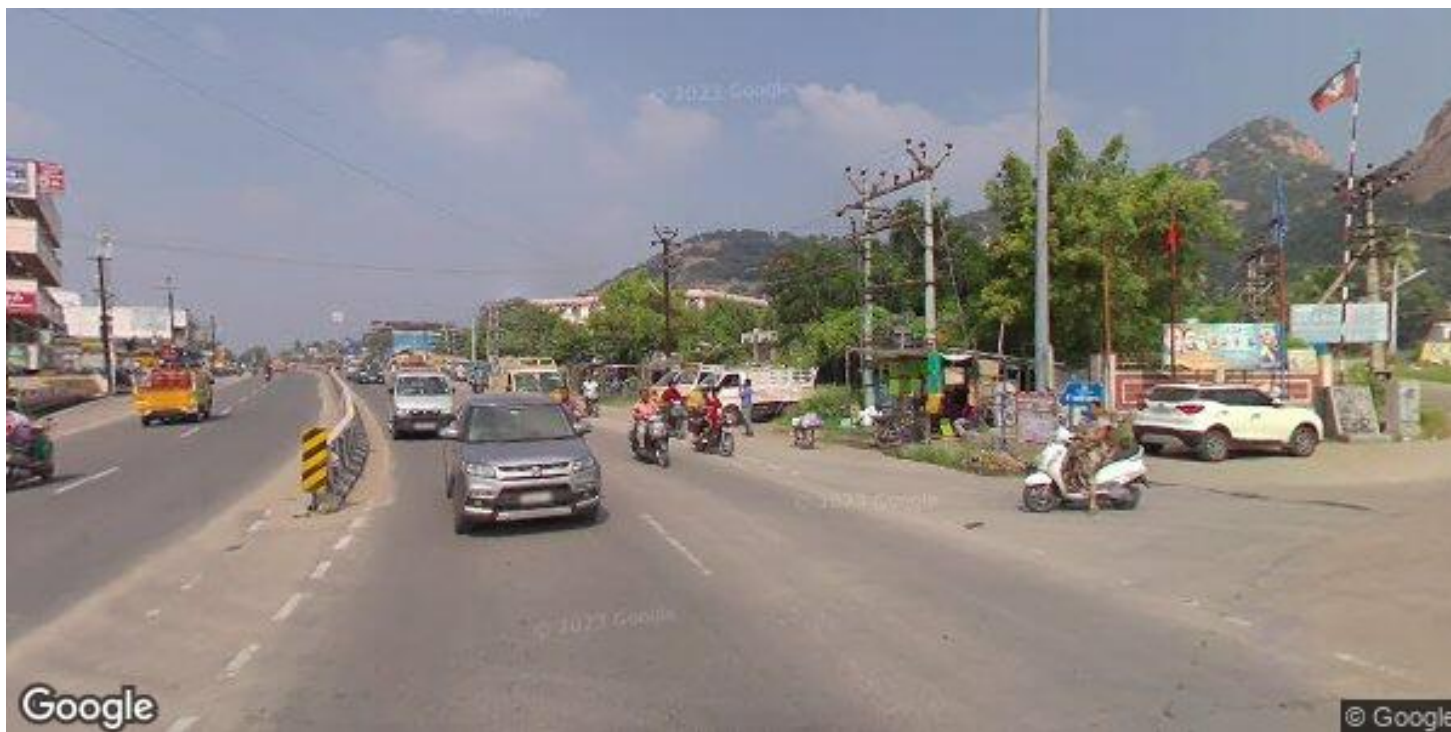
**Coordinates: 11.39671, 77.88878**

**Risk Type: Turn**

**Risk Level: Medium**

**Speed Limit: 30 KM/Hr**

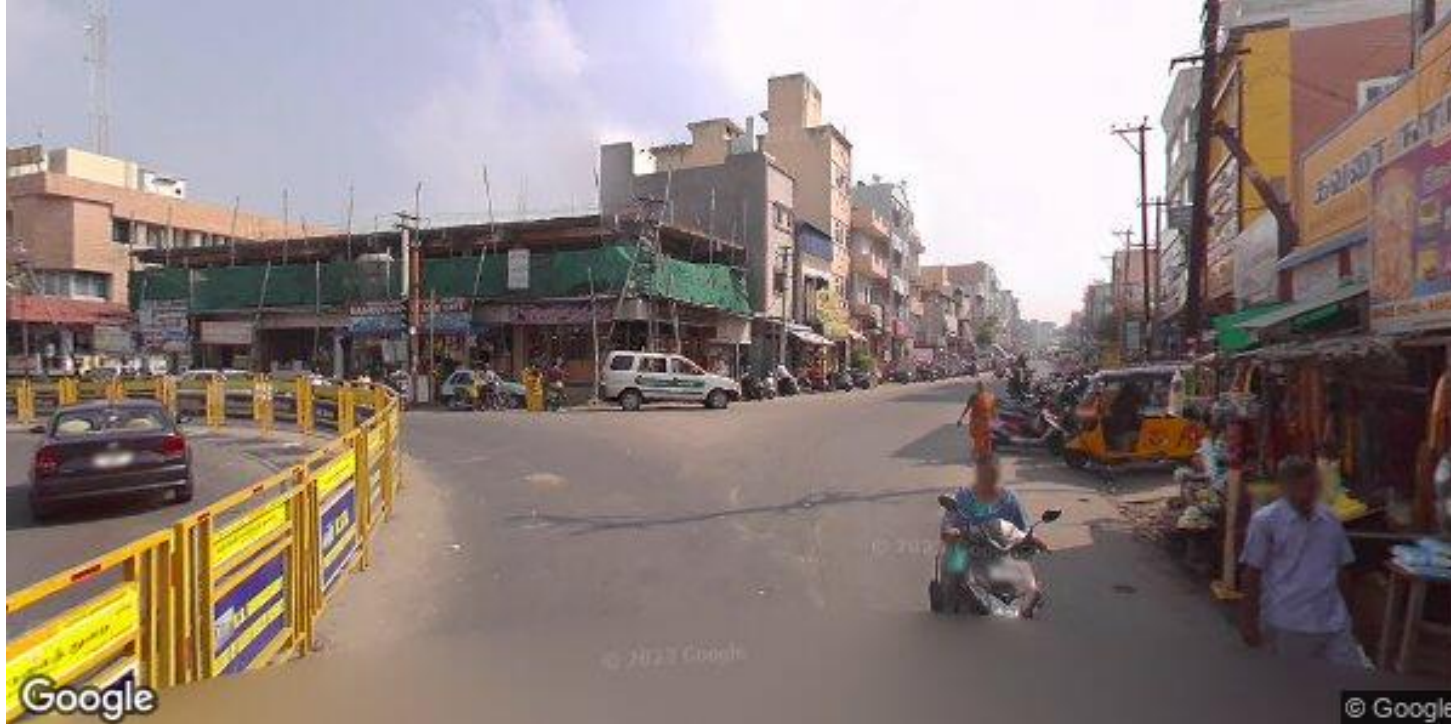
**Coordinates:** 11.37862, 77.89488

**Risk Type:** Turn

**Risk Level:** Medium

**Speed Limit:** 30 KM/Hr

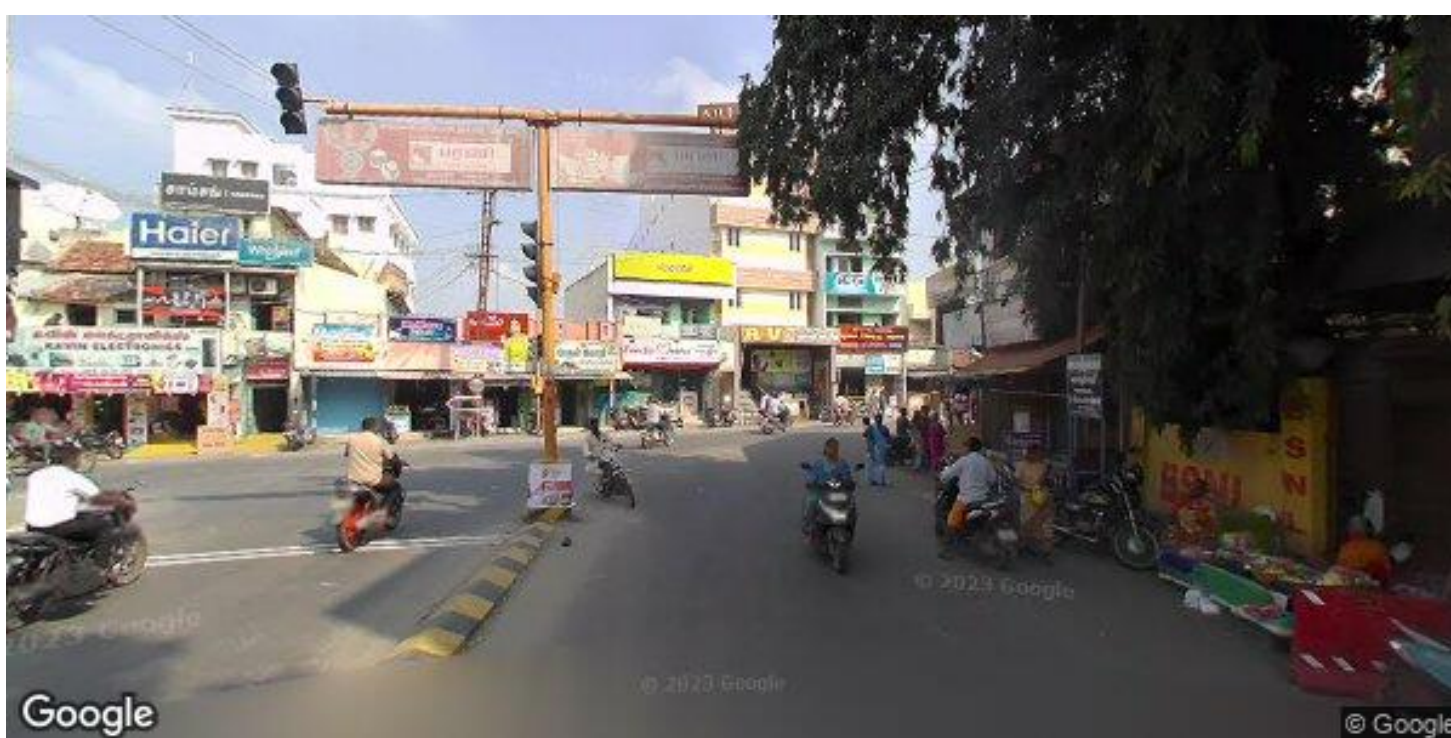
**Coordinates:** 11.37831, 77.89450

**Risk Type:** Turn

**Risk Level:** Medium

**Speed Limit:** 30 KM/Hr

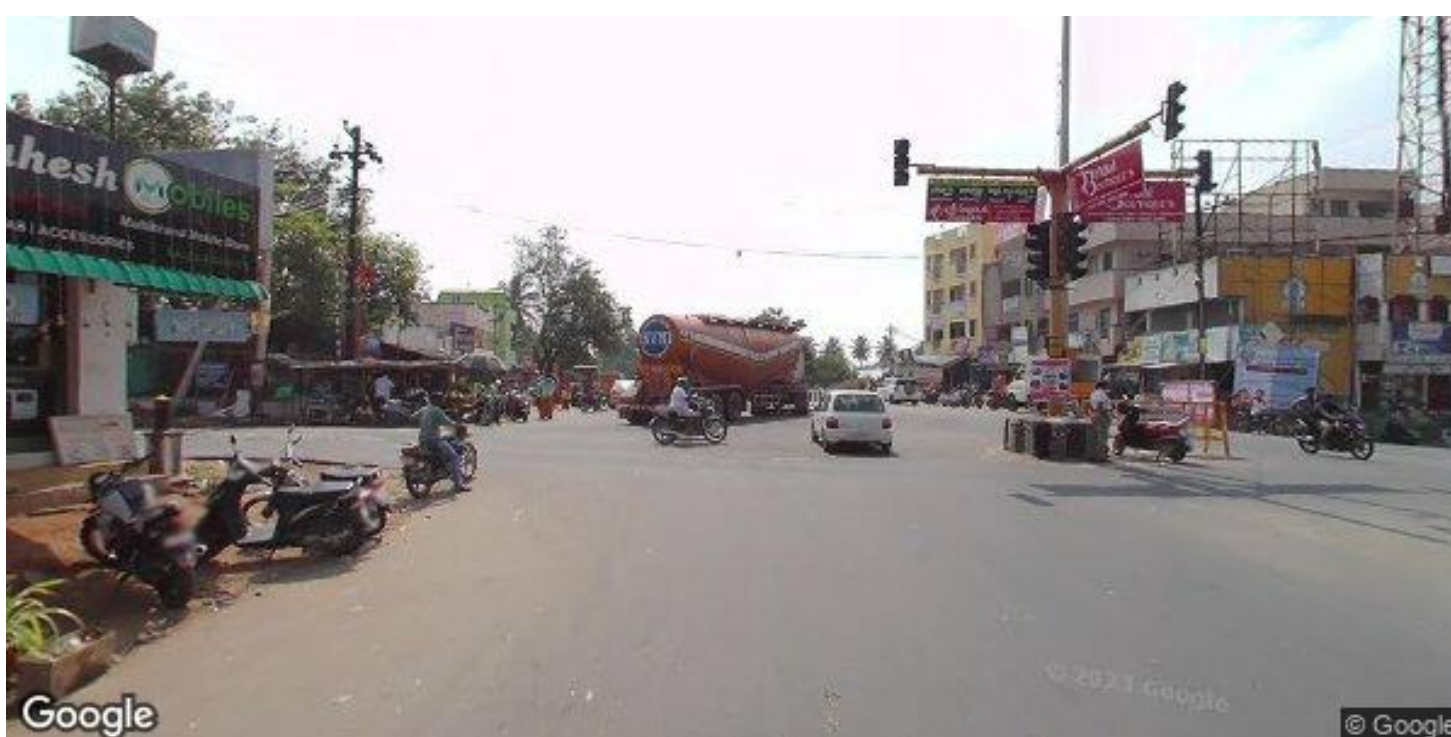
**Coordinates: 11.36616, 77.88885**

**Risk Type:** Turn

**Risk Level:** Medium

**Speed Limit: 30 KM/Hr**

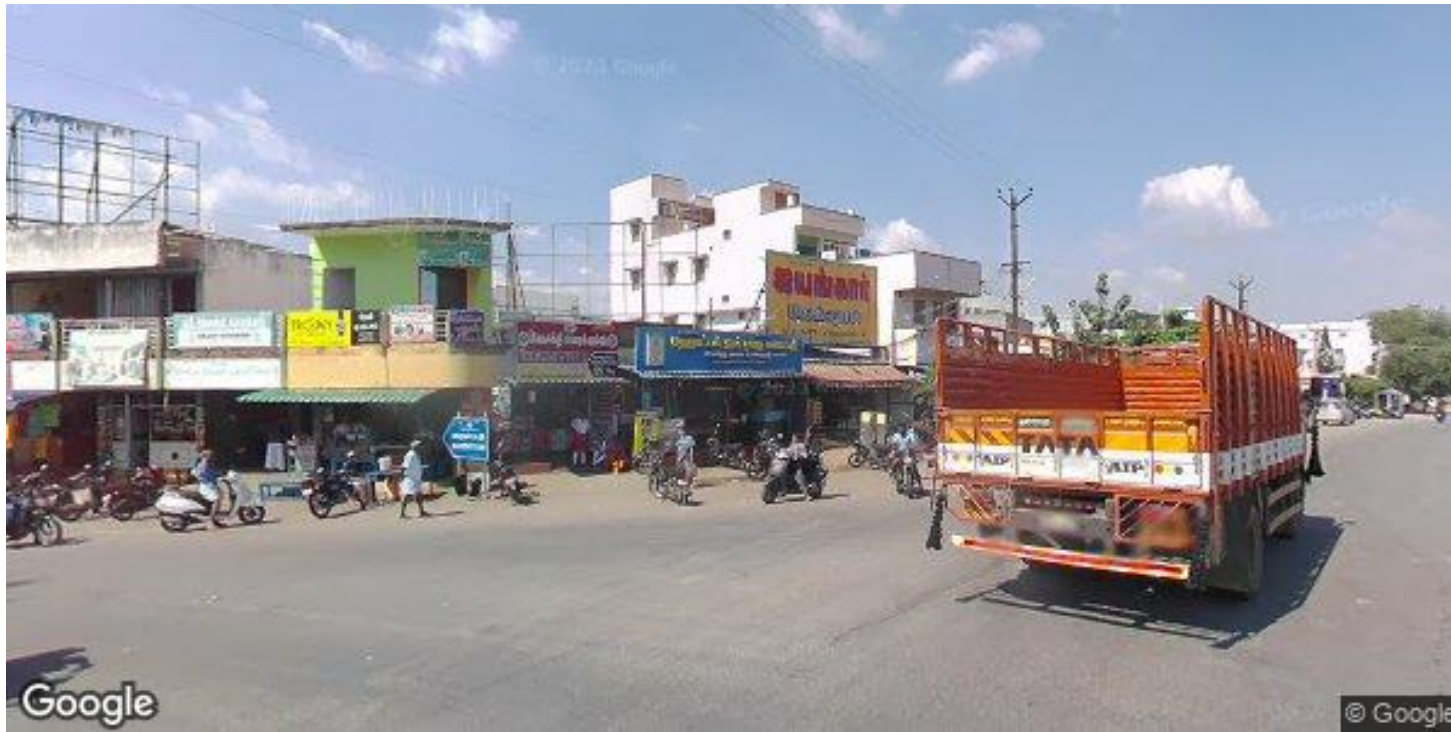
**Coordinates: 11.36602, 77.88875**

**Risk Type: Turn**

**Risk Level: Medium**

**Speed Limit: 30 KM/Hr**

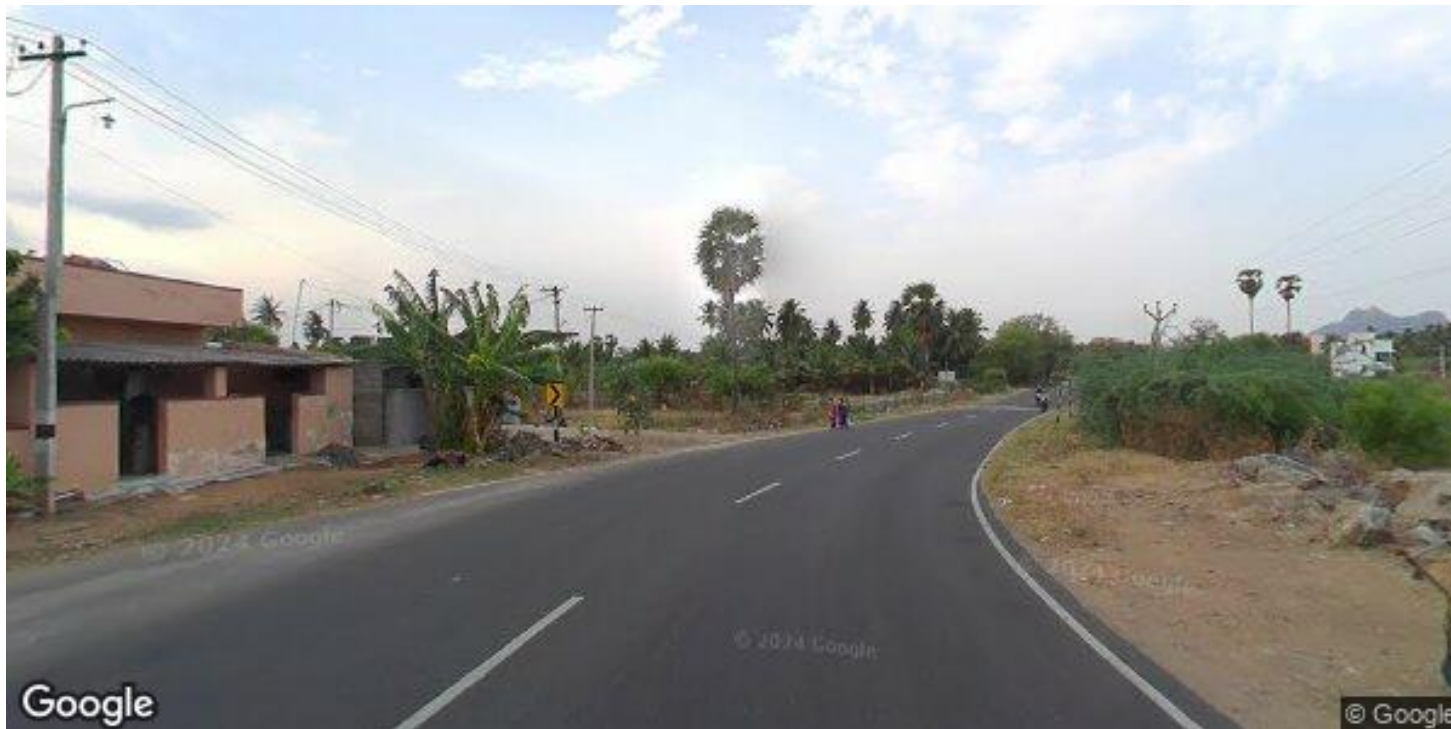
**Coordinates: 11.33882, 77.86218**

**Risk Type: Turn**

**Risk Level: Medium**

**Speed Limit: 30 KM/Hr**

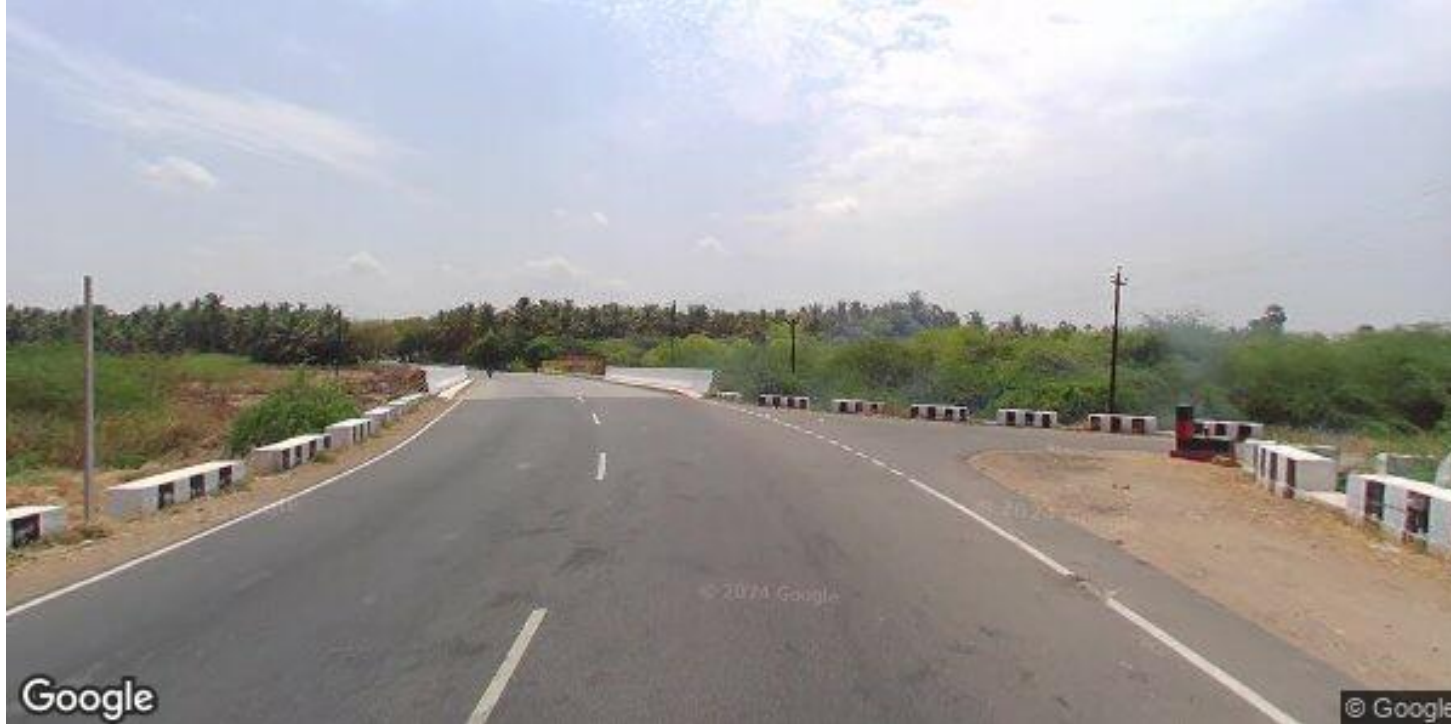
**Coordinates:** 11.31747, 77.84240

**Risk Type:** Turn

**Risk Level:** Medium

**Speed Limit:** 30 KM/Hr

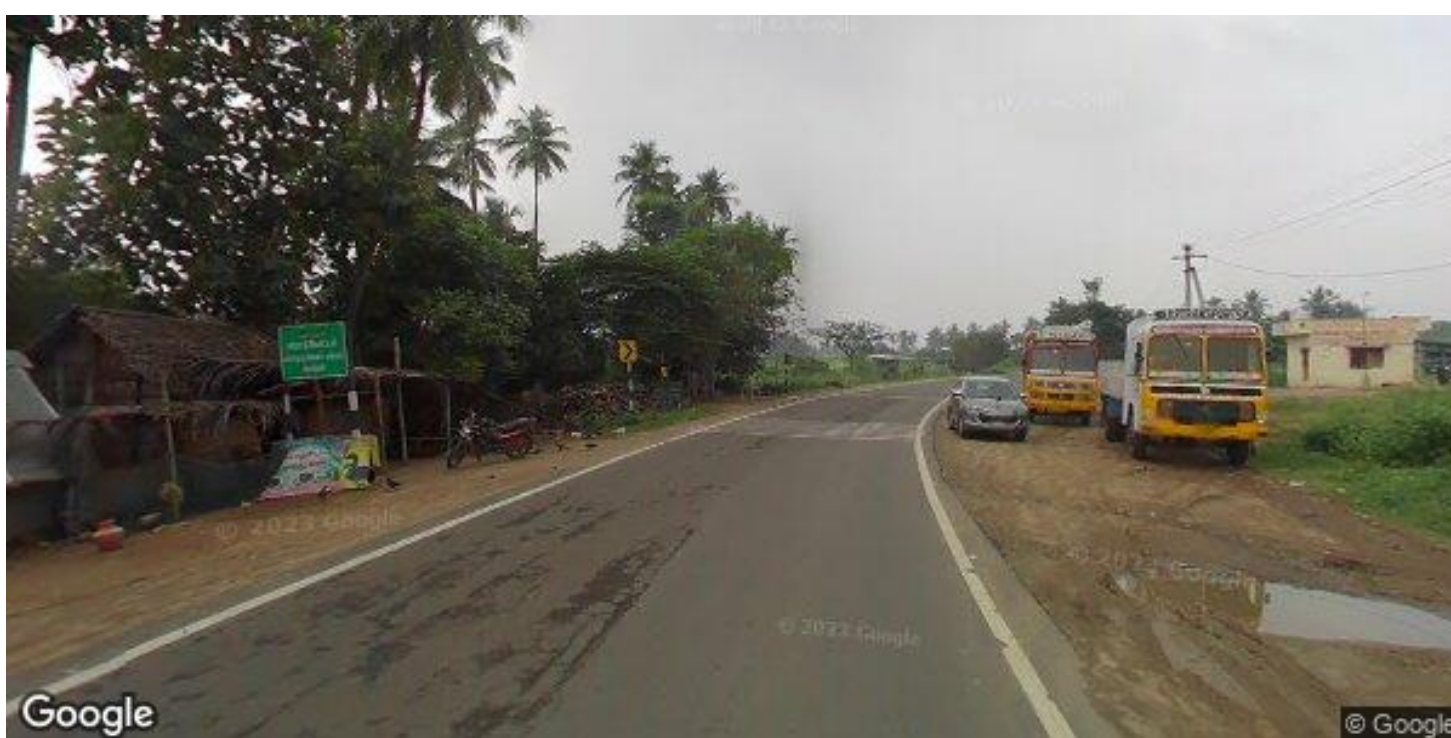
**Coordinates:** 11.30951, 77.77608

**Risk Type:** Turn

**Risk Level:** Medium

**Speed Limit:** 30 KM/Hr

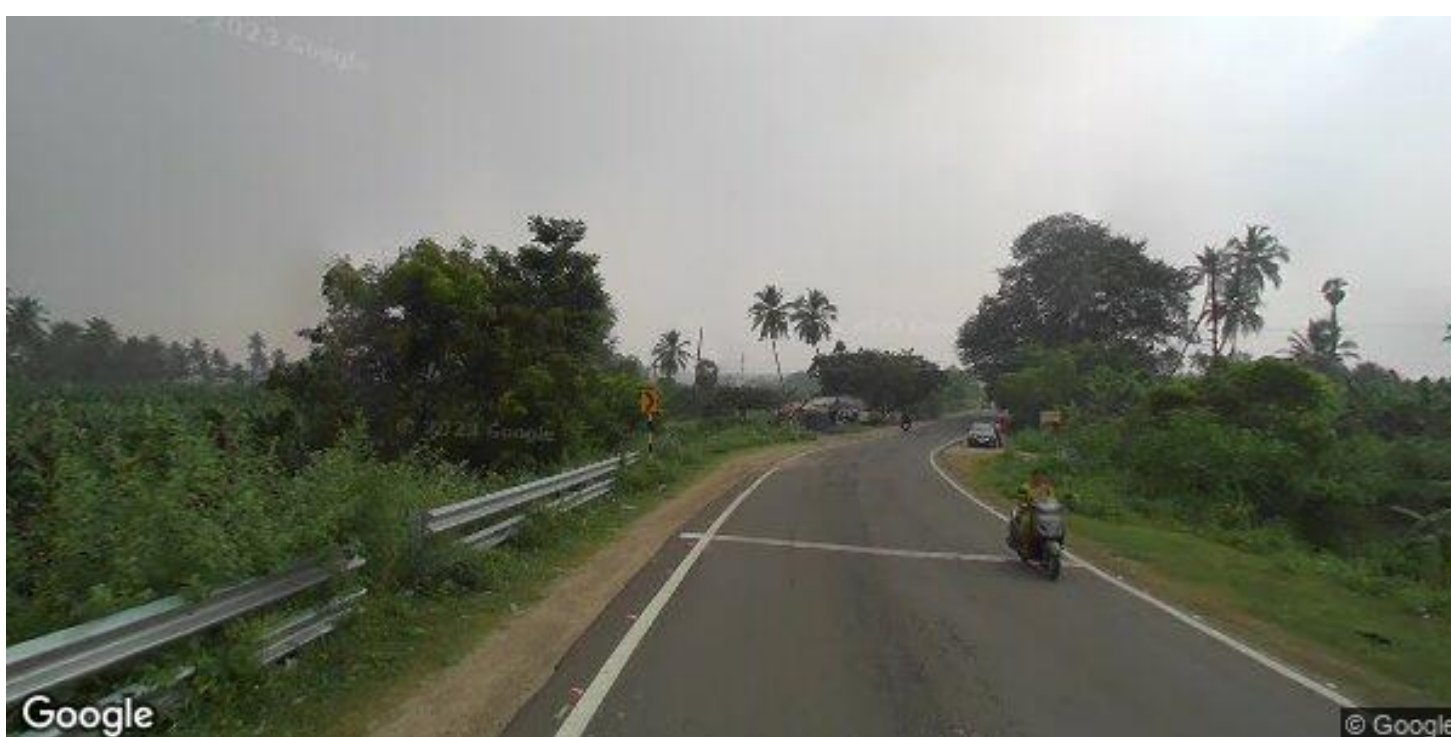
**Coordinates: 11.31118, 77.77139**

**Risk Type:** Turn

**Risk Level:** Medium

**Speed Limit: 30 KM/Hr**

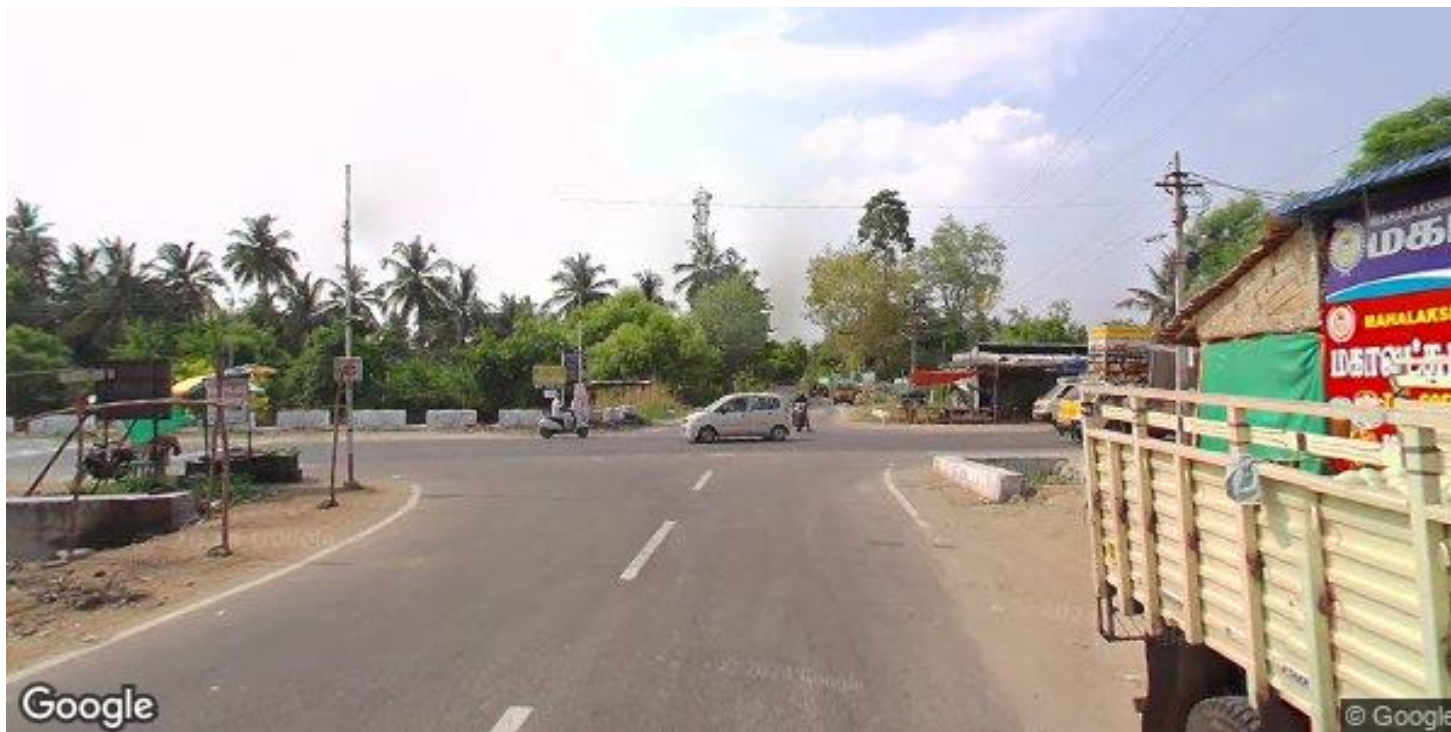
**Coordinates: 11.29473, 77.74685**

**Risk Type: Turn**

**Risk Level: High**

**Speed Limit: 15 KM/Hr**

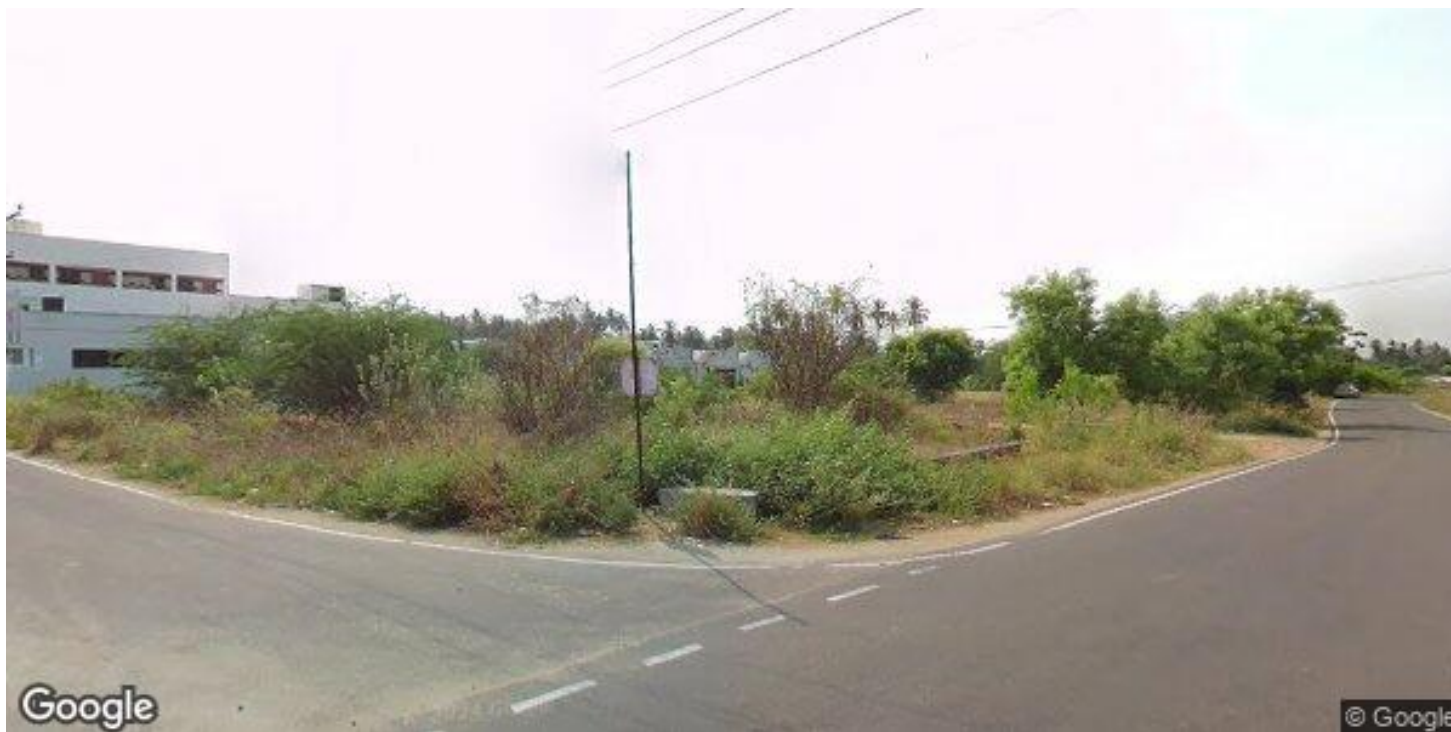
**Coordinates: 11.29133, 77.74660**

**Risk Type: Turn**

**Risk Level: High**

**Speed Limit: 15 KM/Hr**

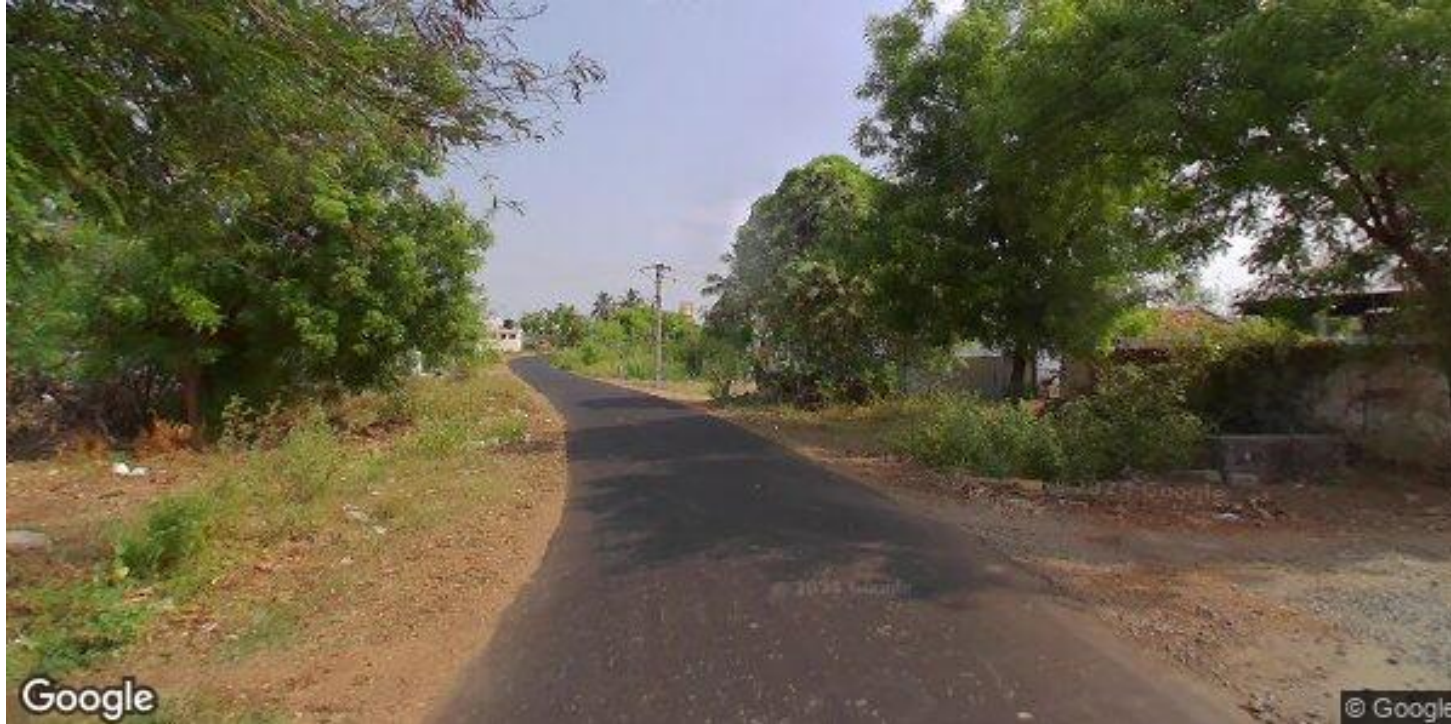
**Coordinates:** 11.28844, 77.74319

**Risk Type:** Turn

**Risk Level:** Medium

**Speed Limit:** 30 KM/Hr

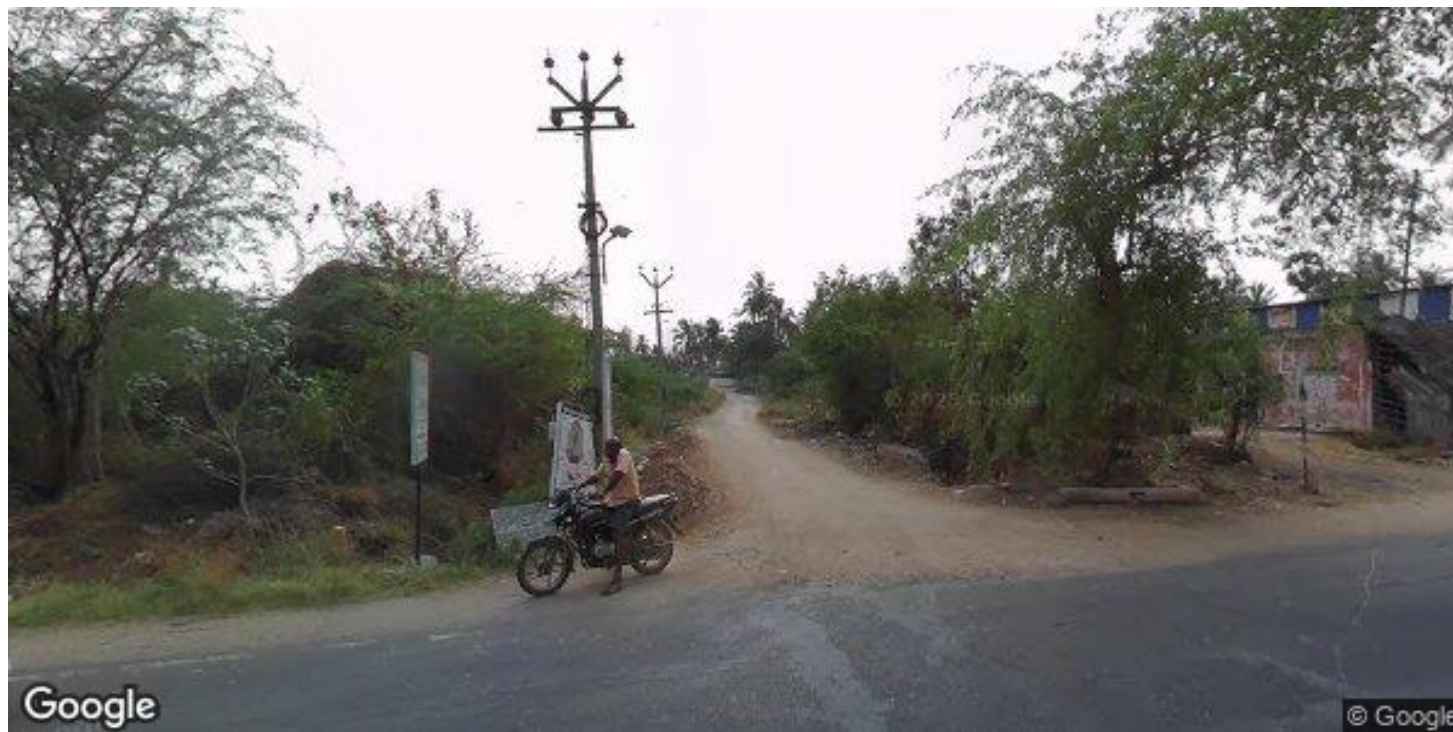
**Coordinates: 11.27330, 77.72711**

**Risk Type: Blind Spot**

**Risk Level: Blind Spot**

**Speed Limit: 10 KM/Hr**

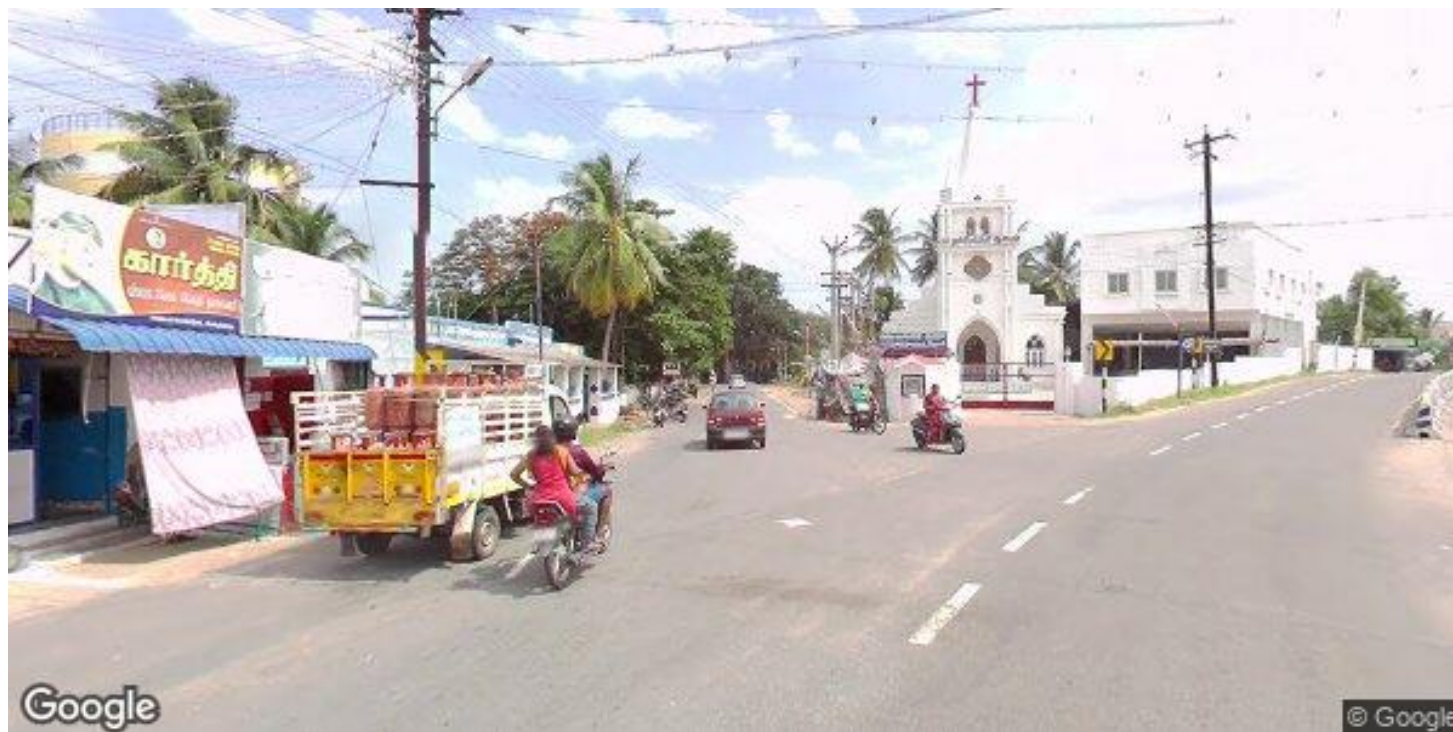
**Coordinates: 11.23054, 77.71796**

**Risk Type: Turn**

**Risk Level: Medium**

**Speed Limit: 30 KM/Hr**

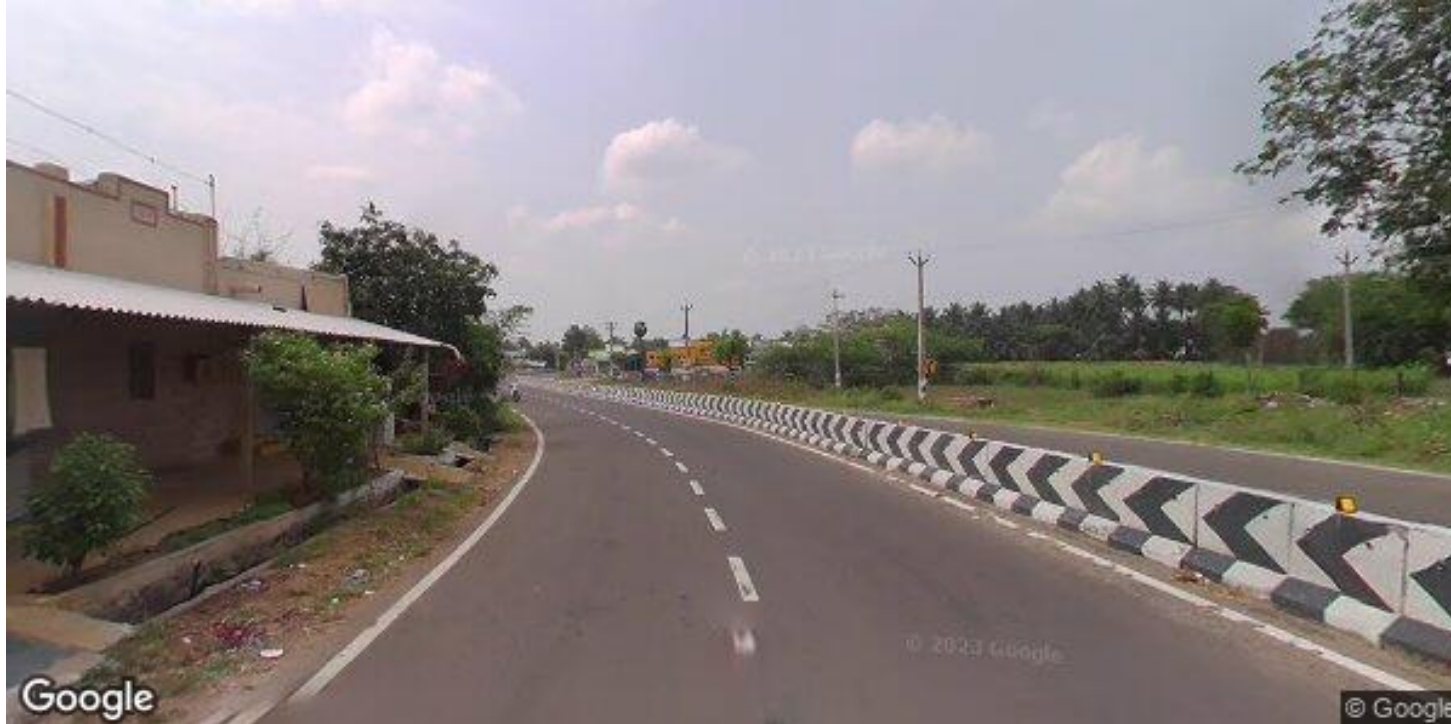
**Risk Type:** Turn  
**Risk Level:** Medium  
**Speed Limit:** 30 KM/Hr  
**Coordinates:** 11.22387, 77.71385

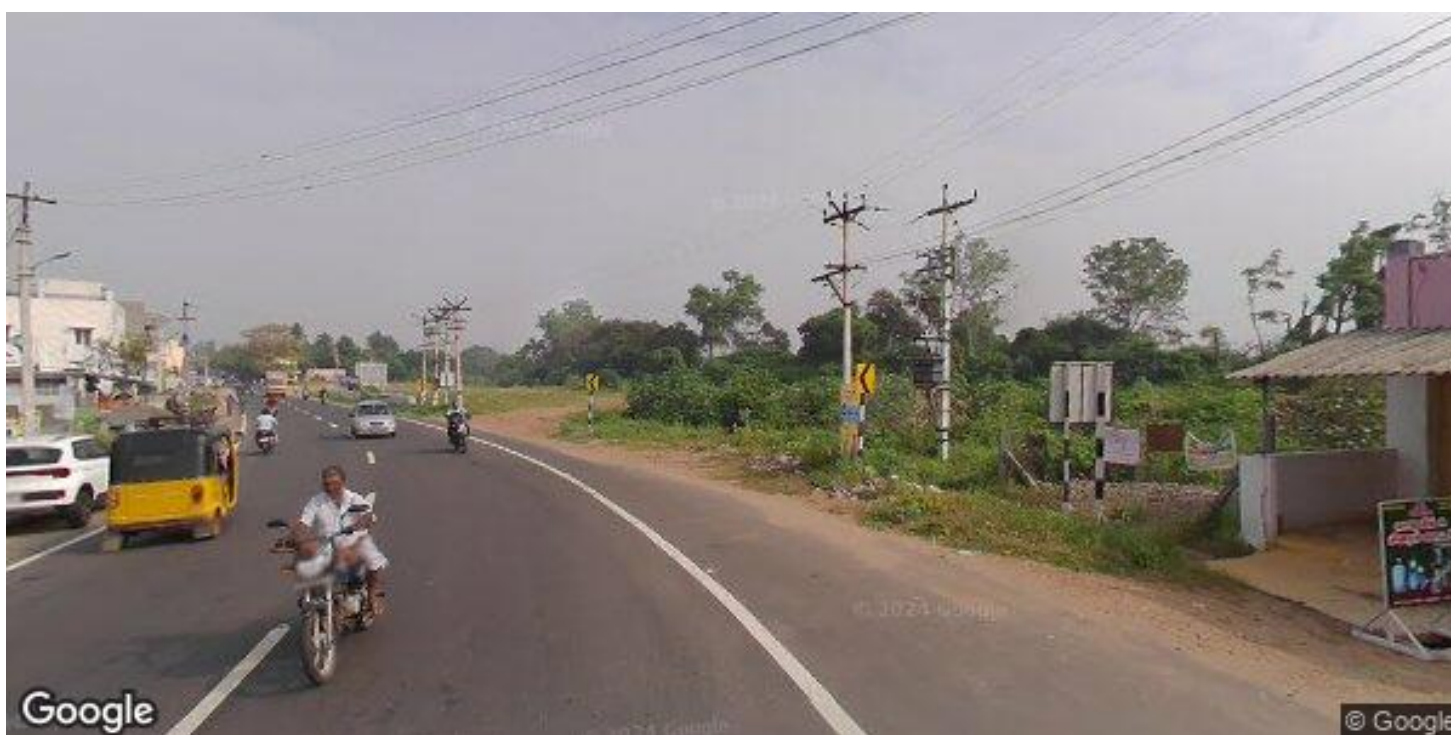
**Risk Type:** Turn  
**Risk Level:** Medium  
**Speed Limit:** 30 KM/Hr  
**Coordinates:** 11.16078, 77.70122

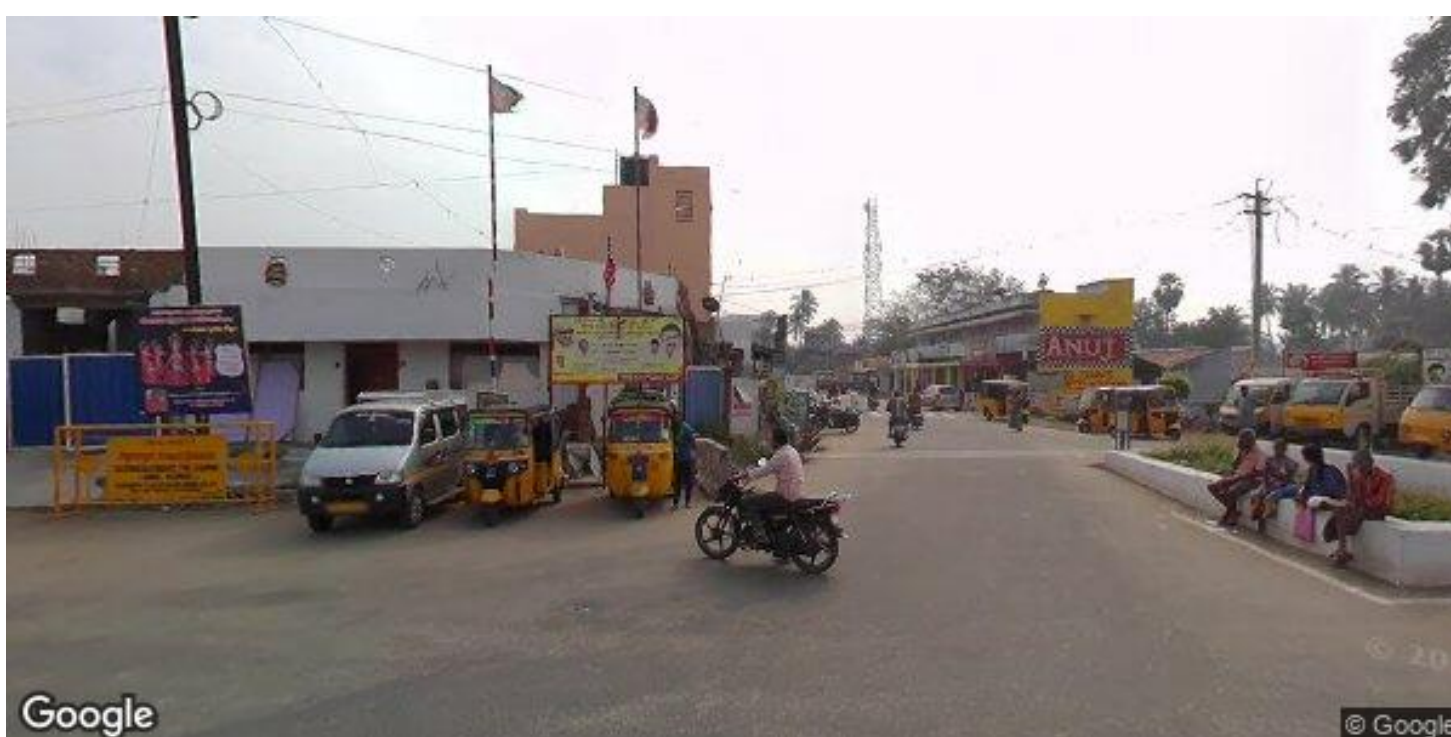
Coordinates: 11.15953, 77.70067

**Risk Type:** Turn  
**Risk Level:** Medium

Speed Limit: 30 KM/Hr
