## **JOURNEY RISK MANAGEMENT (JRM) STUDY**

### **Salem Terminal To SIVA SAKTHI AGENCY**

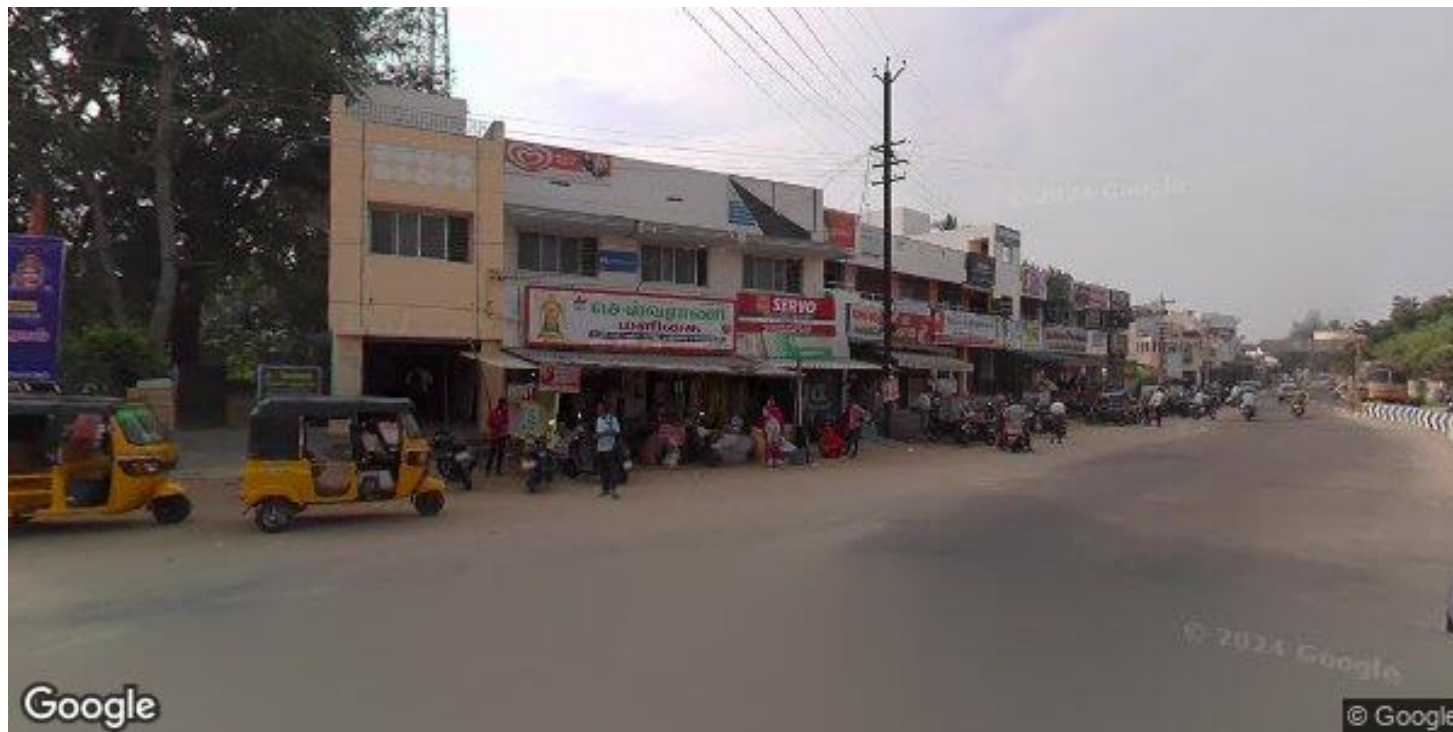
Coordinates: 11.15944, 77.70068

Risk Type: Turn

Risk Level: High

Speed Limit: 15 KM/Hr

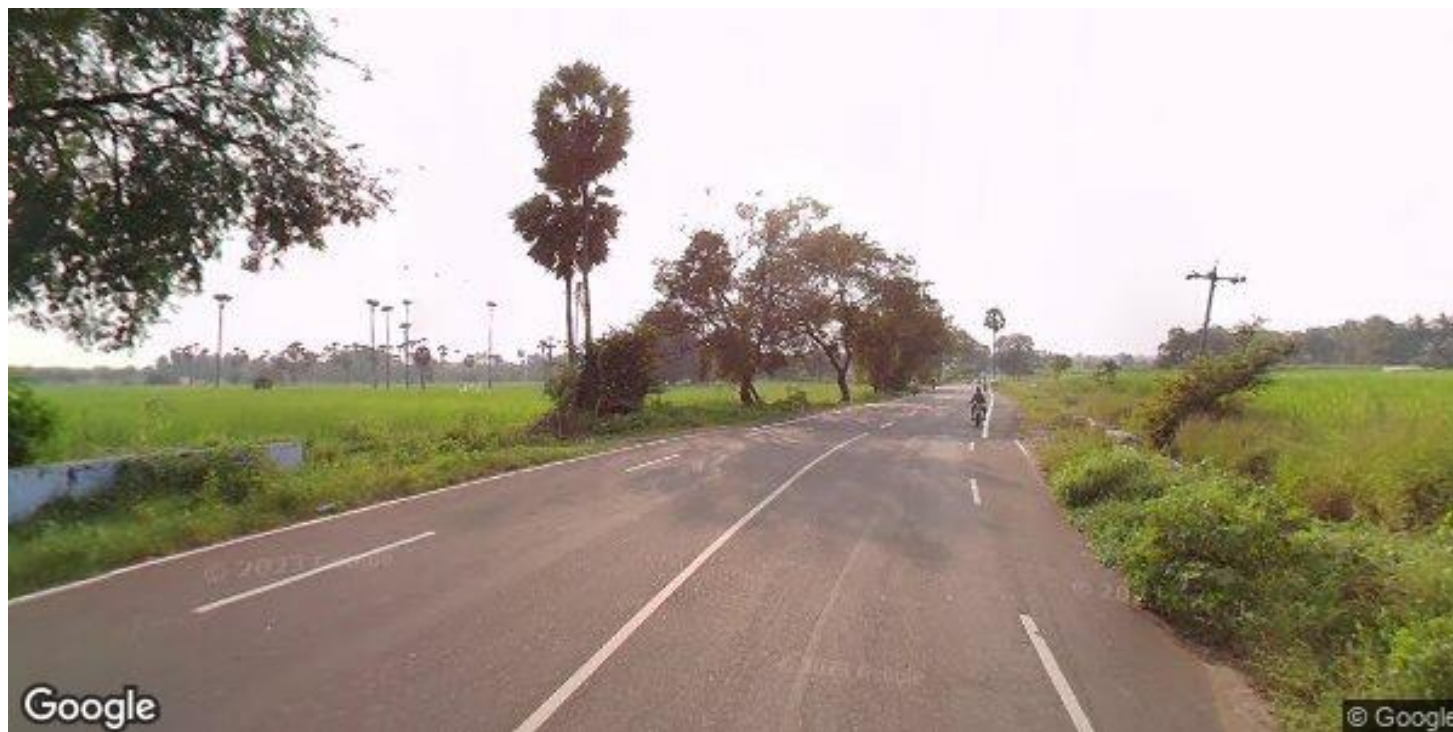
Coordinates: 11.11918, 77.67766

Risk Type: Turn

Risk Level: Medium

Speed Limit: 30 KM/Hr

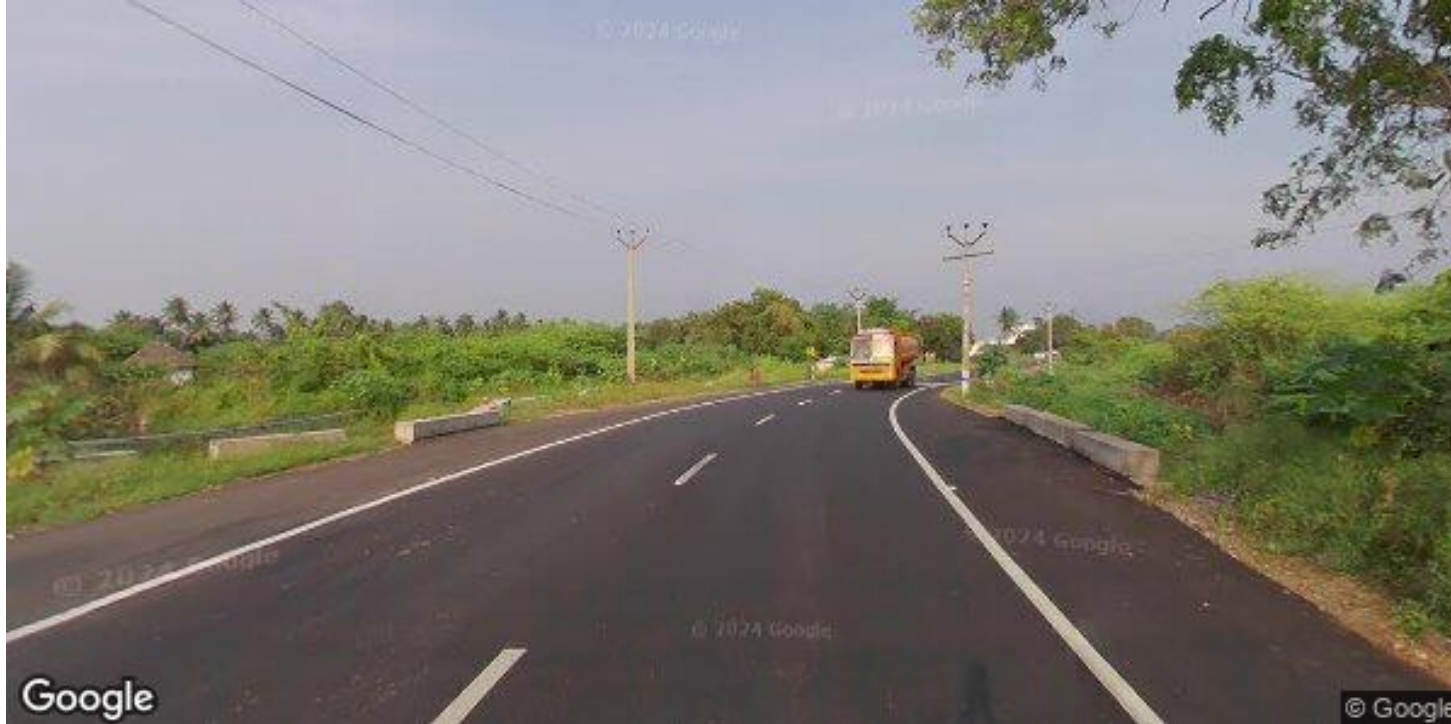
**Coordinates:** 11.11740, 77.67198

**Risk Type:** Turn

**Risk Level:** Medium

**Speed Limit:** 30 KM/Hr

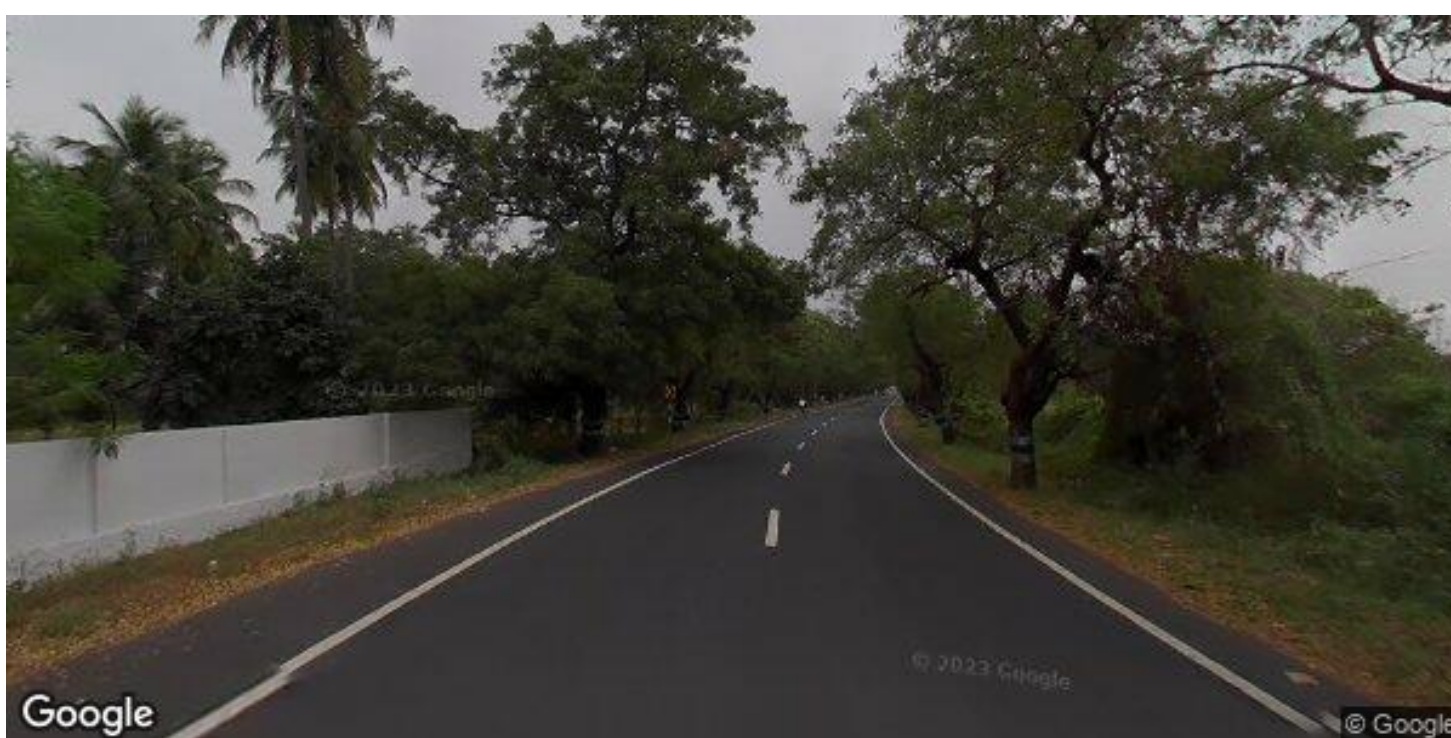
**Coordinates:** 11.10481, 77.67060

**Risk Type:** Turn

**Risk Level:** Medium

**Speed Limit:** 30 KM/Hr

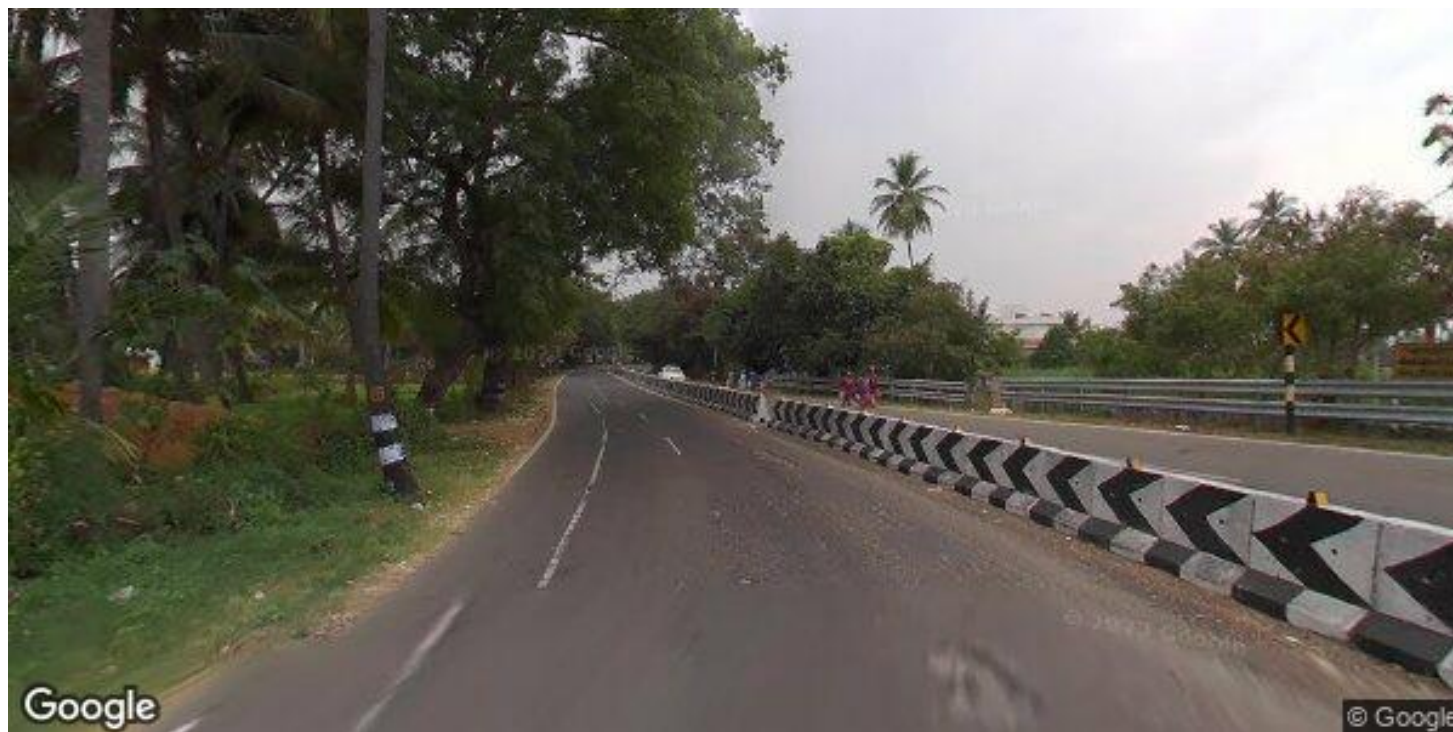
**Coordinates: 11.08282, 77.65837**

**Risk Type: Turn**

**Risk Level: Medium**

**Speed Limit: 30 KM/Hr**

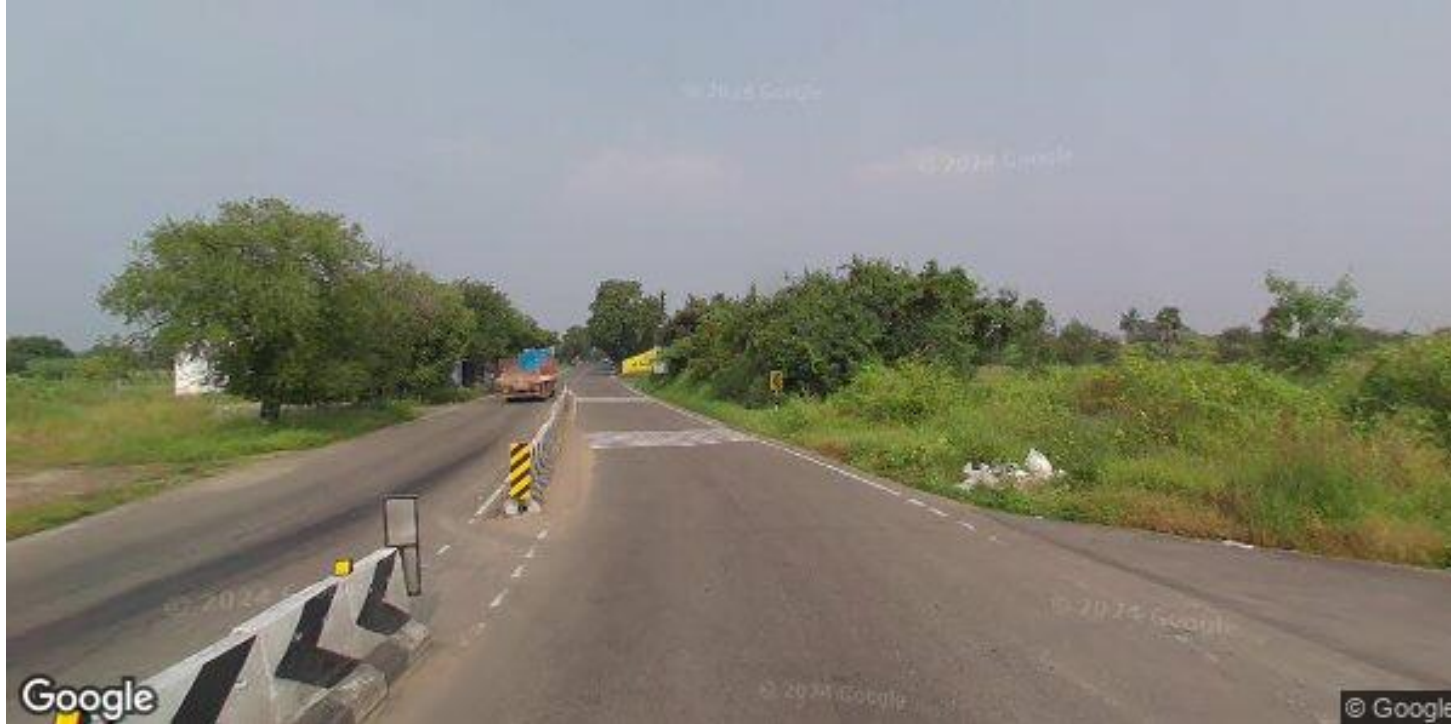
**Coordinates:** 11.06189, 77.63943

**Risk Type:** Turn

**Risk Level:** High

**Speed Limit:** 15 KM/Hr

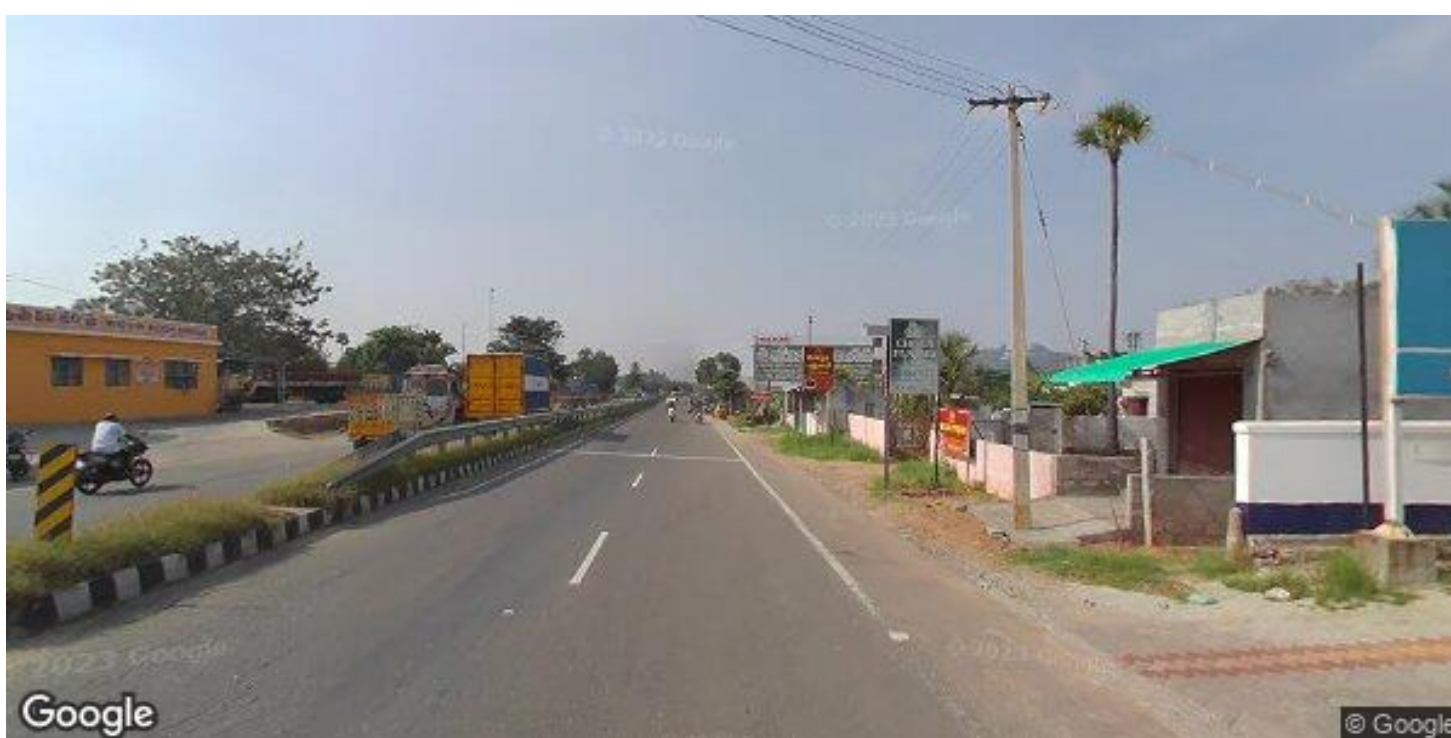
**Coordinates:** 11.01864, 77.54544

**Risk Type:** Blind Spot

**Risk Level:** Blind Spot

**Speed Limit:** 10 KM/Hr
