# IndianOil

## JOURNEY RISK MANAGEMENT (JRM) STUDY

### Salem Terminal to ANNAI PETRO TRADERS IOC DEALE

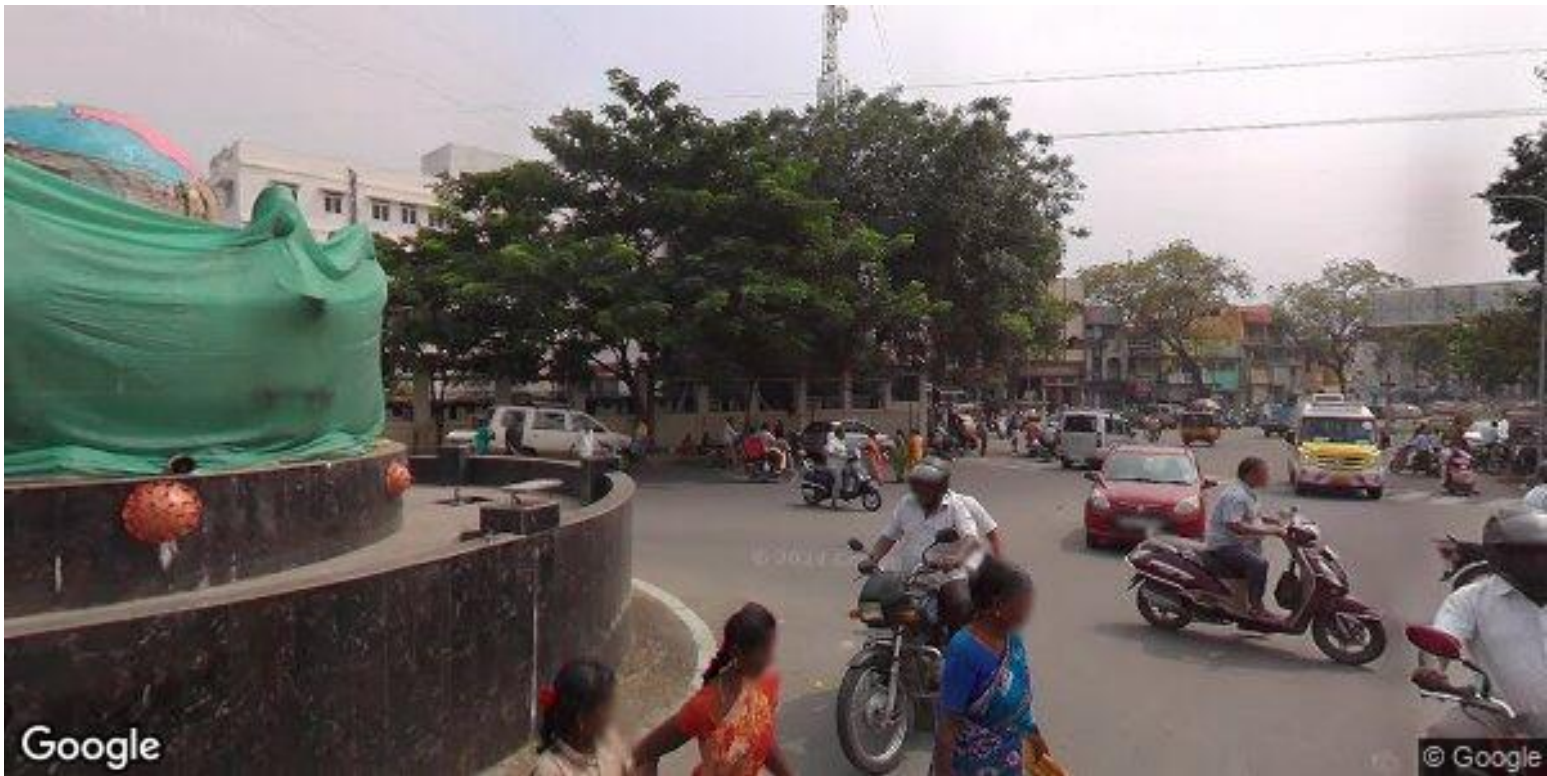
Coordinates: 11.65514, 78.15419

Risk Type: Roundabout

Risk Level: High

Speed Limit: 15 KM/Hr

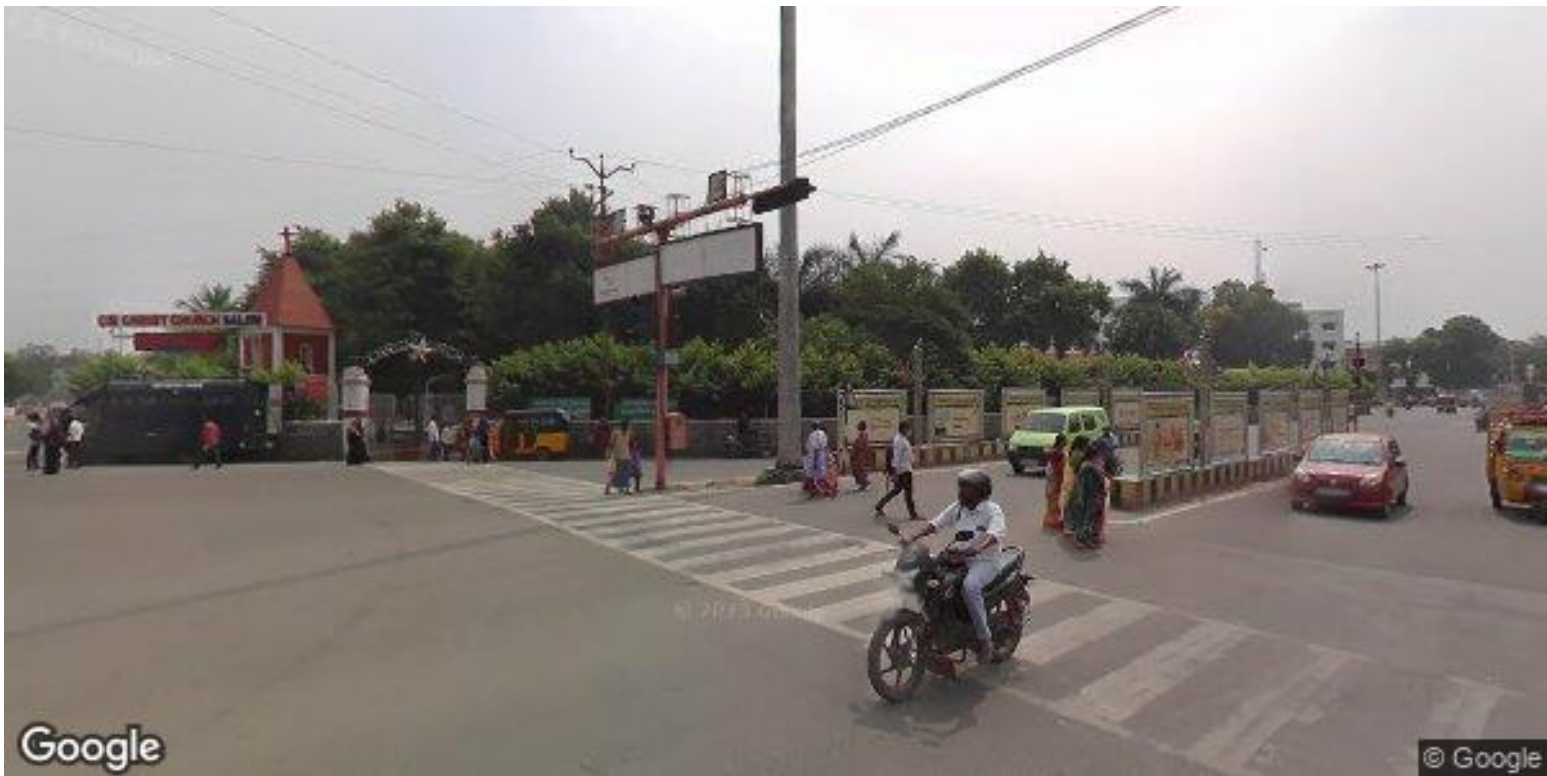
**Coordinates:** 11.65653, 78.15533

**Risk Type:** Roundabout

**Risk Level:** High

**Speed Limit:** 15 KM/Hr

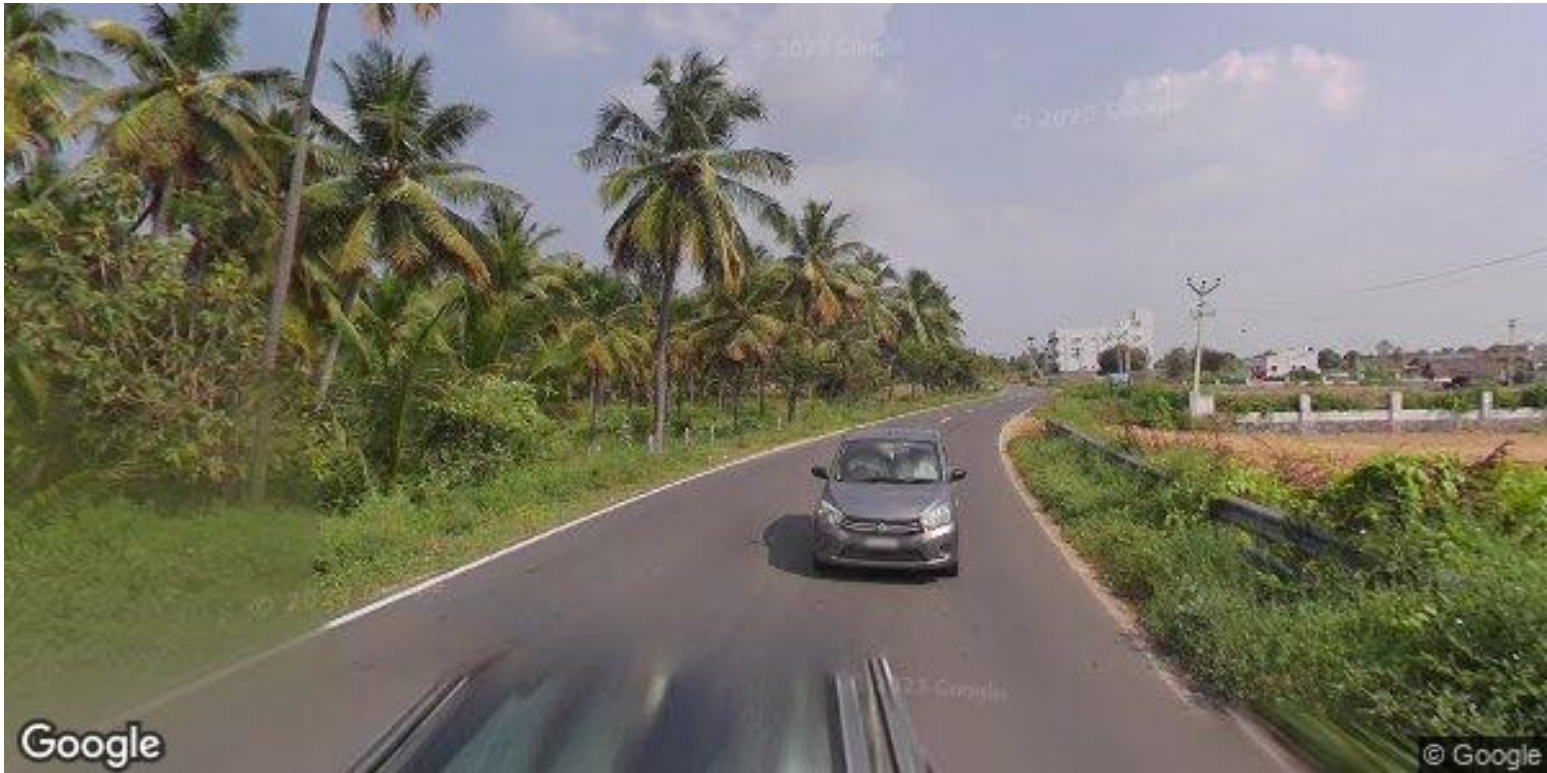
**Coordinates:** 11.45357, 77.85789

**Risk Type:** Turn

**Risk Level:** Medium

**Speed Limit:** 30 KM/Hr

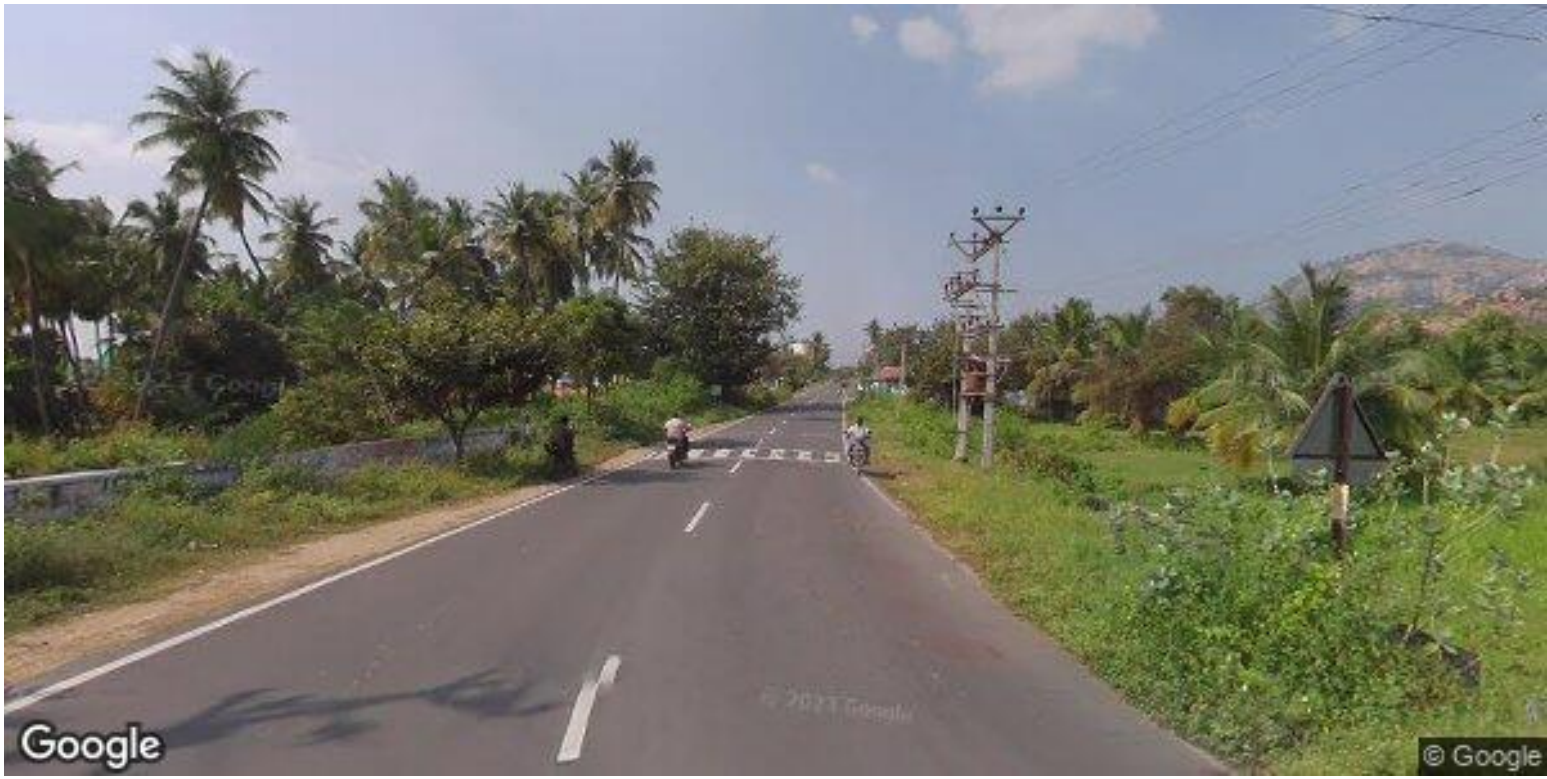
**Risk Type:** Turn  
**Risk Level:** Medium  
**Speed Limit:** 30 KM/Hr  
**Coordinates:** 11.45352, 77.85698

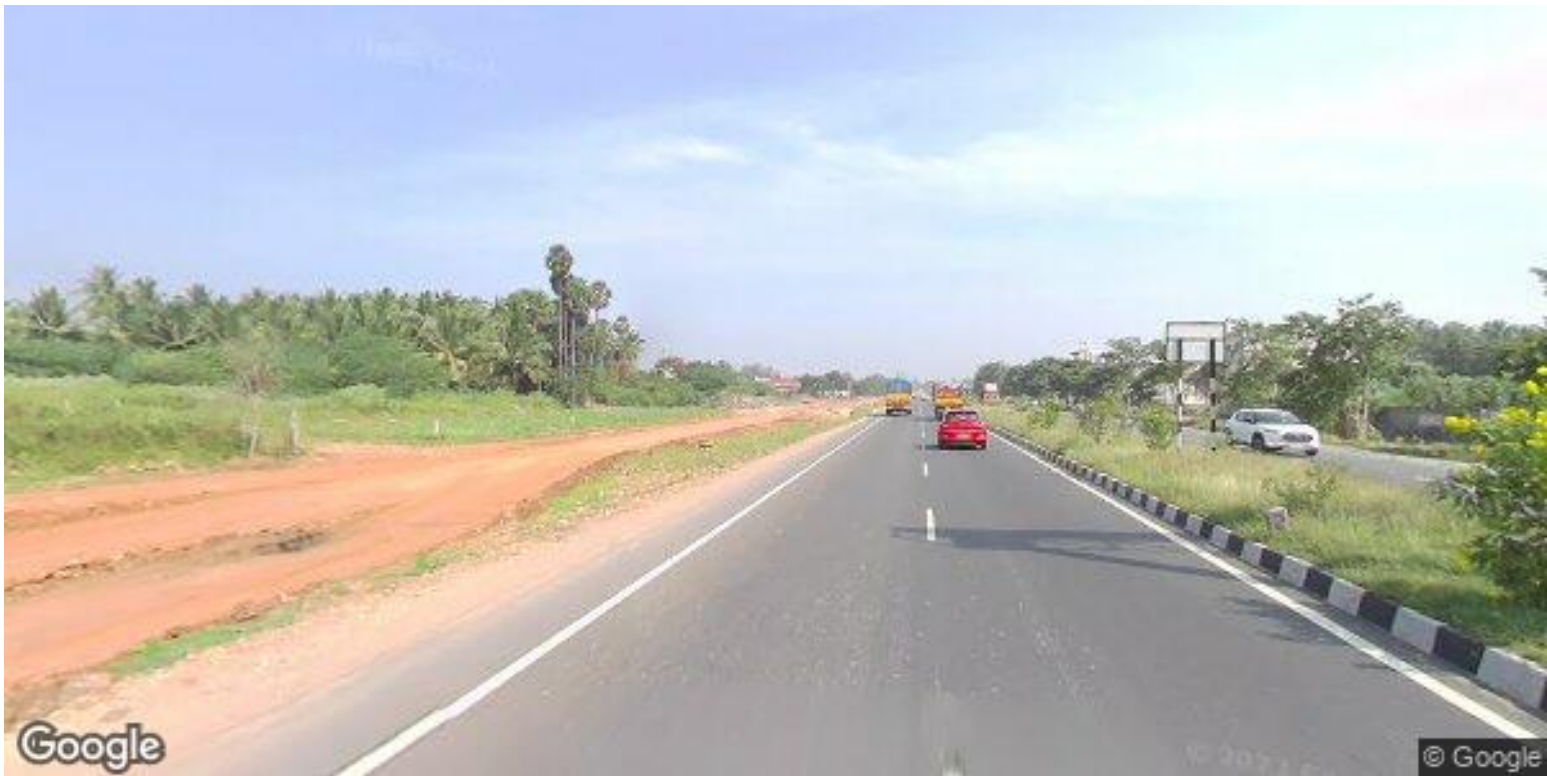
**Risk Type:** Turn  
**Risk Level:** Medium  
**Speed Limit:** 30 KM/Hr  
**Coordinates:** 11.61753, 78.10608

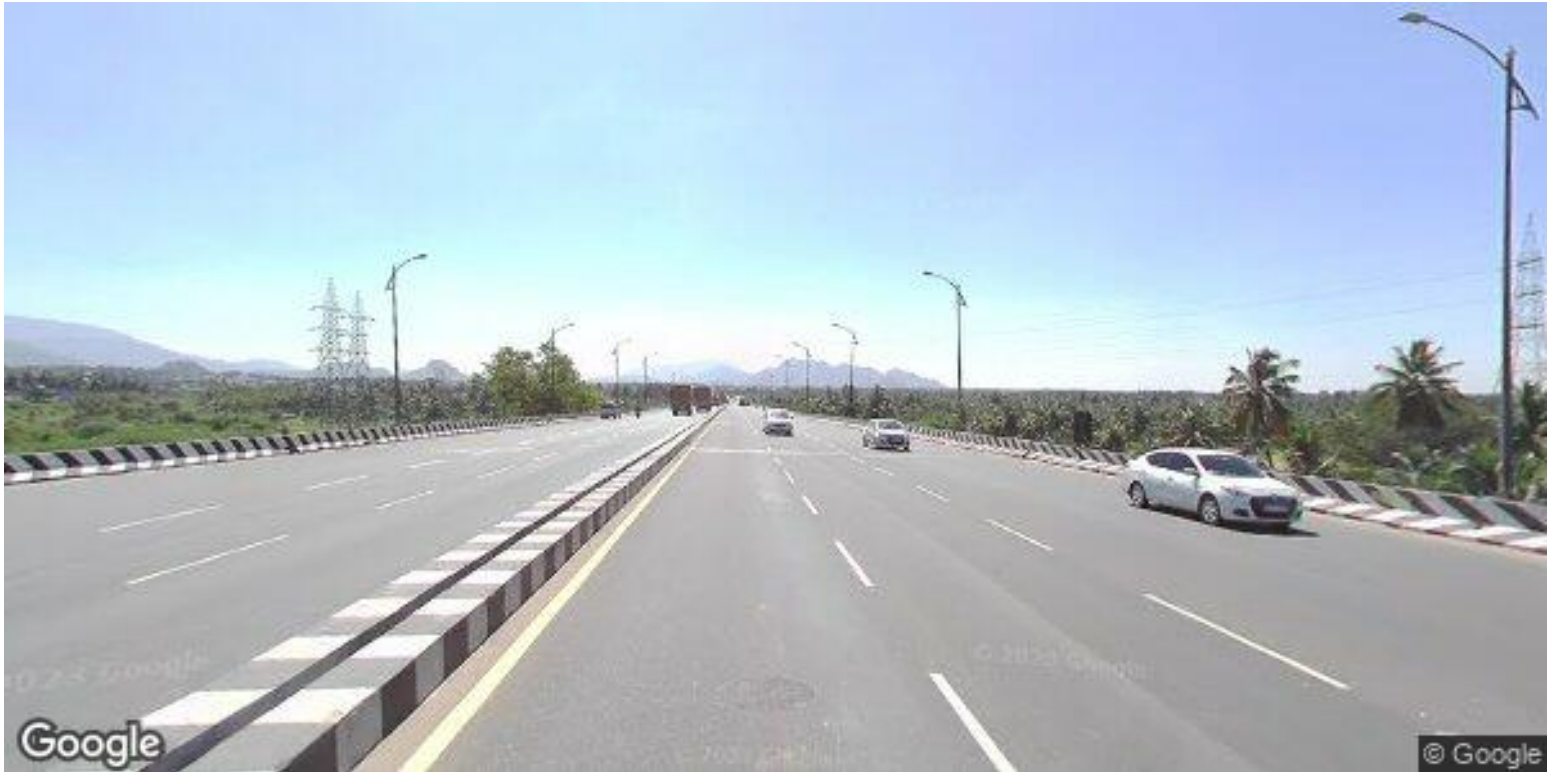
**Risk Type:** Turn  
**Risk Level:** Medium  
**Speed Limit:** 30 KM/Hr  
**Coordinates:** 11.64007, 78.11794

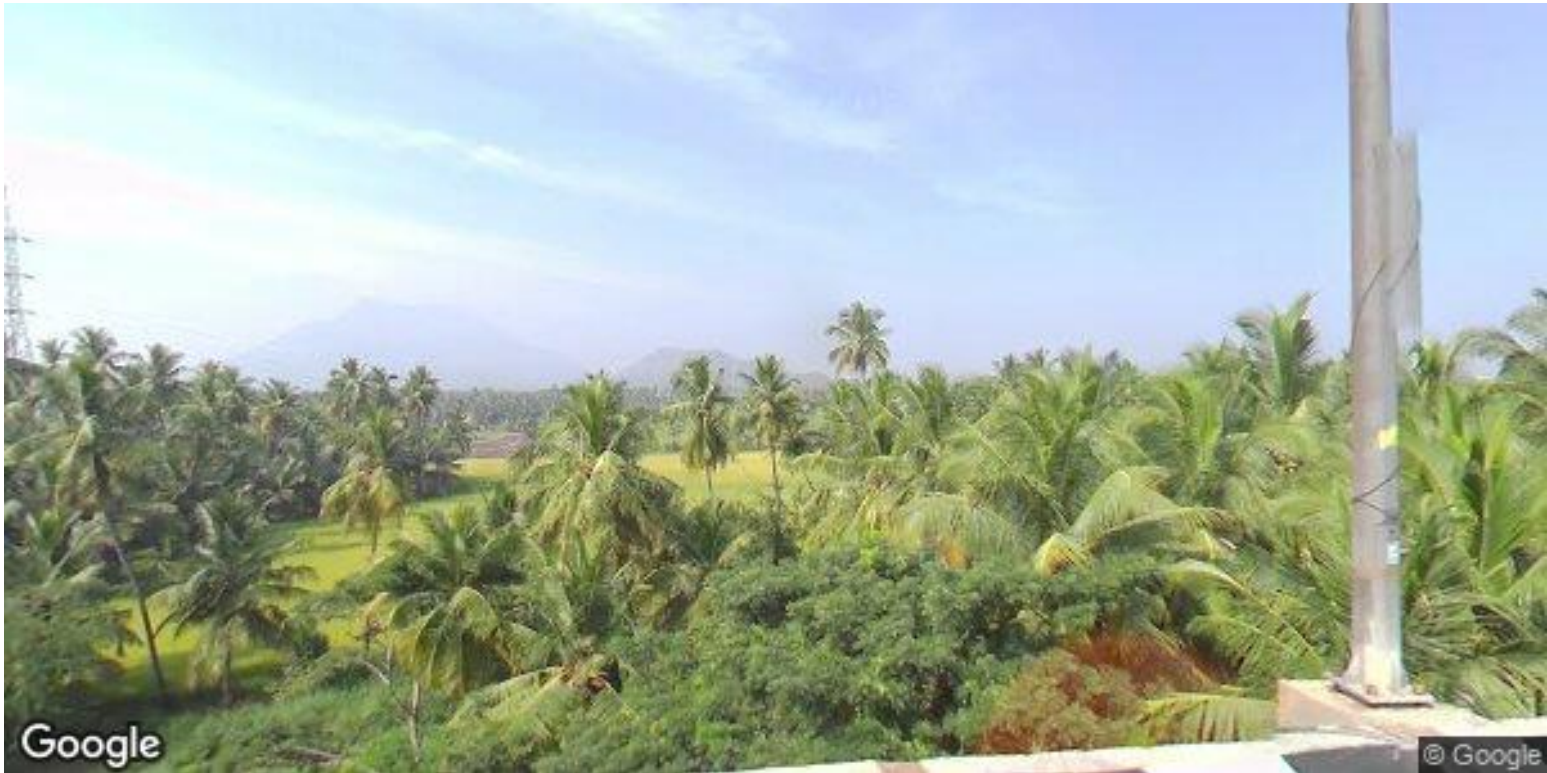
**Risk Type:** Turn  
**Risk Level:** Medium  
**Speed Limit:** 30 KM/Hr  
**Coordinates:** 11.64020, 78.11786

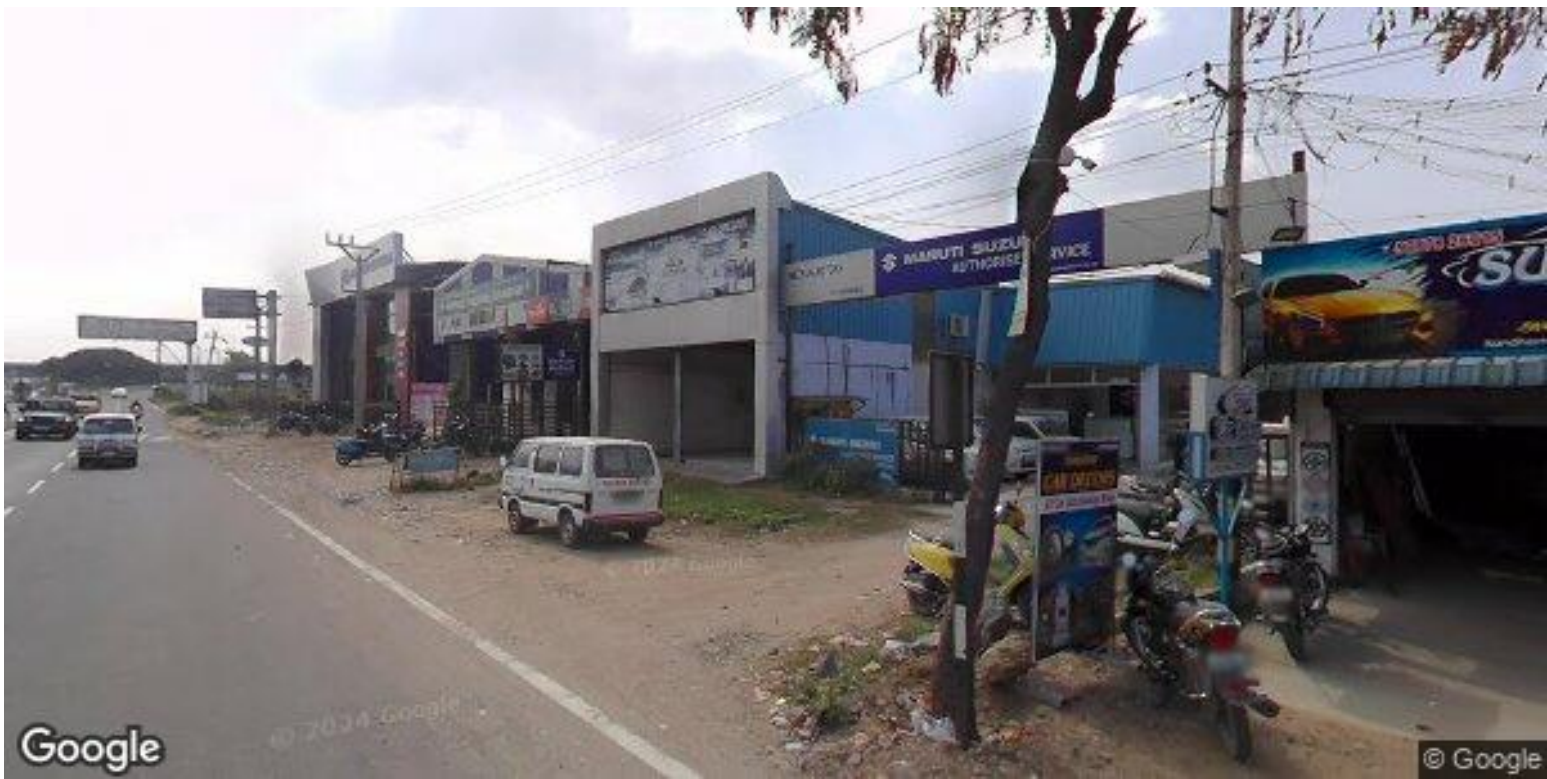
**Coordinates:** 11.64497, 78.12028

**Risk Type:** Turn

**Risk Level:** Medium

**Speed Limit:** 30 KM/Hr

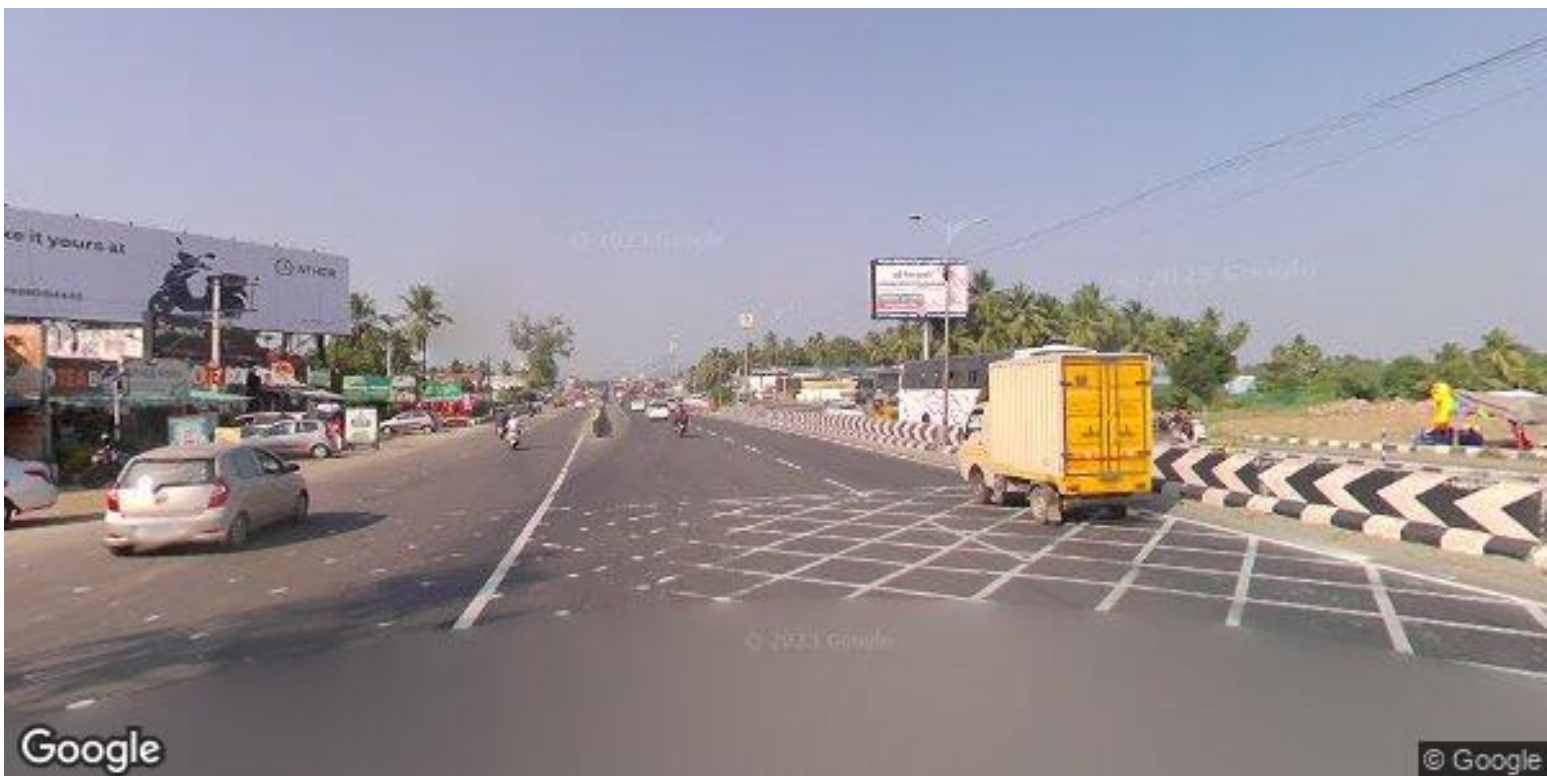
**Coordinates:** 11.64503, 78.12034

**Risk Type:** Turn

**Risk Level:** High

**Speed Limit:** 15 KM/Hr

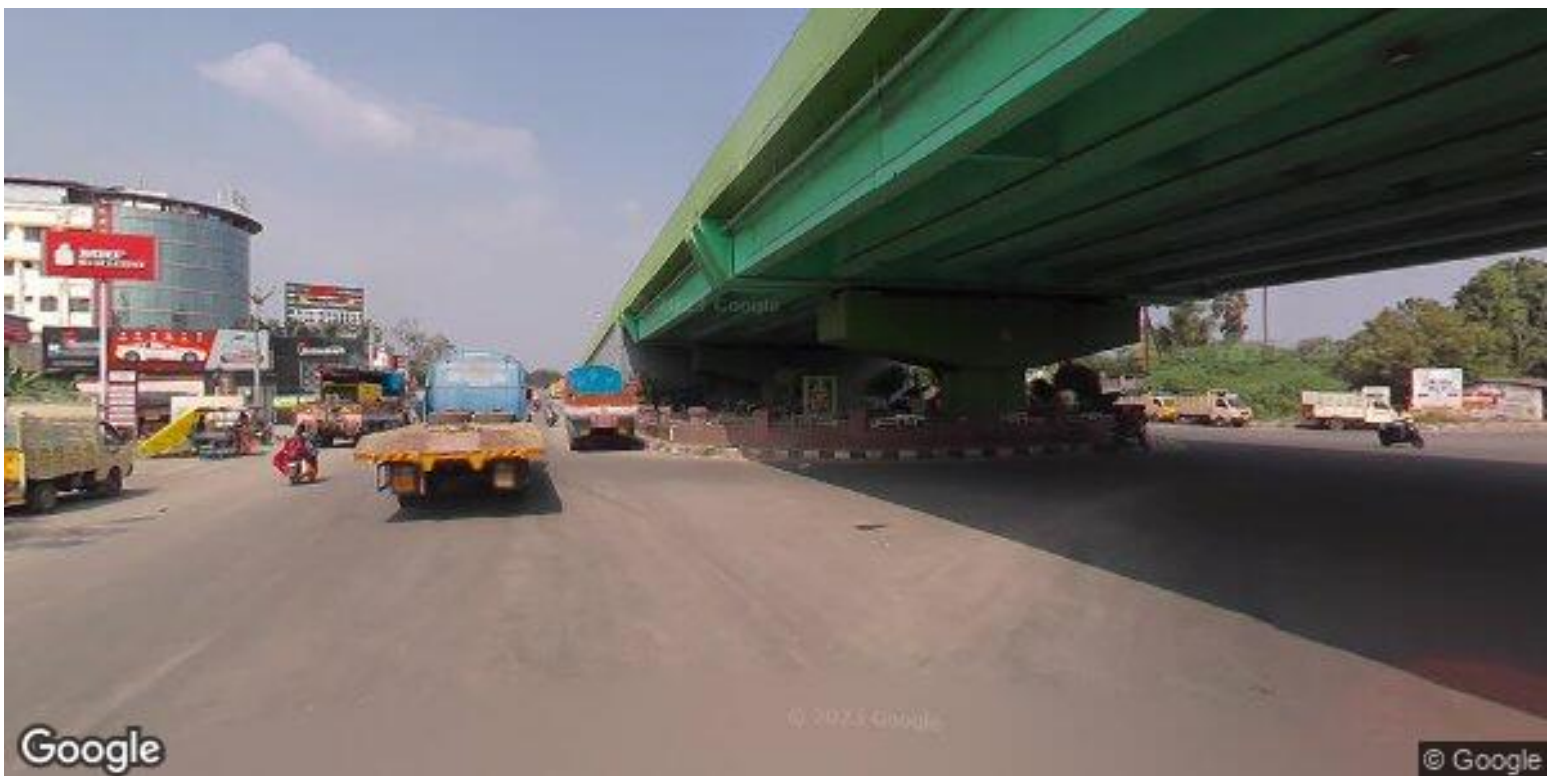
**Risk Type:** Turn  
**Risk Level:** High  
**Speed Limit:** 15 KM/Hr  
**Coordinates:** 11.64970, 78.12064

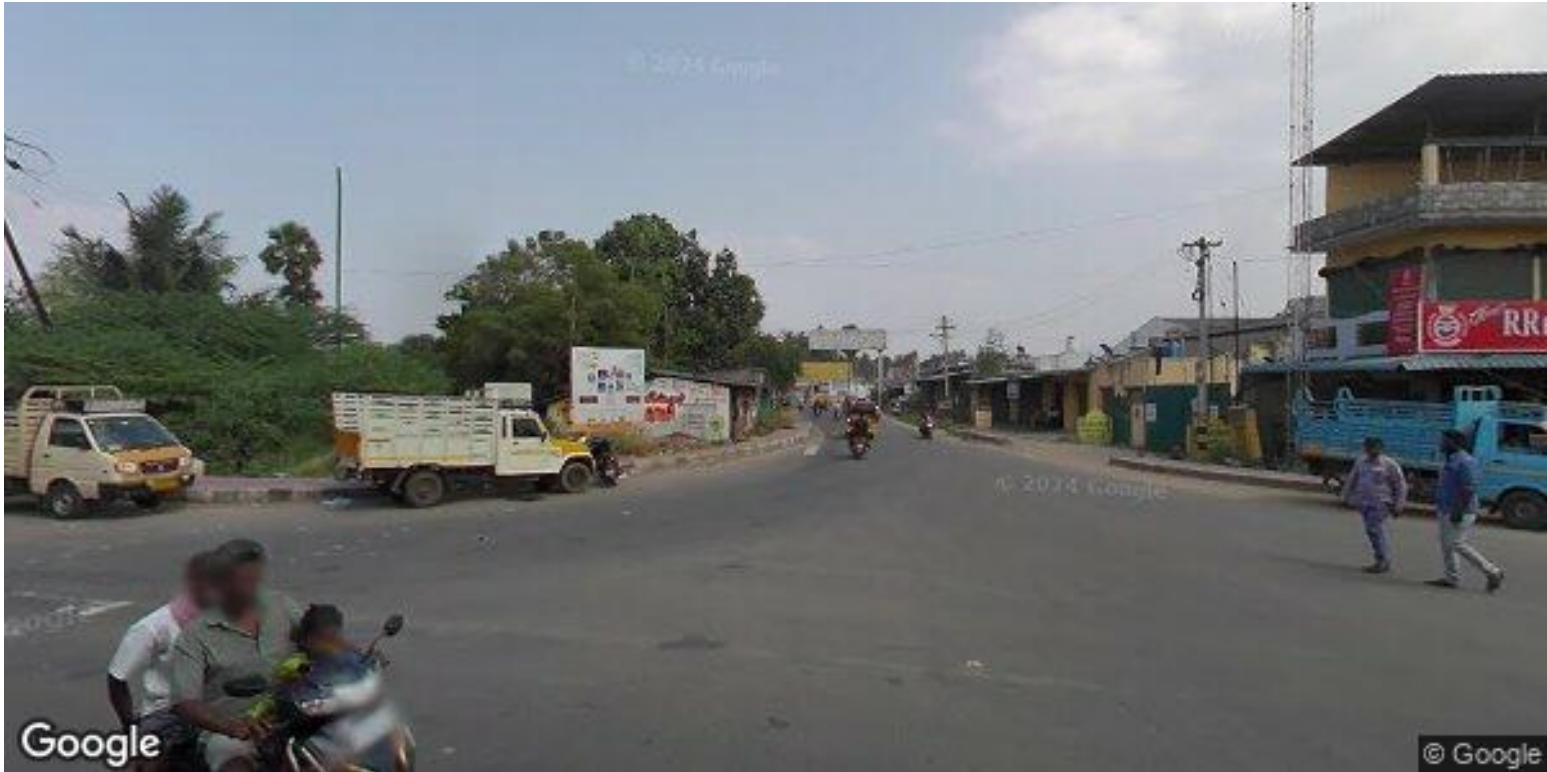
**Risk Type:** Turn  
**Risk Level:** Medium  
**Speed Limit:** 30 KM/Hr  
**Coordinates:** 11.64986, 78.12096

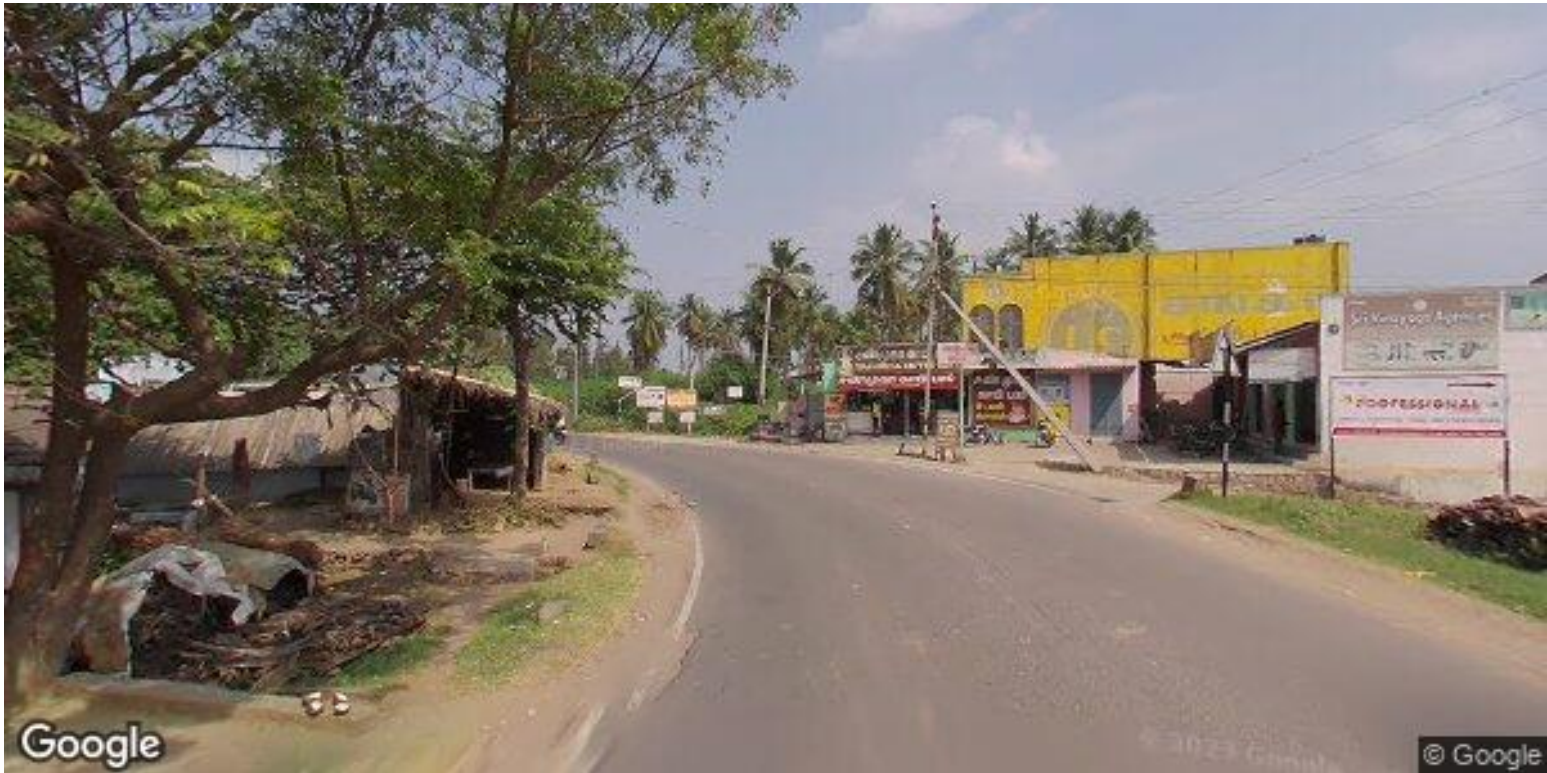
**Risk Type:** Turn  
**Risk Level:** Medium  
**Speed Limit:** 30 KM/Hr  
**Coordinates:** 11.65004, 78.12212

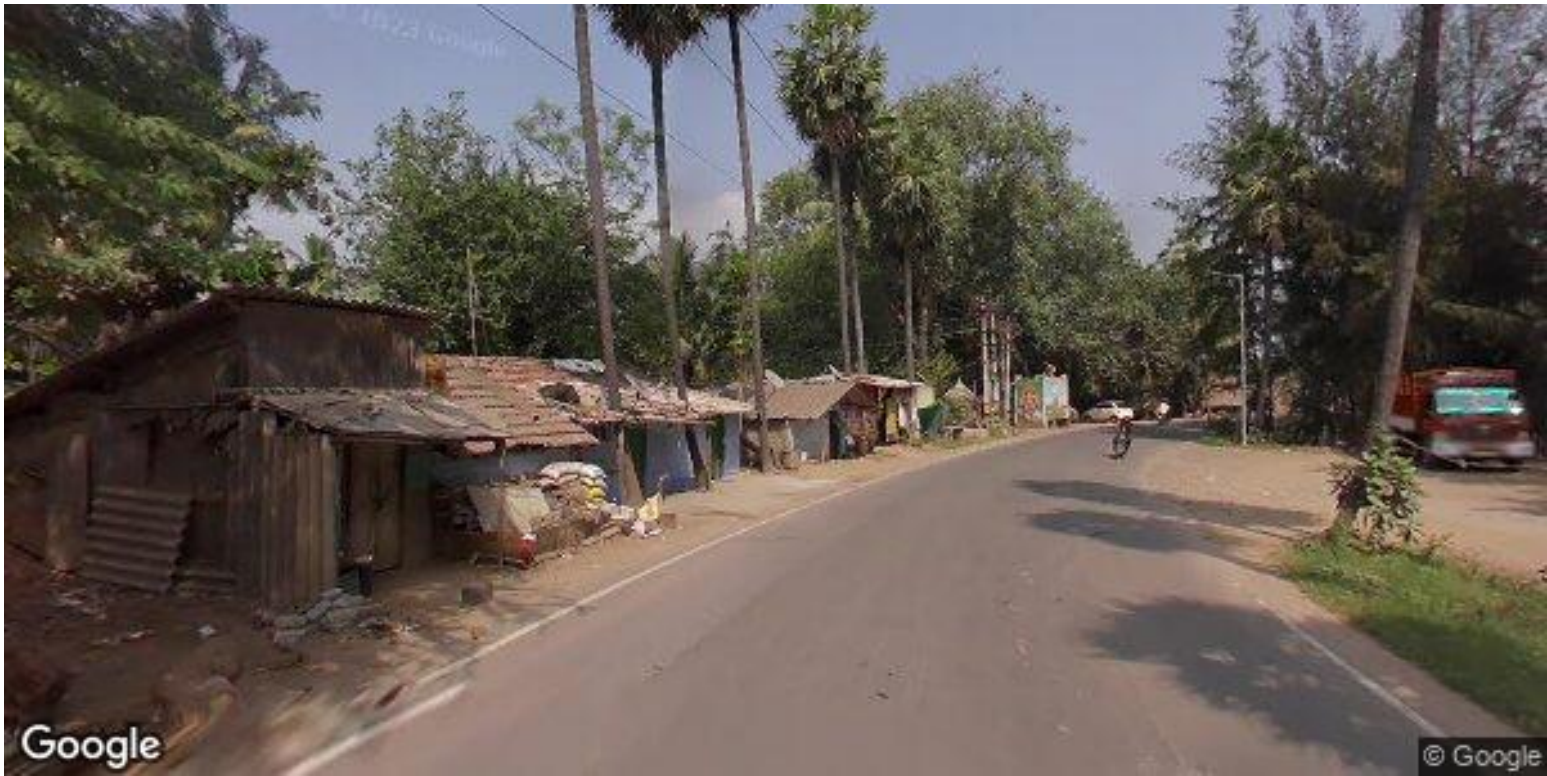
**Risk Type:** Turn  
**Risk Level:** Medium  
**Speed Limit:** 30 KM/Hr  
**Coordinates:** 11.65099, 78.12276

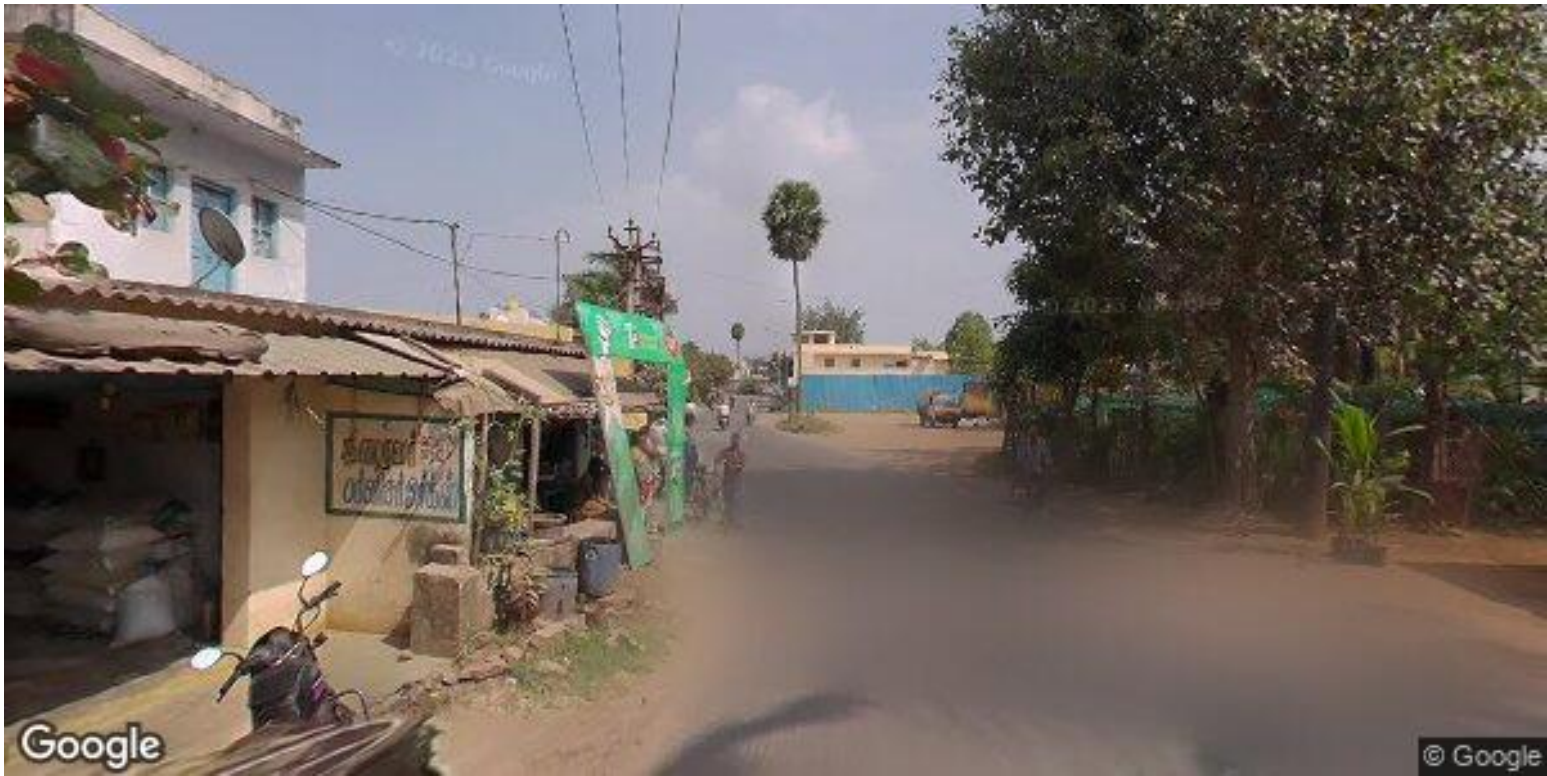
**Risk Type:** Turn  
**Risk Level:** Medium  
**Speed Limit:** 30 KM/Hr  
**Coordinates:** 11.65113, 78.12473

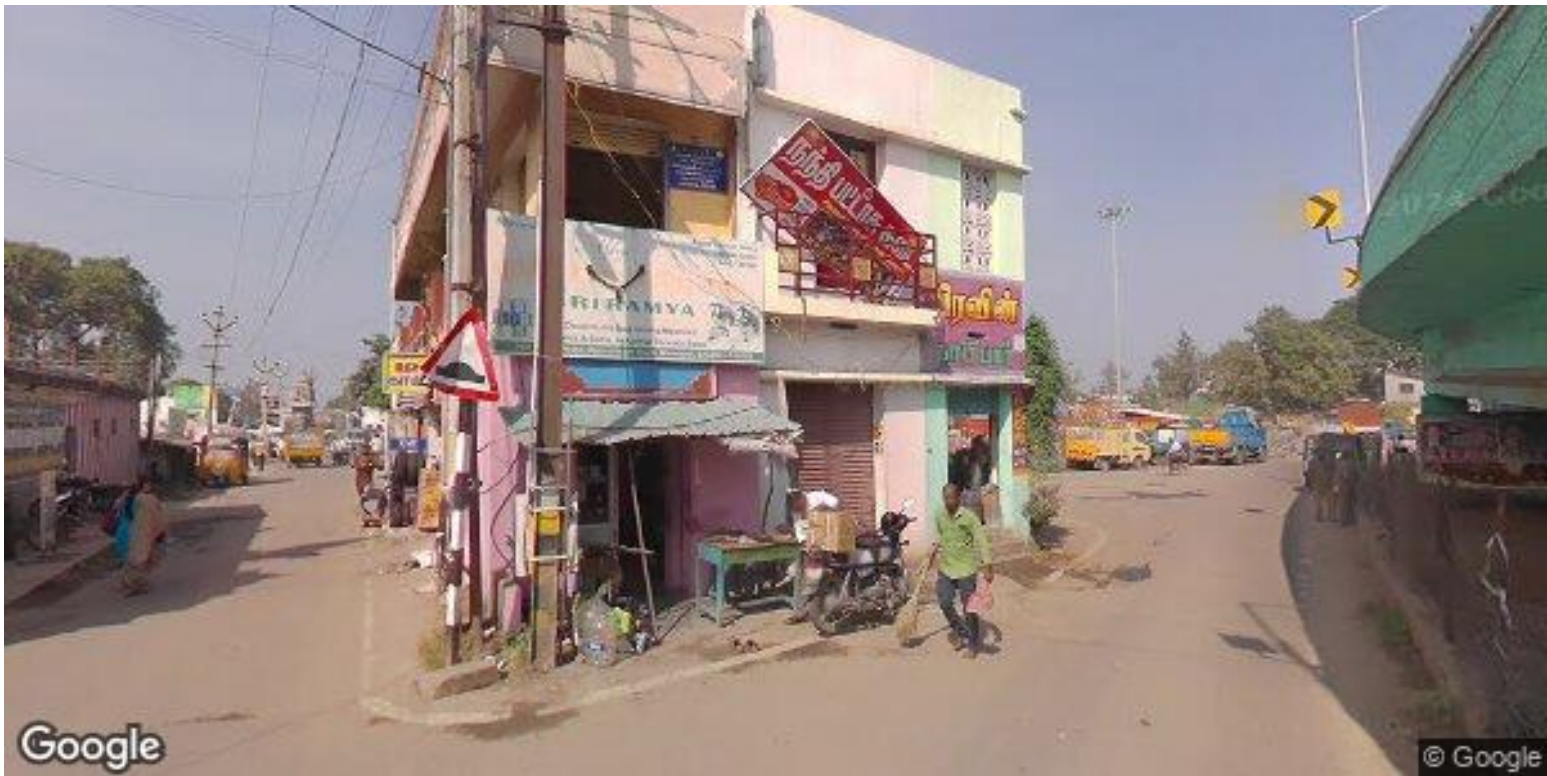
**Risk Type:** Turn  
**Risk Level:** Medium  
**Speed Limit:** 30 KM/Hr  
**Coordinates:** 11.65203, 78.14157

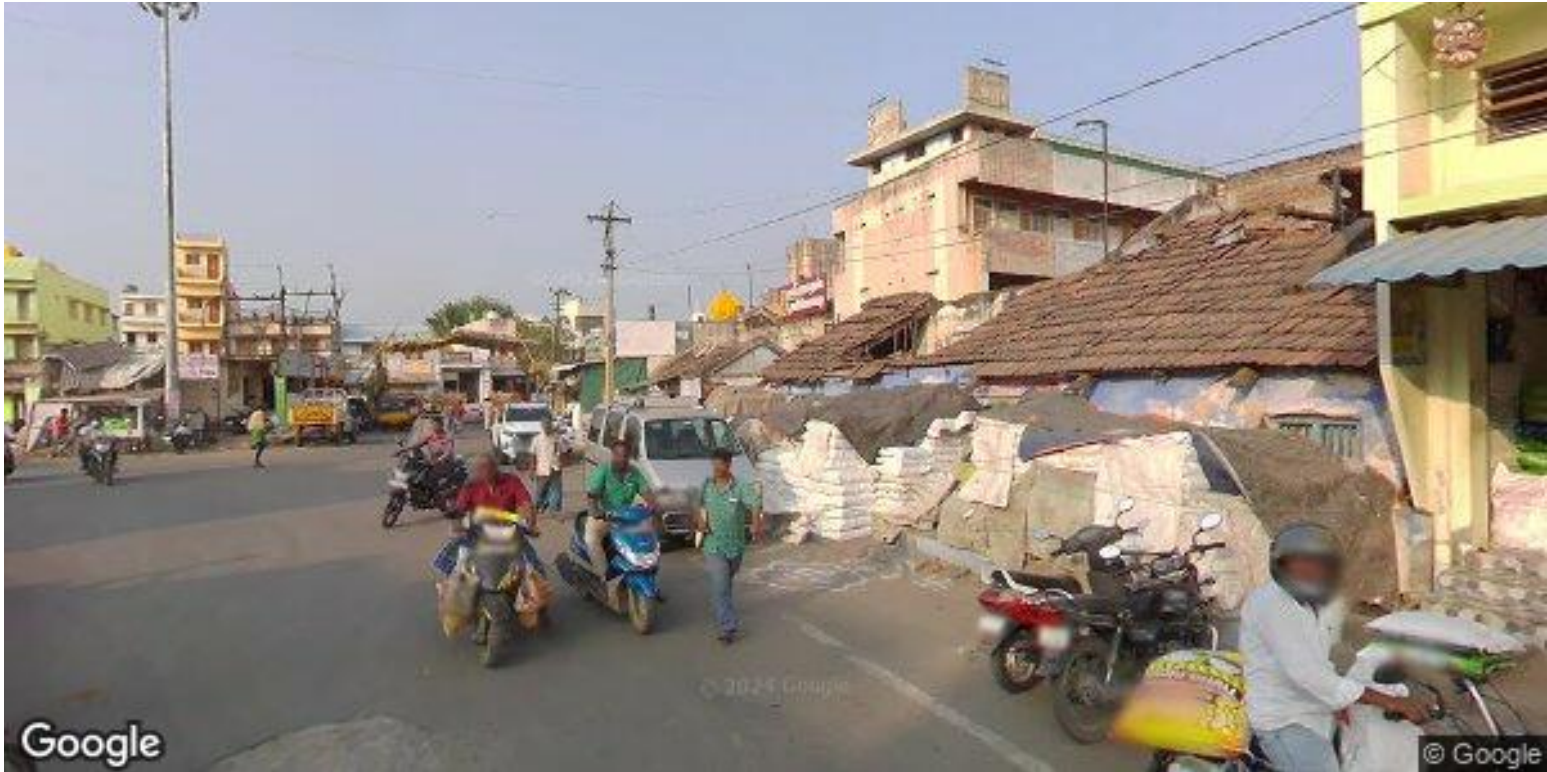
**Risk Type:** Blind Spot  
**Risk Level:** Blind Spot  
**Speed Limit:** 10 KM/Hr  
**Coordinates:** 11.65141, 78.14234

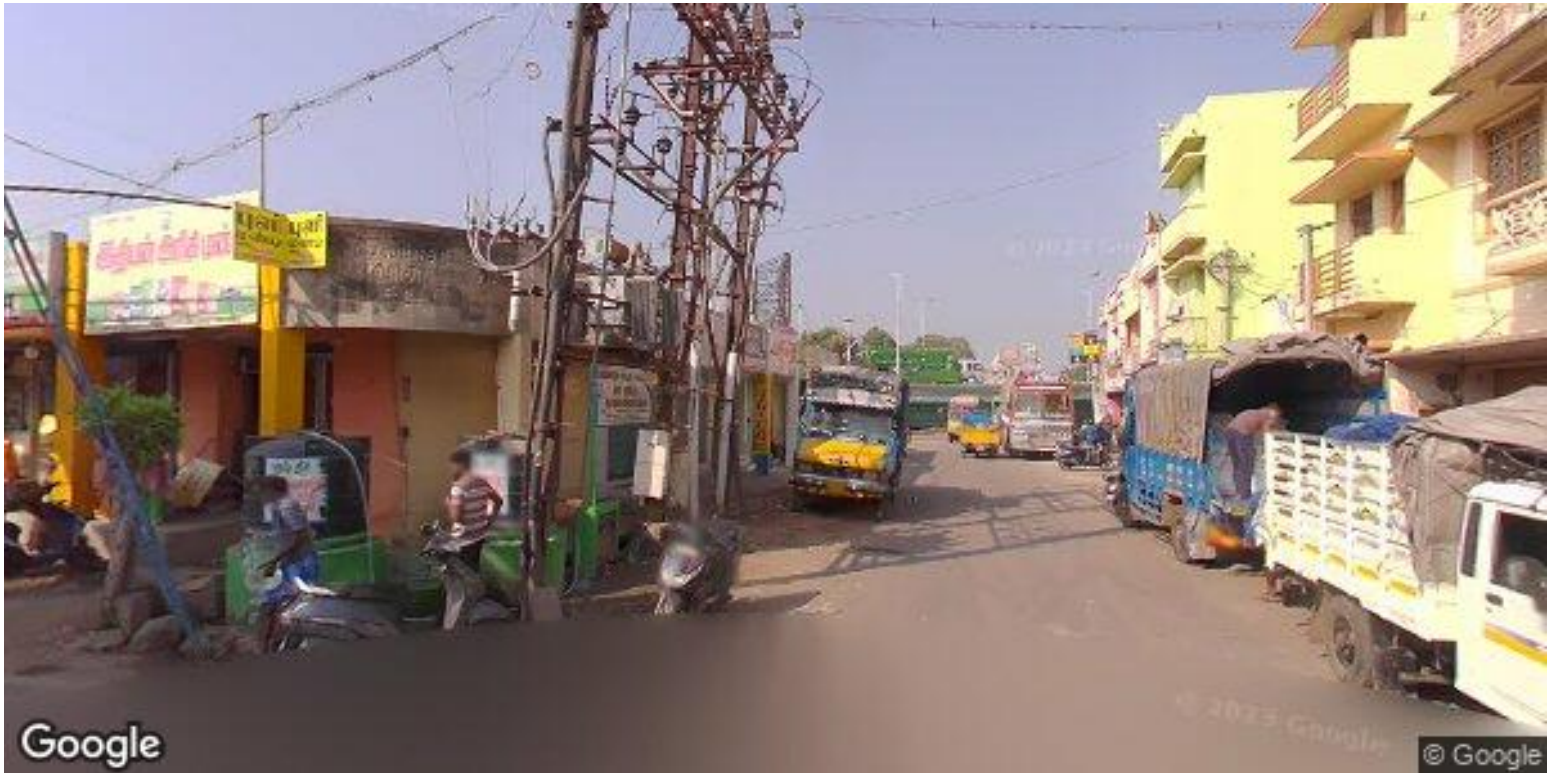
**Risk Type:** Turn  
**Risk Level:** High  
**Speed Limit:** 15 KM/Hr  
**Coordinates:** 11.65197, 78.14241

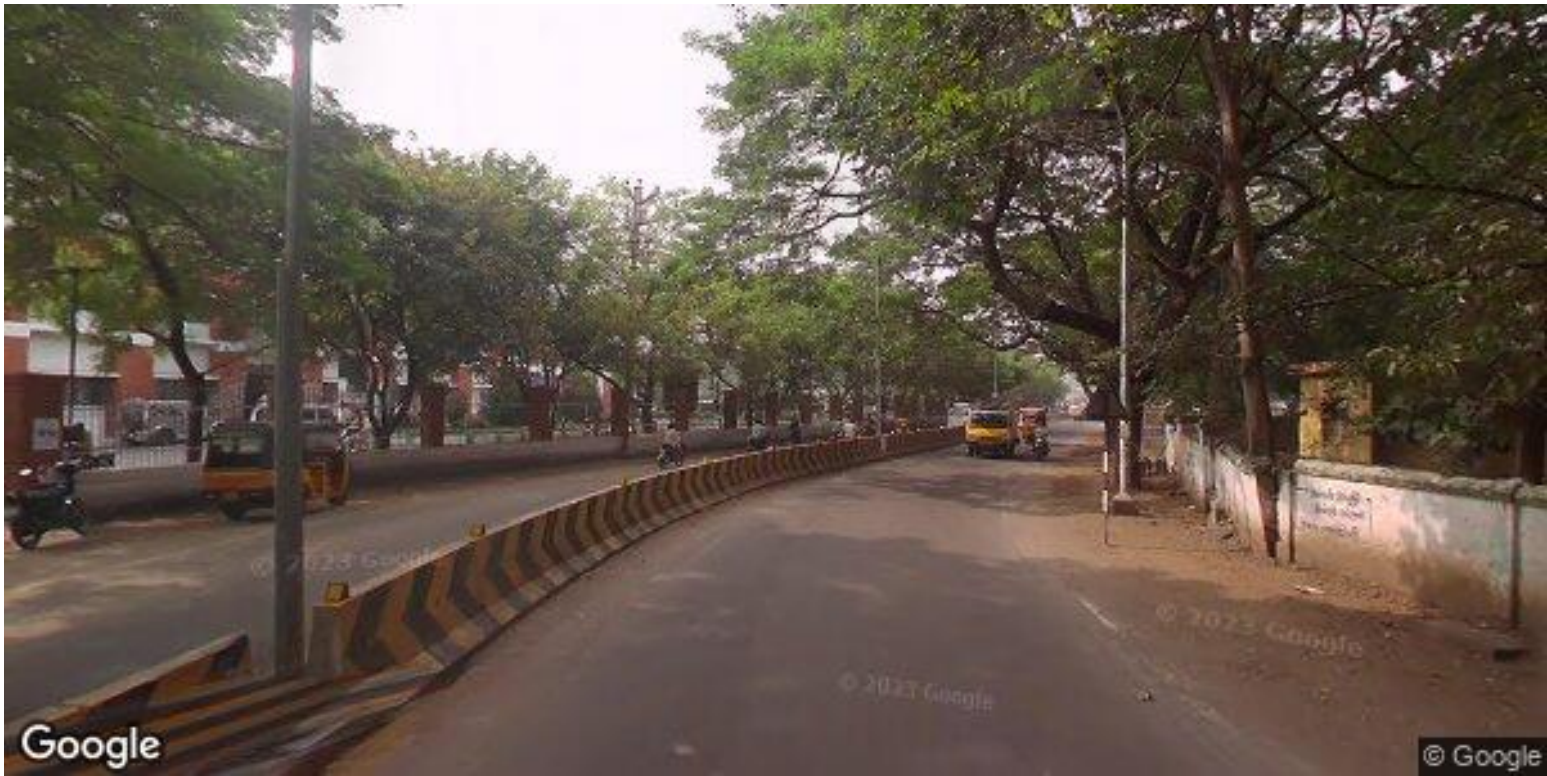
**Coordinates:** 11.65756, 78.15669

**Risk Type:** Turn

**Risk Level:** Medium

**Speed Limit:** 30 KM/Hr
