## JOURNEY RISK MANAGEMENT (JRM) STUDY

### Salem Terminal TO JAYAA JYOTHI ENTERPRISE

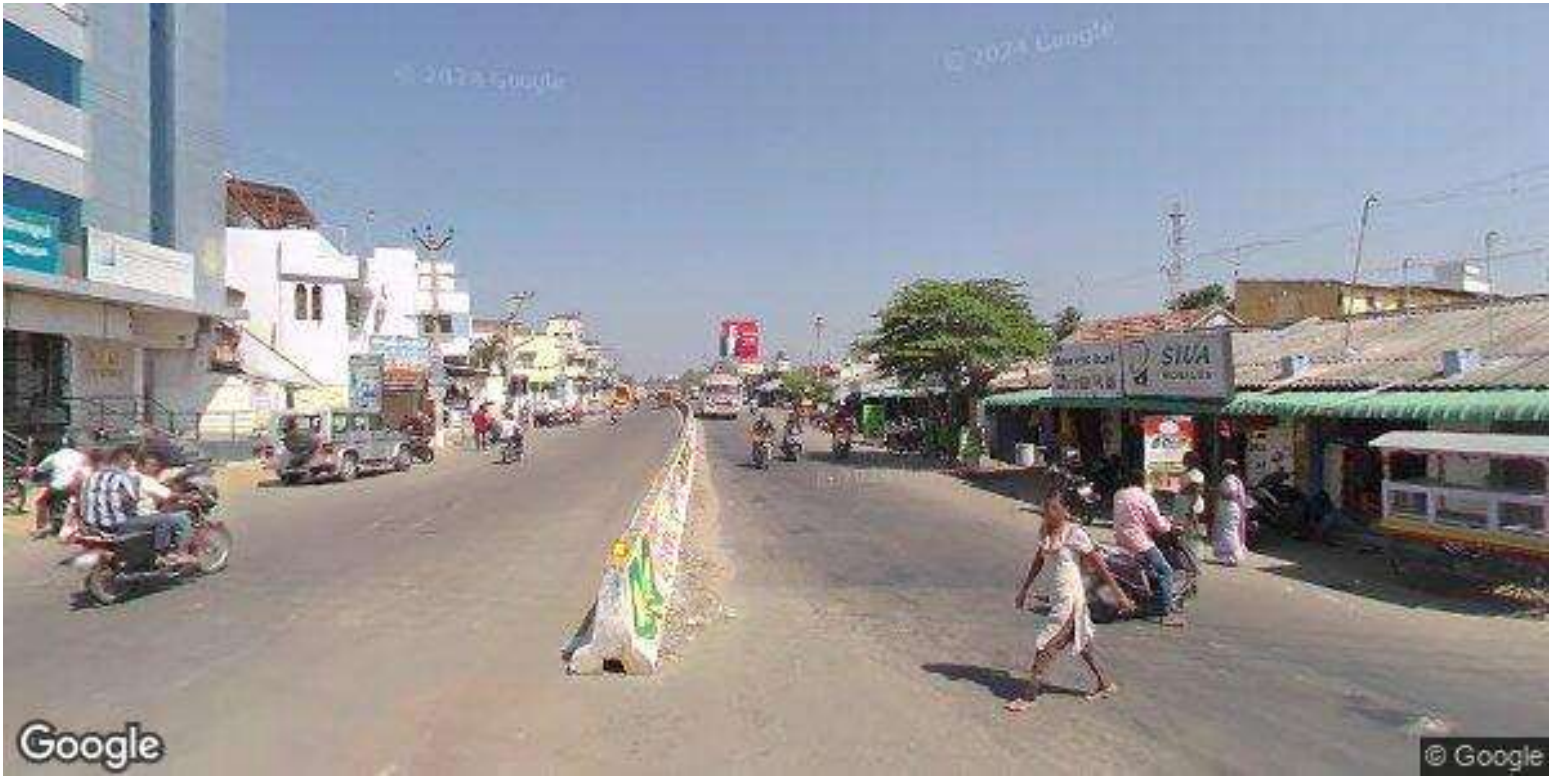
**Speed Limit: 15 KM/Hr**  
**Coordinates: 11.37086, 77.74828**

Risk Type: Roundabout  
Risk Level: High

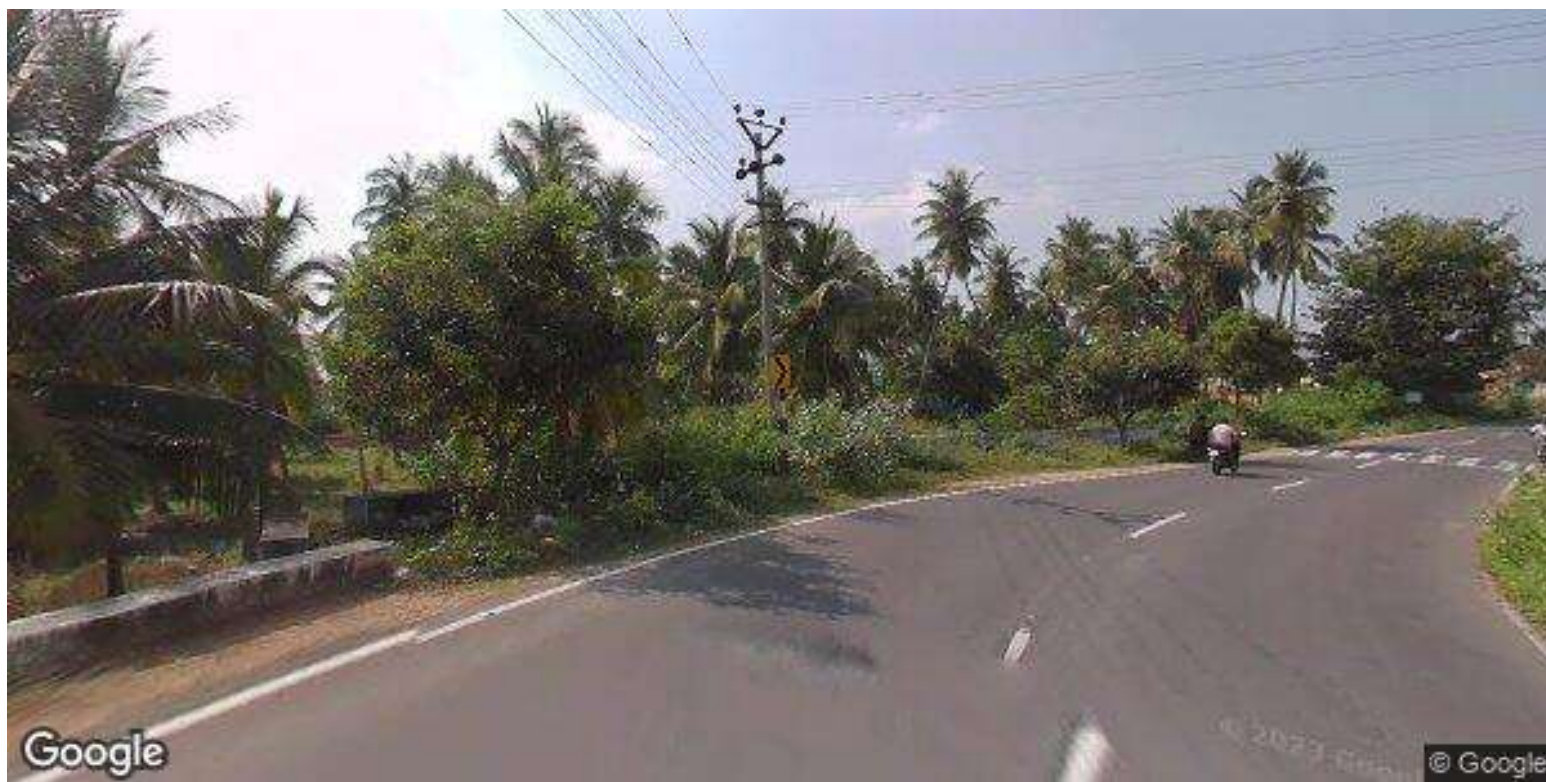
**Coordinates:** 11.45348, 77.85706

**Risk Type:** Turn

**Risk Level:** Medium

**Speed Limit:** 30 KM/Hr

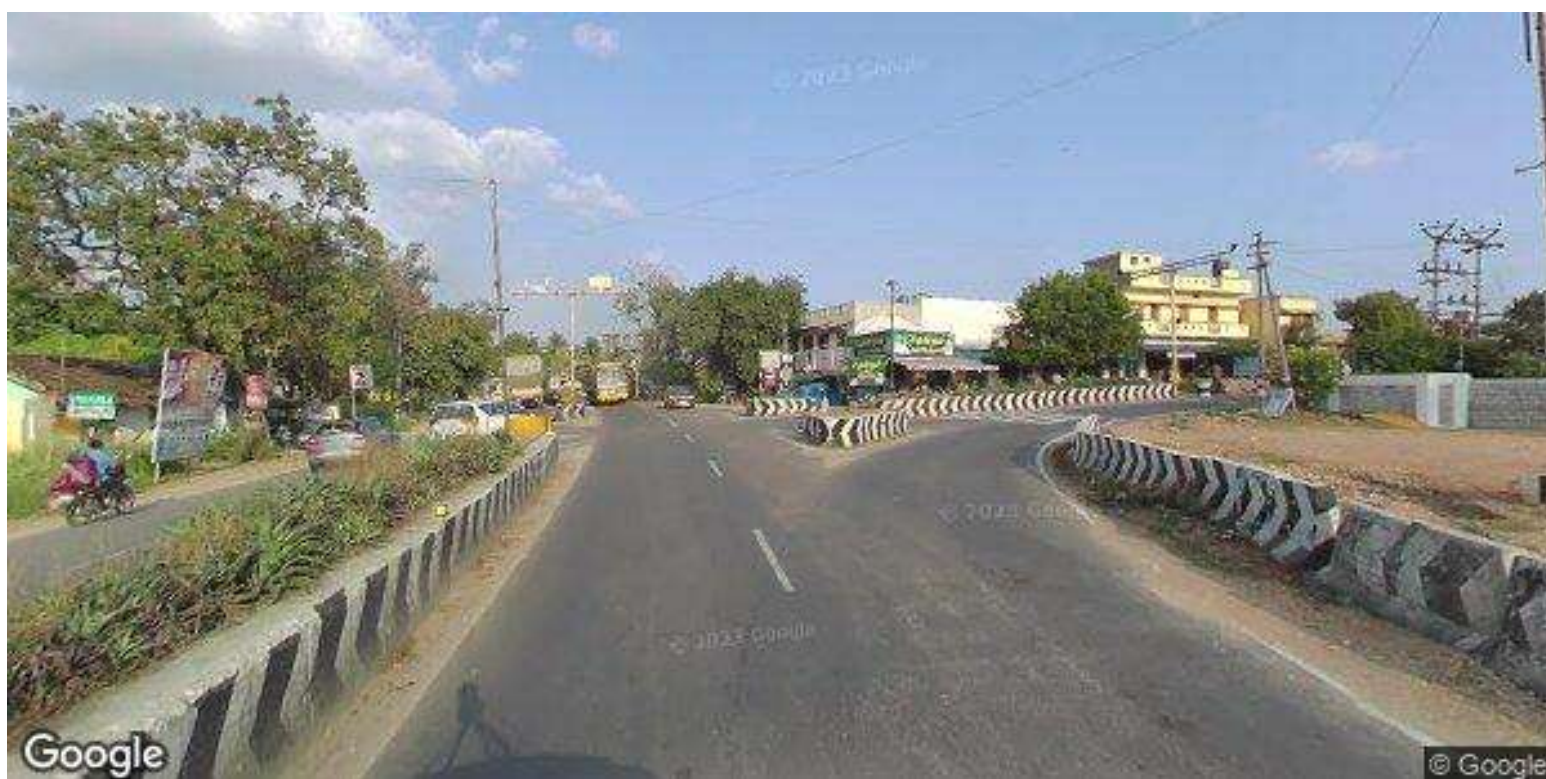
**Coordinates:** 11.46318, 77.84913

**Risk Type:** Turn

**Risk Level:** Medium

**Speed Limit:** 30 KM/Hr

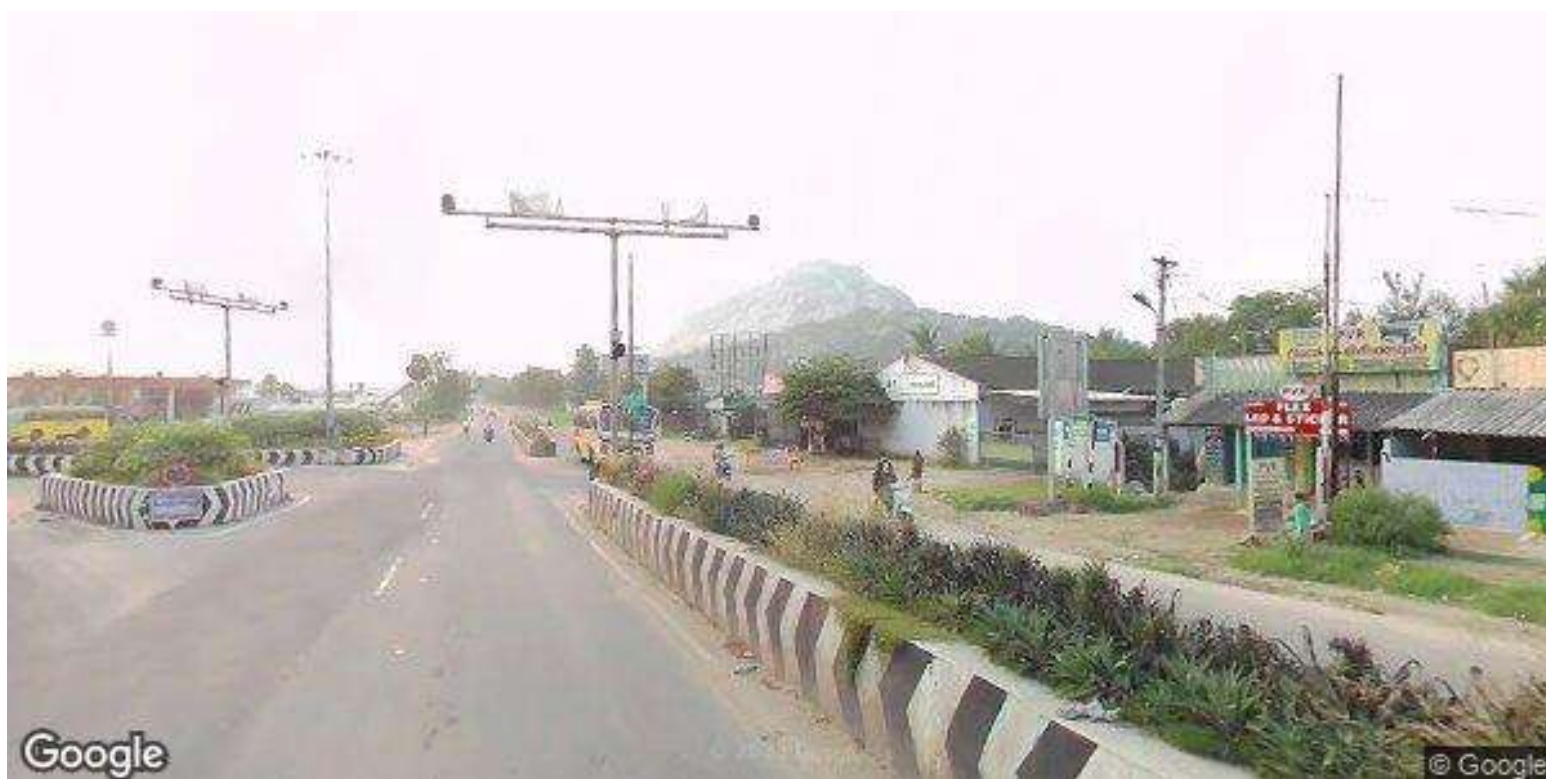
Coordinates: 11.46312, 77.84886

Risk Type: Turn

Risk Level: Medium

Speed Limit: 30 KM/Hr

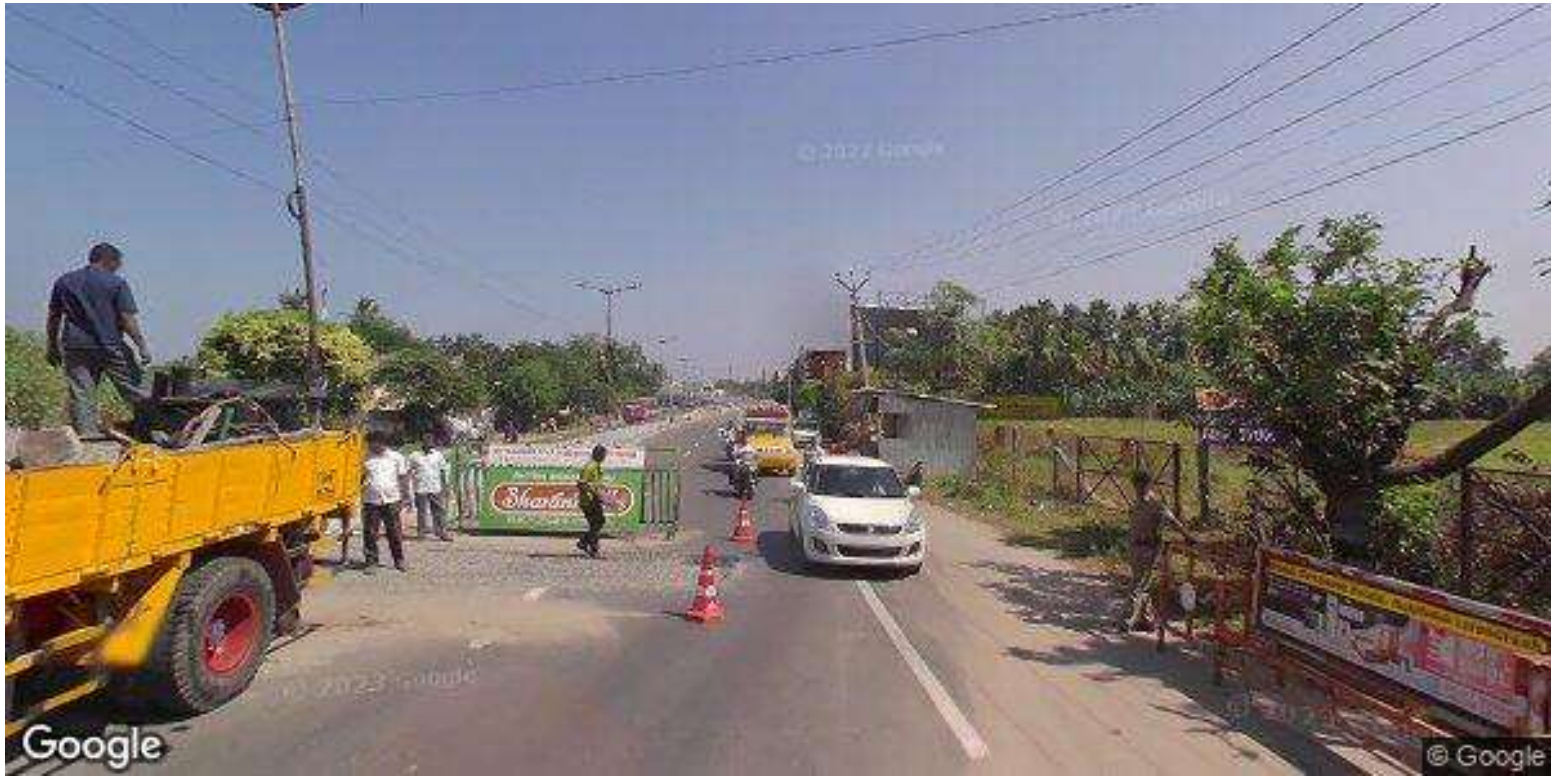
Coordinates: 11.35929, 77.73996

Risk Type: Turn

Risk Level: High

Speed Limit: 15 KM/Hr
