## JOURNEY RISK MANAGEMENT (JRM) STUDY

### Salem Terminal TO SARAS AGENCIES

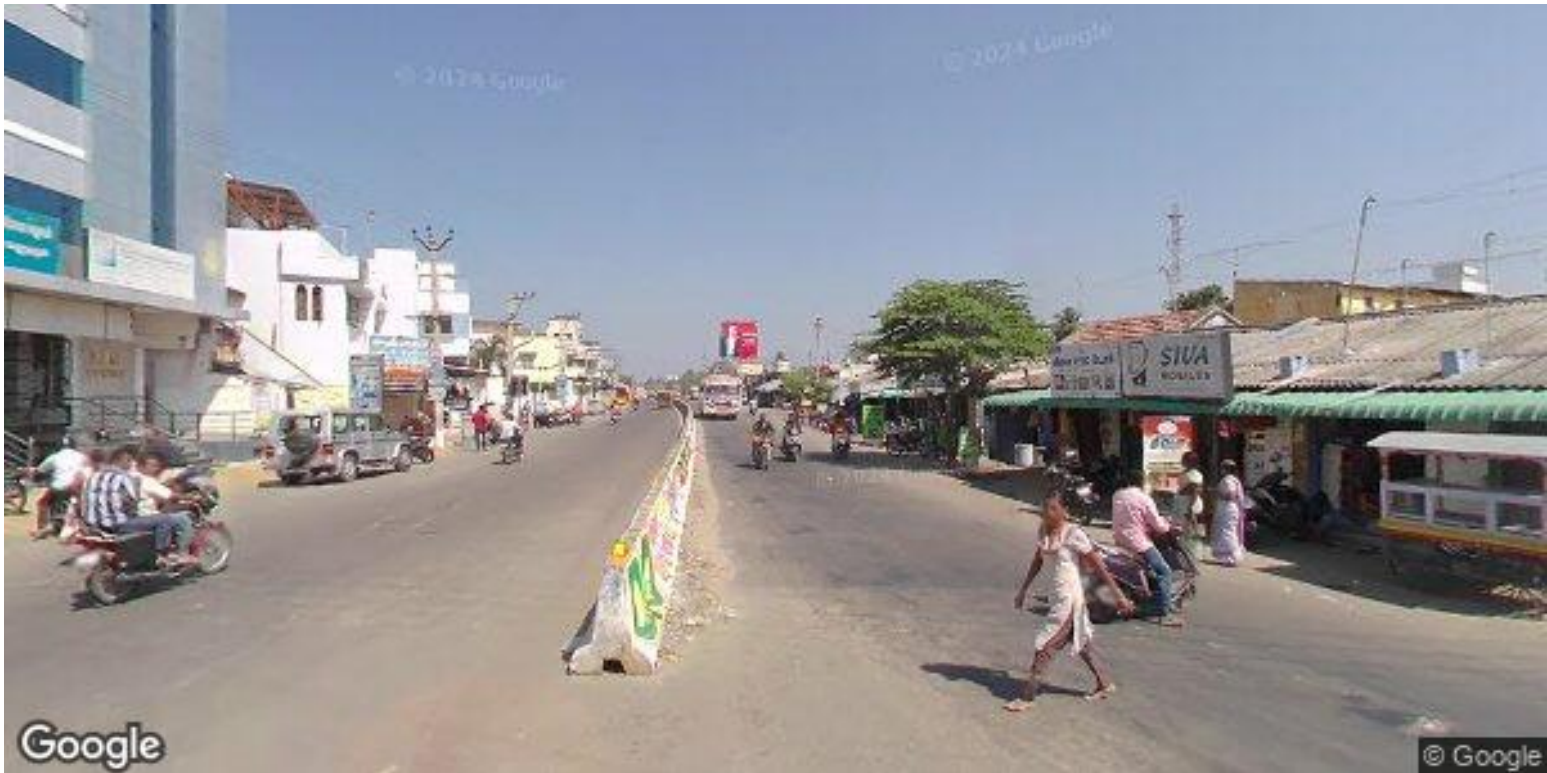
**Coordinates:** 11.37086, 77.74828

**Risk Type:** Roundabout

**Risk Level:** High

**Speed Limit:** 15 KM/Hr

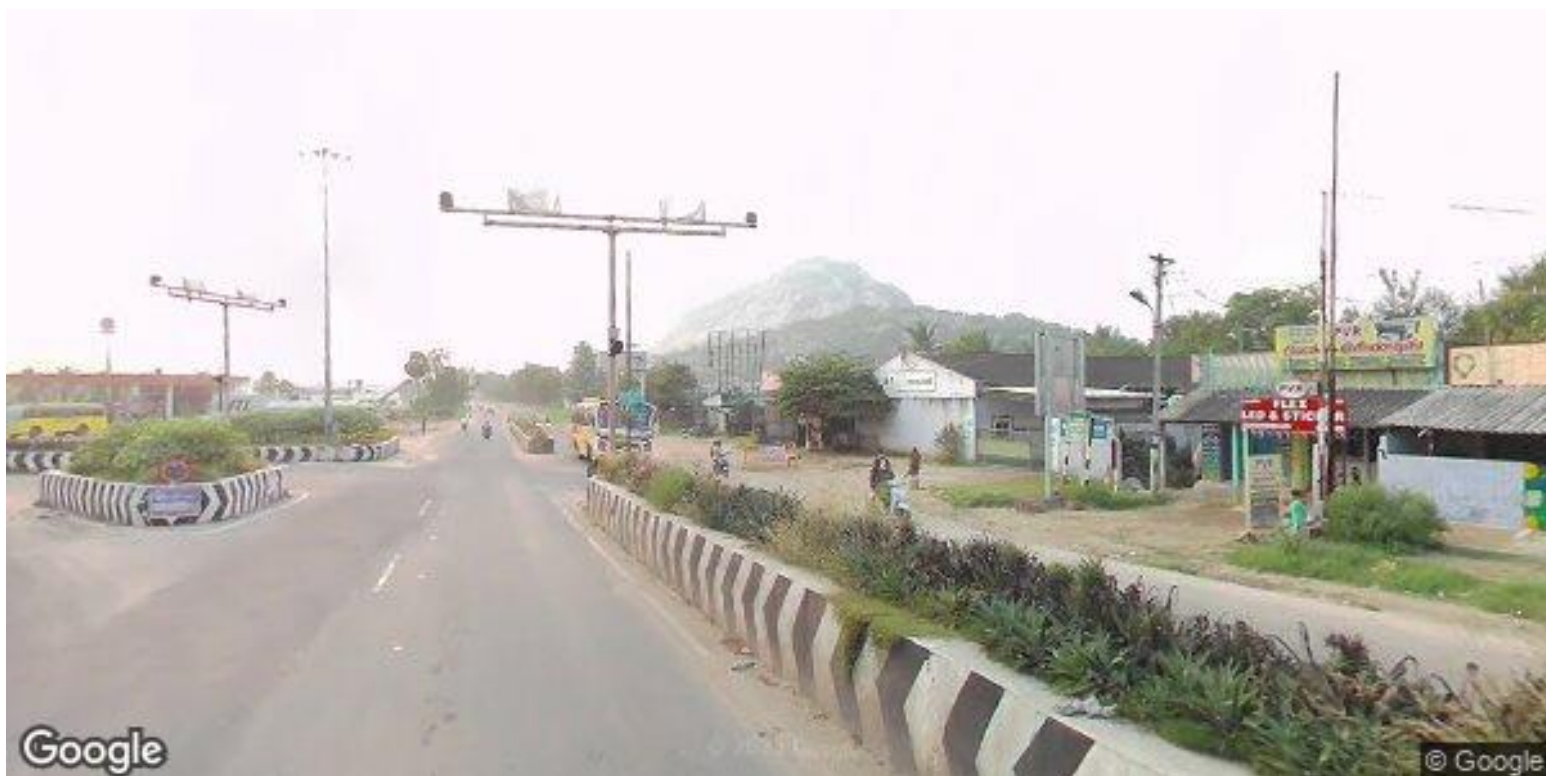
**Coordinates:** 11.46312, 77.84886

**Risk Type:** Turn

**Risk Level:** Medium

**Speed Limit:** 30 KM/Hr

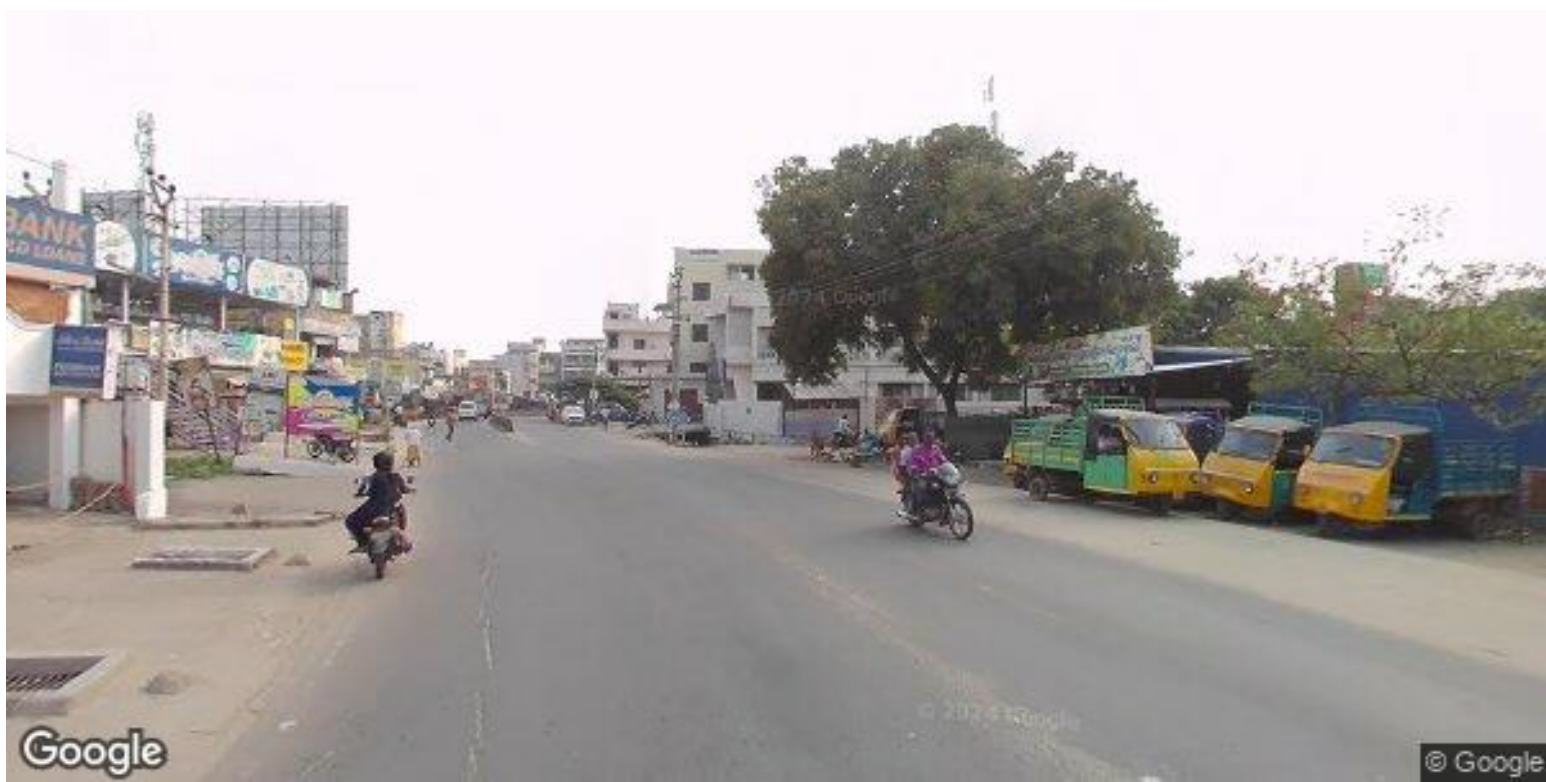
**Coordinates:** 11.36626, 77.74788

**Risk Type:** Turn

**Risk Level:** Medium

**Speed Limit:** 30 KM/Hr

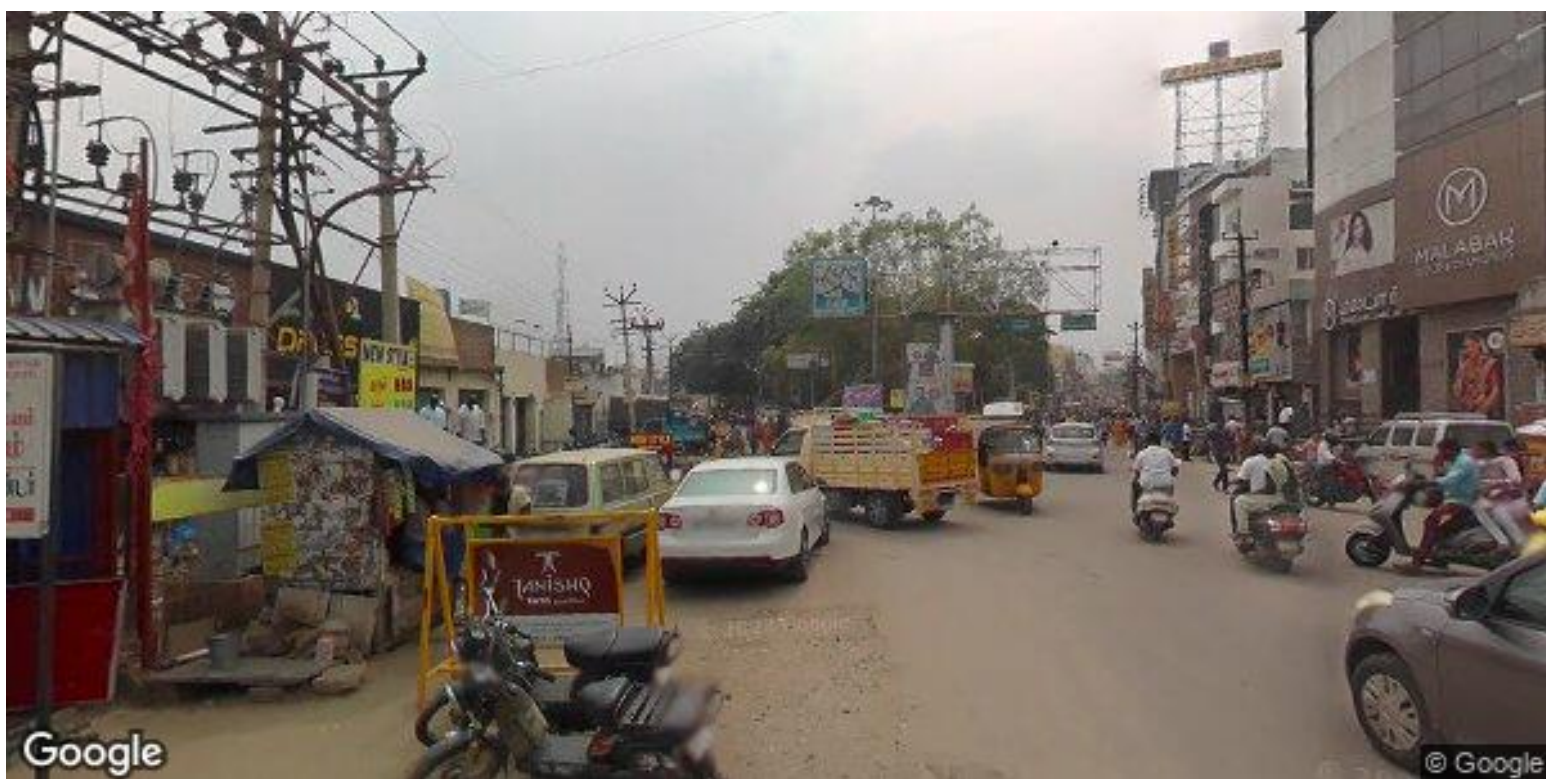
**Coordinates:** 11.34493, 77.73032

**Risk Type:** Turn

**Risk Level:** Medium

**Speed Limit:** 30 KM/Hr

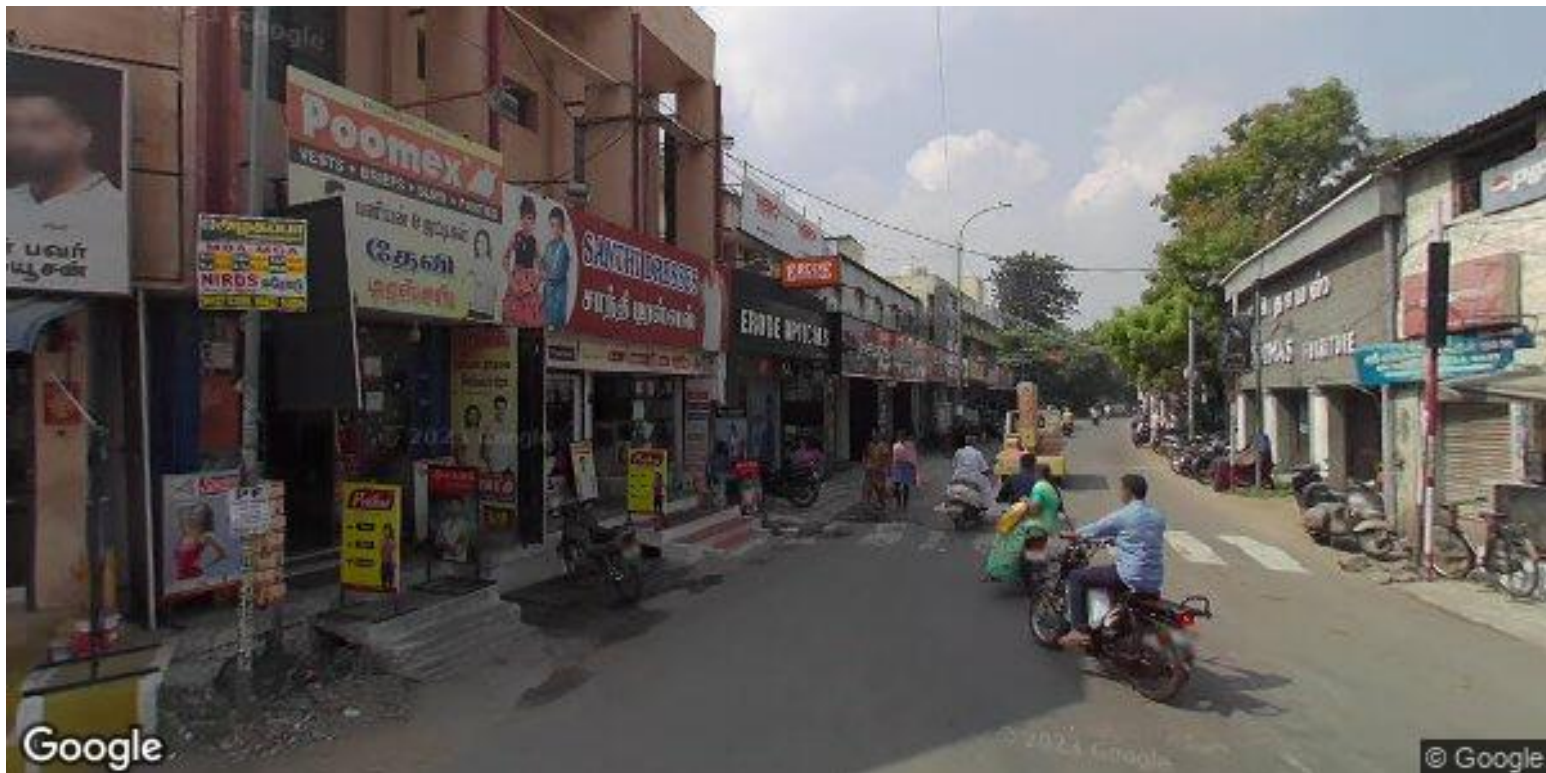
**Coordinates: 11.33920, 77.72902**

**Risk Type: Blind Spot**

**Risk Level: Blind Spot**

**Speed Limit: 10 KM/Hr**

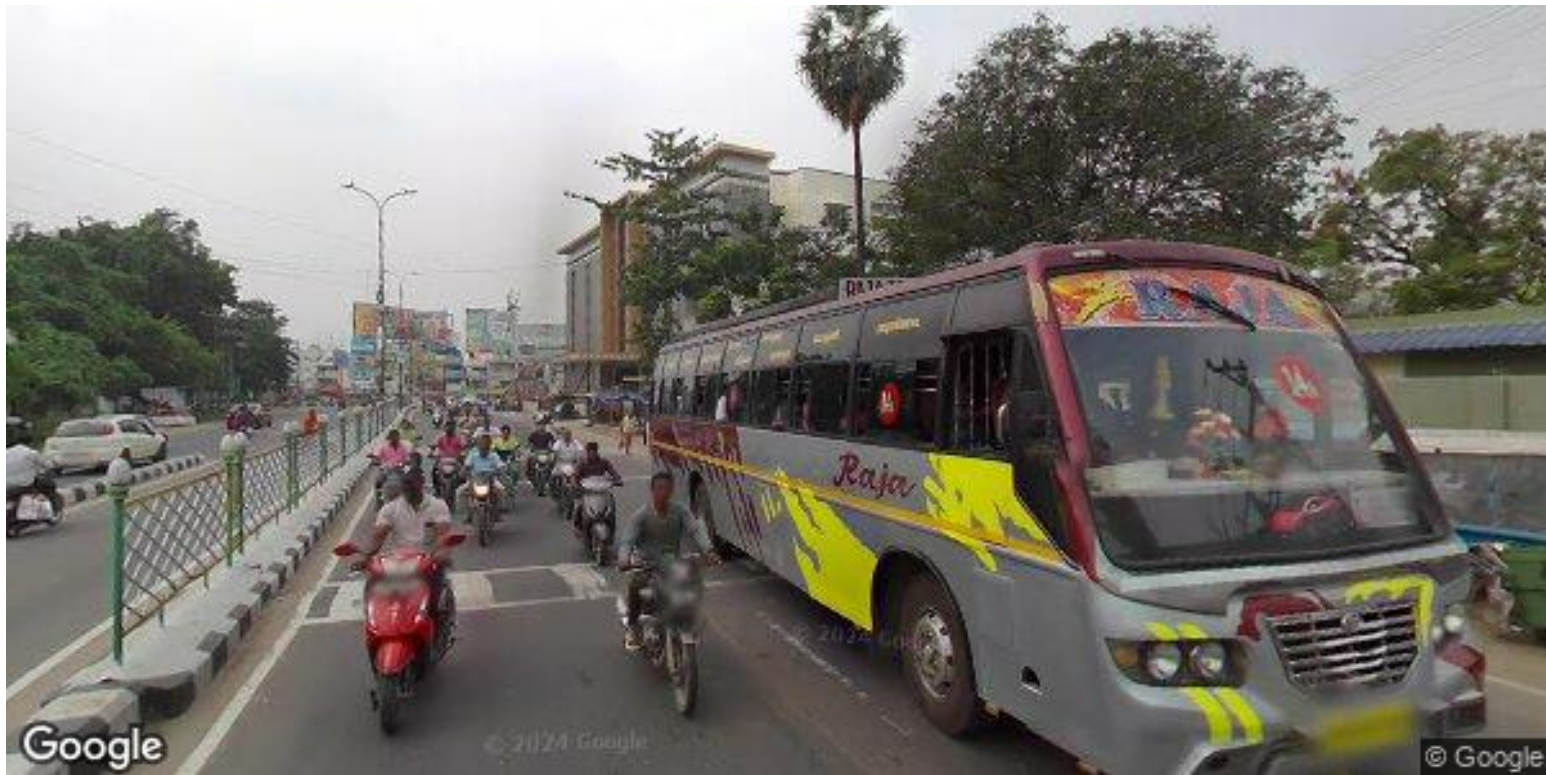
**Coordinates:** 11.33083, 77.72873

**Risk Type:** Turn

**Risk Level:** Medium

**Speed Limit:** 30 KM/Hr
