# IndianOil

## JOURNEY RISK MANAGEMENT (JRM) STUDY

### Salem Terminal to A.GEE.FUELS

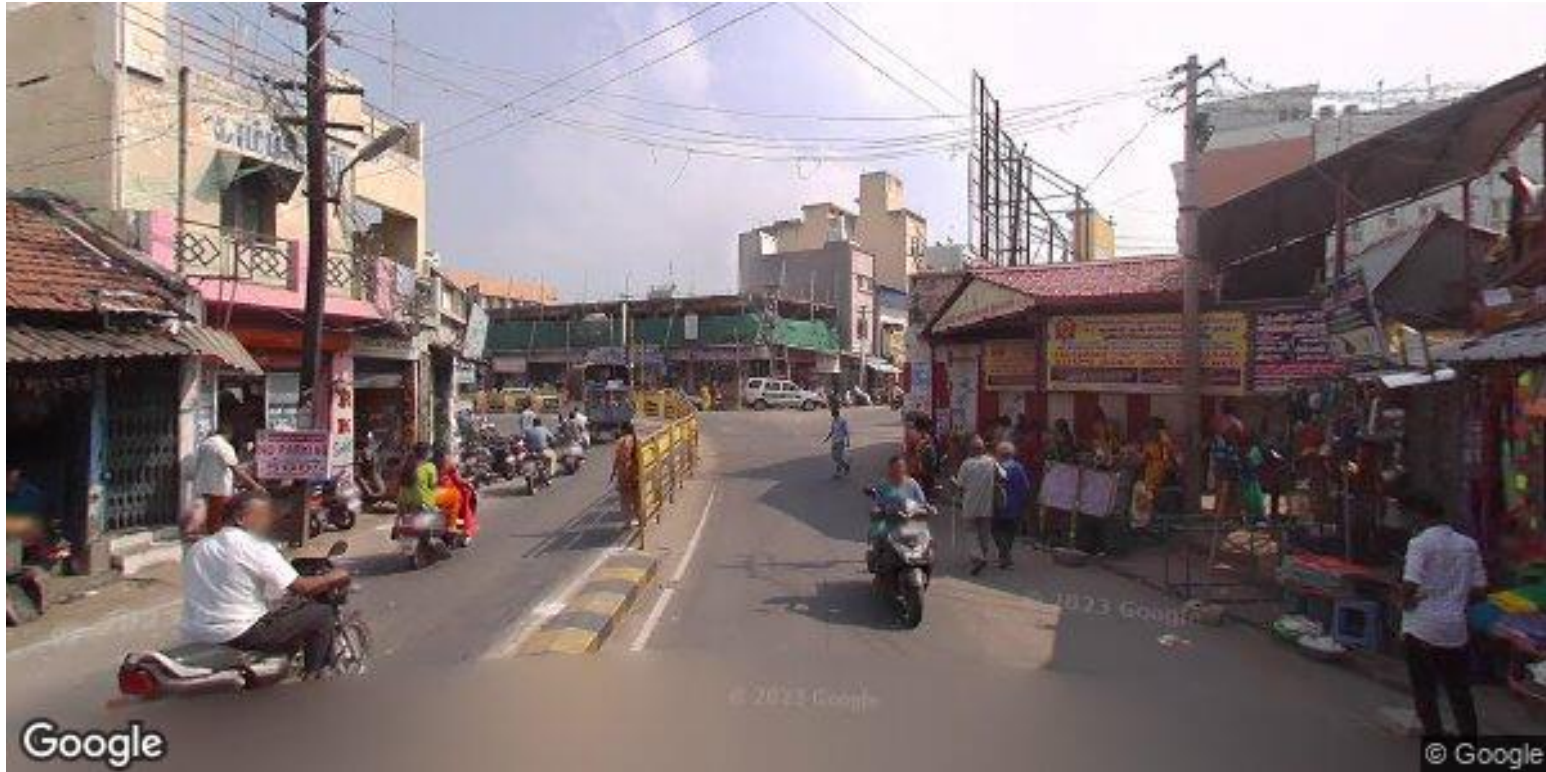
**Risk Type:** Turn  
**Risk Level:** Medium  
**Speed Limit:** 30 KM/Hr  
**Coordinates:** 11.37857, 77.89473

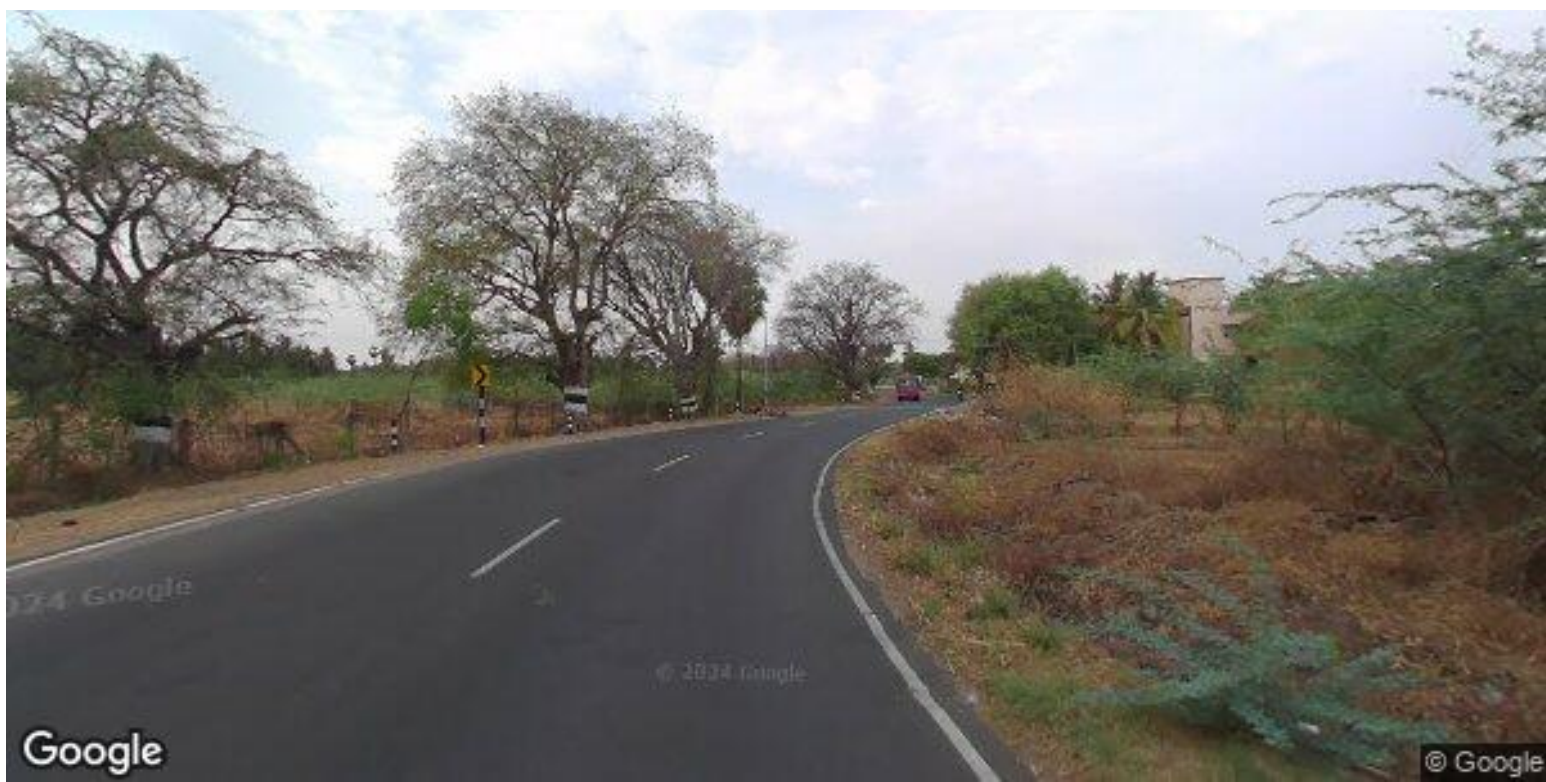
**Risk Type:** Turn

**Risk Level:** Medium

**Speed Limit:** 30 KM/Hr

**Coordinates:** 11.34067, 77.86347

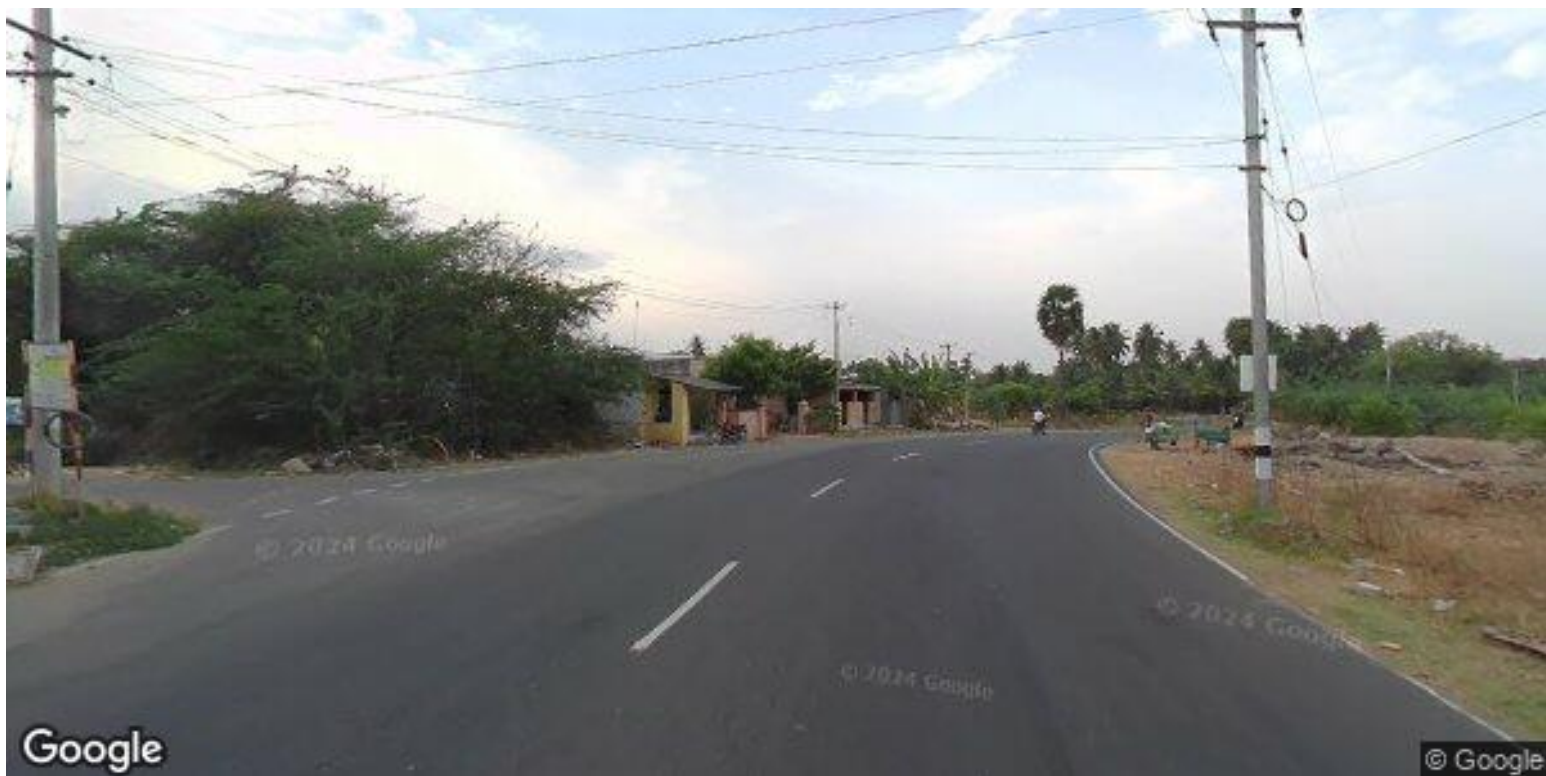
**Risk Type:** Turn

**Risk Level:** Medium

**Speed Limit:** 30 KM/Hr

**Coordinates:** 11.33854, 77.86216

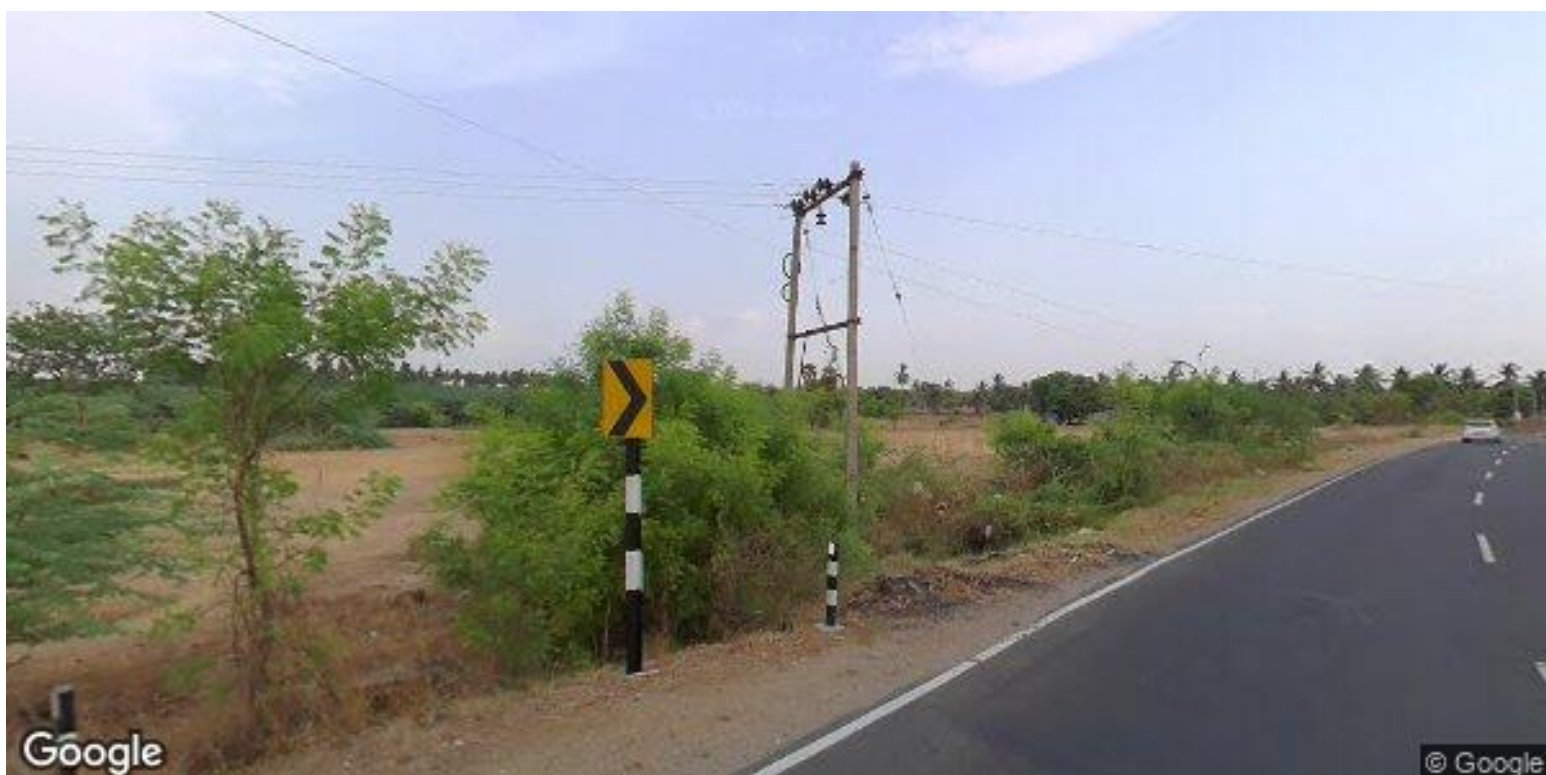
**Risk Type:** Turn

**Risk Level:** Medium

**Speed Limit:** 30 KM/Hr

**Coordinates:** 11.33778, 77.86236

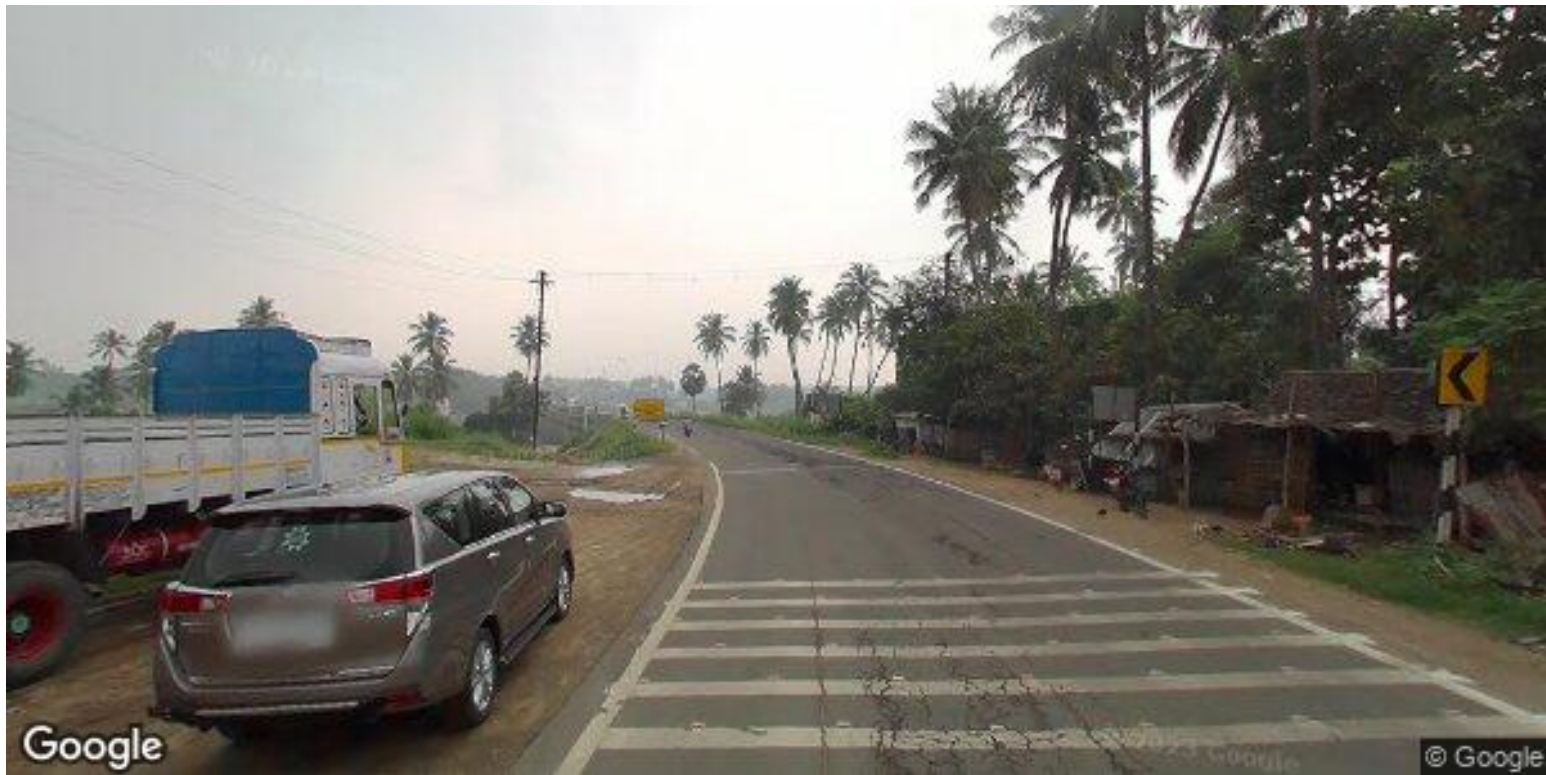
**Risk Type:** Turn

**Risk Level:** Medium

**Speed Limit:** 30 KM/Hr

**Coordinates:** 11.30952, 77.77587

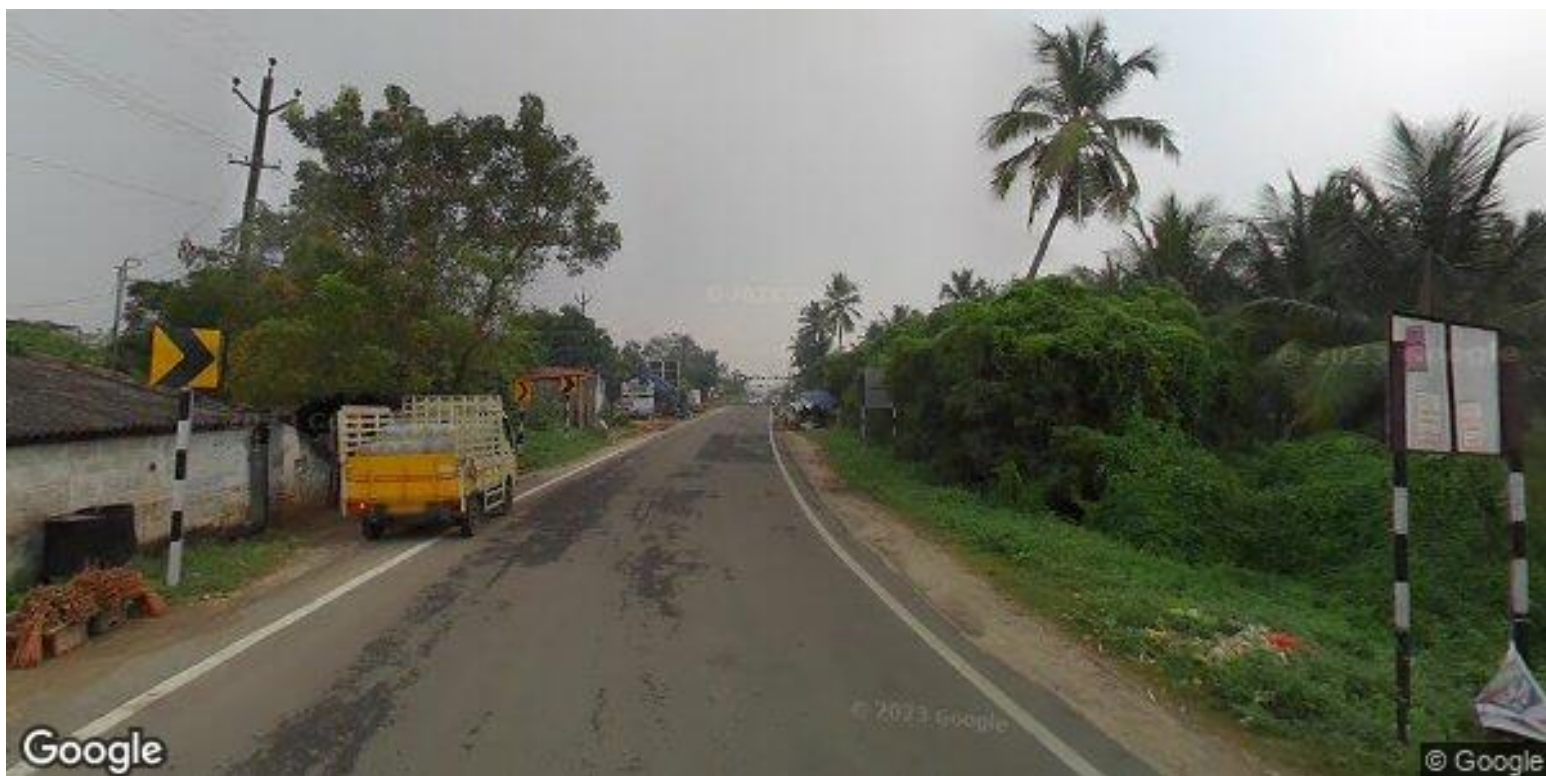
**Risk Type:** Turn

**Risk Level:** Medium

**Speed Limit:** 30 KM/Hr

**Coordinates:** 11.30973, 77.76712

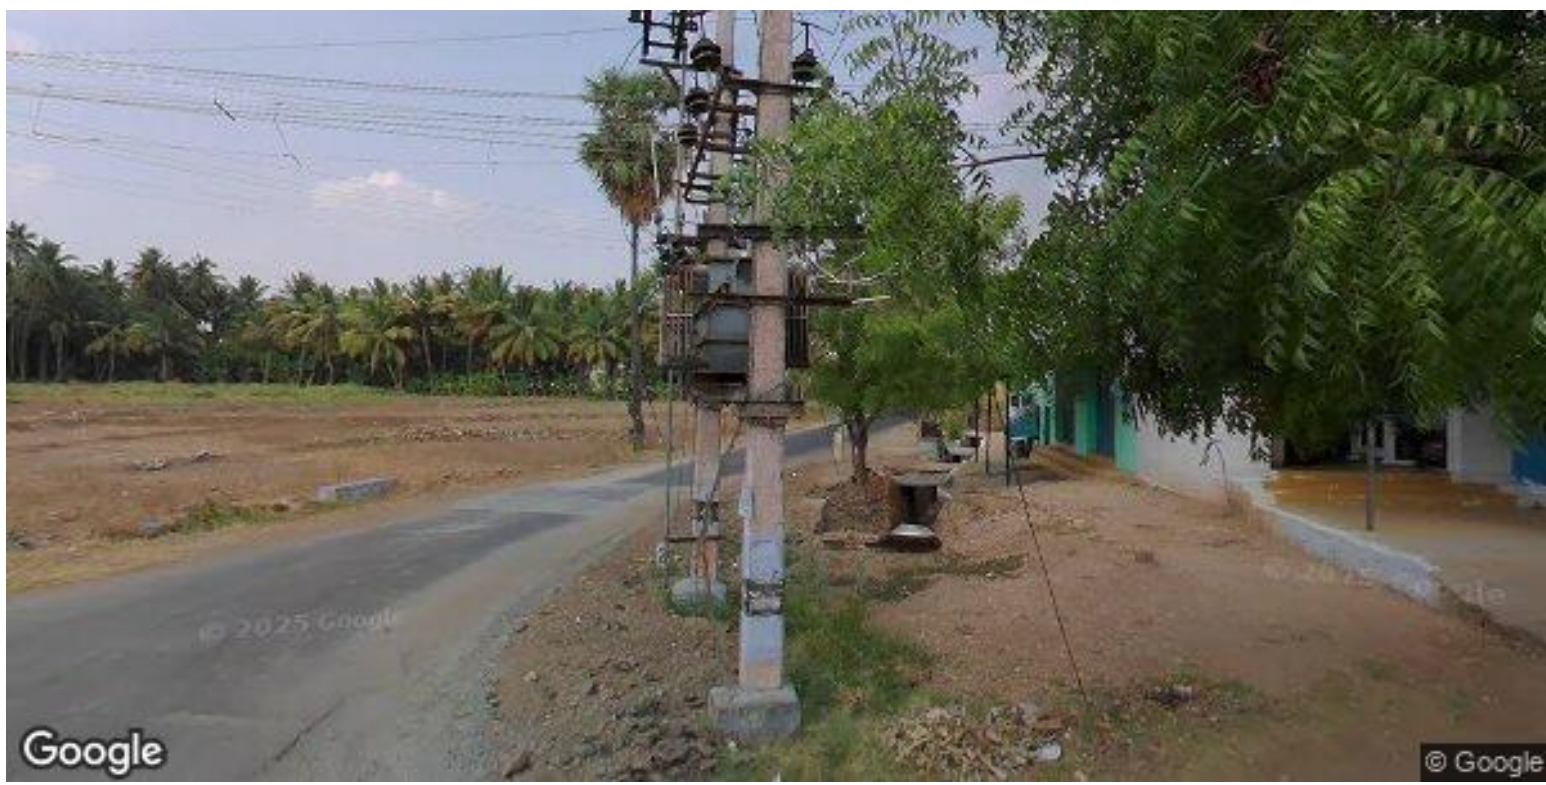
**Risk Type:** Blind Spot

**Risk Level:** Blind Spot

**Speed Limit:** 10 KM/Hr

**Coordinates:** 11.27330, 77.72715

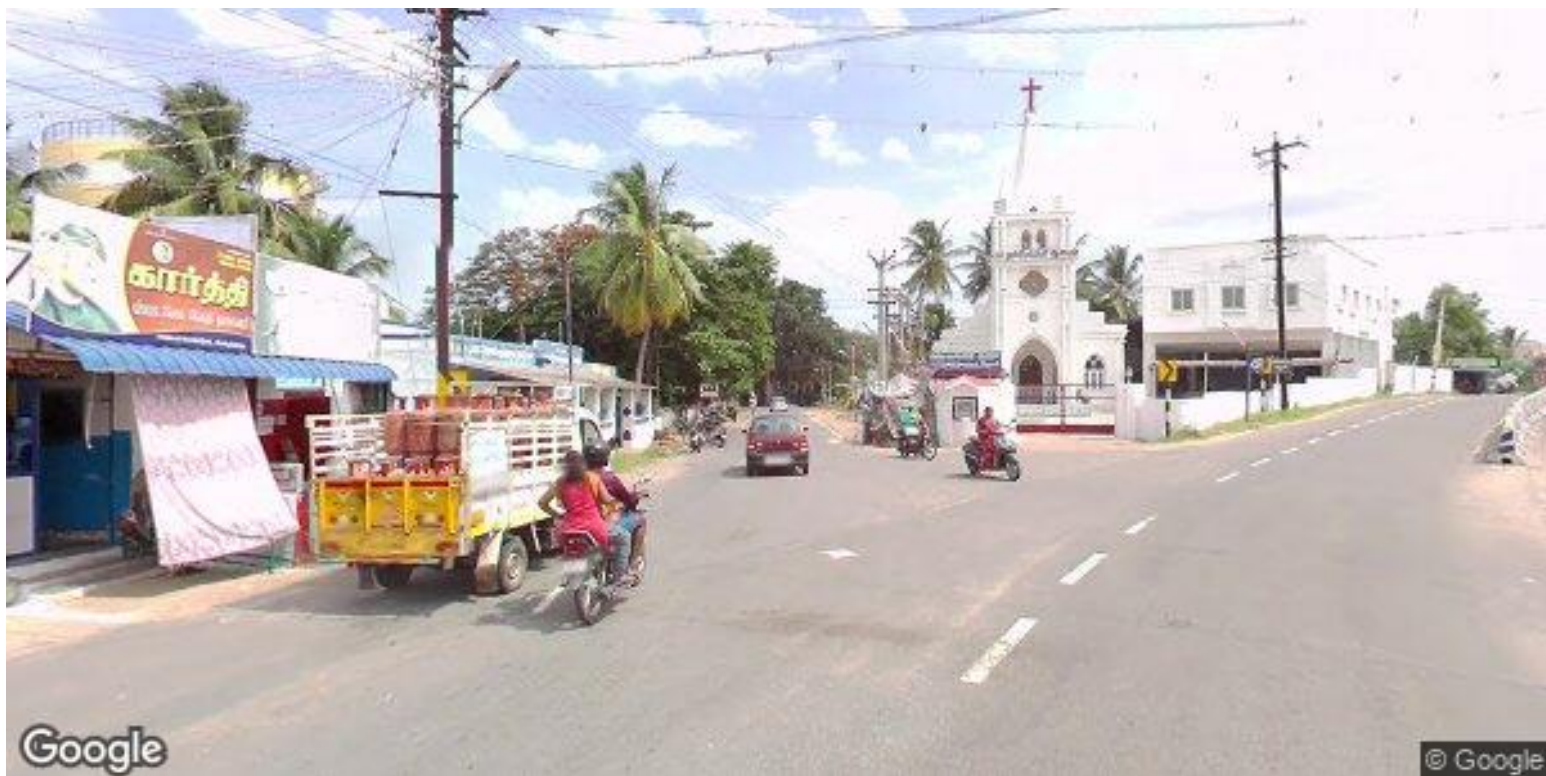
**Risk Type:** Turn

**Risk Level:** Medium

**Speed Limit:** 30 KM/Hr

**Coordinates:** 11.23054, 77.71796

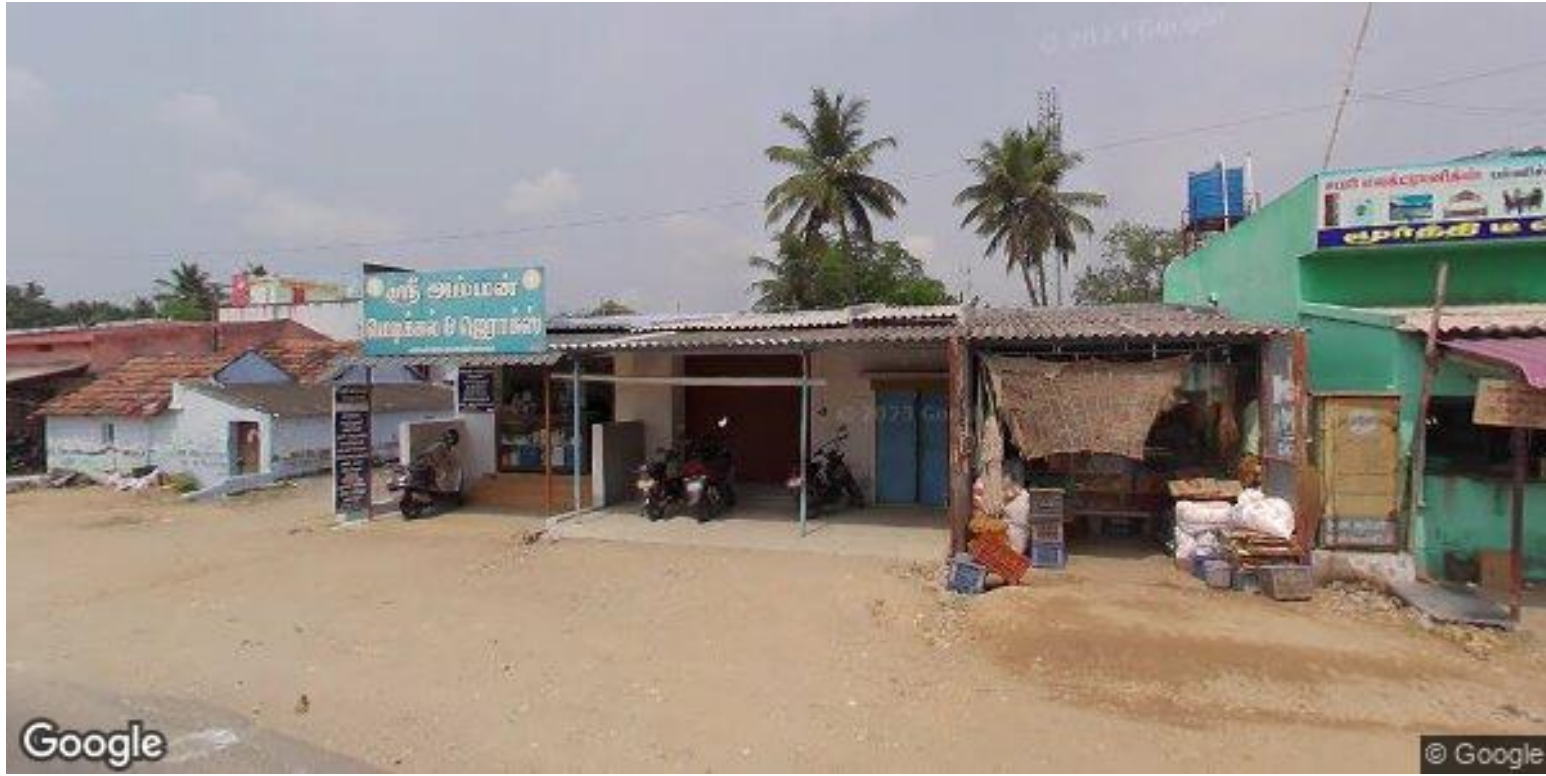
**Risk Type:** Turn

**Risk Level:** Medium

**Speed Limit:** 30 KM/Hr

**Coordinates:** 11.20776, 77.70916

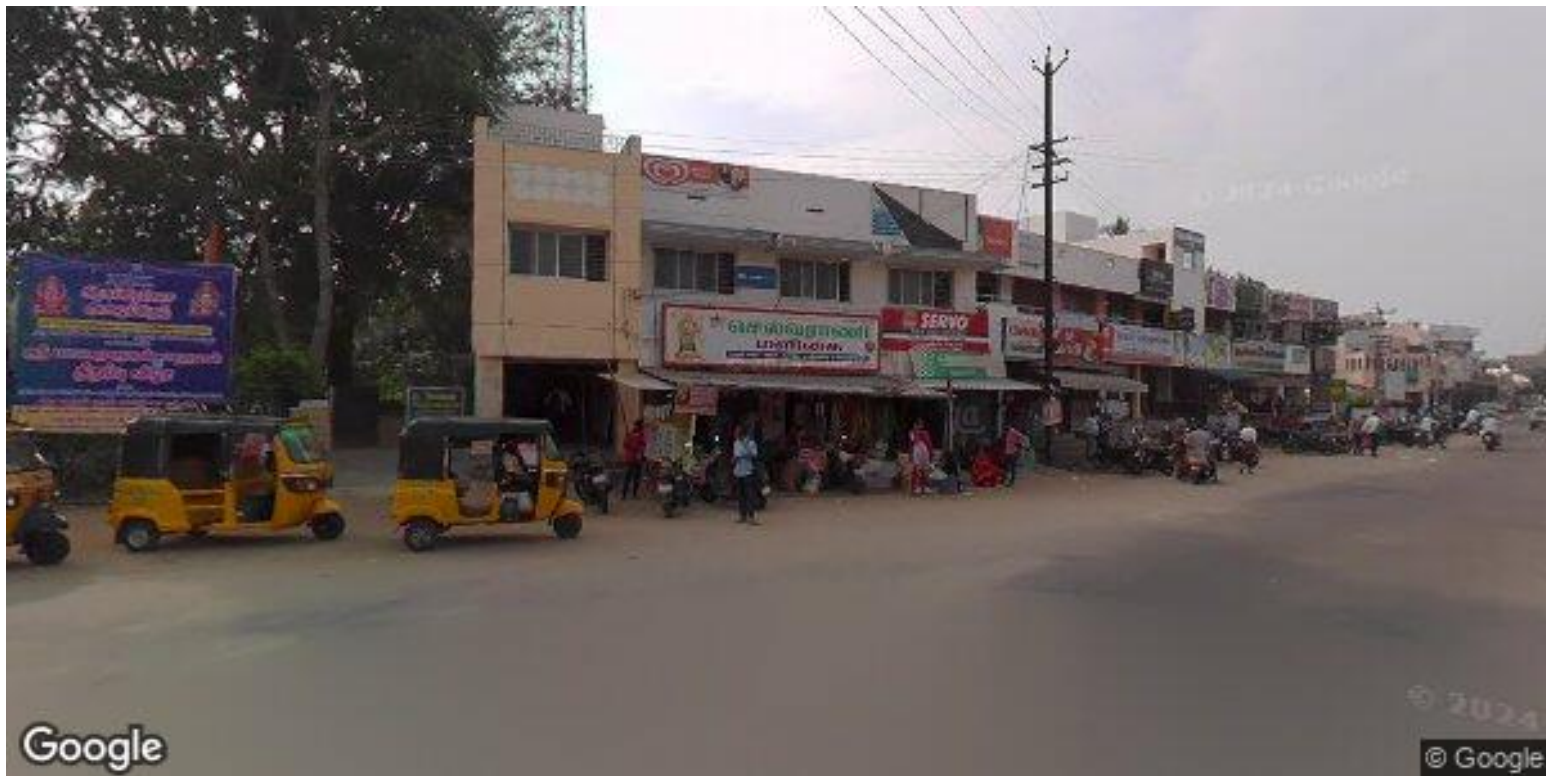
**Risk Type:** Turn

**Risk Level:** High

**Speed Limit:** 15 KM/Hr

**Coordinates:** 11.15942, 77.70068

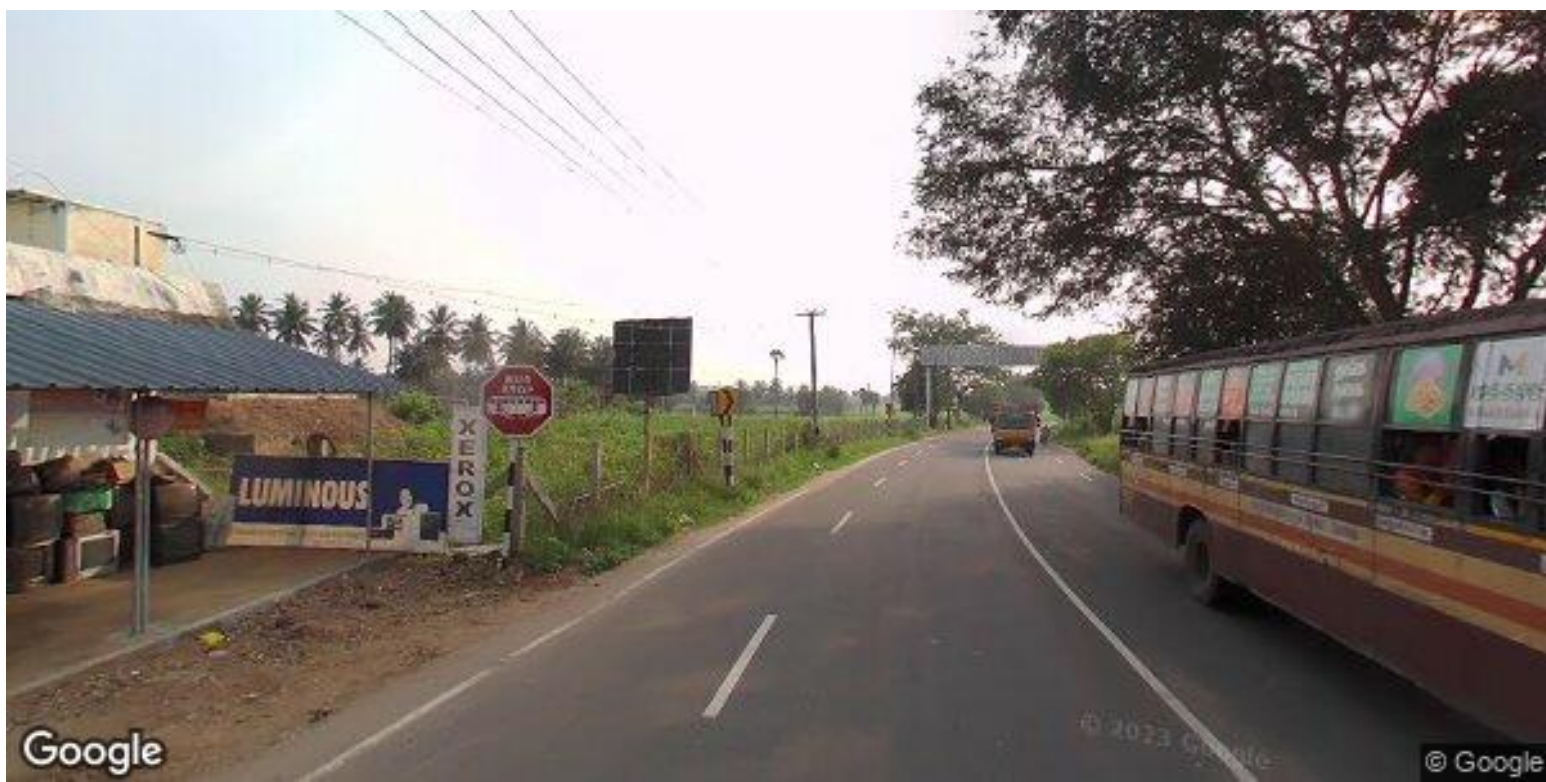
**Risk Type:** Turn

**Risk Level:** Medium

**Speed Limit:** 30 KM/Hr

**Coordinates:** 11.12102, 77.67919

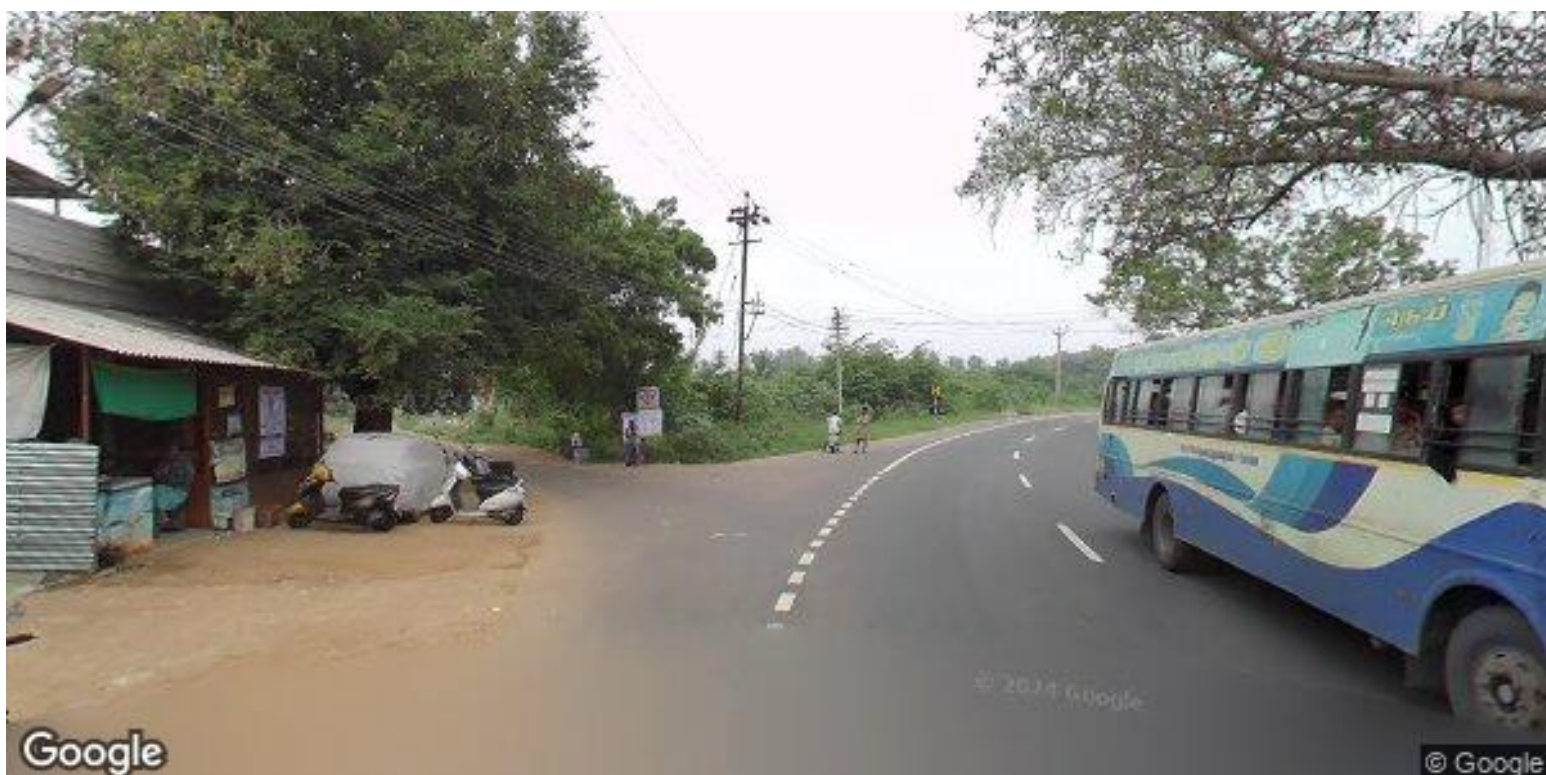
**Risk Type:** Turn  
**Risk Level:** Medium  
**Speed Limit:** 30 KM/Hr  
**Coordinates:** 11.11710, 77.67175

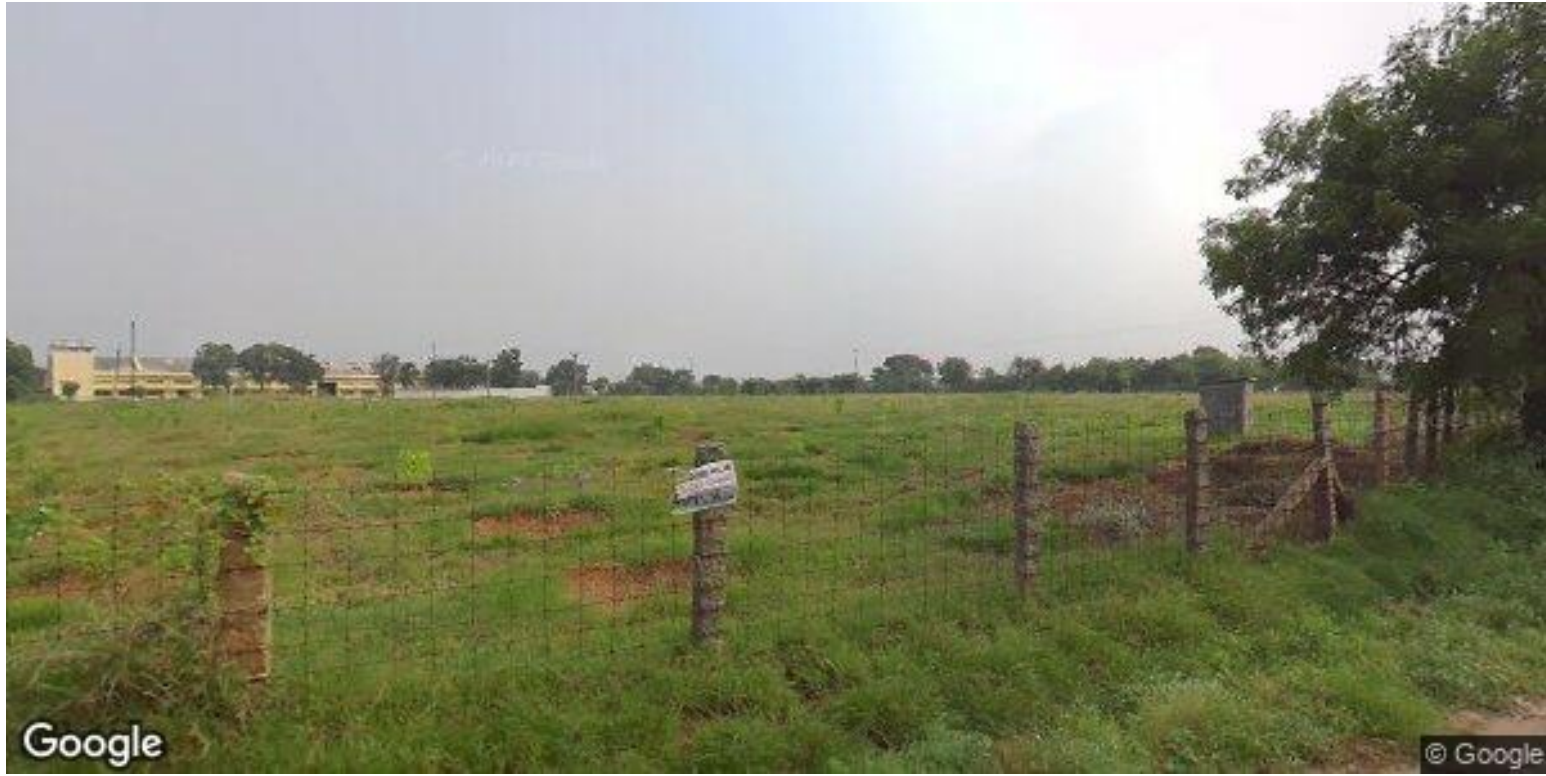
**Risk Type:** Turn  
**Risk Level:** Medium  
**Speed Limit:** 30 KM/Hr  
**Coordinates:** 11.09491, 77.66603

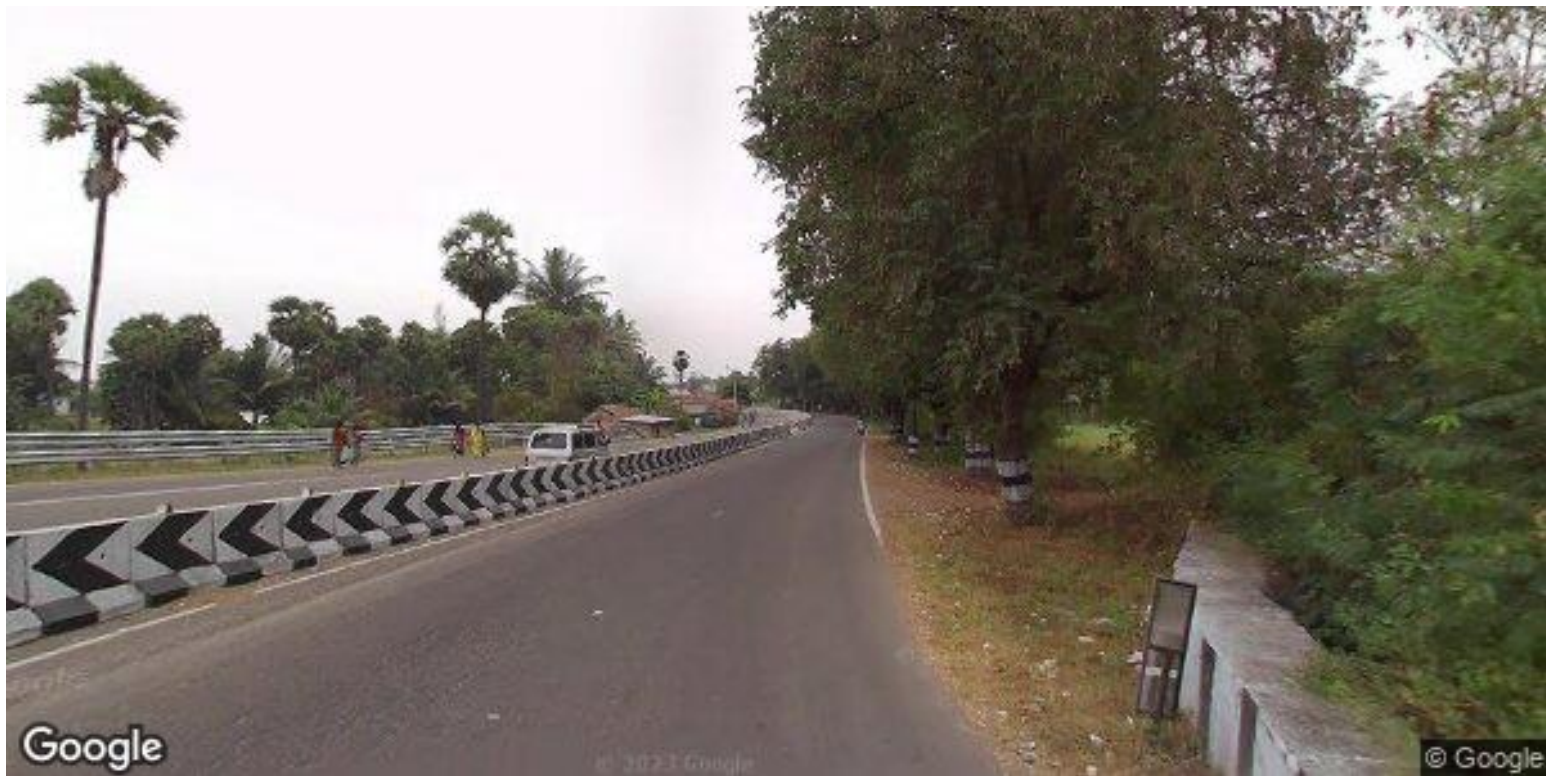
**Risk Type:** Turn  
**Risk Level:** Medium  
**Speed Limit:** 30 KM/Hr  
**Coordinates:** 11.08296, 77.65857

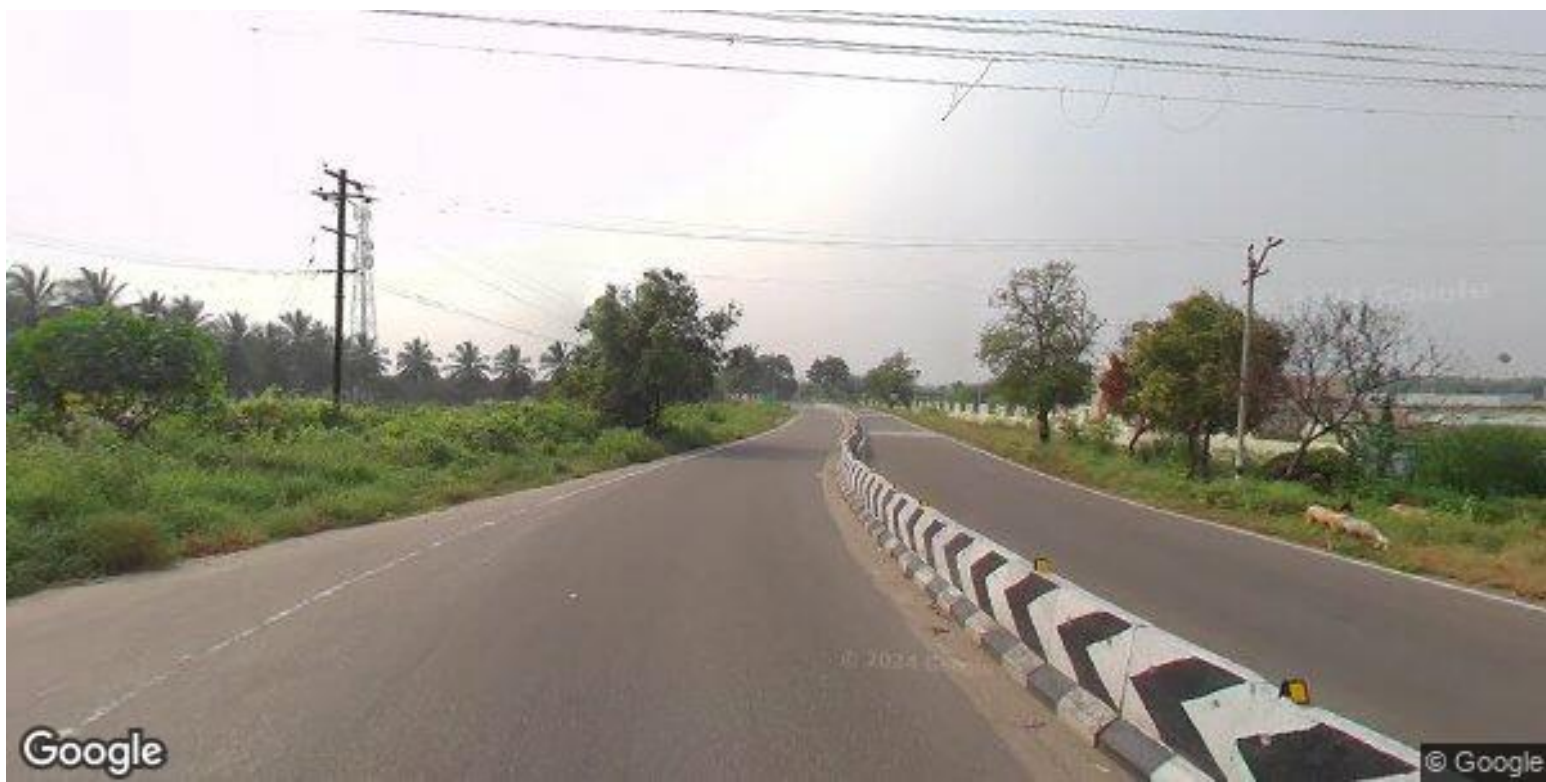
**Risk Type:** Turn

**Risk Level:** Medium

**Speed Limit:** 30 KM/Hr

**Coordinates:** 11.06183, 77.63924

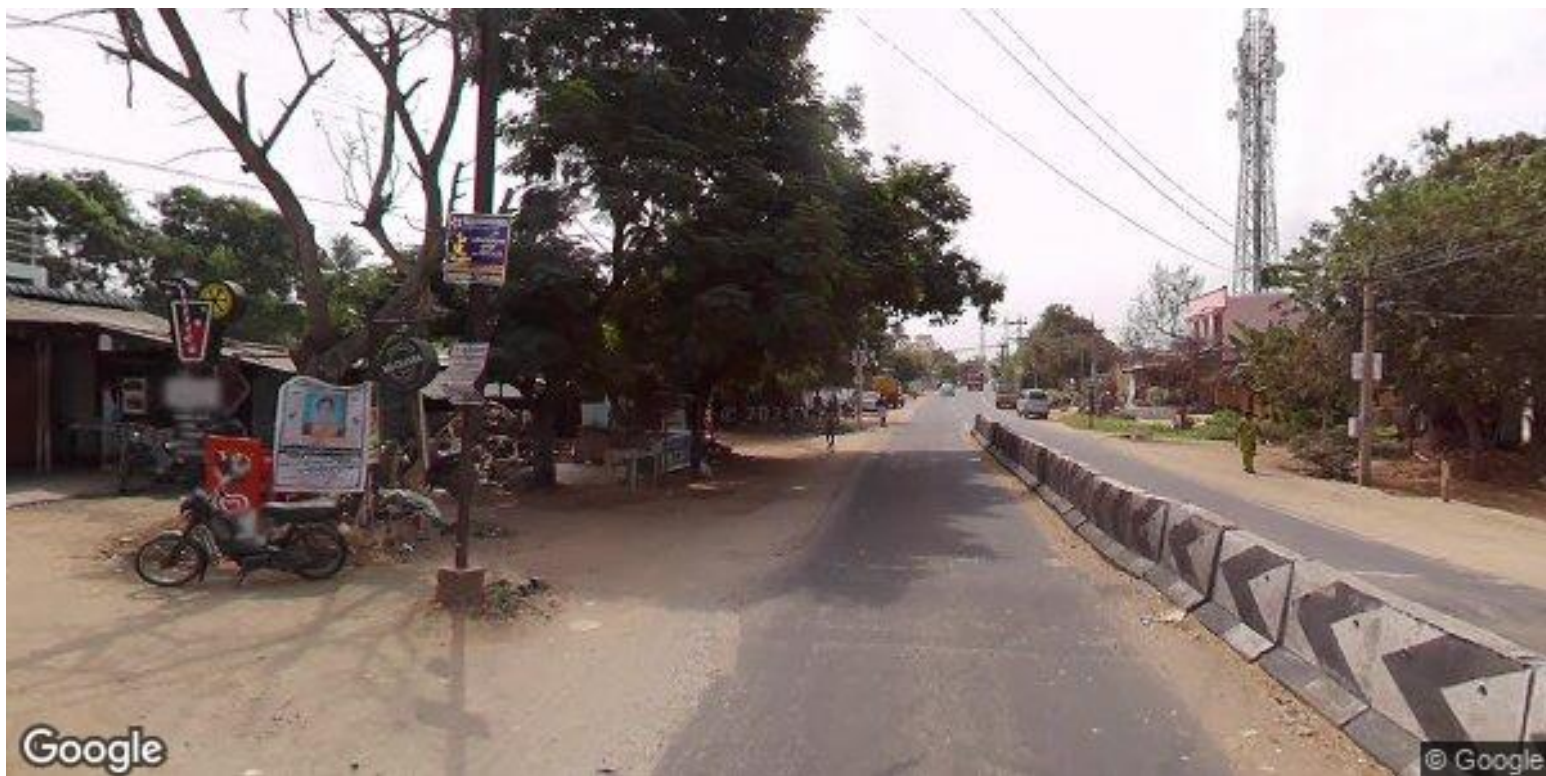
**Risk Type:** Turn

**Risk Level:** High

**Speed Limit:** 15 KM/Hr

**Coordinates:** 11.00826, 77.56962

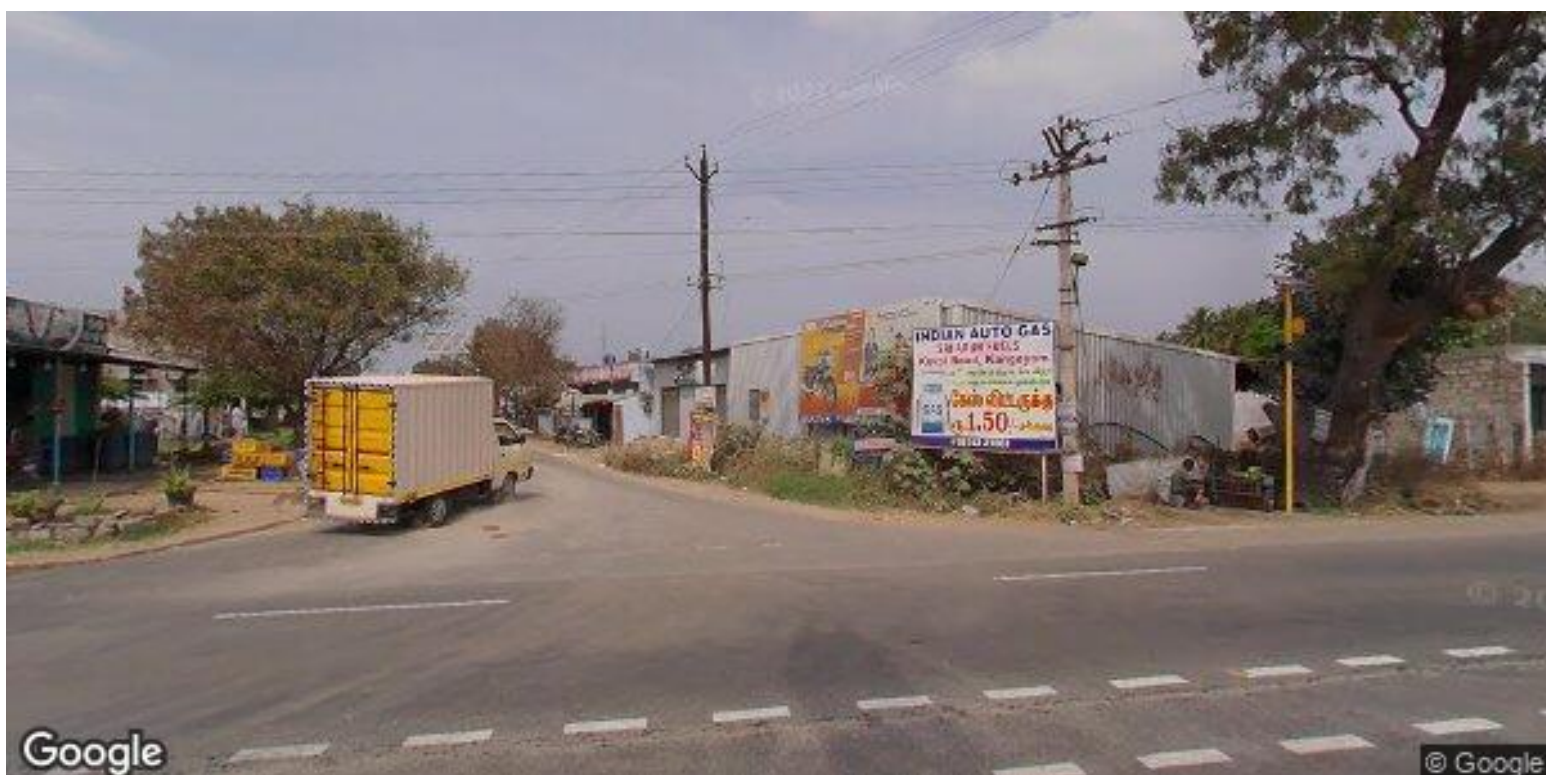
**Risk Type:** Blind Spot  
**Risk Level:** Blind Spot  
**Speed Limit:** 10 KM/Hr  
**Coordinates:** 11.00058, 77.56882

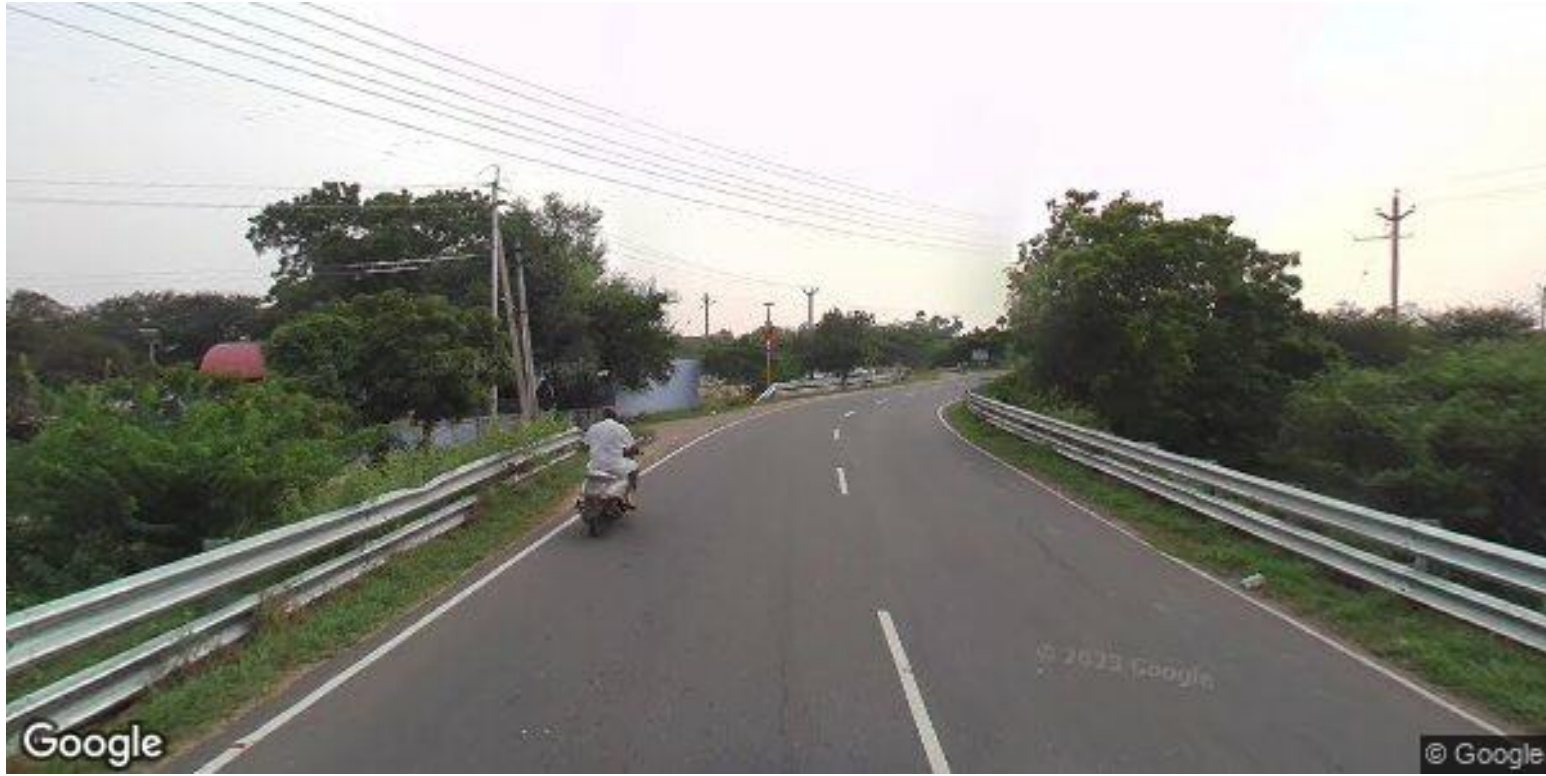
**Risk Type:** Turn  
**Risk Level:** Medium  
**Speed Limit:** 30 KM/Hr  
**Coordinates:** 10.94722, 77.54709

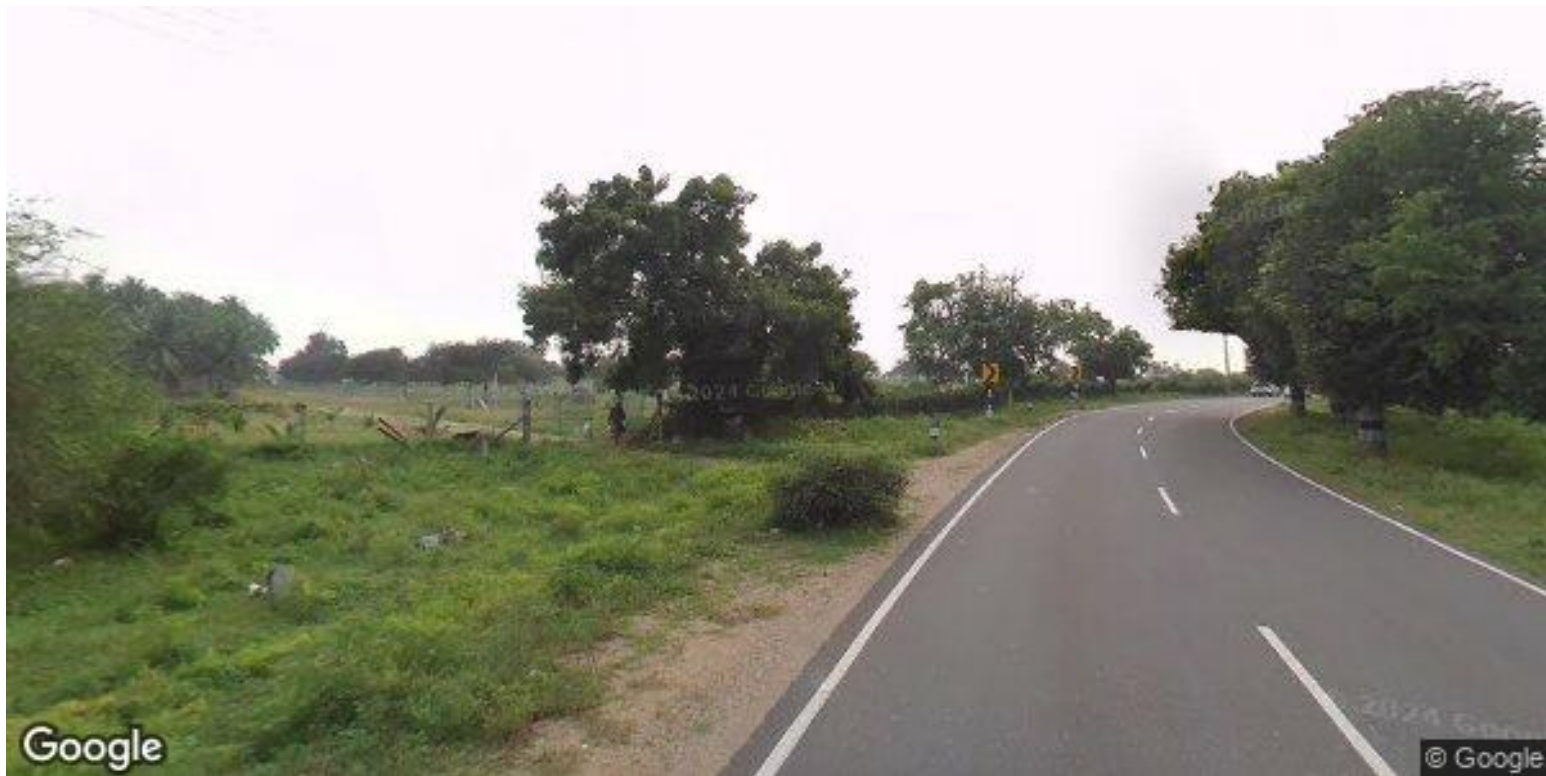
**Risk Type:** Turn  
**Risk Level:** Medium  
**Speed Limit:** 30 KM/Hr  
**Coordinates:** 10.93895, 77.53976
