# IndianOil

## JOURNEY RISK MANAGEMENT (JRM) STUDY

### Salem Terminal to A.GEE.FUELS

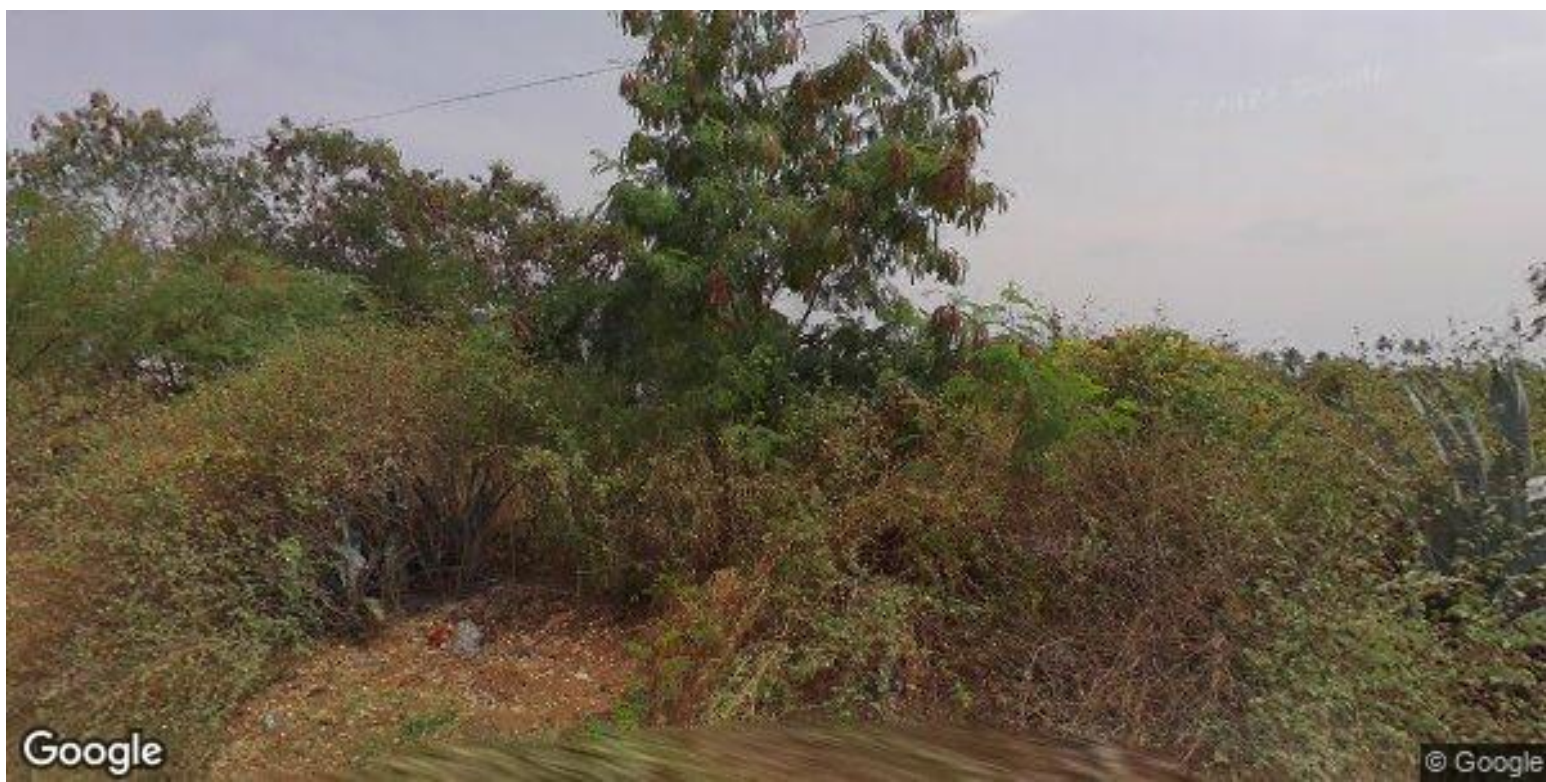
**Risk Type:** Turn

**Risk Level:** Medium

**Speed Limit:** 30 KM/Hr

**Coordinates:** 10.93054, 77.53265

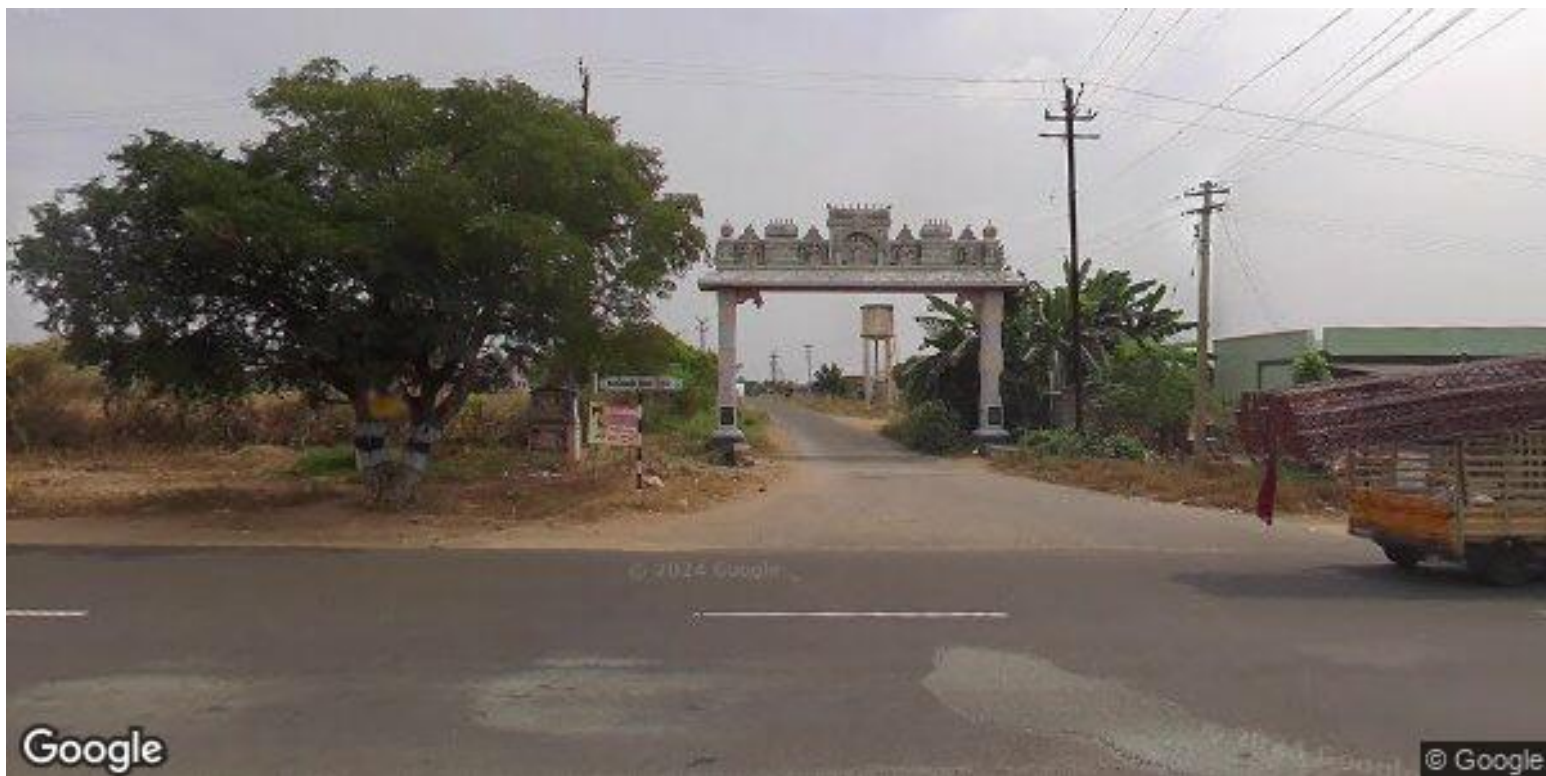
**Risk Type:** Turn

**Risk Level:** High

**Speed Limit:** 15 KM/Hr

**Coordinates:** 10.89940, 77.52804
