## JOURNEY RISK MANAGEMENT (JRM) STUDY

### Salem Terminal to SHIVAM AGENCIES IOC DEALERS- KSK

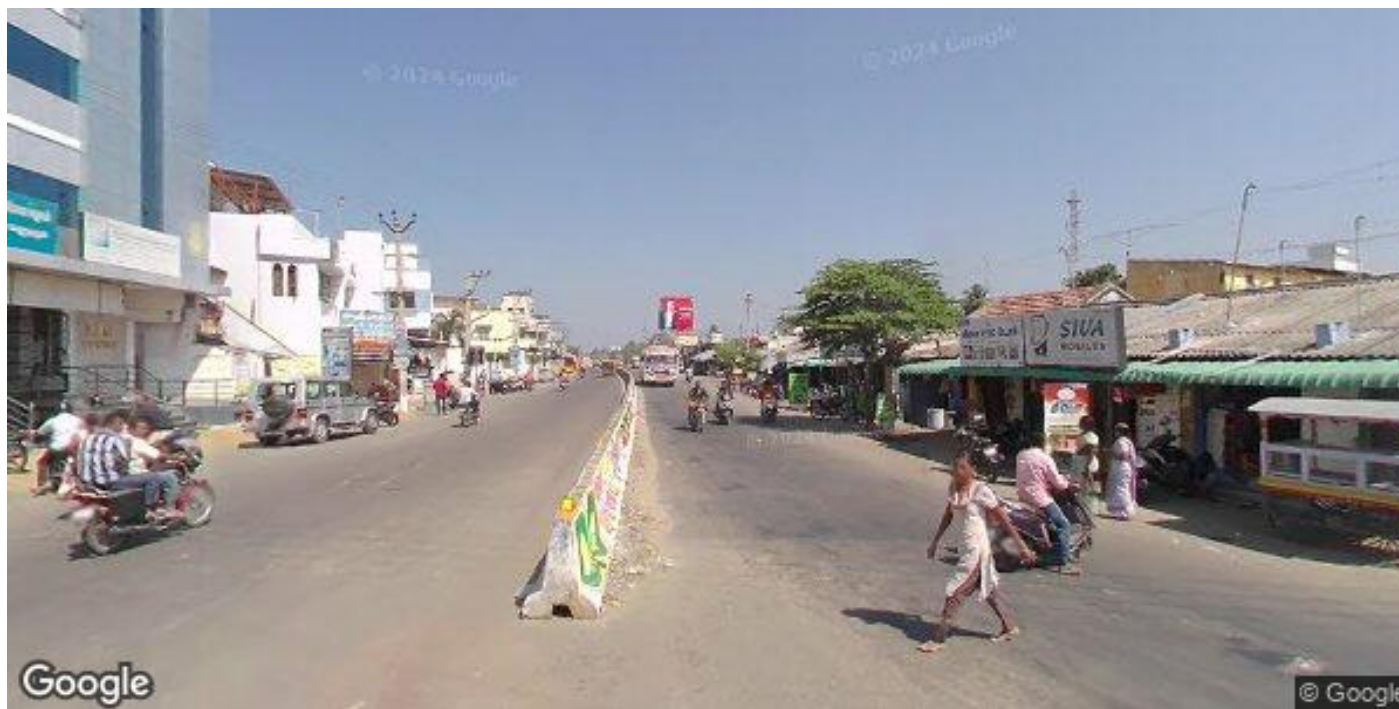
| | Risk Type | Risk Level | Coordinates | Speed Limit |
|---|---|---|---|---|
| 0 | Roundabout | High | 11.37086, 77.74828 | 15 KM/Hr |

**Risk Type:** Roundabout  
**Risk Level:** High  
**Speed Limit:** 15 KM/Hr  
**Coordinates:** 11.37086, 77.74828

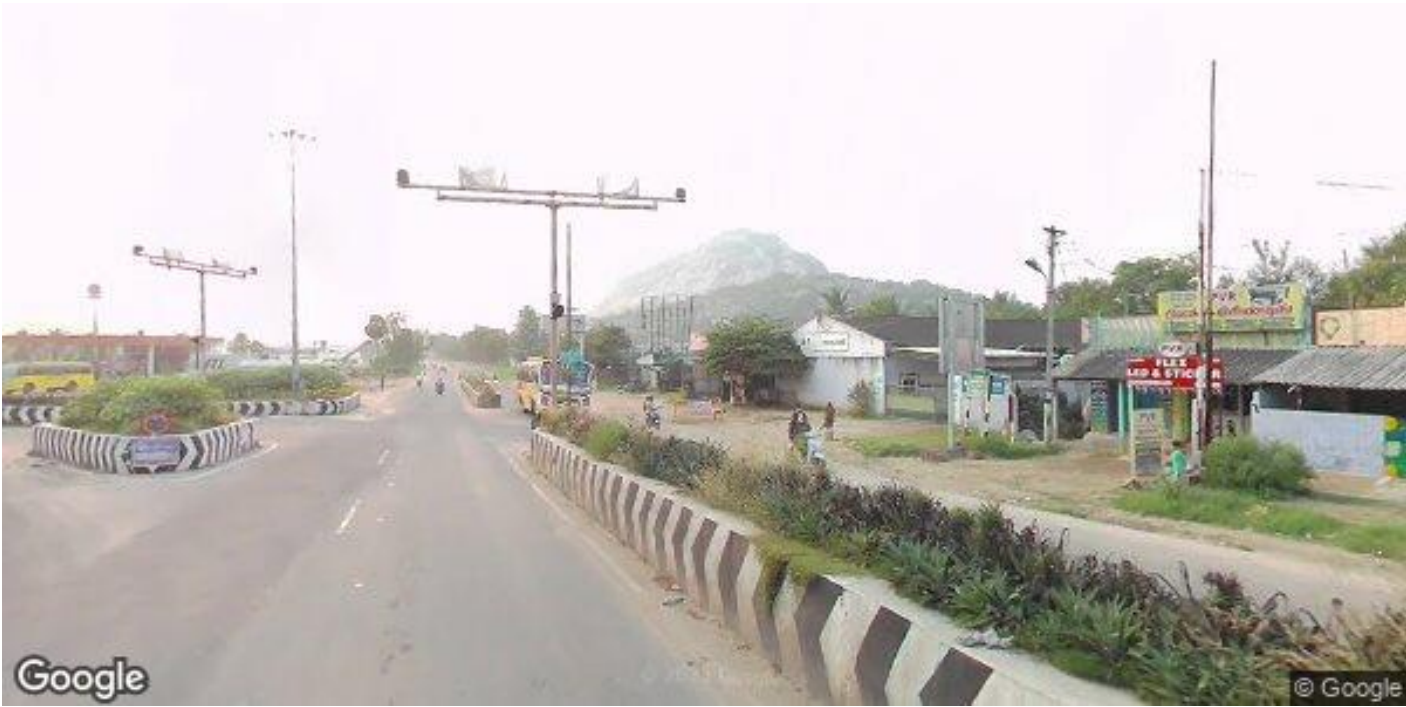
| | Risk Type | Risk Level | Coordinates | Speed Limit |
|---|---|---|---|---|
| 7 | Turn | Medium | 11.46312, 77.84886 | 30 KM/Hr |

**Risk Type:** Turn  
**Risk Level:** Medium  
**Speed Limit:** 30 KM/Hr  
**Coordinates:** 11.46312, 77.84886

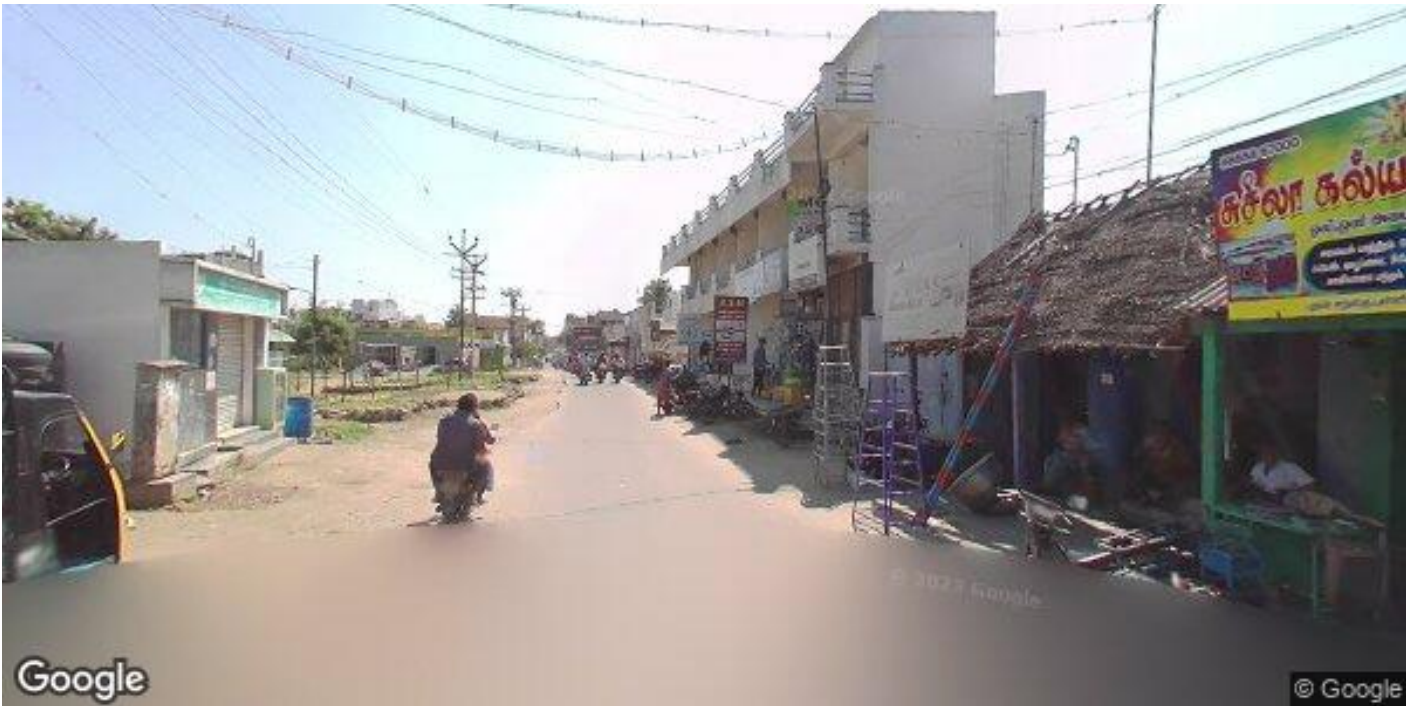
| | Risk Type | Risk Level | Coordinates | Speed Limit |
|---|---|---|---|---|
| 8 | Blind Spot | Blind Spot | 11.36726, 77.74328 | 10 KM/Hr |

**Risk Type:** Blind Spot  
**Risk Level:** Blind Spot  
**Speed Limit:** 10 KM/Hr  
**Coordinates:** 11.36726, 77.74328
