# IndianOil

## JOURNEY RISK MANAGEMENT (JRM) STUDY

### Salem Terminal to A1 FUELS INDIAN OIL DEAL

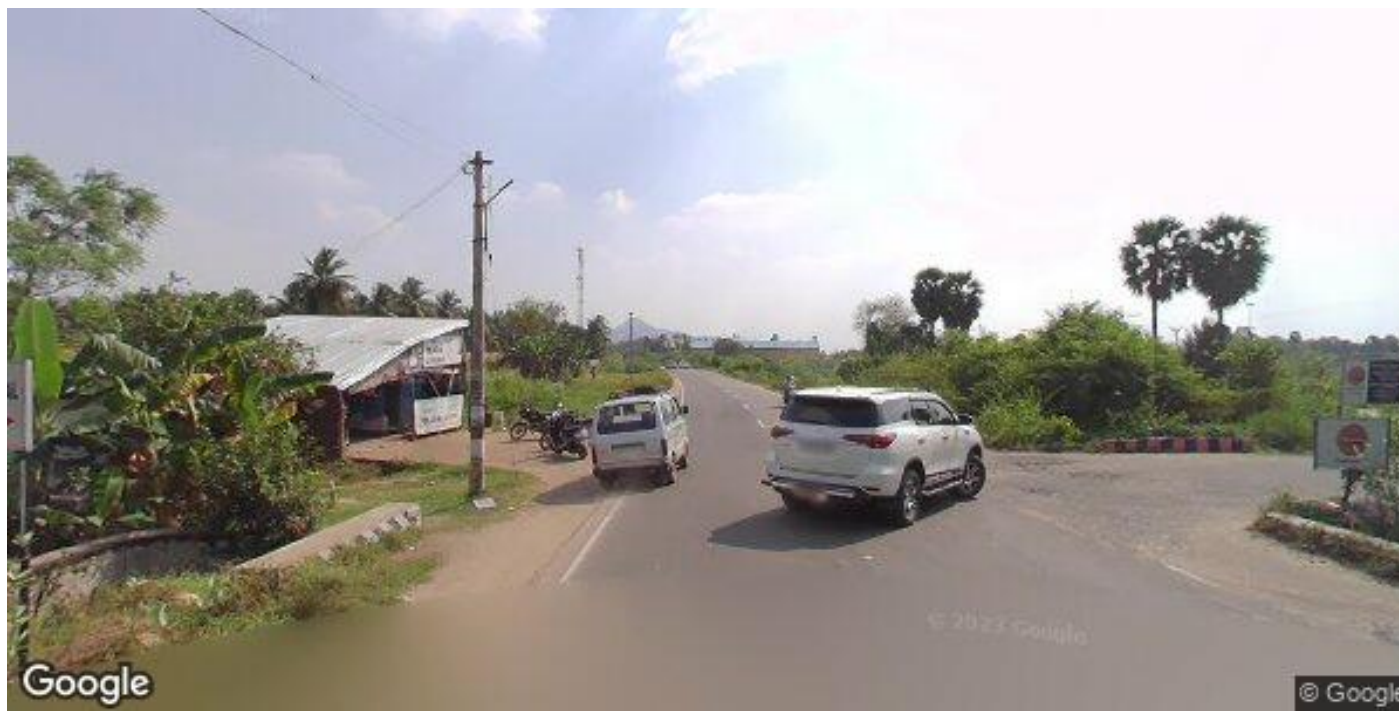
**Risk Type:** Blind Spot  
**Risk Level:** Blind Spot  
**Speed Limit:** 10 KM/Hr  
**Coordinates:** 11.44029, 77.87544

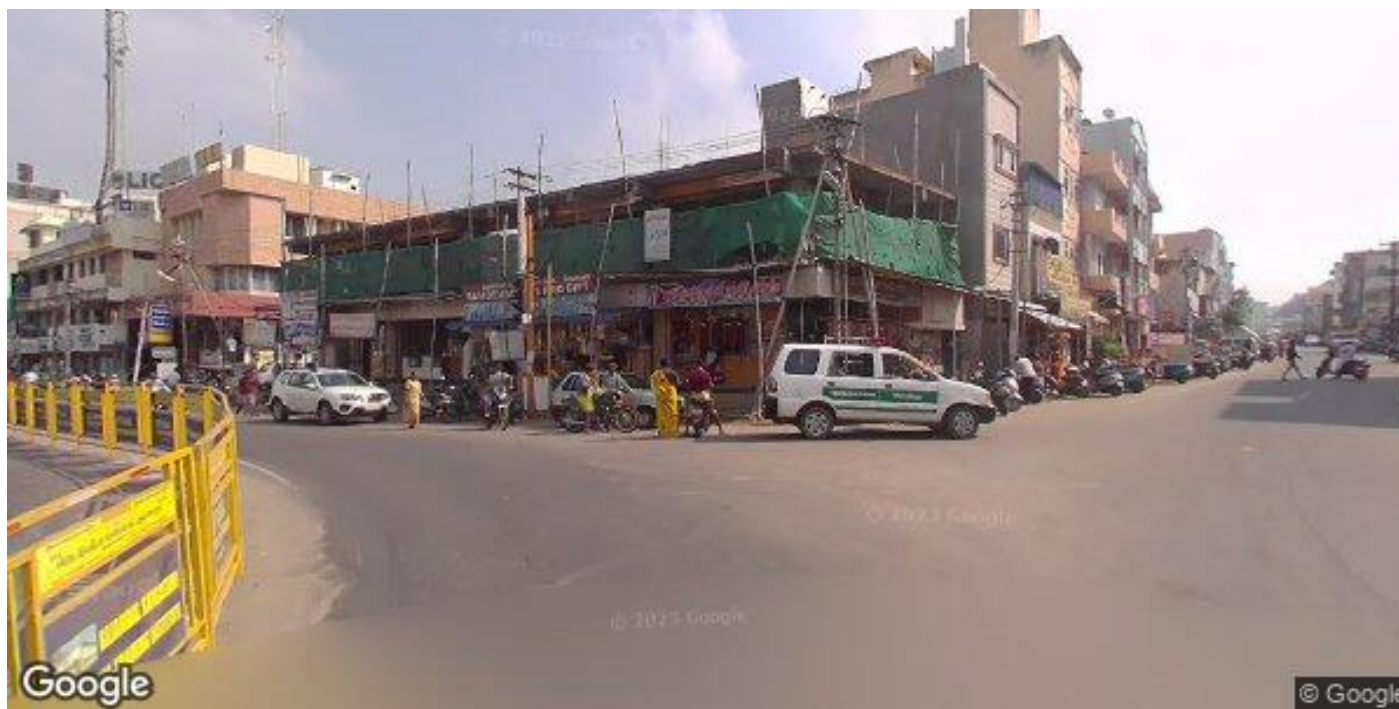
**Risk Type:** Turn  
**Risk Level:** High  
**Speed Limit:** 15 KM/Hr  
**Coordinates:** 11.37868, 77.89498

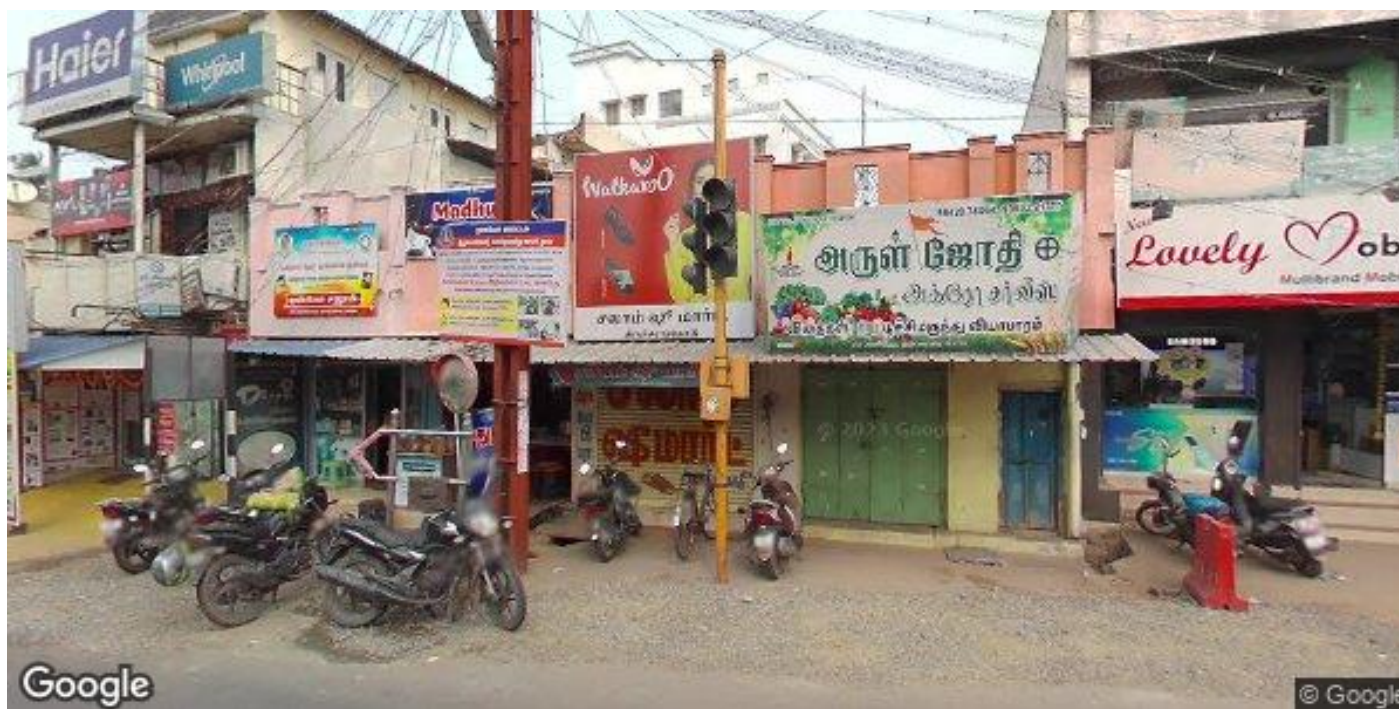
**Risk Type:** Turn  
**Risk Level:** High  
**Speed Limit:** 15 KM/Hr  
**Coordinates:** 11.37850, 77.89453

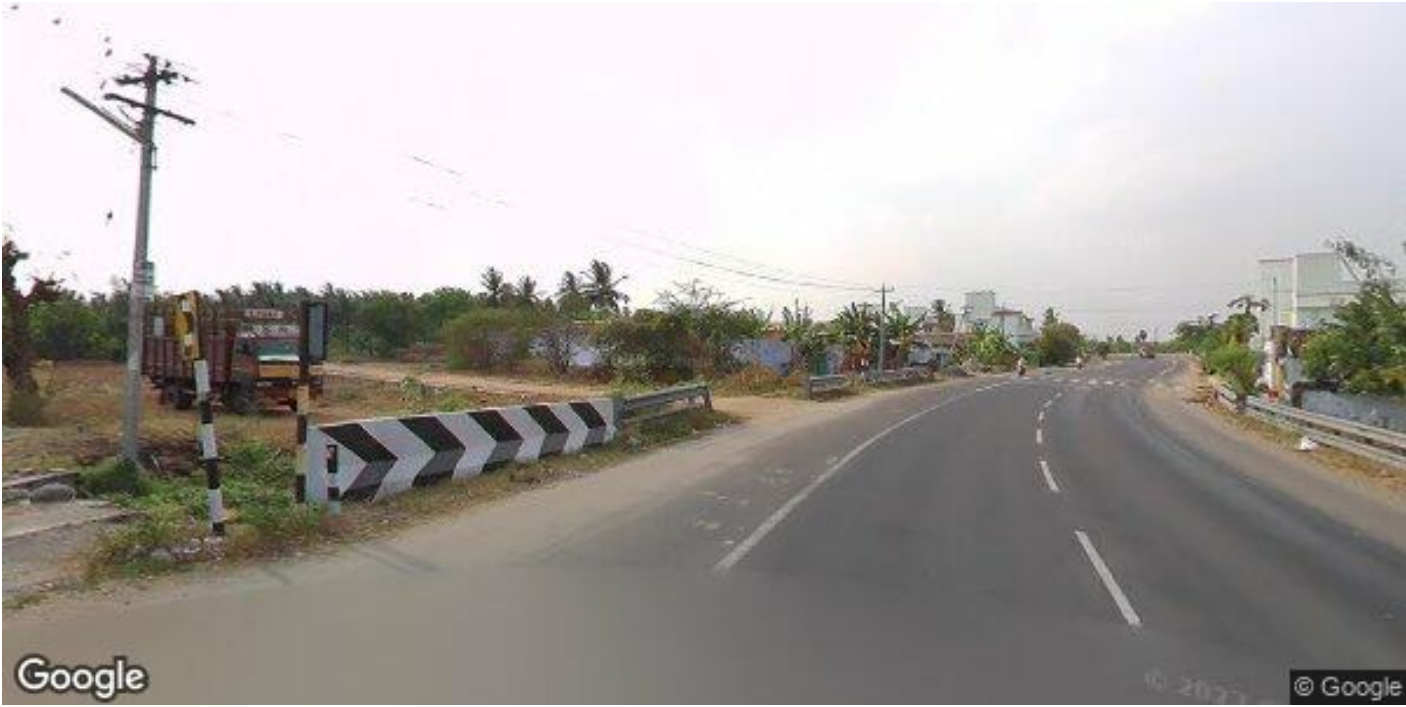
**Risk Type:** Turn  
**Risk Level:** Medium  
**Speed Limit:** 30 KM/Hr  
**Coordinates:** 11.16755, 78.01568

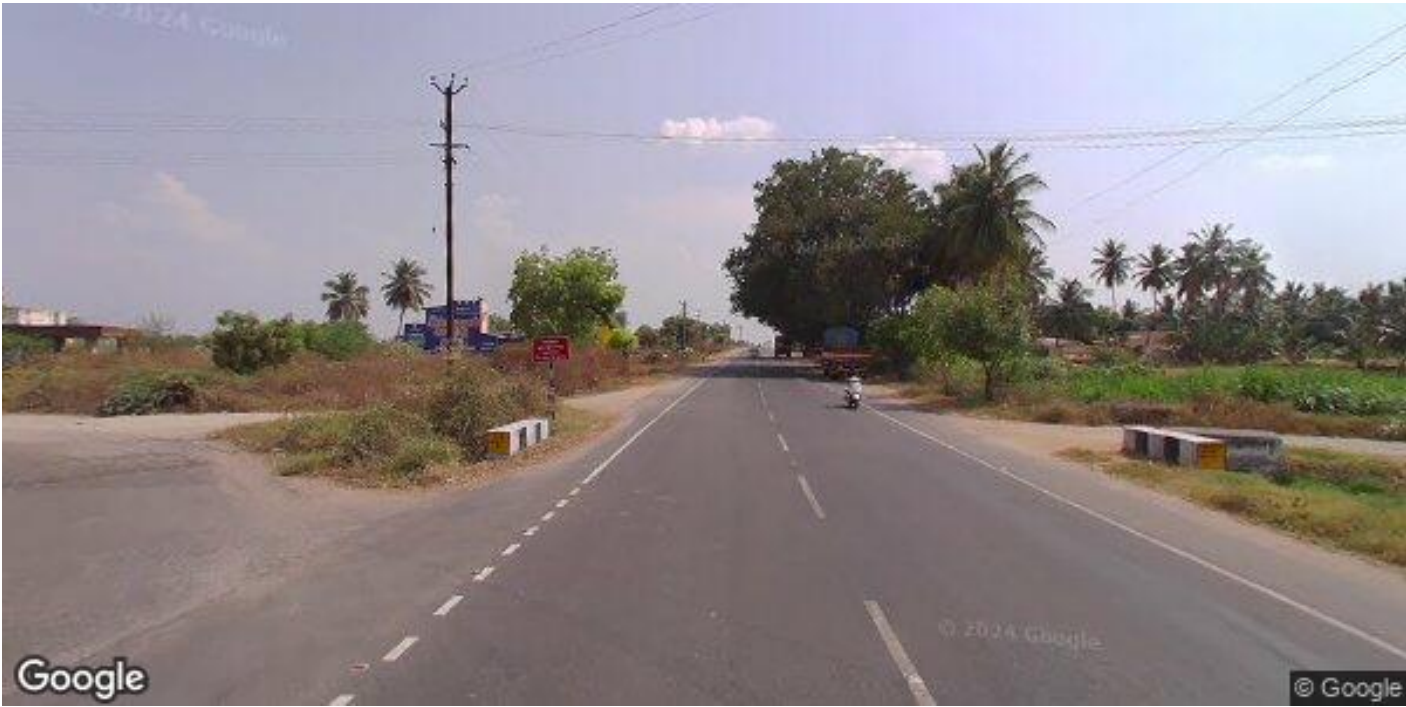
**Risk Type:** Turn  
**Risk Level:** High  
**Speed Limit:** 15 KM/Hr  
**Coordinates:** 11.14545, 78.02208

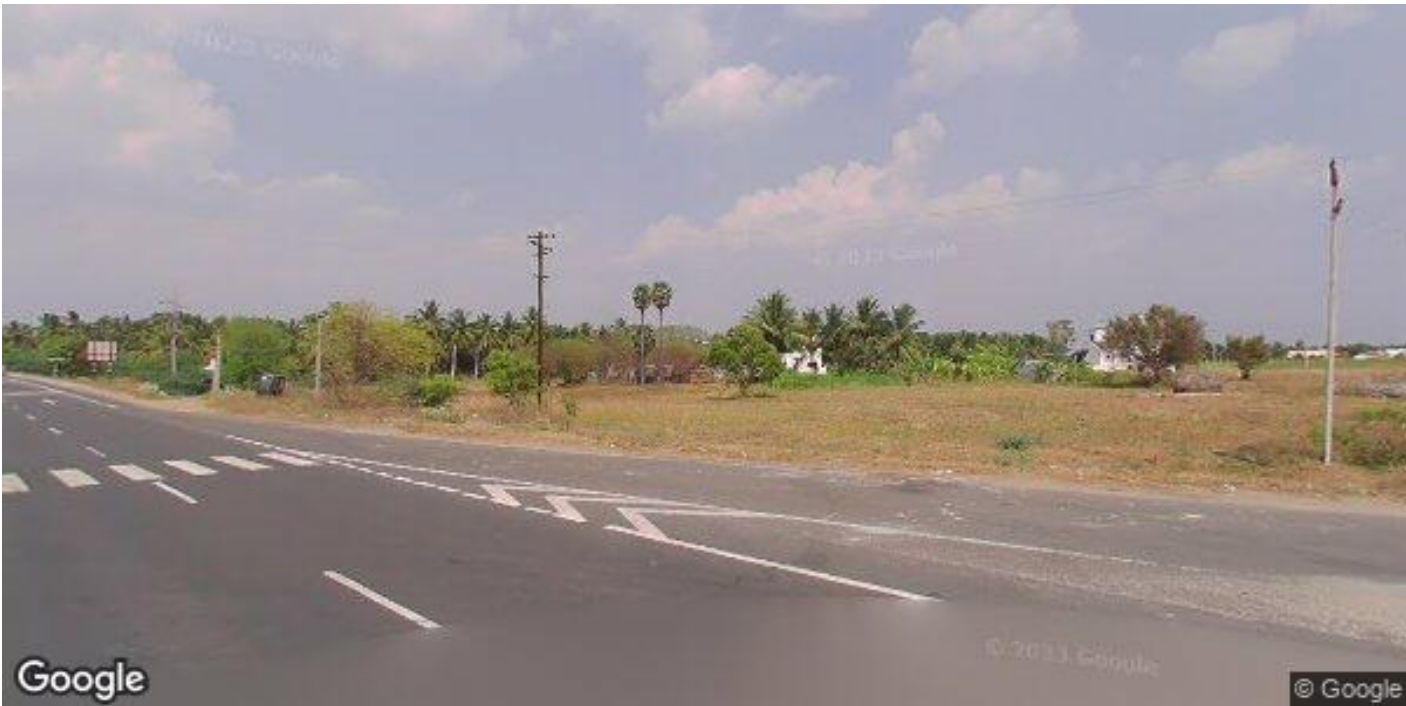
**Risk Type:** Blind Spot  
**Risk Level:** Blind Spot  
**Speed Limit:** 10 KM/Hr  
**Coordinates:** 11.14480, 78.02291
