# IndianOil

## JOURNEY RISK MANAGEMENT (JRM) STUDY

### Salem Terminal to SRI VELAVAN AGENCY

Route Safety Analysis for CVQF+23W, Sangagiri to 531, Erode-  
Chennimalai Rd, Senathipathipalayam, Erode

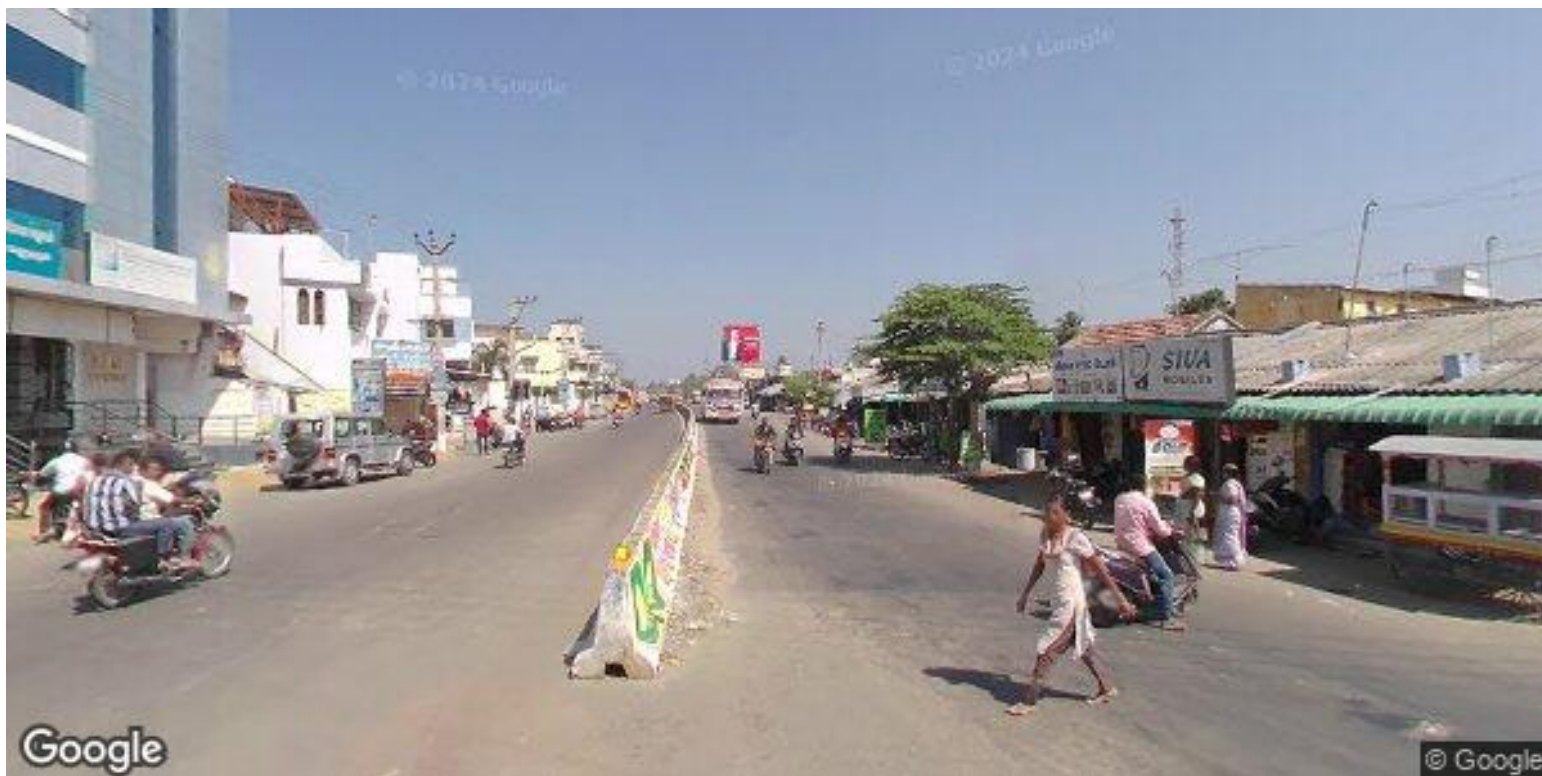
**Coordinates:** 11.37086, 77.74828

**Risk Type:** Roundabout

**Risk Level:** High

**Speed Limit:** 15 KM/Hr

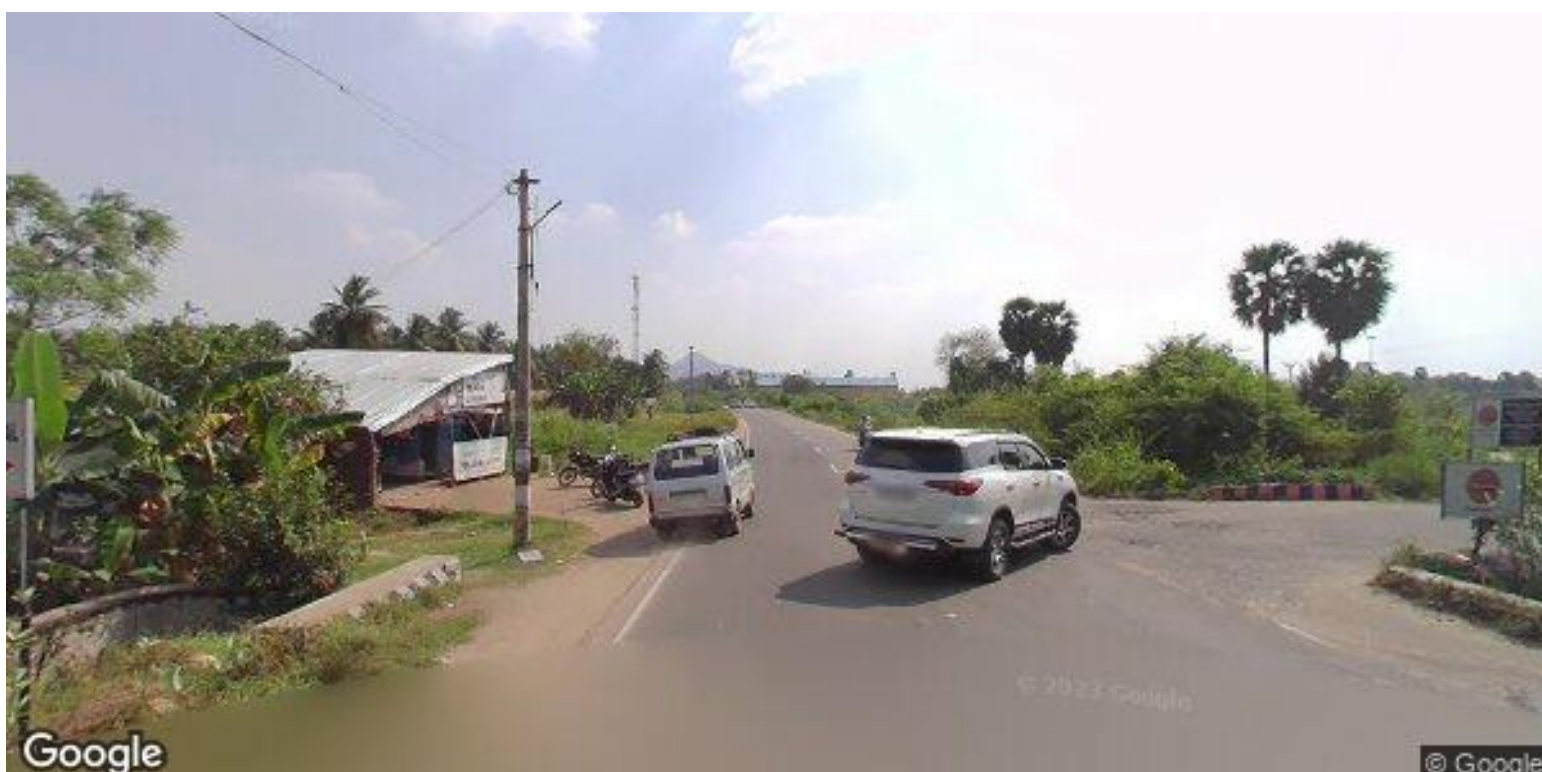
**Coordinates:** 11.44029, 77.87544

**Risk Type:** Turn

**Risk Level:** High

**Speed Limit:** 15 KM/Hr

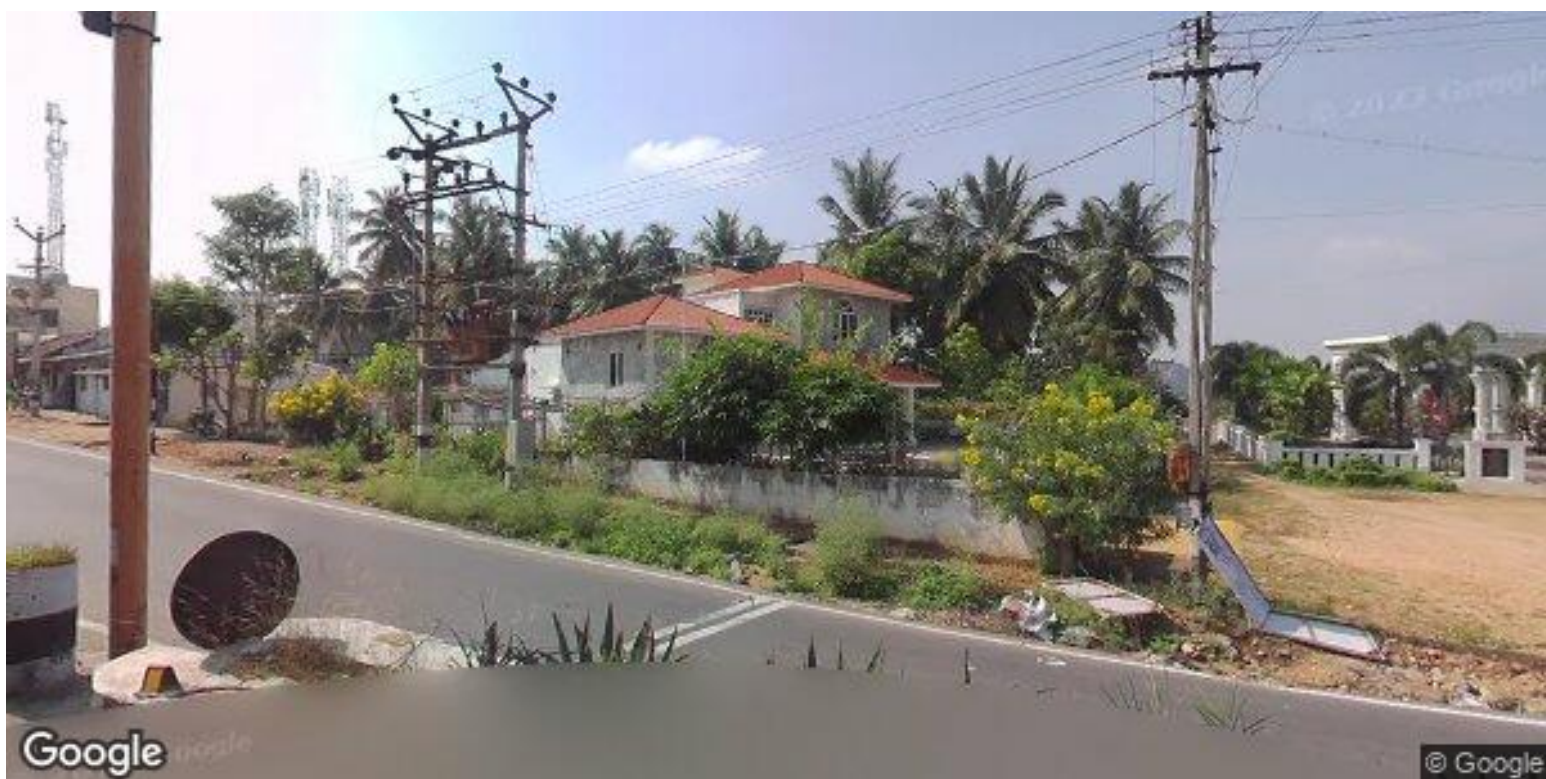
**Coordinates:** 11.46303, 77.84945

**Risk Type:** Turn

**Risk Level:** Medium

**Speed Limit:** 30 KM/Hr

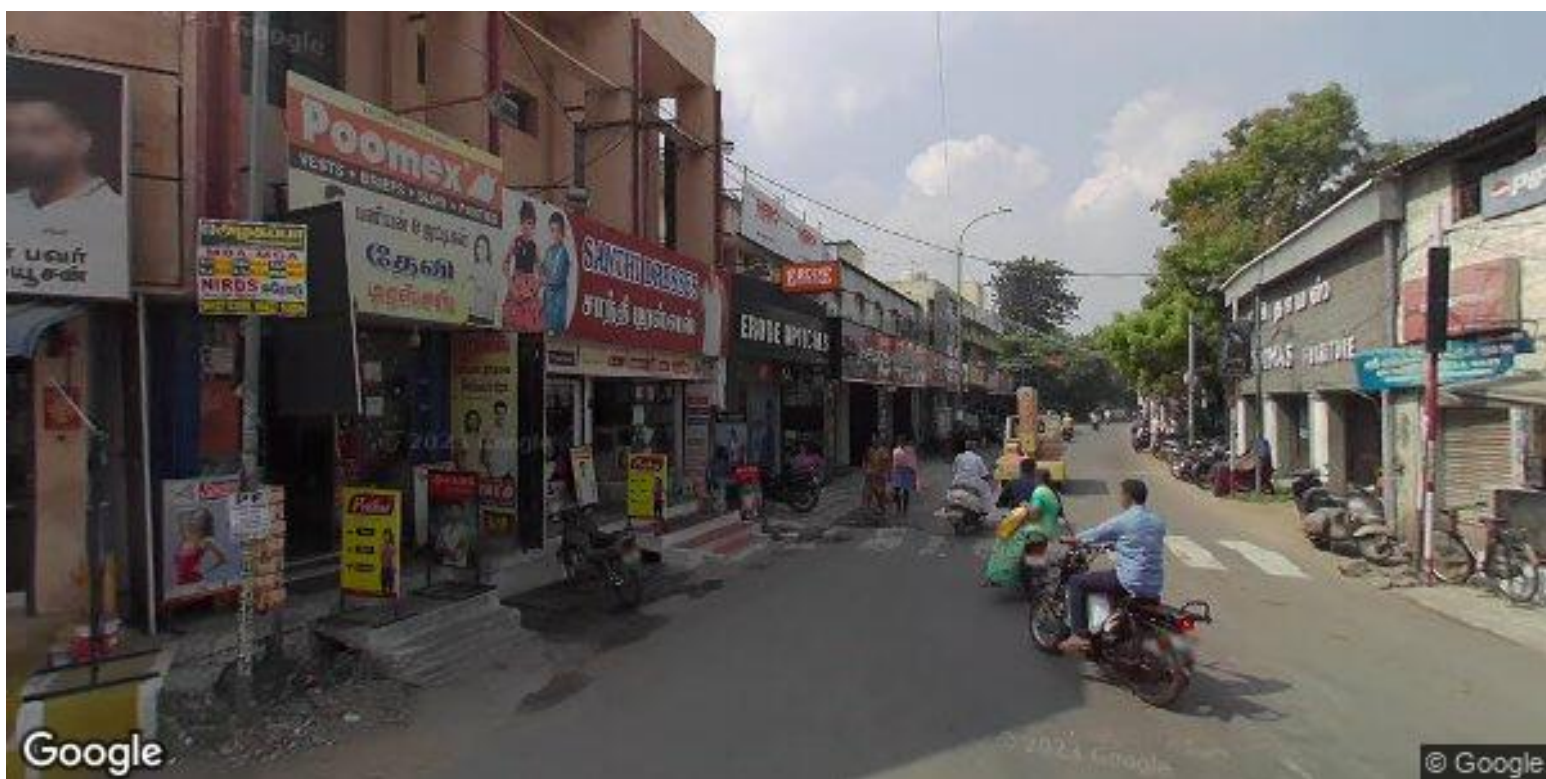
Coordinates: 11.33920, 77.72902

Risk Type: Blind Spot

Risk Level: Blind Spot

Speed Limit: 10 KM/Hr

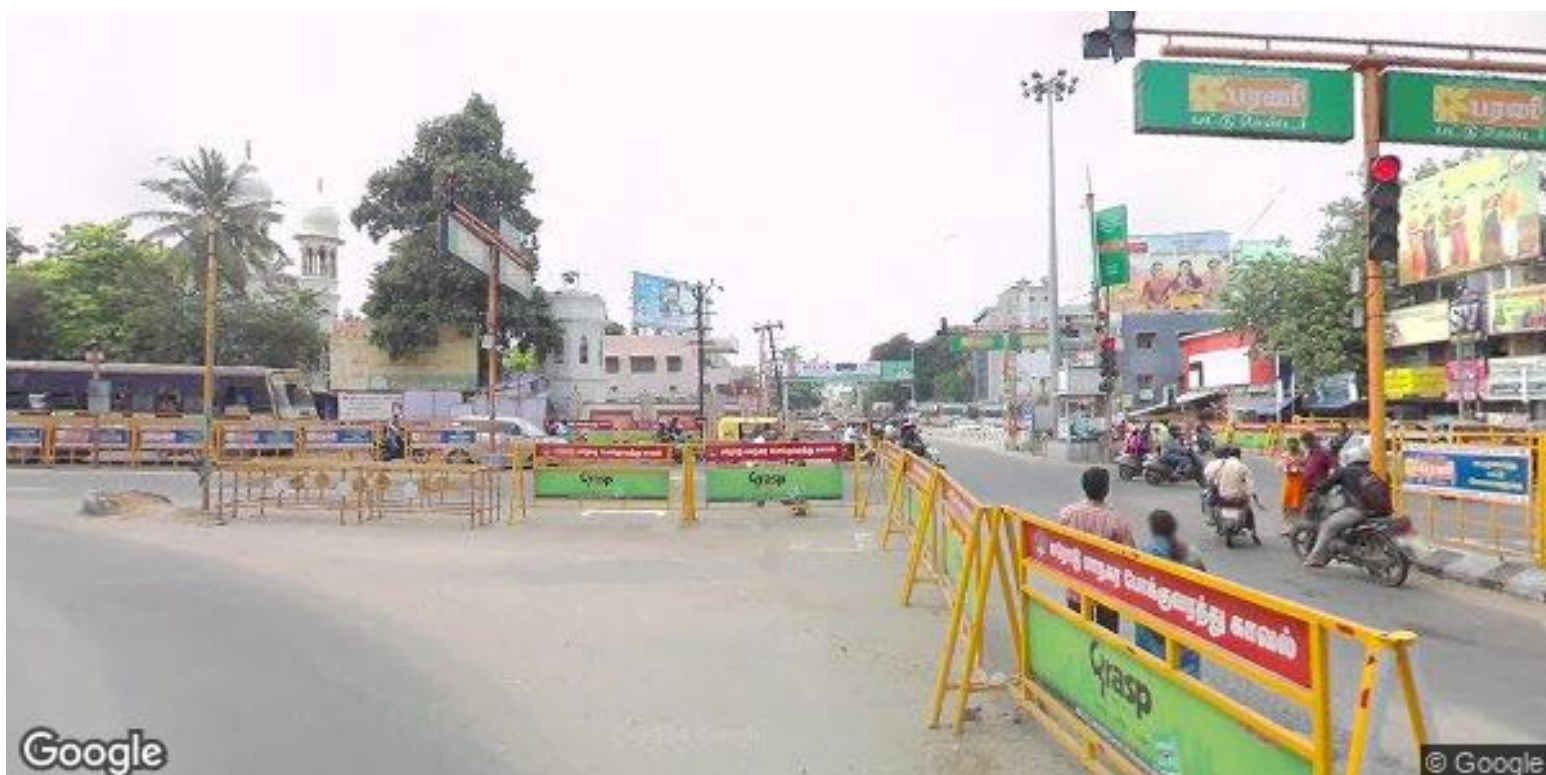
**Coordinates: 11.33914, 77.72659**

**Risk Type: Turn**

**Risk Level: Medium**

**Speed Limit: 30 KM/Hr**

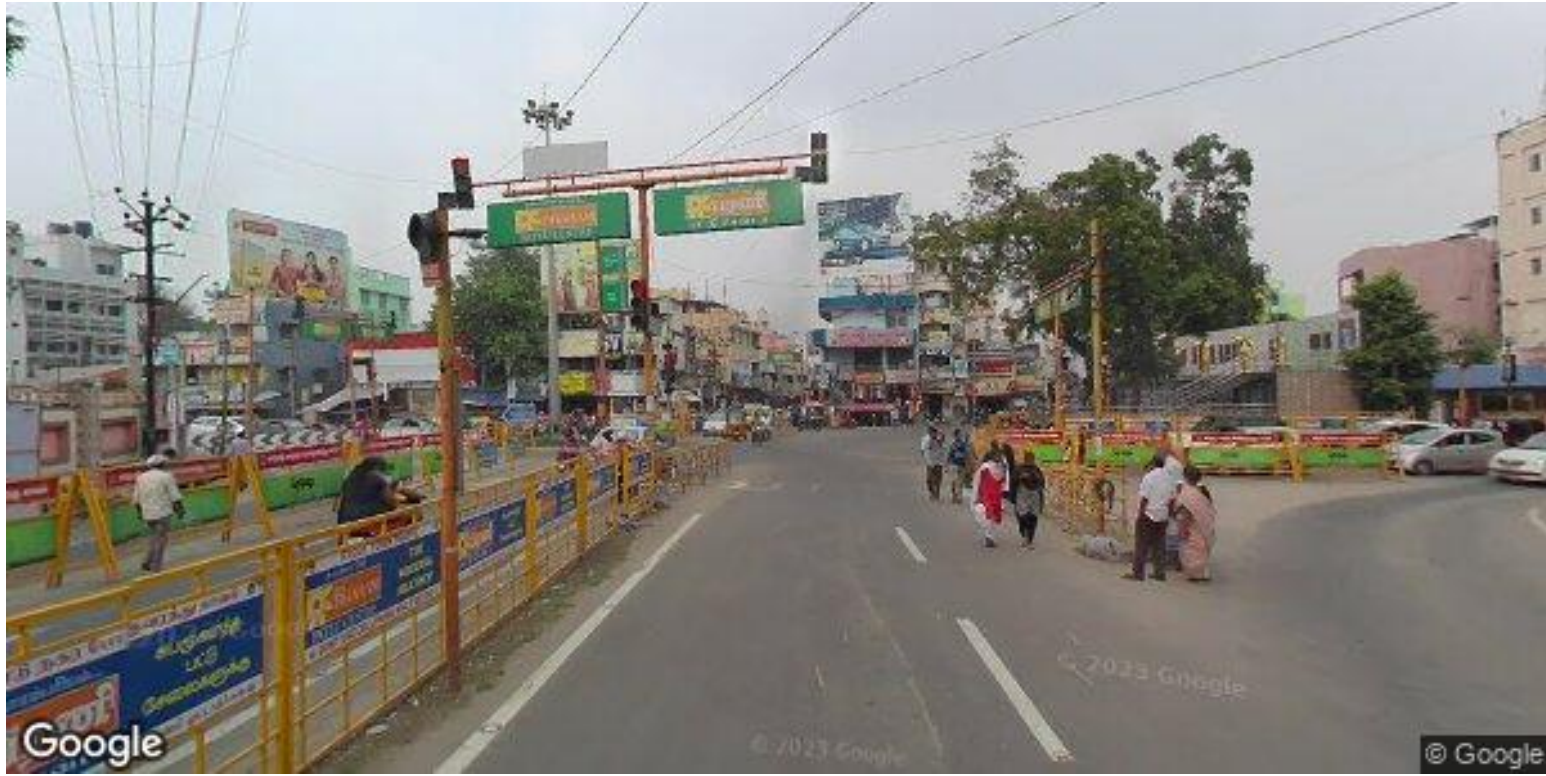
**Coordinates: 11.33890, 77.72637**

**Risk Type: Turn**

**Risk Level: High**

**Speed Limit: 15 KM/Hr**

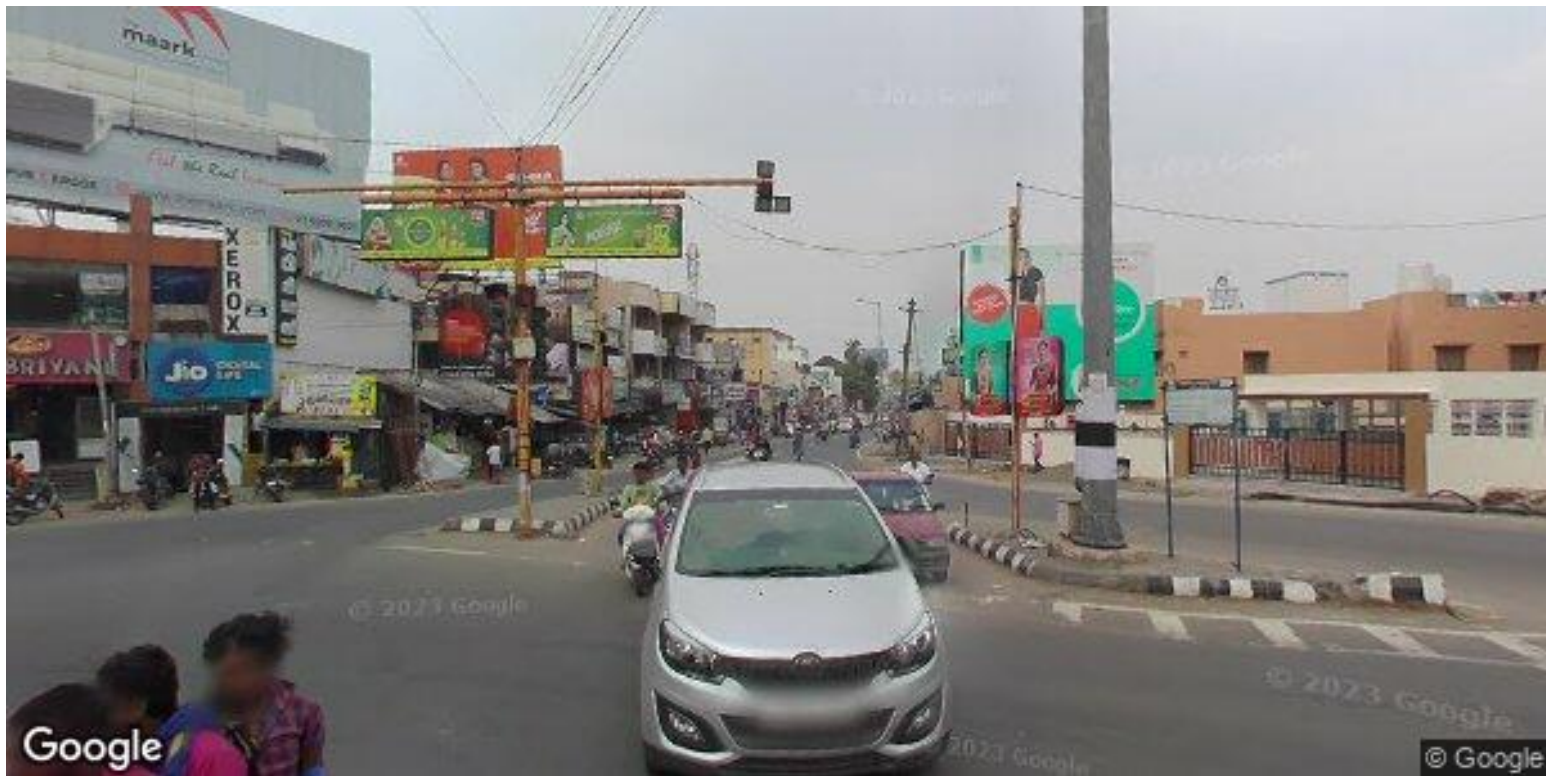
**Coordinates: 11.33095, 77.72748**

**Risk Type: Turn**

**Risk Level: Medium**

**Speed Limit: 30 KM/Hr**

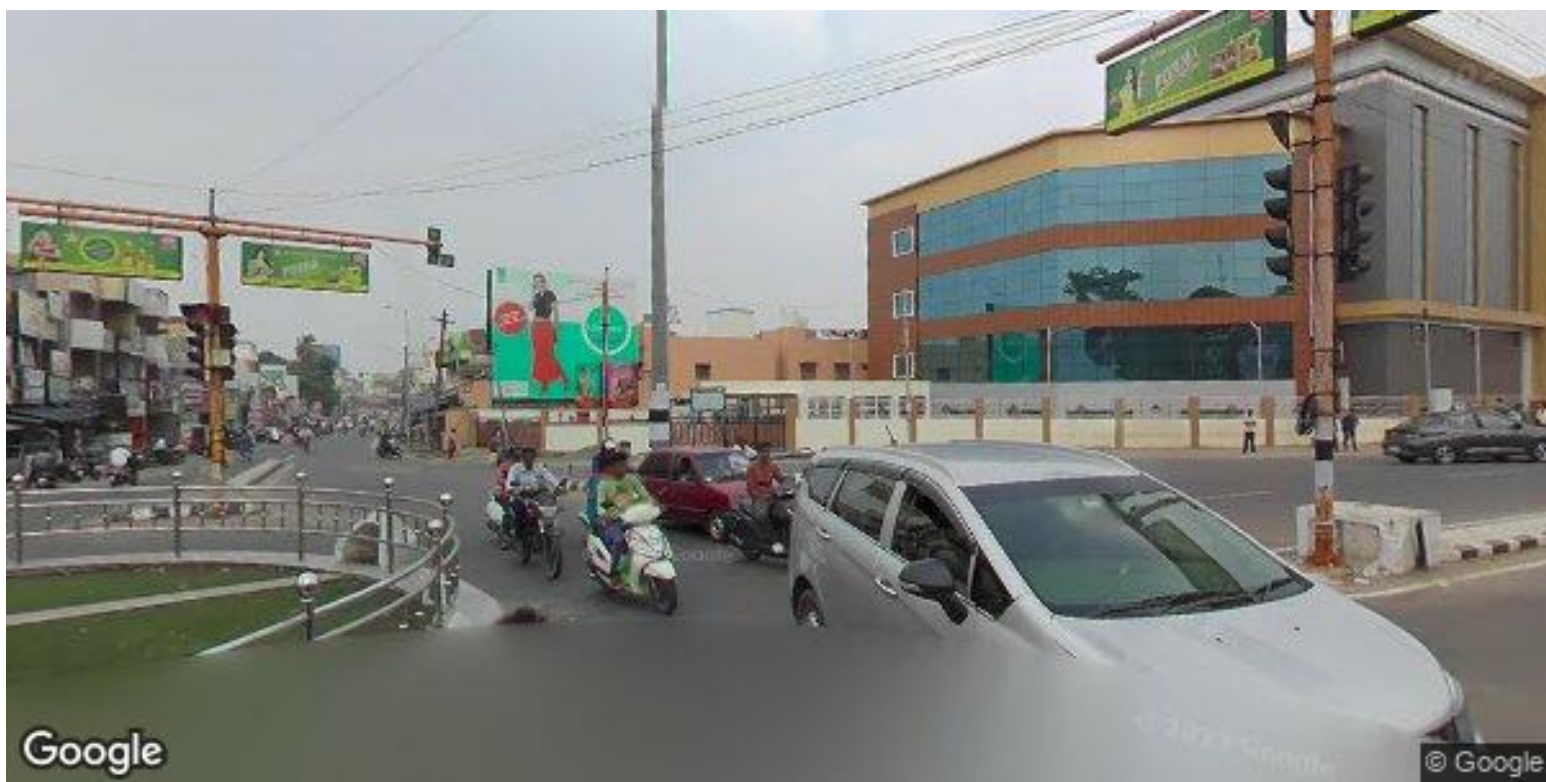
**Coordinates:** 11.33090, 77.72748

**Risk Type:** Turn

**Risk Level:** High

**Speed Limit:** 15 KM/Hr

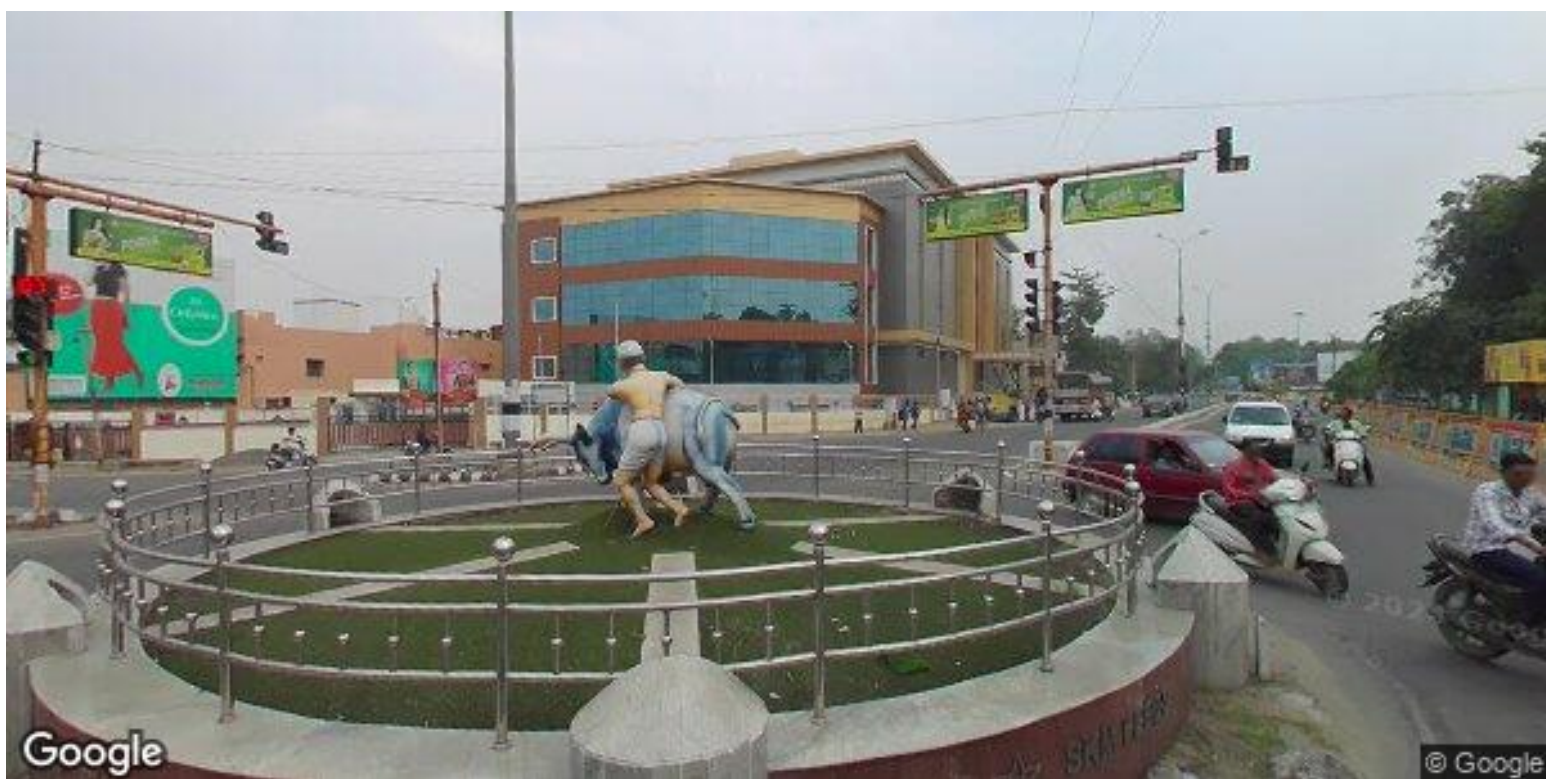
**Coordinates:** 11.33084, 77.72742

**Risk Type:** Turn

**Risk Level:** Medium

**Speed Limit:** 30 KM/Hr

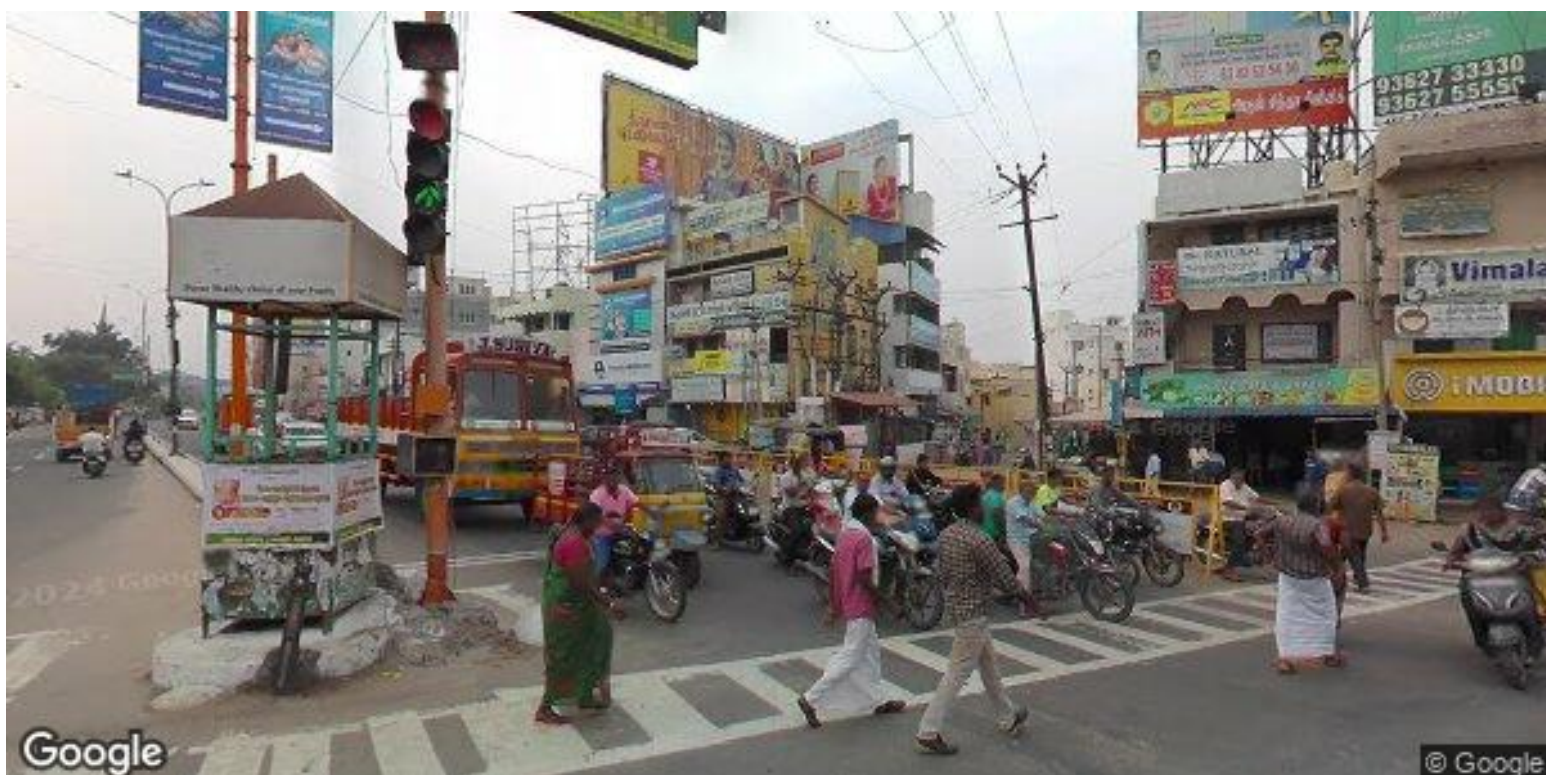
**Coordinates:** 11.33083, 77.72734

**Risk Type:** Turn

**Risk Level:** Medium

**Speed Limit:** 30 KM/Hr

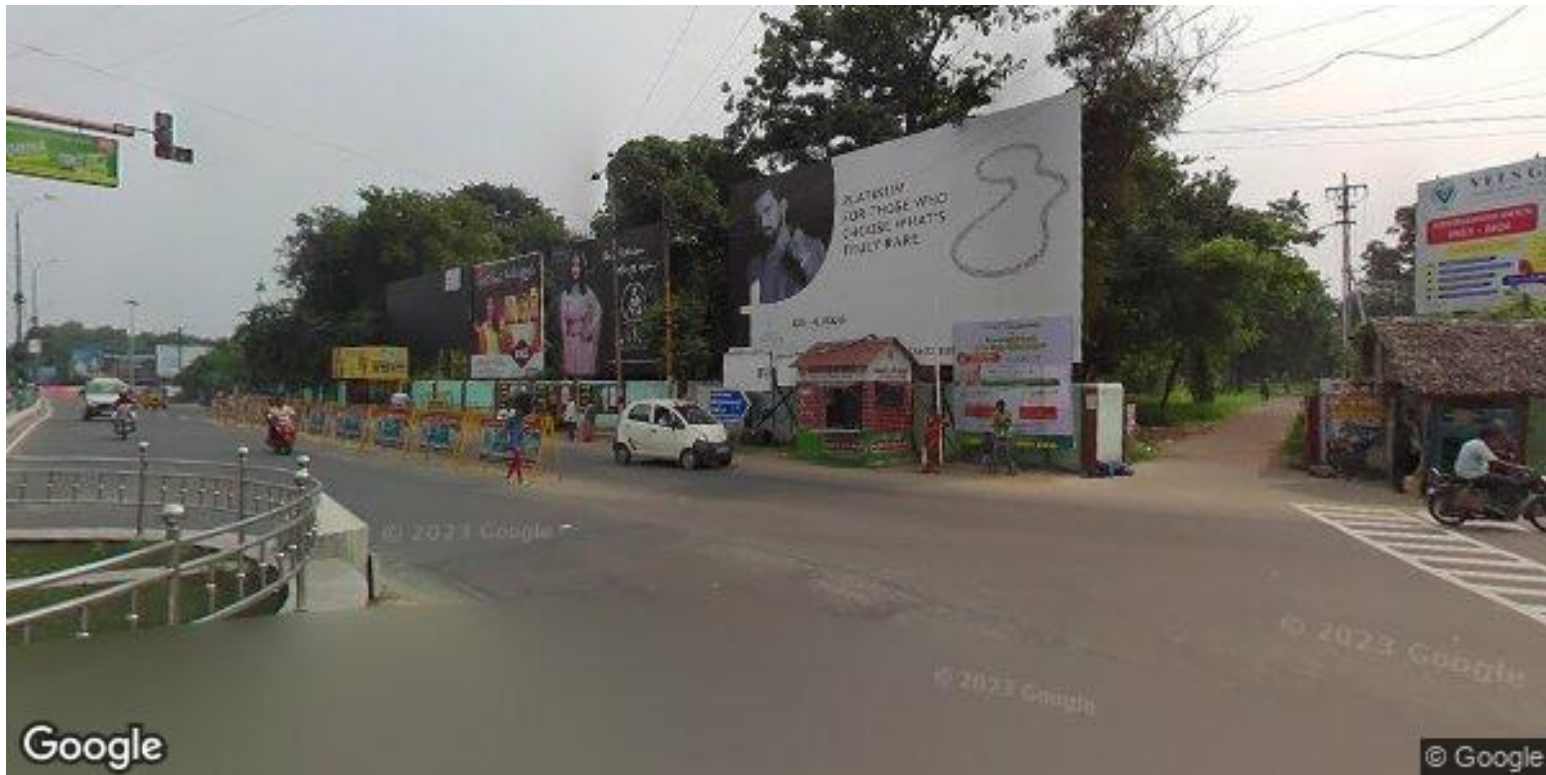
**Coordinates:** 11.33084, 77.72731

**Risk Type:** Turn

**Risk Level:** High

**Speed Limit:** 15 KM/Hr

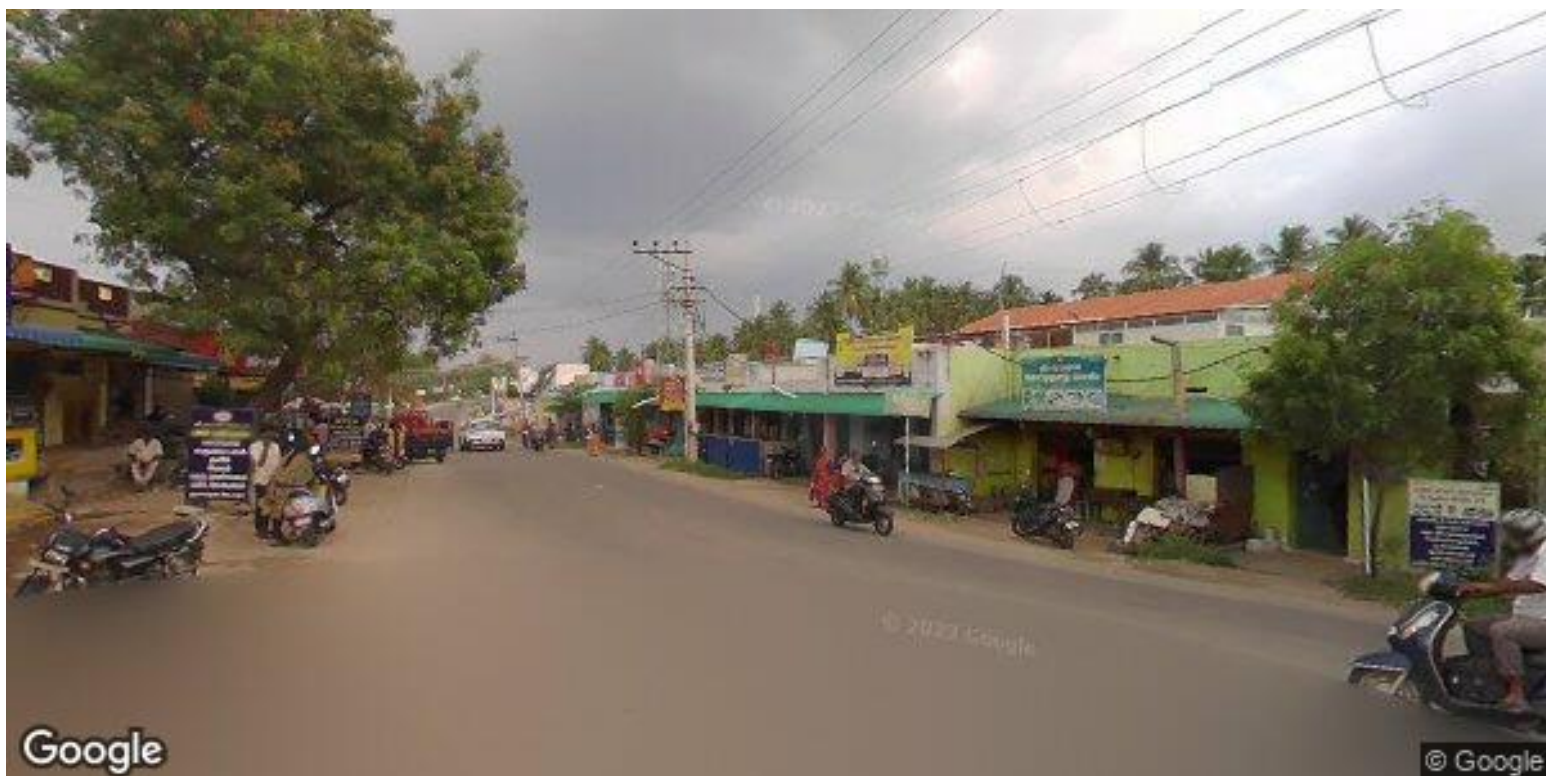
**Coordinates:** 11.31172, 77.70715

**Risk Type:** Turn

**Risk Level:** High

**Speed Limit:** 15 KM/Hr

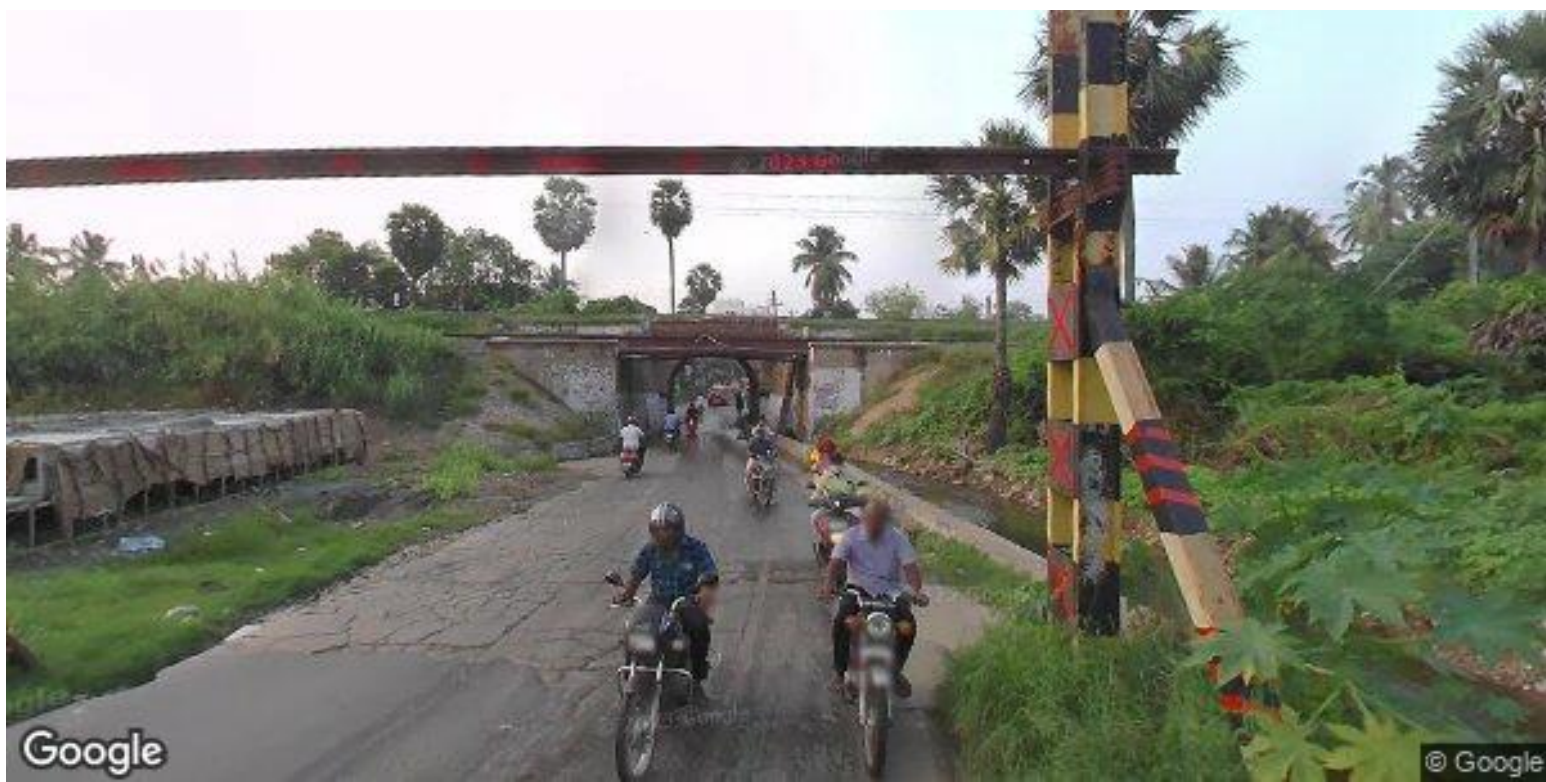
**Coordinates:** 11.31050, 77.70781

**Risk Type:** Turn

**Risk Level:** Medium

**Speed Limit:** 30 KM/Hr

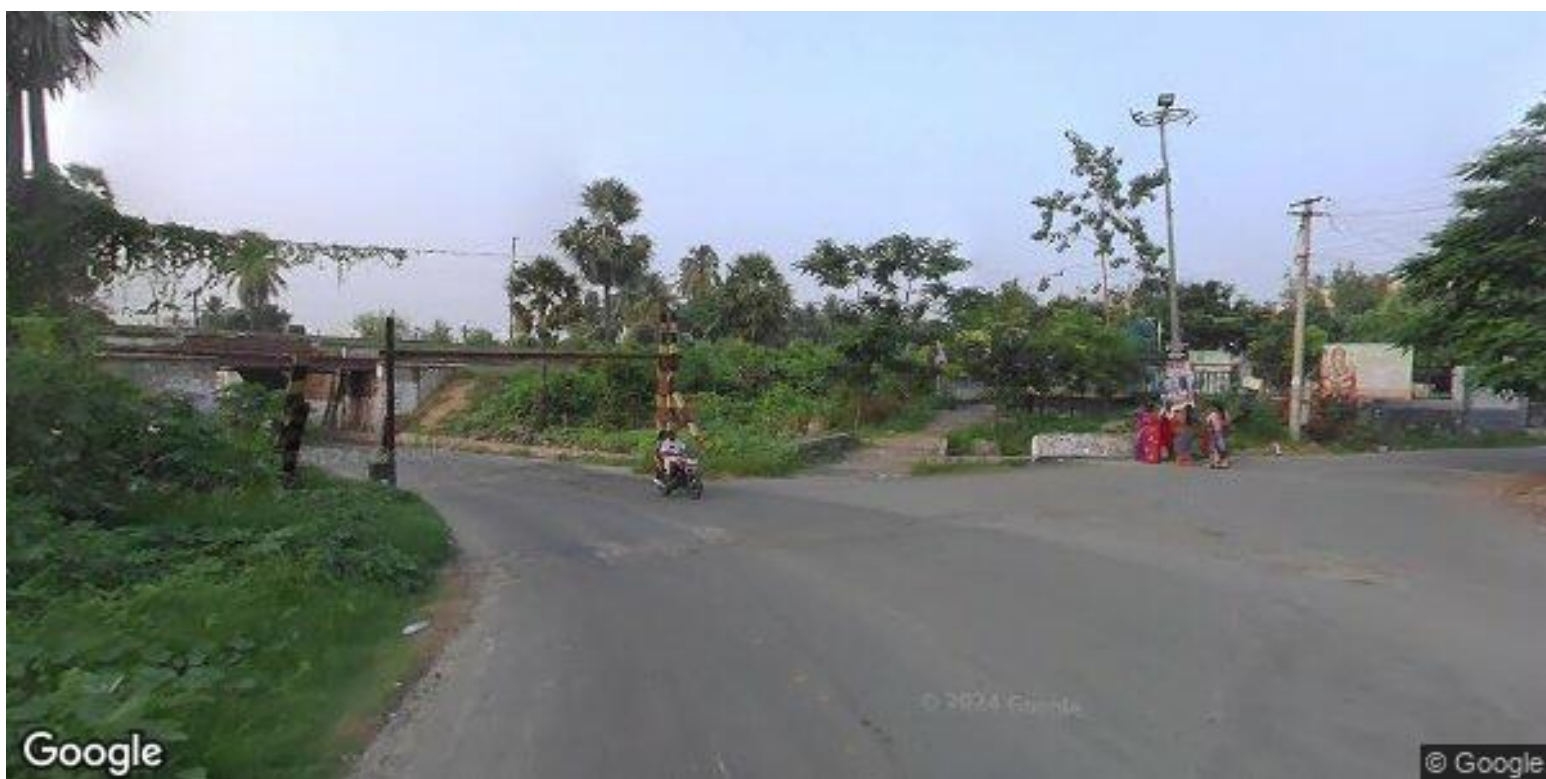
**Coordinates:** 11.31032, 77.70783

**Risk Type:** Turn

**Risk Level:** Medium

**Speed Limit:** 30 KM/Hr

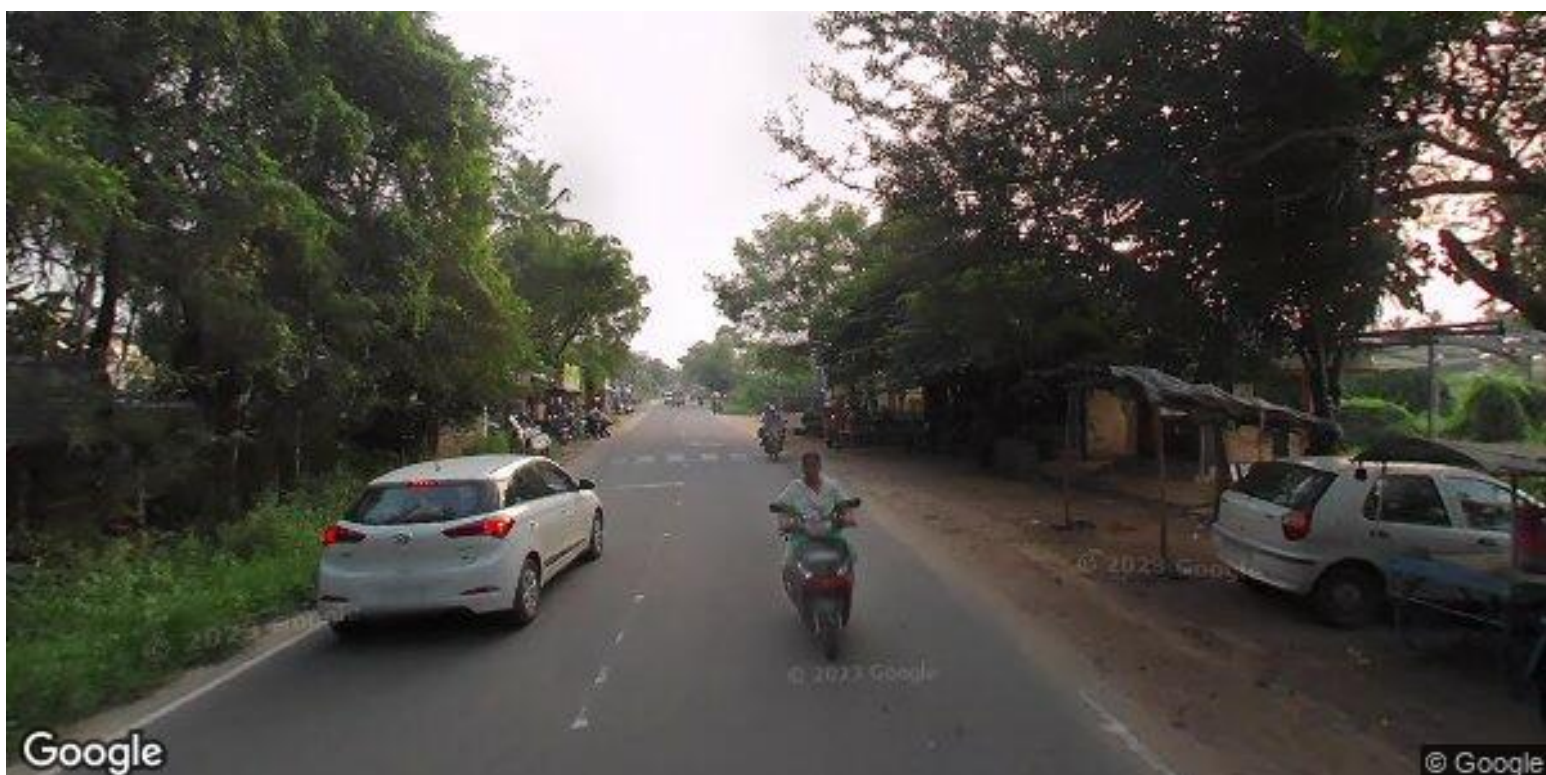
**Coordinates:** 11.30807, 77.70415

**Risk Type:** Turn

**Risk Level:** Medium

**Speed Limit:** 30 KM/Hr
