# IndianOil

## JOURNEY RISK MANAGEMENT (JRM) STUDY

### Salem Terminal to SUMEDHA AGENCIES

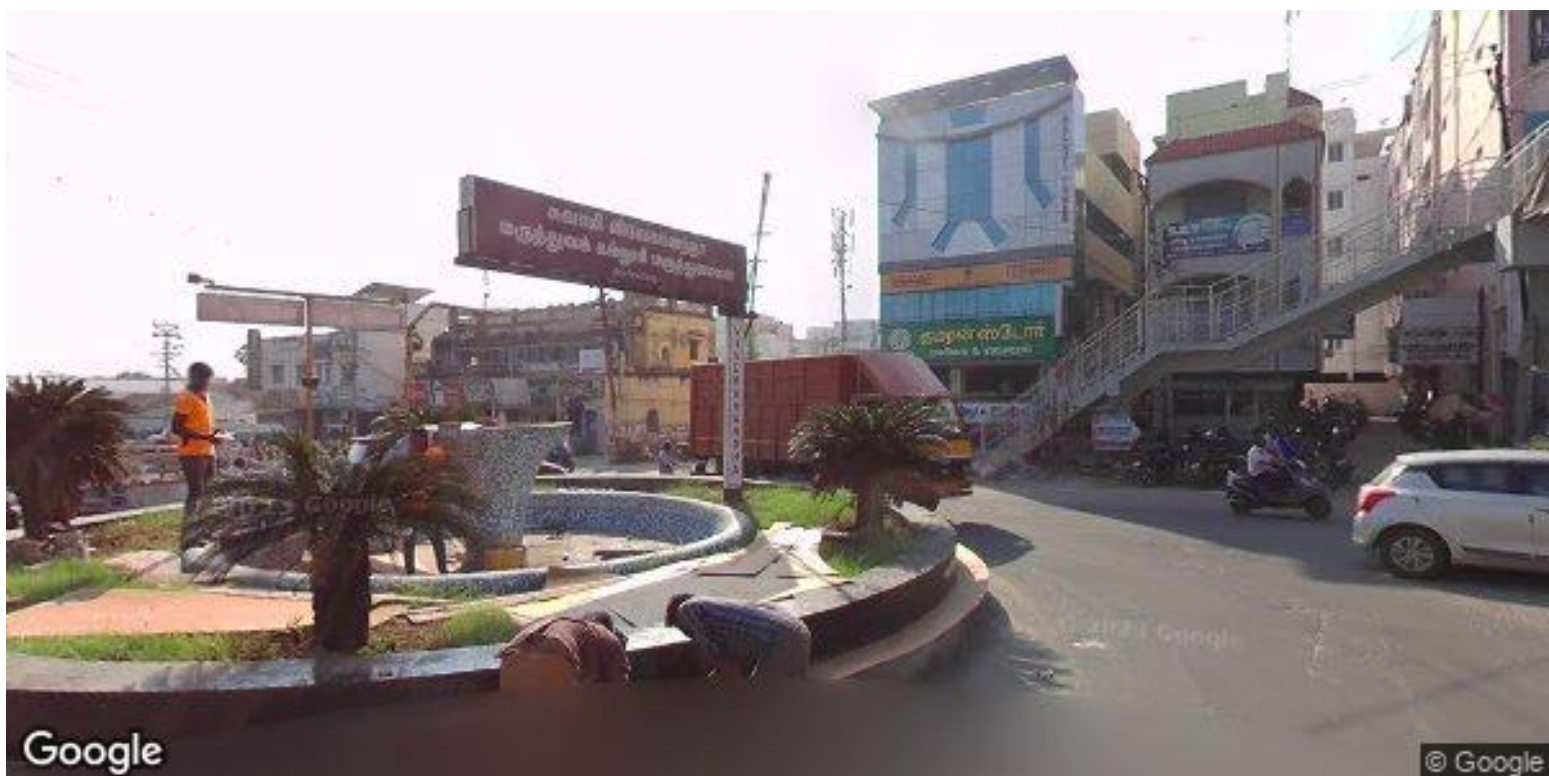
**Coordinates:** 11.38395, 77.89480

**Risk Type:** Roundabout

**Risk Level:** High

**Speed Limit:** 15 KM/Hr

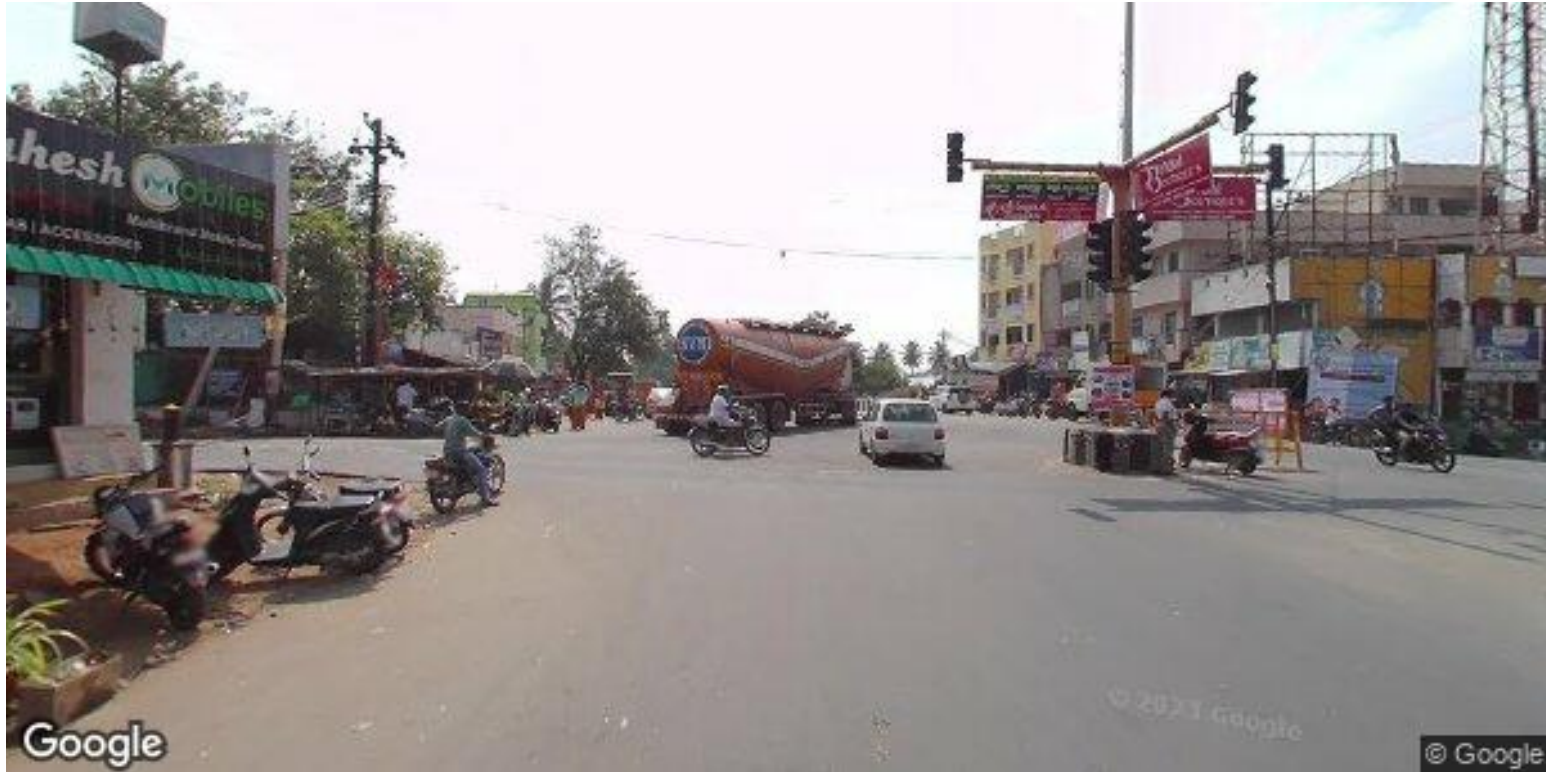
**Coordinates:** 11.36616, 77.88885

**Risk Type:** Turn

**Risk Level:** Medium

**Speed Limit:** 30 KM/Hr

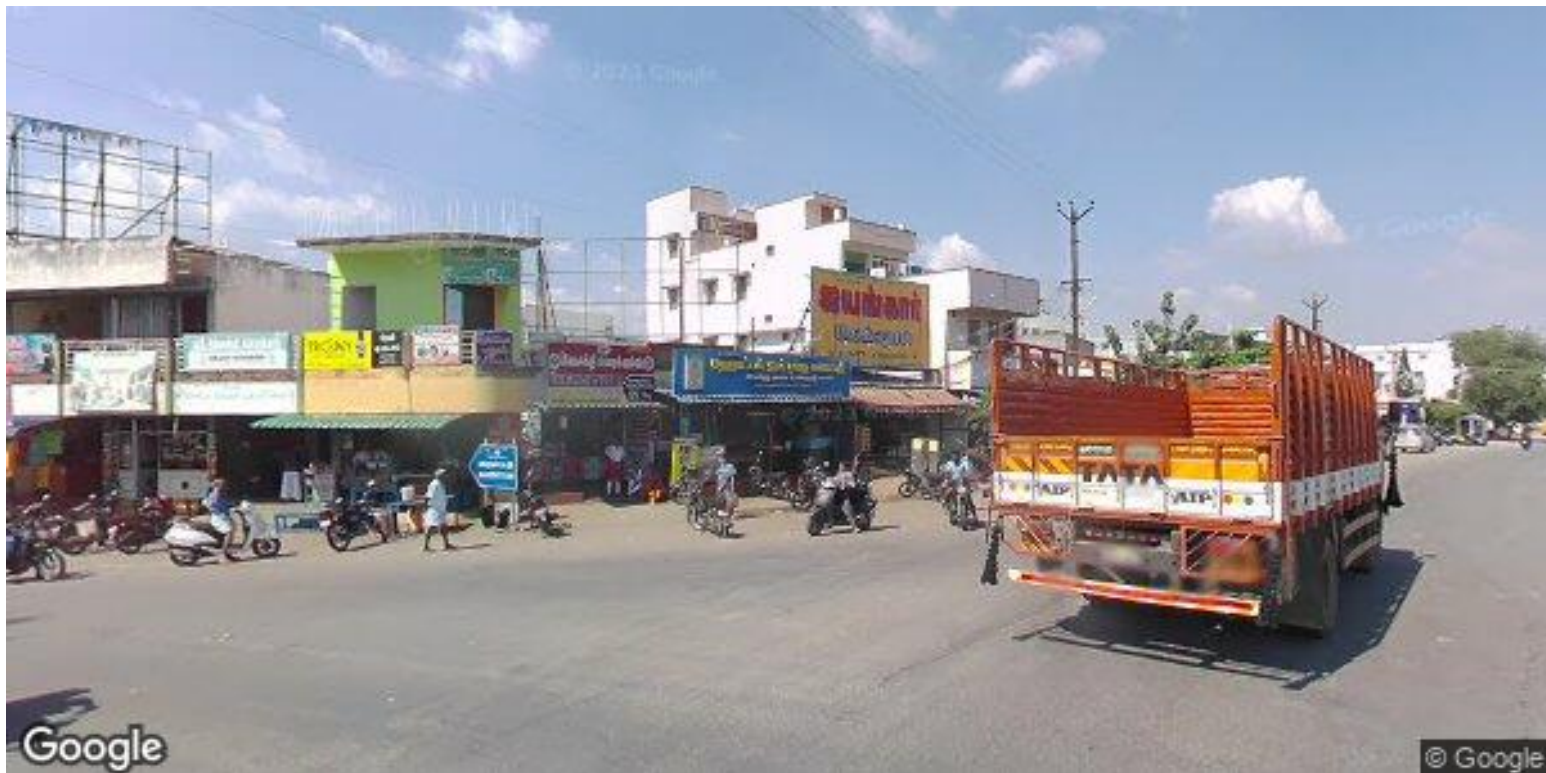
**Coordinates:** 11.36602, 77.88875

**Risk Type:** Turn

**Risk Level:** Medium

**Speed Limit:** 30 KM/Hr

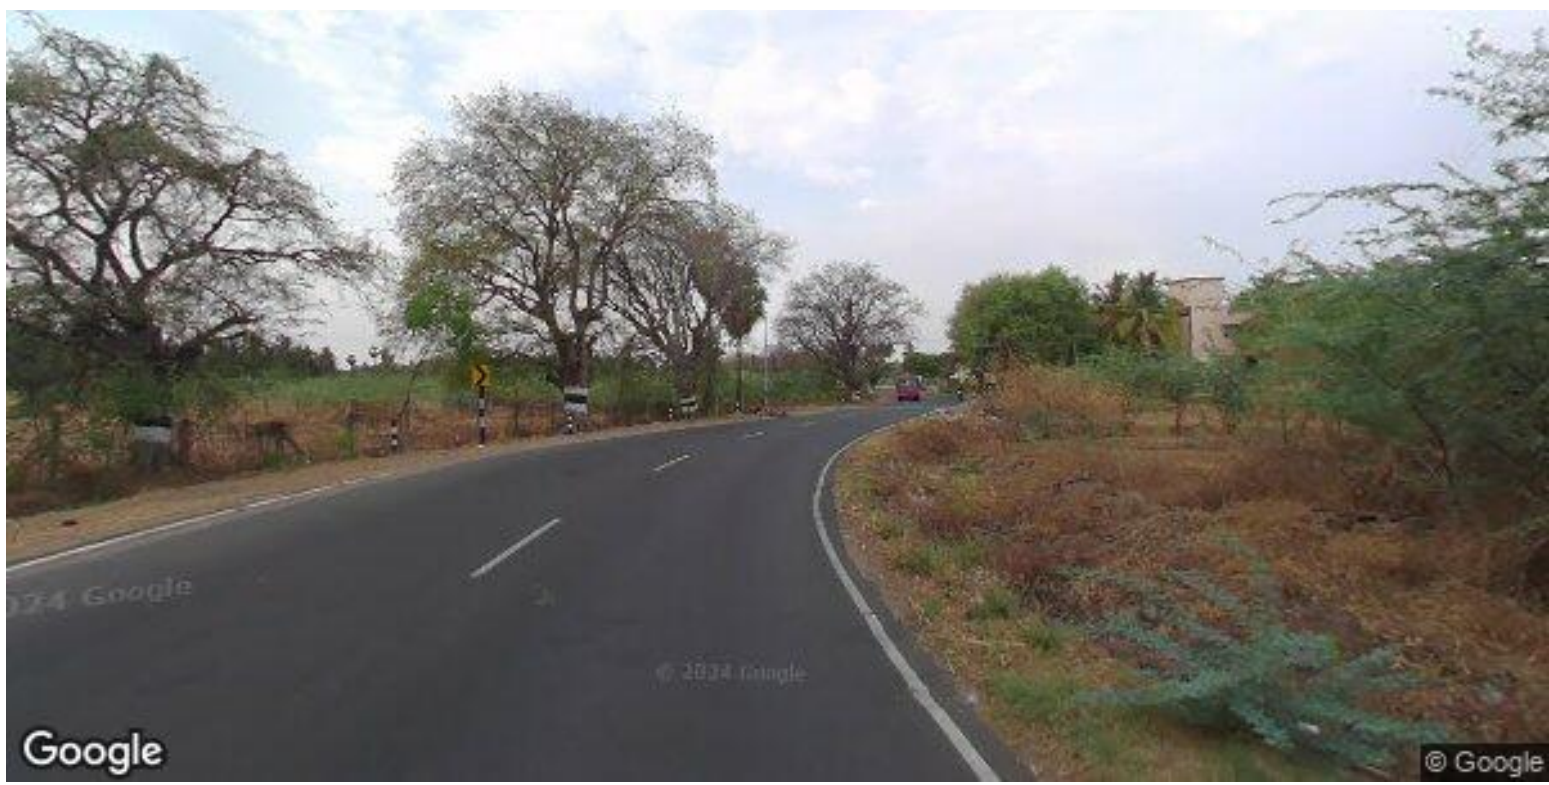
**Coordinates:** 11.34067, 77.86347

**Risk Type:** Turn

**Risk Level:** Medium

**Speed Limit:** 30 KM/Hr

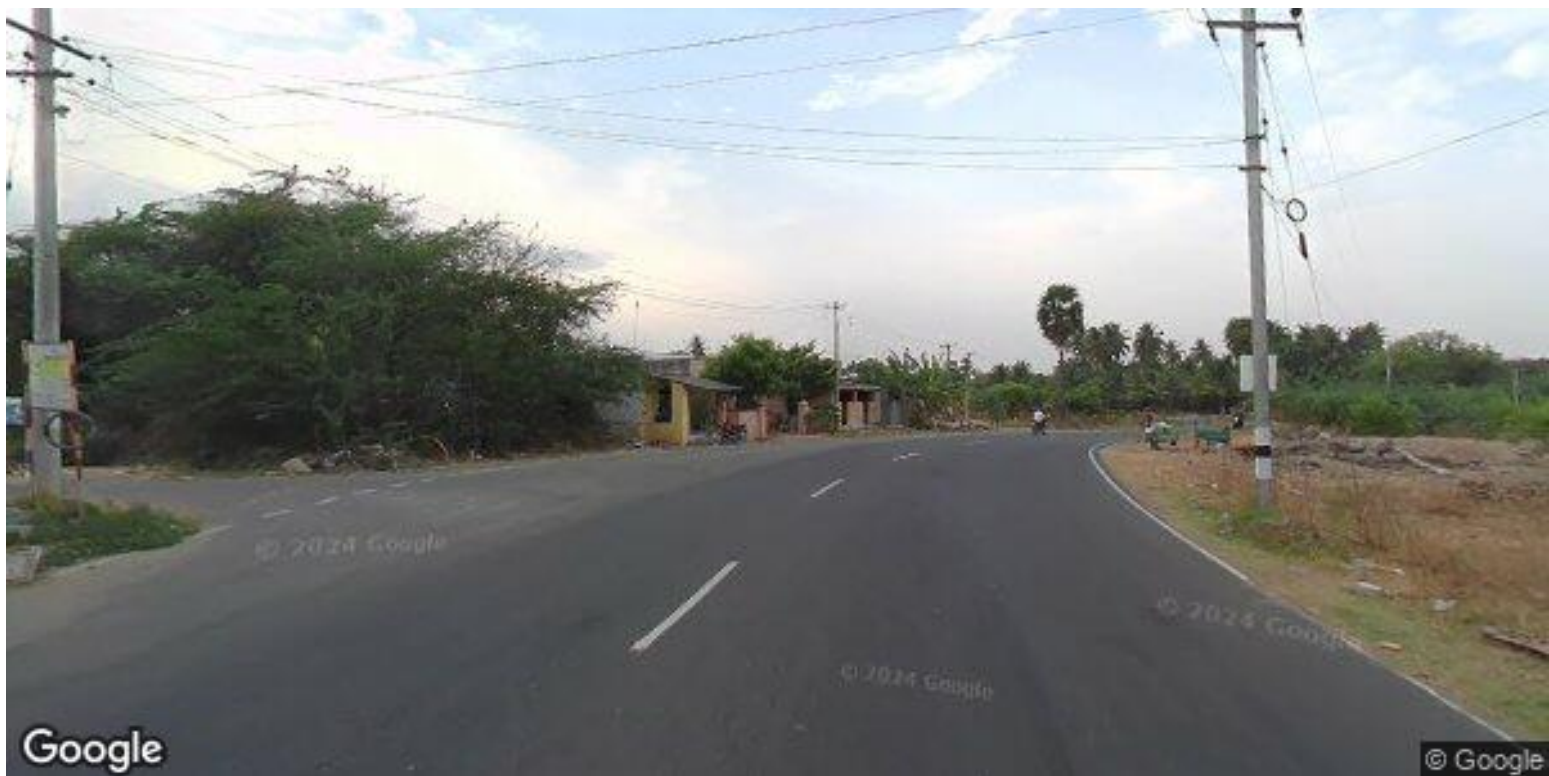
**Coordinates:** 11.33854, 77.86216

**Risk Type:** Turn

**Risk Level:** Medium

**Speed Limit:** 30 KM/Hr

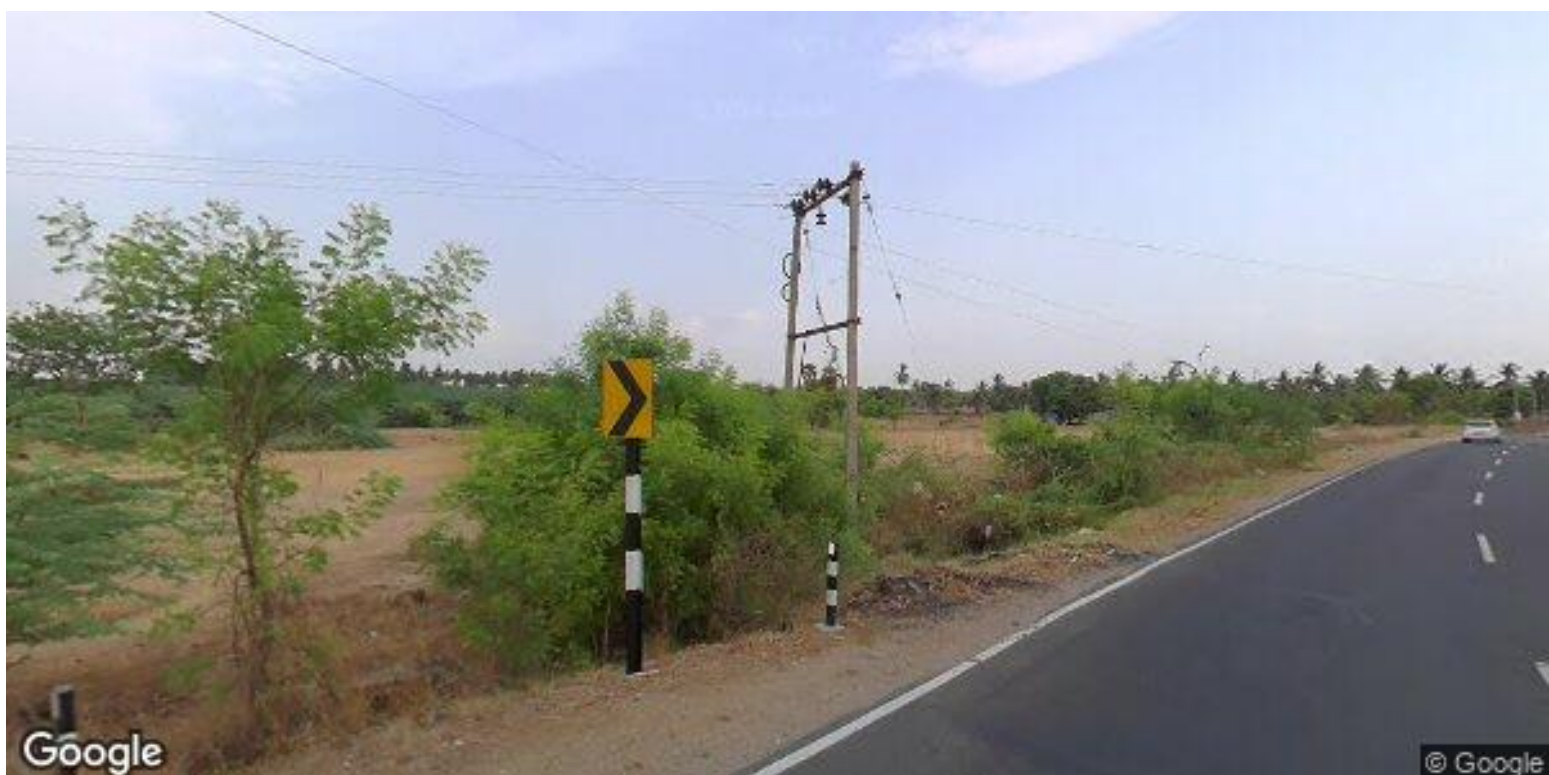
**Coordinates:** 11.33778, 77.86236

**Risk Type:** Turn

**Risk Level:** Medium

**Speed Limit:** 30 KM/Hr

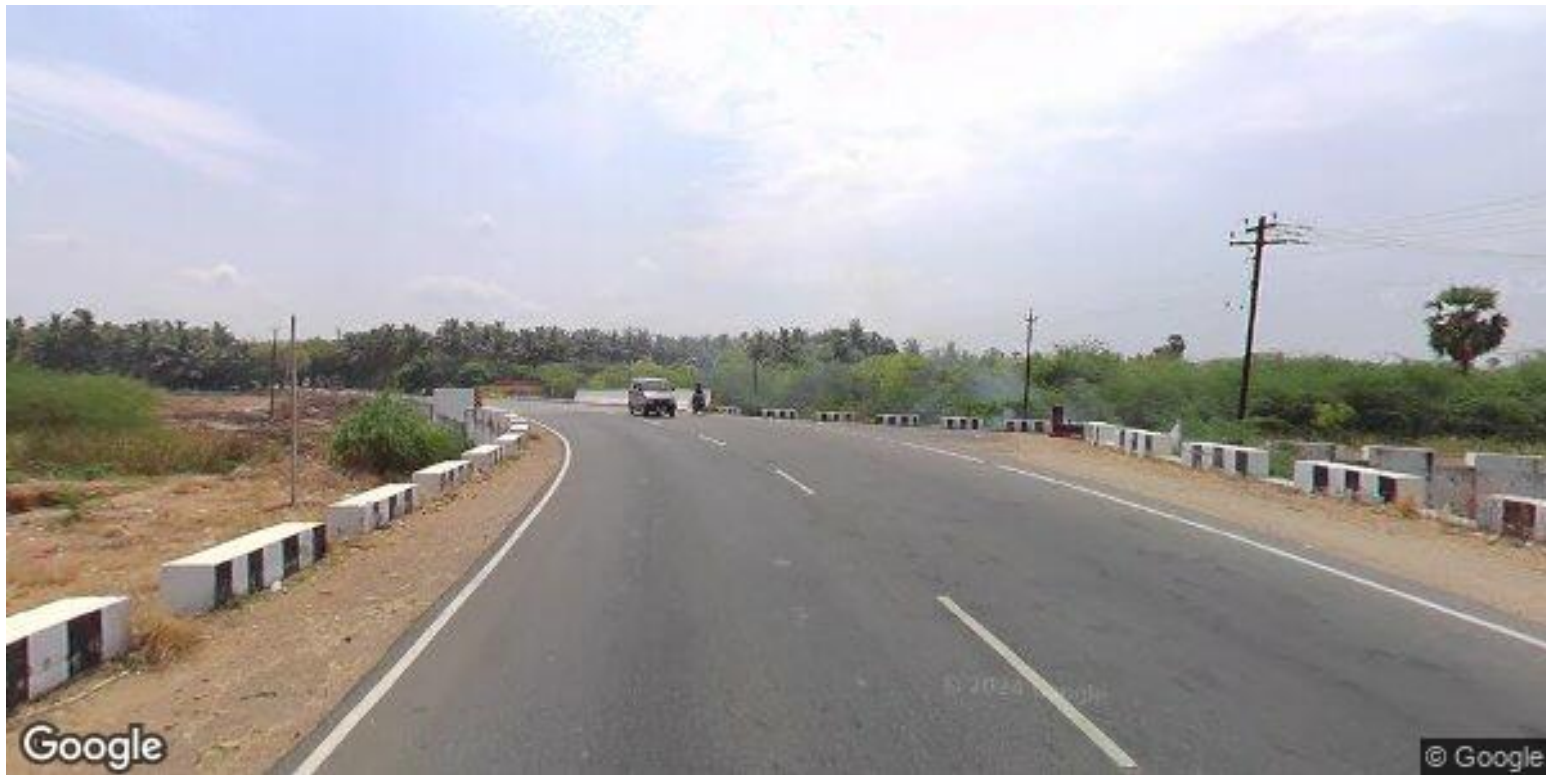
**Coordinates:** 11.31746, 77.84231

**Risk Type:** Turn

**Risk Level:** Medium

**Speed Limit:** 30 KM/Hr

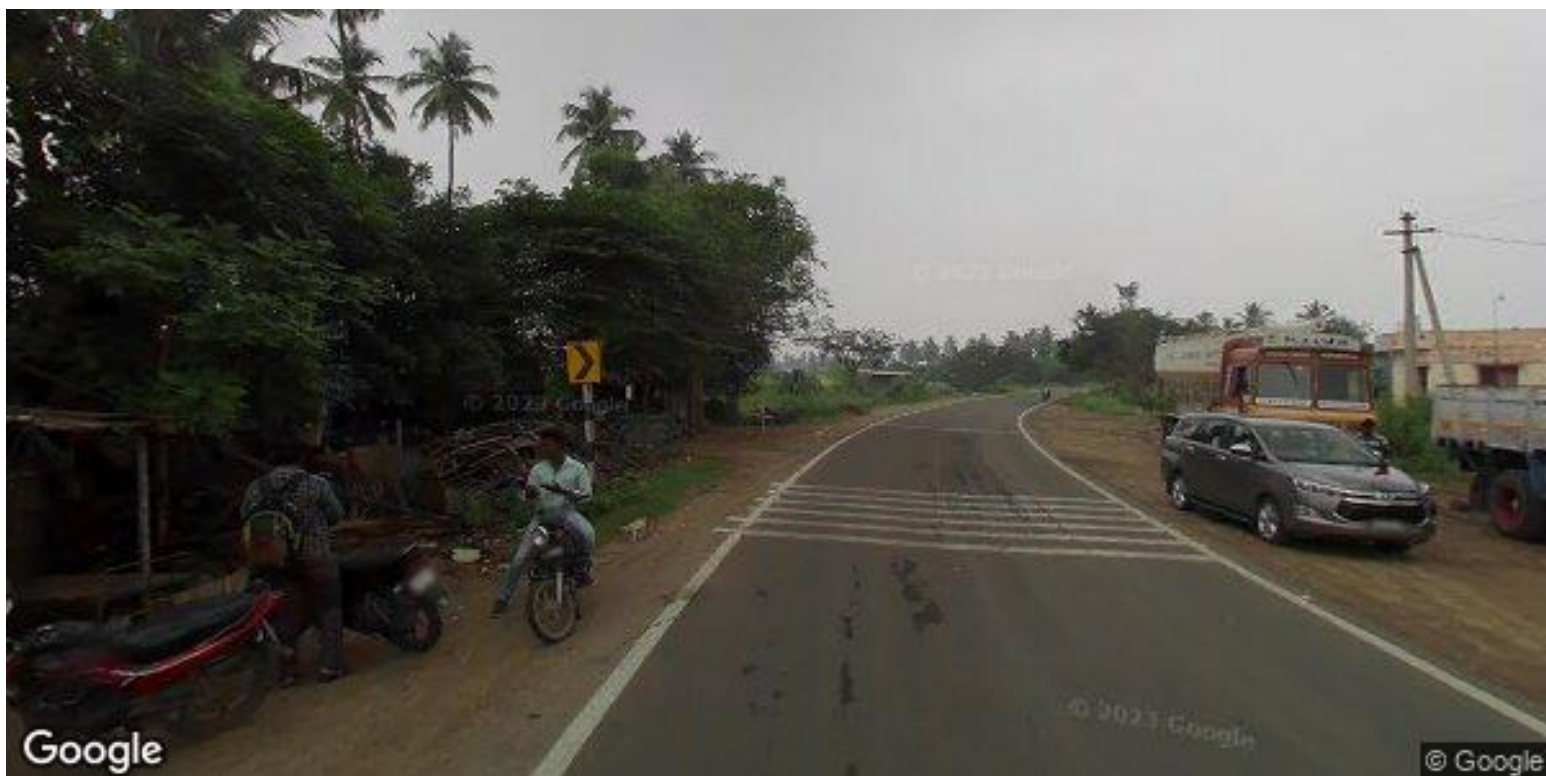
**Coordinates:** 11.30951, 77.77598

**Risk Type:** Turn

**Risk Level:** Medium

**Speed Limit:** 30 KM/Hr

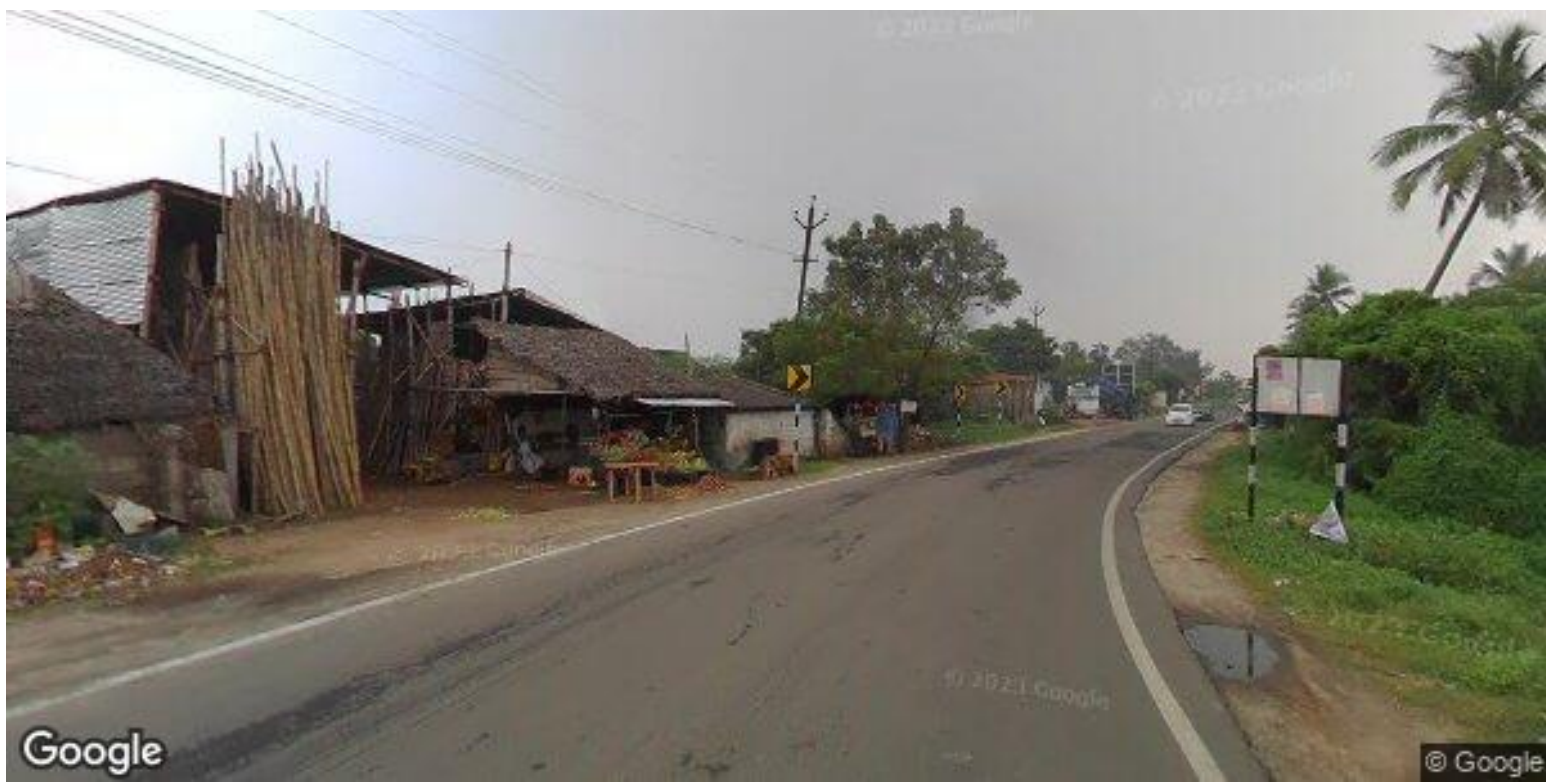
**Coordinates:** 11.30968, 77.76701

**Risk Type:** Turn

**Risk Level:** Medium

**Speed Limit:** 30 KM/Hr

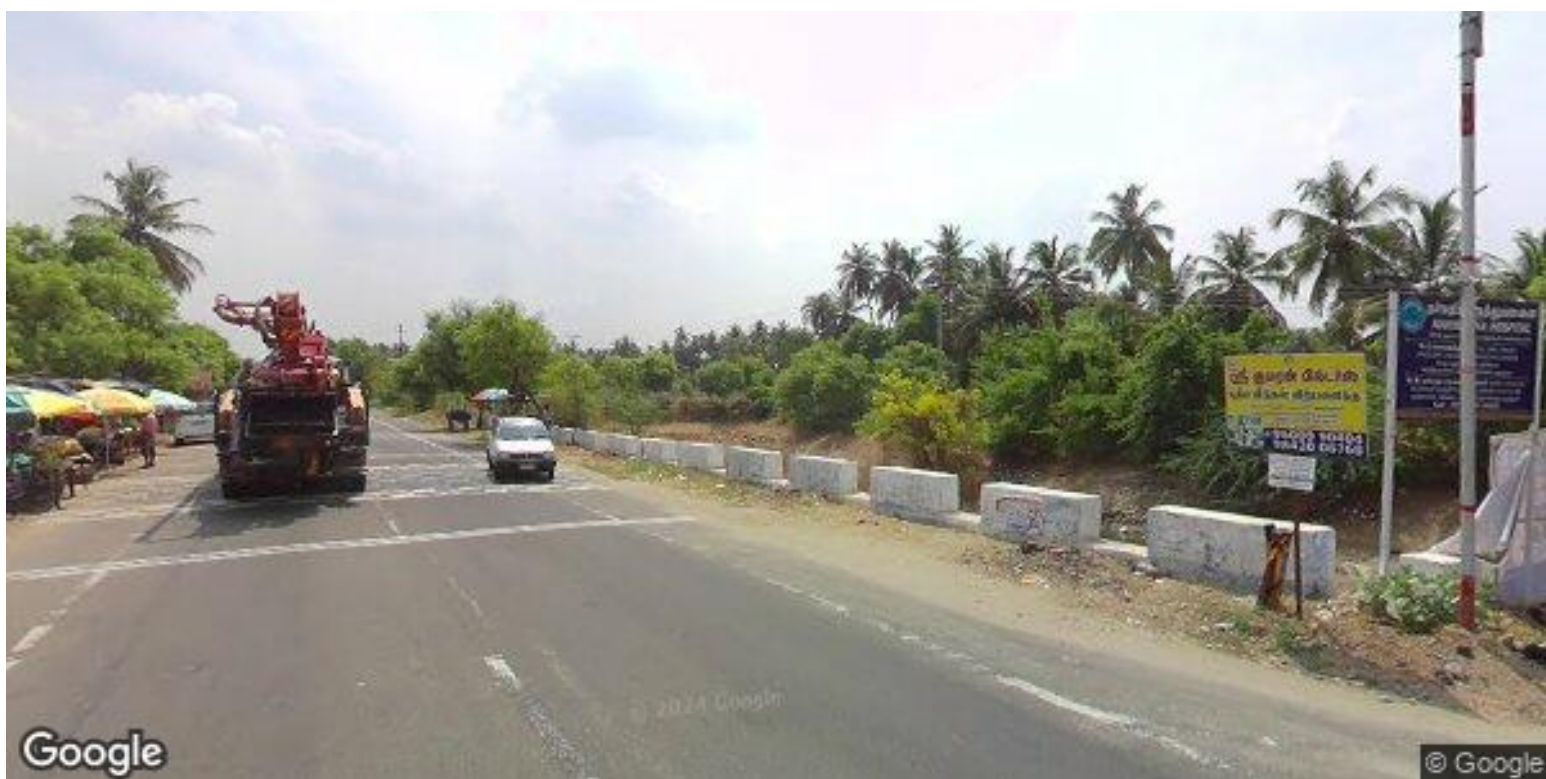
**Coordinates:** 11.29490, 77.74685

**Risk Type:** Turn

**Risk Level:** High

**Speed Limit:** 15 KM/Hr

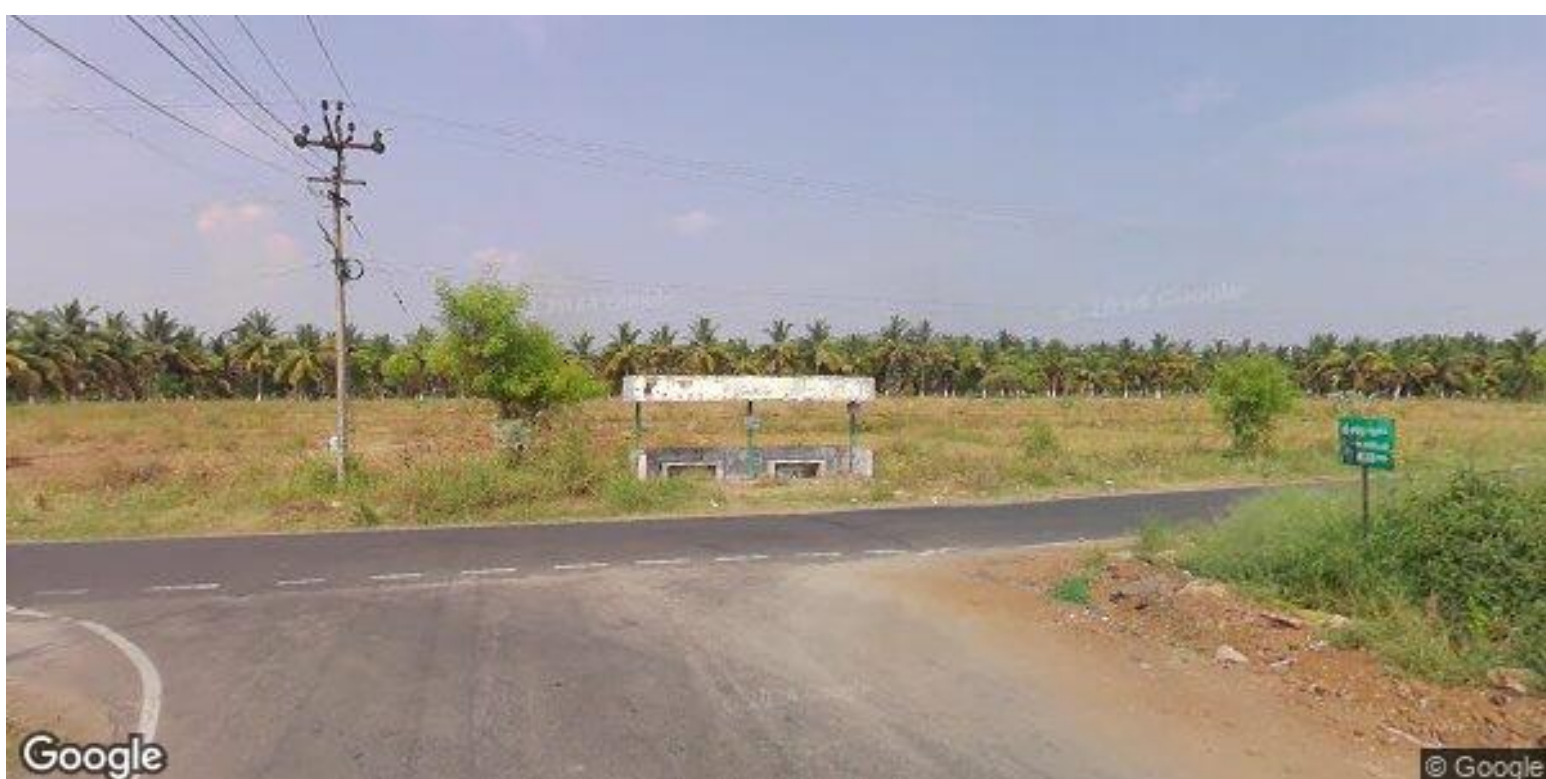
**Risk Type:** Turn  
**Risk Level:** High  
**Speed Limit:** 15 KM/Hr  
**Coordinates:** 11.29128, 77.74656

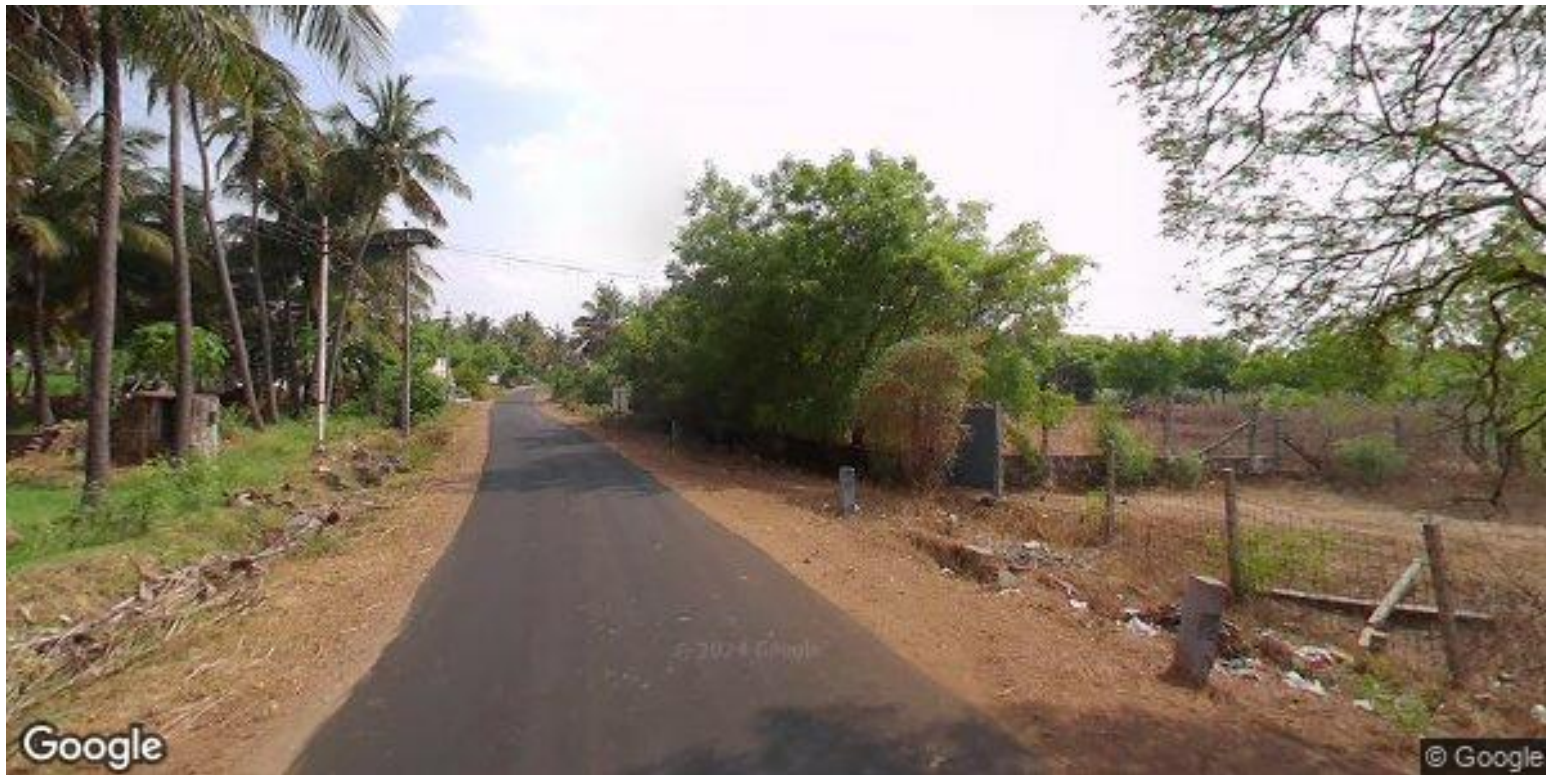
**Risk Type:** Turn  
**Risk Level:** Medium  
**Speed Limit:** 30 KM/Hr  
**Coordinates:** 11.29051, 77.74482

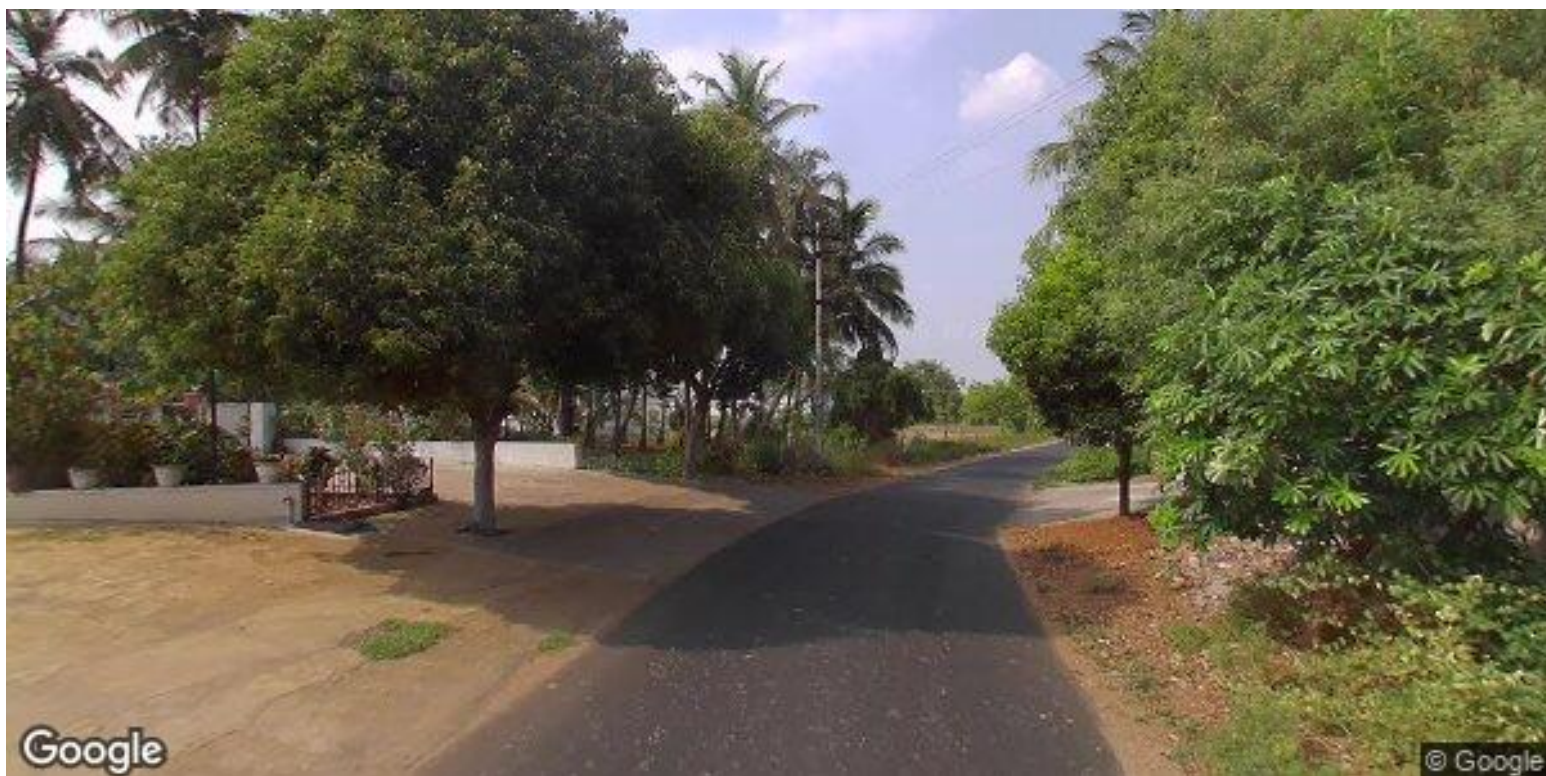
**Risk Type:** Turn  
**Risk Level:** Medium  
**Speed Limit:** 30 KM/Hr  
**Coordinates:** 11.28859, 77.74323

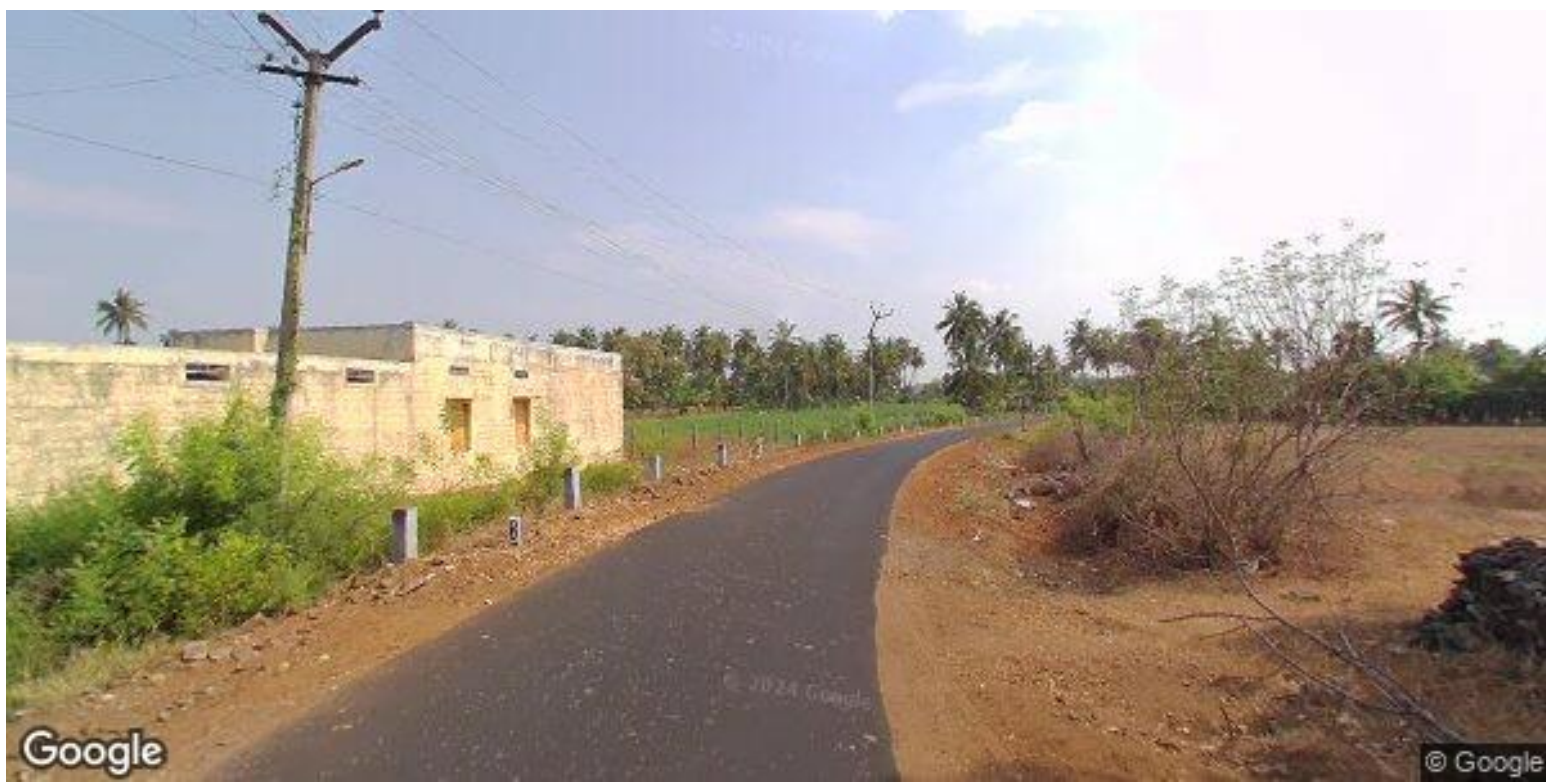
**Coordinates:** 11.28588, 77.74287

**Risk Type:** Turn

**Risk Level:** Medium

**Speed Limit:** 30 KM/Hr

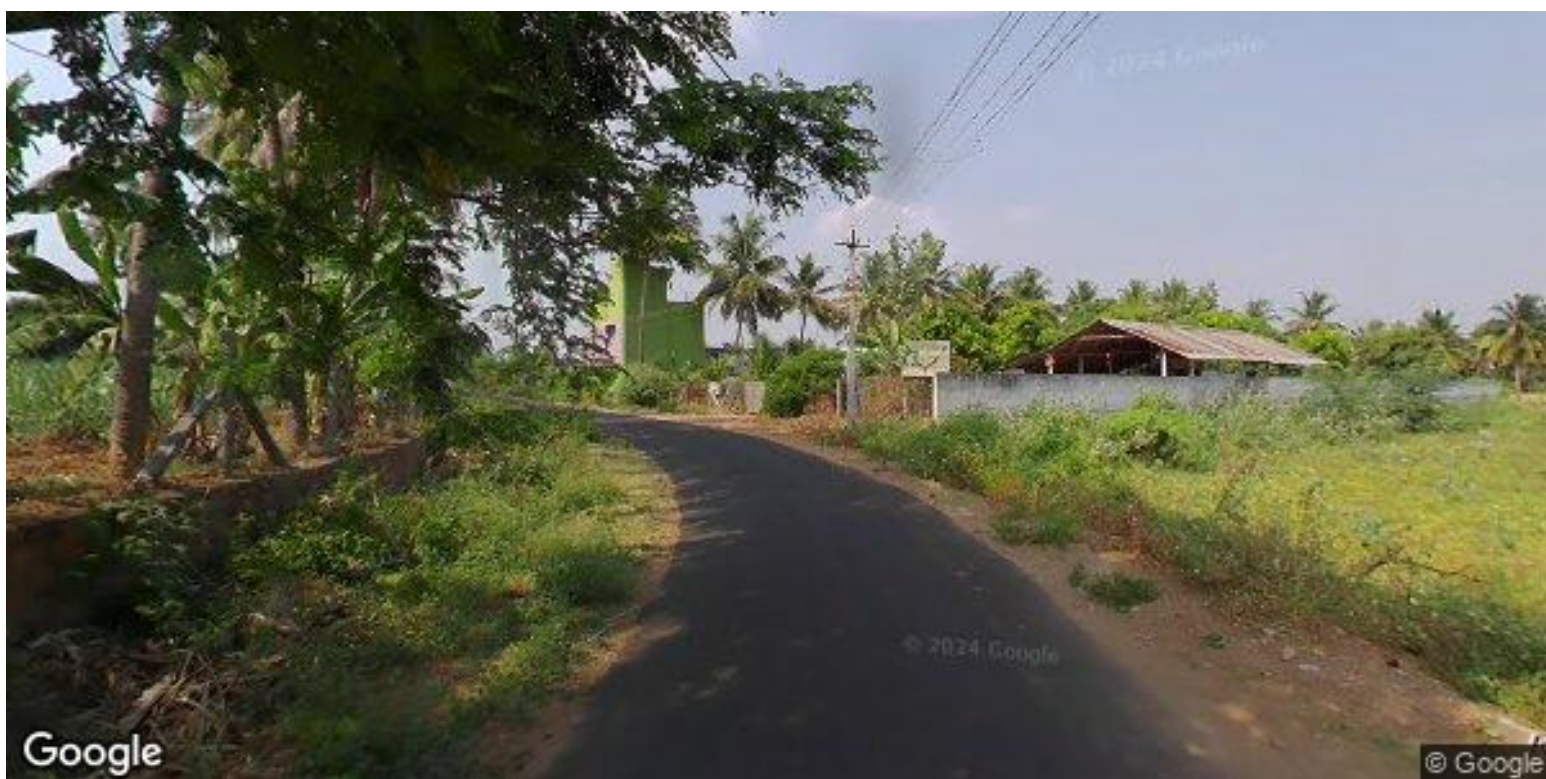
**Coordinates:** 11.27326, 77.72991

**Risk Type:** Turn

**Risk Level:** High

**Speed Limit:** 15 KM/Hr

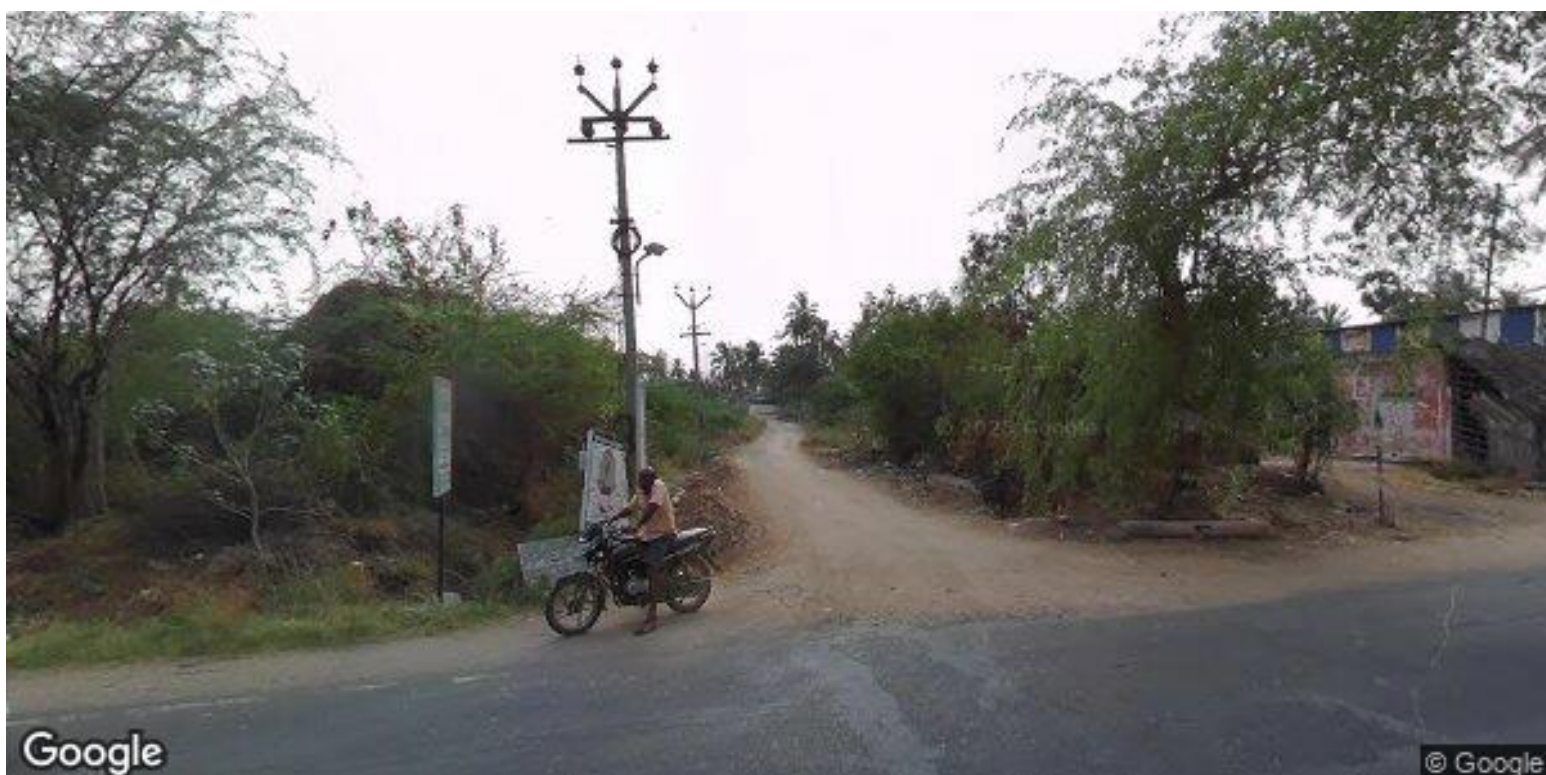
**Risk Type:** Blind Spot  
**Risk Level:** Blind Spot  
**Speed Limit:** 10 KM/Hr  
**Coordinates:** 11.27330, 77.72711

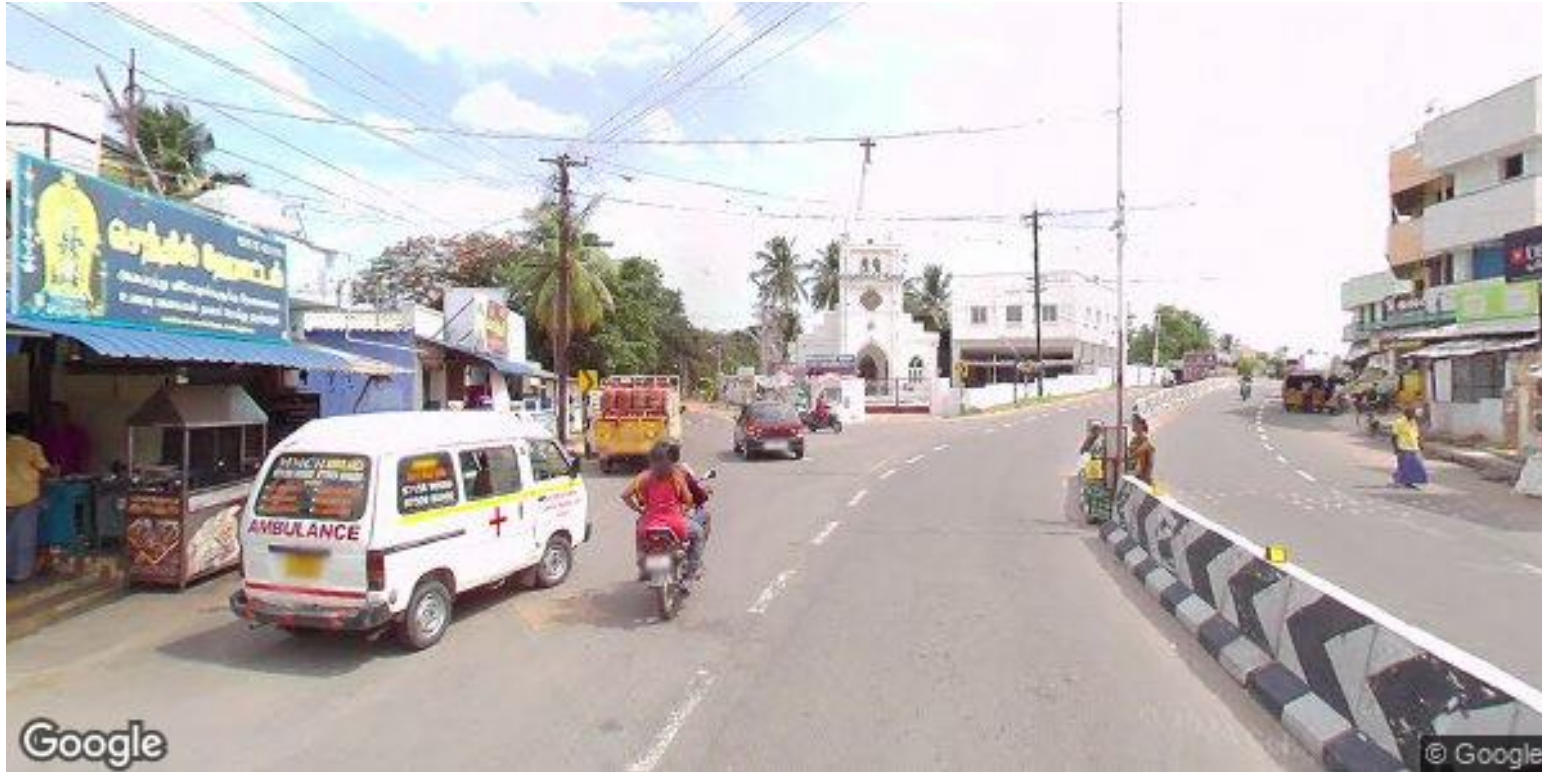
**Risk Type:** Turn  
**Risk Level:** Medium  
**Speed Limit:** 30 KM/Hr  
**Coordinates:** 11.23062, 77.71799

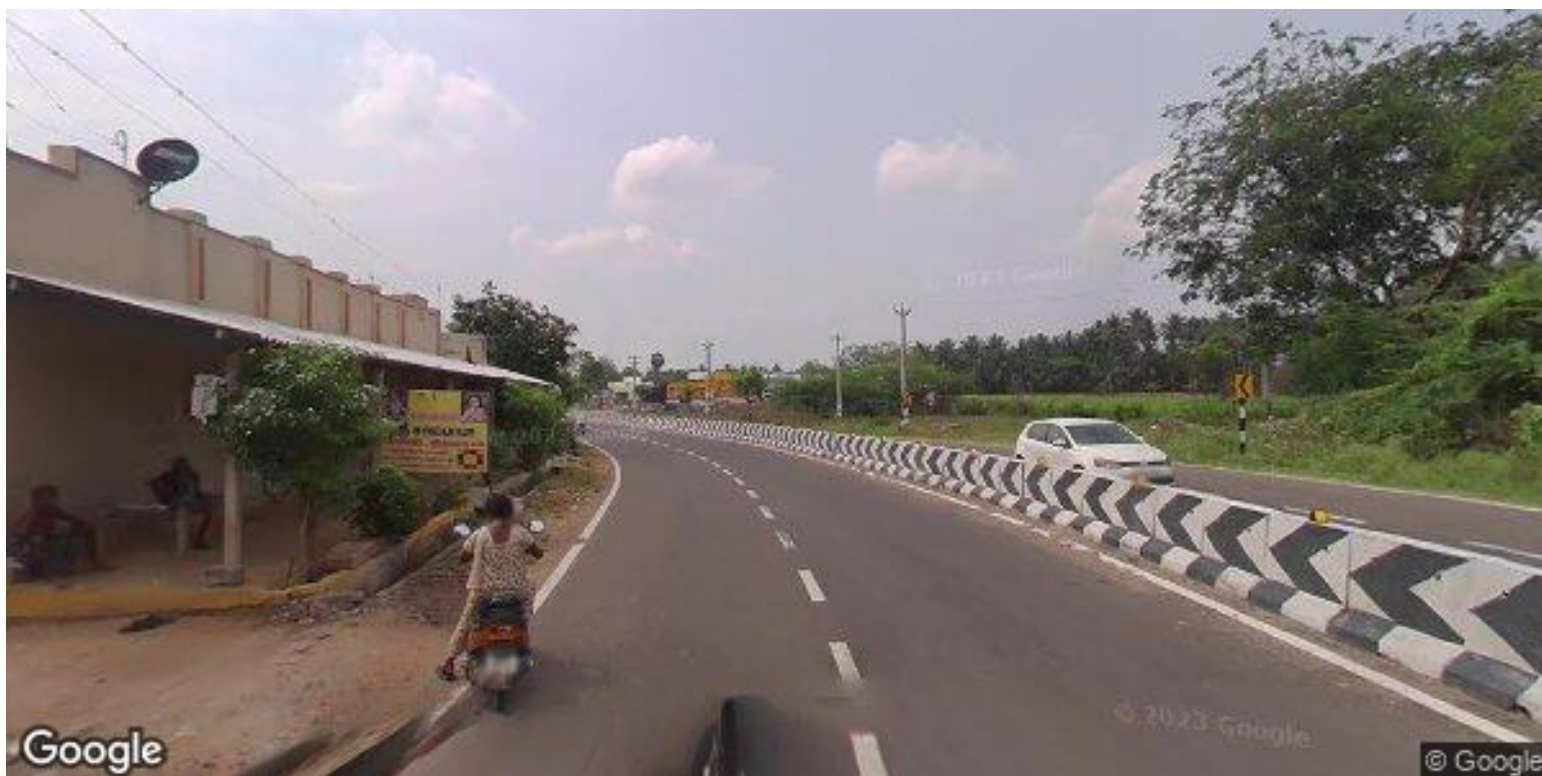
**Risk Type:** Turn  
**Risk Level:** Medium  
**Speed Limit:** 30 KM/Hr  
**Coordinates:** 11.22395, 77.71387

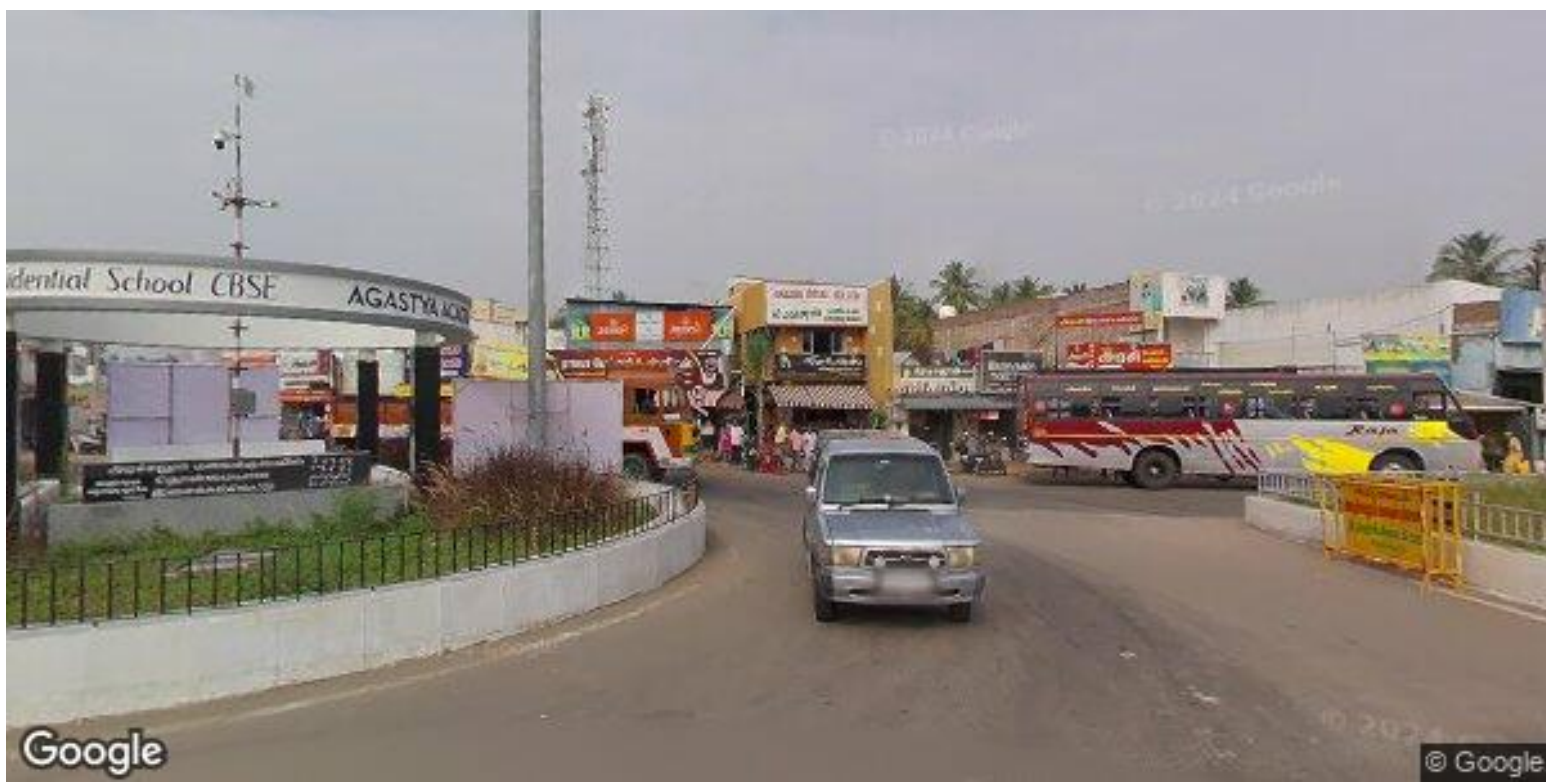
**Coordinates:** 11.15951, 77.70067

**Risk Type:** Turn

**Risk Level:** Medium

**Speed Limit:** 30 KM/Hr
