# IndianOil

## JOURNEY RISK MANAGEMENT (JRM) STUDY

### Salem Terminal to SUMEDHA AGENCIES

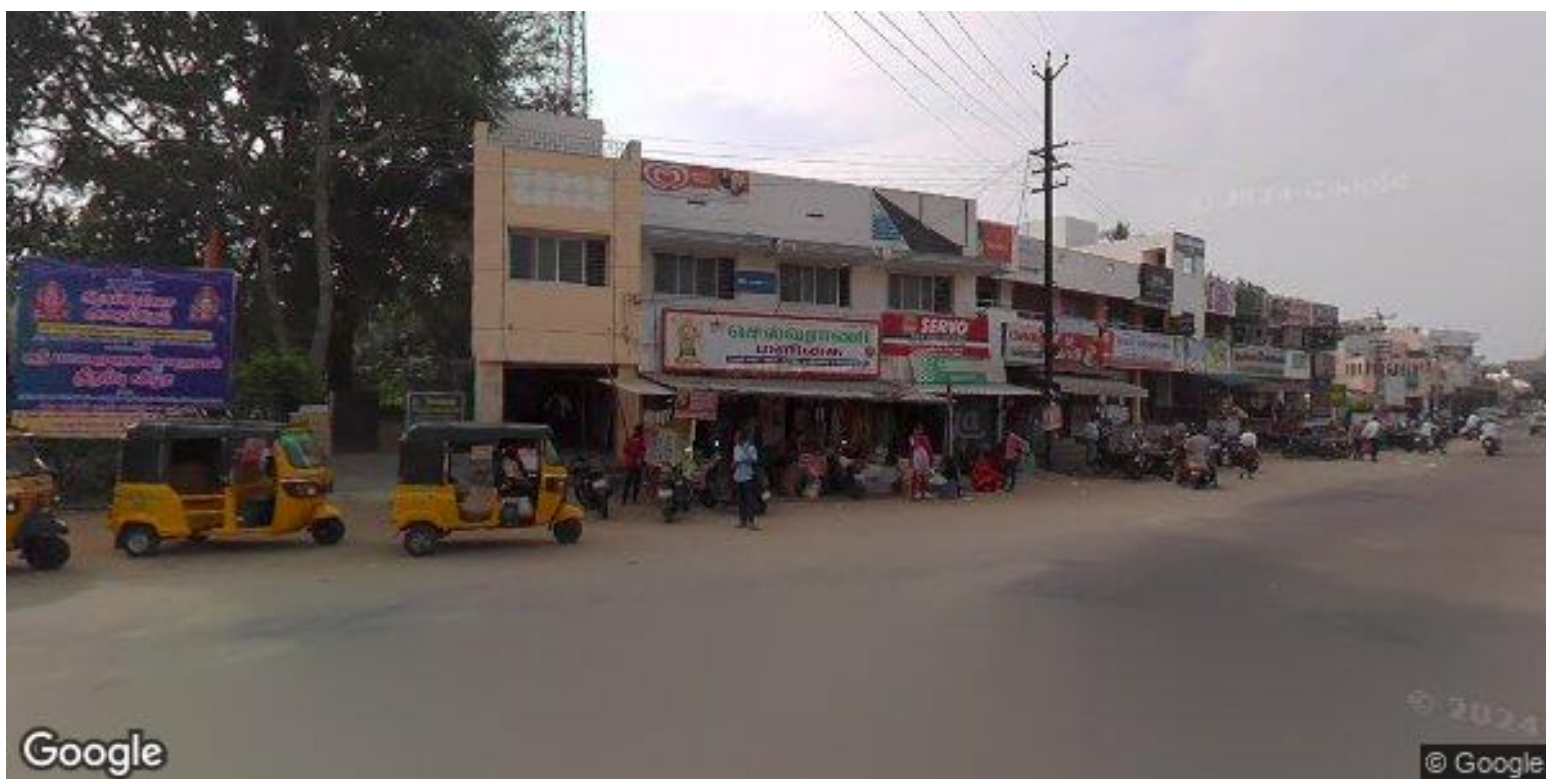
**Coordinates:** 11.15942, 77.70068

**Risk Type:** Turn

**Risk Level:** High

**Speed Limit:** 15 KM/Hr

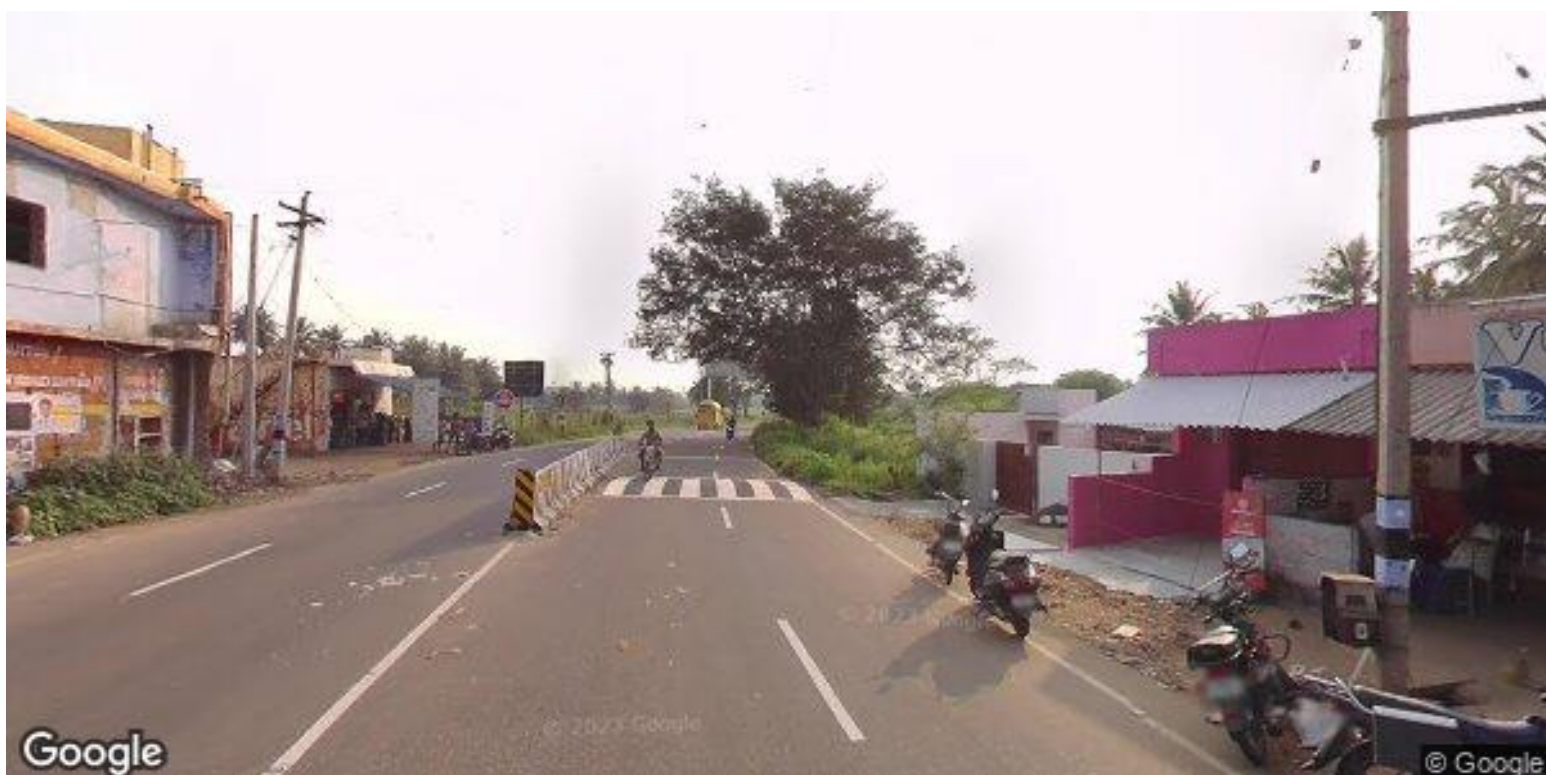
**Coordinates:** 11.12126, 77.67929

**Risk Type:** Turn

**Risk Level:** Medium

**Speed Limit:** 30 KM/Hr

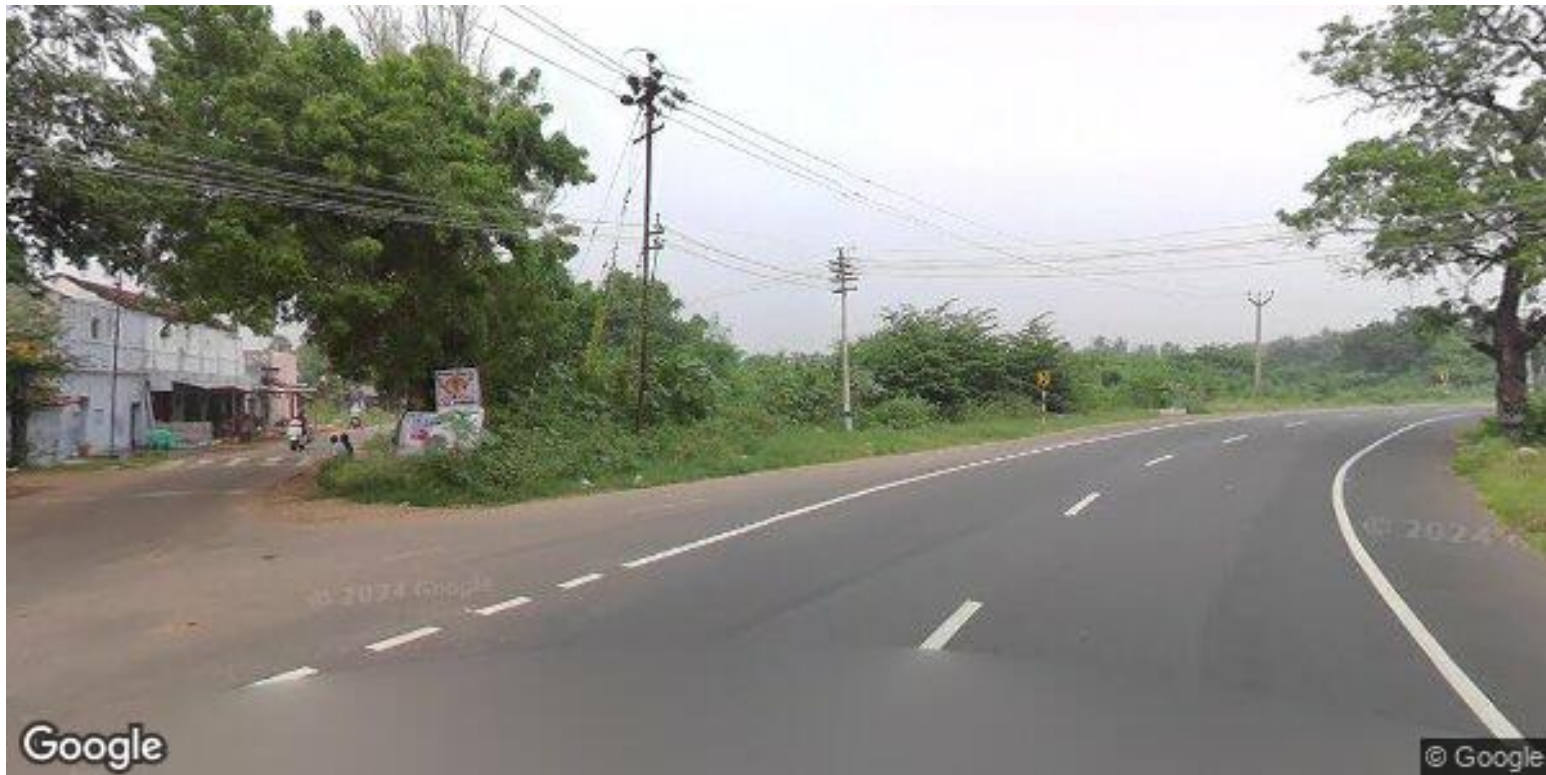
**Coordinates:** 11.11716, 77.67178

**Risk Type:** Turn

**Risk Level:** Medium

**Speed Limit:** 30 KM/Hr

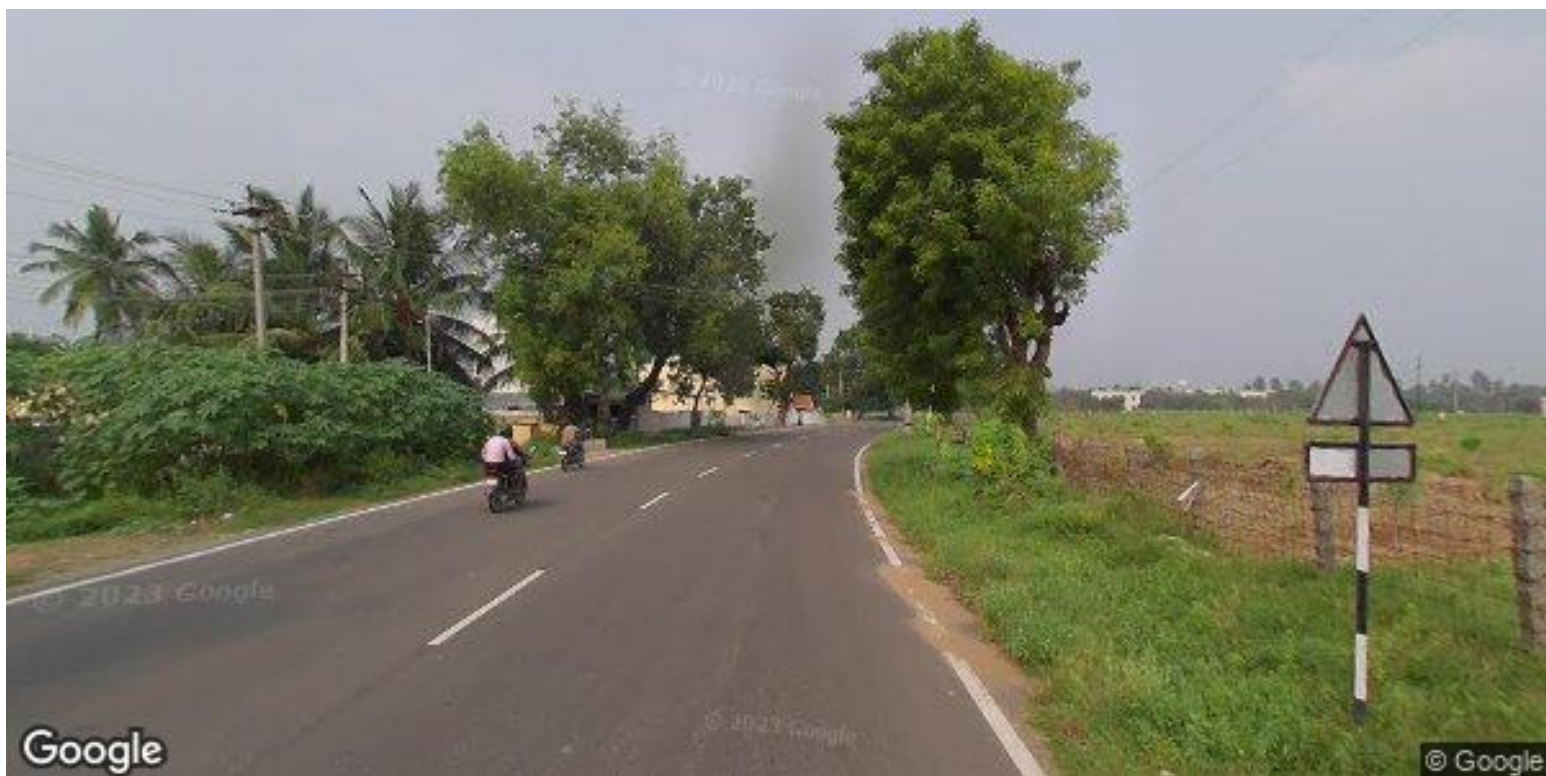
**Coordinates:** 11.09494, 77.66604

**Risk Type:** Turn

**Risk Level:** Medium

**Speed Limit:** 30 KM/Hr

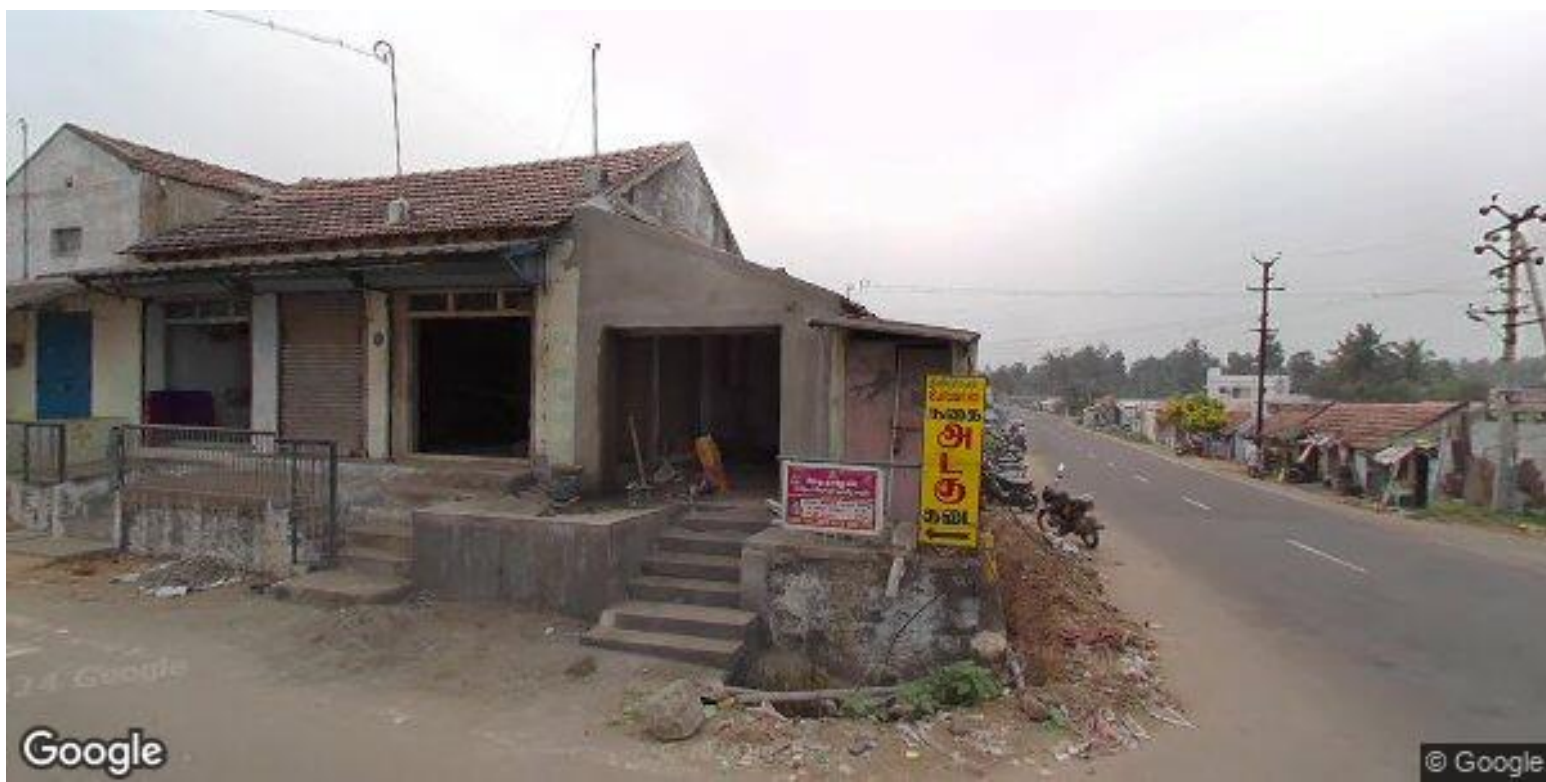
**Coordinates:** 11.08499, 77.66196

**Risk Type:** Turn

**Risk Level:** Medium

**Speed Limit:** 30 KM/Hr

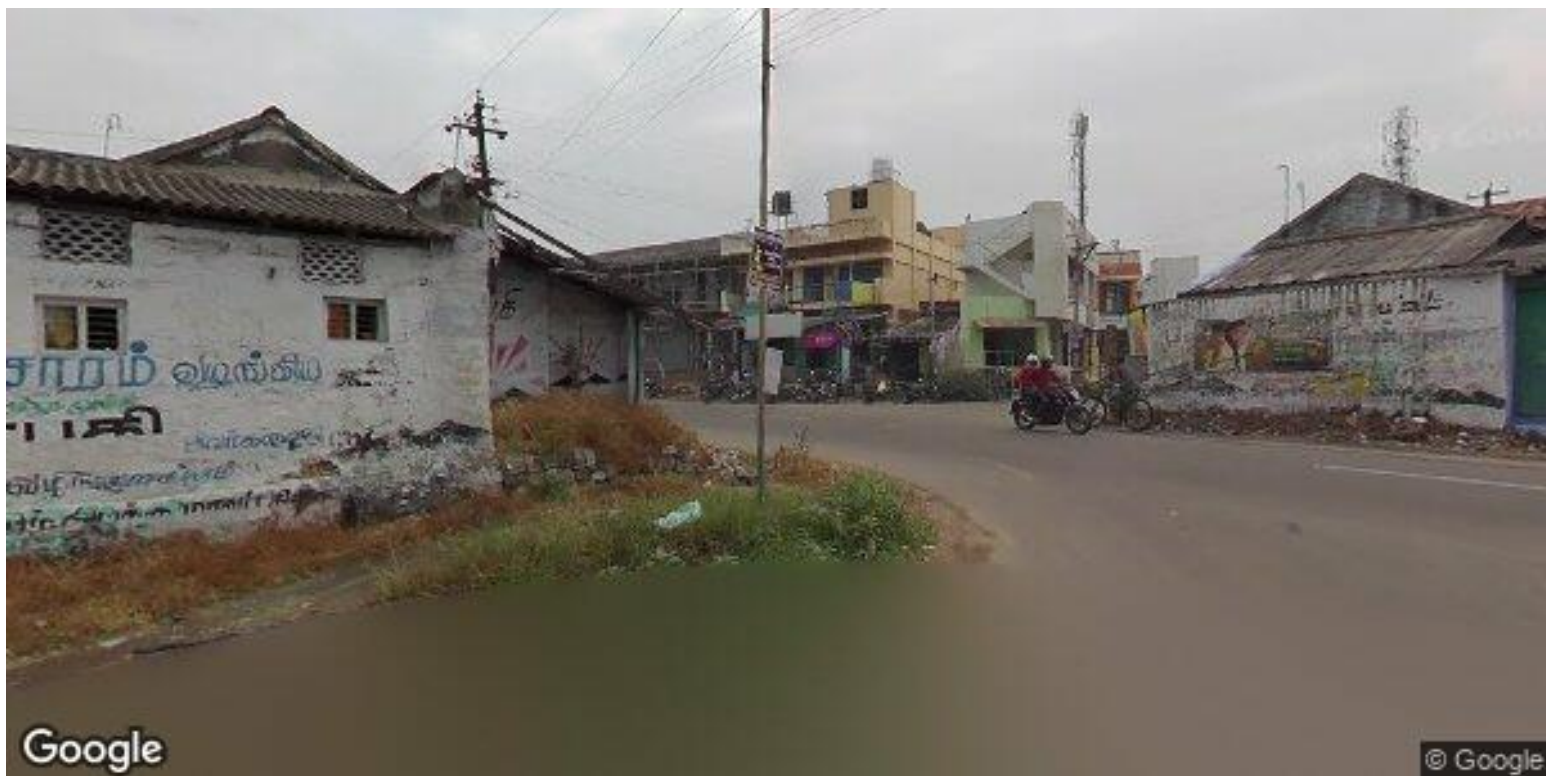
**Coordinates:** 11.08497, 77.66170

**Risk Type:** Turn

**Risk Level:** Medium

**Speed Limit:** 30 KM/Hr

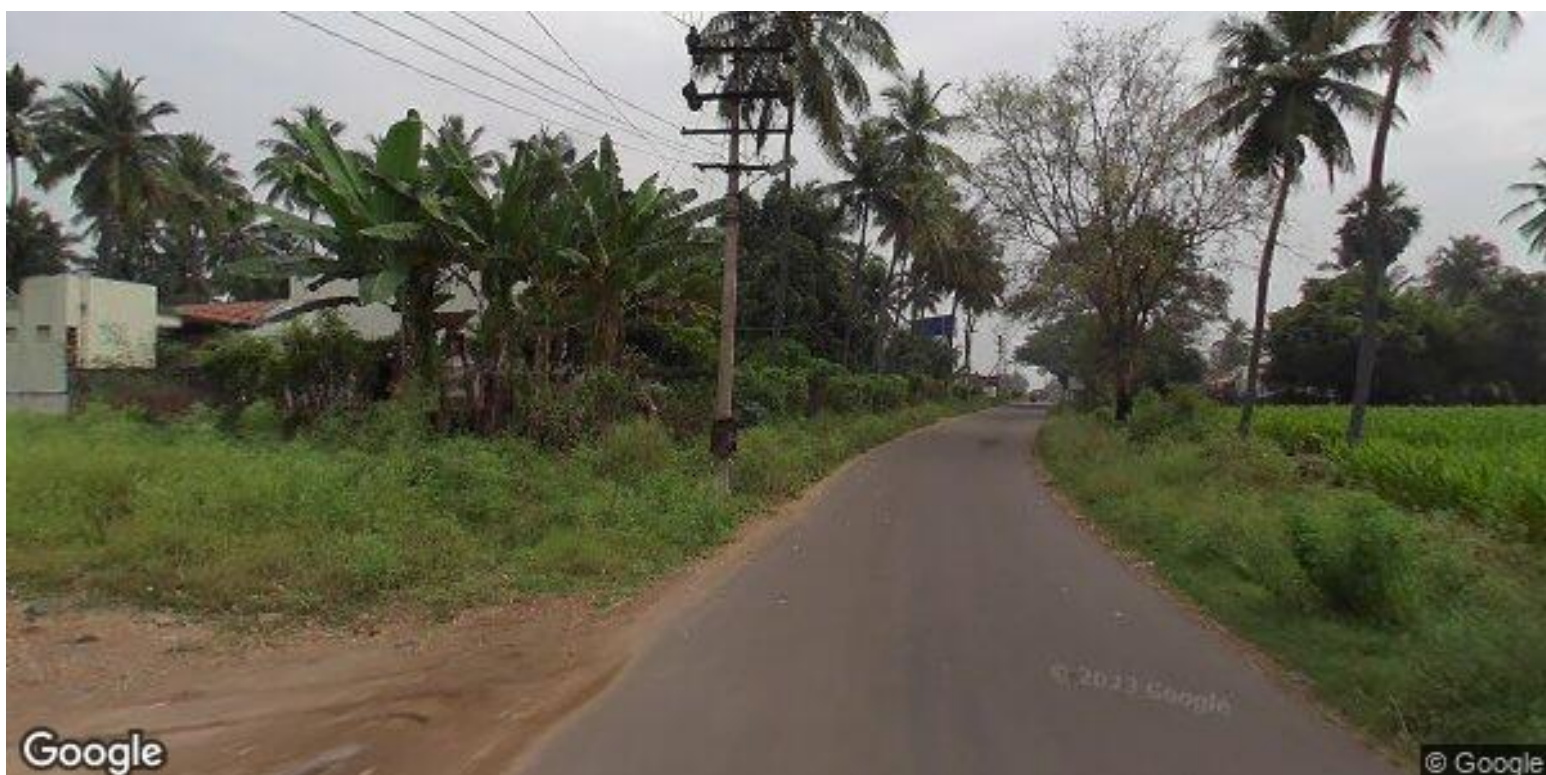
**Risk Type:** Turn  
**Risk Level:** Medium  
**Speed Limit:** 30 KM/Hr  
**Coordinates:** 11.08671, 77.65529

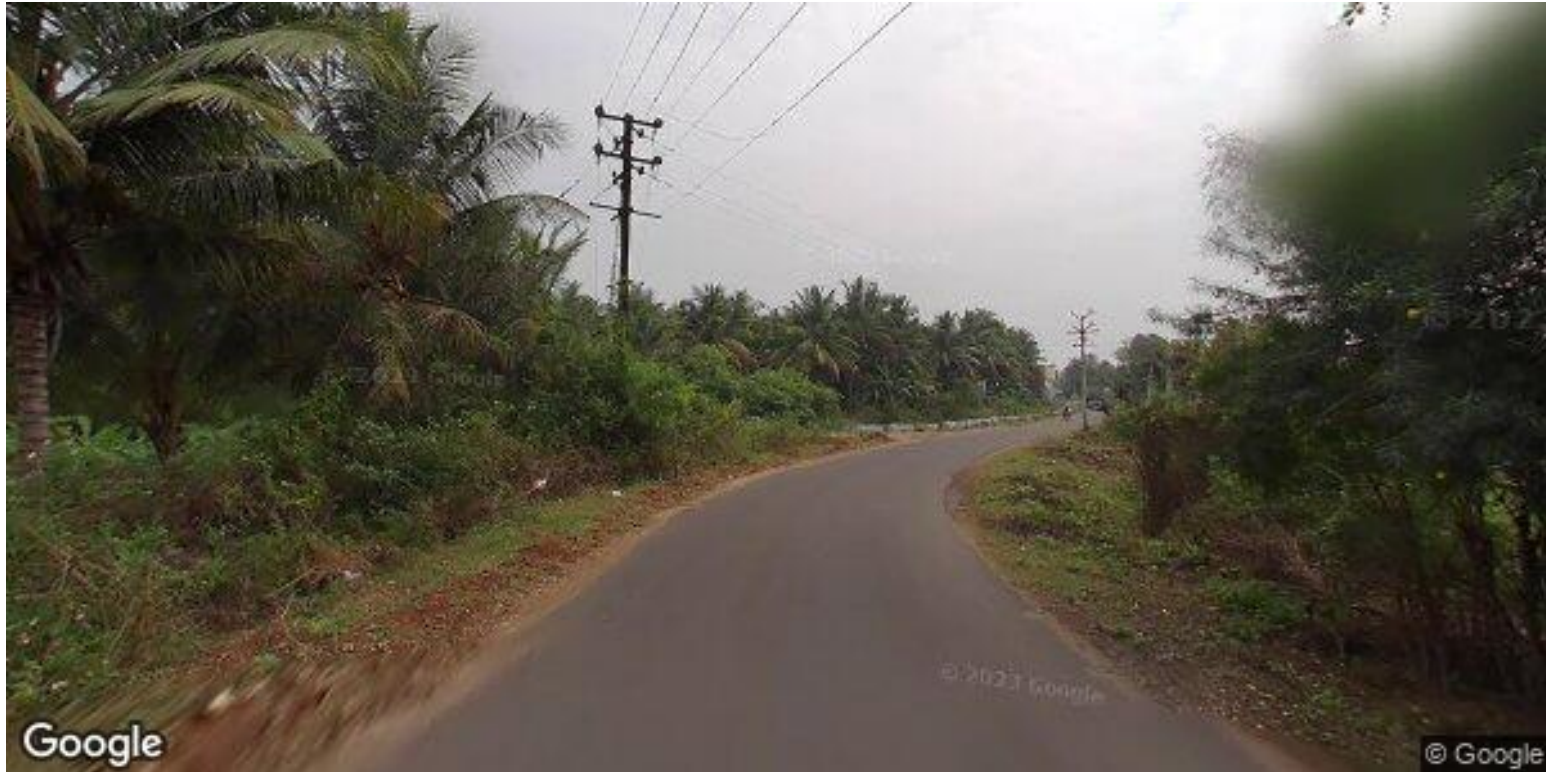
**Risk Type:** Turn  
**Risk Level:** Medium  
**Speed Limit:** 30 KM/Hr  
**Coordinates:** 11.08594, 77.65198

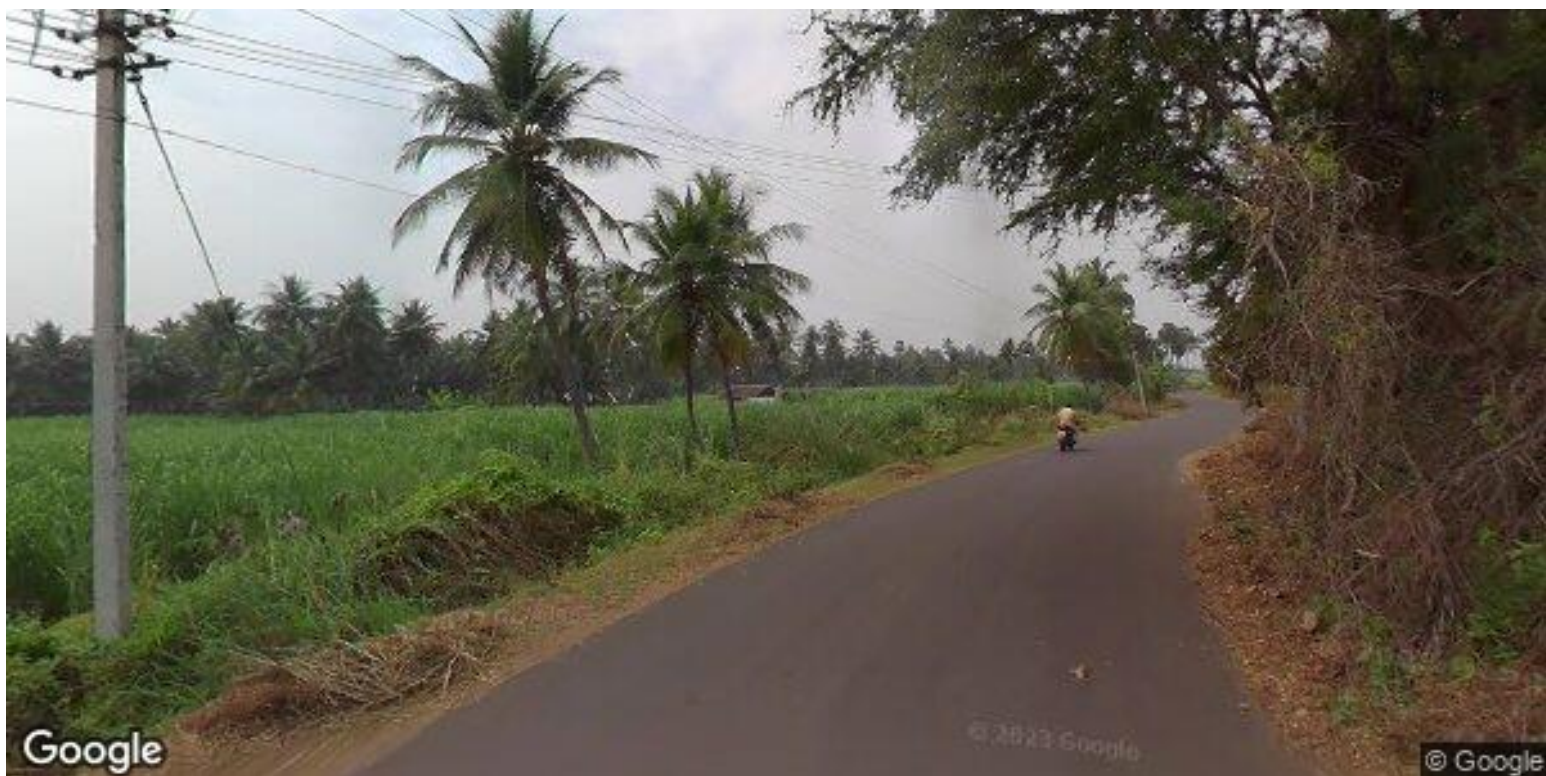
**Risk Type:** Turn  
**Risk Level:** Medium  
**Speed Limit:** 30 KM/Hr  
**Coordinates:** 11.08501, 77.65091

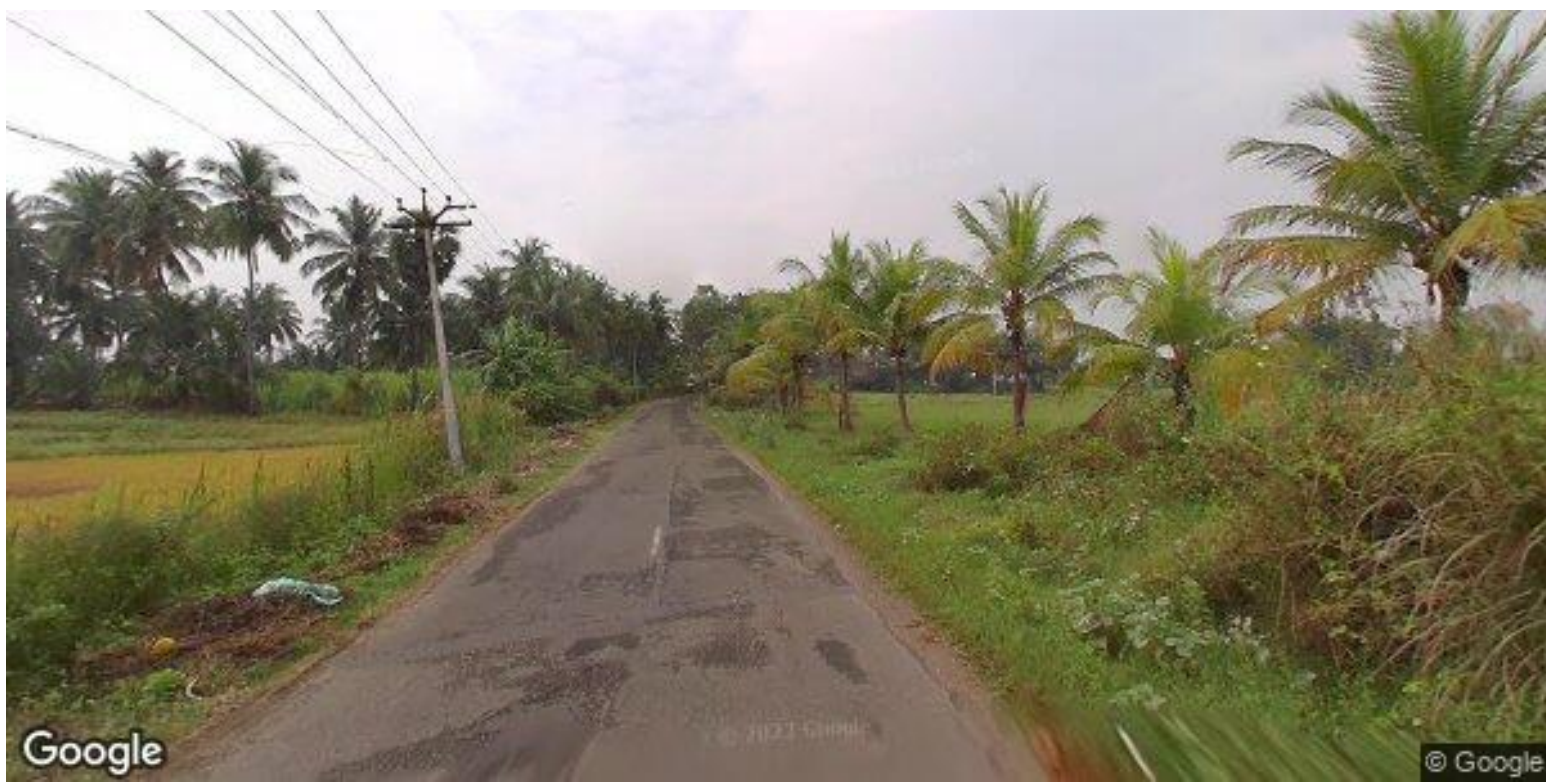
**Coordinates:** 11.08411, 77.64613

**Risk Type:** Turn

**Risk Level:** Medium

**Speed Limit:** 30 KM/Hr

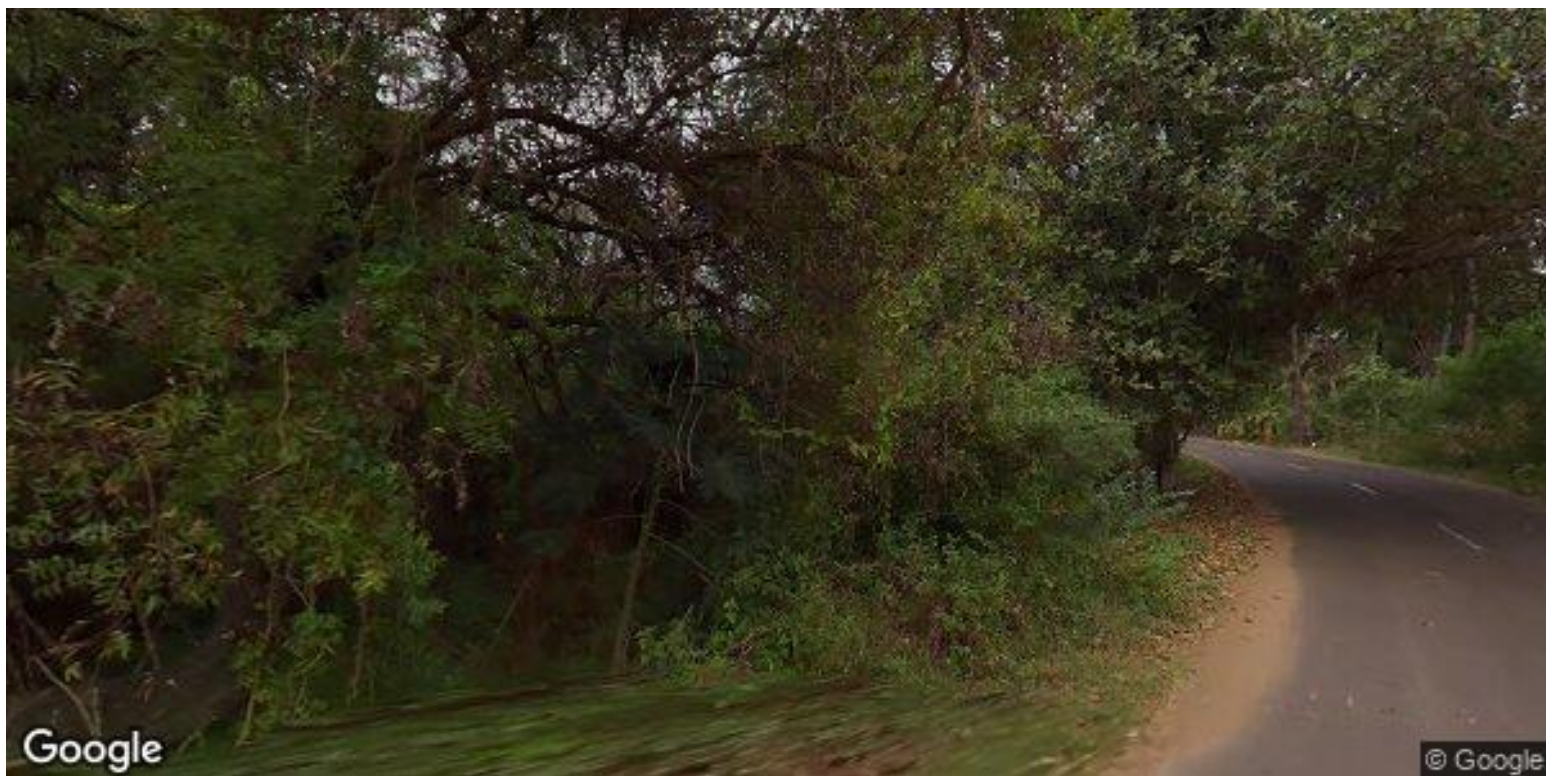
**Coordinates:** 11.08016, 77.64039

**Risk Type:** Turn

**Risk Level:** Medium

**Speed Limit:** 30 KM/Hr

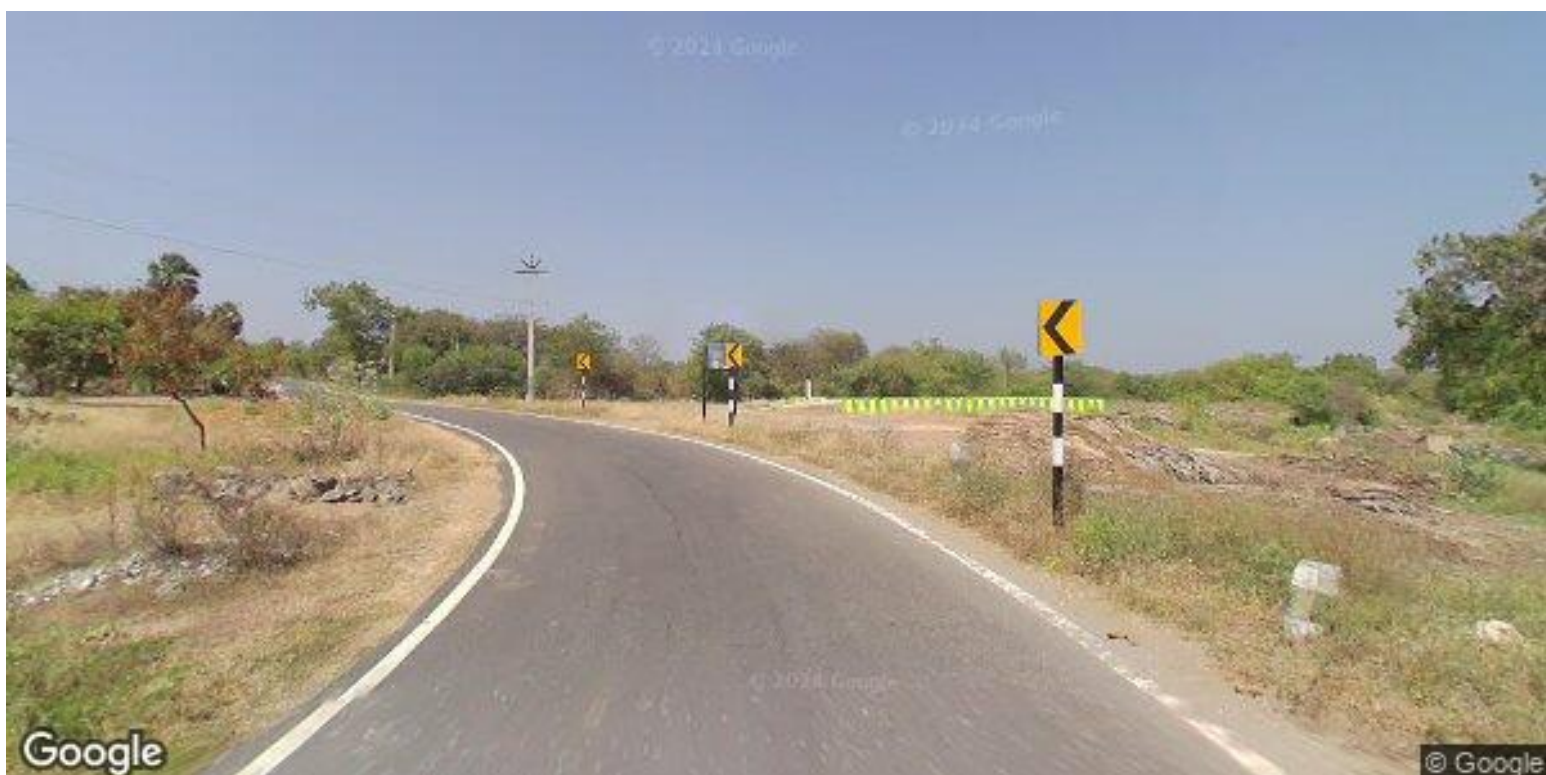
**Risk Type:** Turn  
**Risk Level:** High  
**Speed Limit:** 15 KM/Hr  
**Coordinates:** 11.08011, 77.63502

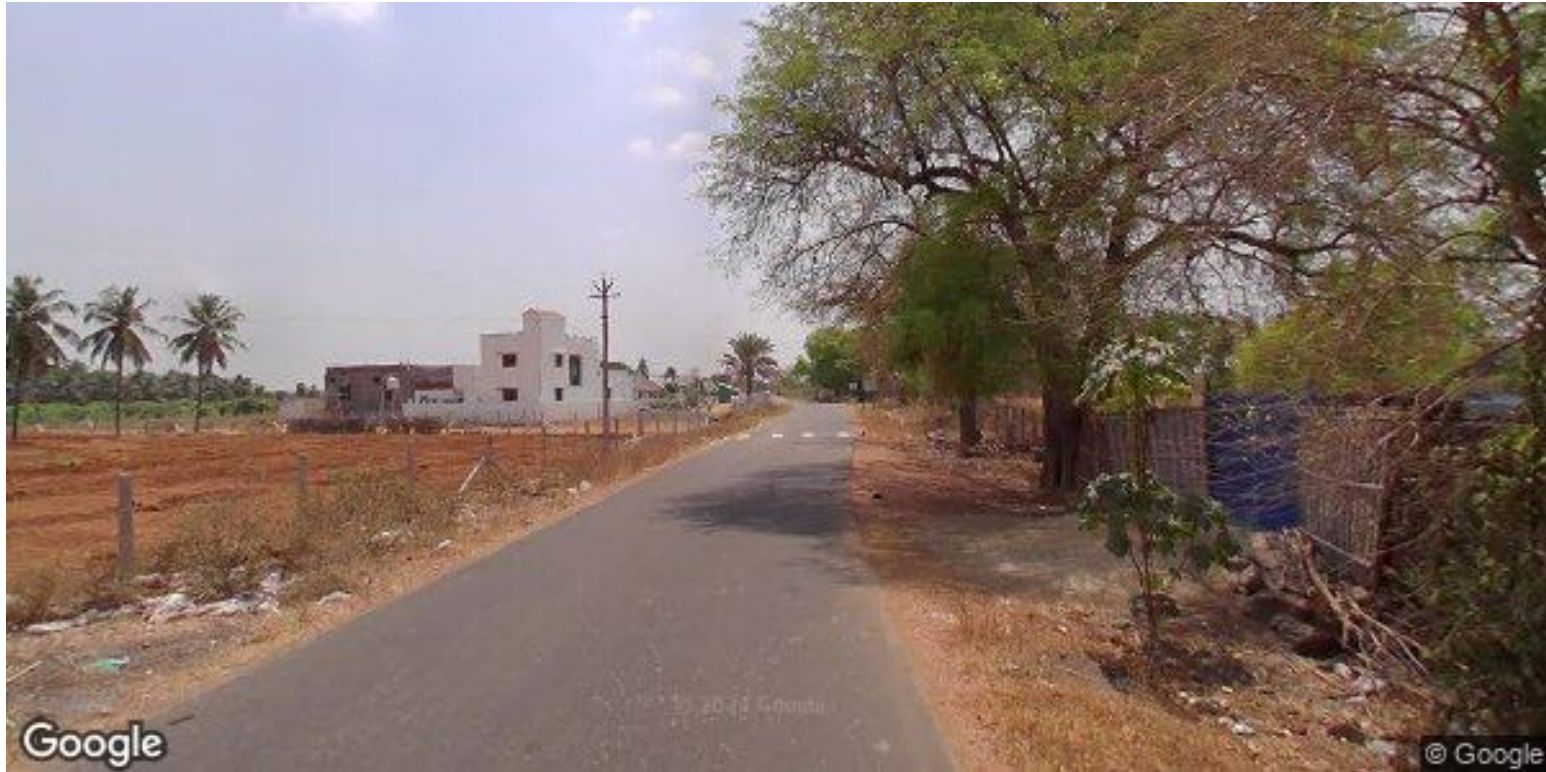
**Risk Type:** Turn  
**Risk Level:** Medium  
**Speed Limit:** 30 KM/Hr  
**Coordinates:** 11.07494, 77.61236

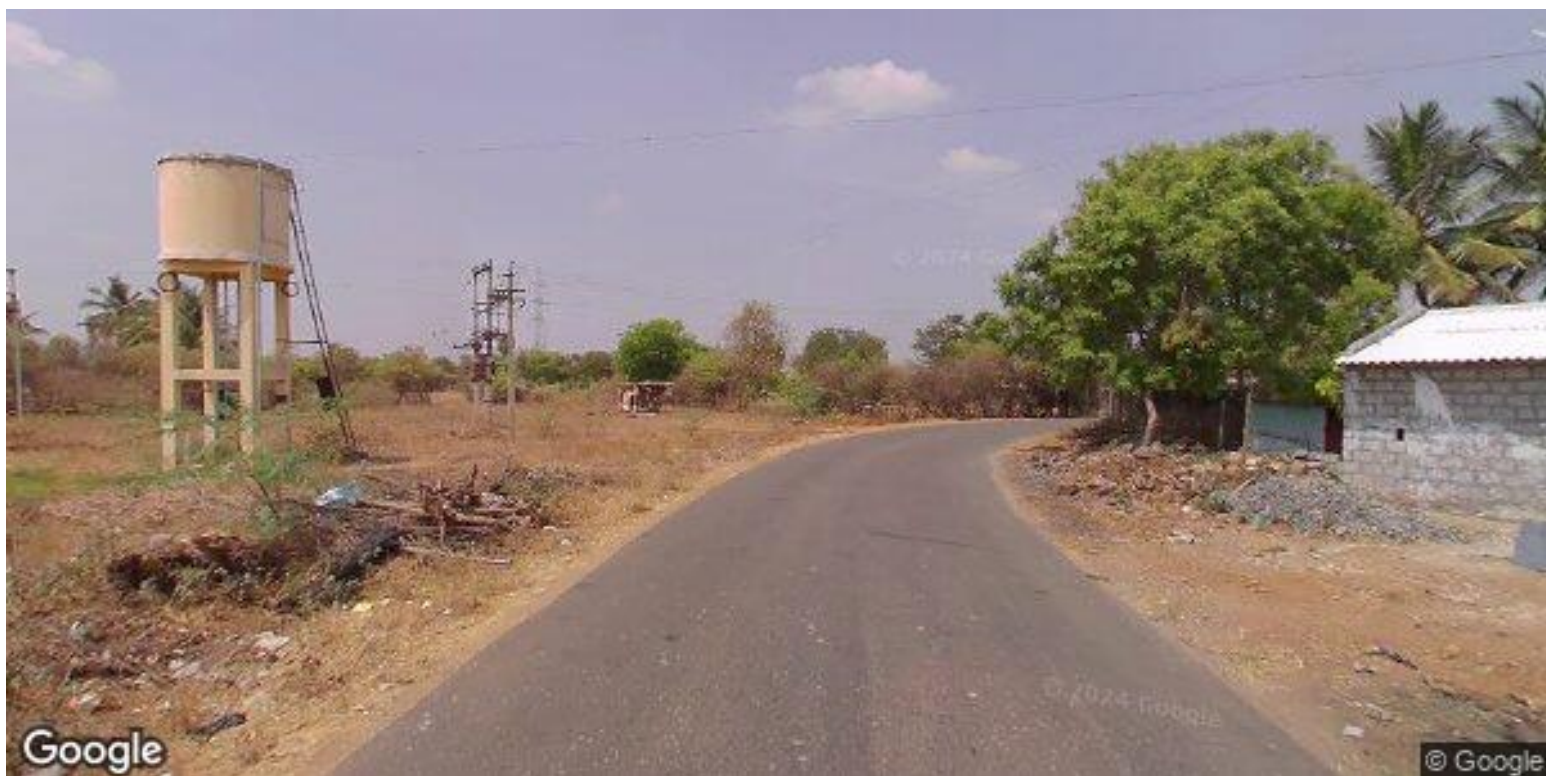
**Risk Type:** Turn  
**Risk Level:** Medium  
**Speed Limit:** 30 KM/Hr  
**Coordinates:** 11.07378, 77.61177

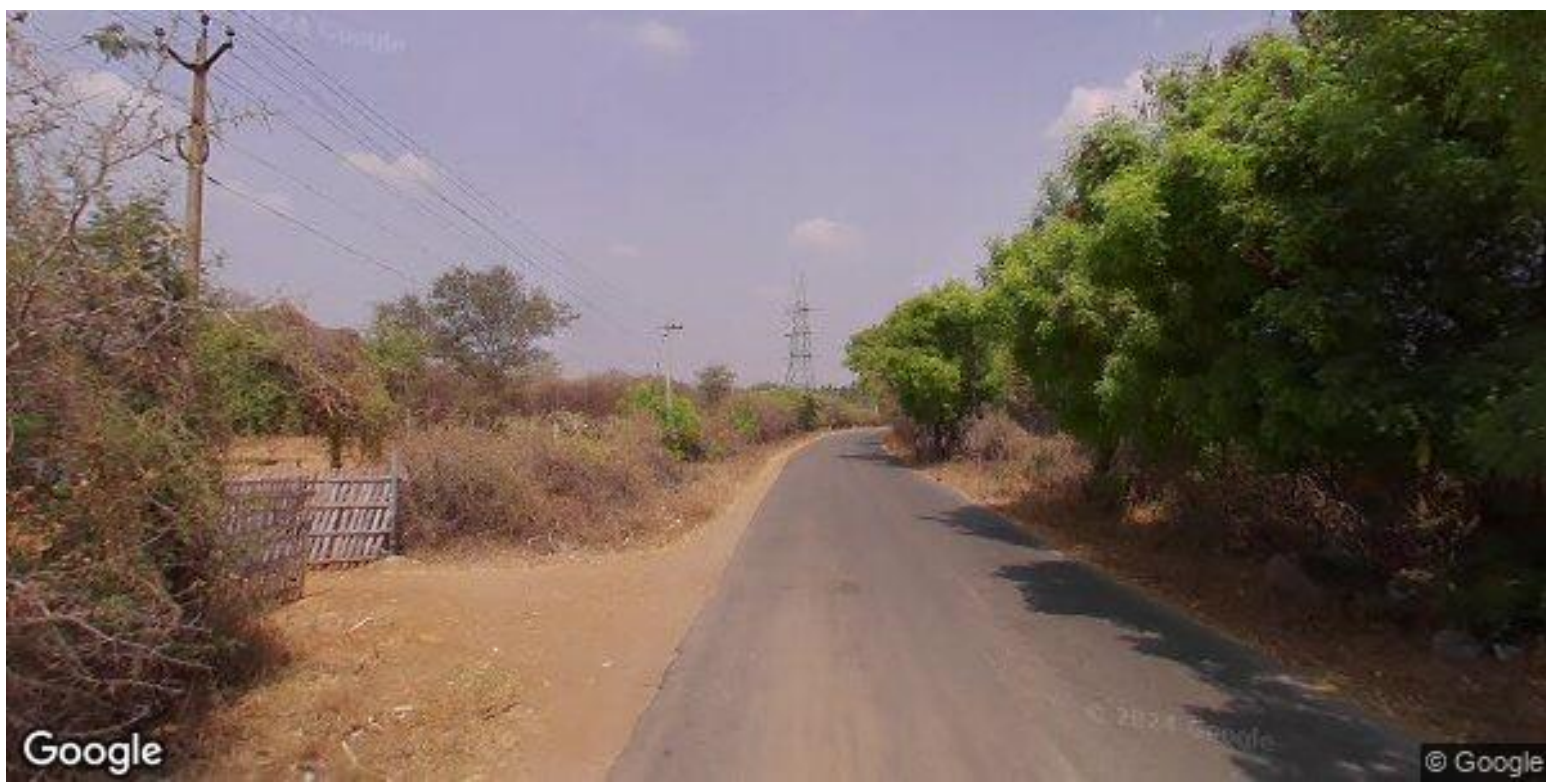
**Coordinates:** 11.07352, 77.61121

**Risk Type:** Turn

**Risk Level:** Medium

**Speed Limit:** 30 KM/Hr

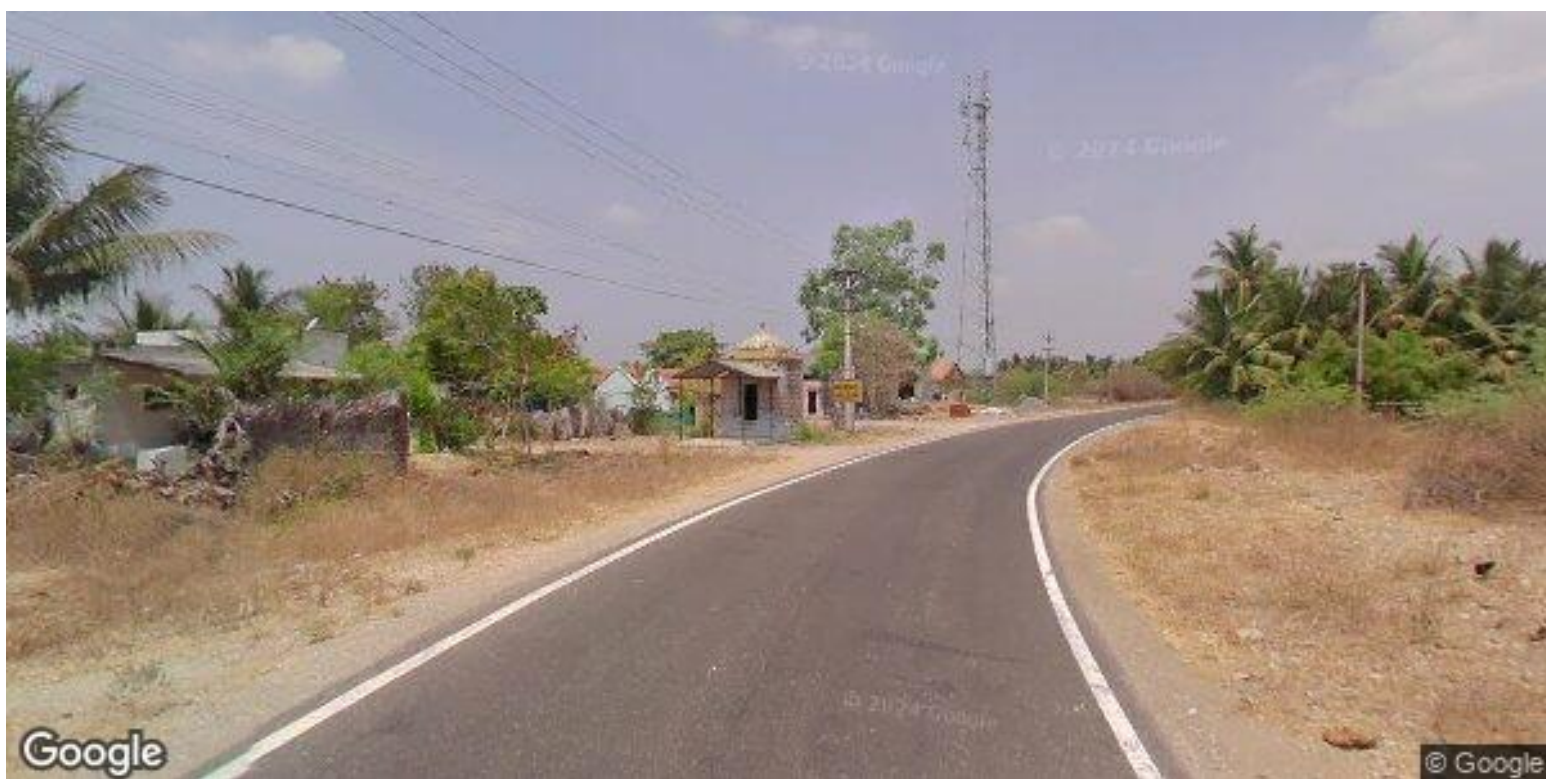
**Coordinates:** 11.07311, 77.60692

**Risk Type:** Turn

**Risk Level:** Medium

**Speed Limit:** 30 KM/Hr

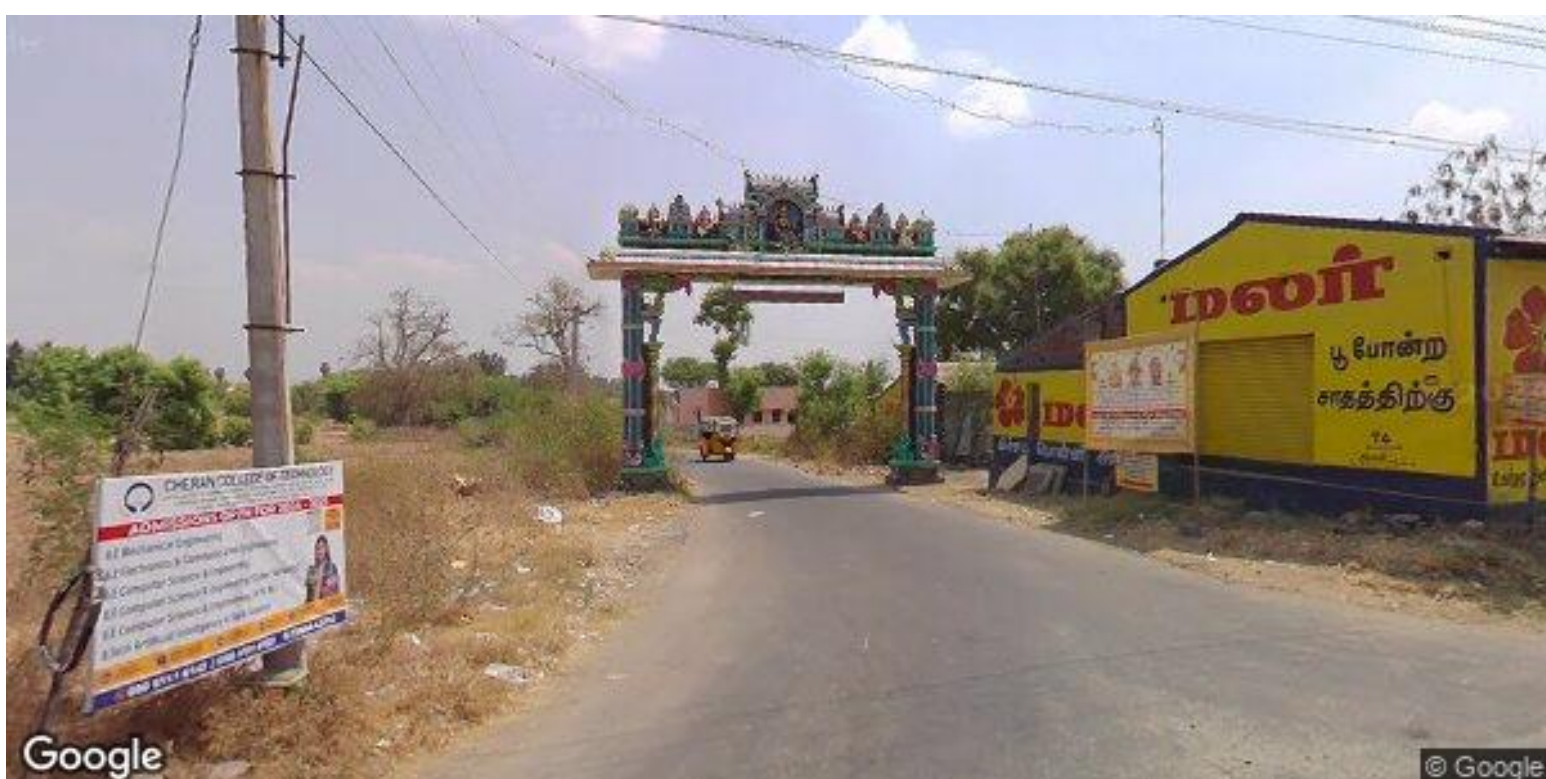
**Coordinates:** 11.07405, 77.59599

**Risk Type:** Turn

**Risk Level:** Medium

**Speed Limit:** 30 KM/Hr
