## JOURNEY RISK MANAGEMENT (JRM) STUDY

### Salem Terminal to NAPCMS

### Route Safety Analysis for Transport from Sangagiri to Namakkal, Tamil Nadu

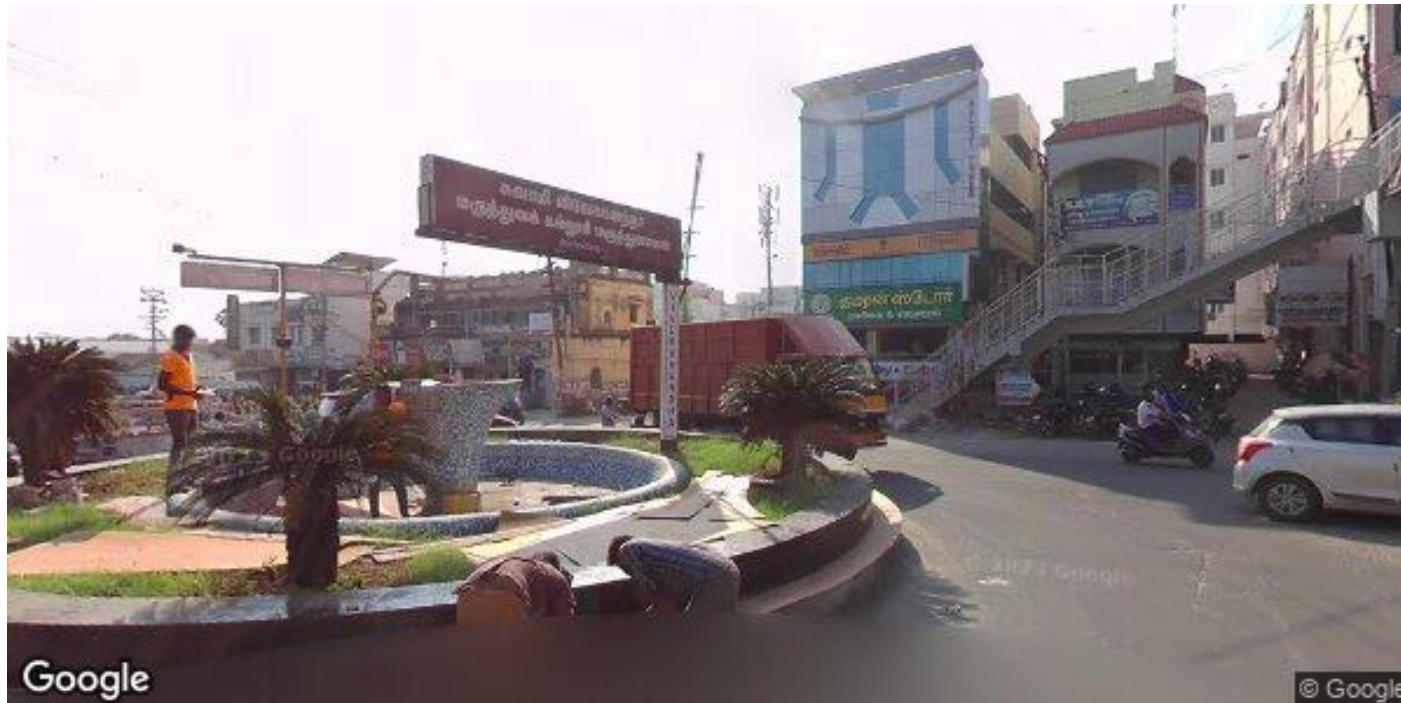
**Coordinates:** 11.38395, 77.89480

**Risk Type:** Roundabout

**Risk Level:** High

**Speed Limit:** 15 KM/Hr

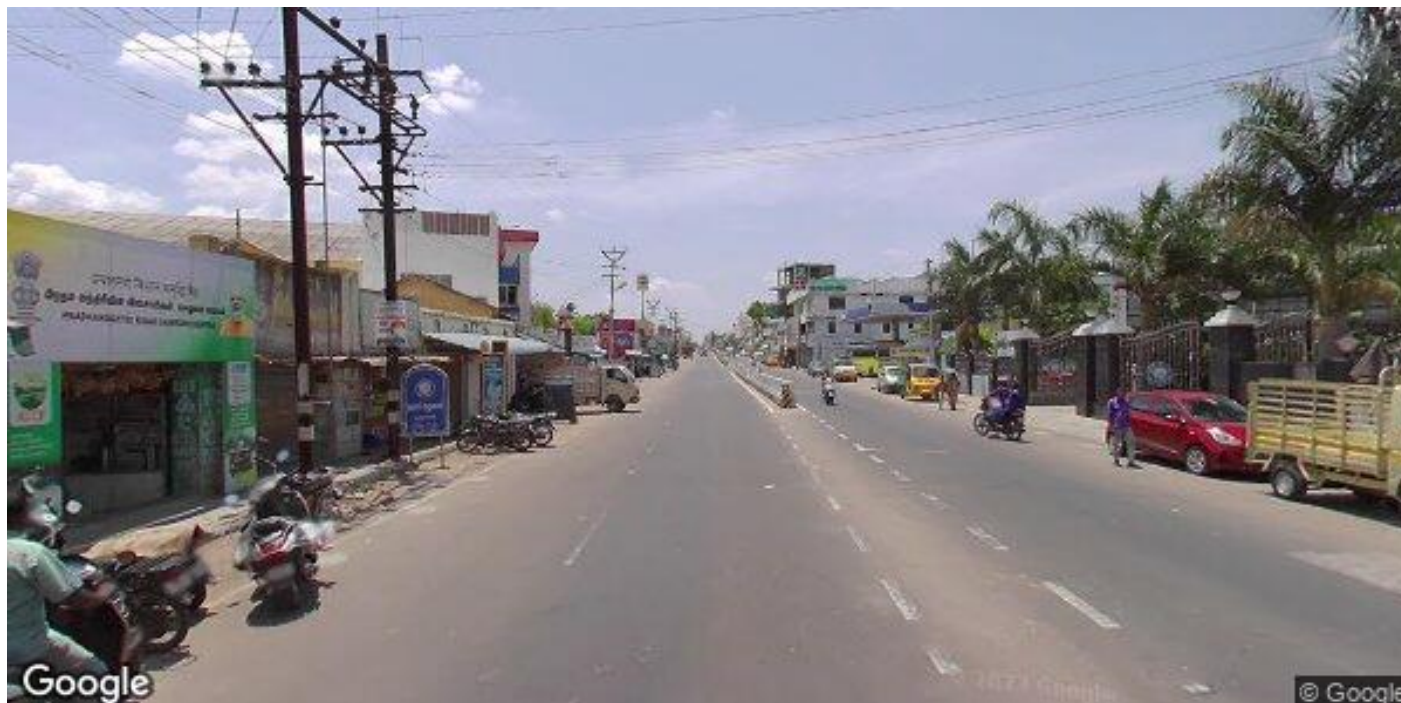
**Coordinates:** 11.2269168, 78.1625554

**Risk Type:** U-Turn

**Risk Level:** High

**Speed Limit:** 10 KM/Hr

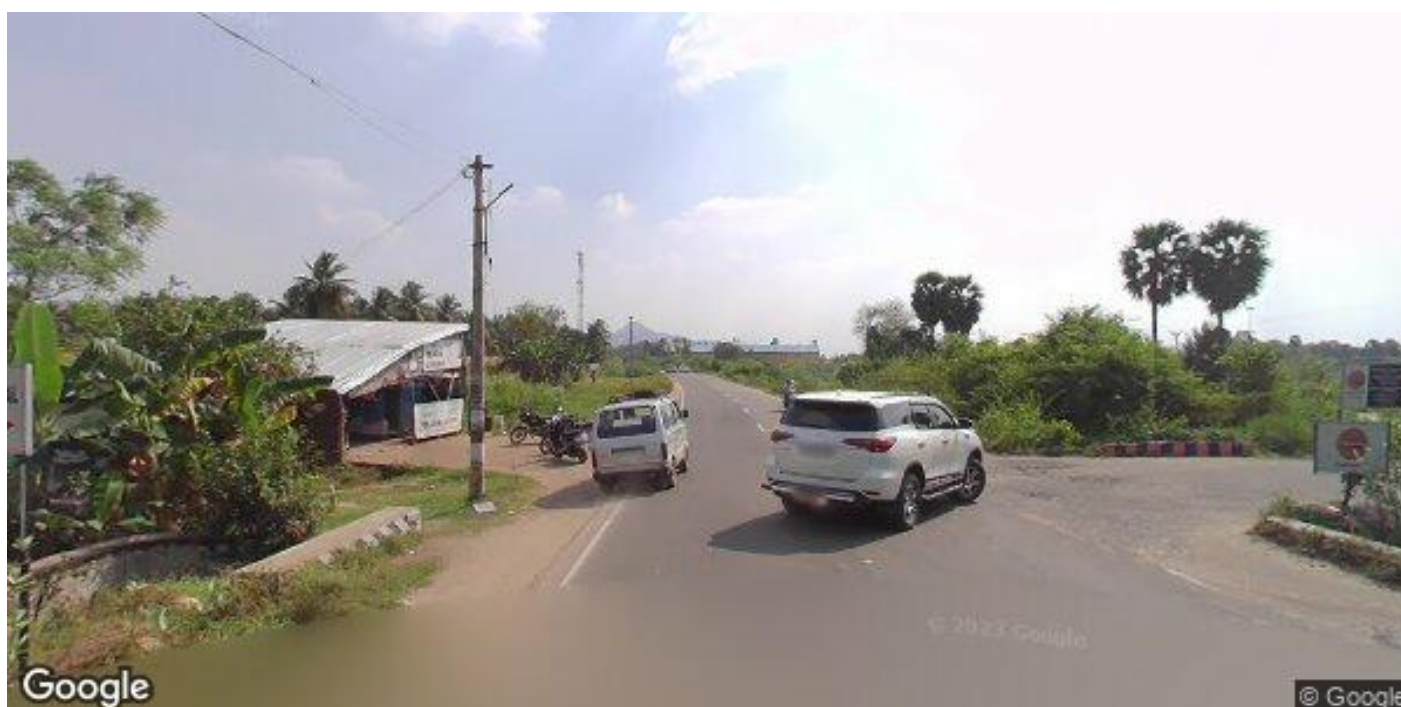
**Risk Type:** Blind Spot

**Risk Level:** Blind Spot

**Speed Limit: 10 KM/Hr**  
**Coordinates: 11.44029, 77.87544**

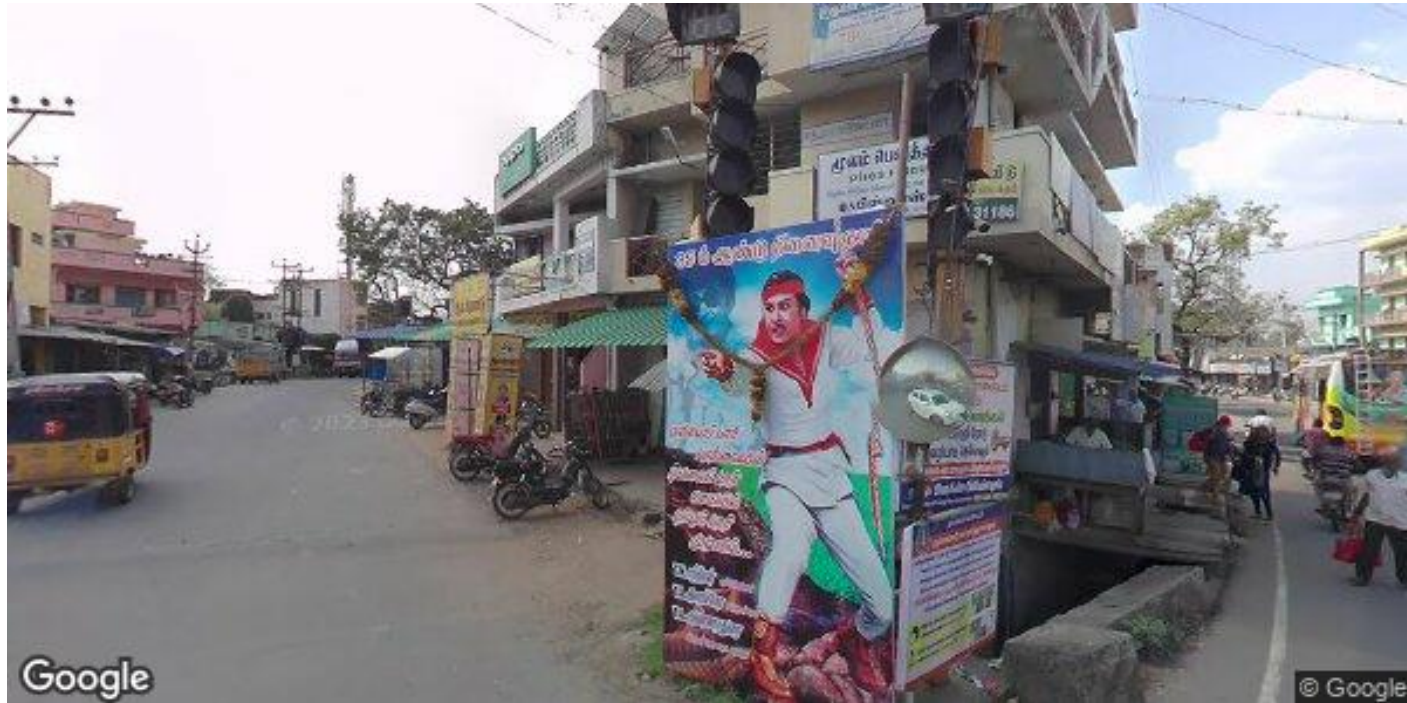
**Risk Type: Turn**  
**Risk Level: Medium**  
**Speed Limit: 30 KM/Hr**  
**Coordinates: 11.38342, 77.89975**

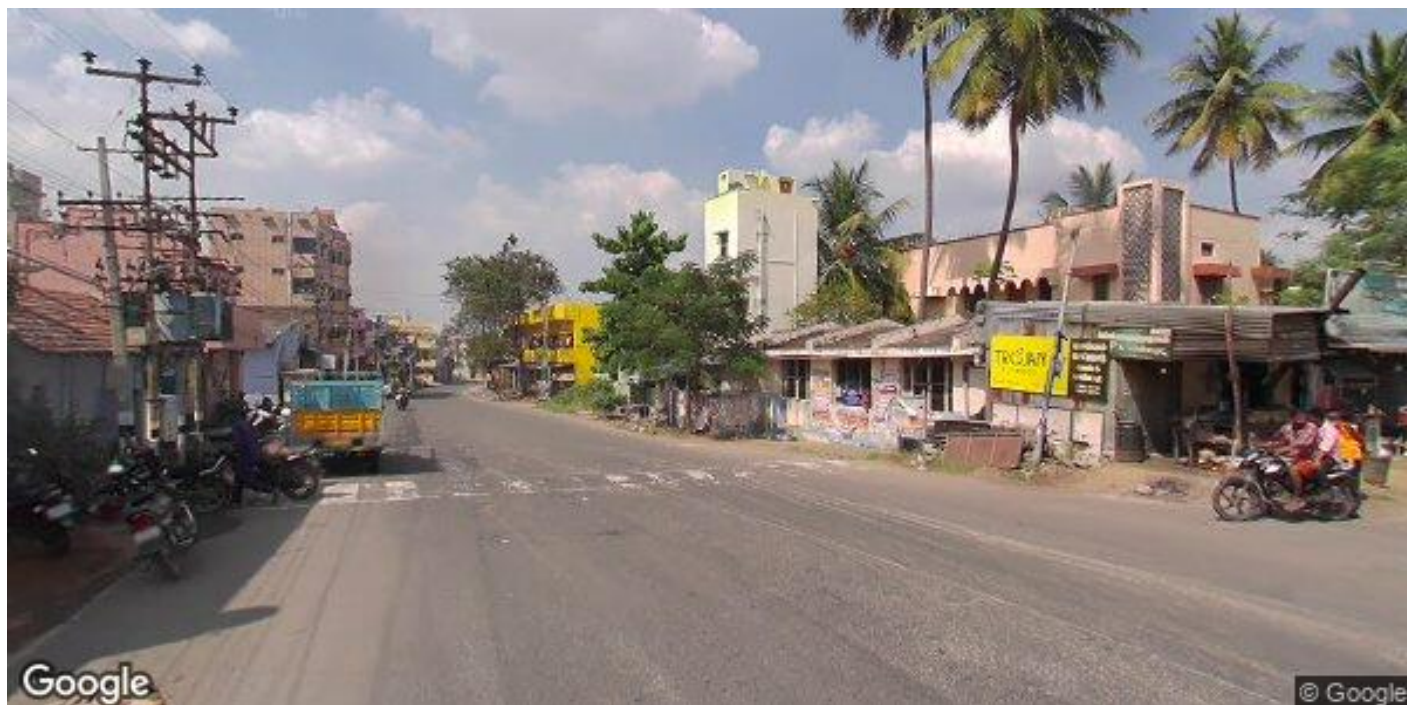
**Risk Type: Turn**  
**Risk Level: Medium**  
**Speed Limit: 30 KM/Hr**  
**Coordinates: 11.38190, 77.90254**

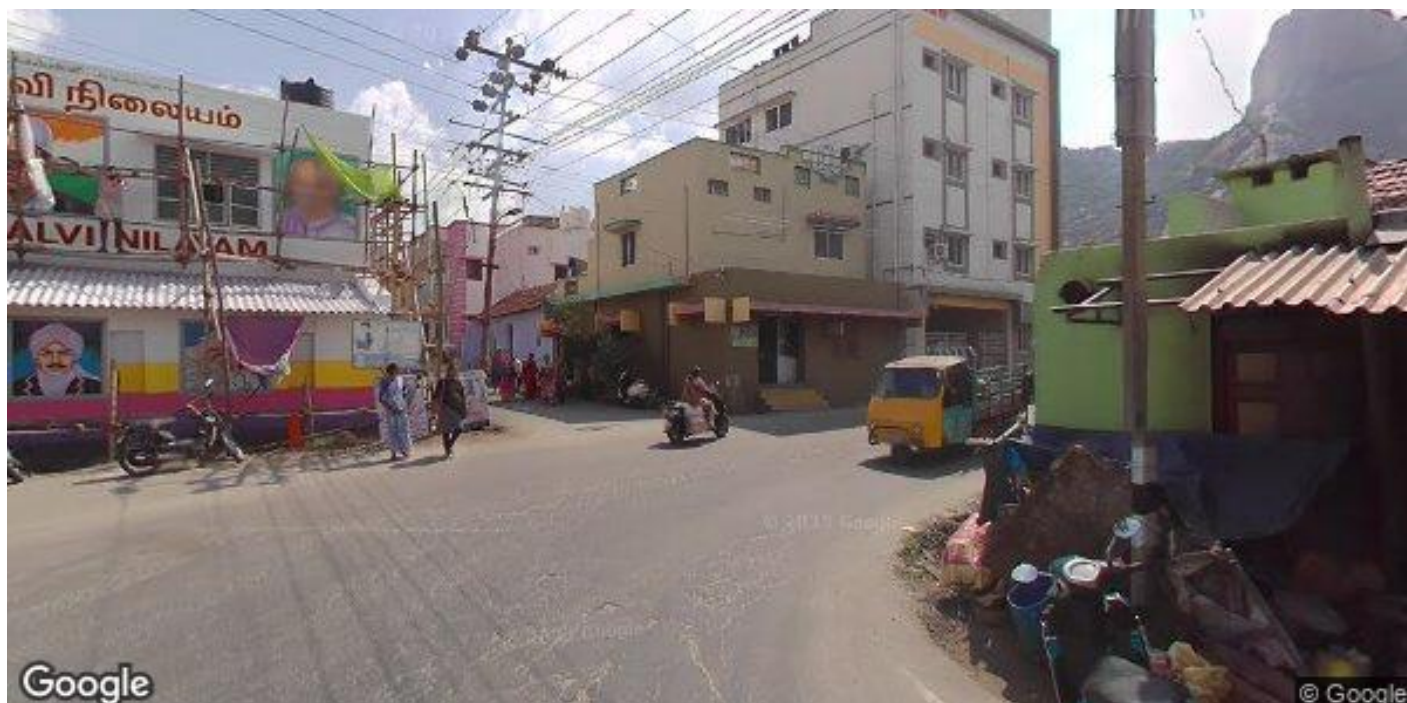
**Risk Type:** Turn  
**Risk Level:** High  
**Speed Limit:** 15 KM/Hr  
**Coordinates:** 11.38186, 77.90258

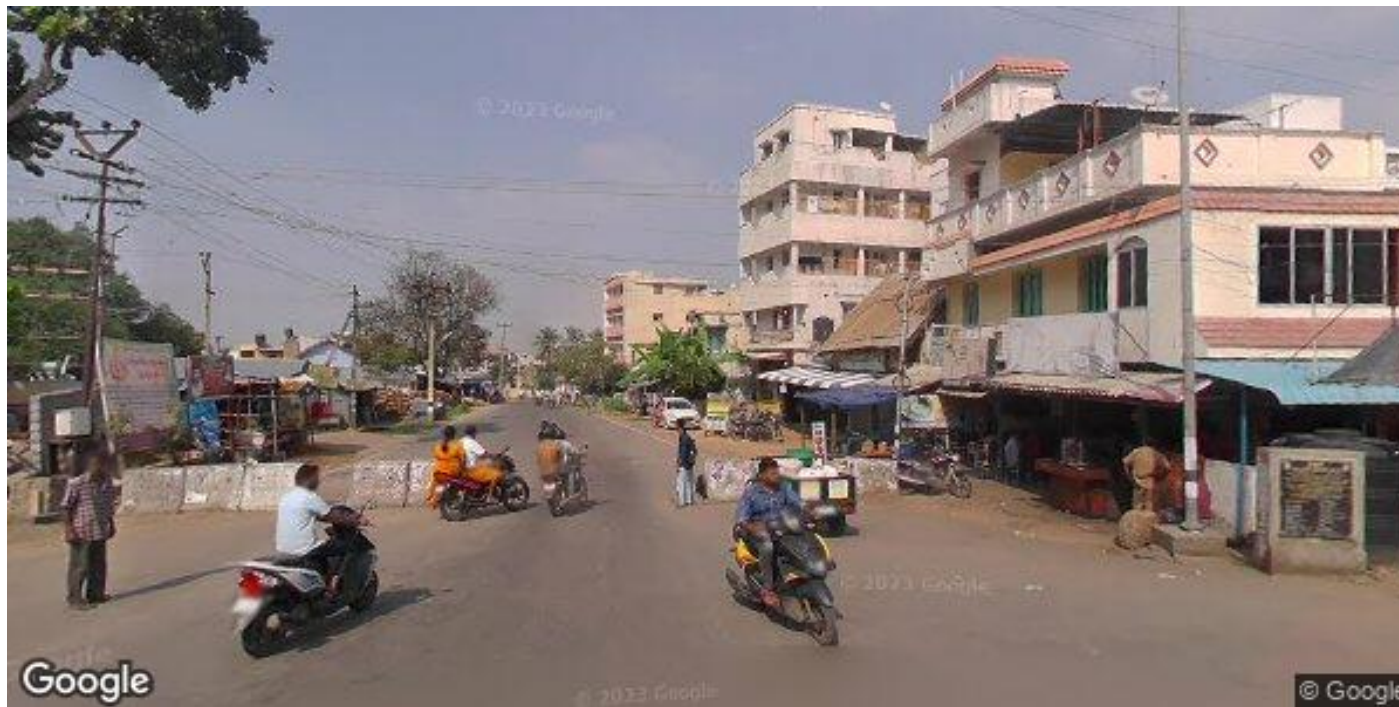
**Risk Type:** Blind Spot  
**Risk Level:** Blind Spot  
**Speed Limit:** 10 KM/Hr  
**Coordinates:** 11.37841, 77.90140

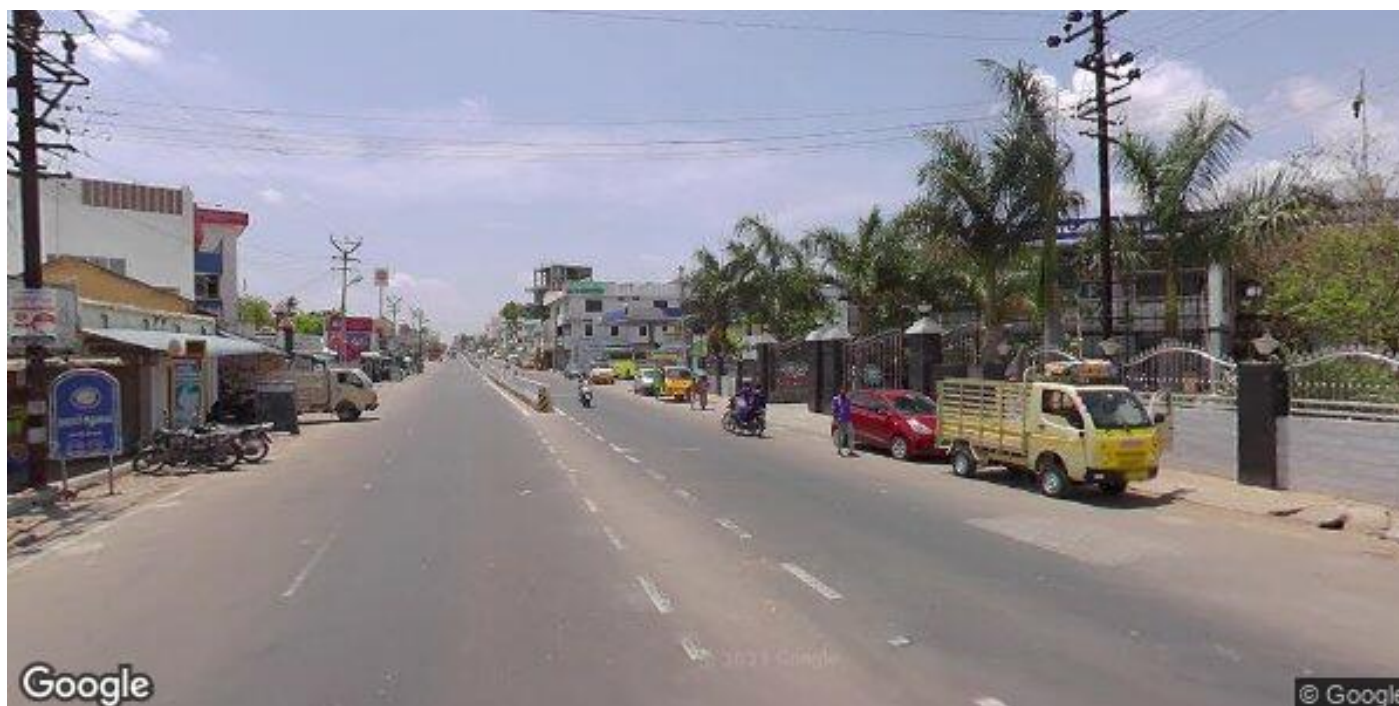
**Risk Type:** Blind Spot  
**Risk Level:** Blind Spot  
**Speed Limit:** 10 KM/Hr  
**Coordinates:** 11.22692, 78.16256

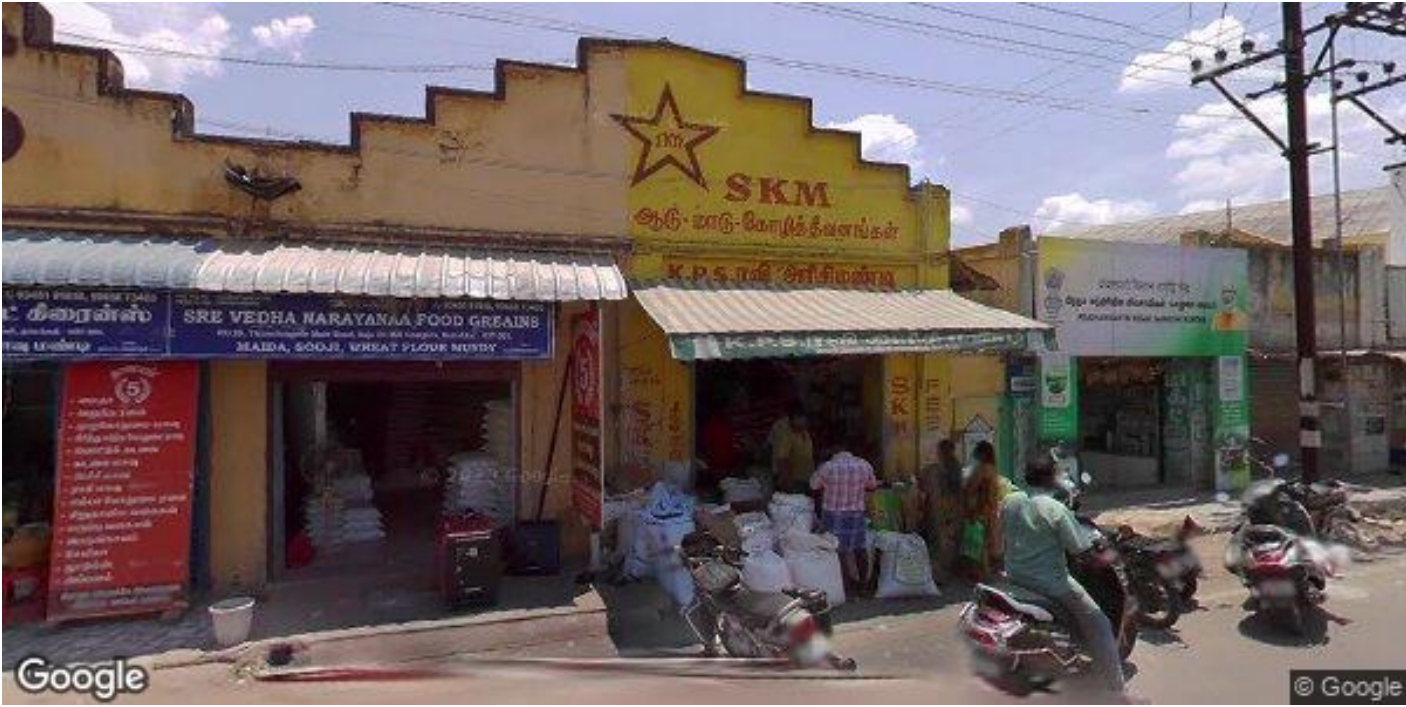
**Risk Type:** Turn  
**Risk Level:** High  
**Speed Limit:** 15 KM/Hr  
**Coordinates:** 11.22688, 78.16250
