## **JOURNEY RISK MANAGEMENT (JRM) STUDY**

### **Salem Terminal To SHIVA MUTHUKUMAR PETROLEUMS**

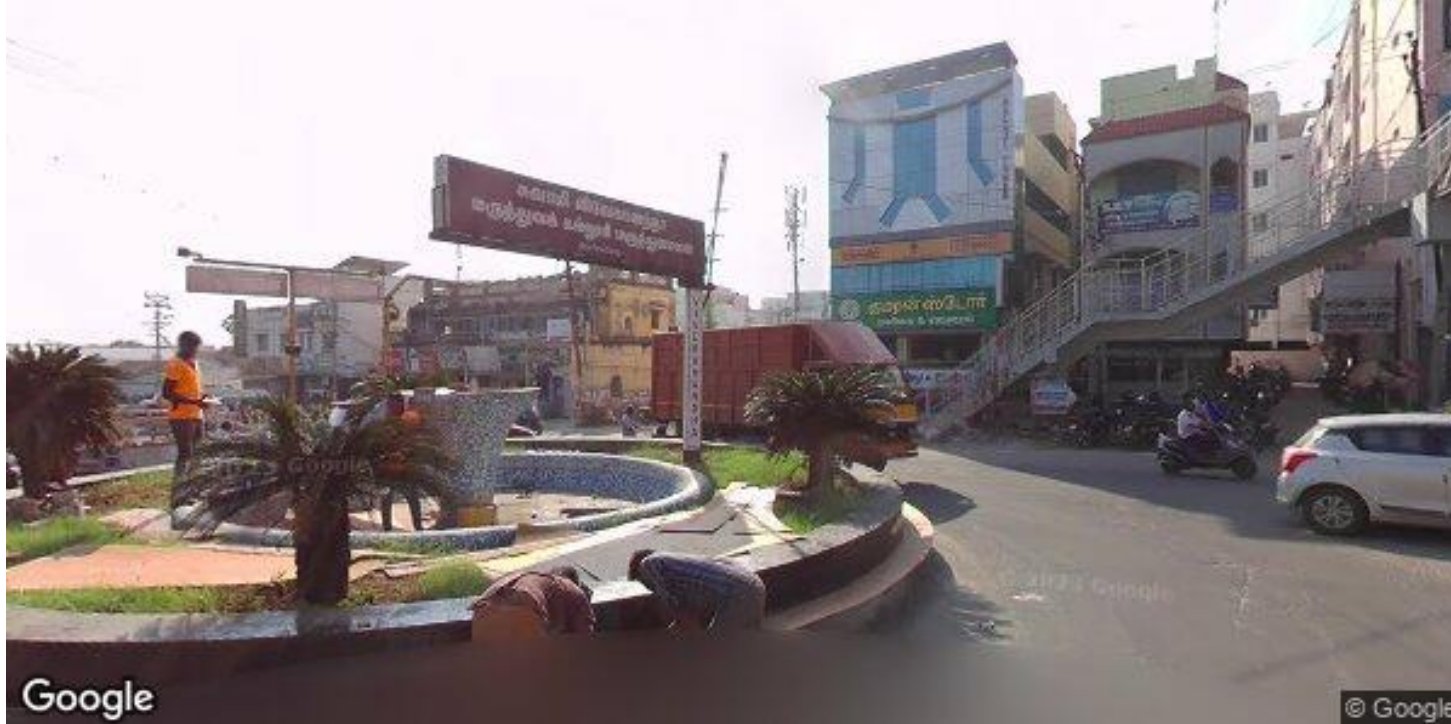
**Risk Type:** Roundabout  
**Risk Level:** High  
**Speed Limit:** 15 KM/Hr  
**Coordinates:** 11.38395, 77.89480

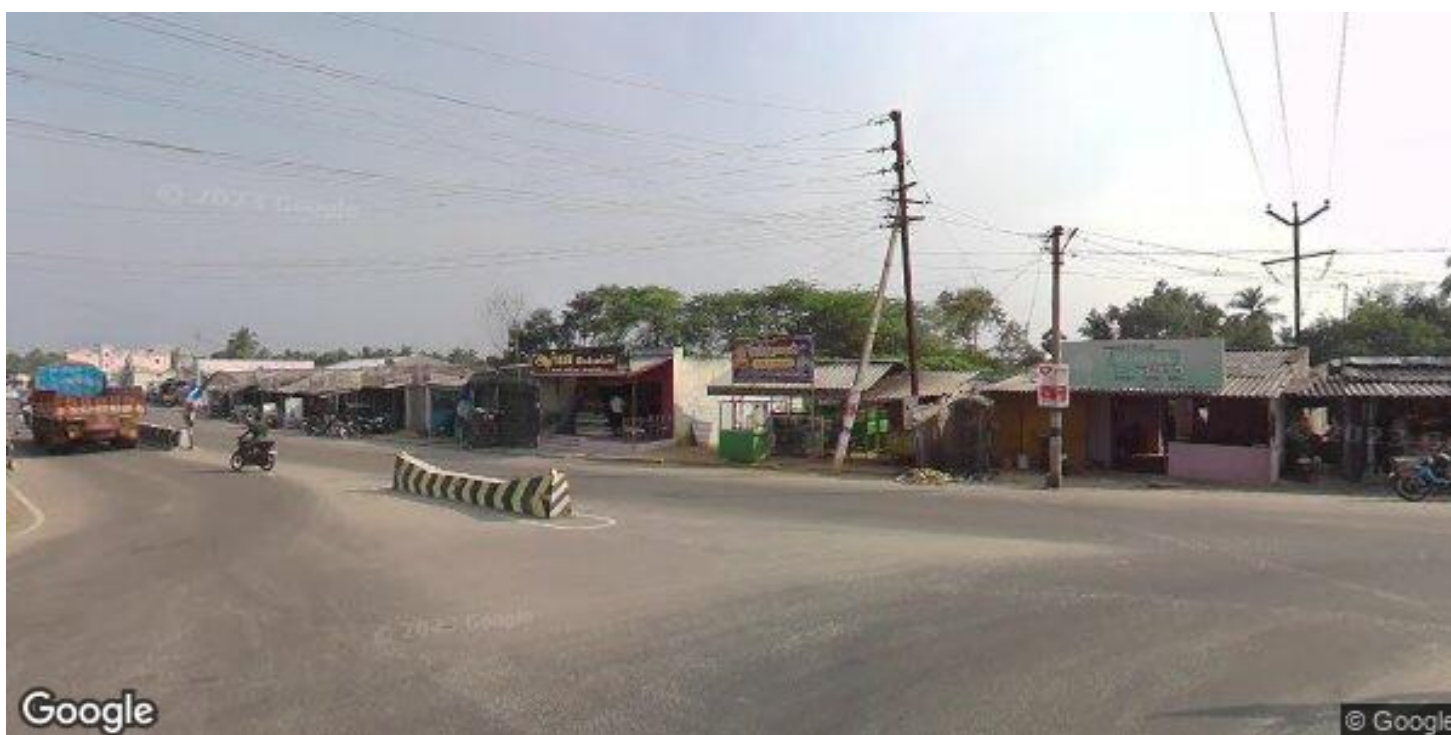
**Risk Type:** Roundabout  
**Risk Level:** High  
**Speed Limit:** 15 KM/Hr  
**Coordinates:** 11.04637, 77.73761

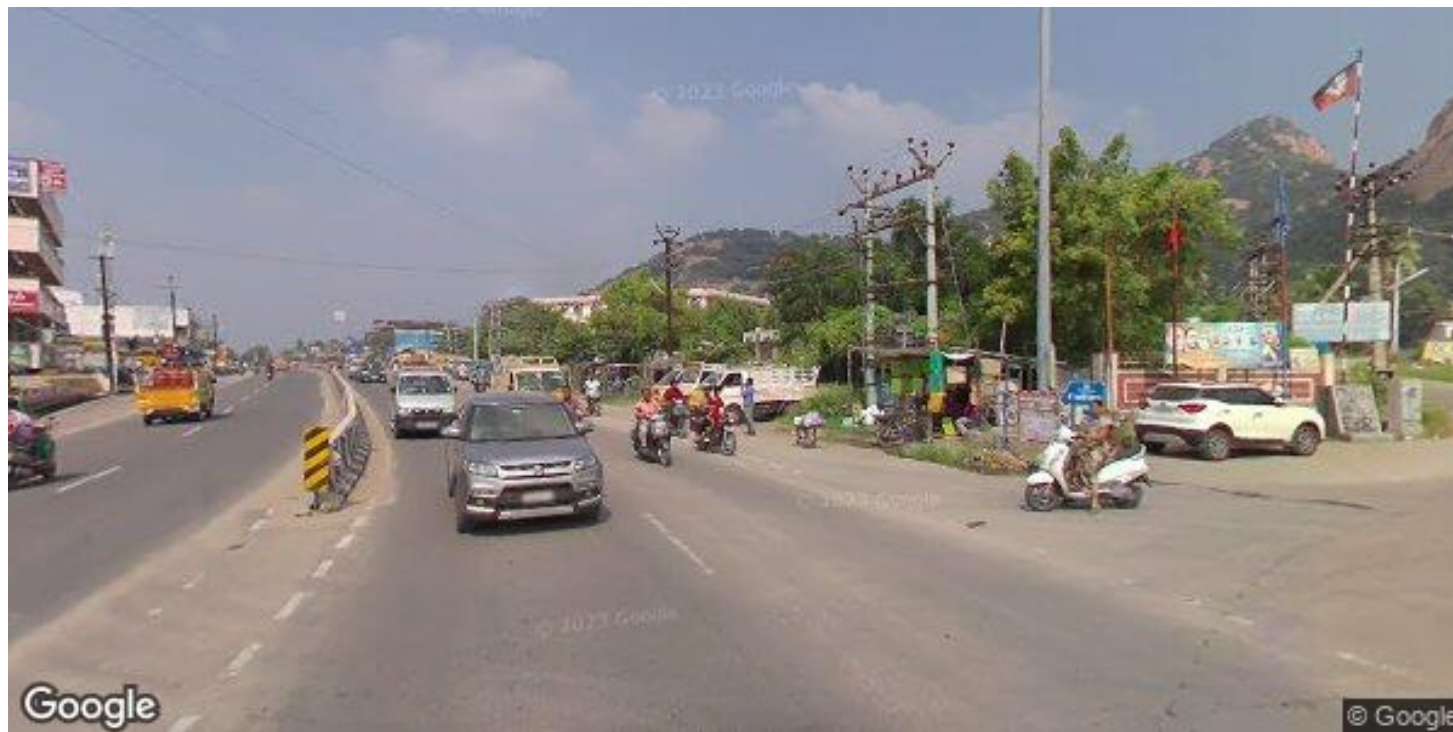
**Risk Type: Turn**

**Risk Level: Medium**

**Speed Limit: 30 KM/Hr**

**Coordinates: 11.39671, 77.88878**

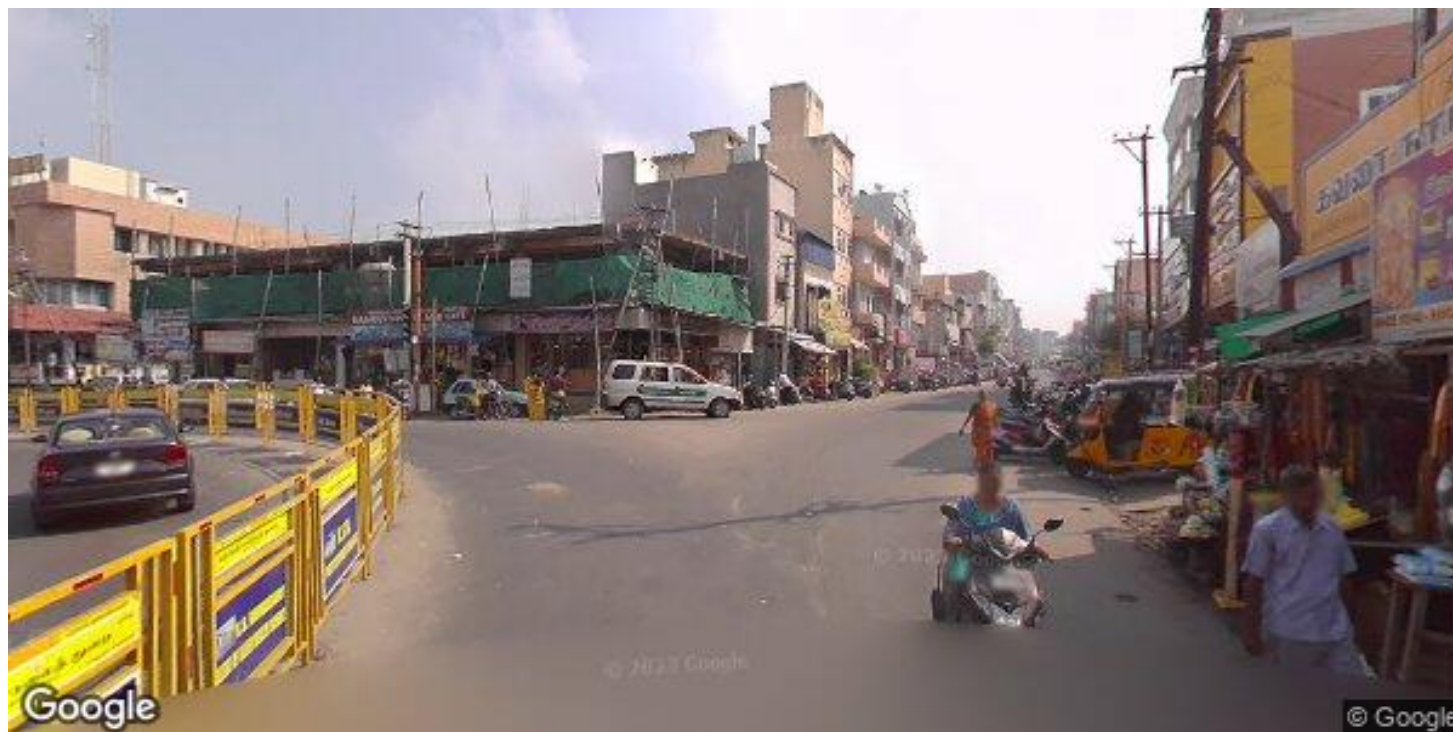
**Risk Type: Turn**

**Risk Level: High**

**Speed Limit: 15 KM/Hr**

**Coordinates: 11.37862, 77.89488**

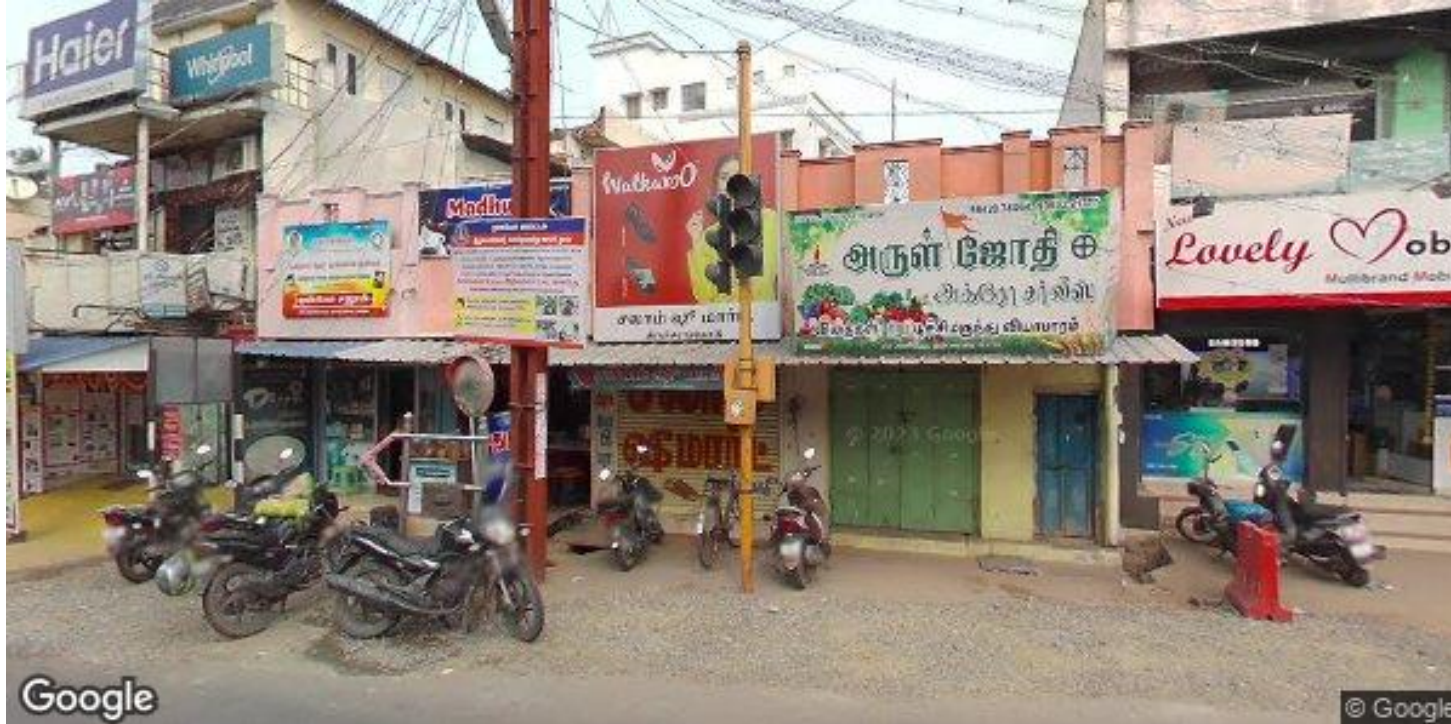
Risk Type: Turn

Risk Level: High

Speed Limit: 15 KM/Hr

Coordinates: 11.37850, 77.89453

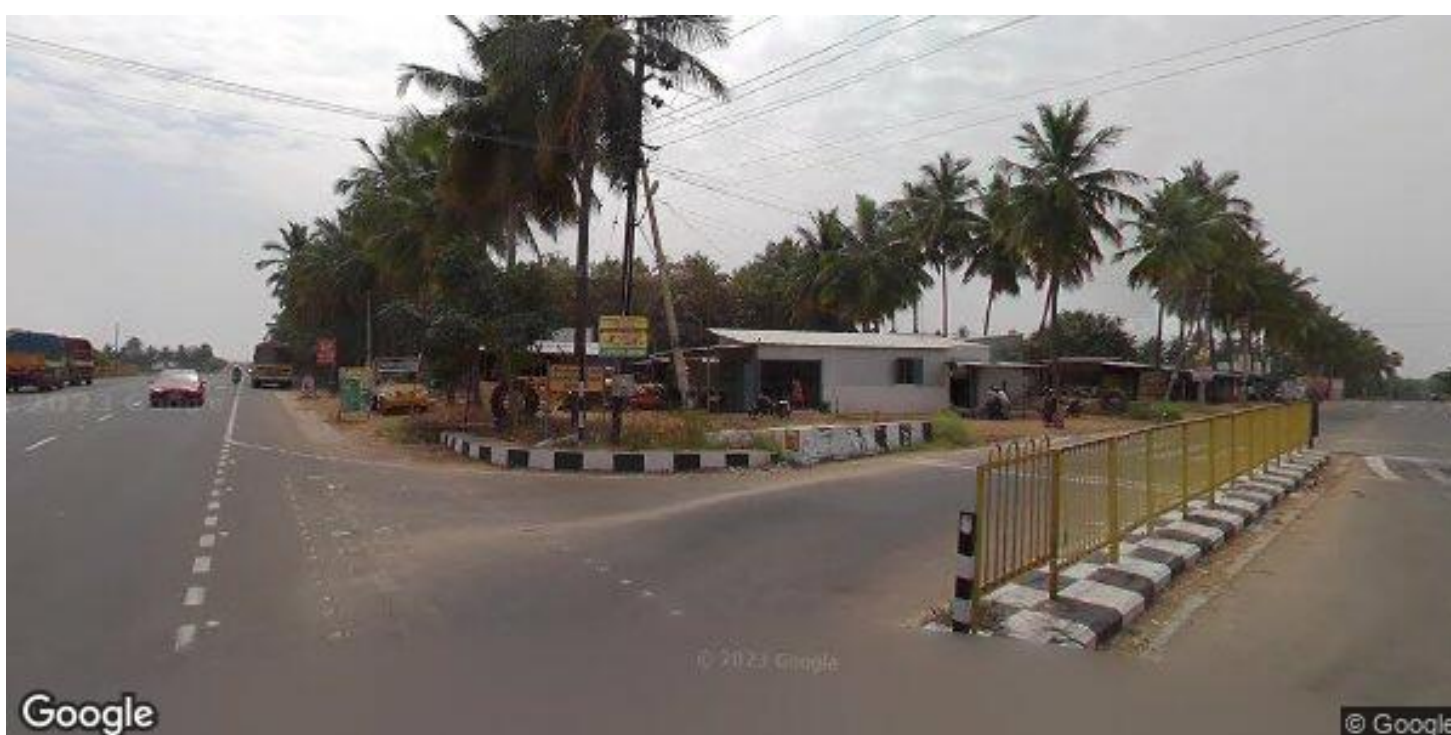
Risk Type: Turn

Risk Level: High

Speed Limit: 15 KM/Hr

Coordinates: 11.30859, 77.92918

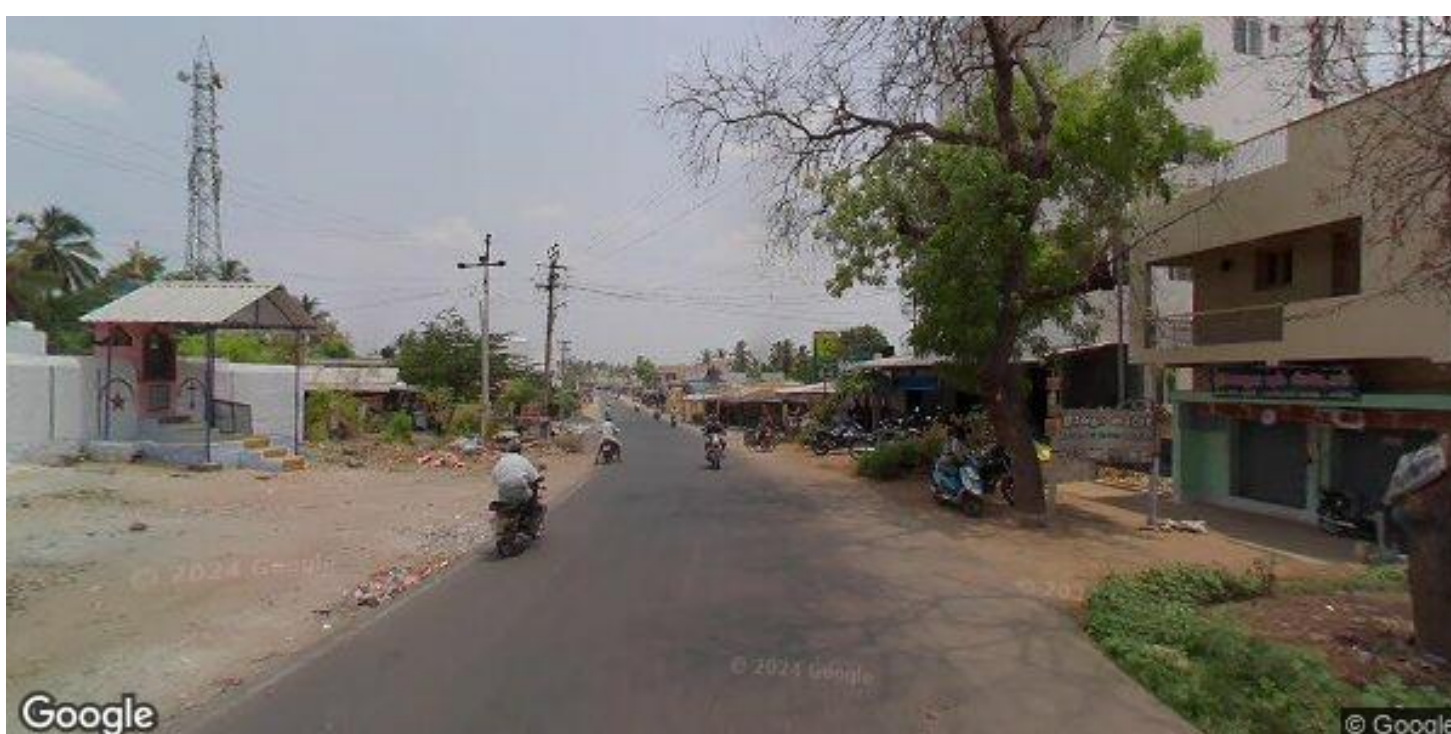
Risk Type: Turn

Risk Level: Medium

**Speed Limit: 30 KM/Hr**

**Coordinates: 11.24421, 77.87541**

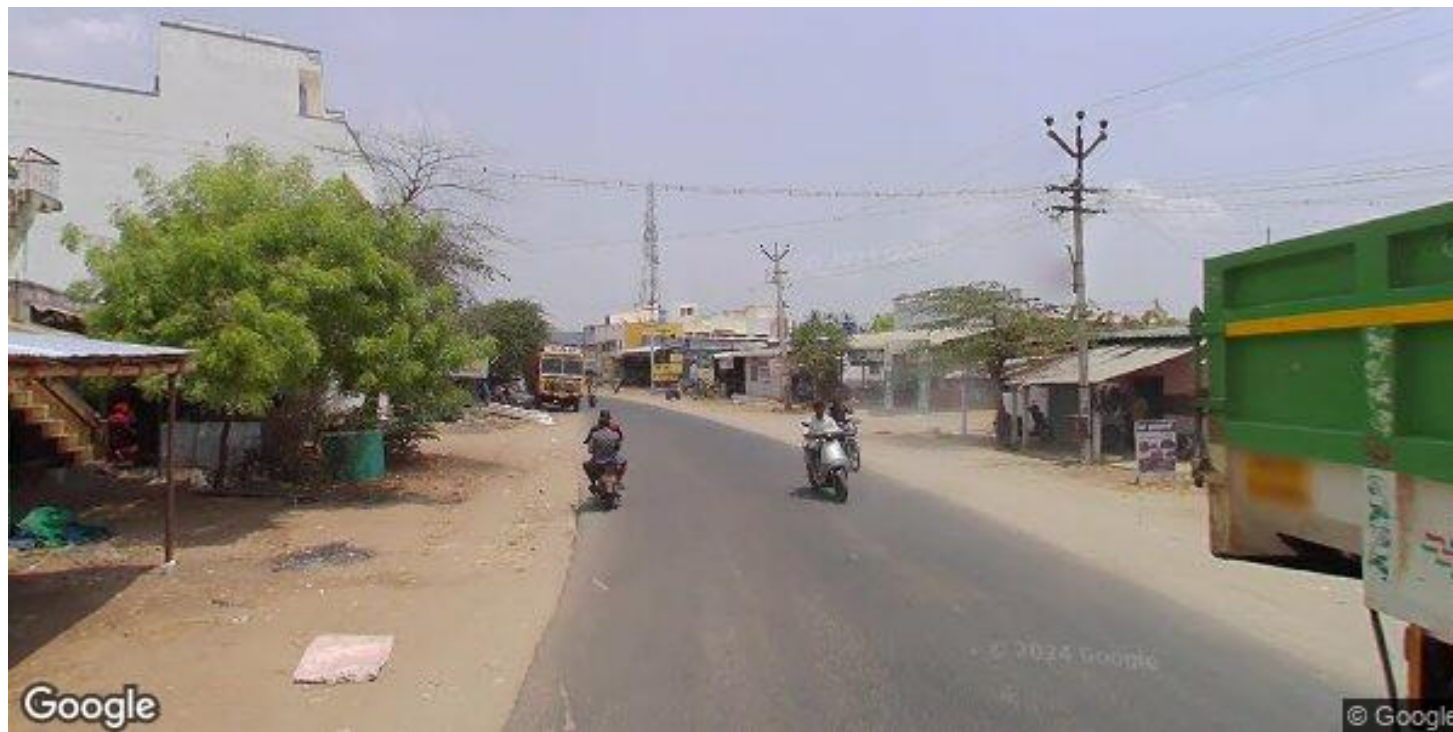
**Risk Type: Turn**

**Risk Level: Medium**

**Speed Limit: 30 KM/Hr**

**Coordinates: 11.24192, 77.87363**

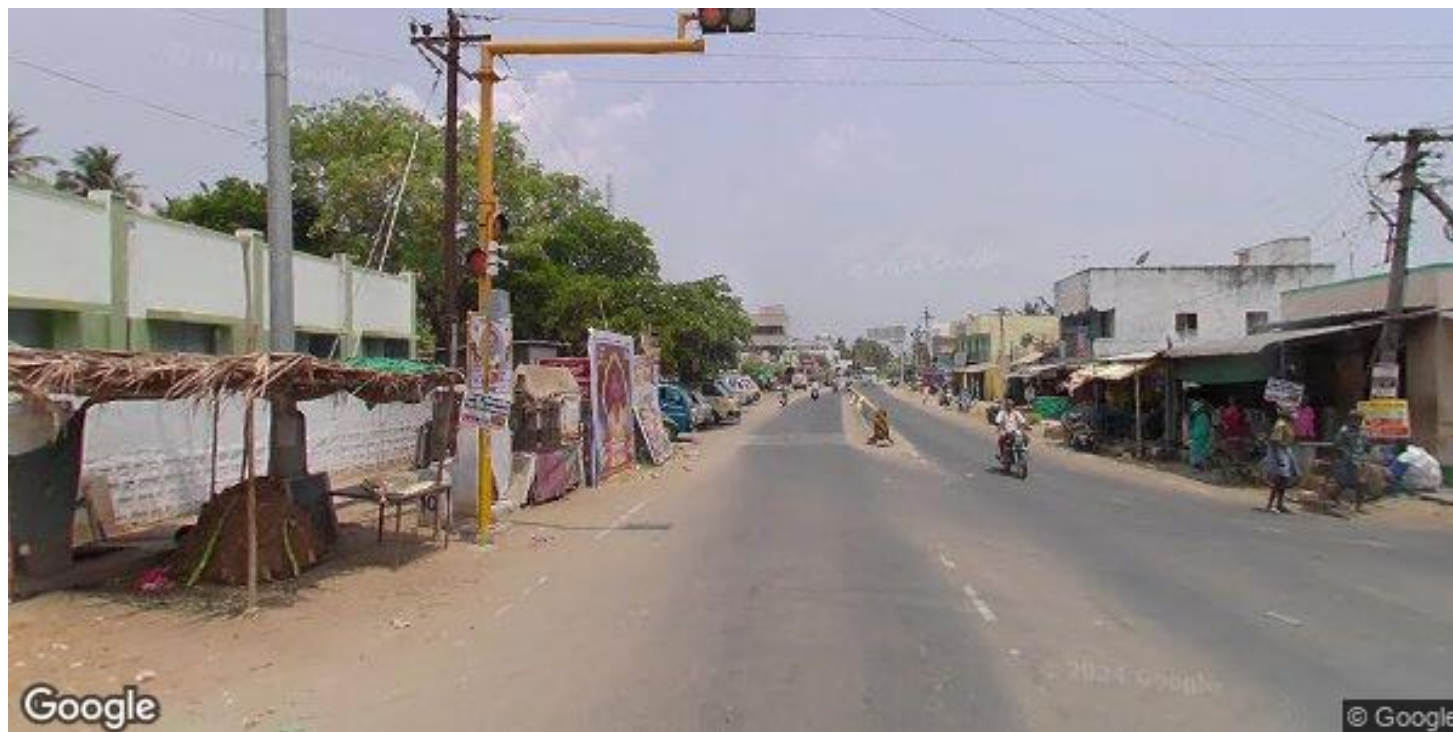
**Risk Type: Turn**

**Risk Level: High**

**Speed Limit: 15 KM/Hr**

**Coordinates: 11.24001, 77.87368**

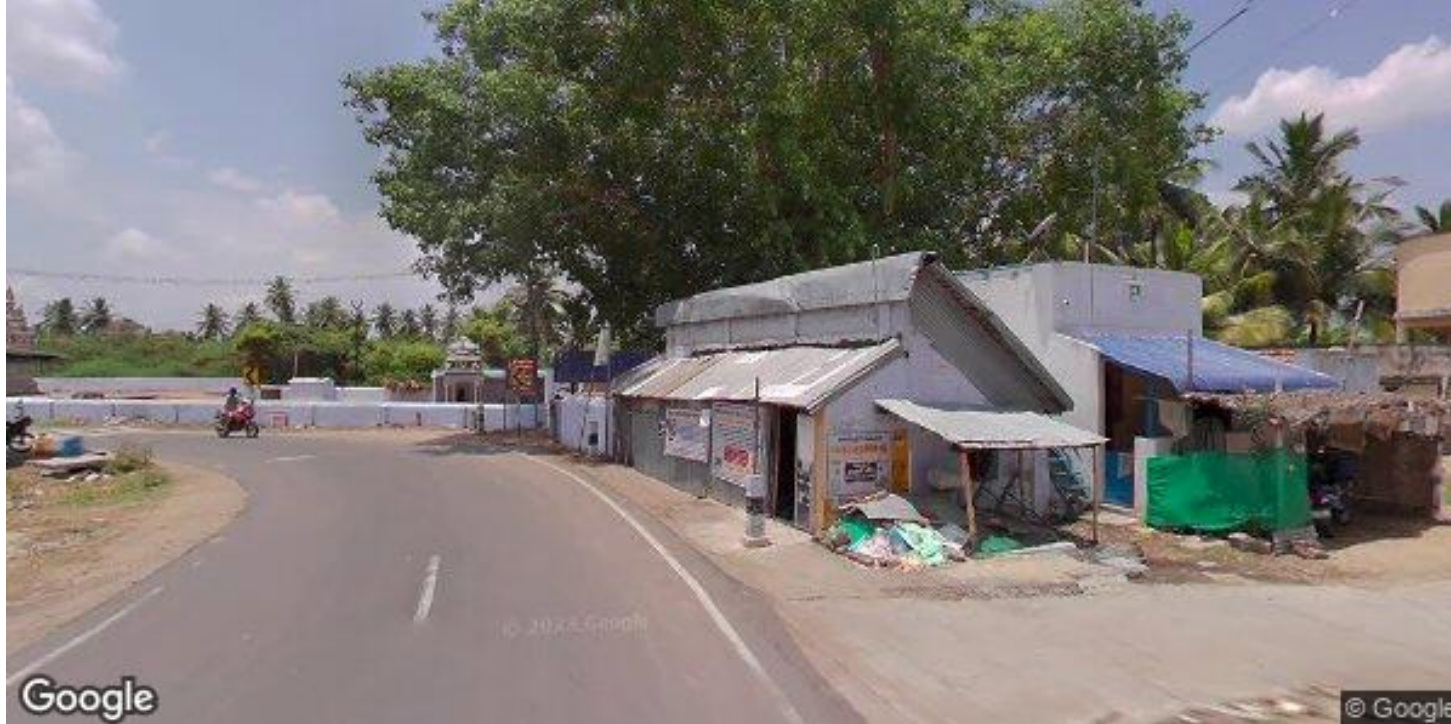
**Risk Type:** Turn

**Risk Level:** High

**Speed Limit:** 15 KM/Hr

**Coordinates:** 11.24061, 77.86899

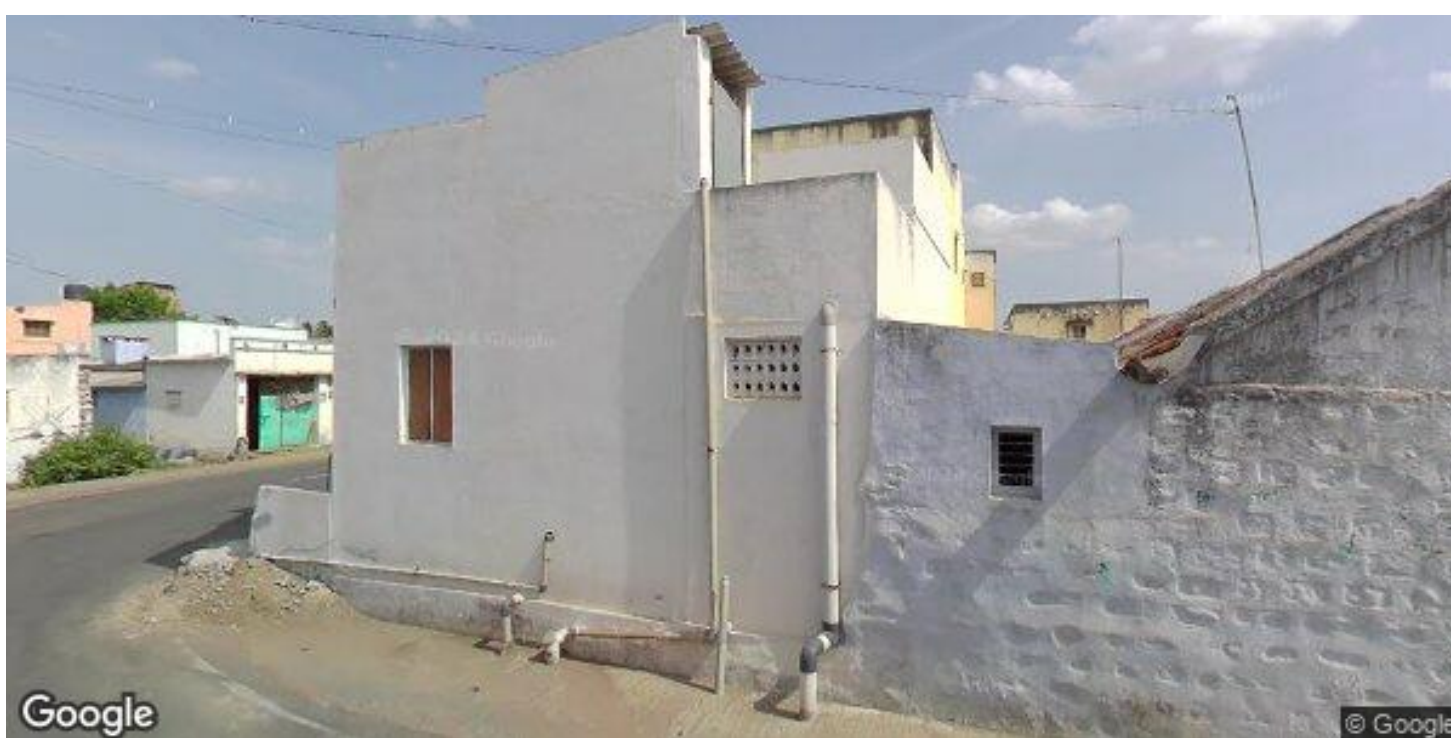
**Risk Type:** Turn

**Risk Level:** High

**Speed Limit:** 15 KM/Hr

**Coordinates:** 11.24155, 77.86877

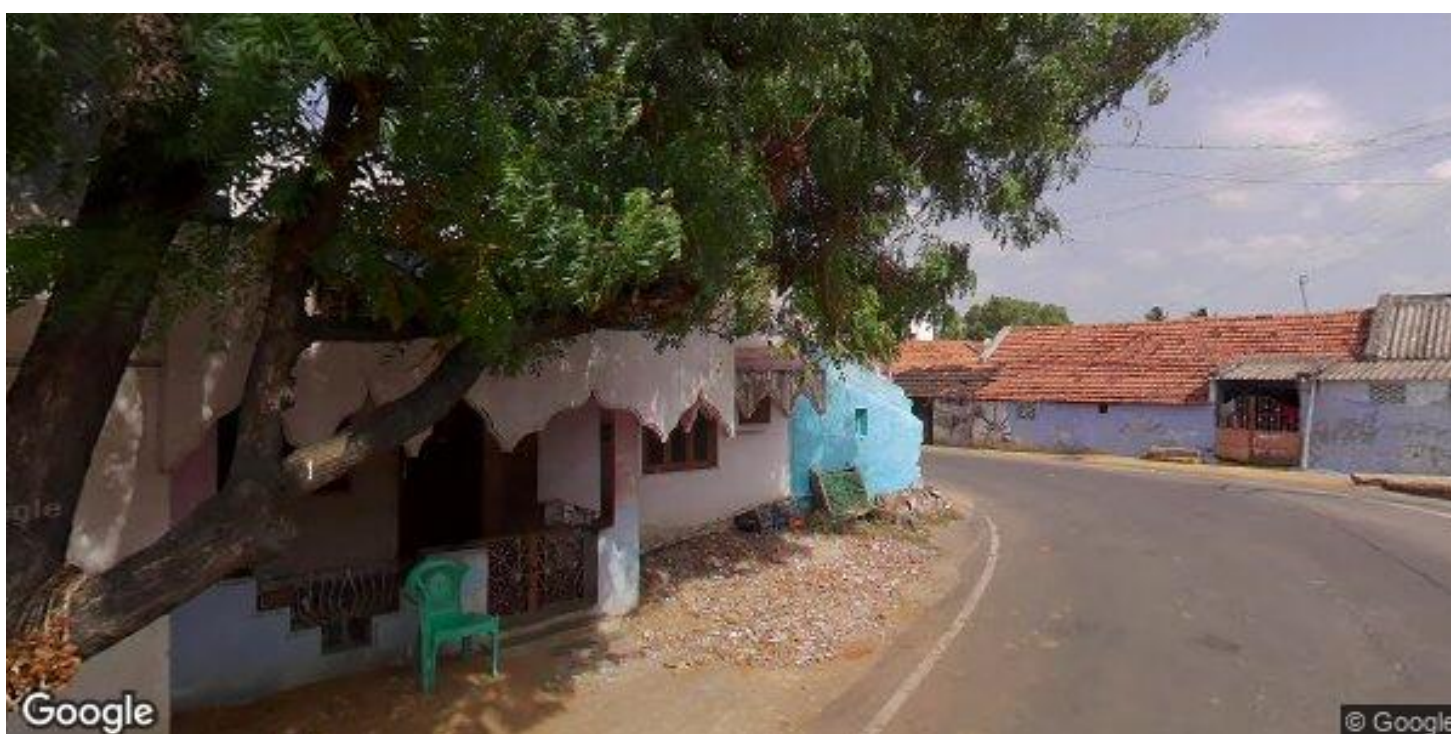
**Risk Type:** Turn

**Risk Level:** High

Speed Limit: 15 KM/Hr

Coordinates: 11.24166, 77.86845

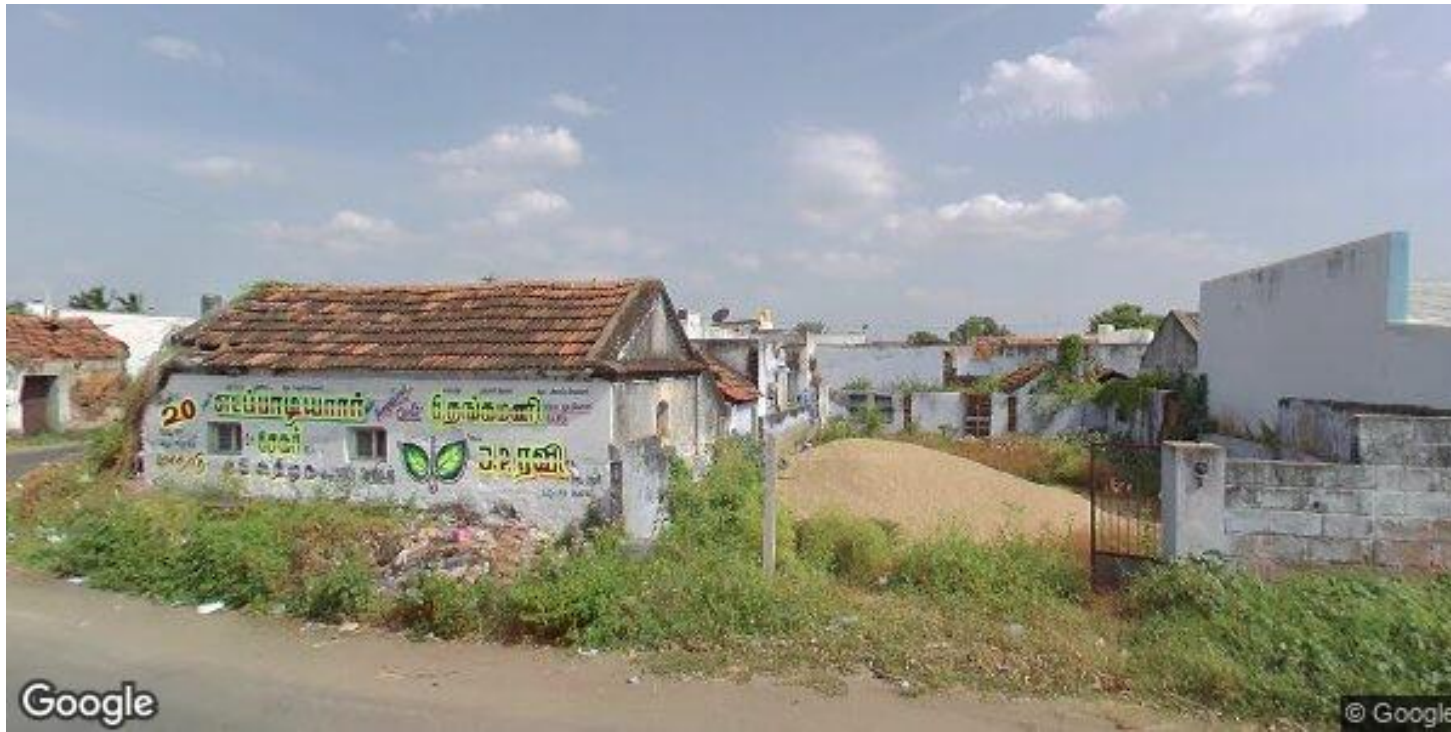
Risk Type: Turn

Risk Level: High

Speed Limit: 15 KM/Hr

Coordinates: 11.24237, 77.86834

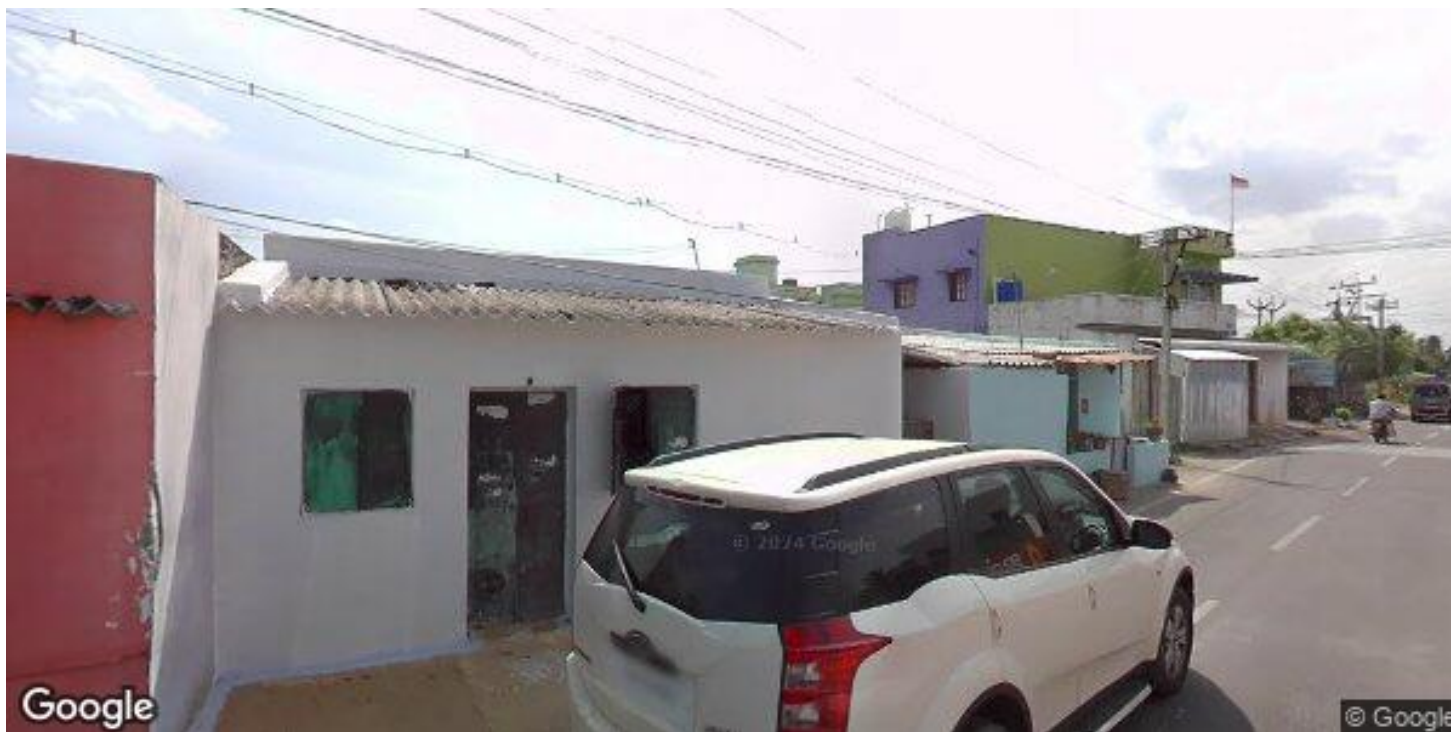
Risk Type: Turn

Risk Level: High

Speed Limit: 15 KM/Hr

Coordinates: 11.24250, 77.86784

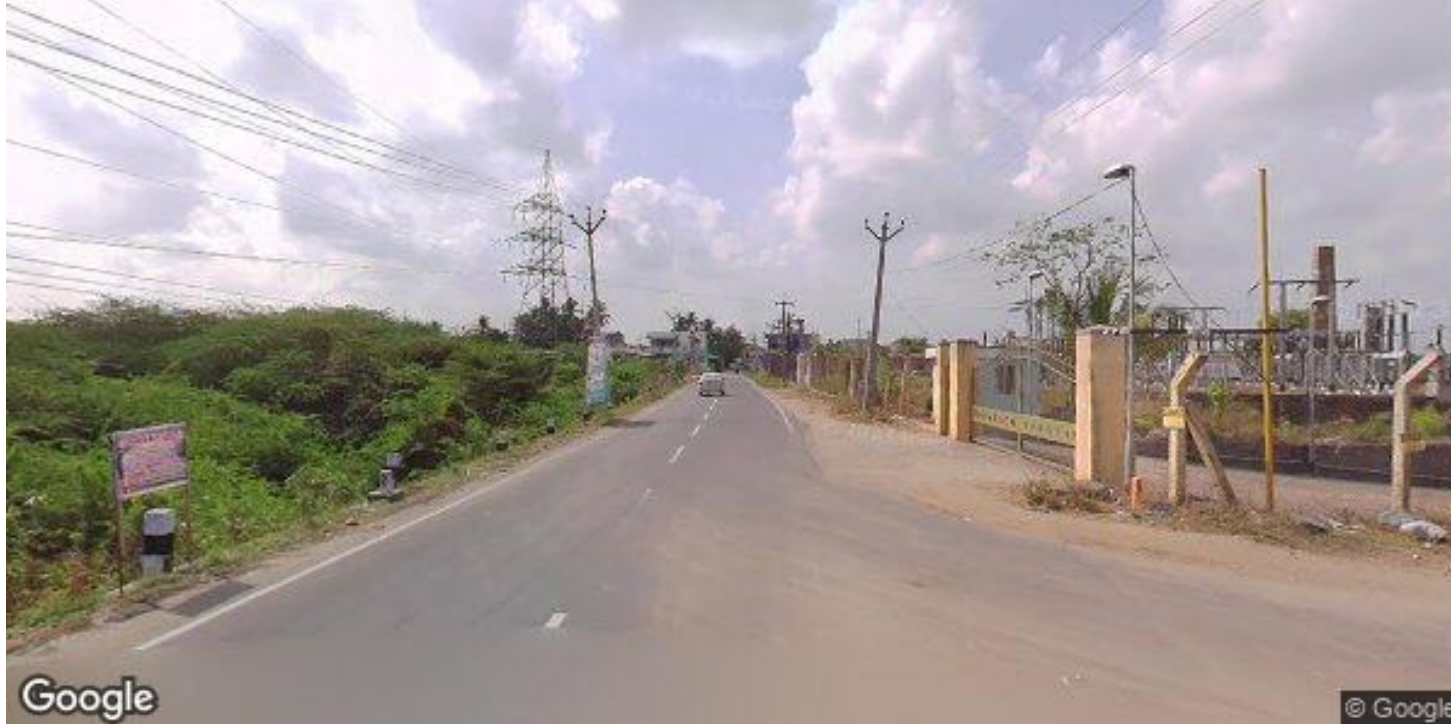
**Risk Type:** Blind Spot  
**Risk Level:** Blind Spot  
**Speed Limit:** 10 KM/Hr  
**Coordinates:** 11.24384, 77.86689

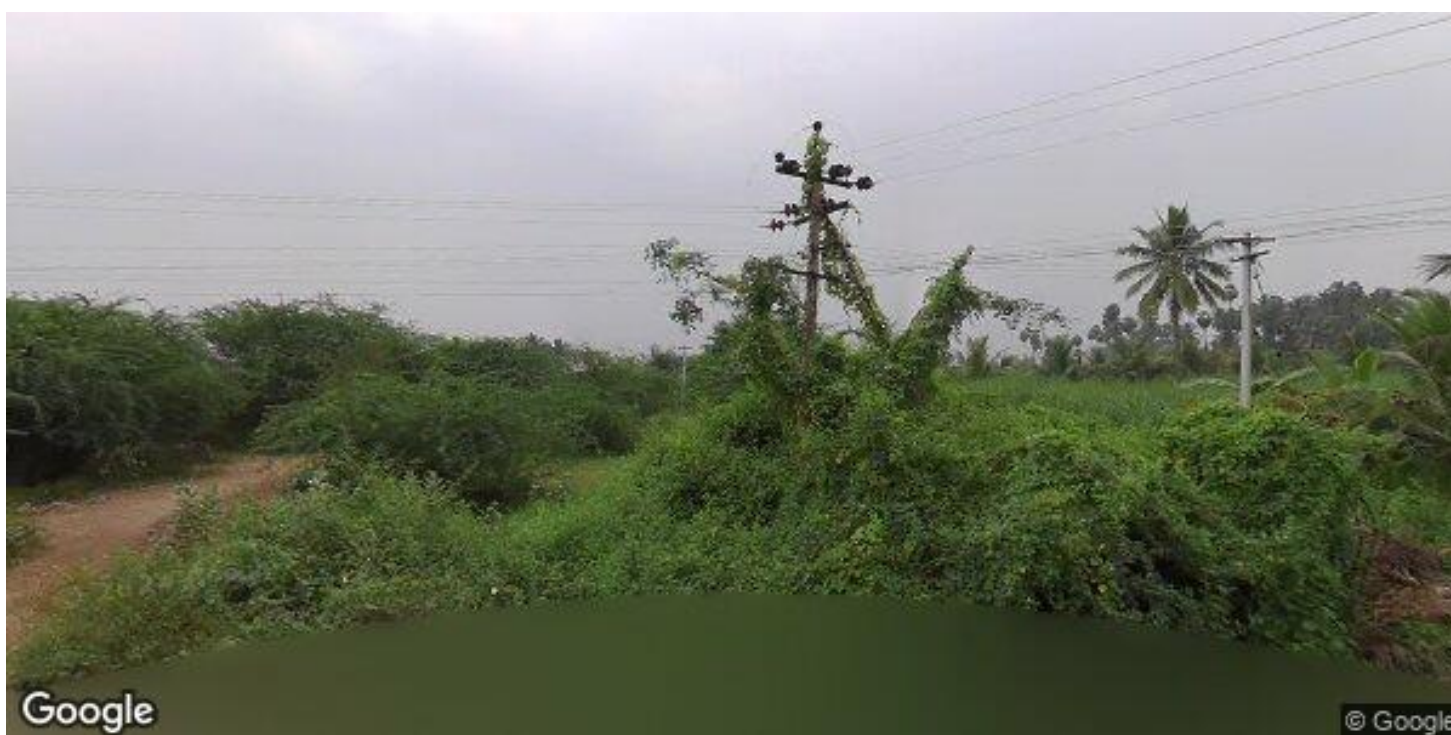
**Risk Type:** Turn  
**Risk Level:** High  
**Speed Limit:** 15 KM/Hr  
**Coordinates:** 11.24100, 77.86026

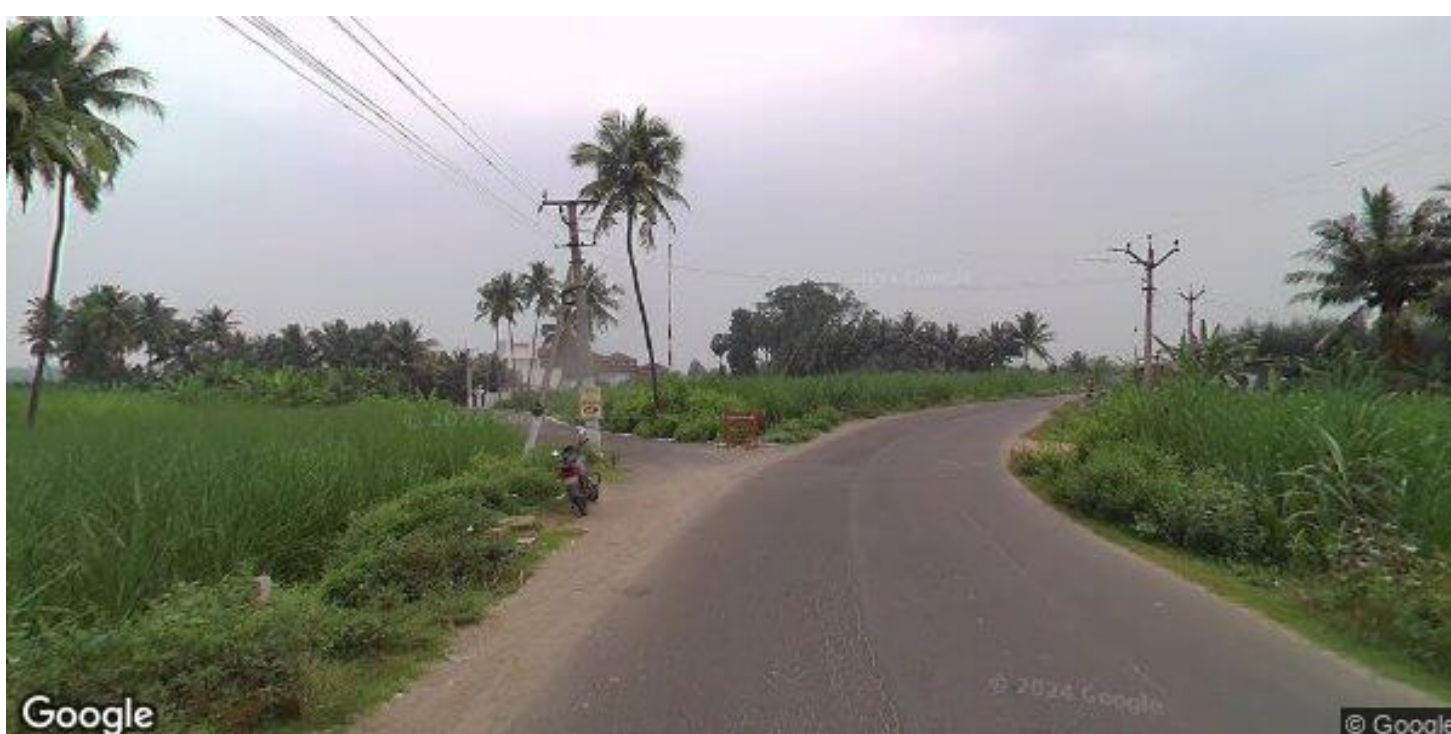
**Risk Type:** Turn  
**Risk Level:** Medium

**Speed Limit: 30 KM/Hr**

**Coordinates: 11.24197, 77.85898**

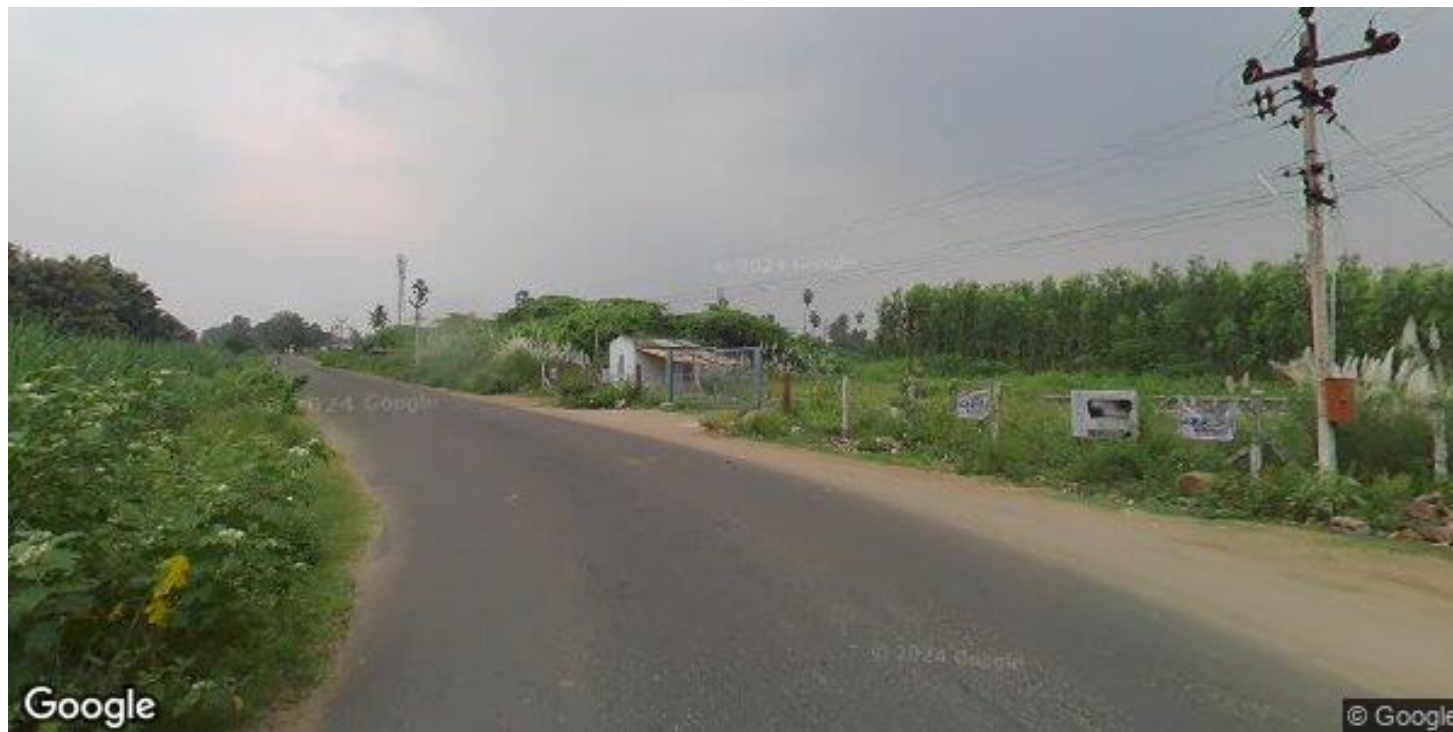
**Risk Type: Turn**

**Risk Level: Medium**

**Speed Limit: 30 KM/Hr**

**Coordinates: 11.24199, 77.85864**

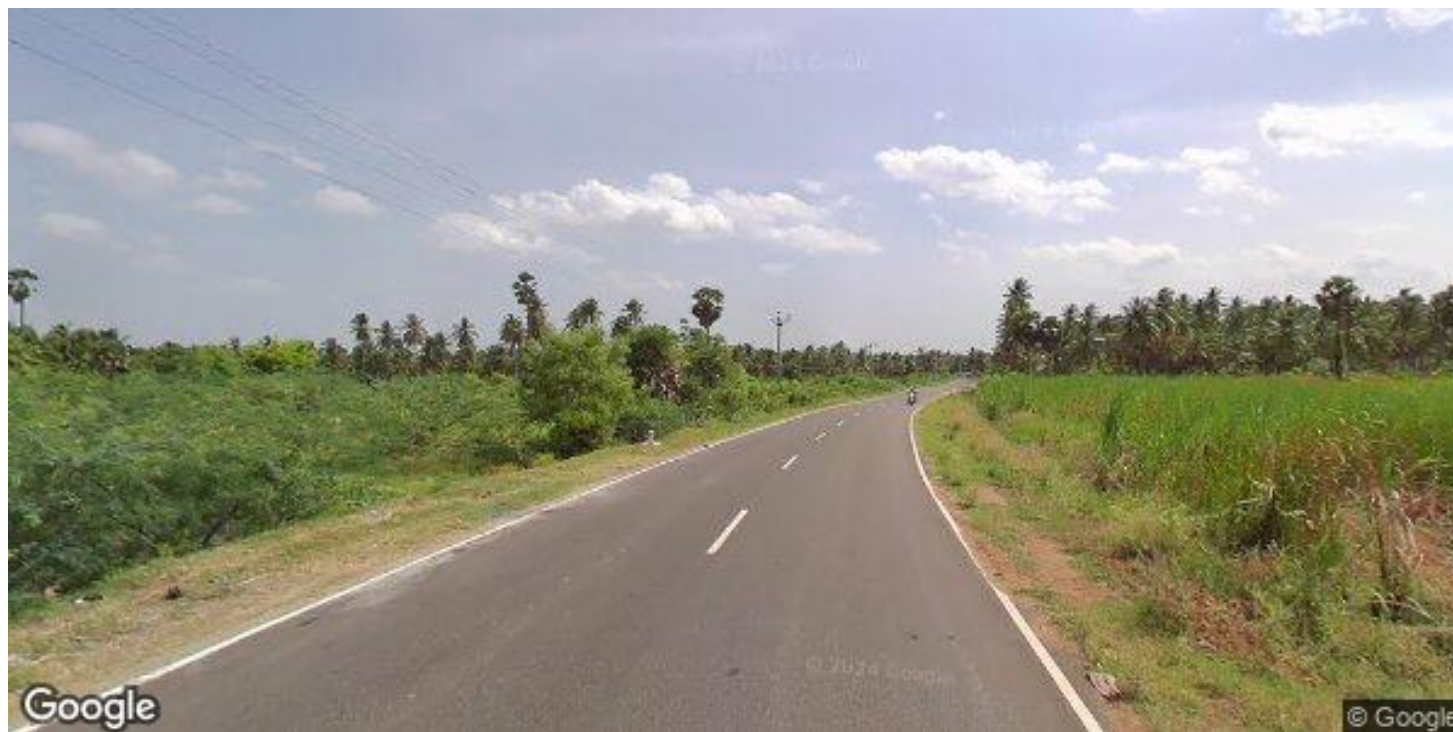
**Risk Type: Turn**

**Risk Level: Medium**

**Speed Limit: 30 KM/Hr**

**Coordinates: 11.20921, 77.81149**

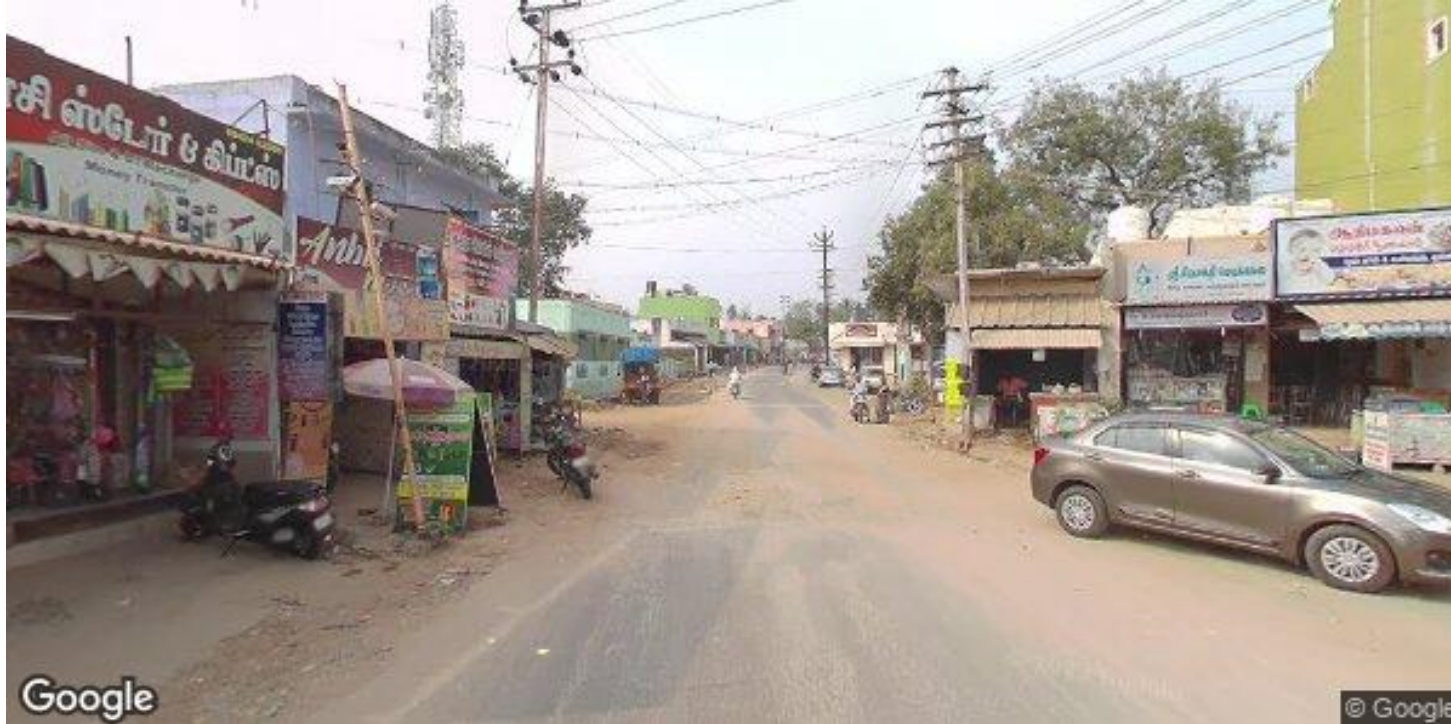
**Risk Type:** Blind Spot  
**Risk Level:** Blind Spot  
**Speed Limit:** 10 KM/Hr  
**Coordinates:** 11.18856, 77.77110

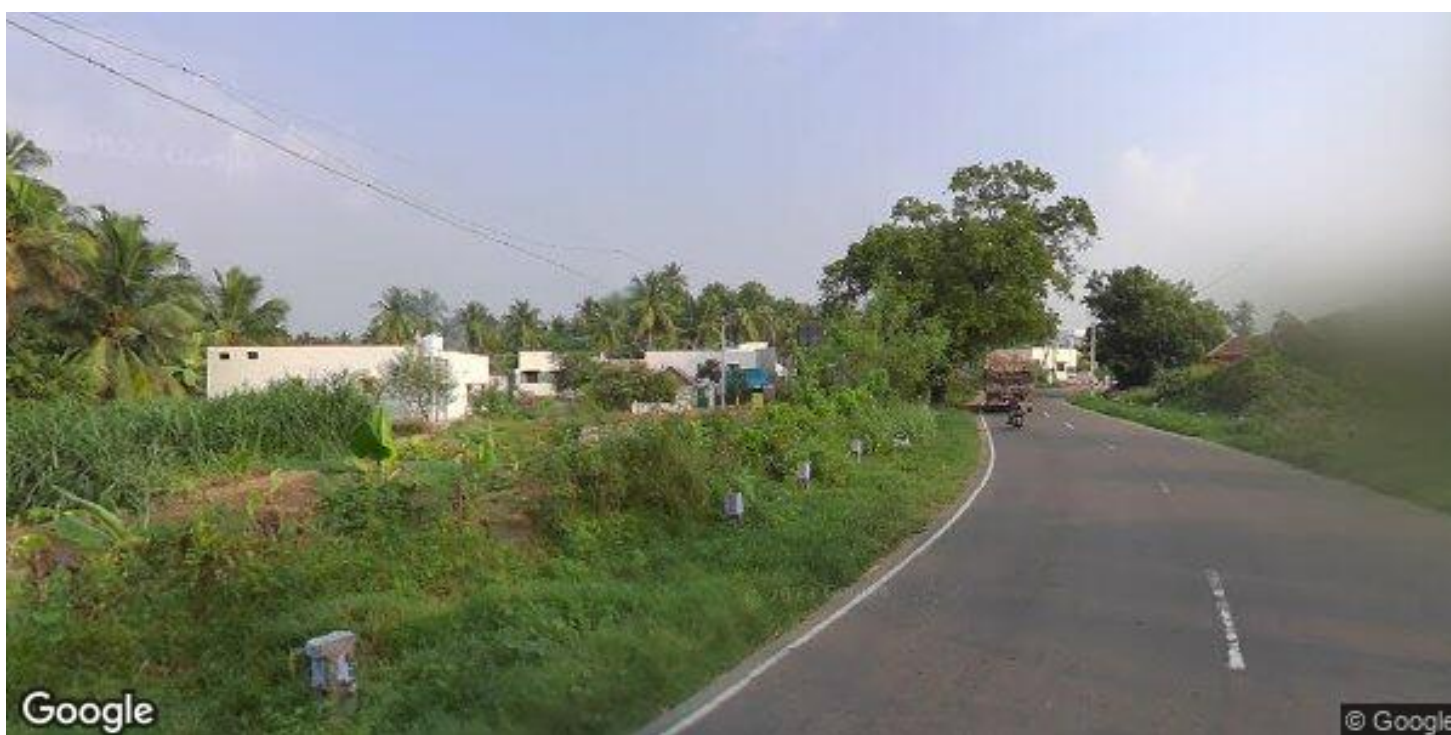
**Risk Type:** Turn  
**Risk Level:** Medium  
**Speed Limit:** 30 KM/Hr  
**Coordinates:** 11.16410, 77.77373
