## **JOURNEY RISK MANAGEMENT (JRM) STUDY**

### **Salem Terminal To SHIVA MUTHUKUMAR PETROLEUMS**

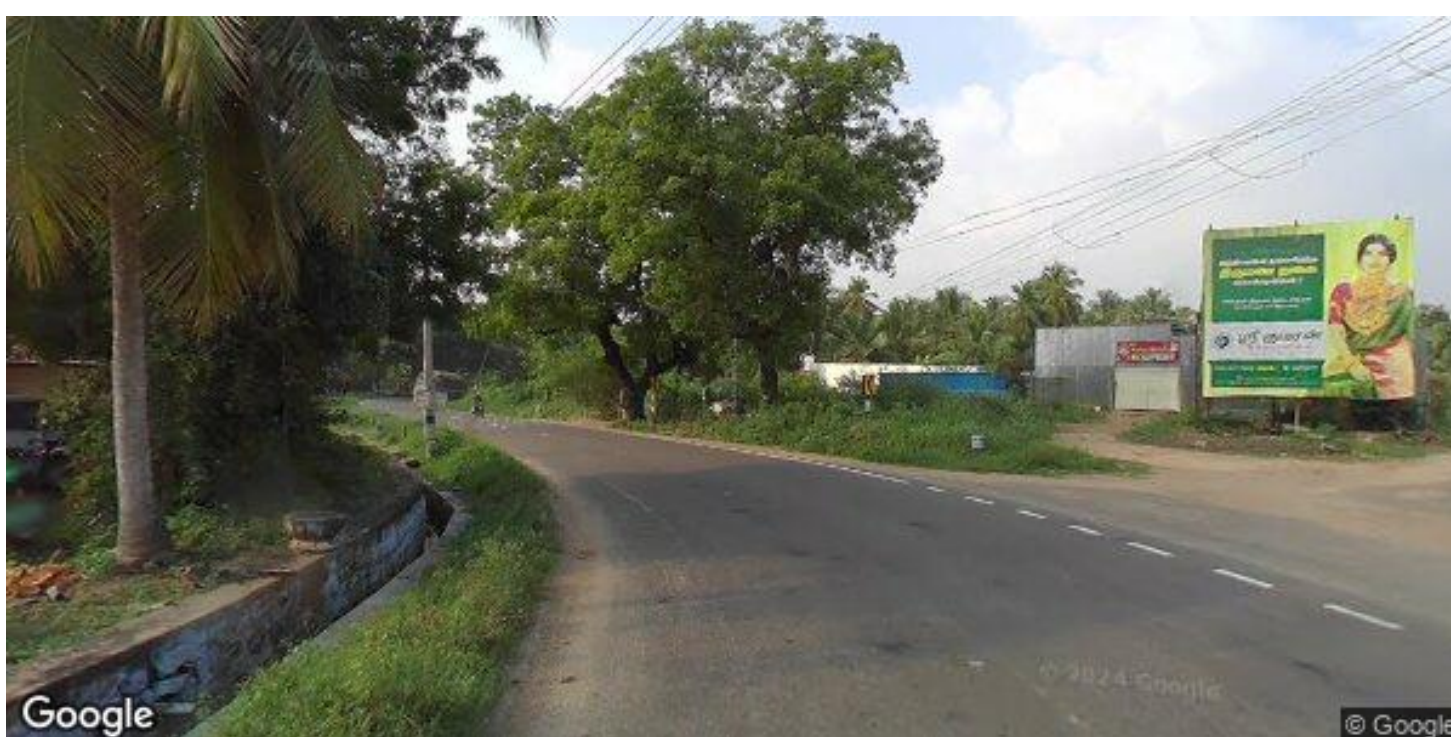
**Risk Type:** Turn  
**Risk Level:** Medium

Speed Limit: 30 KM/Hr

Coordinates: 11.16359, 77.77433

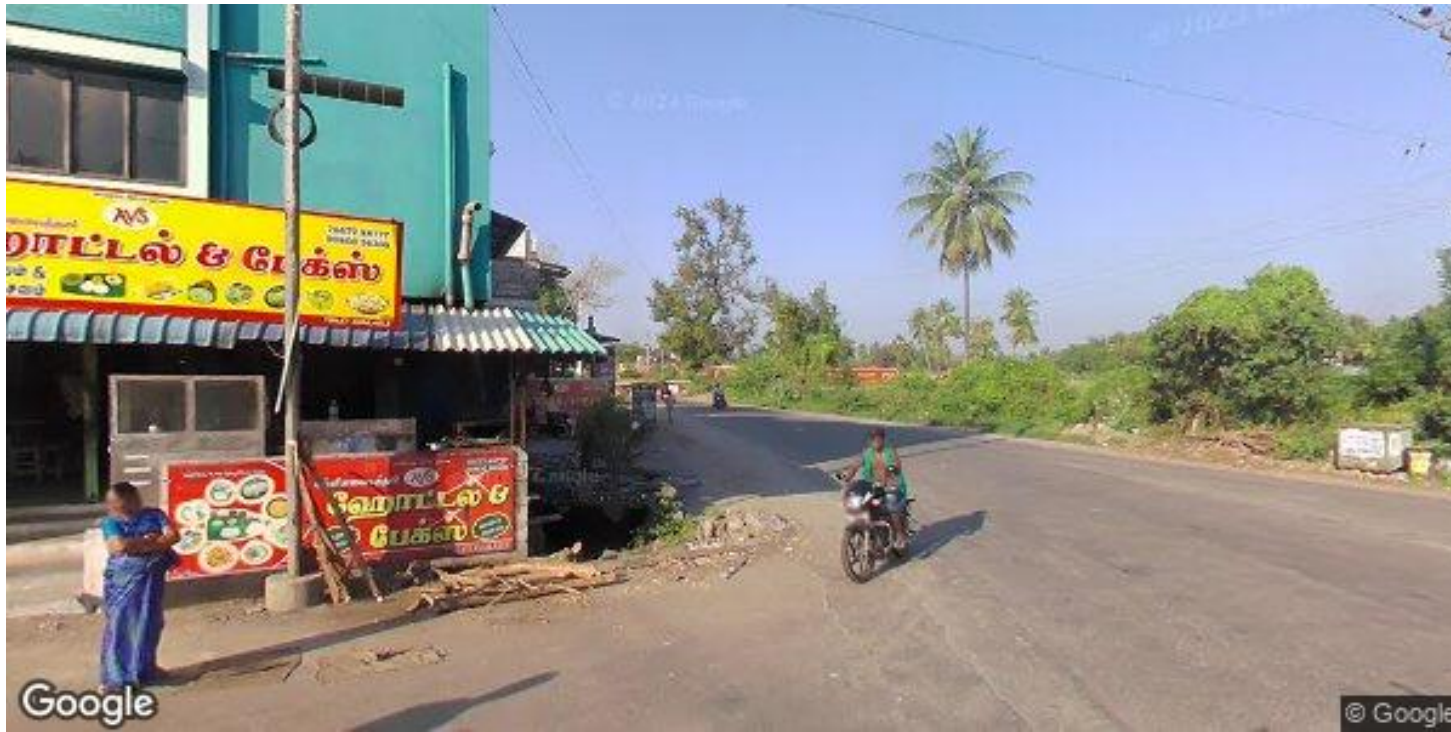
Risk Type: Turn

Risk Level: Medium

Speed Limit: 30 KM/Hr

Coordinates: 11.13679, 77.76533

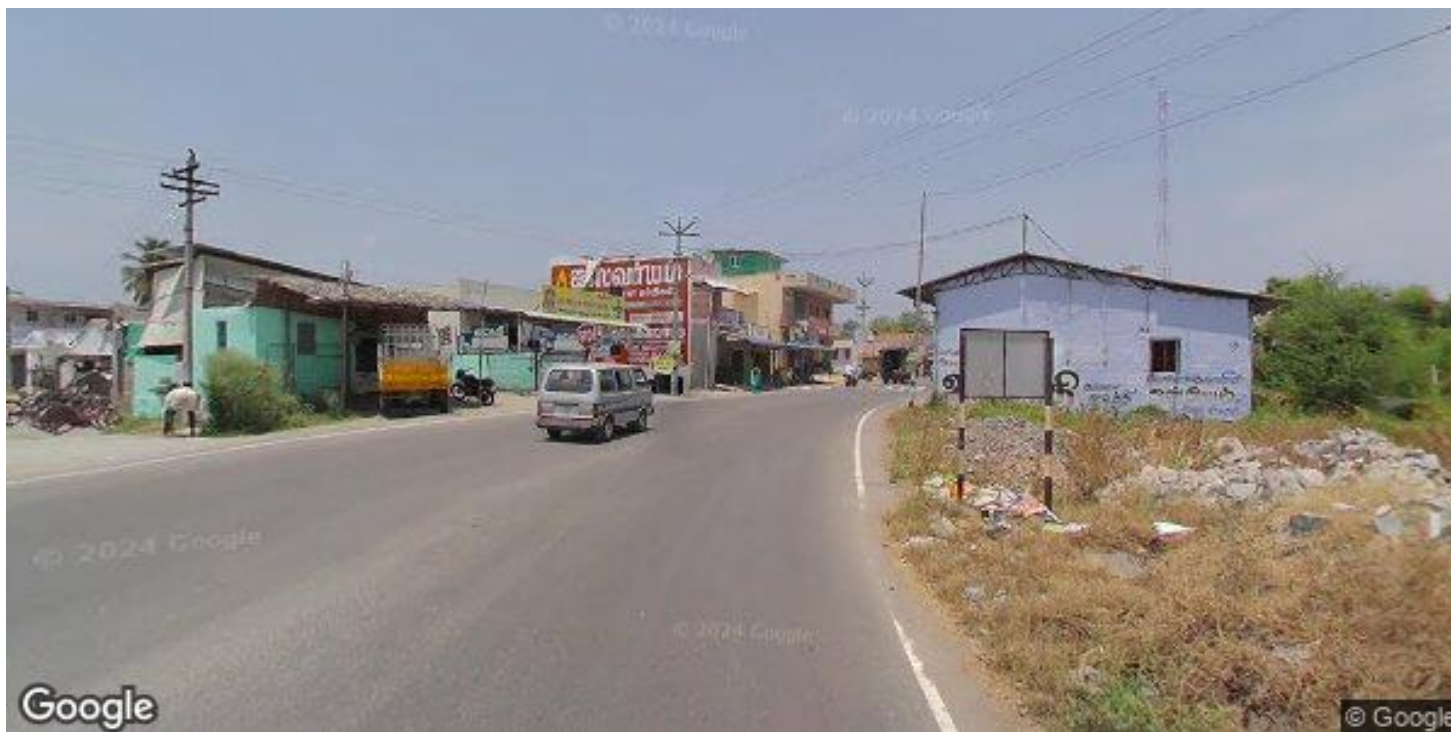
Risk Type: Turn

Risk Level: Medium

Speed Limit: 30 KM/Hr

Coordinates: 11.04708, 77.73744

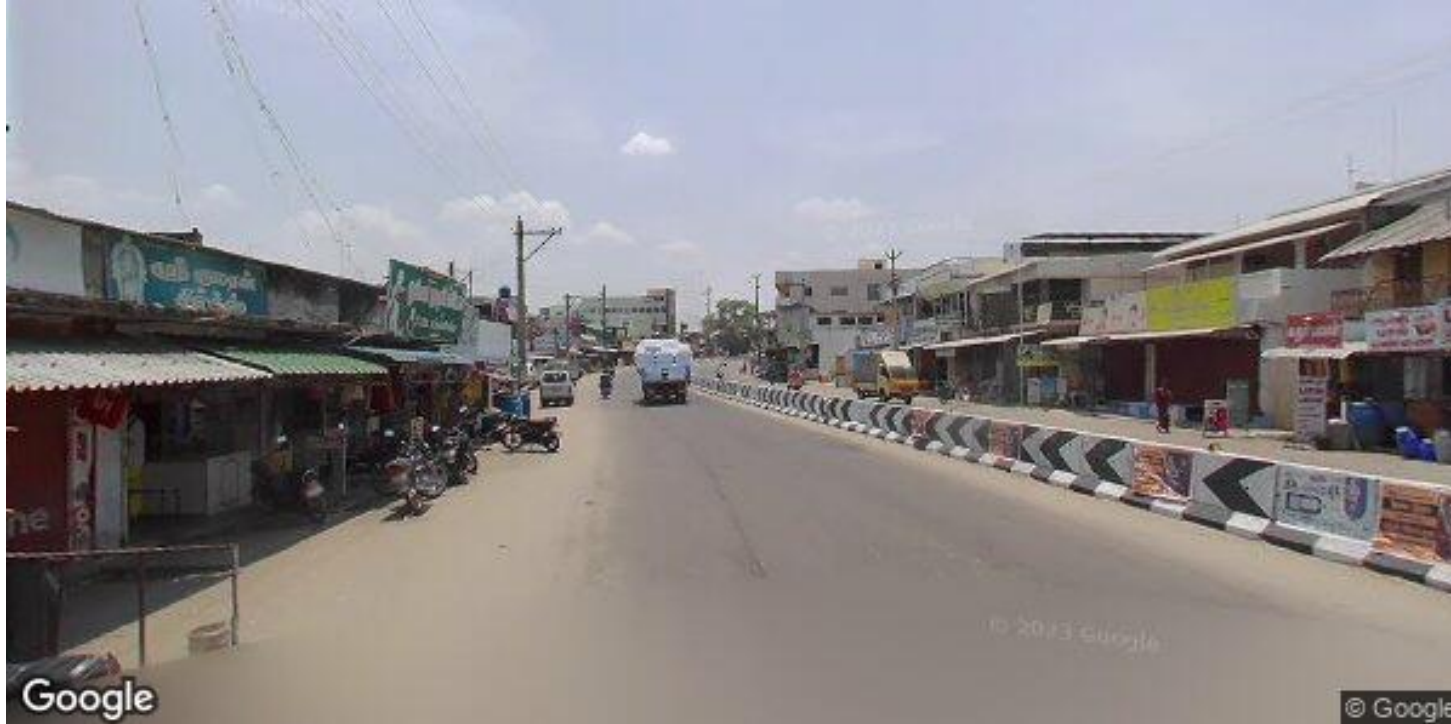
**Risk Type:** Turn

**Risk Level:** Medium

**Speed Limit:** 30 KM/Hr

**Coordinates:** 11.04497, 77.73624

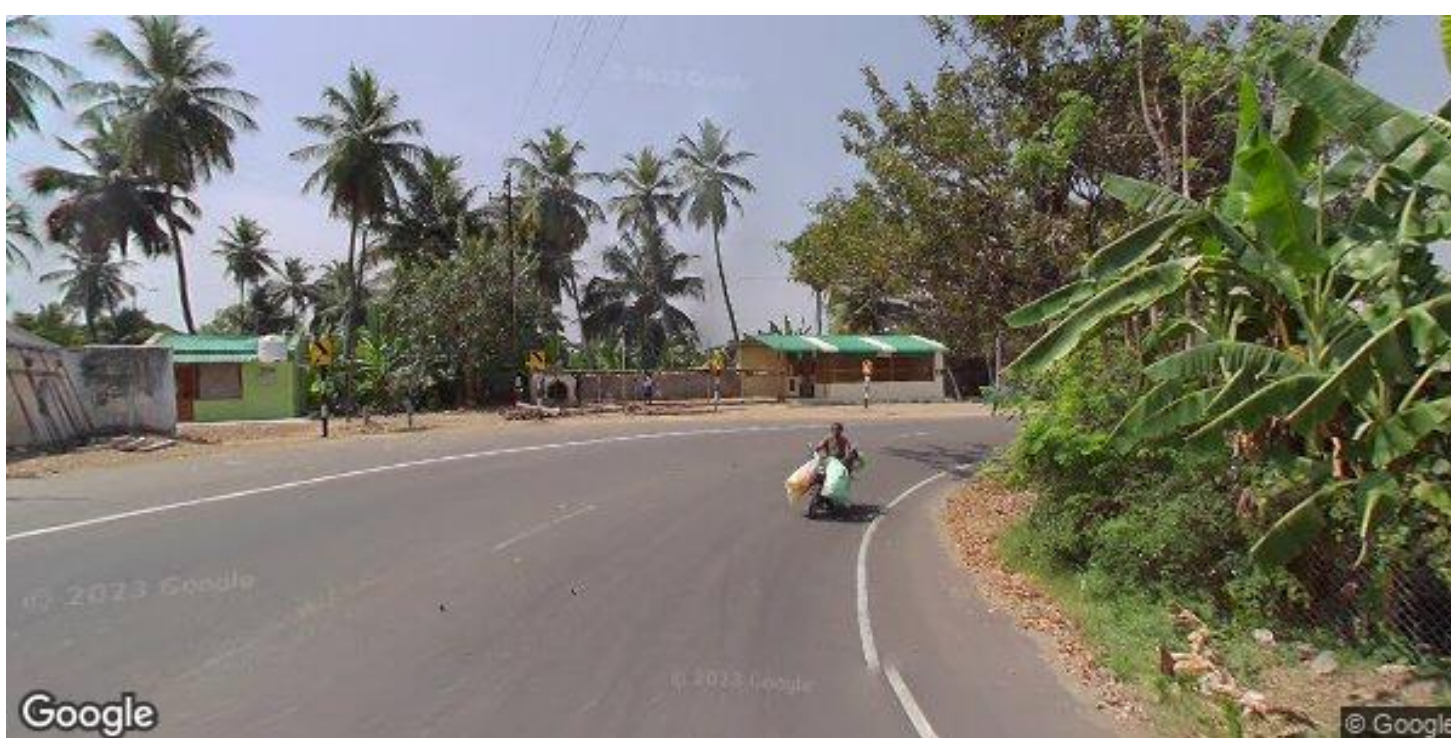
**Risk Type:** Turn

**Risk Level:** High

**Speed Limit:** 15 KM/Hr

**Coordinates:** 10.99033, 77.72516

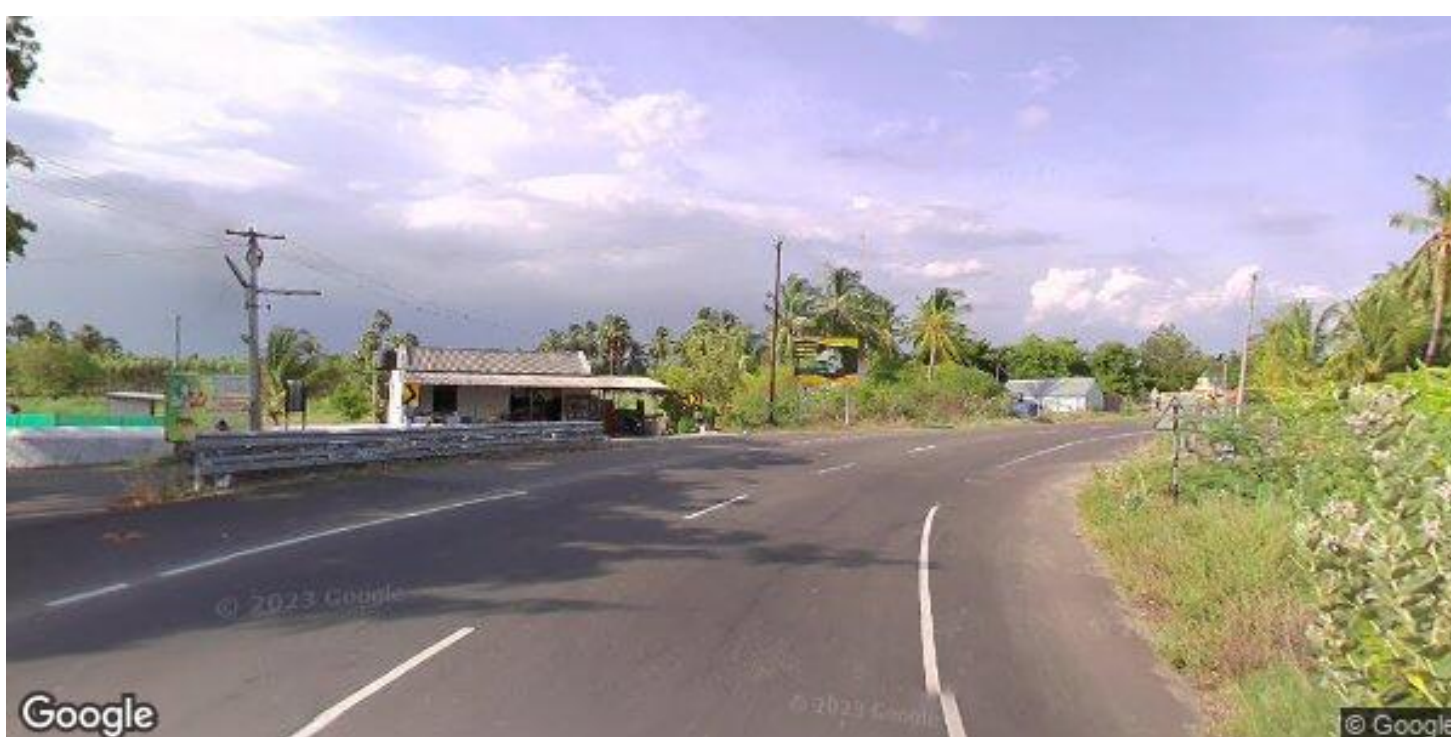
**Risk Type:** Turn

**Risk Level:** High

**Speed Limit: 15 KM/Hr**

**Coordinates: 10.98966, 77.72381**

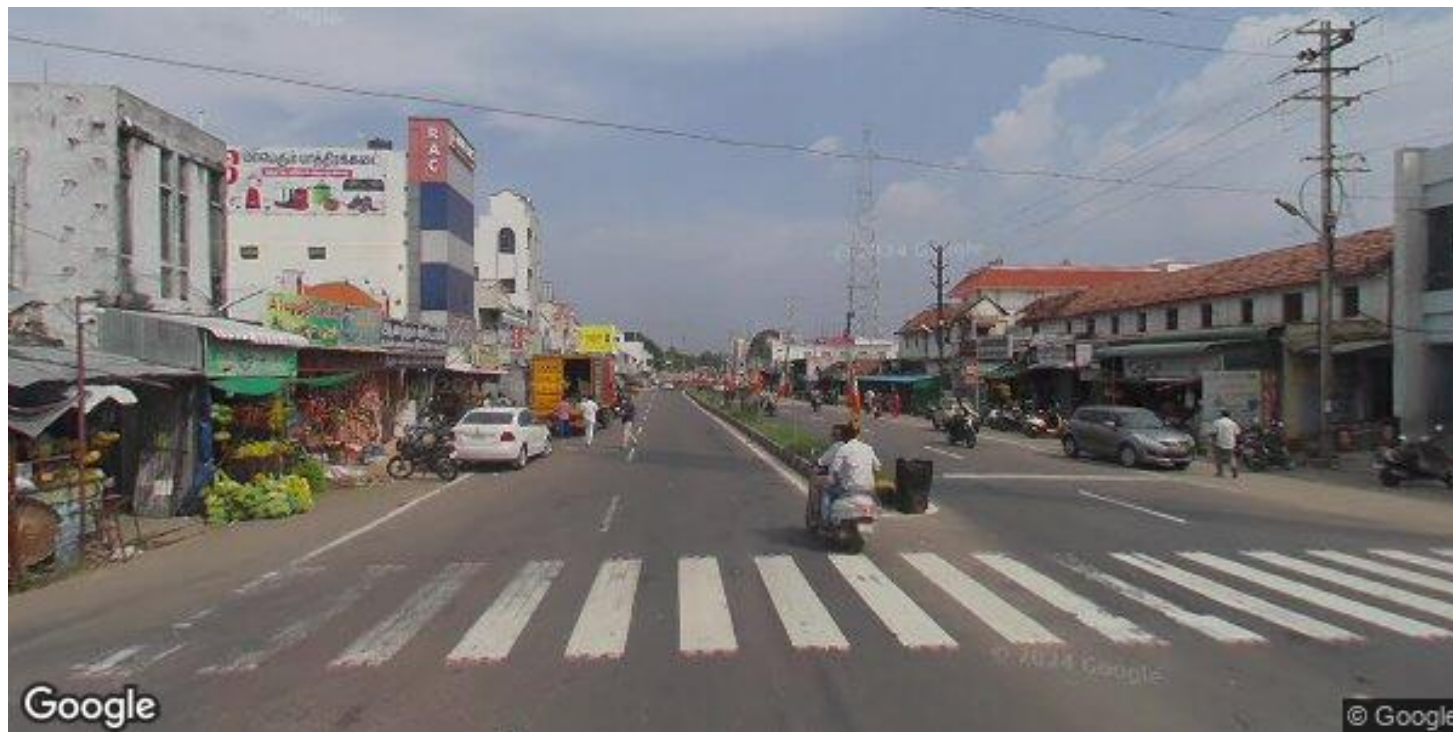
**Risk Type: Blind Spot**

**Risk Level: Blind Spot**

**Speed Limit: 10 KM/Hr**

**Coordinates: 10.94597, 77.71319**

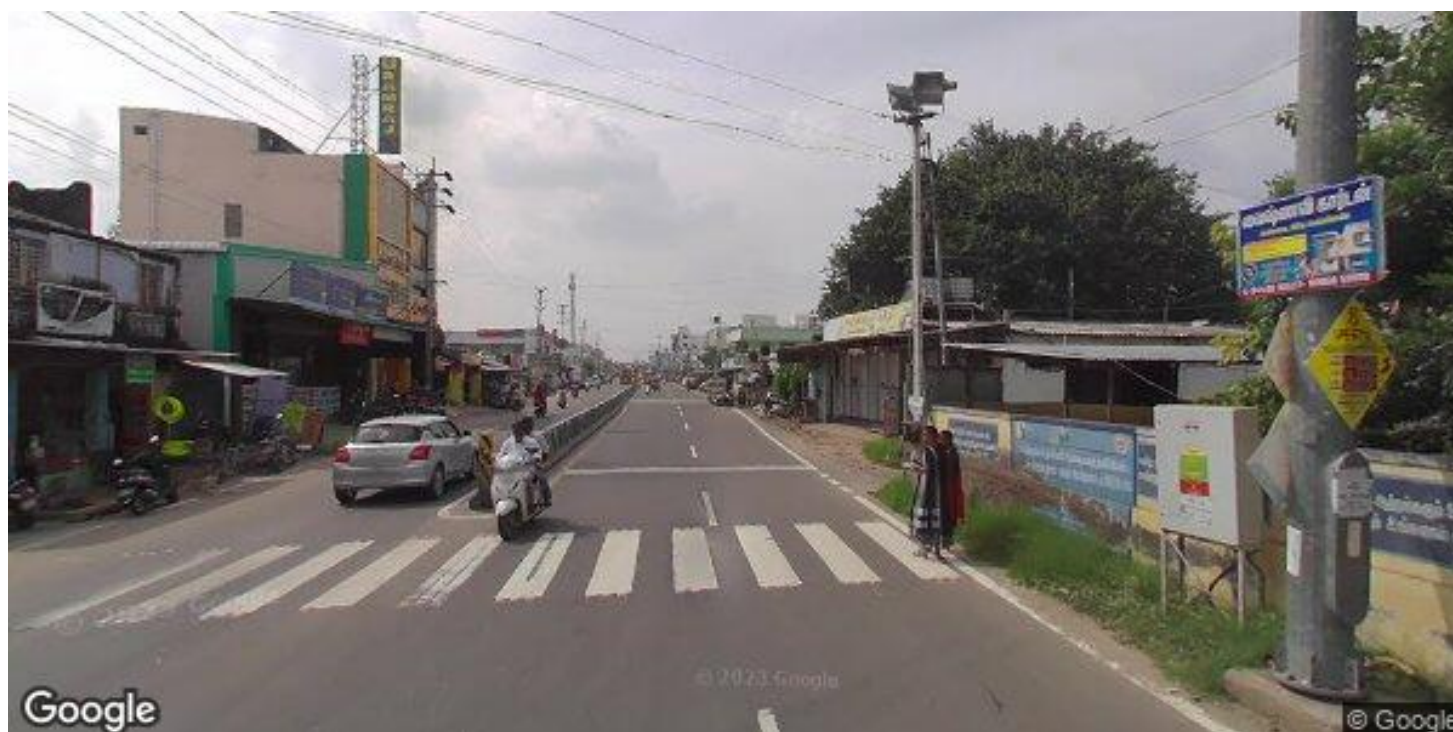
**Risk Type: Turn**

**Risk Level: High**

**Speed Limit: 15 KM/Hr**

**Coordinates: 10.94571, 77.71574**
