# IndianOil

## JOURNEY RISK MANAGEMENT (JRM) STUDY

### Salem Terminal to MARRIYAMMAL AGENCIES

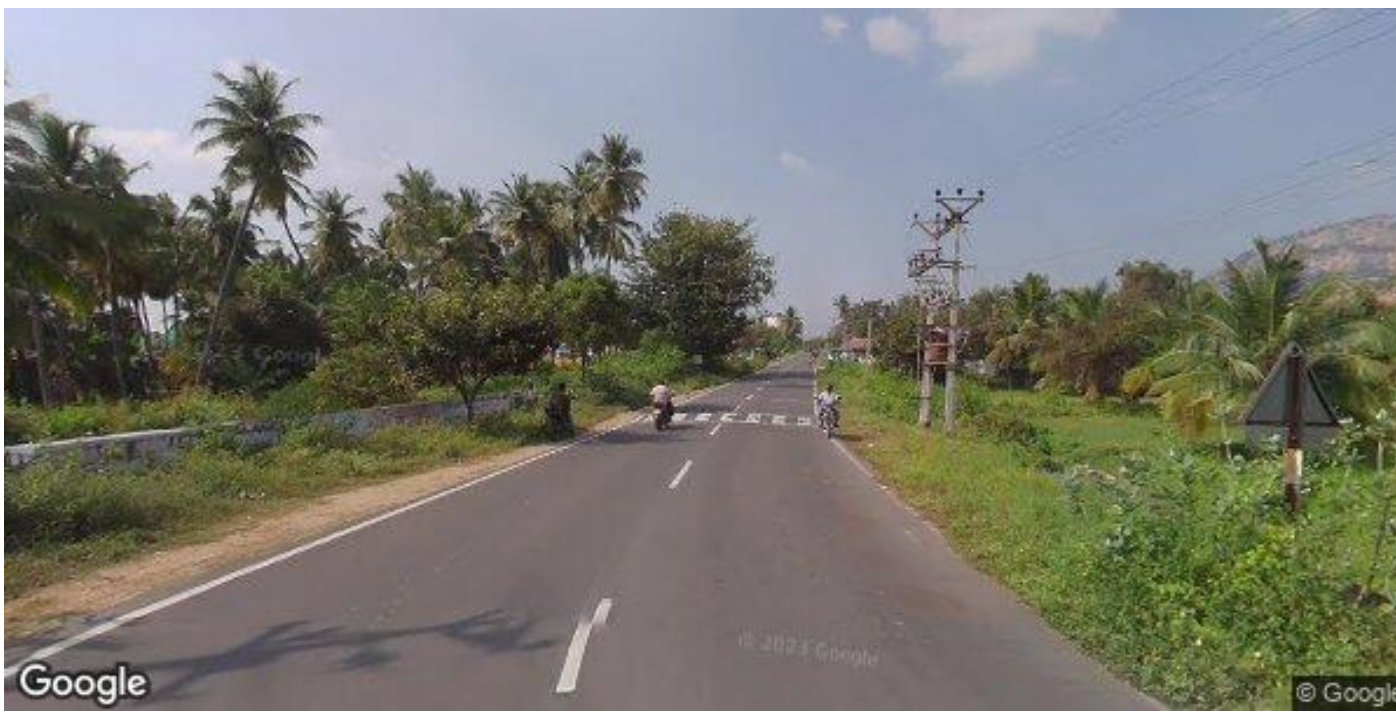
**Risk Type:** Turn  
**Risk Level:** Medium  
**Speed Limit:** 30 KM/Hr  
**Coordinates:** 11.45353, 77.85697

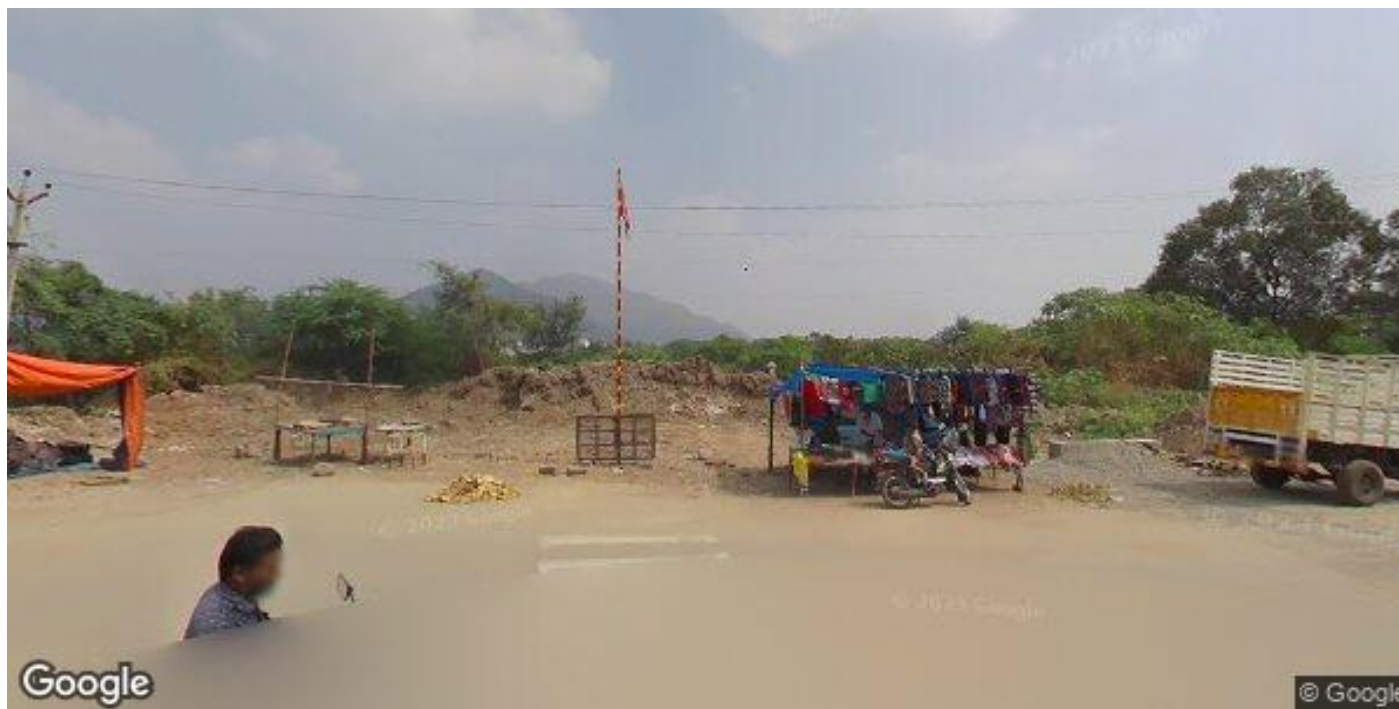
**Risk Type:** Turn  
**Risk Level:** Medium  
**Speed Limit:** 30 KM/Hr  
**Coordinates:** 11.60320, 78.00504

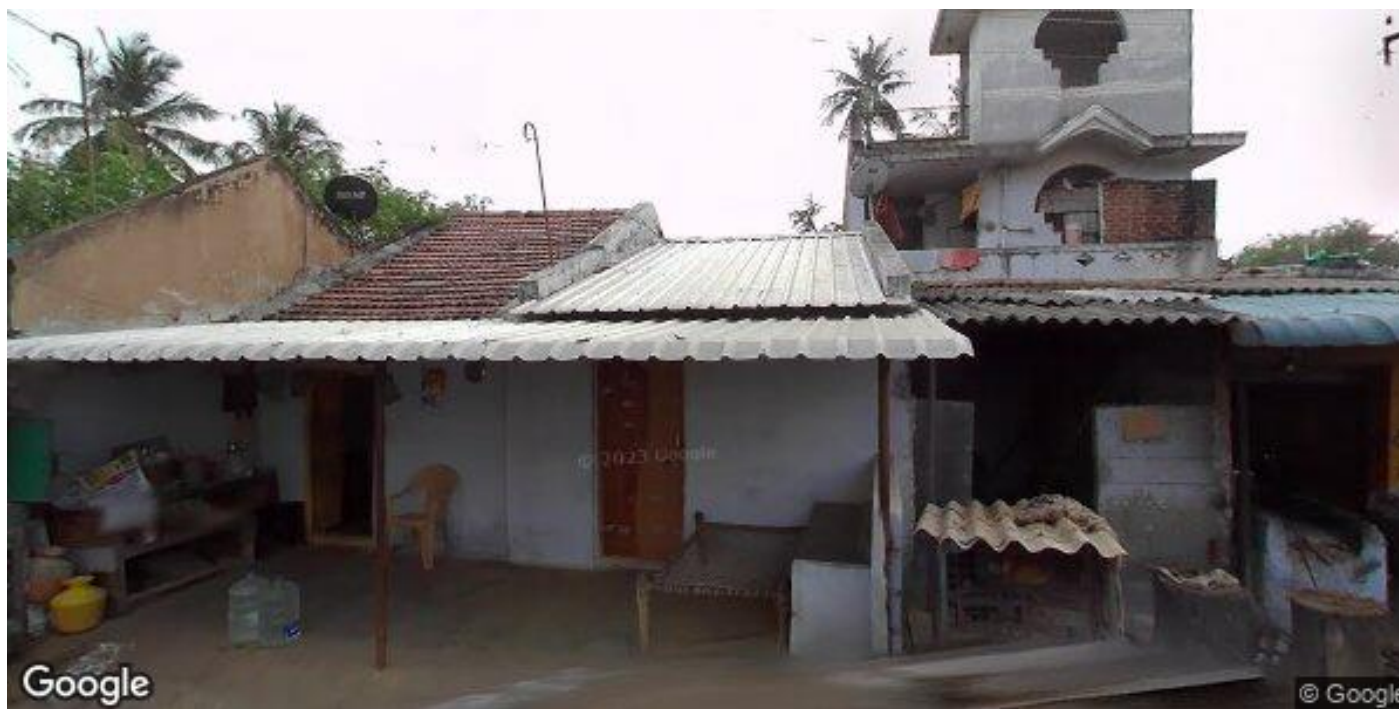
**Risk Type:** Turn  
**Risk Level:** Medium  
**Speed Limit:** 30 KM/Hr  
**Coordinates:** 11.60480, 78.00617

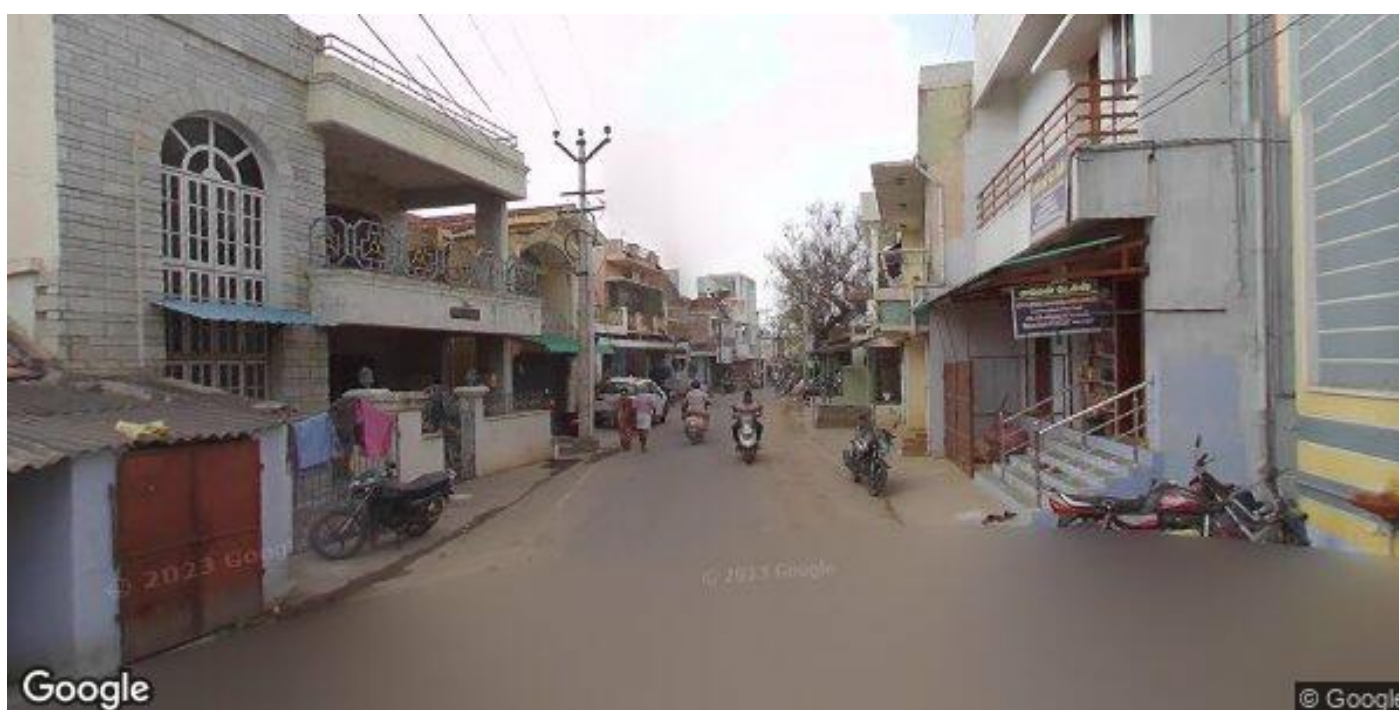
**Risk Type:** Turn  
**Risk Level:** Medium  
**Speed Limit:** 30 KM/Hr  
**Coordinates:** 11.60481, 78.00747

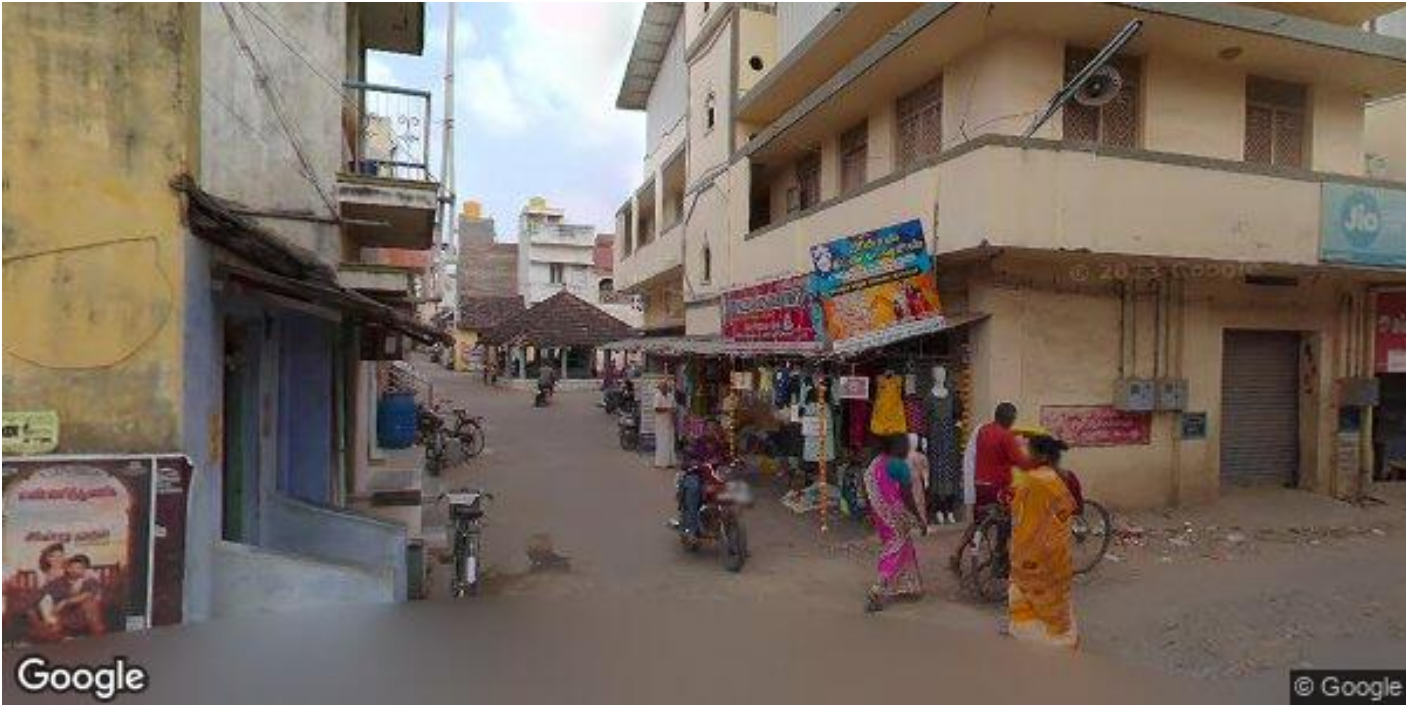
**Risk Type:** Turn  
**Risk Level:** High  
**Speed Limit:** 15 KM/Hr  
**Coordinates:** 11.60552, 78.00827

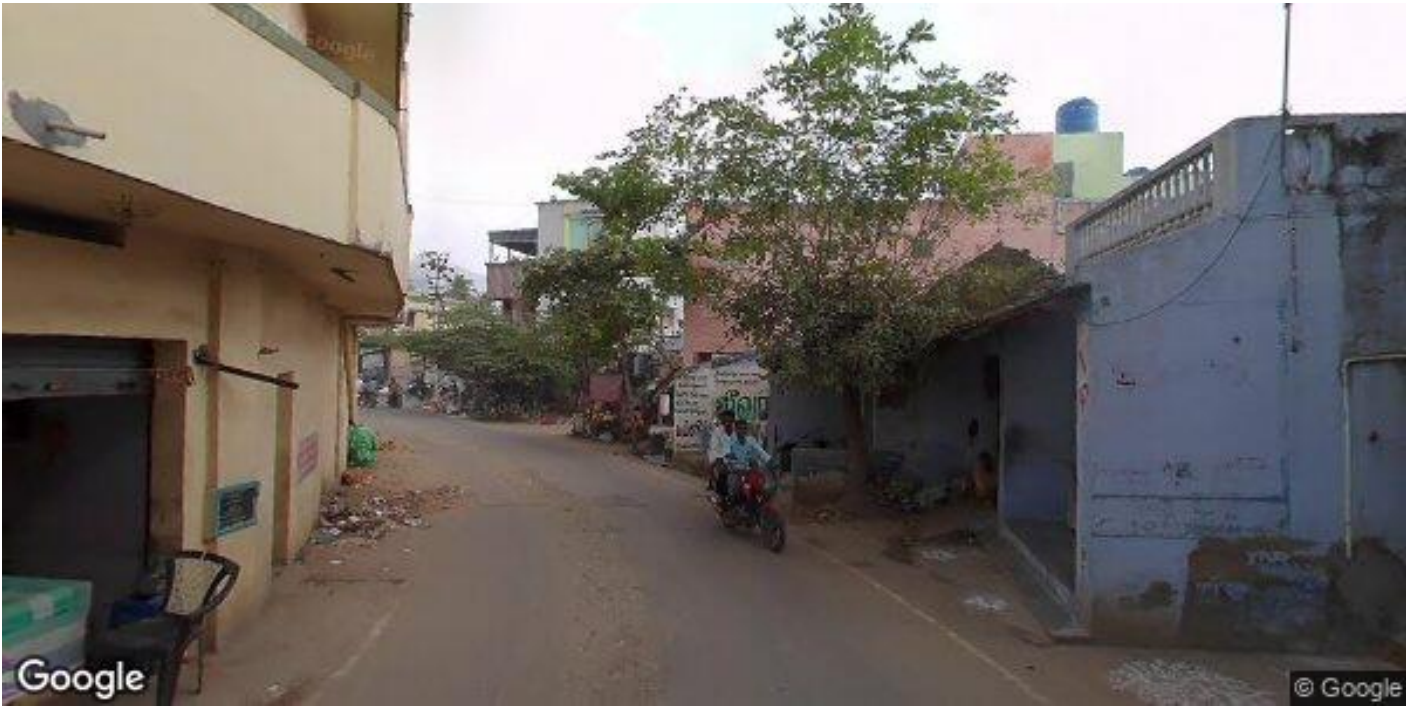
**Risk Type:** Turn  
**Risk Level:** Medium  
**Speed Limit:** 30 KM/Hr  
**Coordinates:** 11.60546, 78.00846

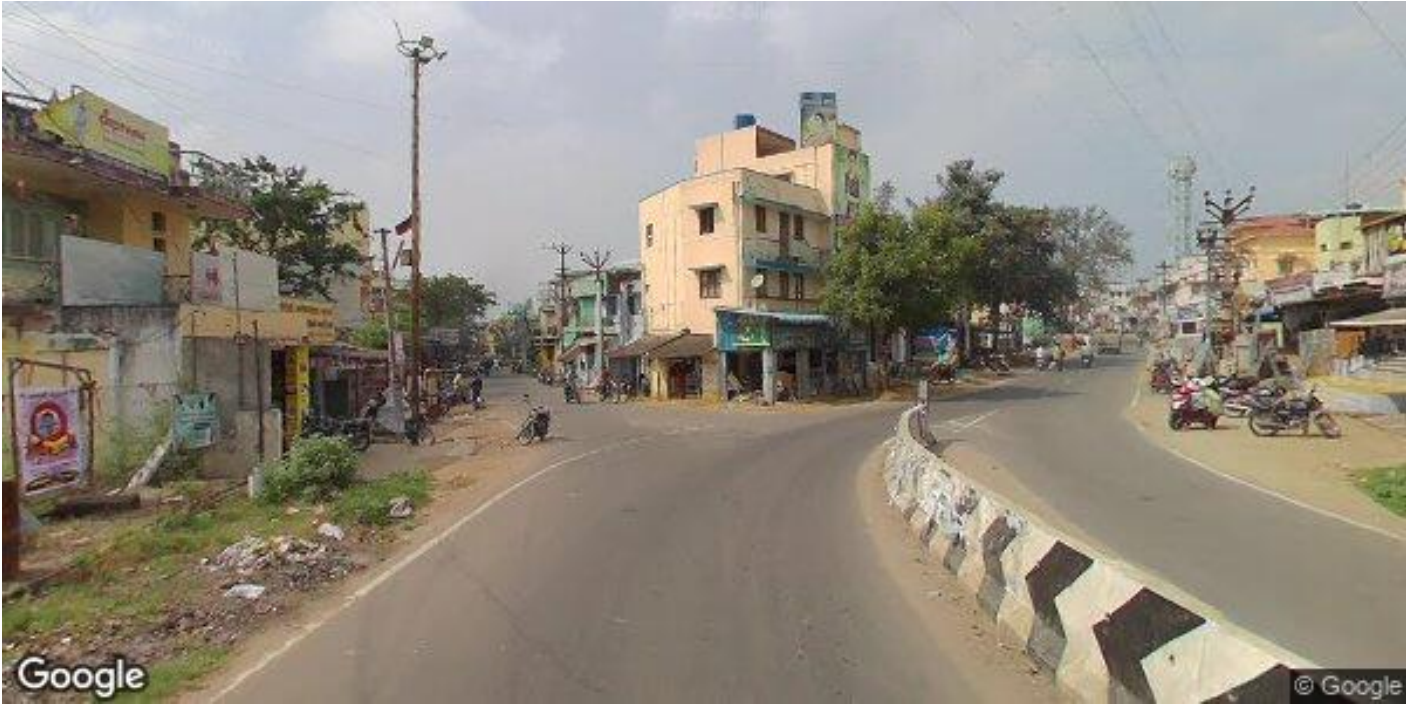
**Risk Type:** Turn  
**Risk Level:** Medium  
**Speed Limit:** 30 KM/Hr  
**Coordinates:** 11.60751, 78.01086

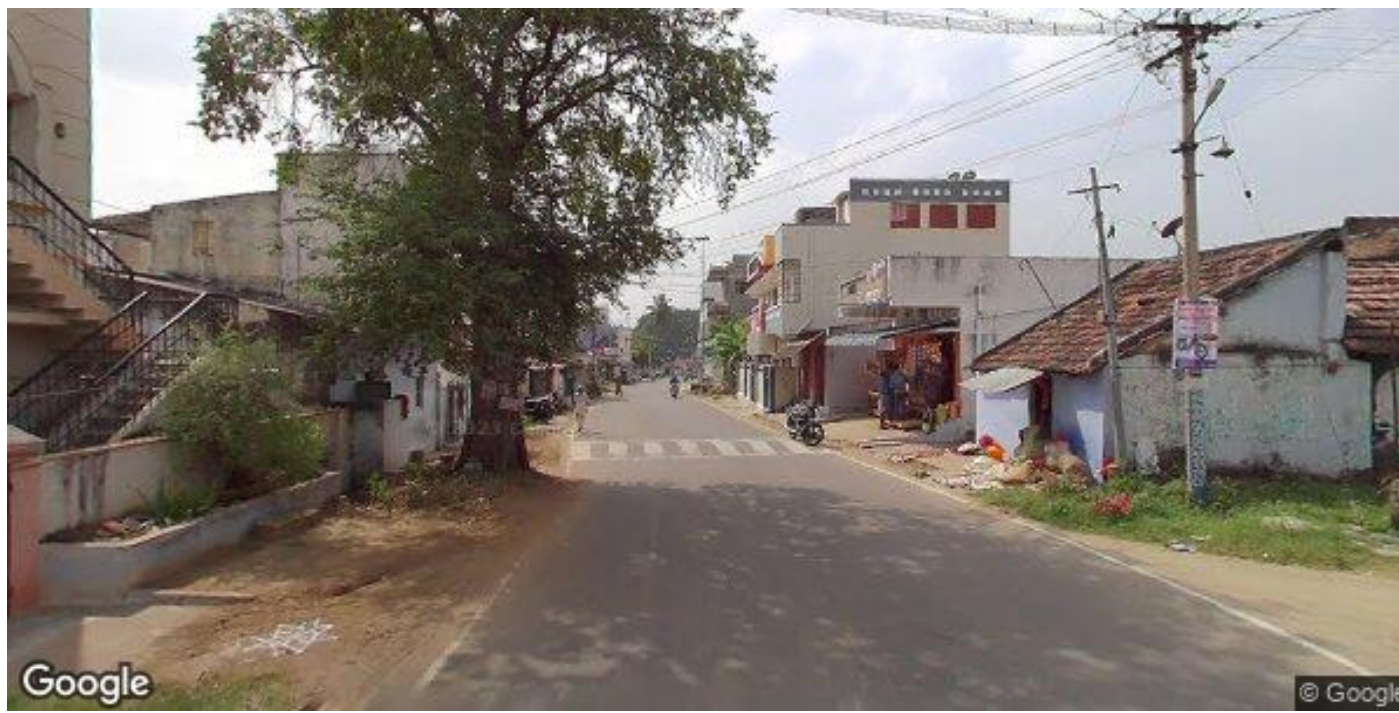
**Risk Type:** Turn  
**Risk Level:** Medium  
**Speed Limit:** 30 KM/Hr  
**Coordinates:** 11.61152, 78.01356

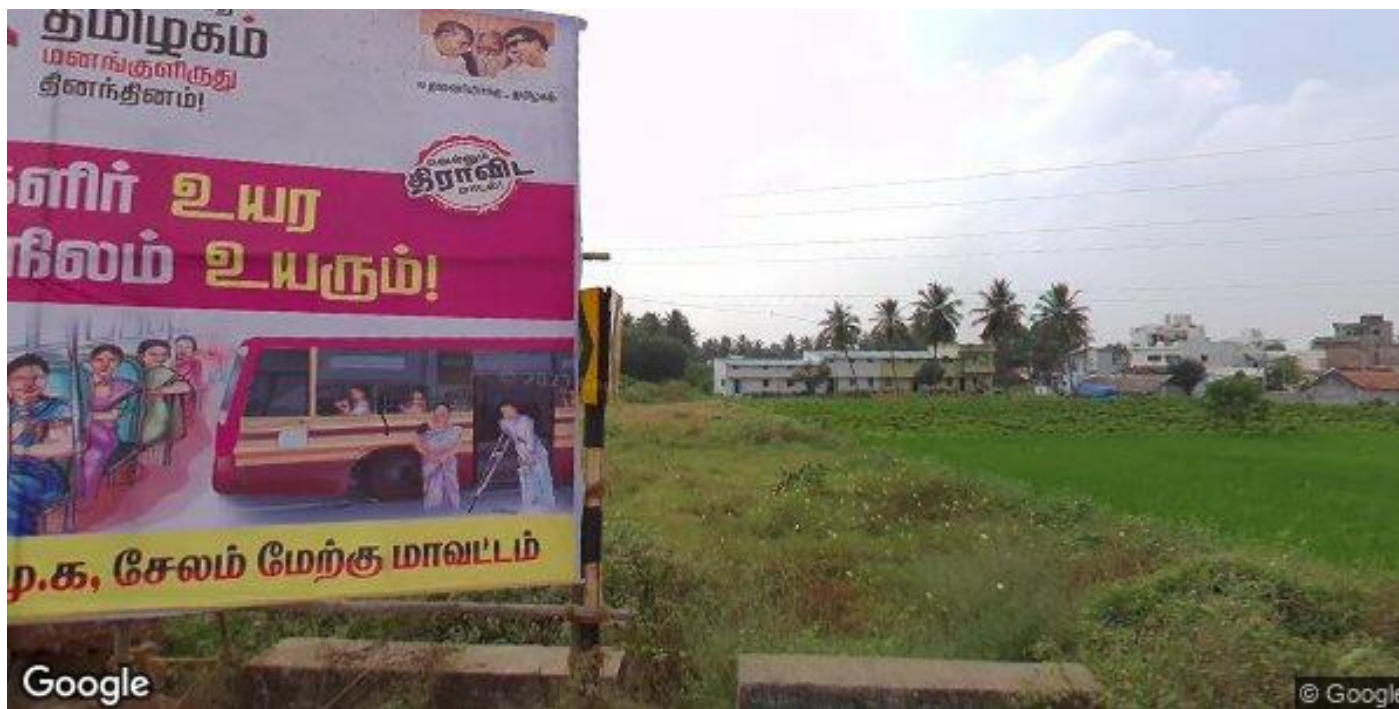
**Risk Type:** Turn  
**Risk Level:** High  
**Speed Limit:** 15 KM/Hr  
**Coordinates:** 11.61170, 78.01516

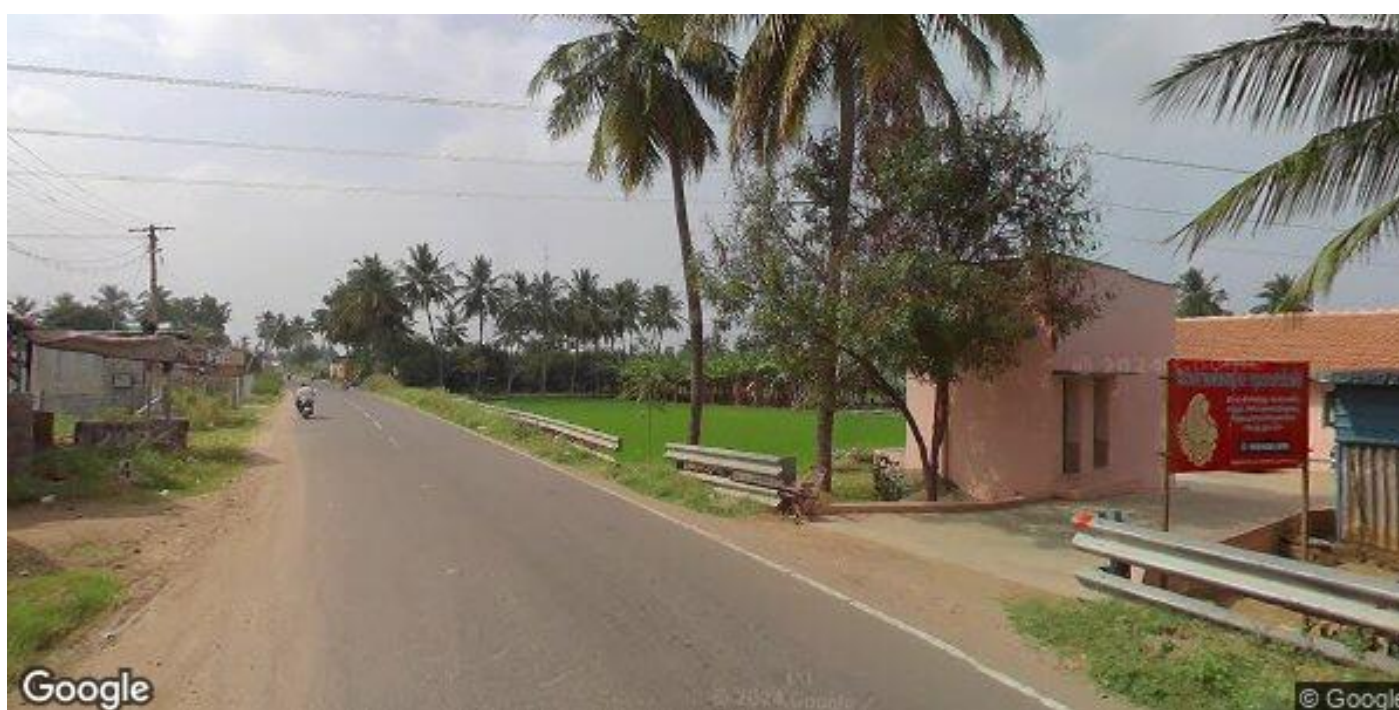
**Risk Type:** Turn  
**Risk Level:** Medium  
**Speed Limit:** 30 KM/Hr  
**Coordinates:** 11.61418, 78.01669

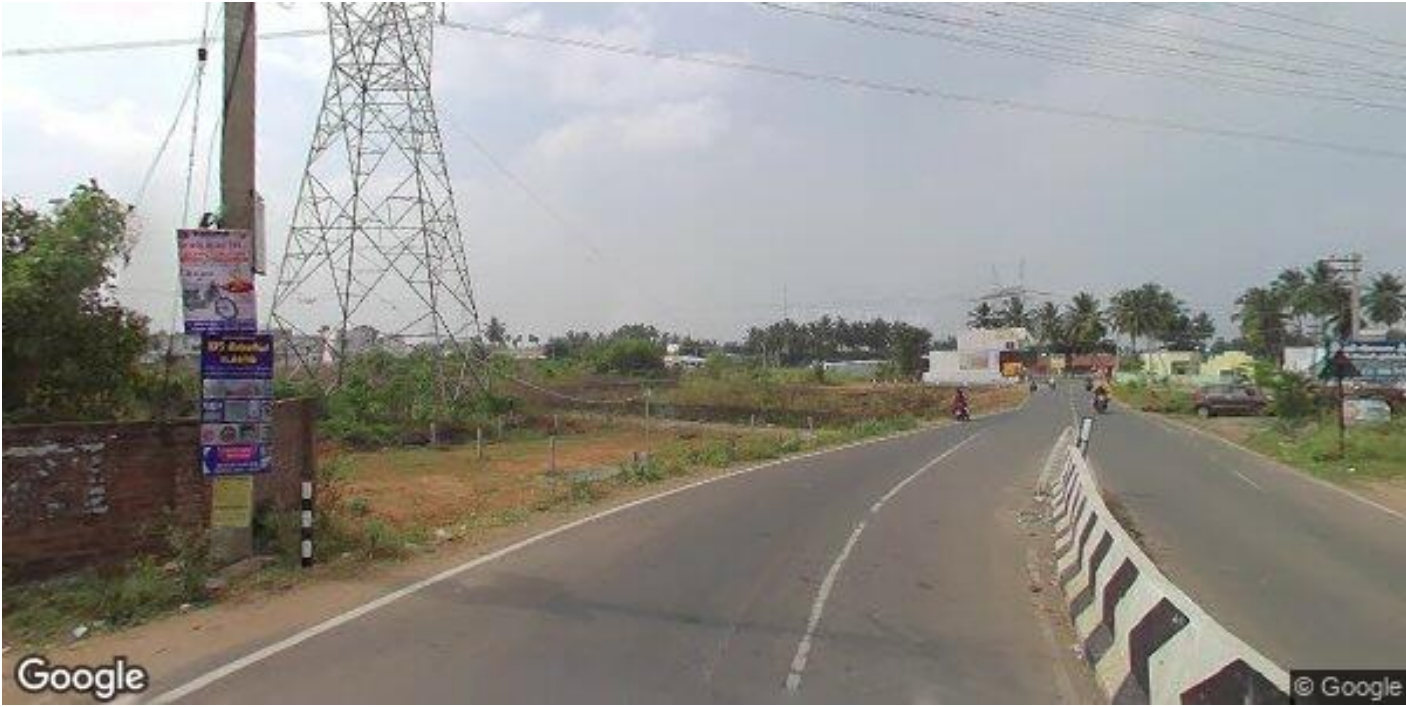
**Risk Type:** Turn  
**Risk Level:** Medium  
**Speed Limit:** 30 KM/Hr  
**Coordinates:** 11.61440, 78.01791
