# IndianOil

## JOURNEY RISK MANAGEMENT (JRM) STUDY

### Salem Terminal TO MURUGAN FUELS

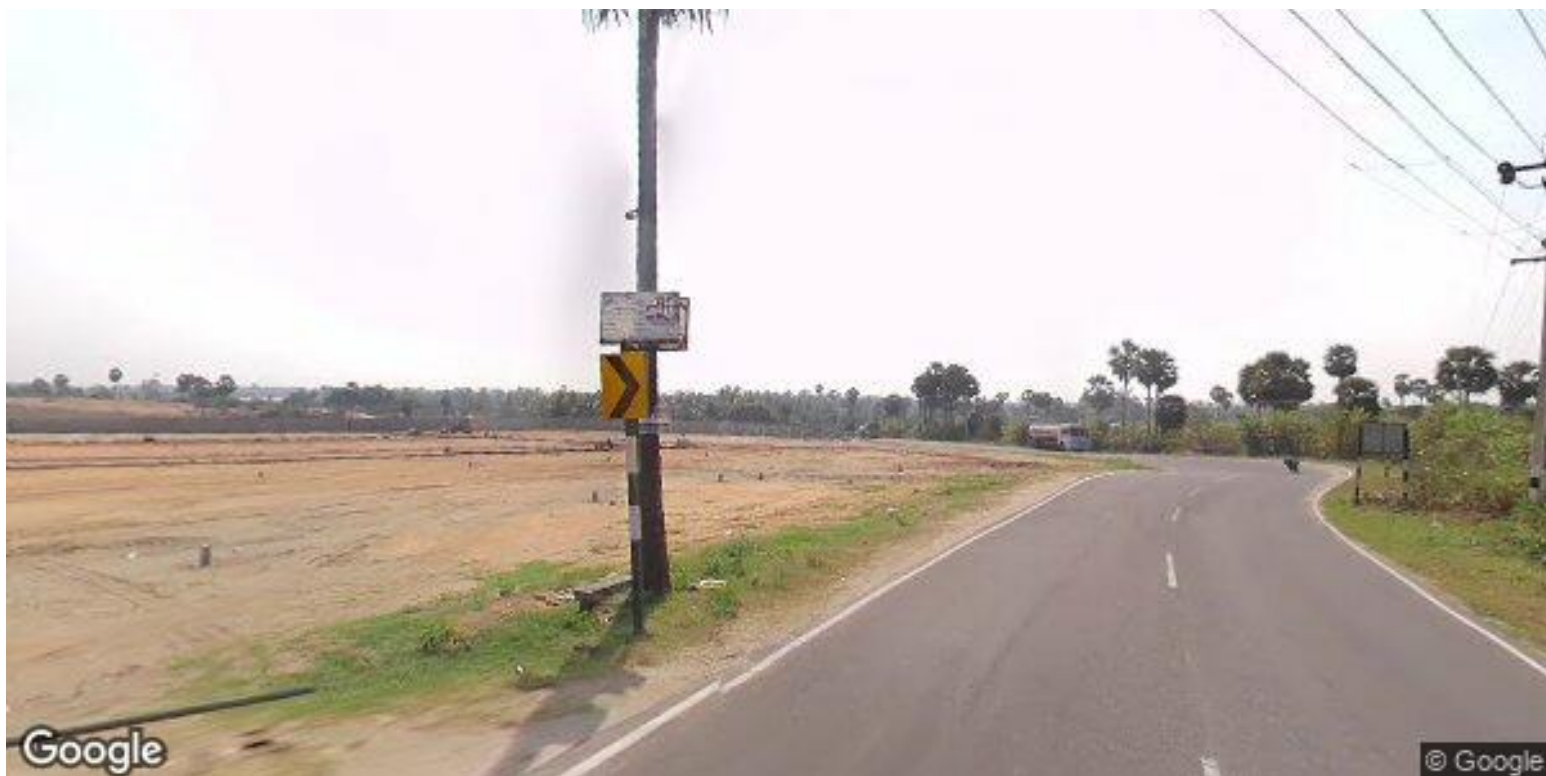
**Risk Type:** Turn  
**Risk Level:** Medium  
**Speed Limit:** 30 KM/Hr  
**Coordinates:** 11.45898, 77.85135

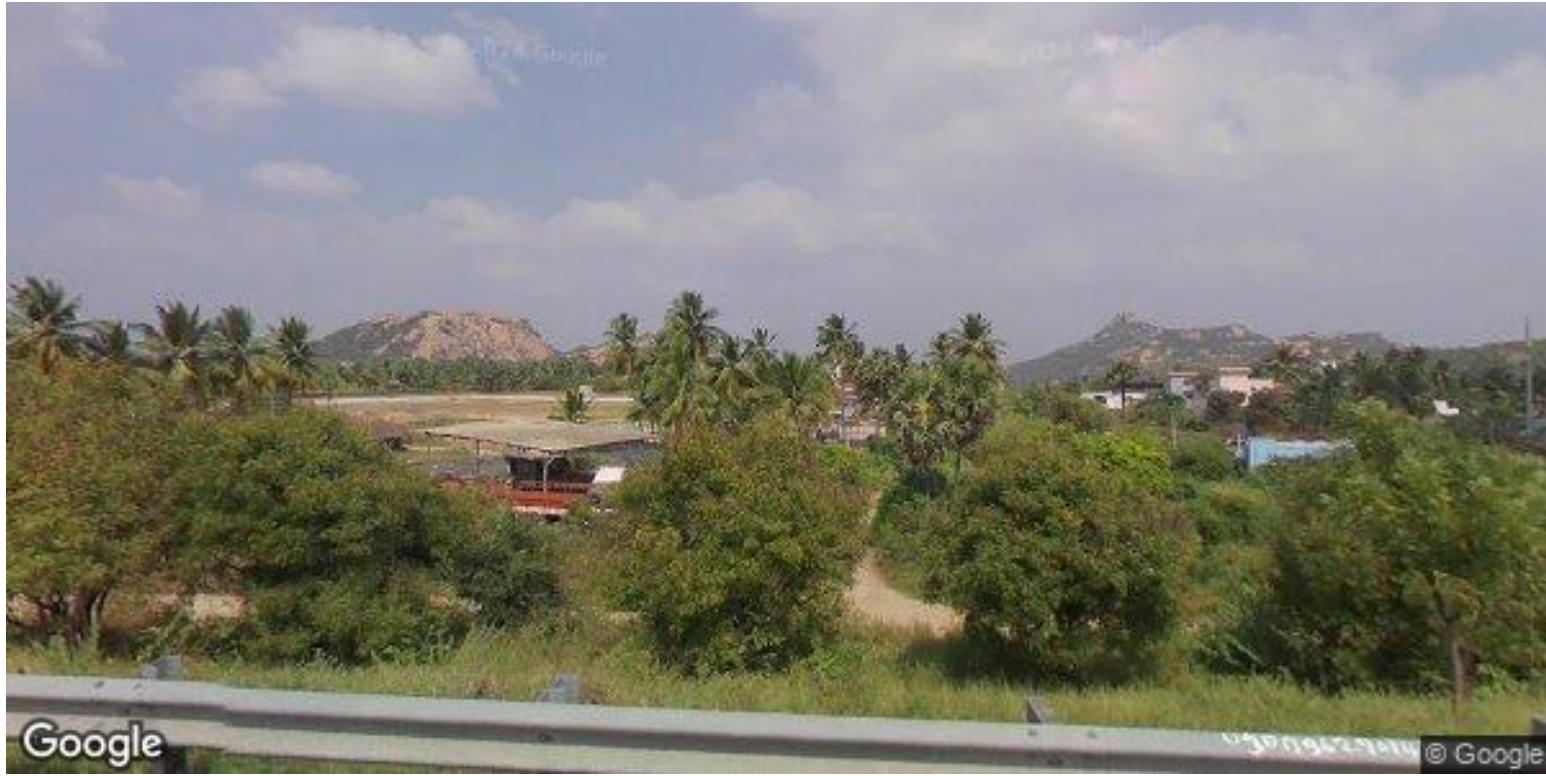
**Risk Type:** Turn  
**Risk Level:** High  
**Speed Limit:** 15 KM/Hr  
**Coordinates:** 11.49383, 77.88442

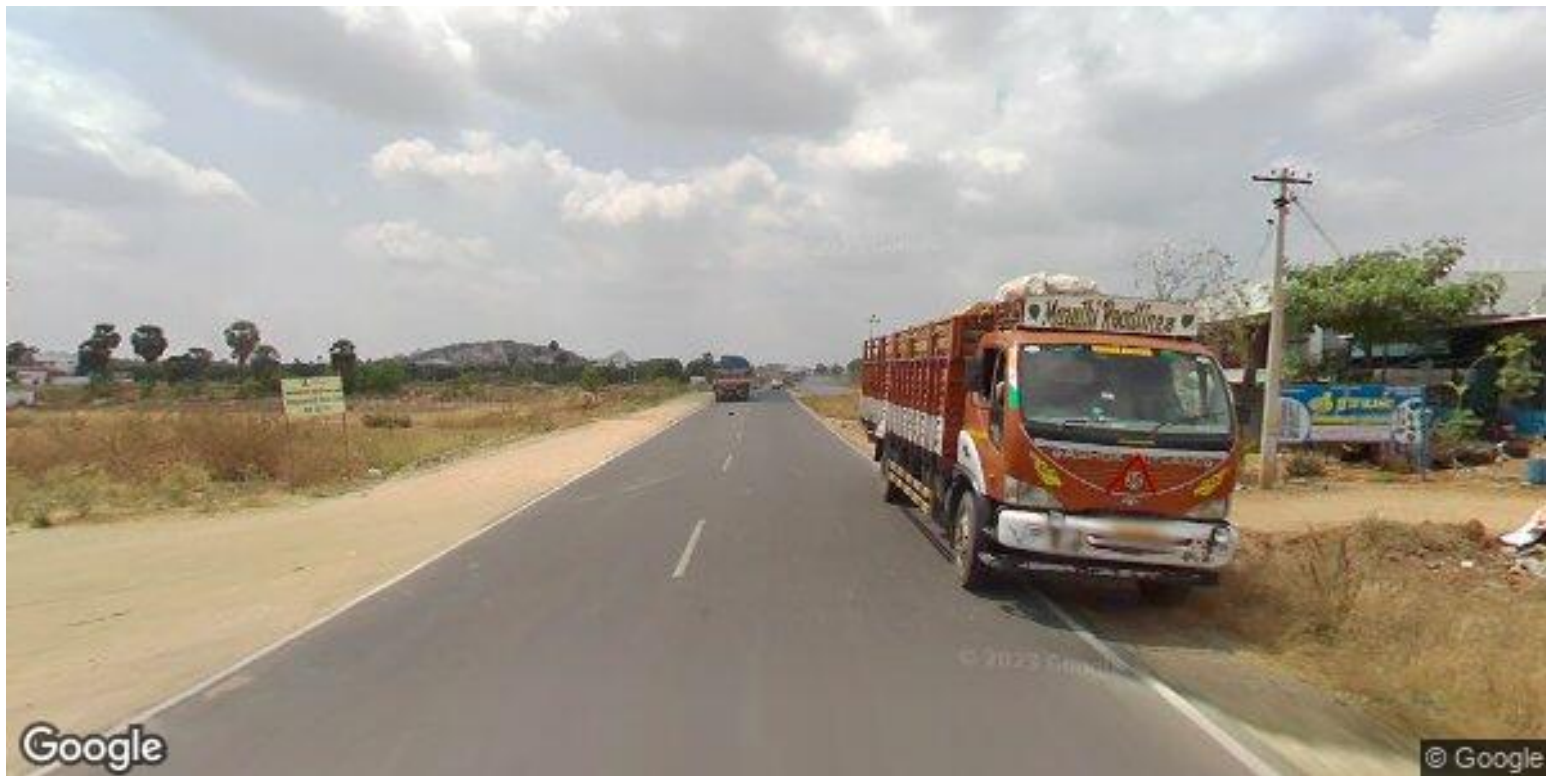
**Risk Type:** Turn  
**Risk Level:** High  
**Speed Limit:** 15 KM/Hr  
**Coordinates:** 11.55608, 77.89762

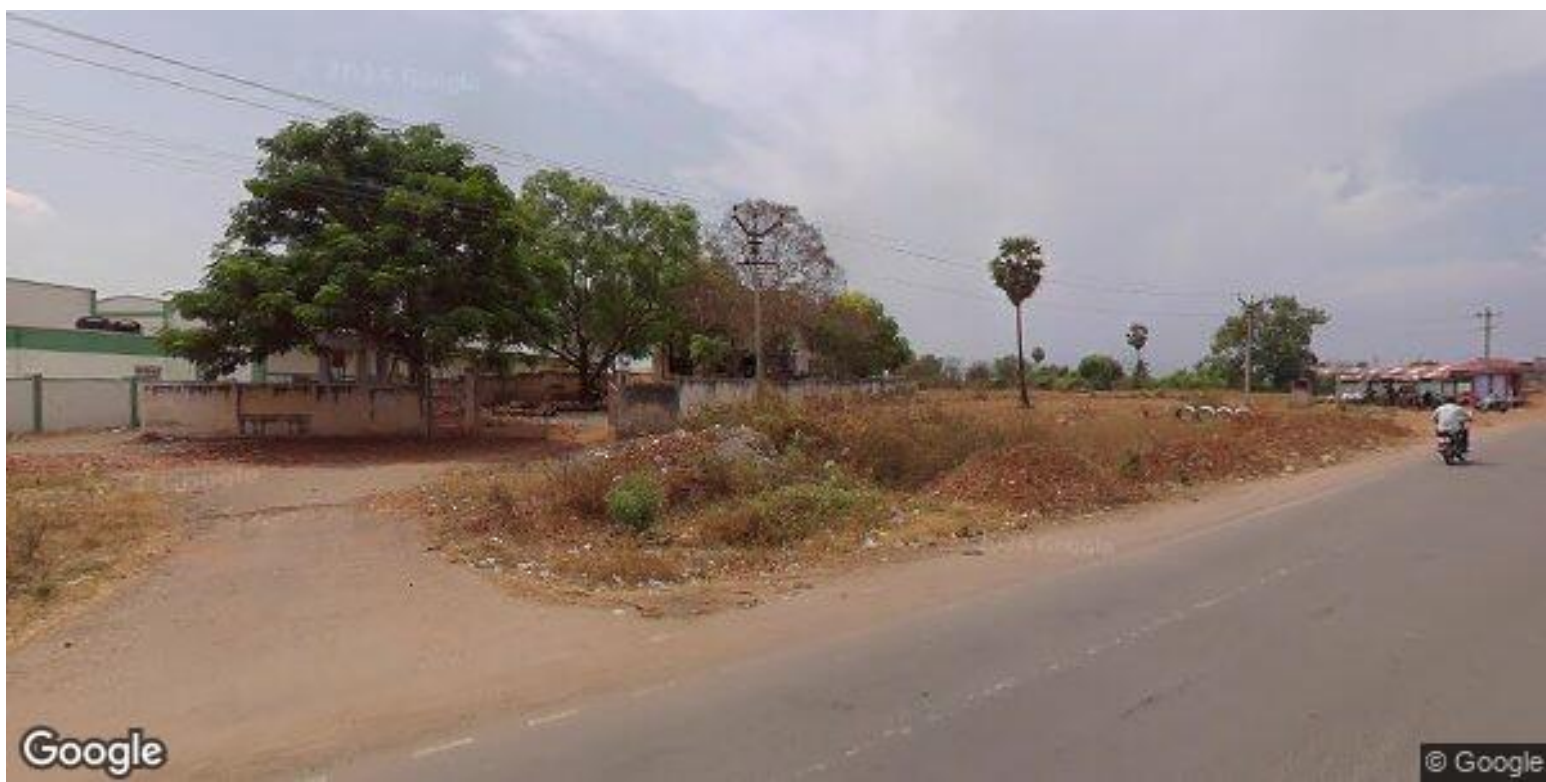
**Coordinates:** 11.58320, 77.90646

**Risk Type:** Turn

**Risk Level:** High

**Speed Limit:** 15 KM/Hr

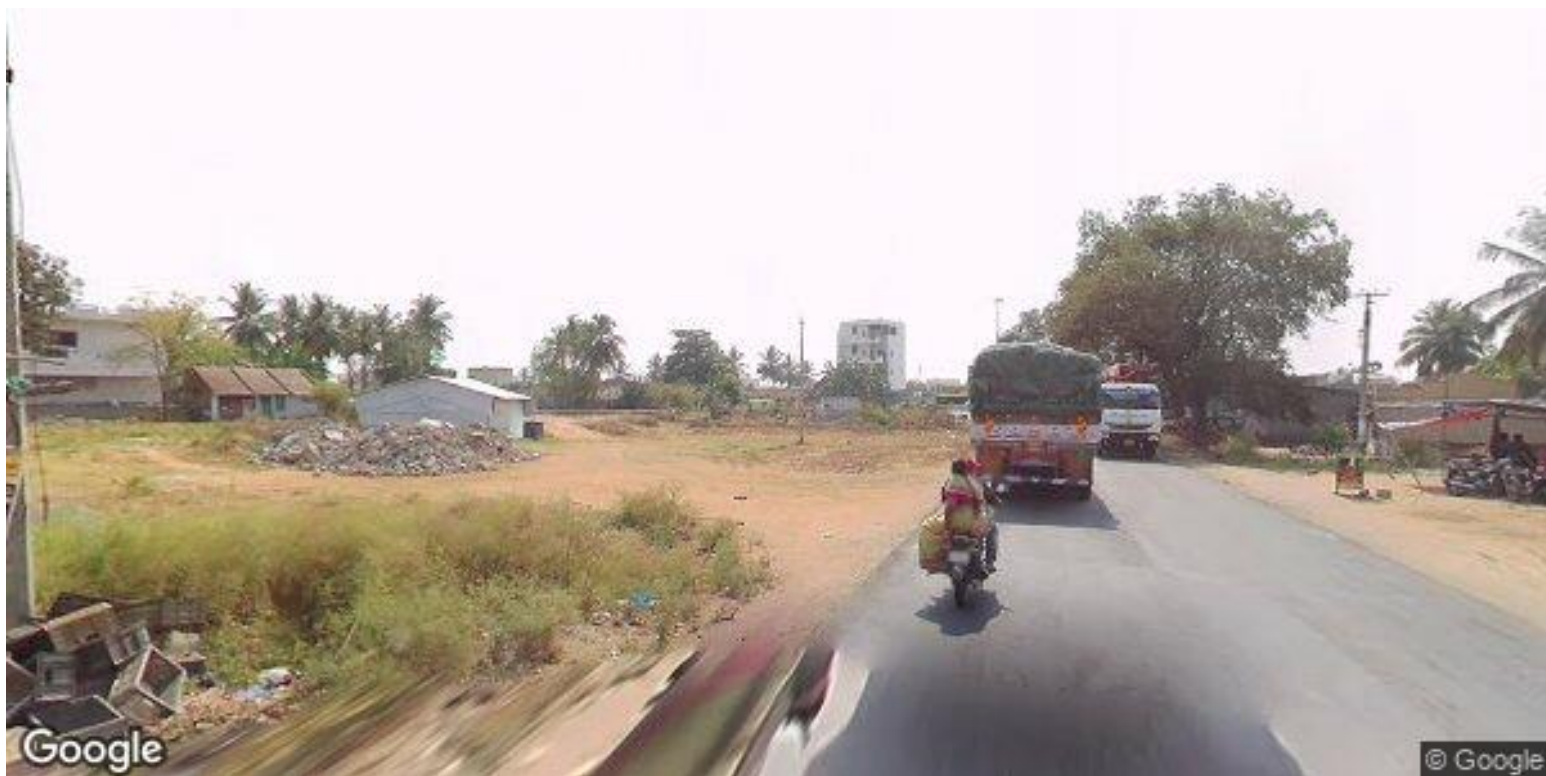
**Coordinates:** 11.59290, 77.90736

**Risk Type:** Turn

**Risk Level:** Medium

**Speed Limit:** 30 KM/Hr

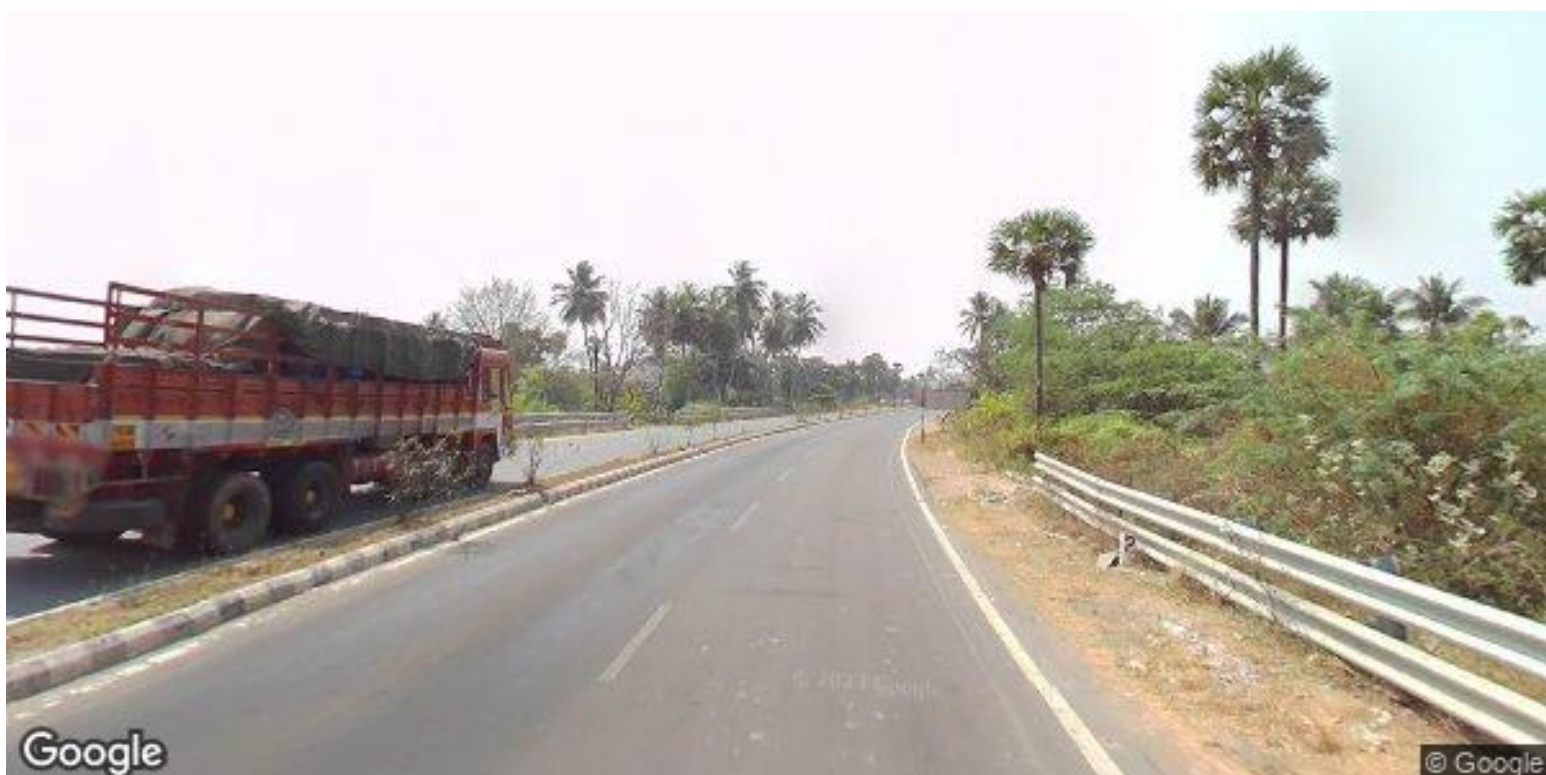
**Coordinates:** 11.70077, 77.97957

**Risk Type:** Turn

**Risk Level:** Medium

**Speed Limit:** 30 KM/Hr

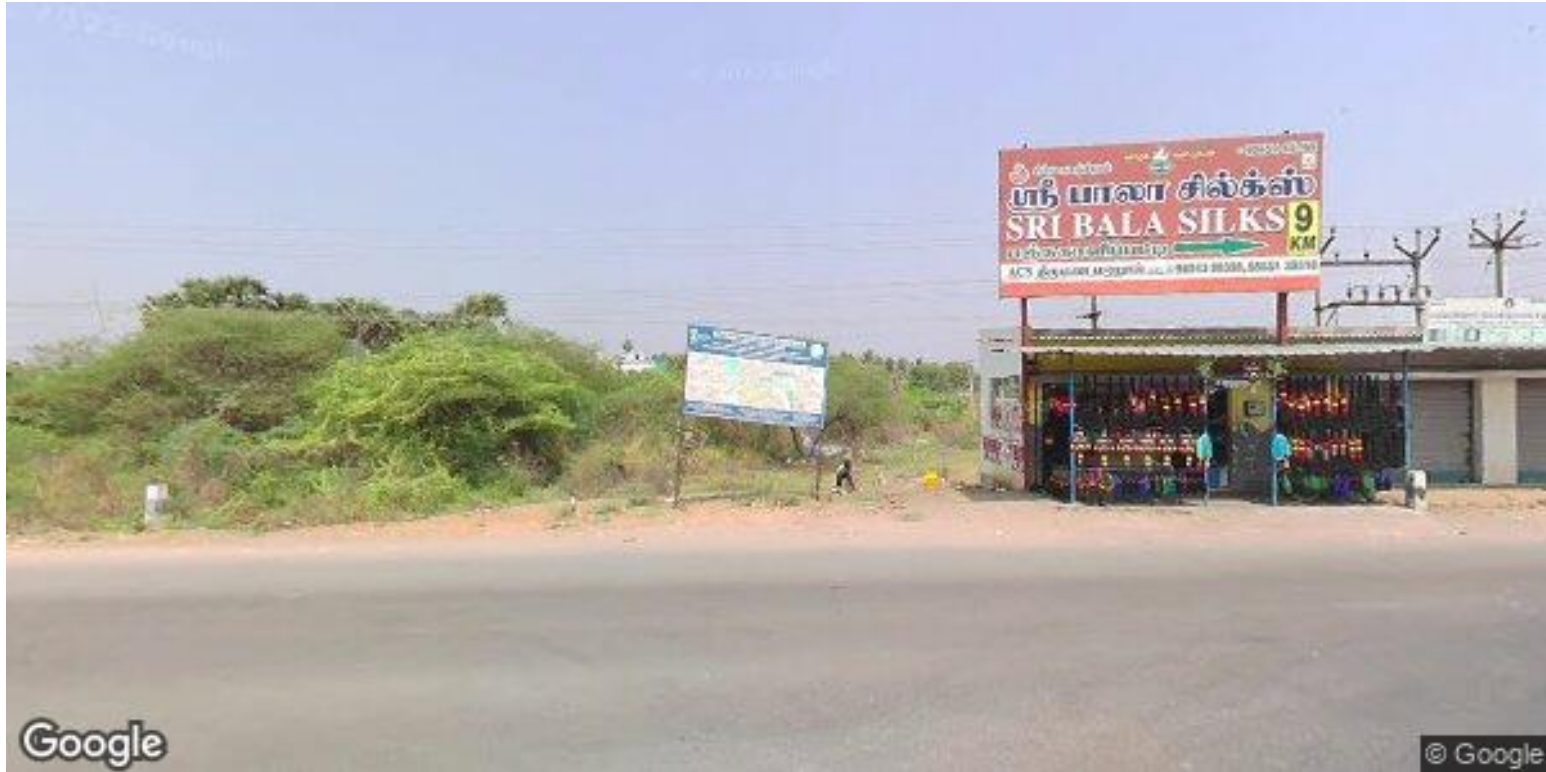
**Coordinates:** 11.70223, 77.97860

**Risk Type:** Turn

**Risk Level:** High

**Speed Limit:** 15 KM/Hr

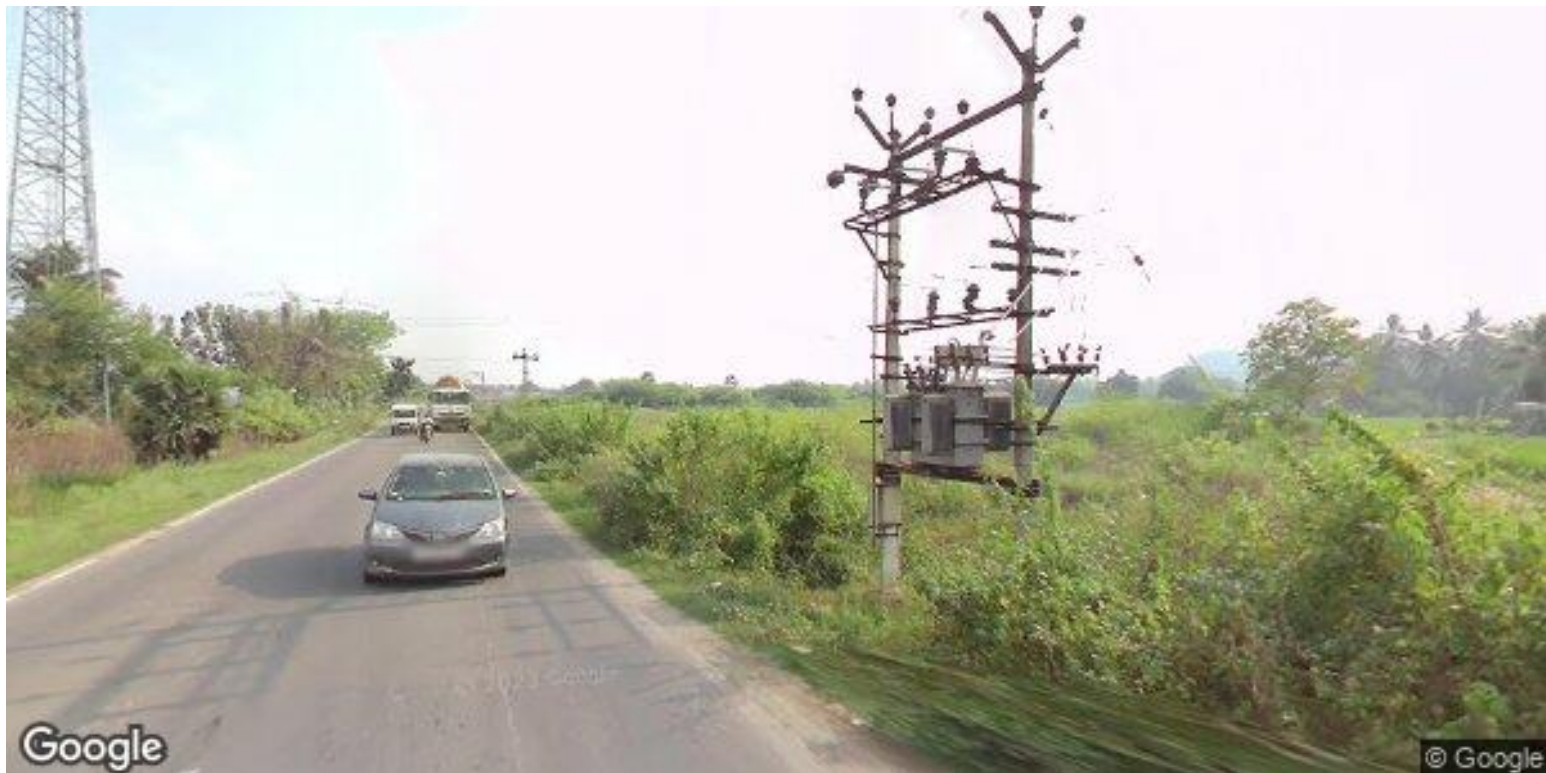
**Coordinates:** 11.71402, 77.99586

**Risk Type:** Turn

**Risk Level:** Medium

**Speed Limit:** 30 KM/Hr

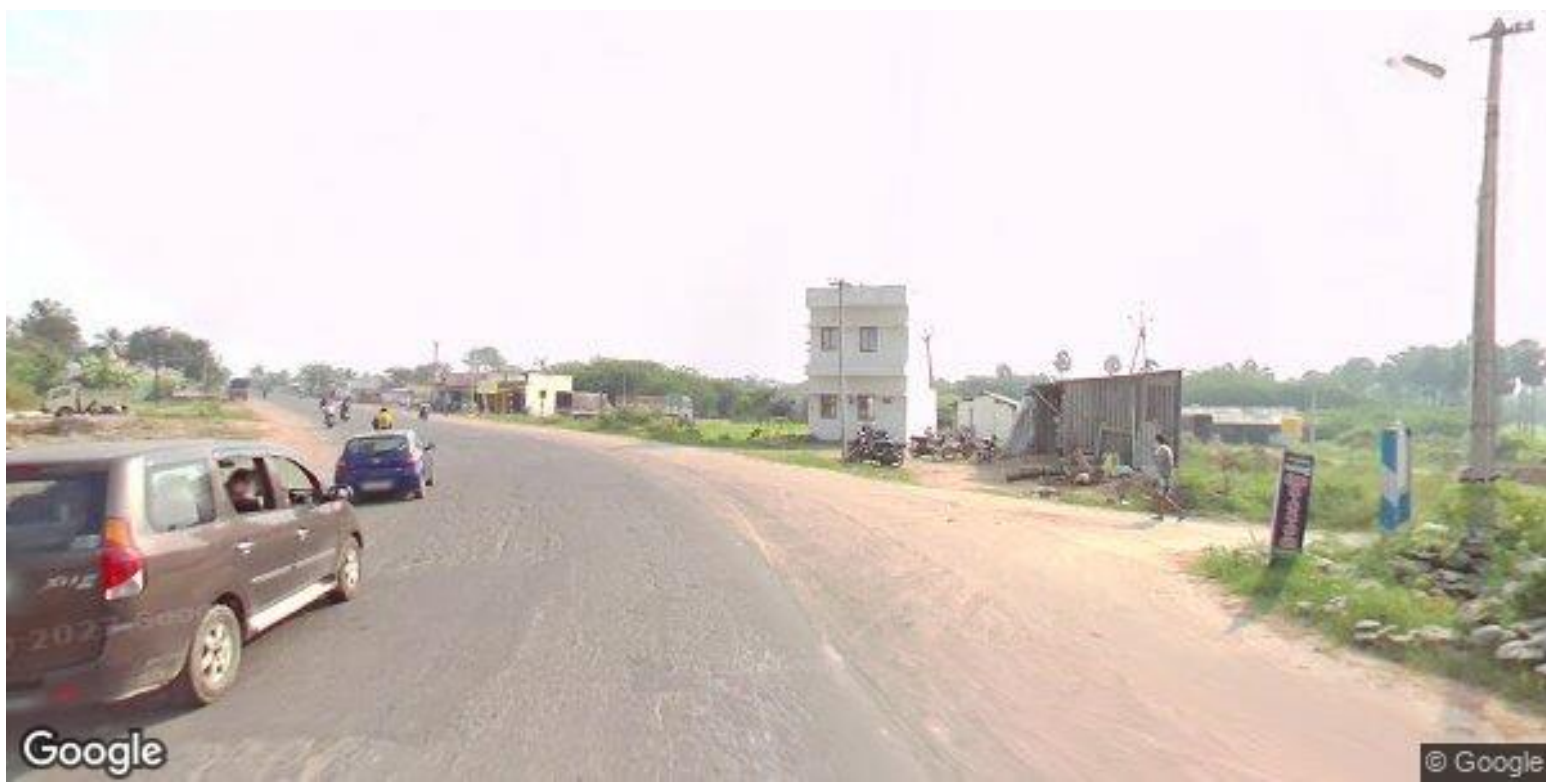
**Coordinates:** 11.71918, 78.01127

**Risk Type:** Turn

**Risk Level:** Medium

**Speed Limit:** 30 KM/Hr

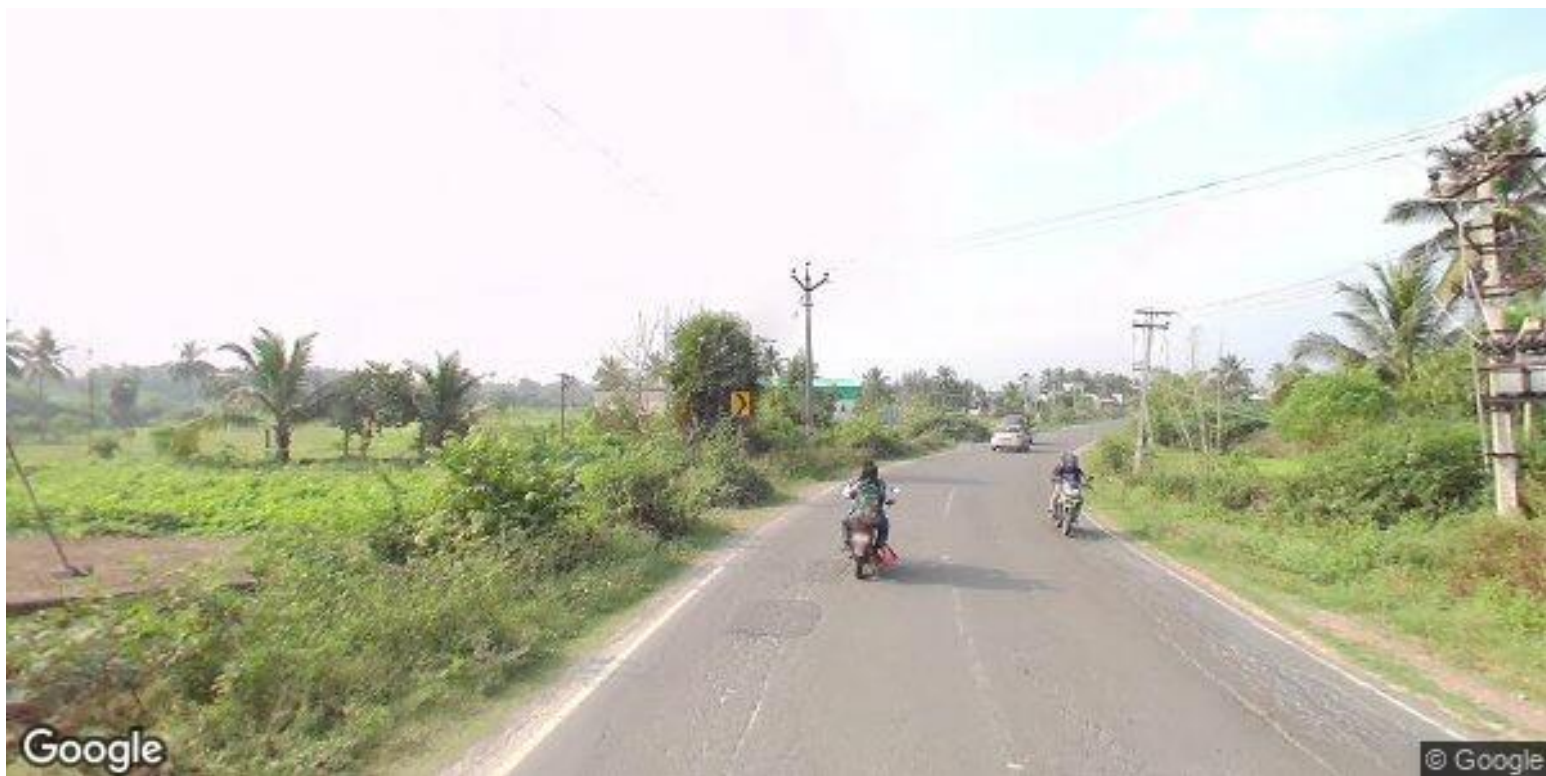
**Coordinates:** 11.72782, 78.02307

**Risk Type:** Turn

**Risk Level:** Medium

**Speed Limit:** 30 KM/Hr

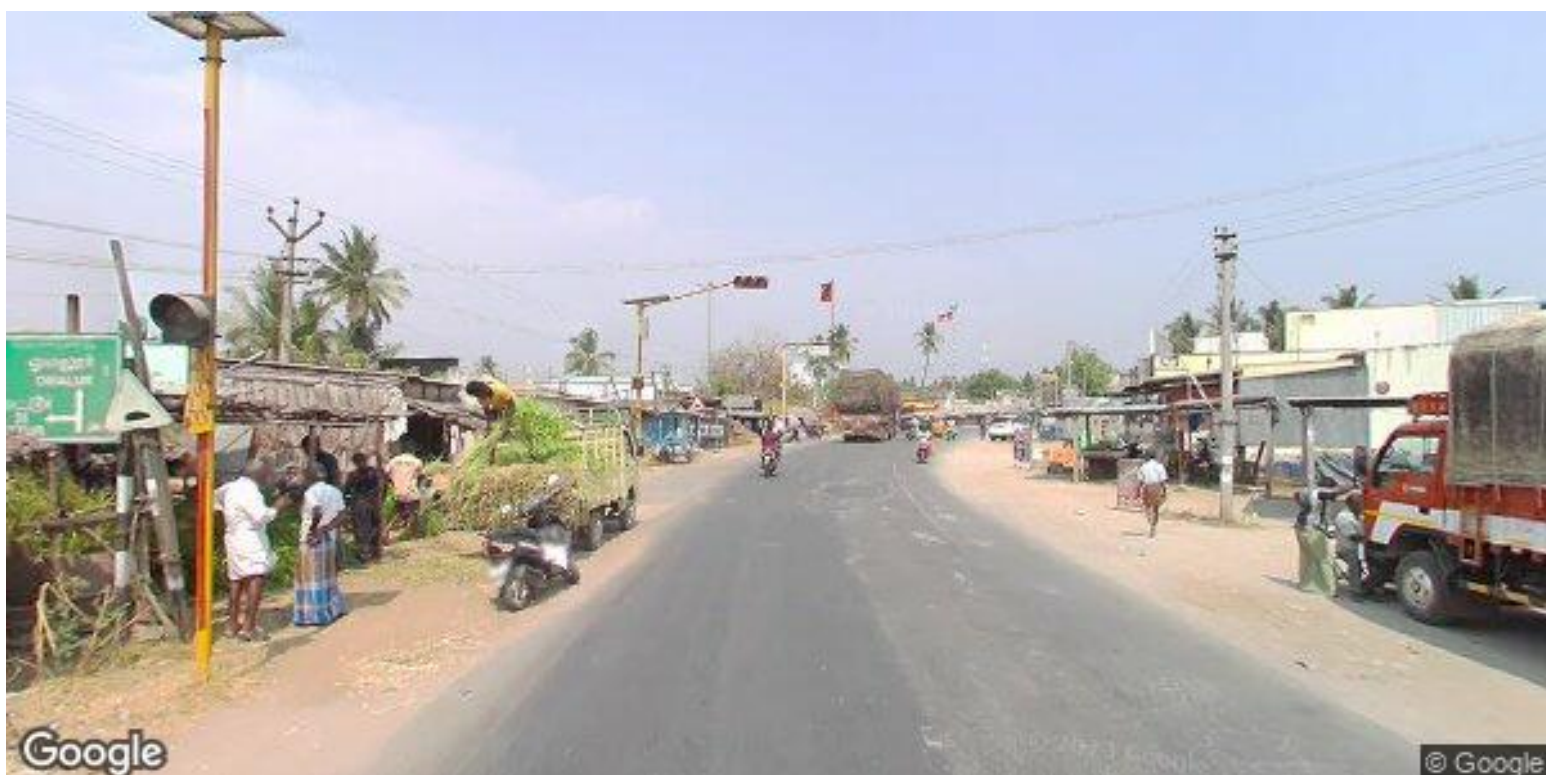
**Coordinates:** 11.73773, 78.03459

**Risk Type:** Turn

**Risk Level:** Medium

**Speed Limit:** 30 KM/Hr

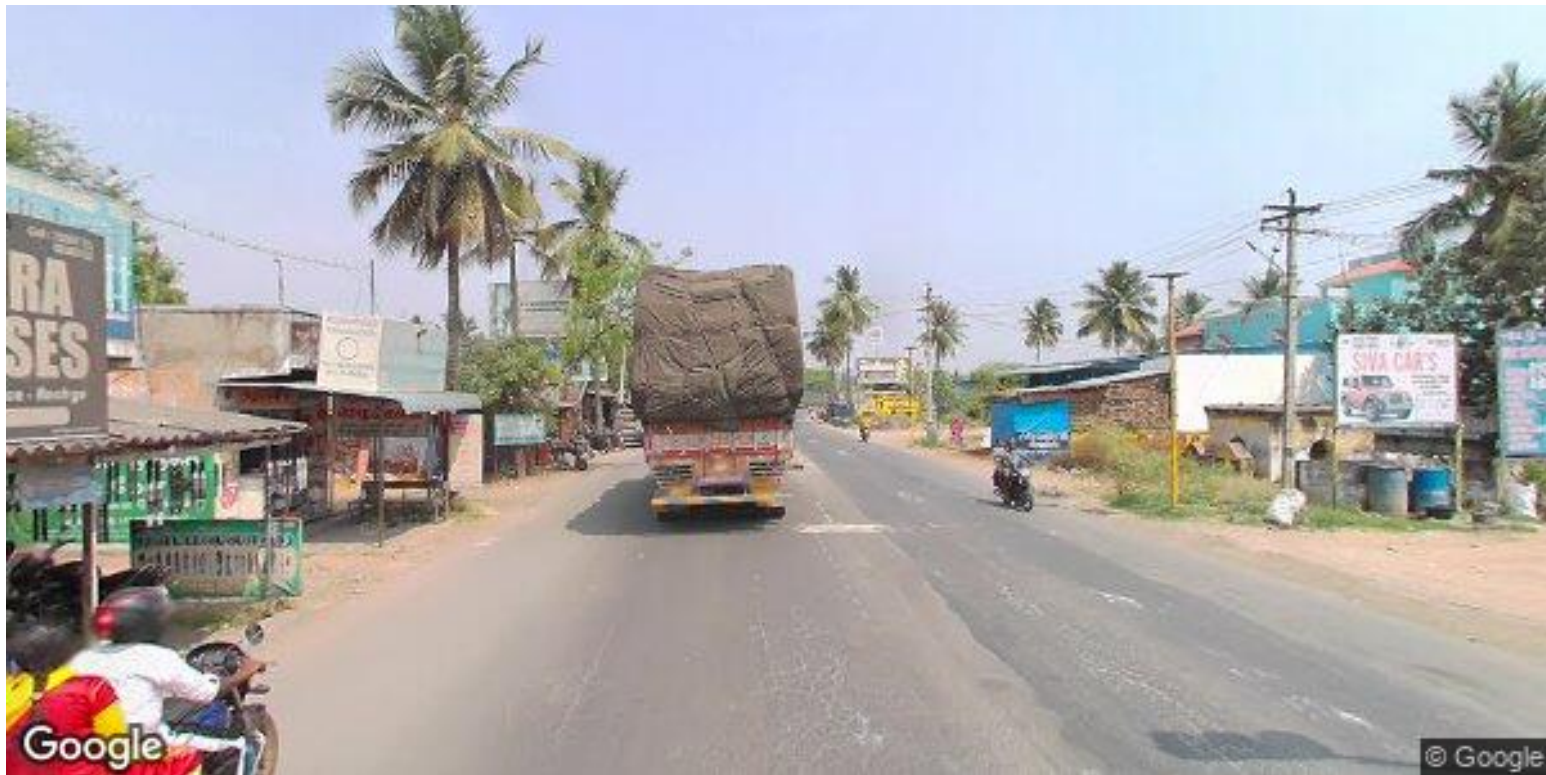
**Coordinates:** 11.73776, 78.03580

**Risk Type:** Turn

**Risk Level:** Medium

**Speed Limit:** 30 KM/Hr

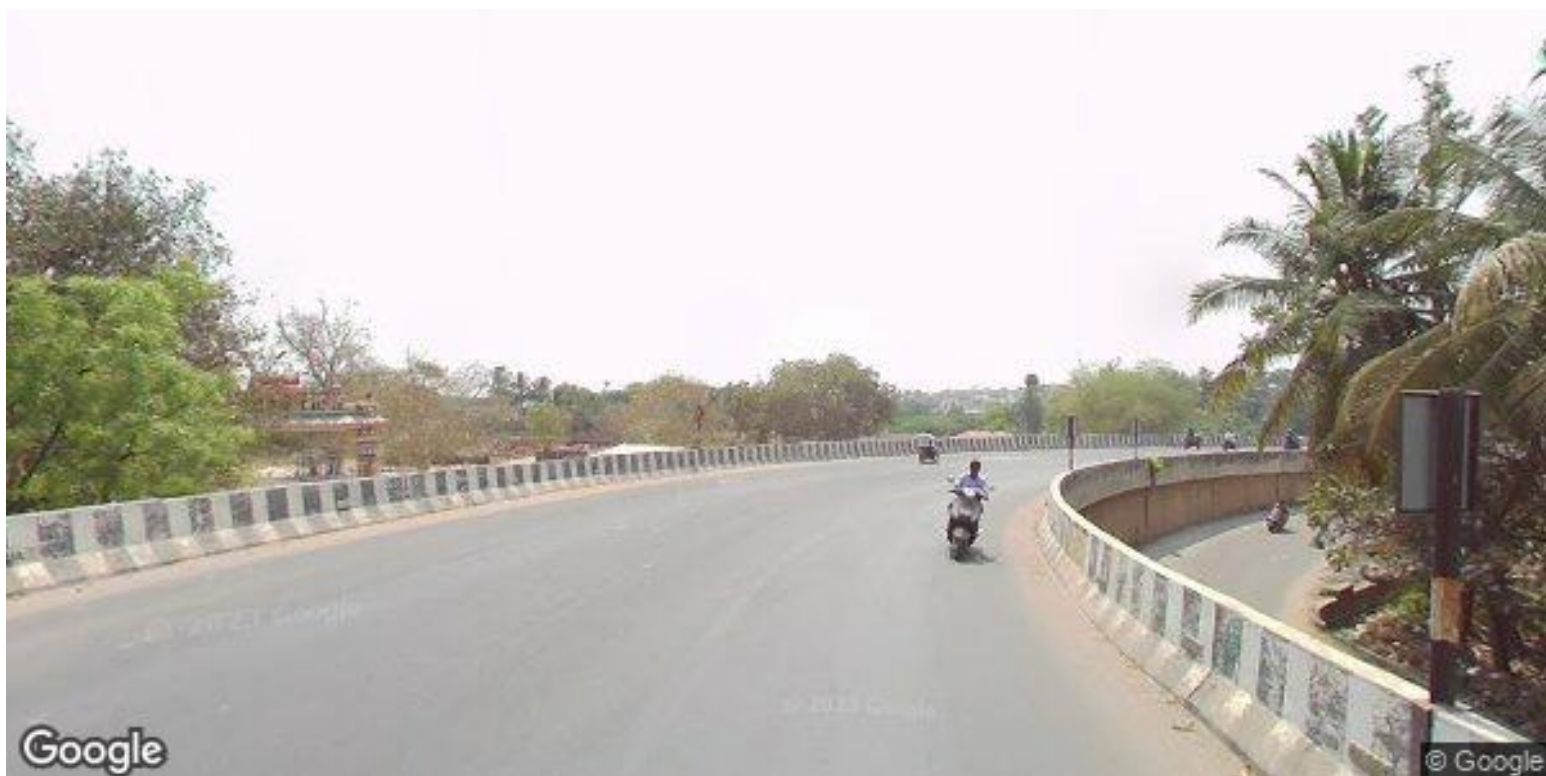
**Coordinates:** 11.73658, 78.03897

**Risk Type:** Turn

**Risk Level:** Medium

**Speed Limit:** 30 KM/Hr

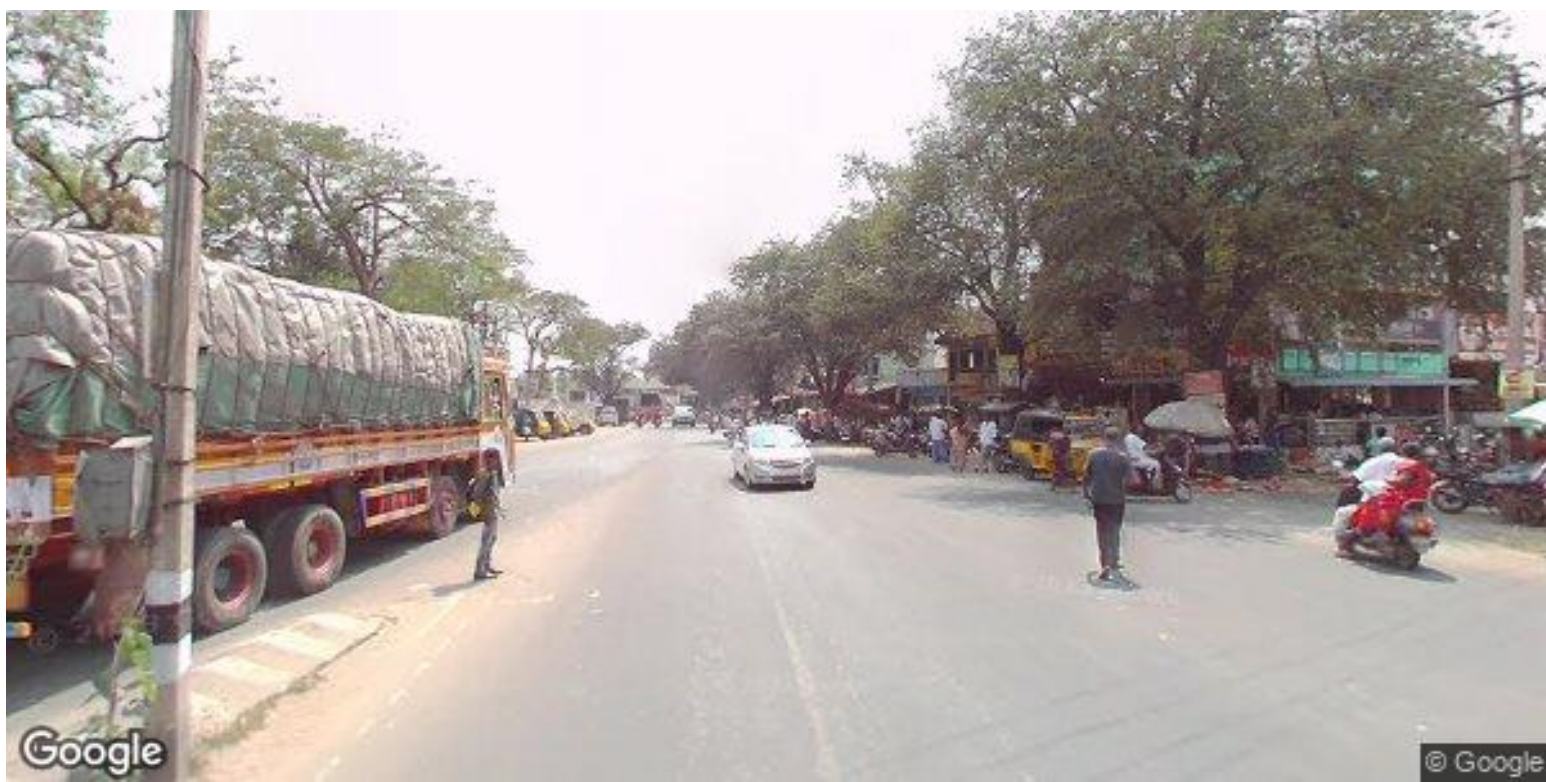
**Coordinates:** 11.74271, 78.04717

**Risk Type:** Turn

**Risk Level:** Medium

**Speed Limit:** 30 KM/Hr

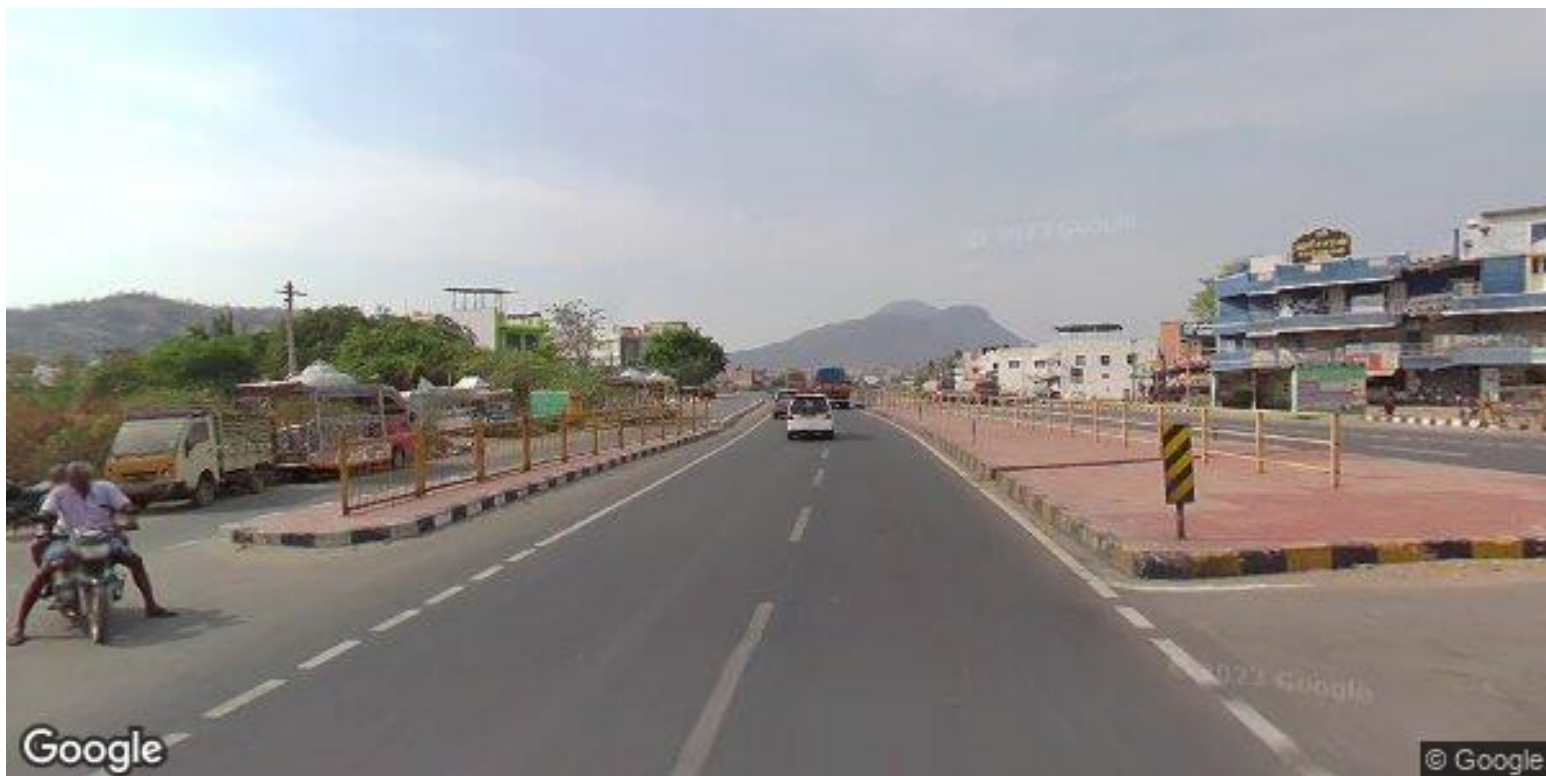
**Coordinates:** 11.87104, 78.08356

**Risk Type:** Blind Spot

**Risk Level:** Blind Spot

**Speed Limit:** 10 KM/Hr

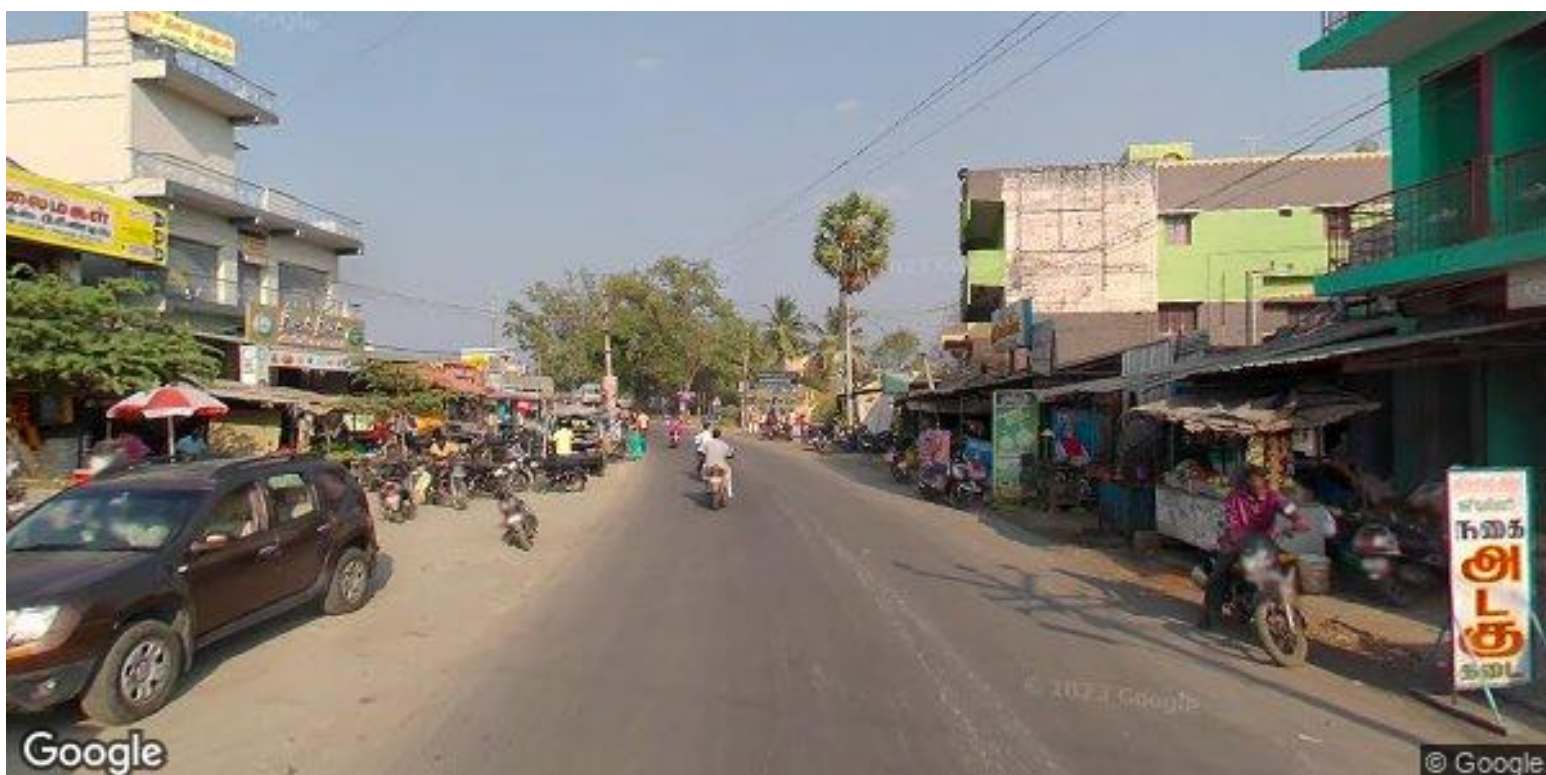
**Risk Type:** Turn  
**Risk Level:** Medium  
**Speed Limit:** 30 KM/Hr  
**Coordinates:** 11.87071, 78.08450

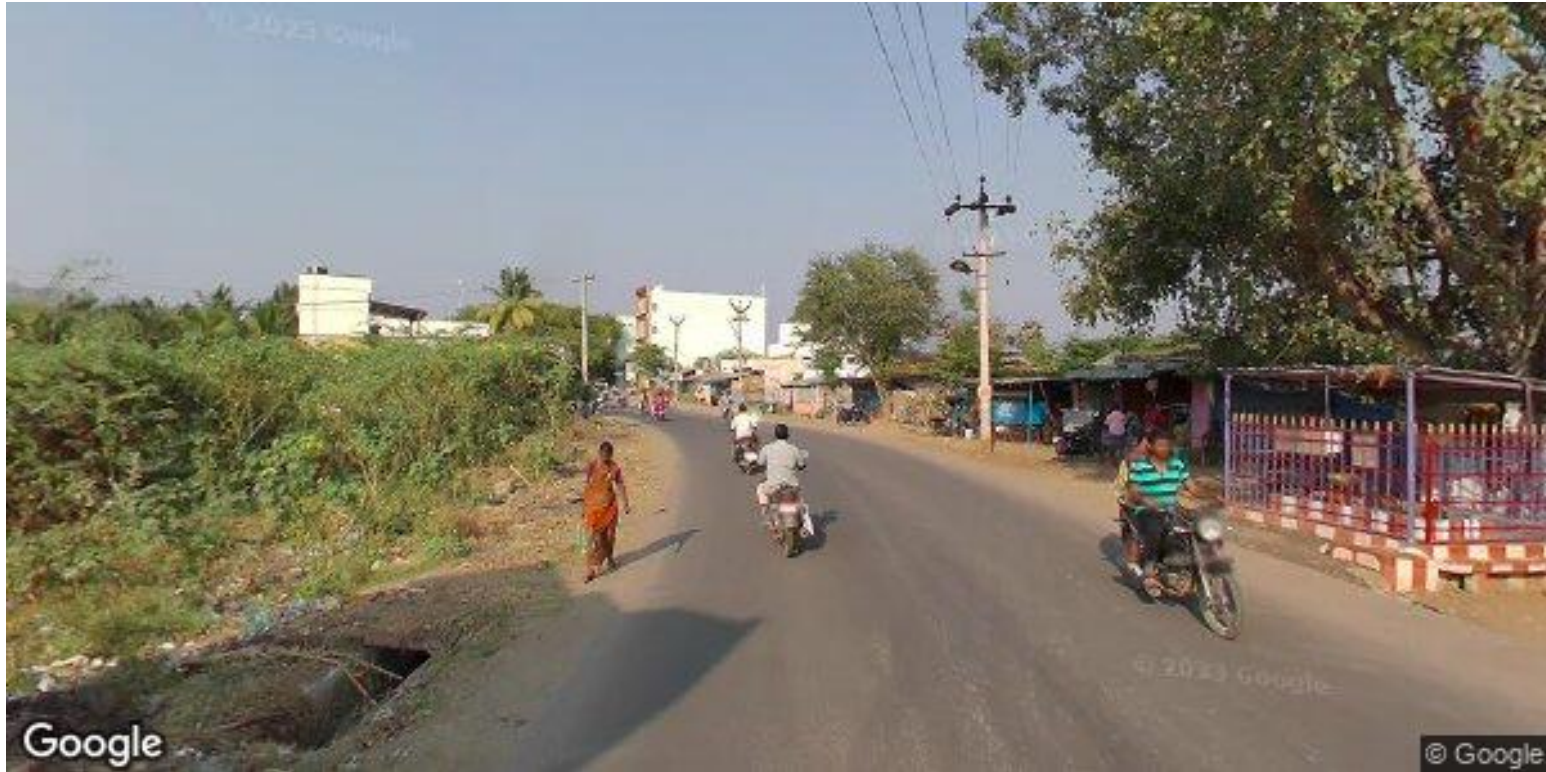
**Risk Type:** Turn  
**Risk Level:** Medium  
**Speed Limit:** 30 KM/Hr  
**Coordinates:** 11.87089, 78.08558

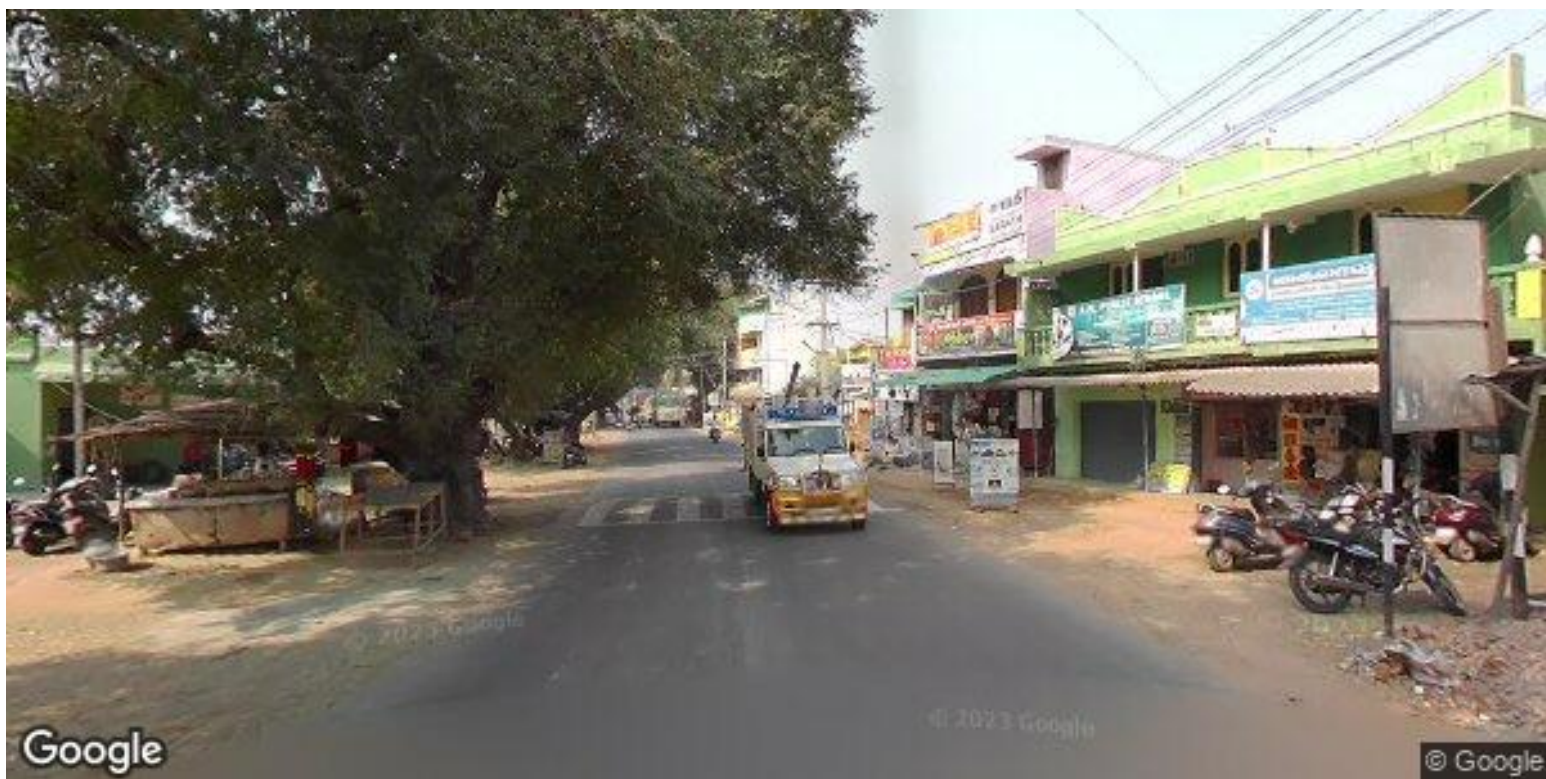
**Risk Type:** Turn  
**Risk Level:** Medium  
**Speed Limit:** 30 KM/Hr  
**Coordinates:** 11.87249, 78.08707

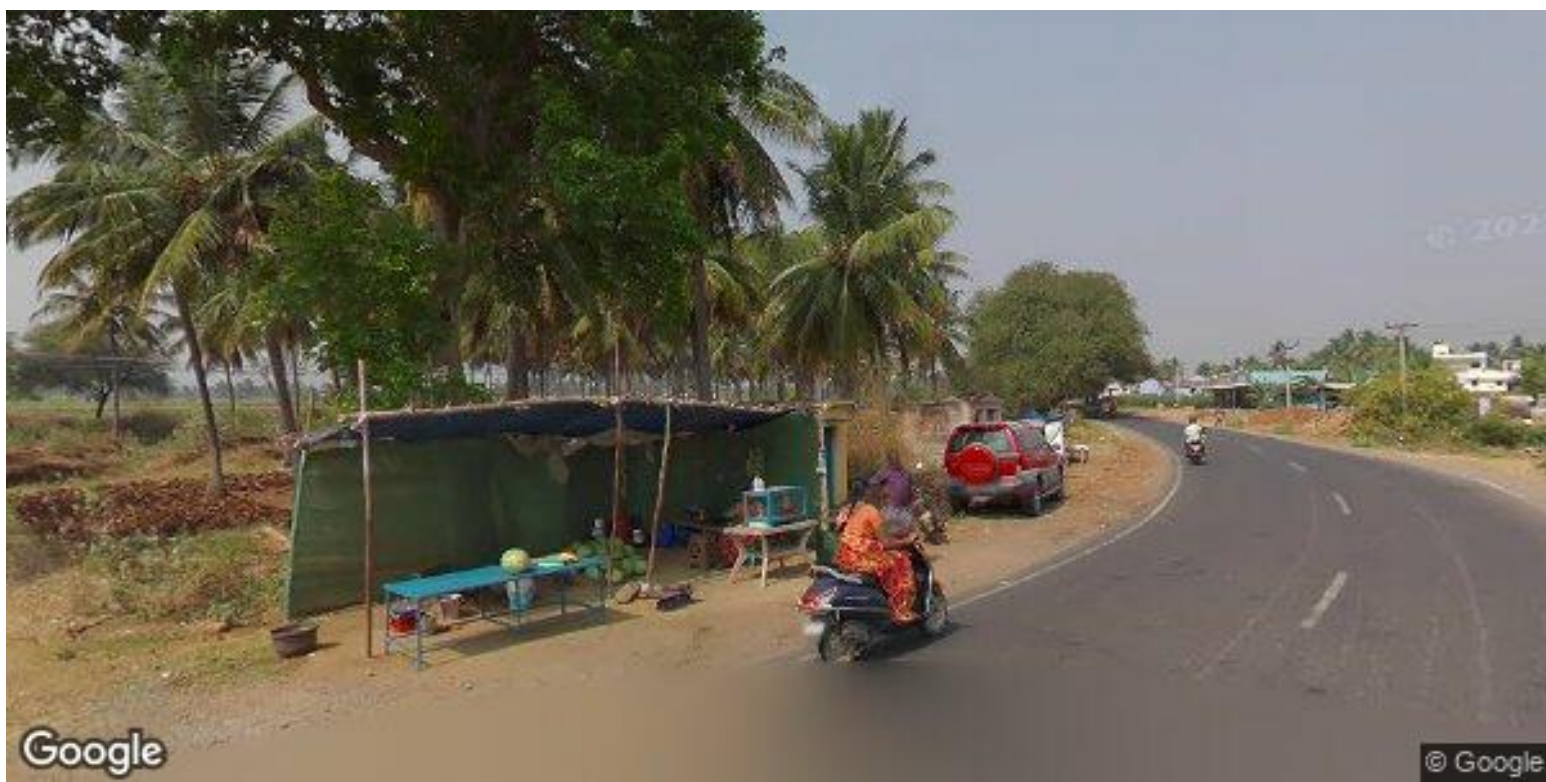
**Coordinates:** 11.86893, 78.12084

**Risk Type:** Turn

**Risk Level:** Medium

**Speed Limit:** 30 KM/Hr
