# IndianOil

## JOURNEY RISK MANAGEMENT (JRM) STUDY

### Salem Terminal TO MURUGAN FUELS

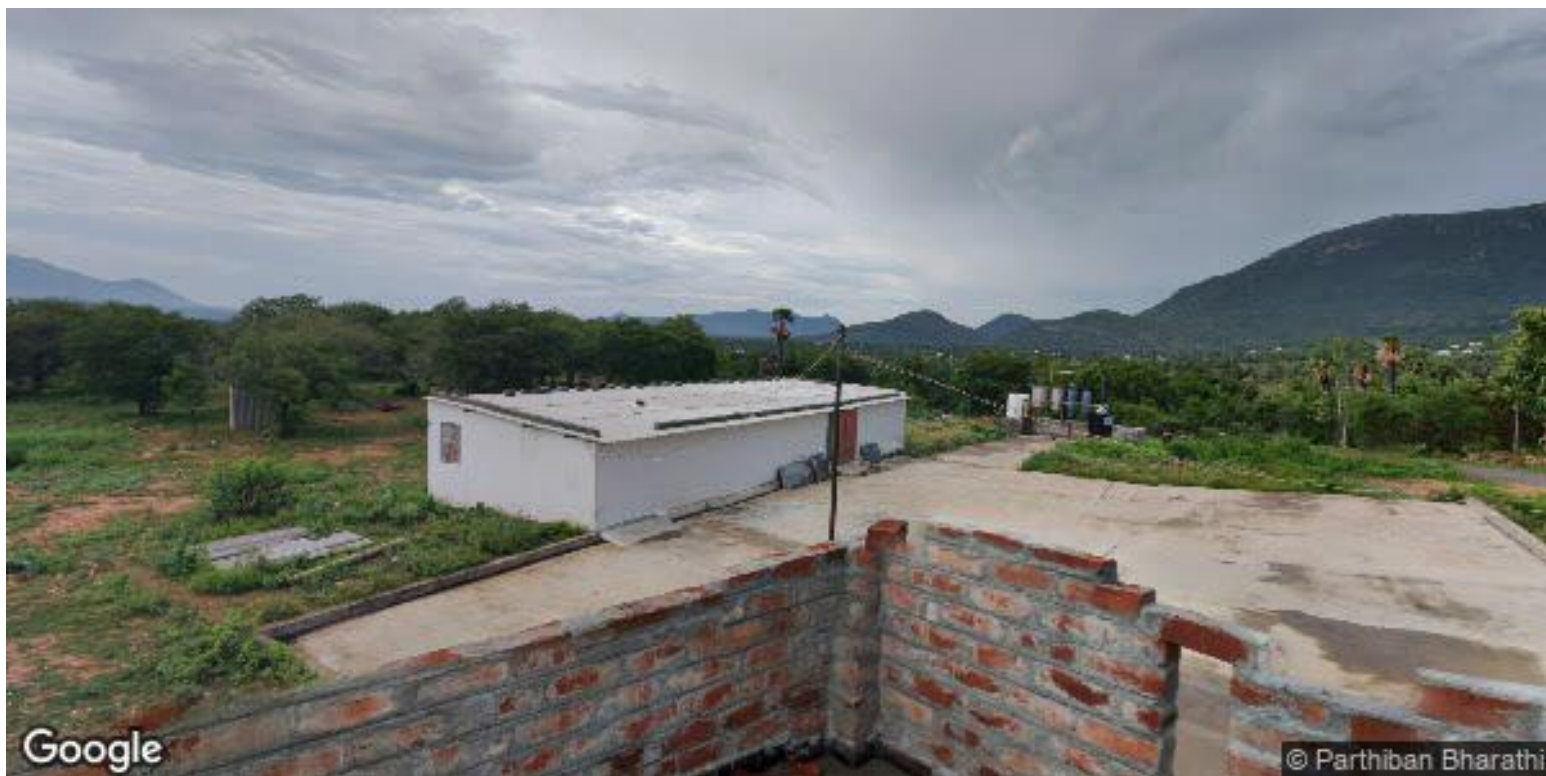
**Coordinates:** 11.95120, 78.20653

**Risk Type:** Turn

**Risk Level:** Medium

**Speed Limit:** 30 KM/Hr

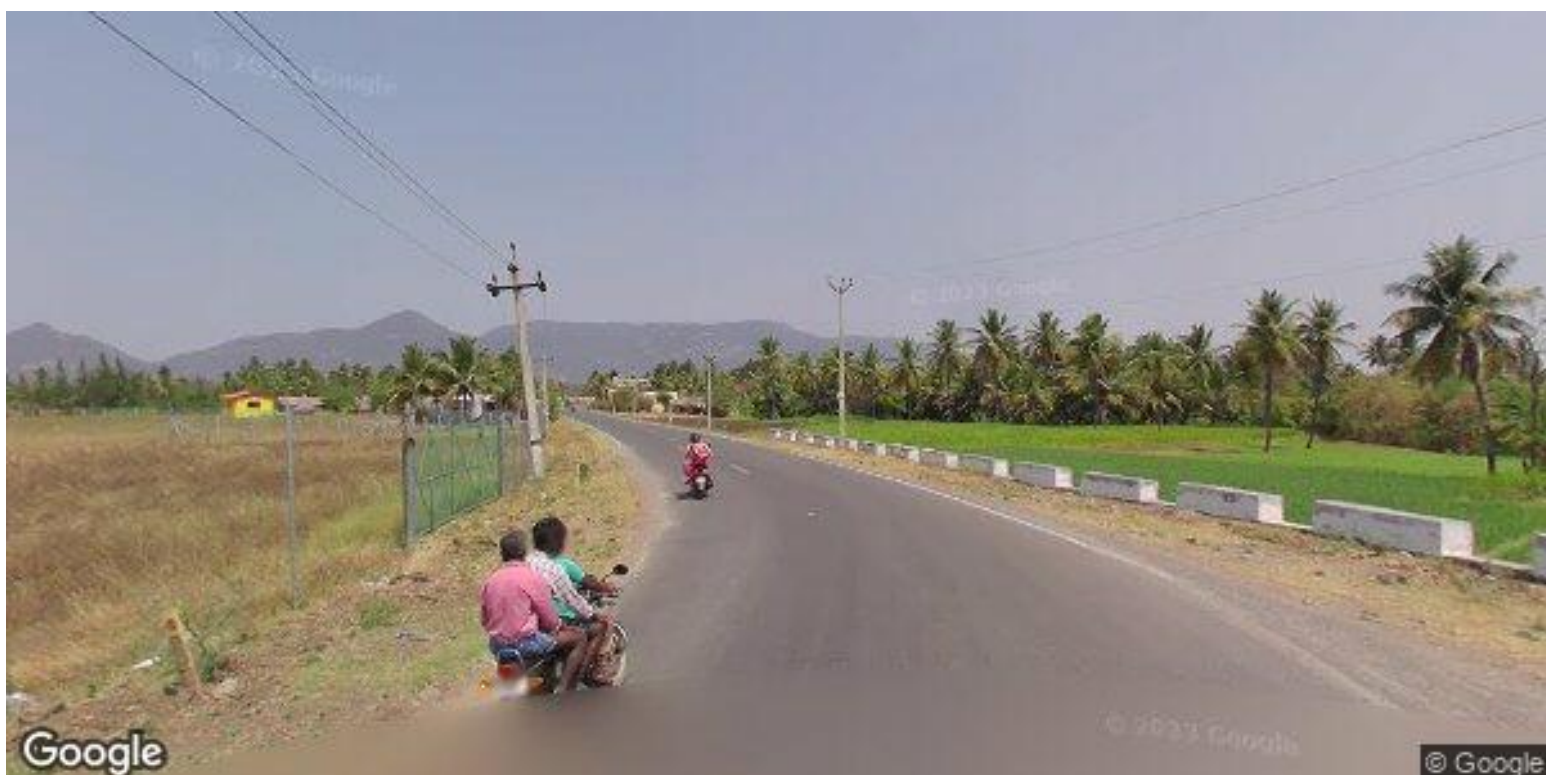
**Risk Type:** Turn  
**Risk Level:** High  
**Speed Limit:** 15 KM/Hr  
**Coordinates:** 11.97329, 78.23713

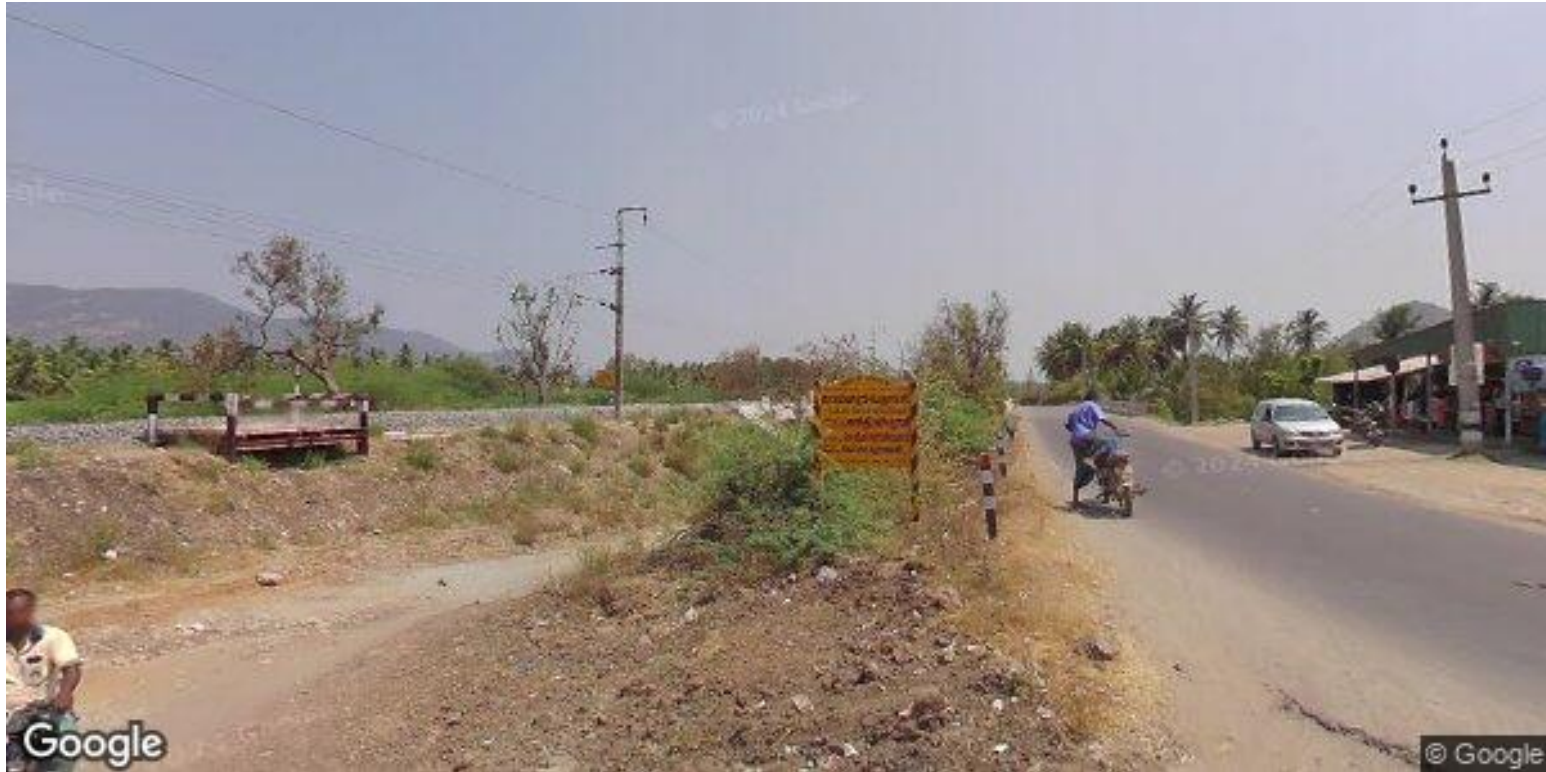
**Risk Type:** Turn  
**Risk Level:** High  
**Speed Limit:** 15 KM/Hr  
**Coordinates:** 11.97765, 78.23556

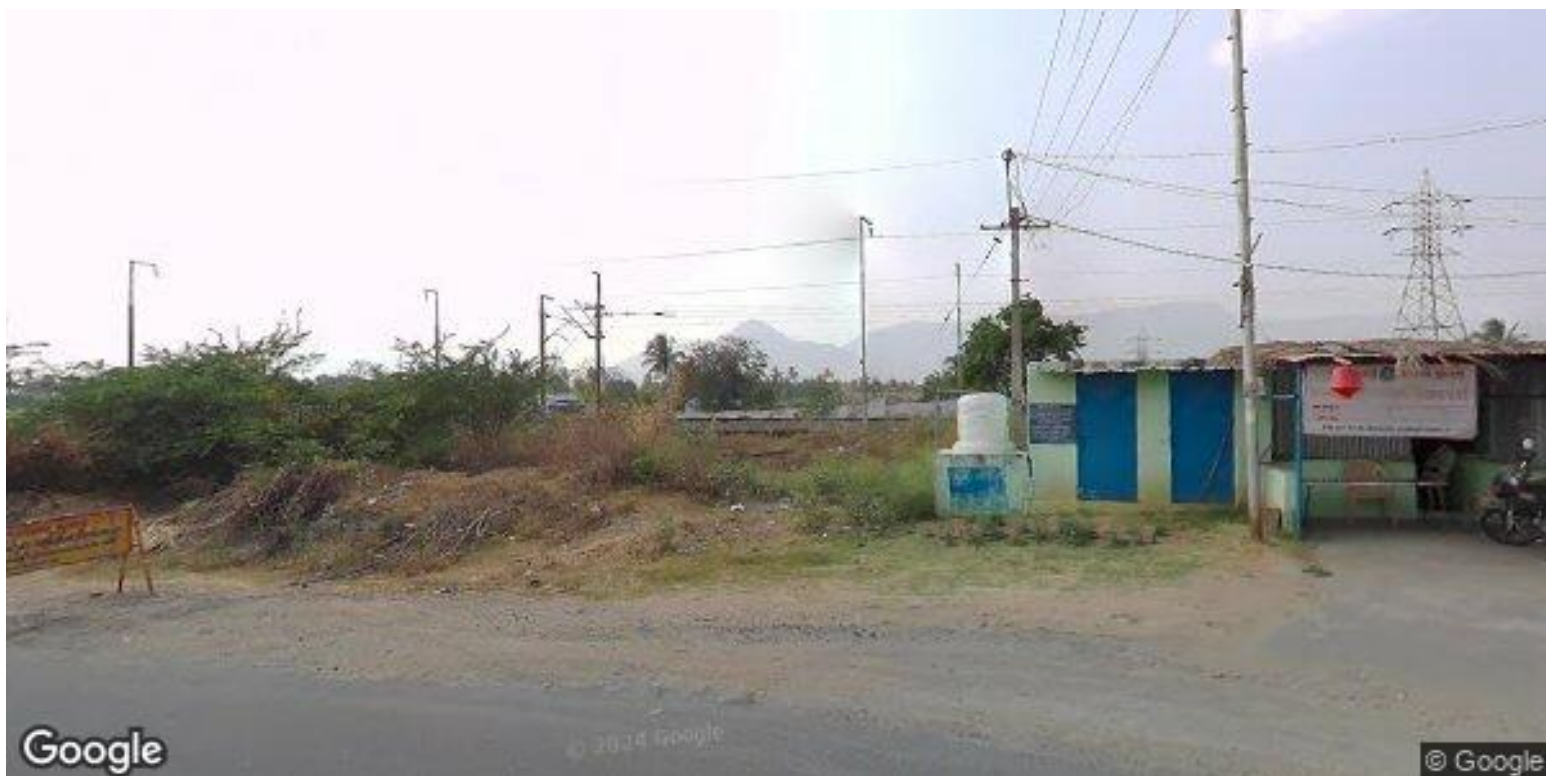
**Risk Type:** Turn  
**Risk Level:** High  
**Speed Limit:** 15 KM/Hr  
**Coordinates:** 11.98242, 78.24309

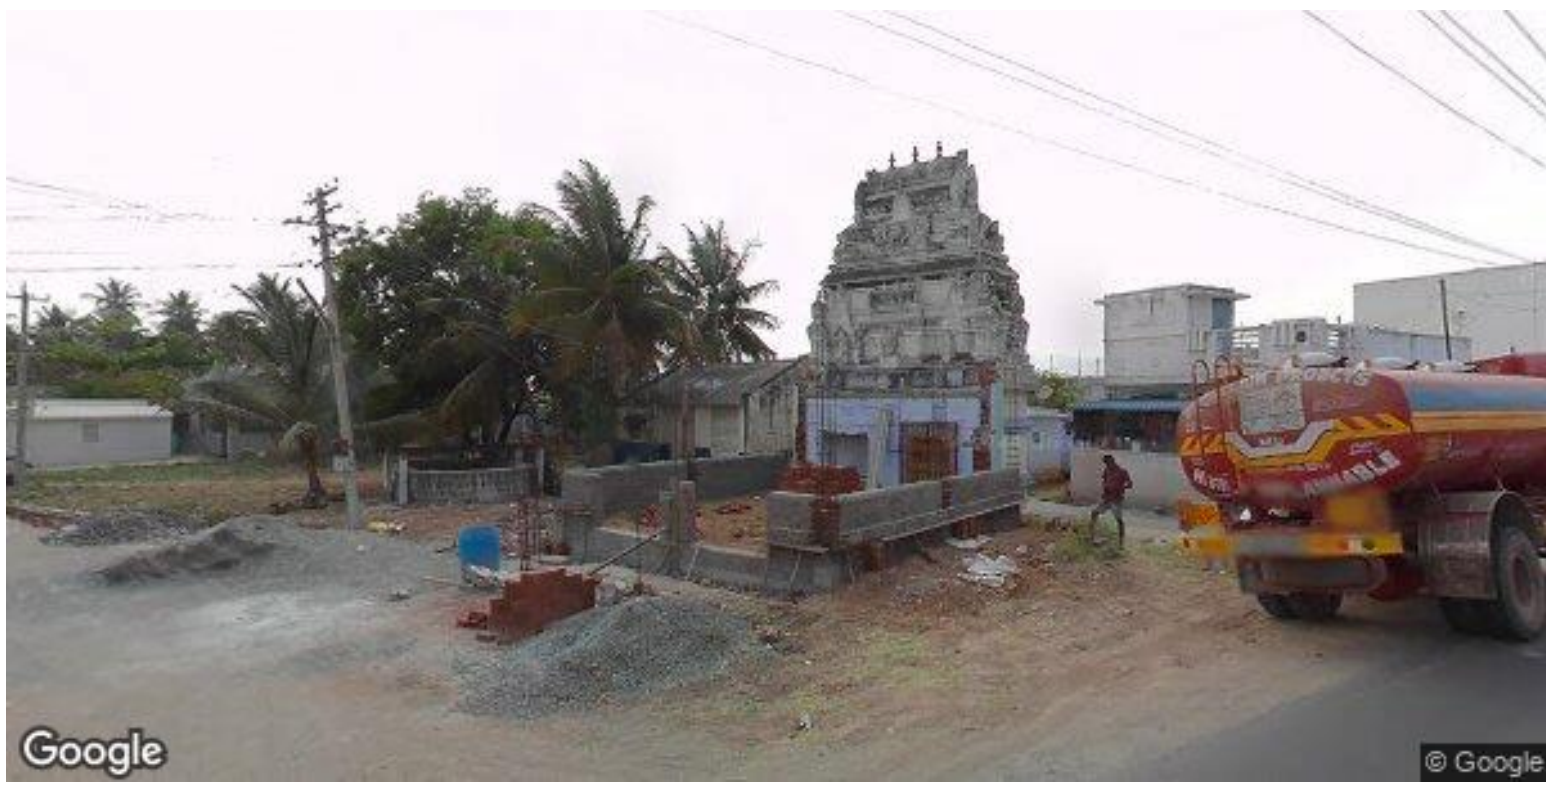
**Coordinates:** 11.98205, 78.24333

**Risk Type:** Turn

**Risk Level:** High

**Speed Limit:** 15 KM/Hr

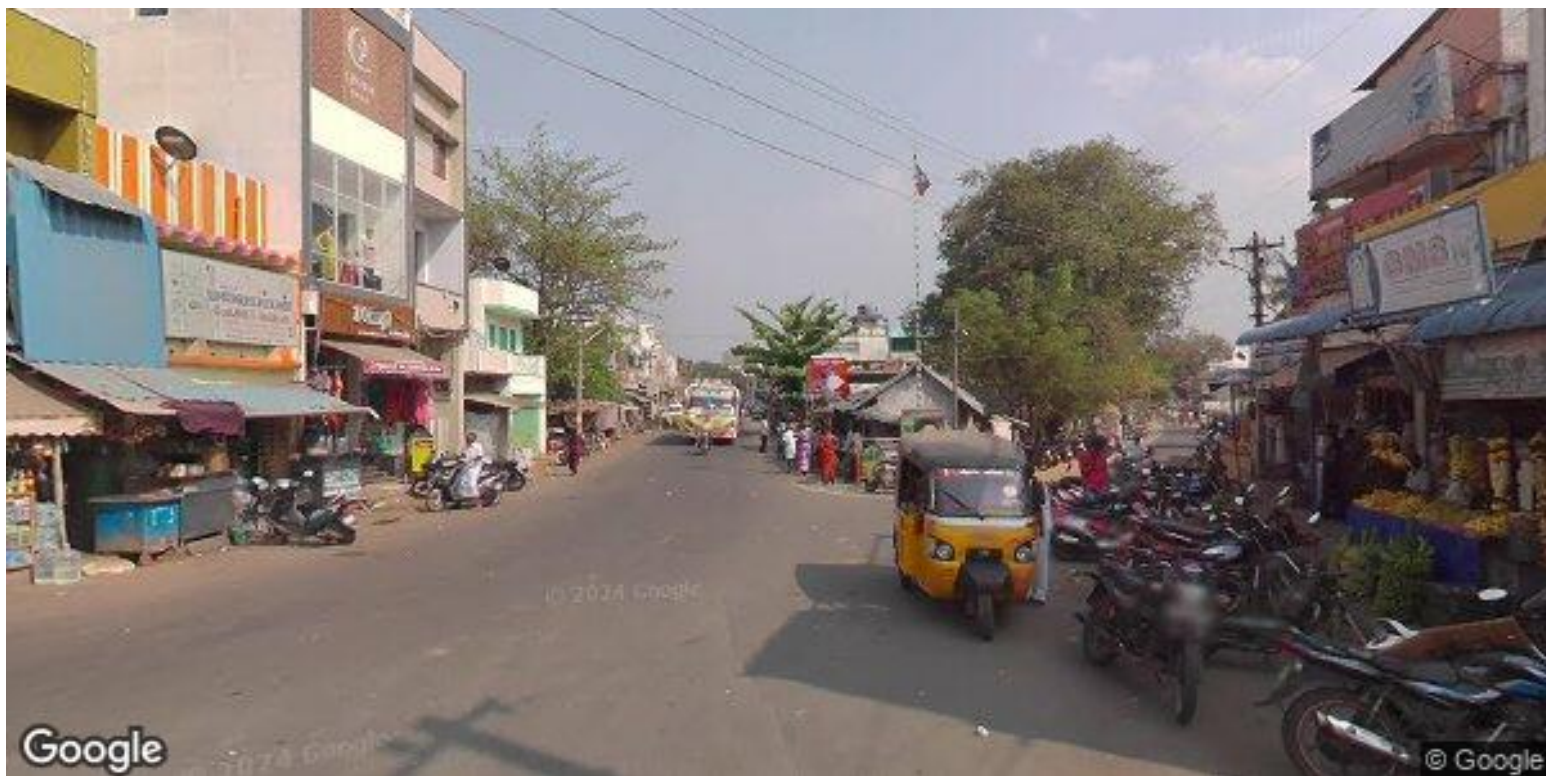
**Coordinates:** 11.98346, 78.24637

**Risk Type:** Turn

**Risk Level:** High

**Speed Limit:** 15 KM/Hr

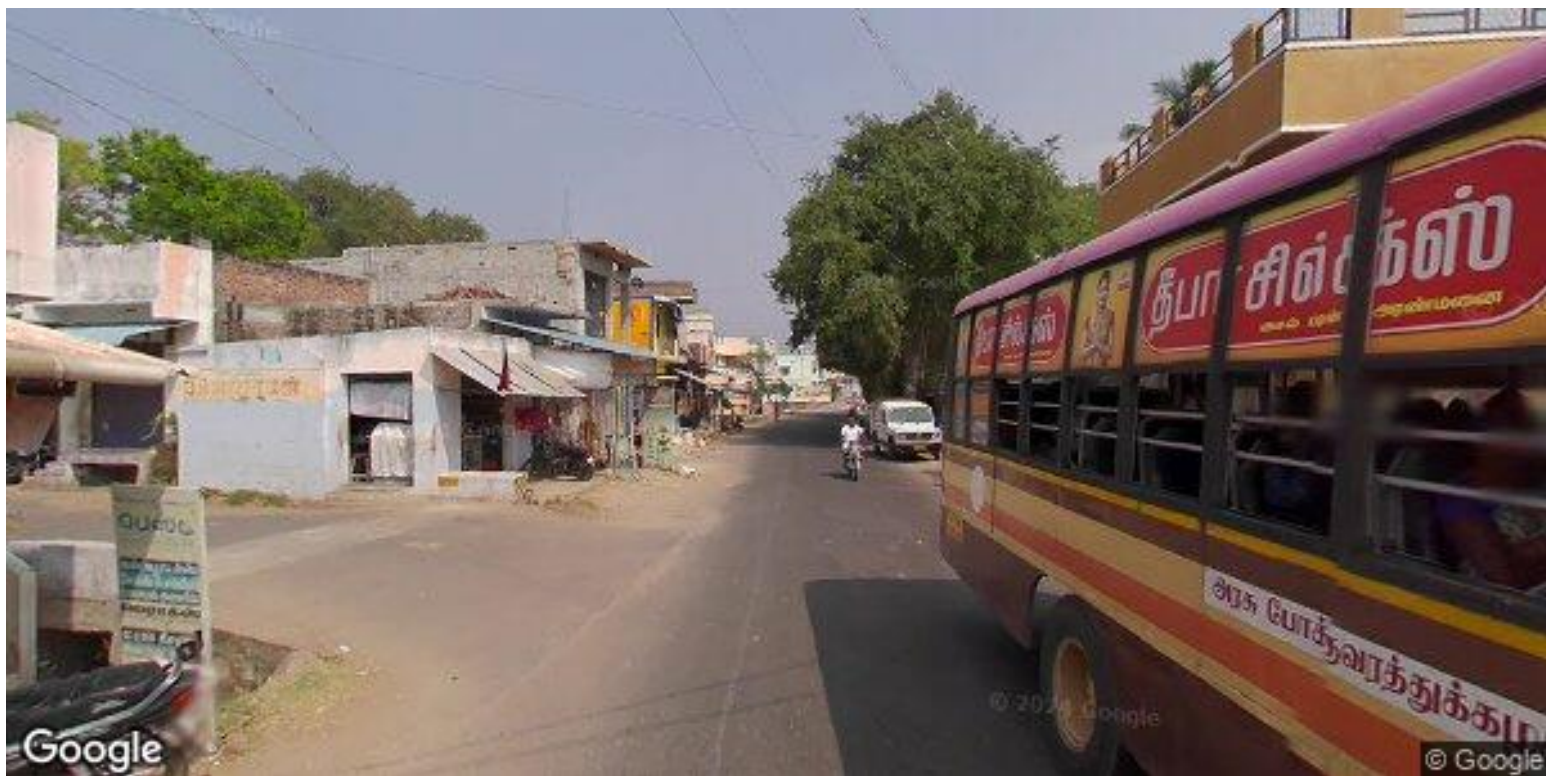
**Coordinates:** 11.96949, 78.26940

**Risk Type:** Turn

**Risk Level:** High

**Speed Limit:** 15 KM/Hr
