# IndianOil

## JOURNEY RISK MANAGEMENT (JRM) STUDY

### Salem Terminal to SRI VK TRADER

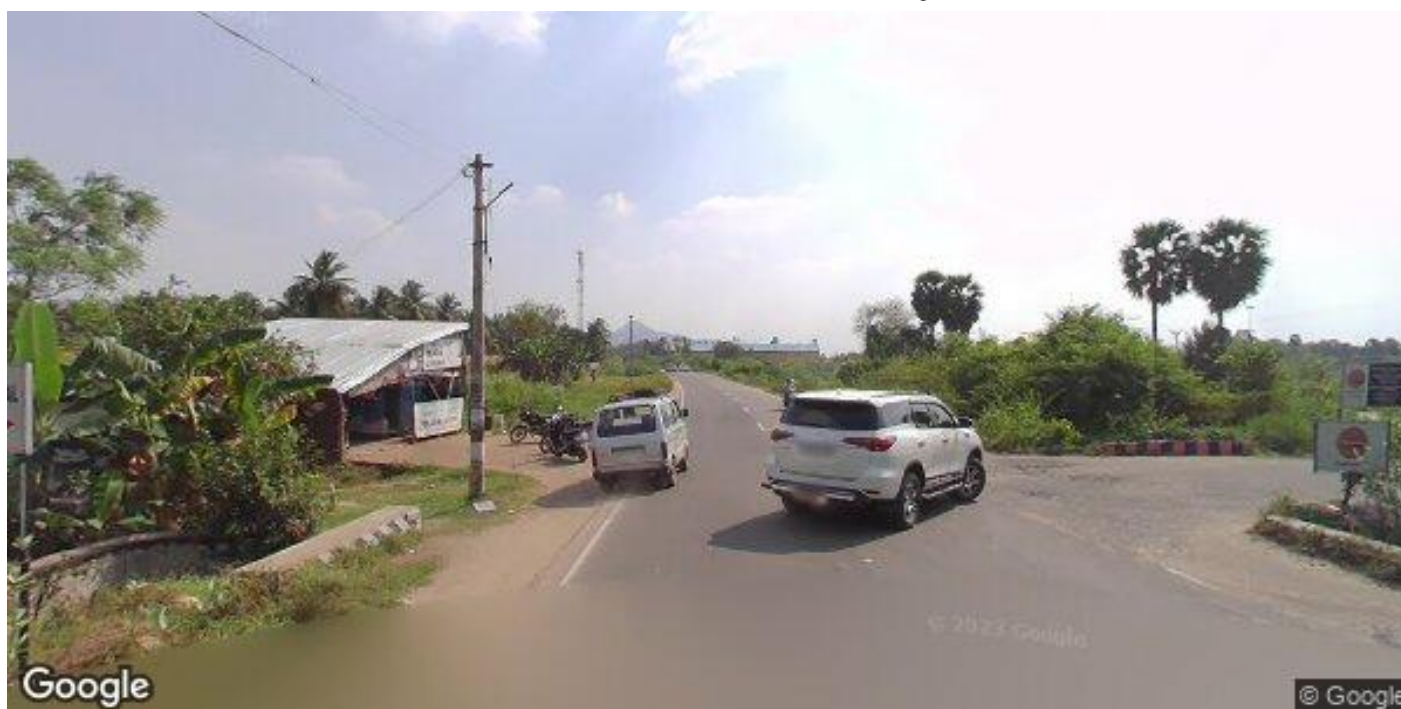
| | Risk Type | Risk Level | Coordinates | Speed Limit |
|---|---|---|---|---|
| 2 | Turn | High | 11.44029, 77.87544 | 15 KM/Hr |

**Risk Type:** Turn  
**Risk Level:** High  
**Speed Limit:** 15 KM/Hr  
**Coordinates:** 11.44029, 77.87544

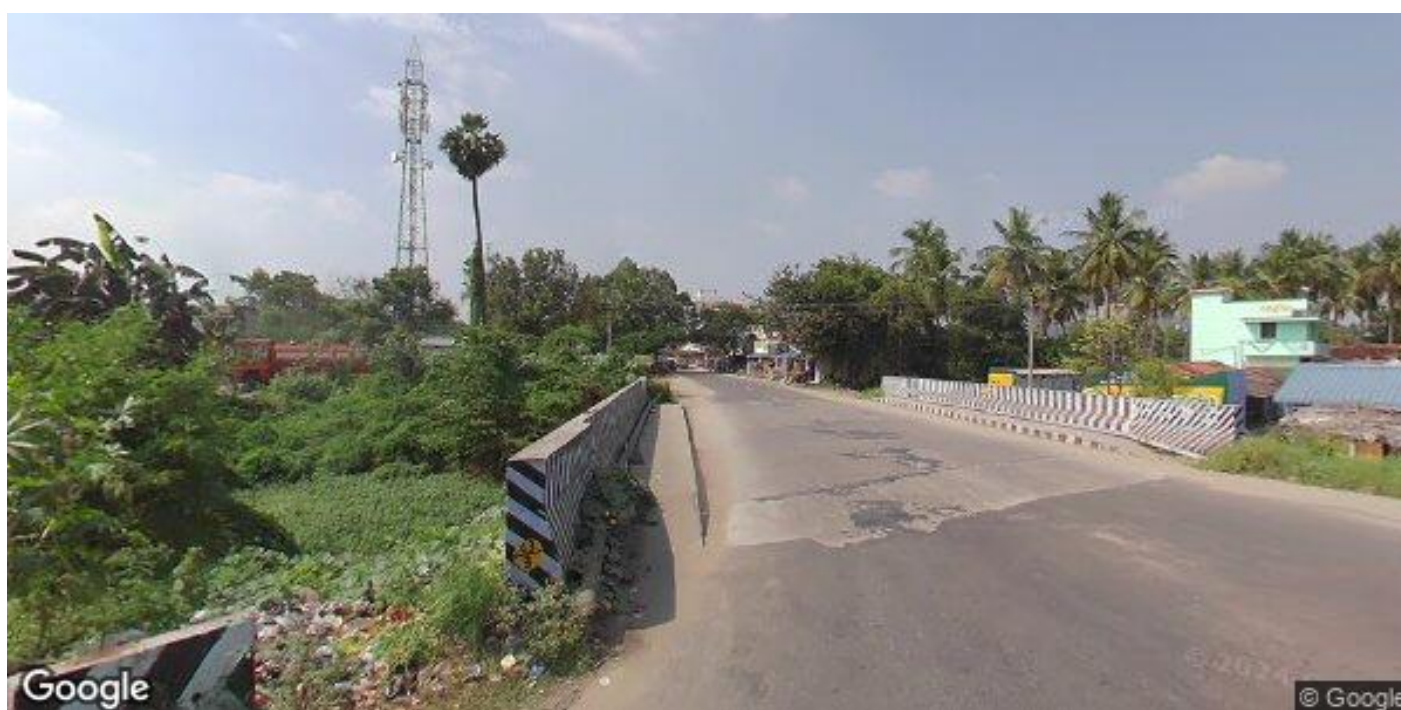
| | Risk Type | Risk Level | Coordinates | Speed Limit |
|---|---|---|---|---|
| 3 | Turn | Medium | 11.44900, 77.87406 | 30 KM/Hr |

**Risk Type:** Turn  
**Risk Level:** Medium  
**Speed Limit:** 30 KM/Hr  
**Coordinates:** 11.44900, 77.87406

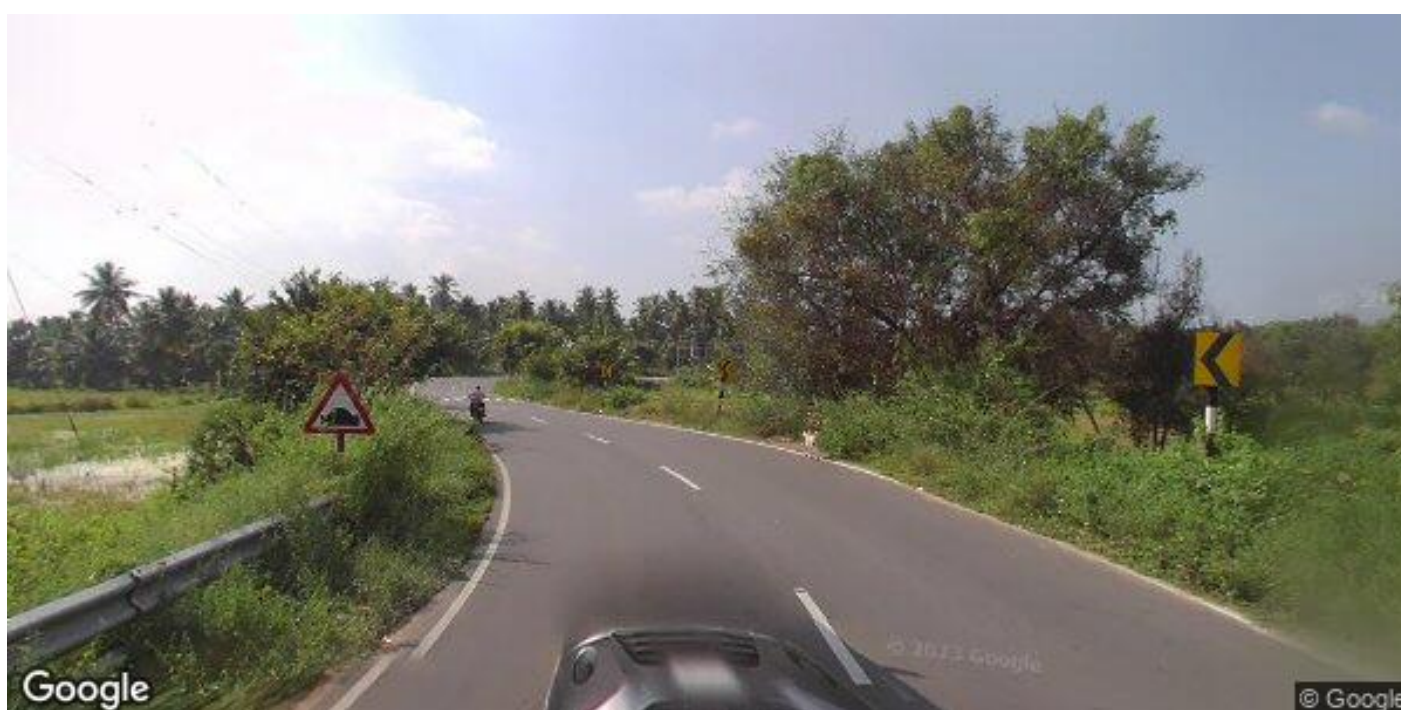
| | Risk Type | Risk Level | Coordinates | Speed Limit |
|---|---|---|---|---|
| 4 | Turn | Medium | 11.45358, 77.85781 | 30 KM/Hr |

**Risk Type:** Turn  
**Risk Level:** Medium  
**Speed Limit:** 30 KM/Hr  
**Coordinates:** 11.45358, 77.85781

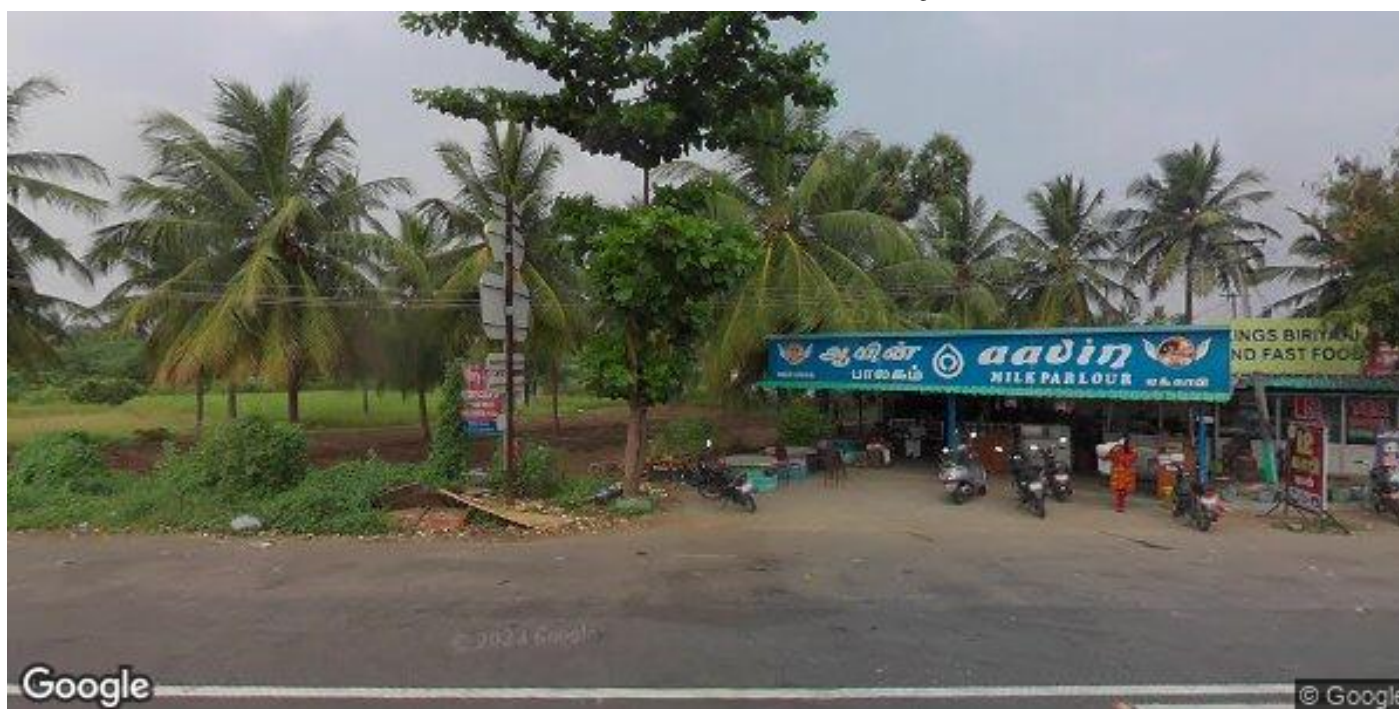
| | Risk Type | Risk Level | Coordinates | Speed Limit |
|---|---|---|---|---|
| 11 | Blind Spot | Blind Spot | 11.45631, 77.81668 | 10 KM/Hr |

**Risk Type:** Blind Spot  
**Risk Level:** Blind Spot  
**Speed Limit:** 10 KM/Hr  
**Coordinates:** 11.45631, 77.81668

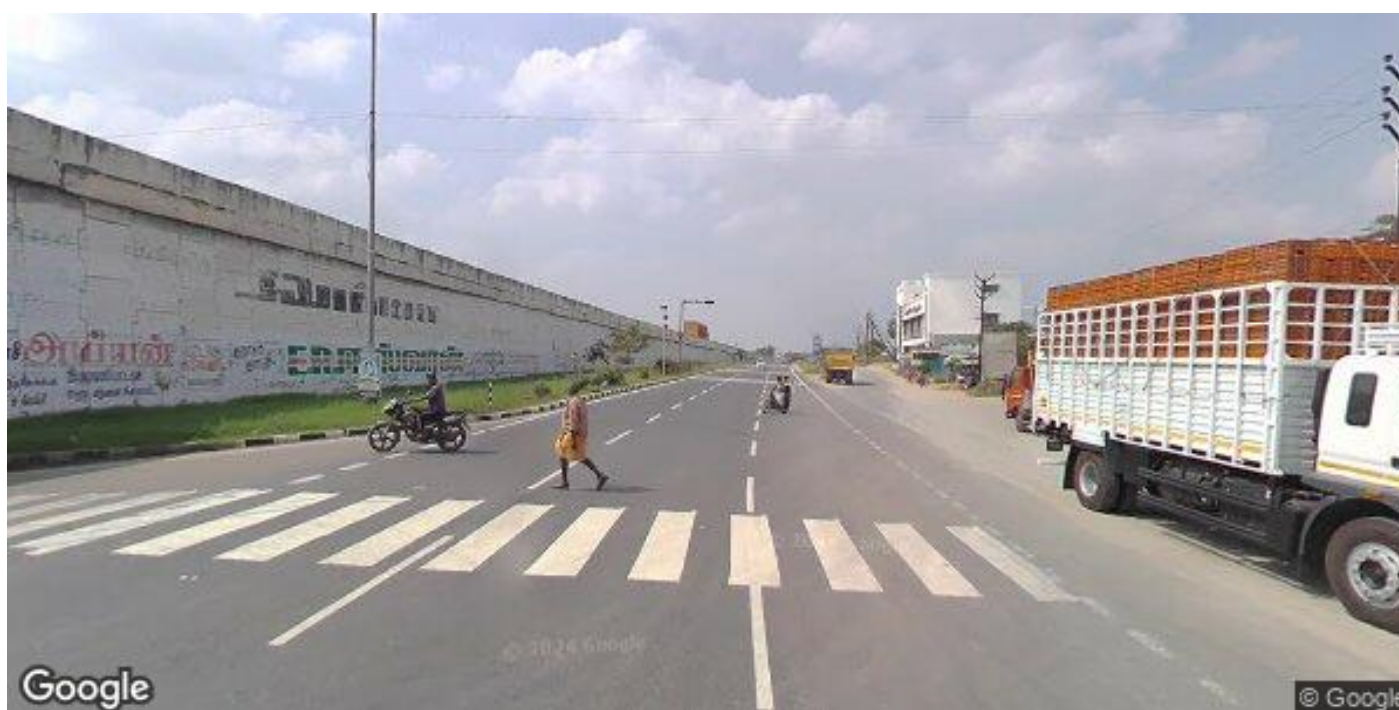
| | Risk Type | Risk Level | Coordinates | Speed Limit |
|---|---|---|---|---|
| 12 | Turn | High | 11.49224, 77.89606 | 15 KM/Hr |

**Risk Type:** Turn  
**Risk Level:** High  
**Speed Limit:** 15 KM/Hr  
**Coordinates:** 11.49224, 77.89606

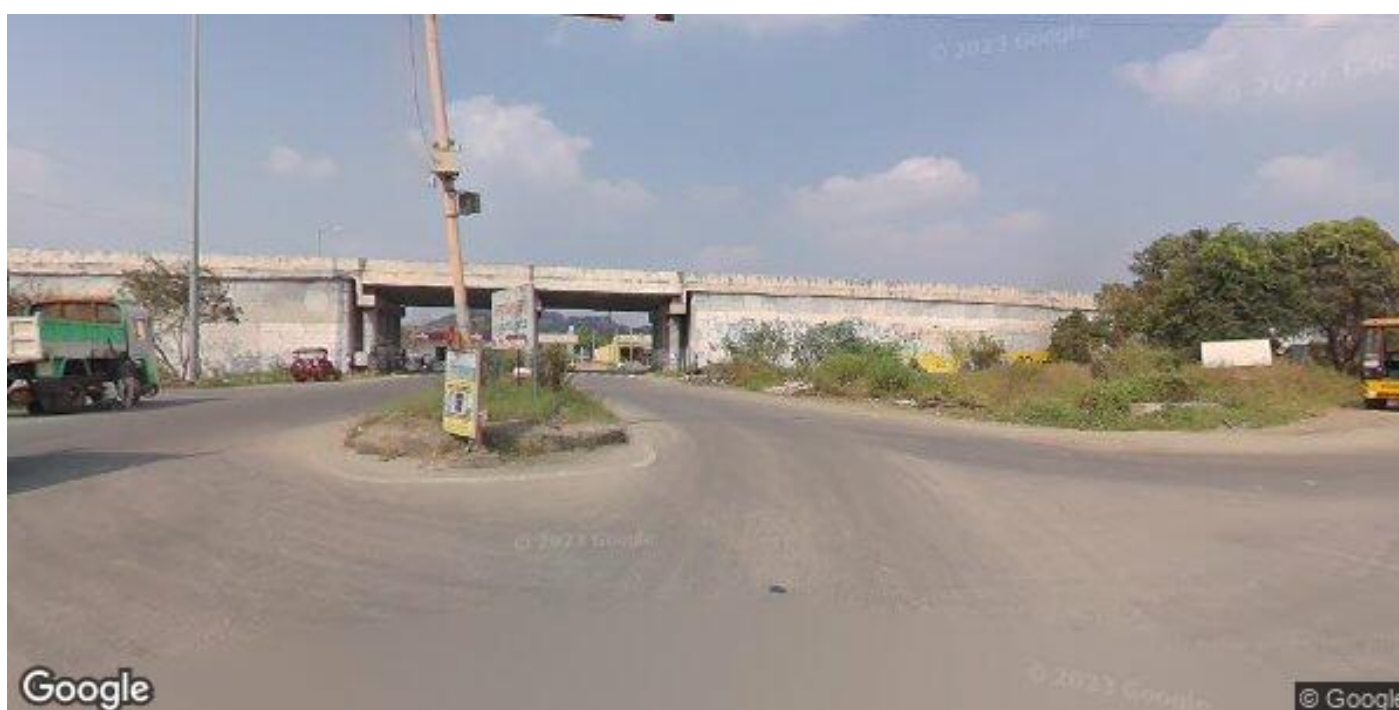
| | Risk Type | Risk Level | Coordinates | Speed Limit |
|---|---|---|---|---|
| 13 | Turn | High | 11.49153, 77.89615 | 15 KM/Hr |

**Risk Type:** Turn  
**Risk Level:** High  
**Speed Limit:** 15 KM/Hr  
**Coordinates:** 11.49153, 77.89615

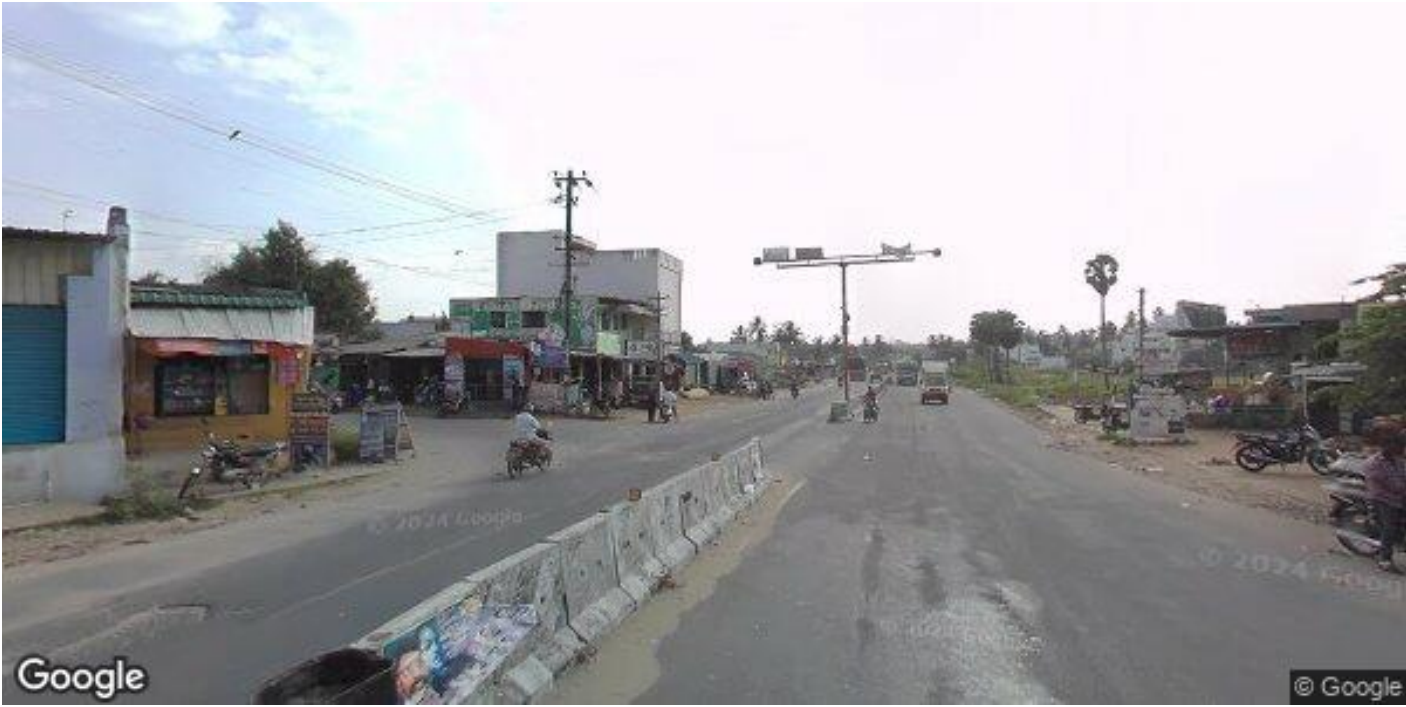
| | Risk Type | Risk Level | Coordinates | Speed Limit |
|---|---|---|---|---|
| 14 | Blind Spot | Blind Spot | 11.48364, 77.88780 | 10 KM/Hr |

**Risk Type:** Blind Spot  
**Risk Level:** Blind Spot  
**Speed Limit:** 10 KM/Hr  
**Coordinates:** 11.48364, 77.88780

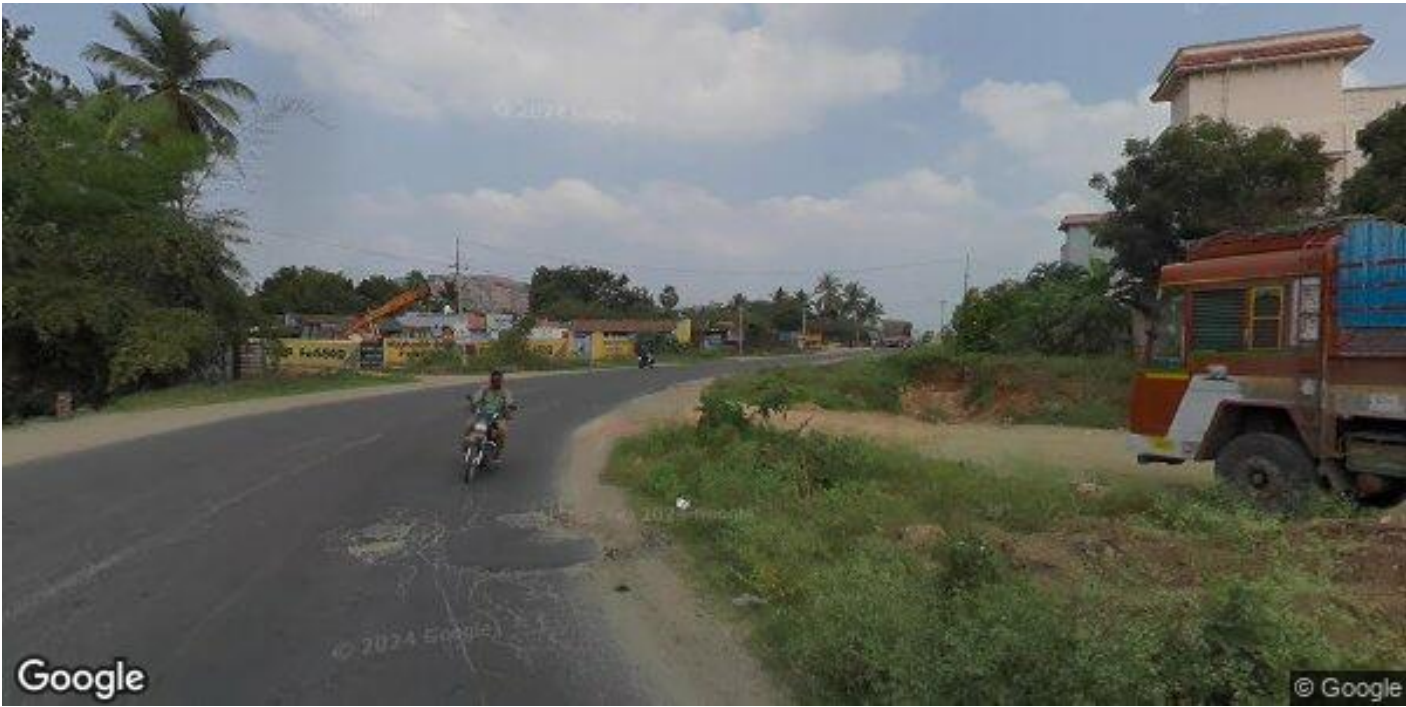
| | Risk Type | Risk Level | Coordinates | Speed Limit |
|---|---|---|---|---|
| 15 | Turn | Medium | 11.49441, 77.88495 | 30 KM/Hr |

**Risk Type:** Turn  
**Risk Level:** Medium  
**Speed Limit:** 30 KM/Hr  
**Coordinates:** 11.49441, 77.88495

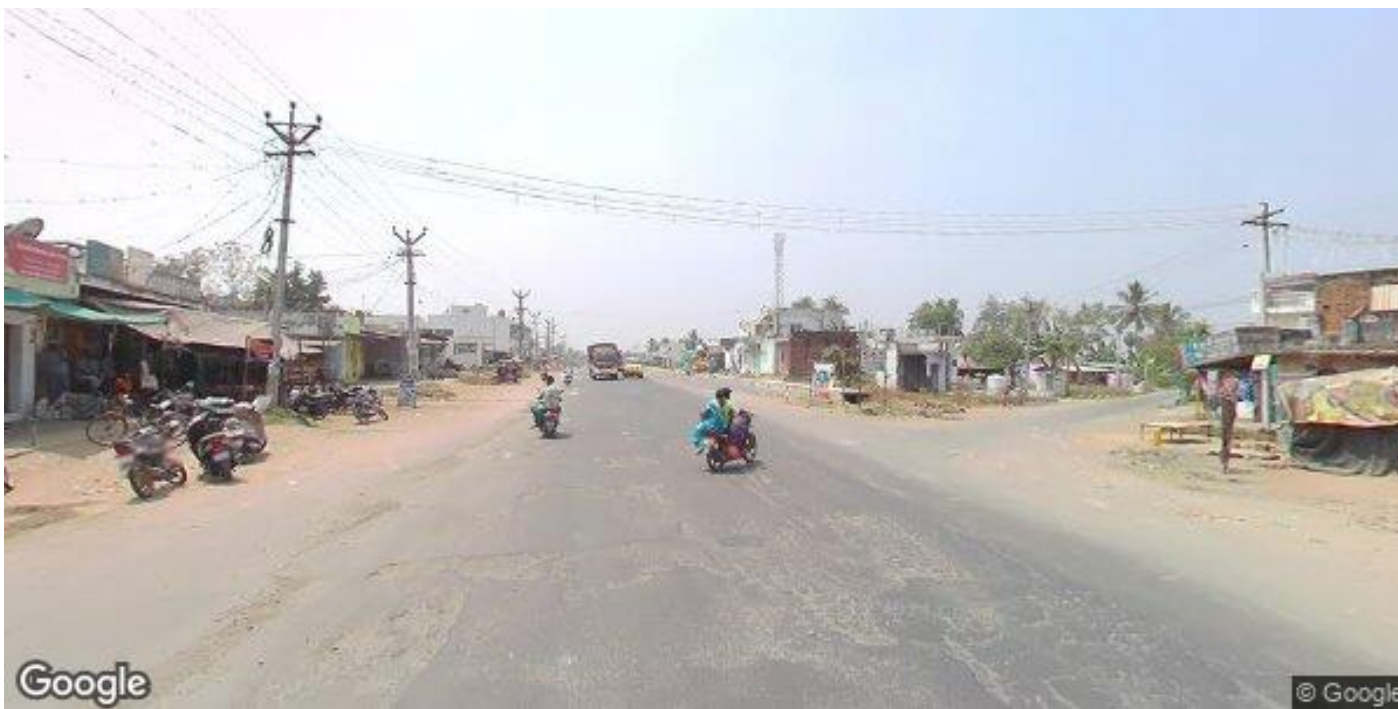
| | Risk Type | Risk Level | Coordinates | Speed Limit |
|---|---|---|---|---|
| 20 | Turn | High | 11.66252, 77.96048 | 15 KM/Hr |

**Risk Type:** Turn  
**Risk Level:** High  
**Speed Limit:** 15 KM/Hr  
**Coordinates:** 11.66252, 77.96048

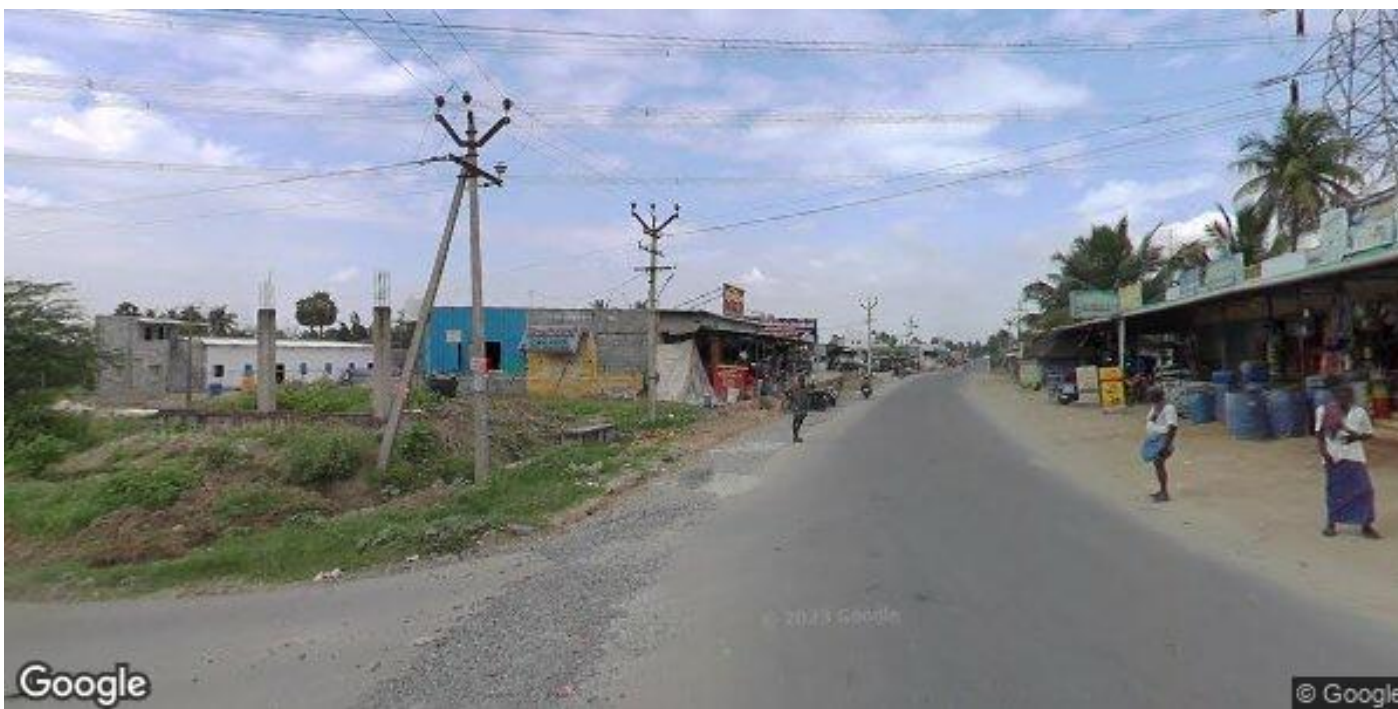
| | Risk Type | Risk Level | Coordinates | Speed Limit |
|---|---|---|---|---|
| 21 | Turn | High | 11.66821, 78.00077 | 15 KM/Hr |

**Risk Type:** Turn  
**Risk Level:** High  
**Speed Limit:** 15 KM/Hr  
**Coordinates:** 11.66821, 78.00077

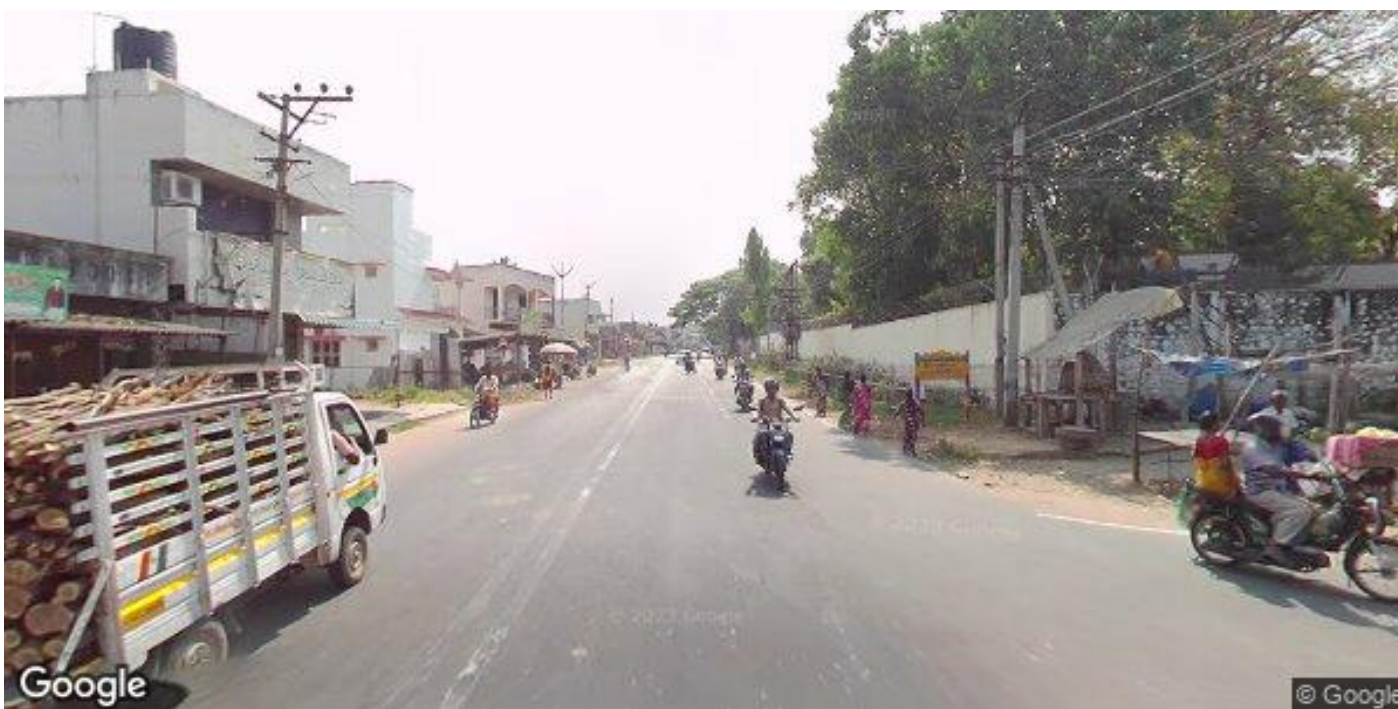
| | Risk Type | Risk Level | Coordinates | Speed Limit |
|---|---|---|---|---|
| 22 | Blind Spot | Blind Spot | 11.67303, 78.00187 | 10 KM/Hr |

**Risk Type:** Blind Spot  
**Risk Level:** Blind Spot  
**Speed Limit:** 10 KM/Hr  
**Coordinates:** 11.67303, 78.00187

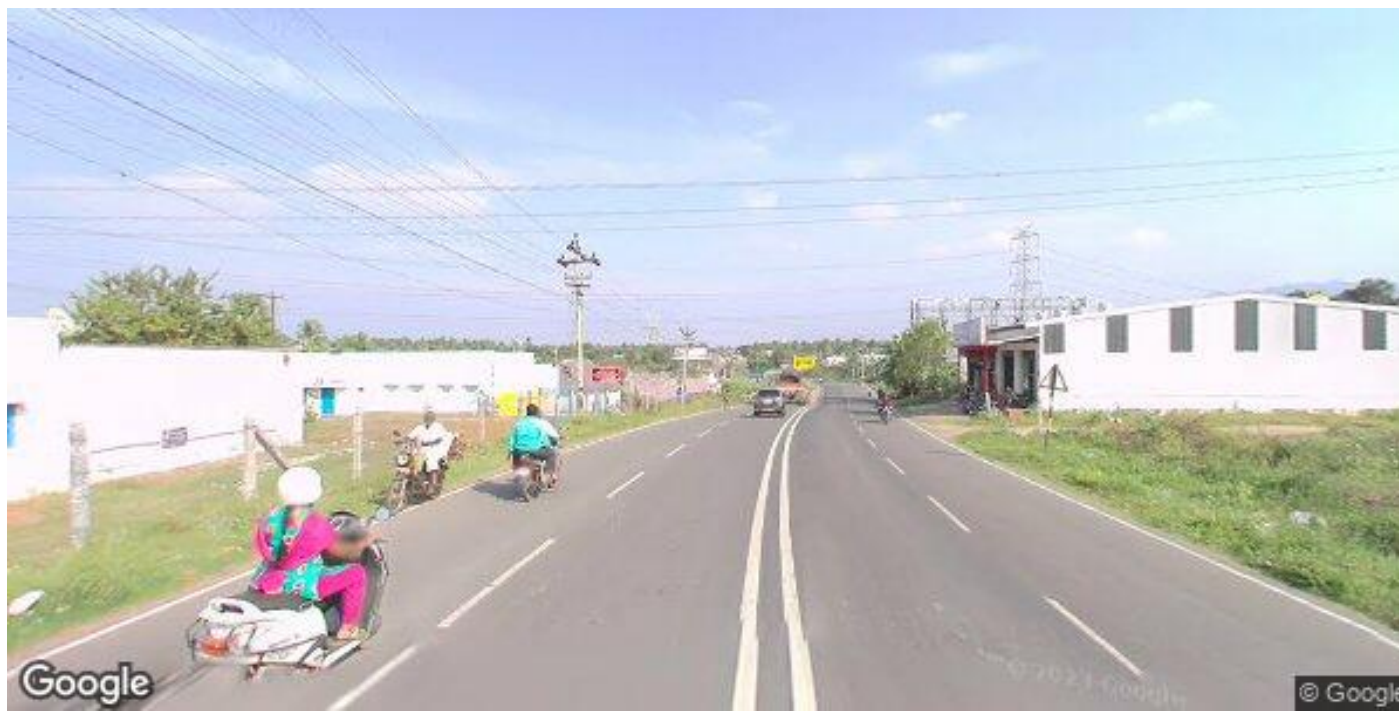
| | Risk Type | Risk Level | Coordinates | Speed Limit |
|---|---|---|---|---|
| 23 | Blind Spot | Blind Spot | 11.67370, 77.99409 | 10 KM/Hr |

**Risk Type:** Blind Spot  
**Risk Level:** Blind Spot  
**Speed Limit:** 10 KM/Hr  
**Coordinates:** 11.67370, 77.99409

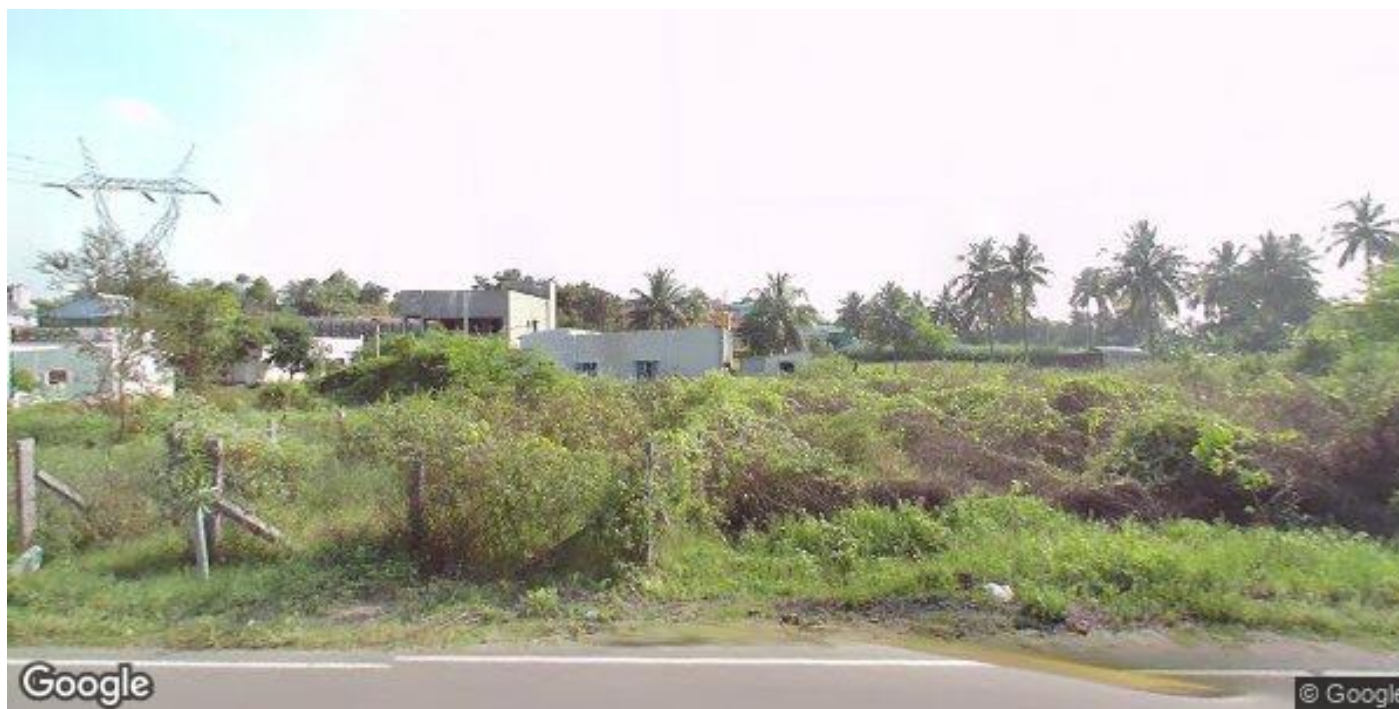
| | Risk Type | Risk Level | Coordinates | Speed Limit |
|---|---|---|---|---|
| 24 | Turn | High | 11.67340, 77.99404 | 15 KM/Hr |

**Risk Type:** Turn  
**Risk Level:** High  
**Speed Limit:** 15 KM/Hr  
**Coordinates:** 11.67340, 77.99404

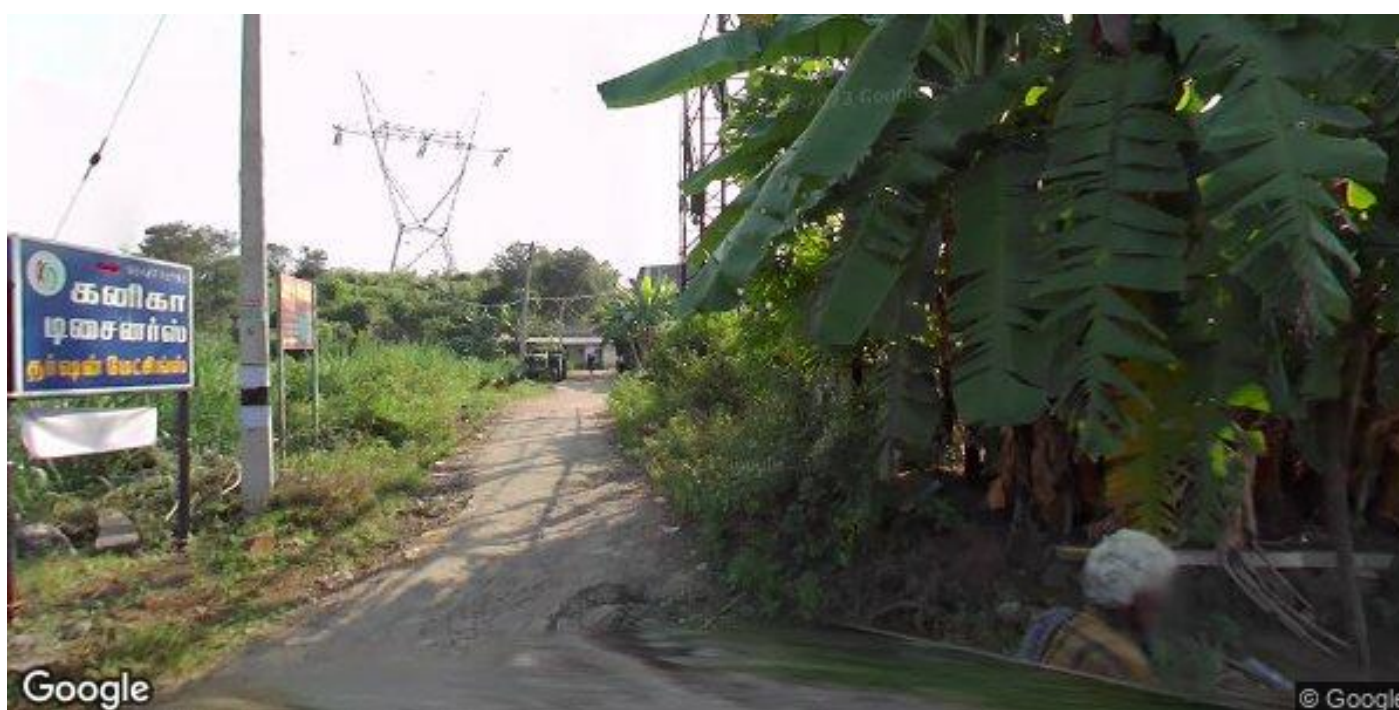
| | Risk Type | Risk Level | Coordinates | Speed Limit |
|---|---|---|---|---|
| 25 | Turn | High | 11.67327, 77.99475 | 15 KM/Hr |

**Risk Type:** Turn  
**Risk Level:** High  
**Speed Limit:** 15 KM/Hr  
**Coordinates:** 11.67327, 77.99475

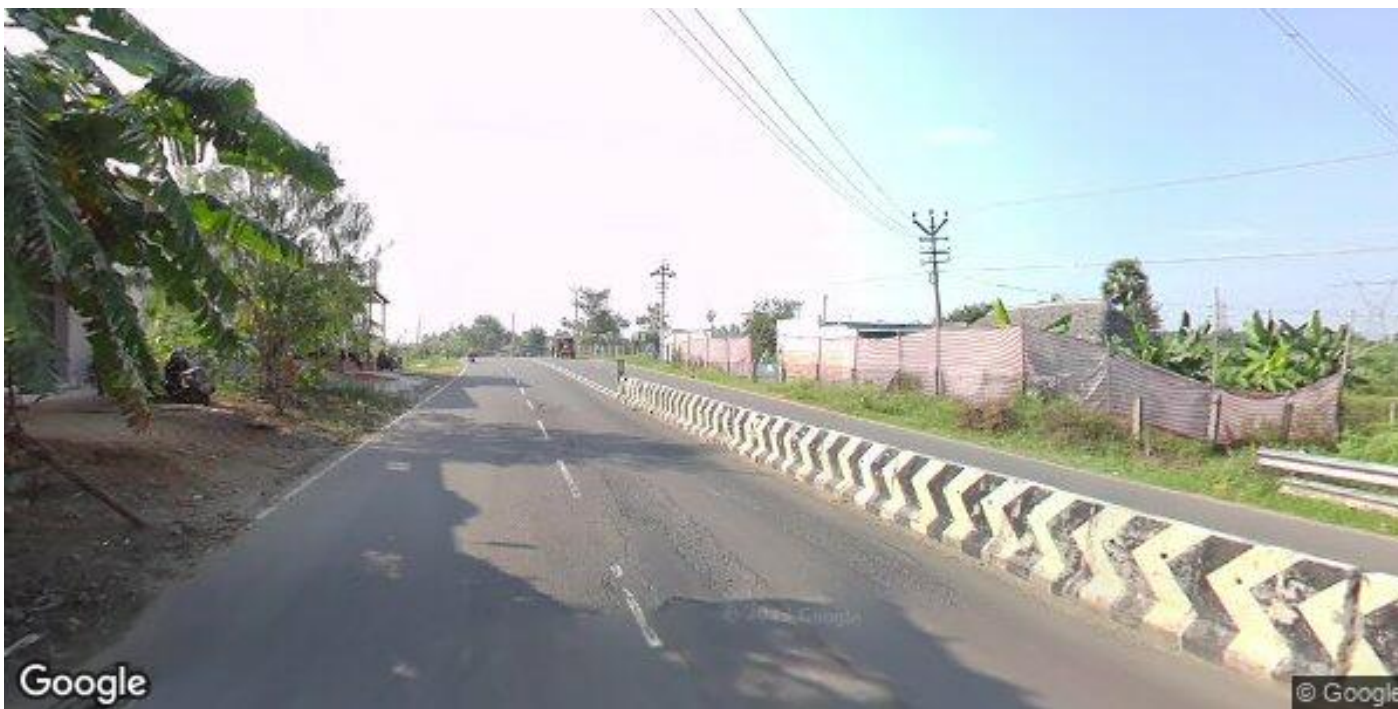
| | Risk Type | Risk Level | Coordinates | Speed Limit |
|---|---|---|---|---|
| 26 | Turn | High | 11.67356, 77.99482 | 15 KM/Hr |

**Risk Type:** Turn  
**Risk Level:** High  
**Speed Limit:** 15 KM/Hr  
**Coordinates:** 11.67356, 77.99482

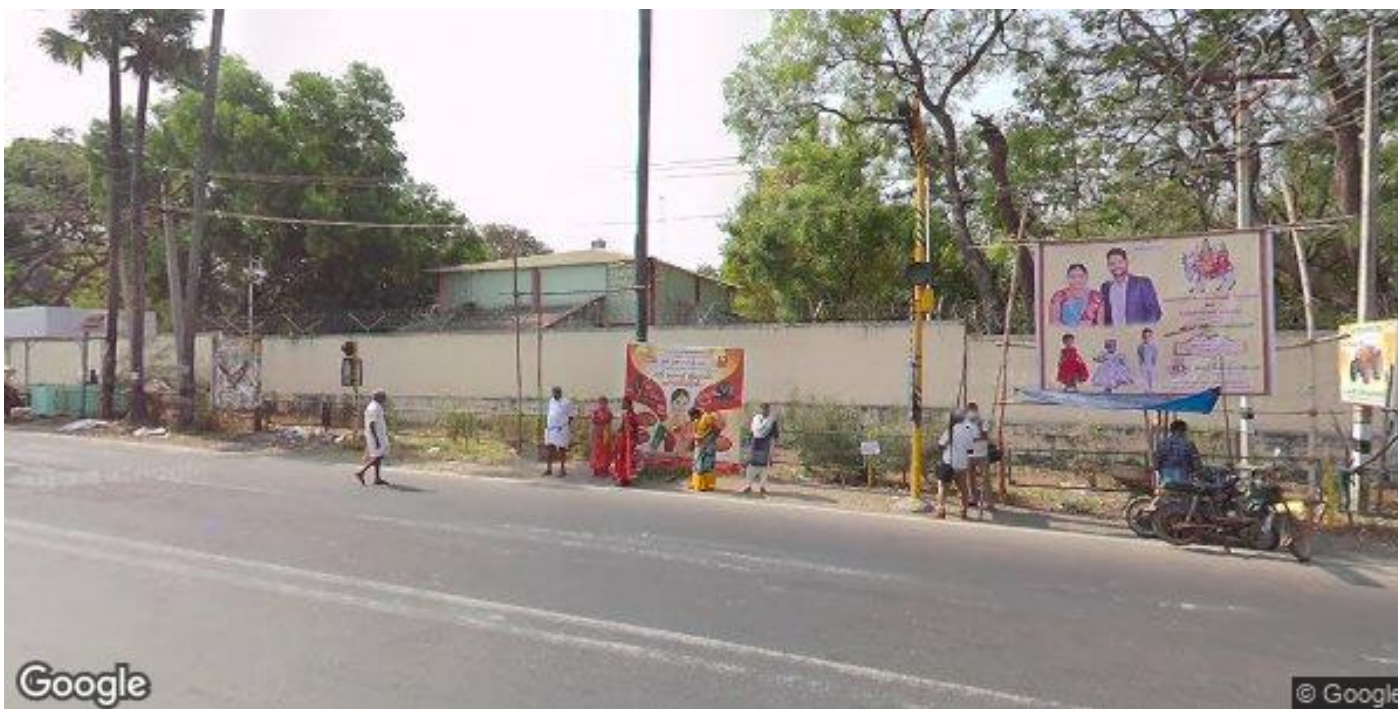
| | Risk Type | Risk Level | Coordinates | Speed Limit |
|---|---|---|---|---|
| 27 | Turn | High | 11.67276, 78.00377 | 15 KM/Hr |

**Risk Type:** Turn  
**Risk Level:** High  
**Speed Limit:** 15 KM/Hr  
**Coordinates:** 11.67276, 78.00377

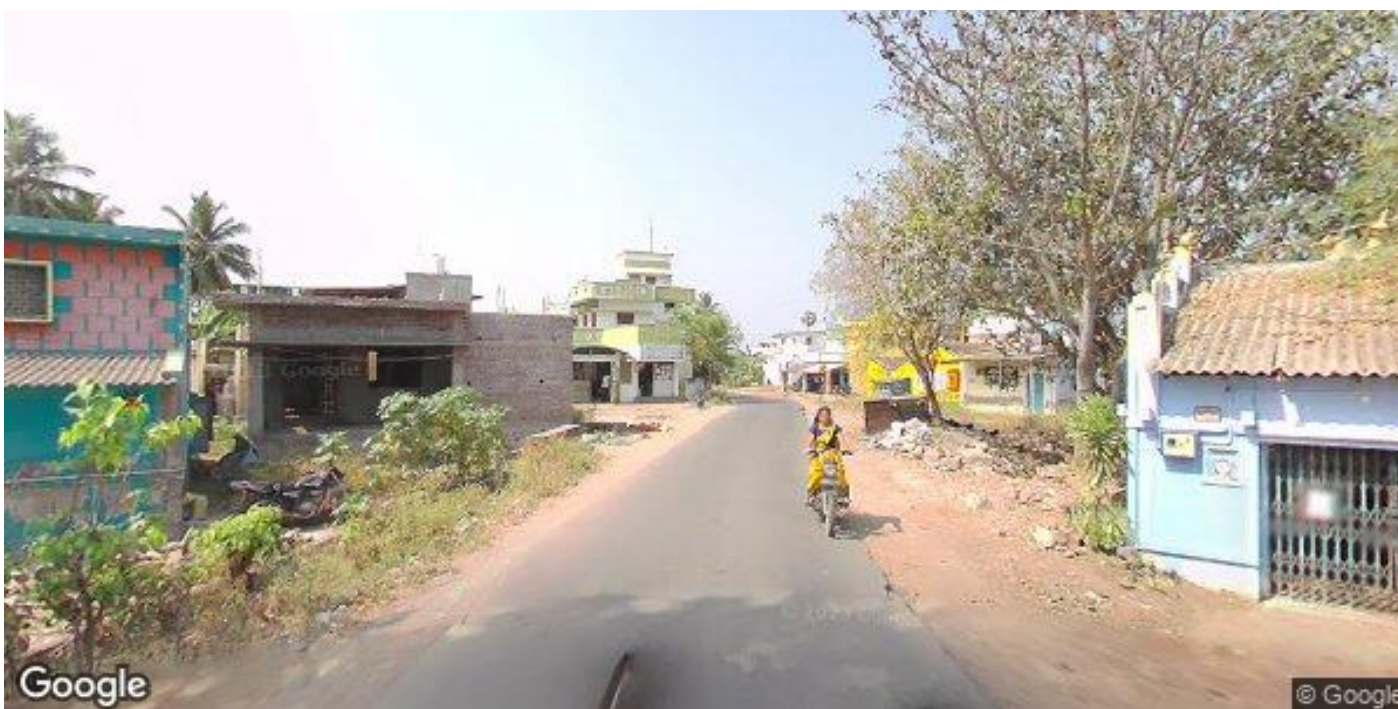
| | Risk Type | Risk Level | Coordinates | Speed Limit |
|---|---|---|---|---|
| 28 | Turn | Medium | 11.68005, 78.00701 | 30 KM/Hr |

**Risk Type:** Turn  
**Risk Level:** Medium  
**Speed Limit:** 30 KM/Hr  
**Coordinates:** 11.68005, 78.00701

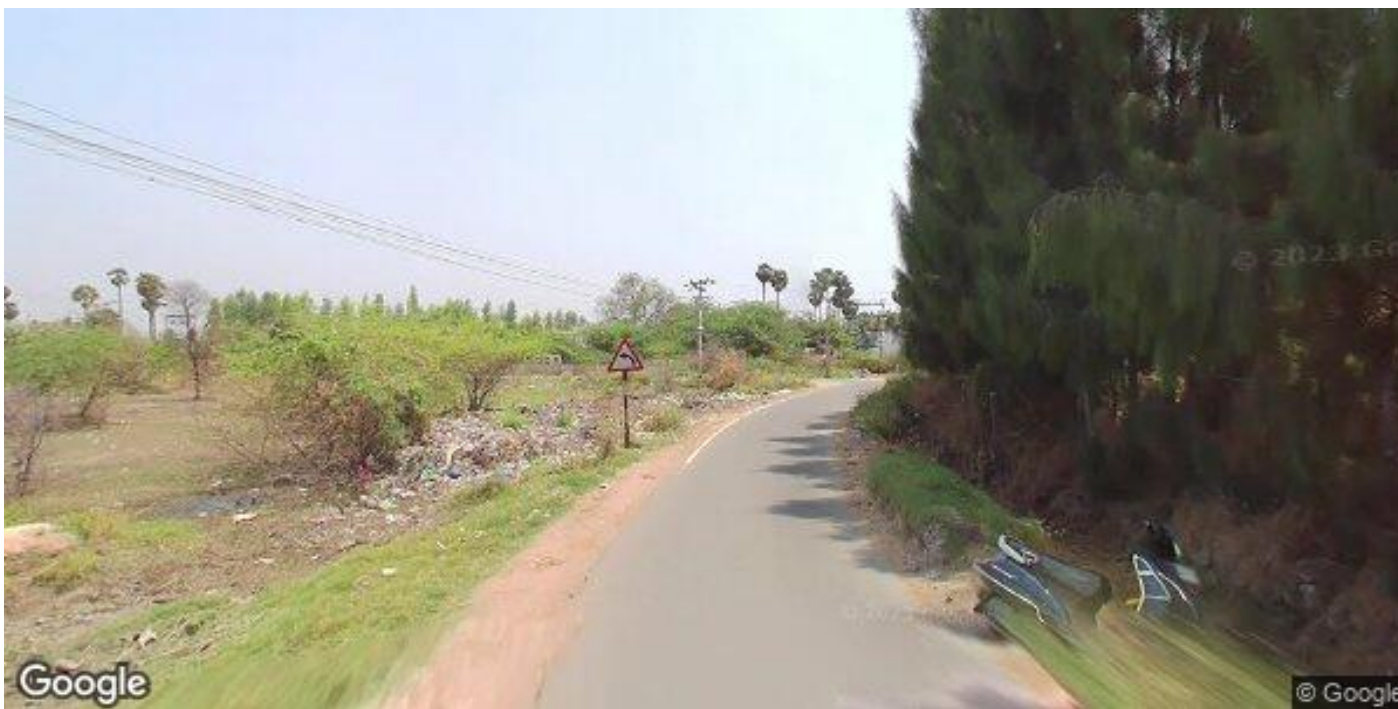
| | Risk Type | Risk Level | Coordinates | Speed Limit |
|---|---|---|---|---|
| 29 | Turn | Medium | 11.69847, 78.02406 | 30 KM/Hr |

**Risk Type:** Turn  
**Risk Level:** Medium  
**Speed Limit:** 30 KM/Hr  
**Coordinates:** 11.69847, 78.02406

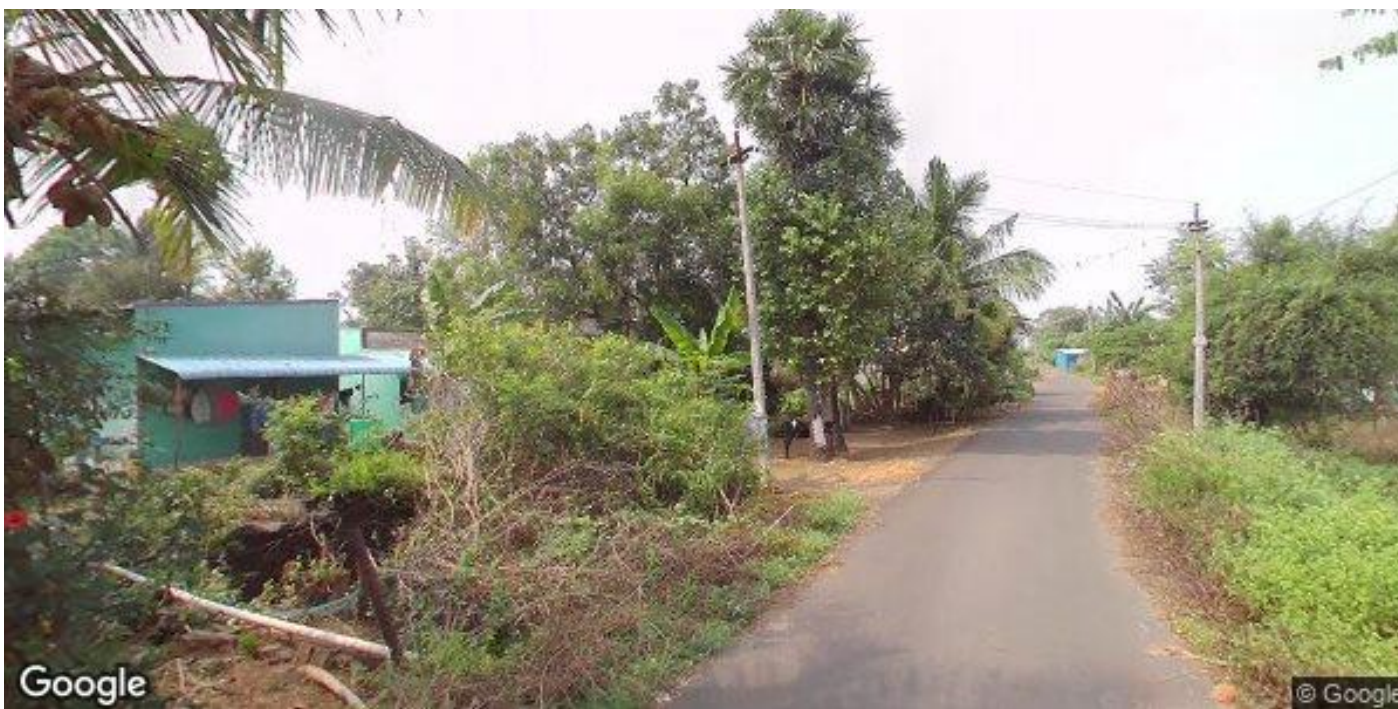
| | Risk Type | Risk Level | Coordinates | Speed Limit |
|---|---|---|---|---|
| 30 | Turn | Medium | 11.69784, 78.03990 | 30 KM/Hr |

**Risk Type:** Turn  
**Risk Level:** Medium  
**Speed Limit:** 30 KM/Hr  
**Coordinates:** 11.69784, 78.03990

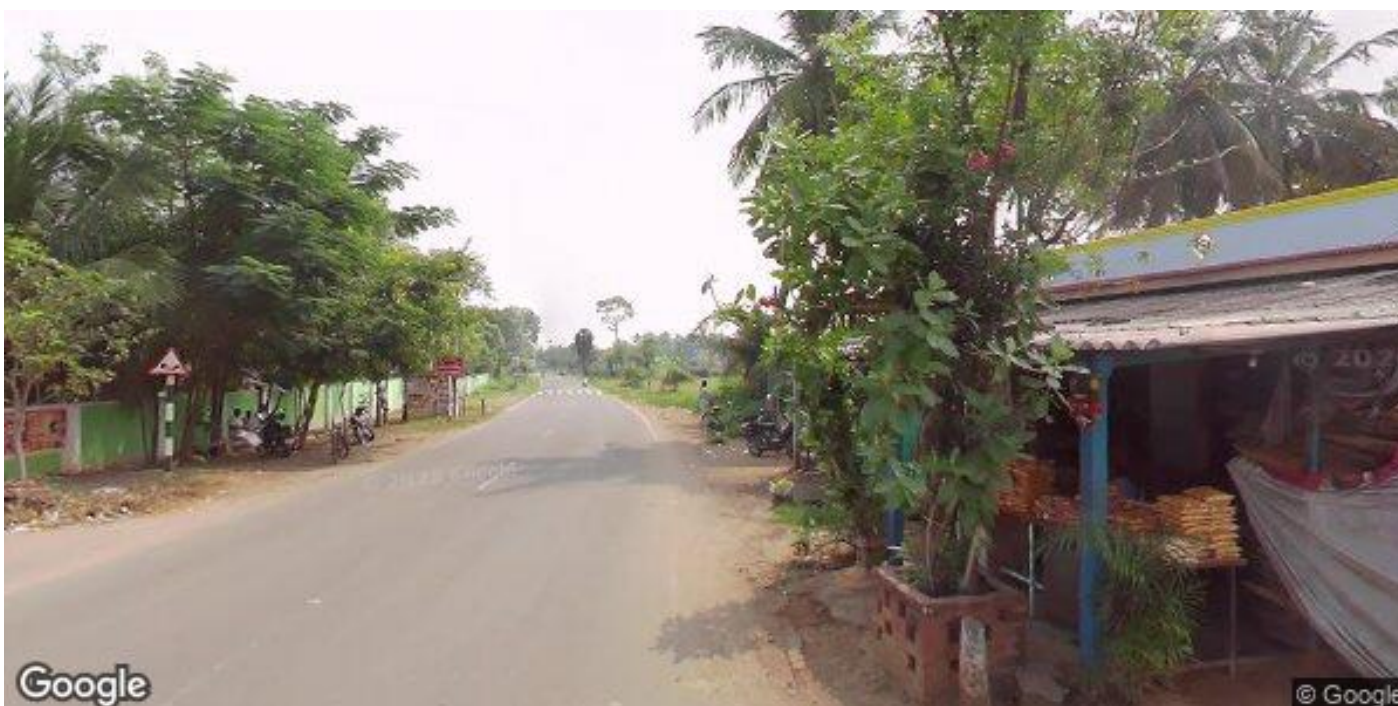
| | Risk Type | Risk Level | Coordinates | Speed Limit |
|---|---|---|---|---|
| 31 | Turn | High | 11.70268, 78.04958 | 15 KM/Hr |

**Risk Type:** Turn  
**Risk Level:** High  
**Speed Limit:** 15 KM/Hr  
**Coordinates:** 11.70268, 78.04958

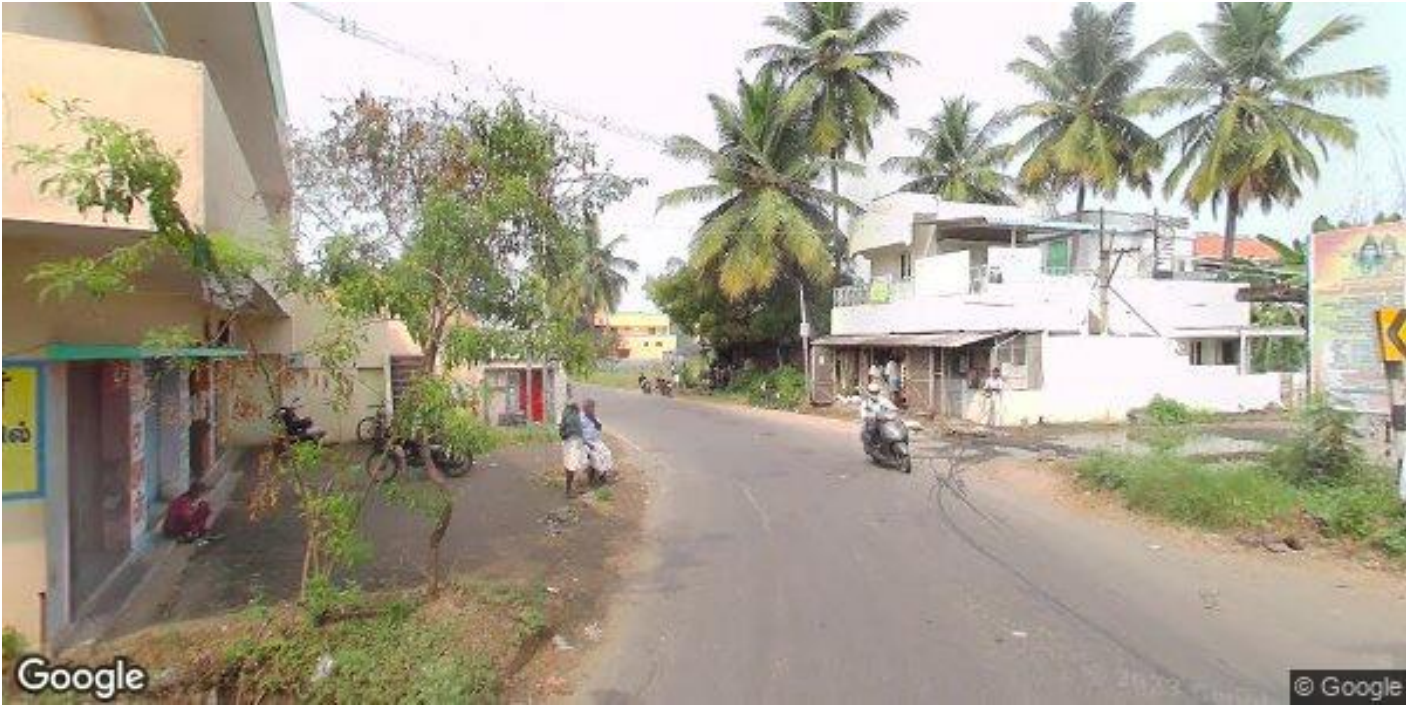
| | Risk Type | Risk Level | Coordinates | Speed Limit |
|---|---|---|---|---|
| 32 | Turn | High | 11.69948, 78.05515 | 15 KM/Hr |

**Risk Type:** Turn  
**Risk Level:** High  
**Speed Limit:** 15 KM/Hr  
**Coordinates:** 11.69948, 78.05515
