# IndianOil

## JOURNEY RISK MANAGEMENT (JRM) STUDY

### Salem Terminal to SRI VK TRADER

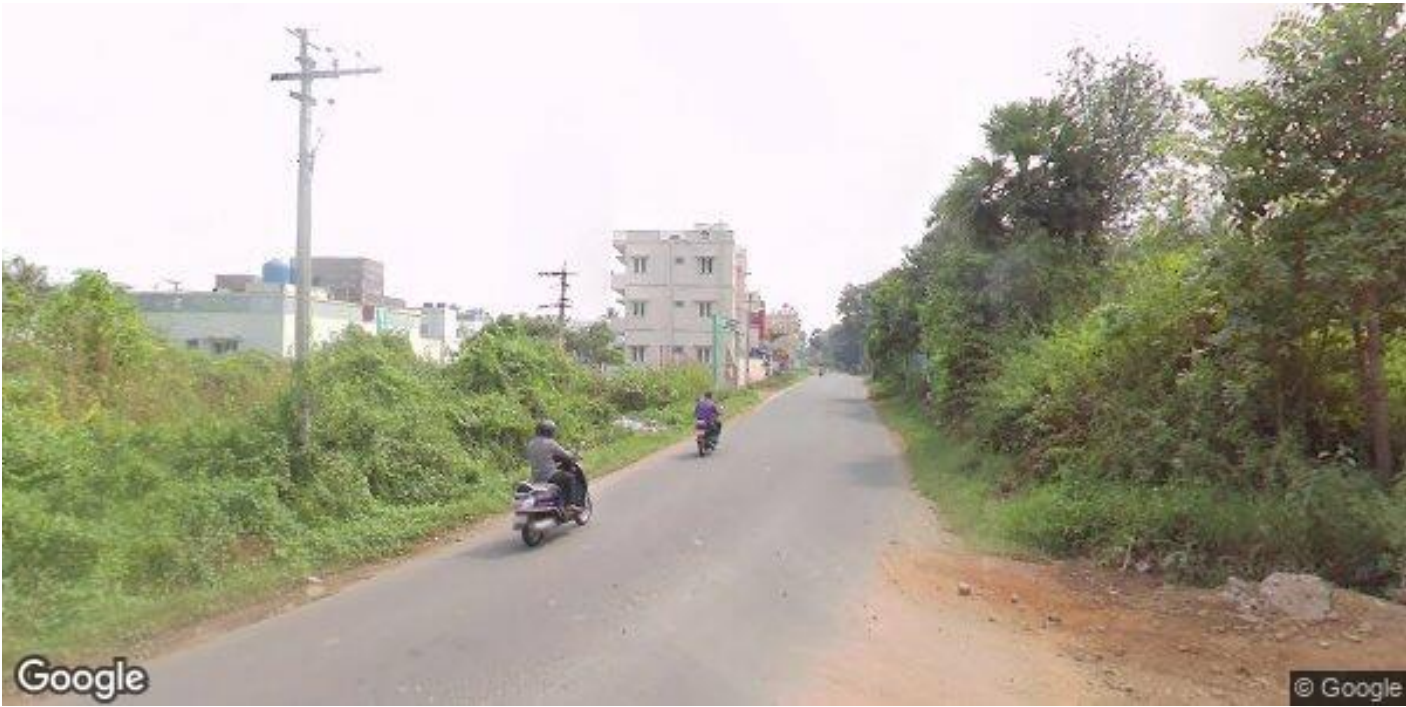
| | Risk Type | Risk Level | Coordinates | Speed Limit |
|---|---|---|---|---|
| 33 | Turn | Medium | 11.69868, 78.05541 | 30 KM/Hr |

**Risk Type:** Turn  
**Risk Level:** Medium  
**Speed Limit:** 30 KM/Hr  
**Coordinates:** 11.69868, 78.05541
