# IndianOil

## JOURNEY RISK MANAGEMENT (JRM) STUDY

### Salem Terminal TO KUMAR AGENCIES

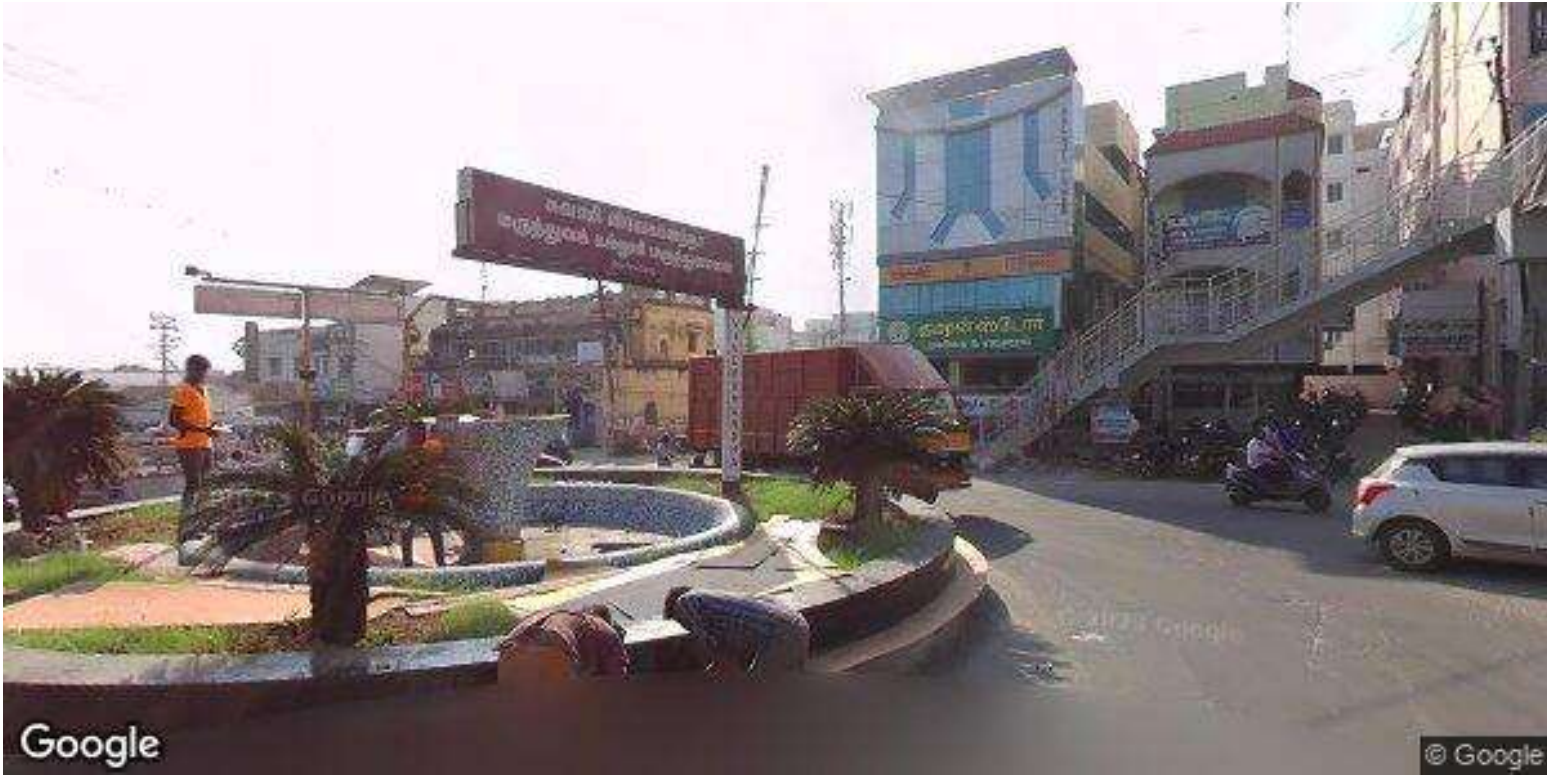
Risk Type: Roundabout  
Risk Level: High  
Speed Limit: 15 KM/Hr  
Coordinates: 11.38395, 77.89480

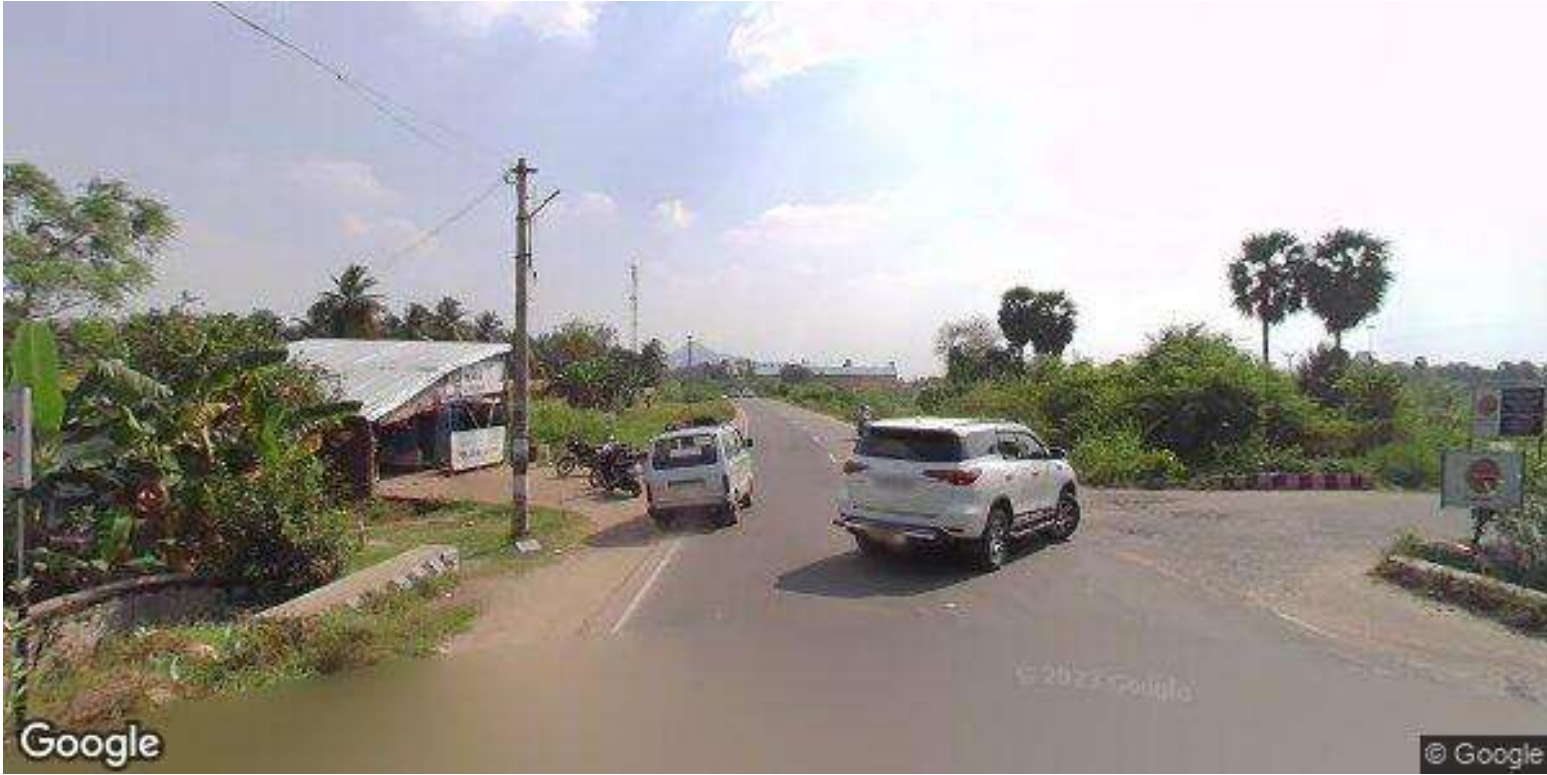
Risk Type: Blind Spot  
Risk Level: Blind Spot

**Speed Limit: 10 KM/Hr**

**Coordinates: 11.44029, 77.87544**

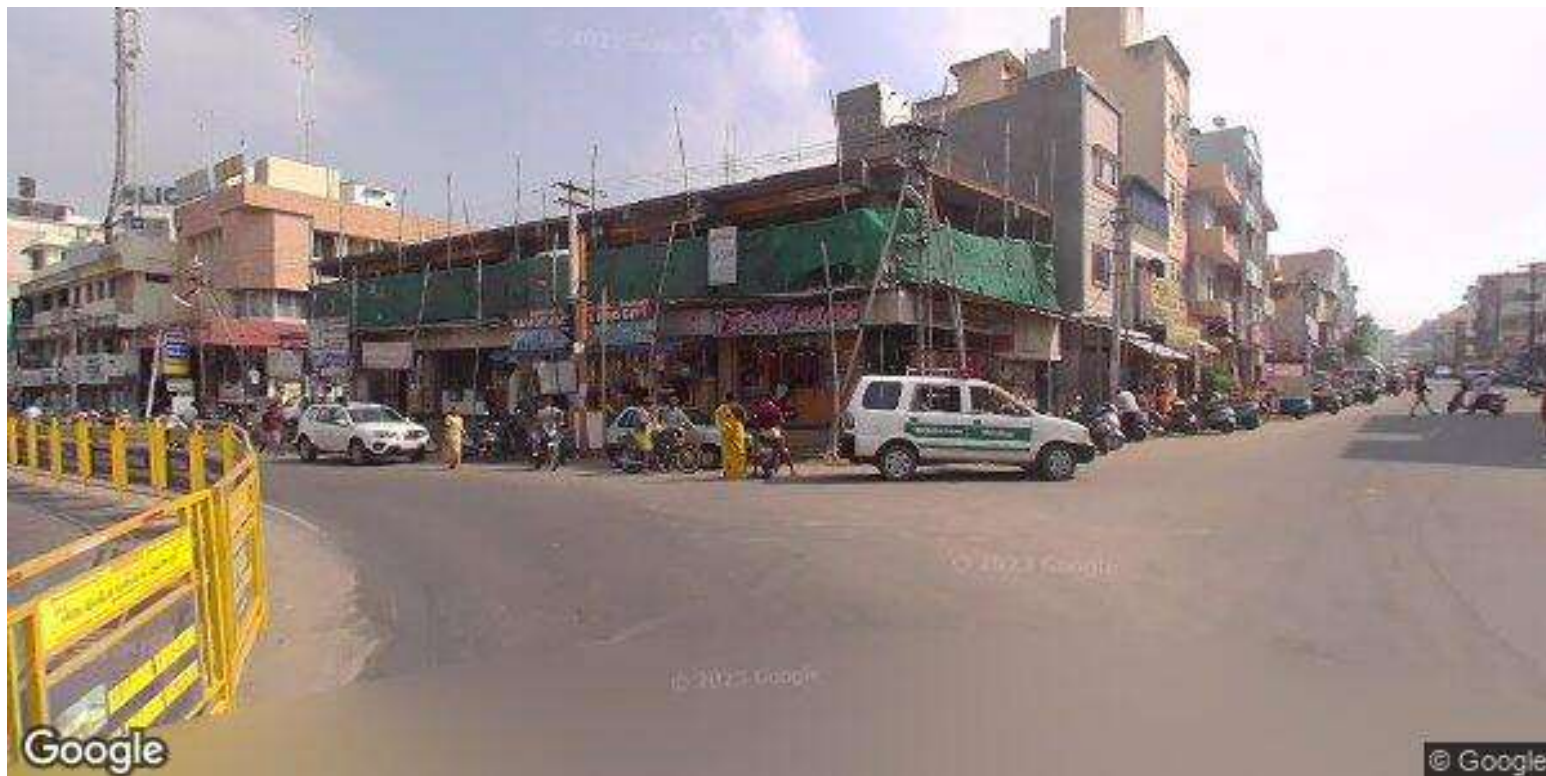
**Risk Type: Turn**

**Risk Level: High**

**Speed Limit: 15 KM/Hr**

**Coordinates: 11.37868, 77.89498**

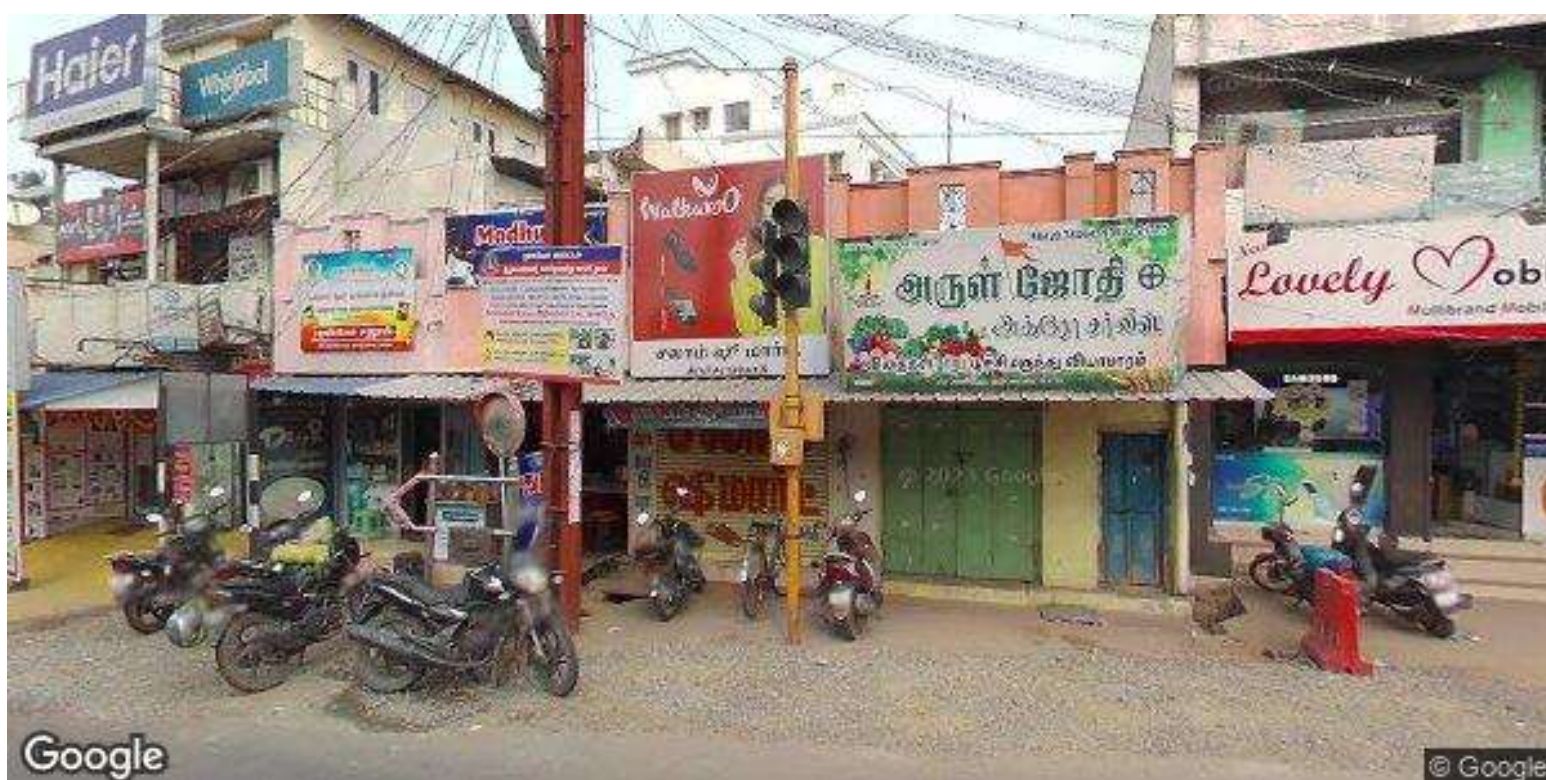
**Risk Type: Turn**

**Risk Level: High**

**Speed Limit: 15 KM/Hr**

**Coordinates: 11.37850, 77.89453**

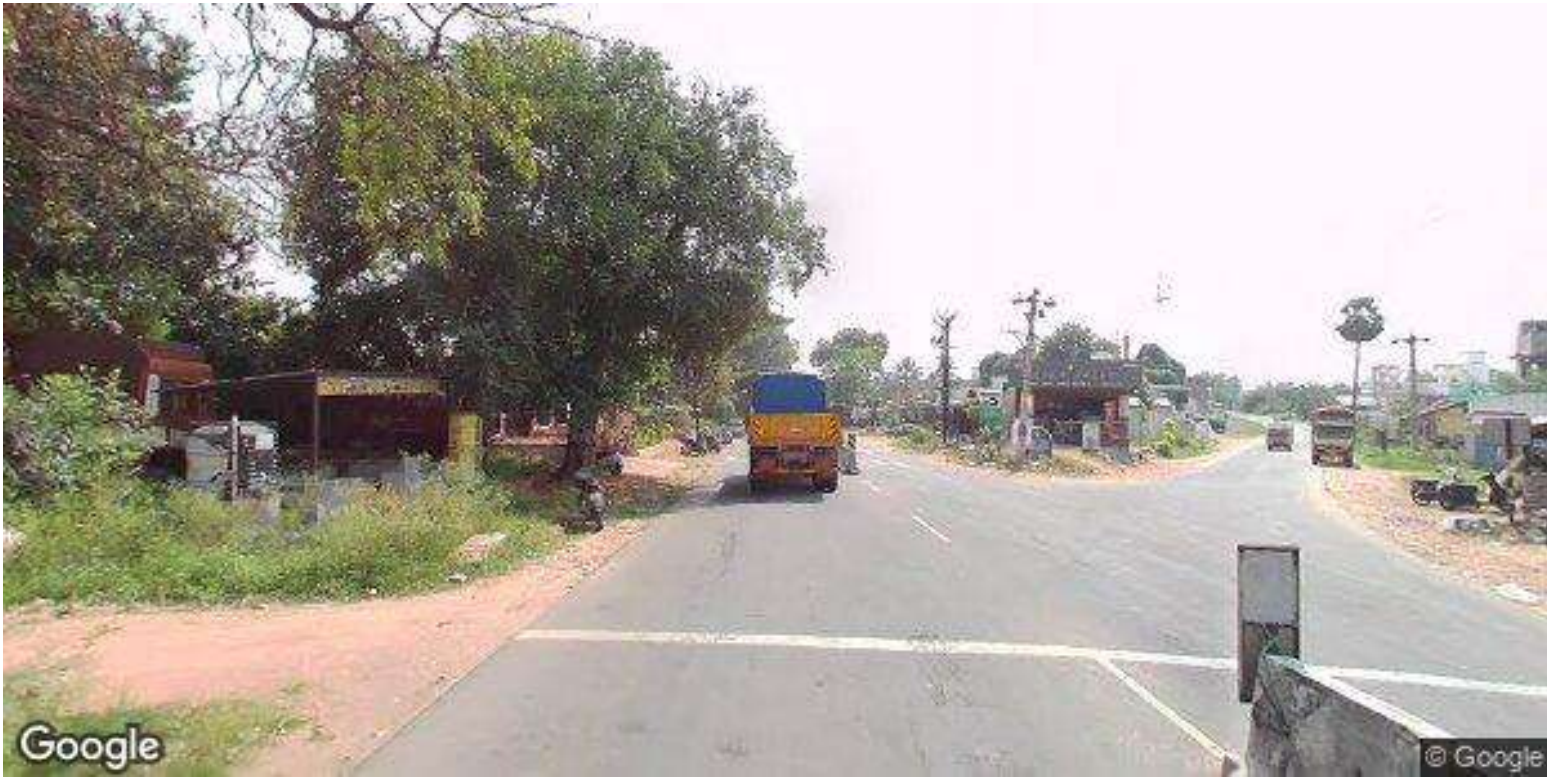
**Risk Type:** Turn  
**Risk Level:** Medium  
**Speed Limit:** 30 KM/Hr  
**Coordinates:** 11.35759, 77.89191

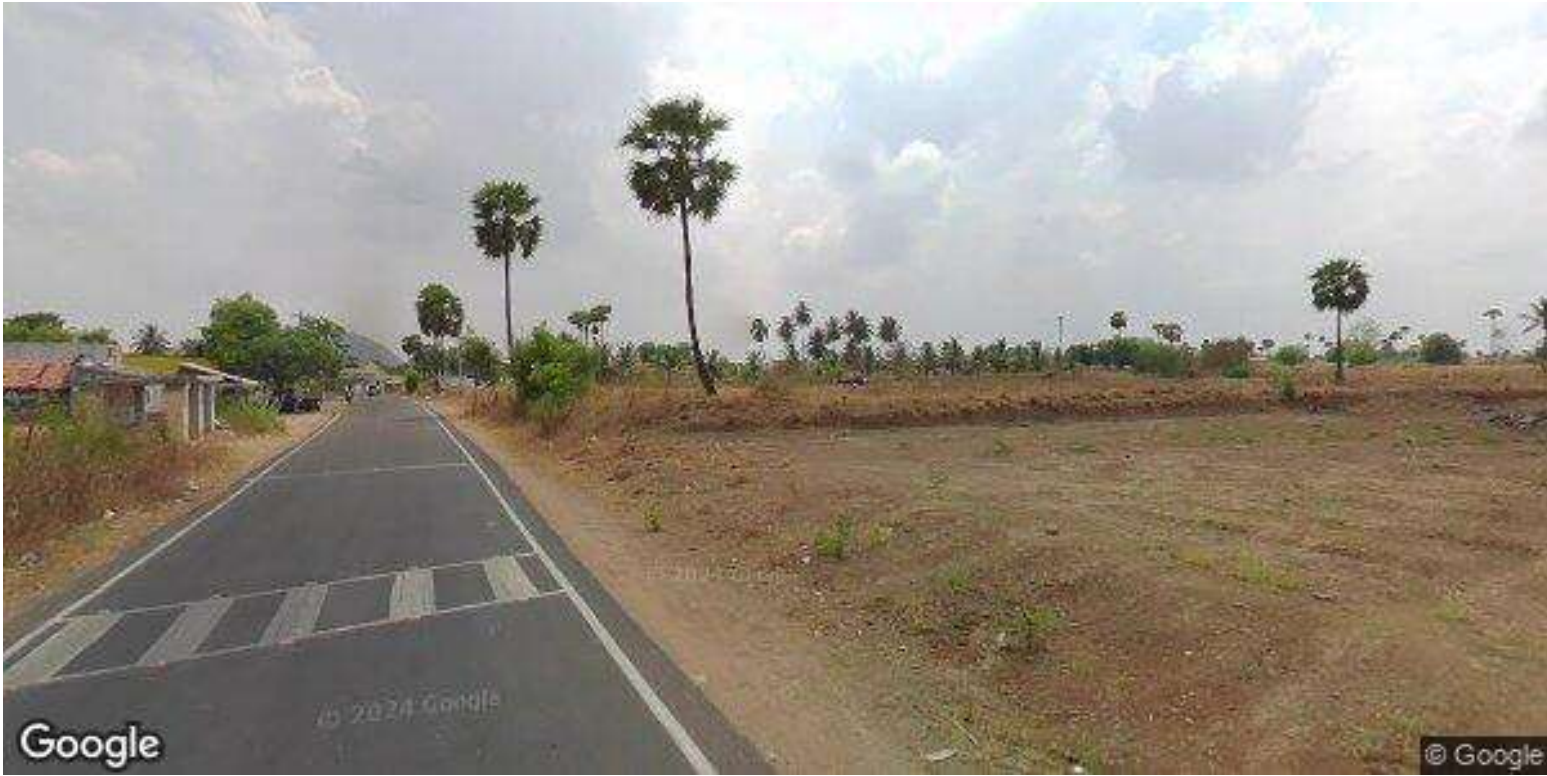
**Risk Type:** Turn  
**Risk Level:** Medium  
**Speed Limit:** 30 KM/Hr  
**Coordinates:** 11.33071, 77.88660

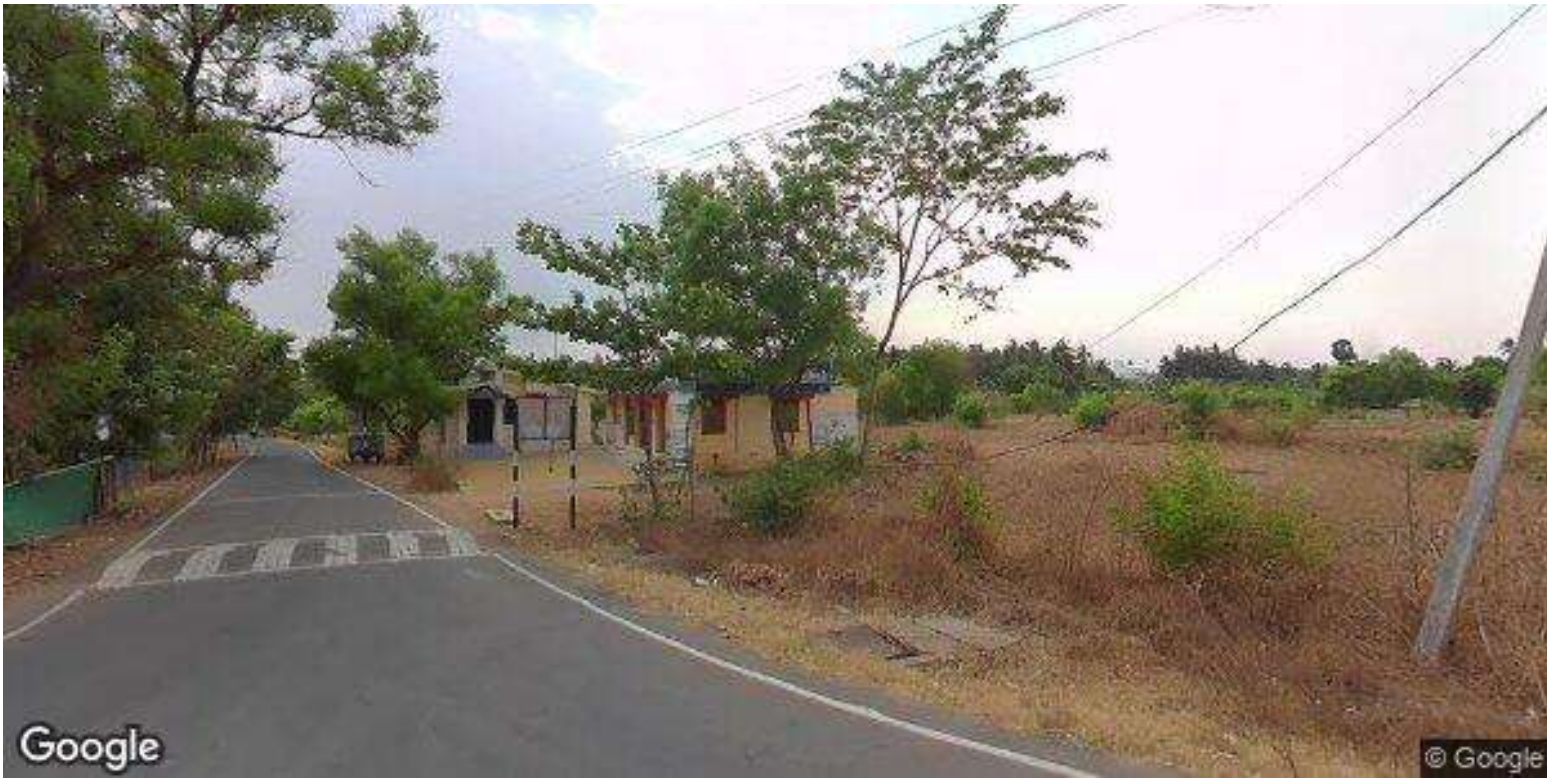
**Risk Type:** Turn  
**Risk Level:** High  
**Speed Limit:** 15 KM/Hr  
**Coordinates:** 11.33065, 77.88650

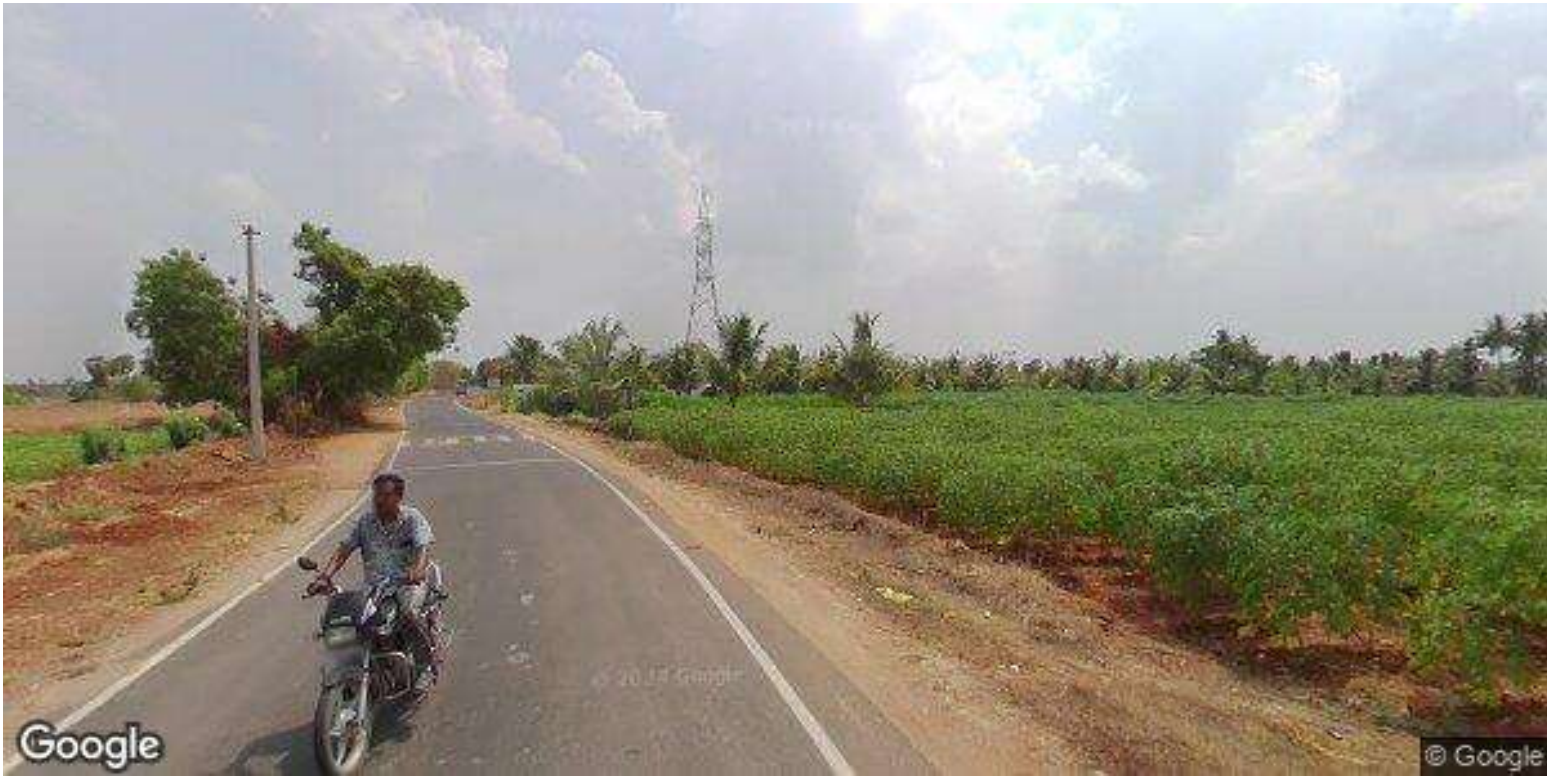
**Risk Type:** Turn  
**Risk Level:** Medium  
**Speed Limit:** 30 KM/Hr  
**Coordinates:** 11.32155, 77.88499

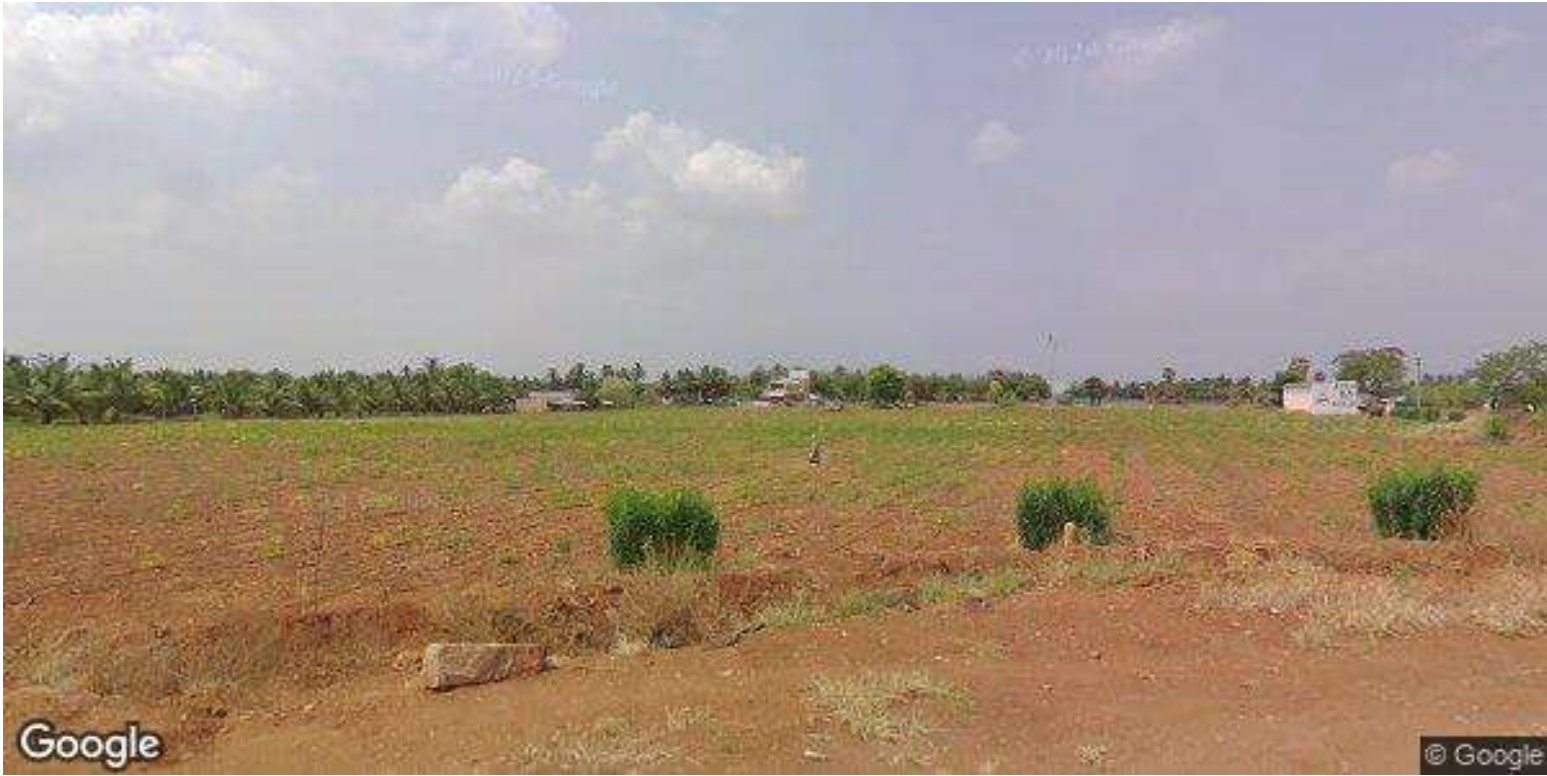
**Risk Type:** Turn  
**Risk Level:** Medium  
**Speed Limit:** 30 KM/Hr  
**Coordinates:** 11.32130, 77.88484

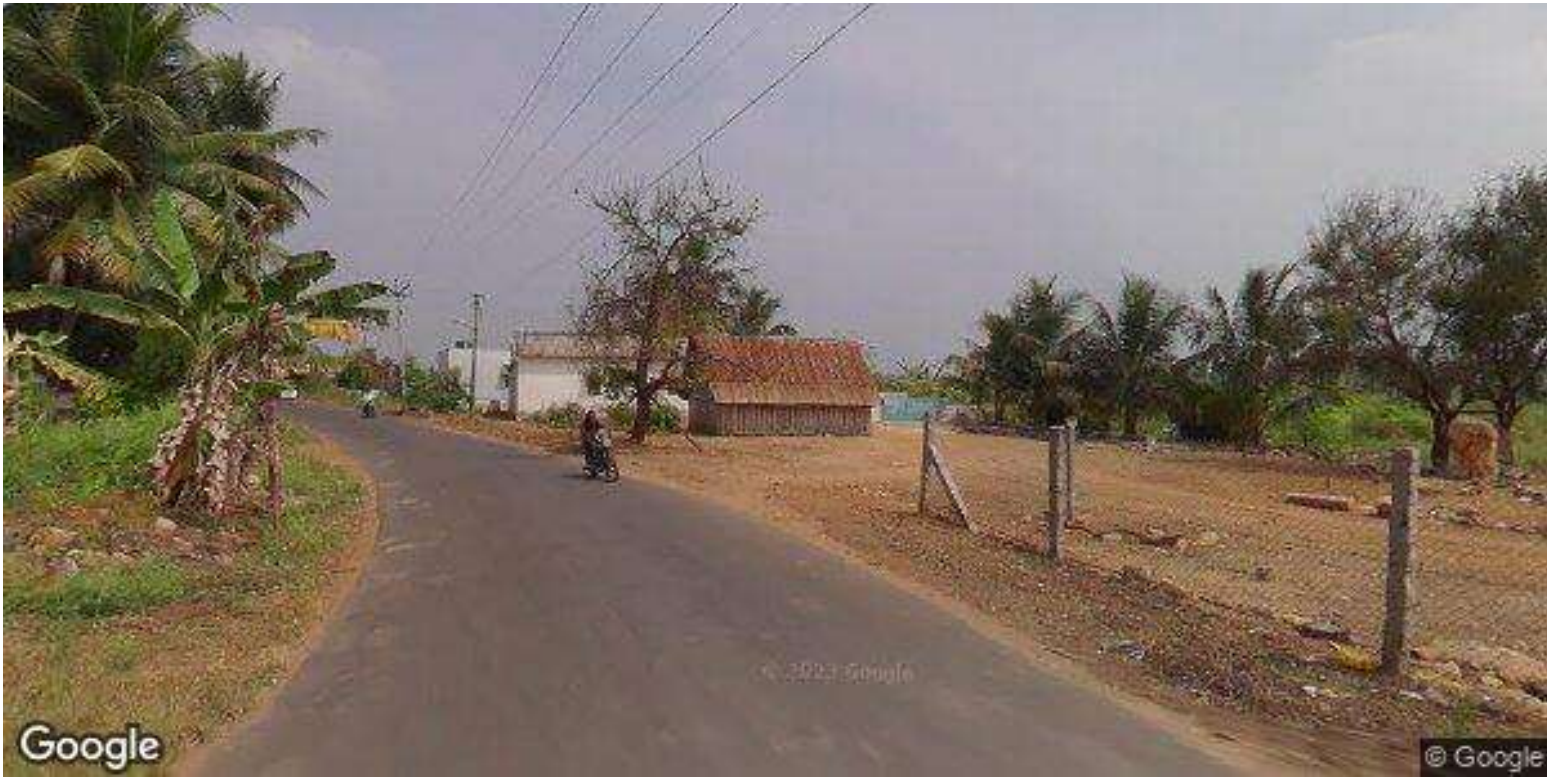
**Risk Type:** Turn  
**Risk Level:** Medium  
**Speed Limit:** 30 KM/Hr  
**Coordinates:** 11.31205, 77.88131

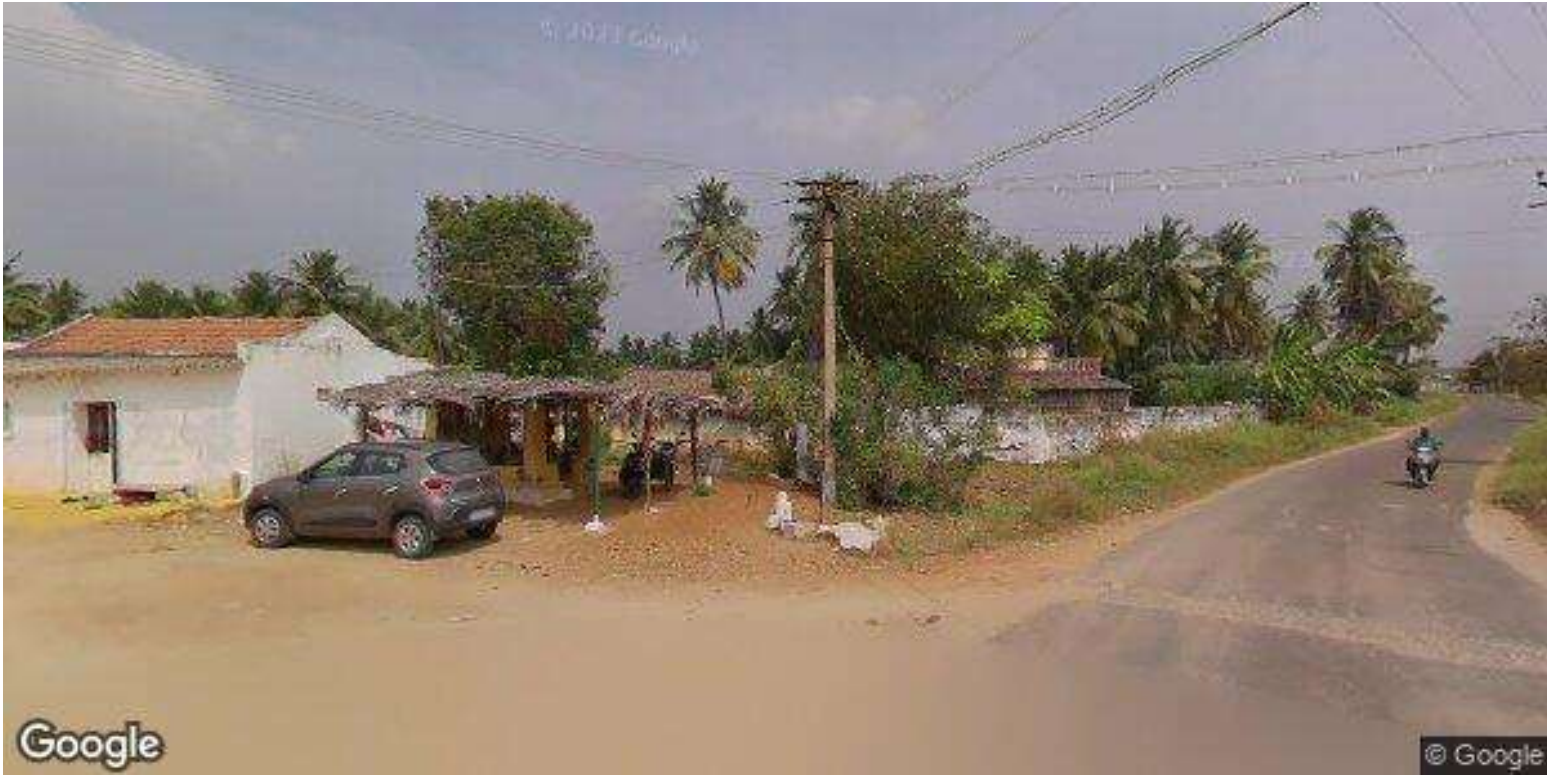
**Risk Type:** Turn  
**Risk Level:** Medium  
**Speed Limit:** 30 KM/Hr  
**Coordinates:** 11.31151, 77.88008

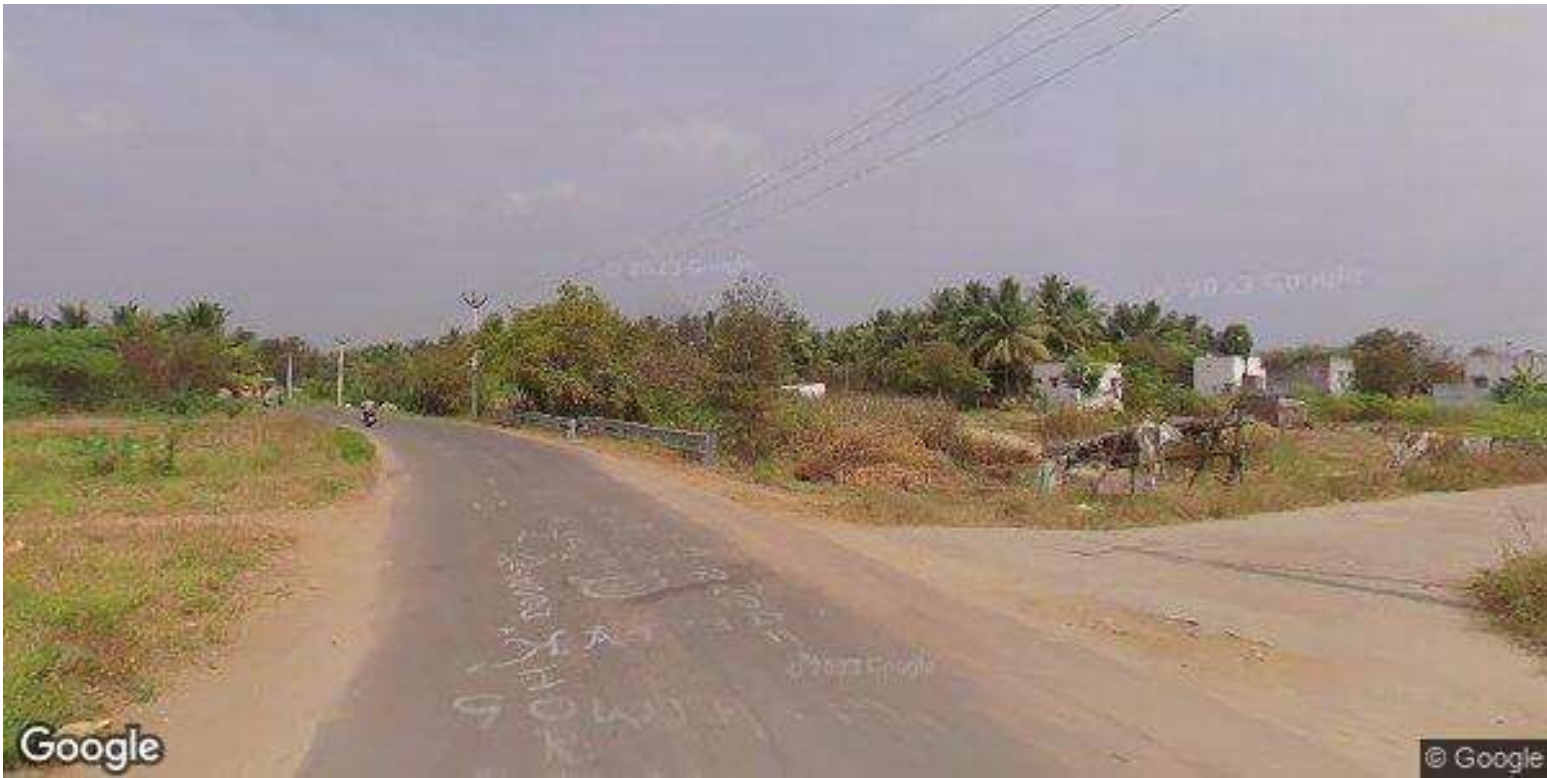
**Risk Type:** Turn  
**Risk Level:** Medium  
**Speed Limit:** 30 KM/Hr  
**Coordinates:** 11.30805, 77.87934

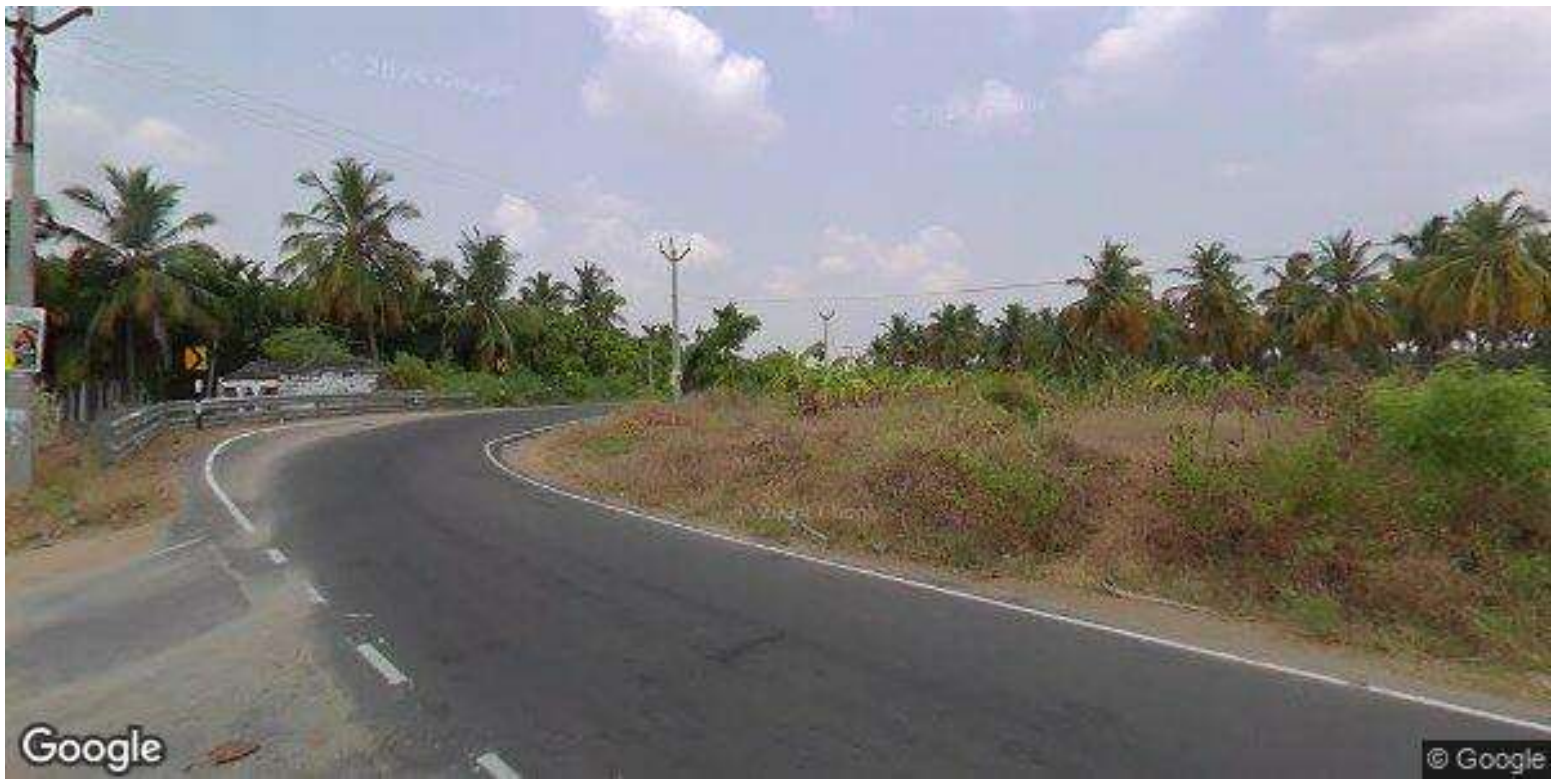
**Risk Type:** Turn  
**Risk Level:** High  
**Speed Limit:** 15 KM/Hr  
**Coordinates:** 11.29763, 77.87710

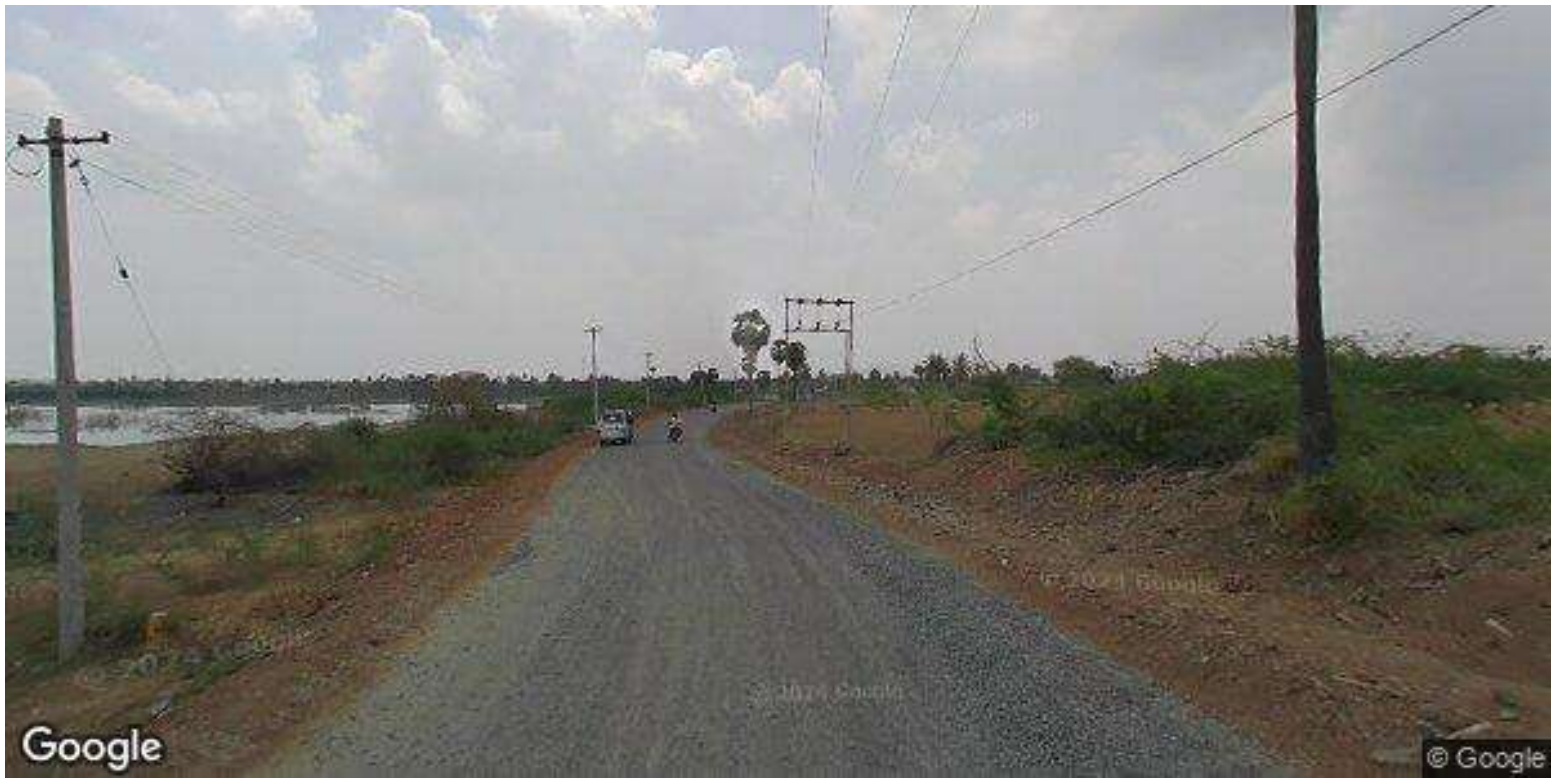
**Risk Type:** Turn  
**Risk Level:** Medium  
**Speed Limit:** 30 KM/Hr  
**Coordinates:** 11.27590, 77.87354

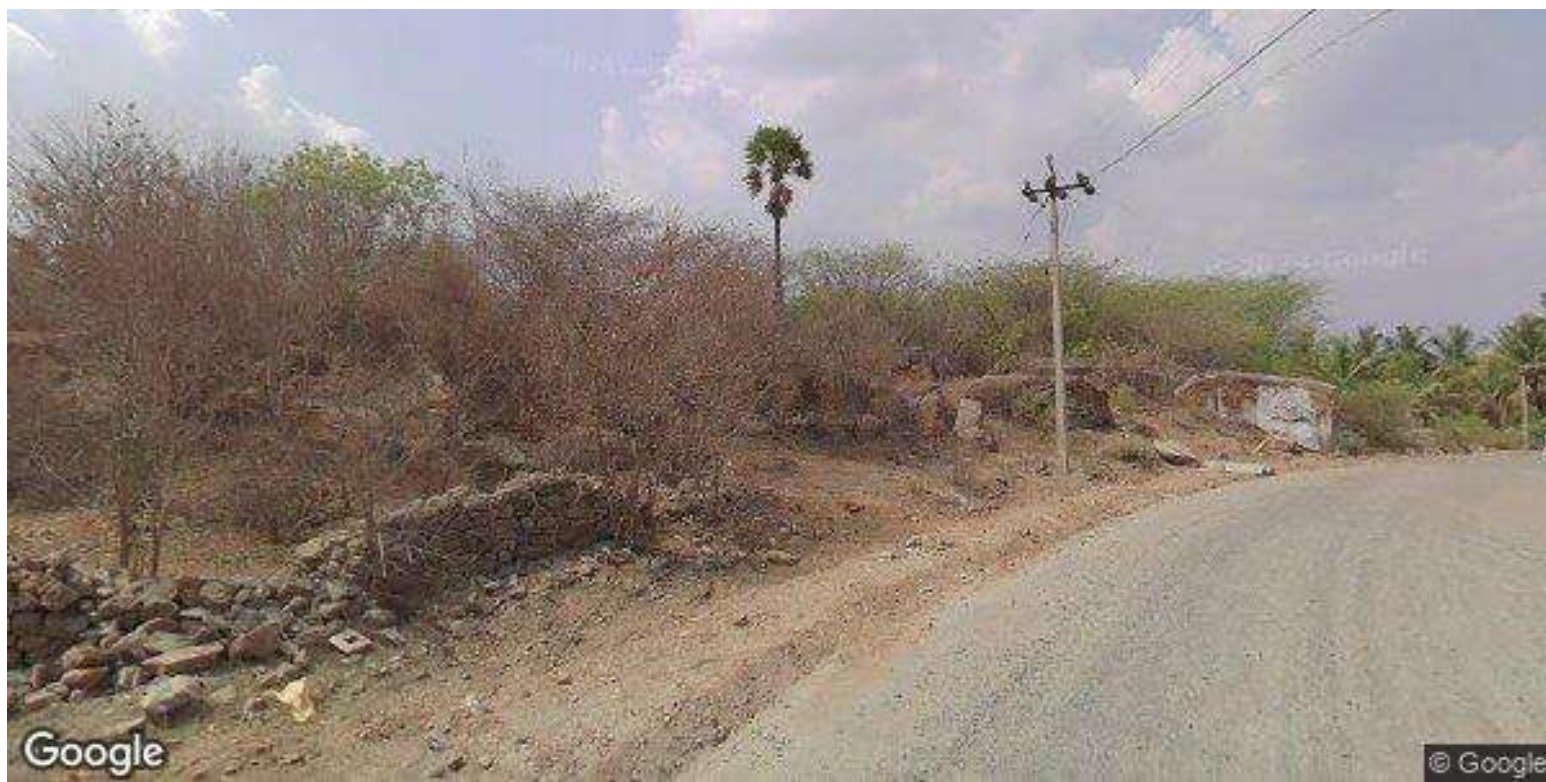
**Risk Type:** Turn

**Risk Level:** Medium

**Speed Limit:** 30 KM/Hr

**Coordinates:** 11.27057, 77.86827

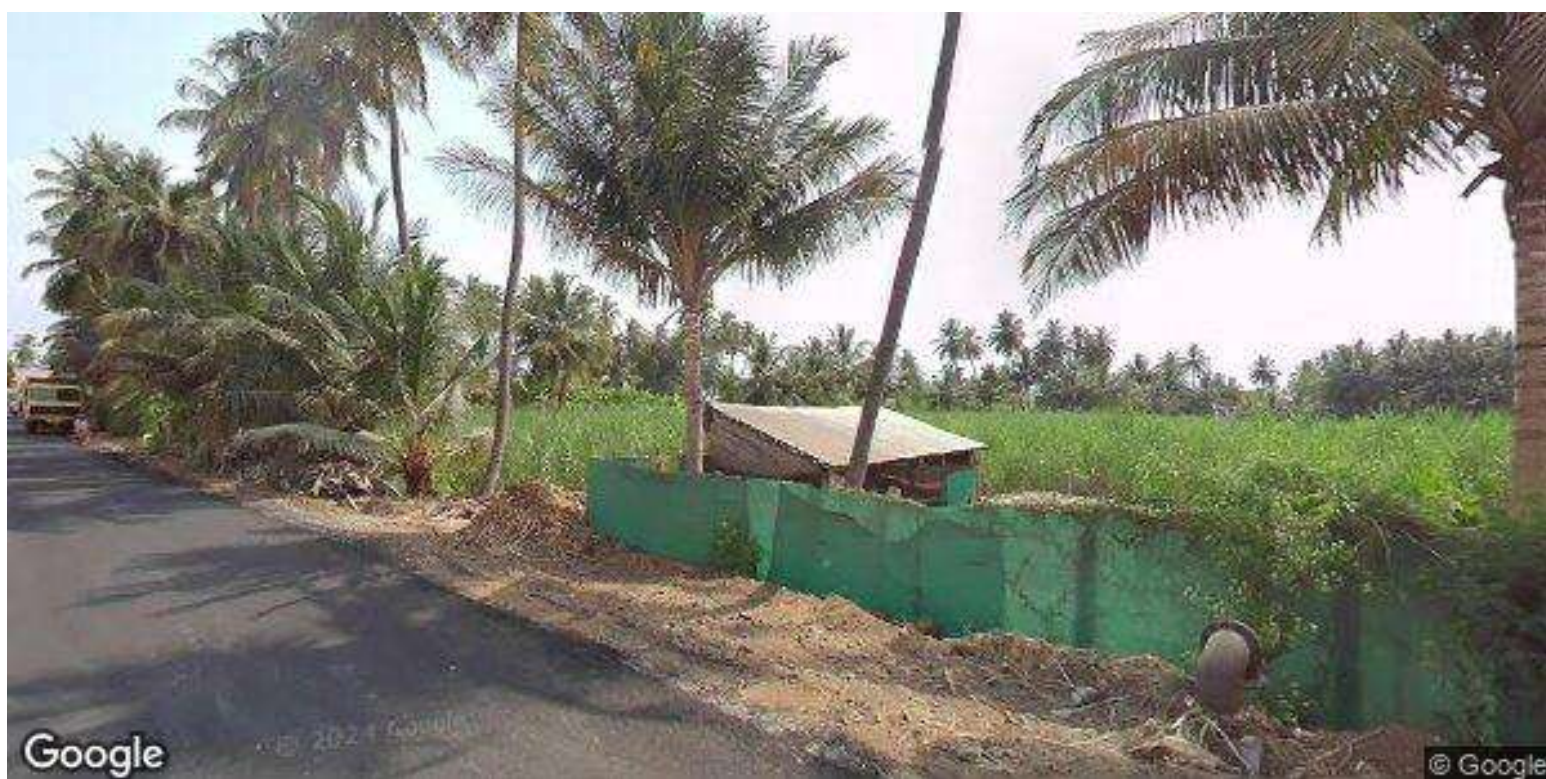
**Risk Type:** Turn

**Risk Level:** High

**Speed Limit:** 15 KM/Hr

**Coordinates:** 11.26017, 77.85606

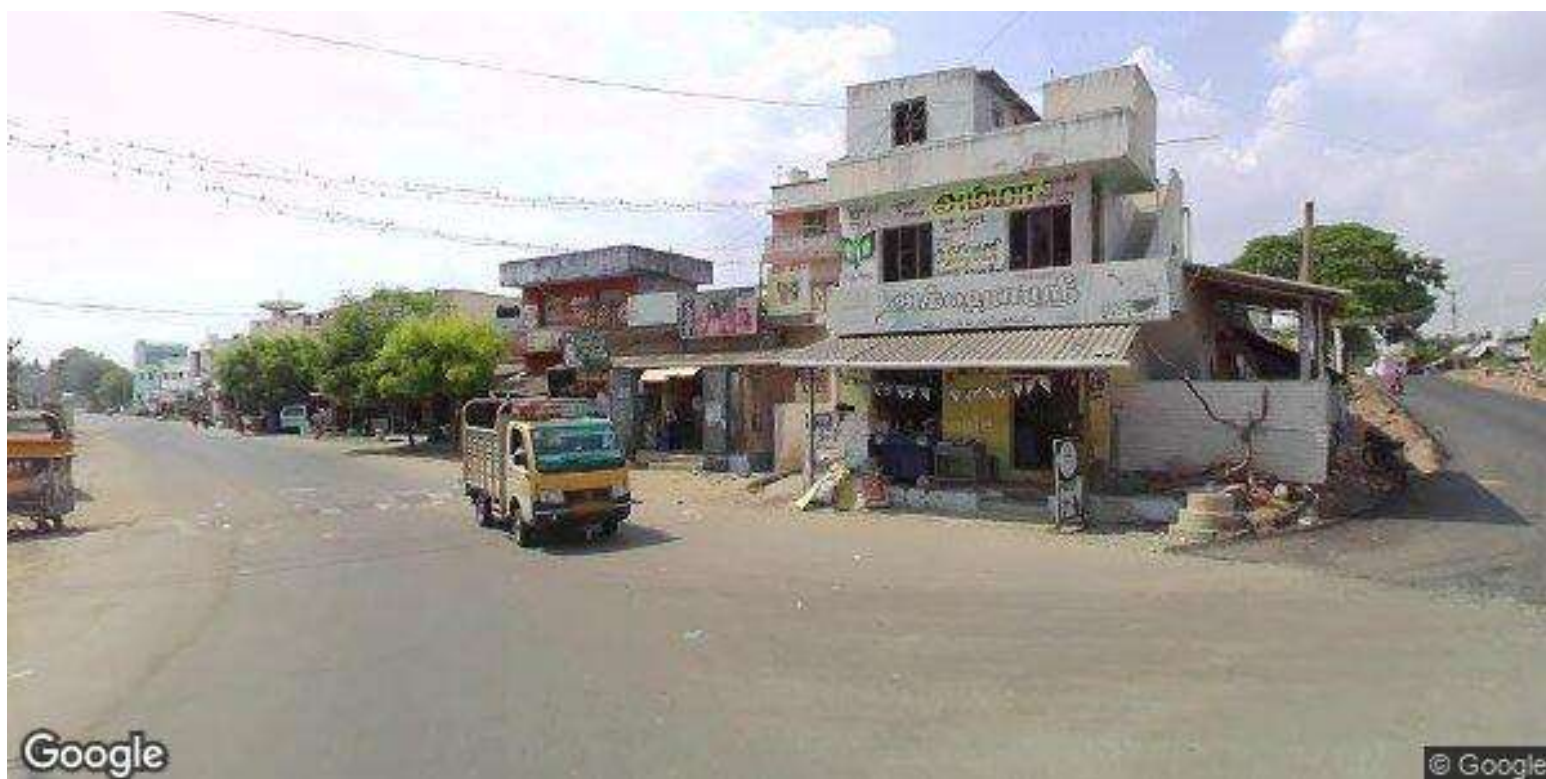
**Risk Type:** Turn  
**Risk Level:** High  
**Speed Limit:** 15 KM/Hr  
**Coordinates:** 11.25802, 77.85511

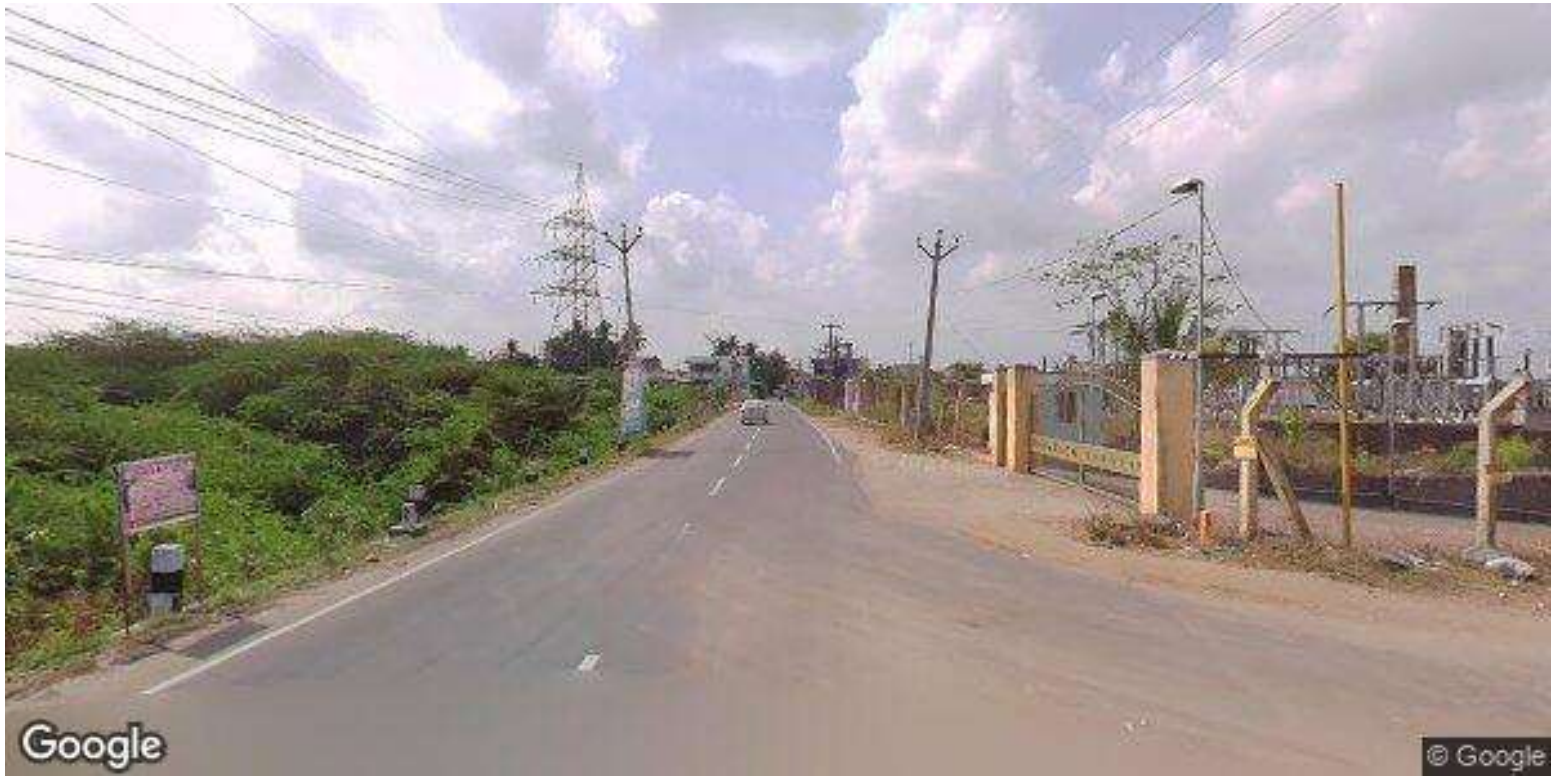
**Risk Type:** Turn  
**Risk Level:** High  
**Speed Limit:** 15 KM/Hr  
**Coordinates:** 11.24384, 77.86689
