# IndianOil

## JOURNEY RISK MANAGEMENT (JRM) STUDY

### Salem Terminal TO KUMAR AGENCIES

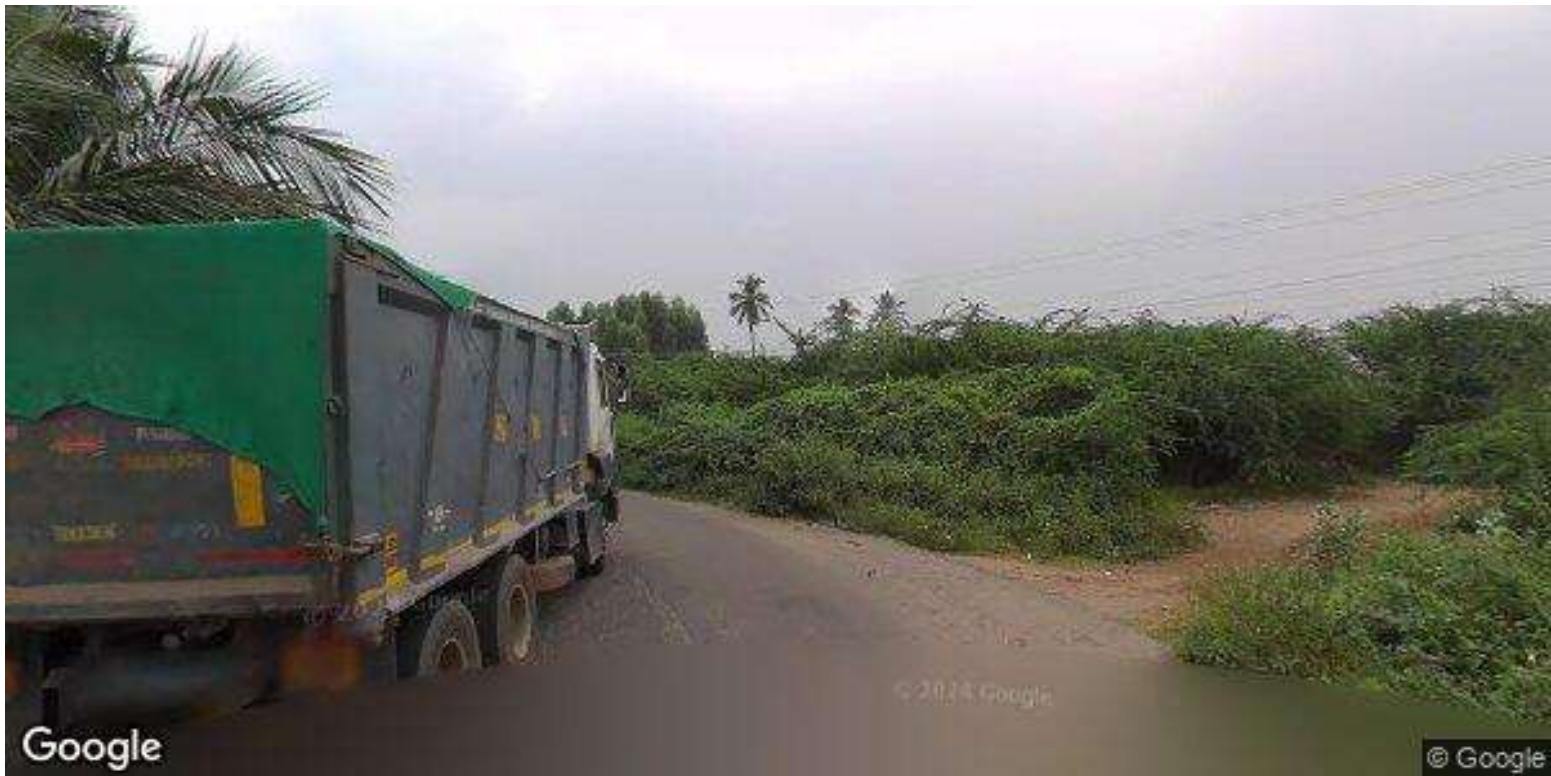
**Risk Type:** Turn  
**Risk Level:** High  
**Speed Limit:** 15 KM/Hr  
**Coordinates:** 11.24100, 77.86030

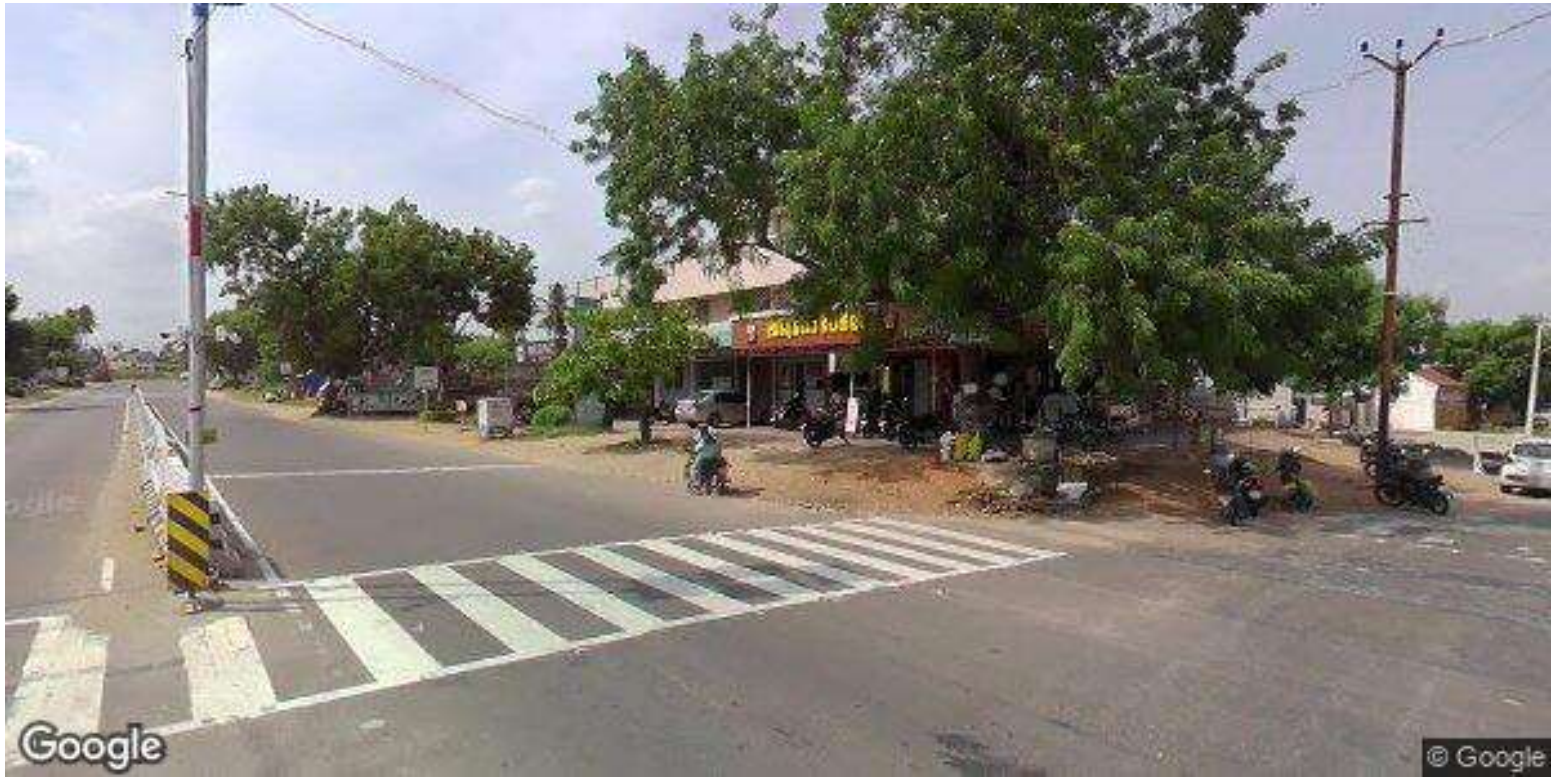
Risk Type: Turn

Risk Level: High

Speed Limit: 15 KM/Hr

Coordinates: 11.22377, 77.83980
