# IndianOil

## **JOURNEY RISK MANAGEMENT (JRM) STUDY**

### **Salem Terminal TO PALACODE MOOGAMBIGAI AGENCIES**

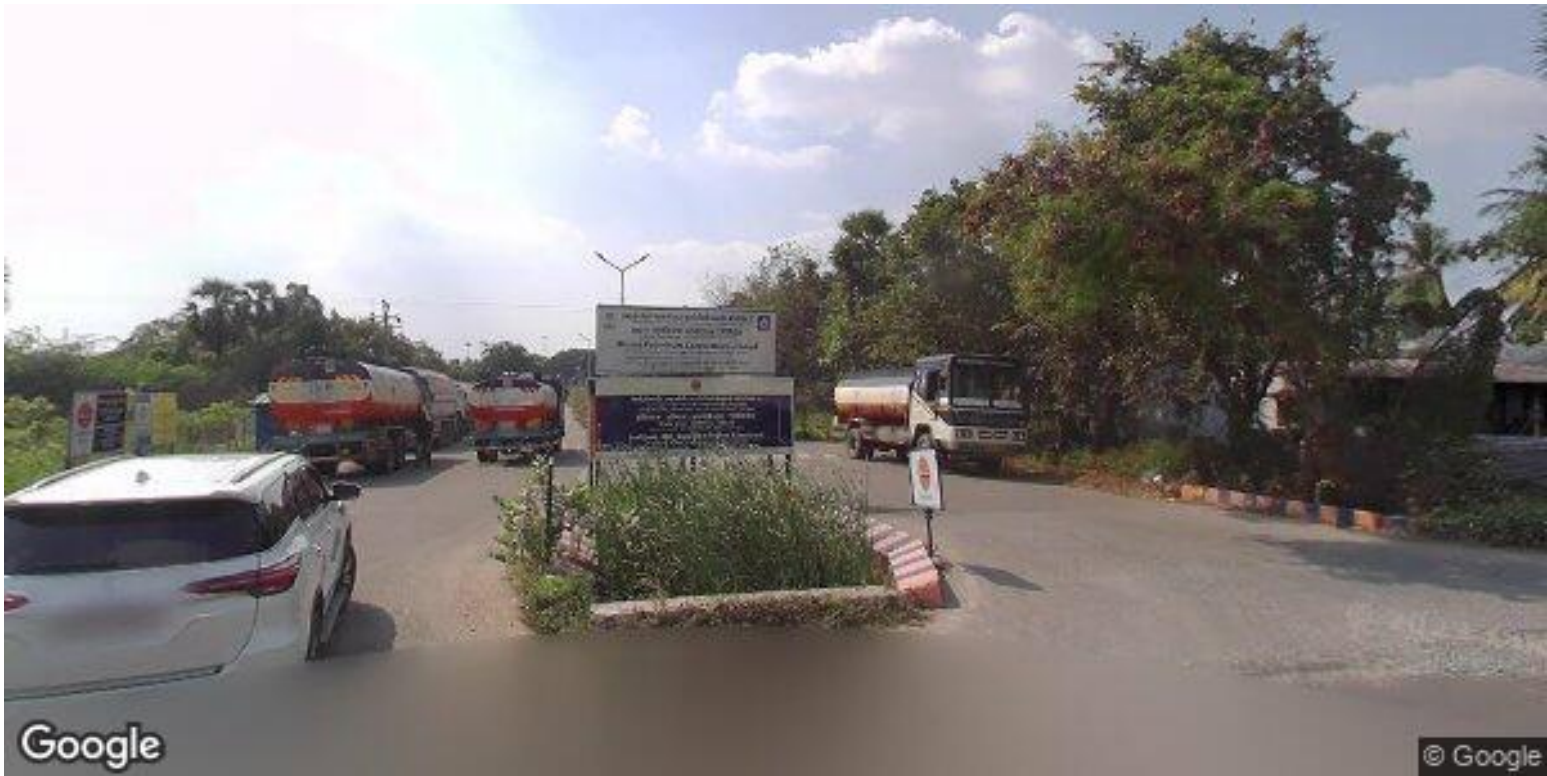
**Coordinates:** 11.44024, 77.87528

**Risk Type:** Turn

**Risk Level:** High

**Speed Limit:** 15 KM/Hr

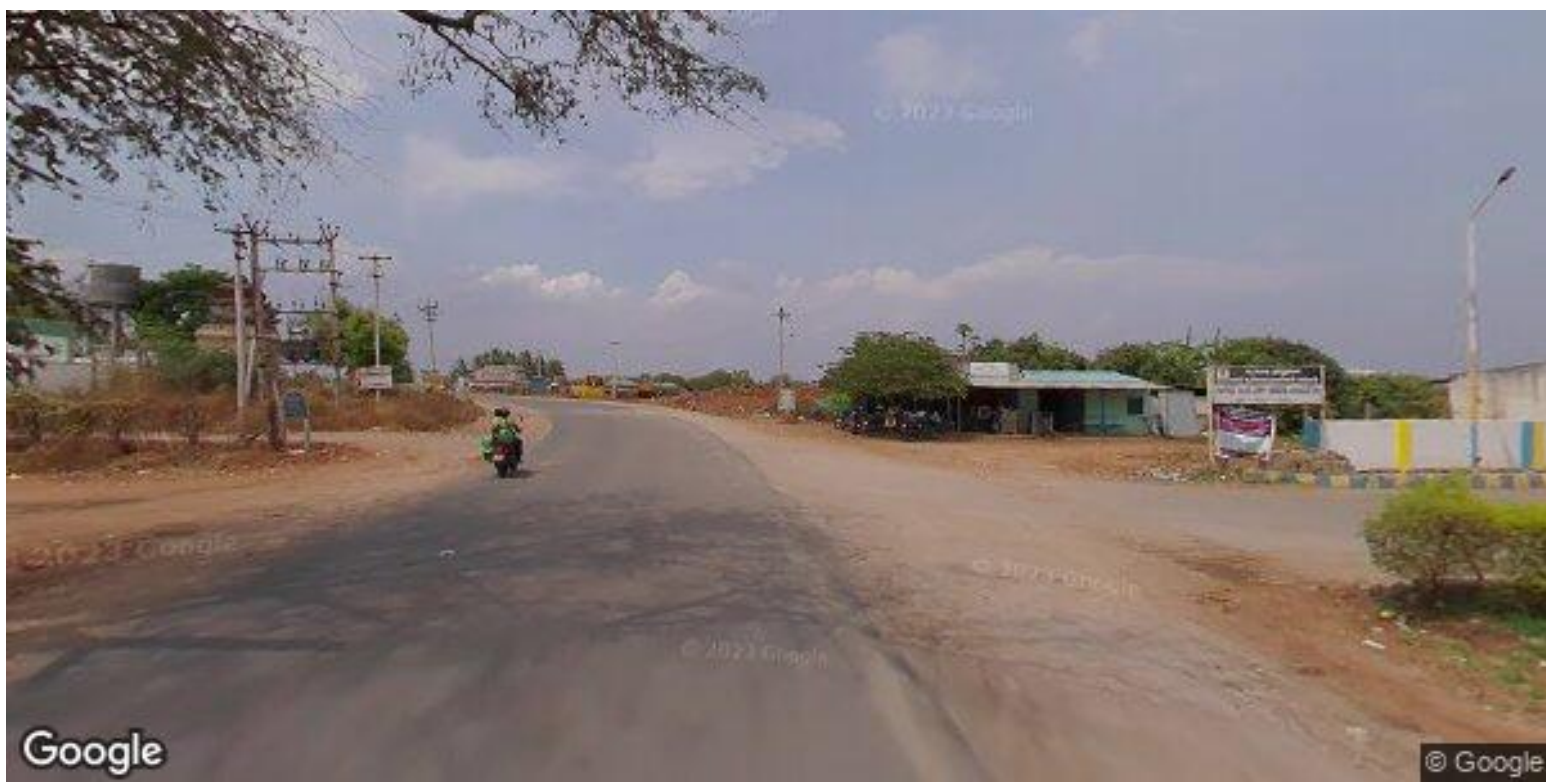
**Coordinates:** 11.58254, 77.90656

**Risk Type:** Turn

**Risk Level:** Medium

**Speed Limit:** 30 KM/Hr

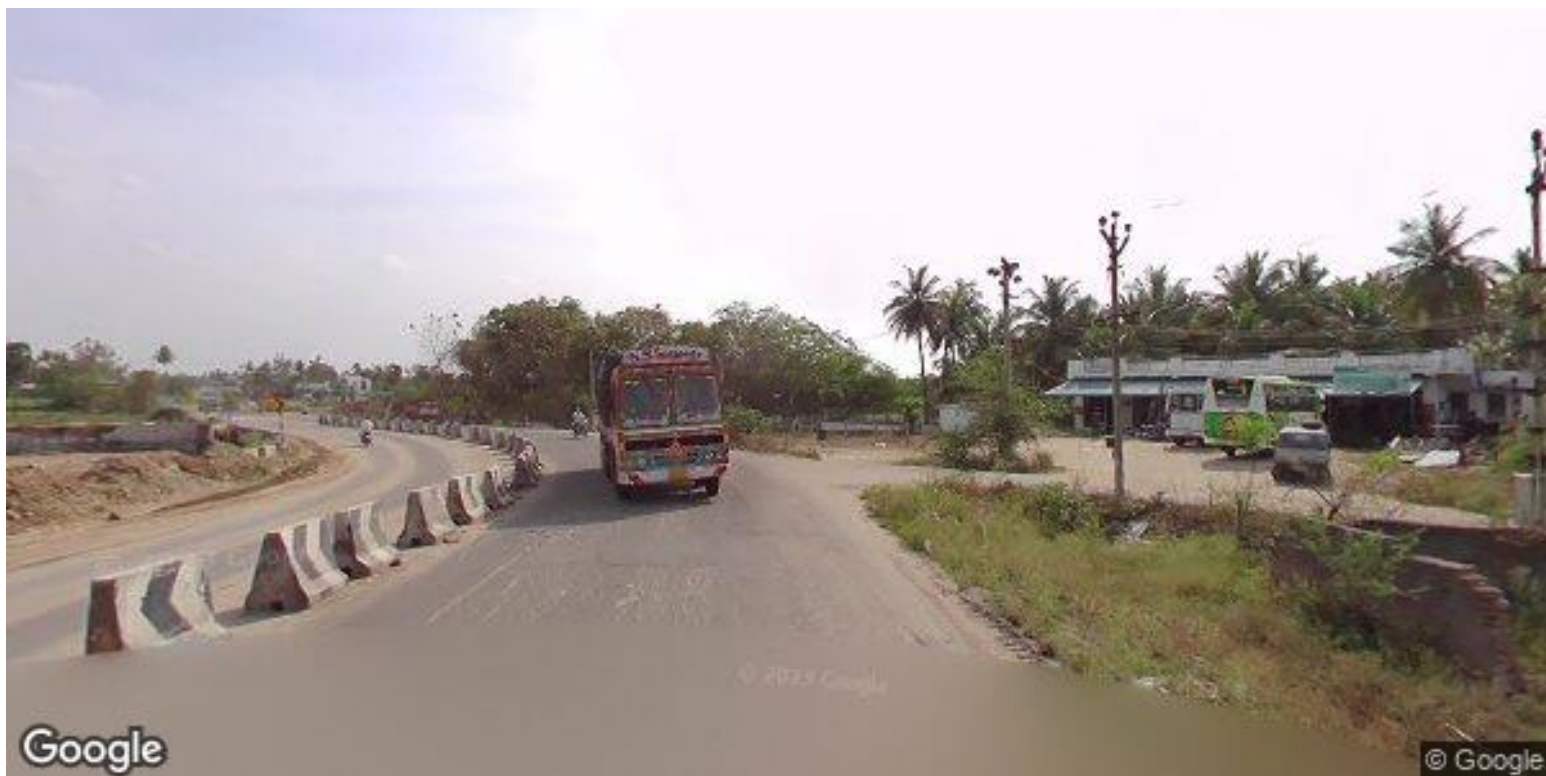
**Coordinates:** 11.63867, 77.94841

**Risk Type:** Turn

**Risk Level:** Medium

**Speed Limit:** 30 KM/Hr

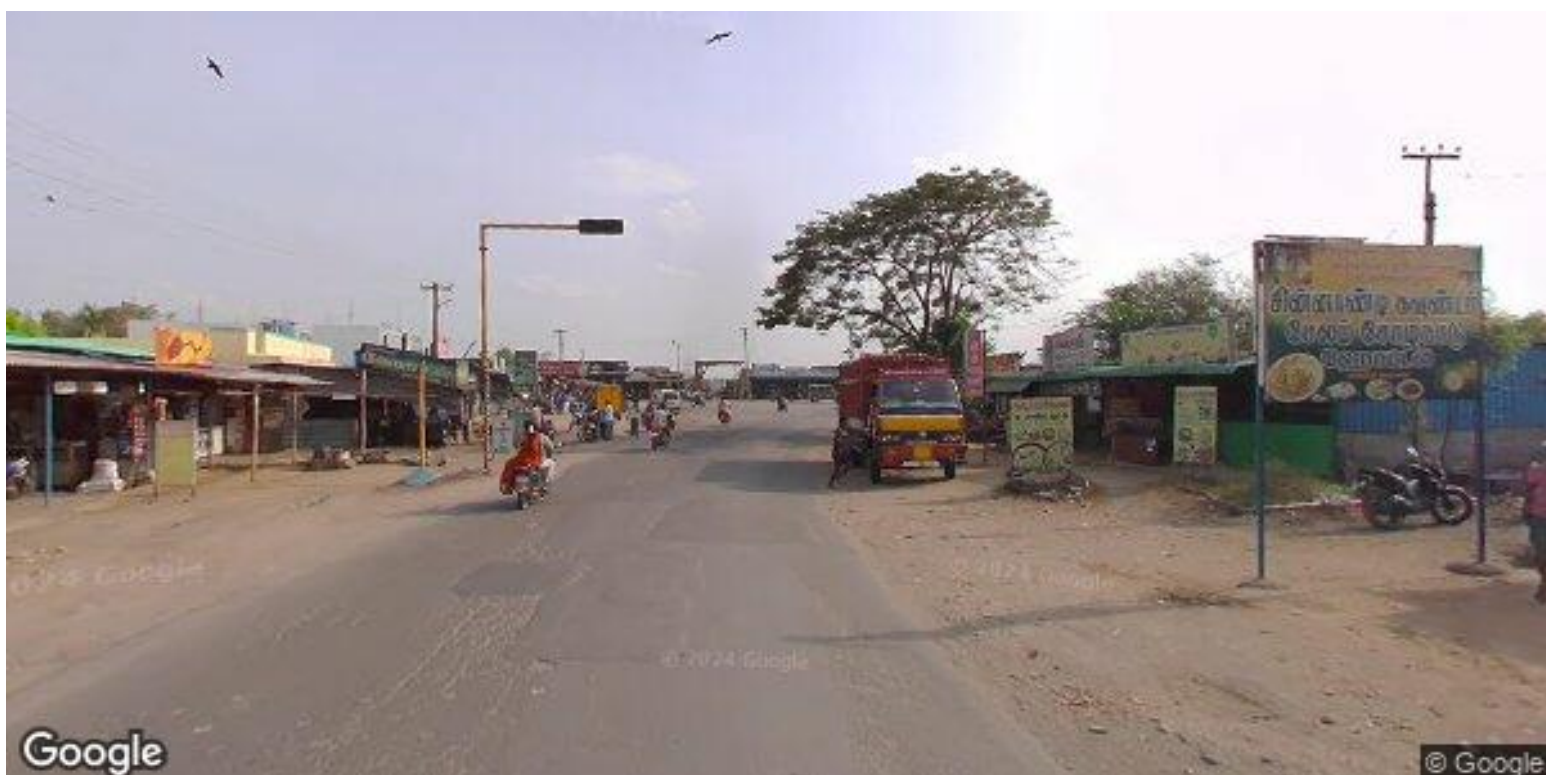
**Coordinates:** 11.64217, 77.95200

**Risk Type:** Turn

**Risk Level:** Medium

**Speed Limit:** 30 KM/Hr

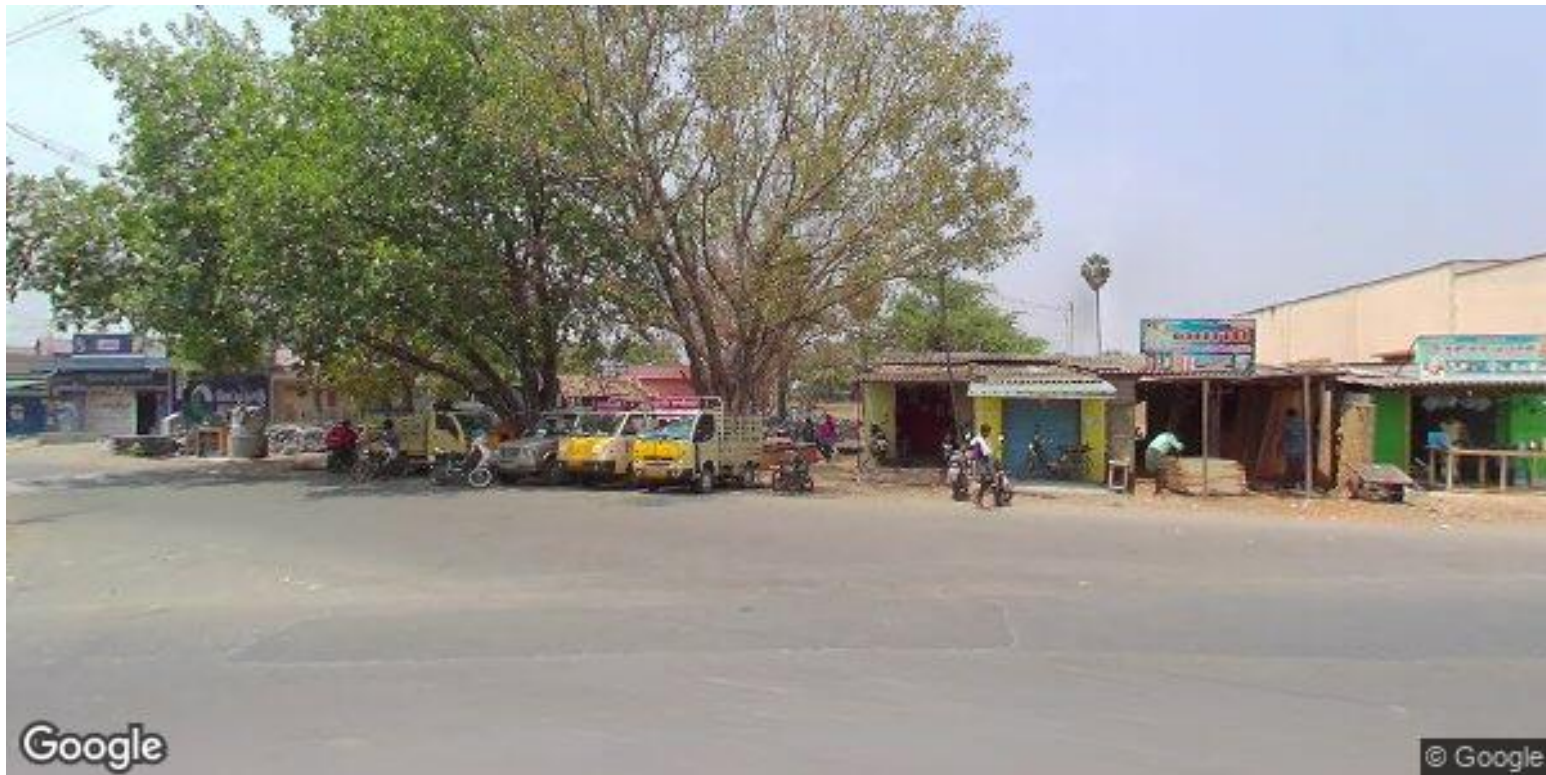
**Coordinates:** 11.64712, 77.95118

**Risk Type:** Turn

**Risk Level:** Medium

**Speed Limit:** 30 KM/Hr

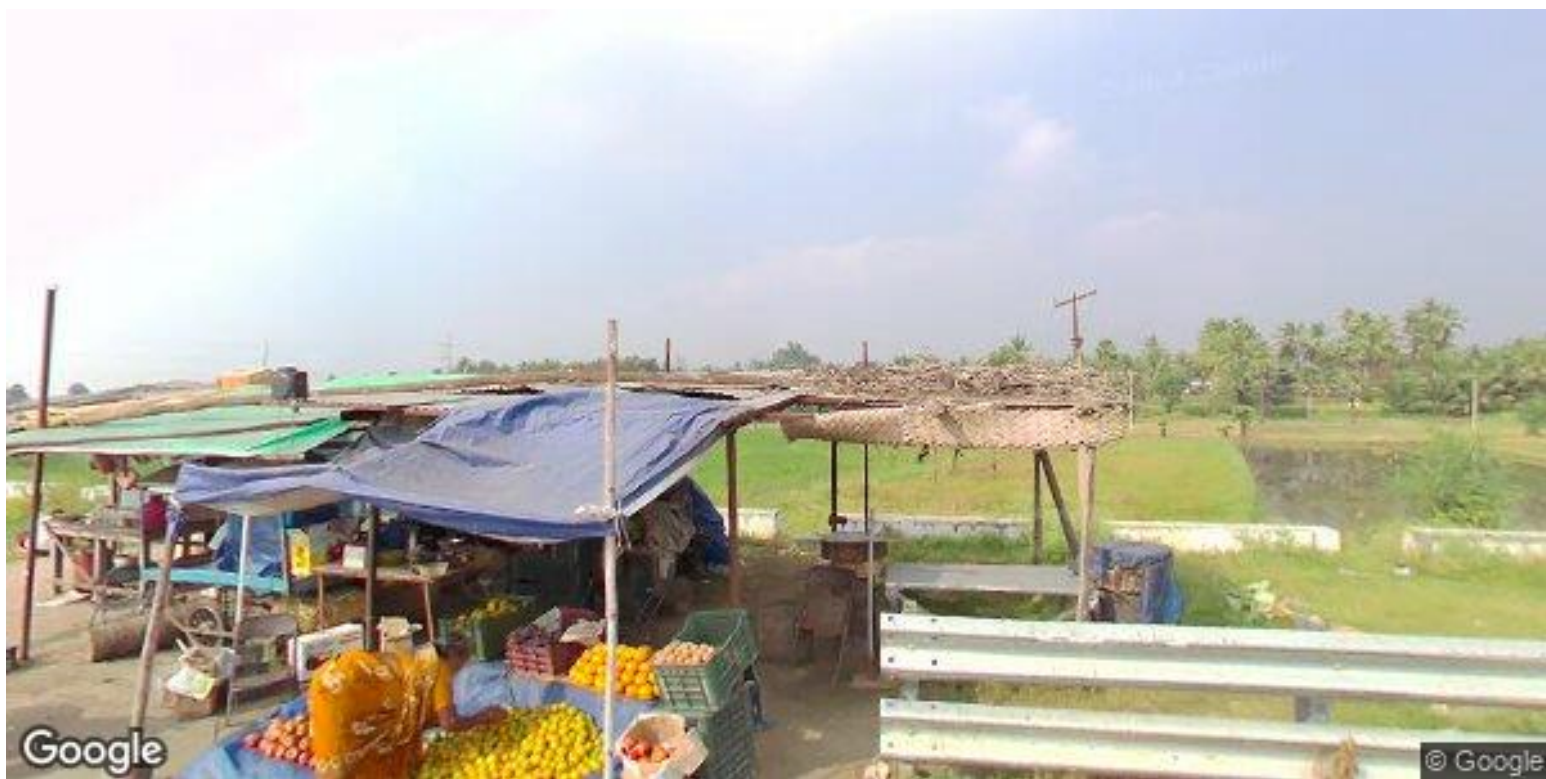
**Coordinates:** 11.67858, 77.96834

**Risk Type:** Turn

**Risk Level:** High

**Speed Limit:** 15 KM/Hr

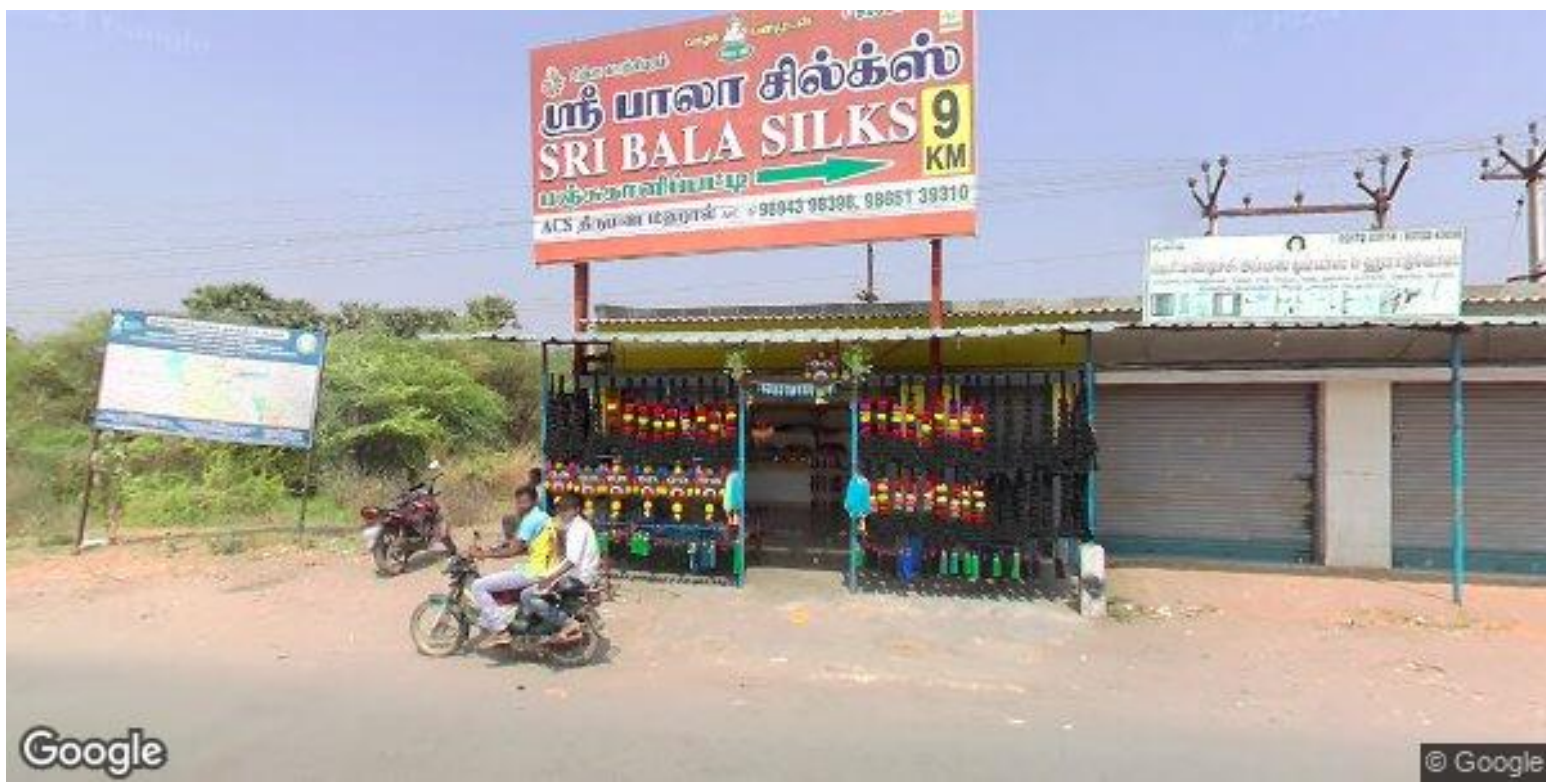
**Coordinates:** 11.70233, 77.97869

**Risk Type:** Turn

**Risk Level:** High

**Speed Limit:** 15 KM/Hr

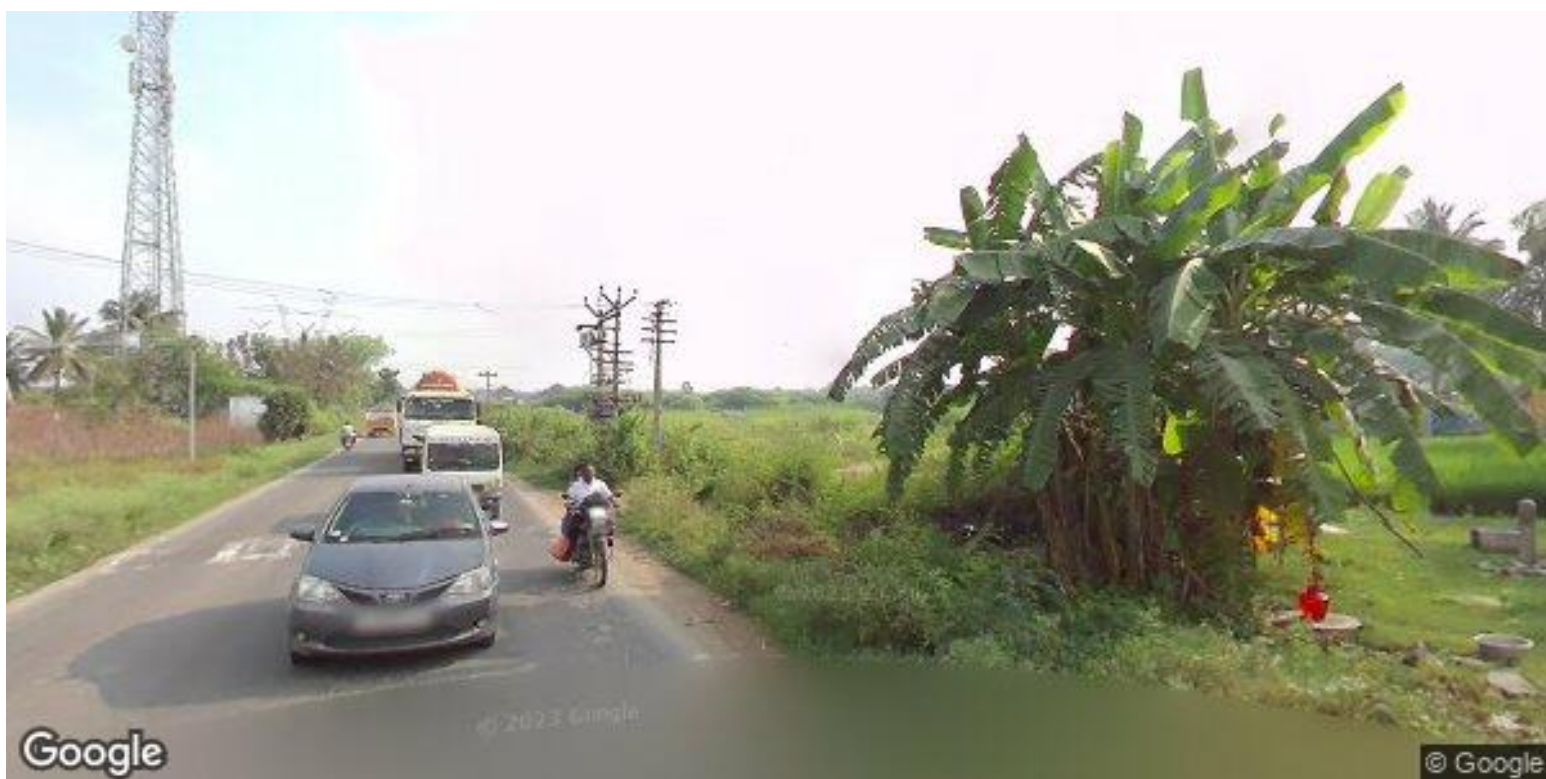
**Coordinates:** 11.71394, 77.99572

**Risk Type:** Turn

**Risk Level:** Medium

**Speed Limit:** 30 KM/Hr

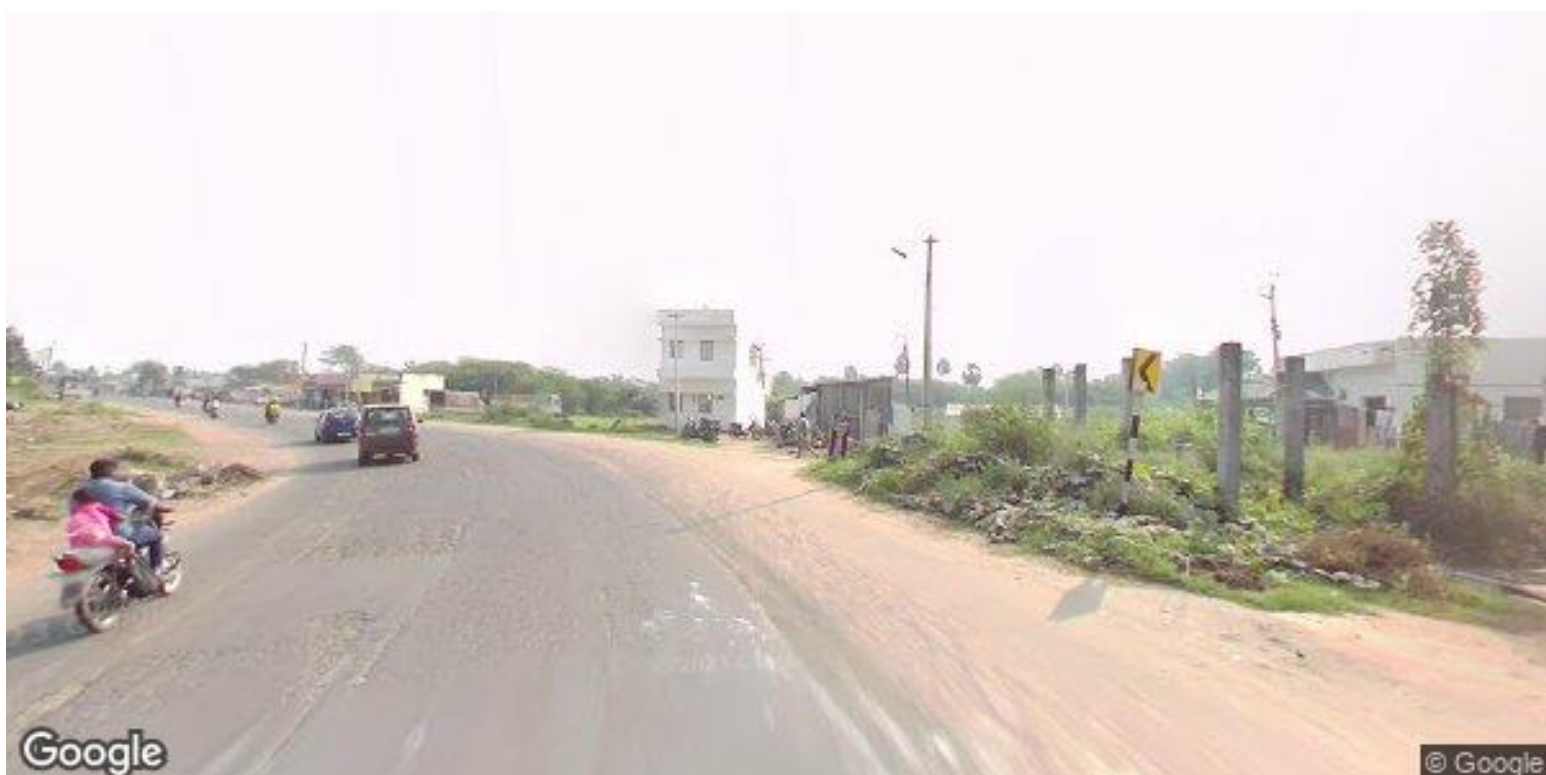
**Coordinates:** 11.71916, 78.01117

**Risk Type:** Turn

**Risk Level:** Medium

**Speed Limit:** 30 KM/Hr

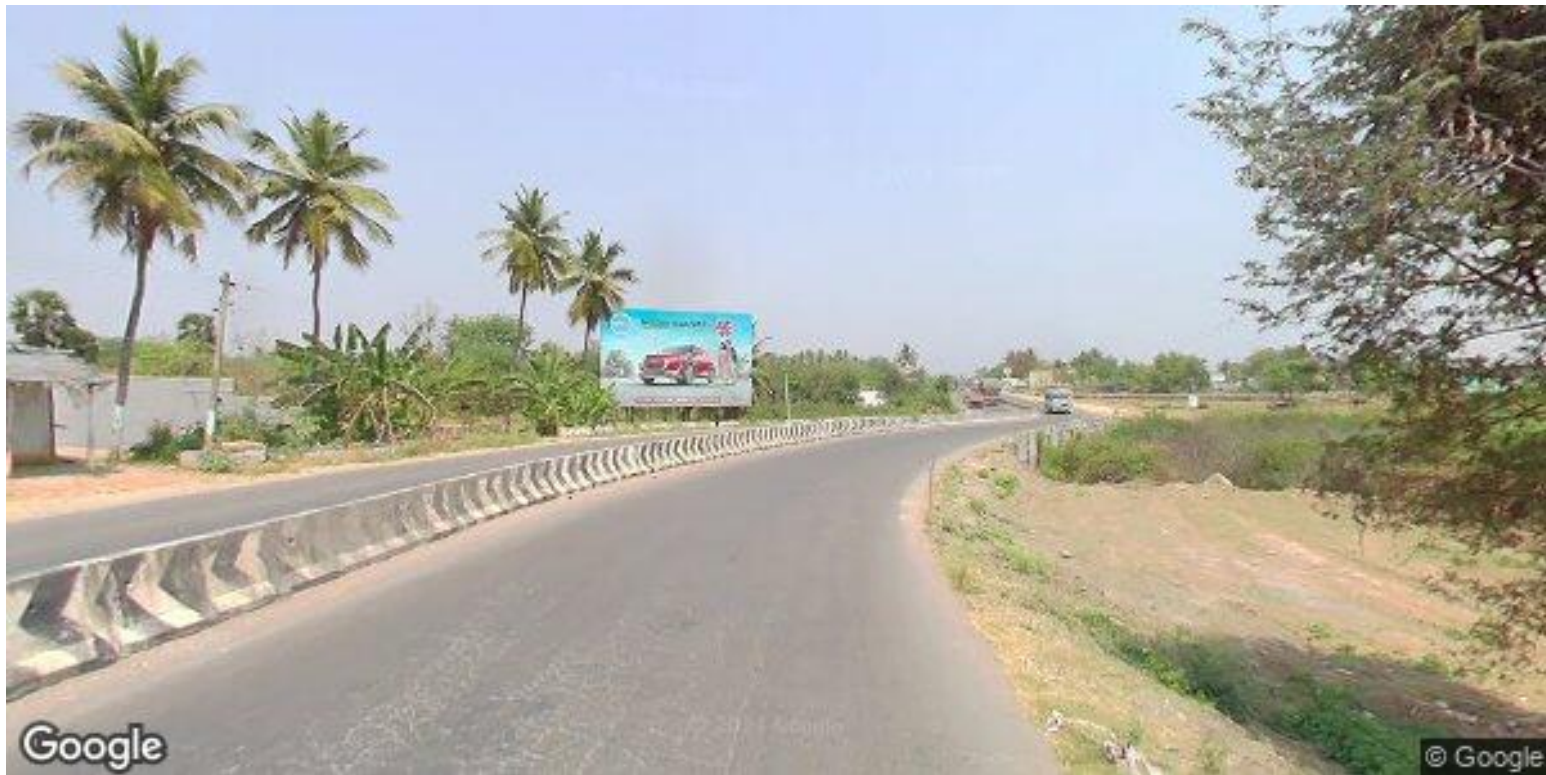
**Coordinates:** 11.72559, 78.01758

**Risk Type:** Turn

**Risk Level:** Medium

**Speed Limit:** 30 KM/Hr

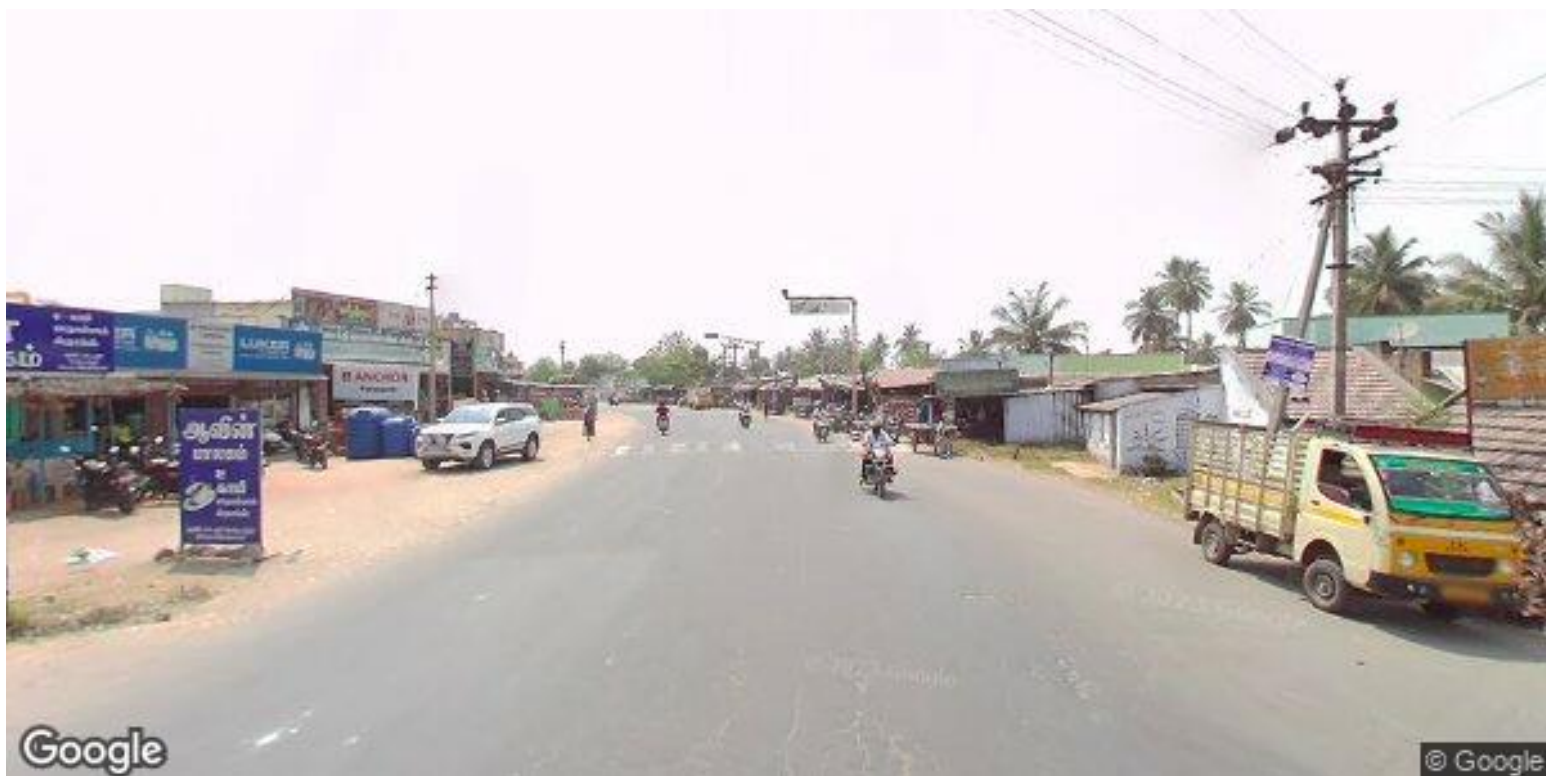
**Coordinates:** 11.73787, 78.03528

**Risk Type:** Turn

**Risk Level:** Medium

**Speed Limit:** 30 KM/Hr

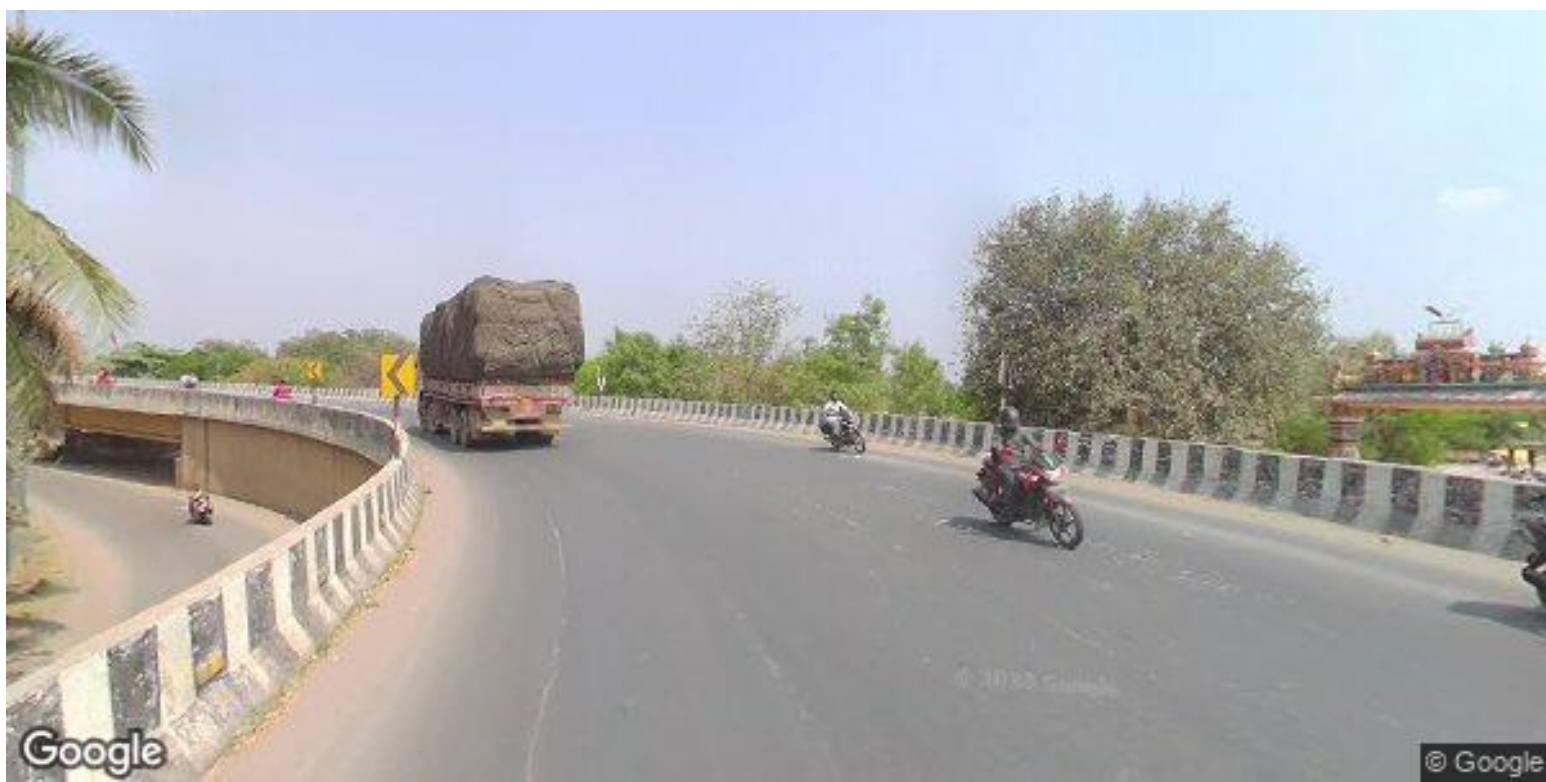
**Coordinates:** 11.73651, 78.03868

**Risk Type:** Turn

**Risk Level:** High

**Speed Limit:** 15 KM/Hr

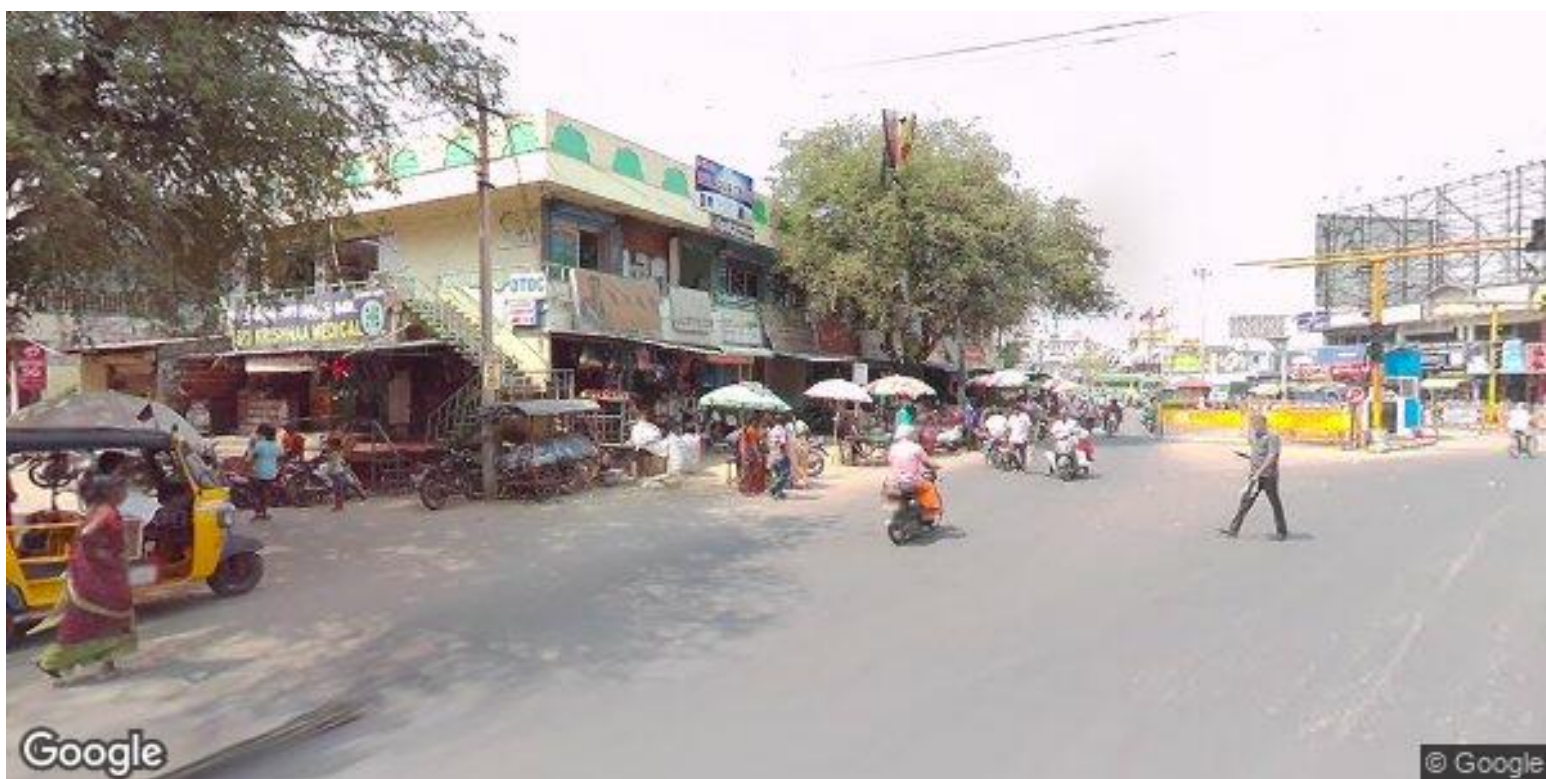
**Coordinates:** 11.74257, 78.04708

**Risk Type:** Turn

**Risk Level:** Medium

**Speed Limit:** 30 KM/Hr

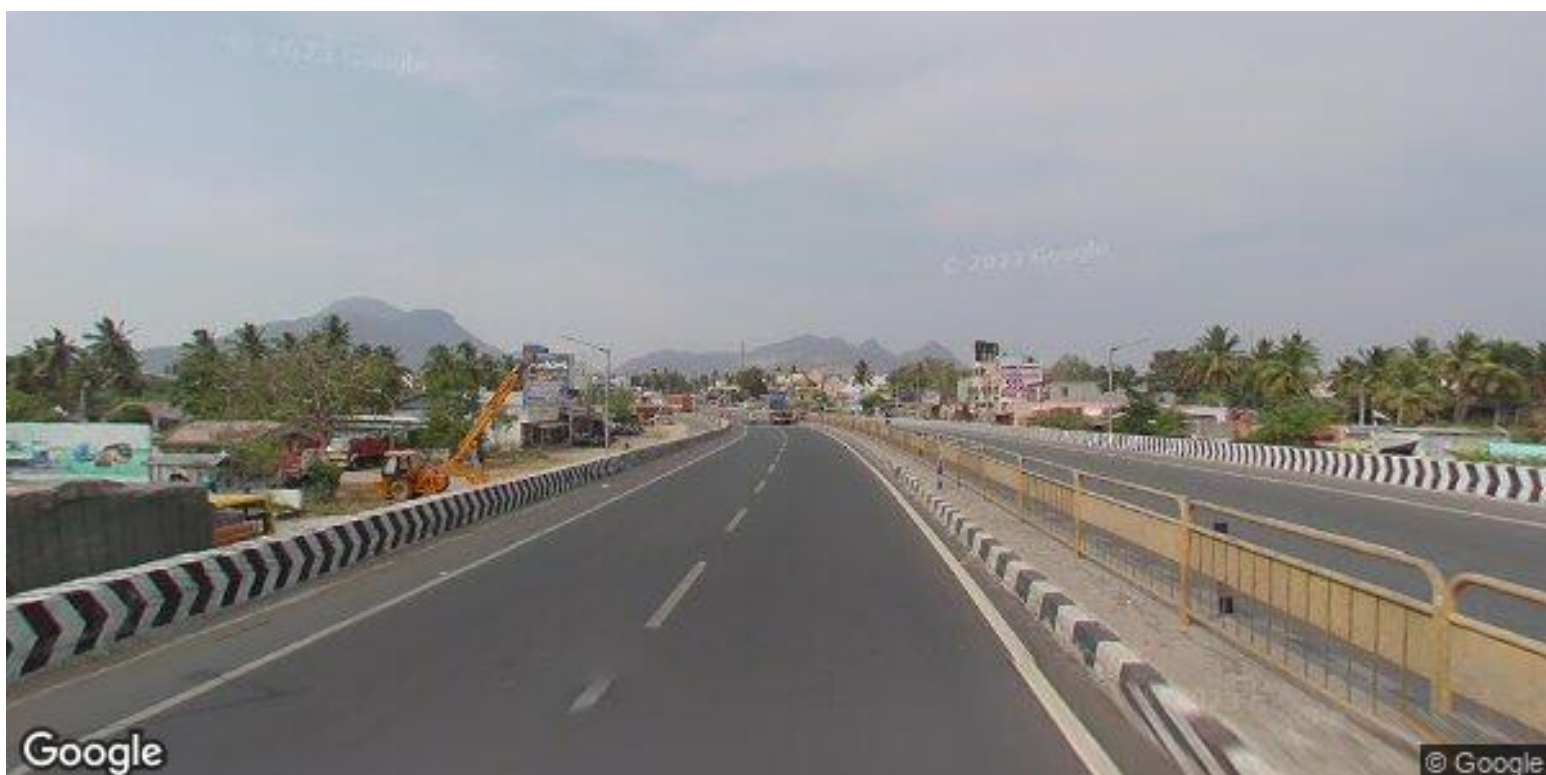
**Risk Type:** Turn  
**Risk Level:** Medium  
**Speed Limit:** 30 KM/Hr  
**Coordinates:** 11.86805, 78.08353

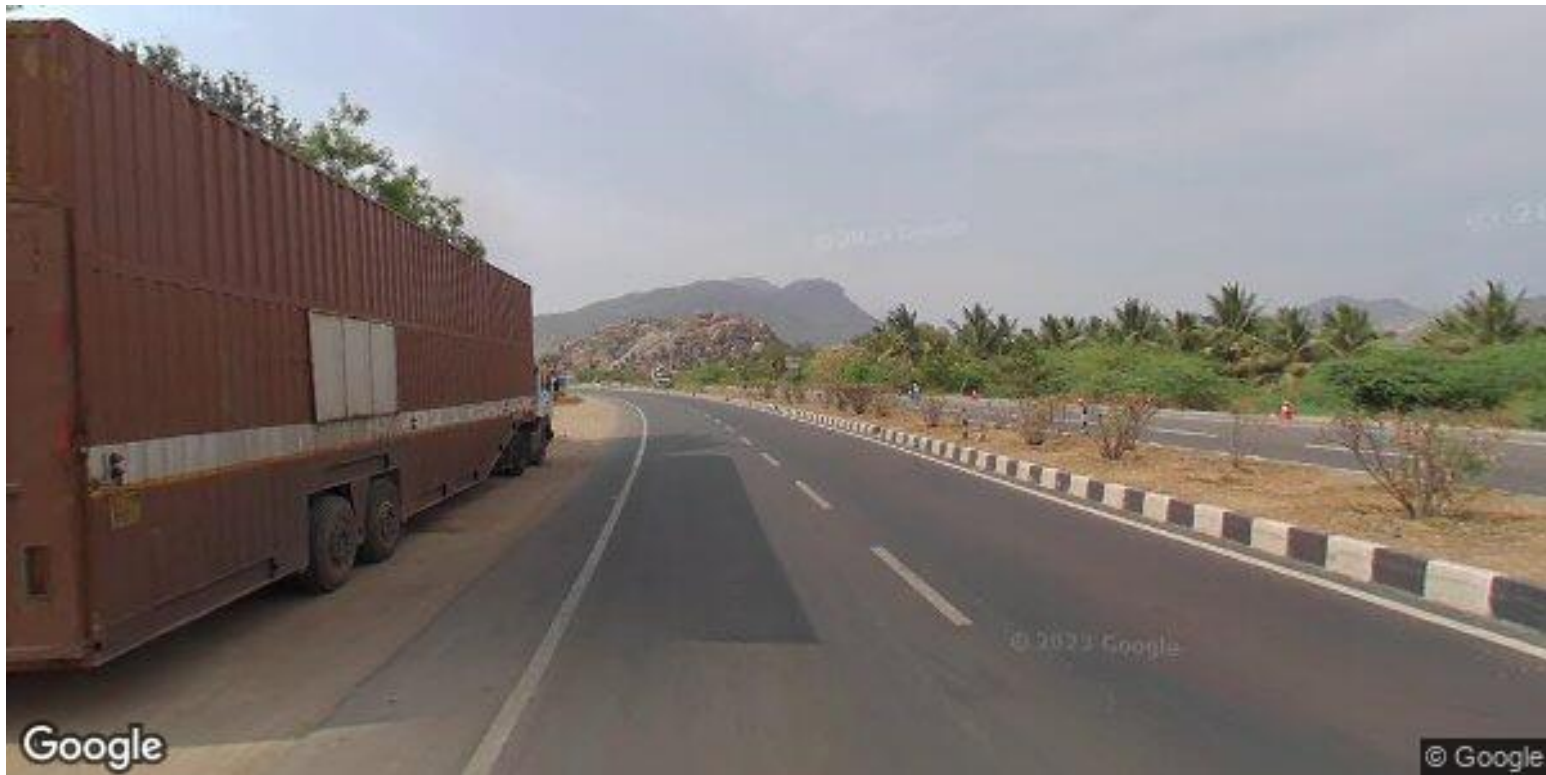
**Risk Type:** Turn  
**Risk Level:** Medium  
**Speed Limit:** 30 KM/Hr  
**Coordinates:** 11.87913, 78.08206

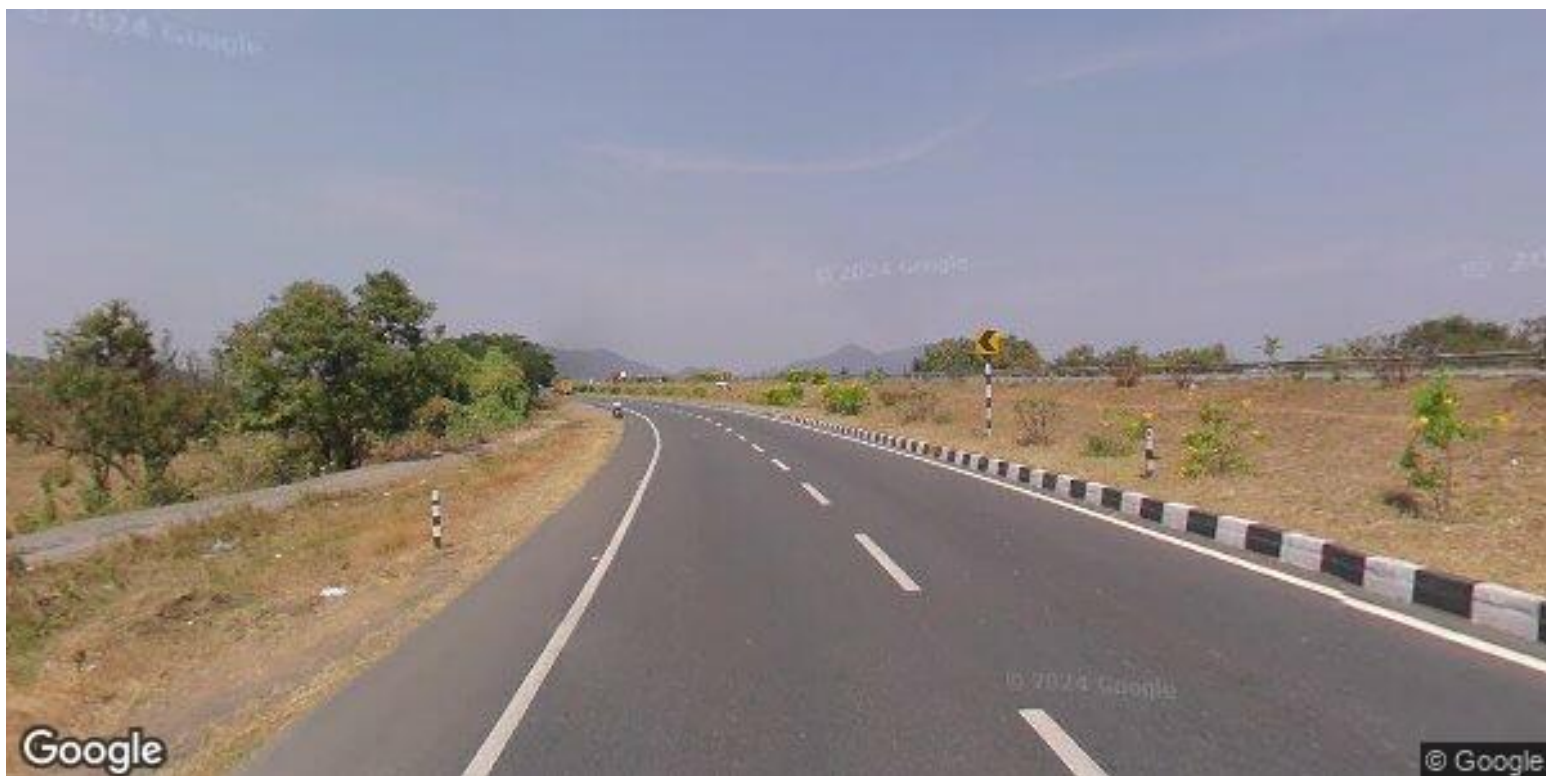
**Risk Type:** Turn  
**Risk Level:** Medium  
**Speed Limit:** 30 KM/Hr  
**Coordinates:** 11.92566, 78.06503

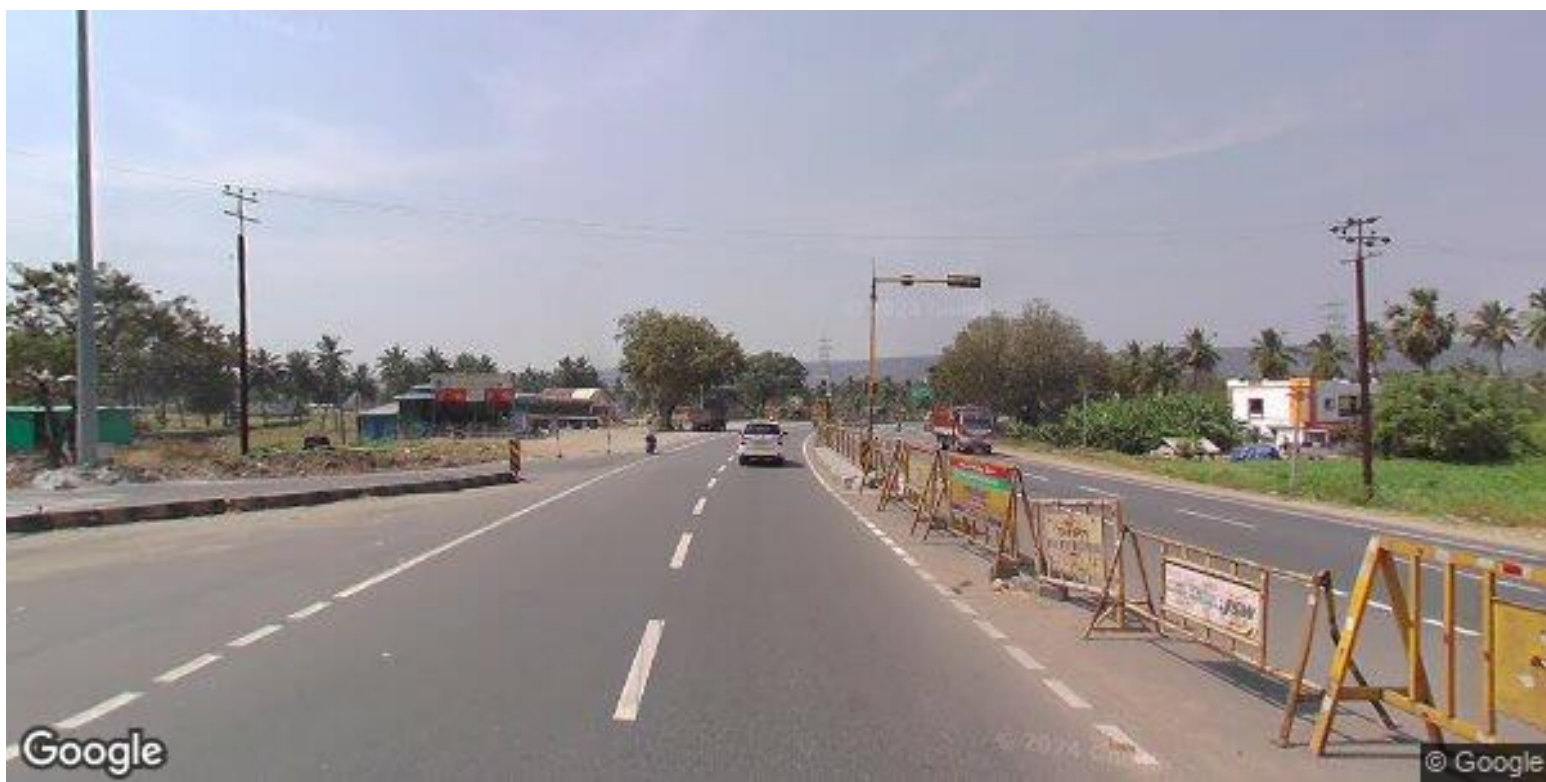
**Coordinates:** 11.93694, 78.05425

**Risk Type:** Turn

**Risk Level:** Medium

**Speed Limit:** 30 KM/Hr

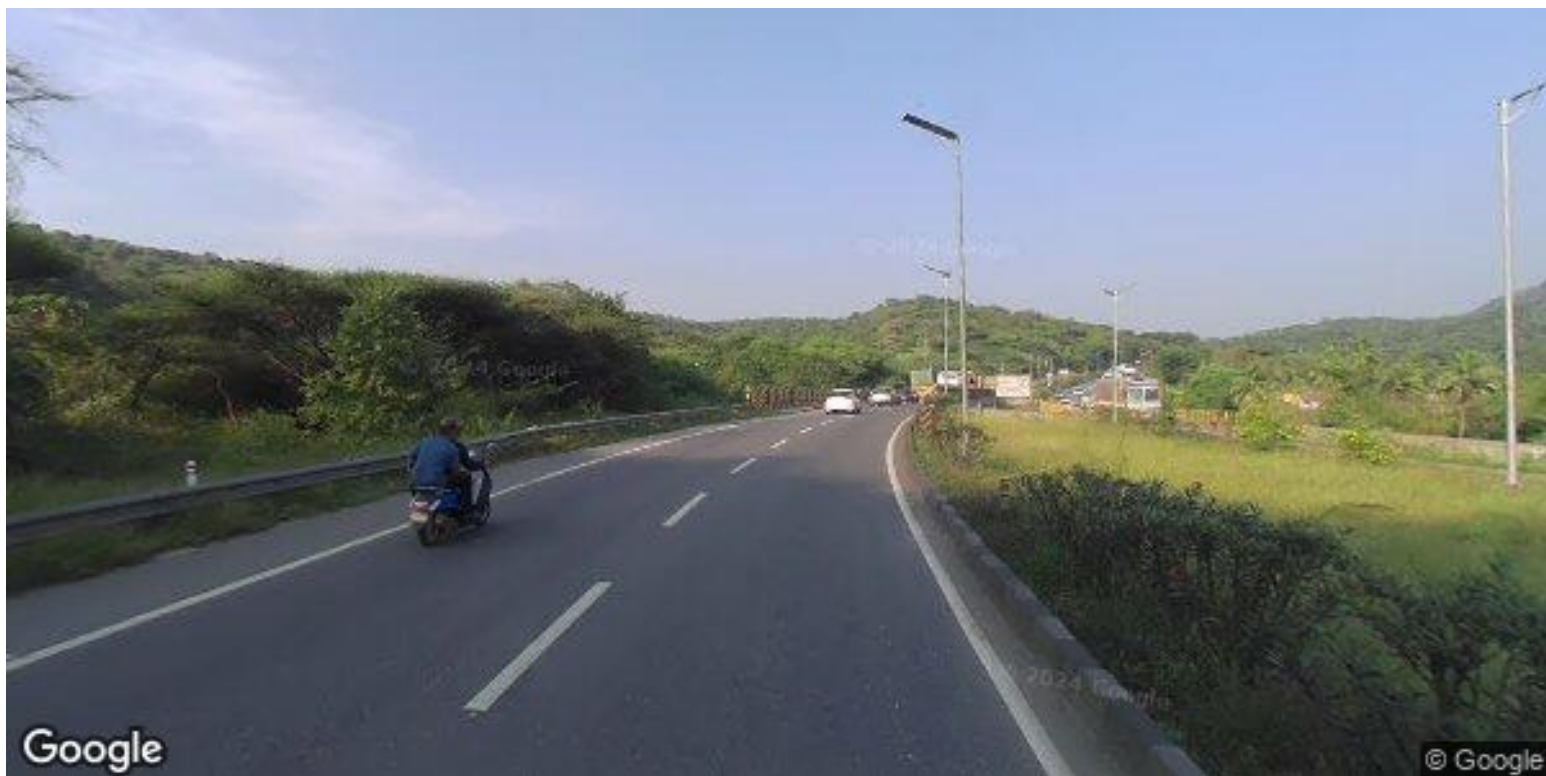
**Coordinates:** 11.95531, 78.04698

**Risk Type:** Turn

**Risk Level:** Medium

**Speed Limit:** 30 KM/Hr
