# IndianOil

## **JOURNEY RISK MANAGEMENT (JRM) STUDY**

### **Salem Terminal TO PALACODE MOOGAMBIGAI AGENCIES**

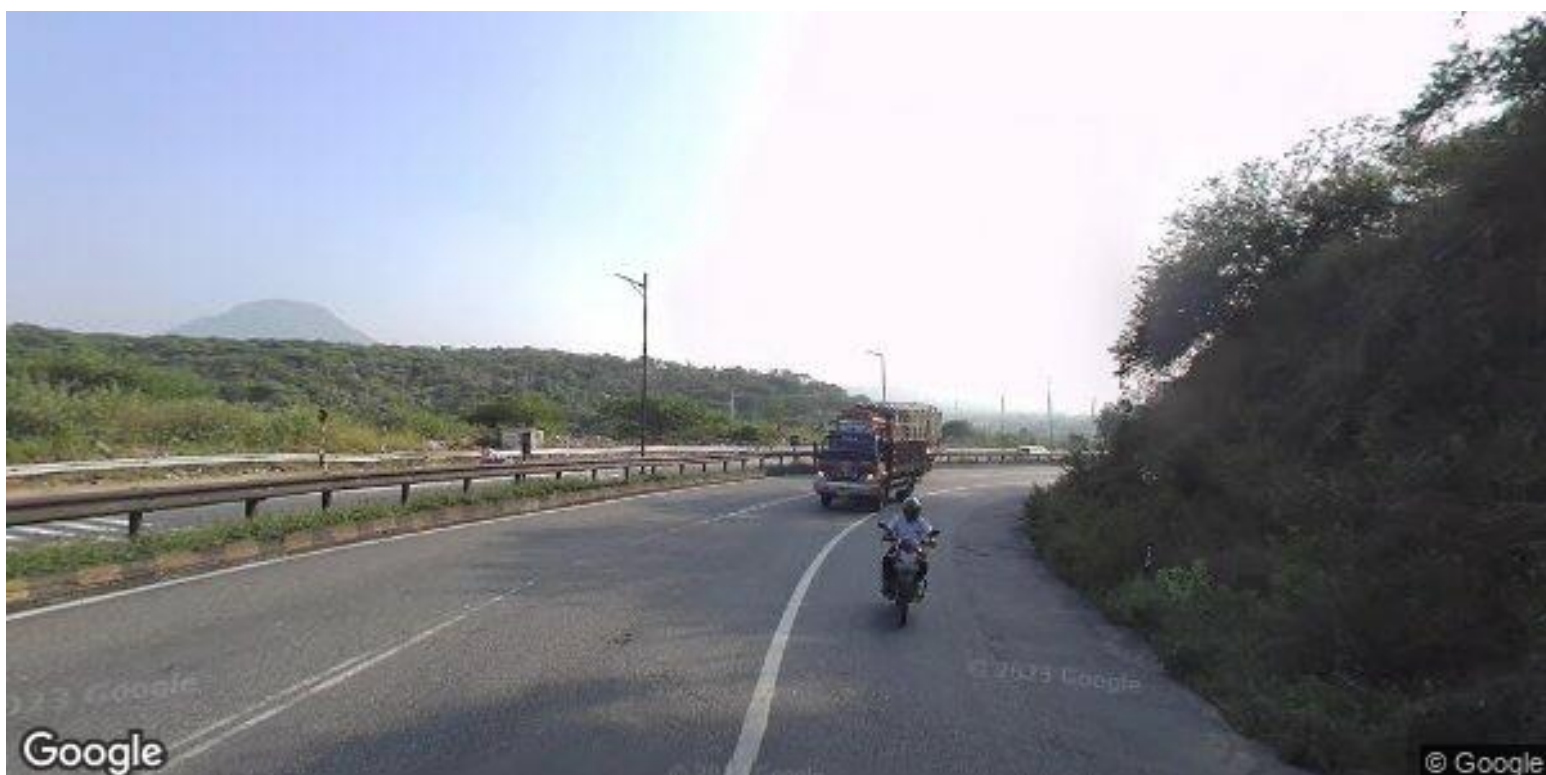
**Risk Type:** Turn  
**Risk Level:** Medium  
**Speed Limit:** 30 KM/Hr  
**Coordinates:** 11.95854, 78.04990

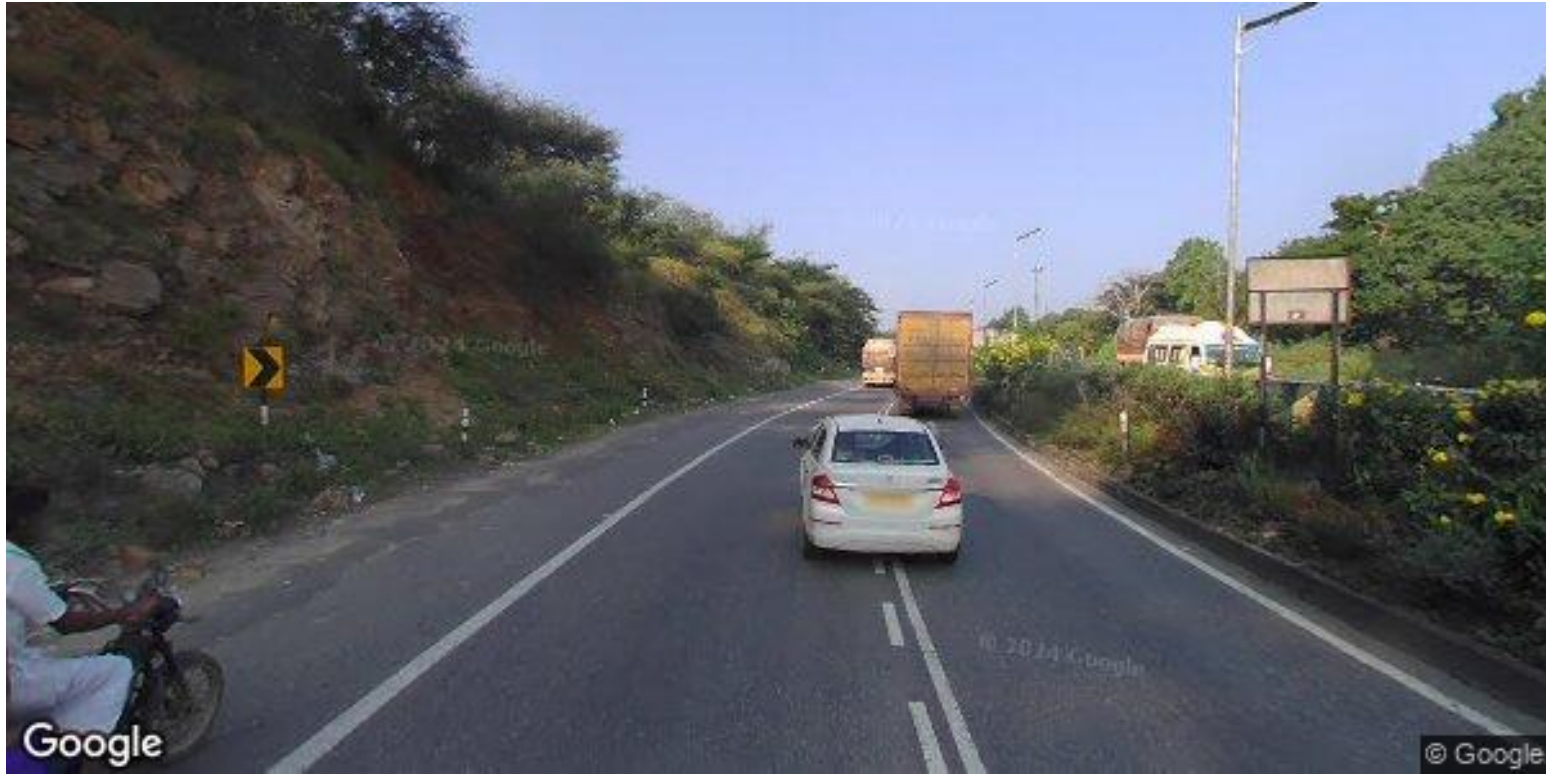
**Risk Type:** Turn  
**Risk Level:** Medium  
**Speed Limit:** 30 KM/Hr  
**Coordinates:** 11.96068, 78.04960

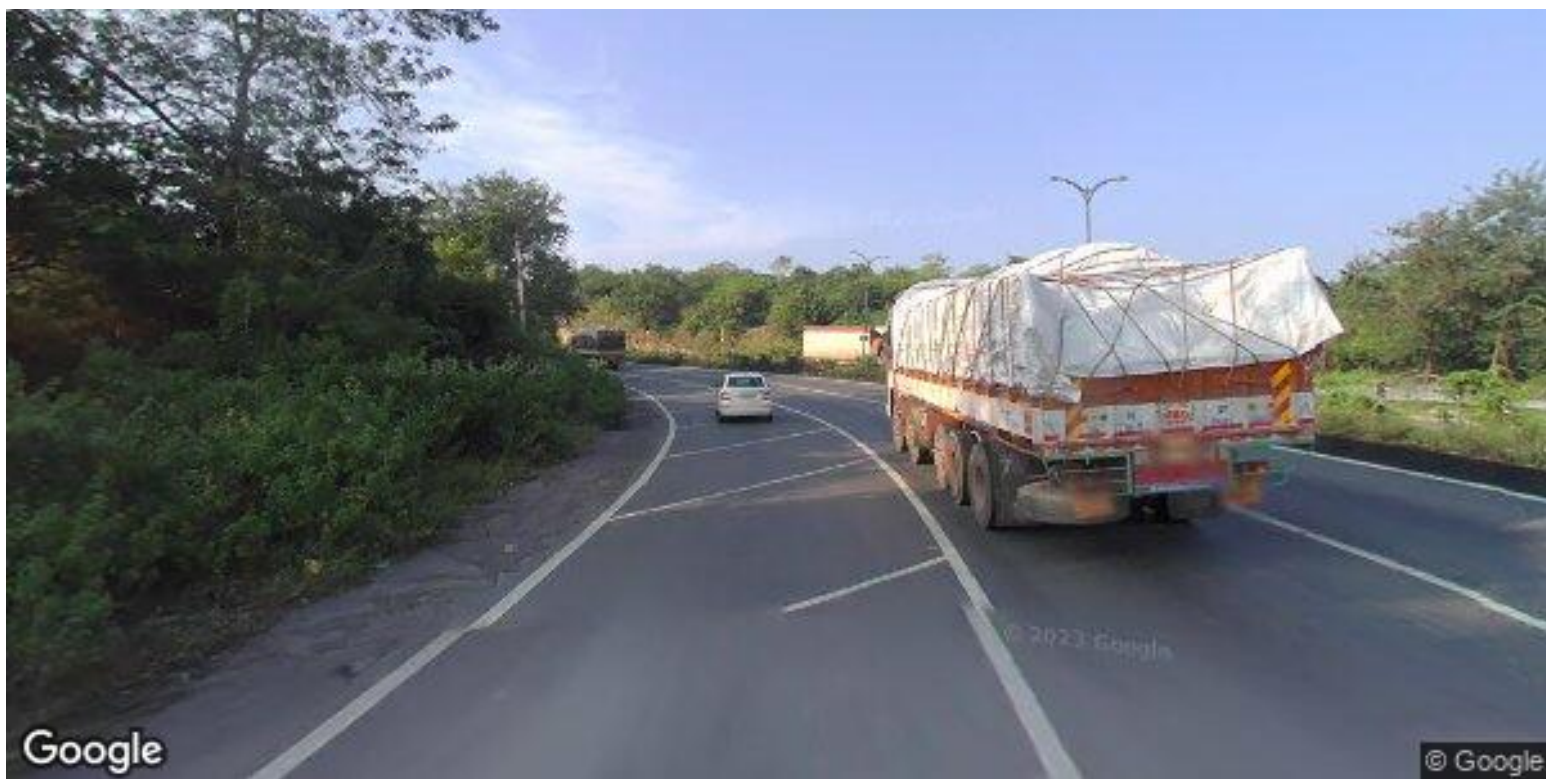
**Risk Type:** Turn  
**Risk Level:** Medium  
**Speed Limit:** 30 KM/Hr  
**Coordinates:** 11.96370, 78.05142

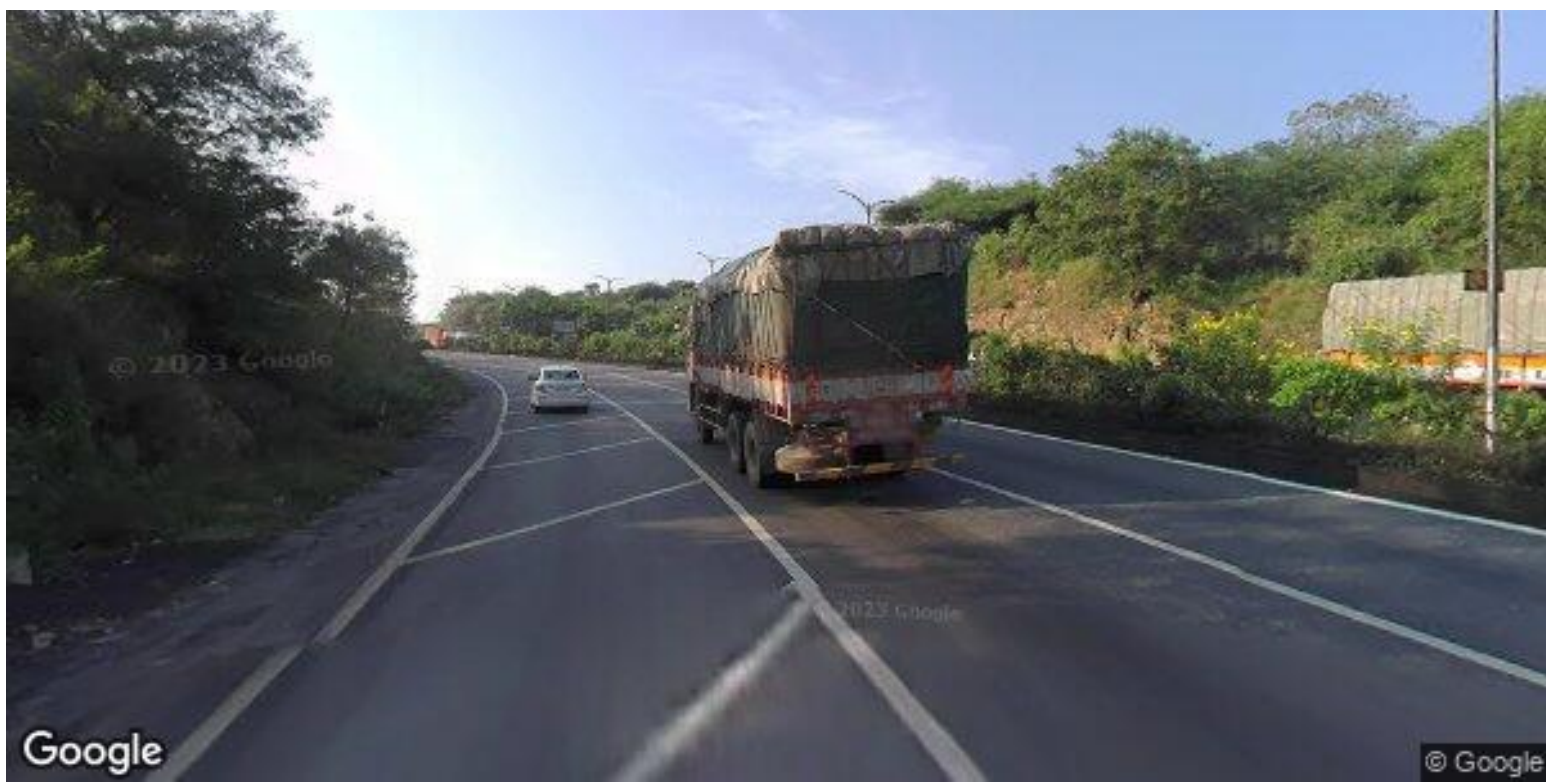
**Coordinates:** 11.96433, 78.05113

**Risk Type:** Turn

**Risk Level:** Medium

**Speed Limit:** 30 KM/Hr

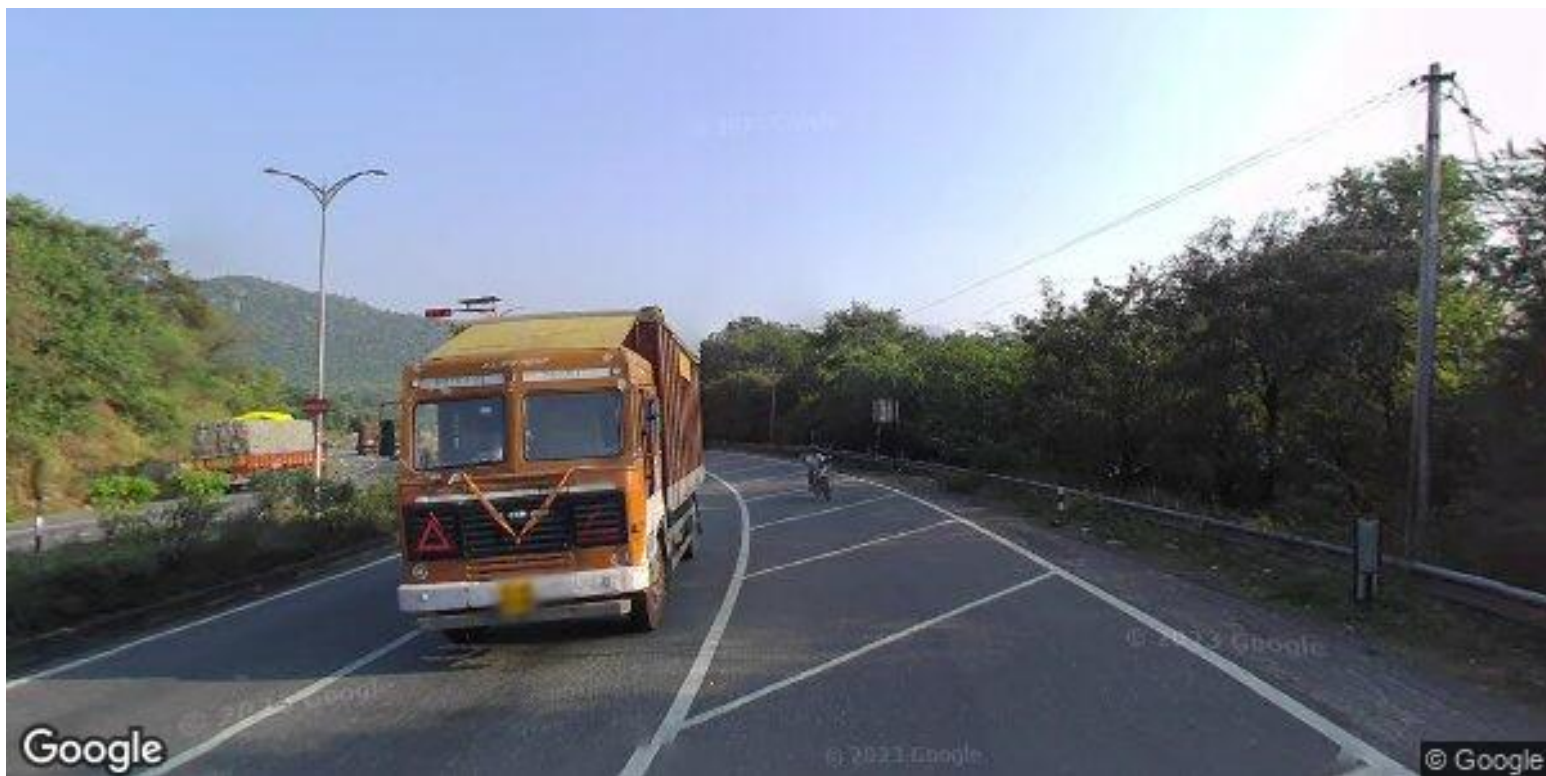
**Coordinates:** 11.96542, 78.04938

**Risk Type:** Turn

**Risk Level:** High

**Speed Limit:** 15 KM/Hr

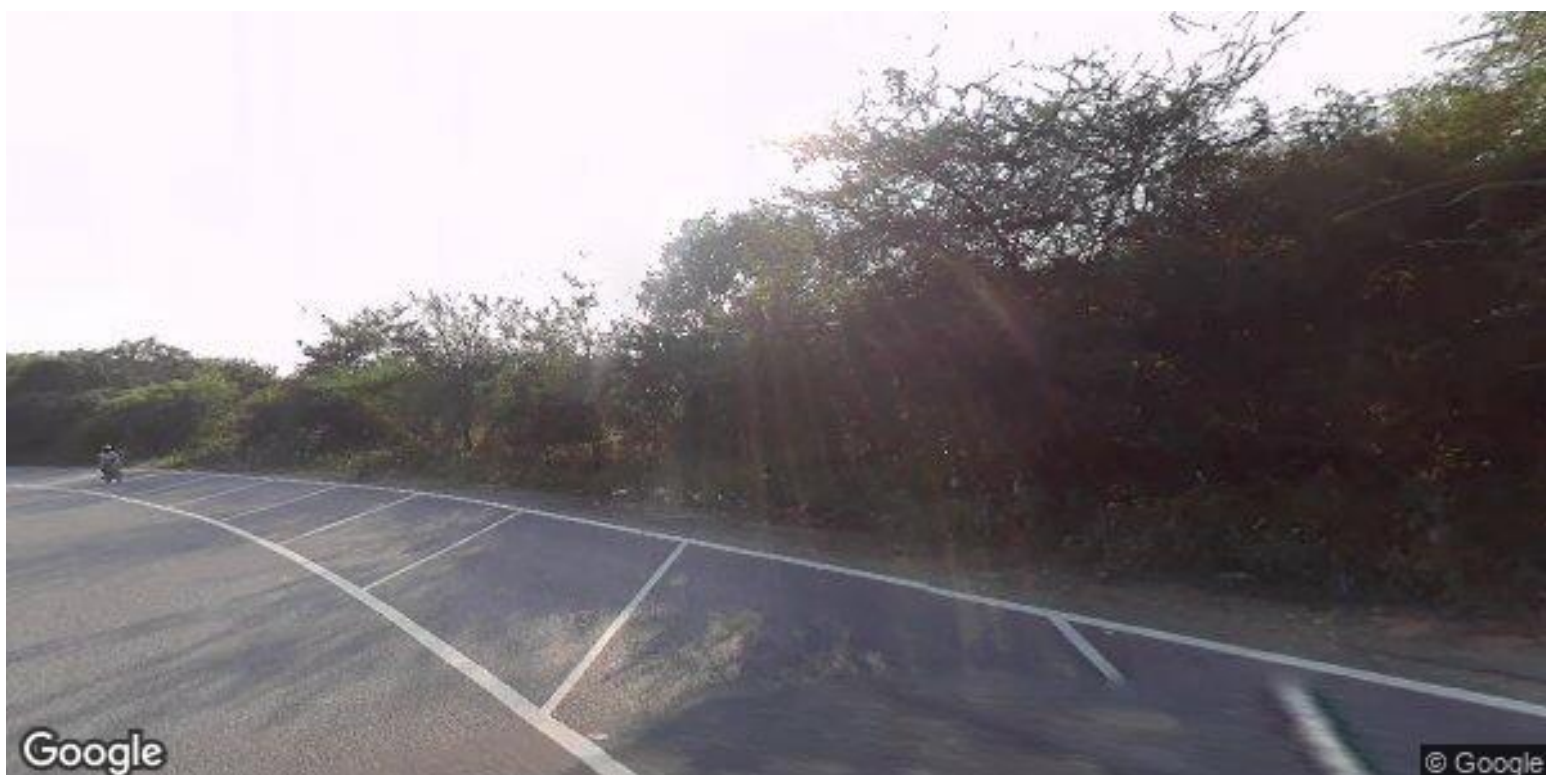
**Risk Type:** Turn  
**Risk Level:** High  
**Speed Limit:** 15 KM/Hr  
**Coordinates:** 11.96650, 78.04927

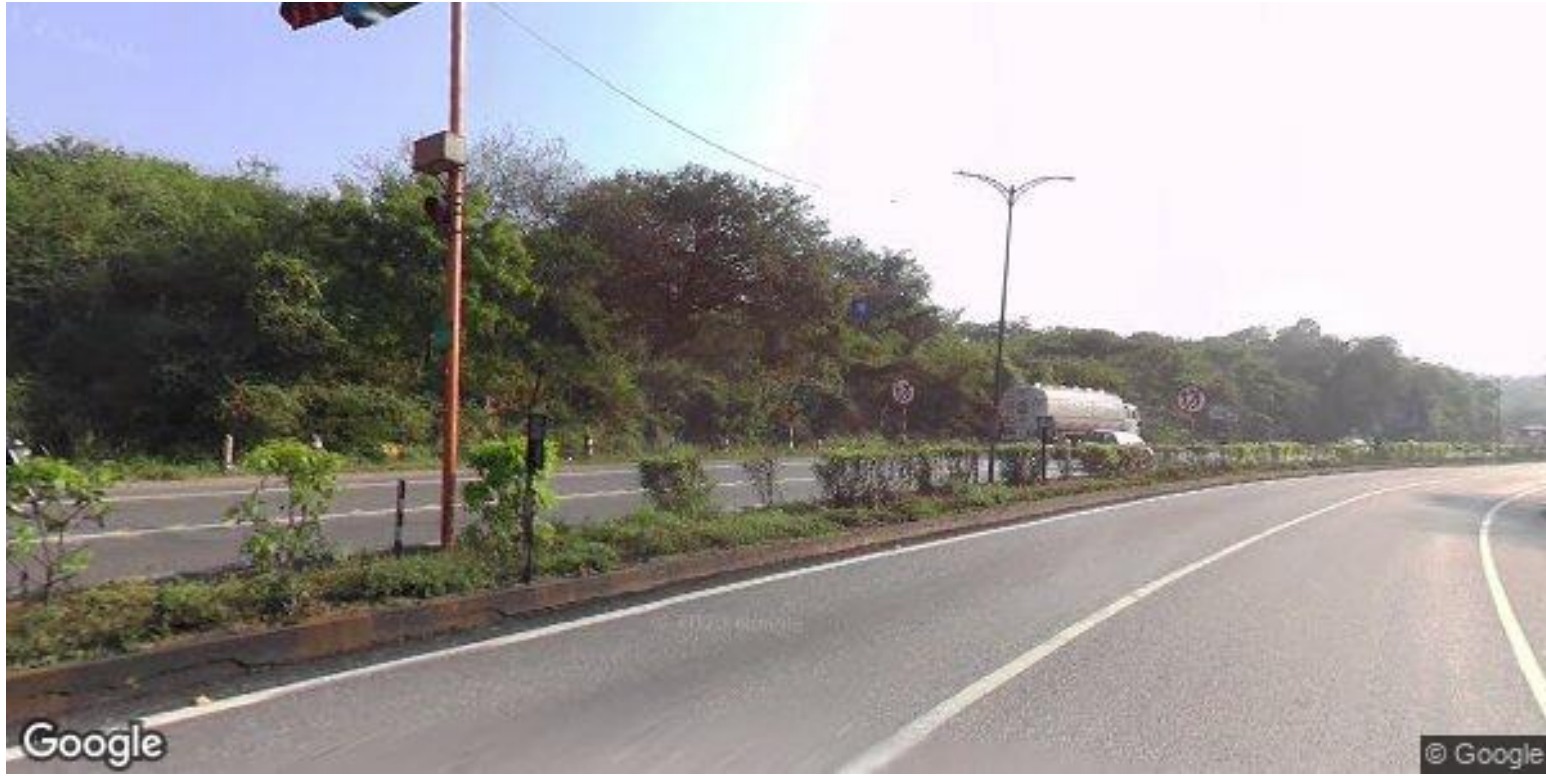
**Risk Type:** Turn  
**Risk Level:** Medium  
**Speed Limit:** 30 KM/Hr  
**Coordinates:** 11.96804, 78.05080

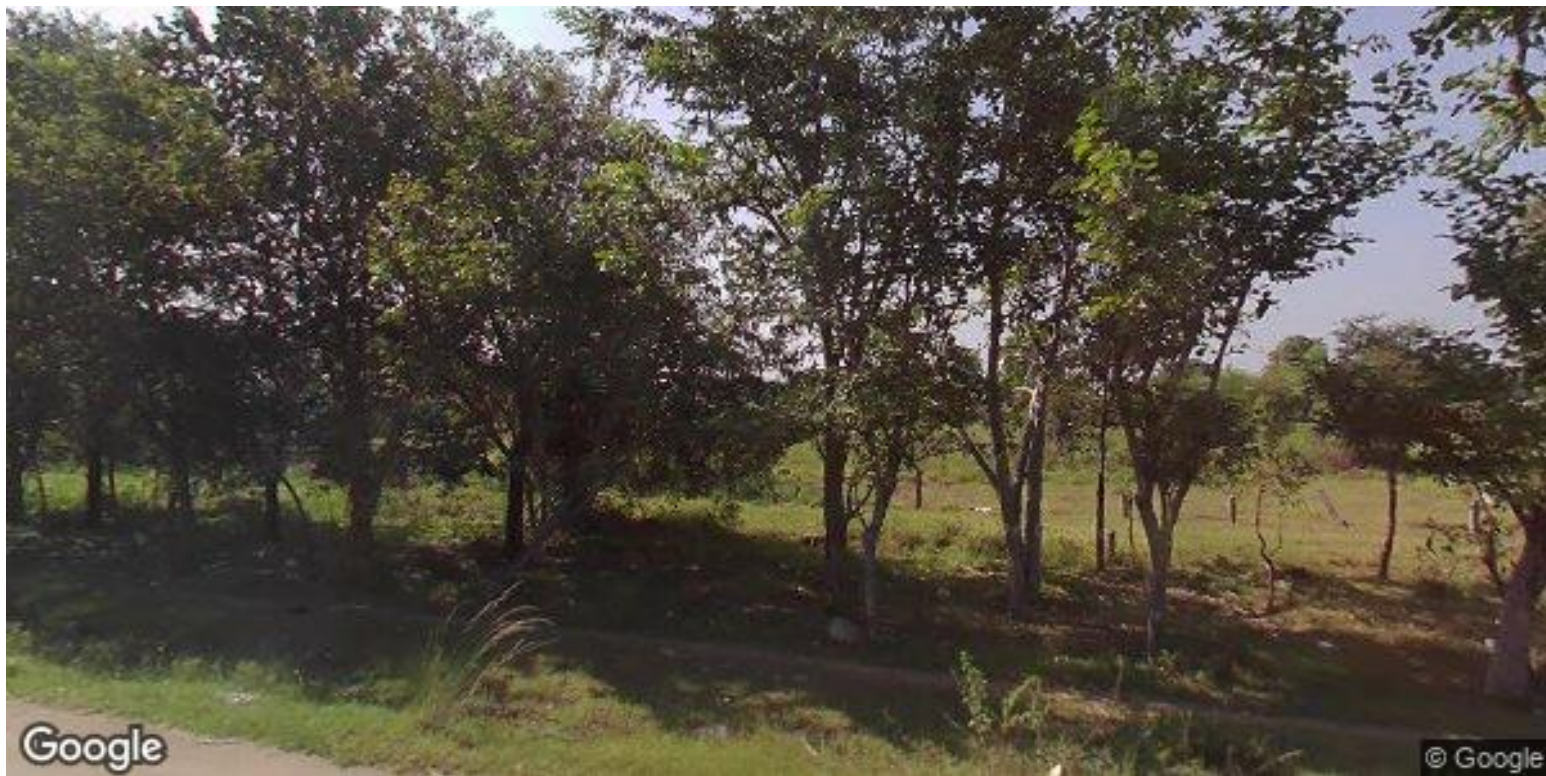
**Risk Type:** Turn  
**Risk Level:** Medium  
**Speed Limit:** 30 KM/Hr  
**Coordinates:** 12.12017, 78.13283

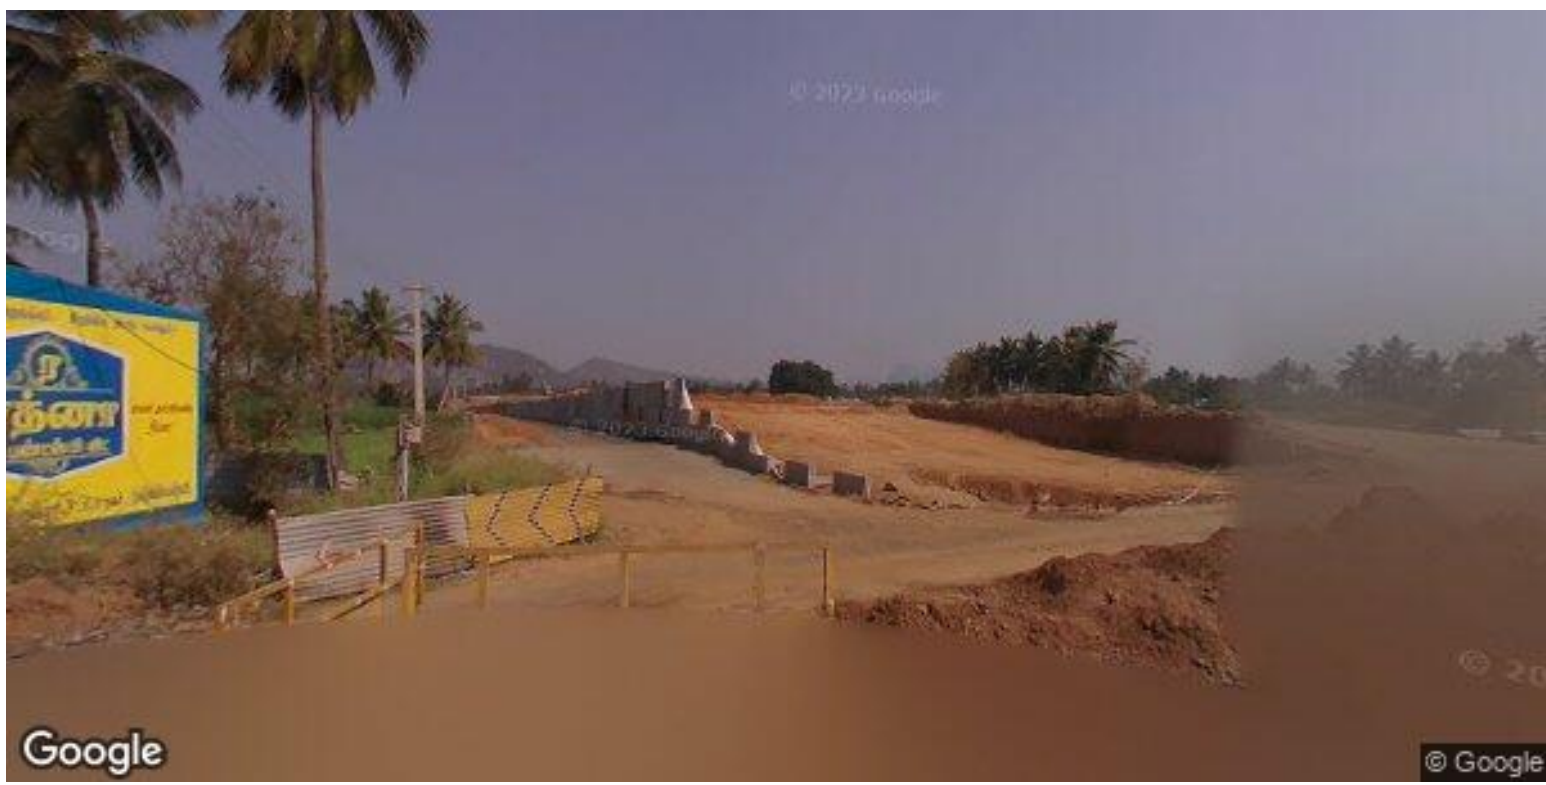
**Coordinates:** 12.30652, 78.06428

**Risk Type:** Turn

**Risk Level:** High

**Speed Limit:** 15 KM/Hr
