## JOURNEY RISK MANAGEMENT (JRM) STUDY

### Salem Terminal TO SHREE VARNIKHA ENTERPRISES

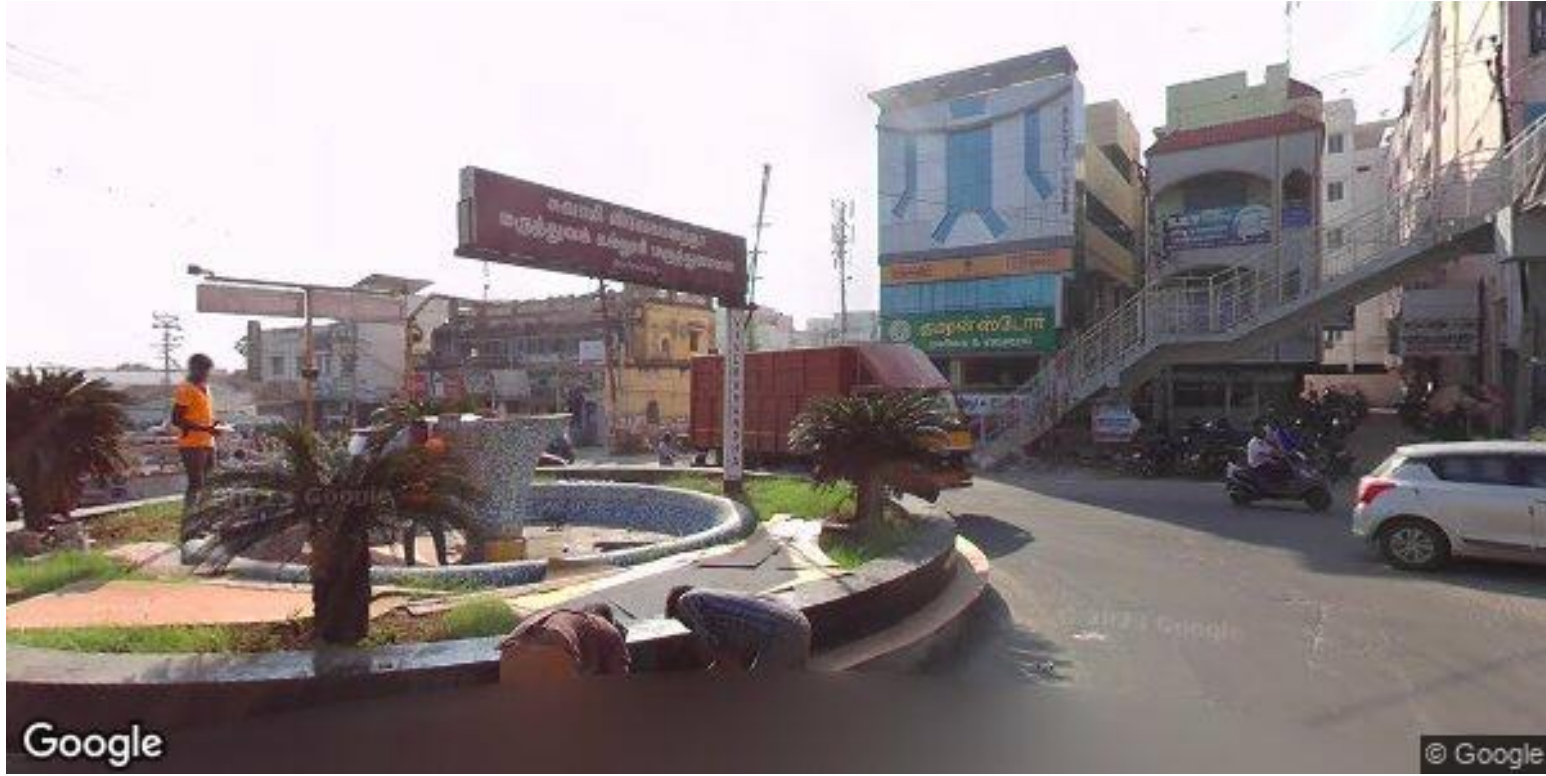
**Coordinates:** 11.38395, 77.89480

**Risk Type:** Roundabout

**Risk Level:** High

**Speed Limit:** 15 KM/Hr

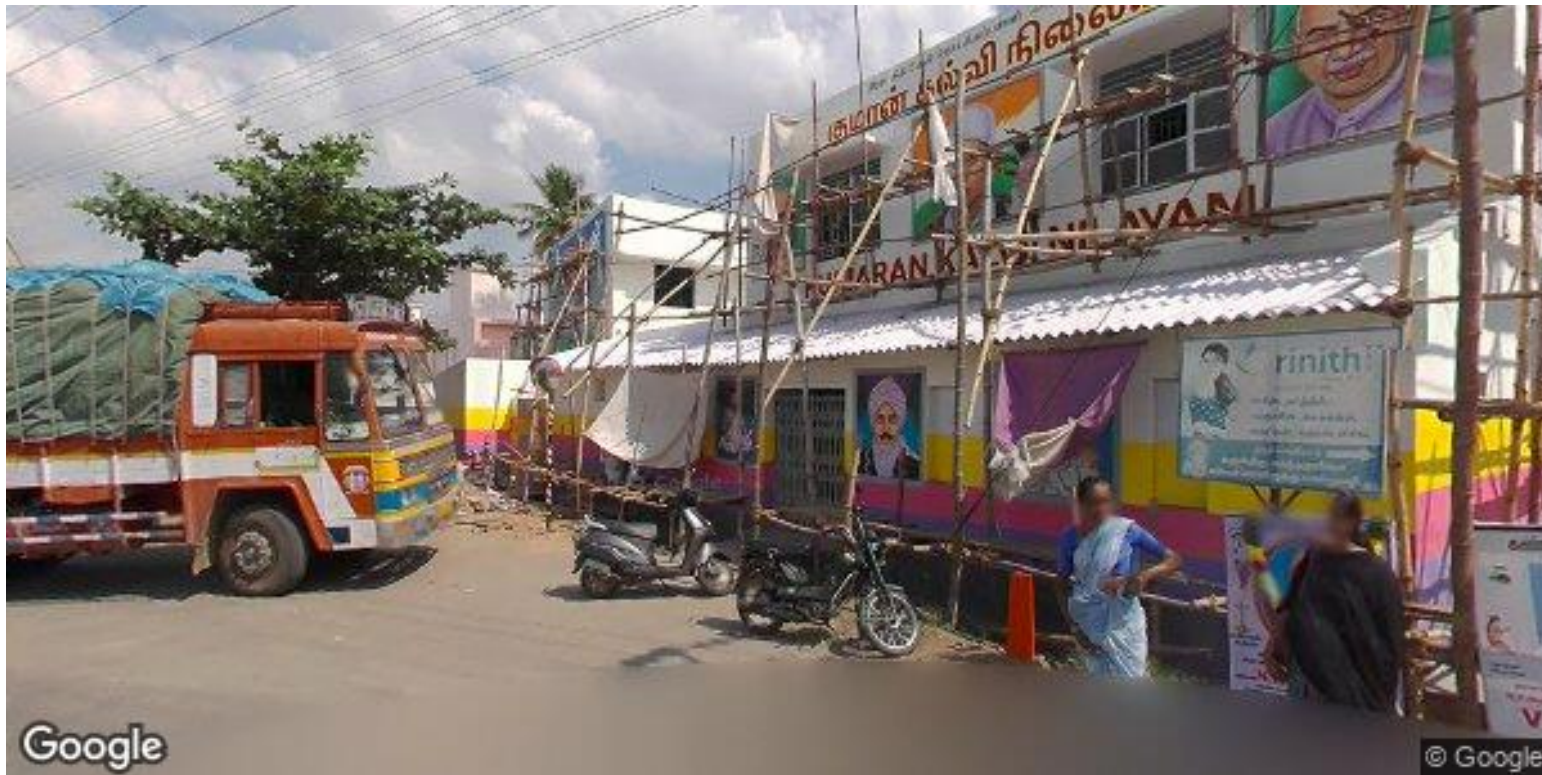
**Coordinates:** 11.38182, 77.90259

**Risk Type:** Turn

**Risk Level:** Medium

**Speed Limit:** 30 KM/Hr

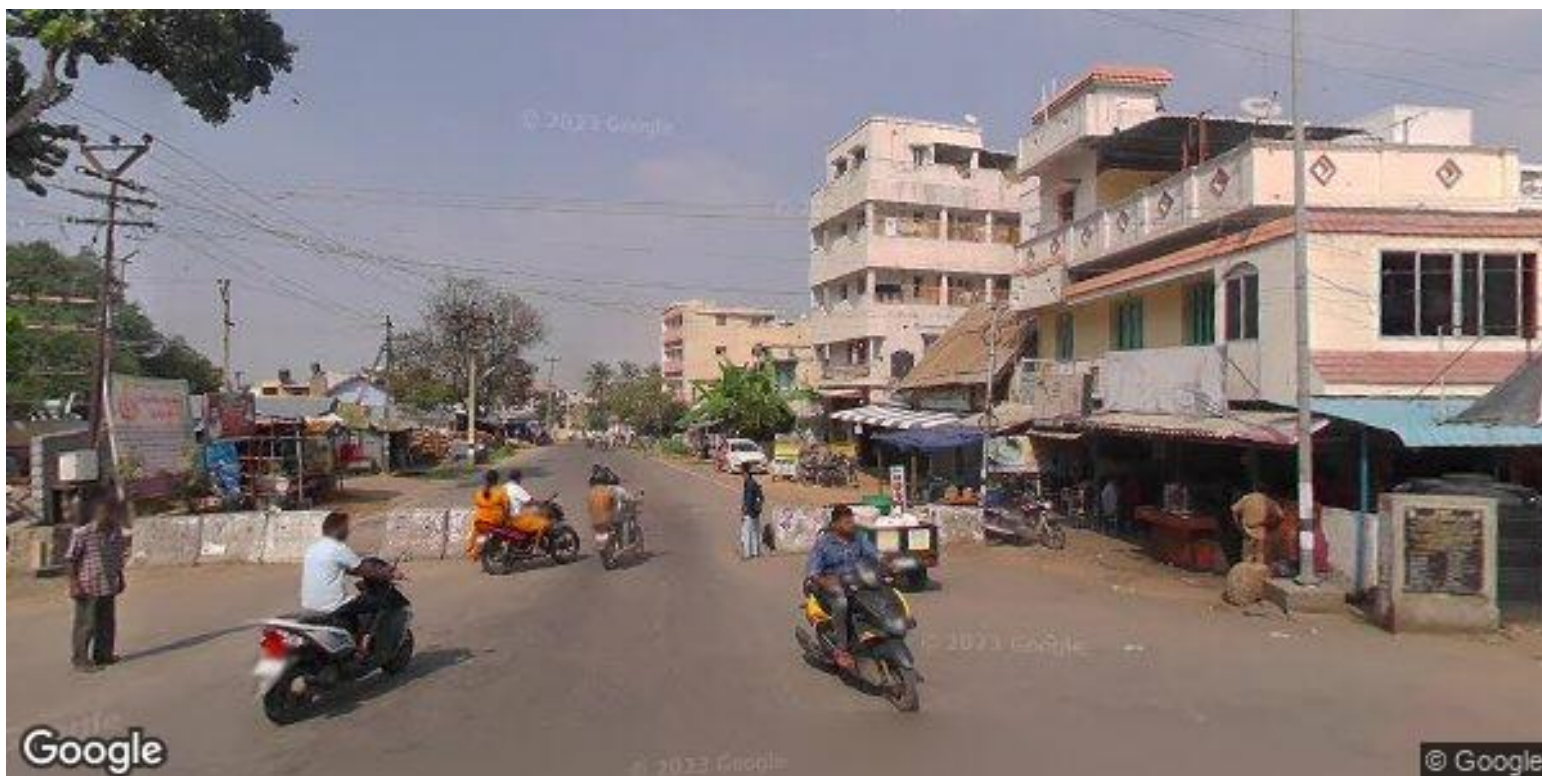
**Coordinates:** 11.37841, 77.90140

**Risk Type:** Blind Spot

**Risk Level:** Blind Spot

**Speed Limit:** 10 KM/Hr

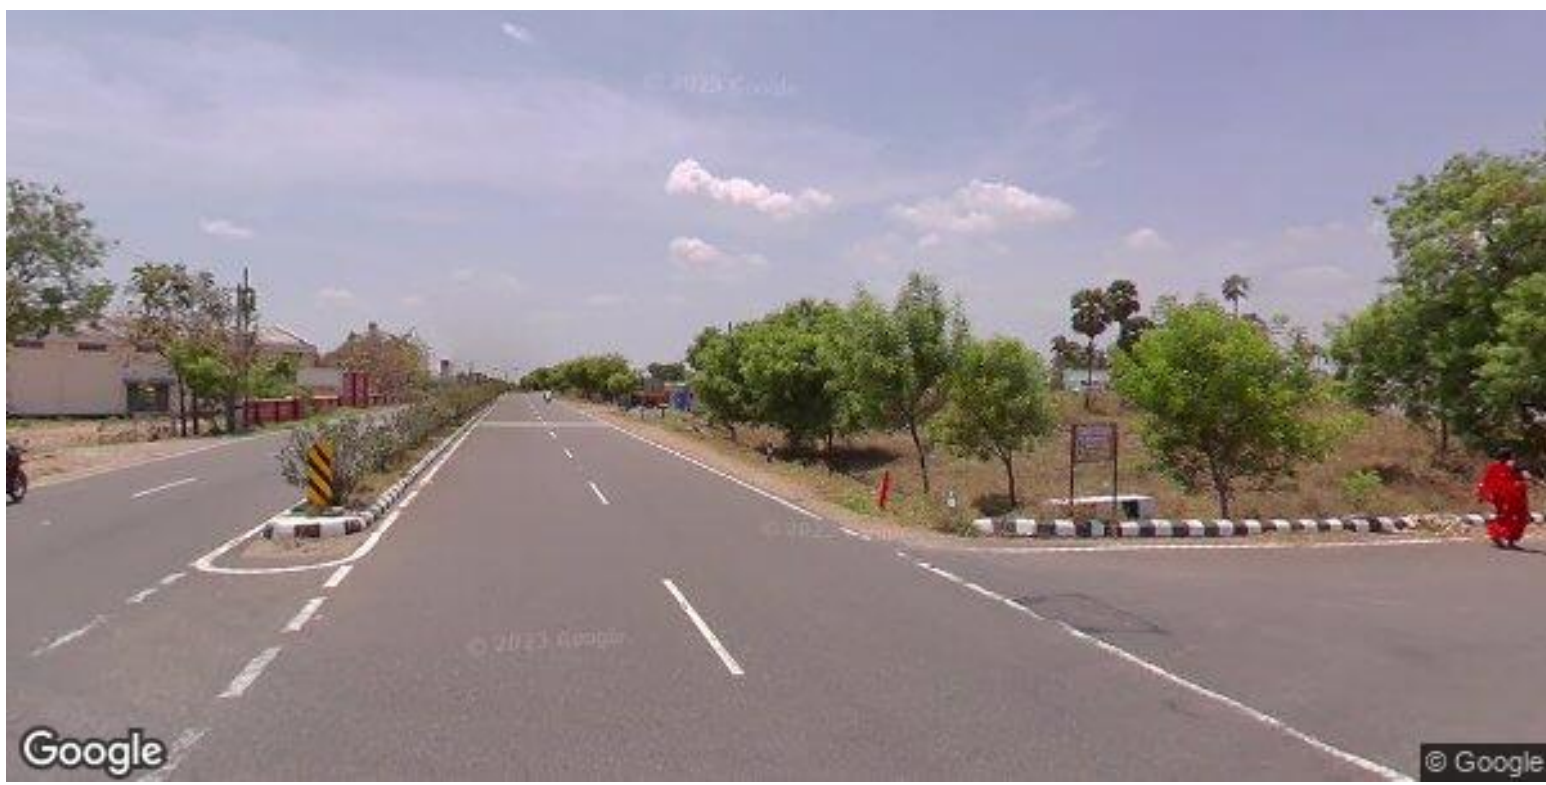
**Coordinates:** 11.27561, 78.08152

**Risk Type:** Blind Spot

**Risk Level:** Blind Spot

**Speed Limit:** 10 KM/Hr

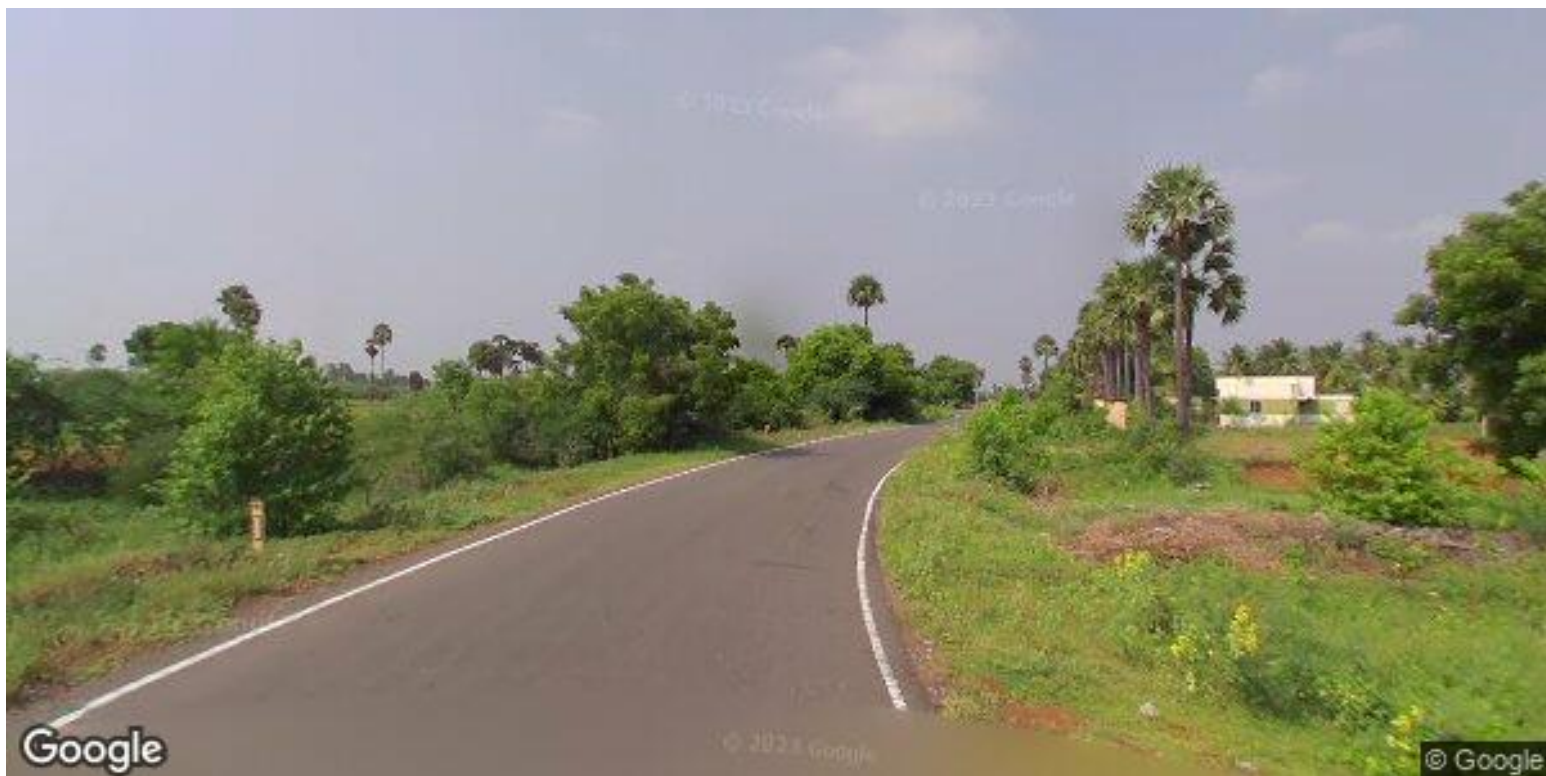
**Coordinates:** 11.28062, 78.08817

**Risk Type:** Turn

**Risk Level:** Medium

**Speed Limit:** 30 KM/Hr
