## JOURNEY RISK MANAGEMENT (JRM) STUDY

### Salem Terminal to PONNI SERVICE STATION

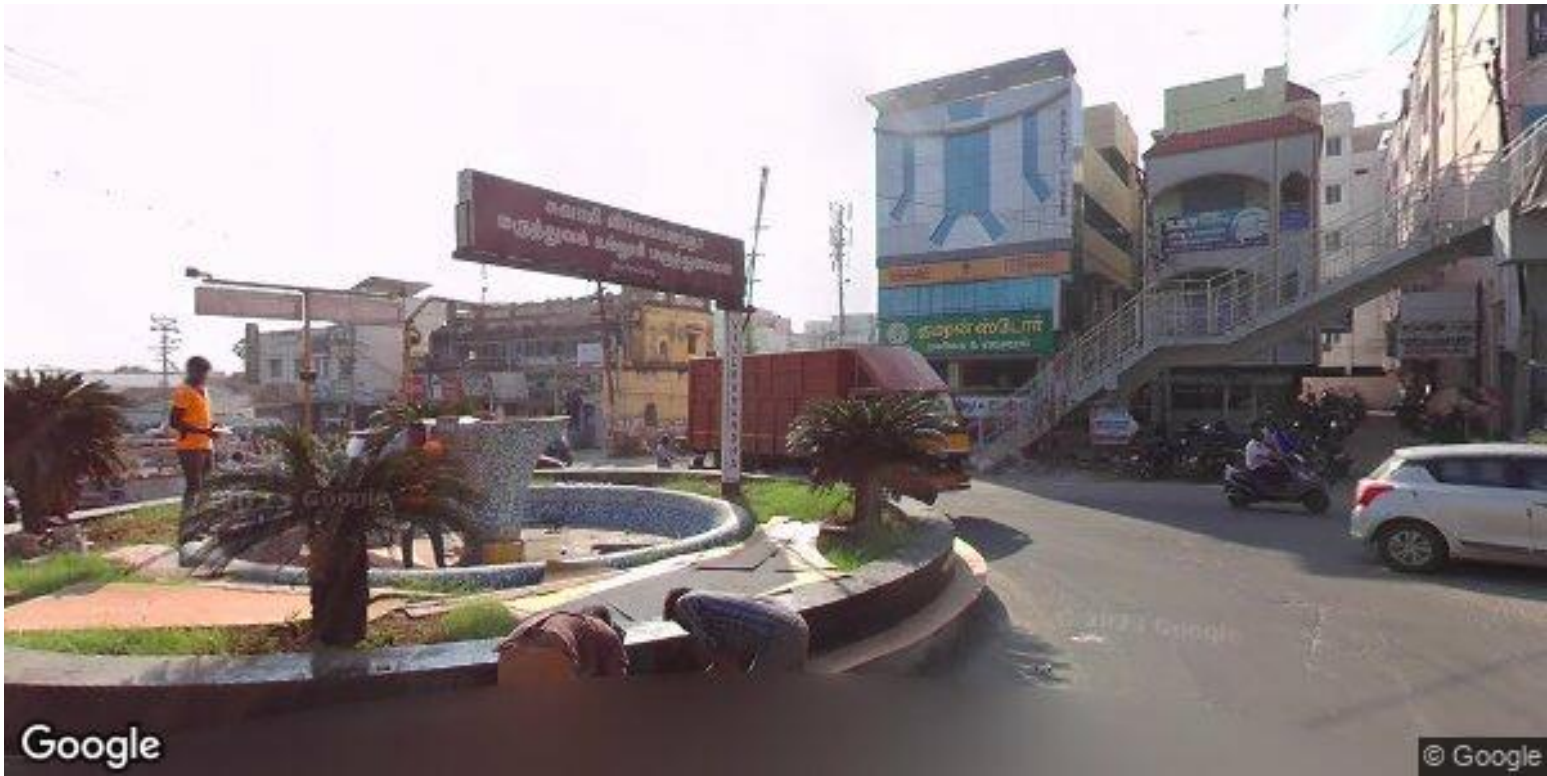
| | Risk Type | Risk Level | Coordinates | Speed Limit |
|---|---|---|---|---|
| 0 | Roundabout | High | 11.38395, 77.89480 | 15 KM/Hr |

Risk Type: Roundabout  
Risk Level: High  
Speed Limit: 15 KM/Hr  
Coordinates: 11.38395, 77.89480

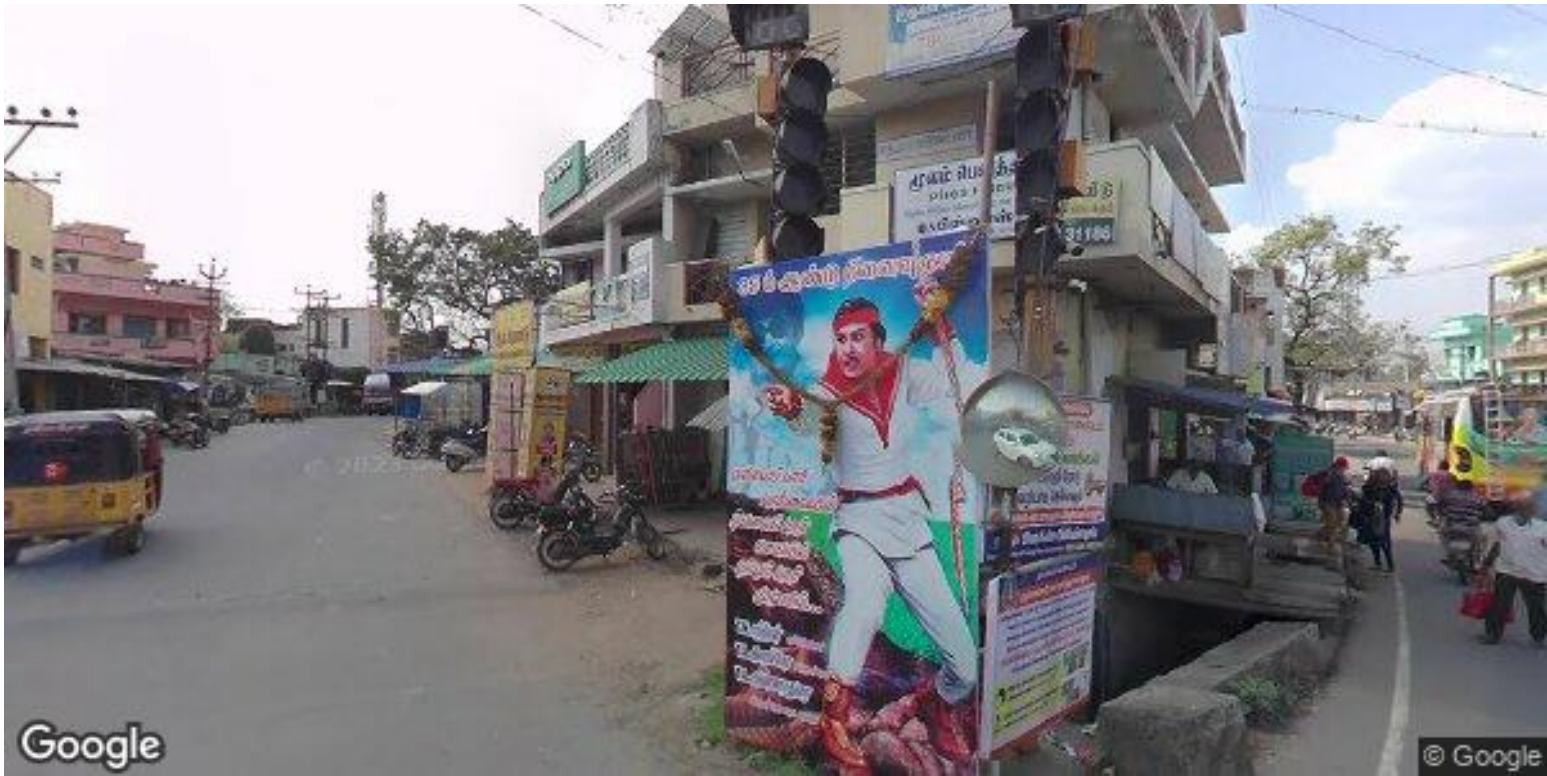
| | Risk Type | Risk Level | Coordinates | Speed Limit |
|---|---|---|---|---|
| 4 | Turn | Medium | 11.38342, 77.89975 | 30 KM/Hr |

**Risk Type:** Turn  
**Risk Level:** Medium  
**Speed Limit:** 30 KM/Hr  
**Coordinates:** 11.38342, 77.89975

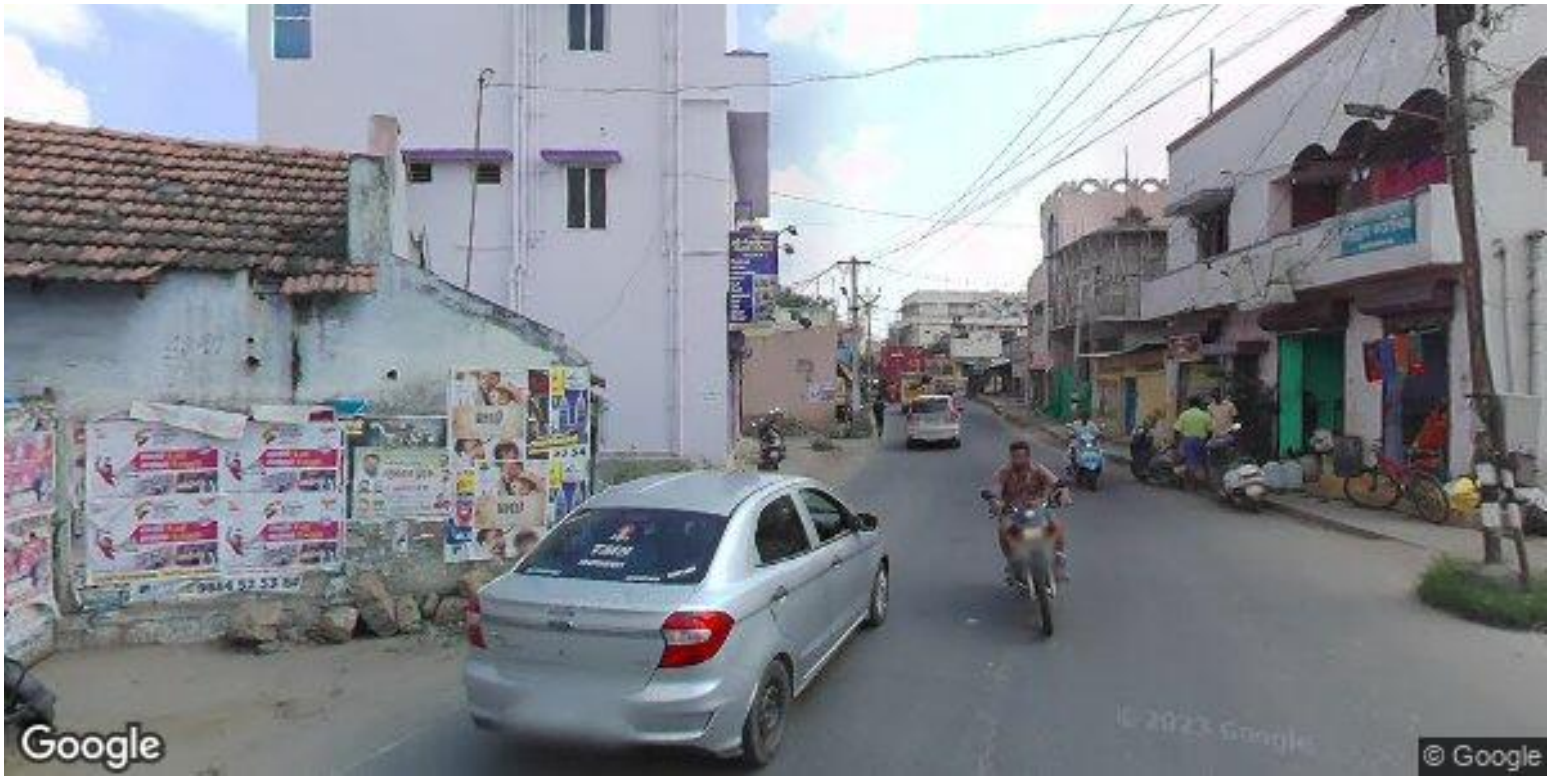
| | Risk Type | Risk Level | Coordinates | Speed Limit |
|---|---|---|---|---|
| 5 | Turn | Medium | 11.38295, 77.90001 | 30 KM/Hr |

**Risk Type:** Turn  
**Risk Level:** Medium  
**Speed Limit:** 30 KM/Hr  
**Coordinates:** 11.38295, 77.90001

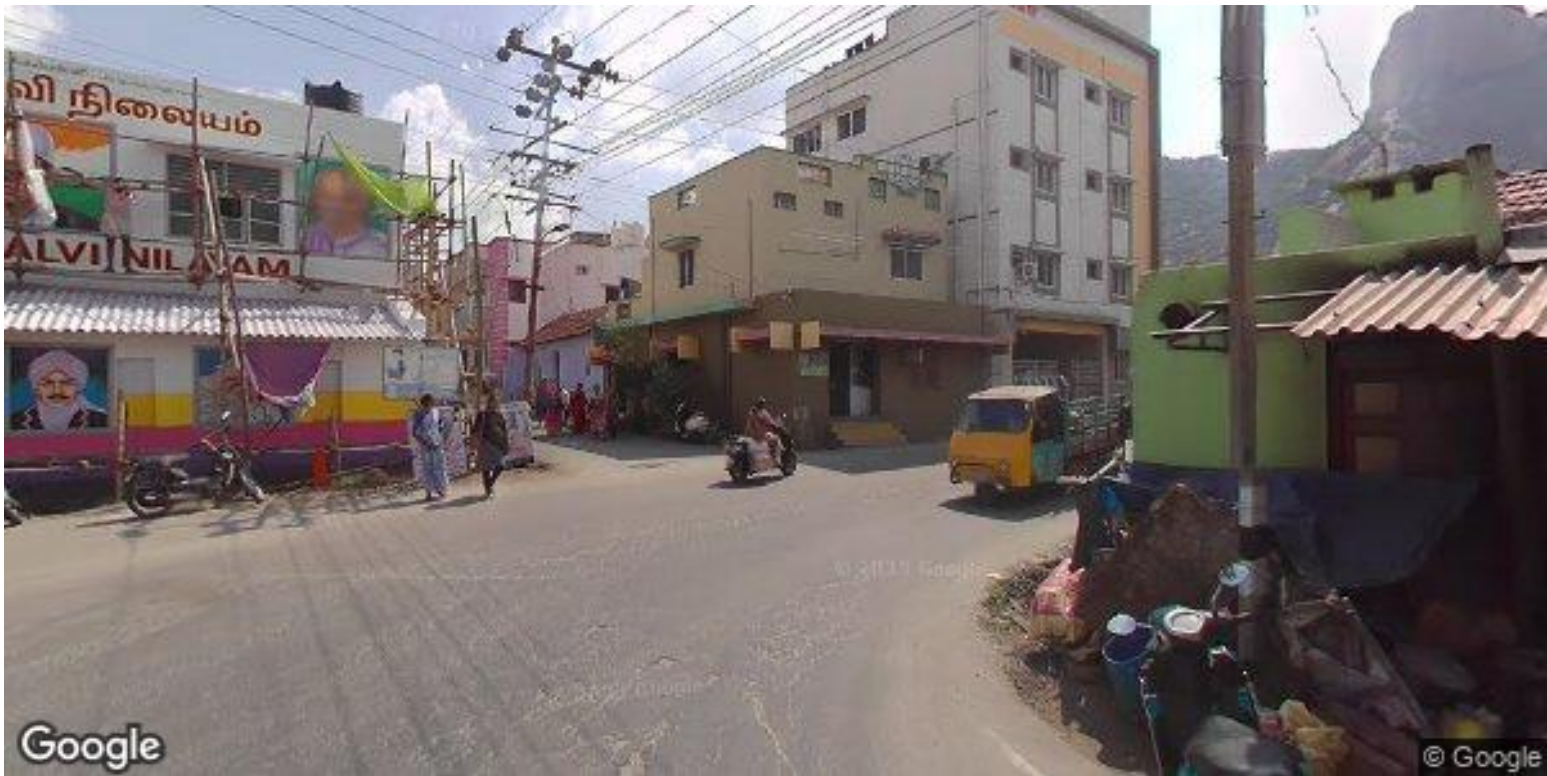
| | Risk Type | Risk Level | Coordinates | Speed Limit |
|---|---|---|---|---|
| 6 | Turn | High | 11.38186, 77.90258 | 15 KM/Hr |

Risk Type: Turn

Risk Level: High

Speed Limit: 15 KM/Hr

Coordinates: 11.38186, 77.90258

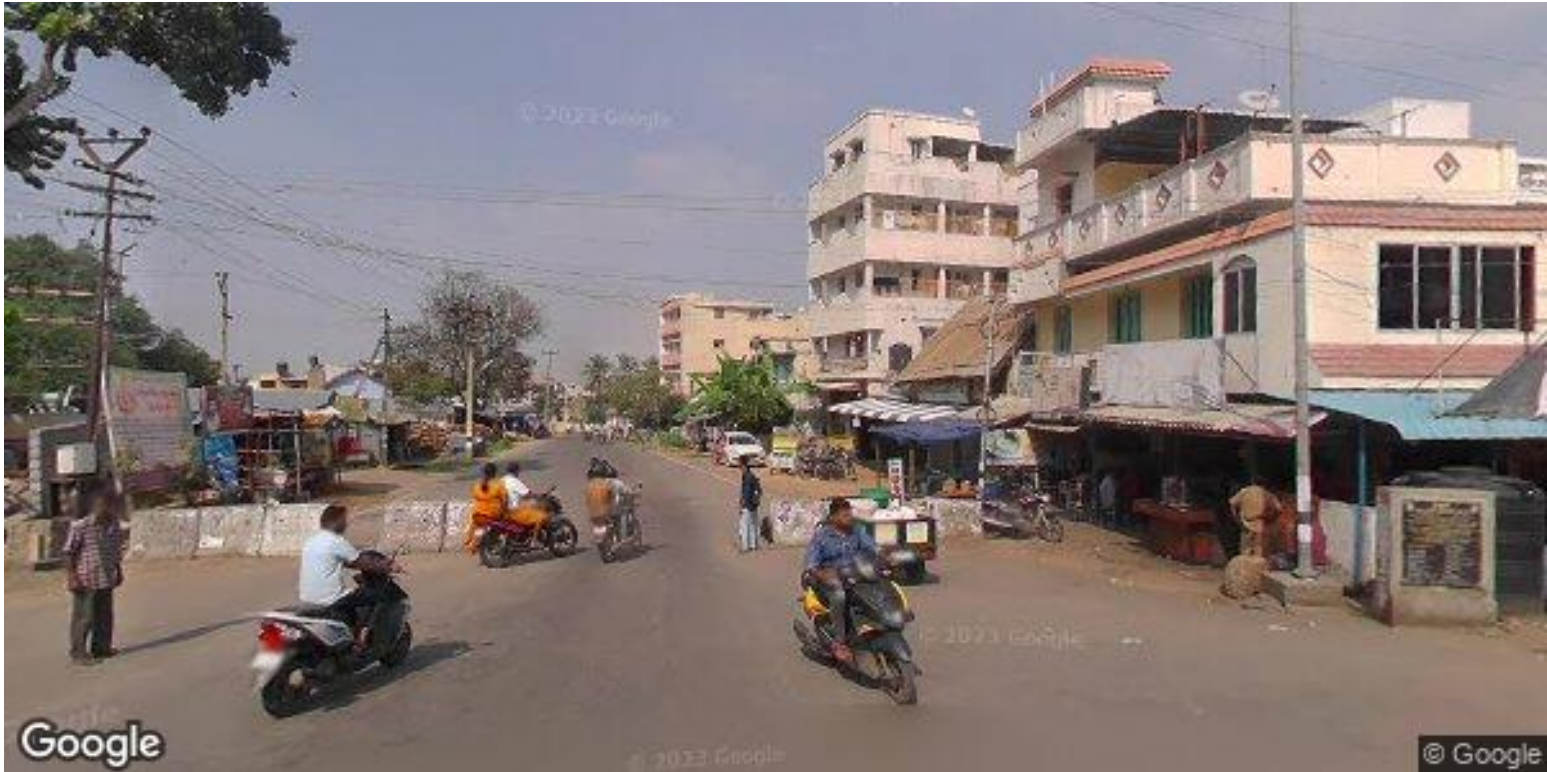
| | Risk Type | Risk Level | Coordinates | Speed Limit |
|---|---|---|---|---|
| 7 | Blind Spot | Blind Spot | 11.37841, 77.90140 | 10 KM/Hr |

Risk Type: Blind Spot

Risk Level: Blind Spot

Speed Limit: 10 KM/Hr

Coordinates: 11.37841, 77.90140

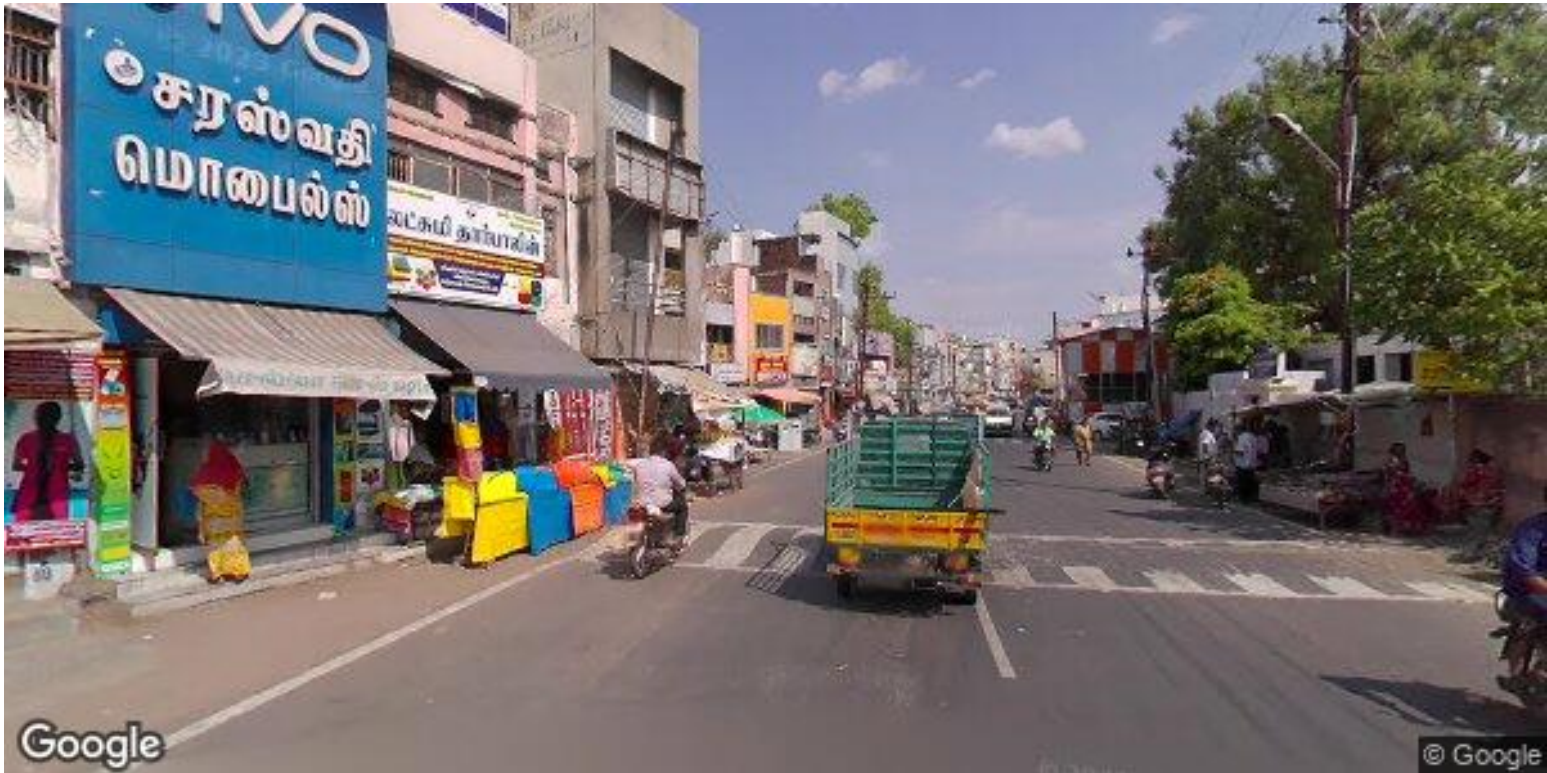
| | Risk Type | Risk Level | Coordinates | Speed Limit |
|---|---|---|---|---|
| 8 | Turn | Medium | 11.22407, 78.16640 | 30 KM/Hr |

Risk Type: Turn

Risk Level: Medium

Speed Limit: 30 KM/Hr

Coordinates: 11.22407, 78.16640

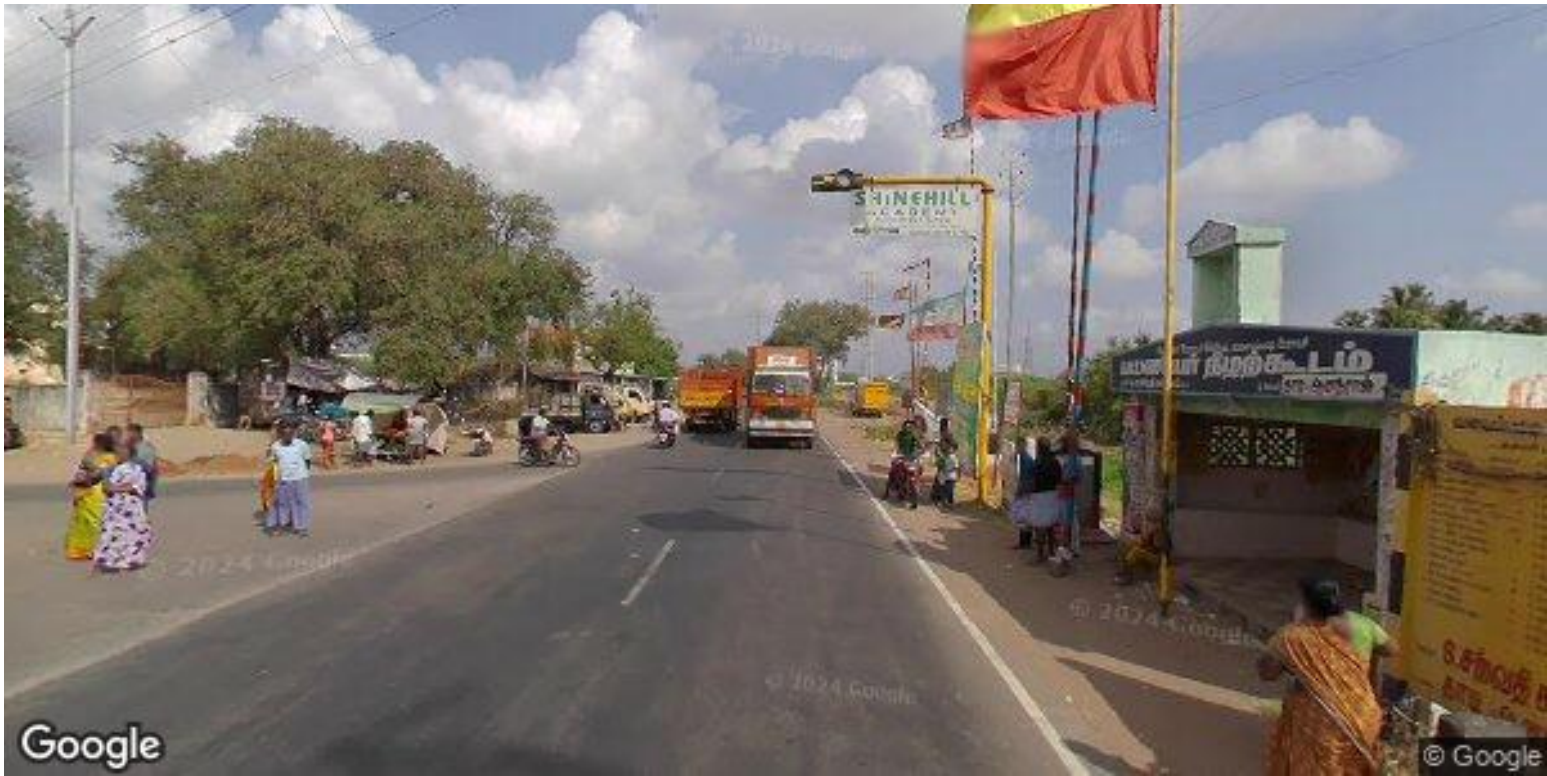
| | Risk Type | Risk Level | Coordinates | Speed Limit |
|---|---|---|---|---|
| 9 | Blind Spot | Blind Spot | 11.12517, 78.23183 | 10 KM/Hr |

**Risk Type:** Blind Spot  
**Risk Level:** Blind Spot  
**Speed Limit:** 10 KM/Hr  
**Coordinates:** 11.12517, 78.23183

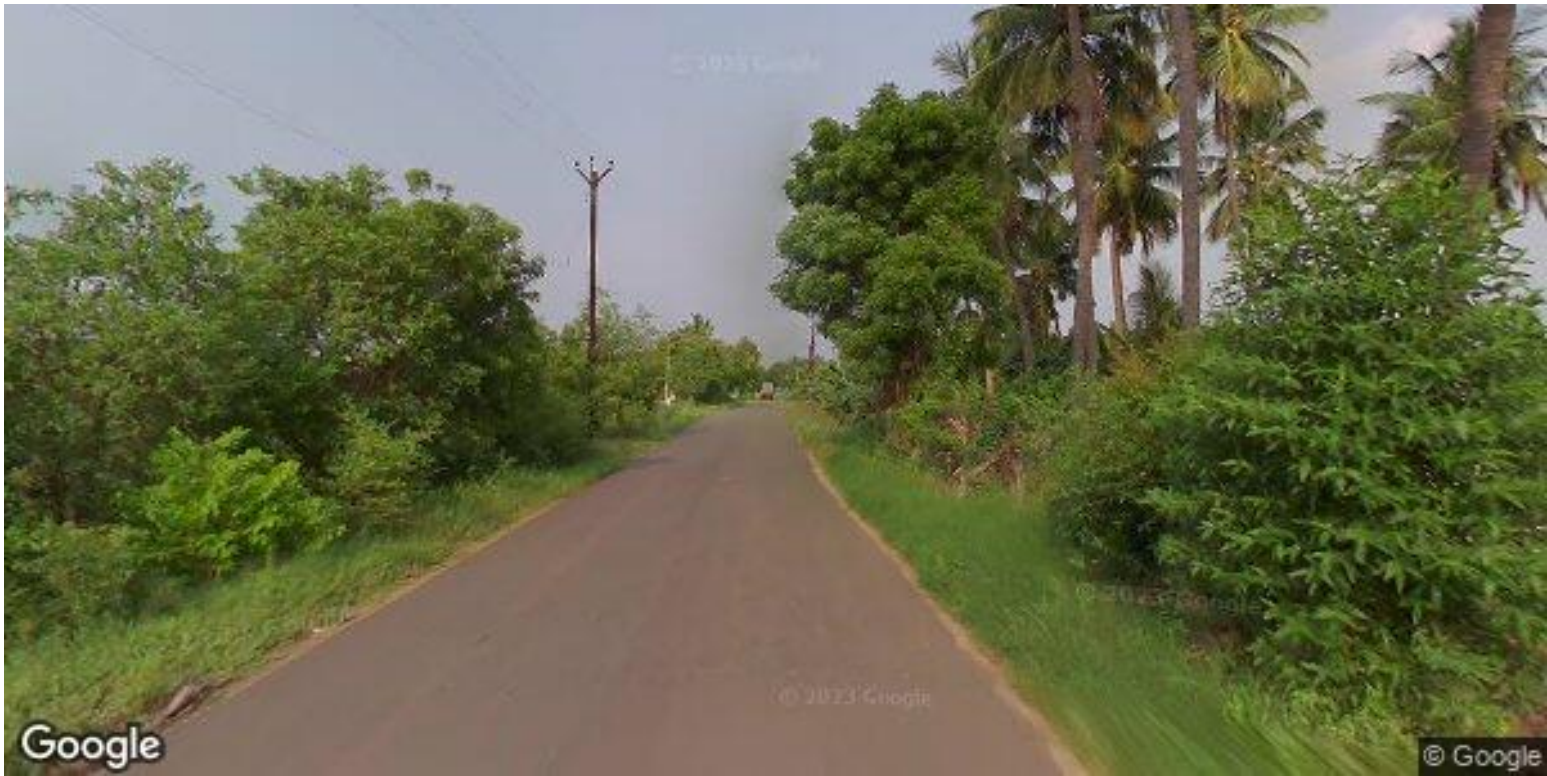
| | Risk Type | Risk Level | Coordinates | Speed Limit |
|---|---|---|---|---|
| 10 | Turn | High | 11.09393, 78.18710 | 15 KM/Hr |

**Risk Type:** Turn  
**Risk Level:** High  
**Speed Limit:** 15 KM/Hr  
**Coordinates:** 11.09393, 78.18710
