# IndianOil

## JOURNEY RISK MANAGEMENT (JRM) STUDY

### Salem Terminal to KANNAPPAN AGENCY

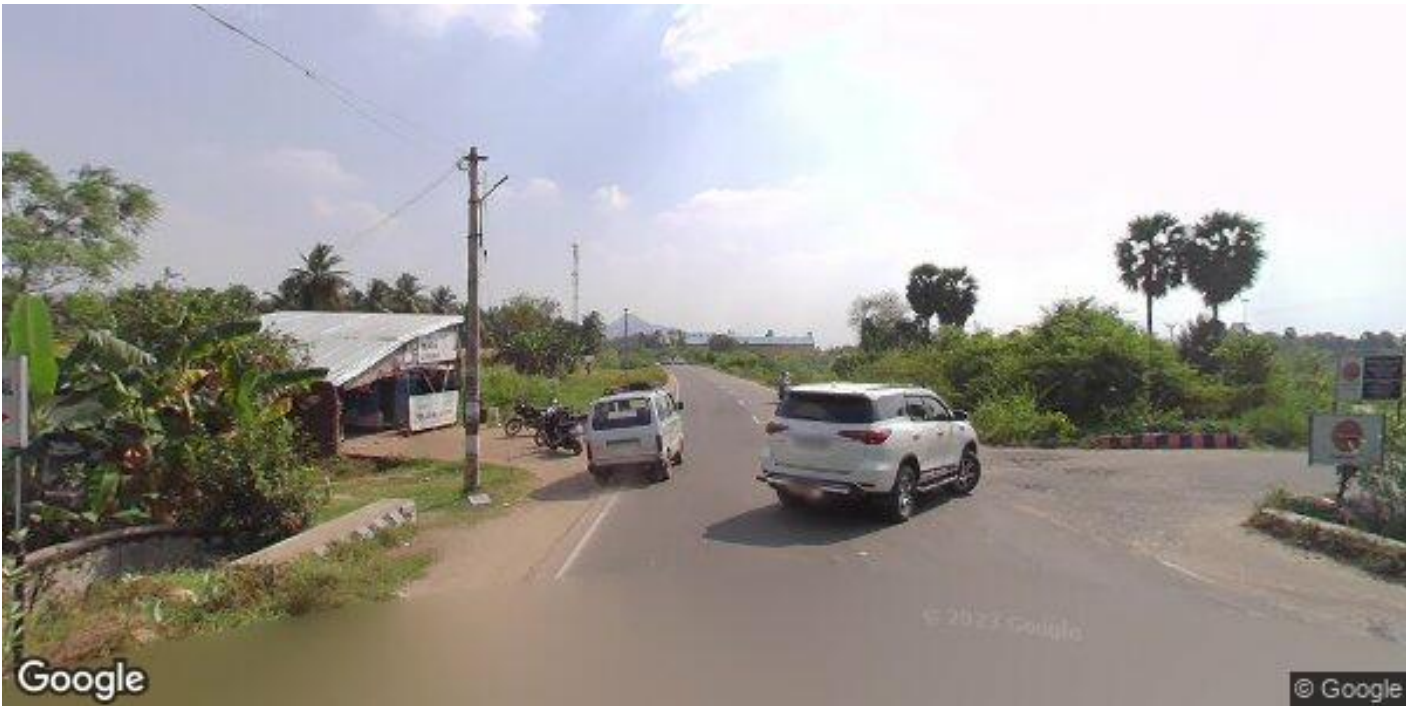
Risk Type: Blind Spot  
Risk Level: Blind Spot  
Speed Limit: 10 KM/Hr  
Coordinates: 11.44029, 77.87544

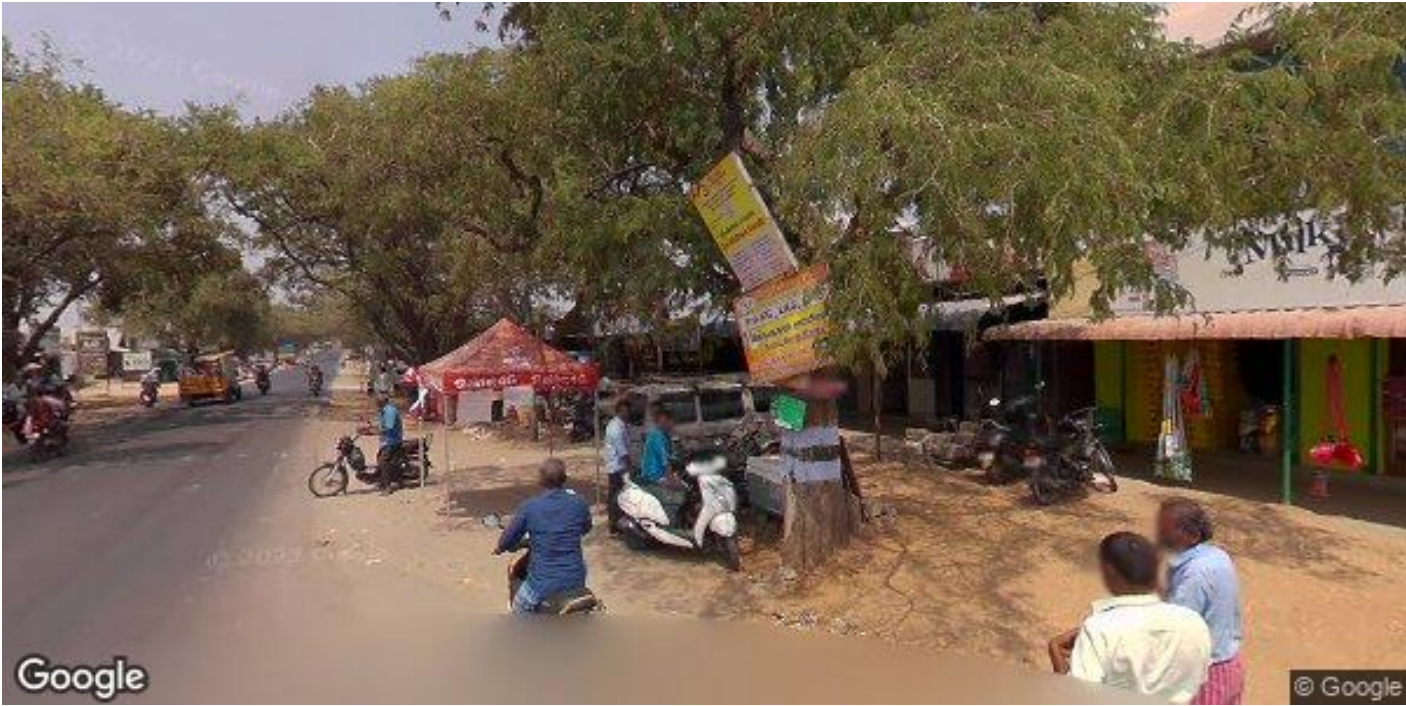
Risk Type: Turn  
Risk Level: High  
Speed Limit: 15 KM/Hr  
Coordinates: 11.41981, 77.88078

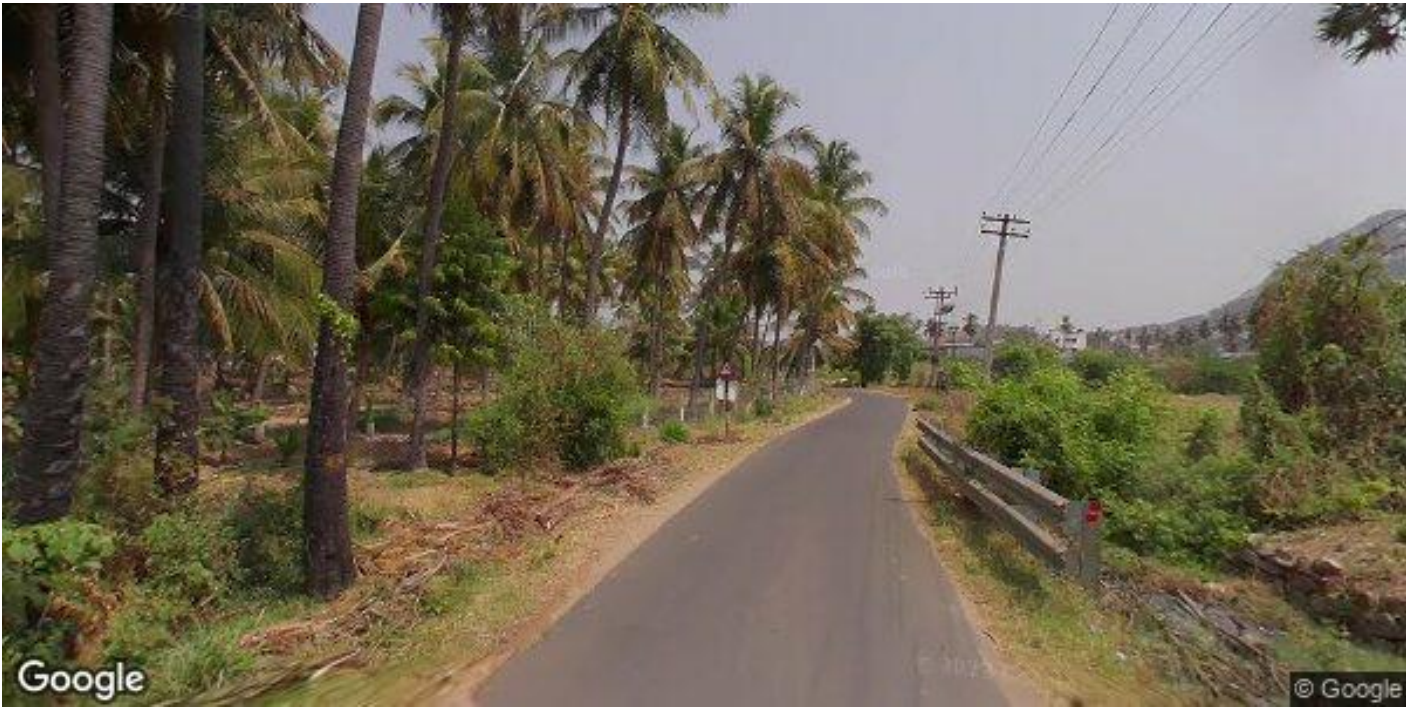
Risk Type: Turn  
Risk Level: Medium

**Speed Limit: 30 KM/Hr**  
**Coordinates: 11.41876, 77.88487**

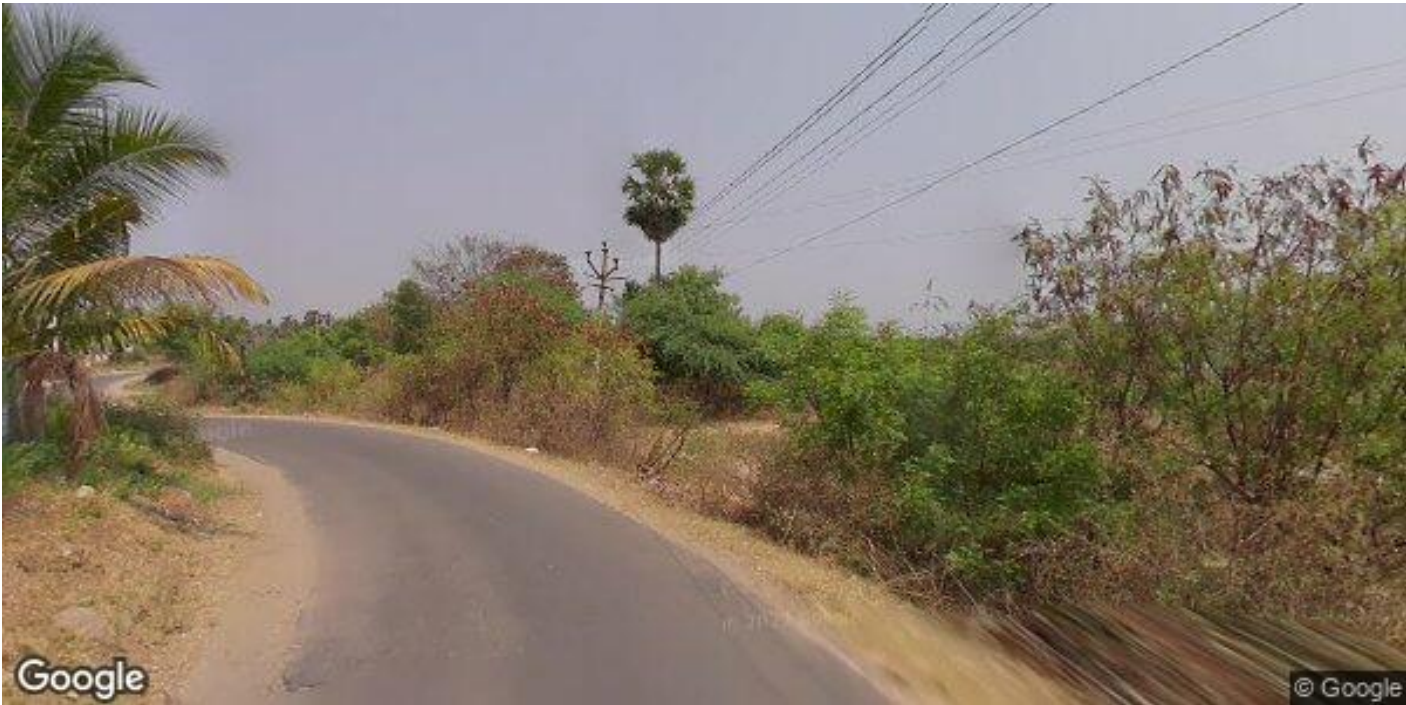
**Risk Type: Turn**  
**Risk Level: Medium**  
**Speed Limit: 30 KM/Hr**  
**Coordinates: 11.41829, 77.88568**

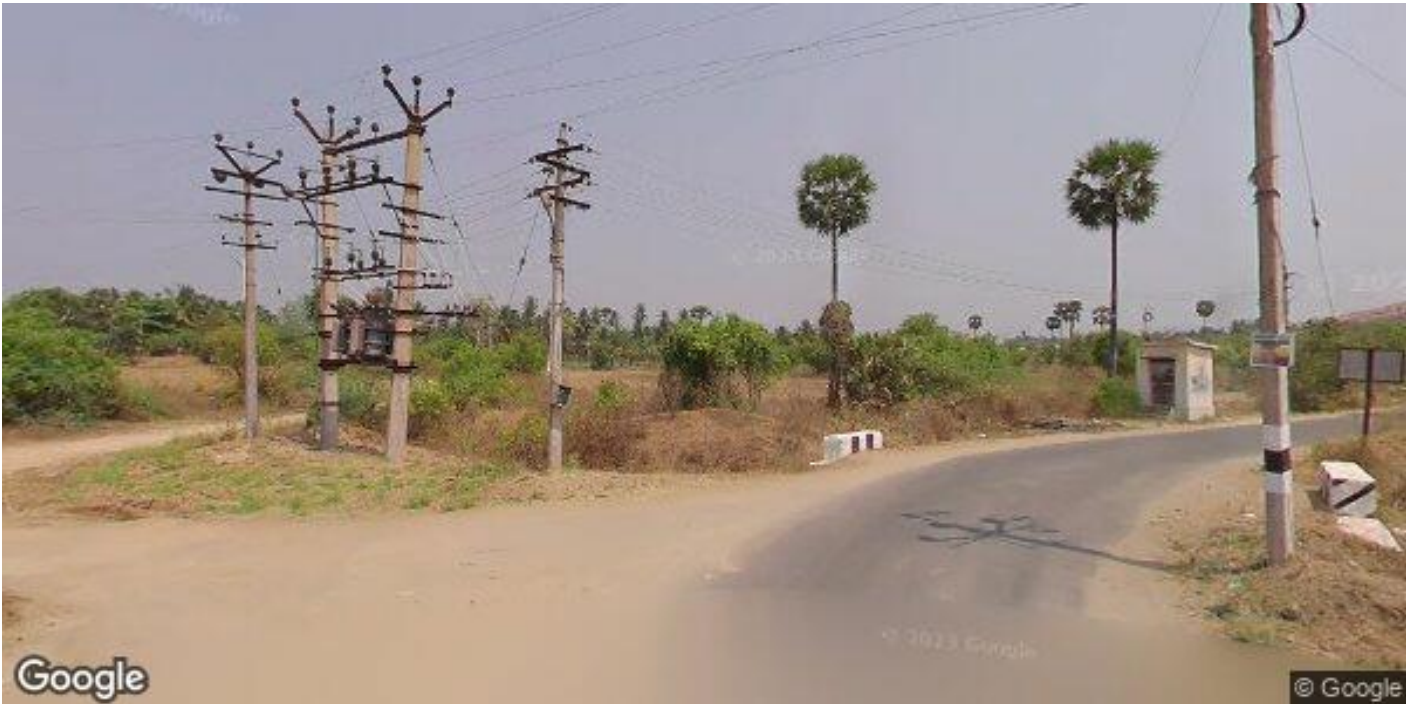
**Risk Type: Turn**  
**Risk Level: High**  
**Speed Limit: 15 KM/Hr**  
**Coordinates: 11.41859, 77.88692**

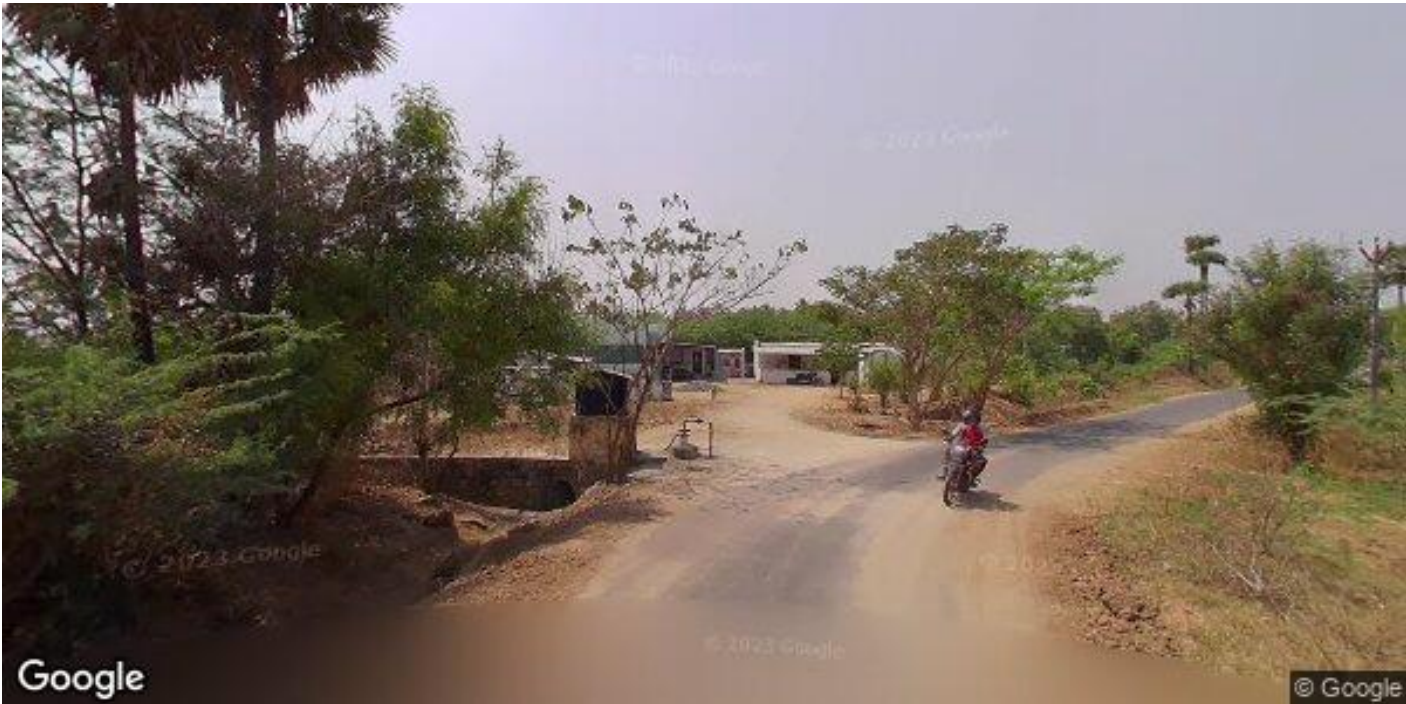
**Risk Type:** Turn  
**Risk Level:** Medium  
**Speed Limit:** 30 KM/Hr  
**Coordinates:** 11.41761, 77.88739

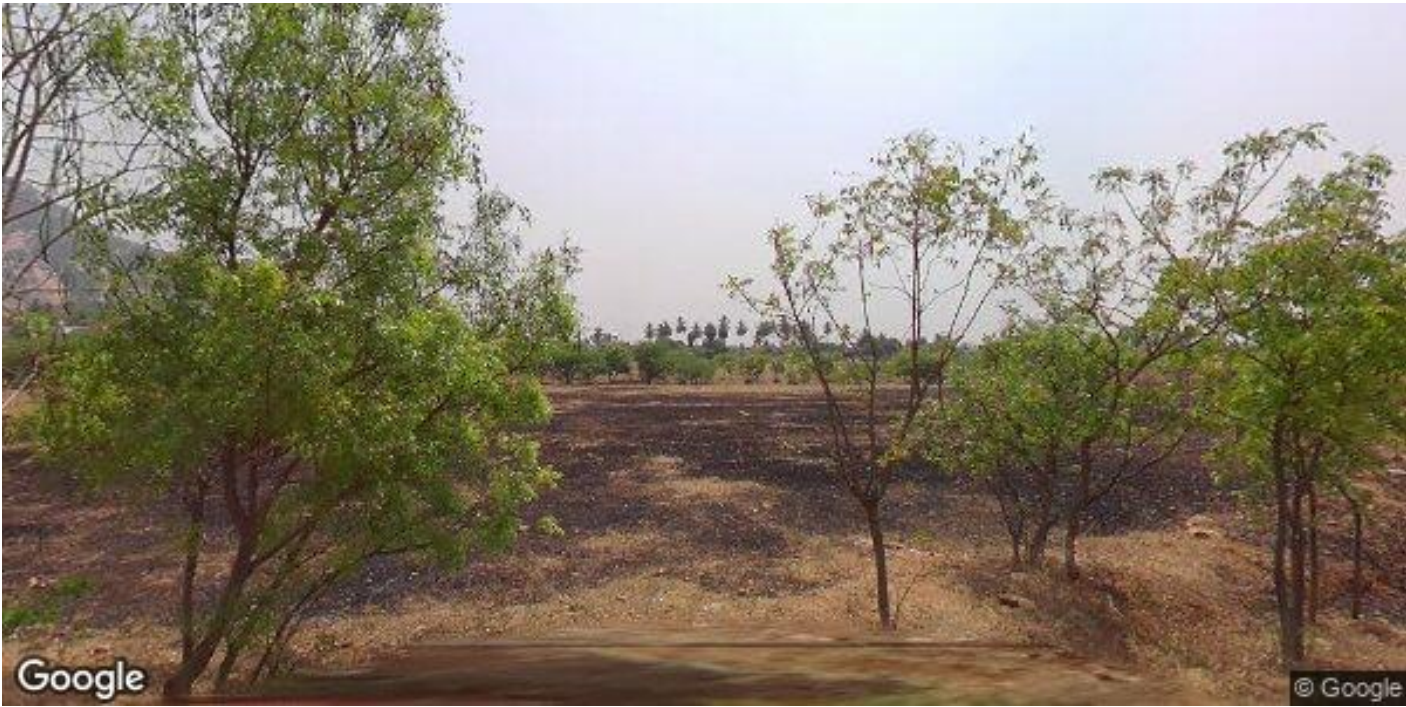
**Risk Type:** Turn  
**Risk Level:** Medium  
**Speed Limit:** 30 KM/Hr  
**Coordinates:** 11.41716, 77.88935

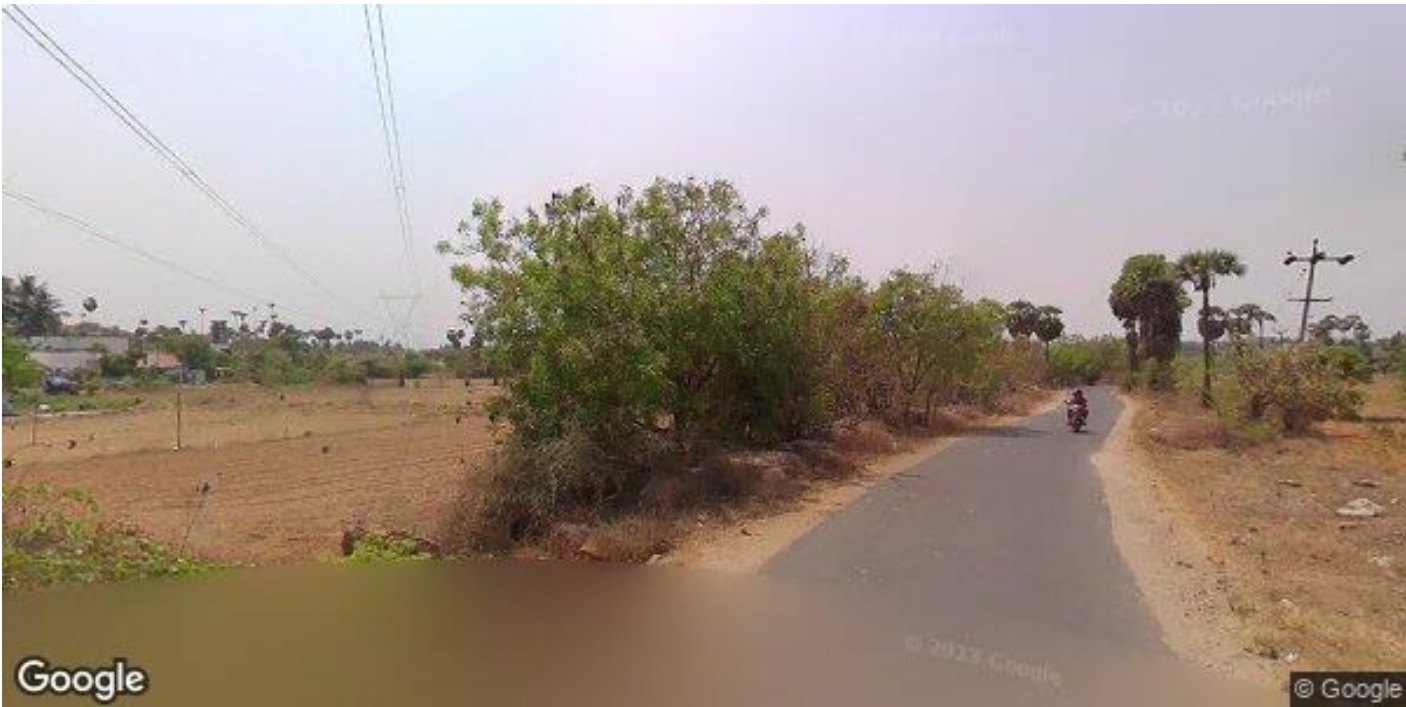
**Risk Type:** Turn  
**Risk Level:** Medium  
**Speed Limit:** 30 KM/Hr  
**Coordinates:** 11.41630, 77.89077

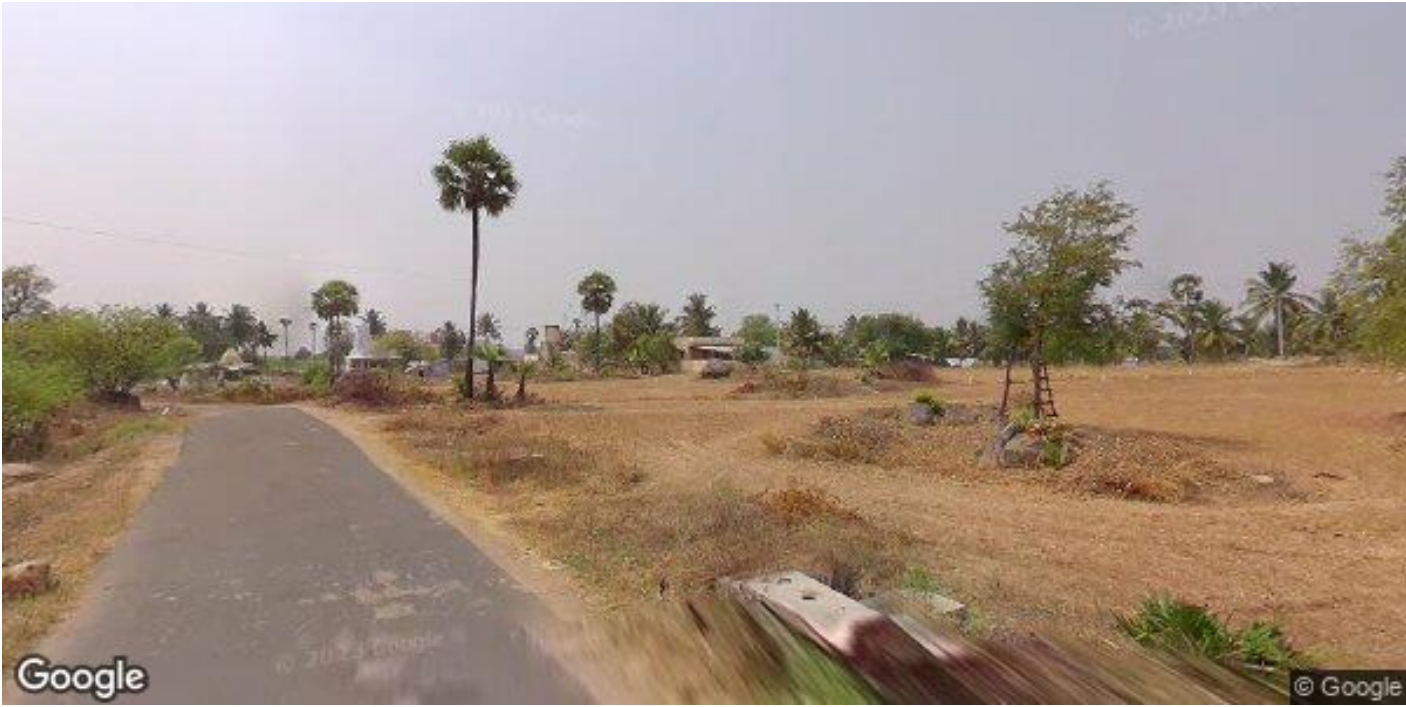
**Risk Type:** Turn  
**Risk Level:** Medium  
**Speed Limit:** 30 KM/Hr  
**Coordinates:** 11.41603, 77.89479

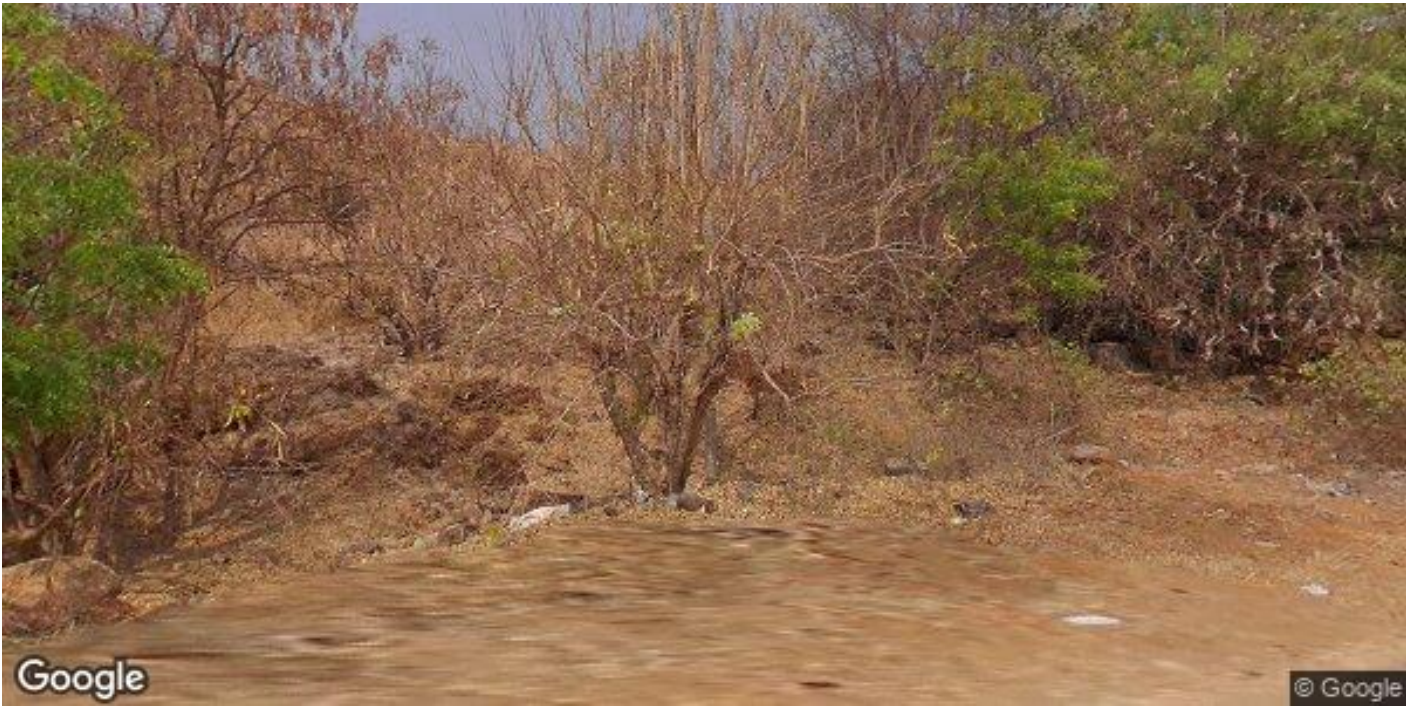
**Risk Type:** Turn  
**Risk Level:** Medium  
**Speed Limit:** 30 KM/Hr  
**Coordinates:** 11.41439, 77.90025

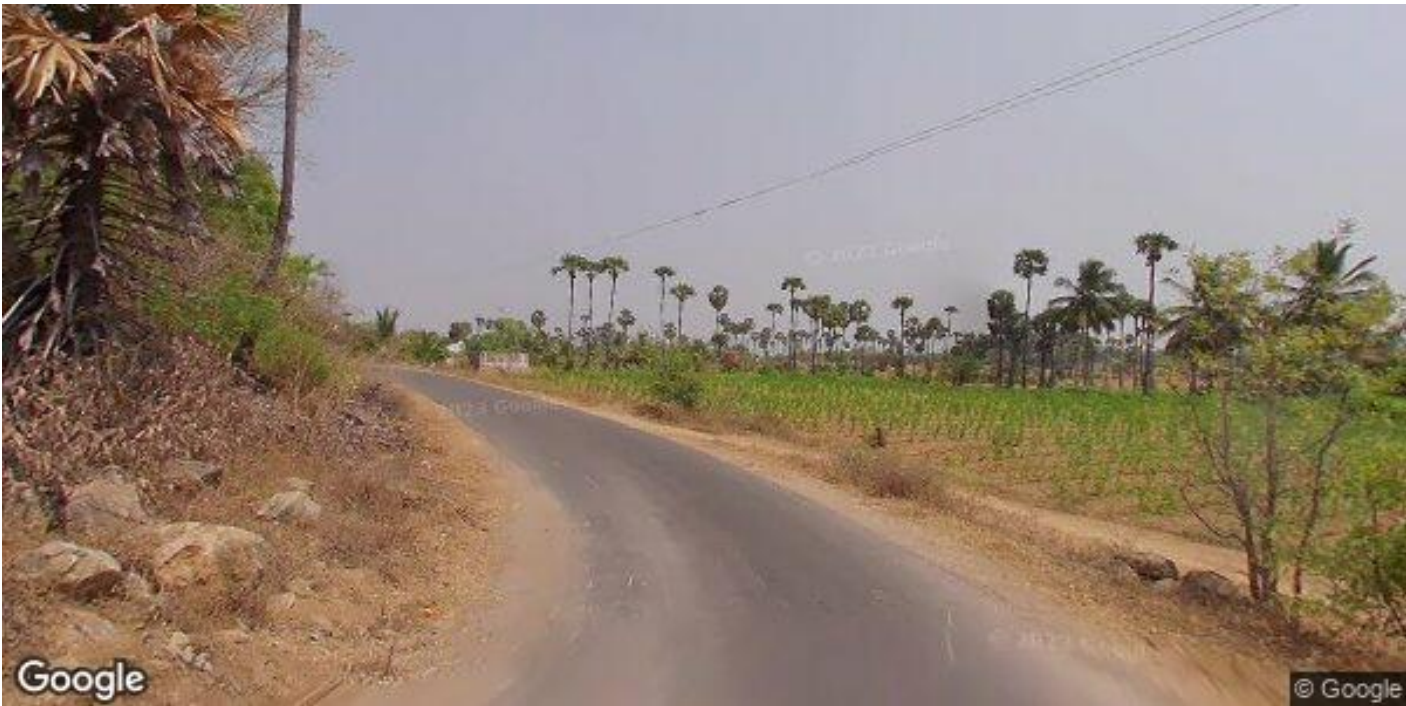
**Risk Type:** Turn  
**Risk Level:** High  
**Speed Limit:** 15 KM/Hr  
**Coordinates:** 11.41377, 77.90073

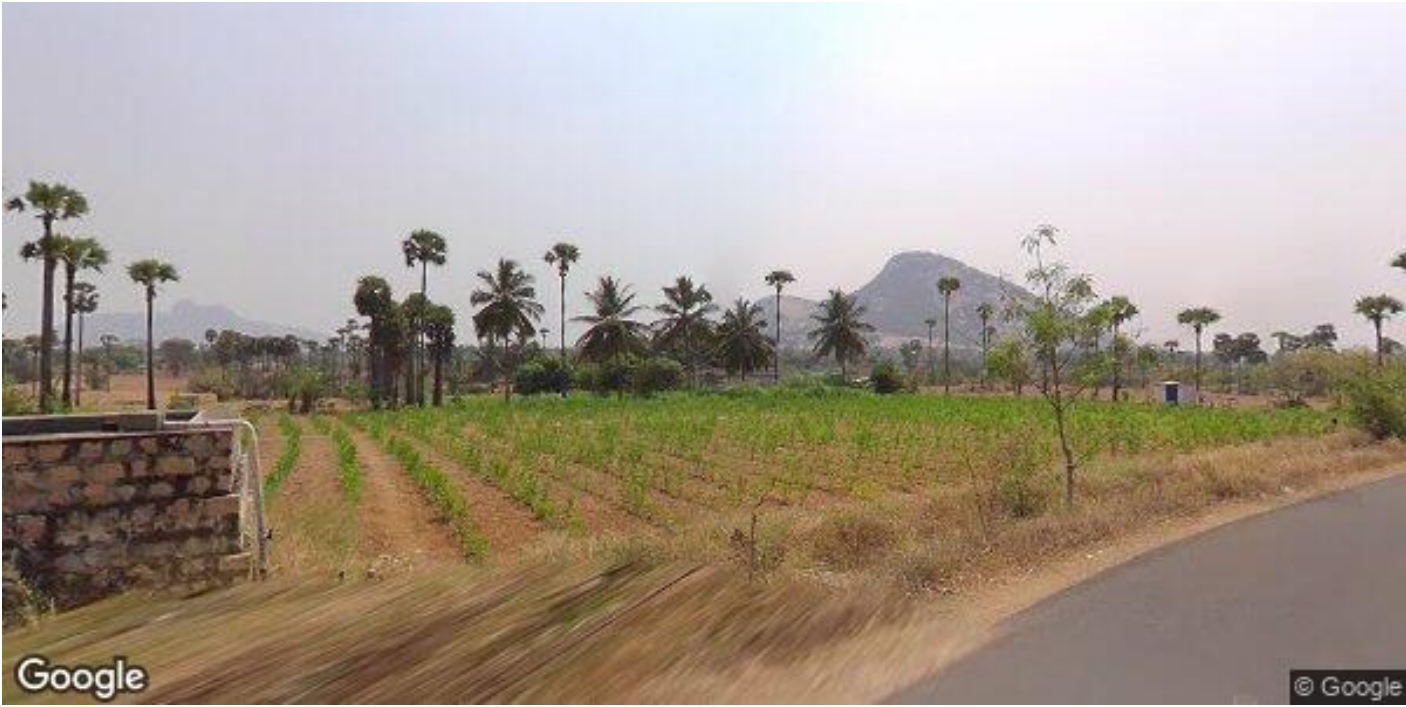
**Risk Type:** Turn  
**Risk Level:** Medium  
**Speed Limit:** 30 KM/Hr  
**Coordinates:** 11.41375, 77.90128

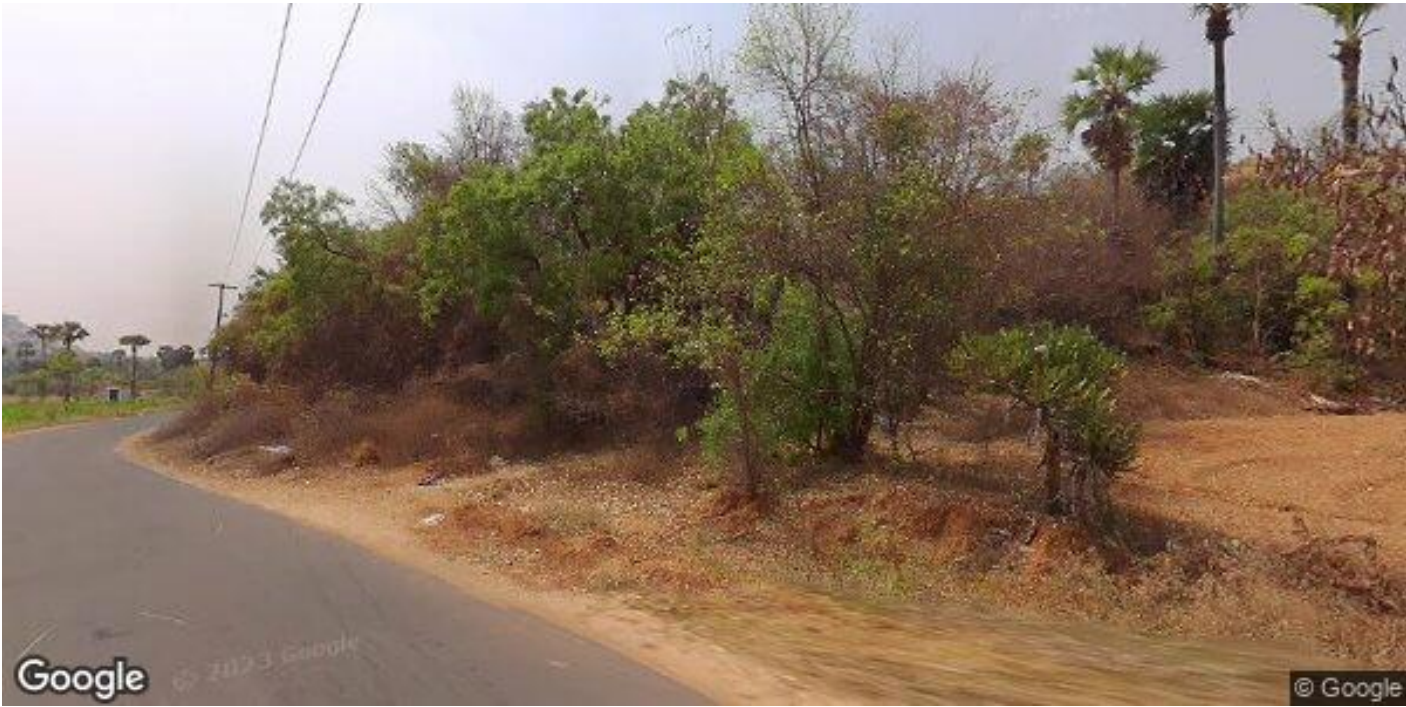
**Risk Type:** Turn  
**Risk Level:** Medium  
**Speed Limit:** 30 KM/Hr  
**Coordinates:** 11.41389, 77.90161

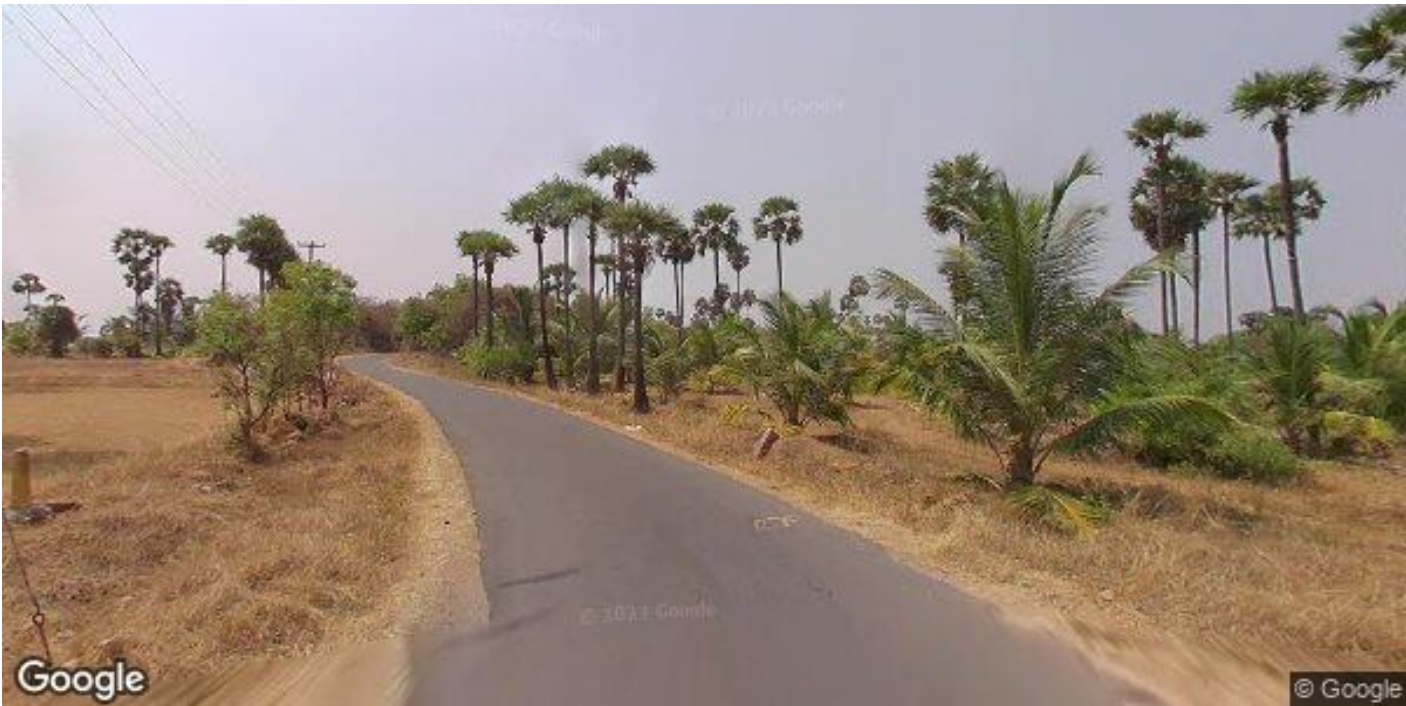
**Risk Type:** Turn  
**Risk Level:** Medium  
**Speed Limit:** 30 KM/Hr  
**Coordinates:** 11.41325, 77.90313

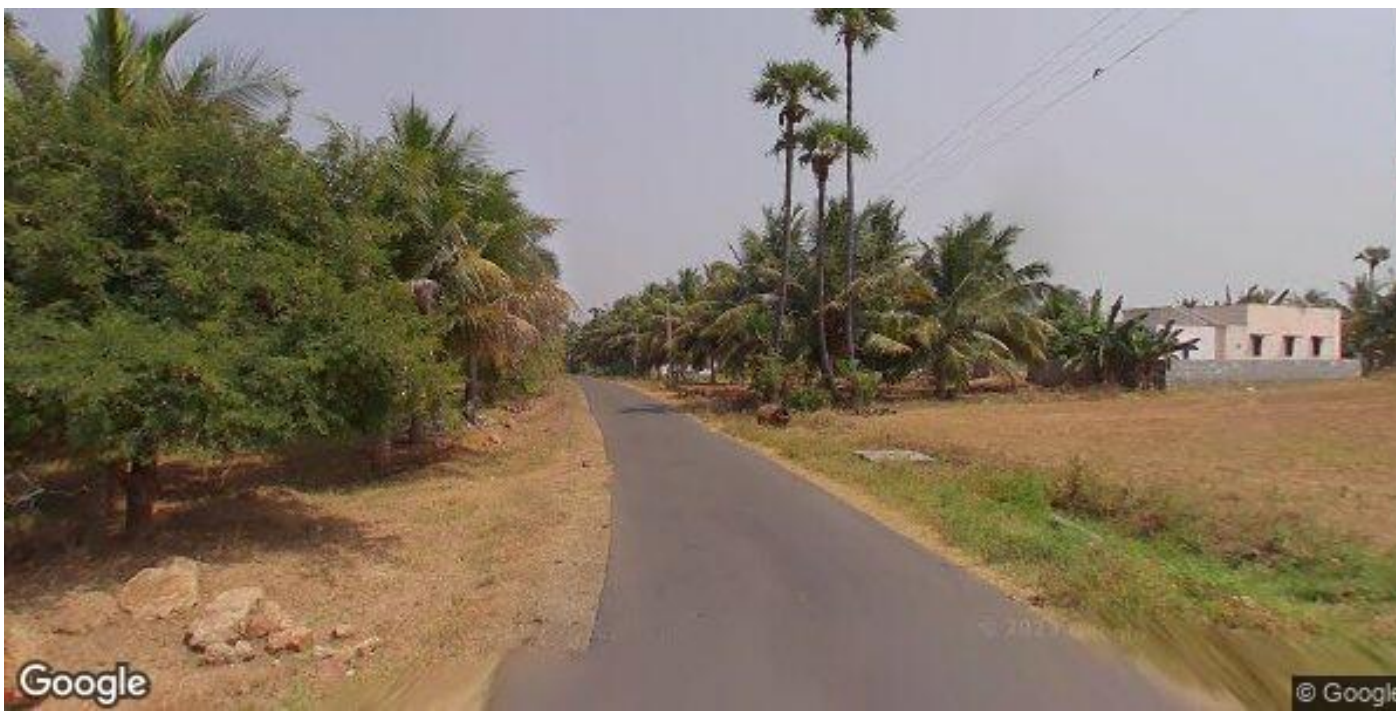
**Risk Type:** Turn  
**Risk Level:** Medium  
**Speed Limit:** 30 KM/Hr  
**Coordinates:** 11.41276, 77.90349

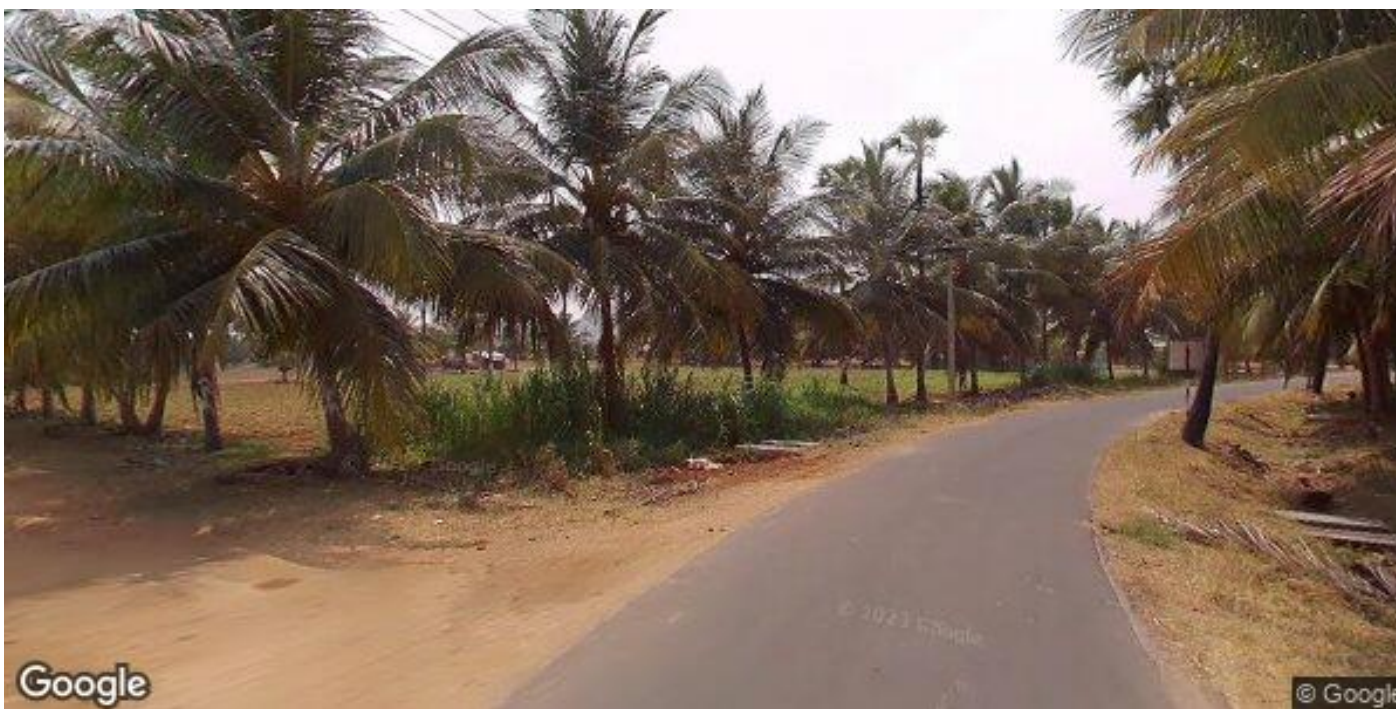
**Risk Type:** Turn  
**Risk Level:** High  
**Speed Limit:** 15 KM/Hr  
**Coordinates:** 11.41230, 77.90485

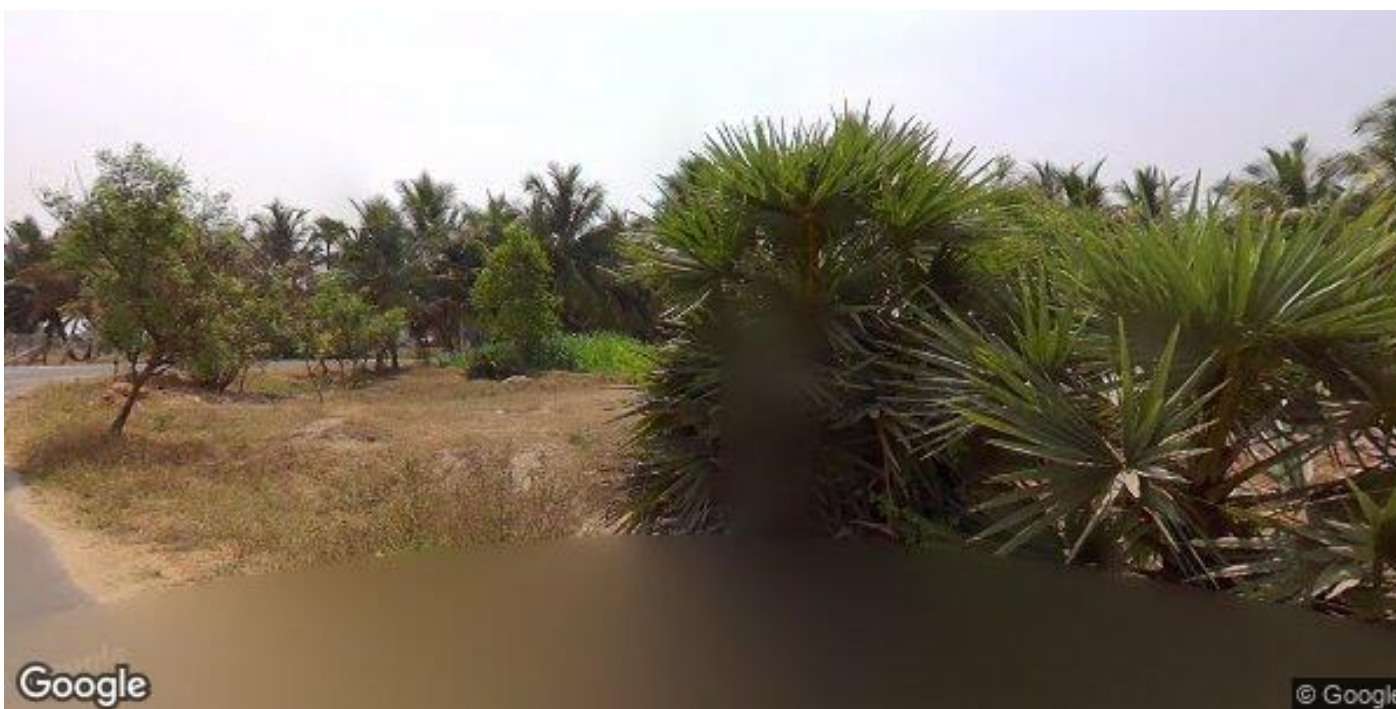
**Risk Type:** Turn  
**Risk Level:** Medium  
**Speed Limit:** 30 KM/Hr  
**Coordinates:** 11.41262, 77.90506

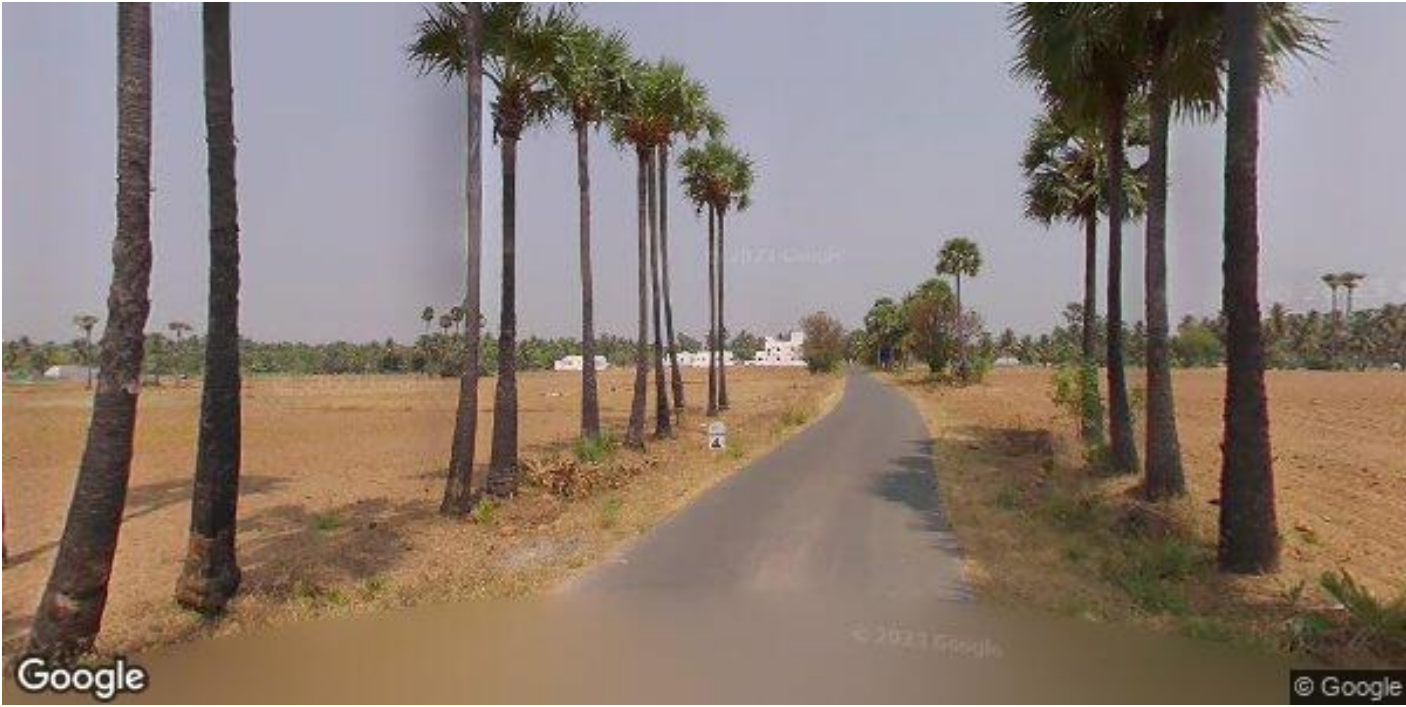
**Risk Type:** Turn  
**Risk Level:** Medium  
**Speed Limit:** 30 KM/Hr  
**Coordinates:** 11.41273, 77.90524

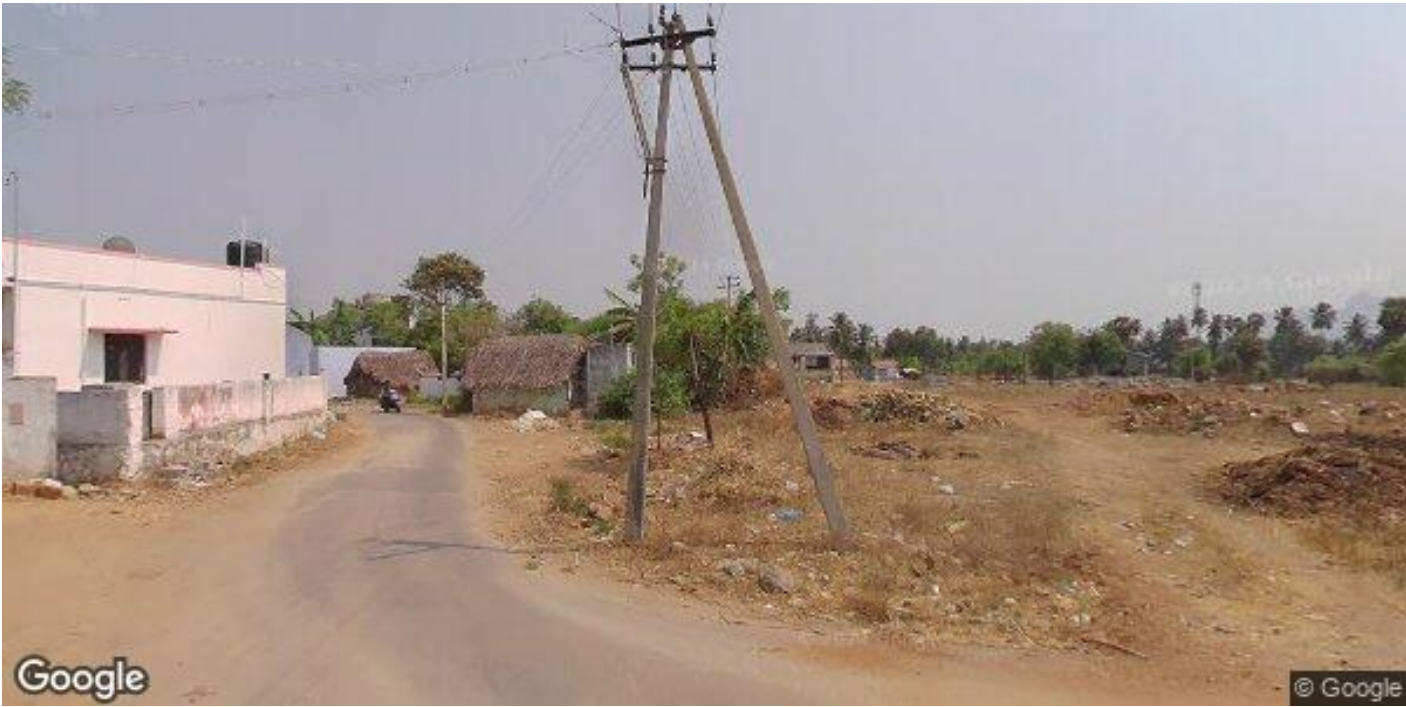
**Risk Type:** Turn  
**Risk Level:** High  
**Speed Limit:** 15 KM/Hr  
**Coordinates:** 11.41329, 77.90978

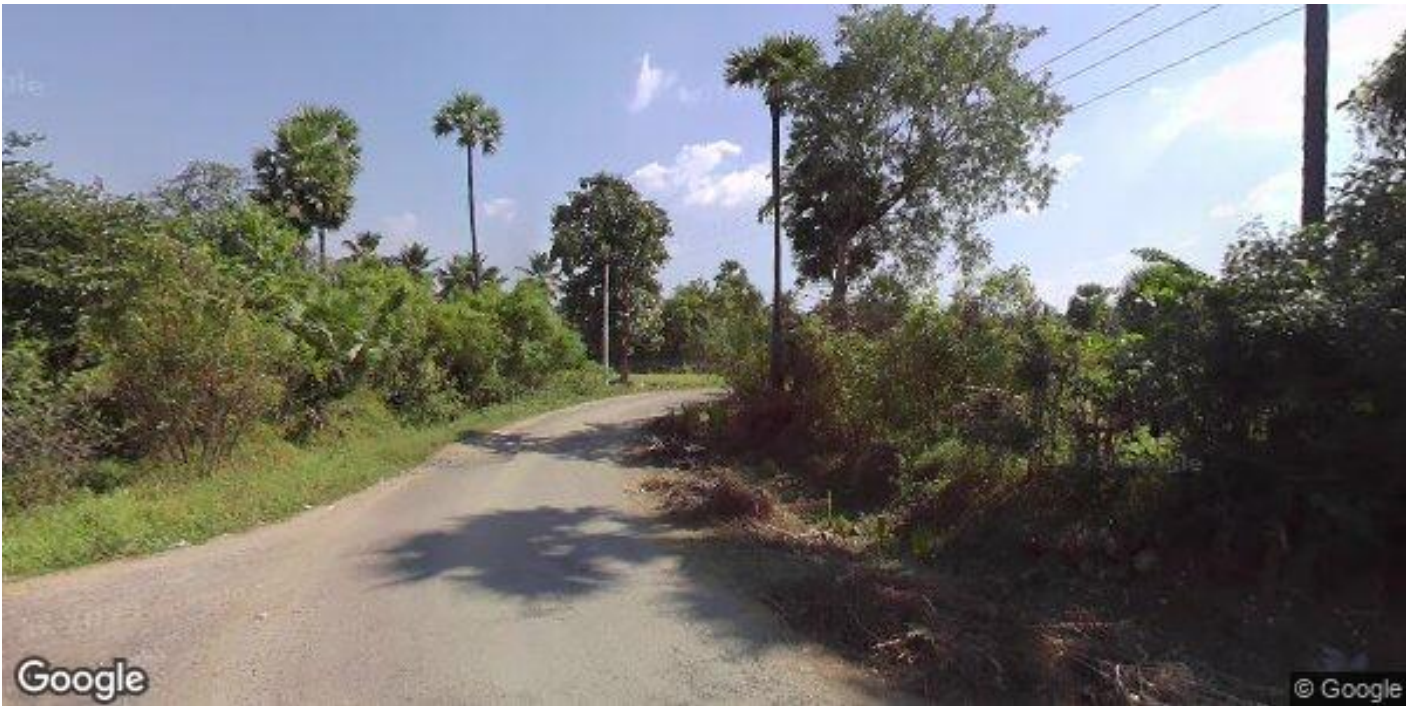
**Risk Type:** Turn  
**Risk Level:** High  
**Speed Limit:** 15 KM/Hr  
**Coordinates:** 11.41424, 77.91433

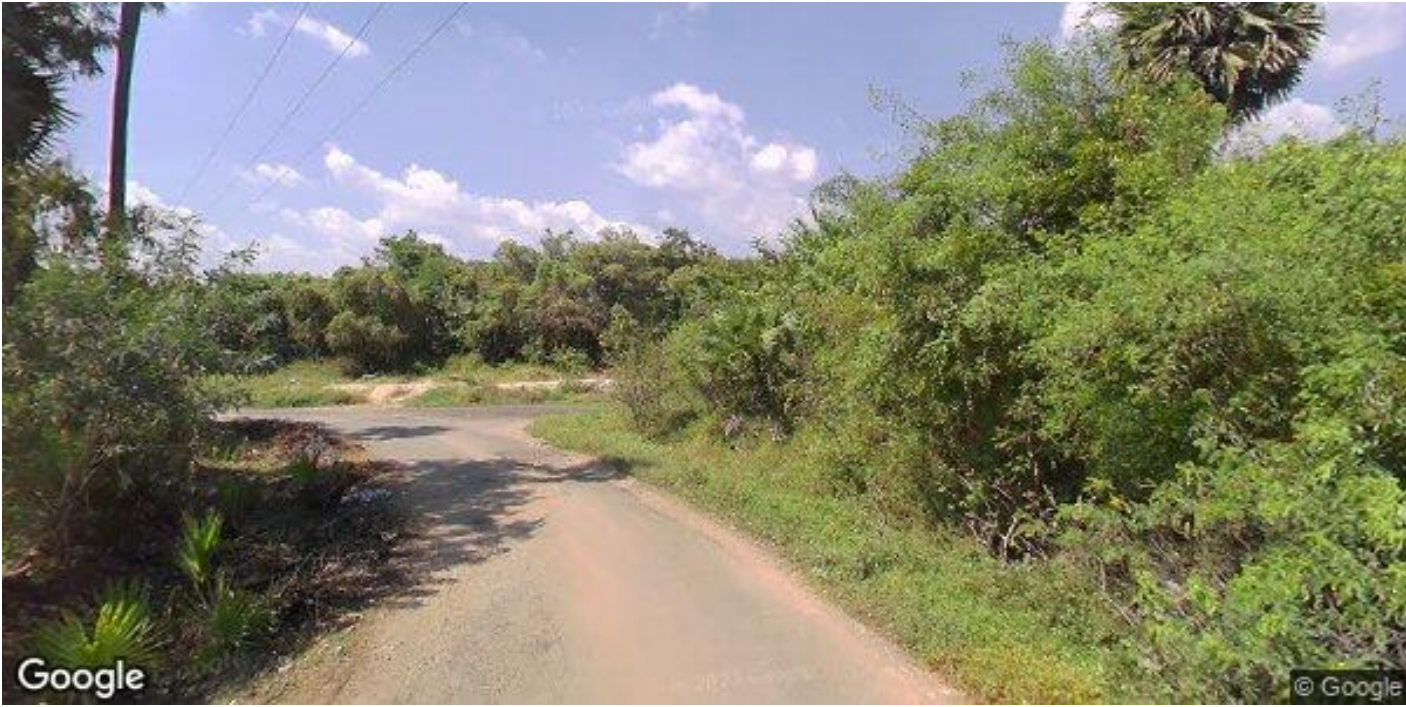
**Risk Type:** Turn  
**Risk Level:** Medium  
**Speed Limit:** 30 KM/Hr  
**Coordinates:** 11.41409, 77.91458

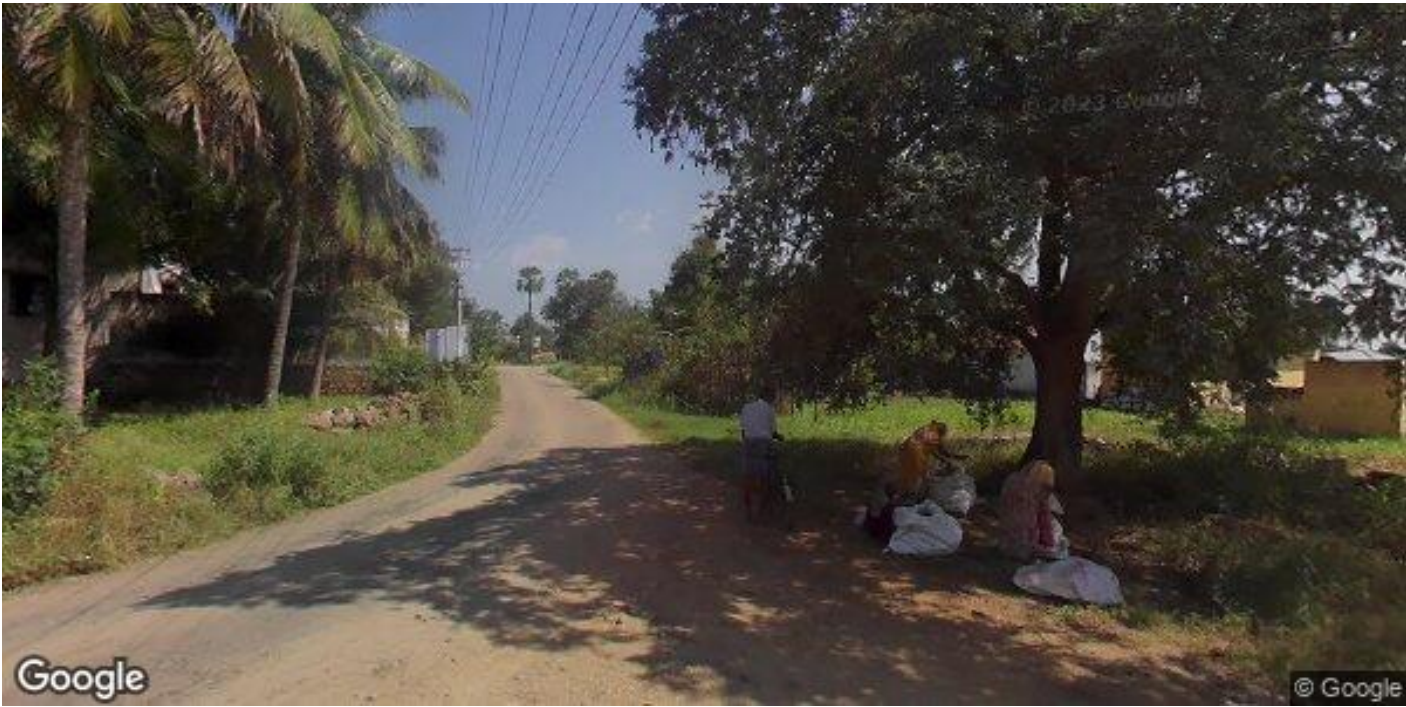
**Risk Type:** Turn  
**Risk Level:** High  
**Speed Limit:** 15 KM/Hr  
**Coordinates:** 11.41208, 77.91551
