# IndianOil

## JOURNEY RISK MANAGEMENT (JRM) STUDY

### Salem Terminal to KANNAPPAN AGENCY

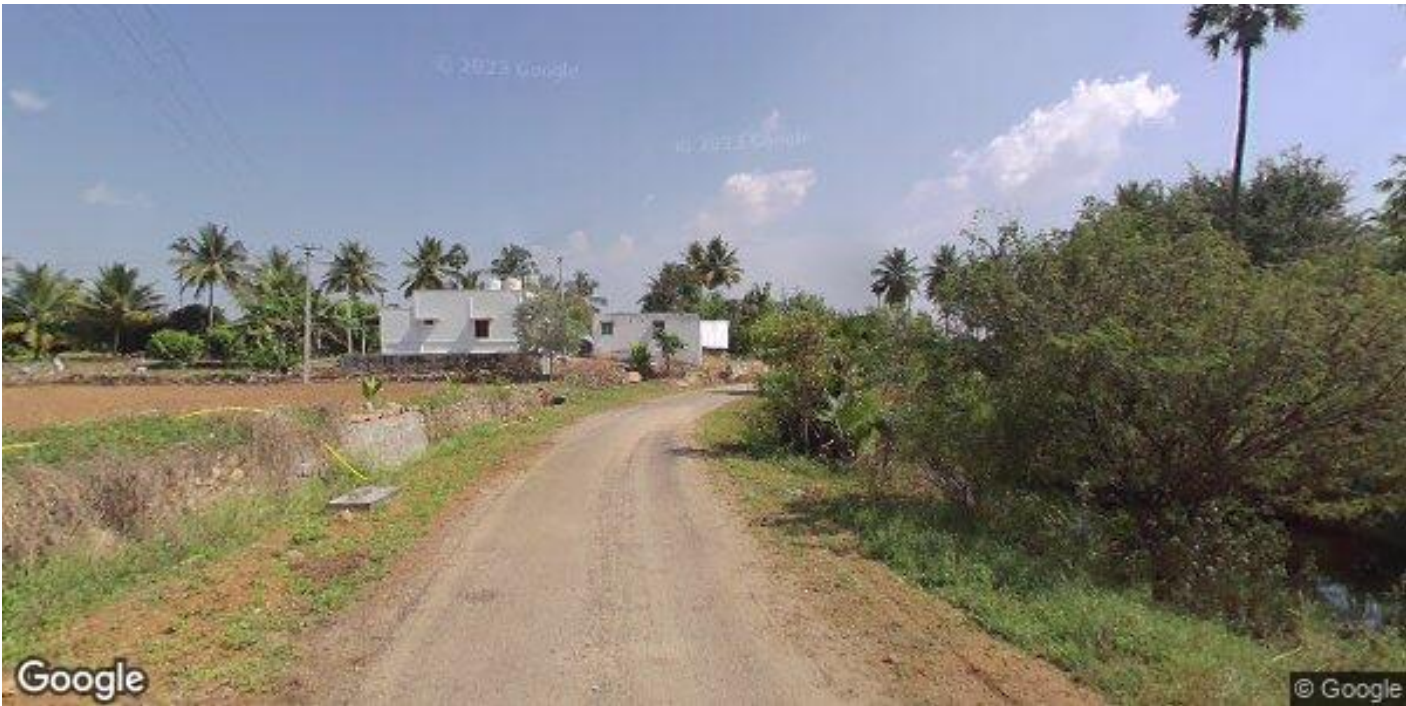
**Risk Type:** Turn  
**Risk Level:** Medium  
**Speed Limit:** 30 KM/Hr  
**Coordinates:** 11.41218, 77.91651

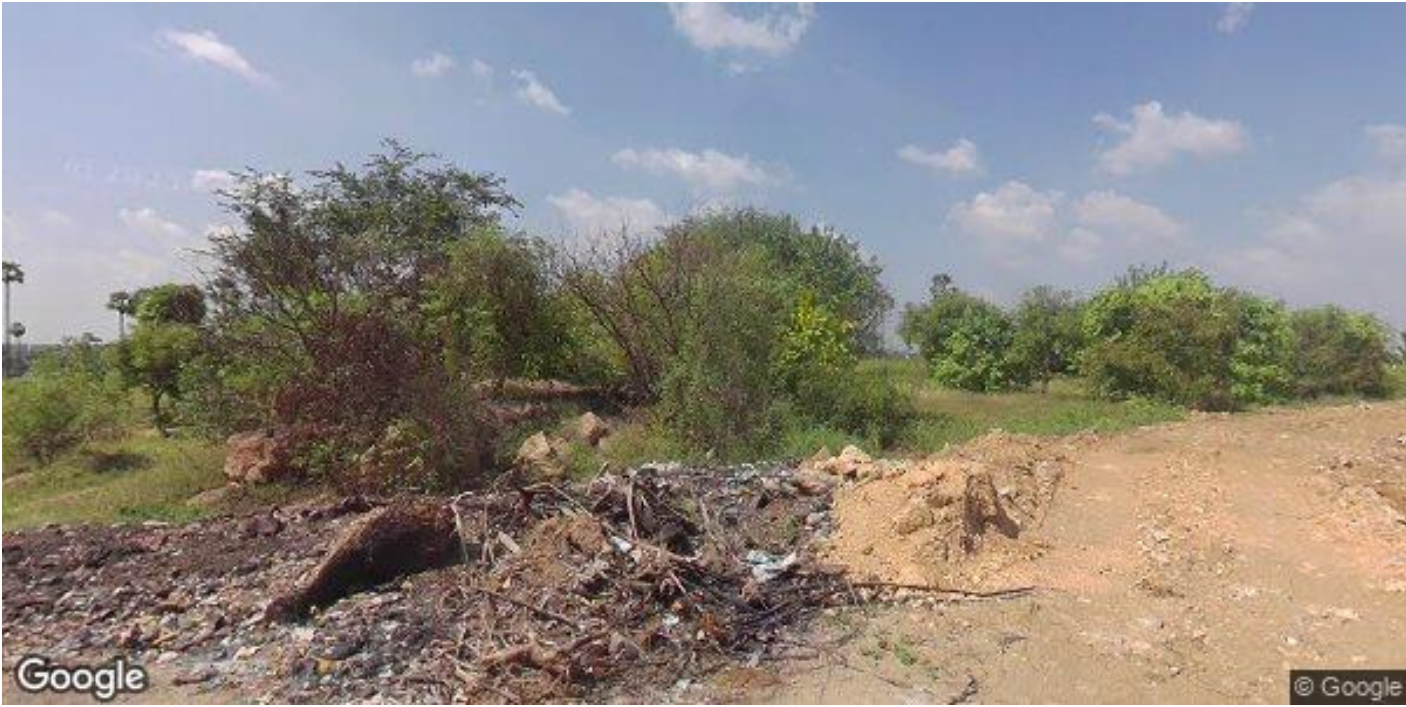
**Risk Type:** Turn  
**Risk Level:** High  
**Speed Limit:** 15 KM/Hr  
**Coordinates:** 11.41347, 77.92096

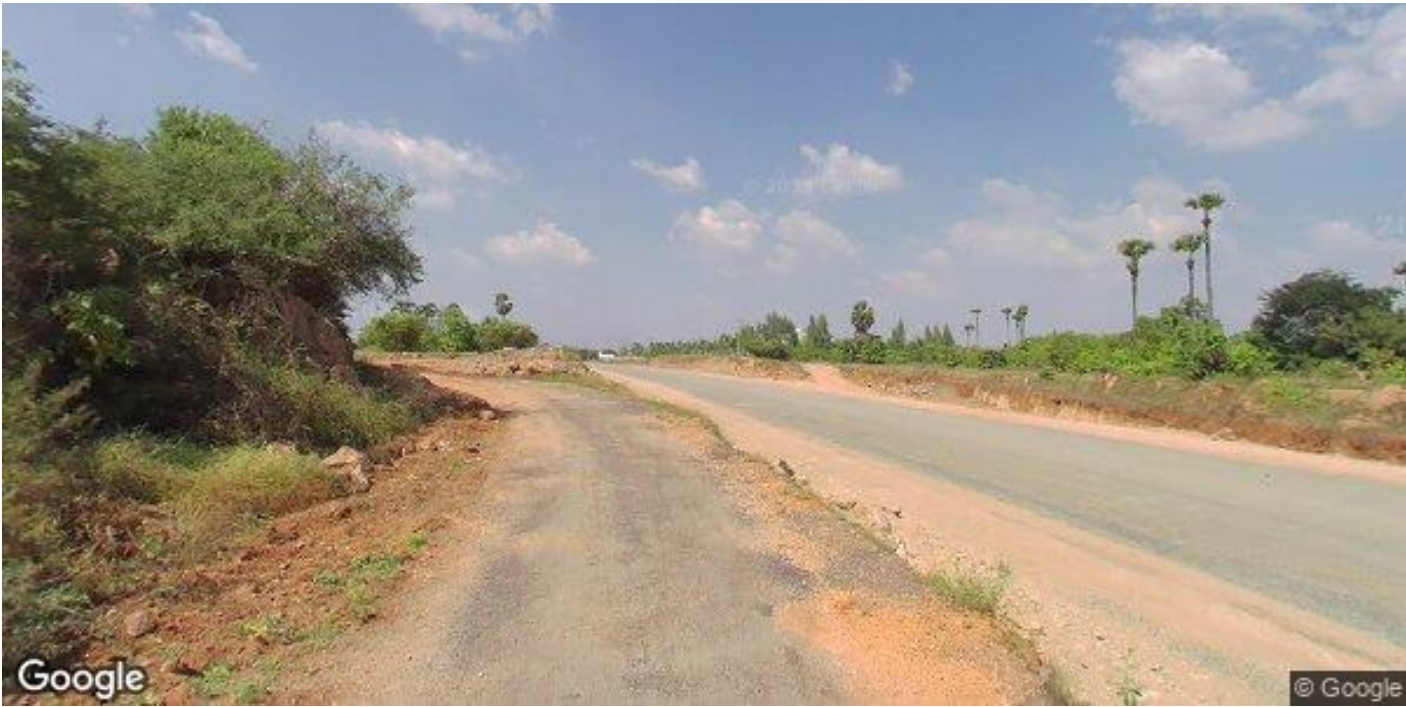
**Risk Type:** Turn  
**Risk Level:** Medium  
**Speed Limit:** 30 KM/Hr  
**Coordinates:** 11.41319, 77.92144

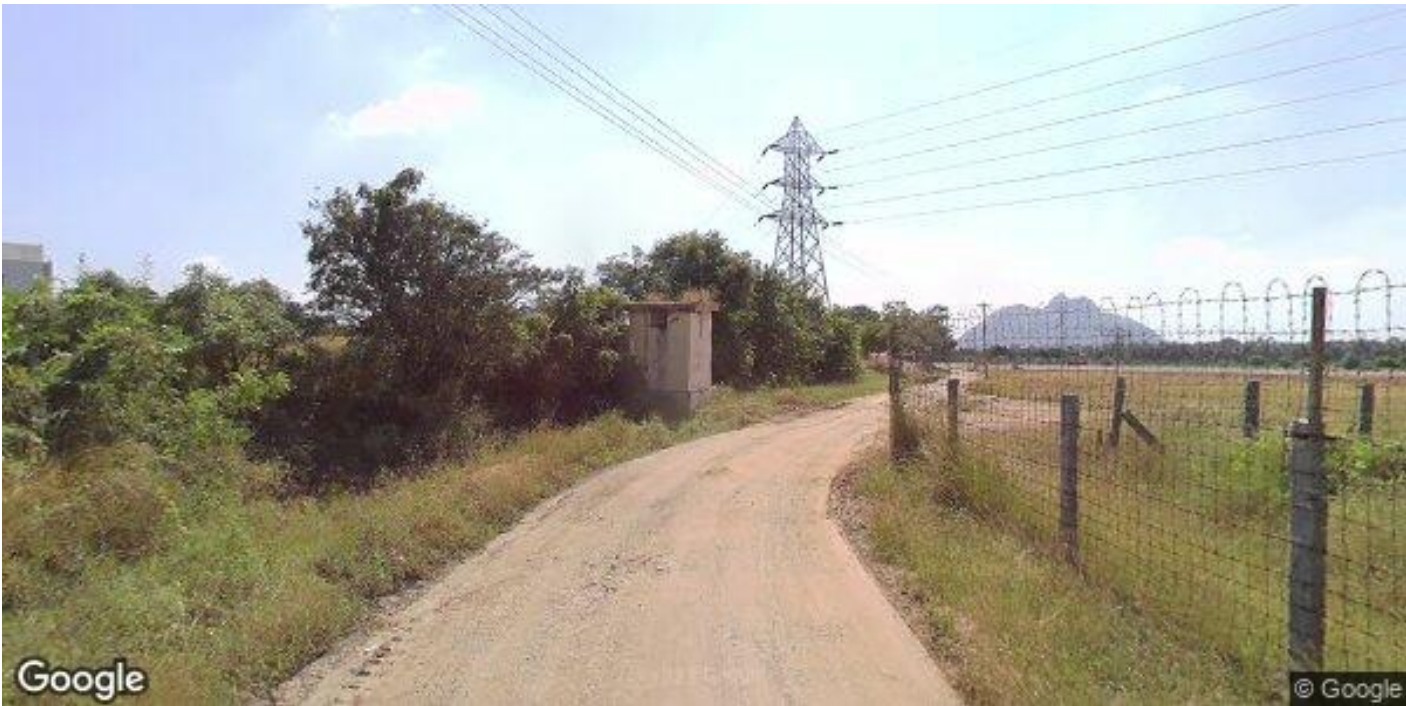
**Risk Type:** Turn  
**Risk Level:** Medium  
**Speed Limit:** 30 KM/Hr  
**Coordinates:** 11.40833, 77.92362

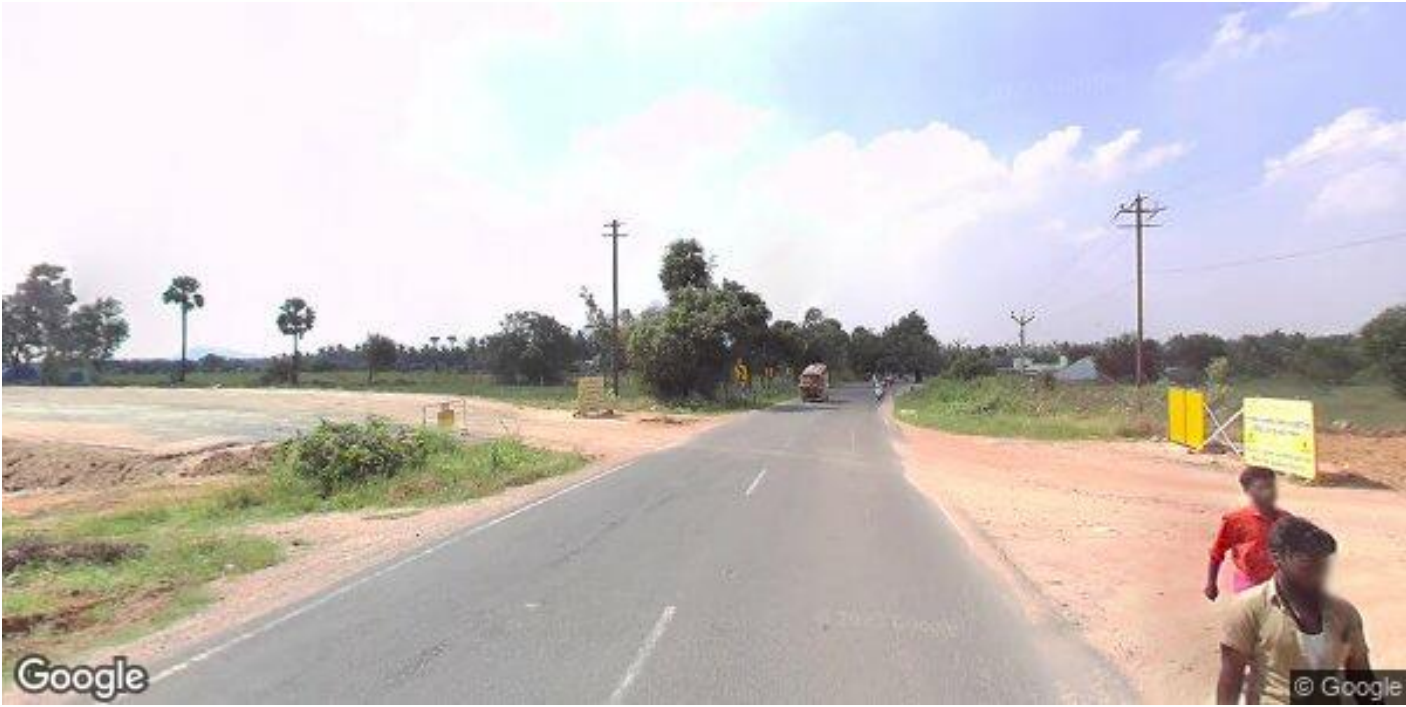
**Risk Type:** Turn  
**Risk Level:** High  
**Speed Limit:** 15 KM/Hr  
**Coordinates:** 11.40566, 77.92355

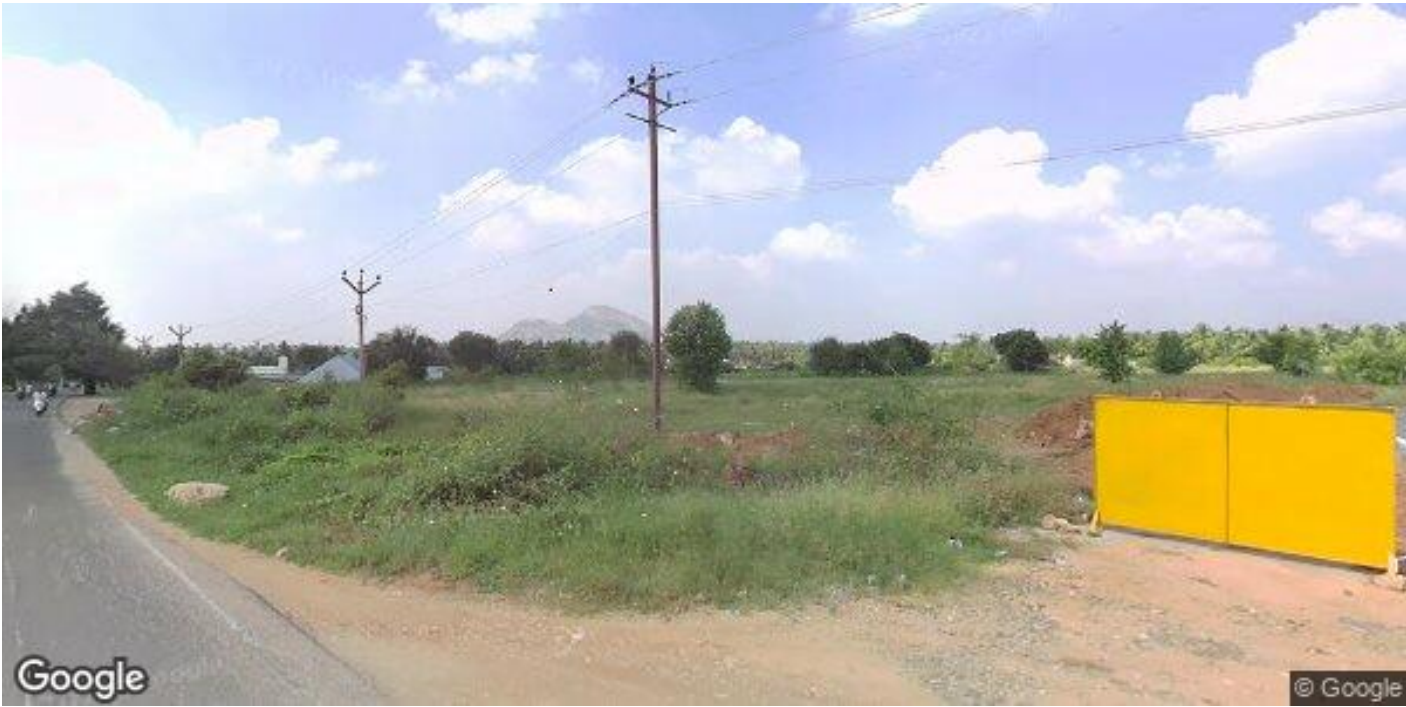
**Risk Type:** Turn  
**Risk Level:** High  
**Speed Limit:** 15 KM/Hr  
**Coordinates:** 11.40557, 77.92343

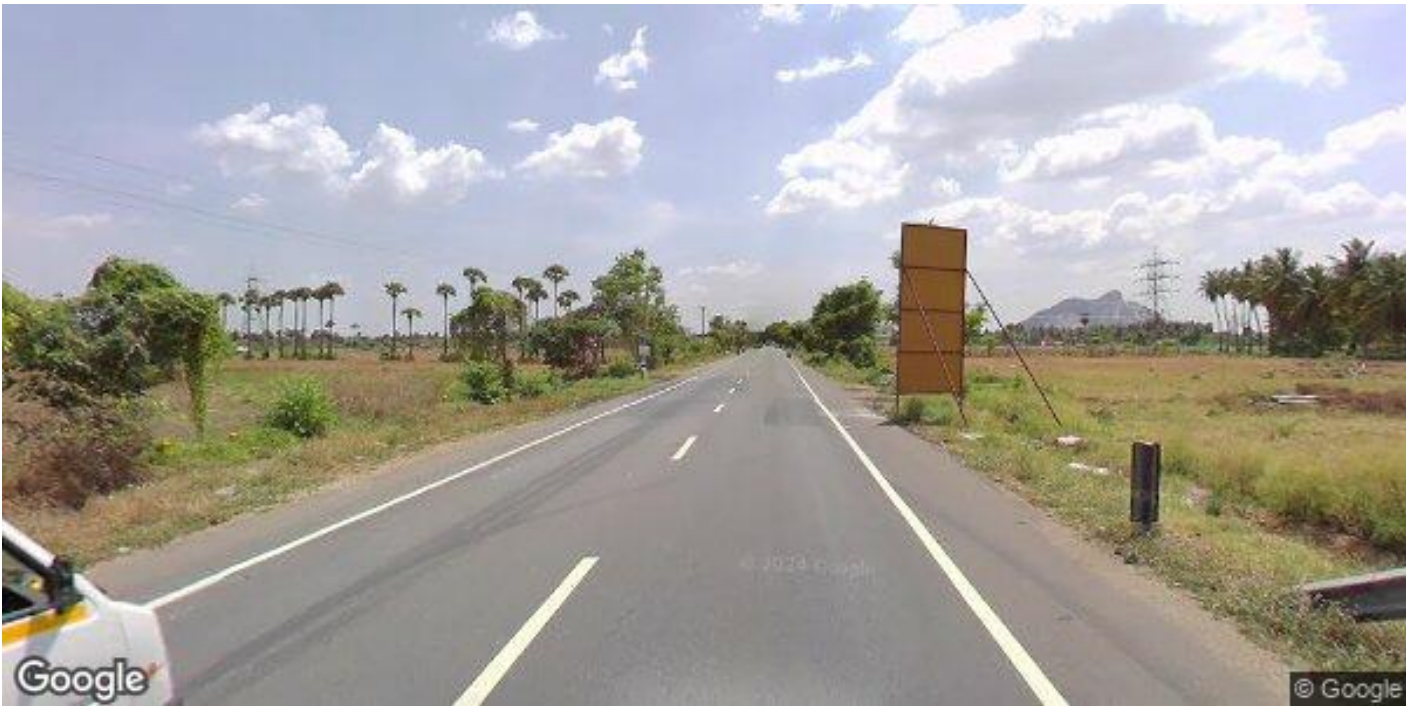
**Risk Type:** Blind Spot  
**Risk Level:** Blind Spot  
**Speed Limit:** 10 KM/Hr  
**Coordinates:** 11.36920, 77.94568

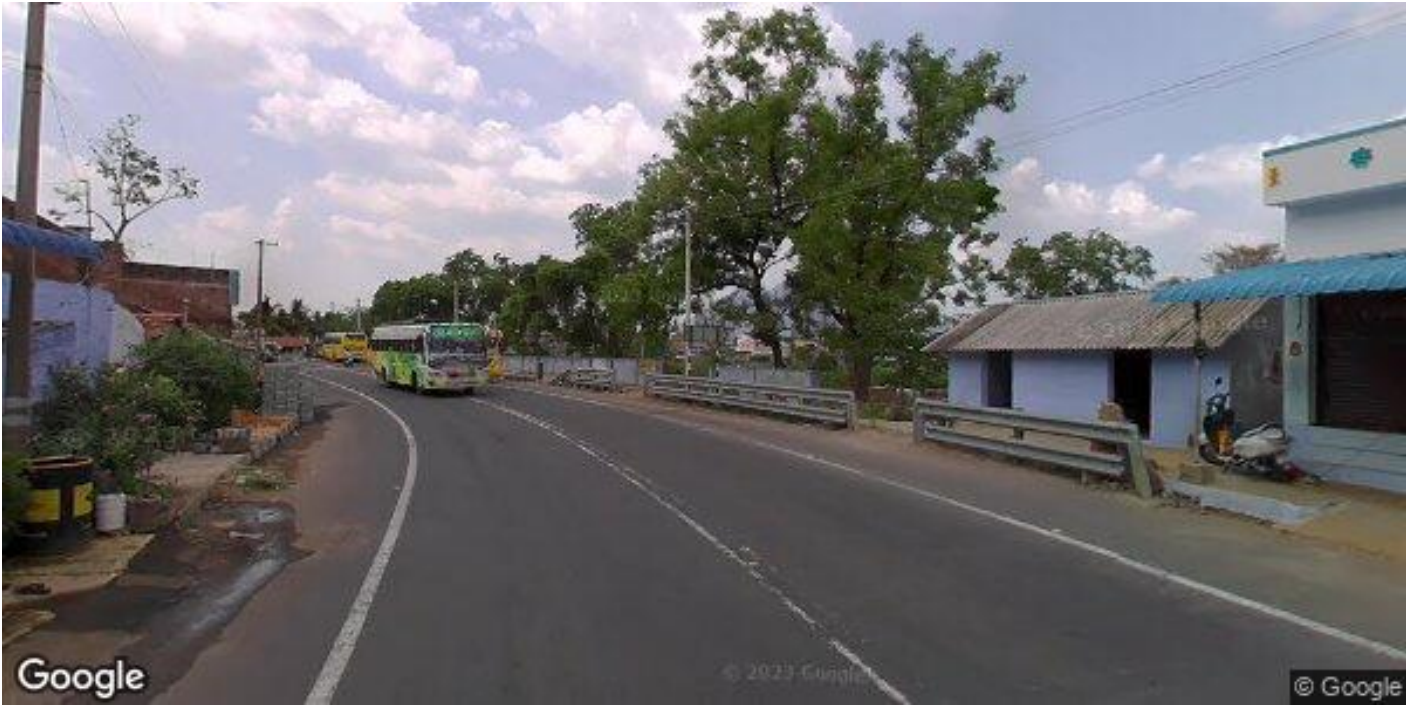
**Risk Type:** Turn  
**Risk Level:** Medium  
**Speed Limit:** 30 KM/Hr  
**Coordinates:** 11.41332, 78.08072

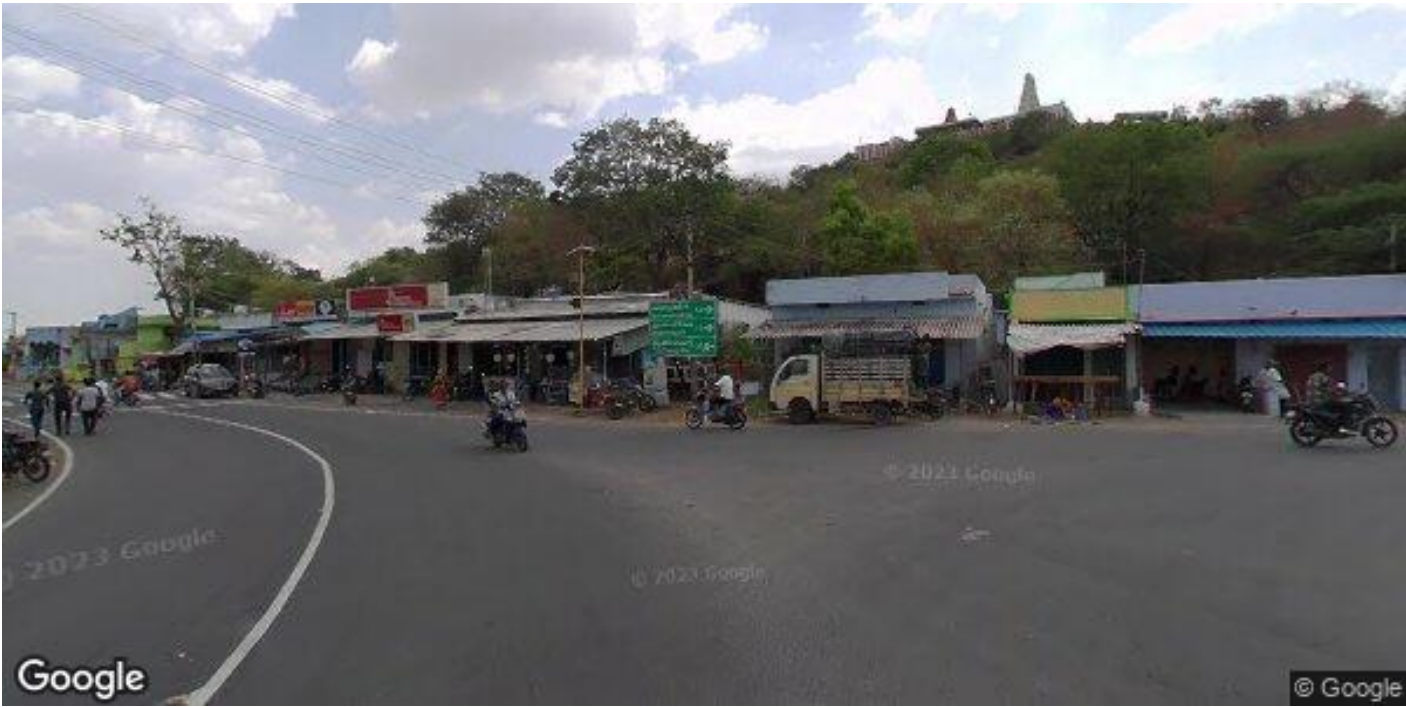
**Risk Type:** Turn  
**Risk Level:** High  
**Speed Limit:** 15 KM/Hr  
**Coordinates:** 11.41463, 78.08067

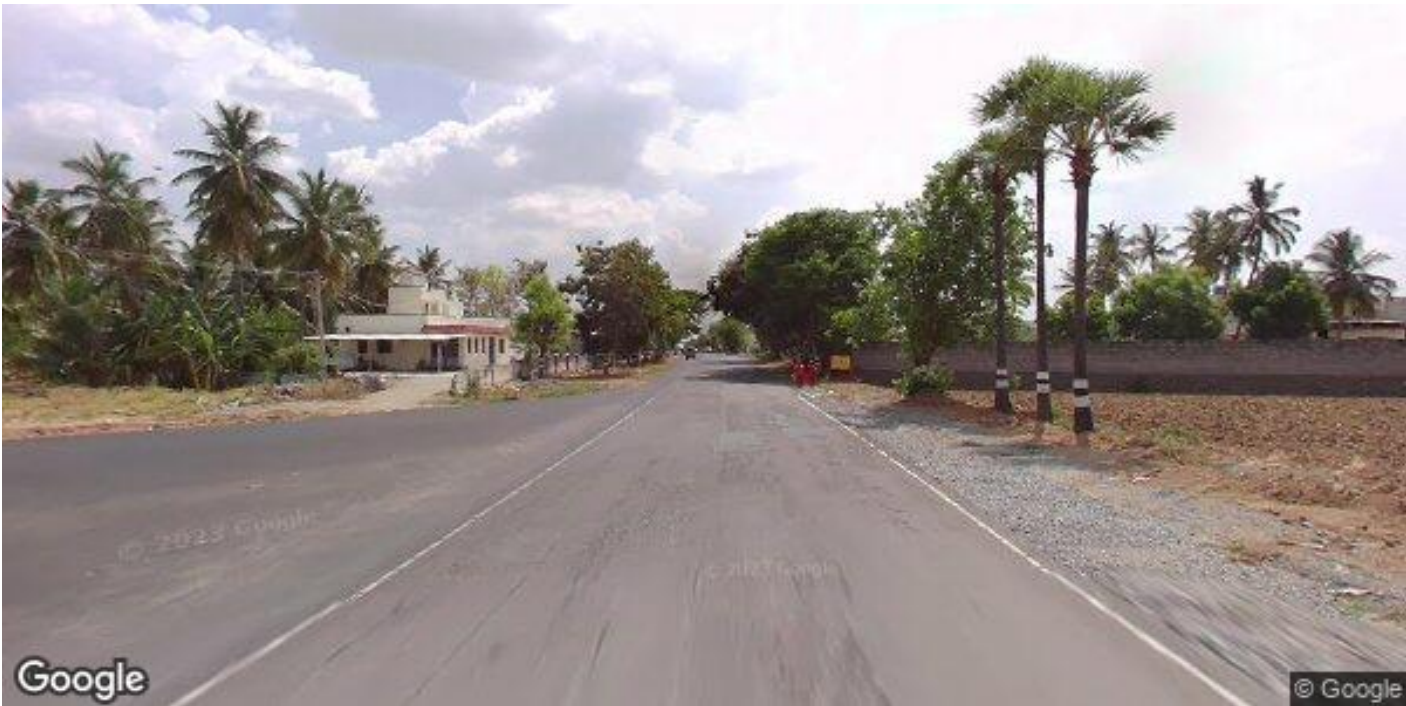
**Risk Type:** Turn  
**Risk Level:** High  
**Speed Limit:** 15 KM/Hr  
**Coordinates:** 11.42964, 78.11587

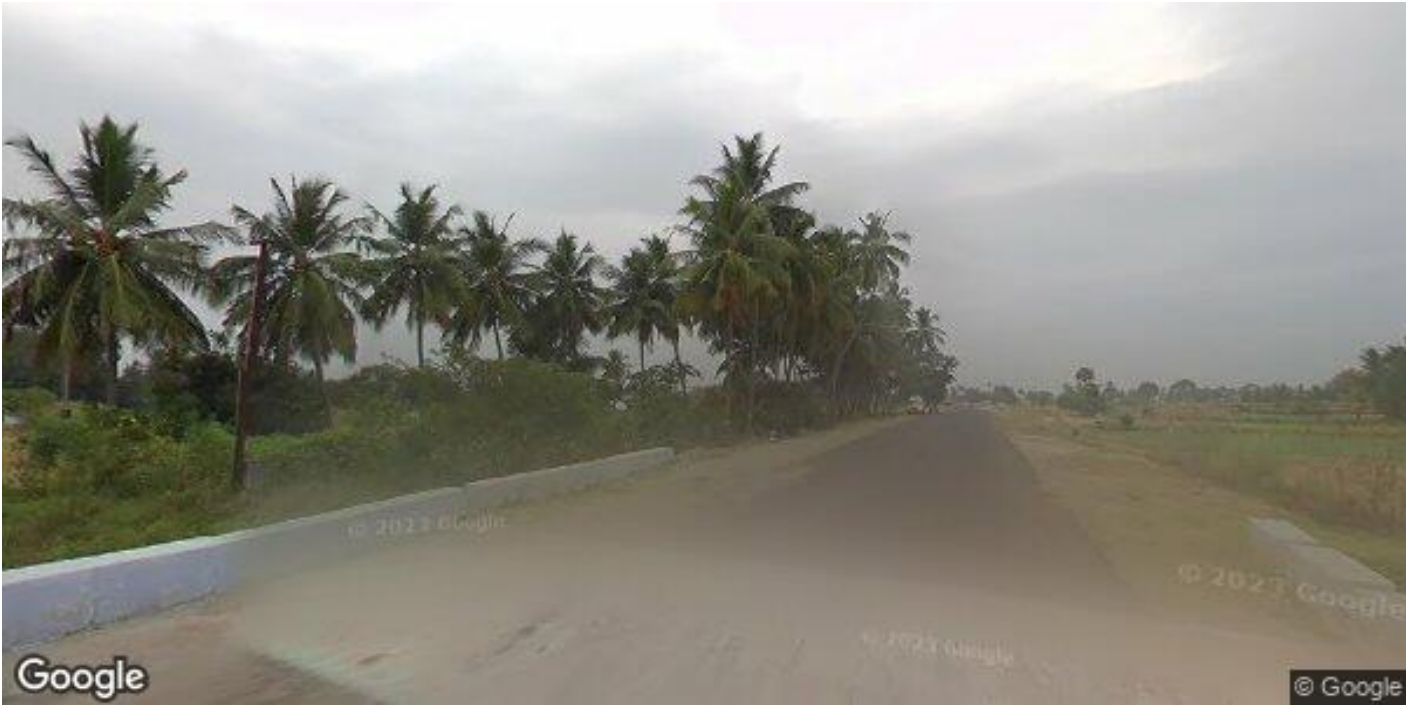
**Risk Type:** Turn  
**Risk Level:** Medium  
**Speed Limit:** 30 KM/Hr  
**Coordinates:** 11.42450, 78.15278

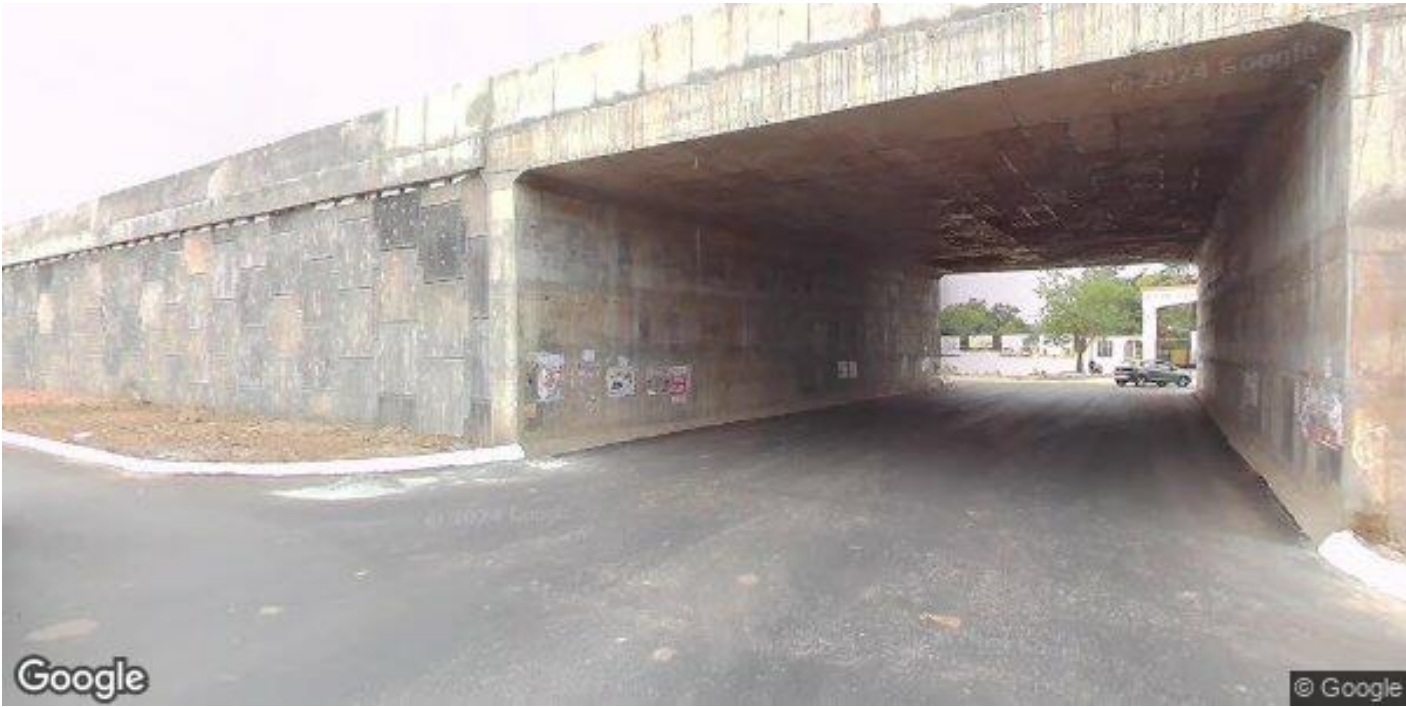
**Risk Type:** Blind Spot  
**Risk Level:** Blind Spot  
**Speed Limit:** 10 KM/Hr  
**Coordinates:** 11.42631, 78.15605

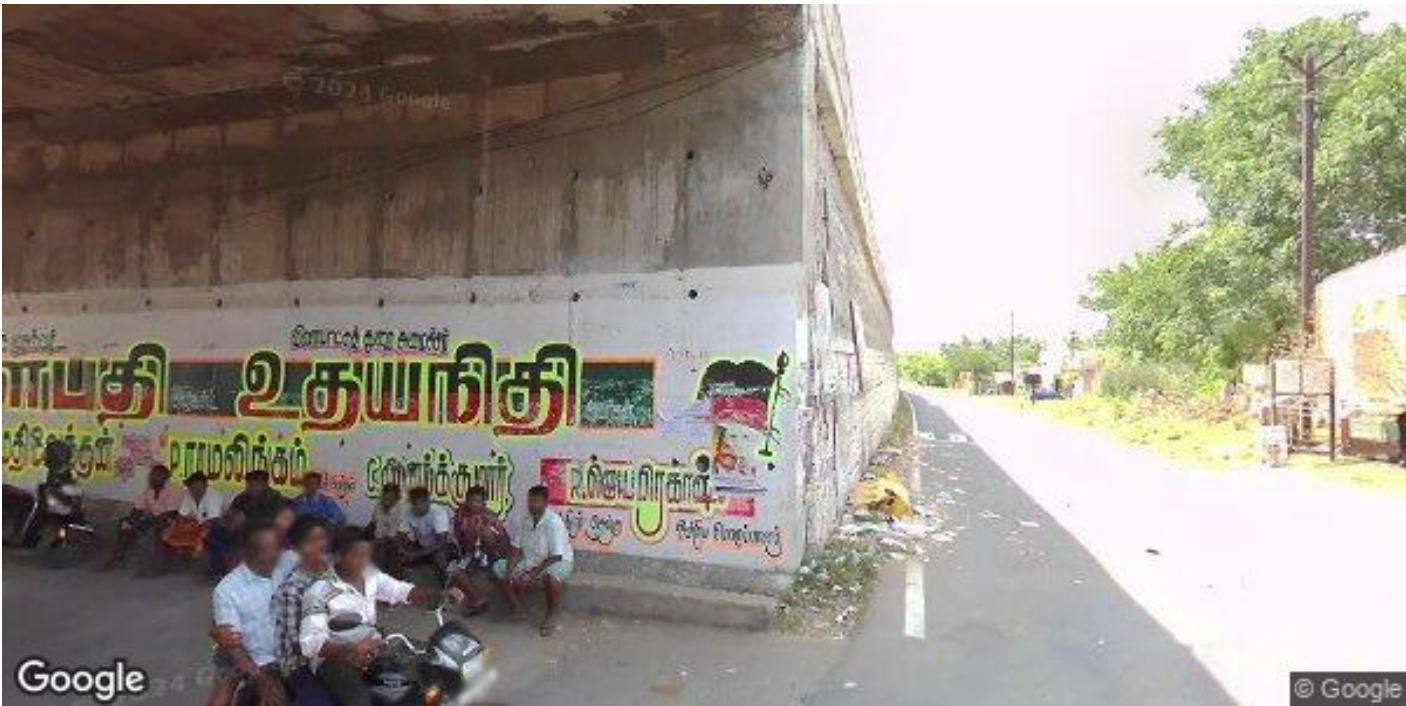
**Risk Type:** Turn  
**Risk Level:** High  
**Speed Limit:** 15 KM/Hr  
**Coordinates:** 11.32214, 78.17258

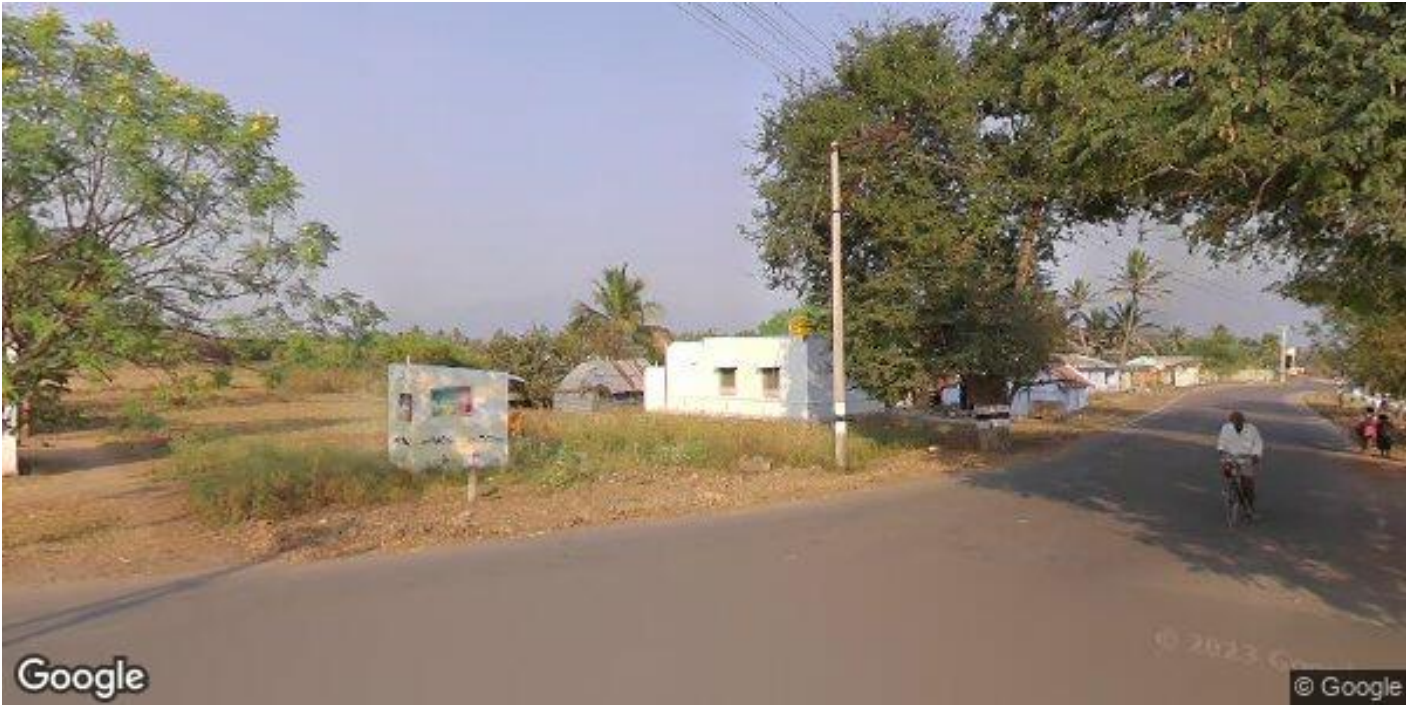
**Risk Type:** Turn  
**Risk Level:** Medium  
**Speed Limit:** 30 KM/Hr  
**Coordinates:** 11.28793, 78.22365

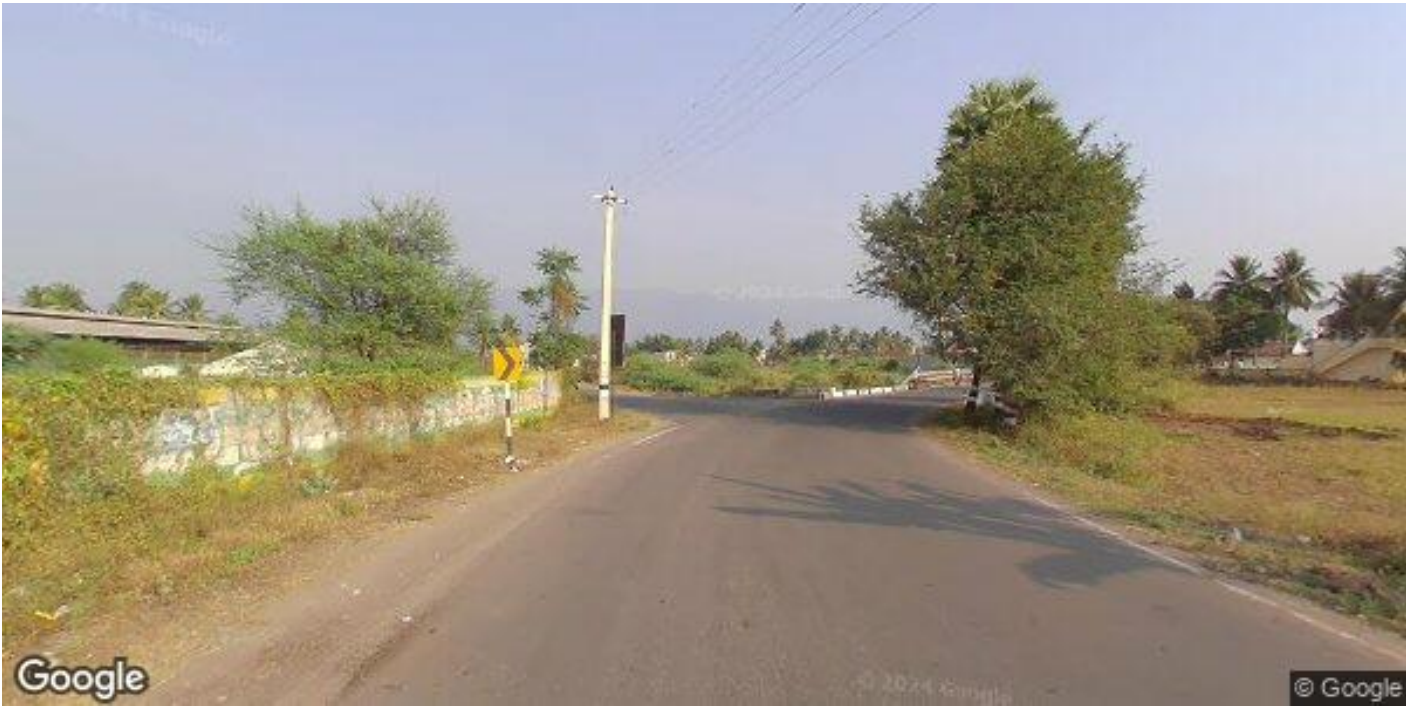
**Risk Type:** Turn  
**Risk Level:** Medium  
**Speed Limit:** 30 KM/Hr  
**Coordinates:** 11.28780, 78.22452
