# IndianOil

## JOURNEY RISK MANAGEMENT (JRM) STUDY

### Salem Terminal to CKM FUELS STATION

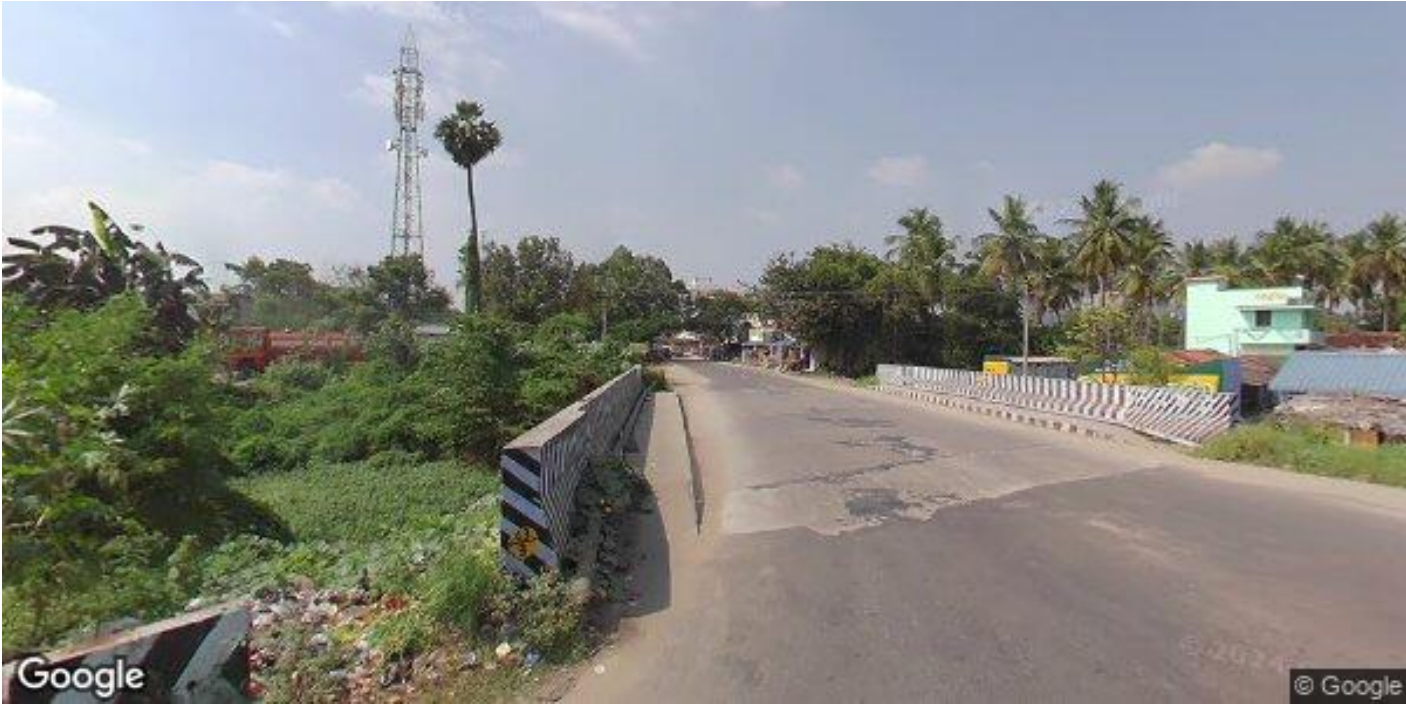
Risk Type: Turn  
Risk Level: Medium  
Speed Limit: 30 KM/Hr  
Coordinates: 11.44900, 77.87406

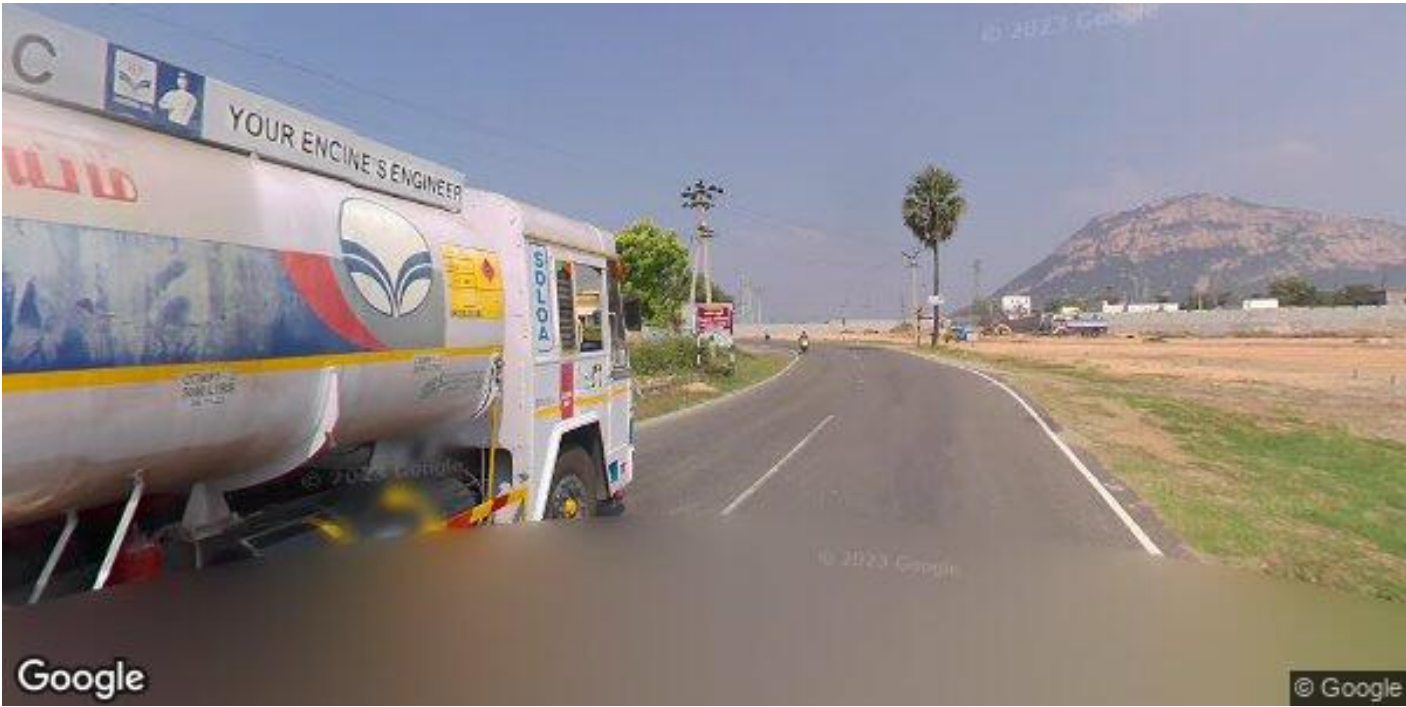
**Risk Type:** Turn  
**Risk Level:** Medium  
**Speed Limit:** 30 KM/Hr  
**Coordinates:** 11.45853, 77.85139

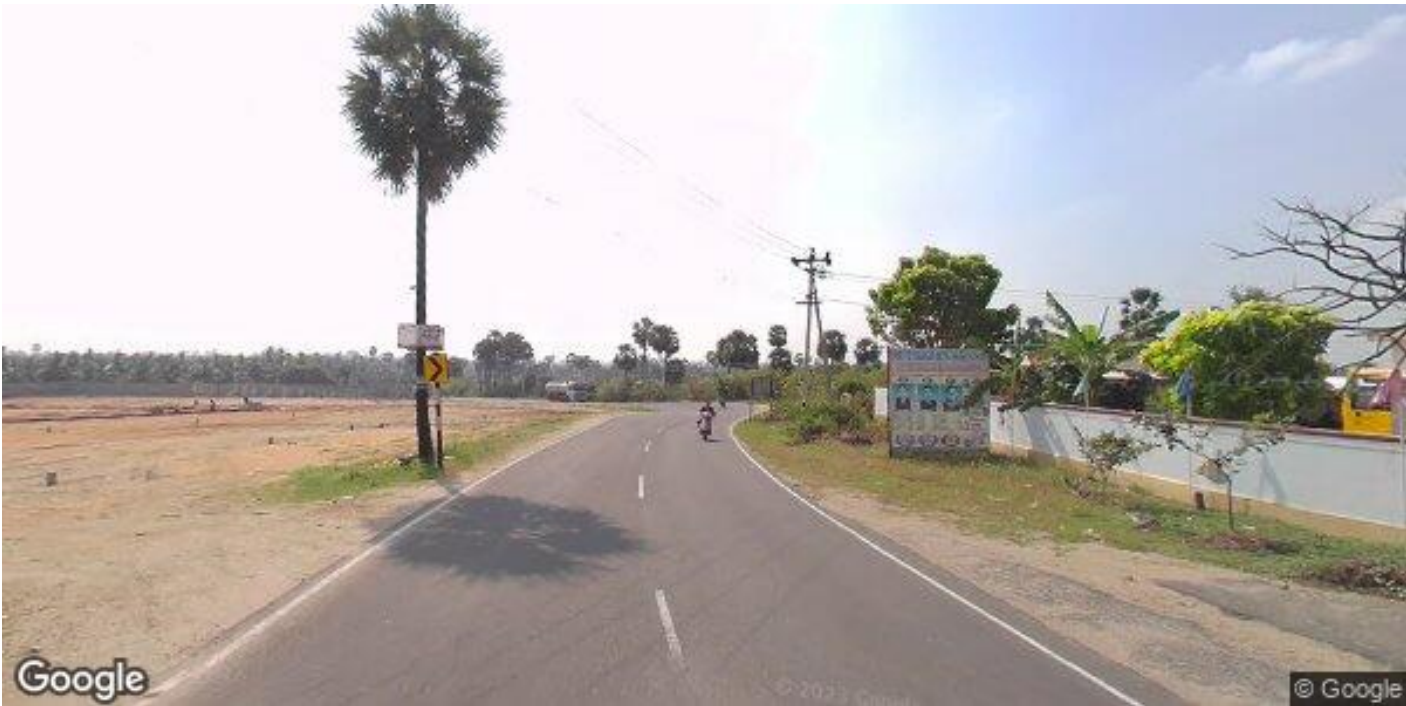
**Risk Type:** Turn  
**Risk Level:** Medium  
**Speed Limit:** 30 KM/Hr  
**Coordinates:** 11.45906, 77.85132

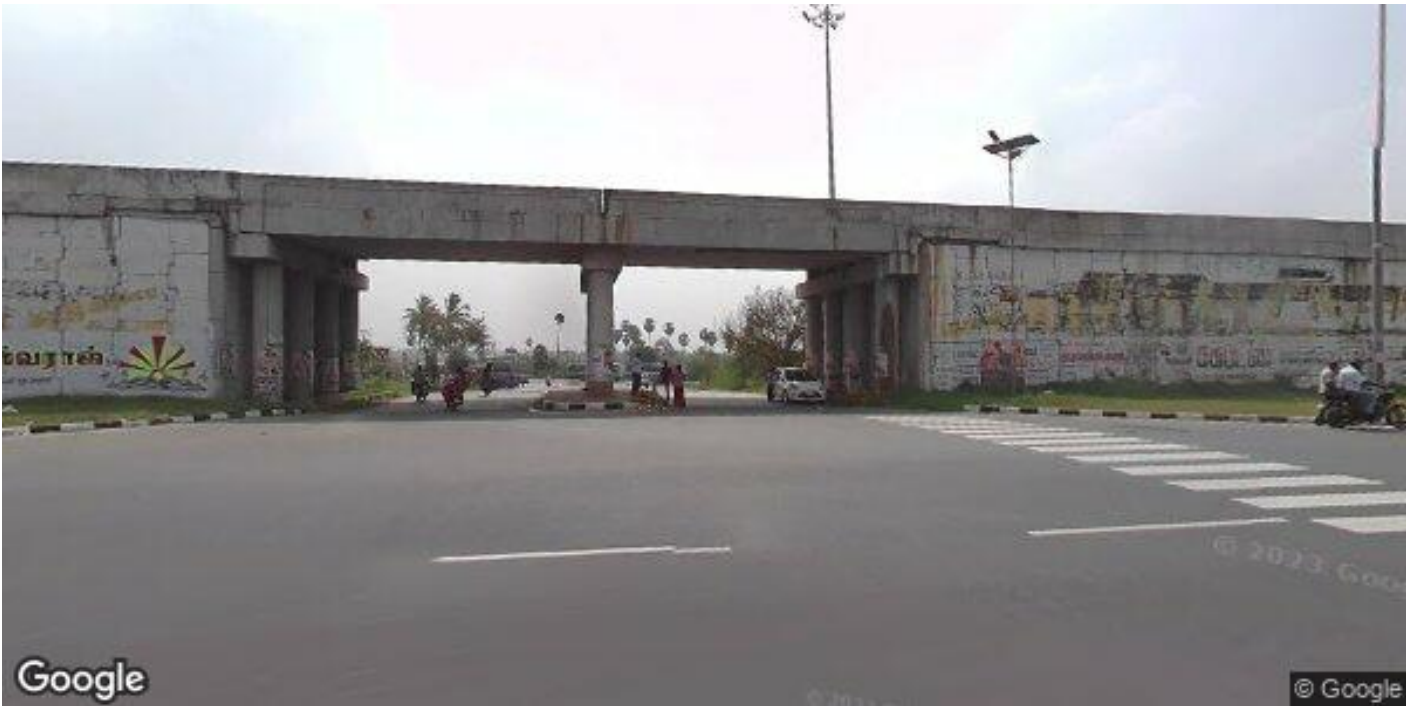
**Risk Type:** Turn  
**Risk Level:** High  
**Speed Limit:** 15 KM/Hr  
**Coordinates:** 11.45636, 77.81678

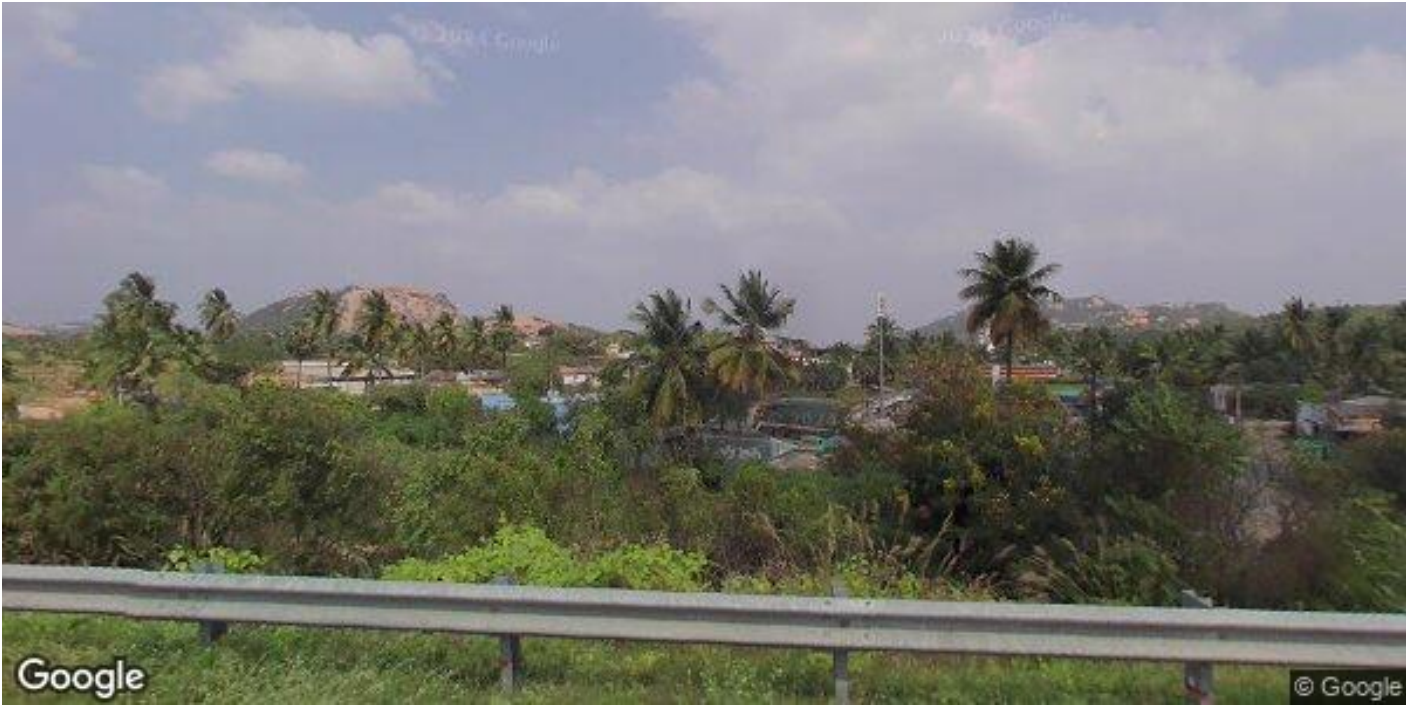
**Risk Type:** Turn  
**Risk Level:** Medium  
**Speed Limit:** 30 KM/Hr  
**Coordinates:** 11.49383, 77.88501

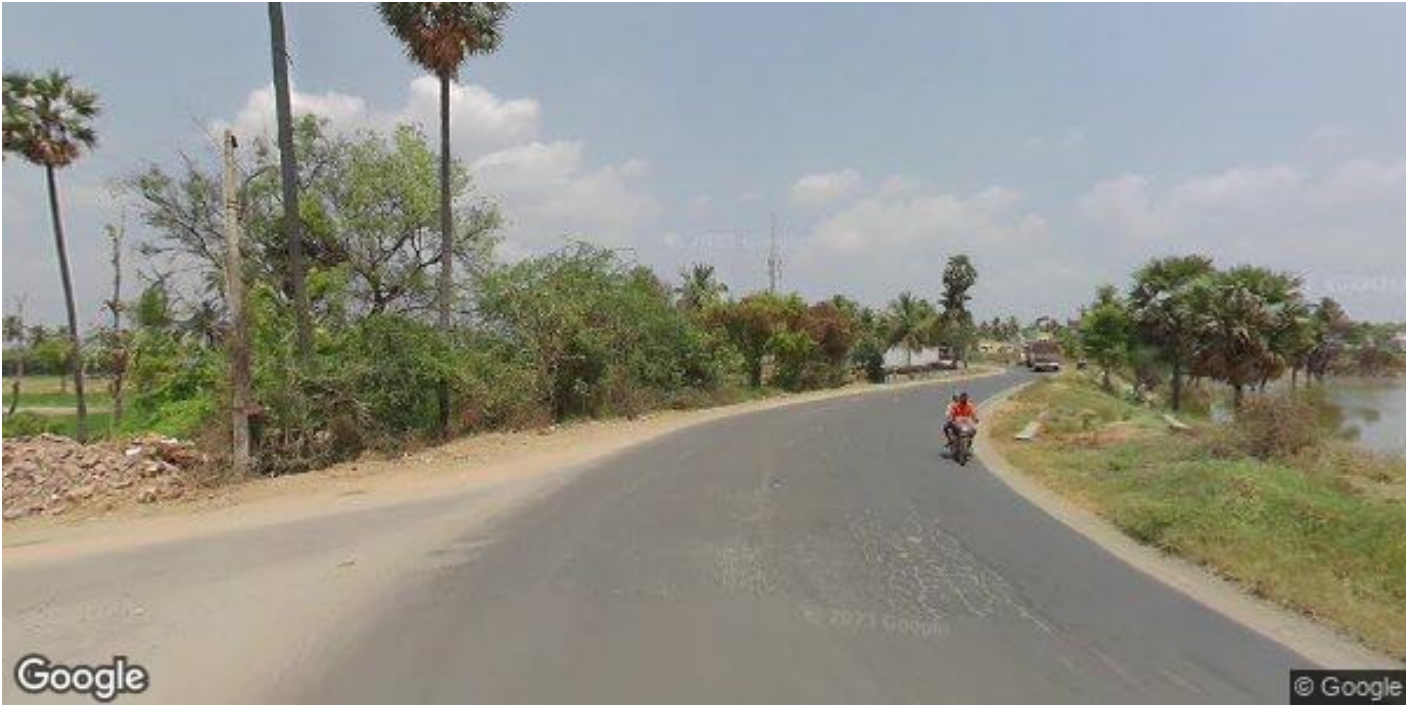
**Risk Type:** Turn  
**Risk Level:** Medium  
**Speed Limit:** 30 KM/Hr  
**Coordinates:** 11.56083, 77.89921

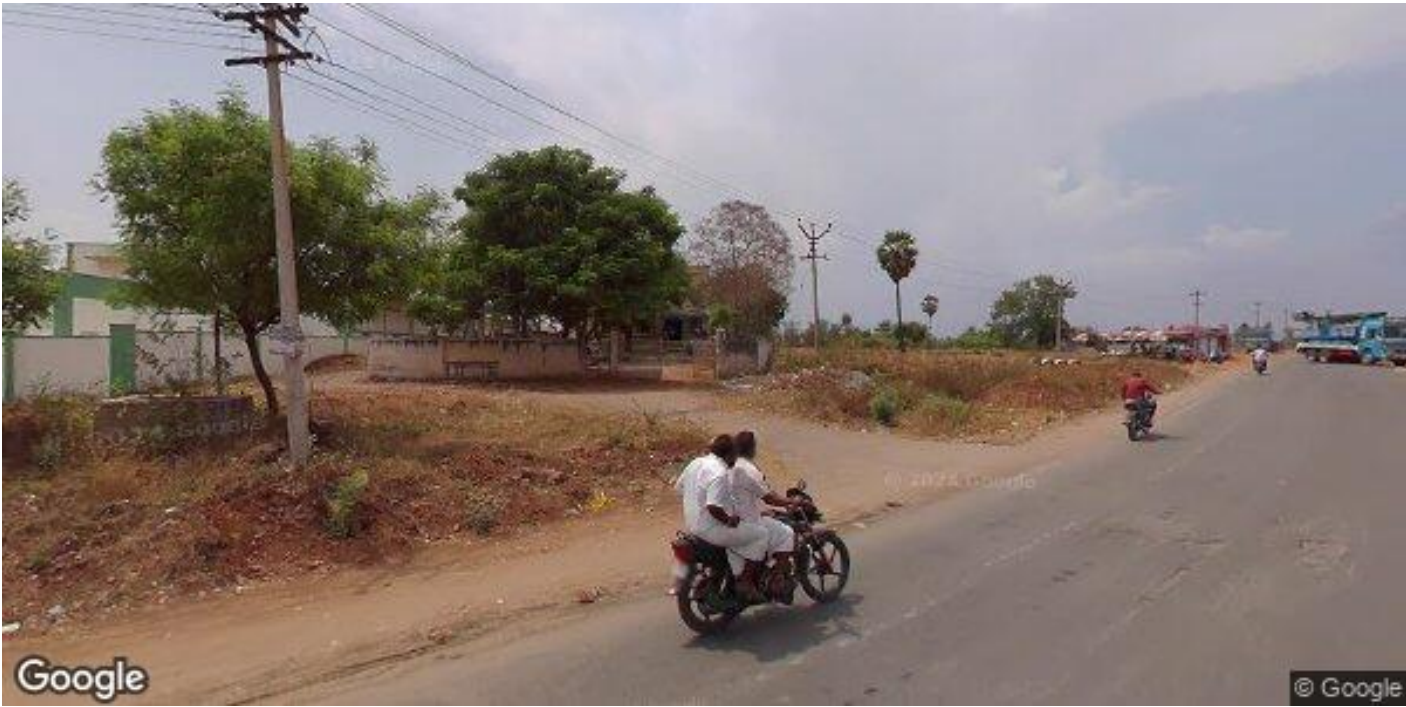
**Risk Type:** Turn  
**Risk Level:** Medium  
**Speed Limit:** 30 KM/Hr  
**Coordinates:** 11.58309, 77.90652

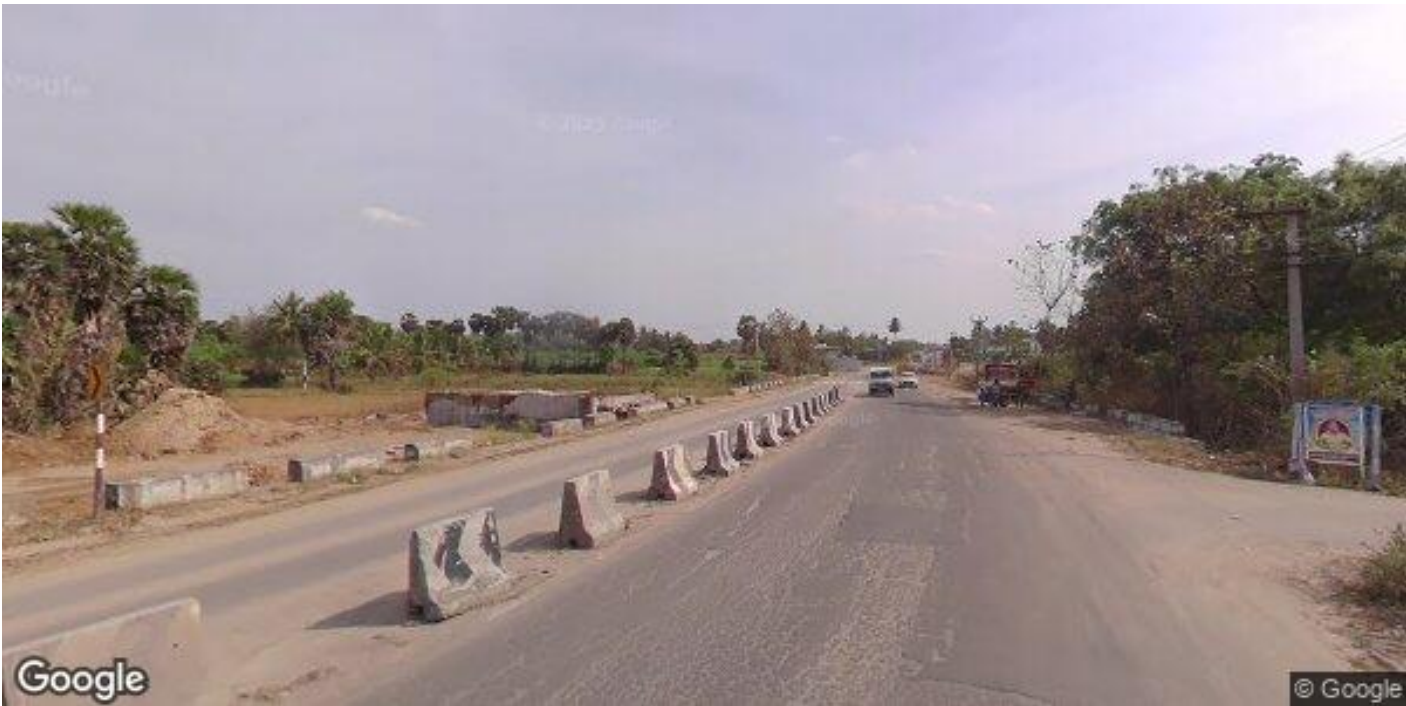
**Risk Type:** Turn  
**Risk Level:** Medium  
**Speed Limit:** 30 KM/Hr  
**Coordinates:** 11.63843, 77.94821

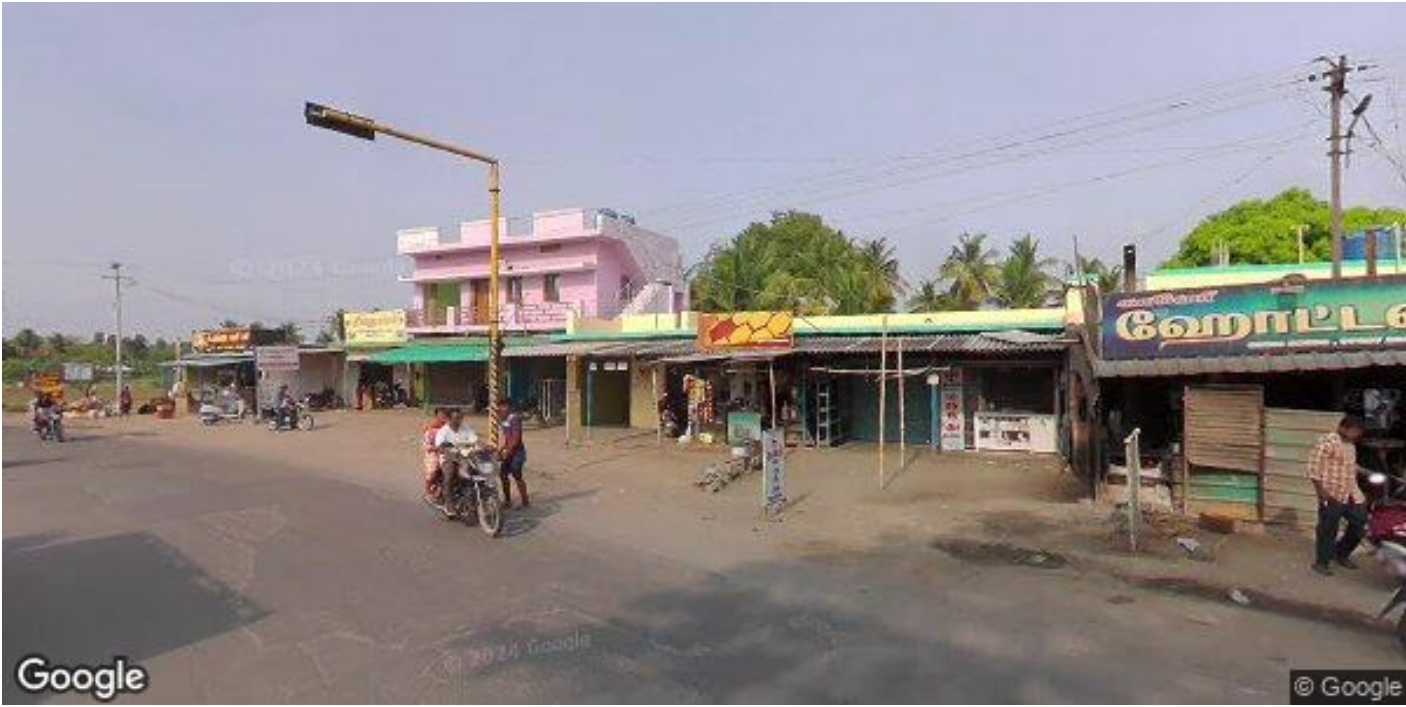
**Risk Type:** Turn  
**Risk Level:** High  
**Speed Limit:** 15 KM/Hr  
**Coordinates:** 11.64192, 77.95195

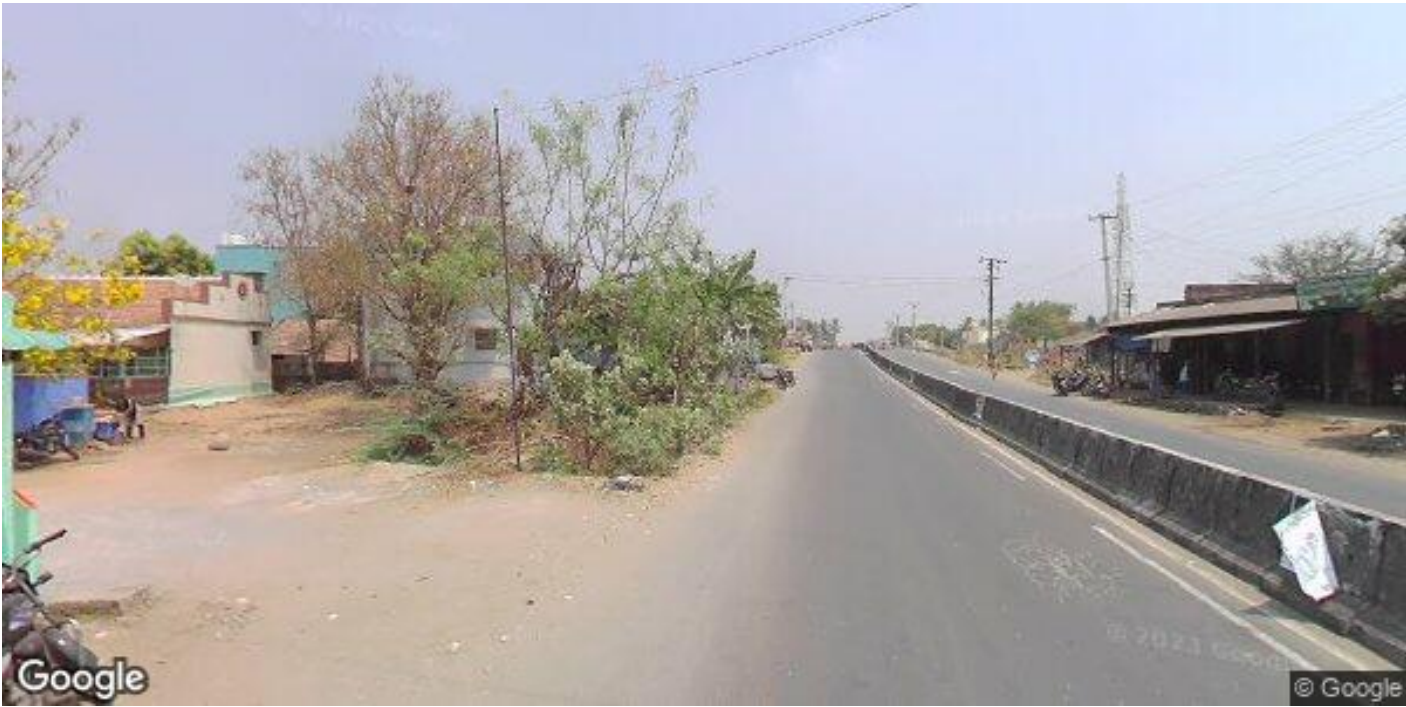
**Risk Type:** Turn  
**Risk Level:** Medium  
**Speed Limit:** 30 KM/Hr  
**Coordinates:** 11.64747, 77.95129

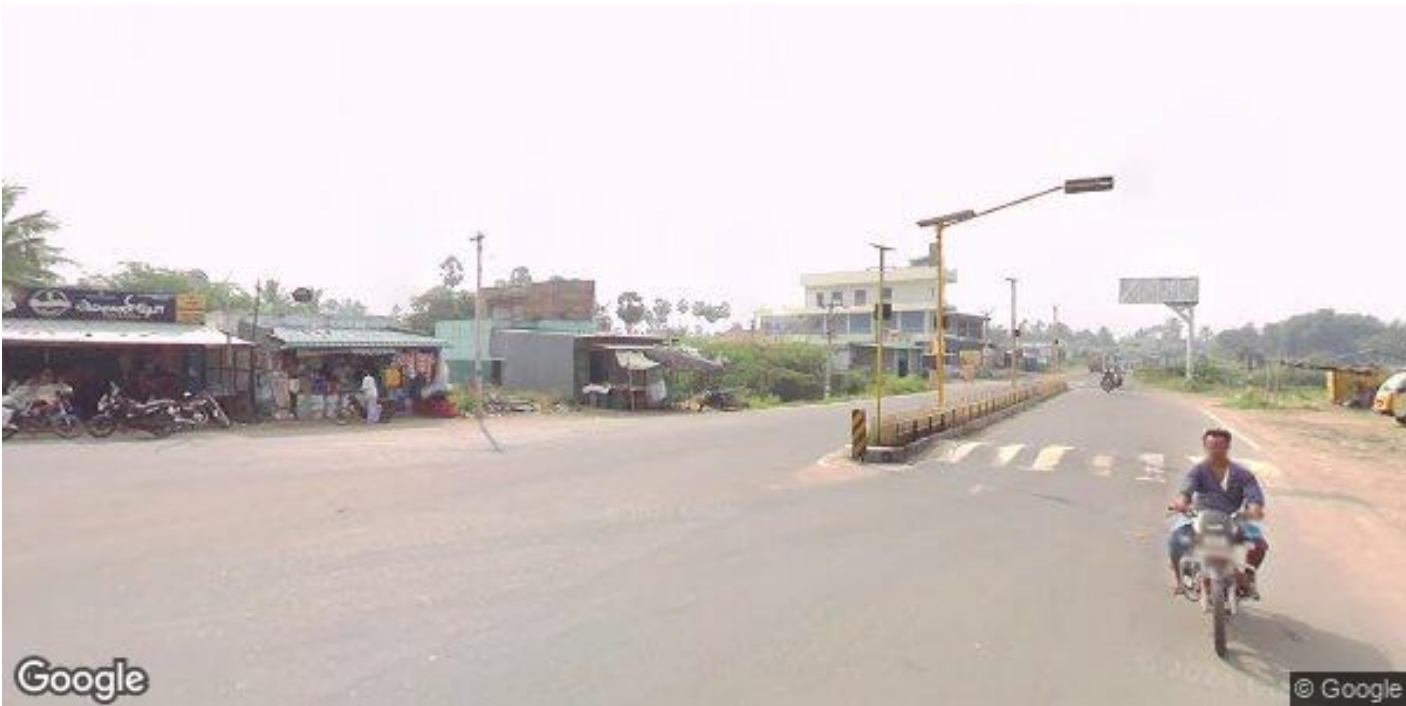
**Risk Type:** Turn  
**Risk Level:** High  
**Speed Limit:** 15 KM/Hr  
**Coordinates:** 11.67868, 77.96836

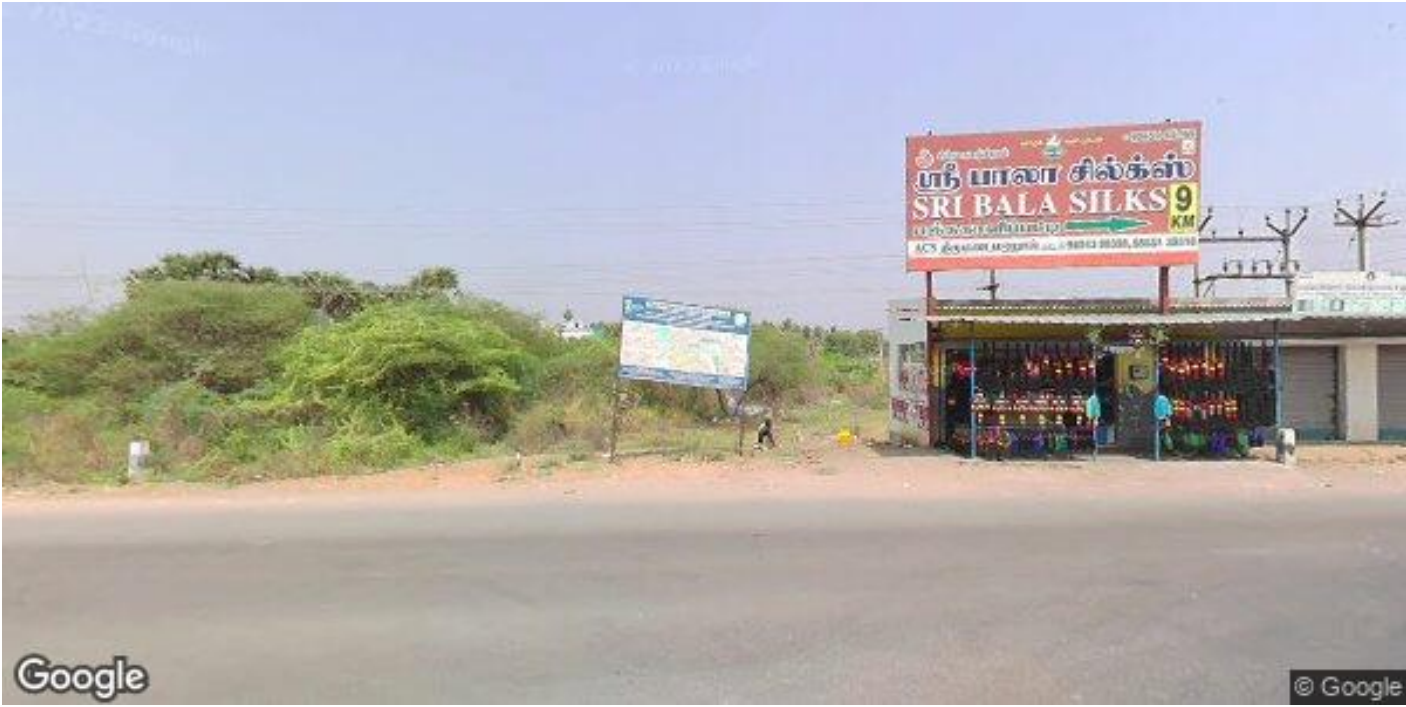
**Risk Type:** Turn  
**Risk Level:** High  
**Speed Limit:** 15 KM/Hr  
**Coordinates:** 11.70223, 77.97860

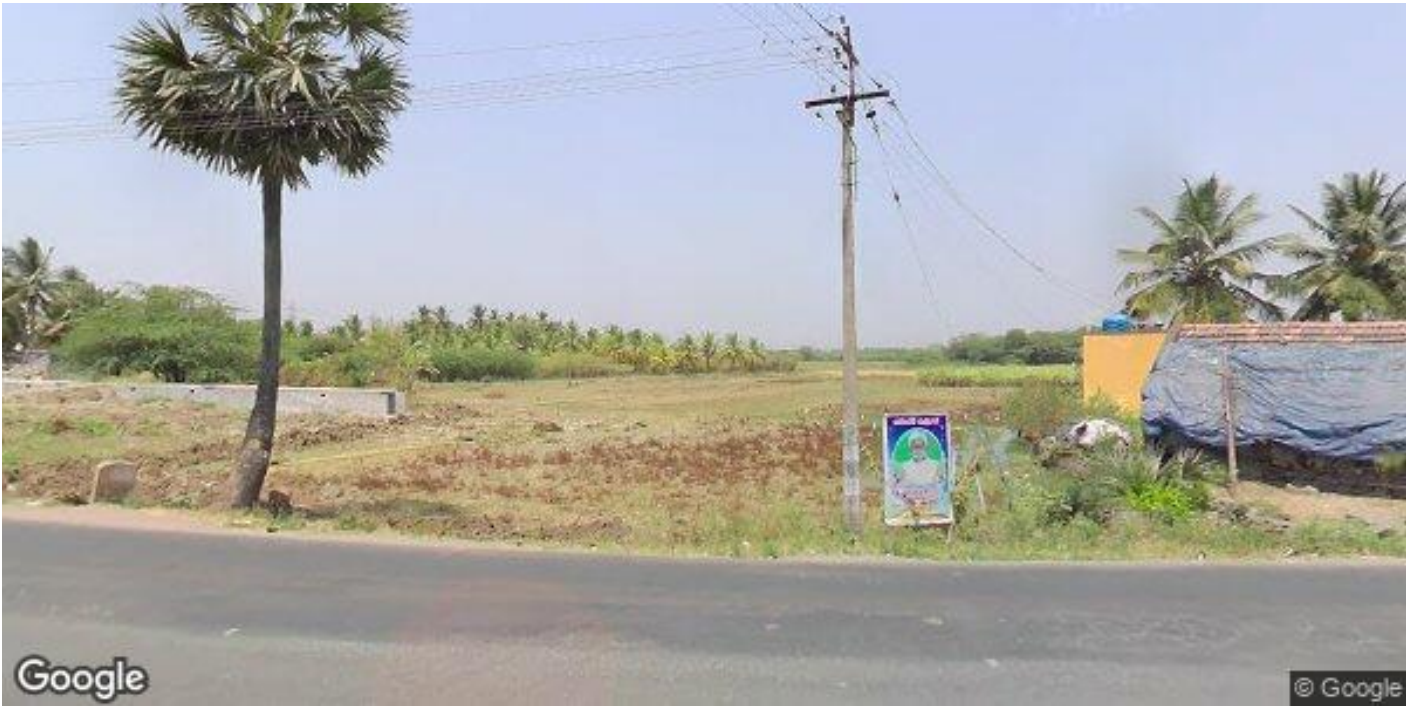
**Risk Type:** Turn  
**Risk Level:** Medium  
**Speed Limit:** 30 KM/Hr  
**Coordinates:** 11.71380, 77.99532

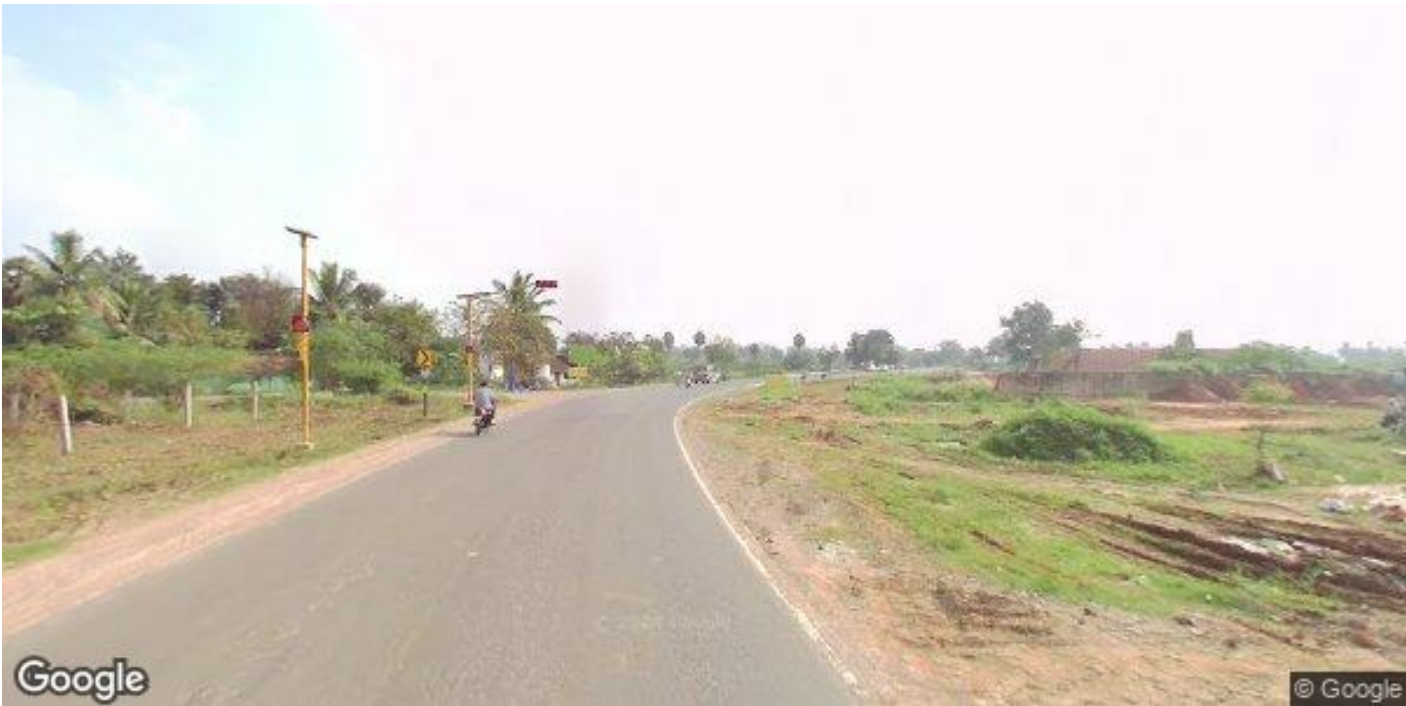
**Risk Type:** Turn  
**Risk Level:** Medium  
**Speed Limit:** 30 KM/Hr  
**Coordinates:** 11.71731, 78.00006

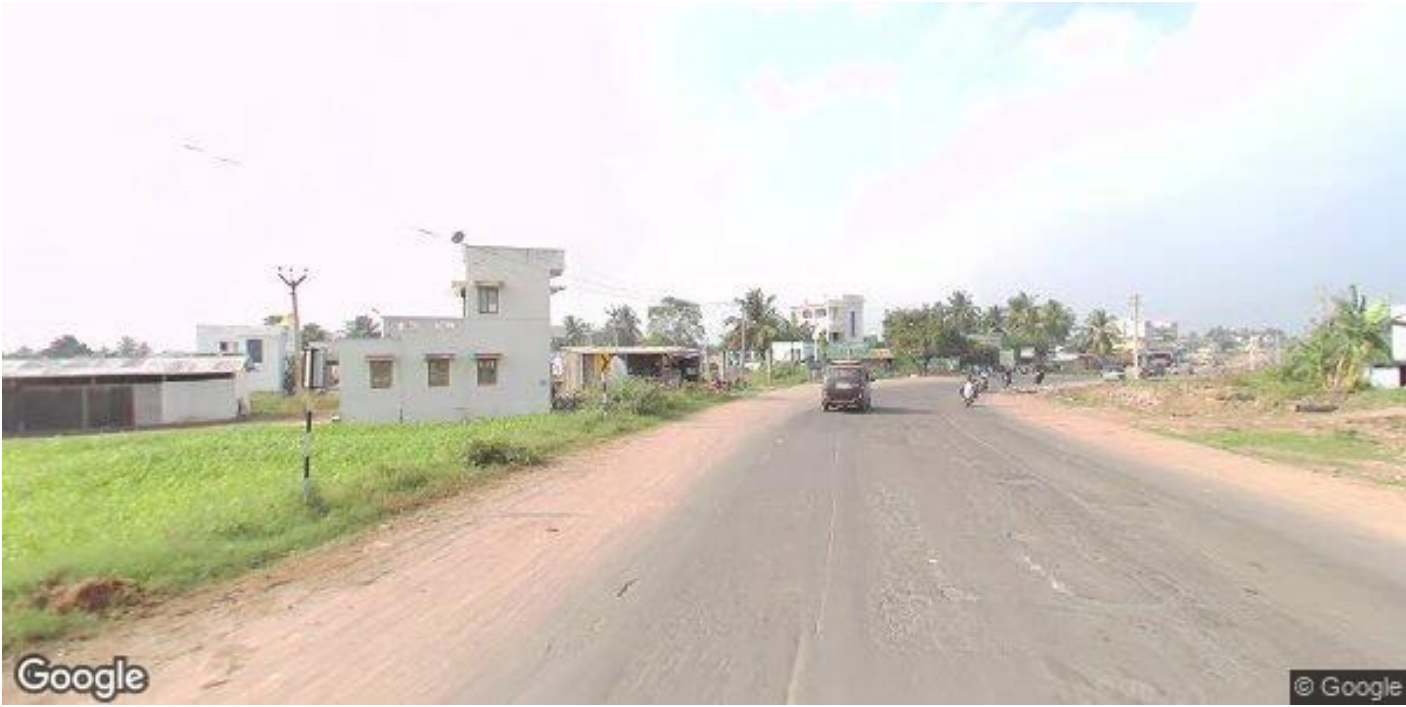
**Risk Type:** Turn  
**Risk Level:** Medium  
**Speed Limit:** 30 KM/Hr  
**Coordinates:** 11.71947, 78.01172

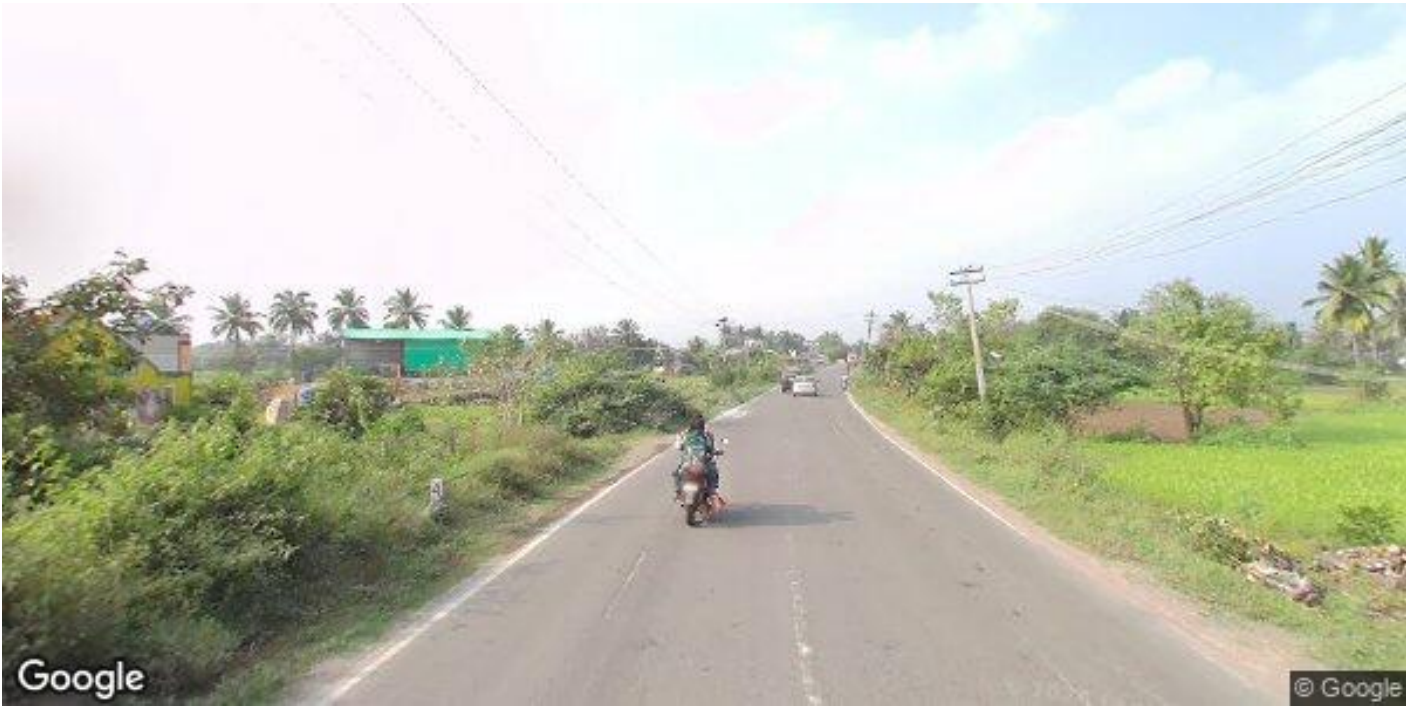
**Risk Type:** Turn  
**Risk Level:** Medium  
**Speed Limit:** 30 KM/Hr  
**Coordinates:** 11.72760, 78.02285

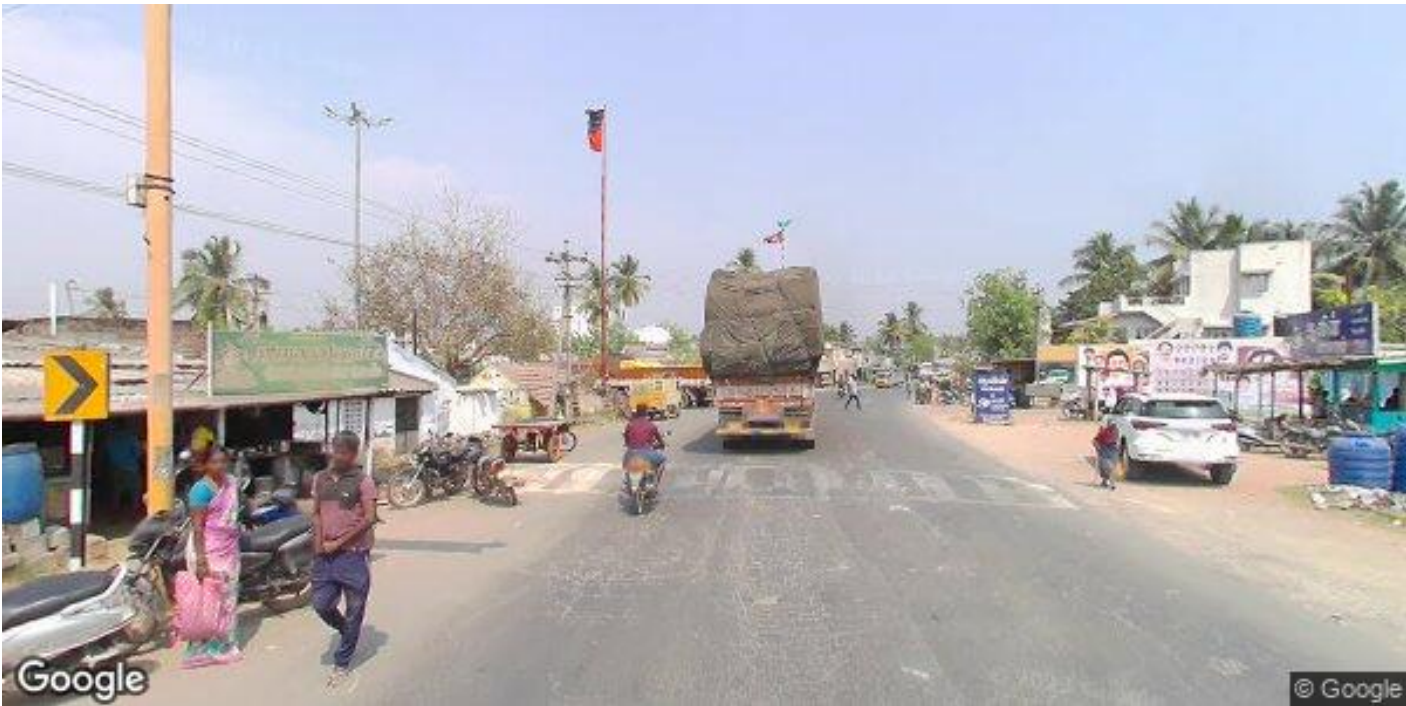
**Risk Type:** Turn  
**Risk Level:** Medium  
**Speed Limit:** 30 KM/Hr  
**Coordinates:** 11.73785, 78.03496

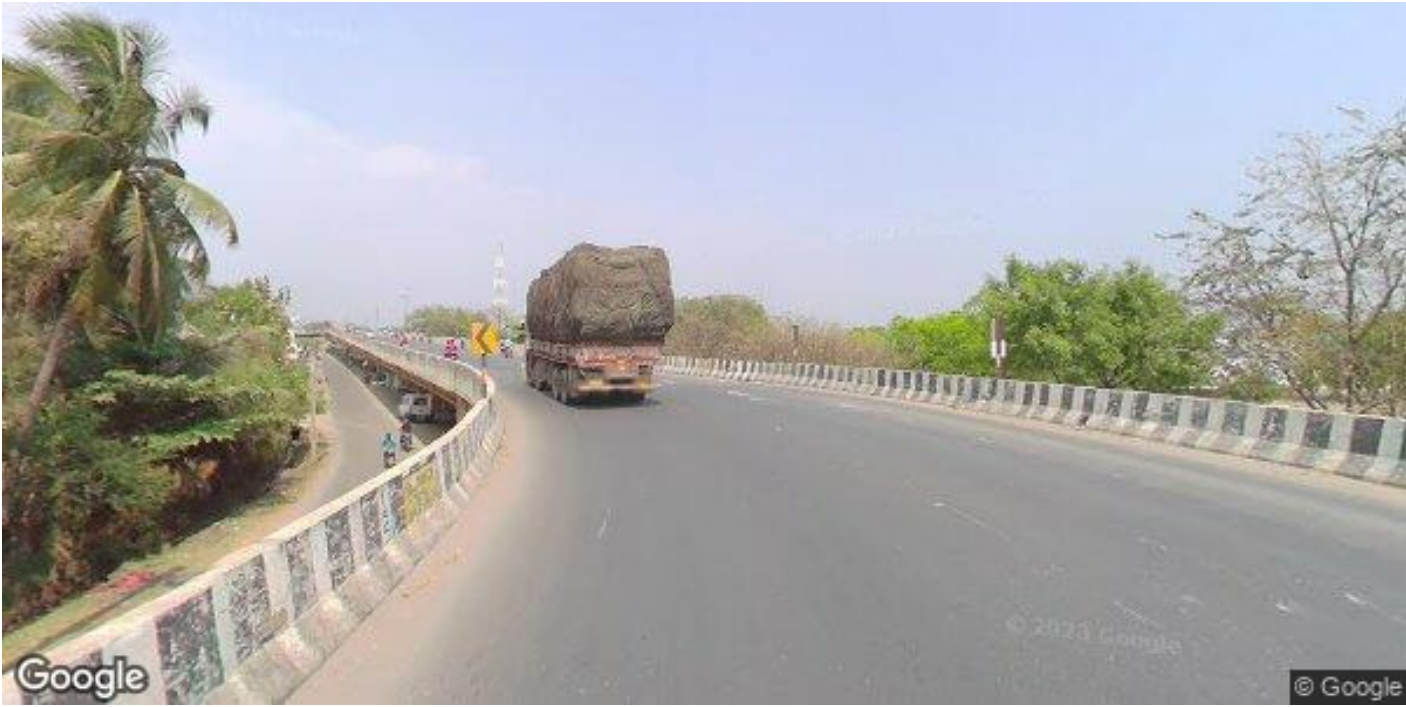
**Risk Type:** Turn  
**Risk Level:** High  
**Speed Limit:** 15 KM/Hr  
**Coordinates:** 11.73653, 78.03886

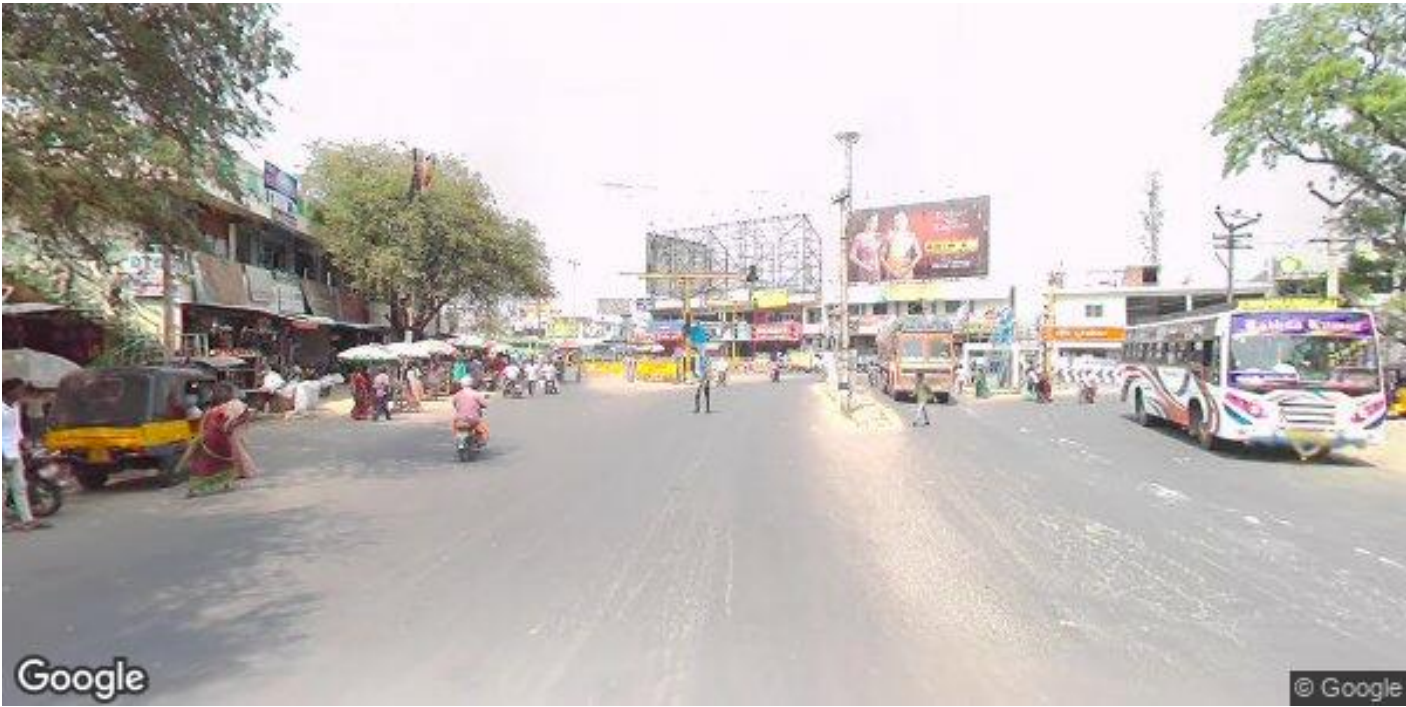
**Risk Type:** Turn  
**Risk Level:** Medium  
**Speed Limit:** 30 KM/Hr  
**Coordinates:** 11.74252, 78.04705

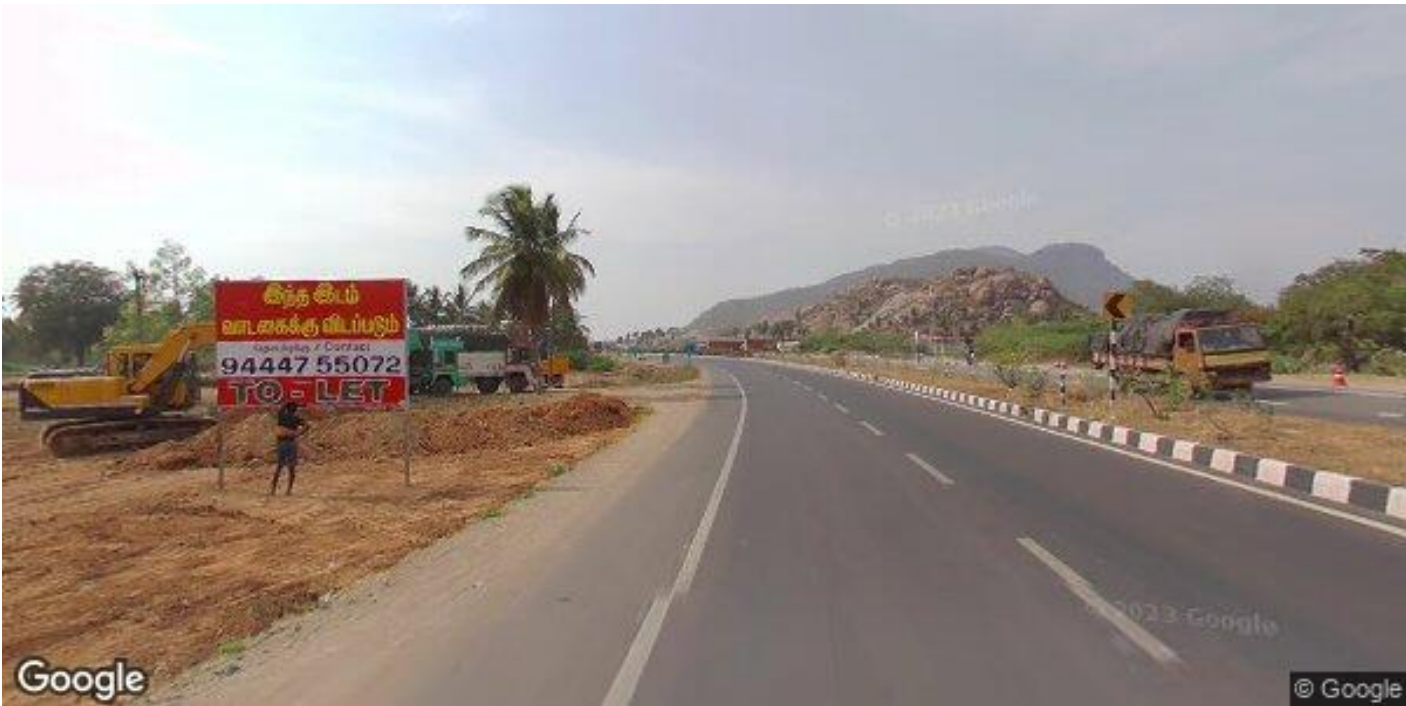
**Risk Type:** Turn  
**Risk Level:** Medium  
**Speed Limit:** 30 KM/Hr  
**Coordinates:** 11.87998, 78.08170

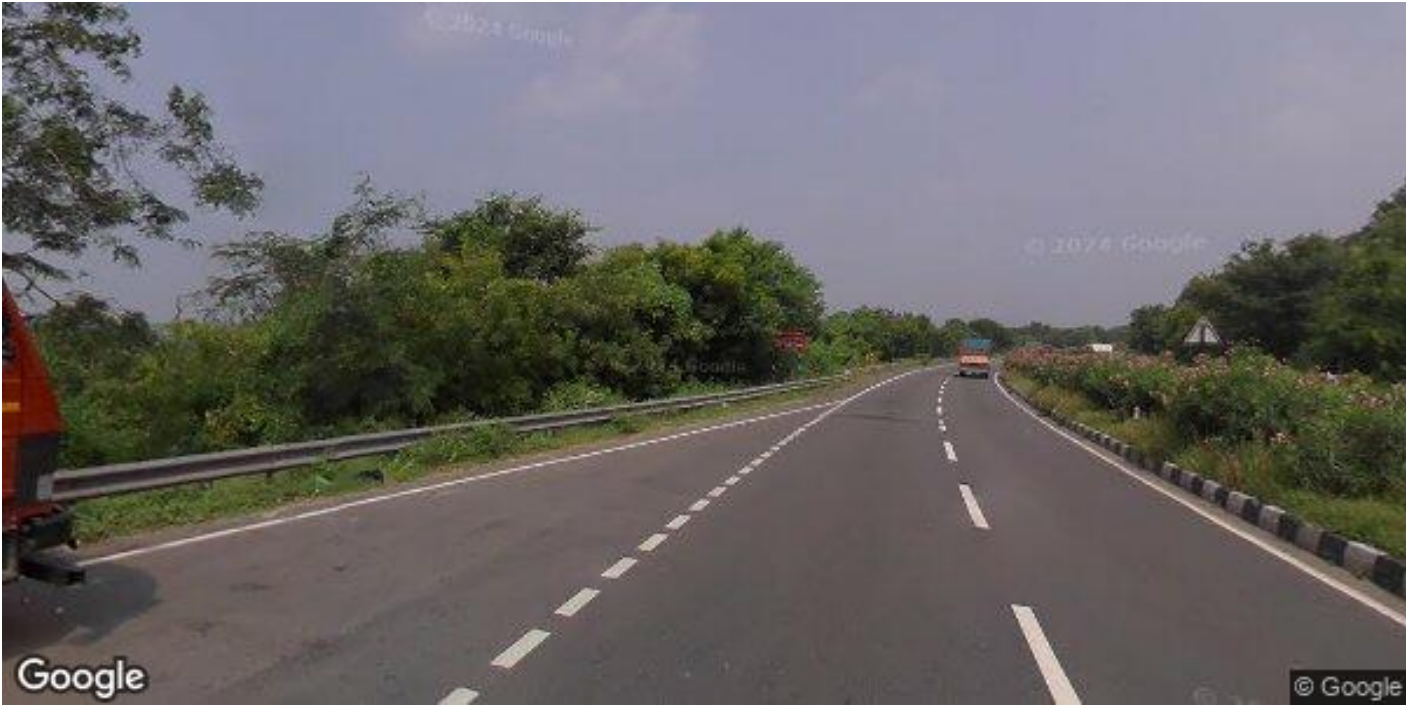
**Risk Type:** Turn  
**Risk Level:** Medium  
**Speed Limit:** 30 KM/Hr  
**Coordinates:** 11.91266, 78.05852

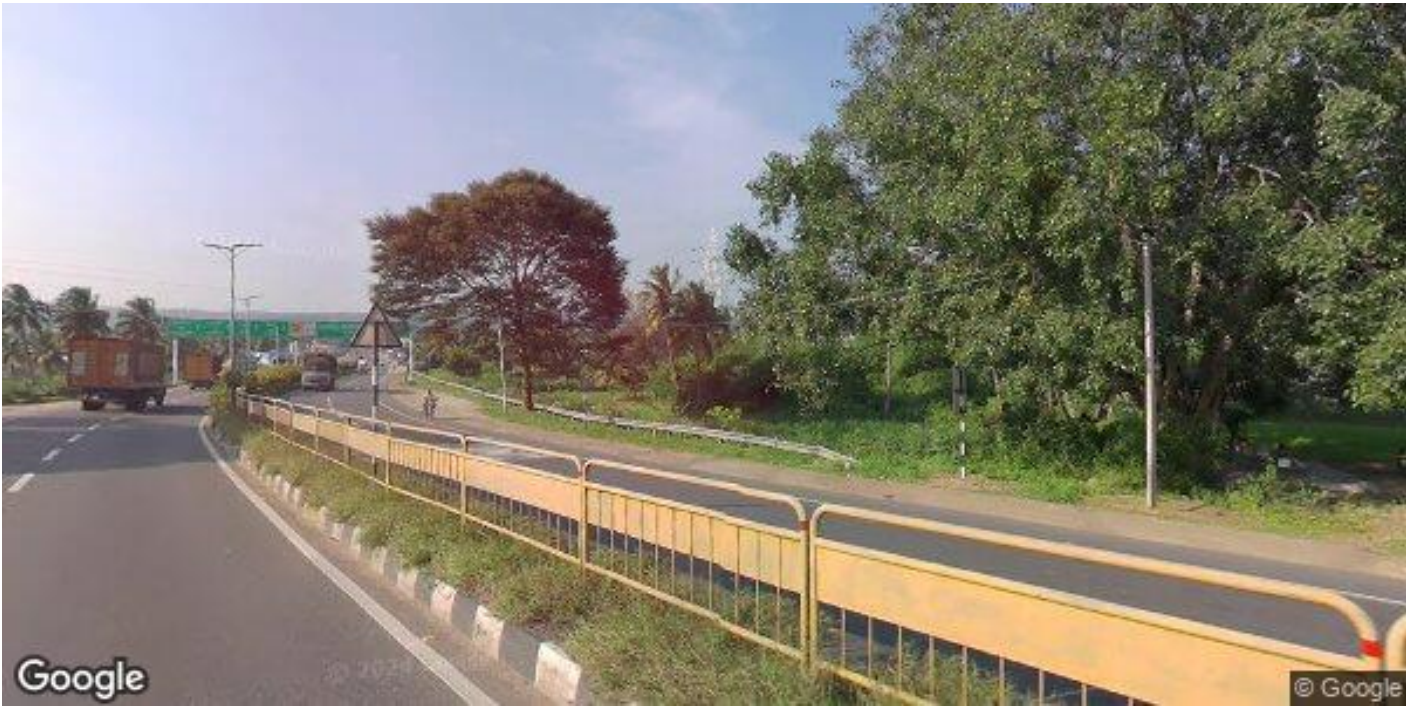
**Risk Type:** Turn  
**Risk Level:** Medium  
**Speed Limit:** 30 KM/Hr  
**Coordinates:** 11.93746, 78.05331
