# IndianOil

## JOURNEY RISK MANAGEMENT (JRM) STUDY

### Salem Terminal to CKM FUELS STATION

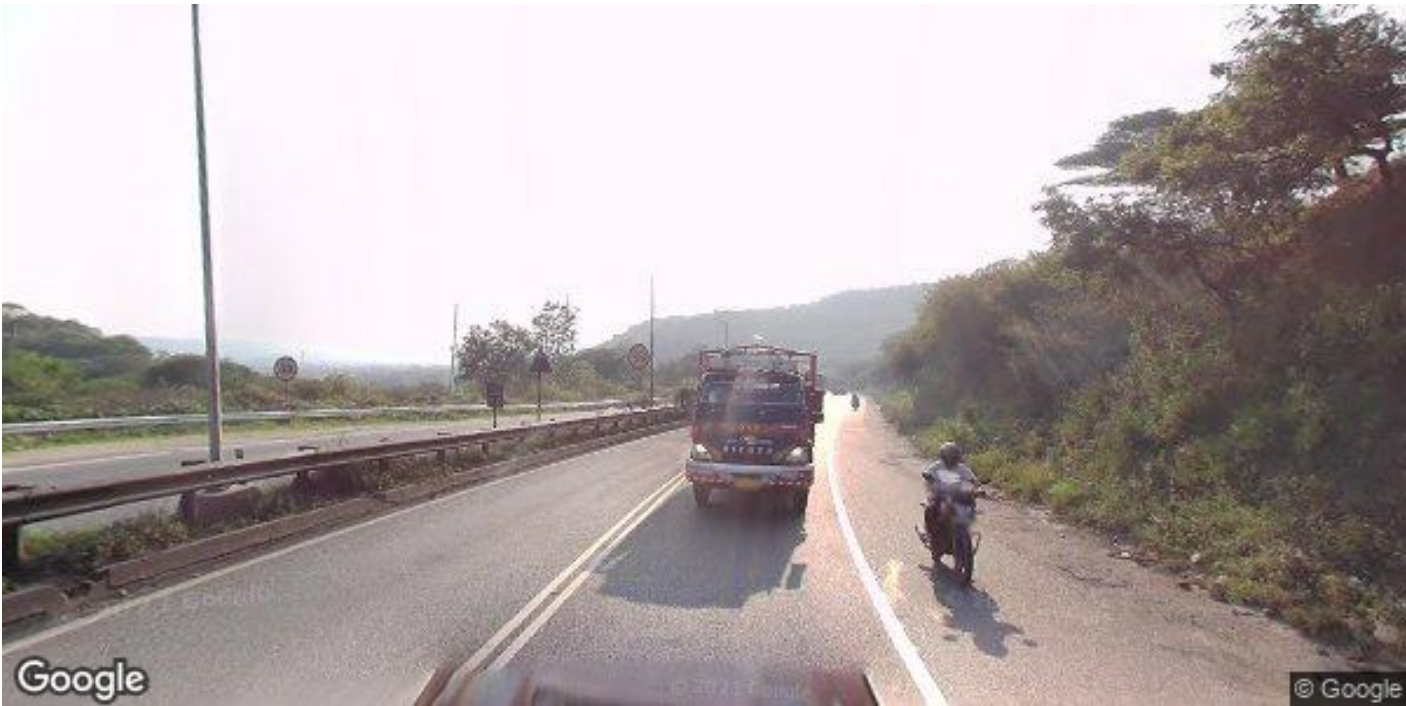
**Risk Type:** Turn  
**Risk Level:** Medium  
**Speed Limit:** 30 KM/Hr  
**Coordinates:** 11.95803, 78.04964

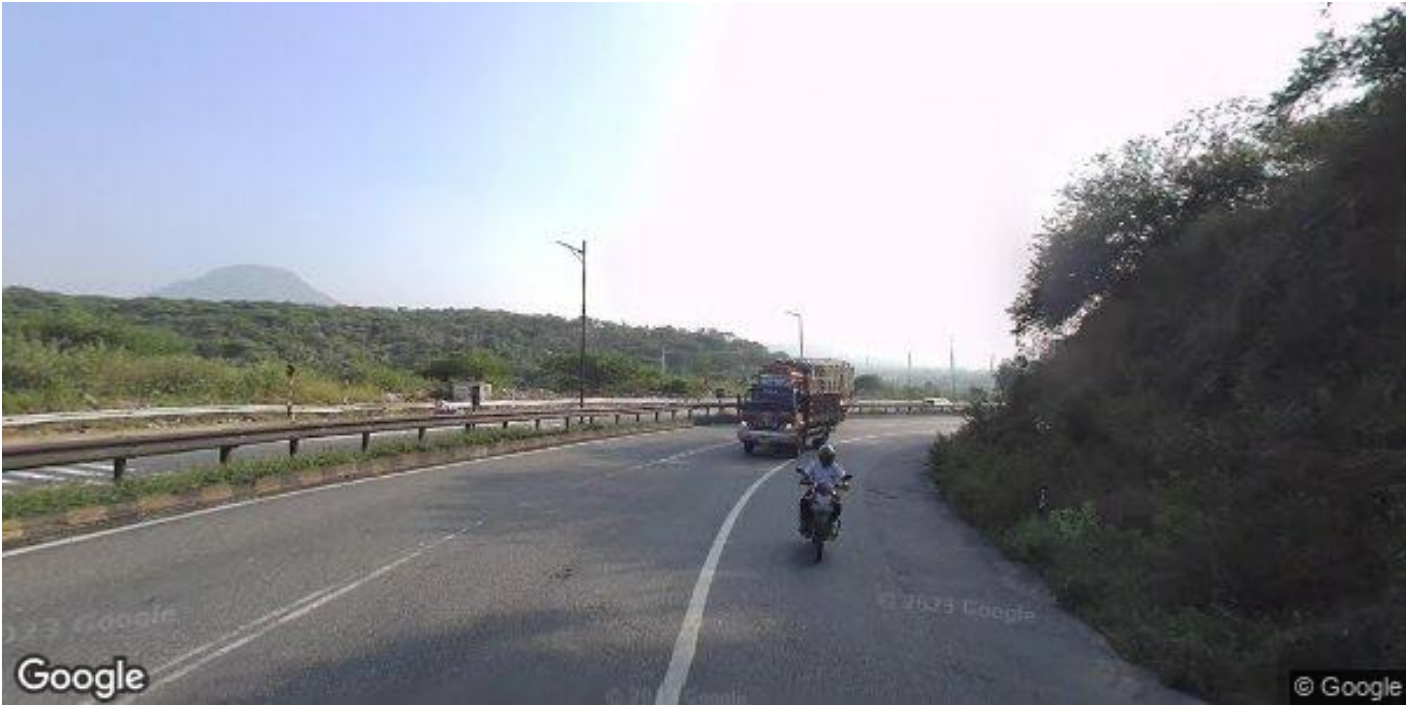
**Risk Type:** Turn  
**Risk Level:** Medium  
**Speed Limit:** 30 KM/Hr  
**Coordinates:** 11.95854, 78.04990

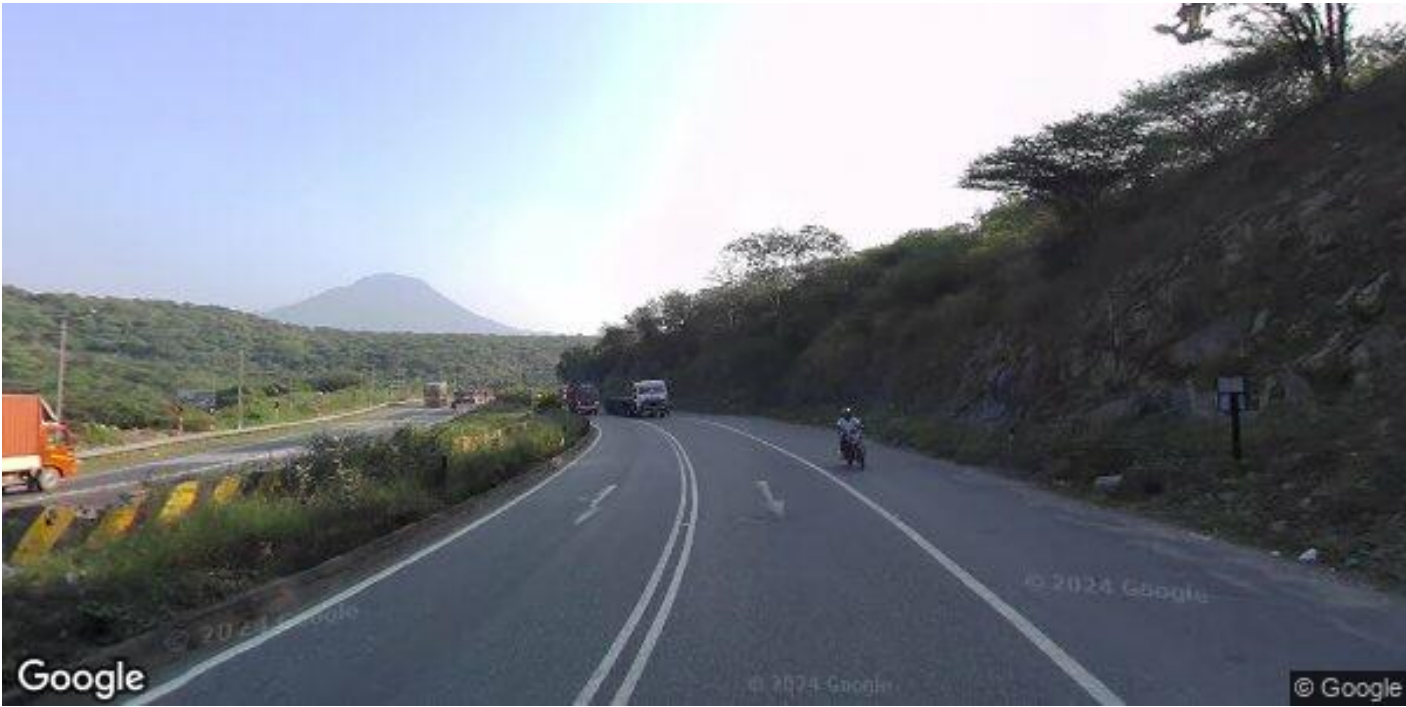
**Risk Type:** Turn  
**Risk Level:** Medium  
**Speed Limit:** 30 KM/Hr  
**Coordinates:** 11.96015, 78.04945

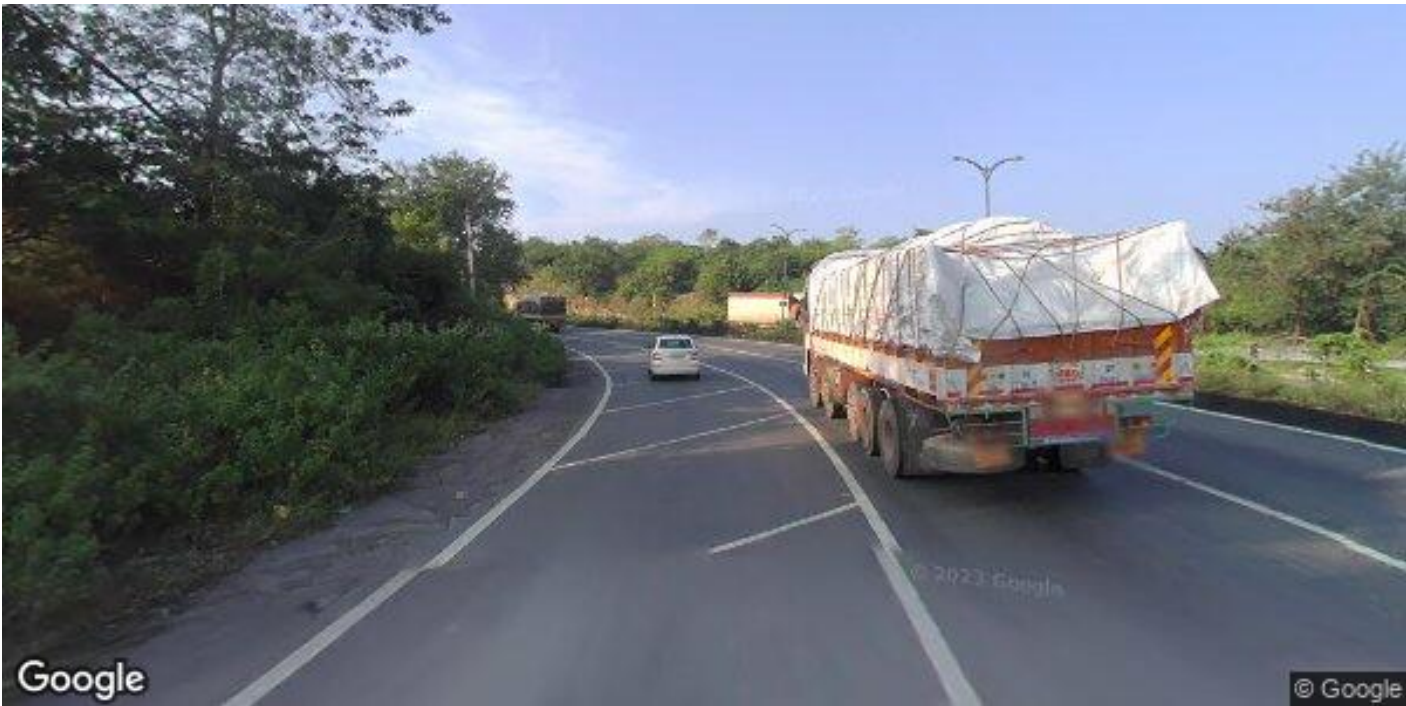
**Risk Type:** Turn  
**Risk Level:** Medium  
**Speed Limit:** 30 KM/Hr  
**Coordinates:** 11.96370, 78.05142

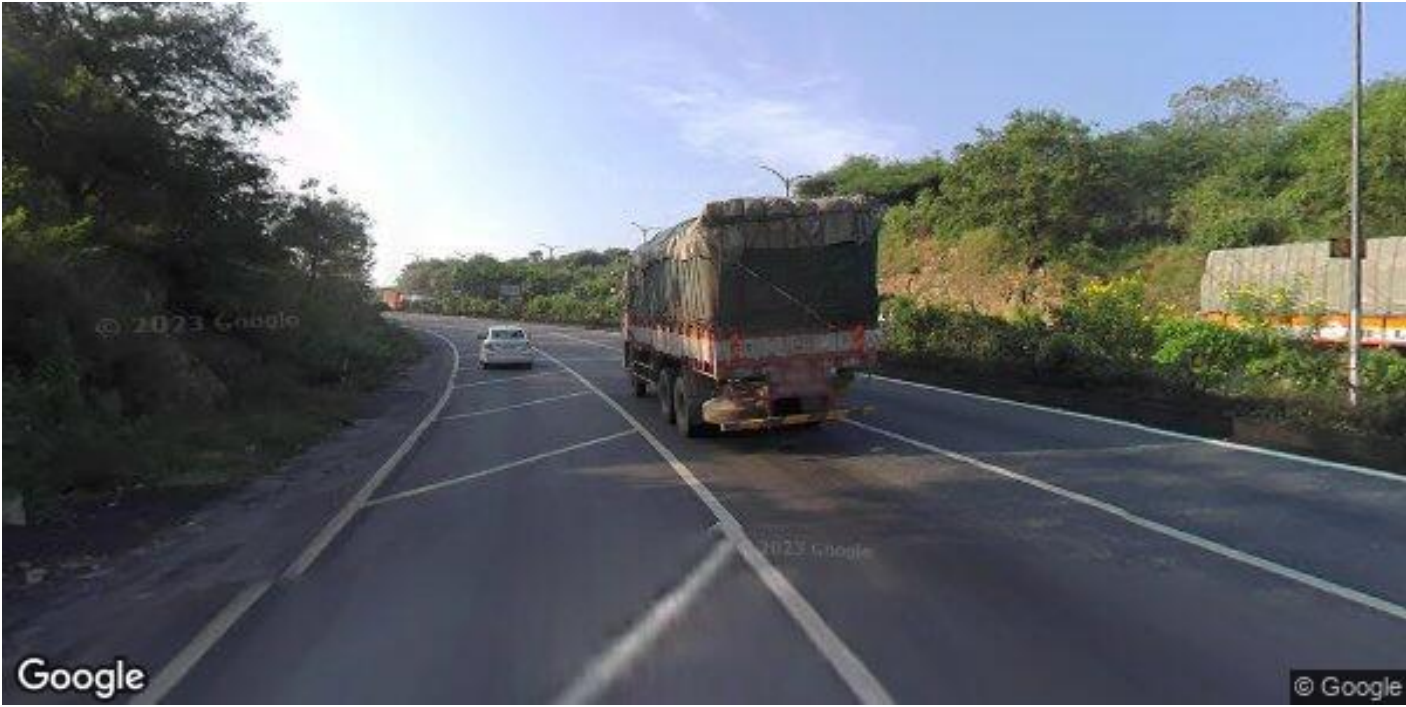
**Risk Type:** Turn  
**Risk Level:** Medium  
**Speed Limit:** 30 KM/Hr  
**Coordinates:** 11.96433, 78.05113

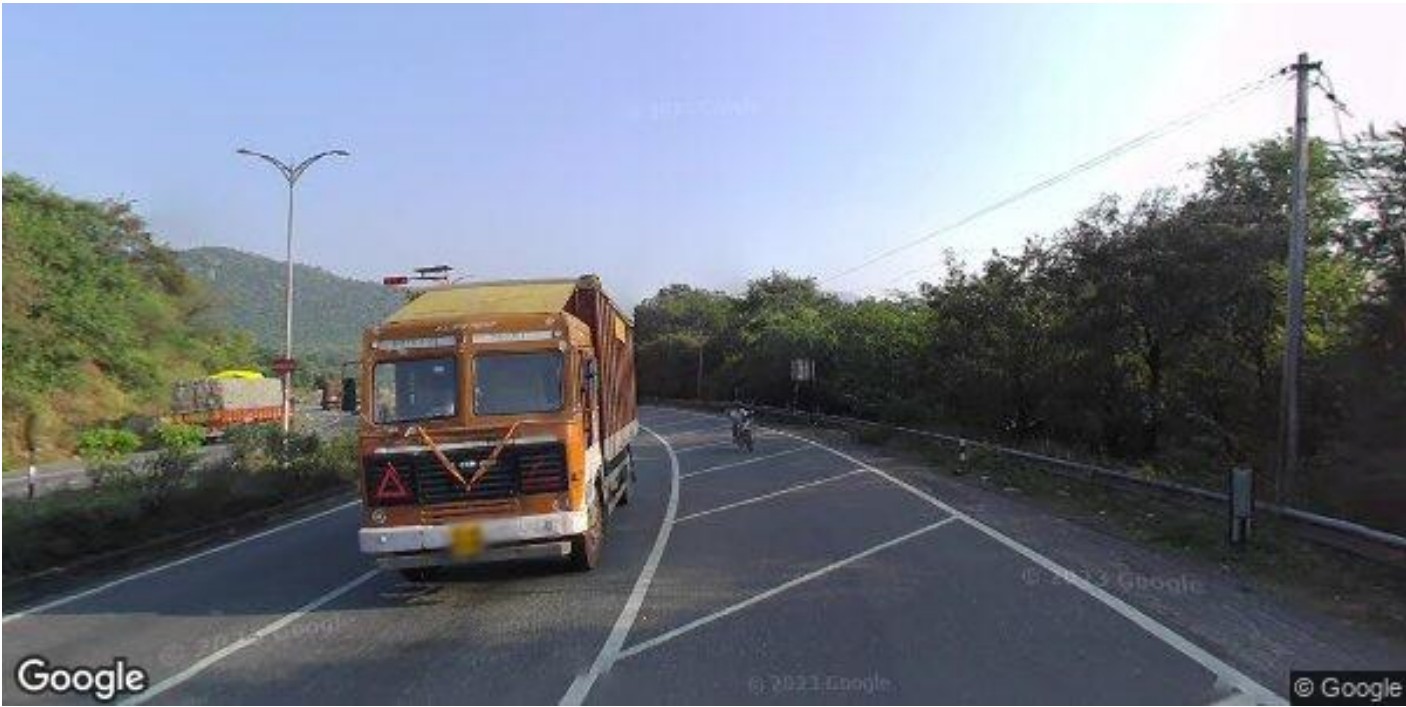
**Risk Type:** Turn  
**Risk Level:** High  
**Speed Limit:** 15 KM/Hr  
**Coordinates:** 11.96542, 78.04938

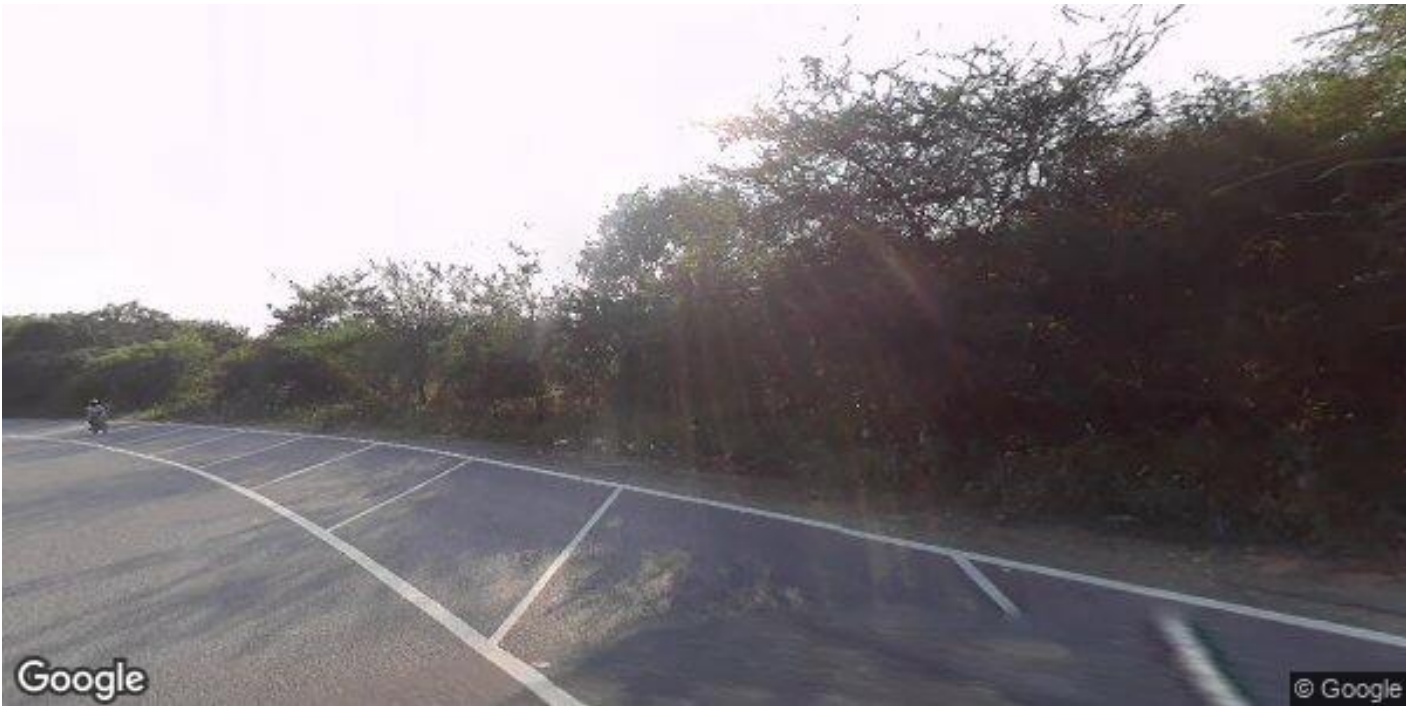
**Risk Type:** Turn  
**Risk Level:** High  
**Speed Limit:** 15 KM/Hr  
**Coordinates:** 11.96650, 78.04927

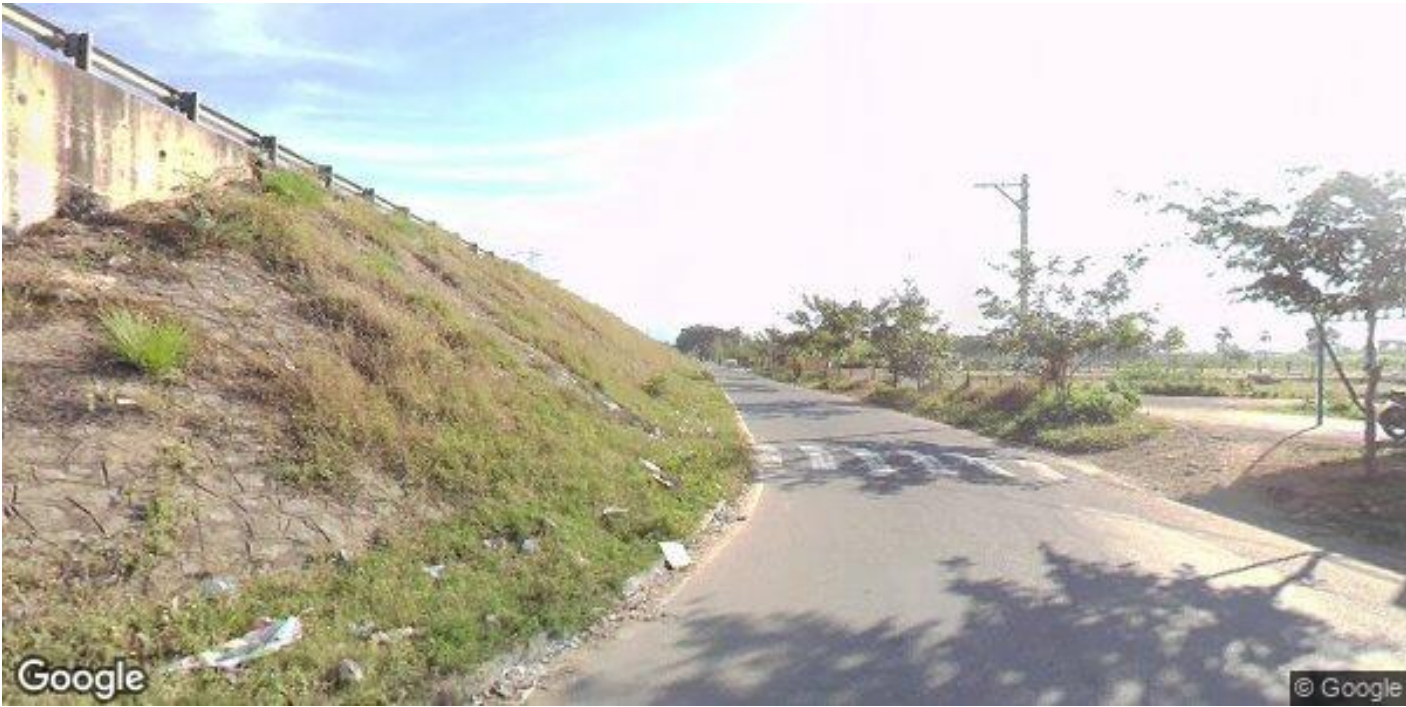
**Risk Type:** Turn  
**Risk Level:** High  
**Speed Limit:** 15 KM/Hr  
**Coordinates:** 12.05835, 78.10789

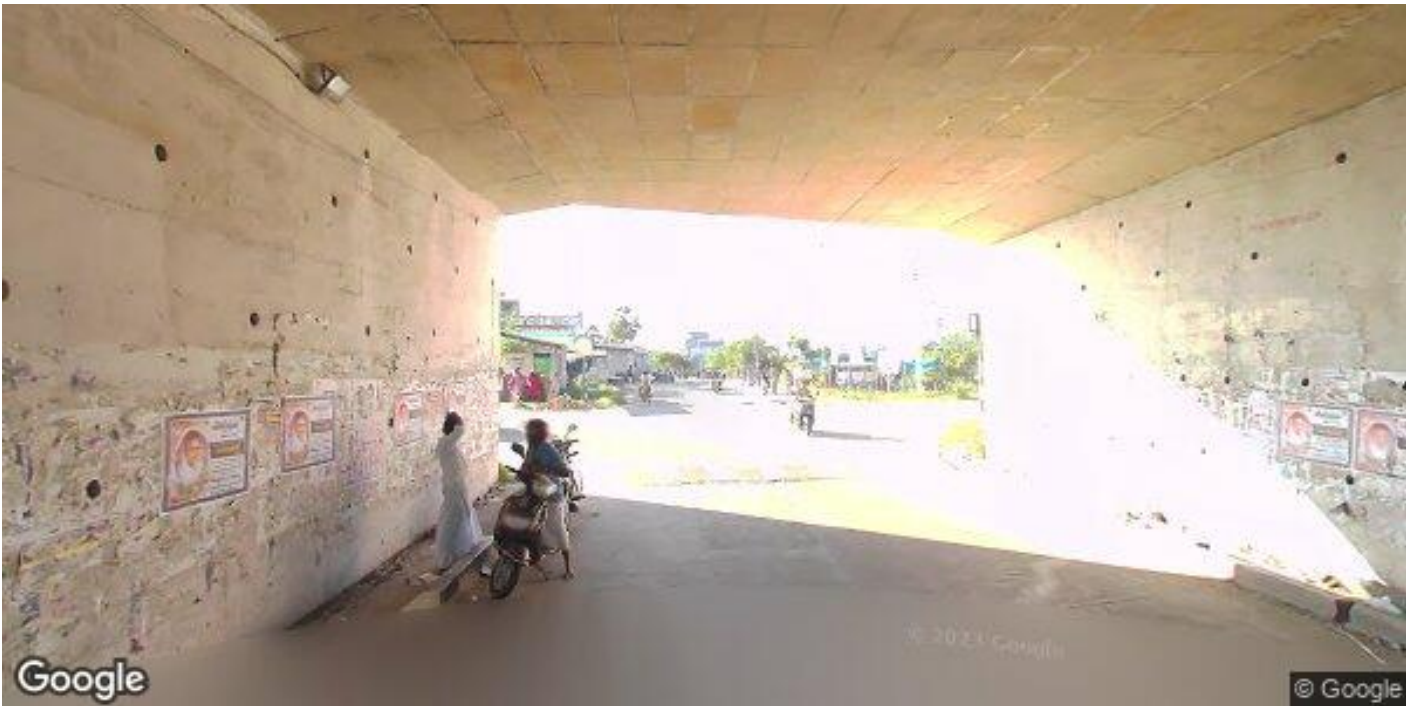
**Risk Type:** Turn  
**Risk Level:** Medium  
**Speed Limit:** 30 KM/Hr  
**Coordinates:** 12.05840, 78.10812

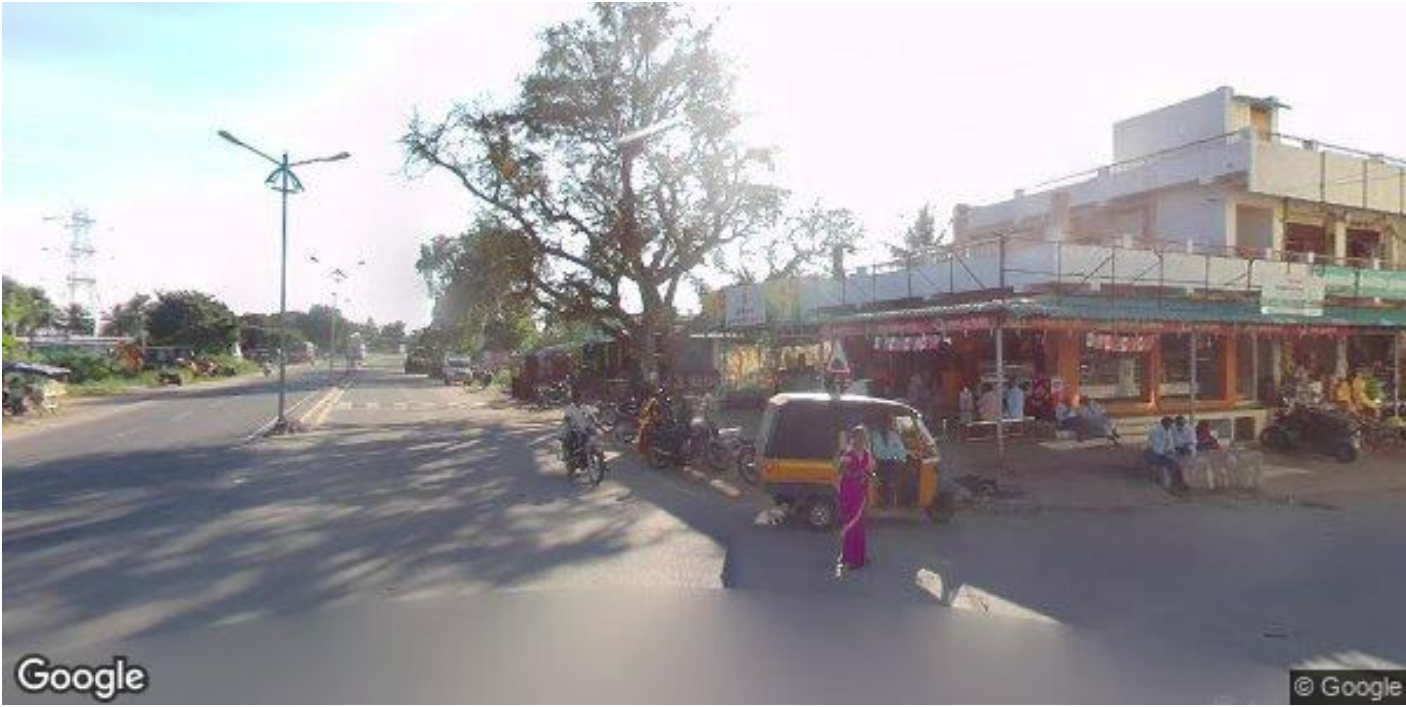
**Risk Type:** Blind Spot  
**Risk Level:** Blind Spot  
**Speed Limit:** 10 KM/Hr  
**Coordinates:** 12.05721, 78.11107
