# IndianOil

## JOURNEY RISK MANAGEMENT (JRM) STUDY

### Salem Terminal TO PONNI FUELS

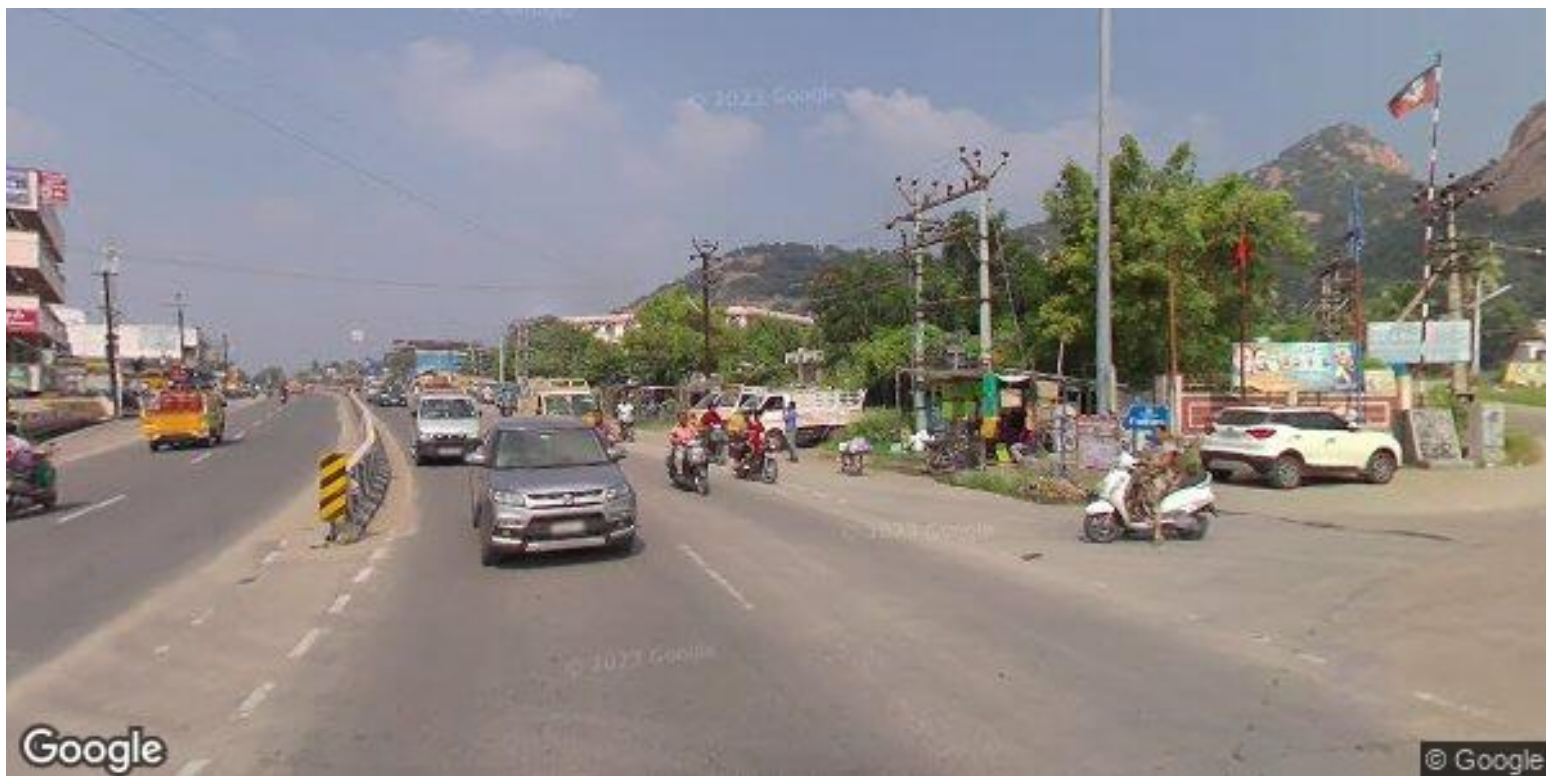
| | Risk Type | Risk Level | Coordinates | Speed Limit |
|---|---|---|---|---|
| 5 | Turn | Medium | 11.39671, 77.88878 | 30 KM/Hr |

**Risk Type:** Turn  
**Risk Level:** Medium  
**Speed Limit:** 30 KM/Hr  
**Coordinates:** 11.39671, 77.88878

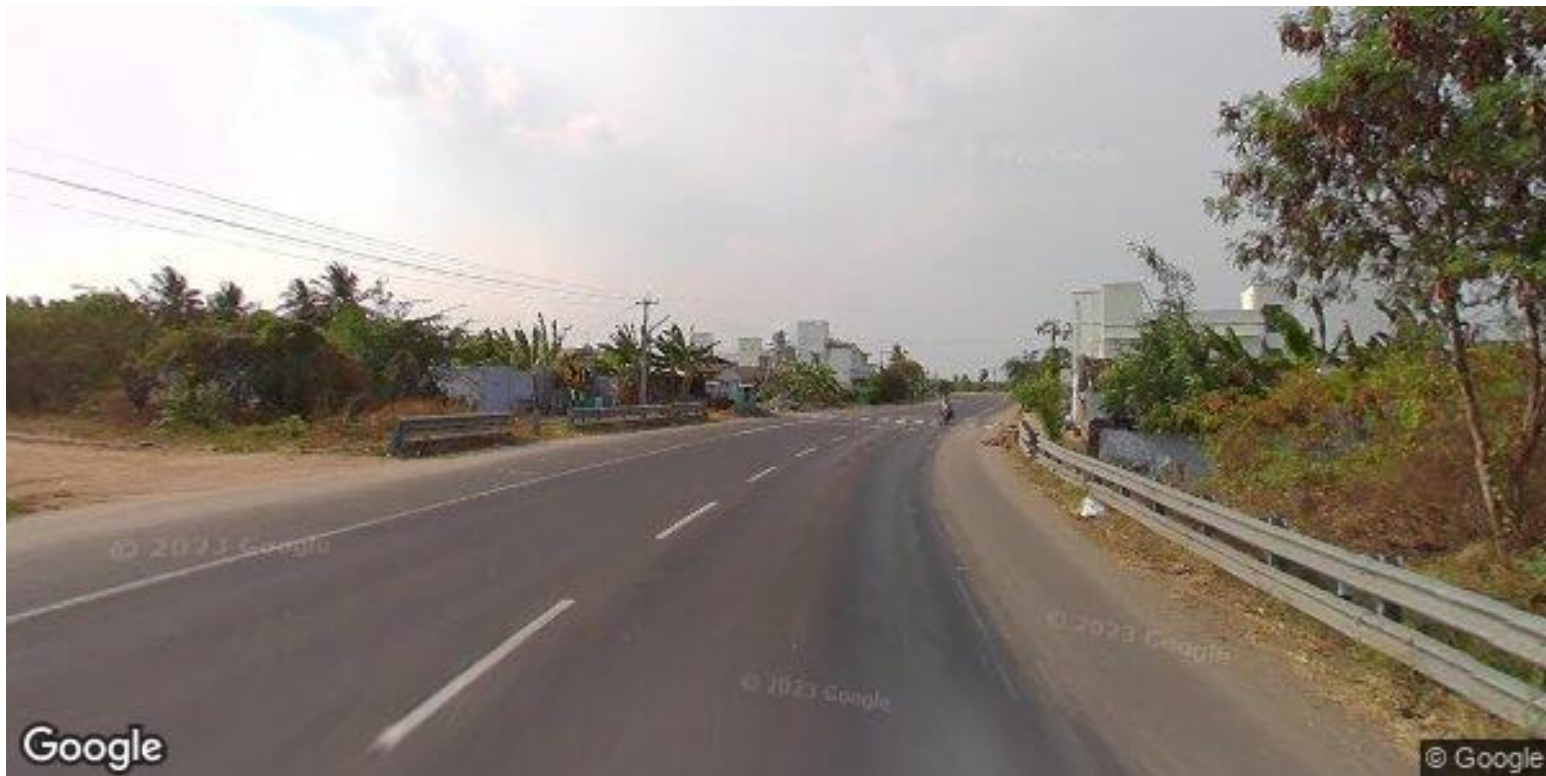
Coordinates: 11.16764, 78.01565

| | Risk Type | Risk Level | Coordinates | Speed Limit |
|---|---|---|---|---|
| 8 | Turn | Medium | 11.16764, 78.01565 | 30 KM/Hr |

Risk Type: Turn

Risk Level: Medium

Speed Limit: 30 KM/Hr

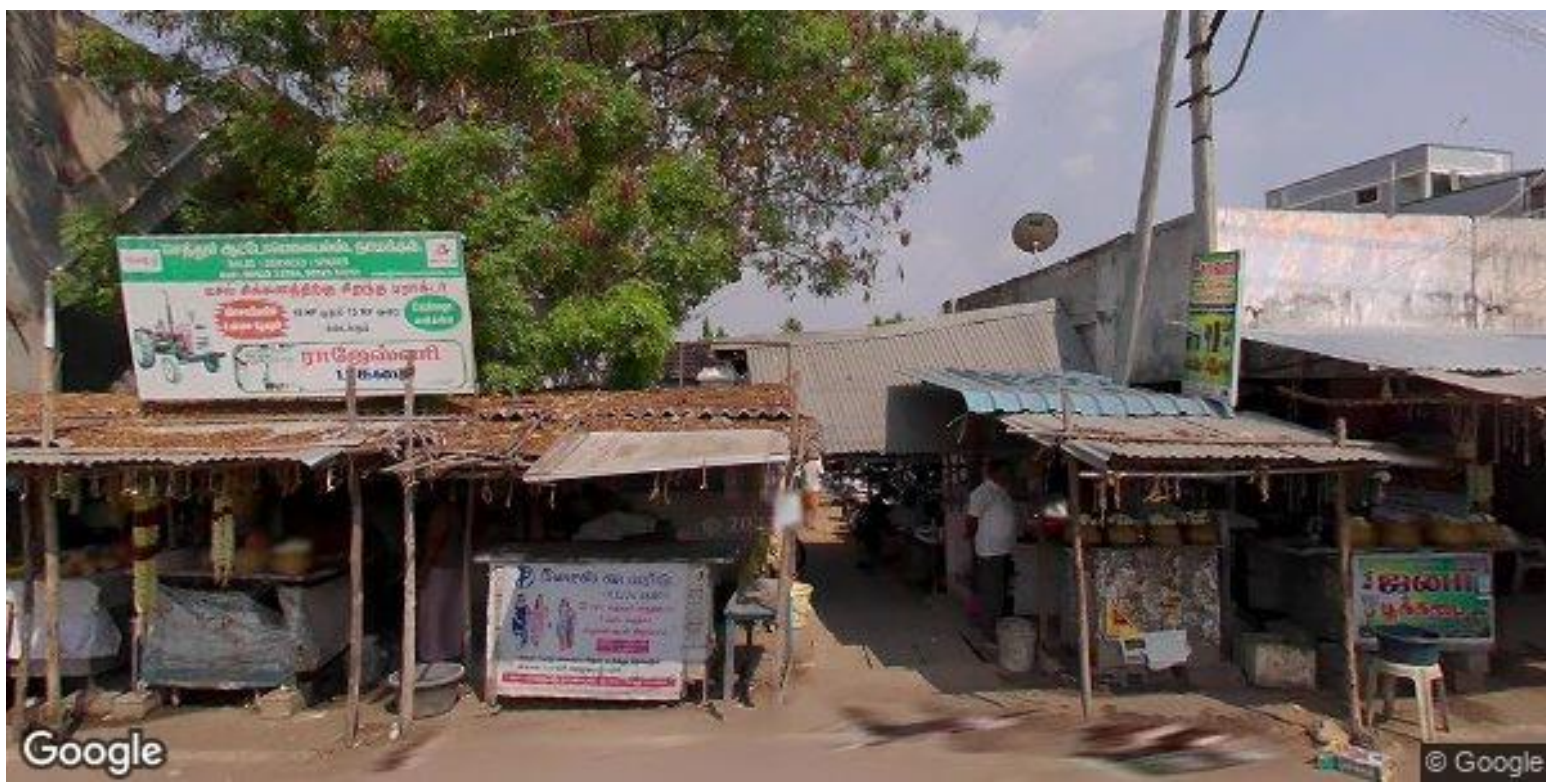
**Coordinates:** 11.15573, 78.02176

| | Risk Type | Risk Level | Coordinates | Speed Limit |
|---|---|---|---|---|
| 9 | Turn | High | 11.15573, 78.02176 | 15 KM/Hr |

**Risk Type:** Turn

**Risk Level:** High

**Speed Limit:** 15 KM/Hr

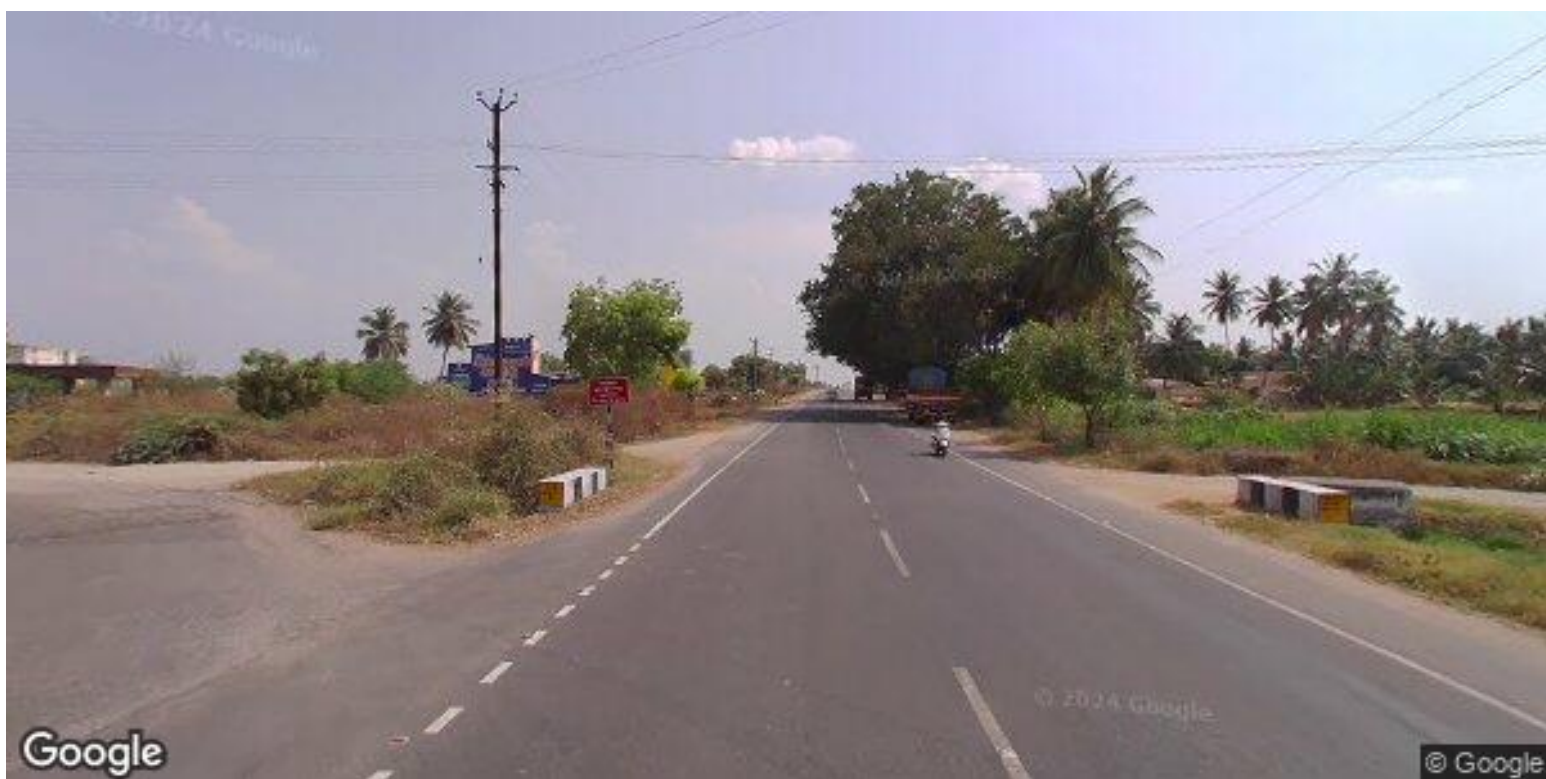
**Coordinates:** 11.14545, 78.02208

| | Risk Type | Risk Level | Coordinates | Speed Limit |
|---|---|---|---|---|
| 10 | Turn | High | 11.14545, 78.02208 | 15 KM/Hr |

**Risk Type:** Turn

**Risk Level:** High

**Speed Limit:** 15 KM/Hr

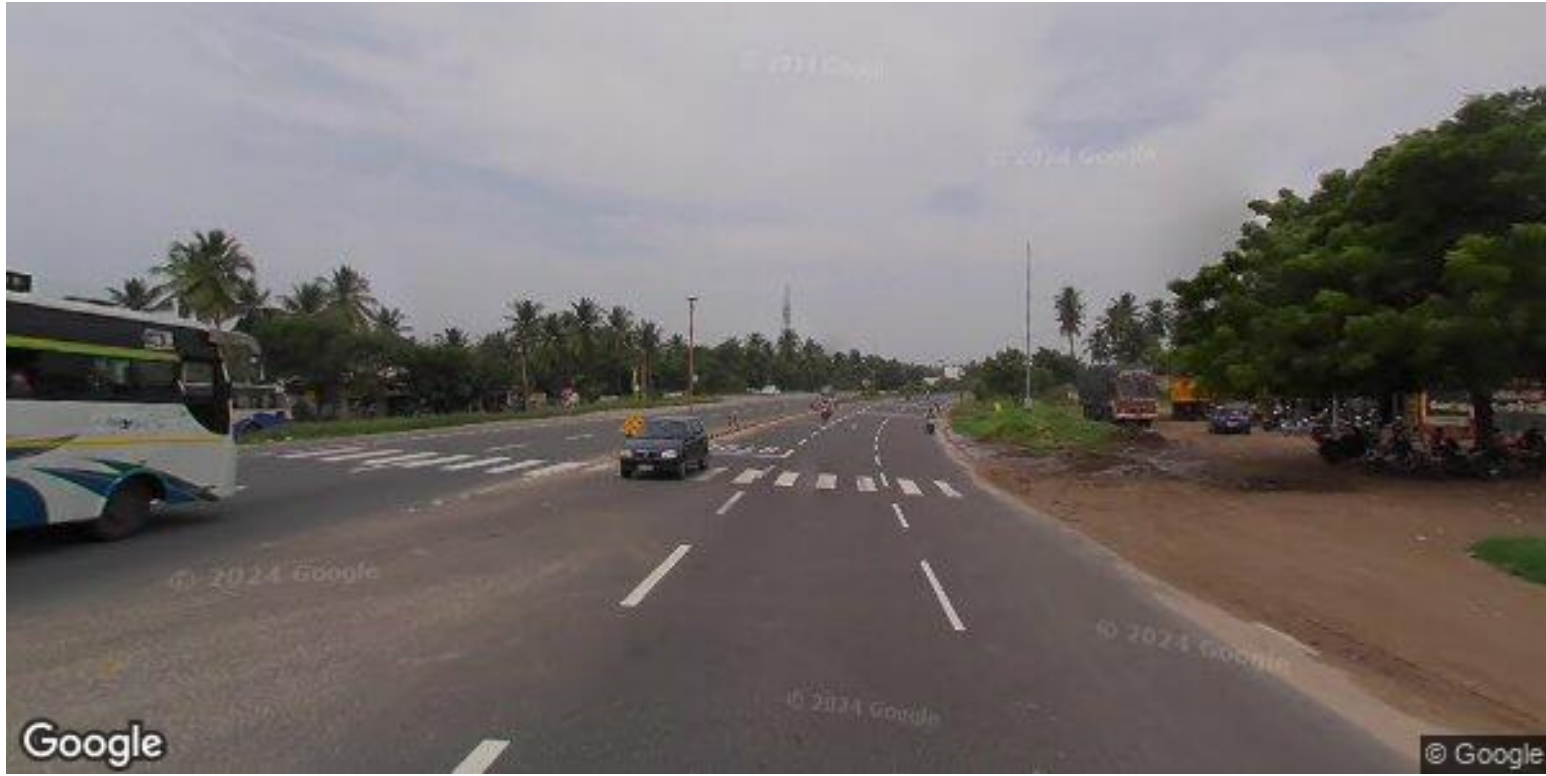
| | Risk Type | Risk Level | Coordinates | Speed Limit |
|---|---|---|---|---|
| 12 | Turn | High | 11.12555, 78.01664 | 15 KM/Hr |

**Risk Type:** Turn  
**Risk Level:** High  
**Speed Limit:** 15 KM/Hr  
**Coordinates:** 11.12555, 78.01664

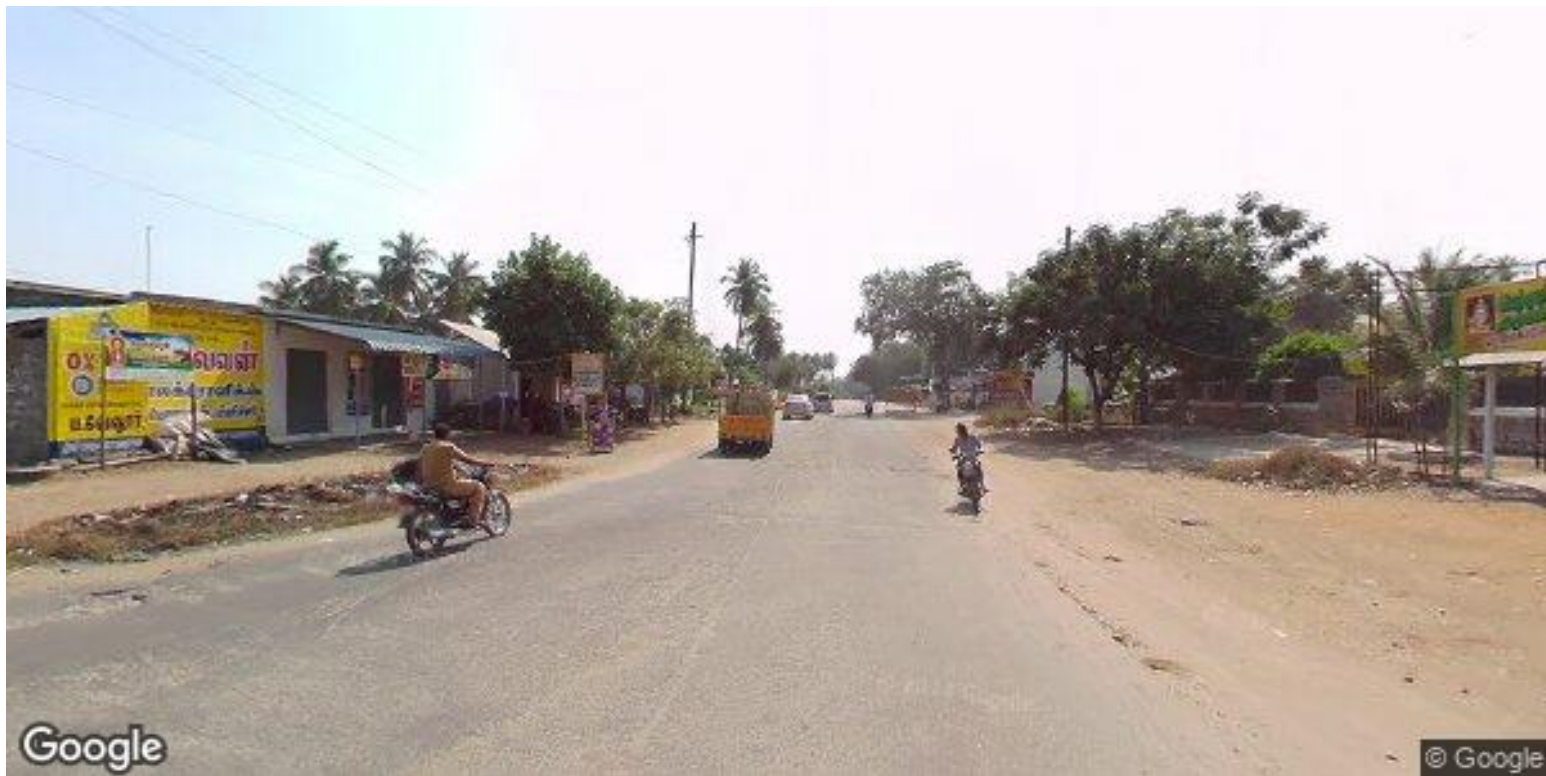
| | Risk Type | Risk Level | Coordinates | Speed Limit |
|---|---|---|---|---|
| 13 | Turn | High | 11.12540, 78.01613 | 15 KM/Hr |

**Risk Type:** Turn  
**Risk Level:** High  
**Speed Limit:** 15 KM/Hr  
**Coordinates:** 11.12540, 78.01613

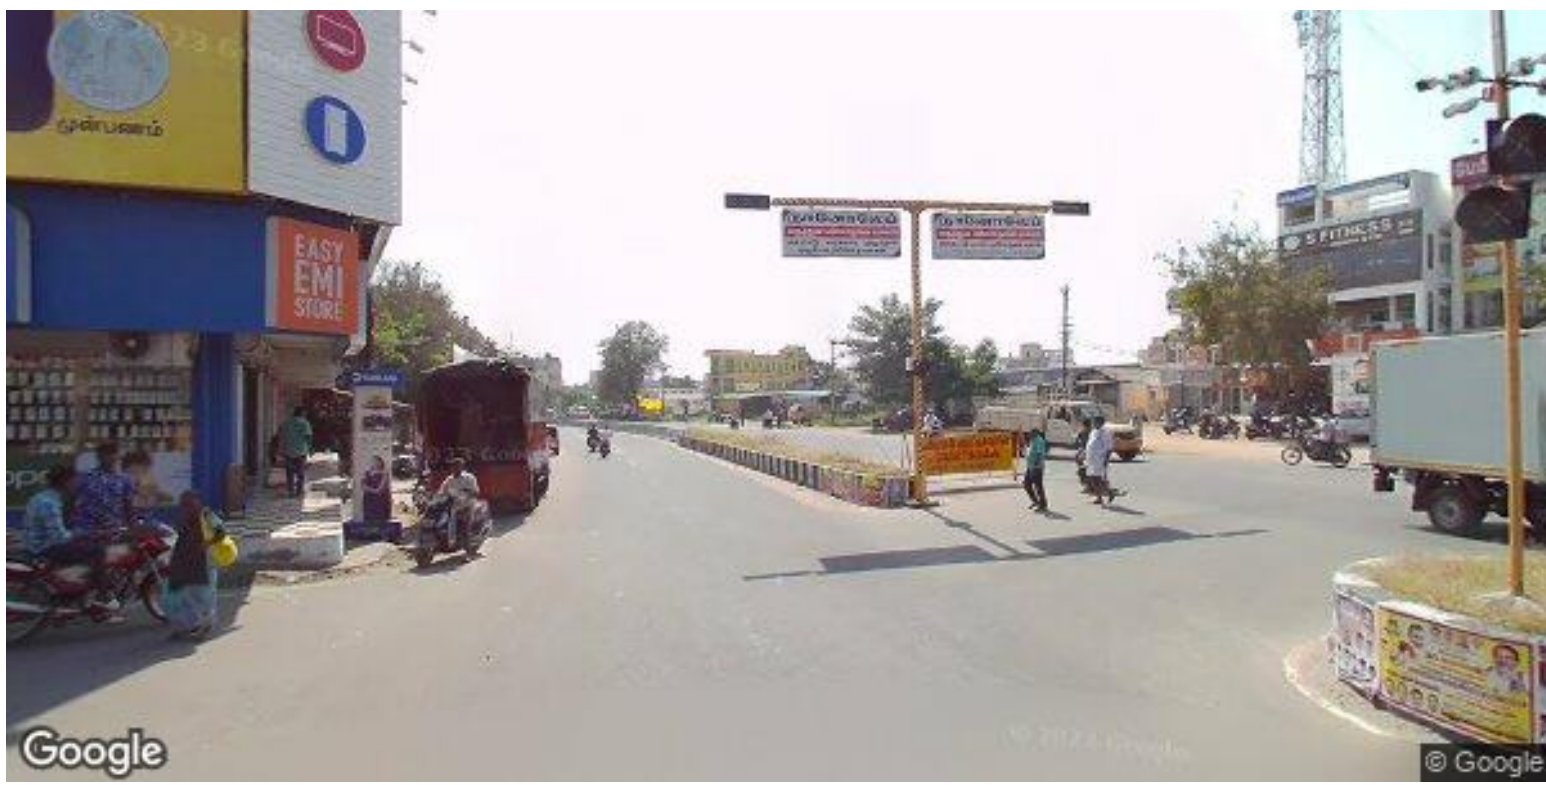
**Coordinates:** 11.11211, 78.00450

| | Risk Type | Risk Level | Coordinates | Speed Limit |
|---|---|---|---|---|
| 14 | Turn | High | 11.11211, 78.00450 | 15 KM/Hr |

**Risk Type:** Turn

**Risk Level:** High

**Speed Limit:** 15 KM/Hr
