# IndianOil

## JOURNEY RISK MANAGEMENT (JRM) STUDY

### Salem Terminal TO RKV PETROL BUNK

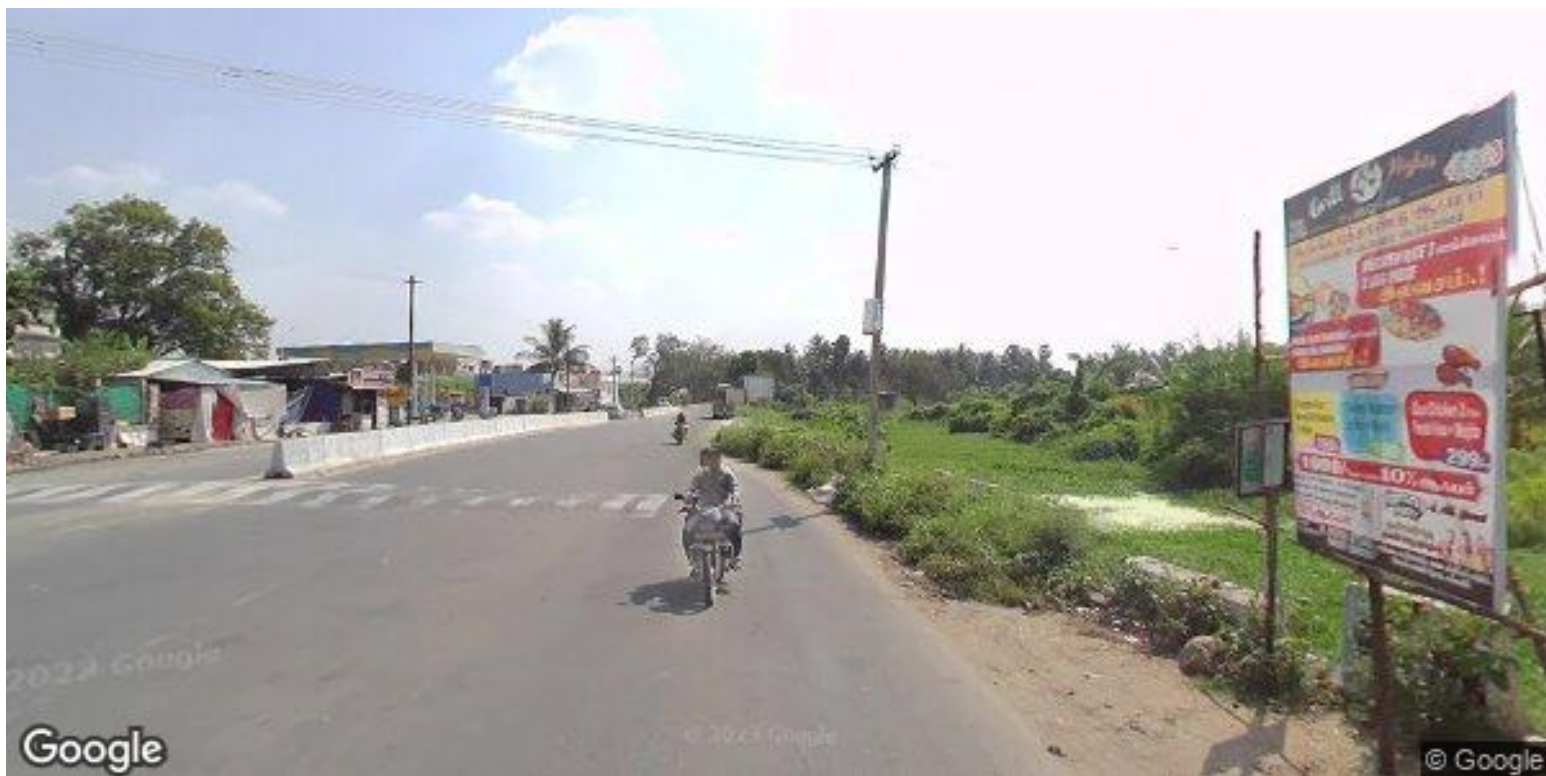
**Coordinates:** 11.44861, 77.87429

**Risk Type:** Turn

**Risk Level:** High

**Speed Limit:** 15 KM/Hr

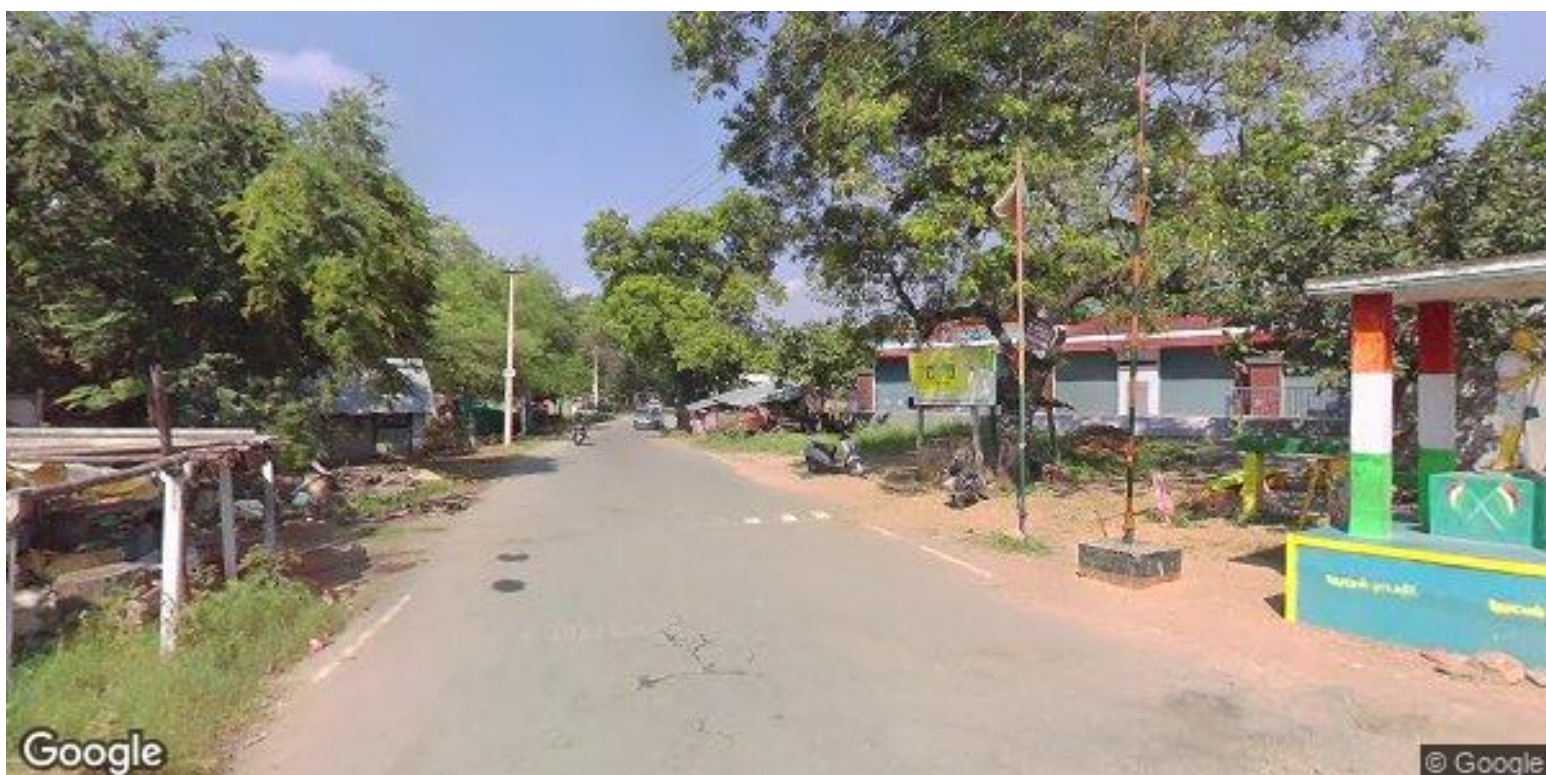
**Risk Type:** Turn  
**Risk Level:** High  
**Speed Limit:** 15 KM/Hr  
**Coordinates:** 11.43673, 77.91703

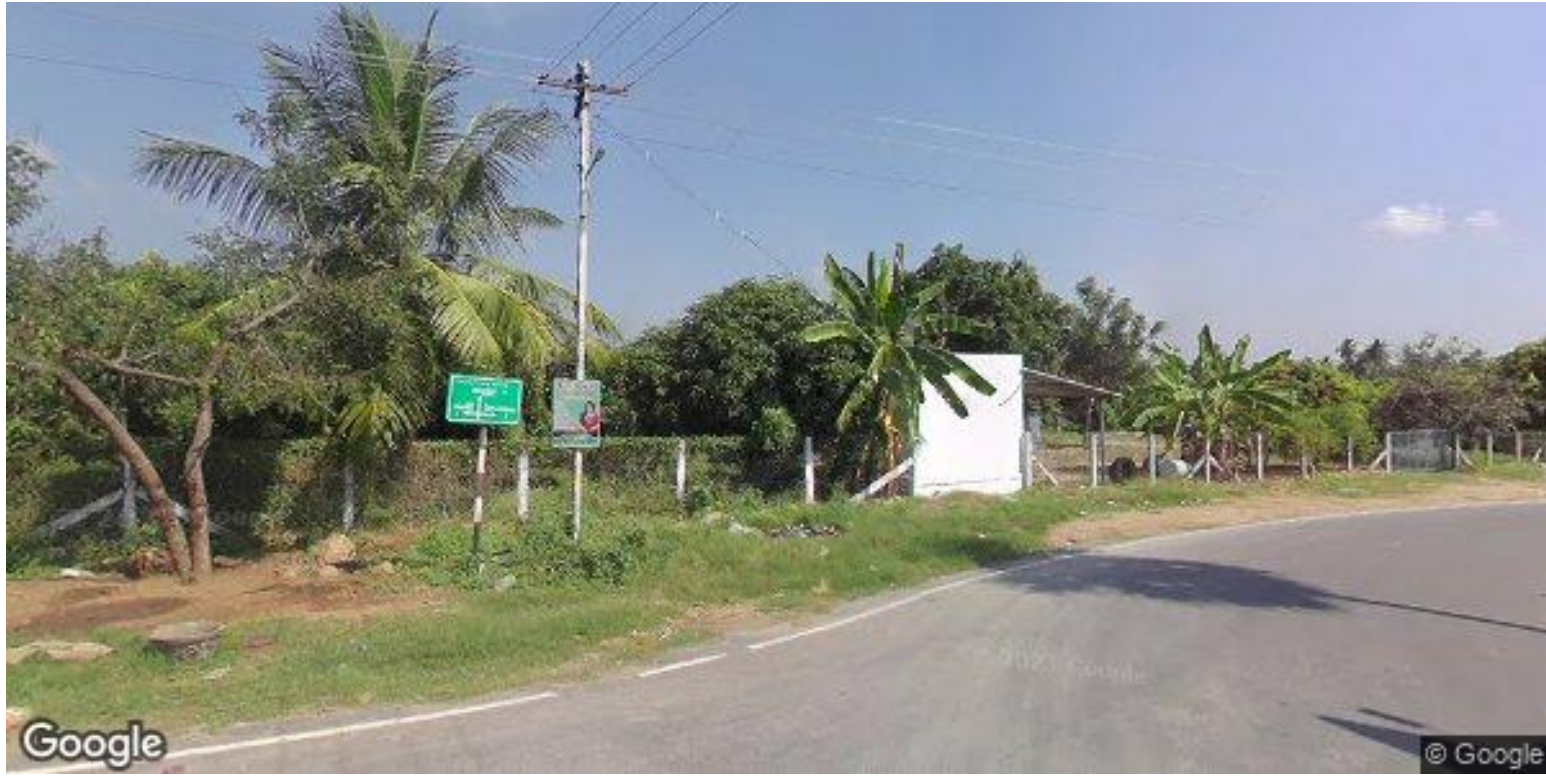
**Risk Type:** Turn  
**Risk Level:** High  
**Speed Limit:** 15 KM/Hr  
**Coordinates:** 11.43926, 77.91705

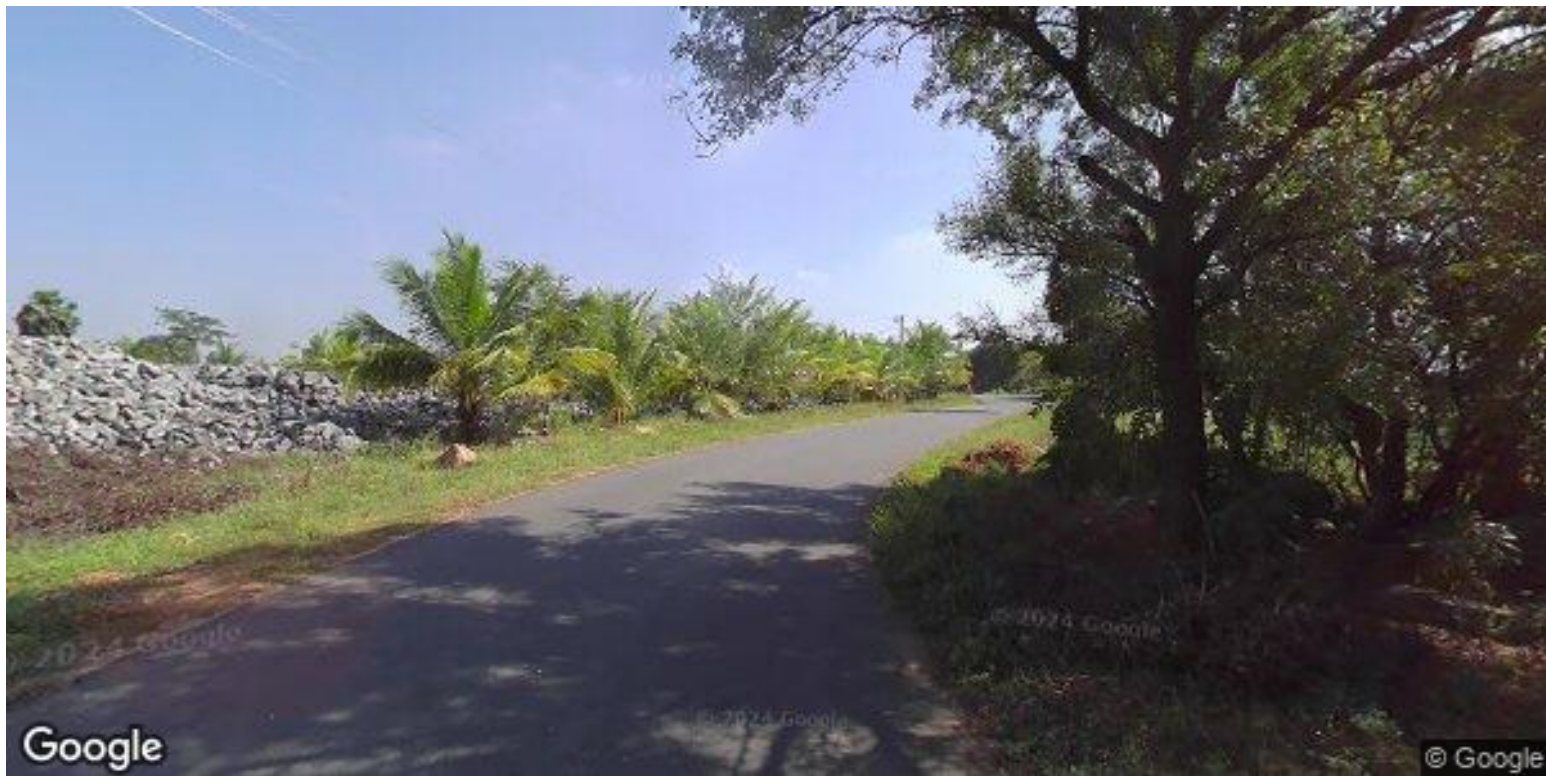
**Risk Type:** Turn  
**Risk Level:** Medium  
**Speed Limit:** 30 KM/Hr  
**Coordinates:** 11.44030, 77.93066

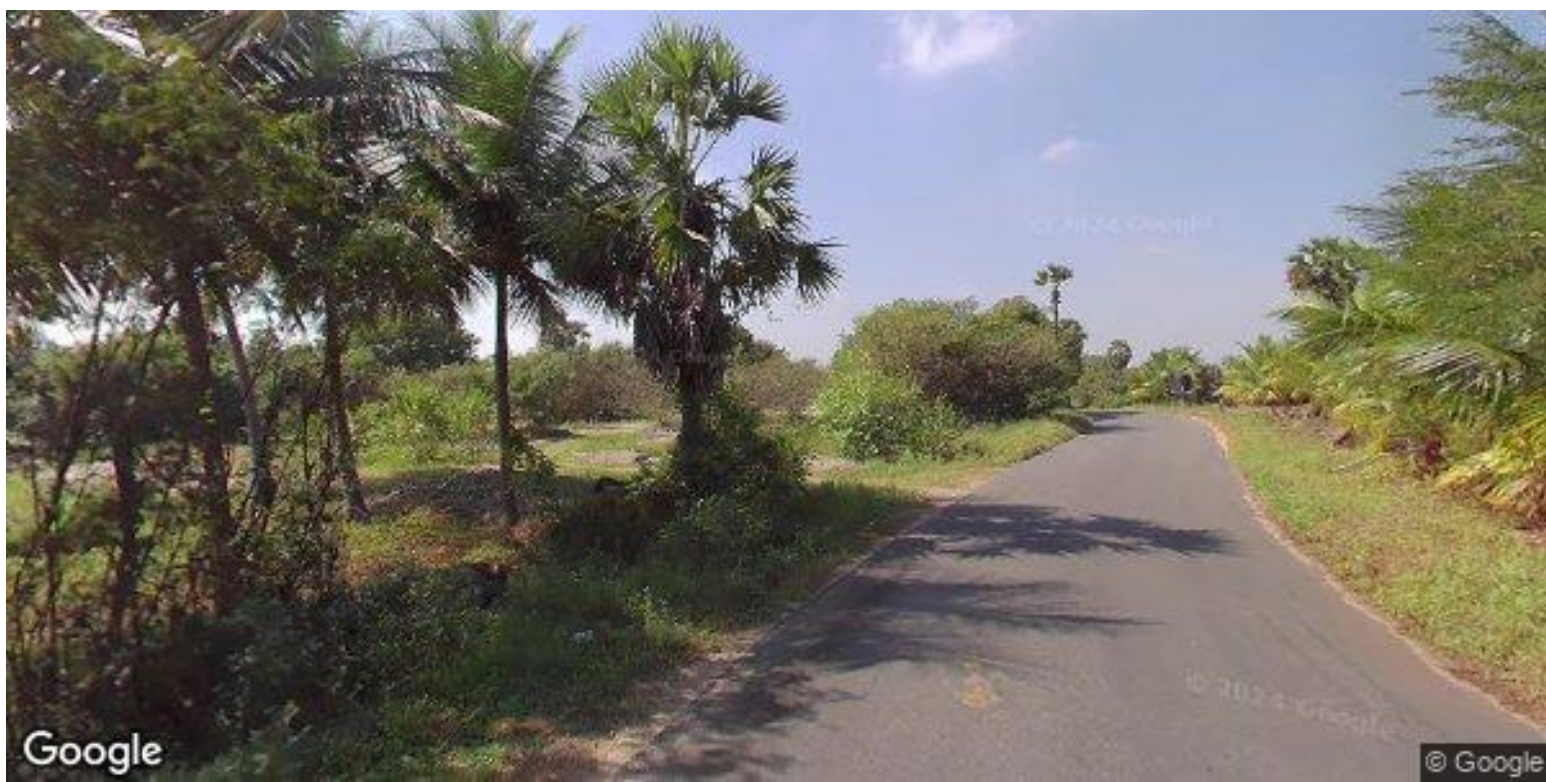
**Coordinates:** 11.44075, 77.93216

**Risk Type:** Turn

**Risk Level:** Medium

**Speed Limit:** 30 KM/Hr

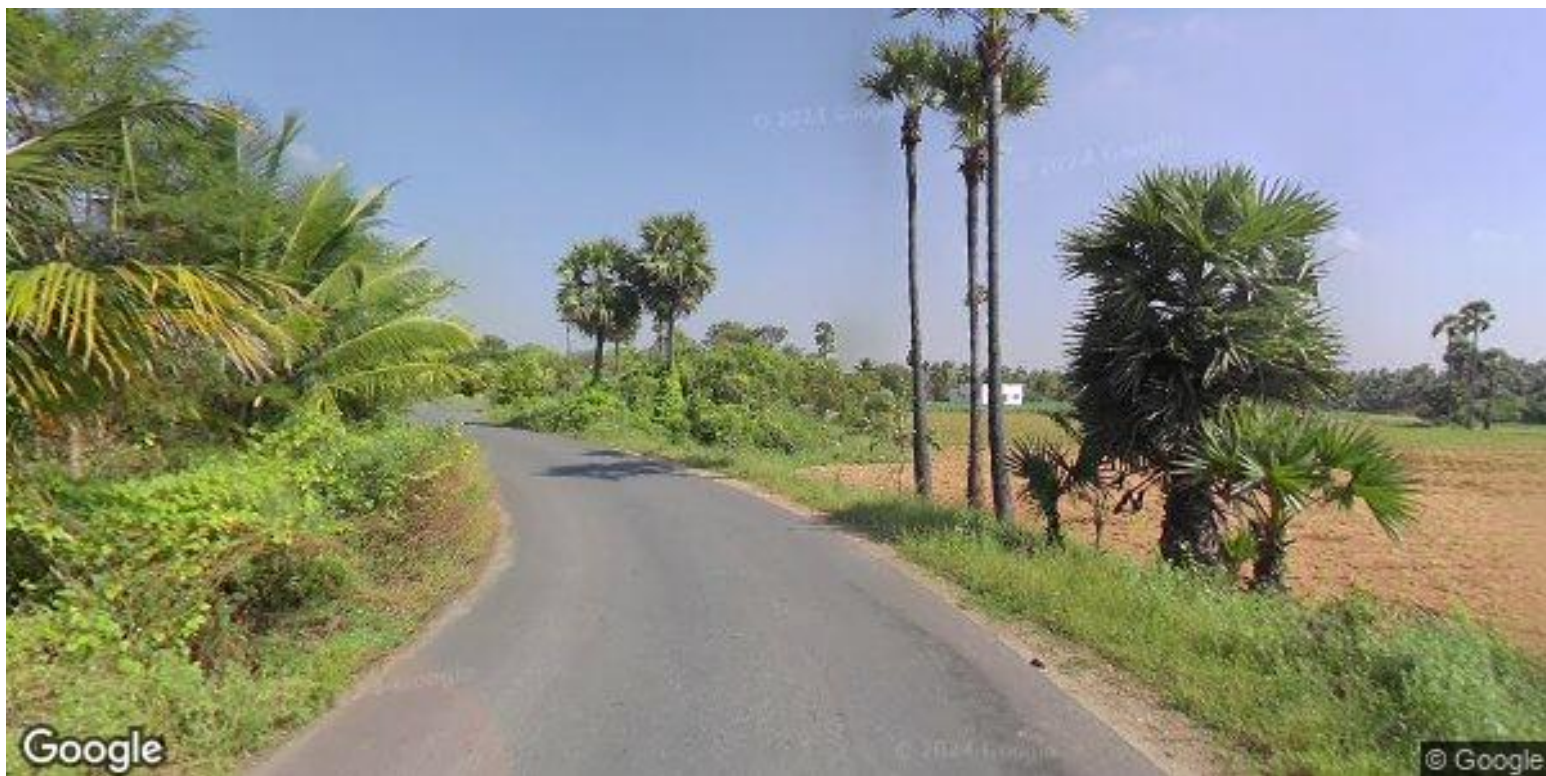
**Coordinates:** 11.44088, 77.93223

**Risk Type:** Turn

**Risk Level:** Medium

**Speed Limit:** 30 KM/Hr

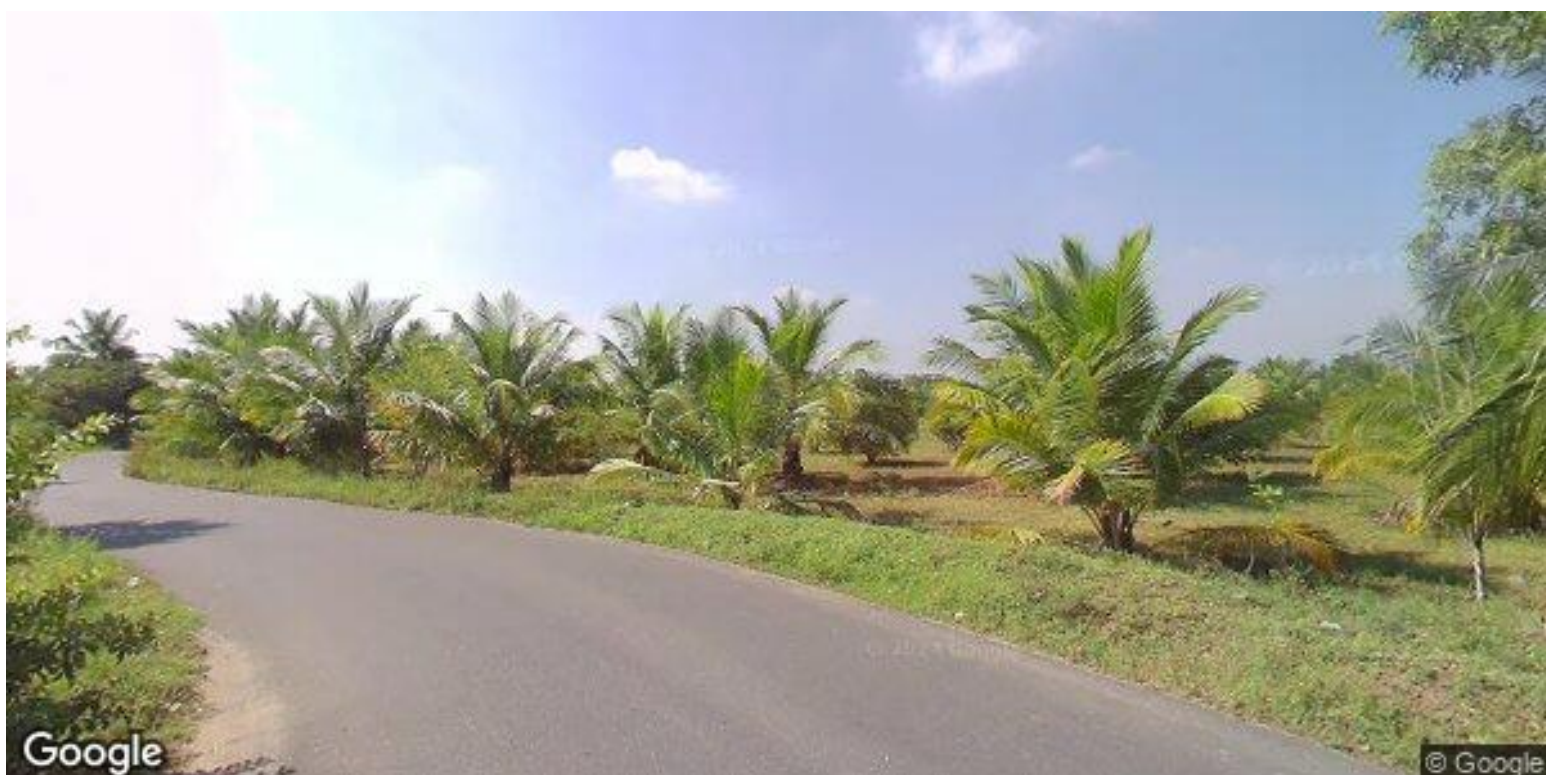
**Risk Type:** Turn  
**Risk Level:** Medium  
**Speed Limit:** 30 KM/Hr  
**Coordinates:** 11.44135, 77.93220

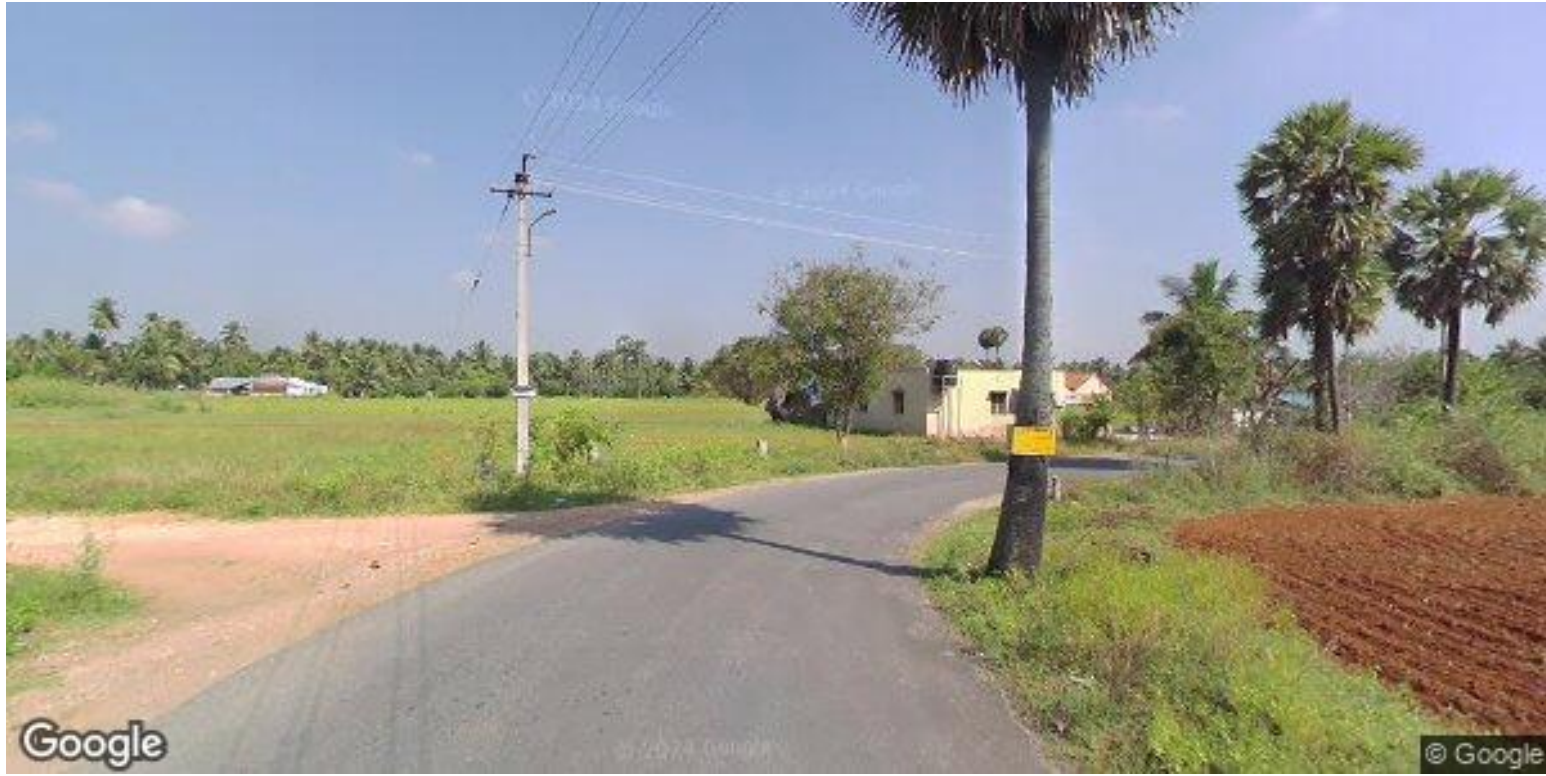
**Risk Type:** Turn  
**Risk Level:** Medium  
**Speed Limit:** 30 KM/Hr  
**Coordinates:** 11.44243, 77.93244

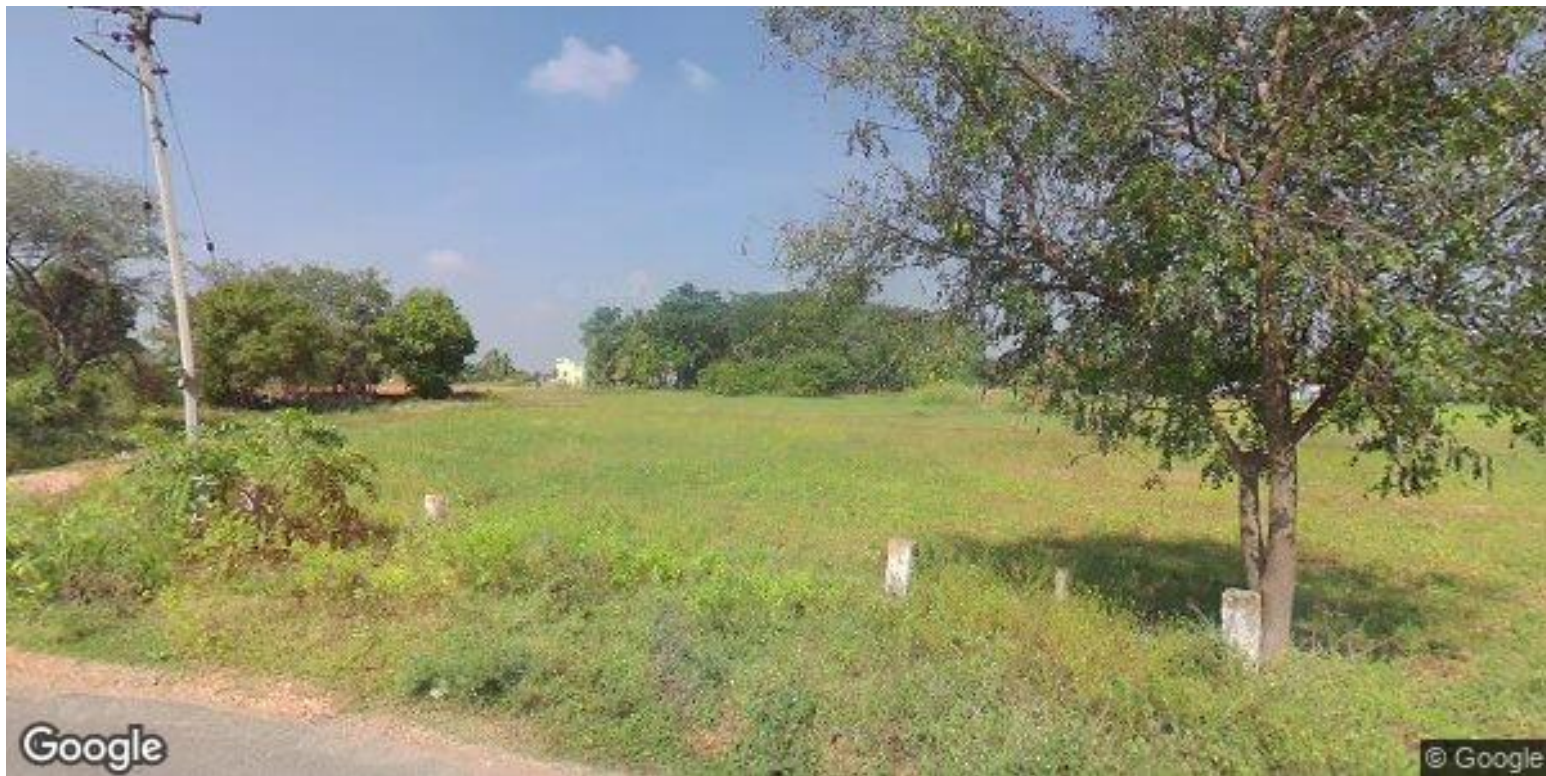
**Risk Type:** Turn  
**Risk Level:** Medium  
**Speed Limit:** 30 KM/Hr  
**Coordinates:** 11.44254, 77.93256

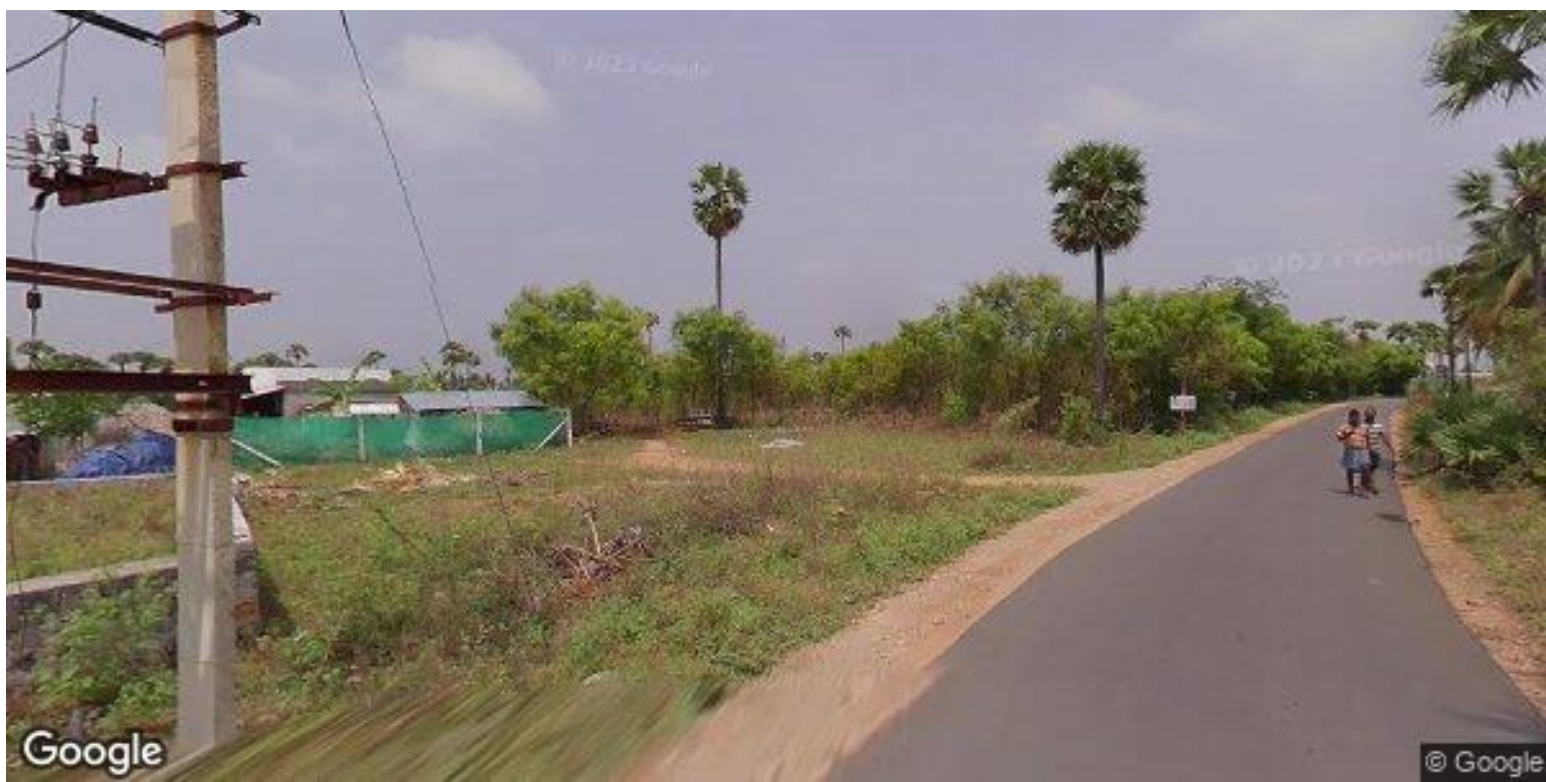
**Coordinates:** 11.44369, 77.96036

**Risk Type:** Turn

**Risk Level:** Medium

**Speed Limit:** 30 KM/Hr

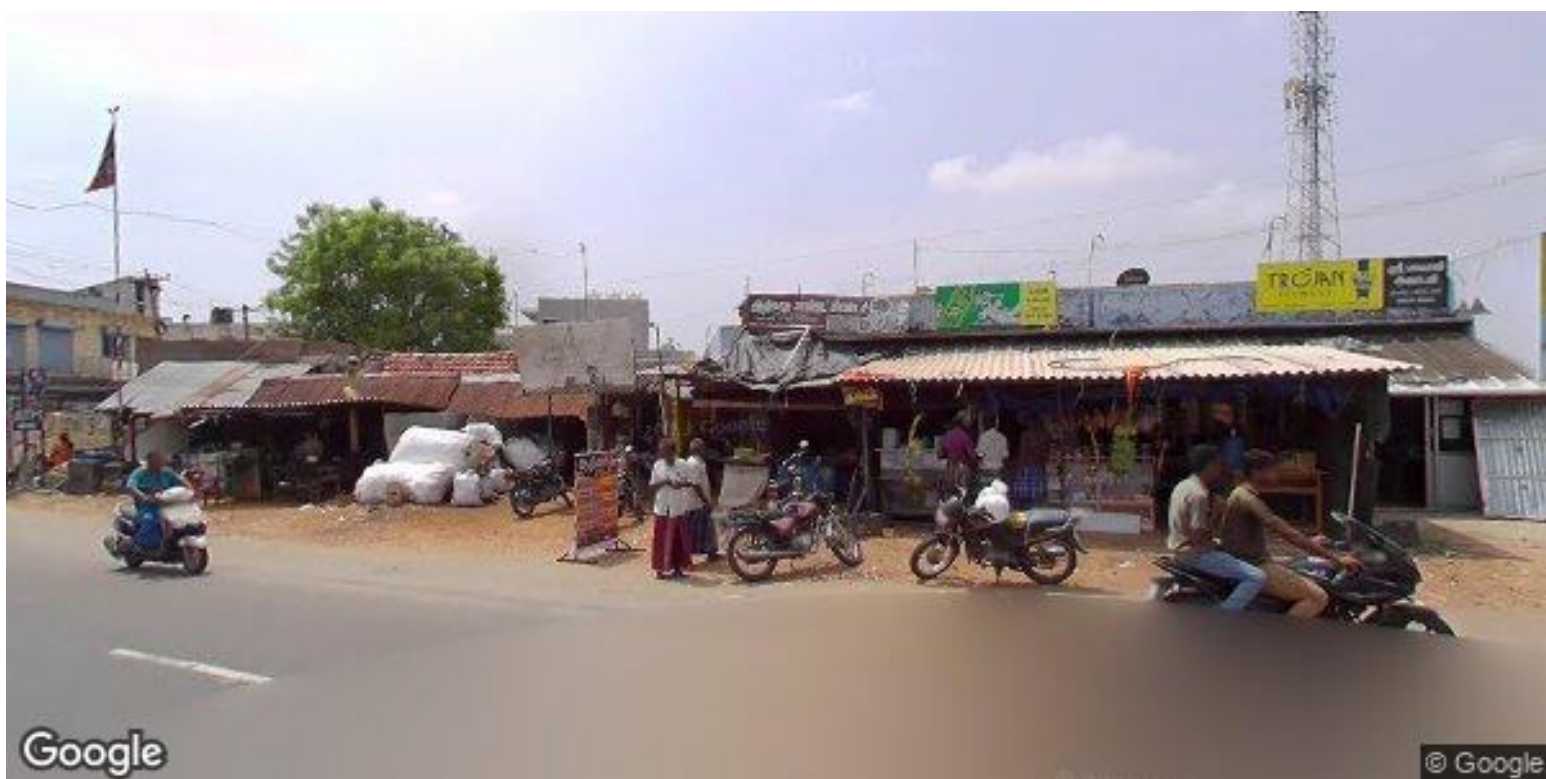
**Coordinates:** 11.44387, 77.96283

**Risk Type:** Turn

**Risk Level:** High

**Speed Limit:** 15 KM/Hr

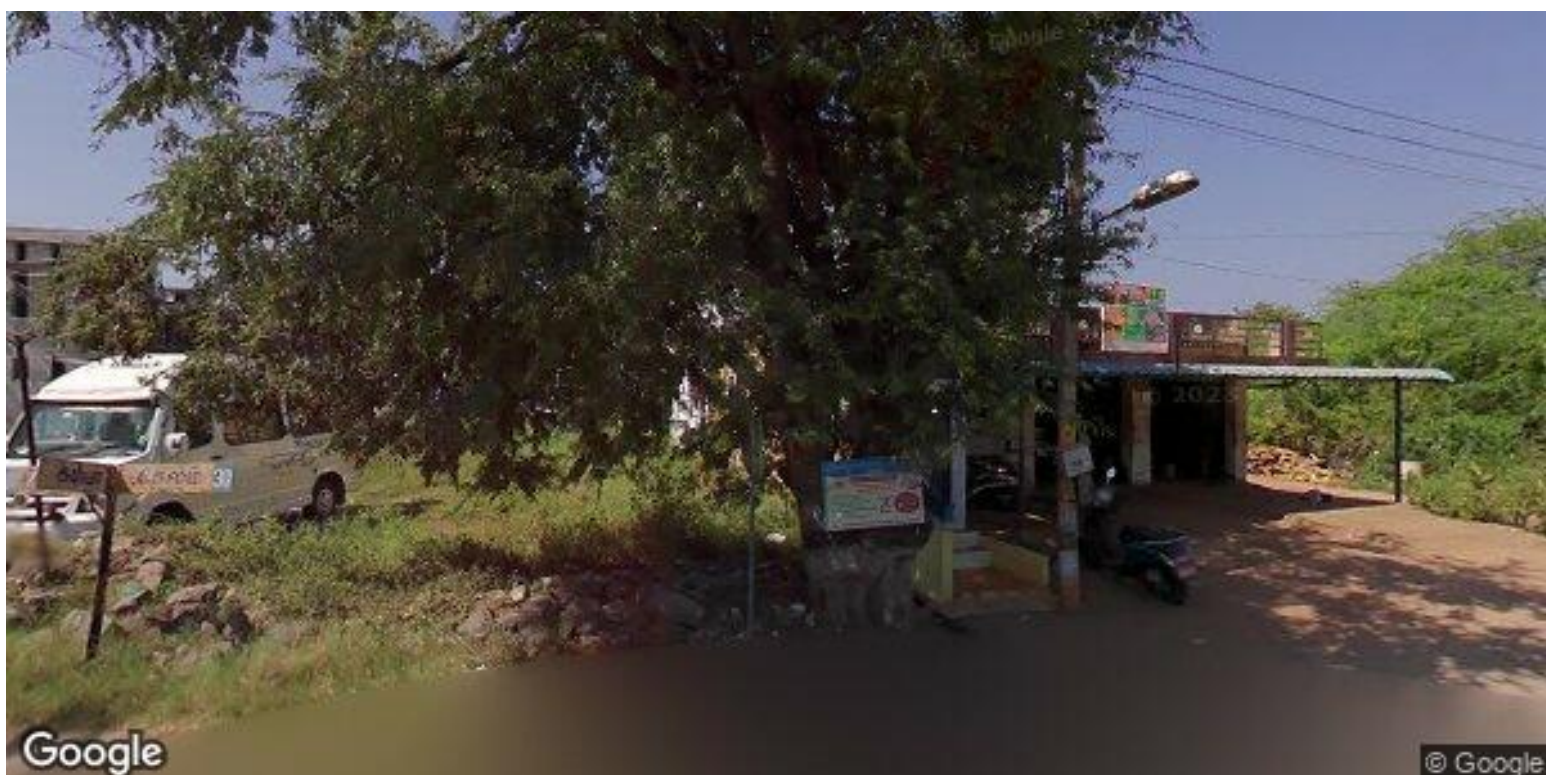
**Coordinates:** 11.49063, 78.02680

**Risk Type:** Turn

**Risk Level:** High

**Speed Limit:** 15 KM/Hr
