# IndianOil

## **JOURNEY RISK MANAGEMENT (JRM) STUDY**

### **Salem Terminal to THE ERODE DT CONS COOP WHOL STORES**

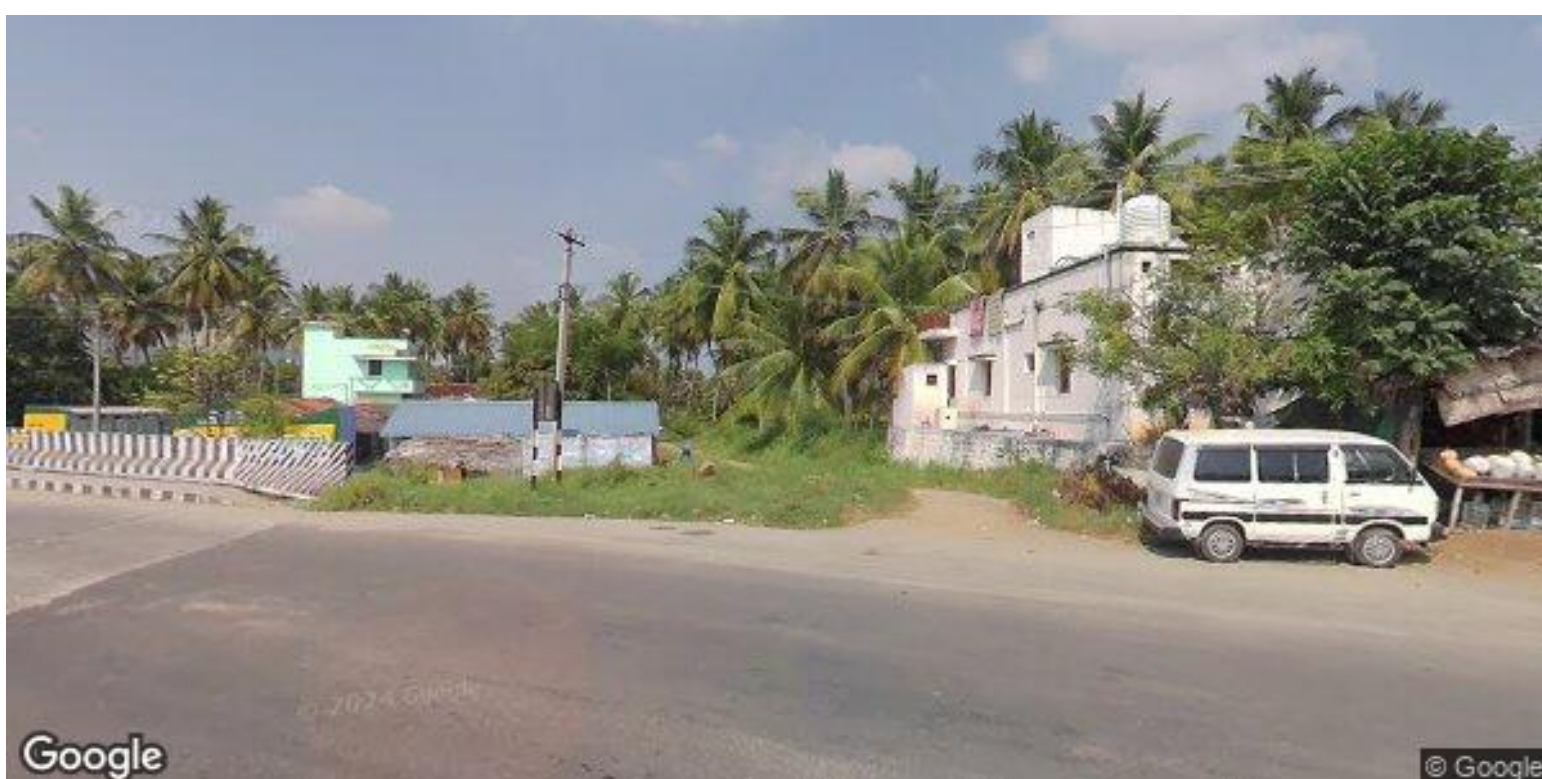
**Coordinates:** 11.44898, 77.87410

**Risk Type:** Turn

**Risk Level:** Medium

**Speed Limit:** 30 KM/Hr

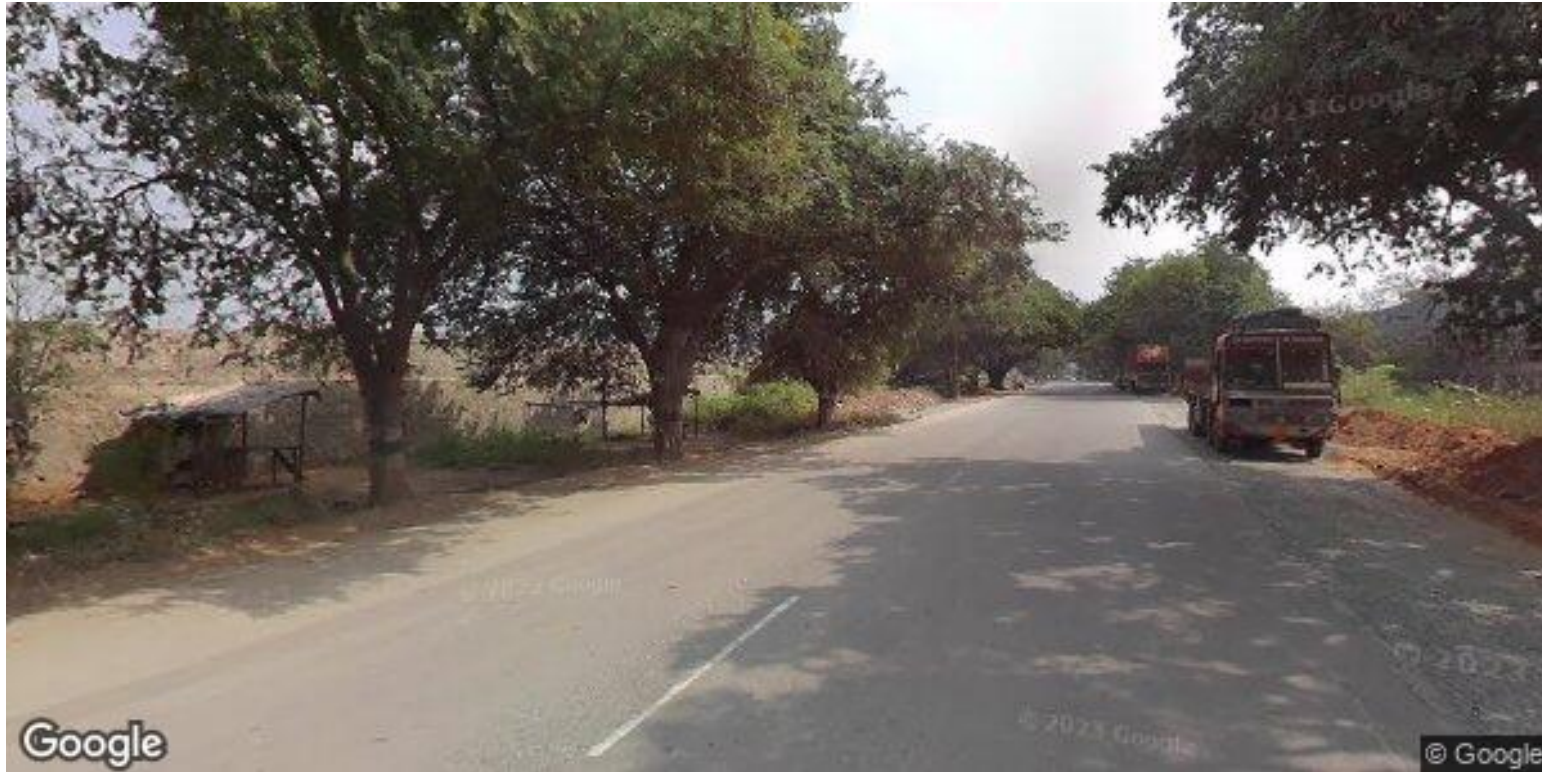
**Risk Type:** Turn  
**Risk Level:** Medium  
**Speed Limit:** 30 KM/Hr  
**Coordinates:** 11.45697, 77.82719

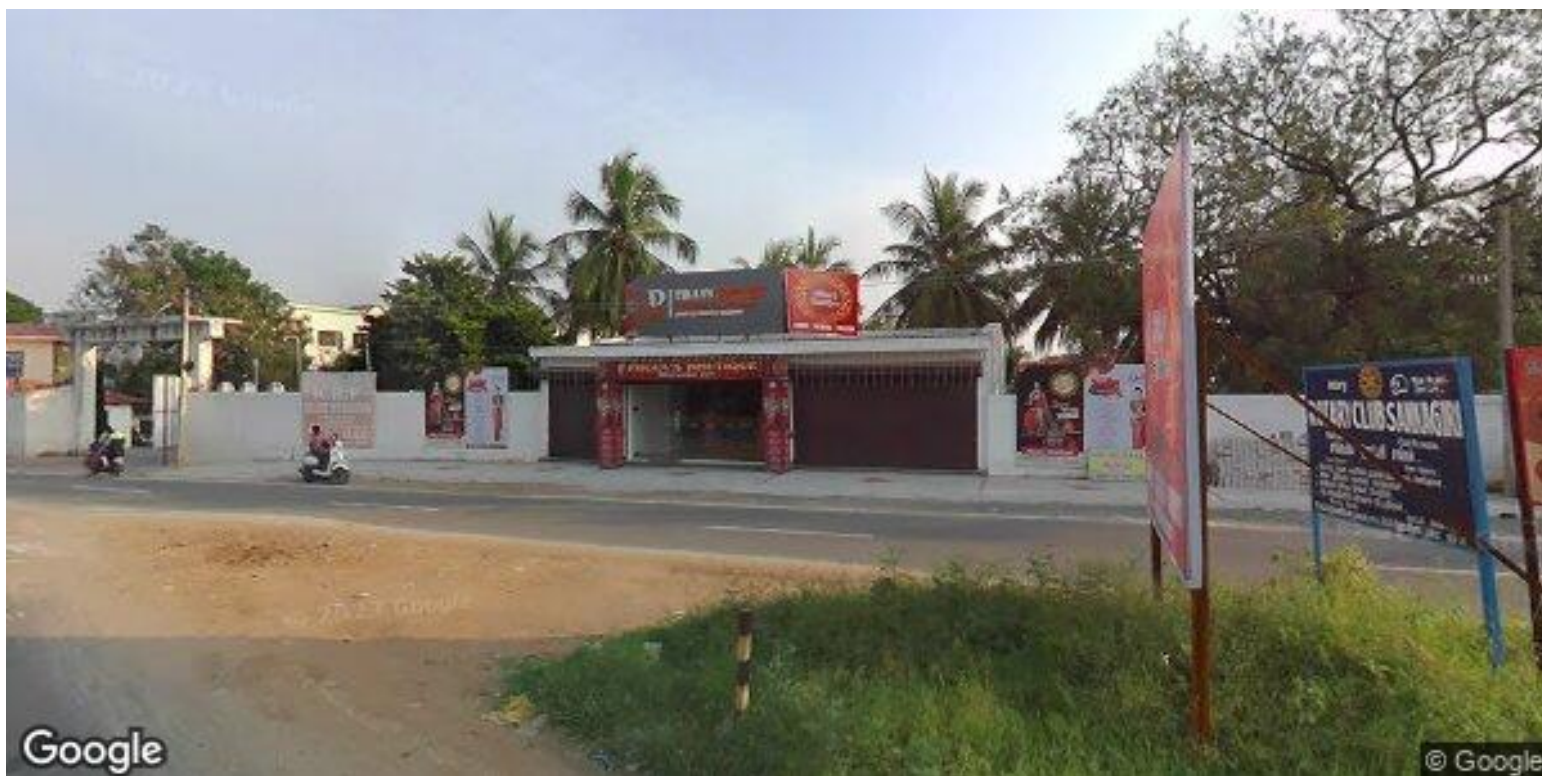
**Risk Type:** Turn  
**Risk Level:** High  
**Speed Limit:** 15 KM/Hr  
**Coordinates:** 11.45516, 77.81346

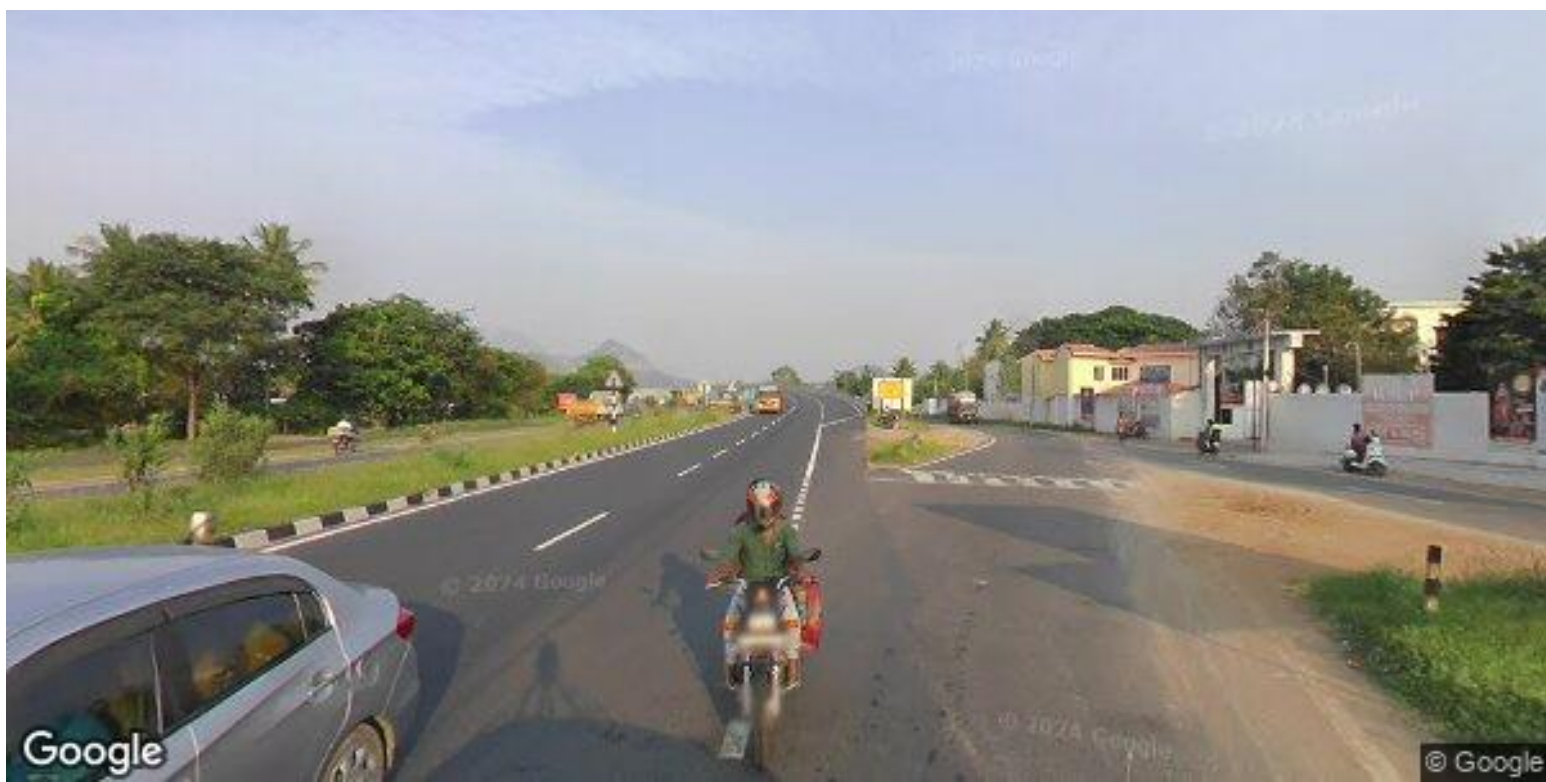
**Coordinates:** 11.45521, 77.81343

**Risk Type:** Turn

**Risk Level:** High

**Speed Limit:** 15 KM/Hr

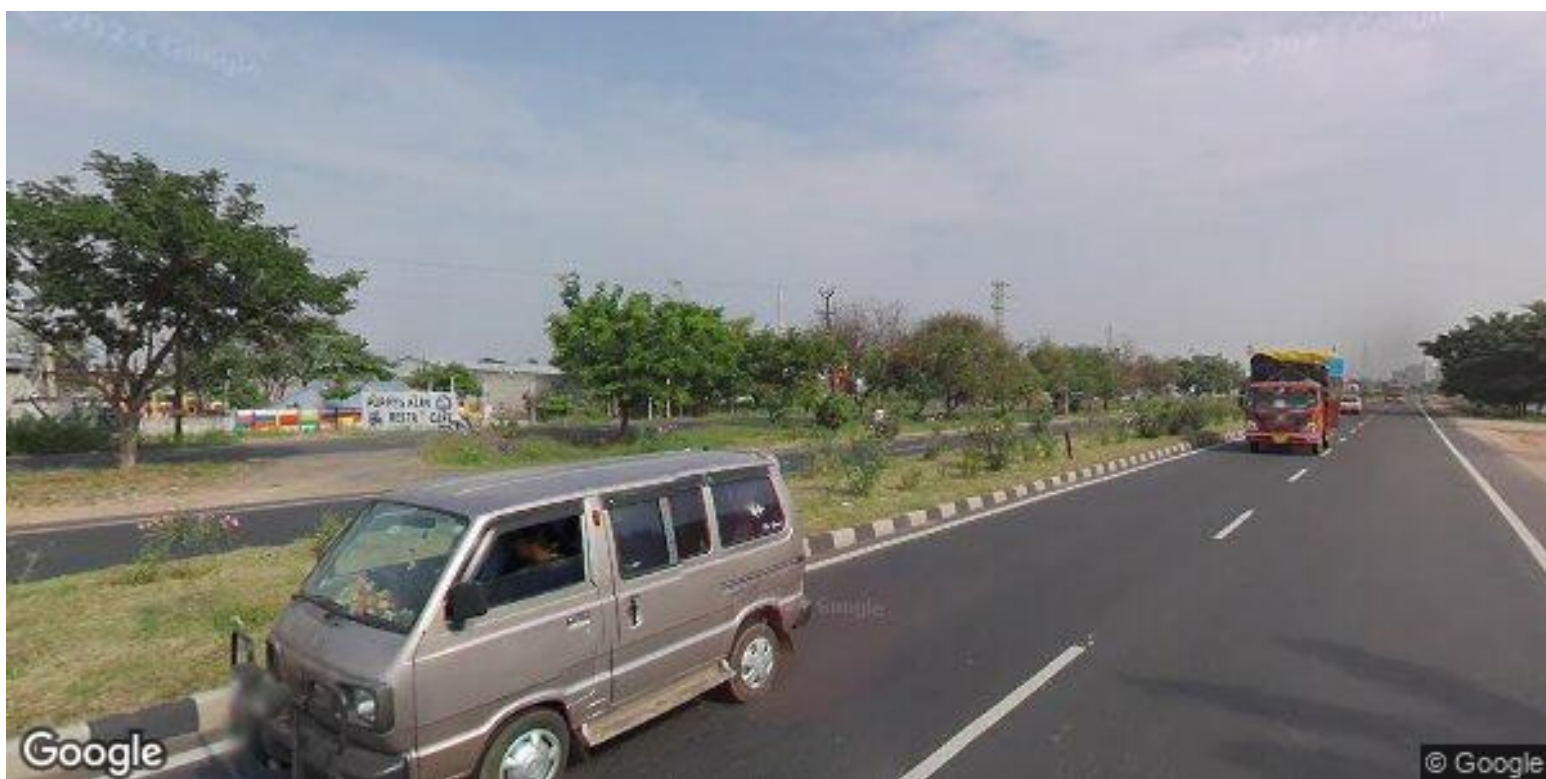
**Risk Type:** Turn  
**Risk Level:** Medium  
**Speed Limit:** 30 KM/Hr  
**Coordinates:** 11.43982, 77.71084

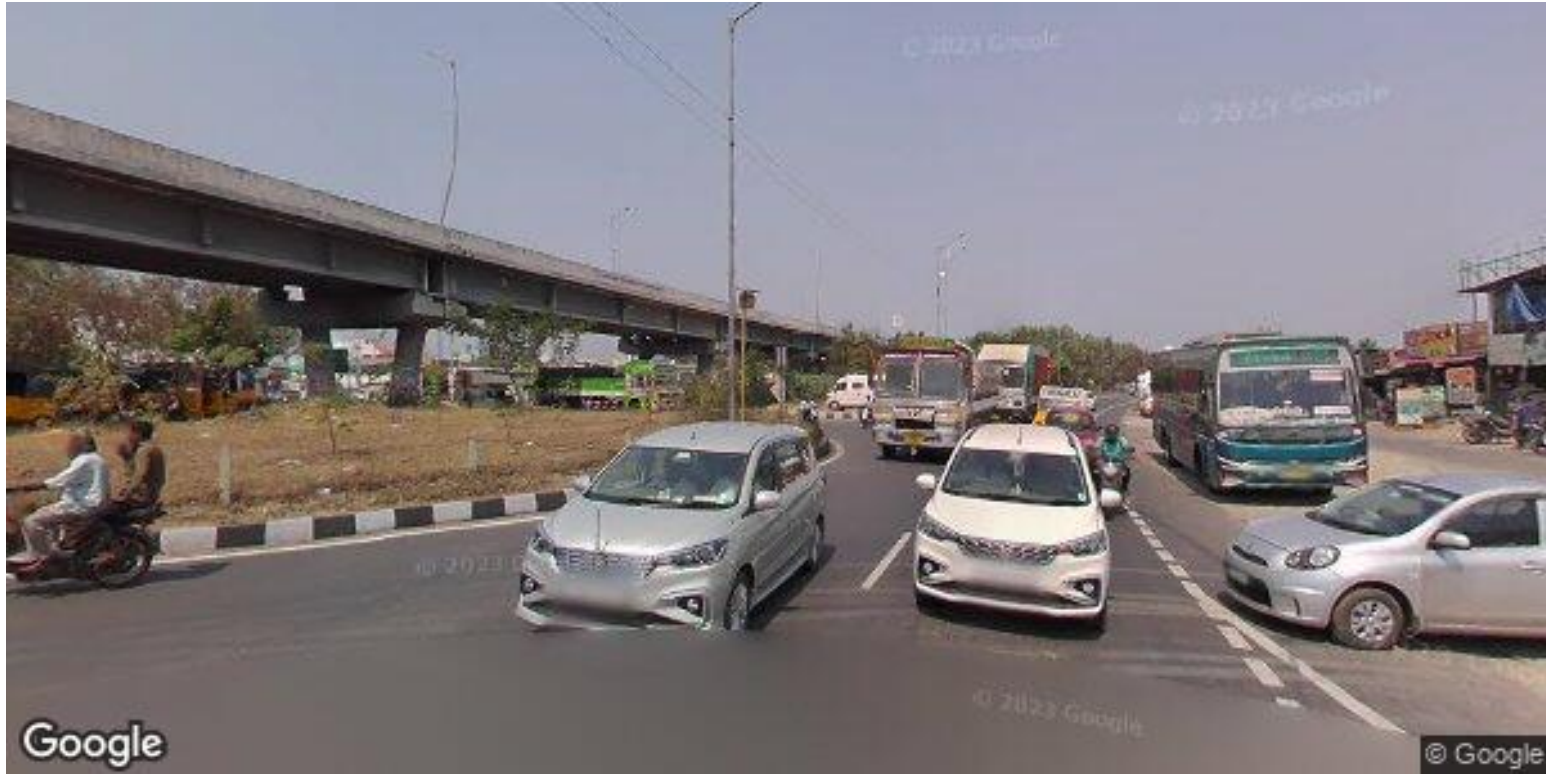
**Risk Type:** Turn  
**Risk Level:** High  
**Speed Limit:** 15 KM/Hr  
**Coordinates:** 11.43001, 77.67575

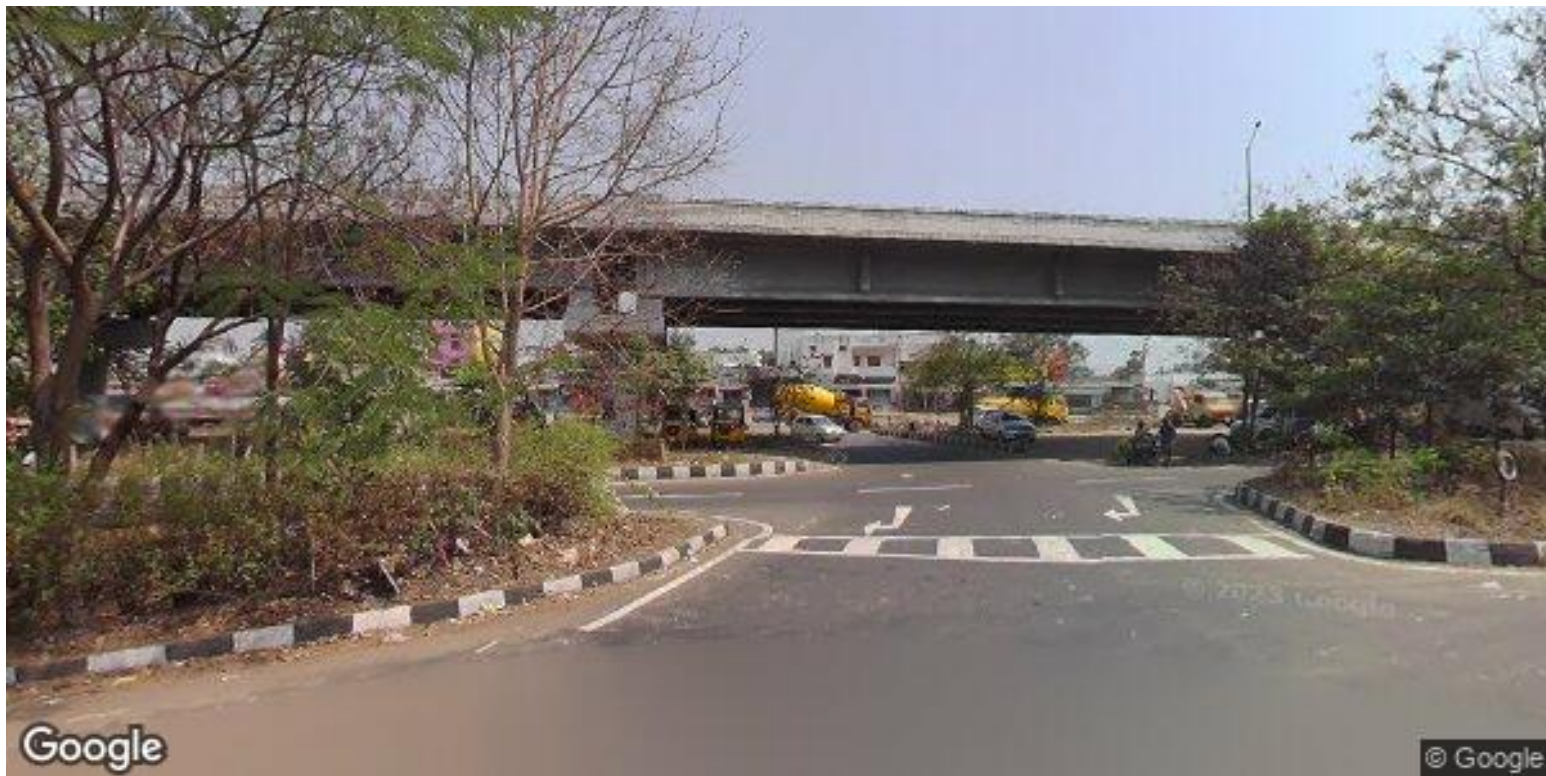
**Risk Type:** Turn  
**Risk Level:** High  
**Speed Limit:** 15 KM/Hr  
**Coordinates:** 11.43026, 77.67525

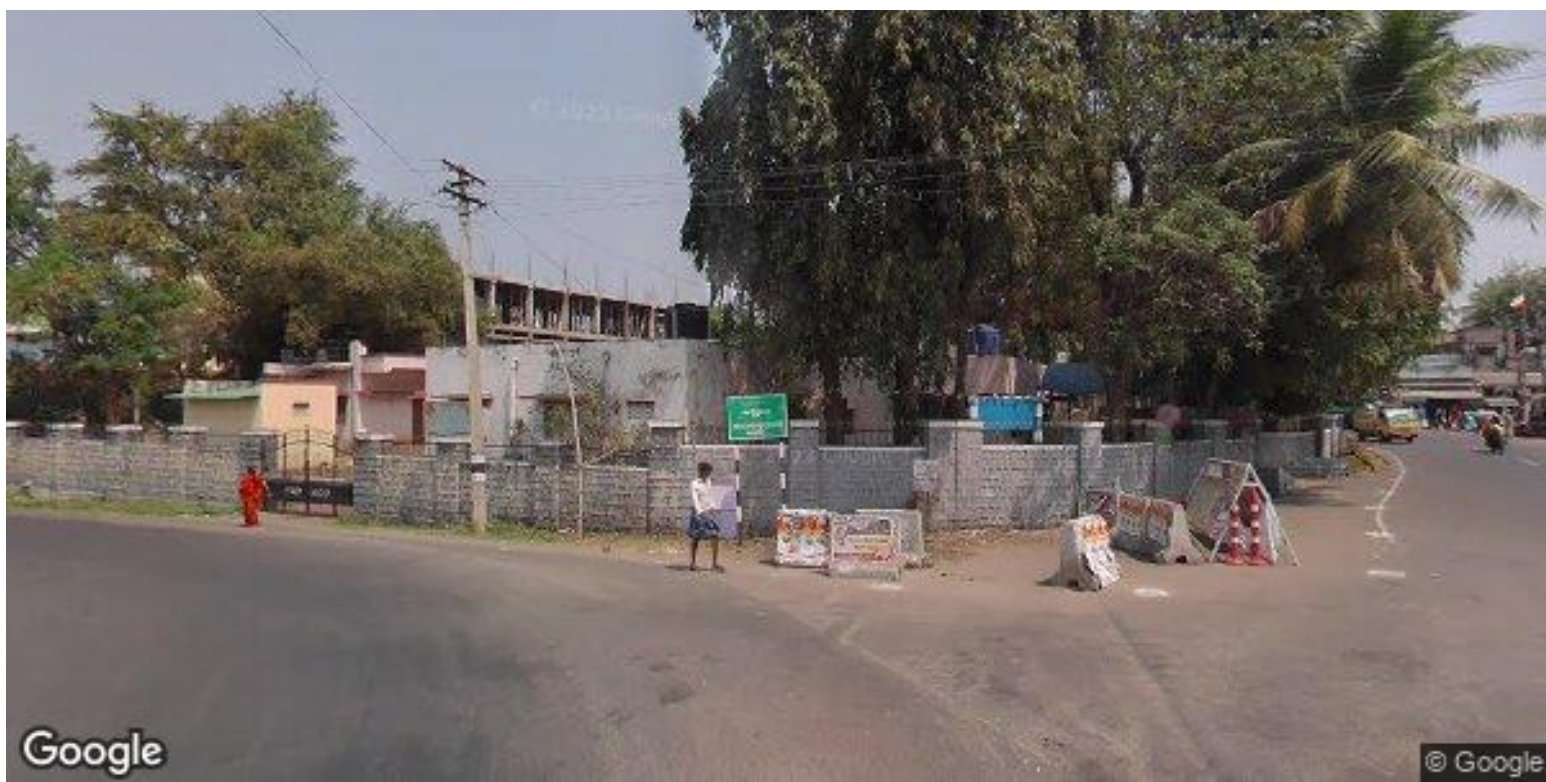
**Coordinates:** 11.43865, 77.68226

**Risk Type:** Turn

**Risk Level:** Medium

**Speed Limit:** 30 KM/Hr

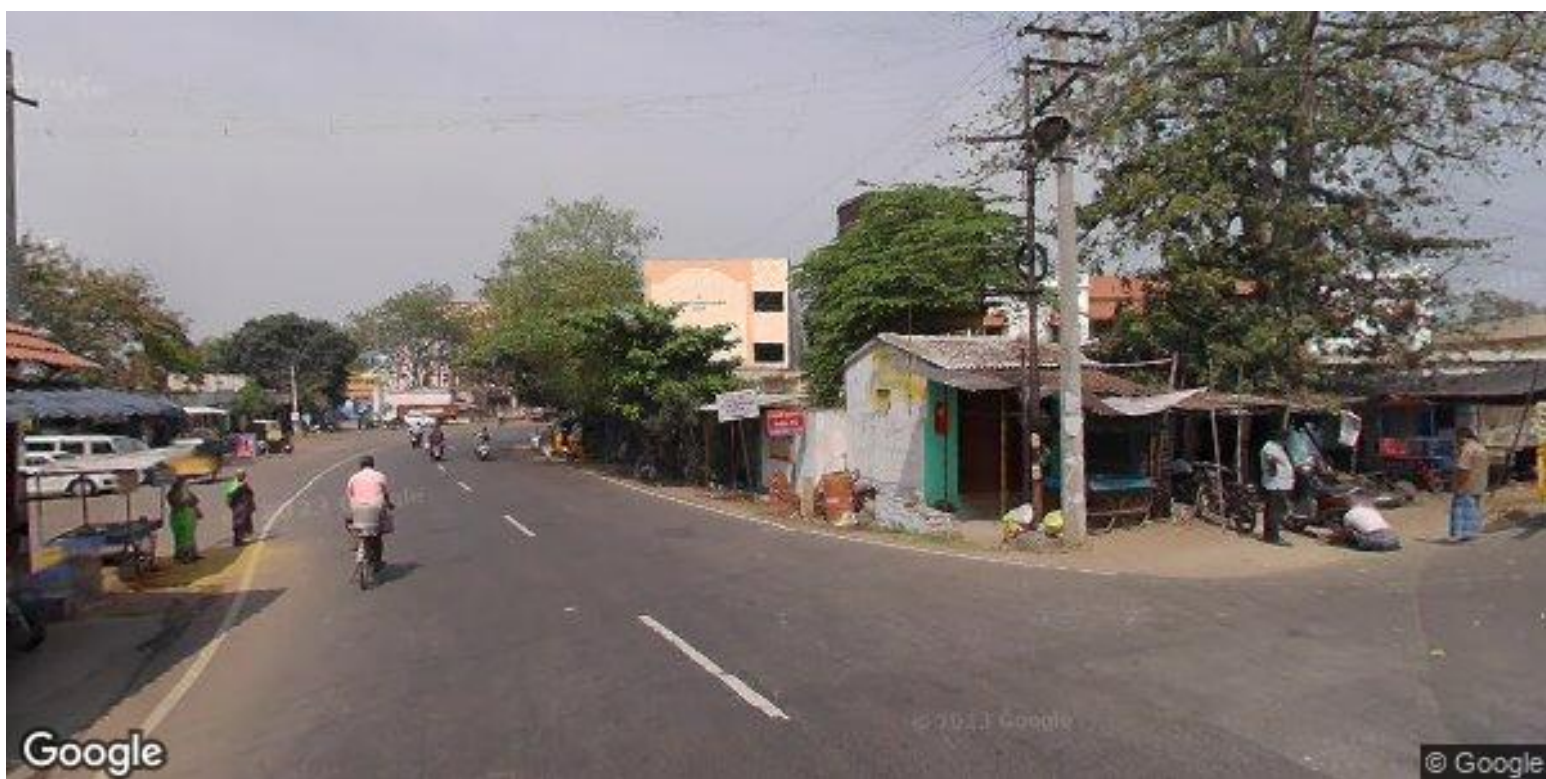
**Coordinates:** 11.43965, 77.68224

**Risk Type:** Turn

**Risk Level:** Medium

**Speed Limit:** 30 KM/Hr

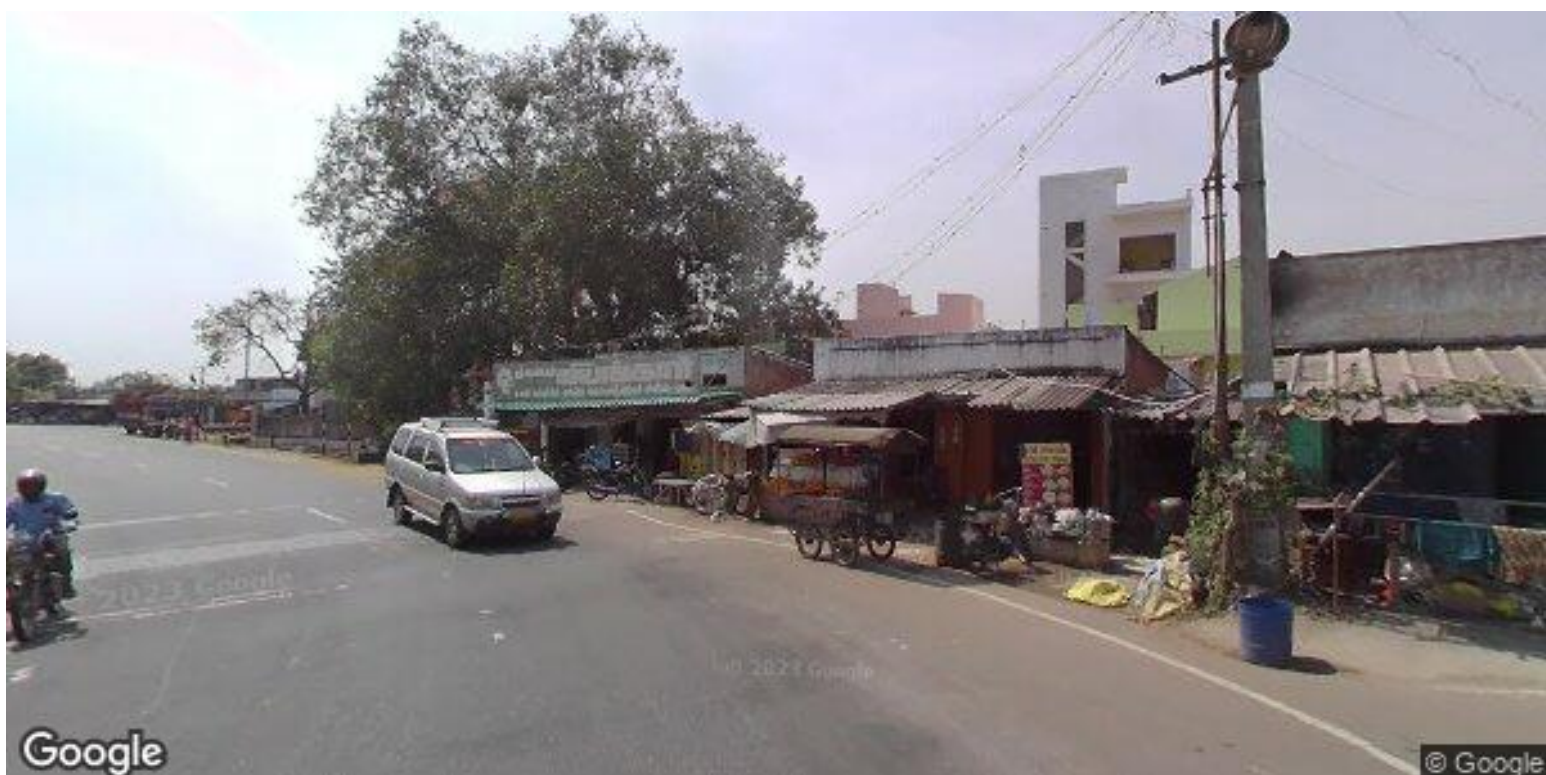
**Risk Type:** Turn  
**Risk Level:** High  
**Speed Limit:** 15 KM/Hr  
**Coordinates:** 11.44105, 77.68187

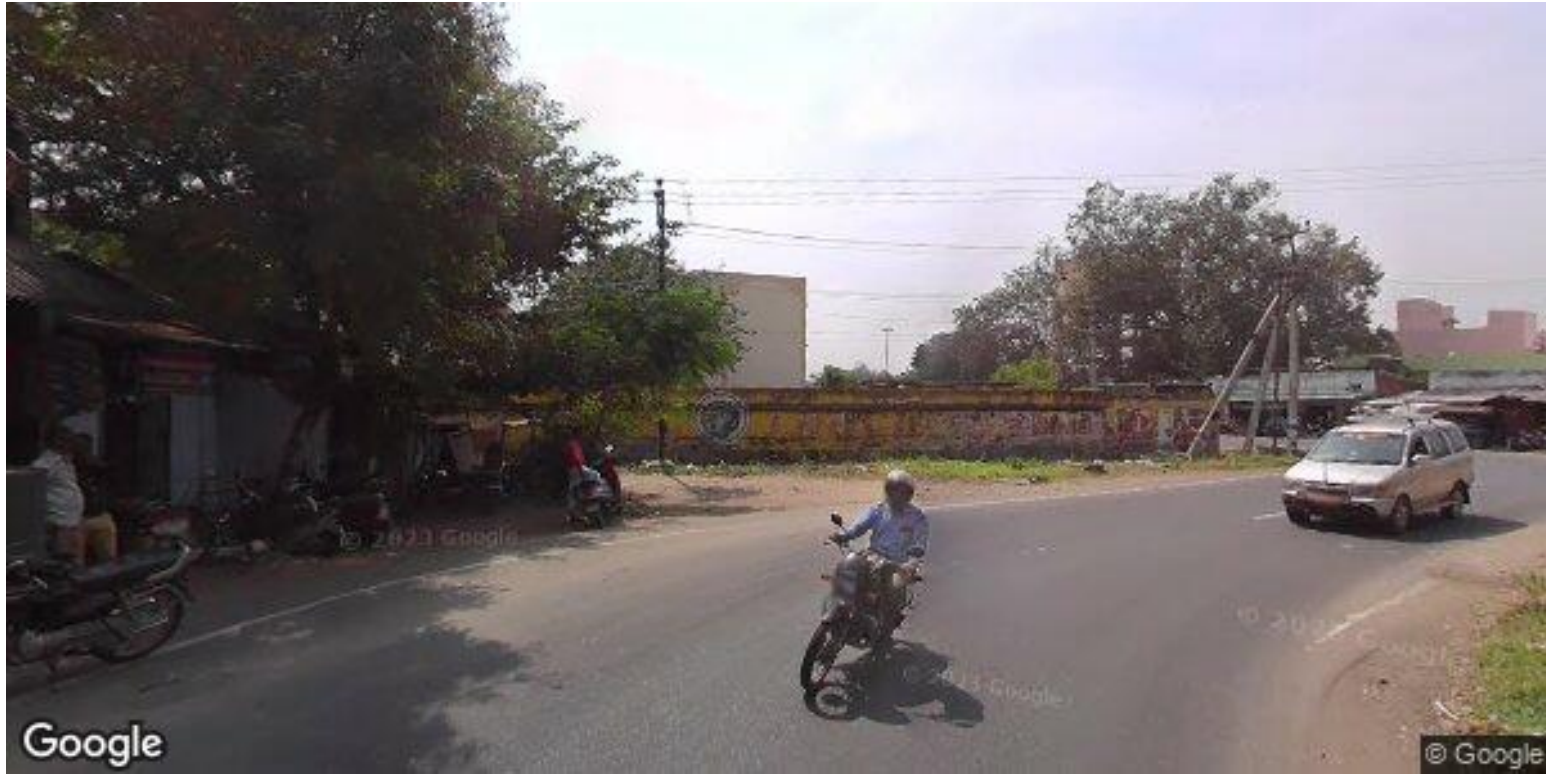
**Risk Type:** Turn  
**Risk Level:** Medium  
**Speed Limit:** 30 KM/Hr  
**Coordinates:** 11.44122, 77.68219

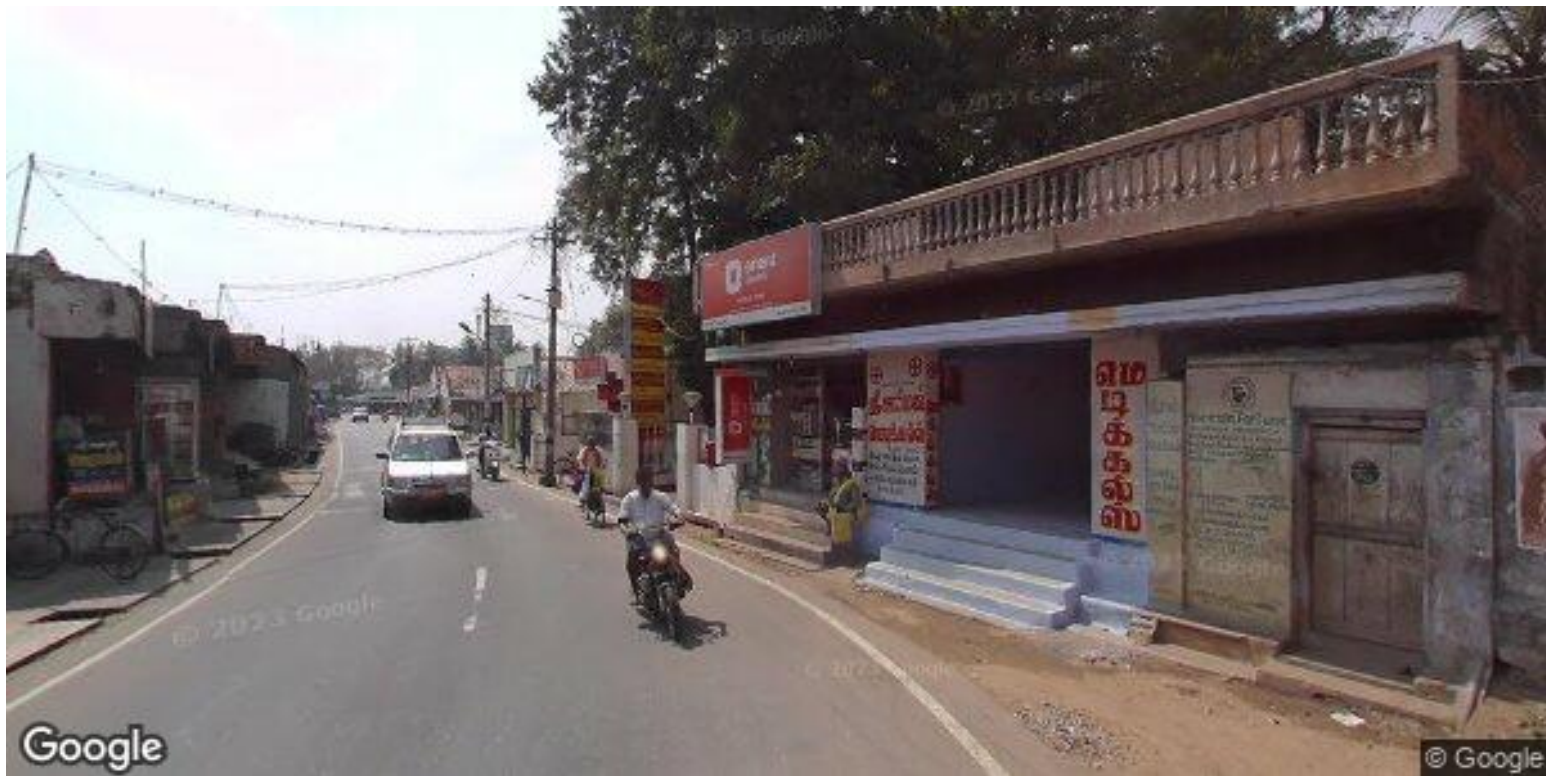
**Risk Type:** Turn  
**Risk Level:** Medium  
**Speed Limit:** 30 KM/Hr  
**Coordinates:** 11.44291, 77.68256

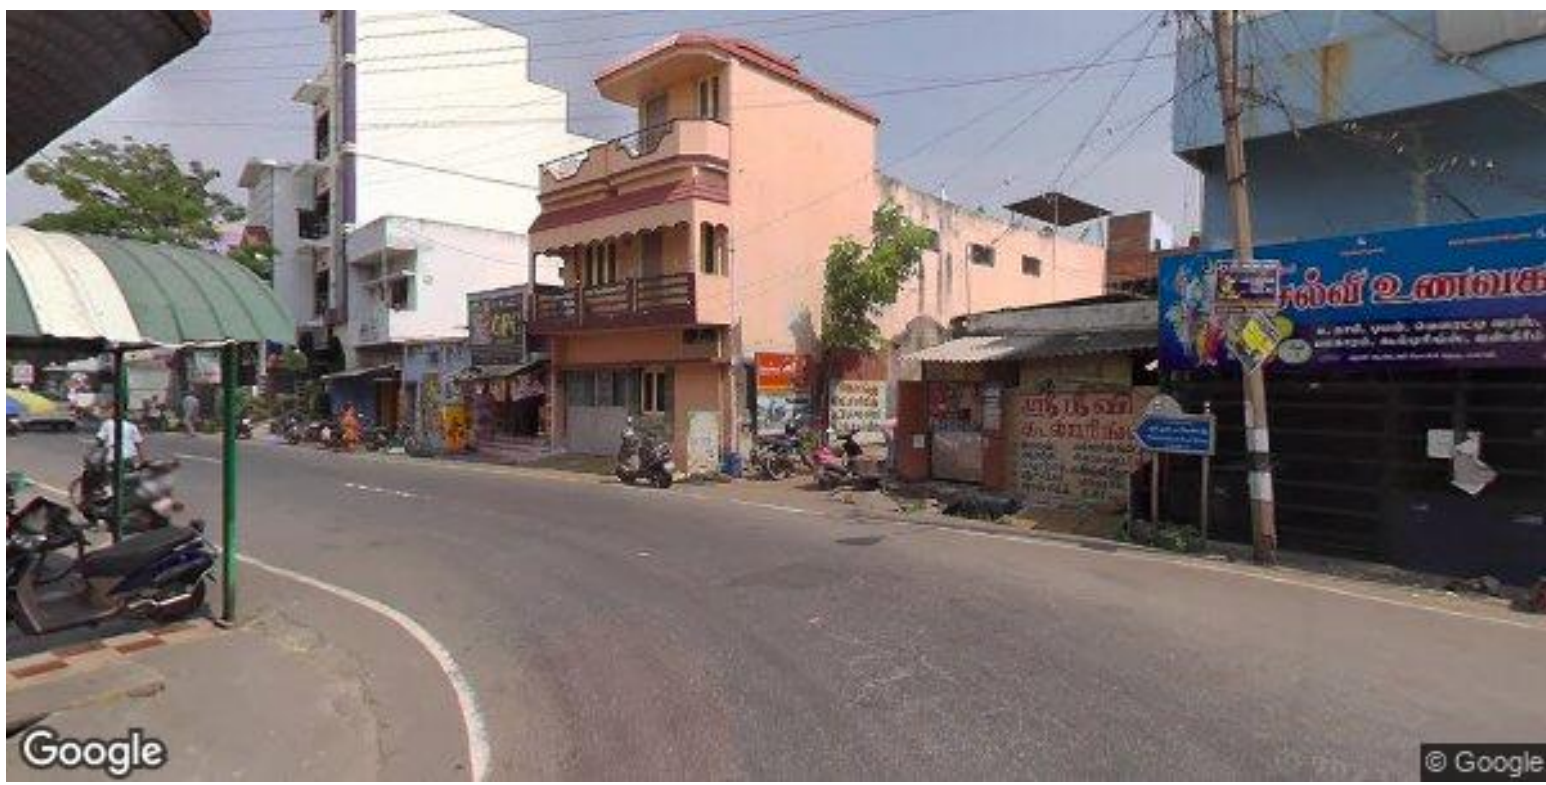
Coordinates: 11.44300, 77.68275

Risk Type: Turn

Risk Level: High

Speed Limit: 15 KM/Hr

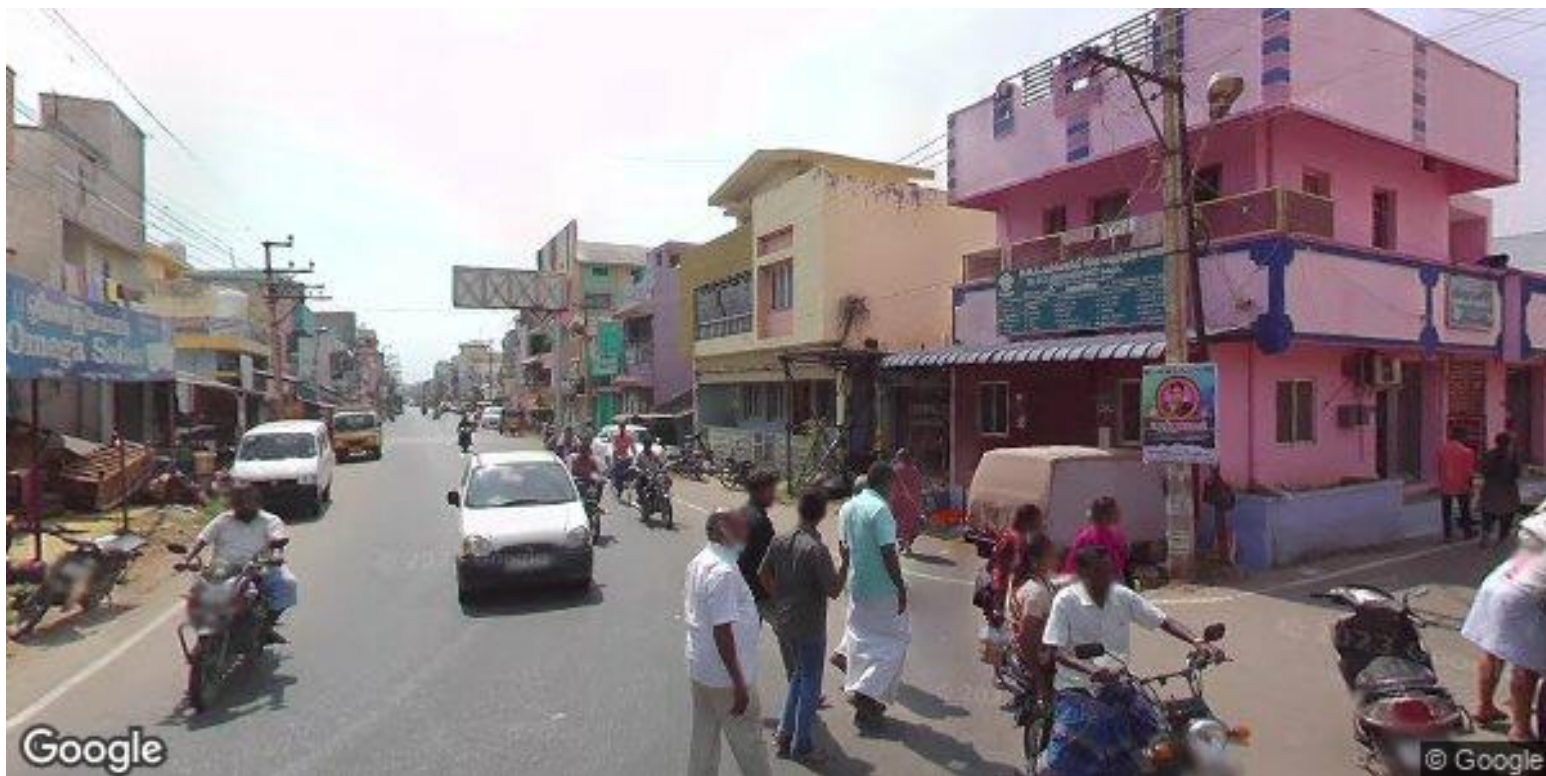
Coordinates: 11.44715, 77.68304

Risk Type: Turn

Risk Level: High

Speed Limit: 15 KM/Hr

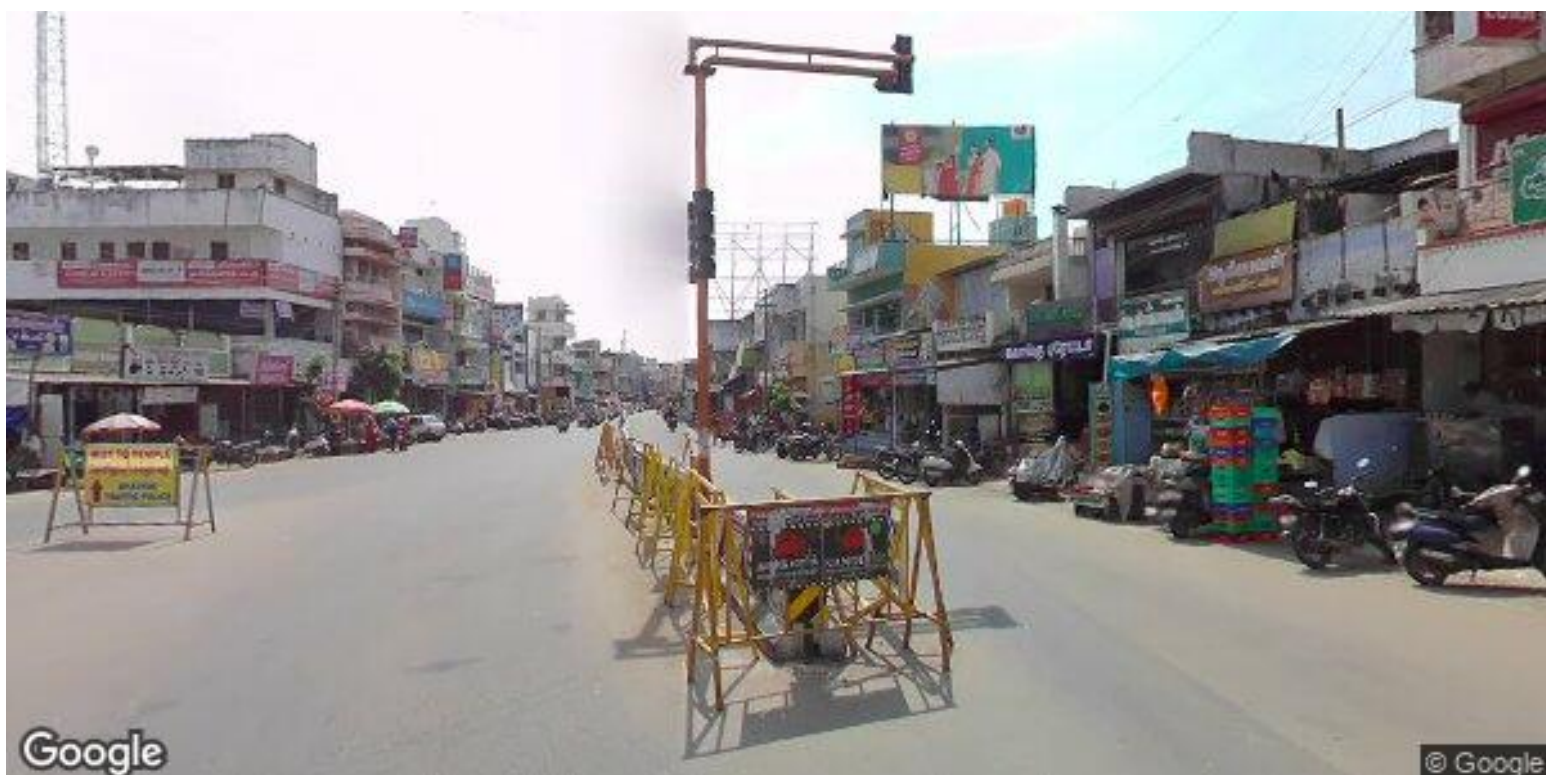
**Coordinates:** 11.44710, 77.68396

**Risk Type:** Turn

**Risk Level:** Medium

**Speed Limit:** 30 KM/Hr

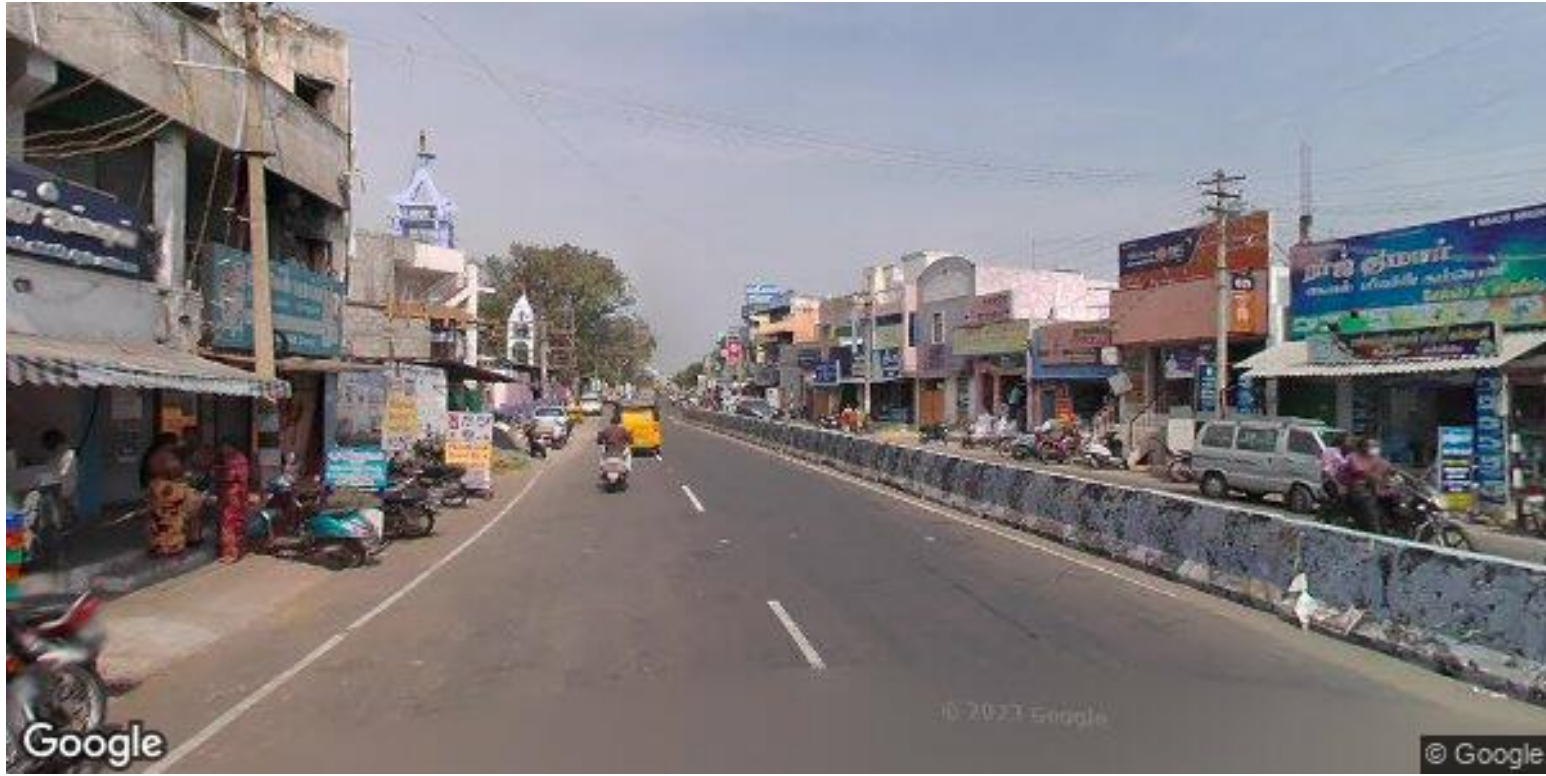
**Coordinates:** 11.44725, 77.68412

**Risk Type:** Turn

**Risk Level:** Medium

**Speed Limit:** 30 KM/Hr
