## JOURNEY RISK MANAGEMENT (JRM) STUDY

### Salem Terminal to SRI RAM AGENCIES

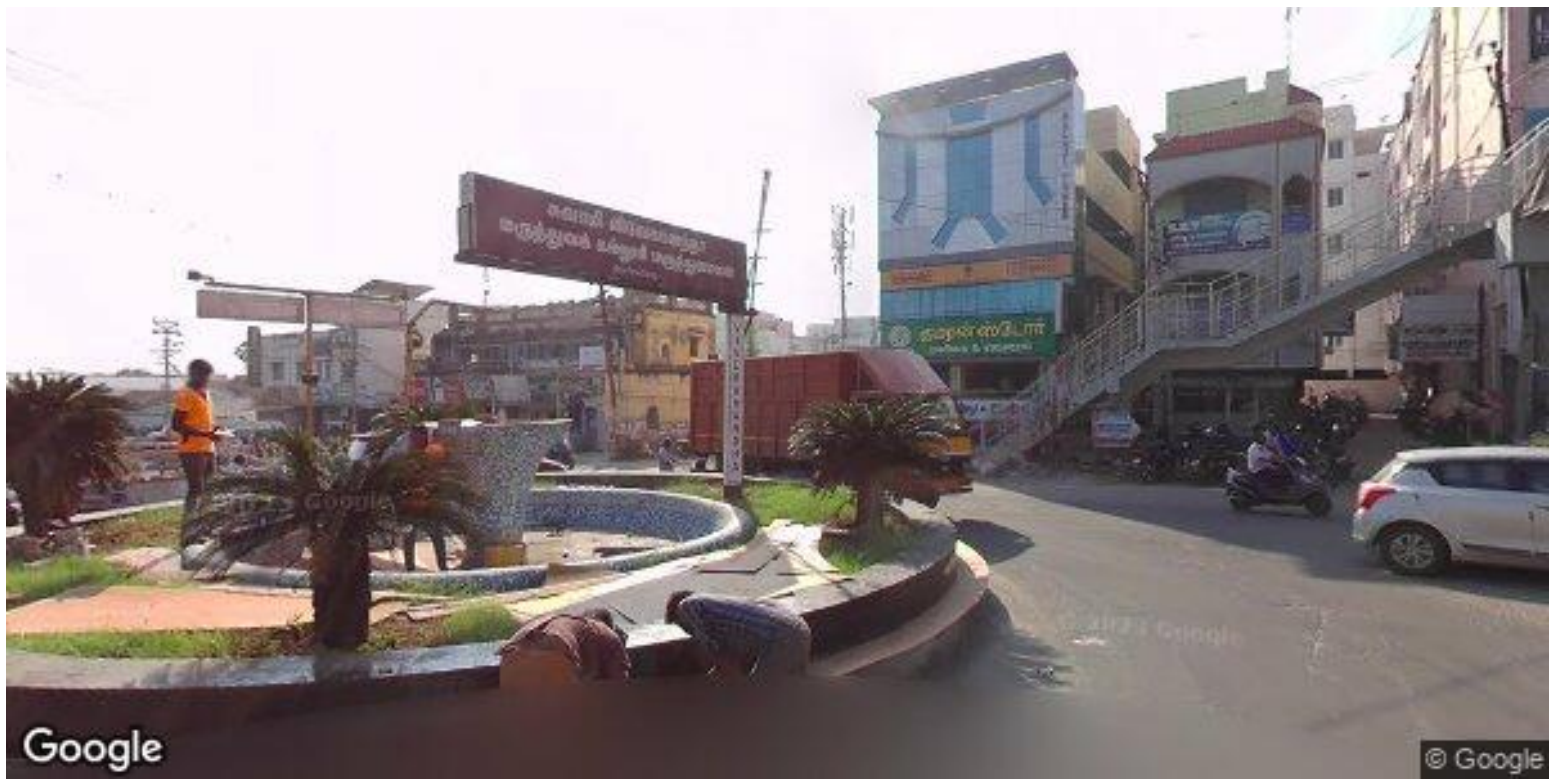
**Coordinates:** 11.38395, 77.89480

**Risk Type:** Roundabout

**Risk Level:** High

**Speed Limit:** 15 KM/Hr

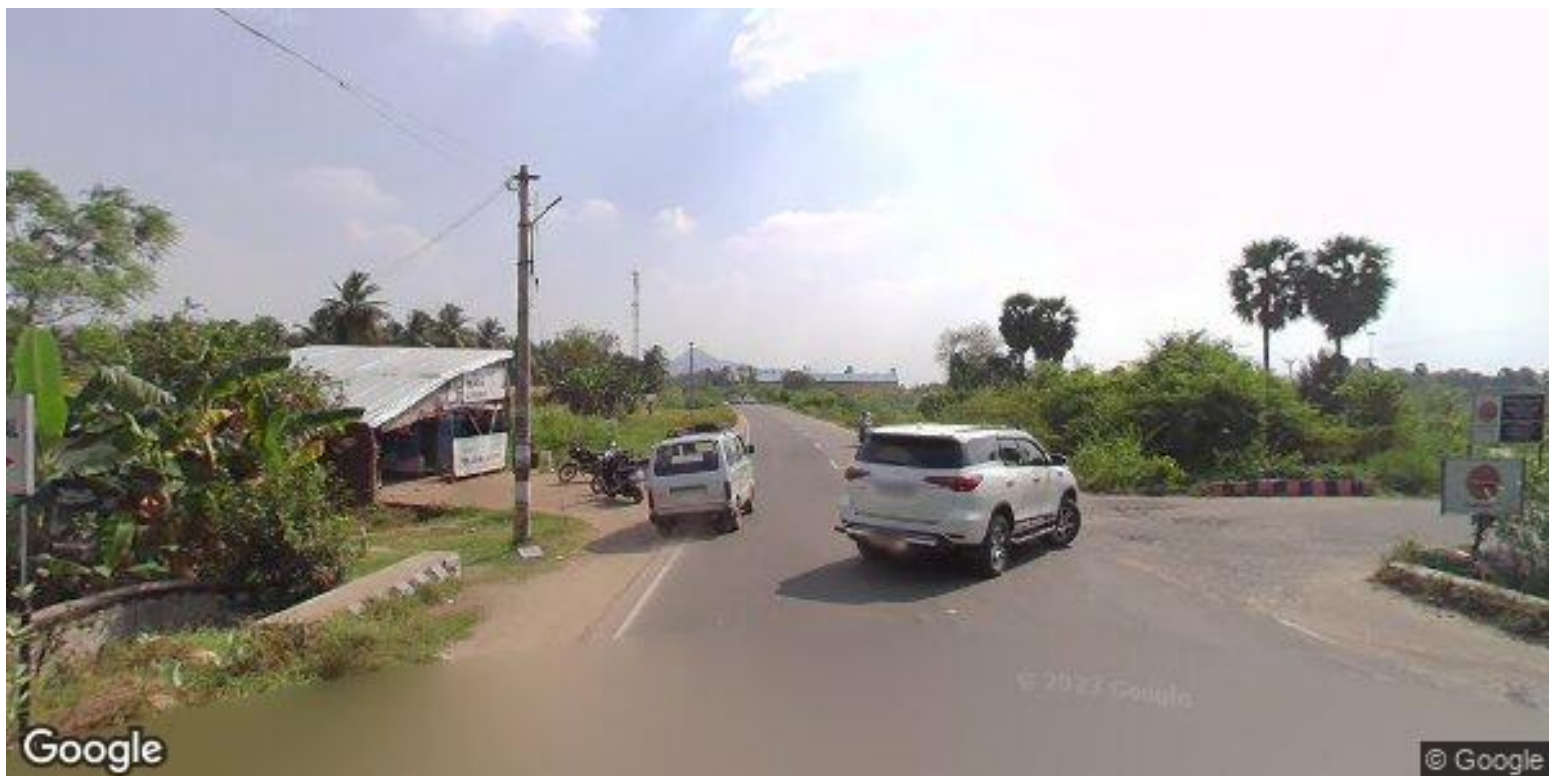
**Coordinates:** 11.44029, 77.87544

**Risk Type:** Blind Spot

**Risk Level:** Blind Spot

**Speed Limit:** 10 KM/Hr

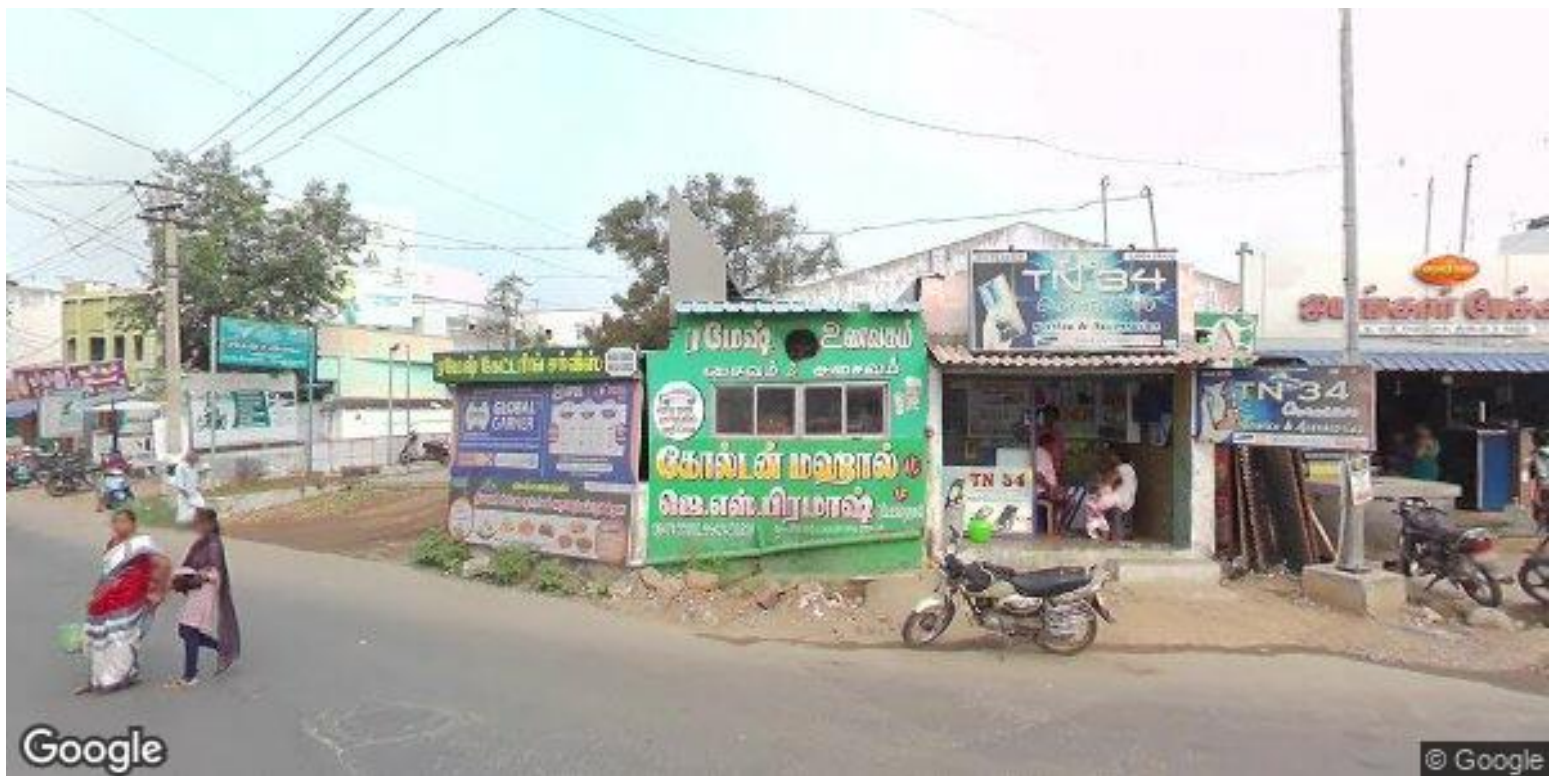
**Coordinates: 11.38346, 77.89975**

**Risk Type: Turn**

**Risk Level: Medium**

**Speed Limit: 30 KM/Hr**

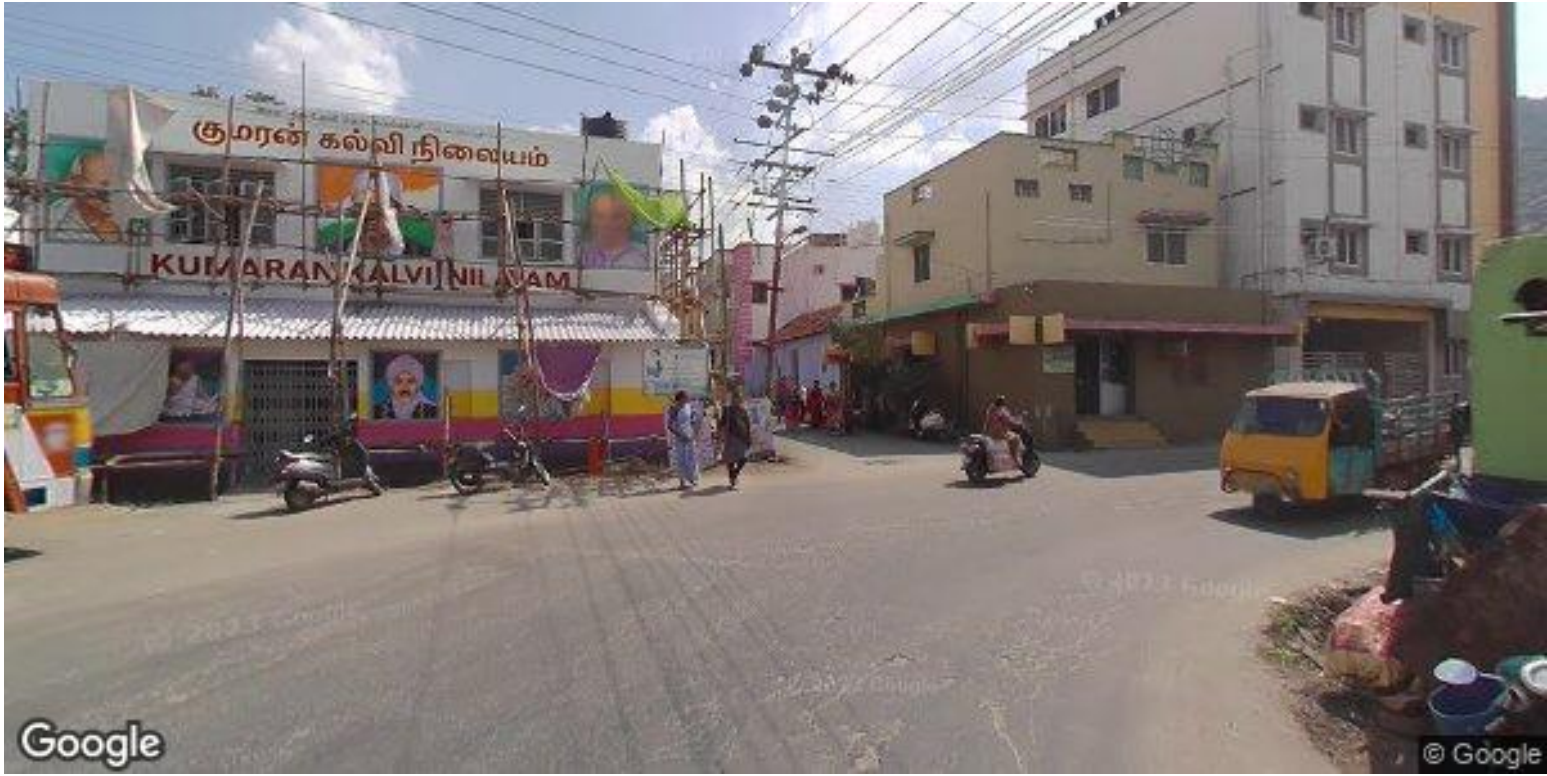
**Coordinates: 11.38188, 77.90257**

**Risk Type: Blind Spot**

**Risk Level: Blind Spot**

**Speed Limit: 10 KM/Hr**

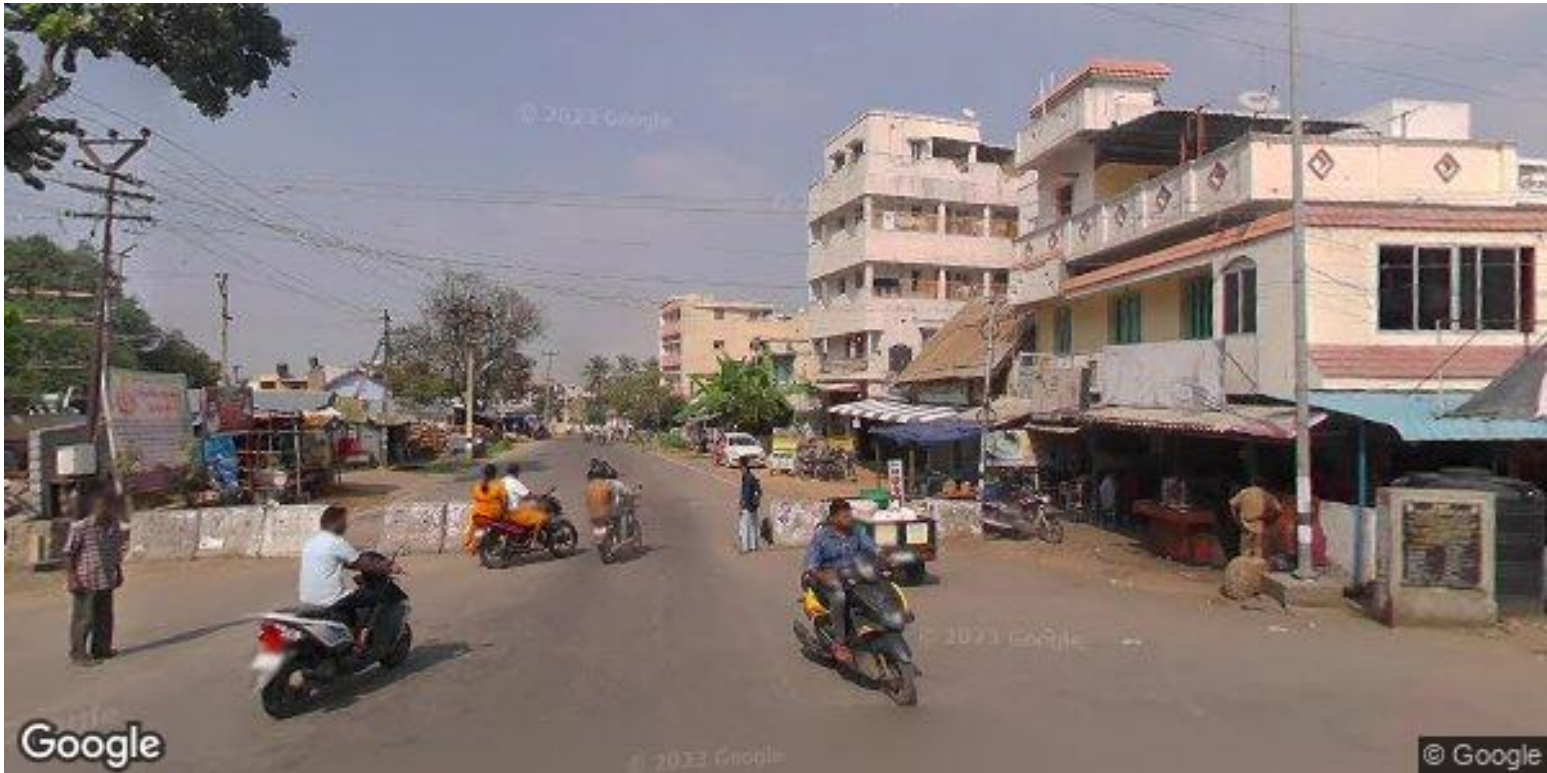
**Coordinates: 11.37841, 77.90140**

**Risk Type: Blind Spot**

**Risk Level: Blind Spot**

**Speed Limit: 10 KM/Hr**

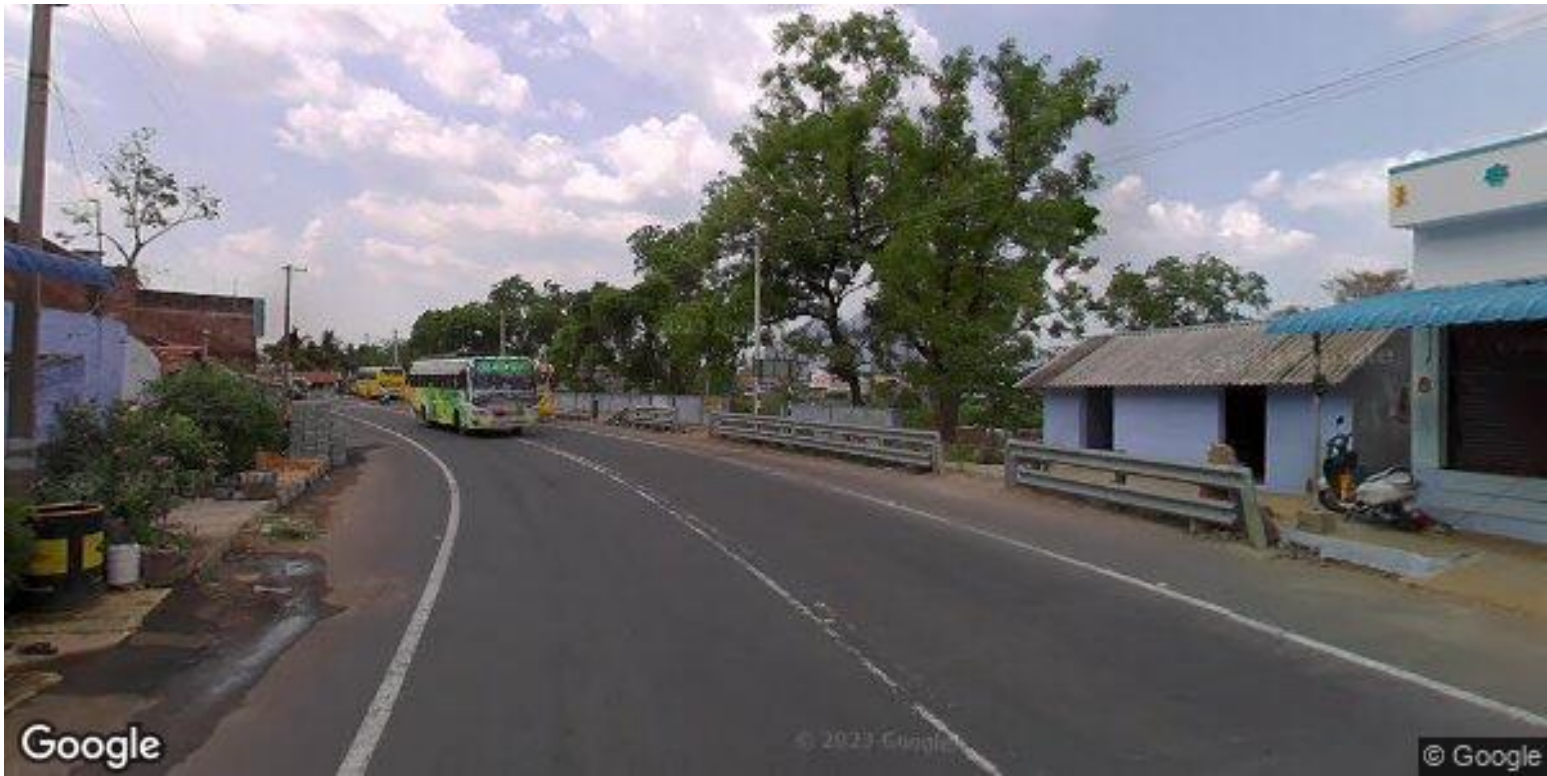
**Risk Type:** Turn  
**Risk Level:** Medium  
**Speed Limit:** 30 KM/Hr  
**Coordinates:** 11.41332, 78.08072

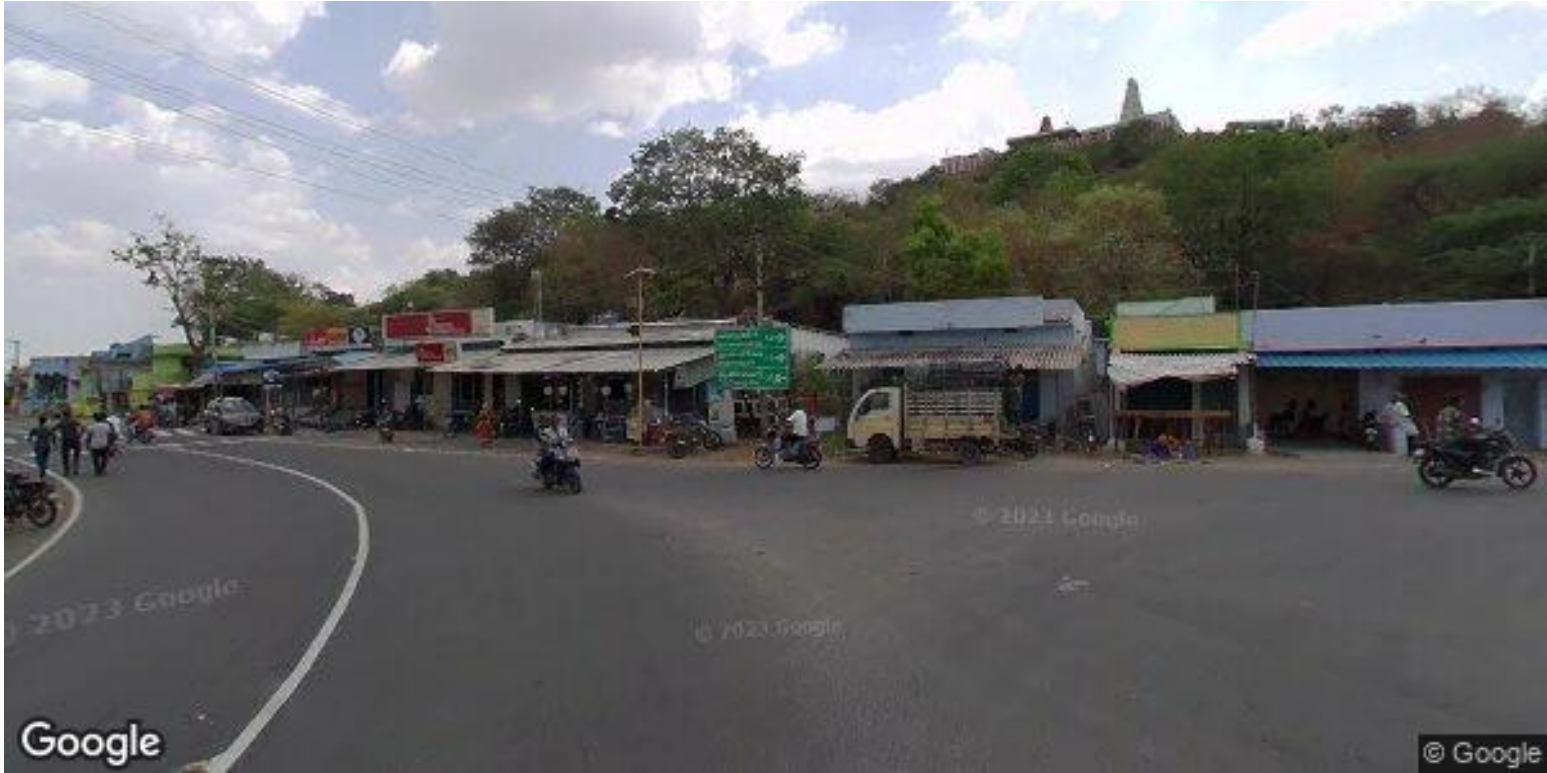
**Risk Type:** Turn  
**Risk Level:** Medium  
**Speed Limit:** 30 KM/Hr  
**Coordinates:** 11.41463, 78.08067

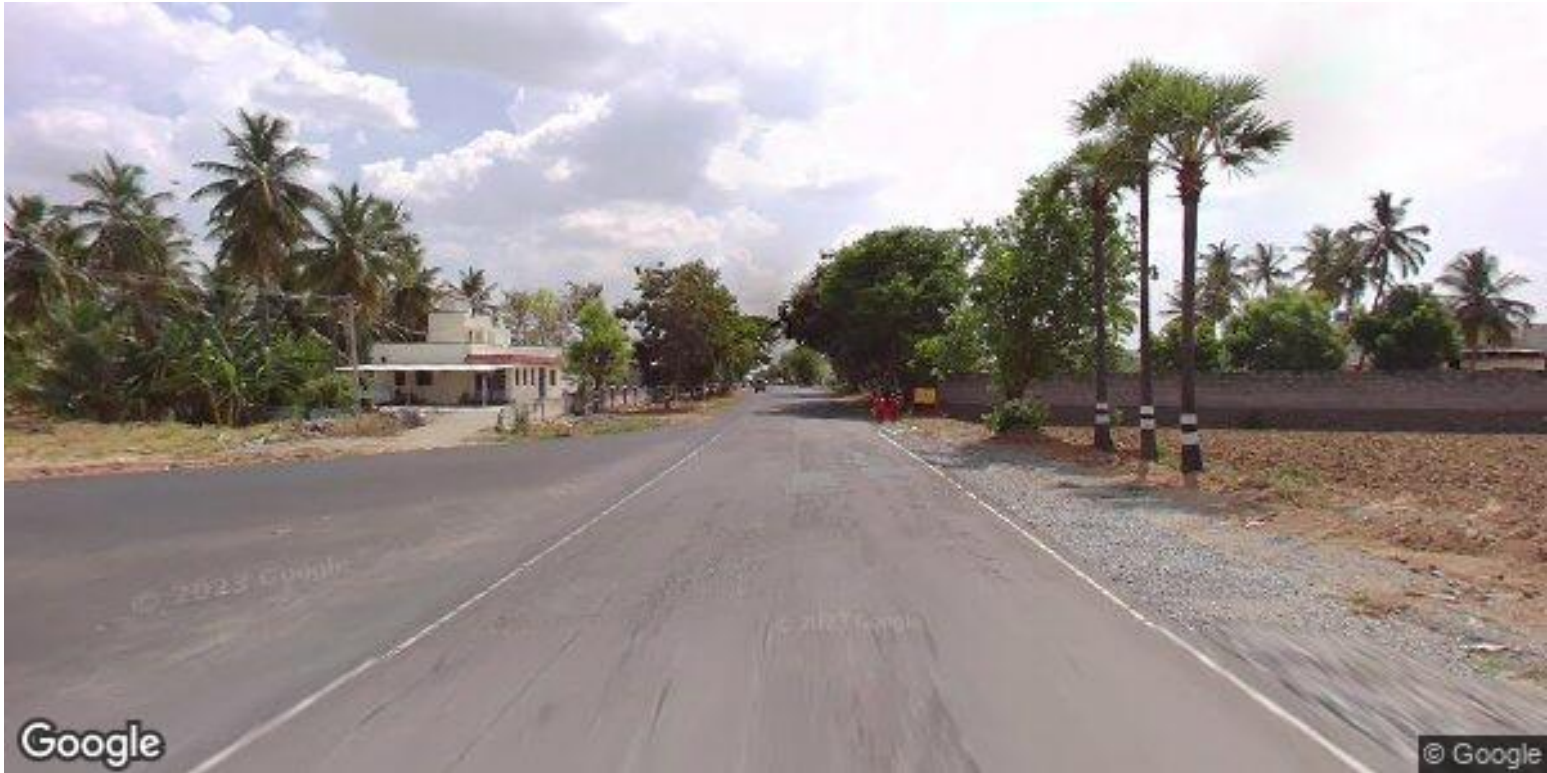
Coordinates: 11.42964, 78.11587

Risk Type: Turn

Risk Level: High

Speed Limit: 15 KM/Hr

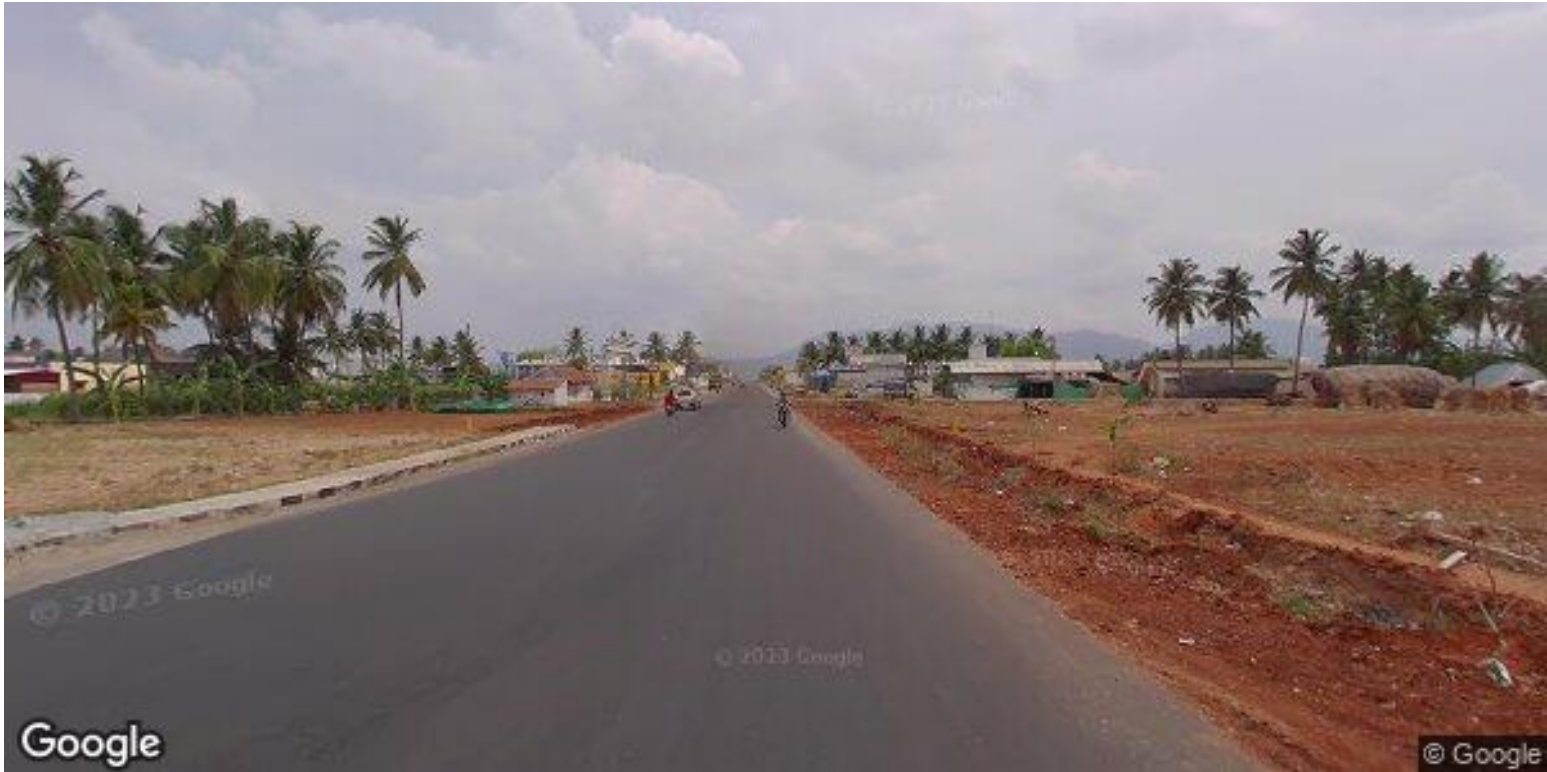
Coordinates: 11.43542, 78.20754

Risk Type: Turn

Risk Level: High

Speed Limit: 15 KM/Hr

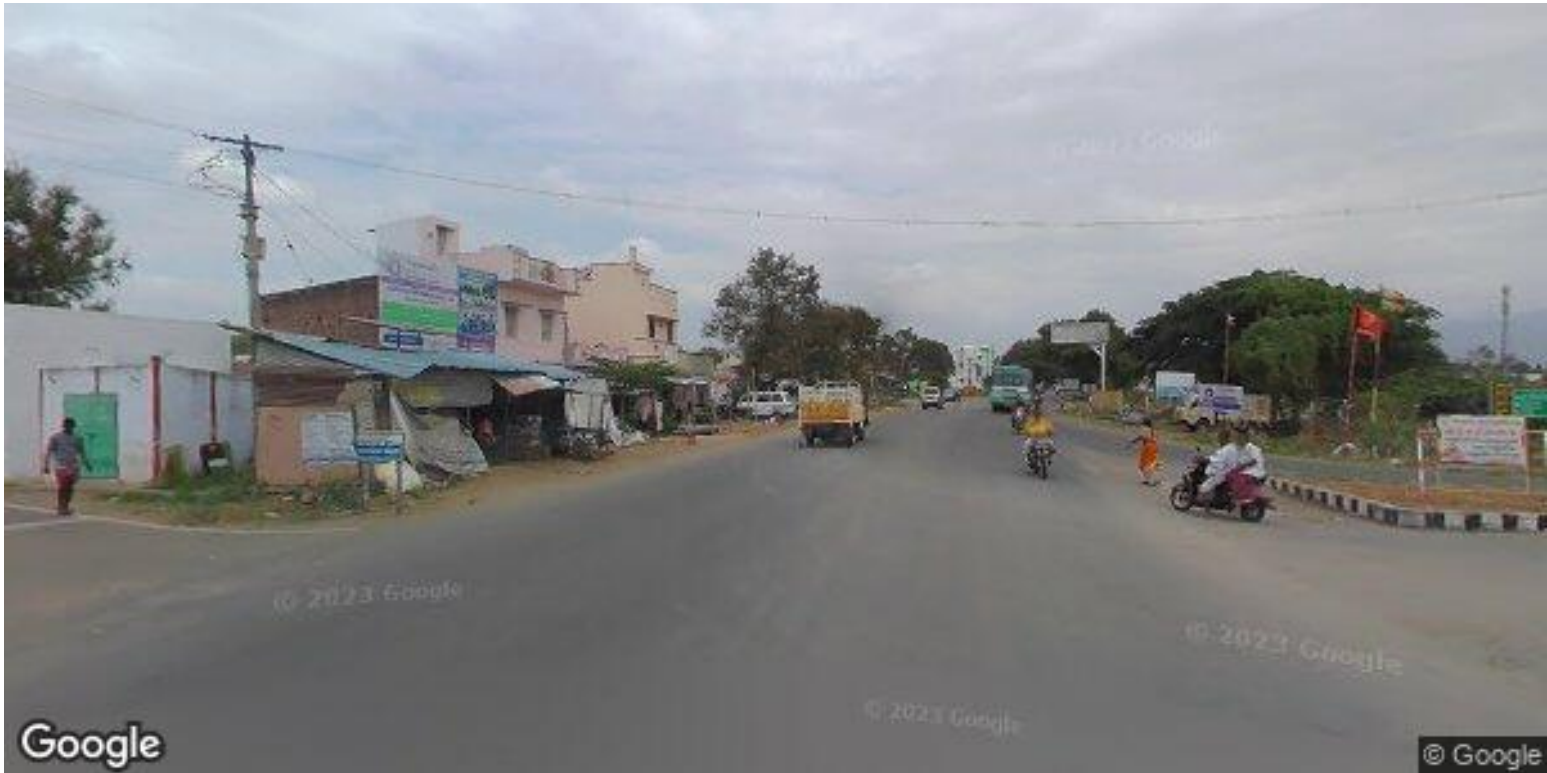
Coordinates: 11.45100, 78.20385

Risk Type: Blind Spot

Risk Level: Blind Spot

Speed Limit: 10 KM/Hr

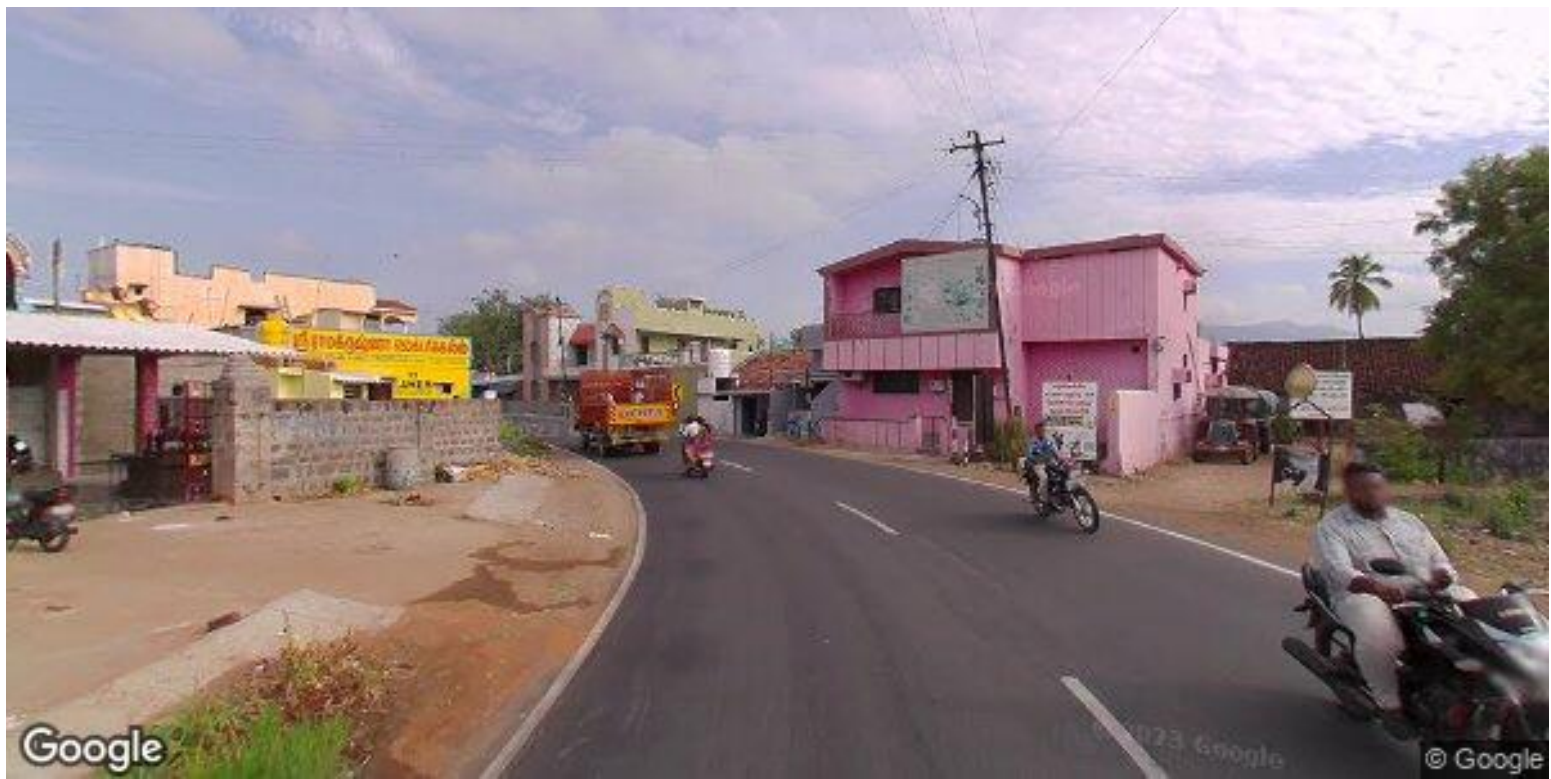
**Coordinates:** 11.44925, 78.22288

**Risk Type:** Turn

**Risk Level:** Medium

**Speed Limit:** 30 KM/Hr

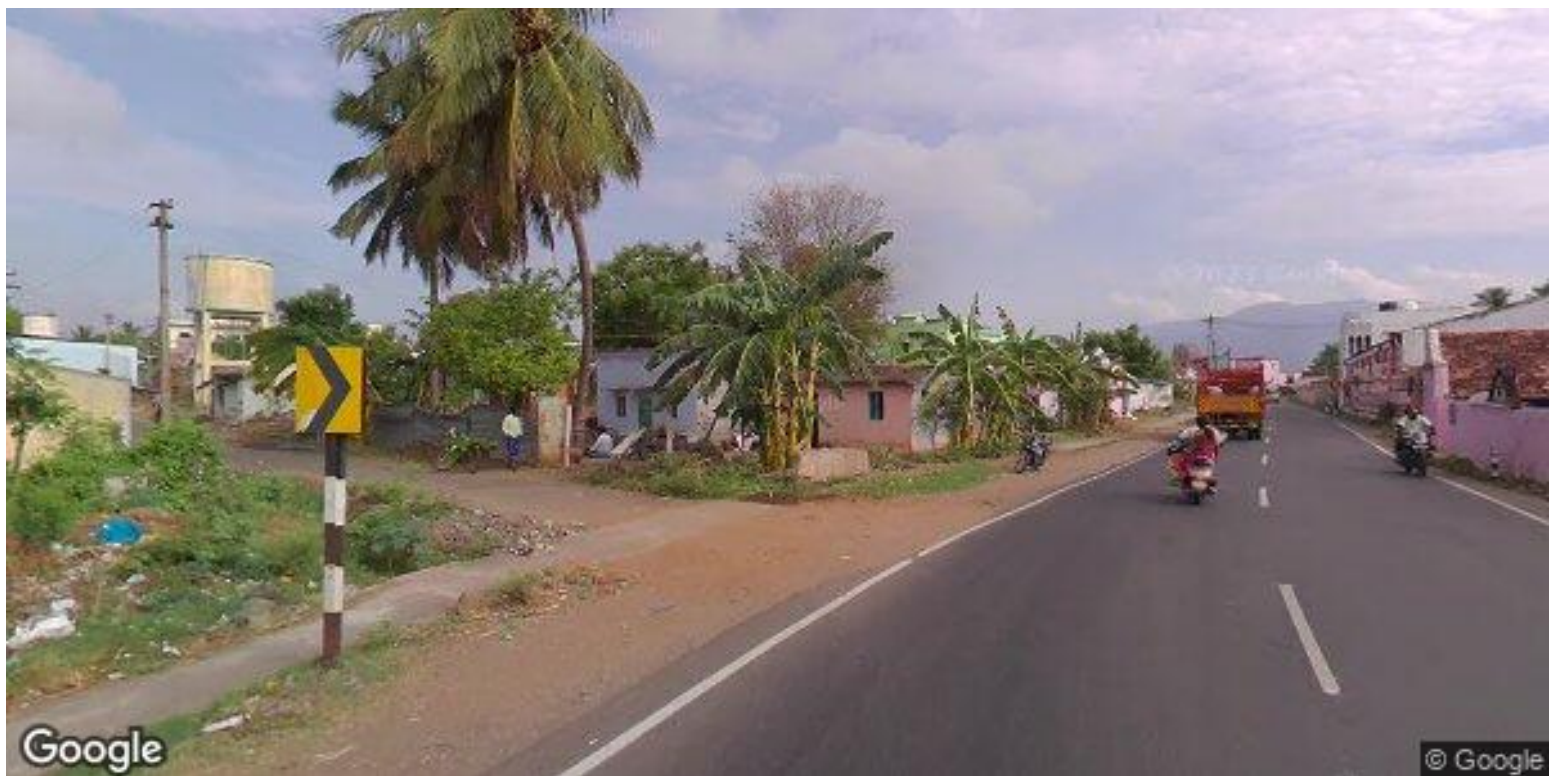
**Coordinates:** 11.44813, 78.22305

**Risk Type:** Turn

**Risk Level:** Medium

**Speed Limit:** 30 KM/Hr

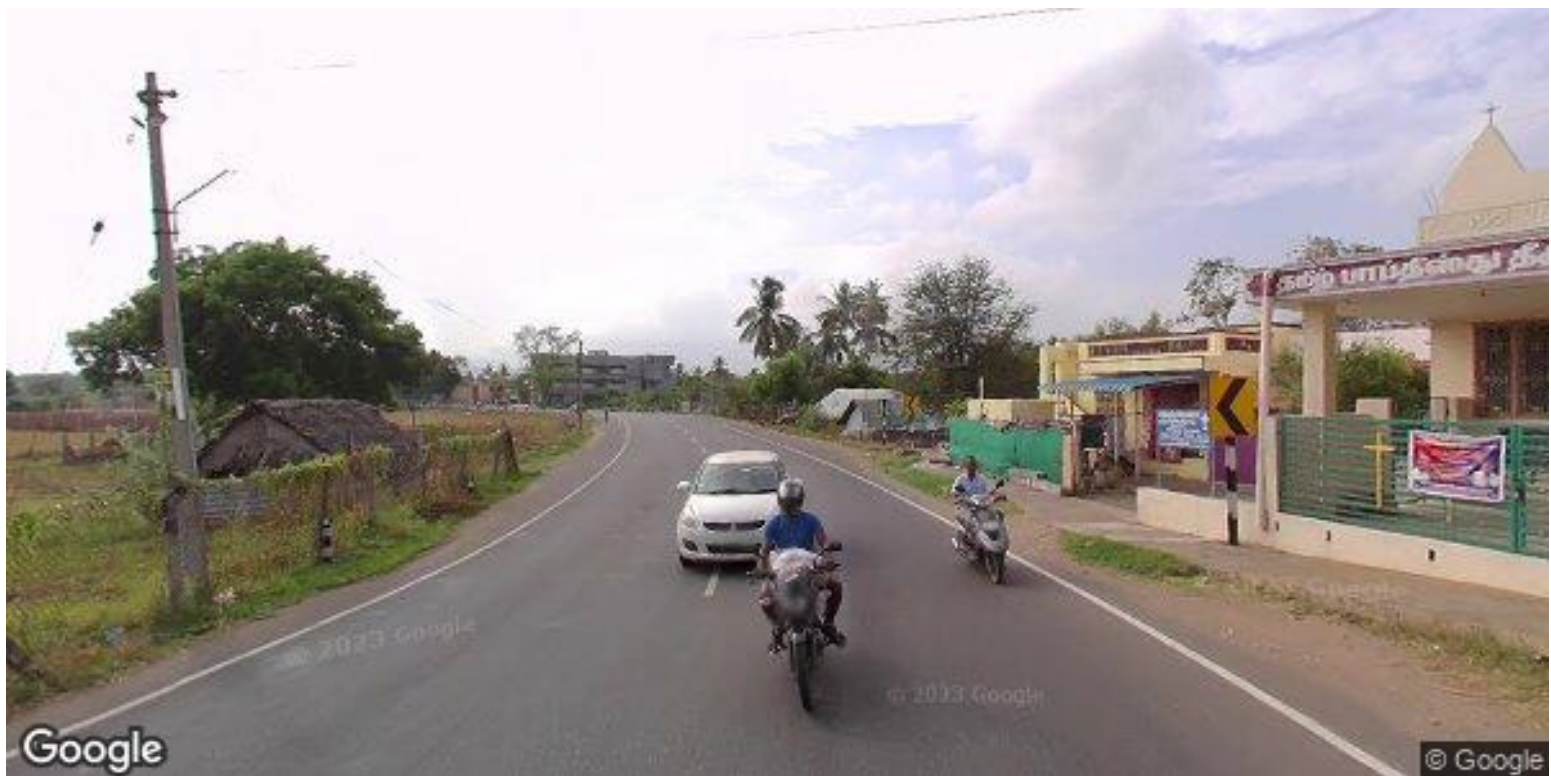
**Coordinates:** 11.44793, 78.22320

**Risk Type:** Turn

**Risk Level:** Medium

**Speed Limit:** 30 KM/Hr
