## JOURNEY RISK MANAGEMENT (JRM) STUDY

### Salem Terminal to JEYAM FUELS

### Route Safety Analysis from Sangagiri to Mathagiri, Tamil Nadu

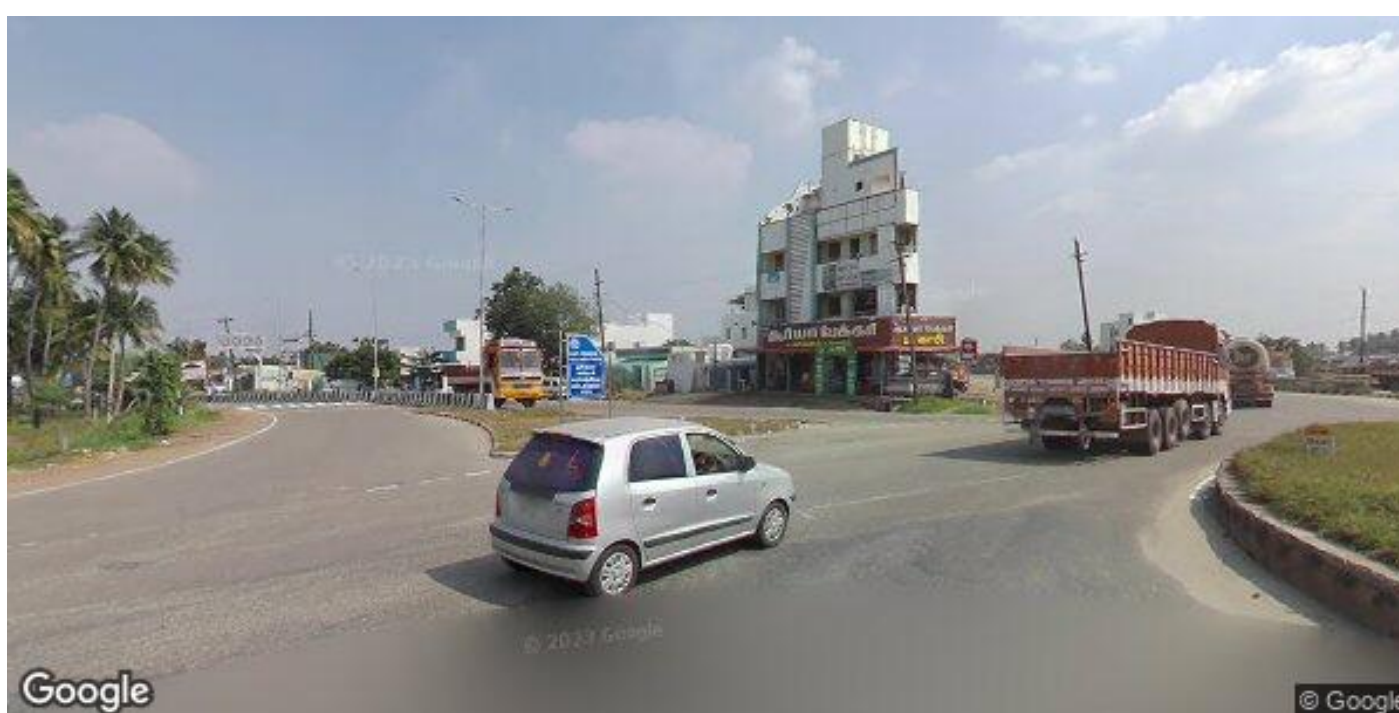
**Risk Type:** Roundabout  
**Risk Level:** High  
**Speed Limit:** 15 KM/Hr  
**Coordinates:** 10.92958, 78.05452

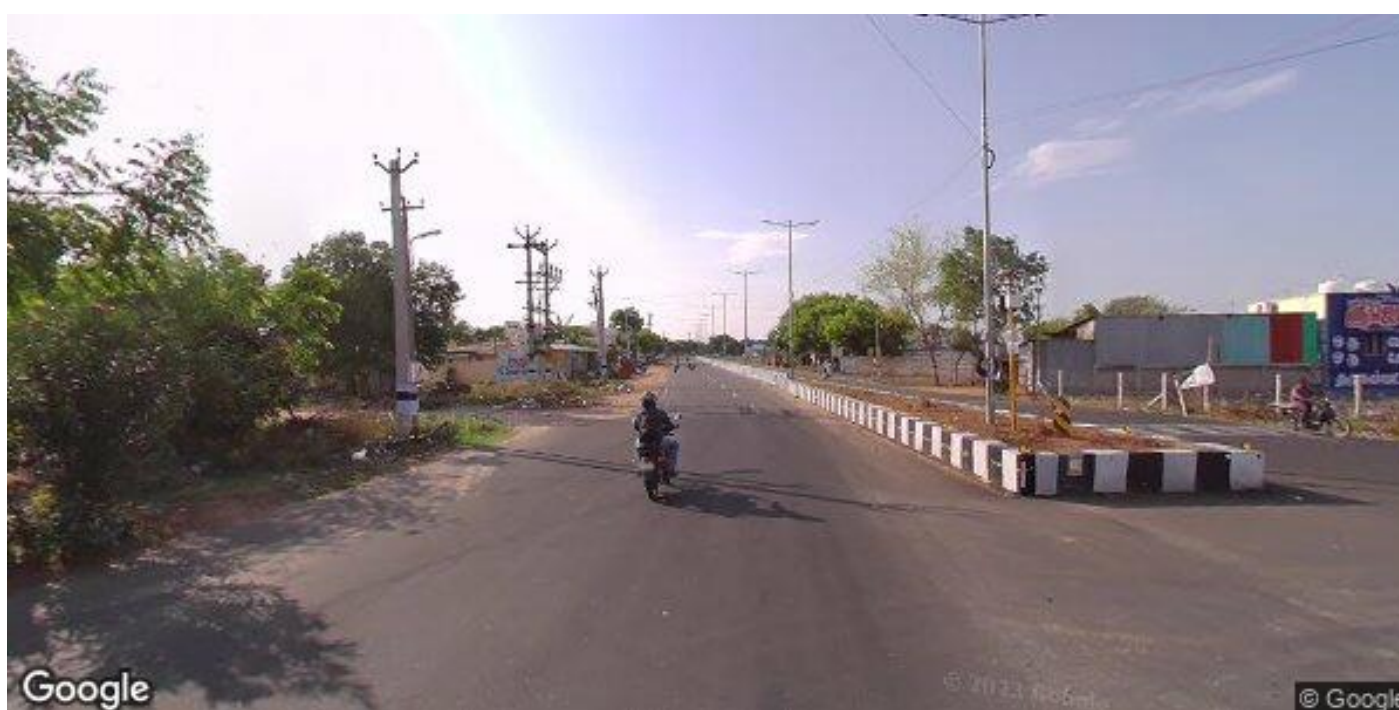
**Risk Type:** U-Turn  
**Risk Level:** High  
**Speed Limit:** 10 KM/Hr  
**Coordinates:** 10.9110477, 78.09713769999999

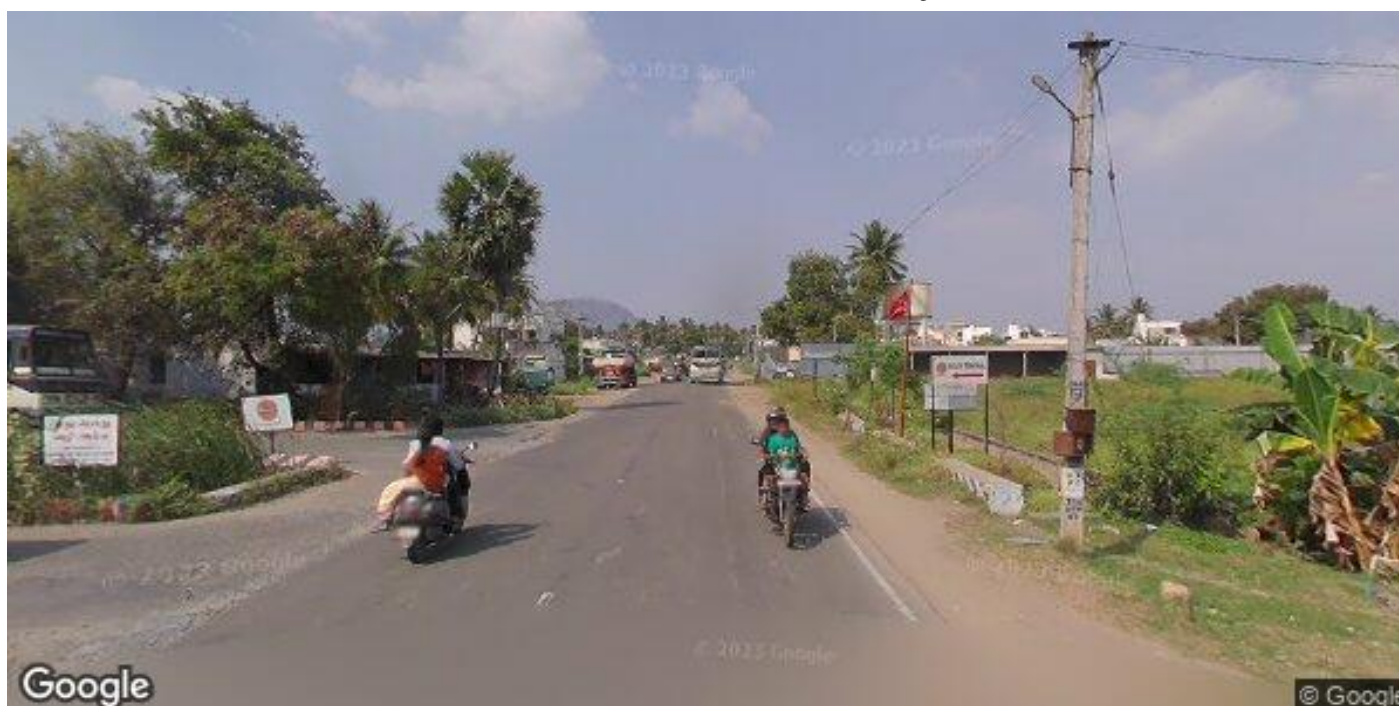
**Risk Type:** Turn  
**Risk Level:** High  
**Speed Limit:** 15 KM/Hr  
**Coordinates:** 11.44019, 77.87547

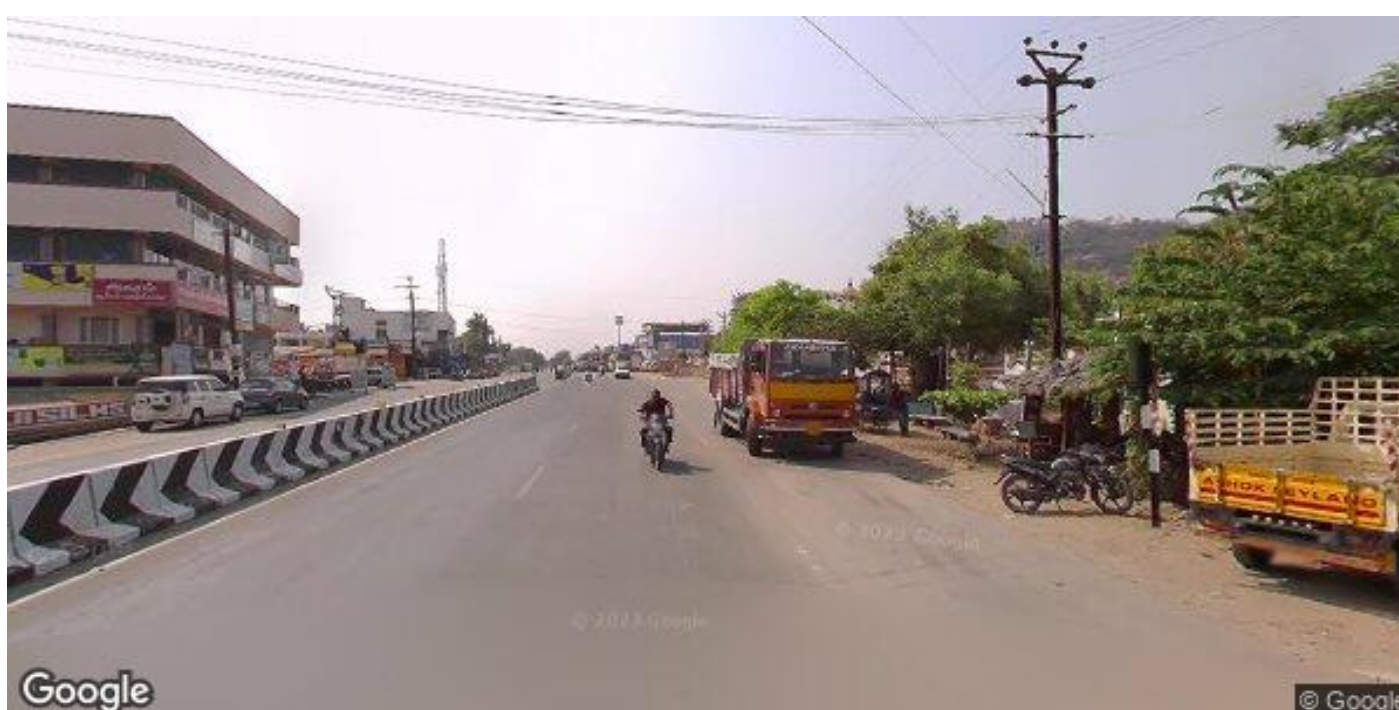
**Risk Type:** Turn  
**Risk Level:** Medium  
**Speed Limit:** 30 KM/Hr  
**Coordinates:** 11.39685, 77.88861

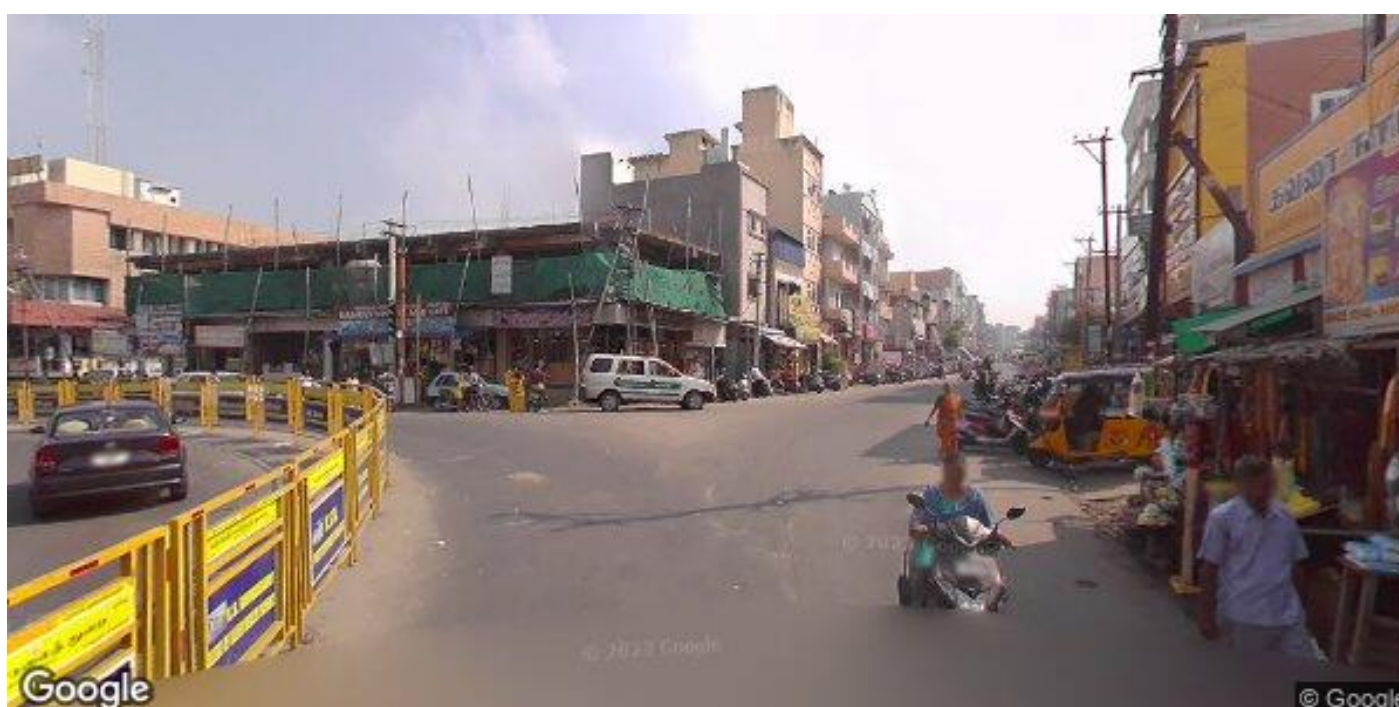
**Risk Type:** Turn  
**Risk Level:** High  
**Speed Limit:** 15 KM/Hr  
**Coordinates:** 11.37862, 77.89488

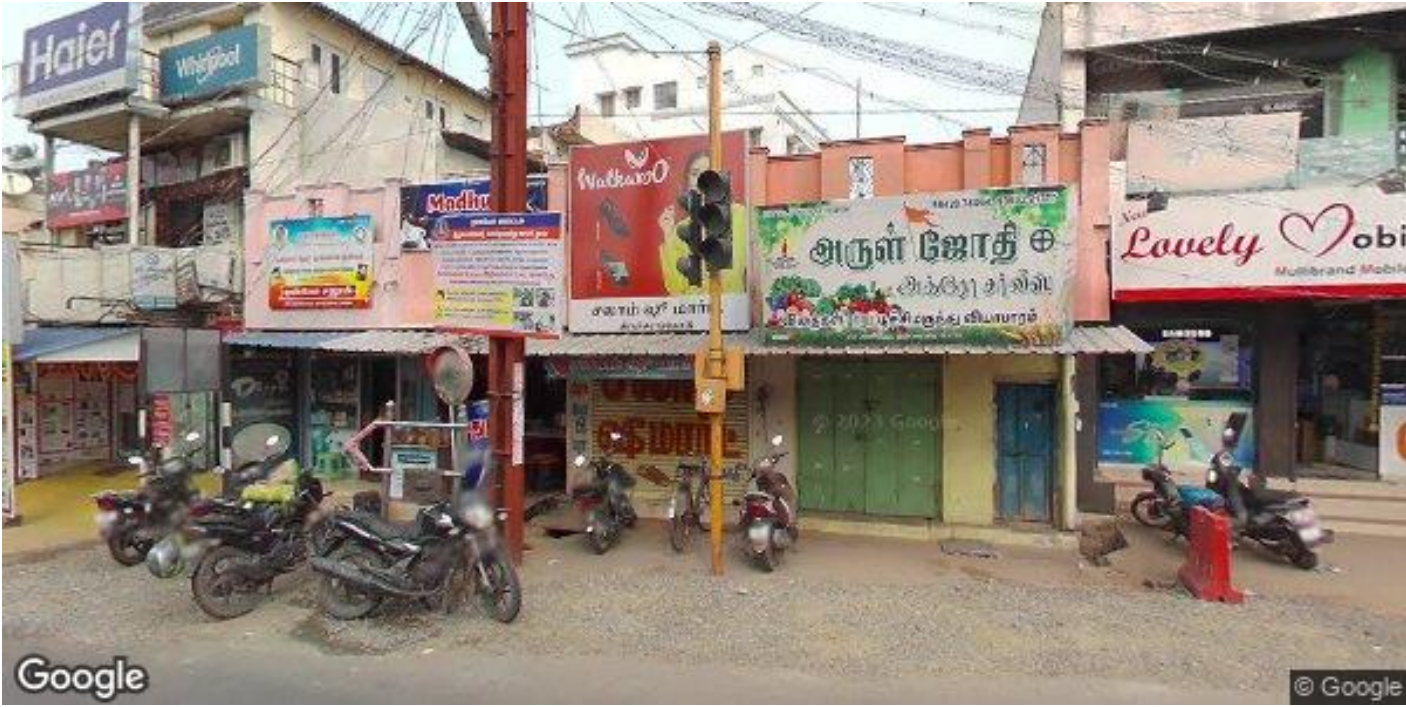
Risk Type: Turn  
Risk Level: High  
Speed Limit: 15 KM/Hr  
Coordinates: 11.37850, 77.89453

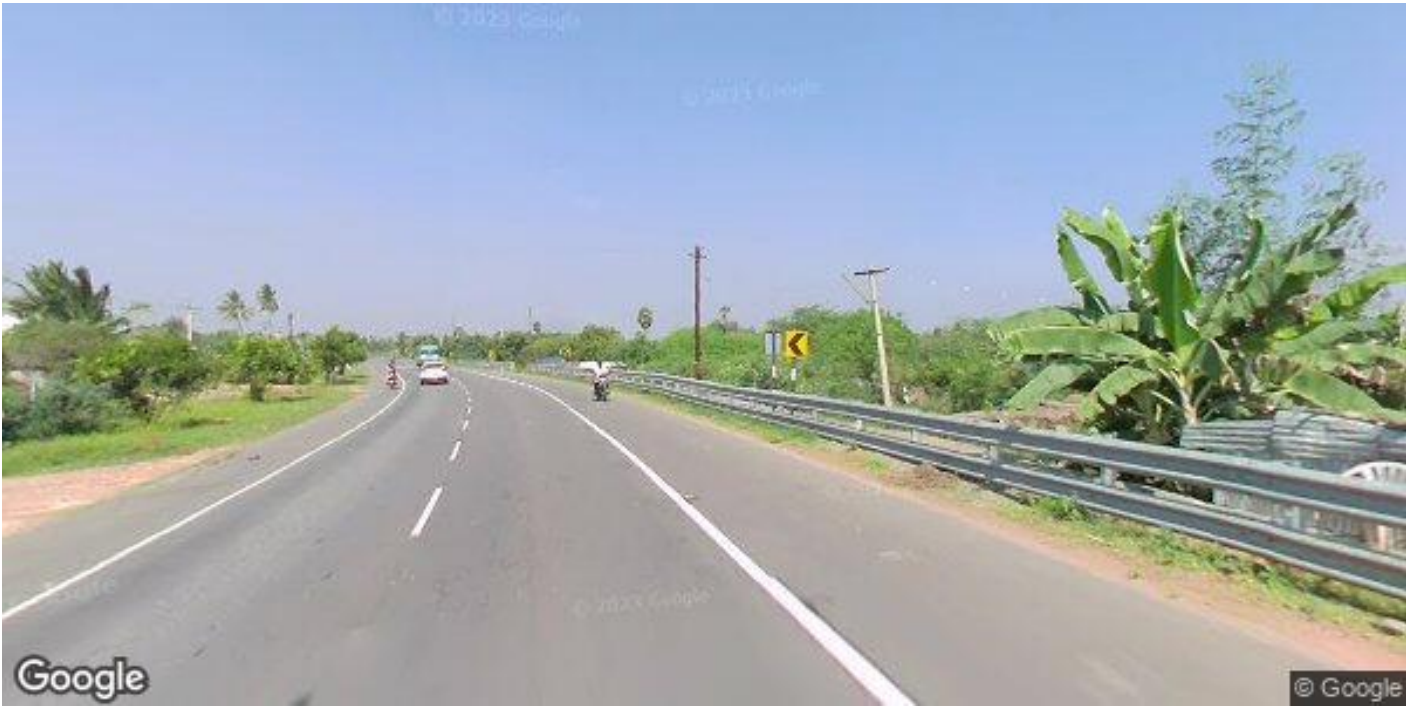
Risk Type: Turn  
Risk Level: Medium  
Speed Limit: 30 KM/Hr  
Coordinates: 11.16950, 78.01544

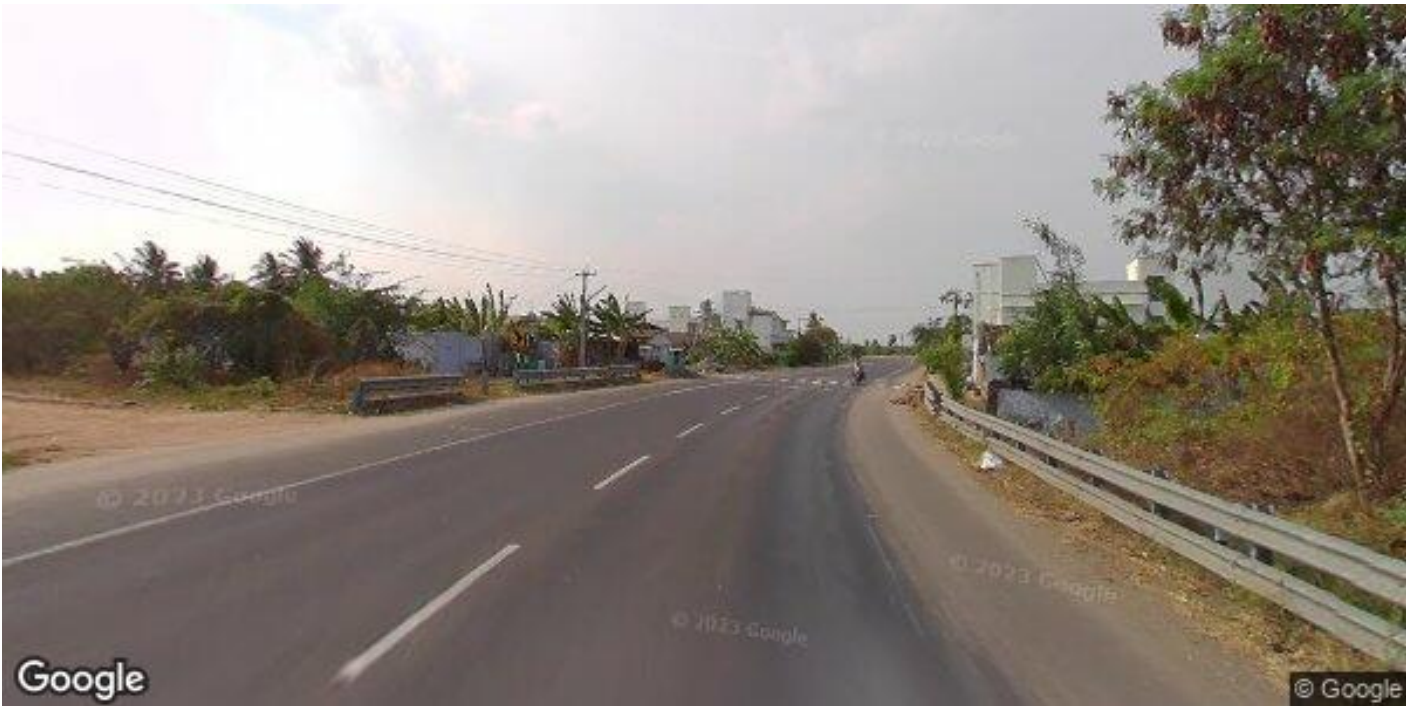
Risk Type: Turn  
Risk Level: Medium  
Speed Limit: 30 KM/Hr  
Coordinates: 11.16764, 78.01565

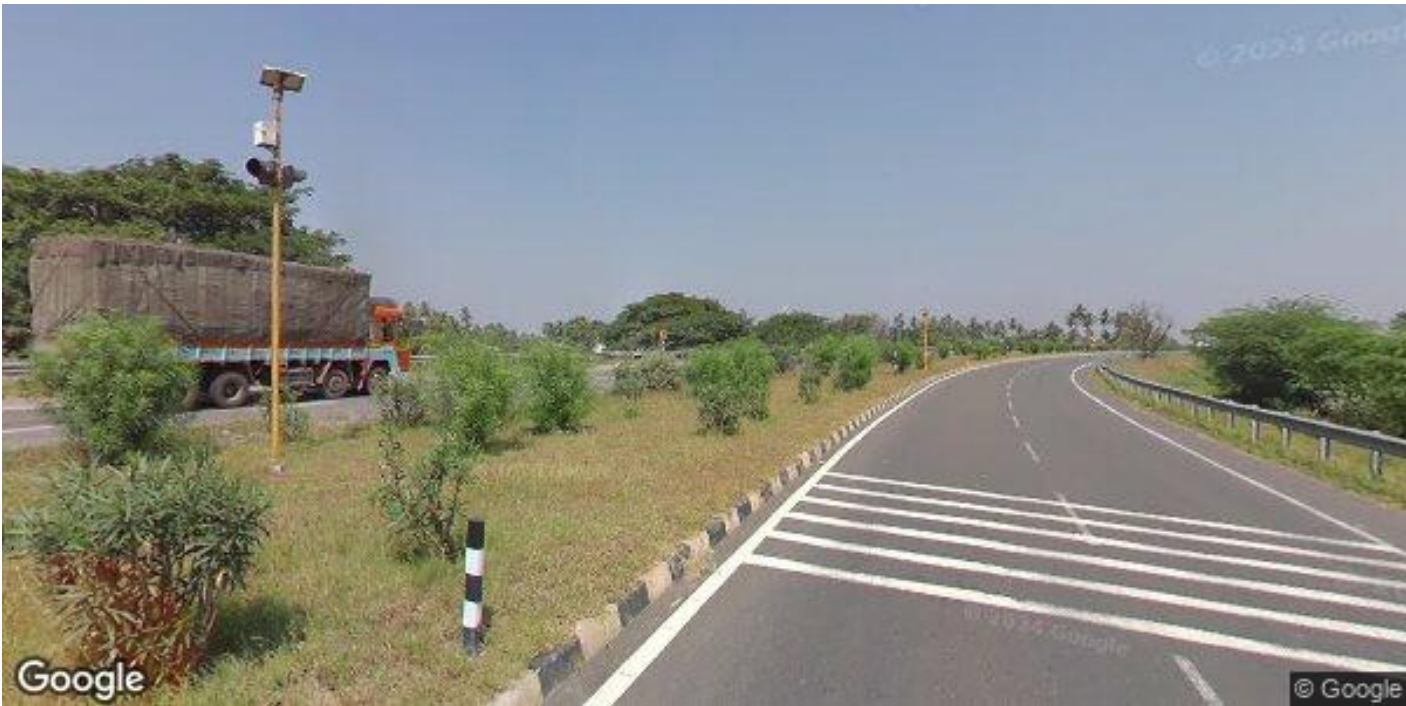
**Risk Type:** Turn  
**Risk Level:** Medium  
**Speed Limit:** 30 KM/Hr  
**Coordinates:** 11.10102, 78.00572

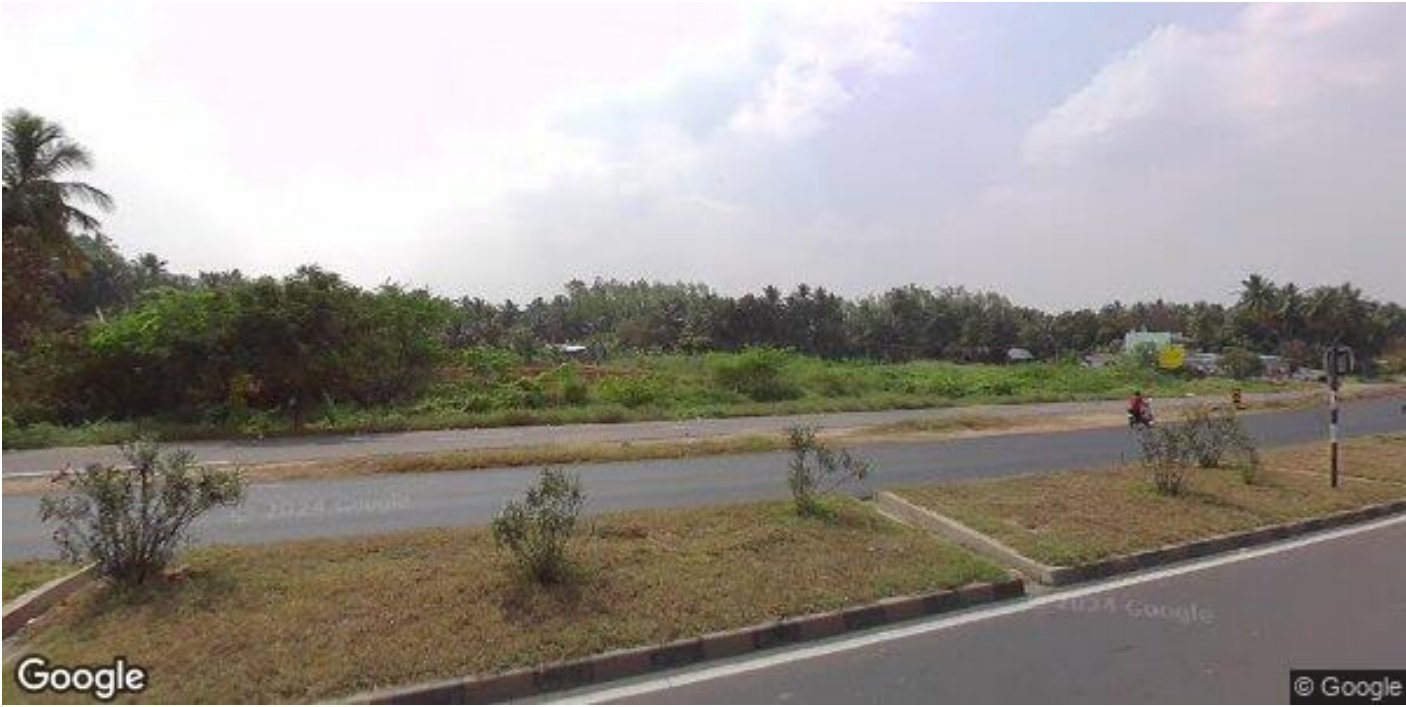
**Risk Type:** Turn  
**Risk Level:** Medium  
**Speed Limit:** 30 KM/Hr  
**Coordinates:** 11.05261, 78.05138

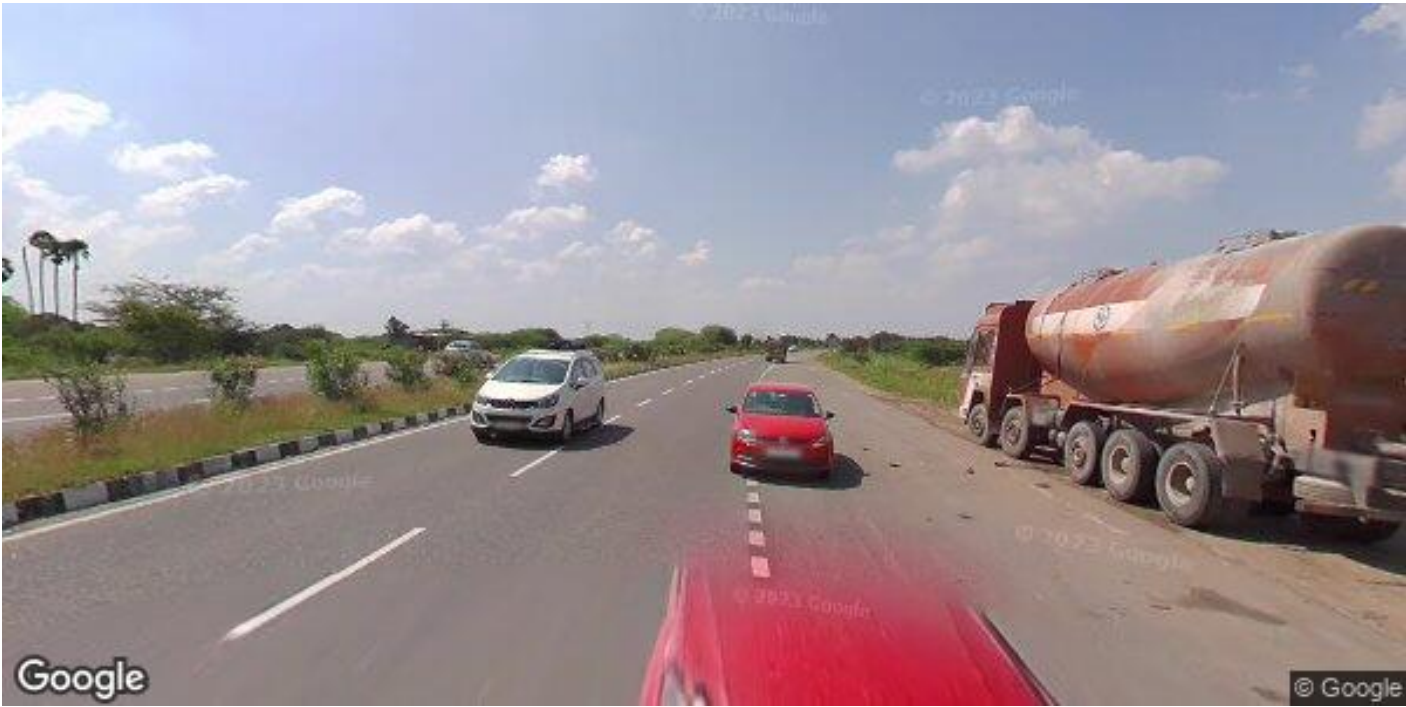
**Risk Type:** Turn  
**Risk Level:** Medium  
**Speed Limit:** 30 KM/Hr  
**Coordinates:** 10.90767, 78.09893

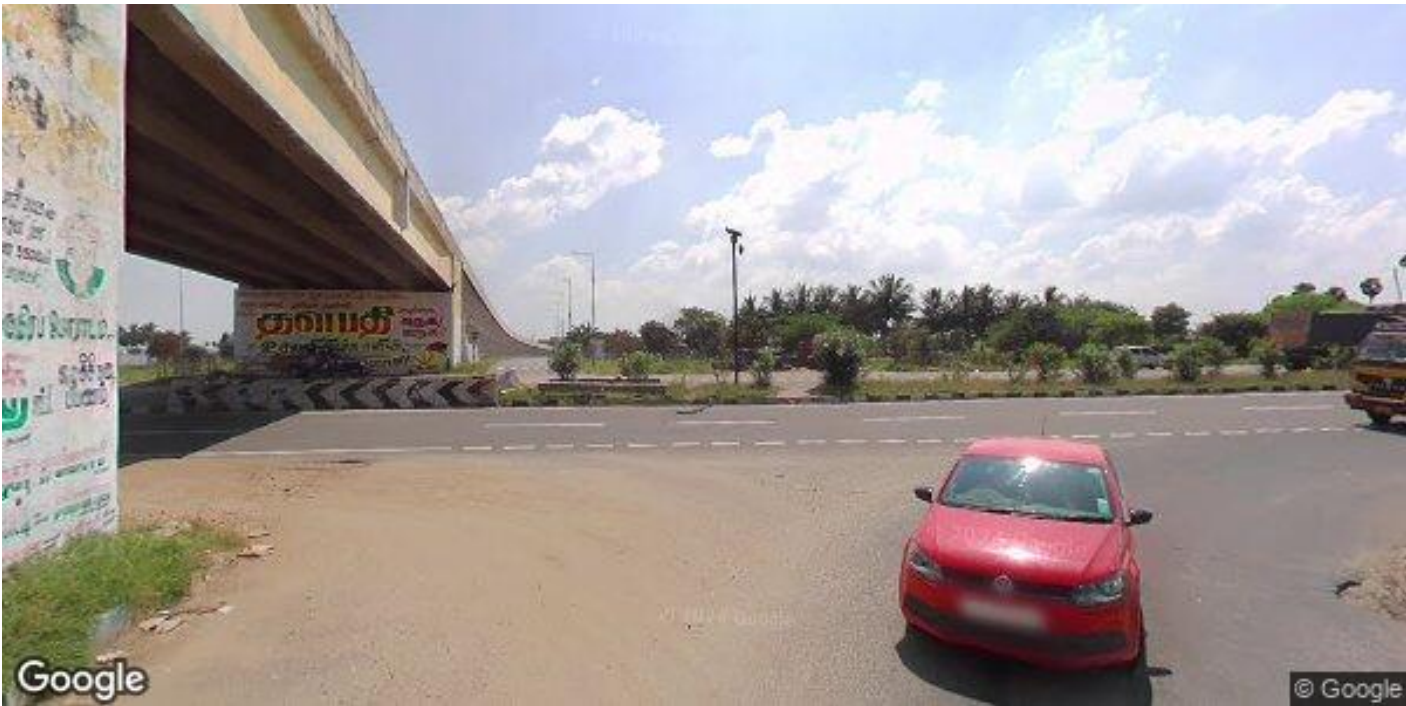
**Risk Type:** Turn  
**Risk Level:** High  
**Speed Limit:** 15 KM/Hr  
**Coordinates:** 10.90793, 78.09916

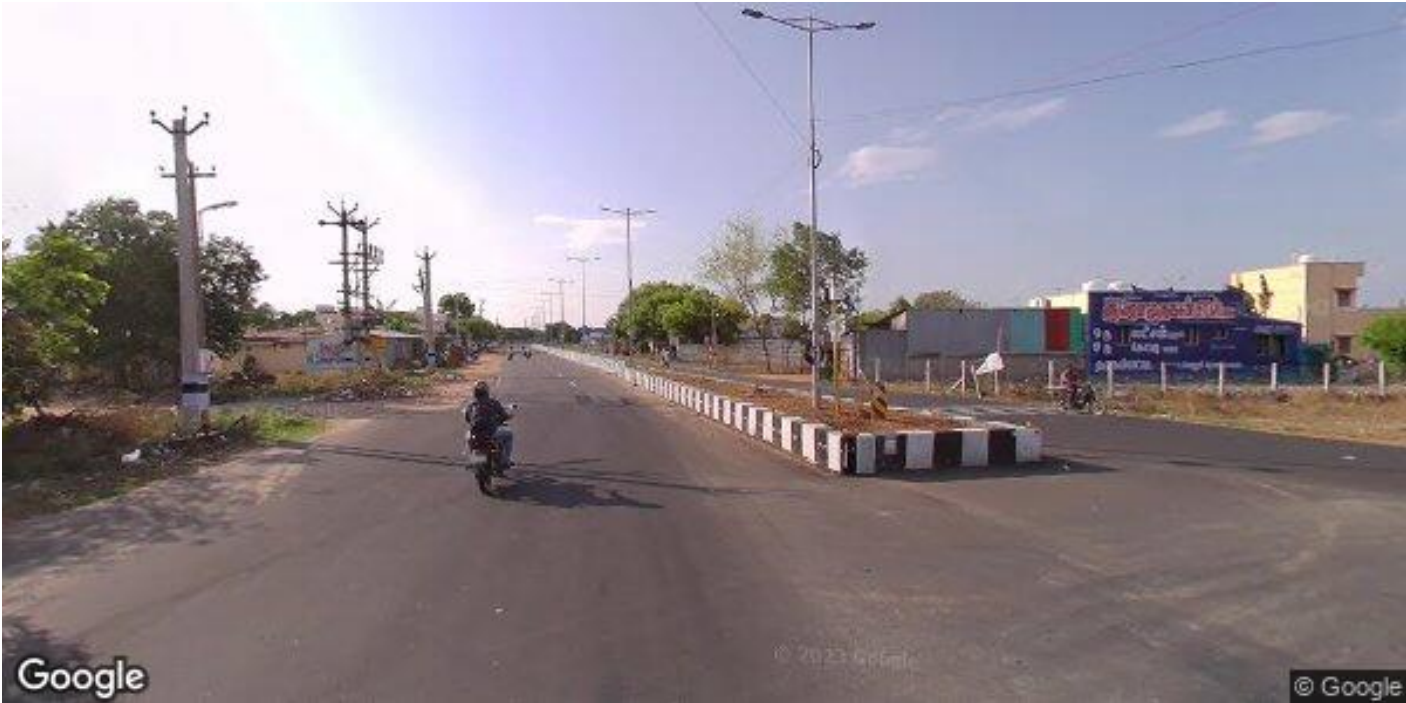
**Risk Type:** Blind Spot  
**Risk Level:** Blind Spot  
**Speed Limit:** 10 KM/Hr  
**Coordinates:** 10.91105, 78.09714

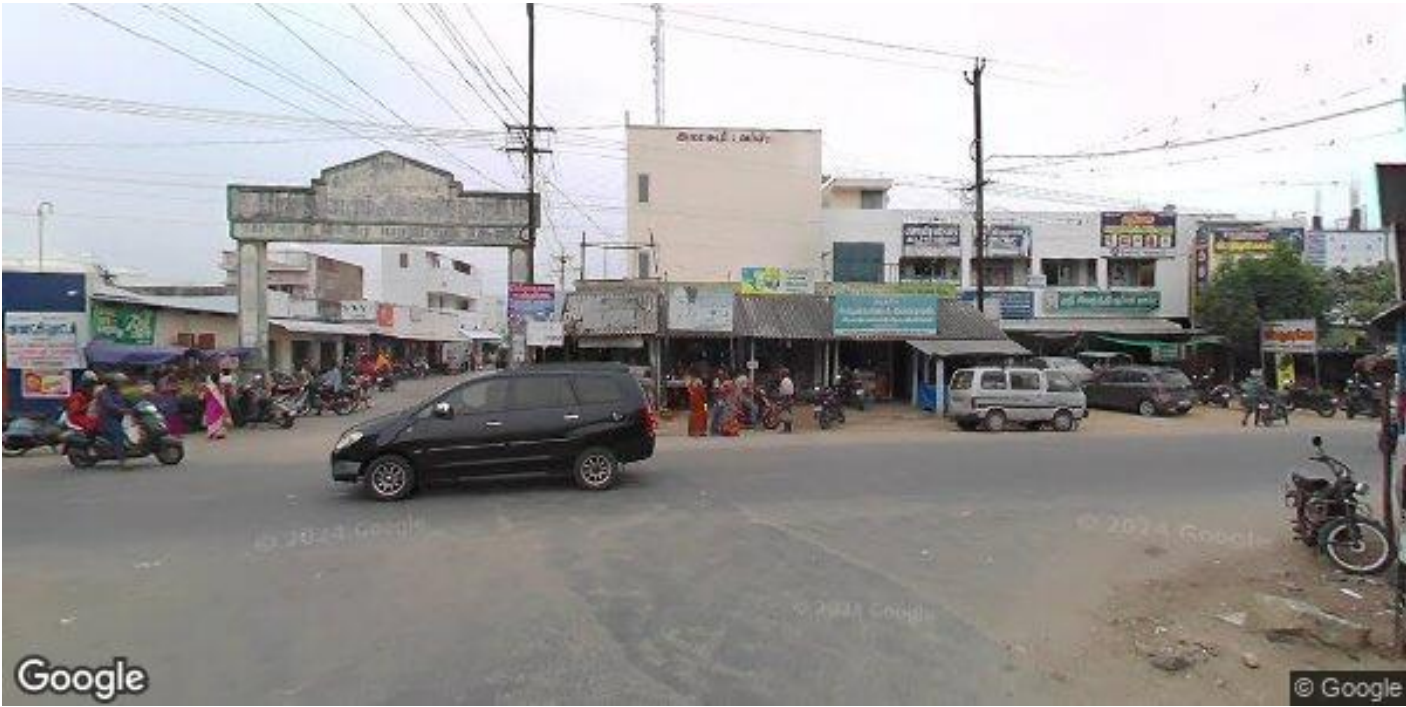
**Risk Type:** Turn  
**Risk Level:** High  
**Speed Limit:** 15 KM/Hr  
**Coordinates:** 10.84613, 78.12000

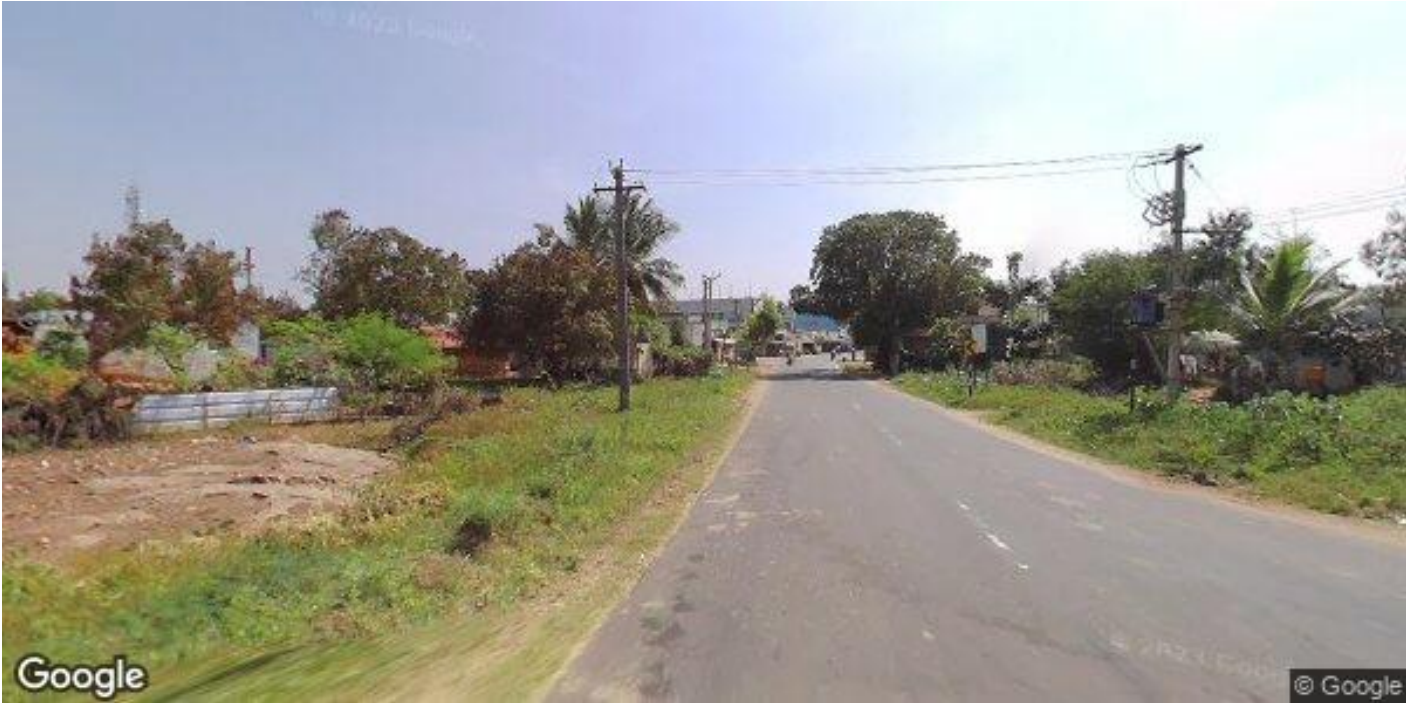
**Risk Type:** Turn  
**Risk Level:** Medium  
**Speed Limit:** 30 KM/Hr  
**Coordinates:** 10.84321, 78.16436

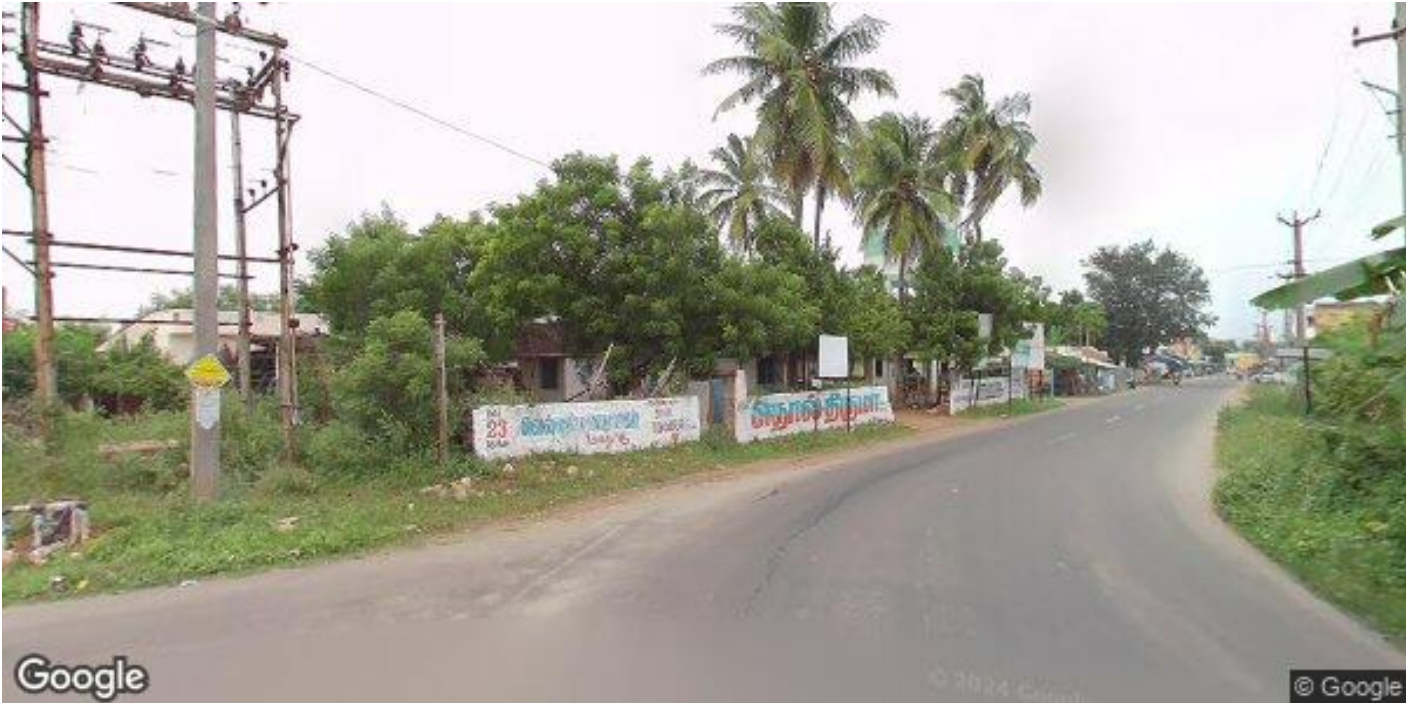
**Risk Type:** Turn  
**Risk Level:** High  
**Speed Limit:** 15 KM/Hr  
**Coordinates:** 10.84057, 78.16518

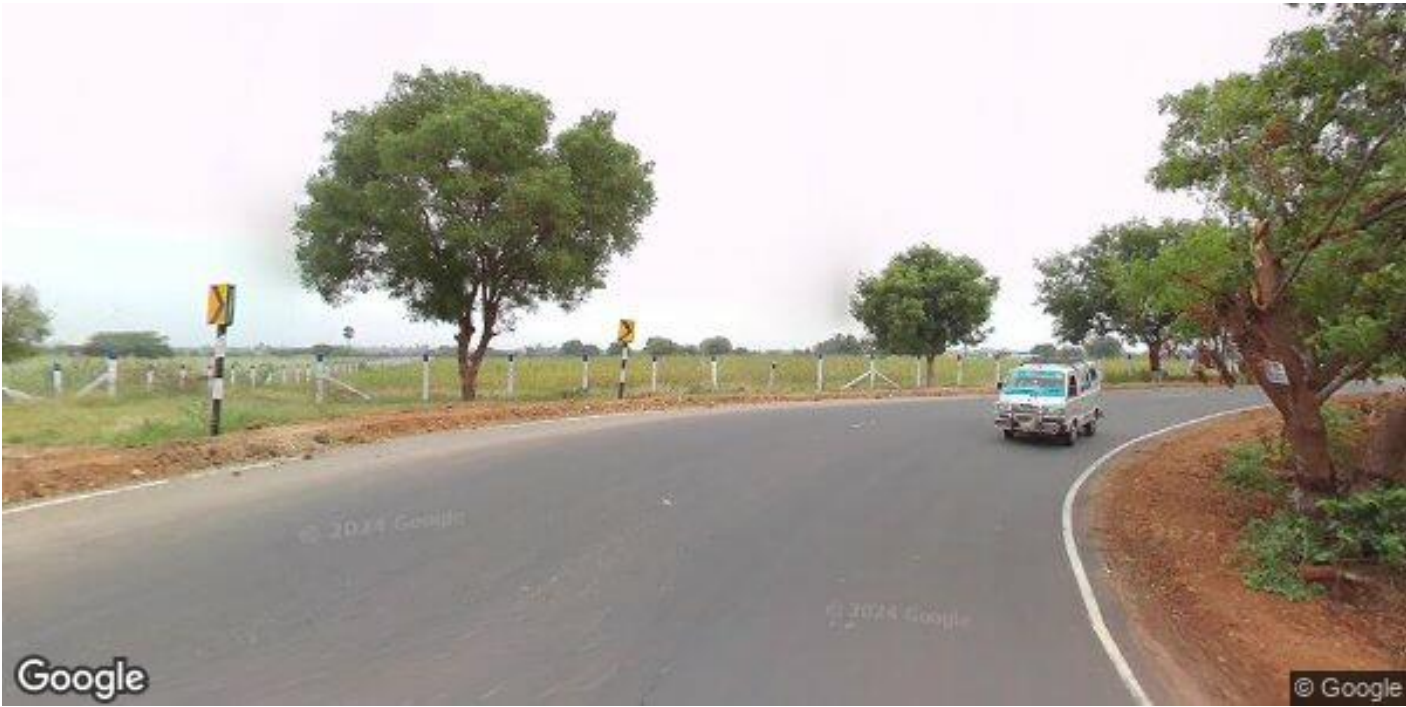
**Risk Type:** Turn  
**Risk Level:** High  
**Speed Limit:** 15 KM/Hr  
**Coordinates:** 10.83953, 78.18108

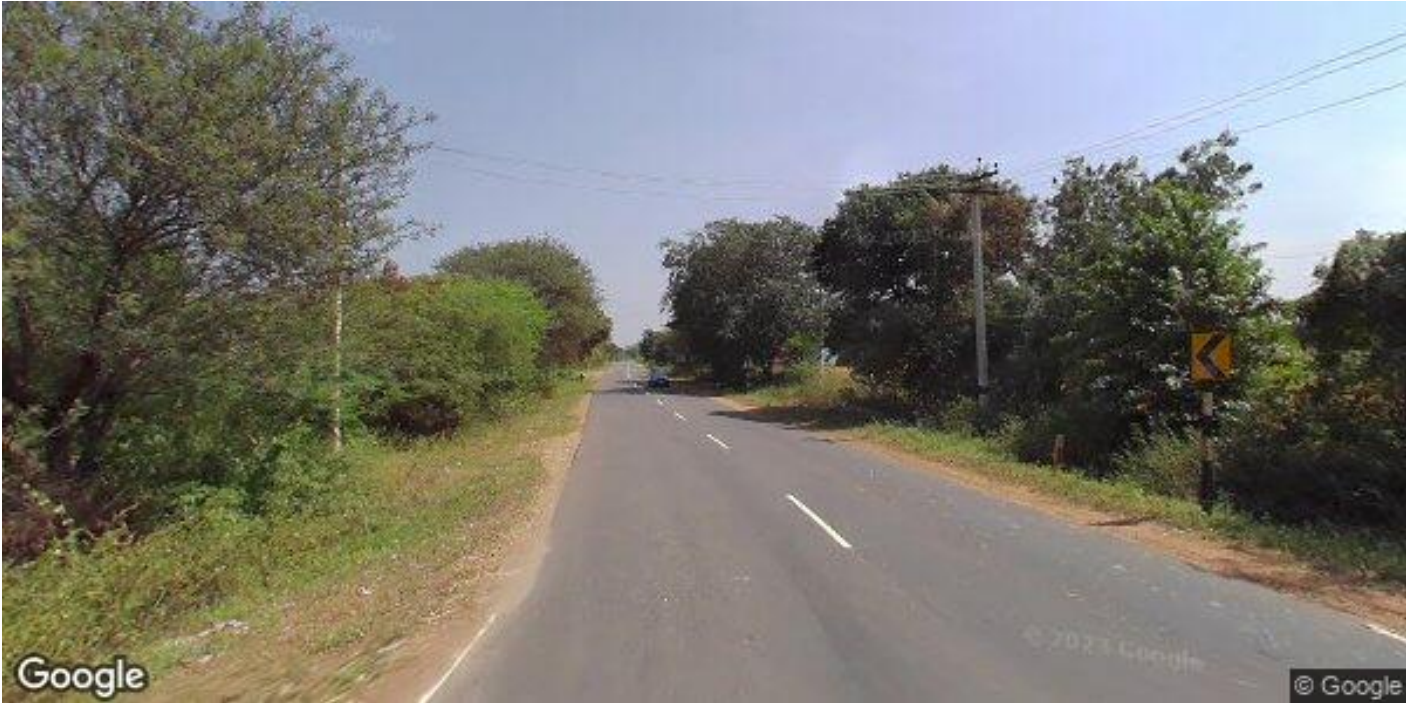
**Risk Type:** Turn  
**Risk Level:** Medium  
**Speed Limit:** 30 KM/Hr  
**Coordinates:** 10.83523, 78.18173

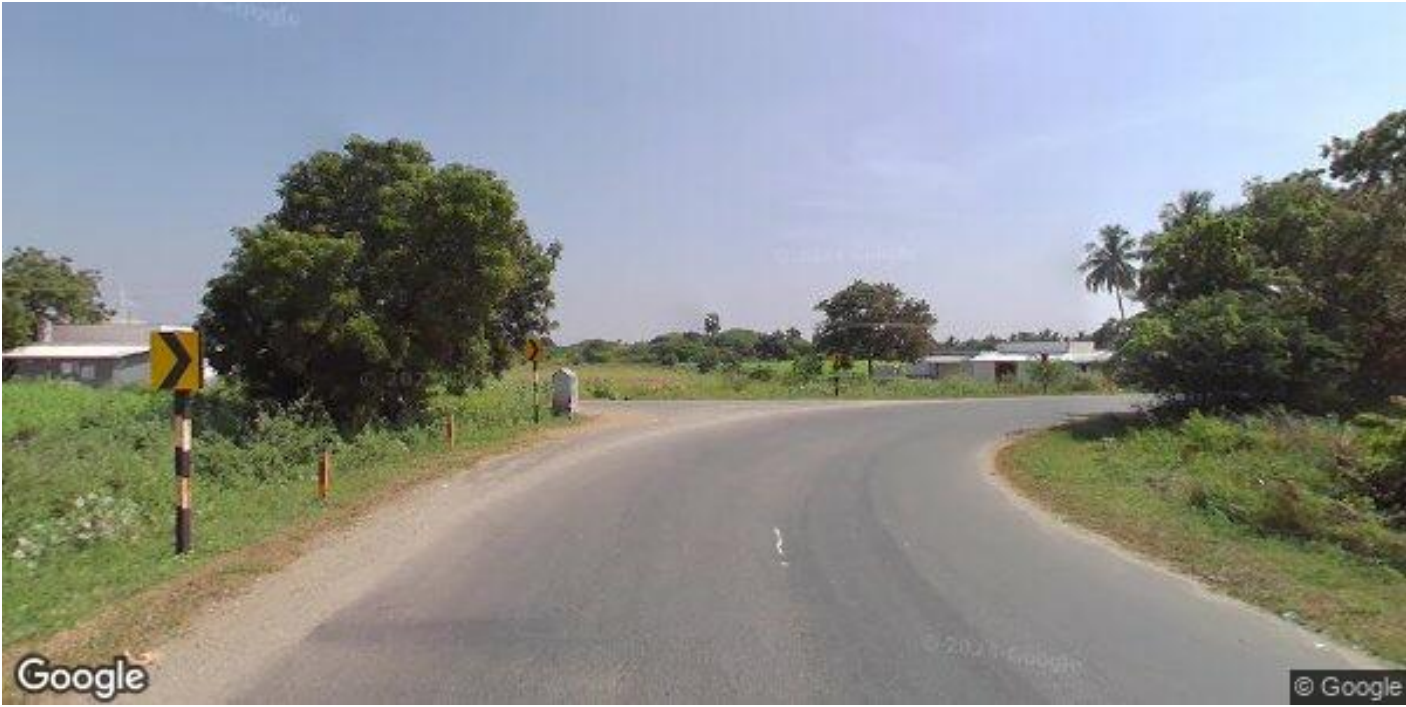
**Risk Type:** Turn  
**Risk Level:** Medium  
**Speed Limit:** 30 KM/Hr  
**Coordinates:** 10.82892, 78.20166

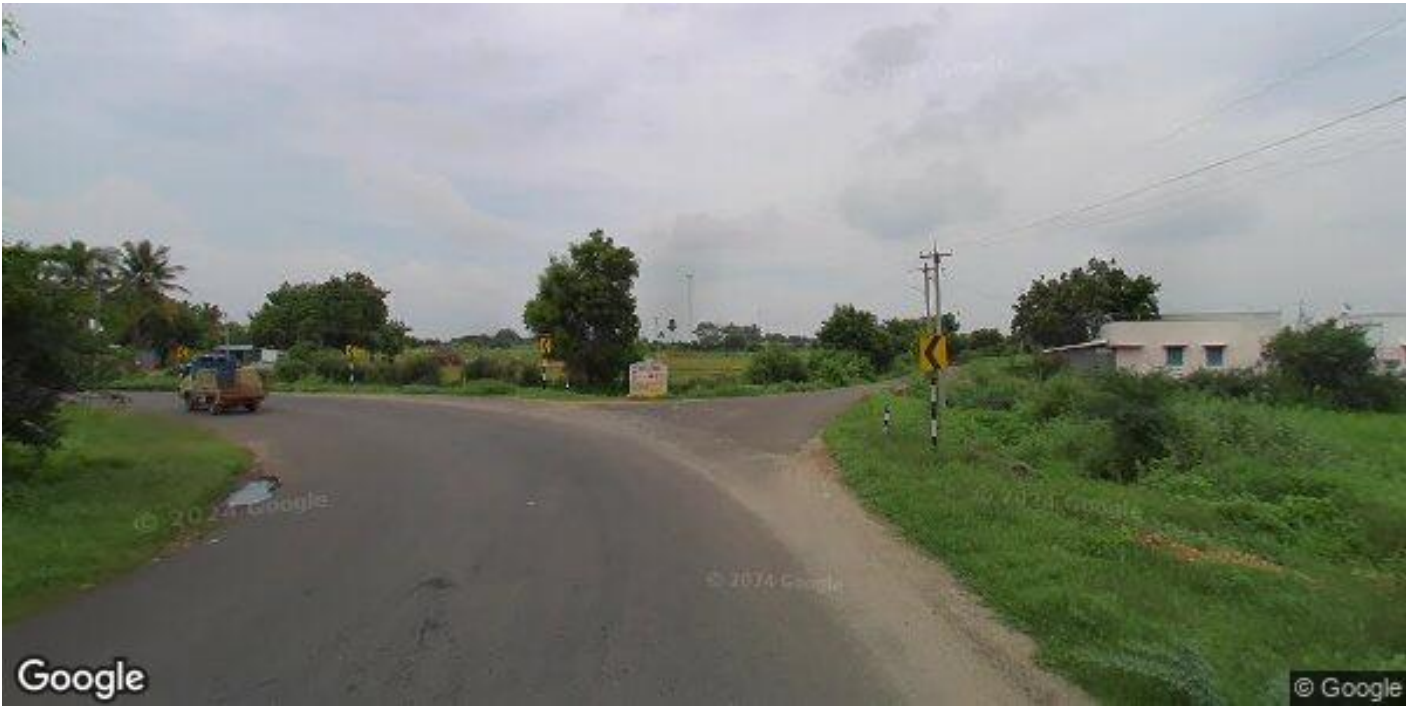
**Risk Type:** Turn  
**Risk Level:** Medium  
**Speed Limit:** 30 KM/Hr  
**Coordinates:** 10.82865, 78.20188

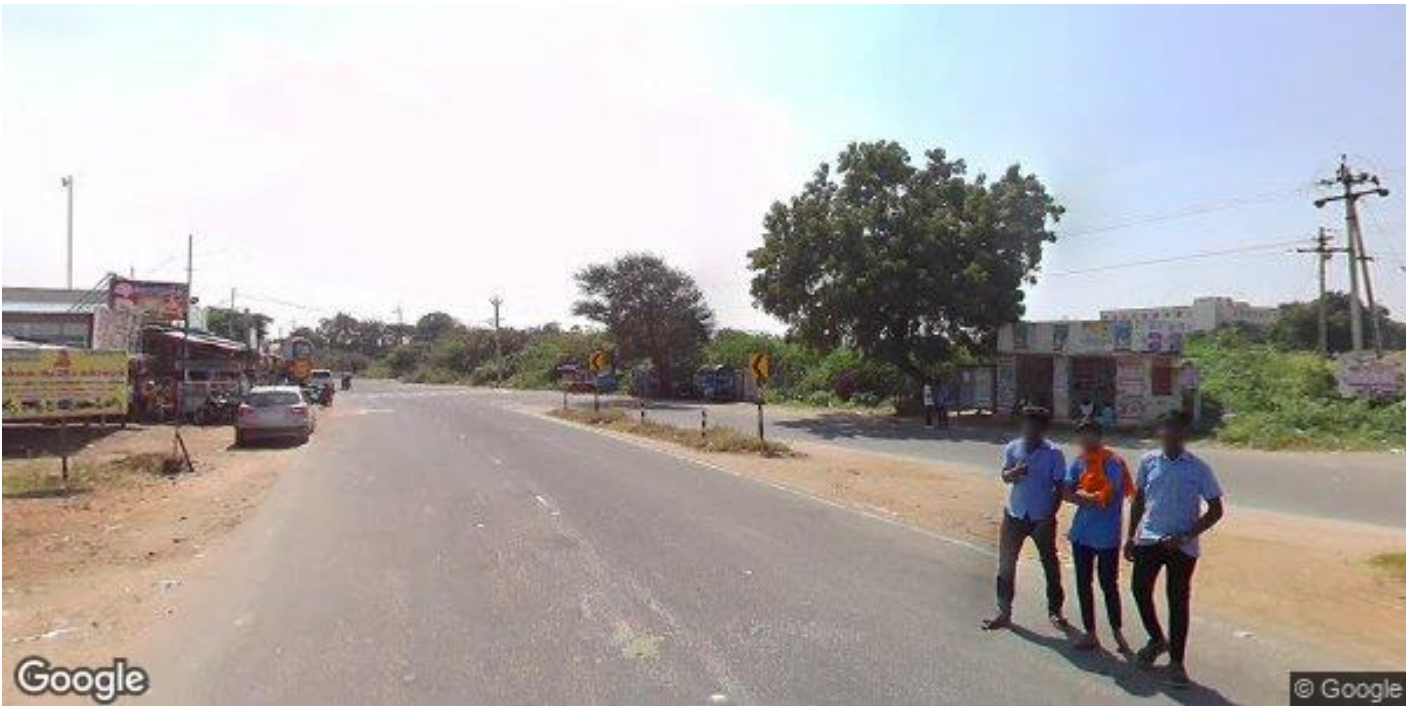
**Risk Type:** Turn  
**Risk Level:** Medium  
**Speed Limit:** 30 KM/Hr  
**Coordinates:** 10.80081, 78.20092

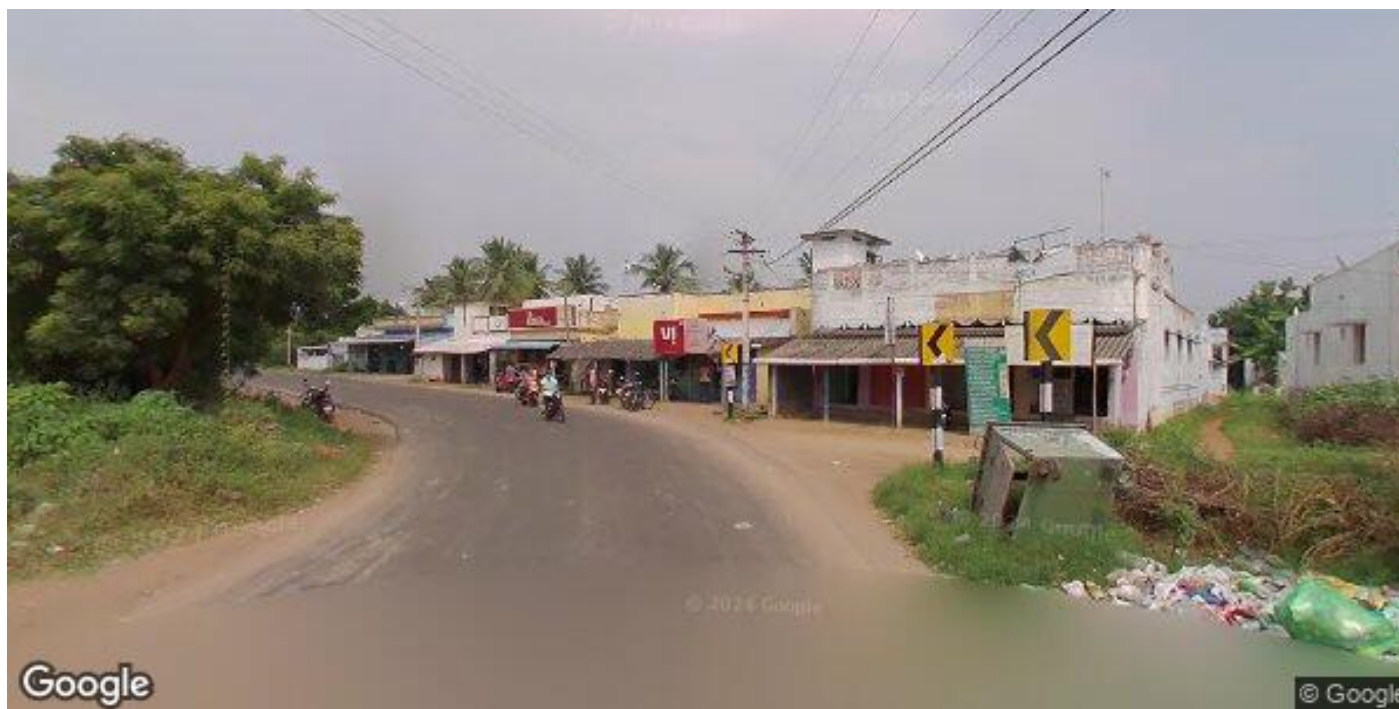
**Risk Type:** Turn  
**Risk Level:** Medium  
**Speed Limit:** 30 KM/Hr  
**Coordinates:** 10.79217, 78.20276
