## JOURNEY RISK MANAGEMENT (JRM) STUDY

### Salem Terminal to JEYAM FUELS

### Route Safety Analysis from Sangagiri to Mathagiri, Tamil Nadu

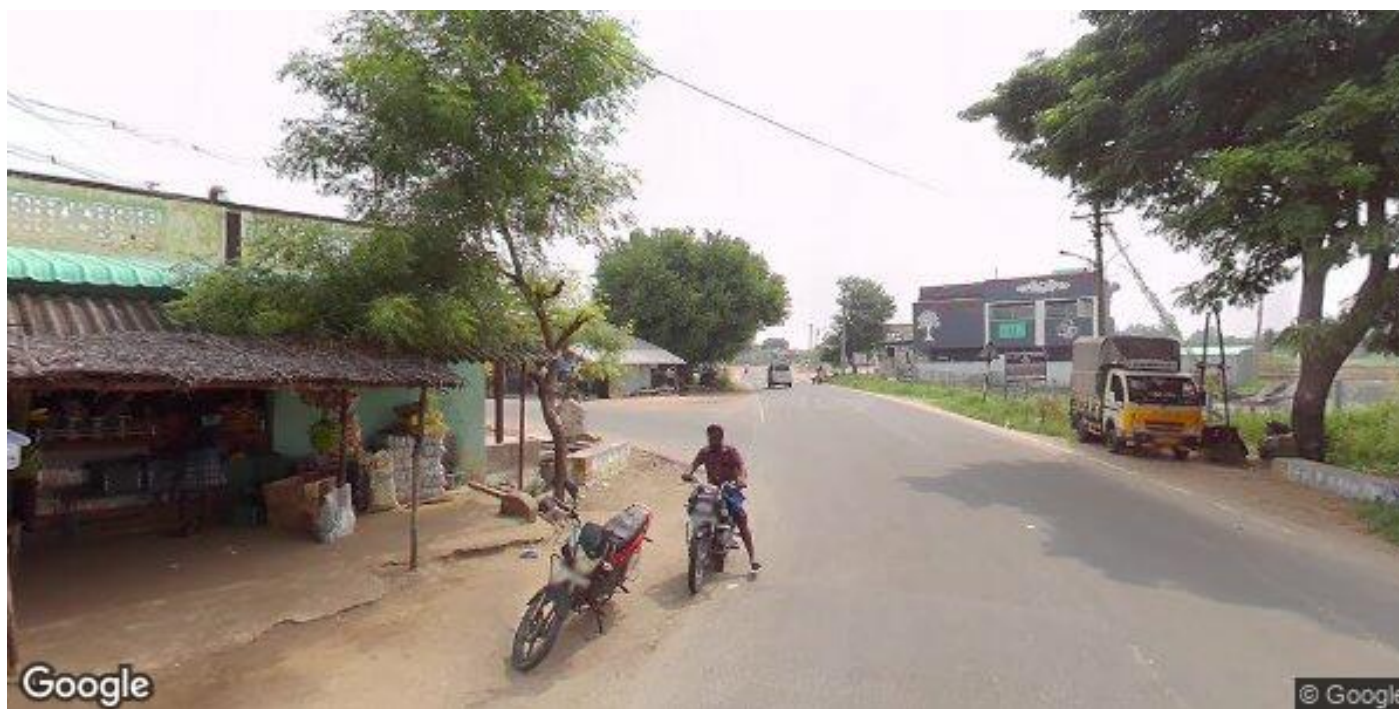
**Risk Type:** Turn  
**Risk Level:** Medium  
**Speed Limit:** 30 KM/Hr  
**Coordinates:** 10.79013, 78.20307

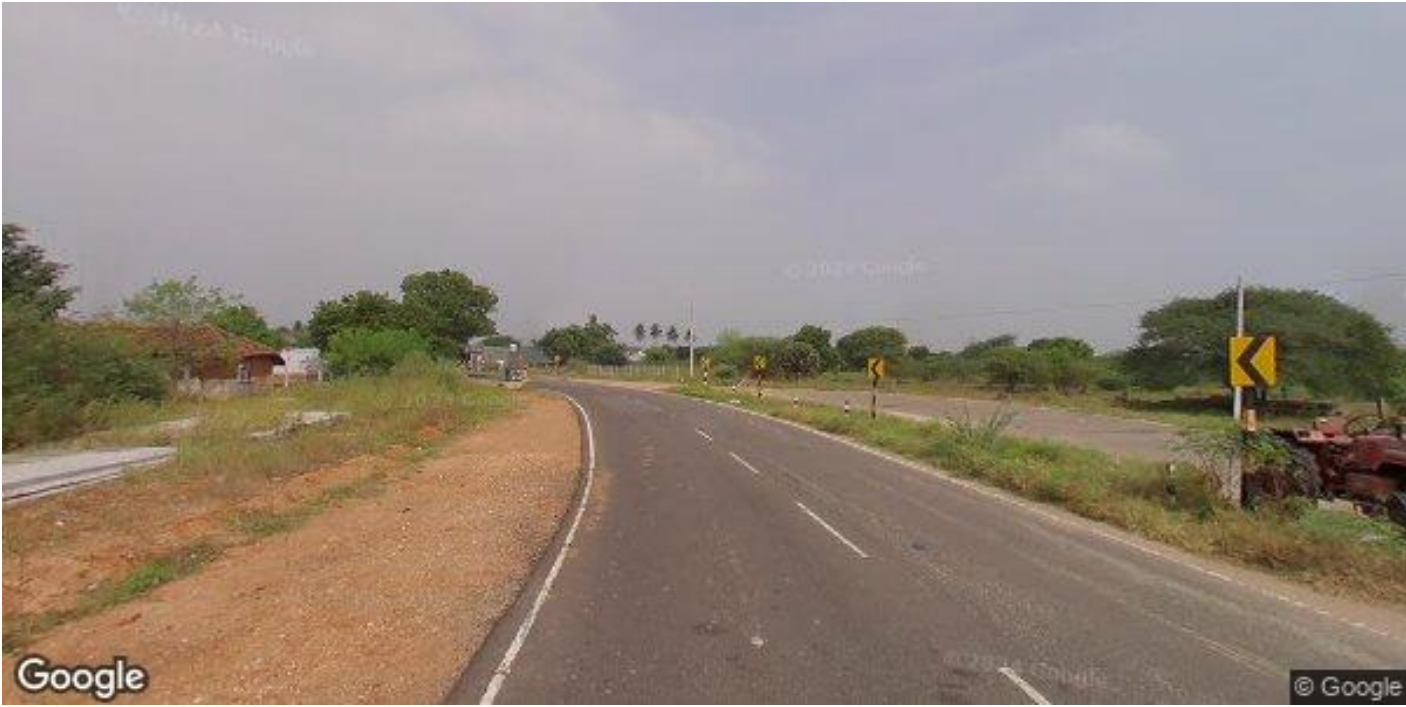
**Risk Type:** Turn  
**Risk Level:** Medium  
**Speed Limit:** 30 KM/Hr  
**Coordinates:** 10.78767, 78.20438

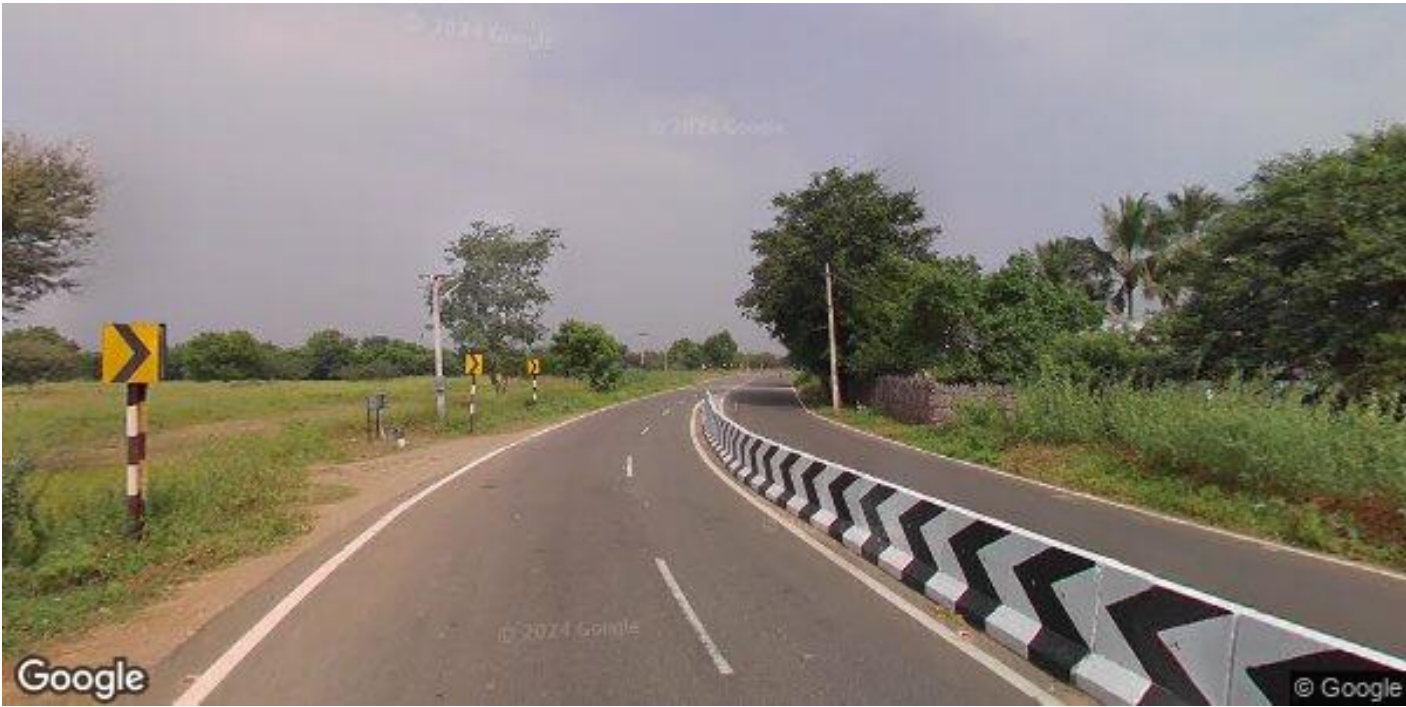
**Risk Type:** Turn  
**Risk Level:** Medium  
**Speed Limit:** 30 KM/Hr  
**Coordinates:** 10.78380, 78.20278

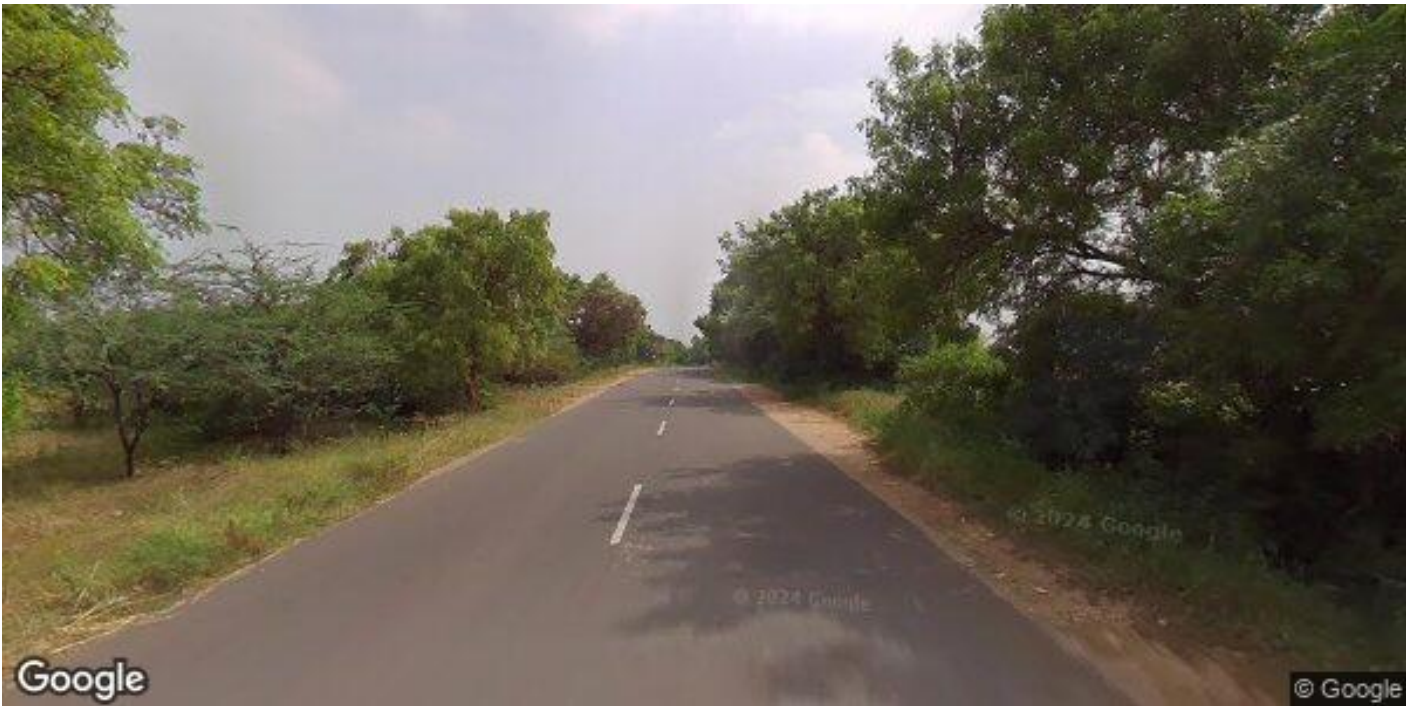
**Risk Type:** Turn  
**Risk Level:** Medium  
**Speed Limit:** 30 KM/Hr  
**Coordinates:** 10.78037, 78.20649

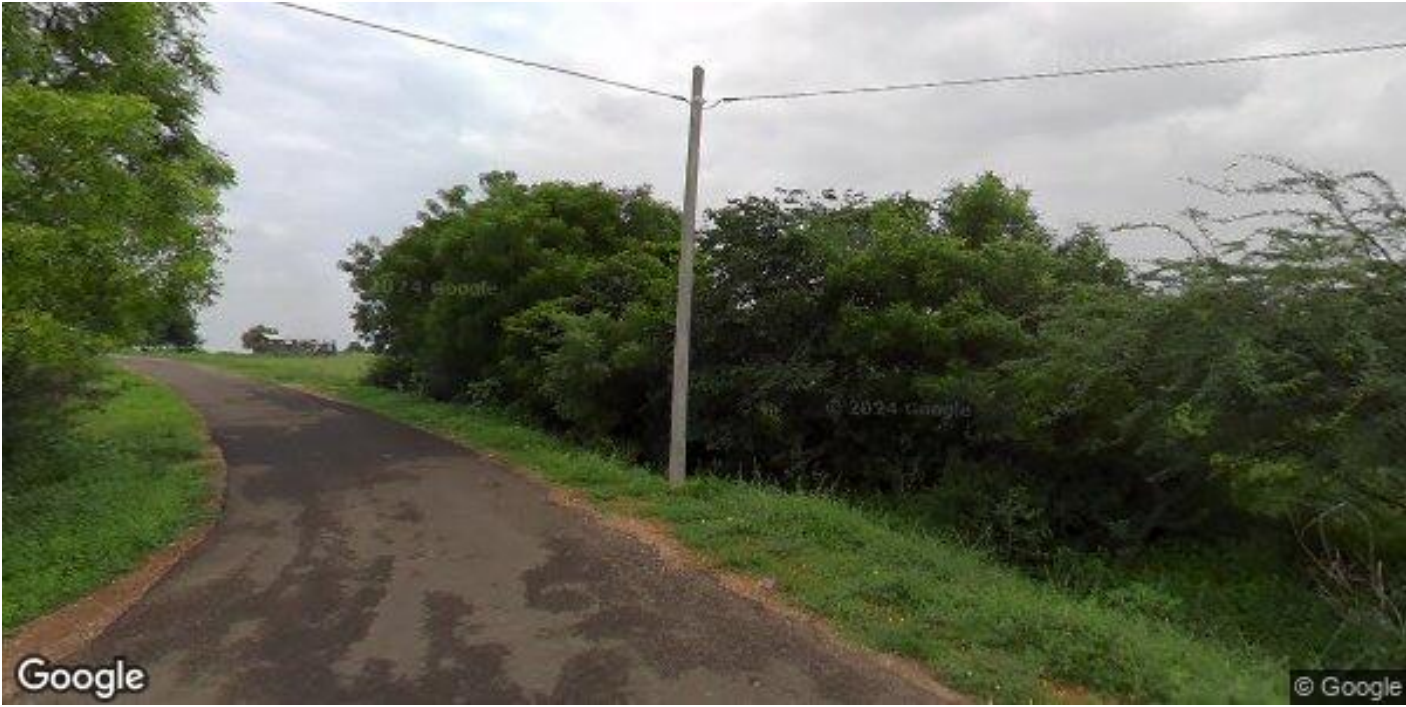
**Risk Type:** Turn  
**Risk Level:** High  
**Speed Limit:** 15 KM/Hr  
**Coordinates:** 10.77911, 78.21461

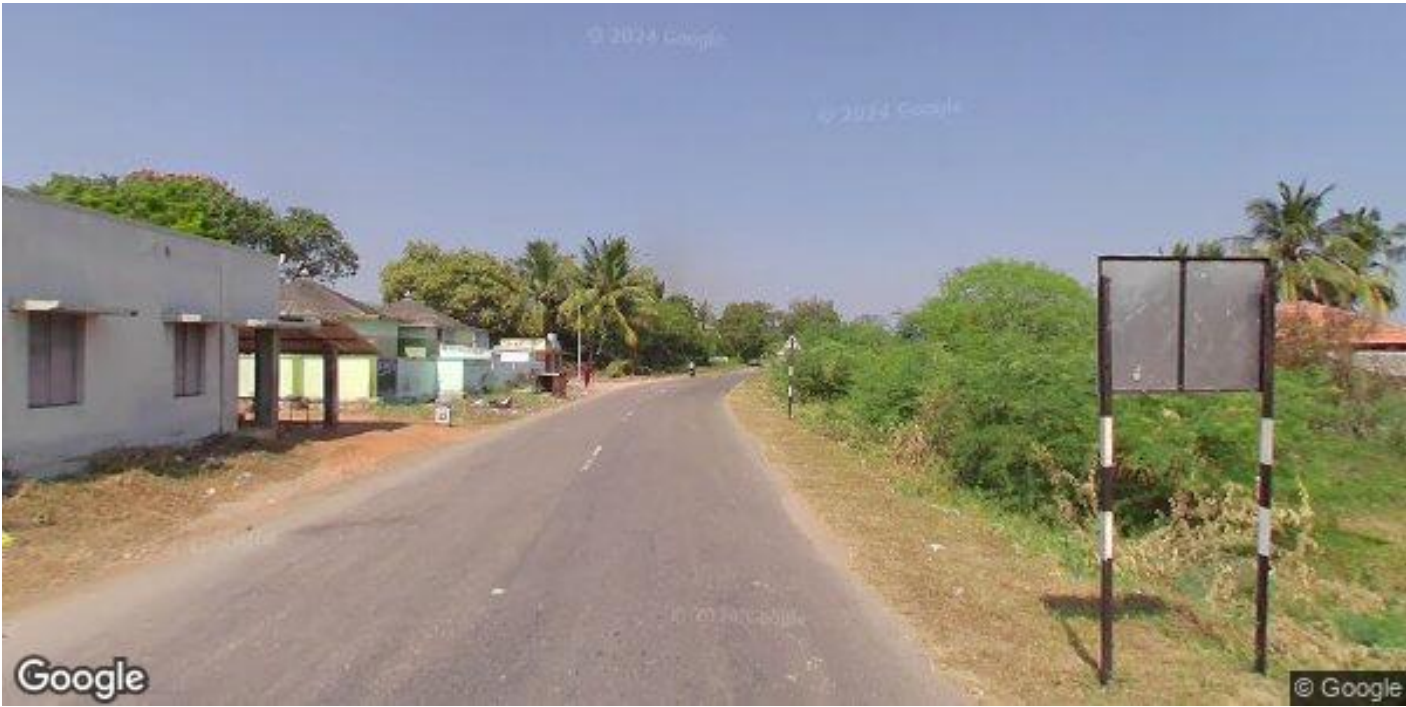
**Risk Type:** Turn  
**Risk Level:** Medium  
**Speed Limit:** 30 KM/Hr  
**Coordinates:** 10.77330, 78.21431

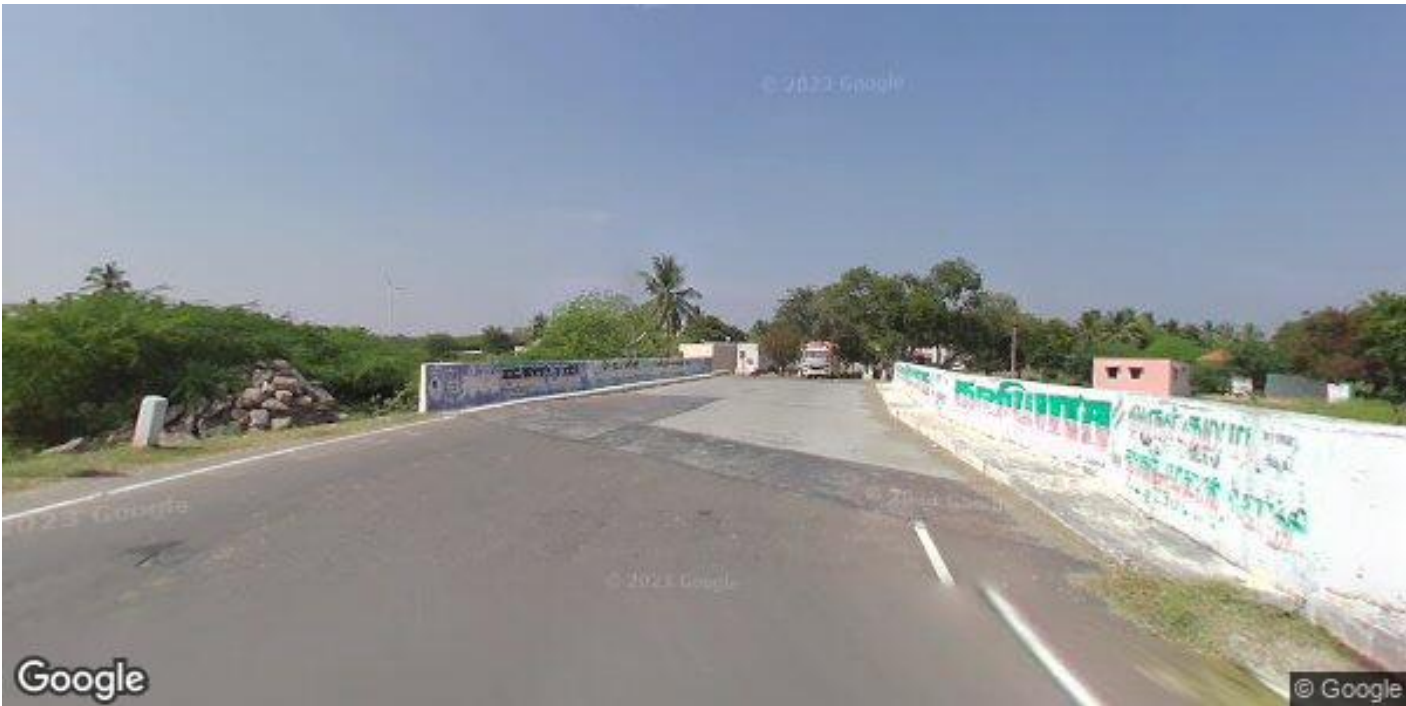
**Risk Type:** Turn  
**Risk Level:** High  
**Speed Limit:** 15 KM/Hr  
**Coordinates:** 10.77239, 78.21467

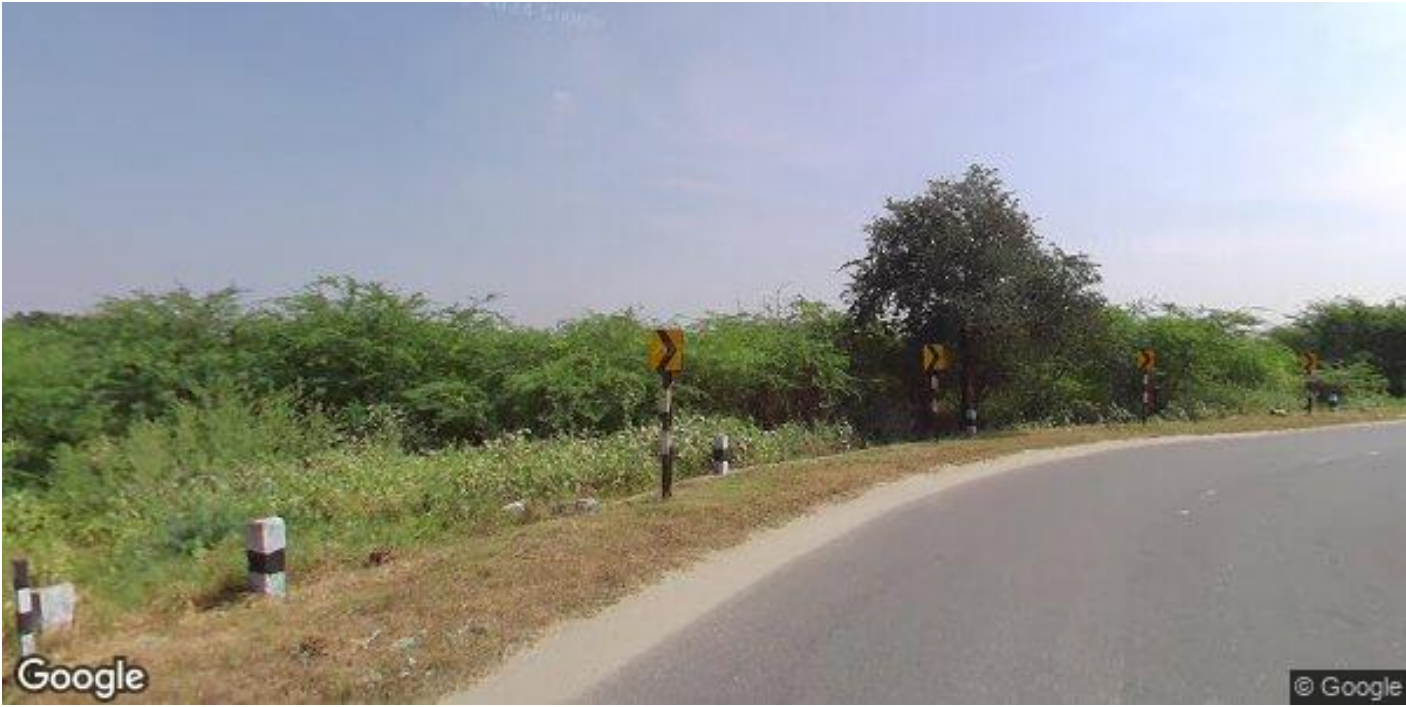
**Risk Type:** Turn  
**Risk Level:** High  
**Speed Limit:** 15 KM/Hr  
**Coordinates:** 10.77215, 78.21560

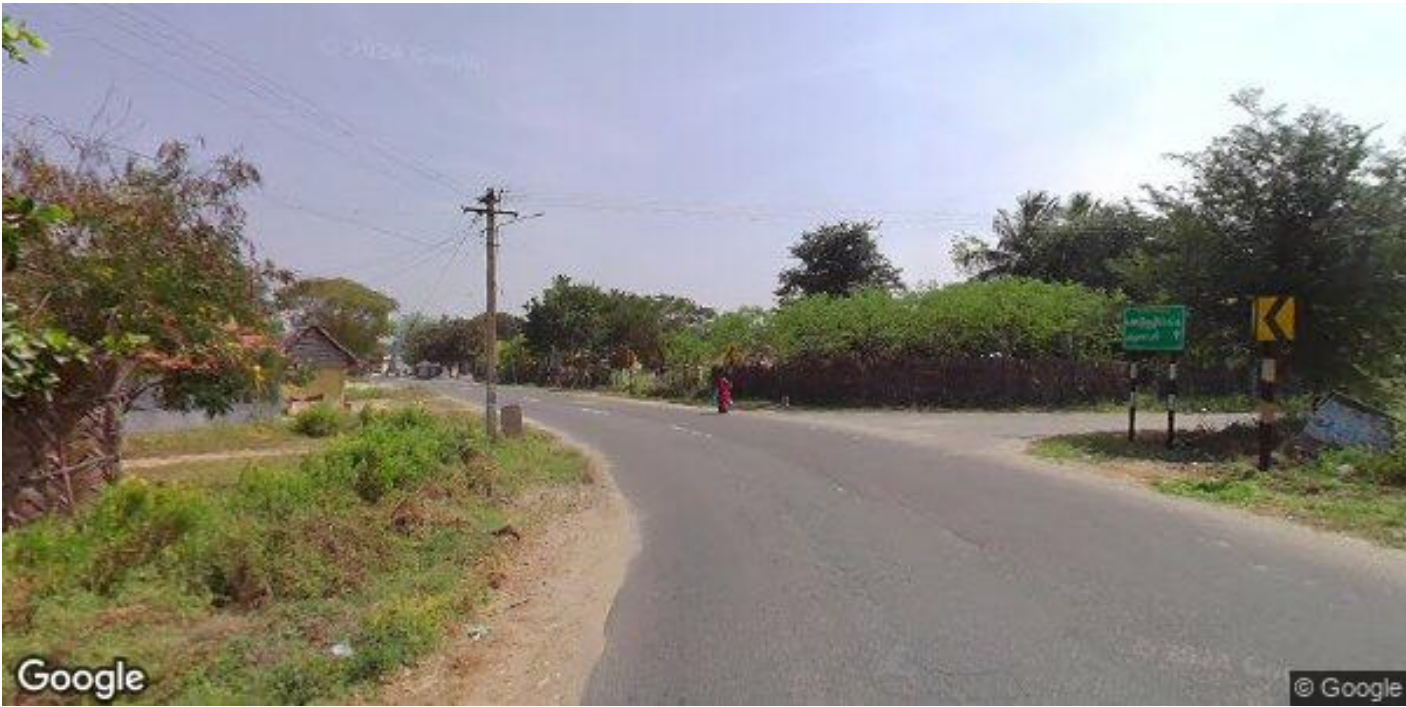
**Risk Type:** Turn  
**Risk Level:** High  
**Speed Limit:** 15 KM/Hr  
**Coordinates:** 10.76401, 78.21632

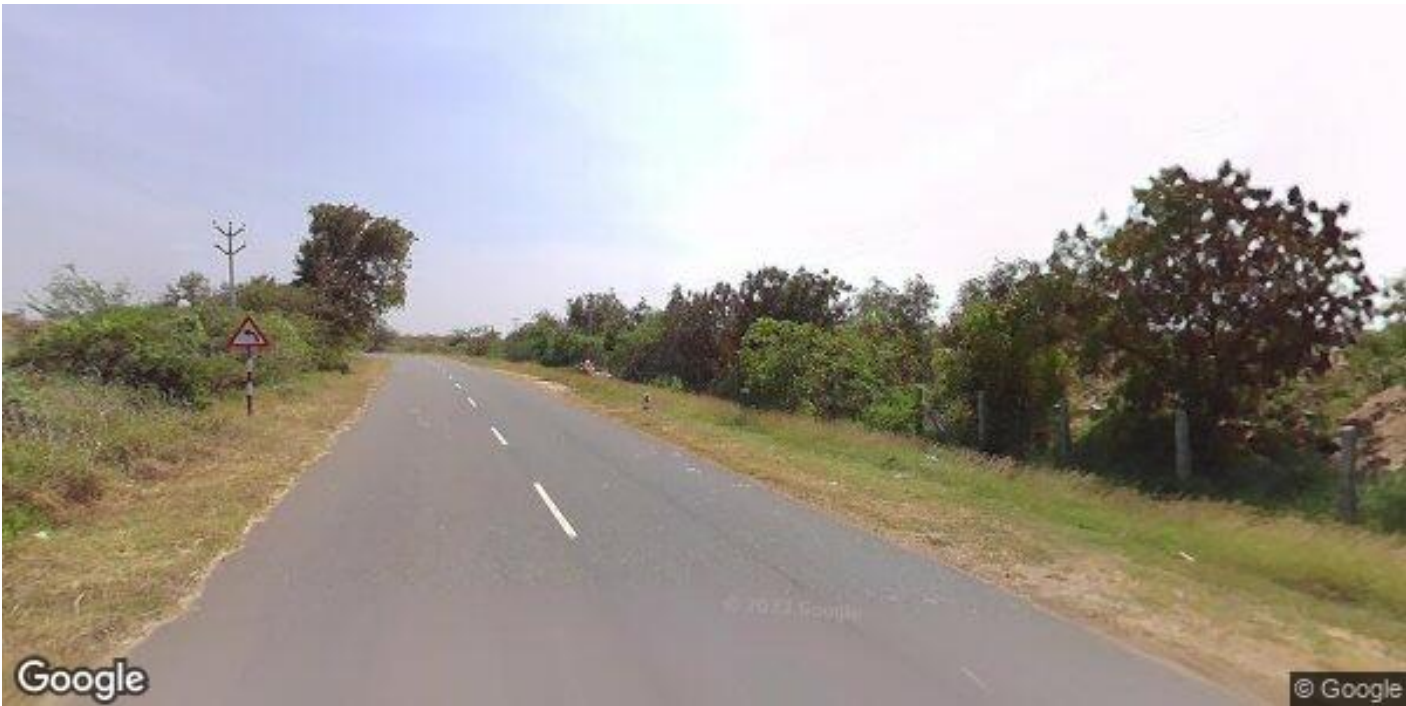
**Risk Type:** Turn  
**Risk Level:** Medium  
**Speed Limit:** 30 KM/Hr  
**Coordinates:** 10.75296, 78.22112

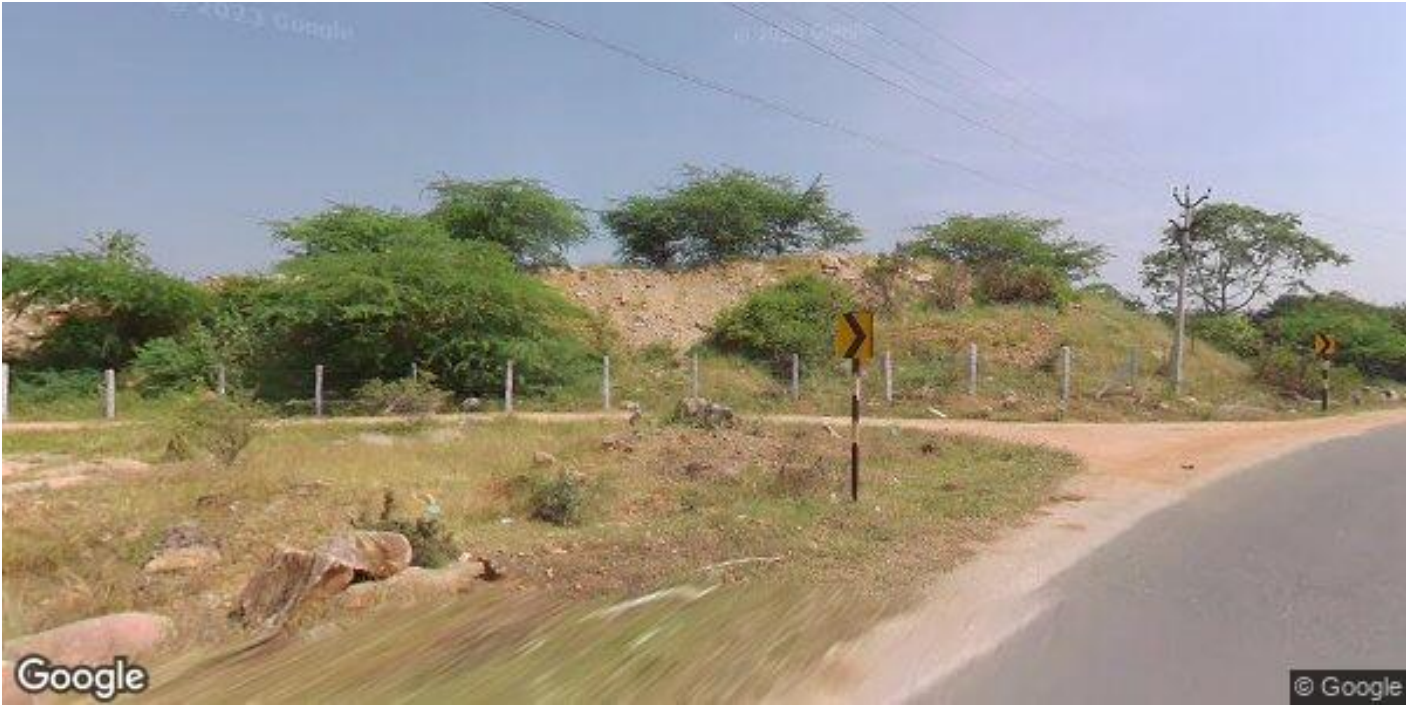
**Risk Type:** Turn  
**Risk Level:** Medium  
**Speed Limit:** 30 KM/Hr  
**Coordinates:** 10.75178, 78.22246

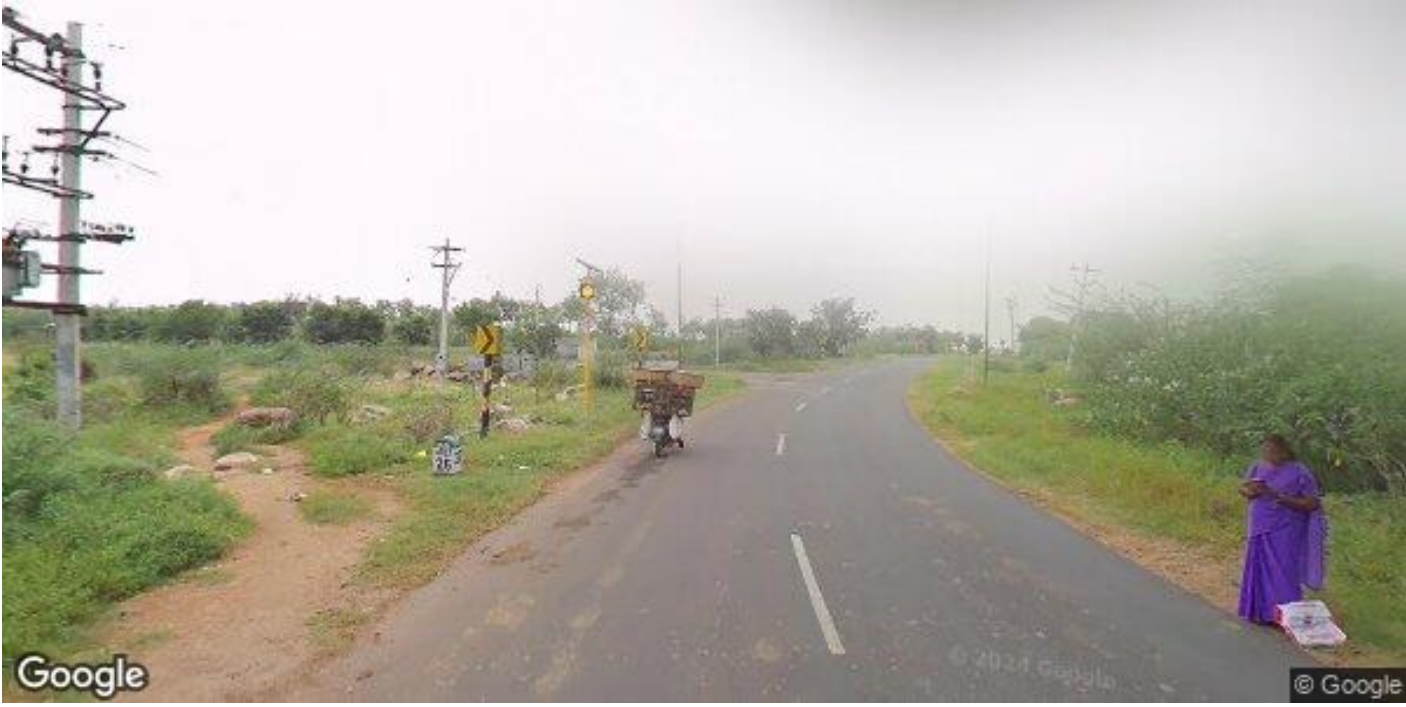
**Risk Type:** Turn  
**Risk Level:** Medium  
**Speed Limit:** 30 KM/Hr  
**Coordinates:** 10.74981, 78.22308

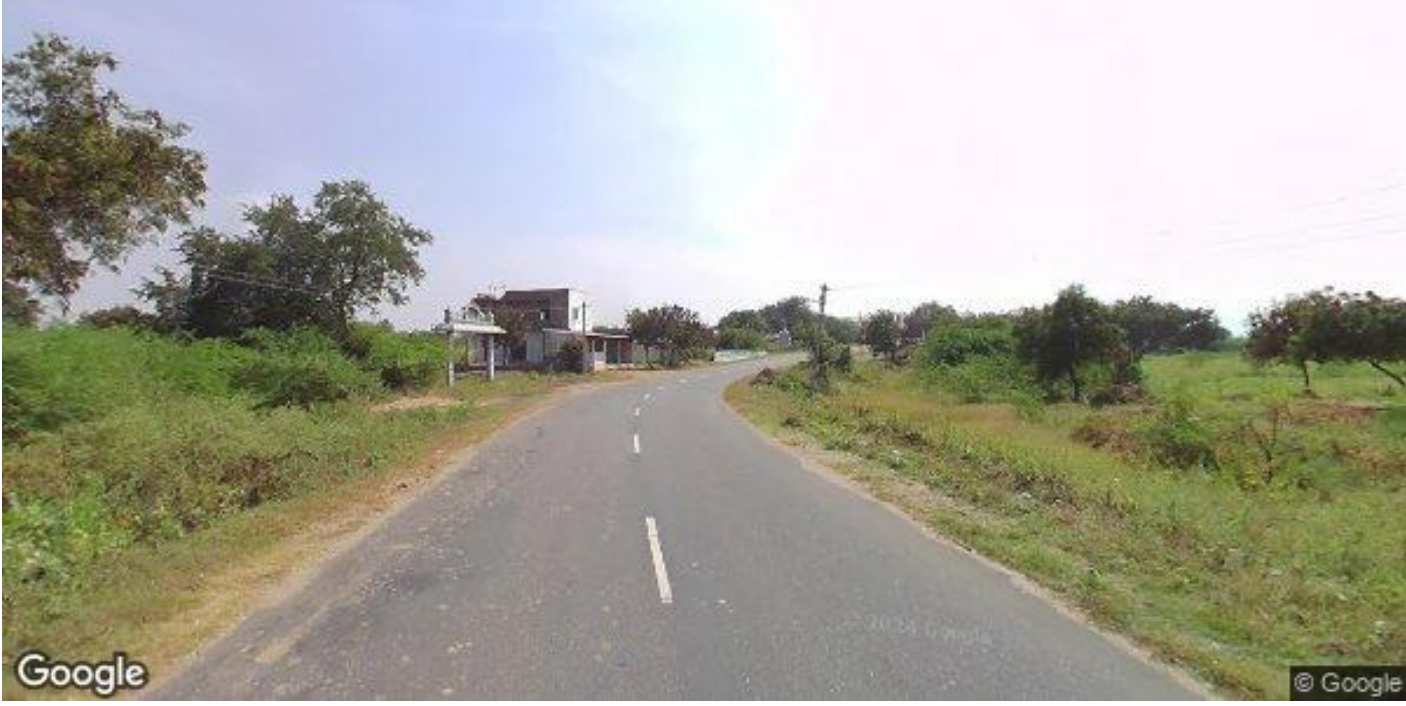
**Risk Type:** Turn  
**Risk Level:** Medium  
**Speed Limit:** 30 KM/Hr  
**Coordinates:** 10.74551, 78.22709

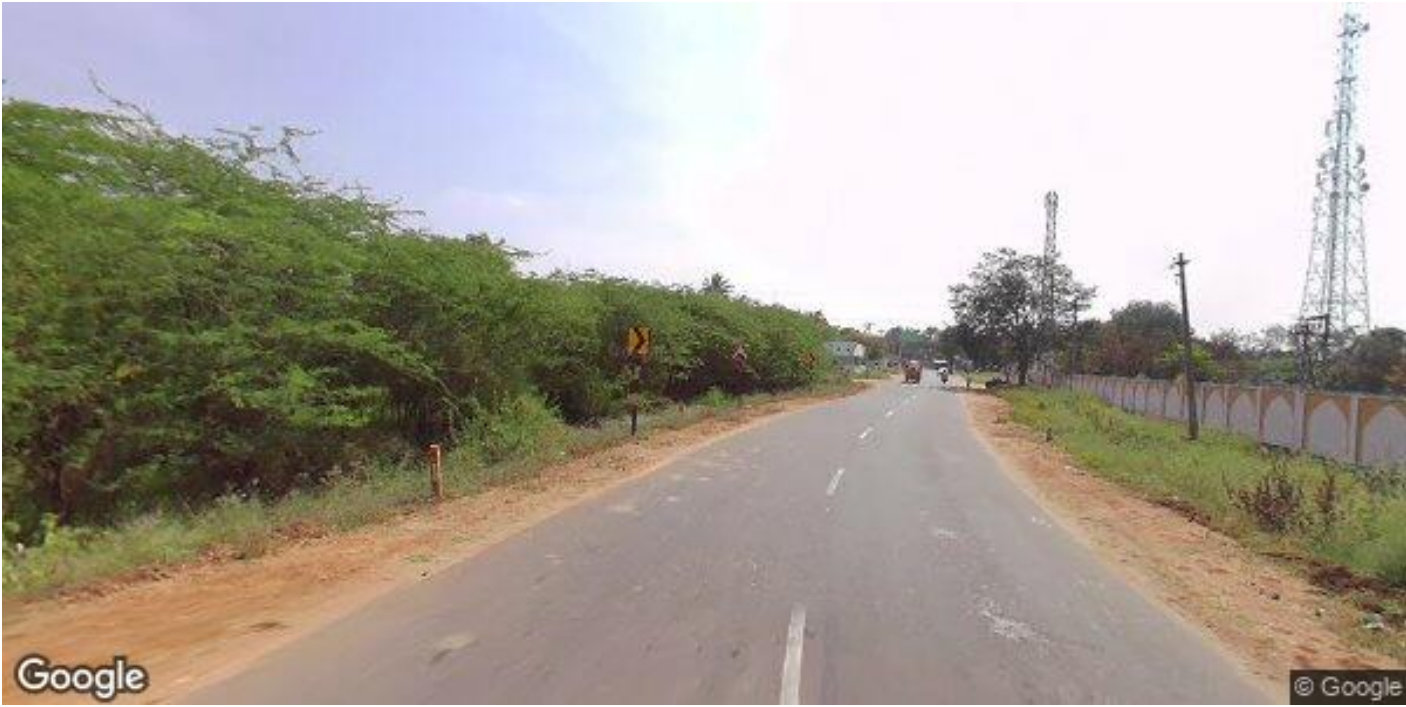
**Risk Type:** Turn  
**Risk Level:** Medium  
**Speed Limit:** 30 KM/Hr  
**Coordinates:** 10.73084, 78.23146

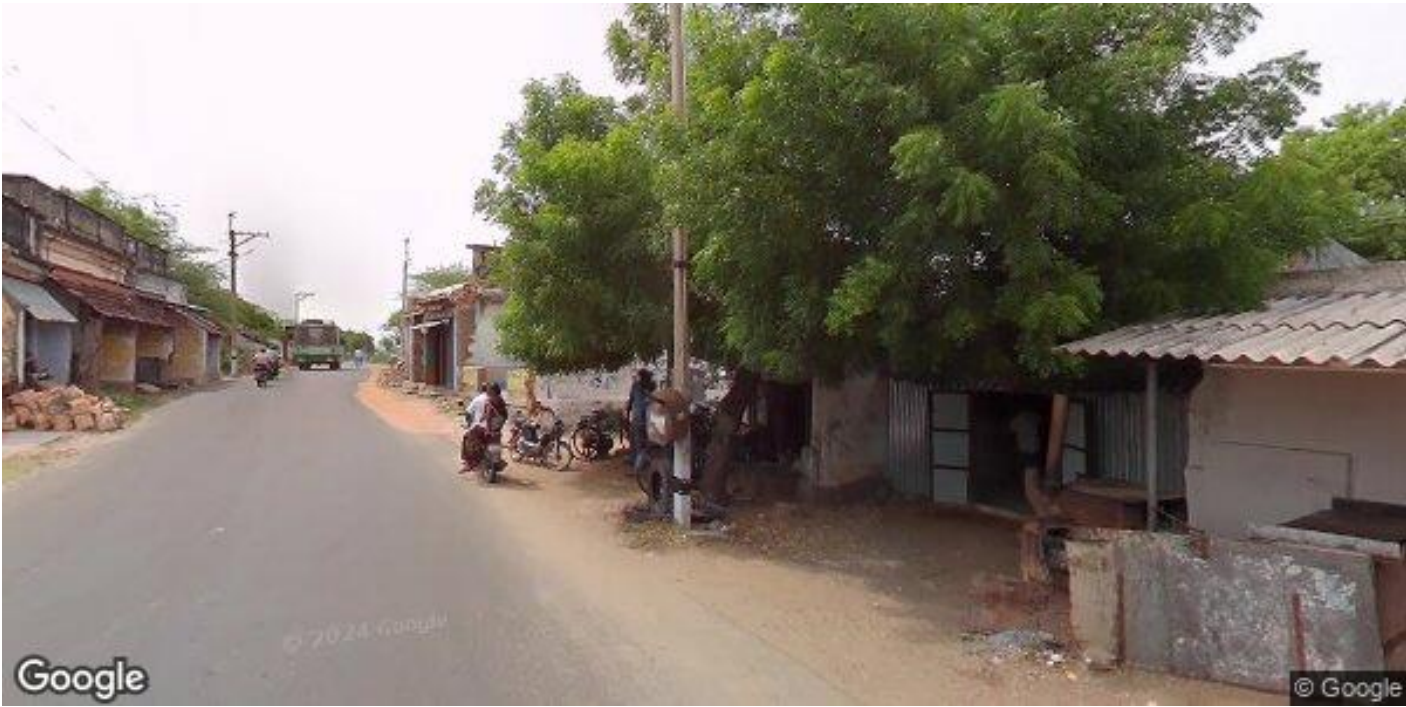
**Risk Type:** Turn  
**Risk Level:** High  
**Speed Limit:** 15 KM/Hr  
**Coordinates:** 10.72910, 78.23136

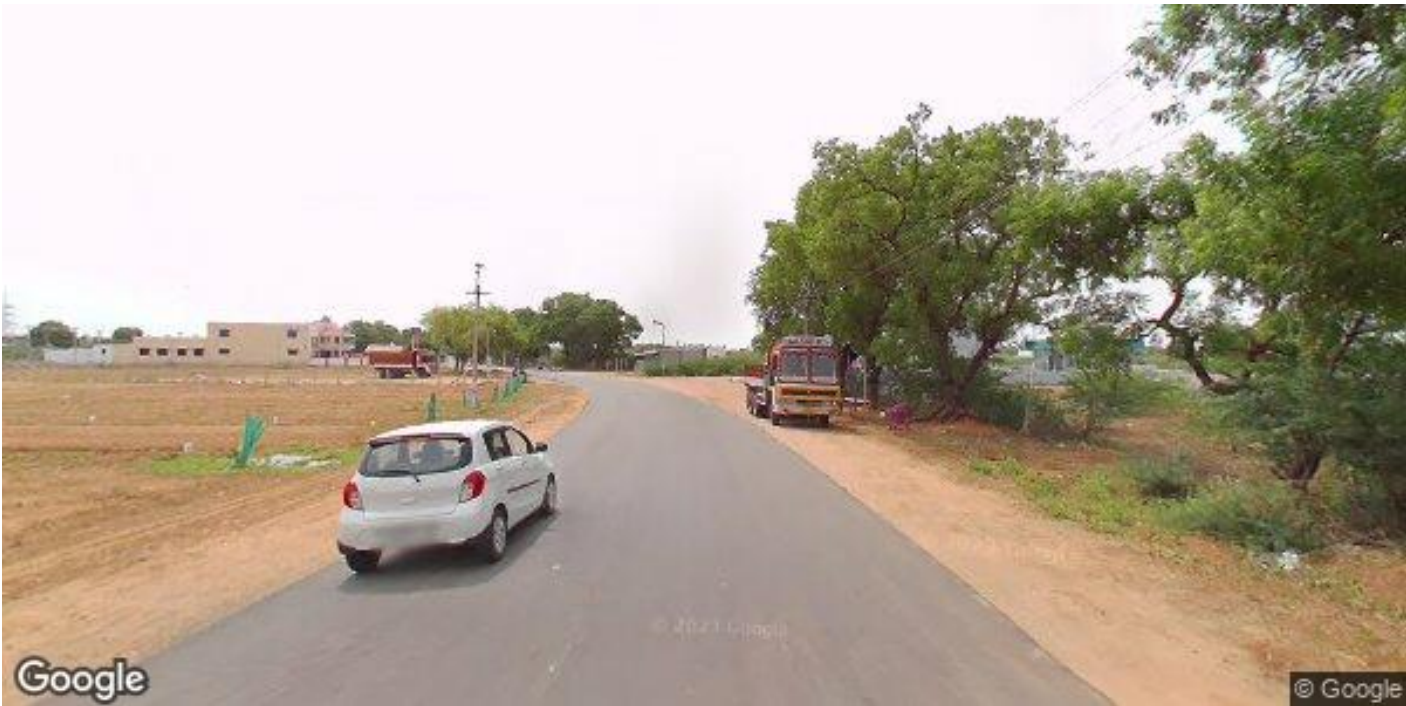
**Risk Type:** Turn  
**Risk Level:** Medium  
**Speed Limit:** 30 KM/Hr  
**Coordinates:** 10.72872, 78.23407
