# IndianOil

## JOURNEY RISK MANAGEMENT (JRM) STUDY

### Salem Terminal to GK FUELS

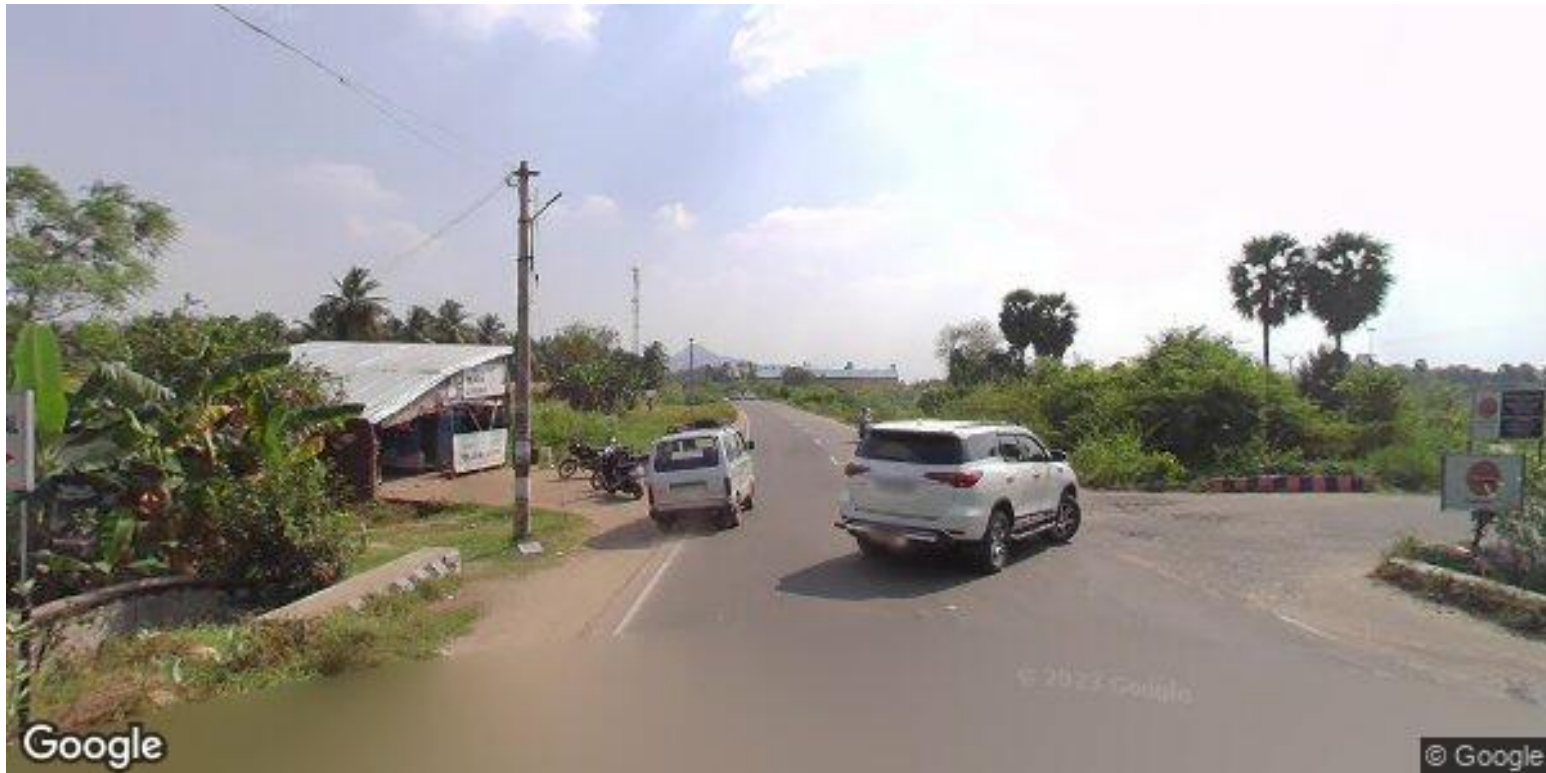
**Coordinates:** 11.44029, 77.87544

**Risk Type:** Turn

**Risk Level:** High

**Speed Limit:** 15 KM/Hr

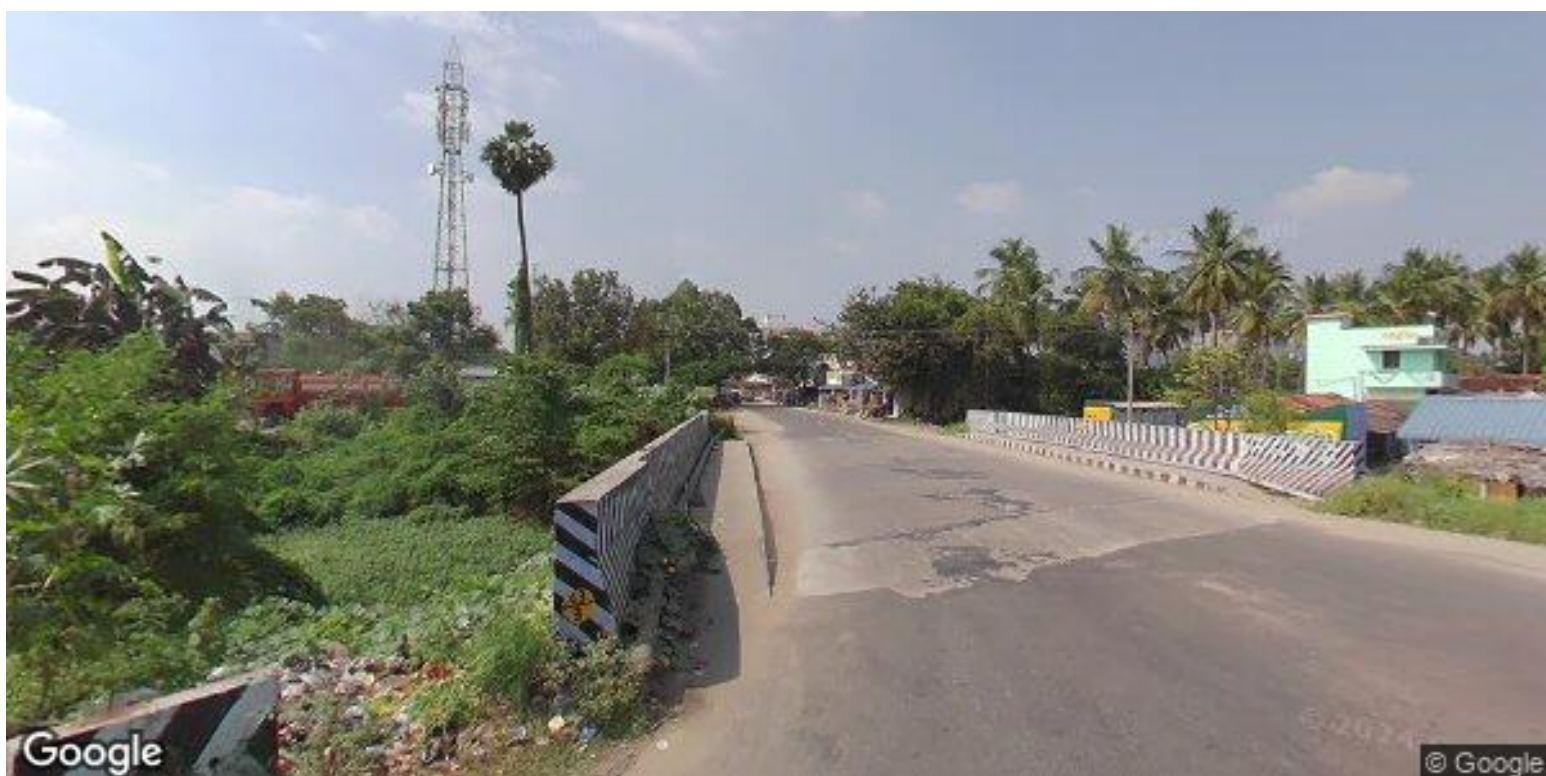
**Coordinates:** 11.44900, 77.87406

**Risk Type:** Turn

**Risk Level:** Medium

**Speed Limit:** 30 KM/Hr

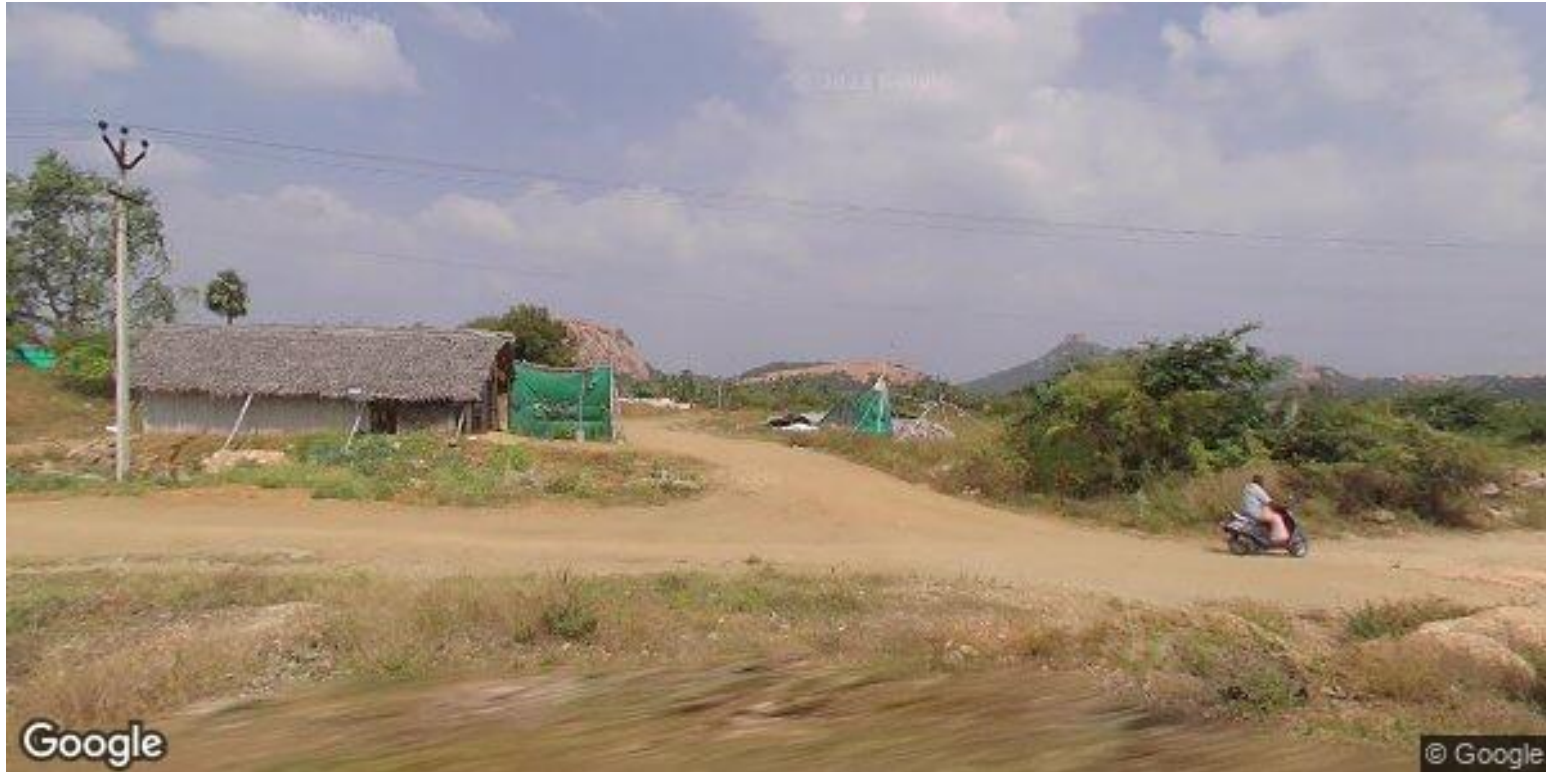
**Risk Type:** Turn  
**Risk Level:** Medium  
**Speed Limit:** 30 KM/Hr  
**Coordinates:** 11.49416, 77.88011

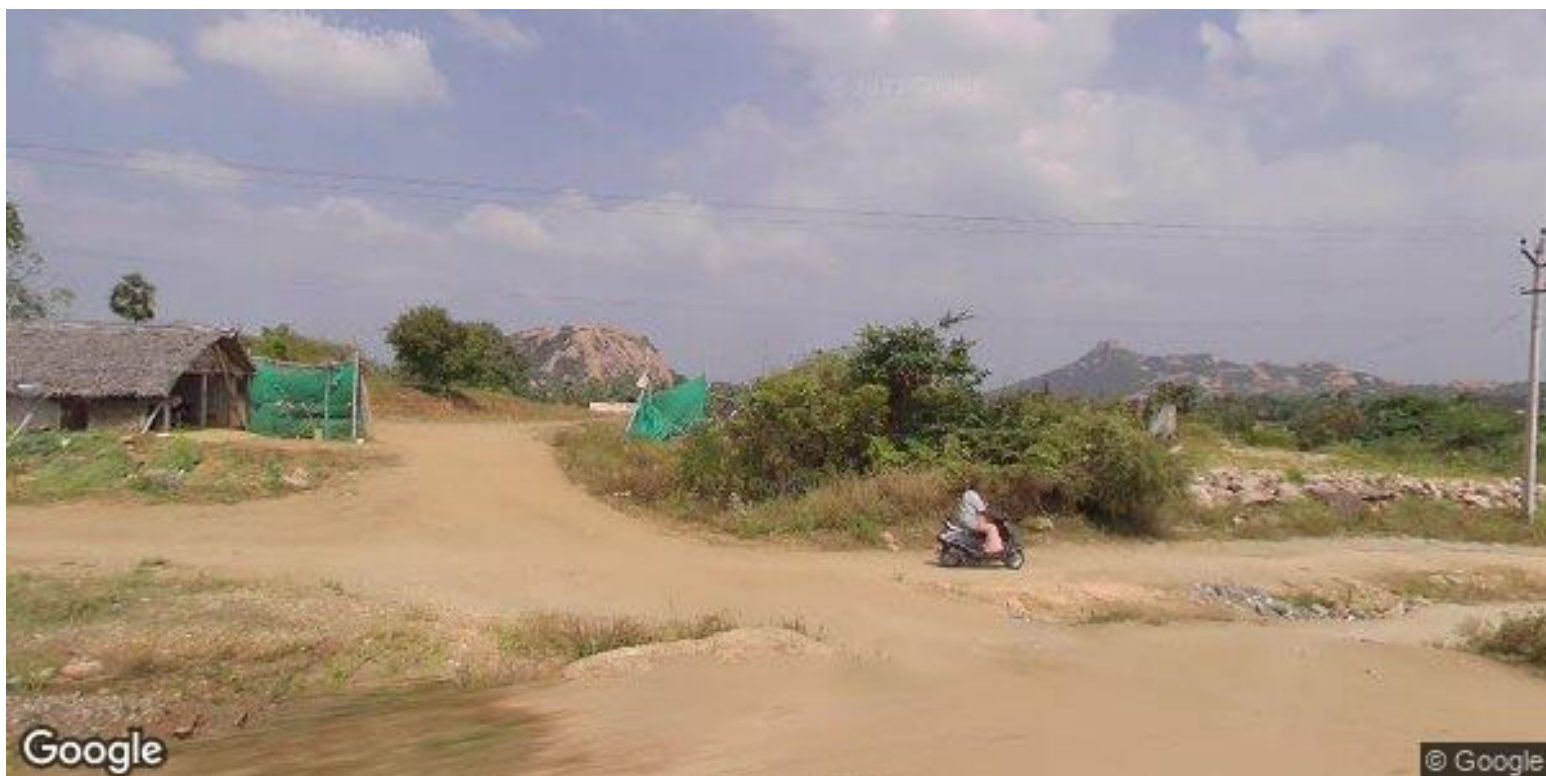
**Risk Type:** Turn  
**Risk Level:** Medium  
**Speed Limit:** 30 KM/Hr  
**Coordinates:** 11.49421, 77.88021

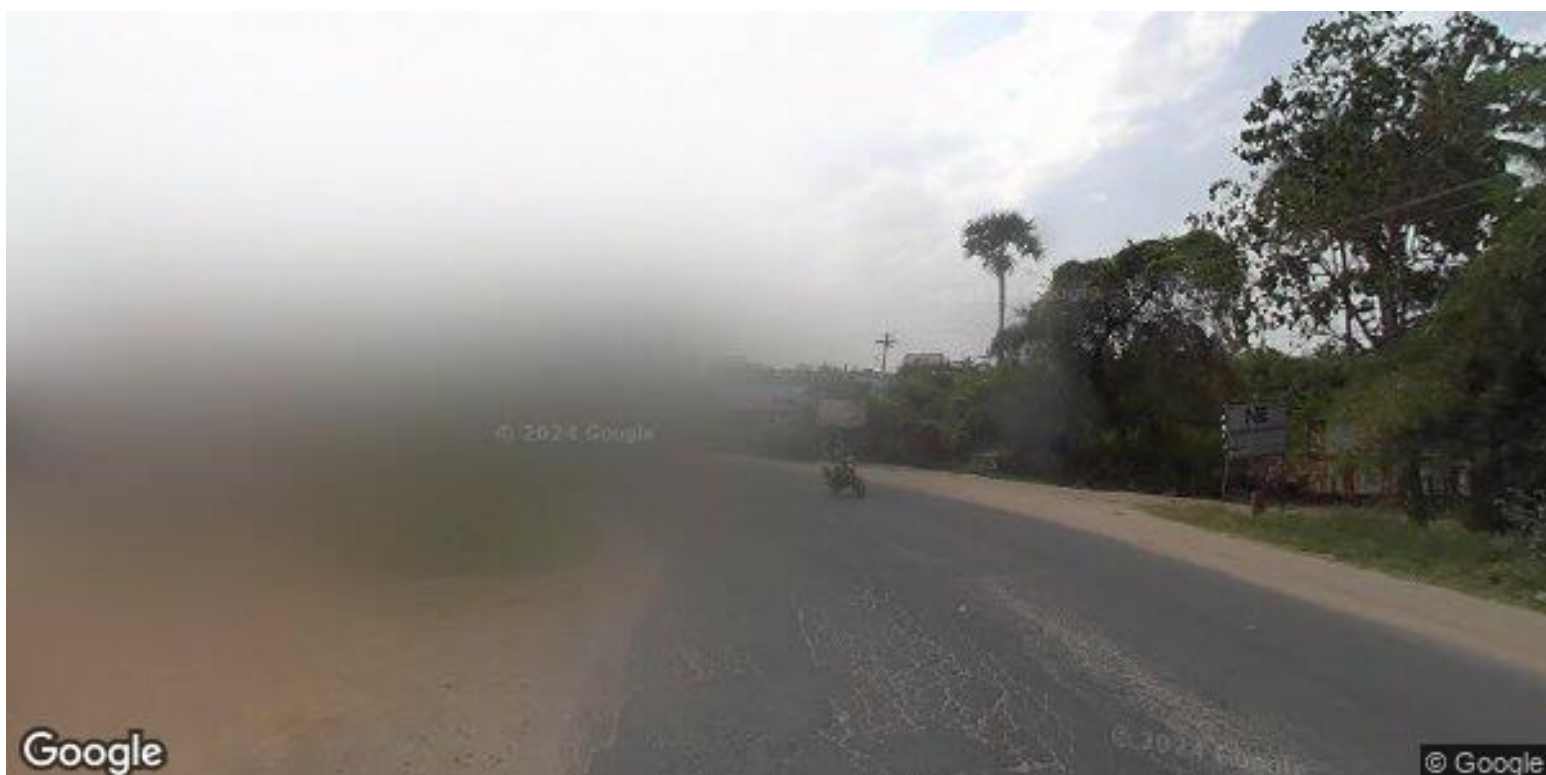
**Coordinates: 11.49465, 77.88488**

**Risk Type: Turn**

**Risk Level: Medium**

**Speed Limit: 30 KM/Hr**

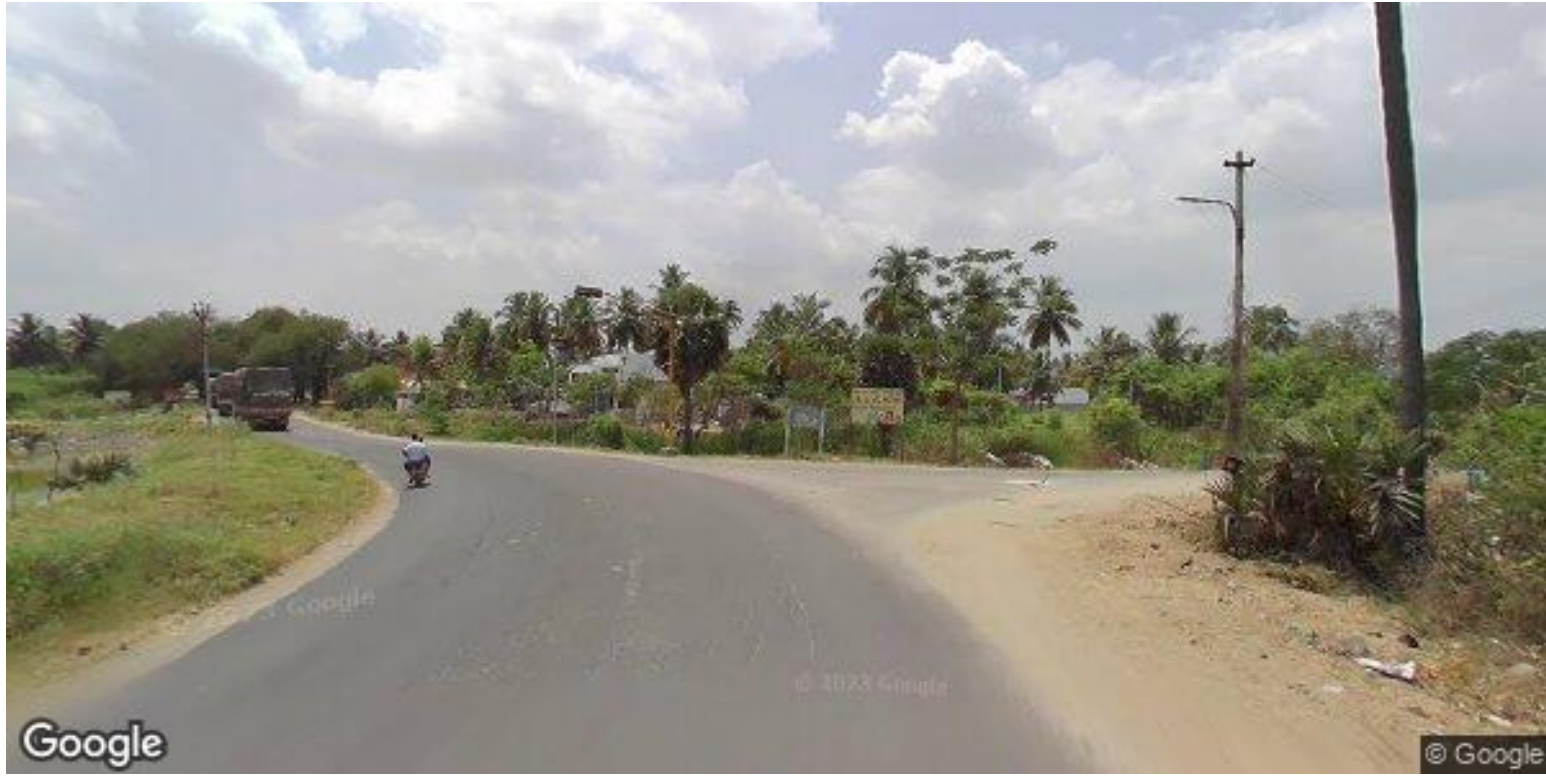
**Coordinates: 11.56096, 77.89931**

**Risk Type: Turn**

**Risk Level: Medium**

**Speed Limit: 30 KM/Hr**

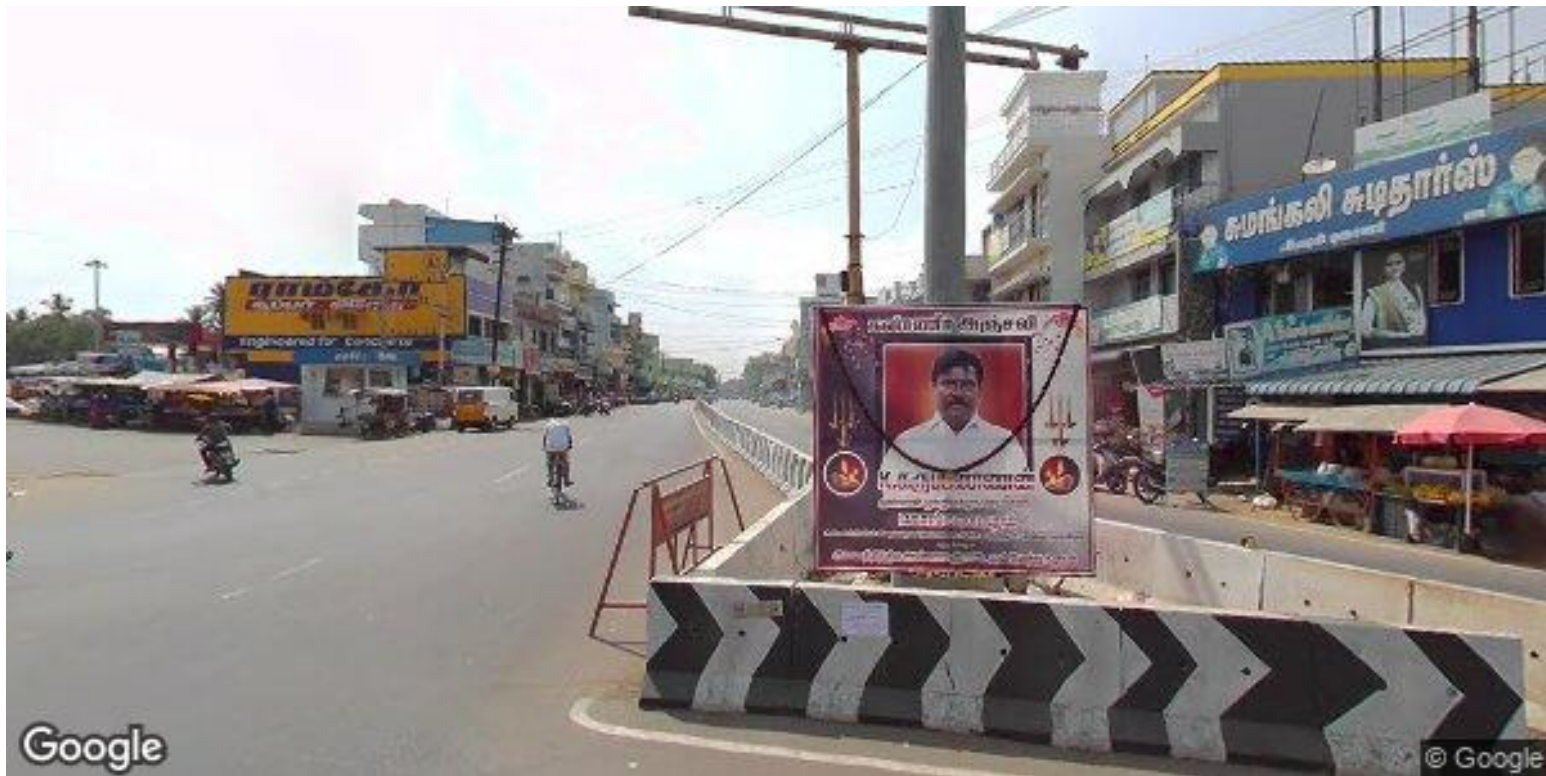
**Coordinates: 11.57035, 77.90223**

**Risk Type: Turn**

**Risk Level: High**

**Speed Limit: 15 KM/Hr**

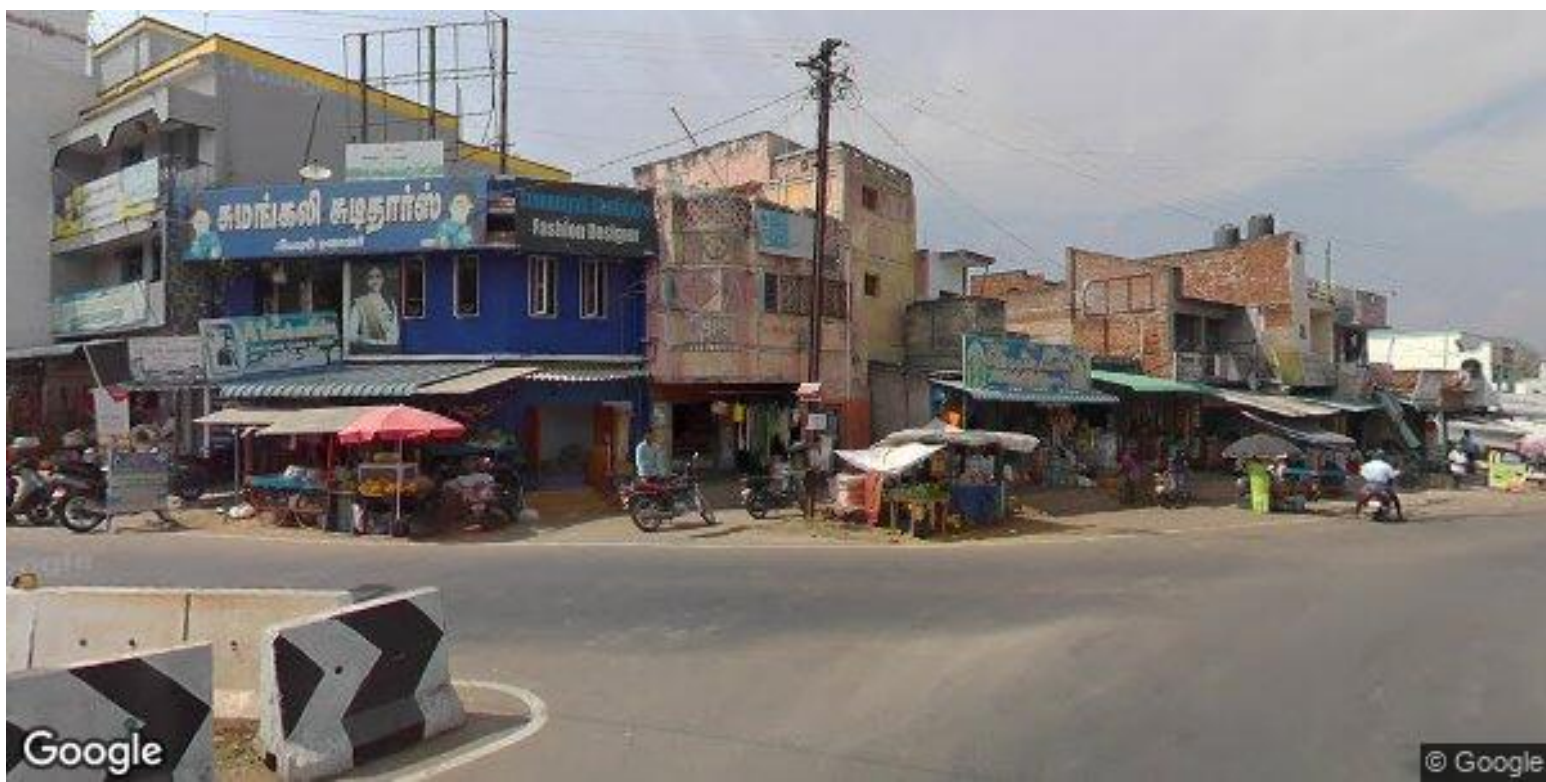
**Coordinates:** 11.57041, 77.90221

**Risk Type:** Turn

**Risk Level:** High

**Speed Limit:** 15 KM/Hr

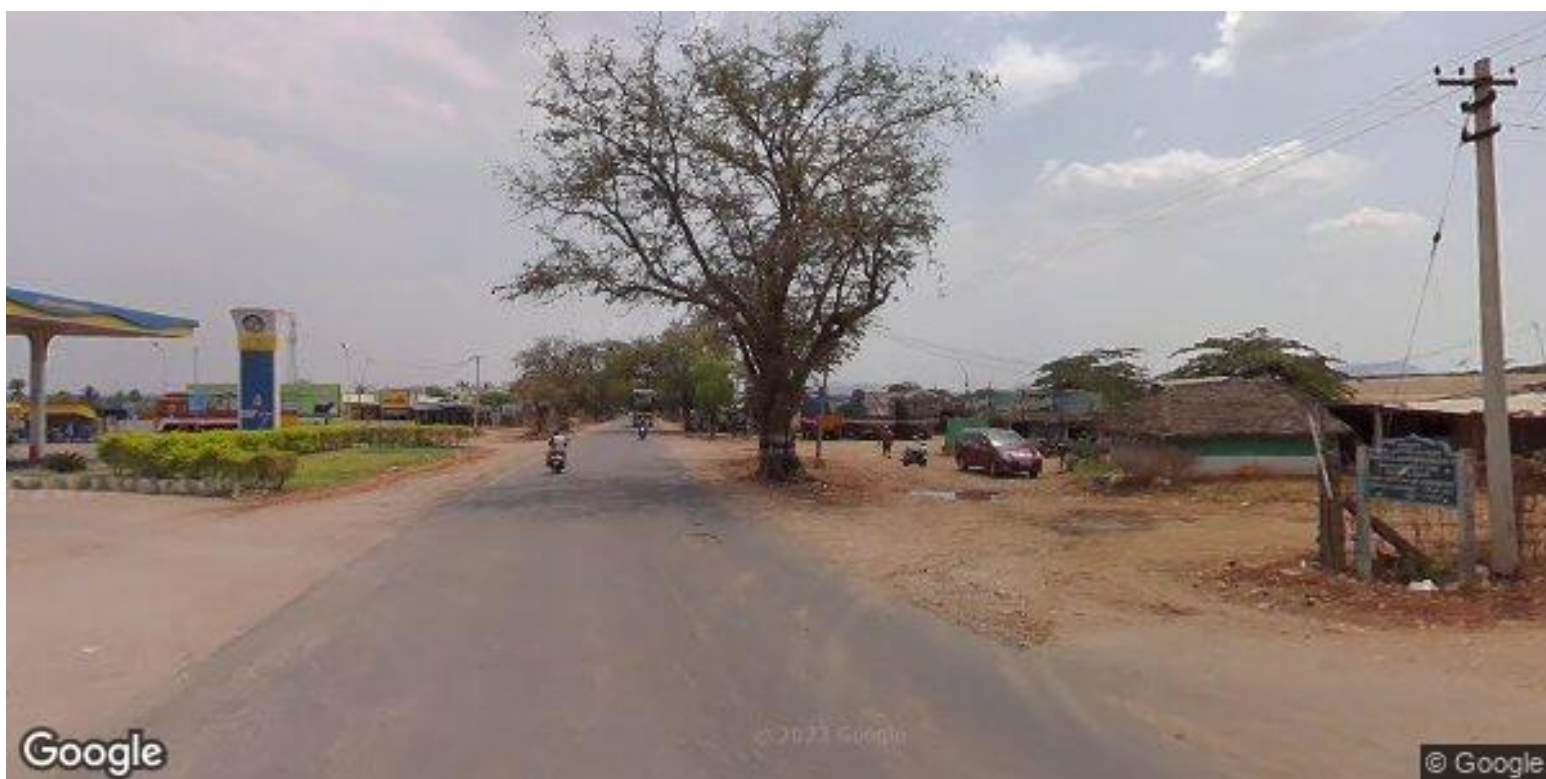
**Coordinates:** 11.58279, 77.90658

**Risk Type:** Turn

**Risk Level:** Medium

**Speed Limit:** 30 KM/Hr

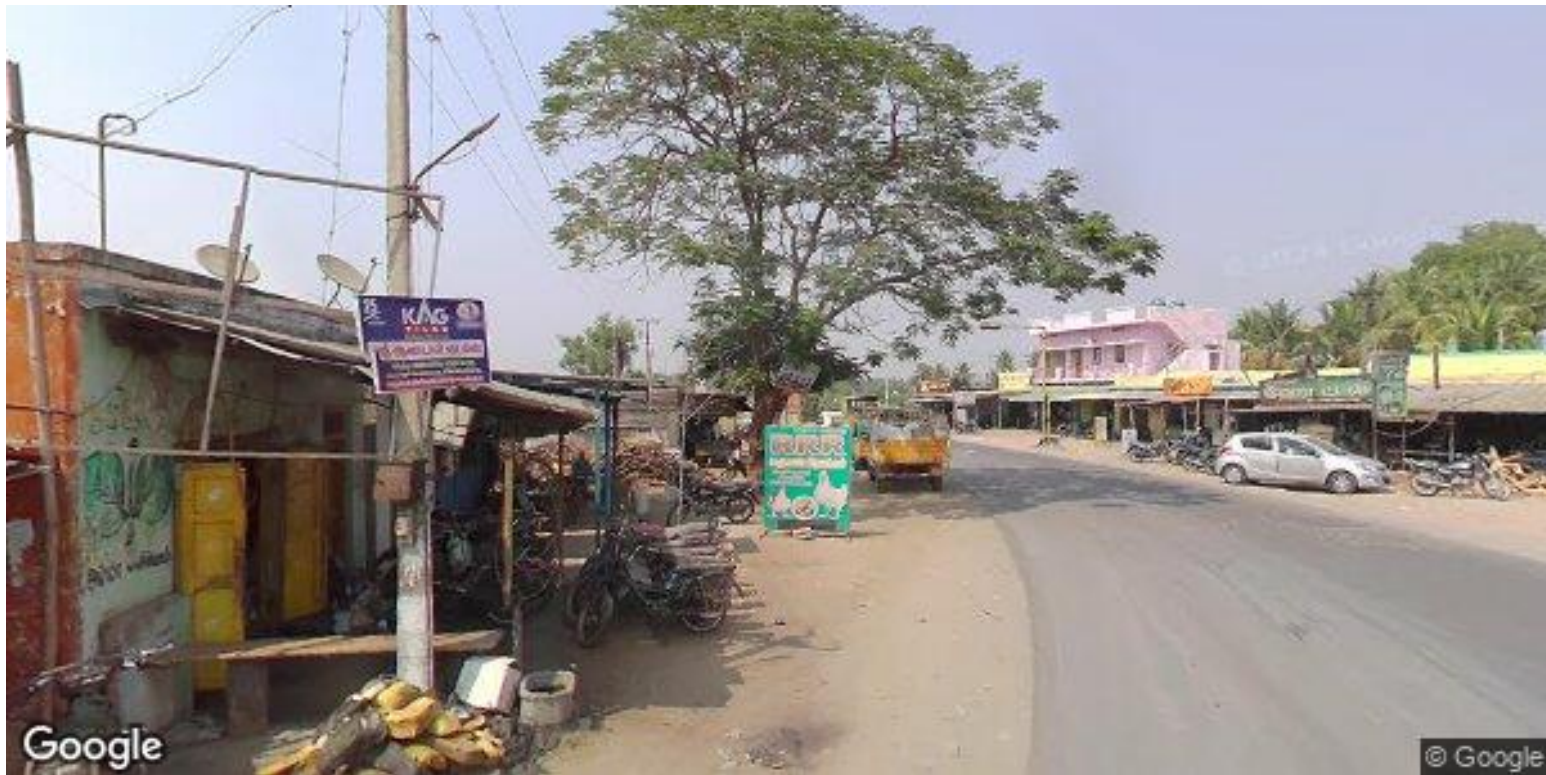
**Coordinates:** 11.64171, 77.95184

**Risk Type:** Turn

**Risk Level:** Medium

**Speed Limit:** 30 KM/Hr

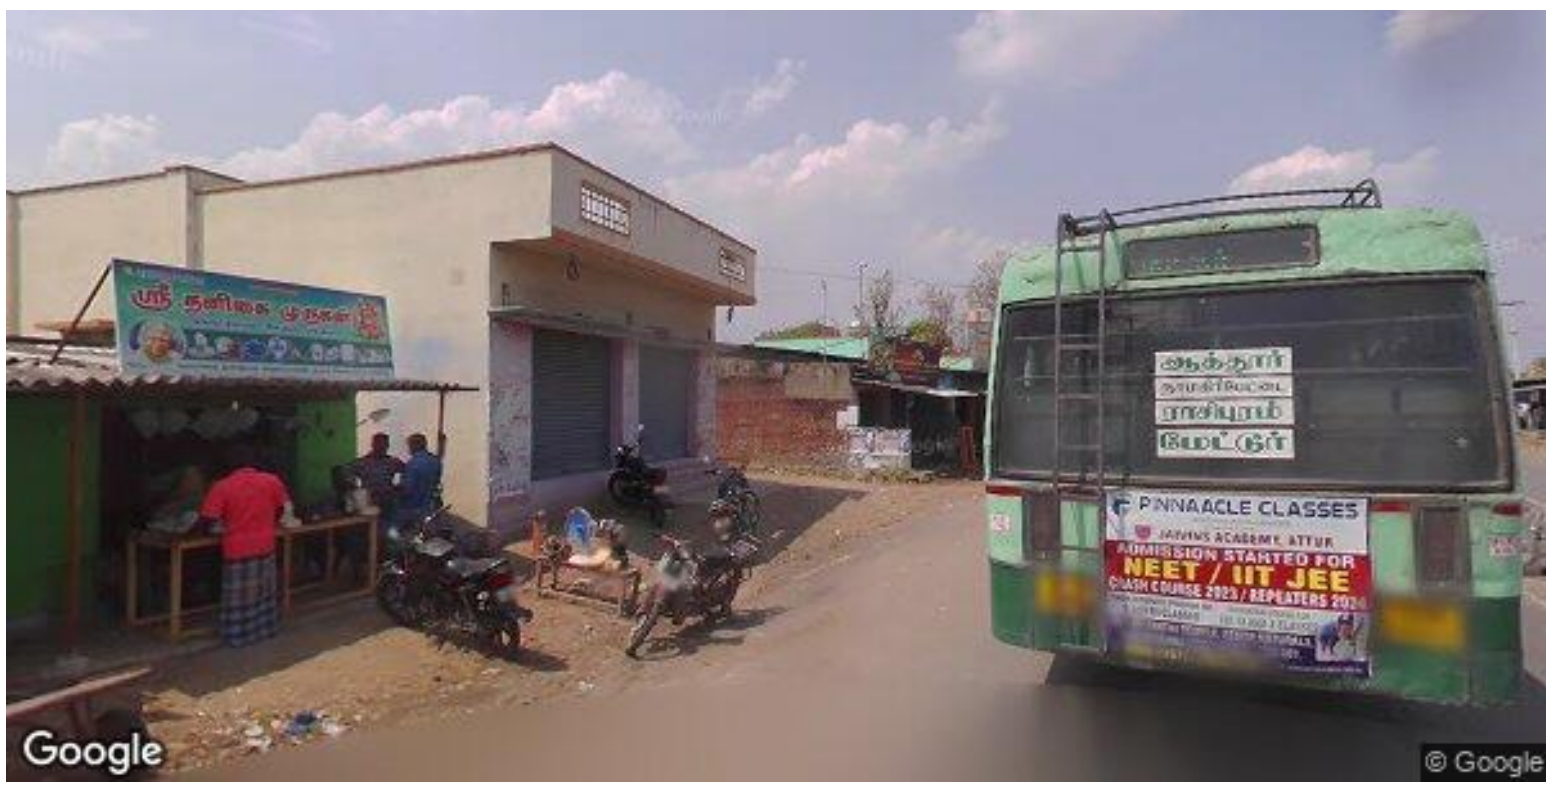
**Coordinates:** 11.64721, 77.95118

**Risk Type:** Turn

**Risk Level:** Medium

**Speed Limit:** 30 KM/Hr

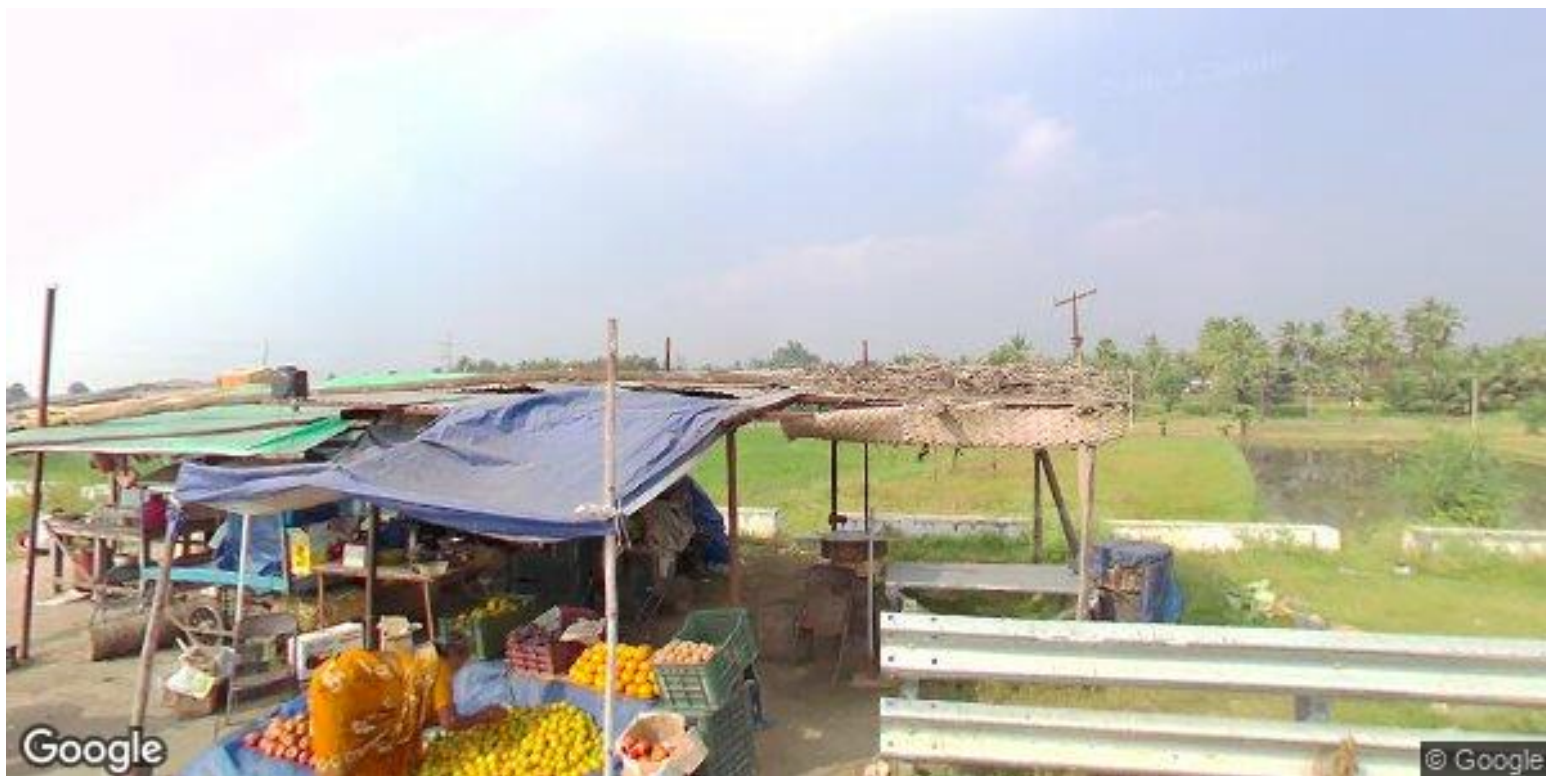
**Coordinates:** 11.67858, 77.96834

**Risk Type:** Turn

**Risk Level:** Medium

**Speed Limit:** 30 KM/Hr

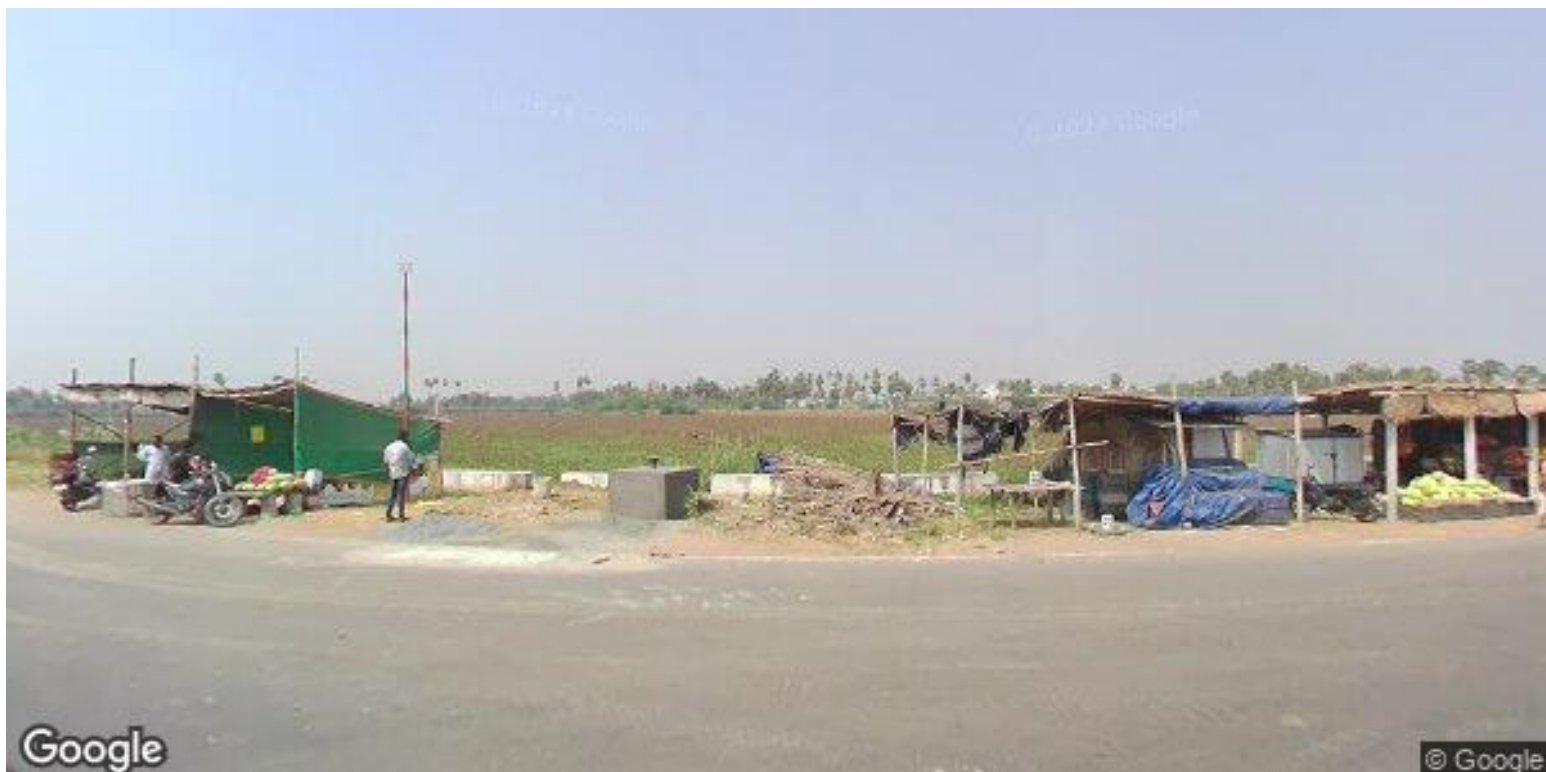
**Risk Type:** Turn  
**Risk Level:** Medium  
**Speed Limit:** 30 KM/Hr  
**Coordinates:** 11.68915, 77.97734

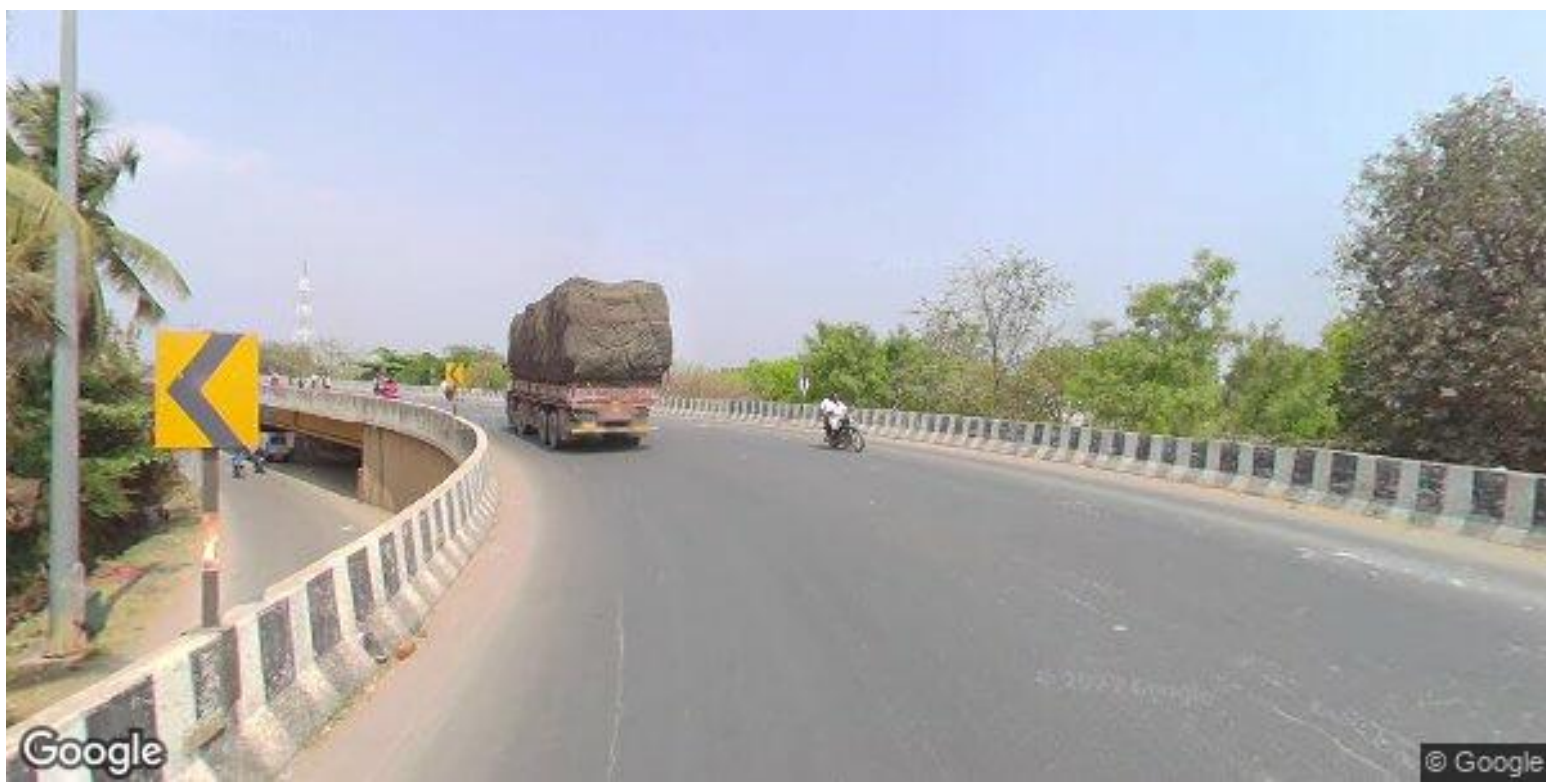
**Coordinates:** 11.73651, 78.03878

**Risk Type:** Turn

**Risk Level:** High

**Speed Limit:** 15 KM/Hr

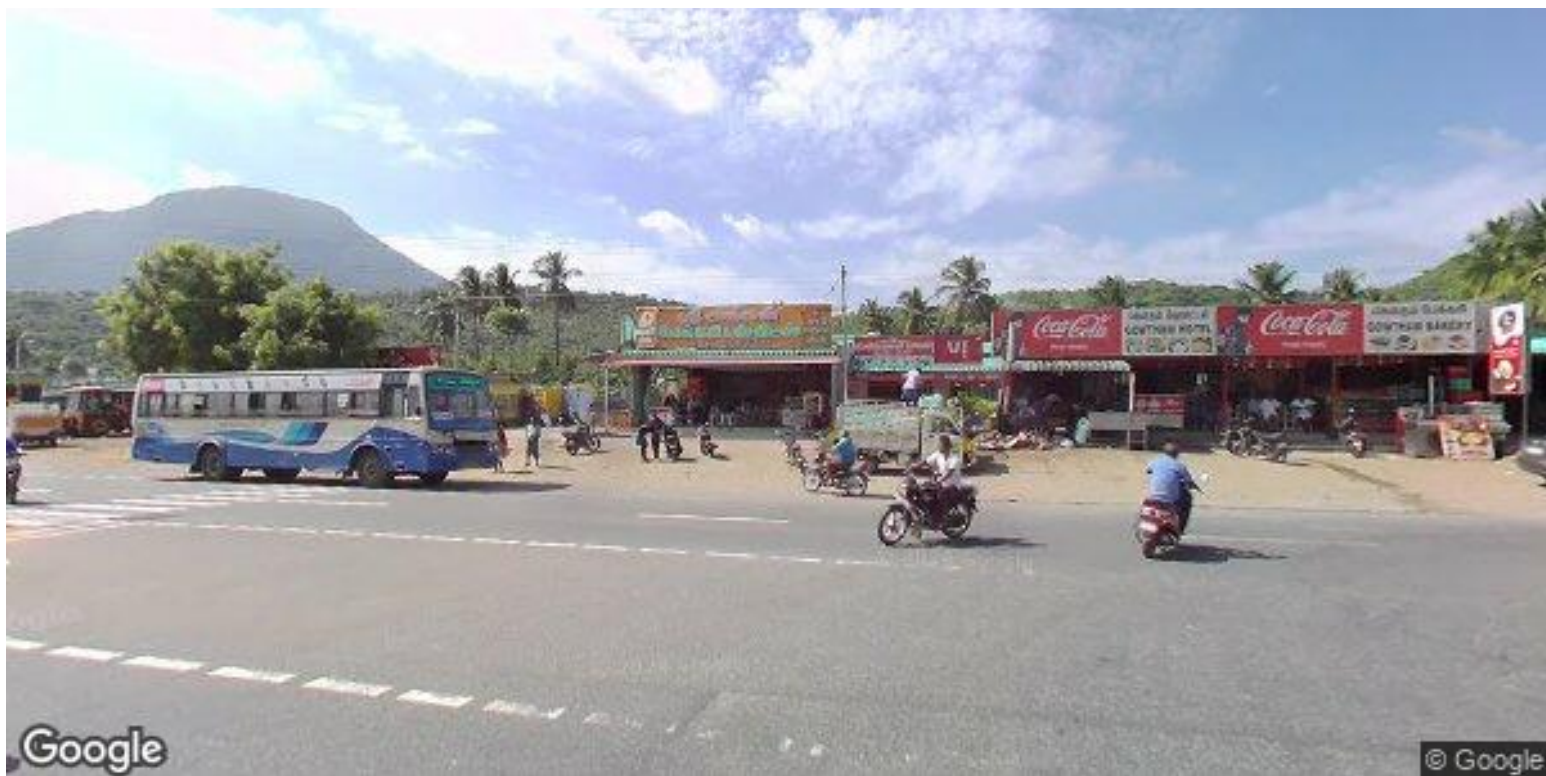
**Coordinates:** 11.93670, 78.05606

**Risk Type:** Turn

**Risk Level:** High

**Speed Limit:** 15 KM/Hr

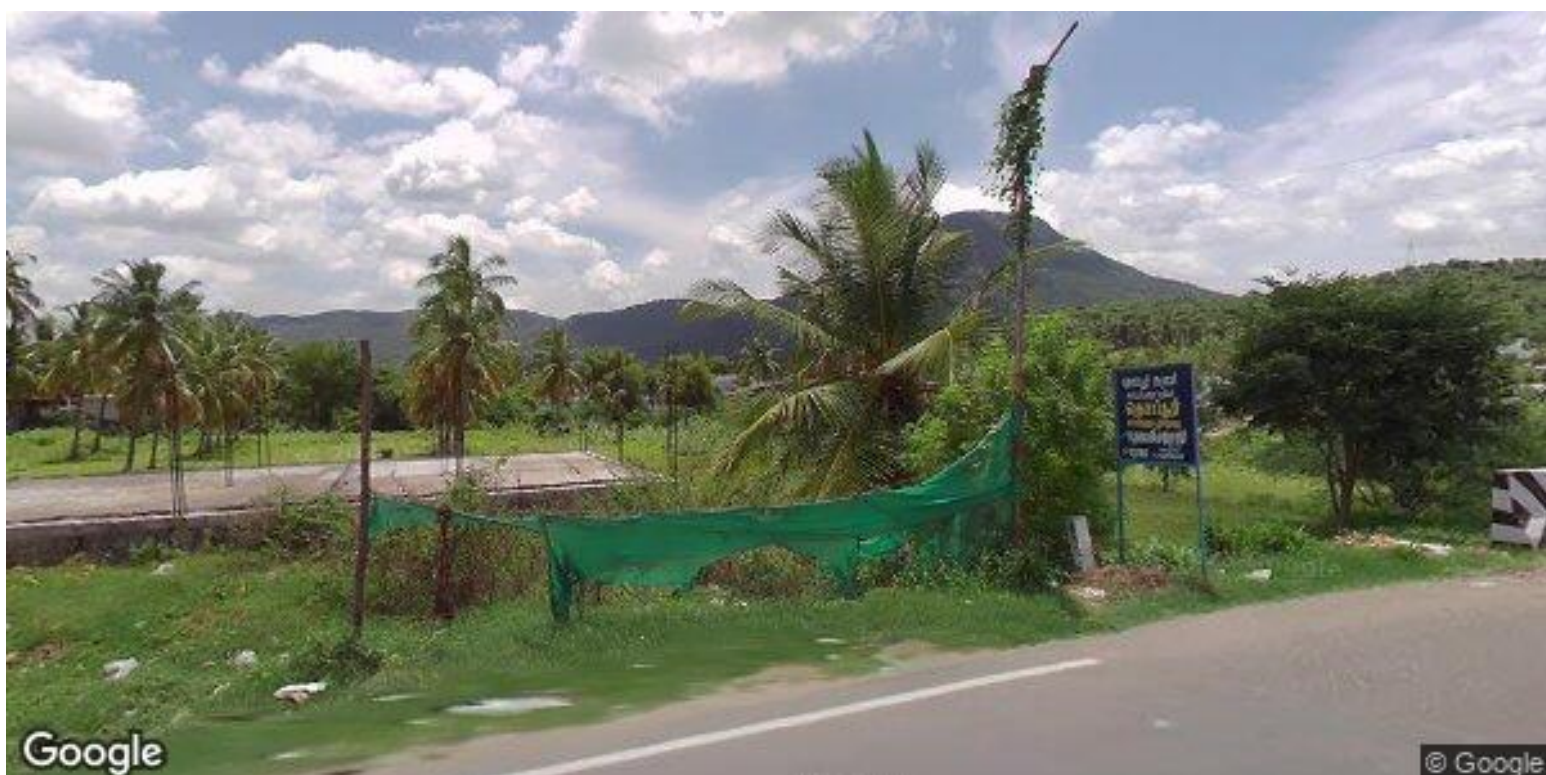
**Coordinates:** 11.93877, 78.05736

**Risk Type:** Turn

**Risk Level:** Medium

**Speed Limit:** 30 KM/Hr

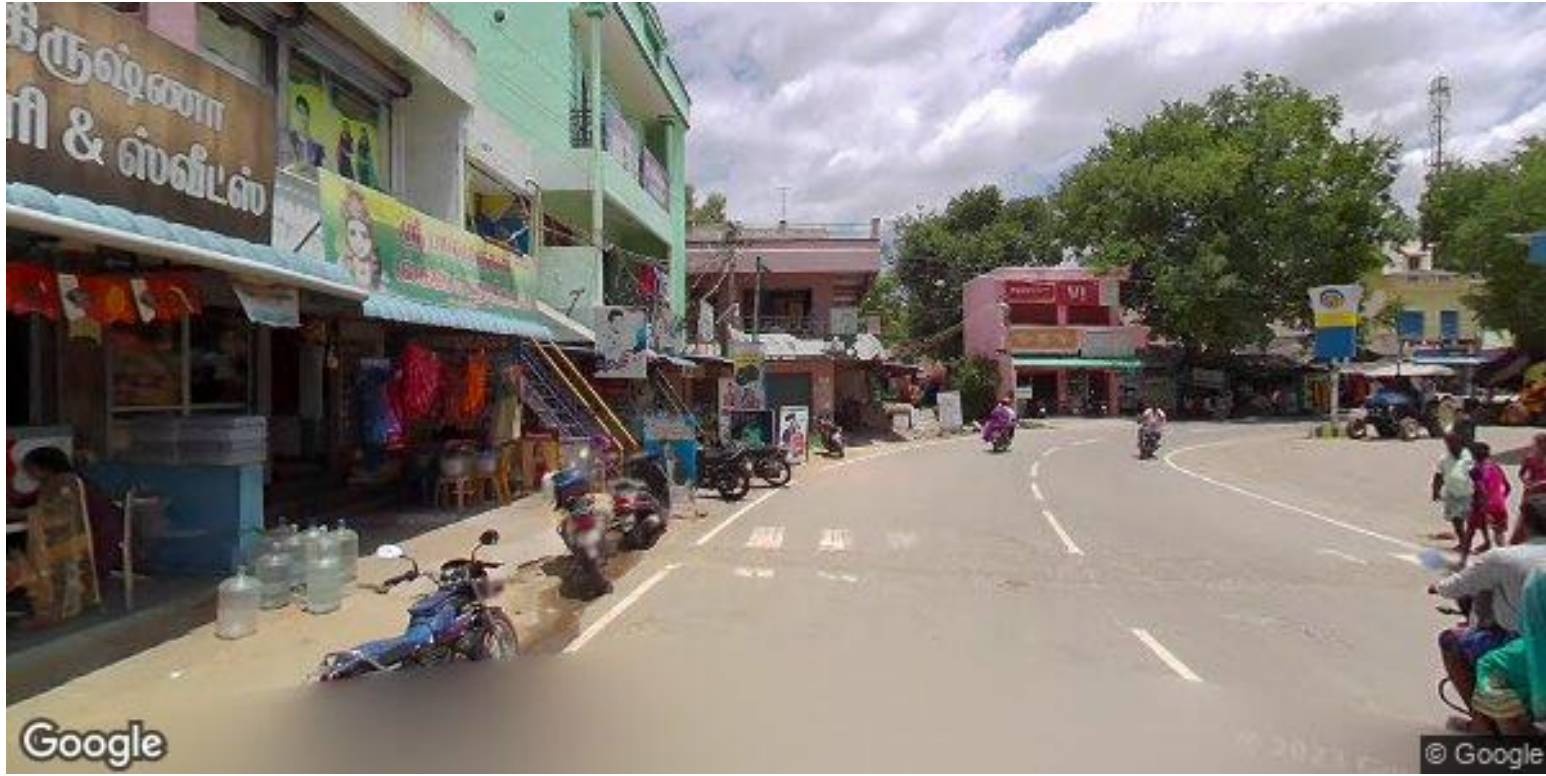
**Coordinates:** 11.93965, 78.05742

**Risk Type:** Turn

**Risk Level:** Medium

**Speed Limit:** 30 KM/Hr

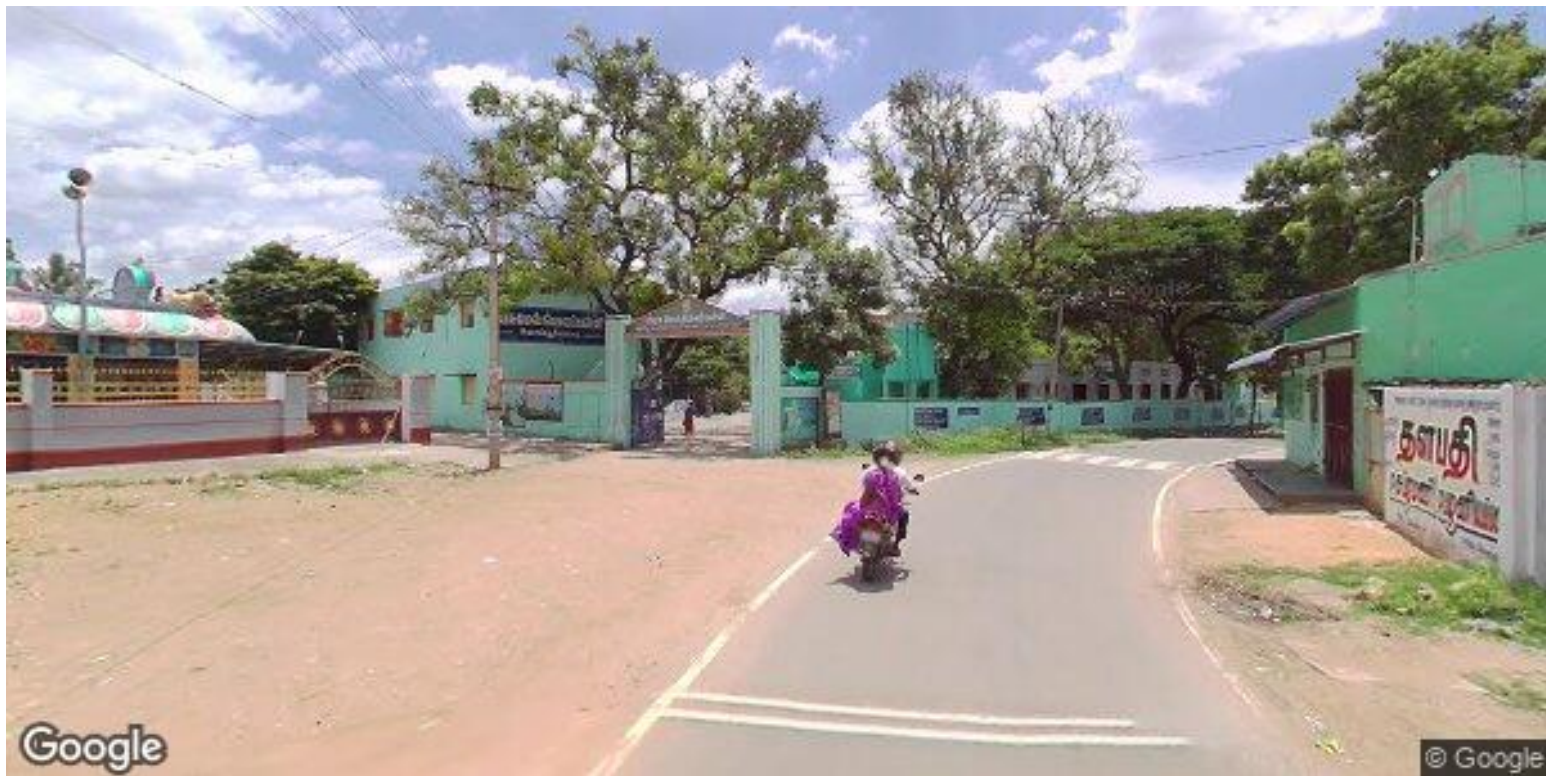
**Coordinates:** 11.94007, 78.05886

**Risk Type:** Turn

**Risk Level:** Medium

**Speed Limit:** 30 KM/Hr

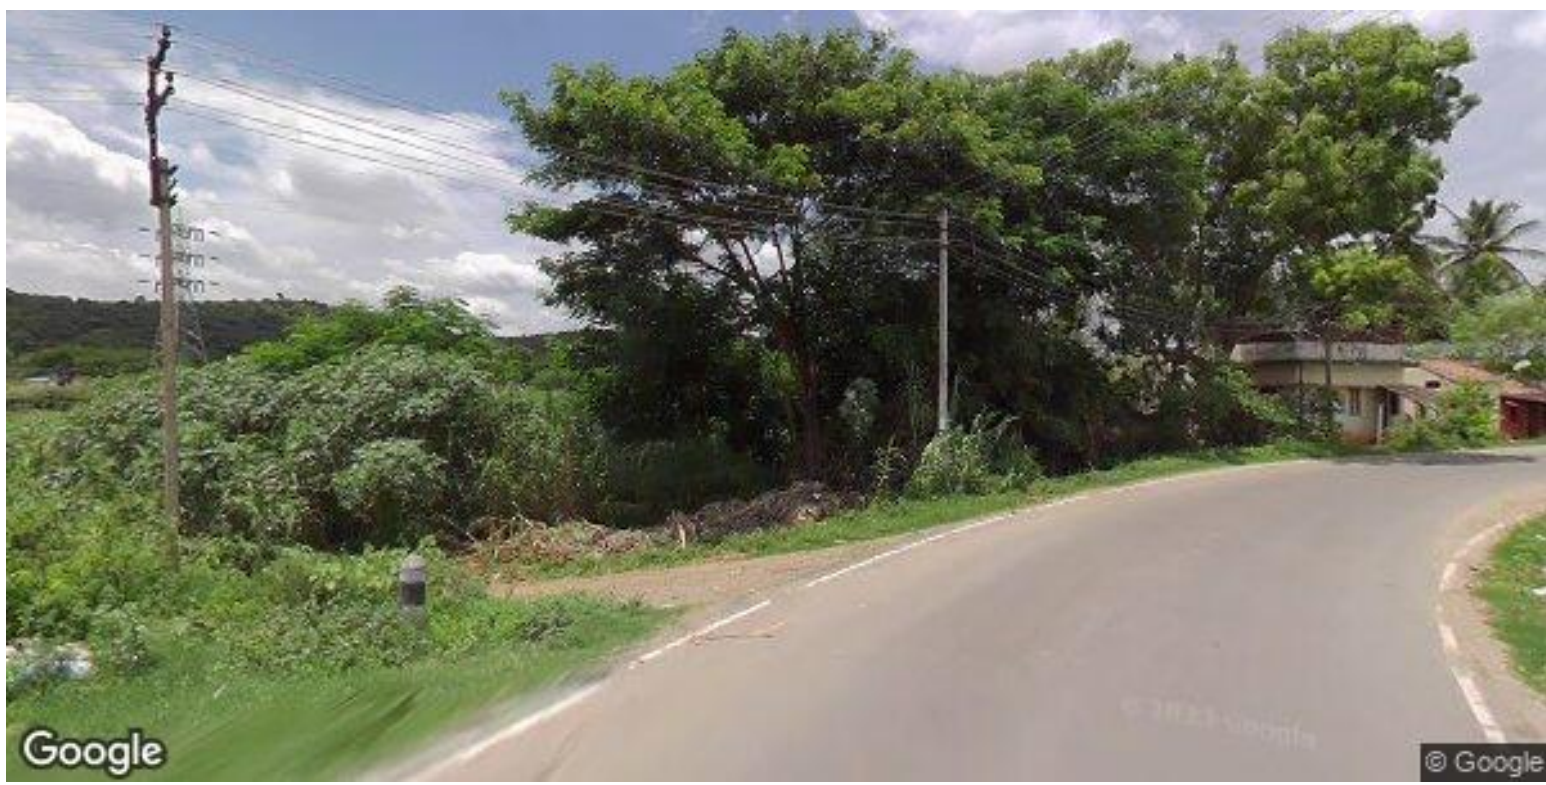
**Coordinates:** 11.93896, 78.06064

**Risk Type:** Turn

**Risk Level:** High

**Speed Limit:** 15 KM/Hr
