# IndianOil

## JOURNEY RISK MANAGEMENT (JRM) STUDY

### Salem Terminal to MURUGAN AGENCY

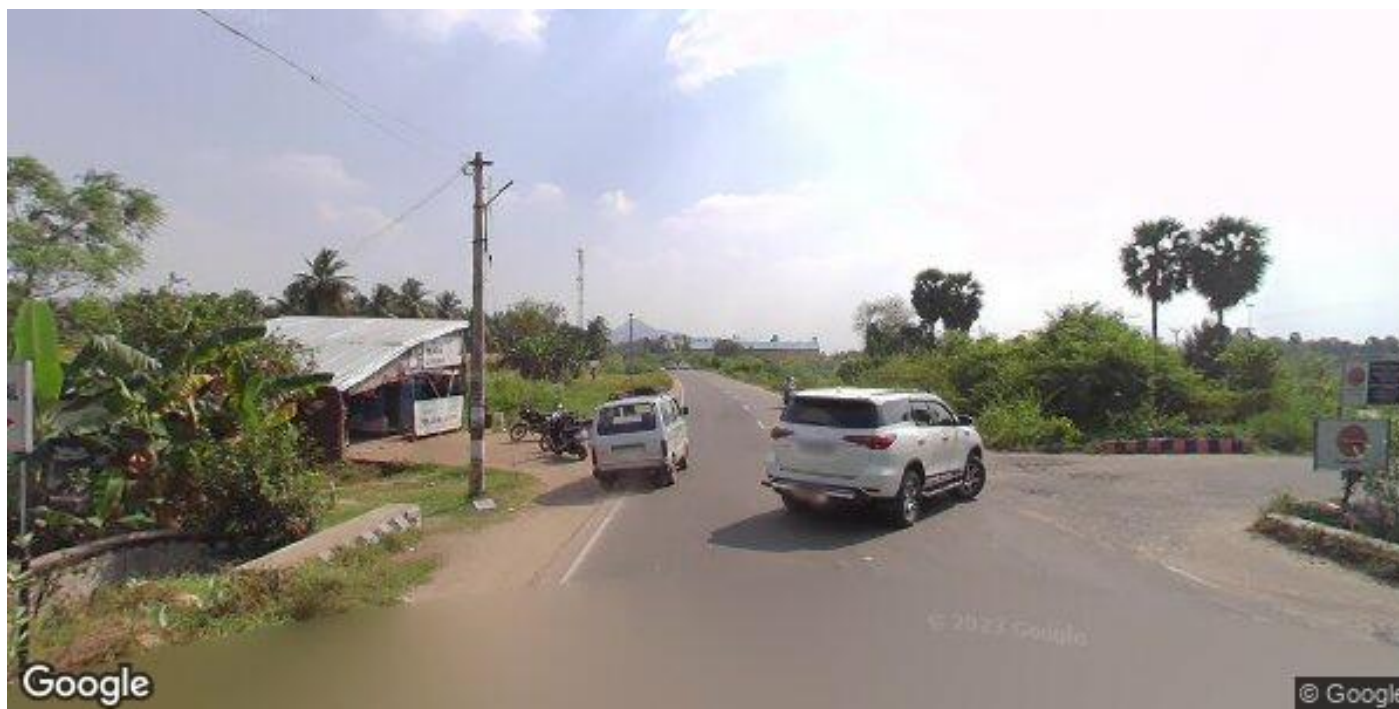
**Coordinates:** 11.44029, 77.87544

**Risk Type:** Blind Spot

**Risk Level:** Blind Spot

**Speed Limit:** 10 KM/Hr

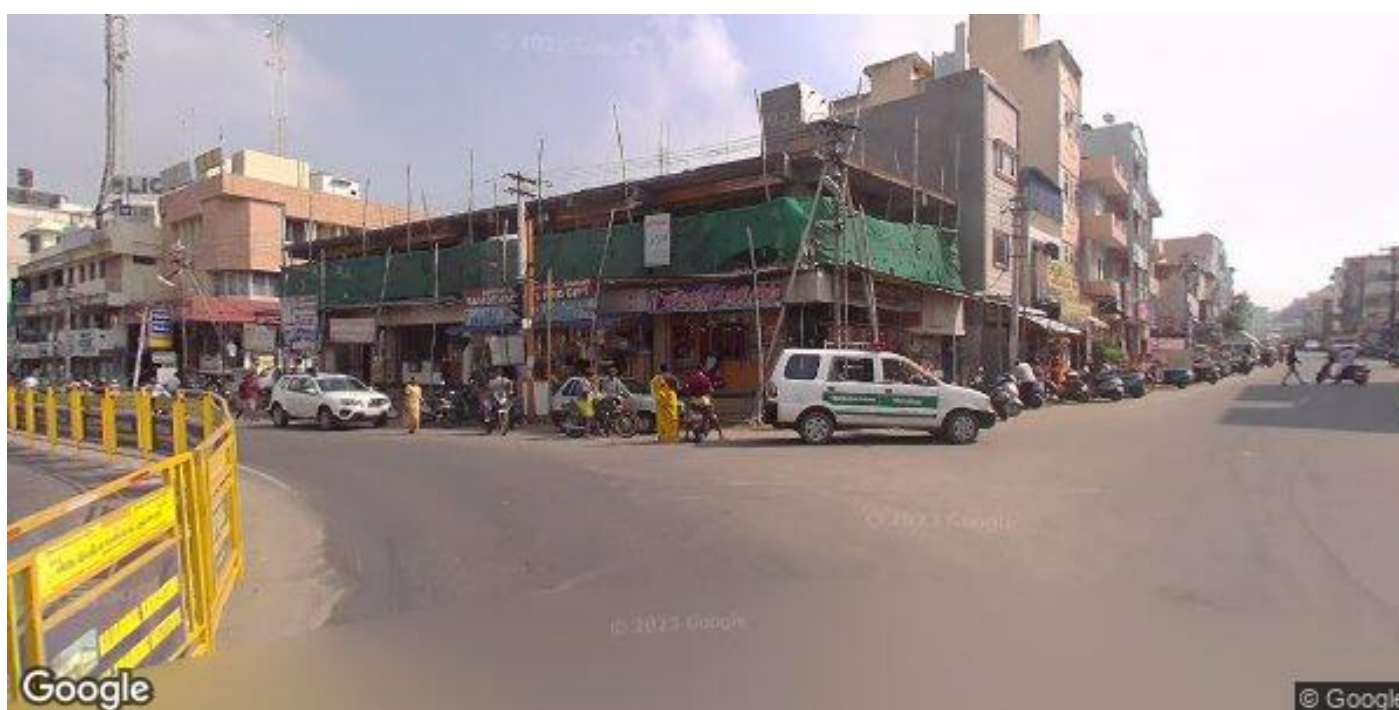
**Coordinates:** 11.37868, 77.89498

**Risk Type:** Turn

**Risk Level:** High

**Speed Limit:** 15 KM/Hr

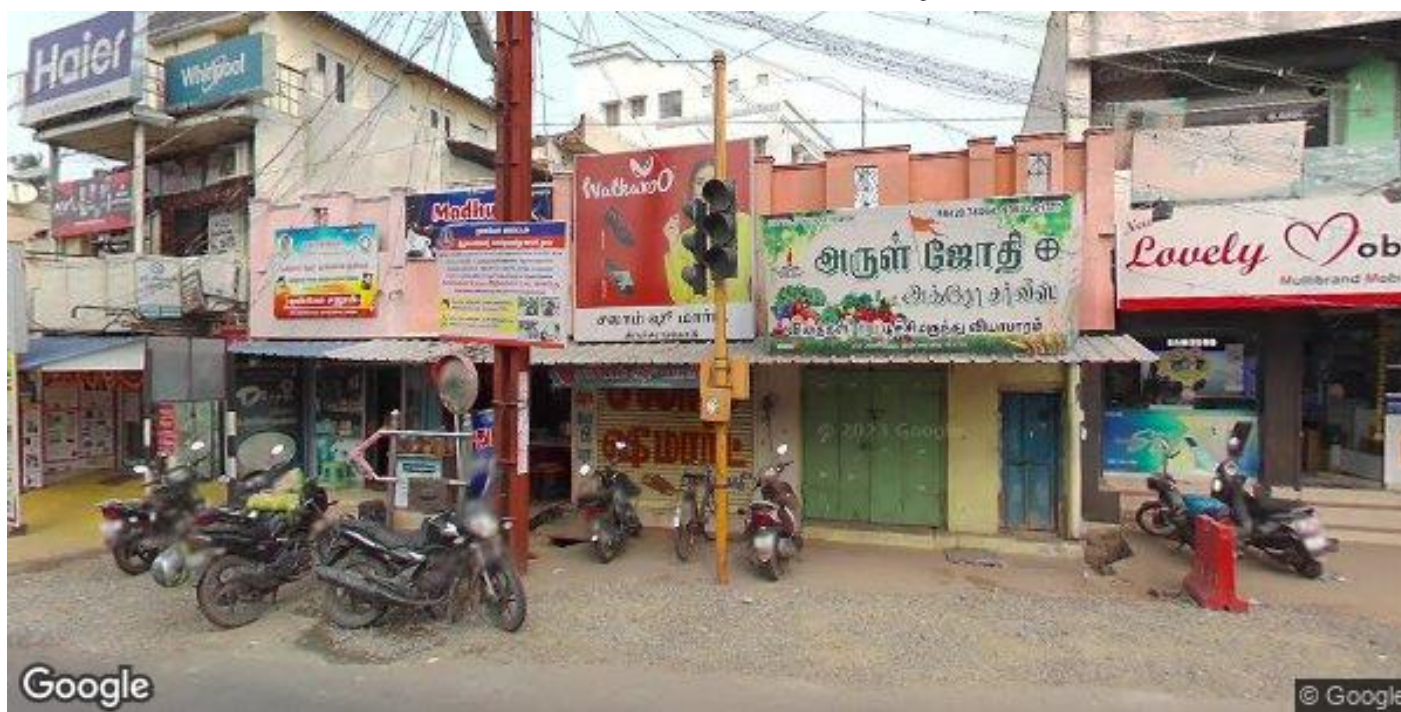
**Risk Type:** Turn  
**Risk Level:** High  
**Speed Limit:** 15 KM/Hr  
**Coordinates:** 11.37850, 77.89453

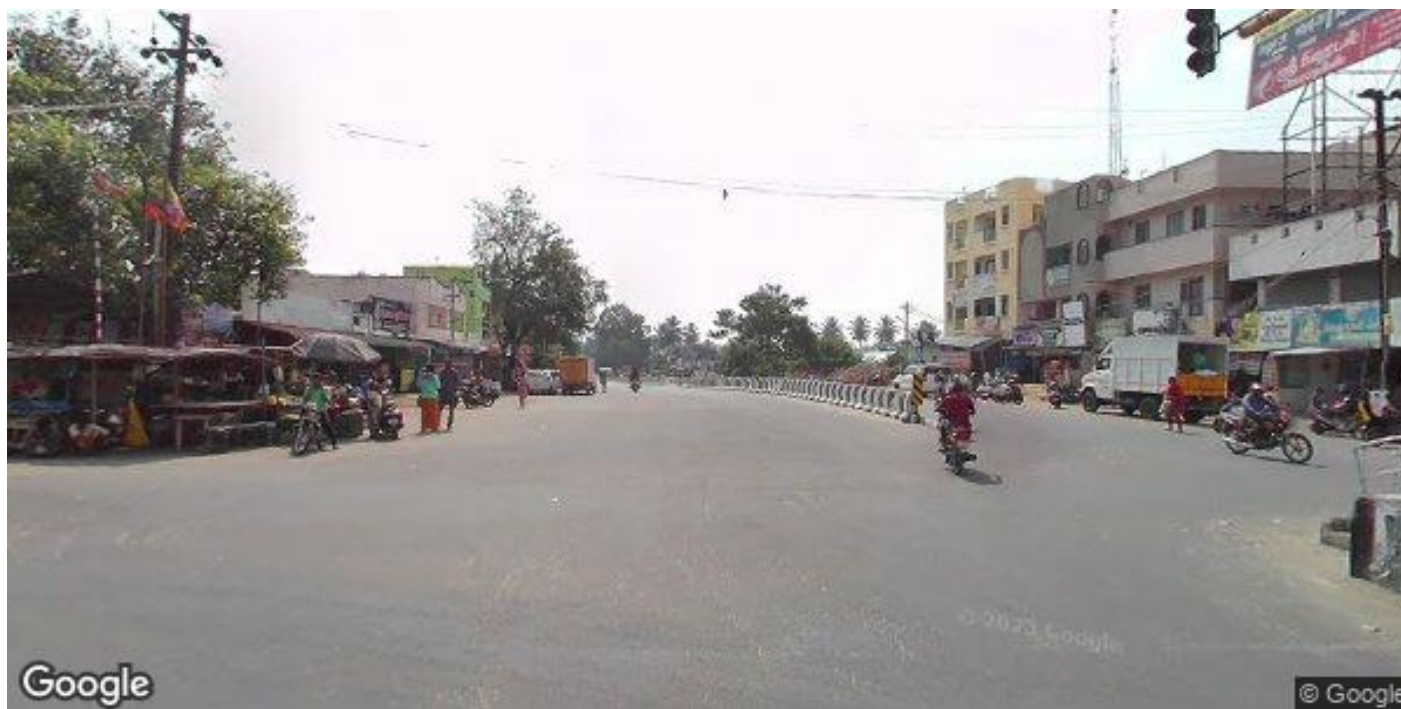
**Risk Type:** Turn  
**Risk Level:** High  
**Speed Limit:** 15 KM/Hr  
**Coordinates:** 11.36604, 77.88887
