# IndianOil

## JOURNEY RISK MANAGEMENT (JRM) STUDY

### Salem Terminal TO SARASWATHI FUELS

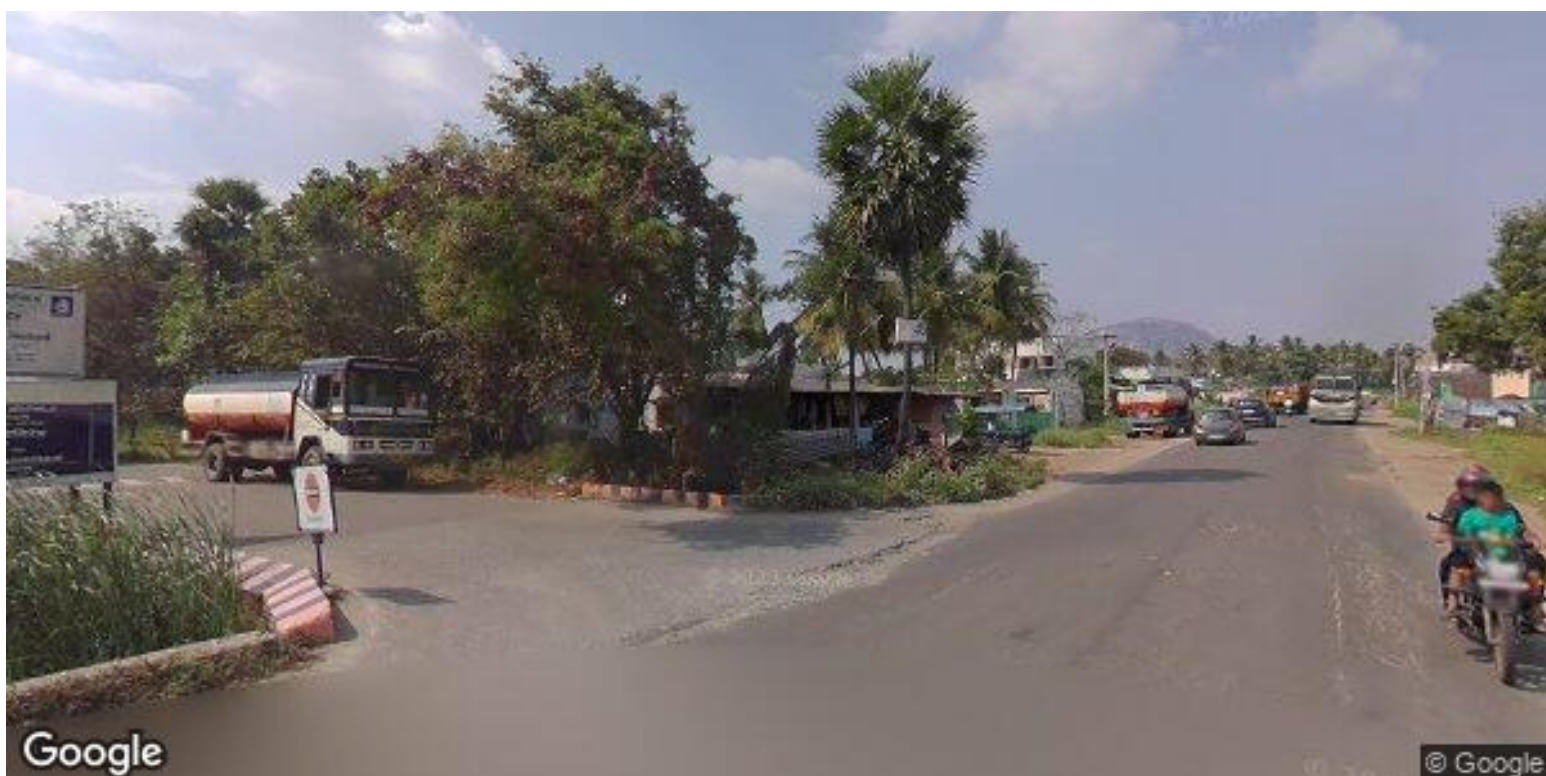
**Coordinates:** 11.44028, 77.87541

**Risk Type:** Turn

**Risk Level:** High

**Speed Limit:** 15 KM/Hr

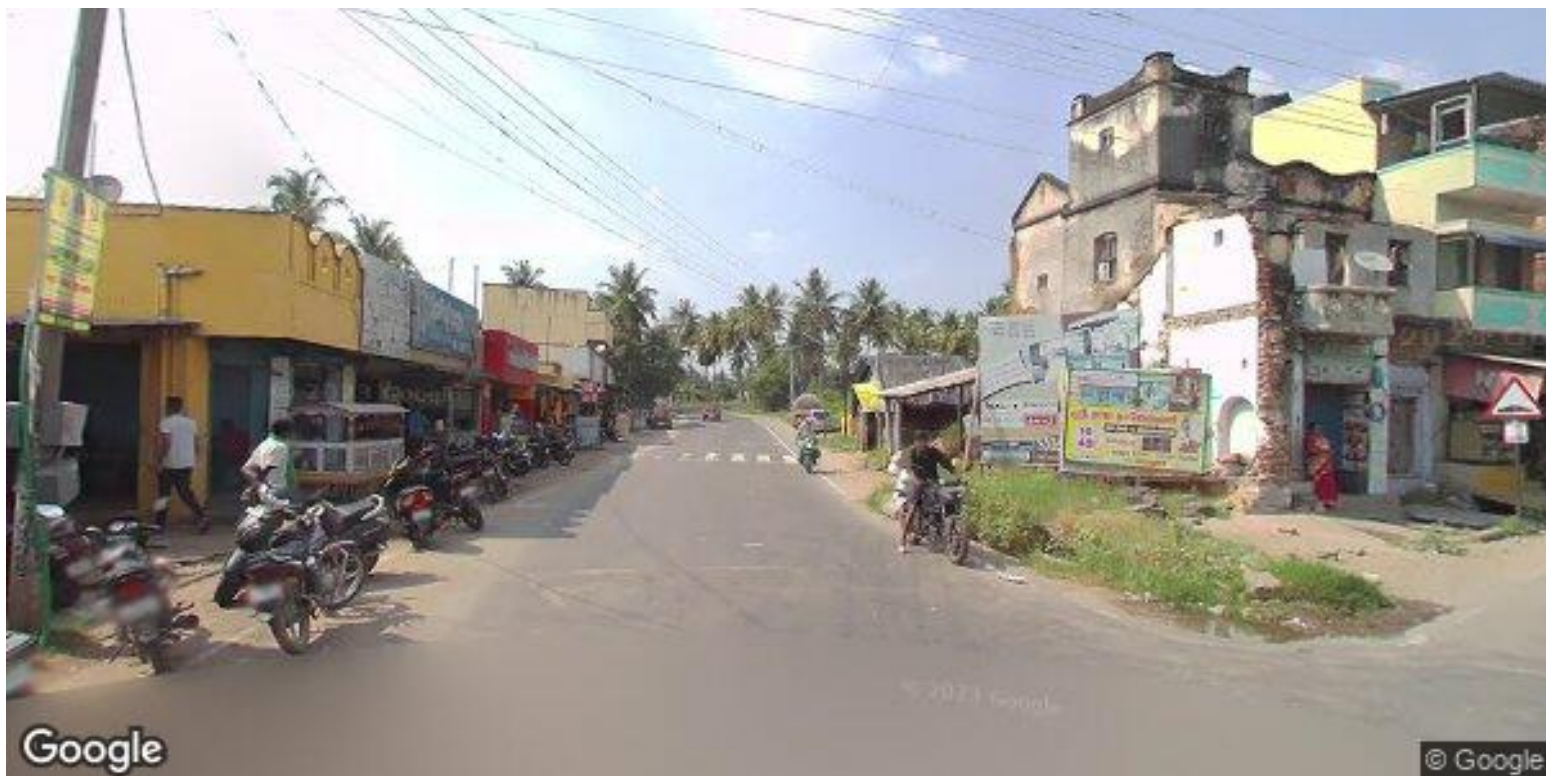
**Coordinates:** 11.45007, 77.87201

**Risk Type:** Turn

**Risk Level:** High

**Speed Limit:** 15 KM/Hr

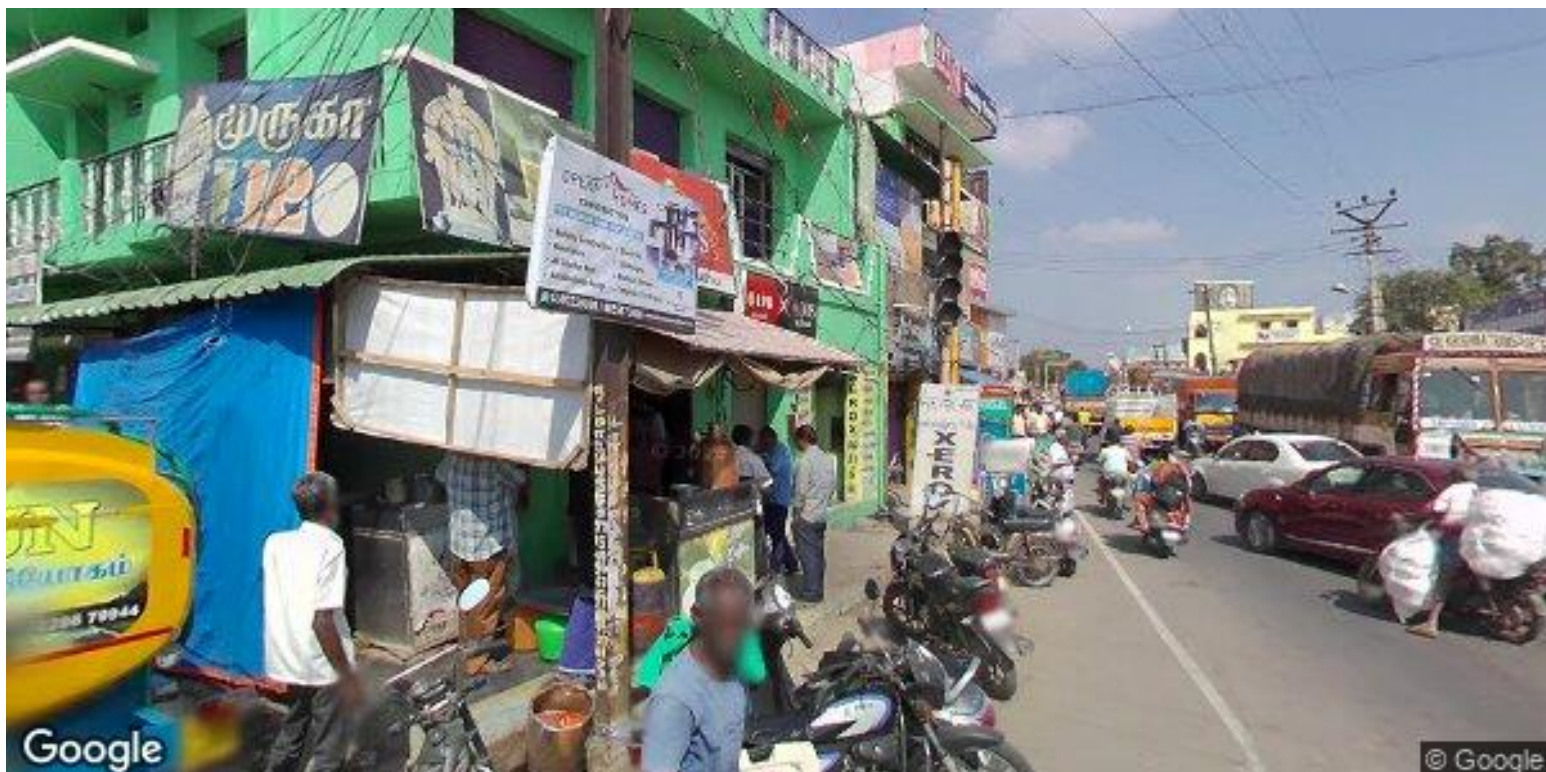
**Coordinates:** 11.47407, 77.86839

**Risk Type:** Turn

**Risk Level:** High

**Speed Limit:** 15 KM/Hr

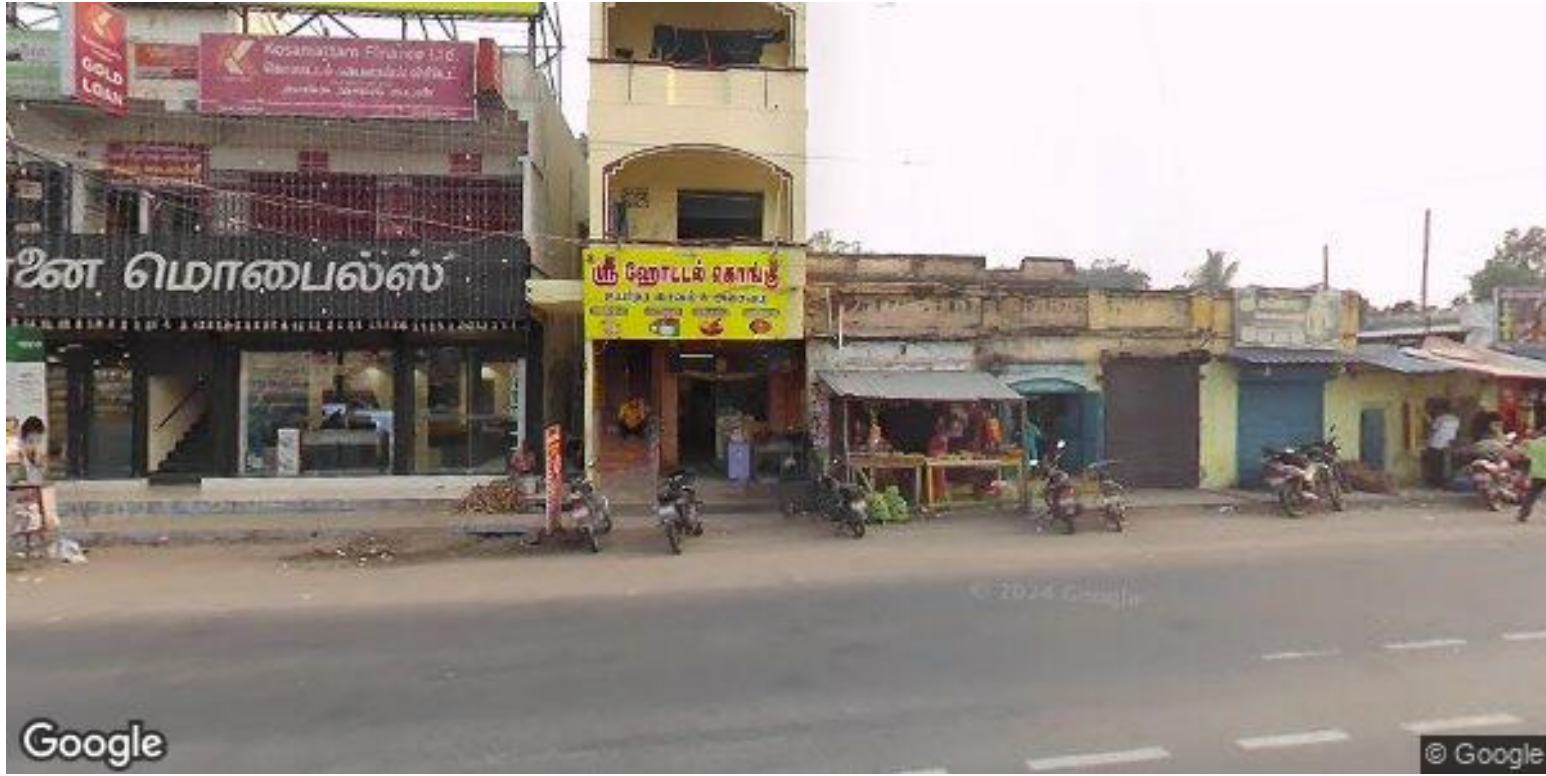
**Coordinates:** 11.47451, 77.86914

**Risk Type:** Turn

**Risk Level:** High

**Speed Limit:** 15 KM/Hr

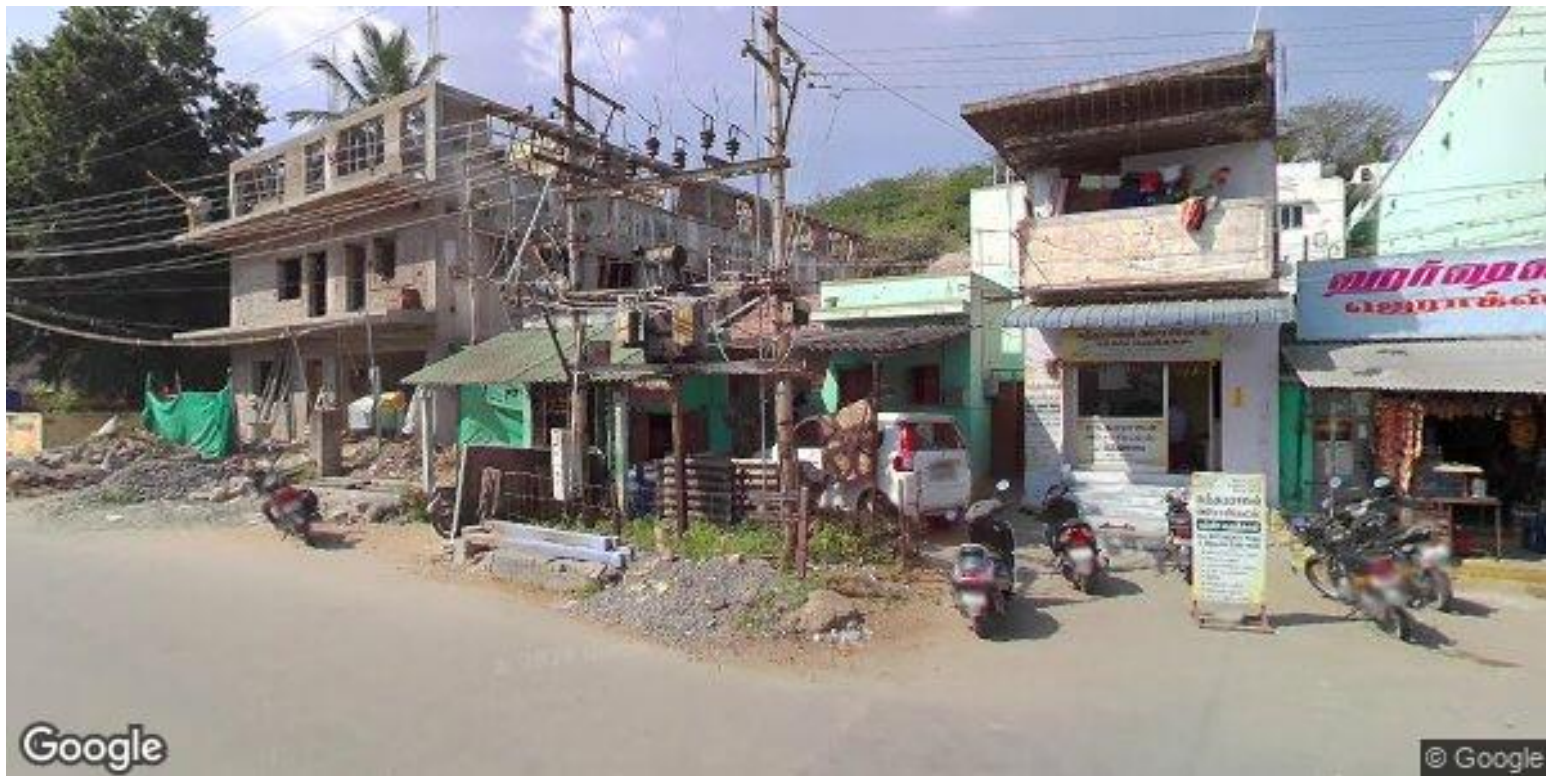
**Coordinates:** 11.47920, 77.86989

**Risk Type:** Turn

**Risk Level:** Medium

**Speed Limit:** 30 KM/Hr

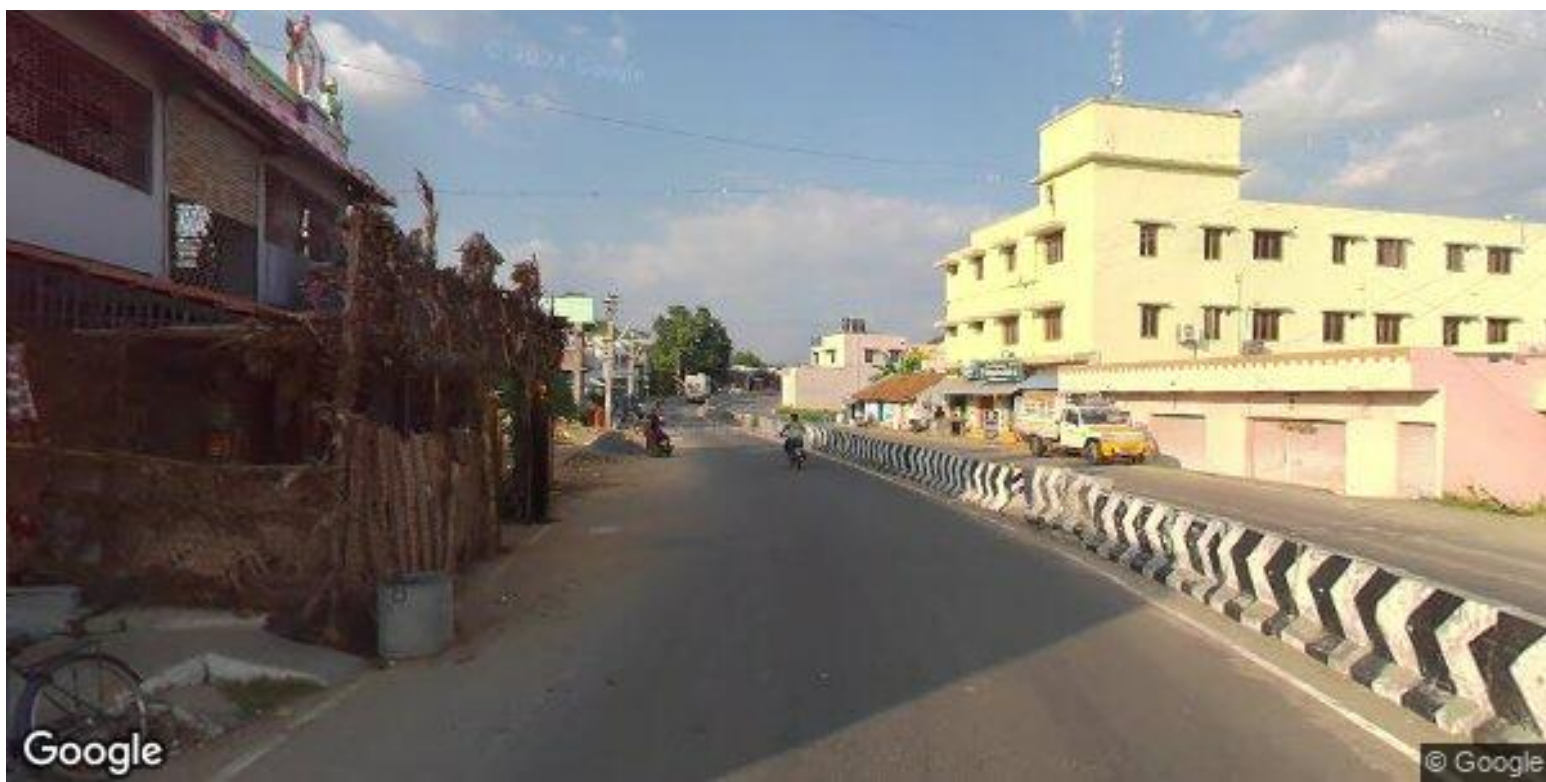
**Coordinates:** 11.48063, 77.87165

**Risk Type:** Turn

**Risk Level:** Medium

**Speed Limit:** 30 KM/Hr

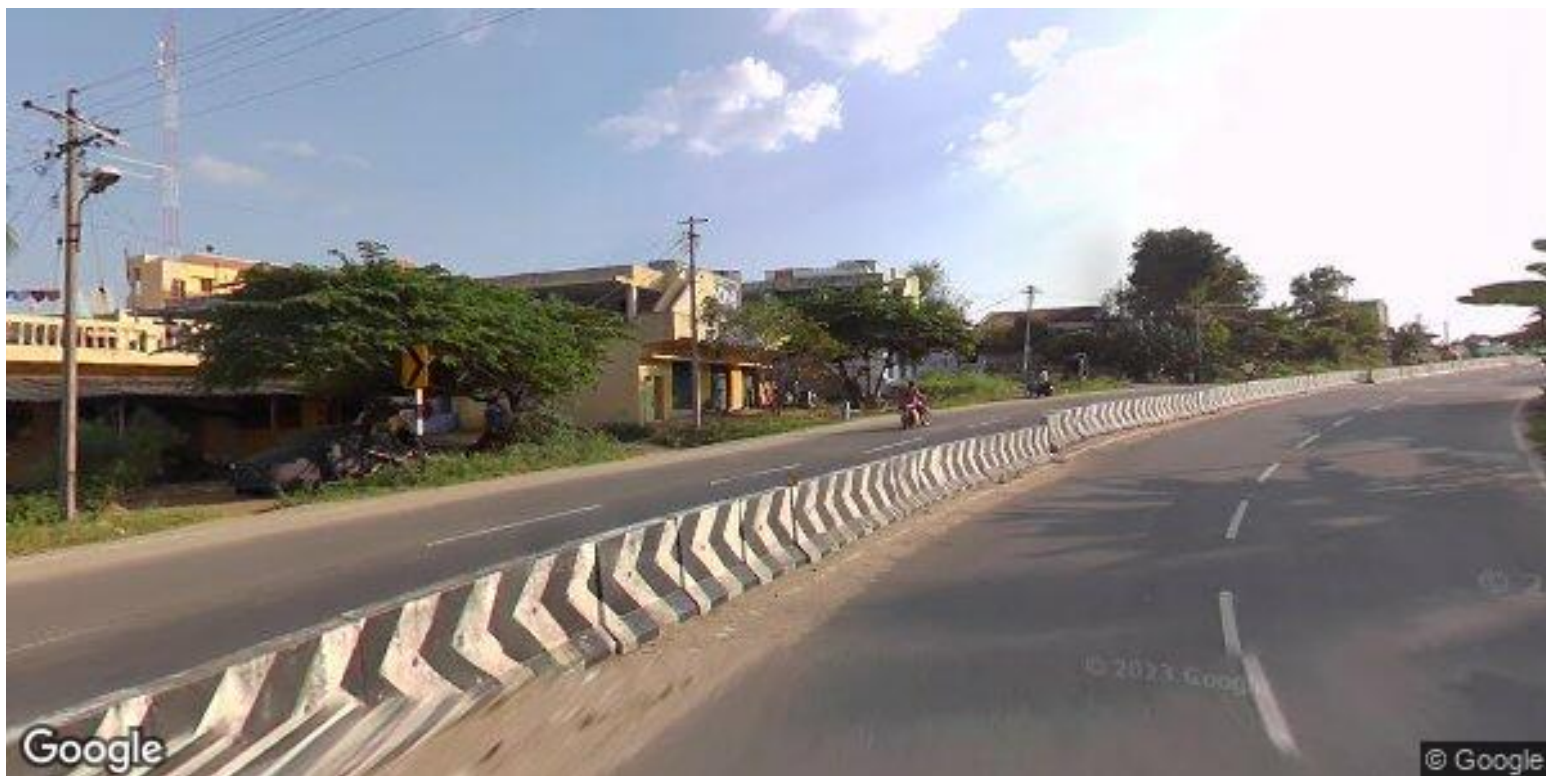
**Coordinates:** 11.48258, 77.87250

**Risk Type:** Turn

**Risk Level:** Medium

**Speed Limit:** 30 KM/Hr

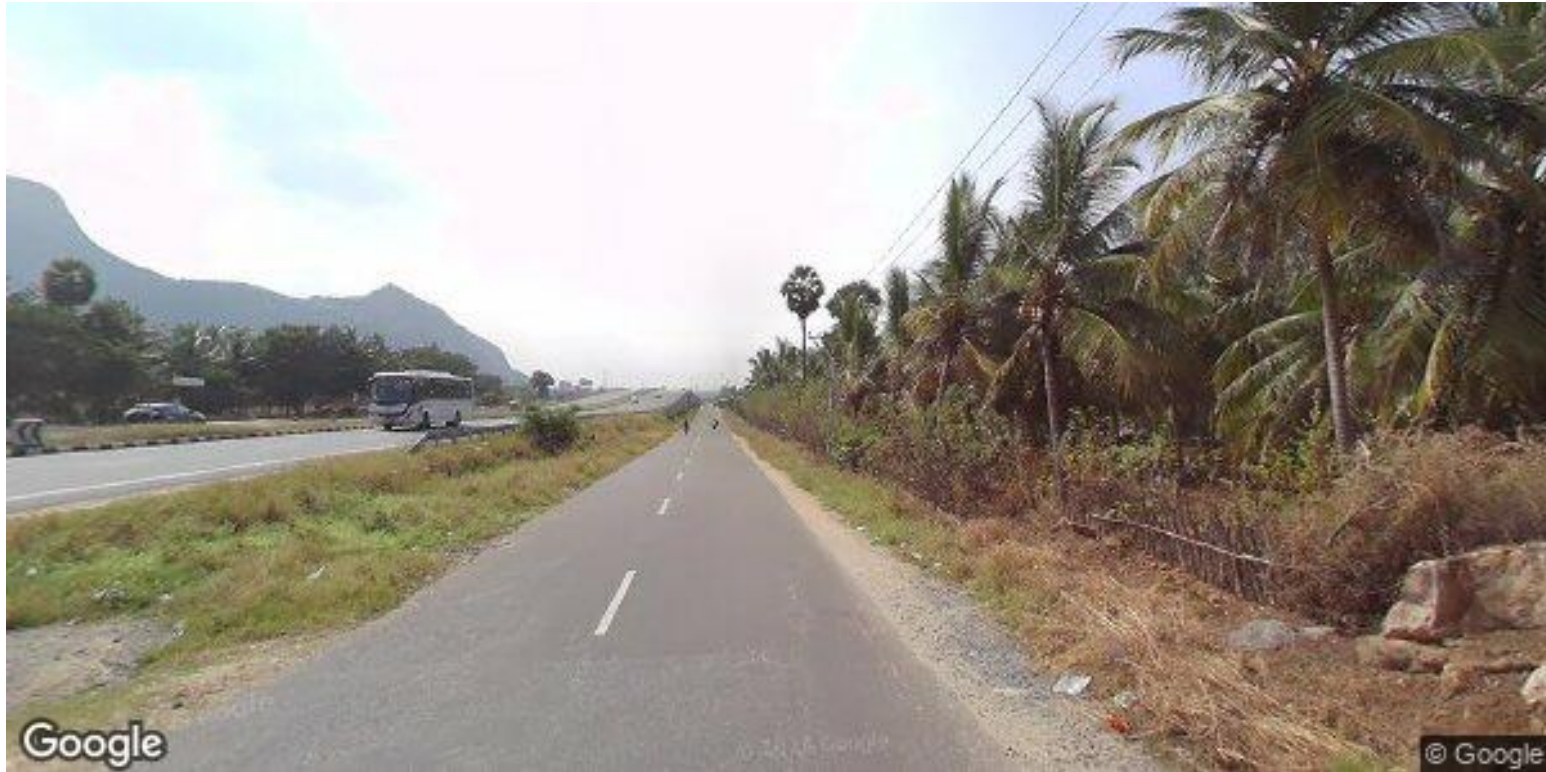
**Risk Type:** Turn  
**Risk Level:** Medium  
**Speed Limit:** 30 KM/Hr  
**Coordinates:** 11.49431, 77.87032

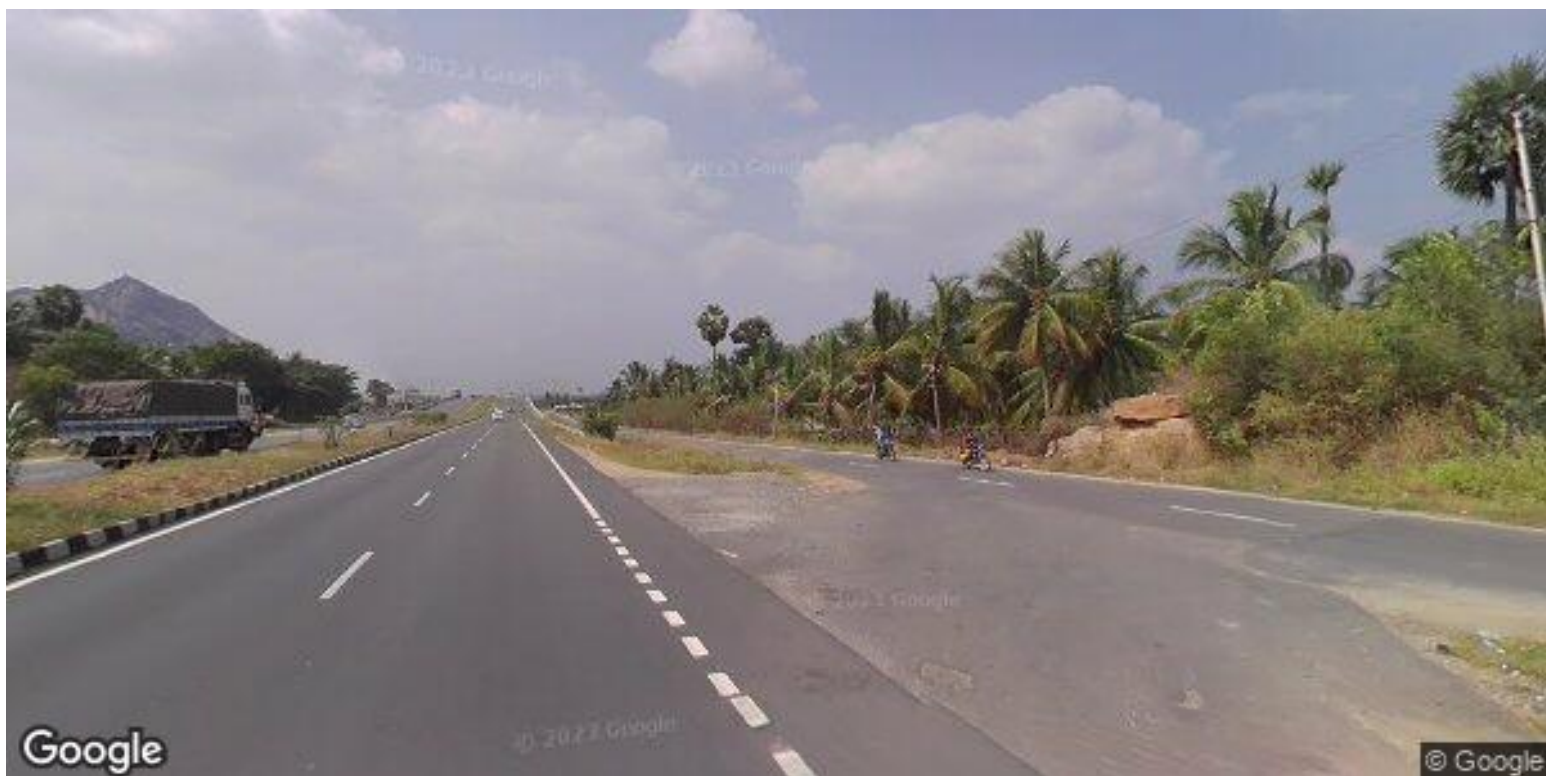
**Risk Type:** Turn  
**Risk Level:** Medium  
**Speed Limit:** 30 KM/Hr  
**Coordinates:** 11.49420, 77.87051

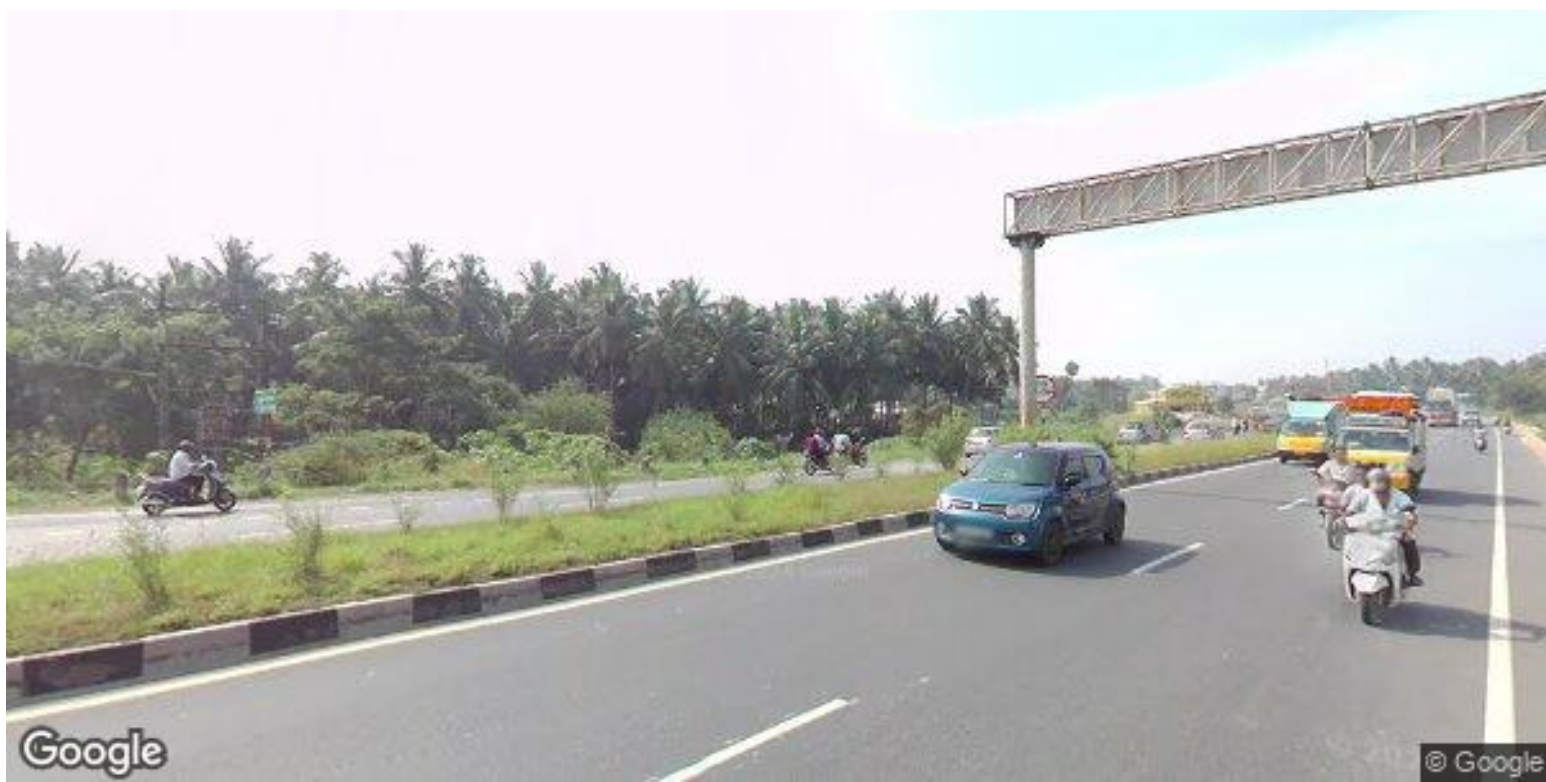
**Coordinates:** 11.60942, 78.10056

**Risk Type:** Turn

**Risk Level:** Medium

**Speed Limit:** 30 KM/Hr

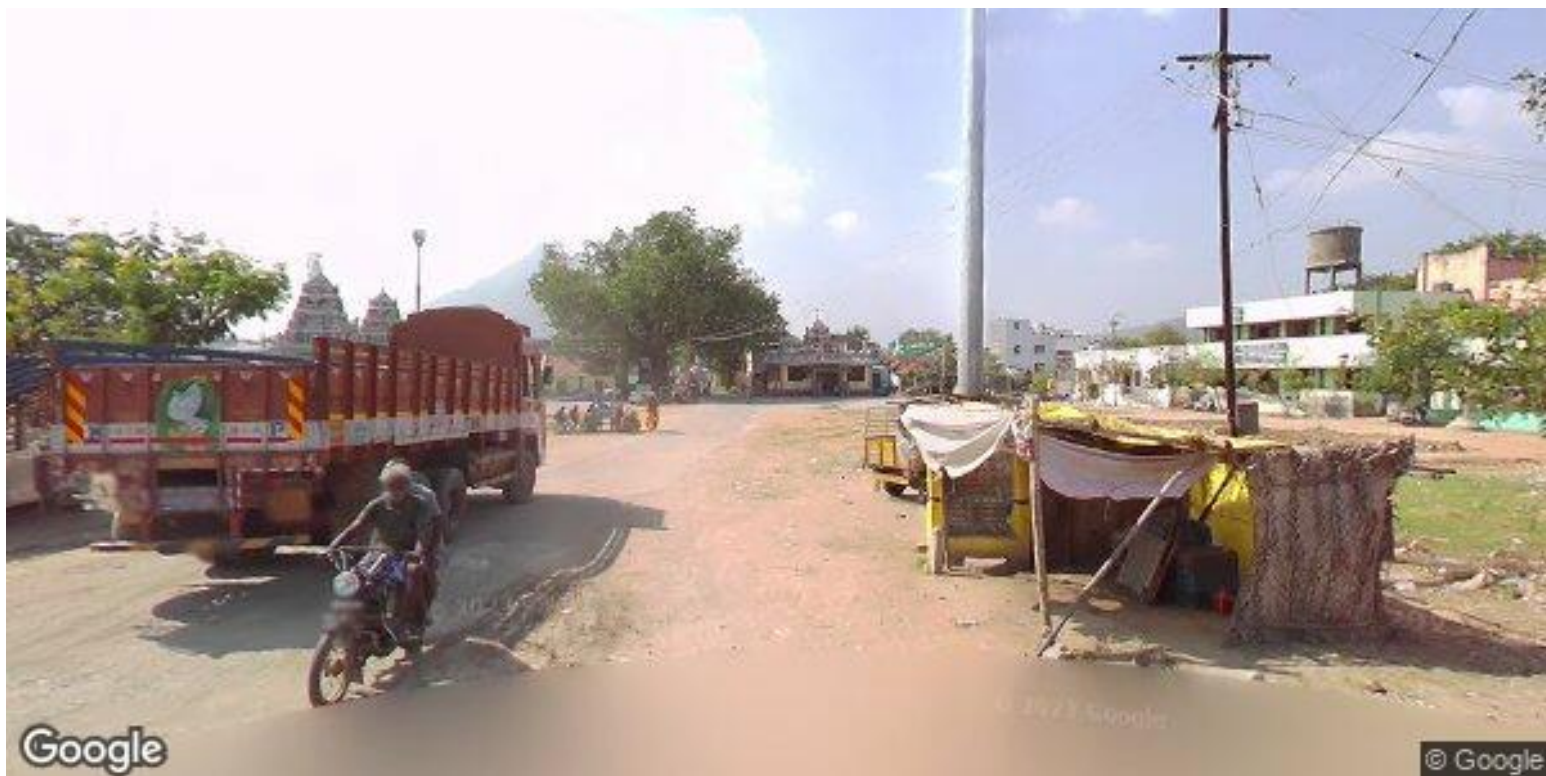
**Coordinates:** 11.62145, 78.10740

**Risk Type:** Blind Spot

**Risk Level:** Blind Spot

**Speed Limit:** 10 KM/Hr

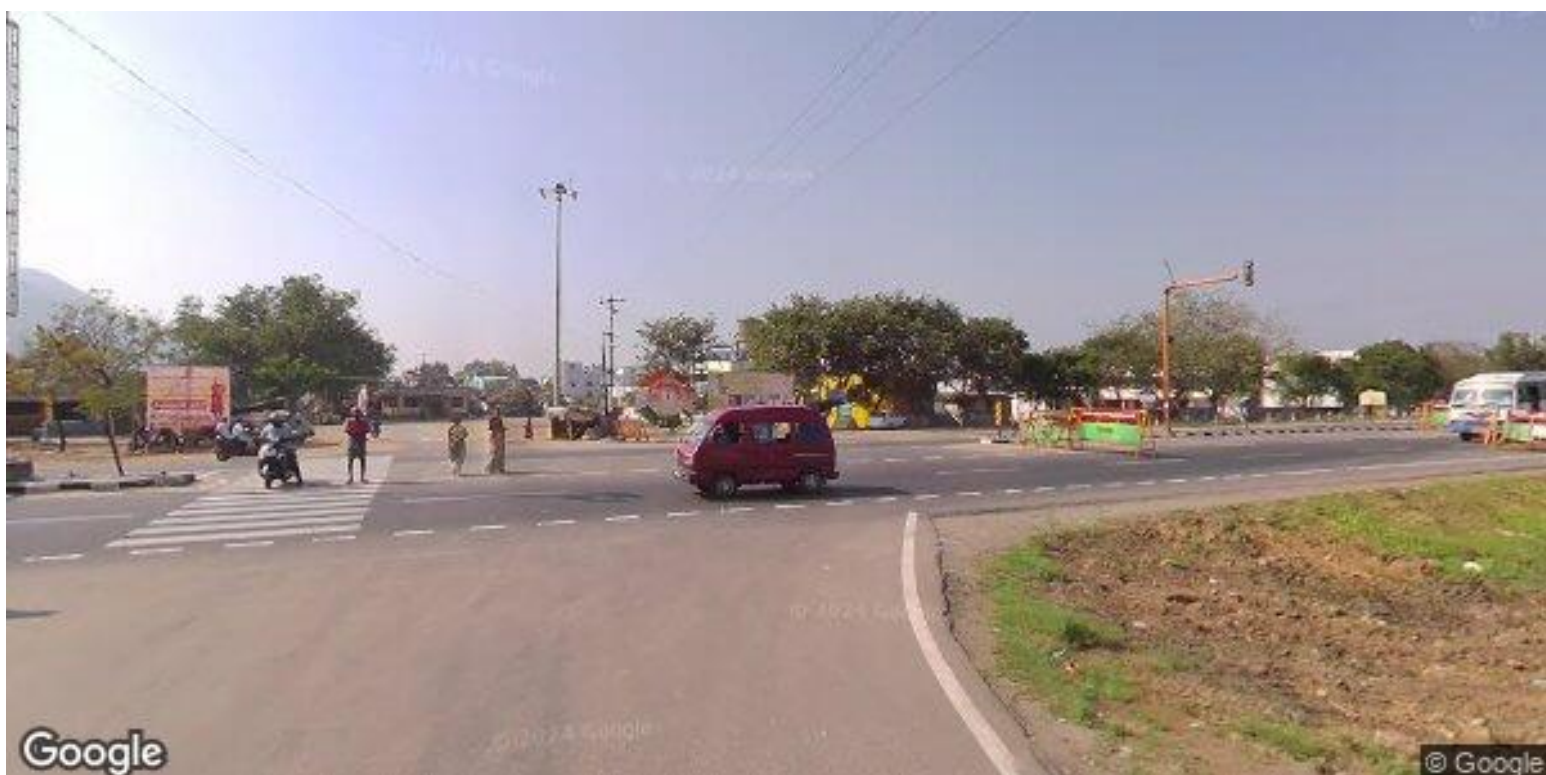
**Coordinates:** 11.62130, 78.10776

**Risk Type:** Turn

**Risk Level:** High

**Speed Limit:** 15 KM/Hr

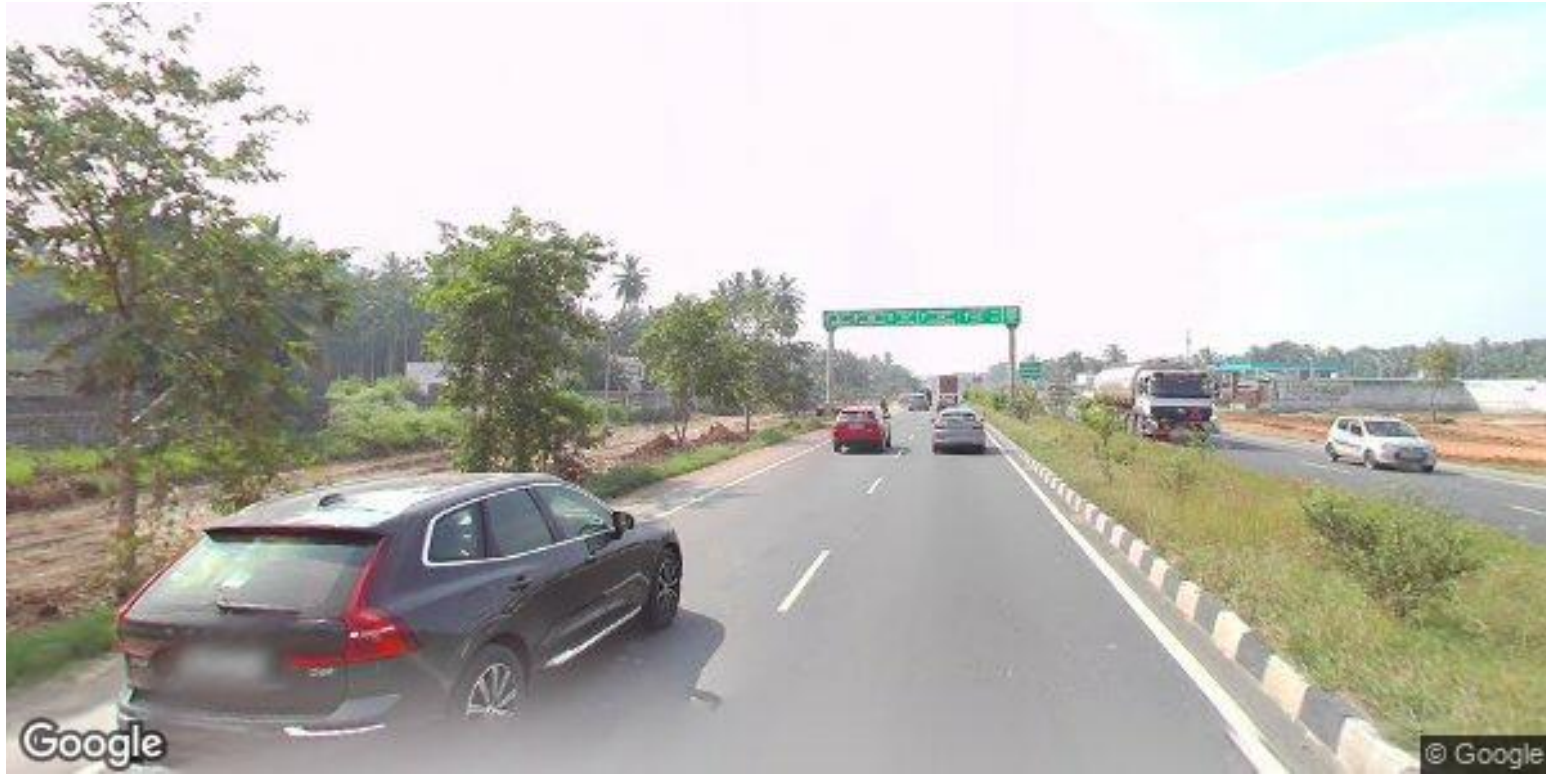
**Coordinates:** 11.61801, 78.10639

**Risk Type:** Turn

**Risk Level:** Medium

**Speed Limit:** 30 KM/Hr
