## **JOURNEY RISK MANAGEMENT (JRM) STUDY**

### **Salem Terminal To SK FUELS**

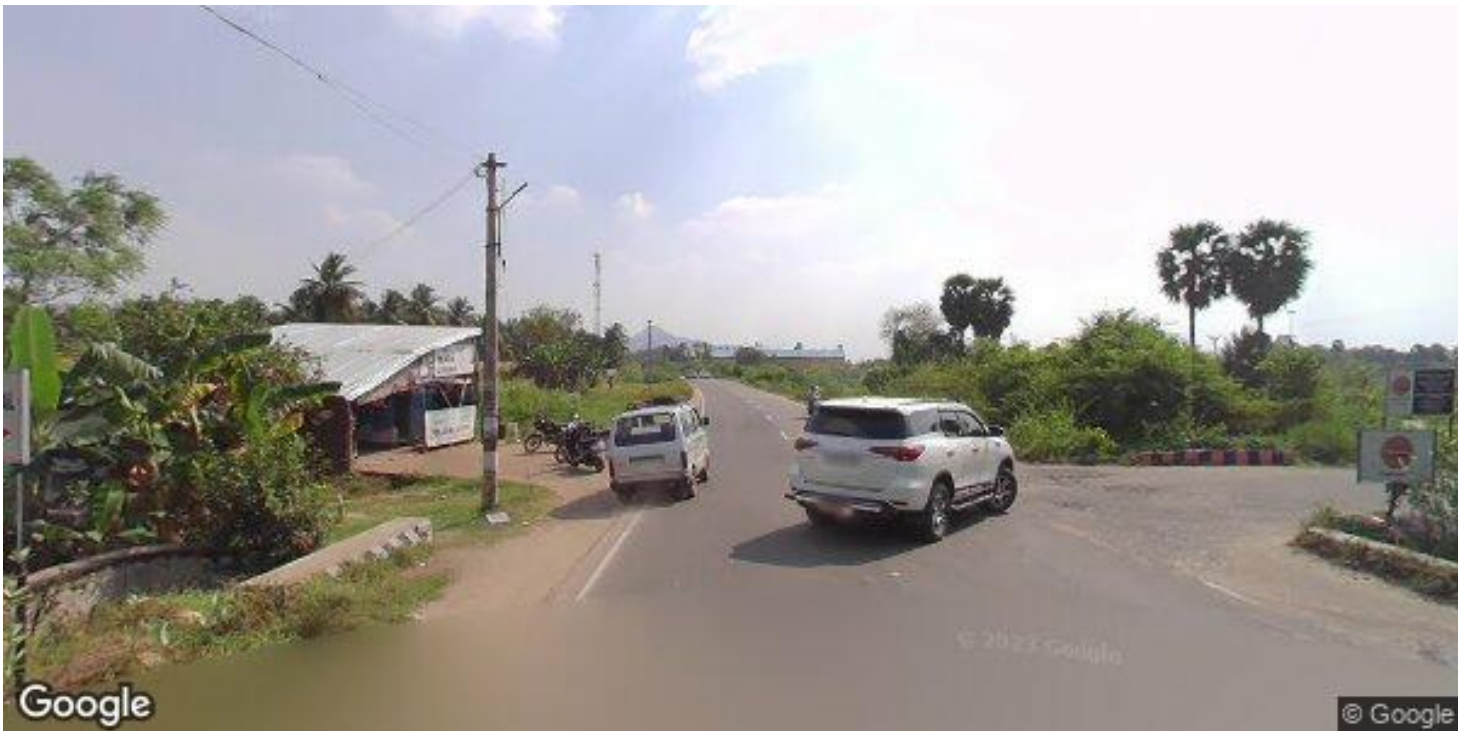
**Coordinates:** 11.44029, 77.87544

**Risk Type:** Turn

**Risk Level:** High

**Speed Limit:** 15 KM/Hr

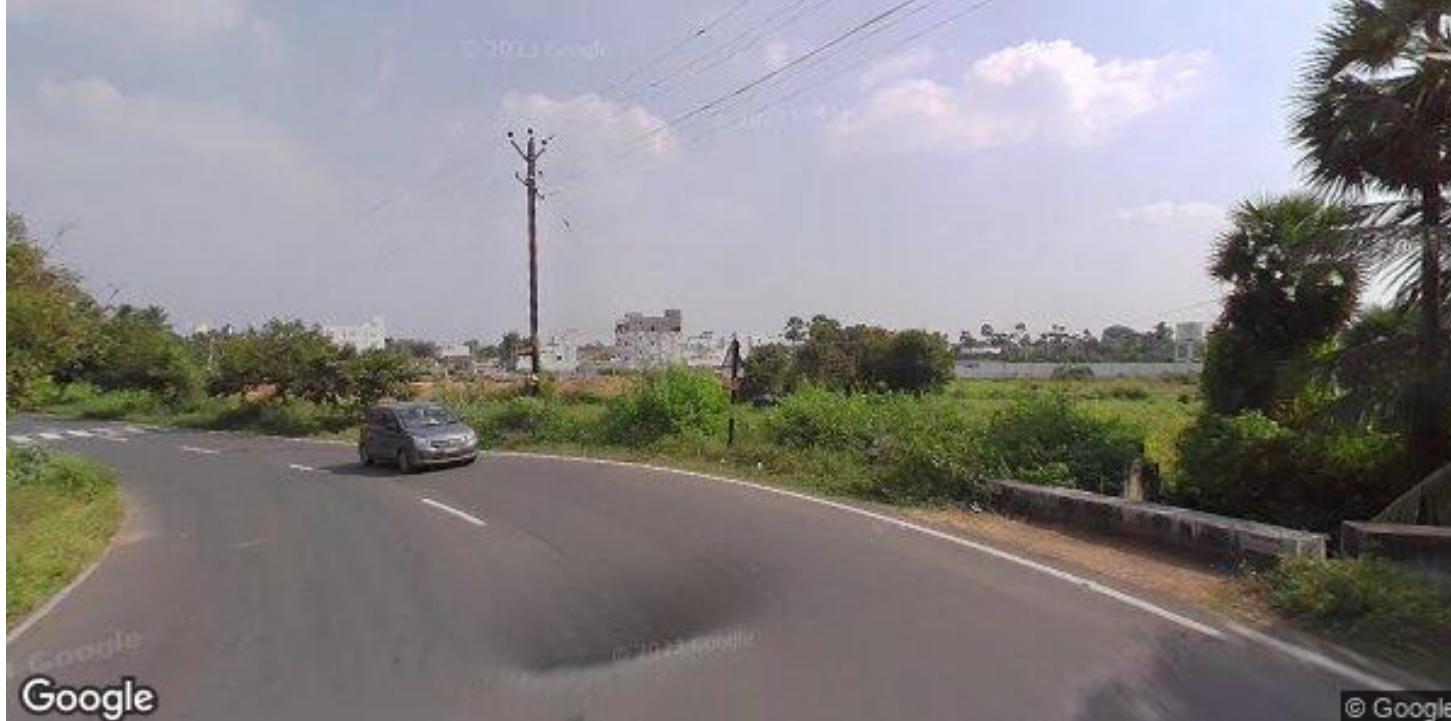
**Risk Type:** Turn  
**Risk Level:** Medium  
**Speed Limit:** 30 KM/Hr  
**Coordinates:** 11.45350, 77.85700

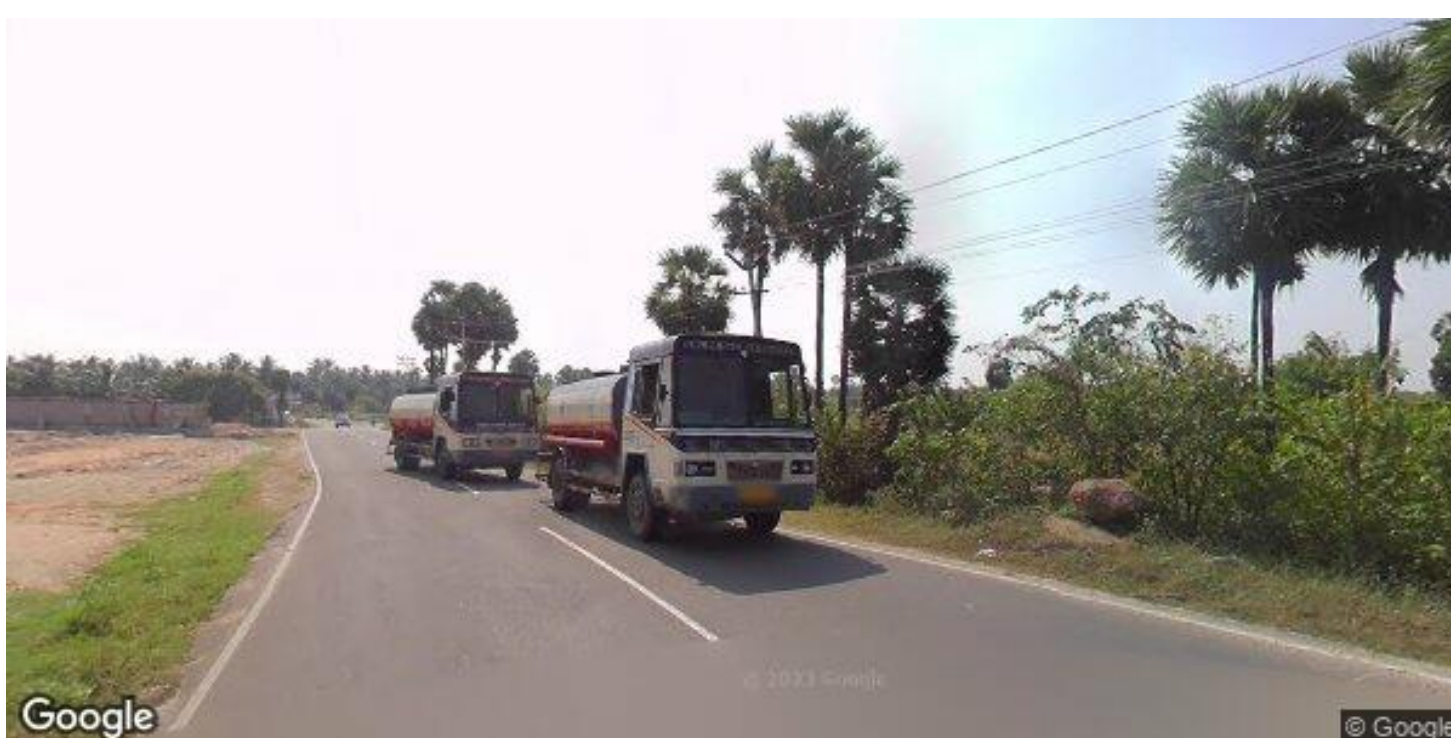
**Risk Type:** Turn  
**Risk Level:** Medium  
**Speed Limit:** 30 KM/Hr  
**Coordinates:** 11.45833, 77.85146

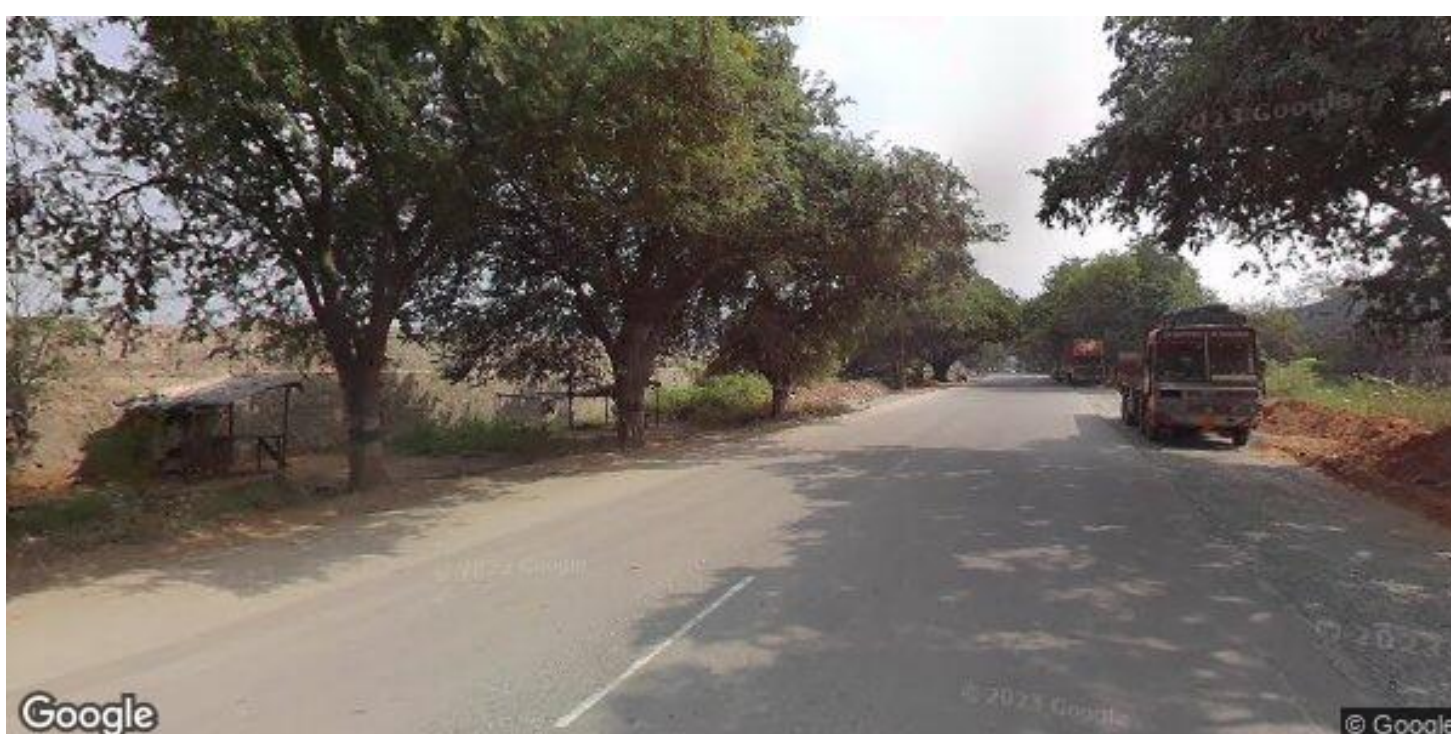
Coordinates: 11.45697, 77.82719

**Risk Type:** Turn  
**Risk Level:** Medium

Speed Limit: 30 KM/Hr

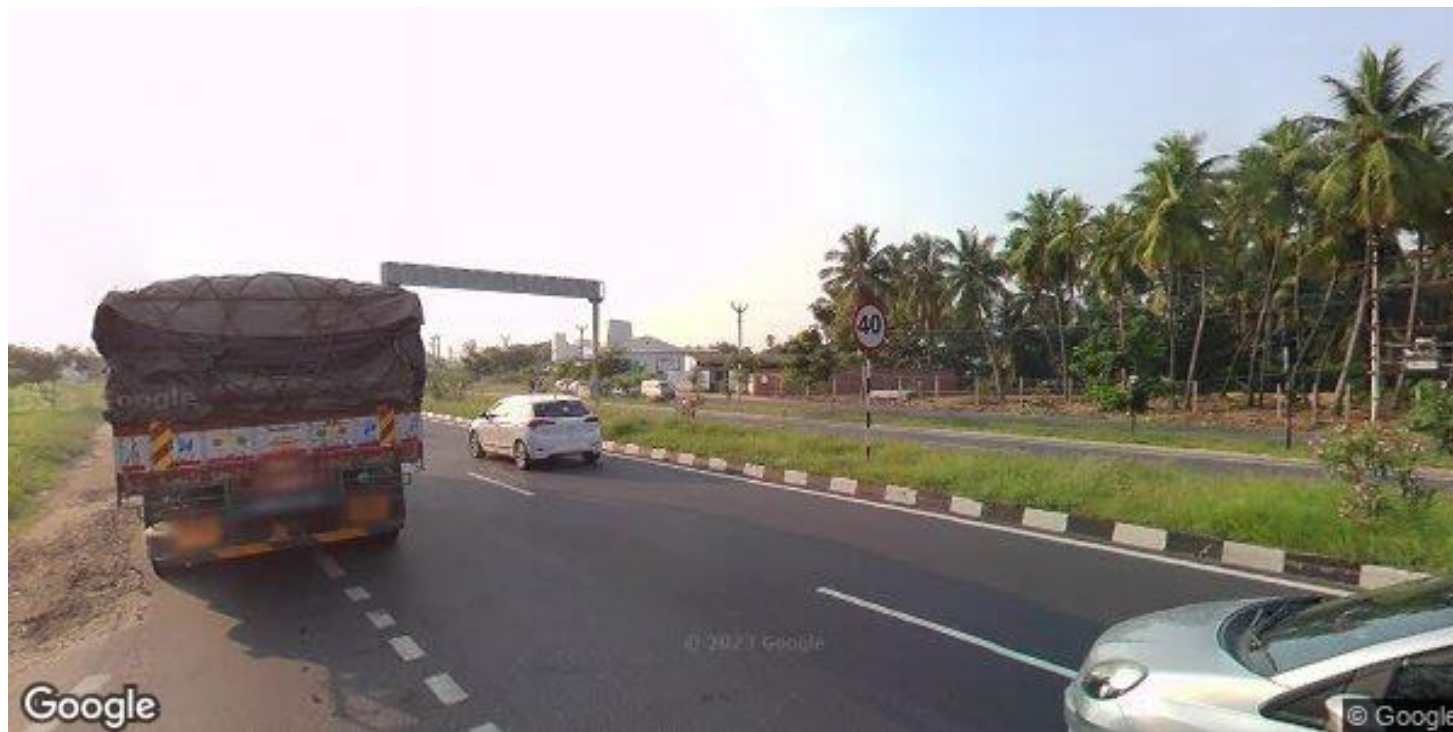
Coordinates: 11.45518, 77.81344

Risk Type: Turn

Risk Level: High

Speed Limit: 15 KM/Hr

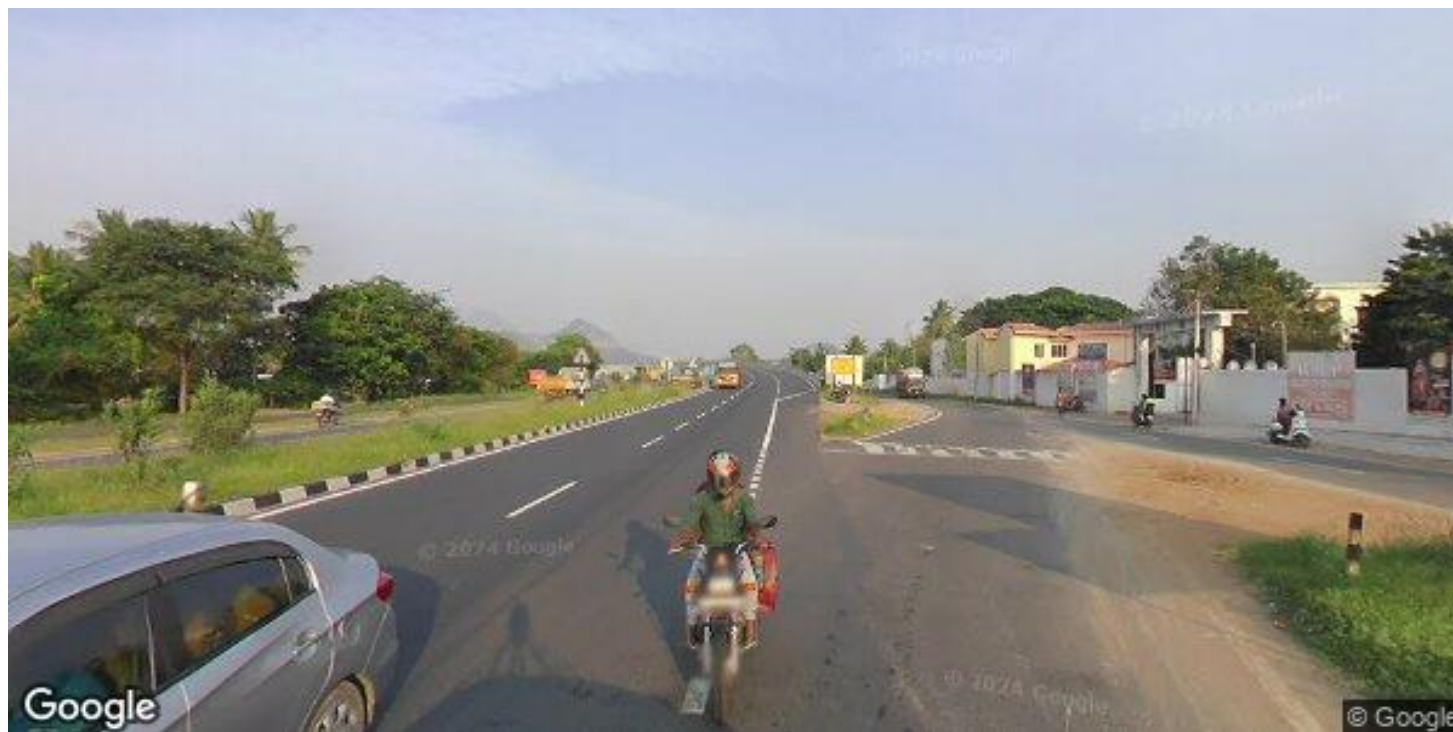
Coordinates: 11.45521, 77.81343

Risk Type: Turn

Risk Level: High

Speed Limit: 15 KM/Hr

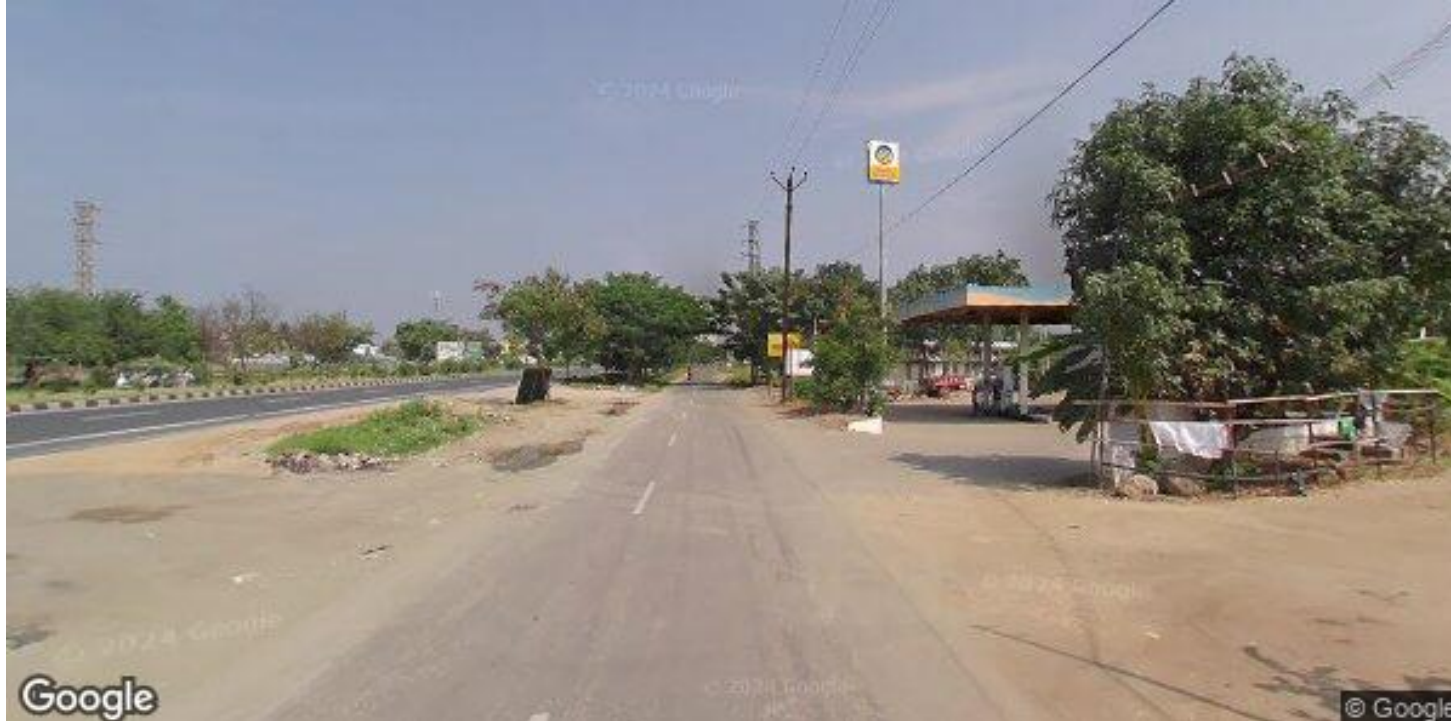
**Coordinates:** 11.43994, 77.71111

**Risk Type:** Turn

**Risk Level:** Medium

**Speed Limit:** 30 KM/Hr

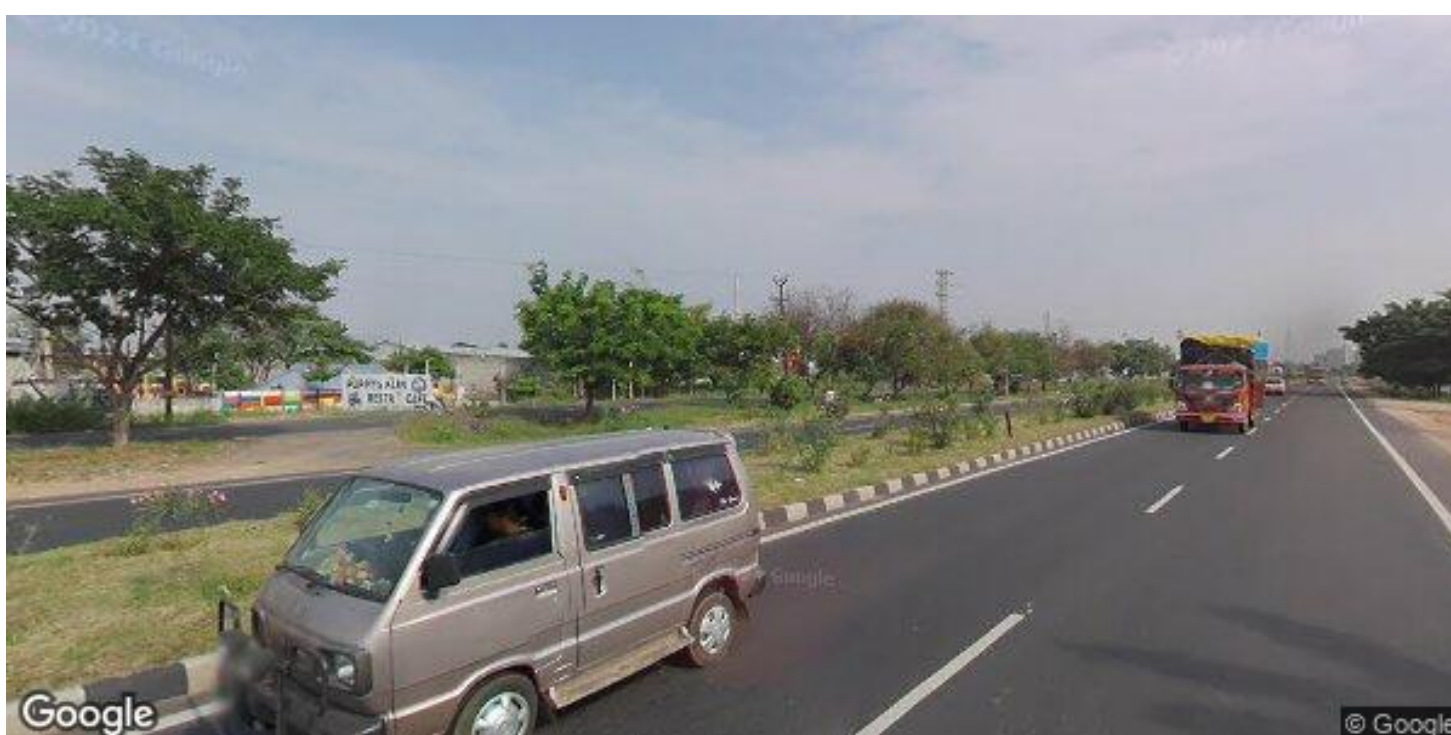
**Coordinates:** 11.43982, 77.71084

**Risk Type:** Turn

**Risk Level:** Medium

**Speed Limit:** 30 KM/Hr

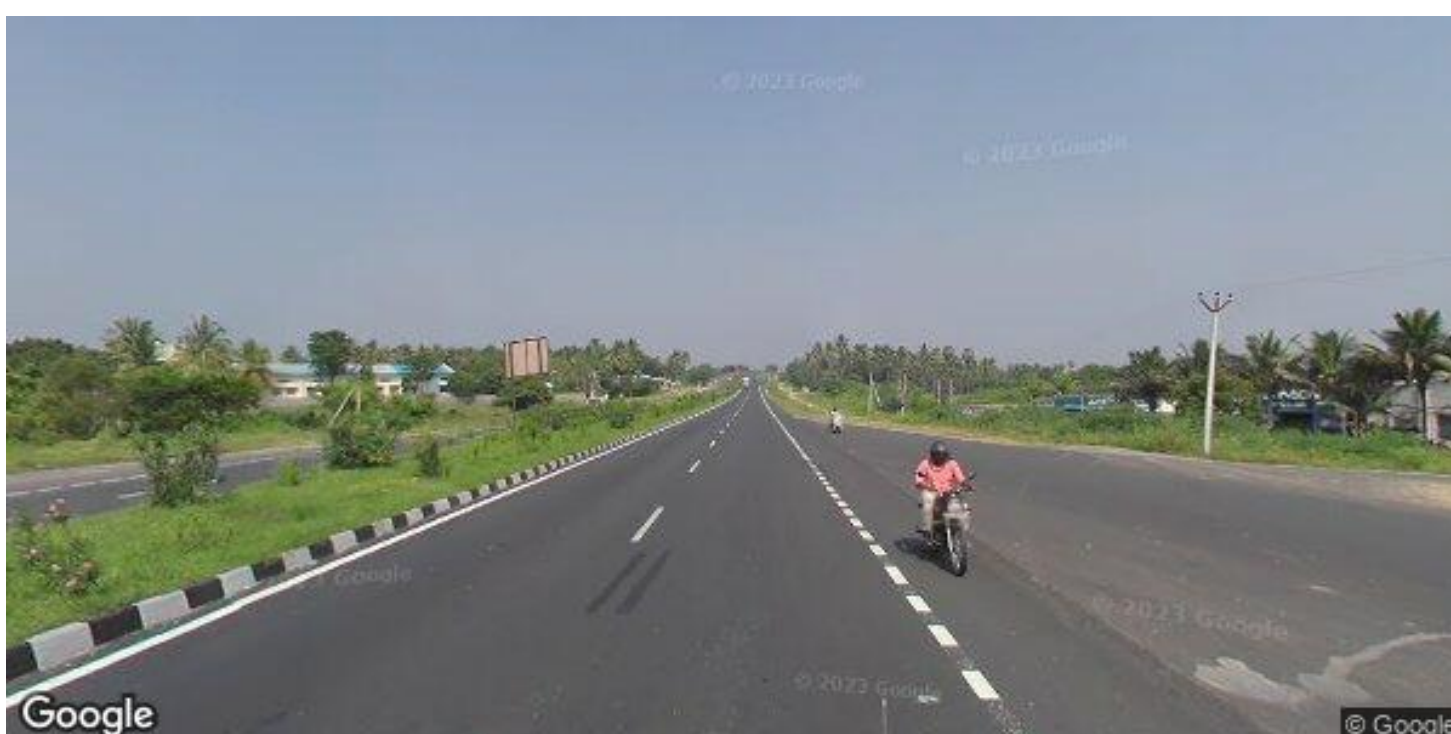
**Coordinates: 11.40046, 77.65371**

**Risk Type:** Turn

**Risk Level:** High

**Speed Limit: 15 KM/Hr**

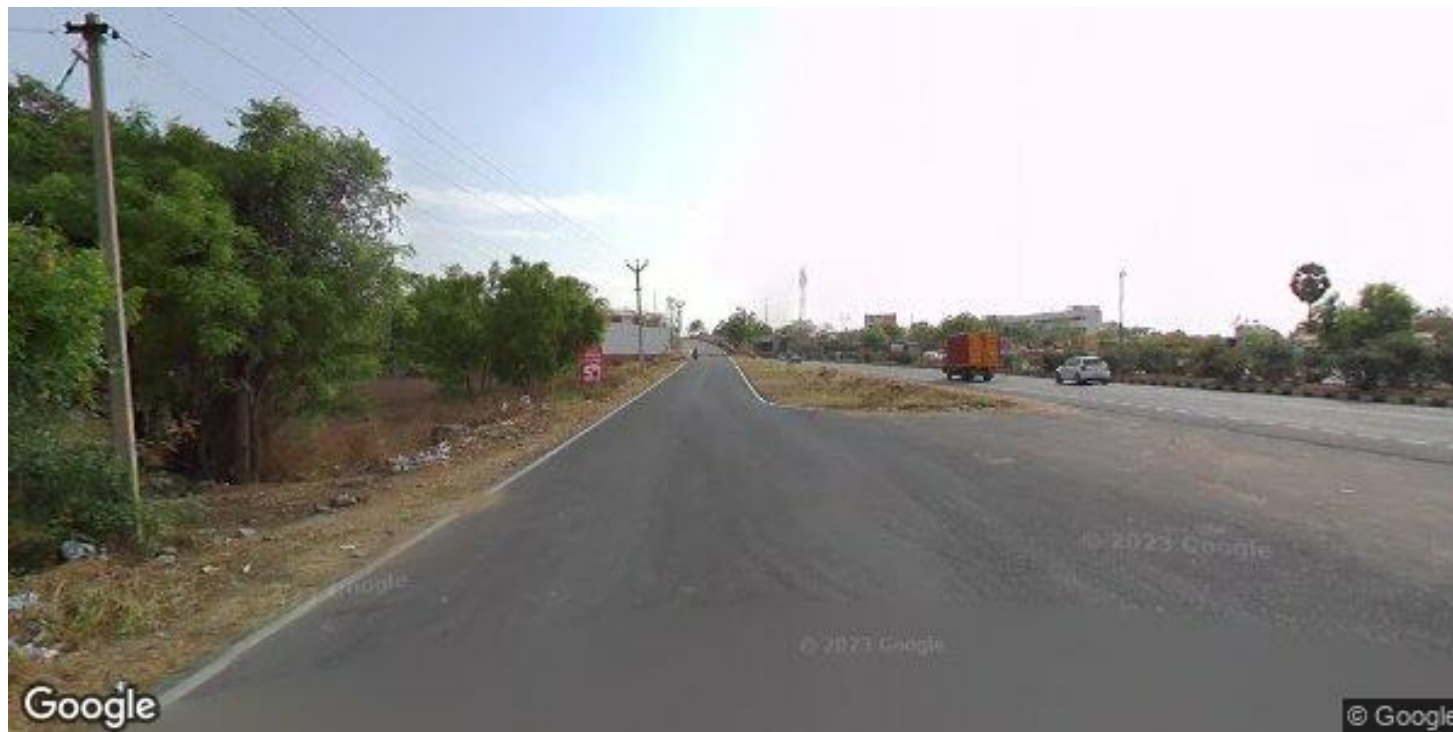
**Coordinates: 11.40035, 77.65383**

**Risk Type: Turn**

**Risk Level: High**

**Speed Limit: 15 KM/Hr**

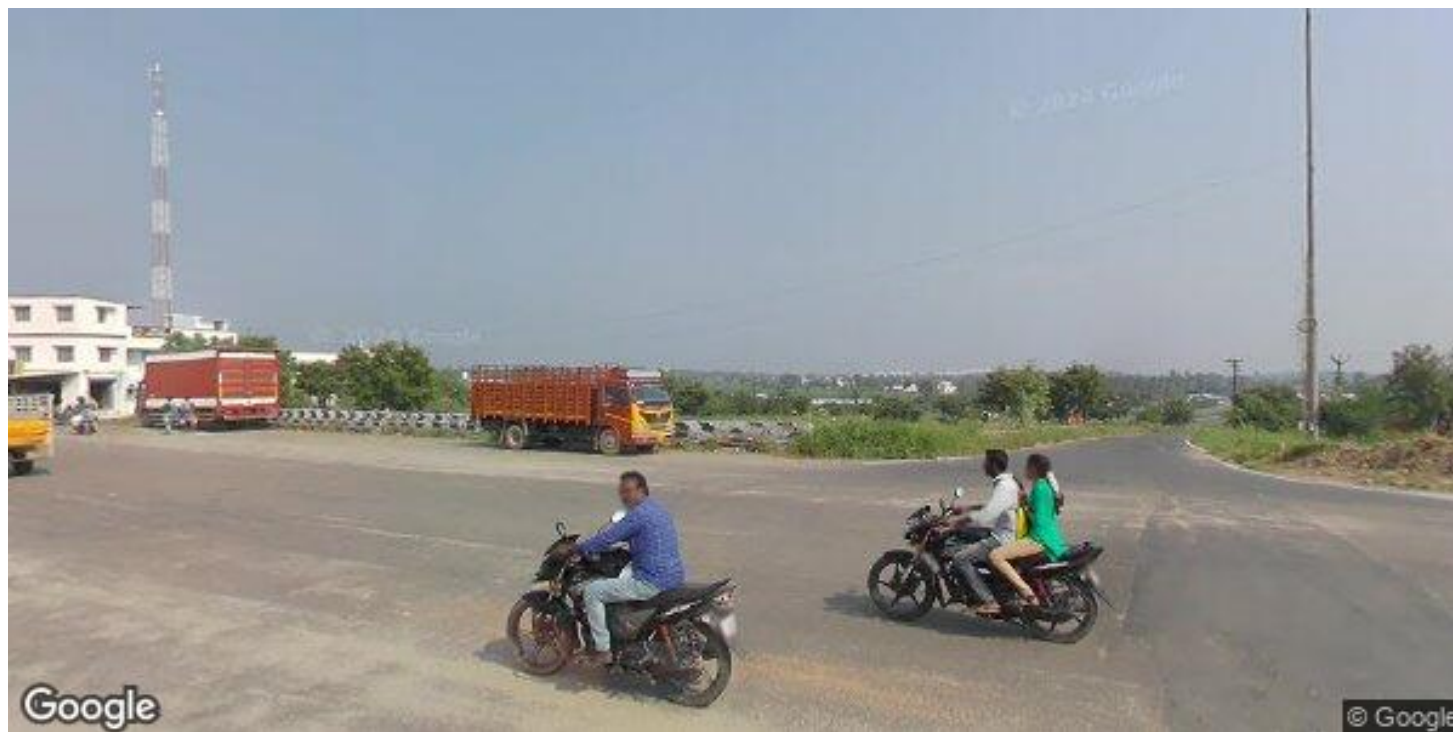
**Coordinates: 11.39827, 77.65237**

**Risk Type: Turn**

**Risk Level: High**

**Speed Limit: 15 KM/Hr**

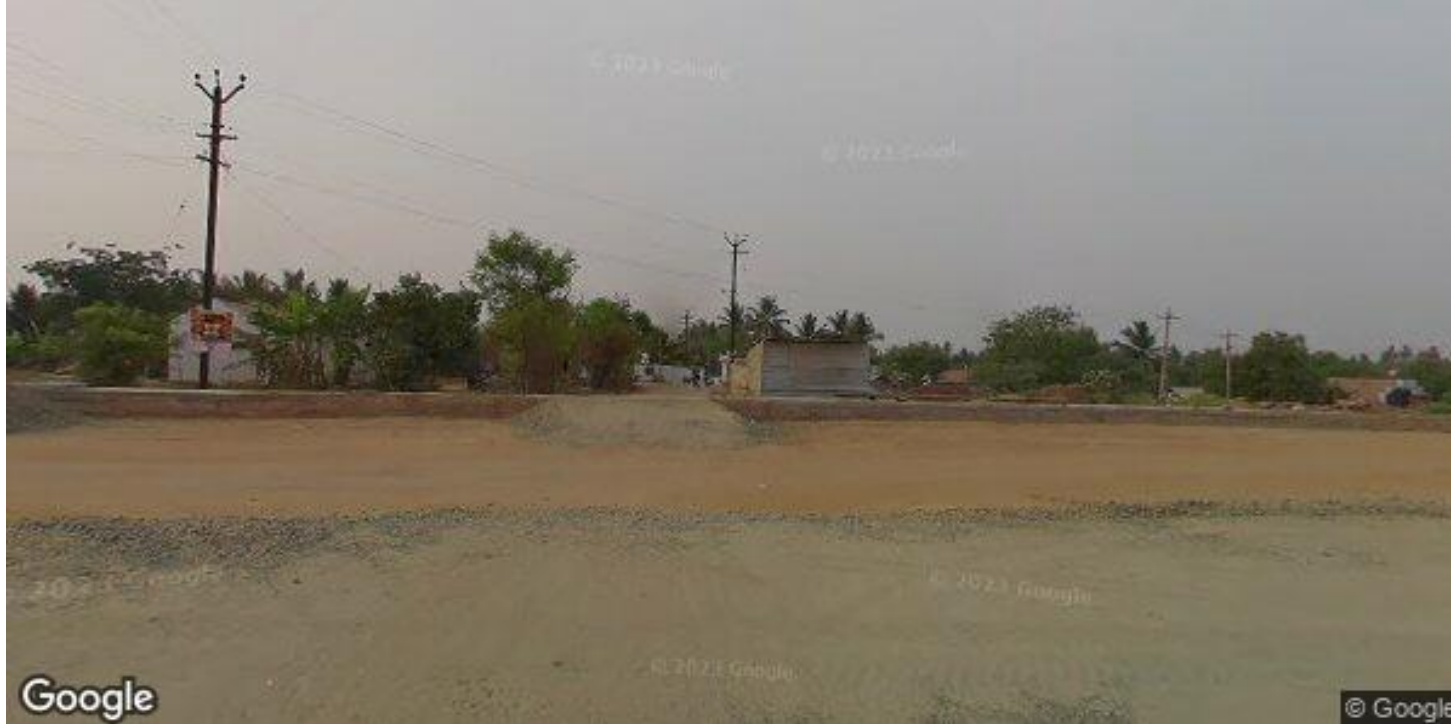
**Coordinates:** 11.39972, 77.64797

**Risk Type:** Turn

**Risk Level:** High

**Speed Limit:** 15 KM/Hr

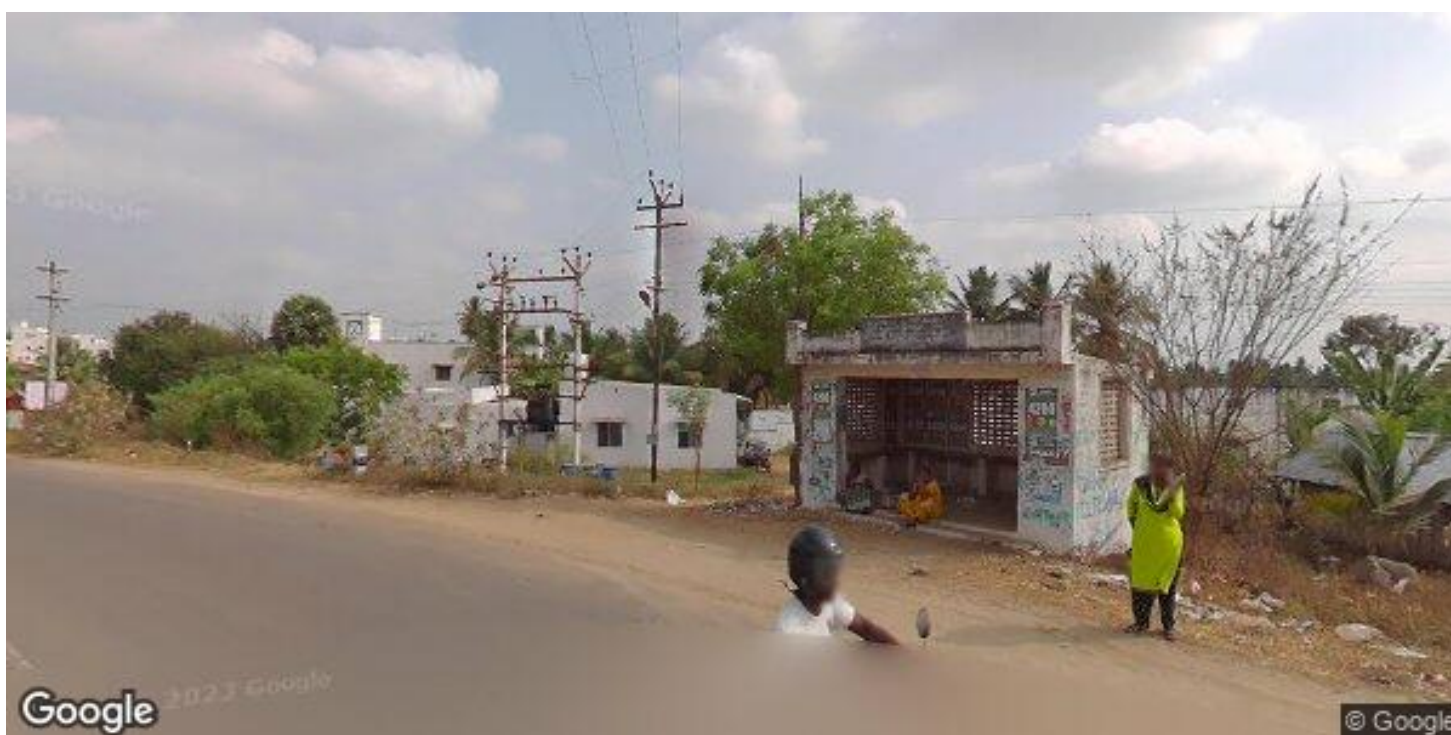
**Coordinates:** 11.40025, 77.64811

**Risk Type:** Turn

**Risk Level:** High

**Speed Limit:** 15 KM/Hr

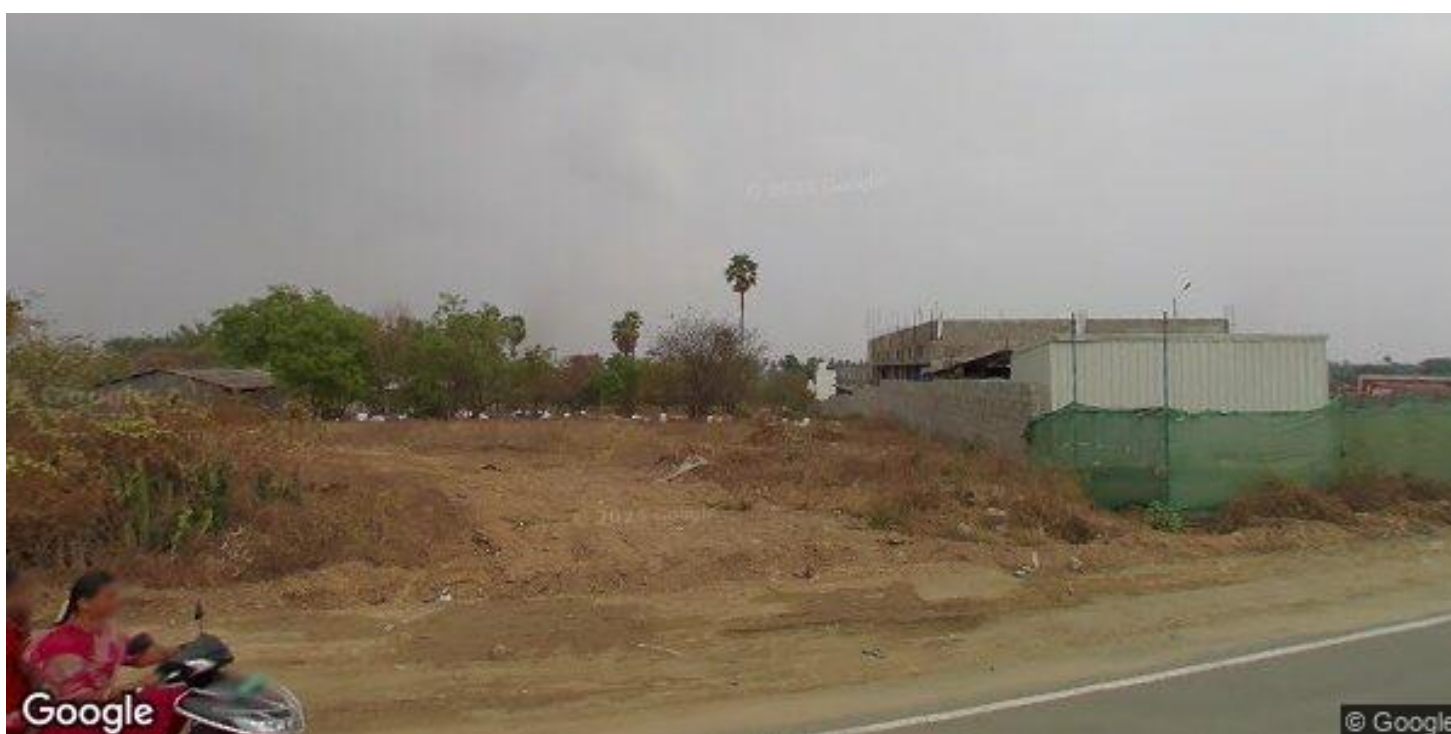
**Risk Type:** Blind Spot

**Risk Level:** Blind Spot

**Speed Limit: 10 KM/Hr**  
**Coordinates: 11.39995, 77.64214**
