# IndianOil

## JOURNEY RISK MANAGEMENT (JRM) STUDY

**Salem Terminal to ADHOC SRI GARUDA AGENCY UNIT  
II, 330720 JANANEYSHRI FUELS**

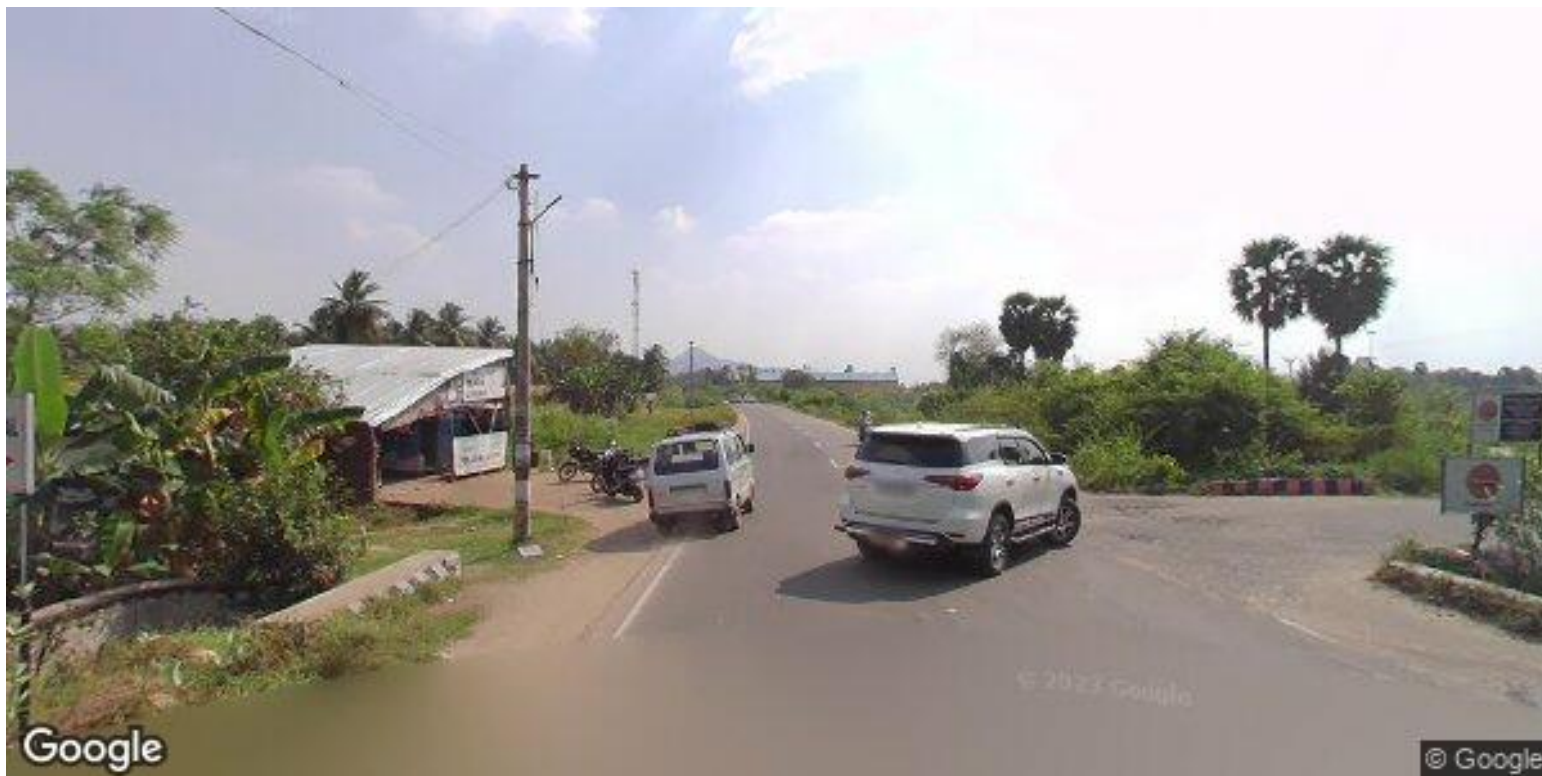
**Coordinates:** 11.44029, 77.87544

**Risk Type:** Turn

**Risk Level:** High

**Speed Limit:** 15 KM/Hr

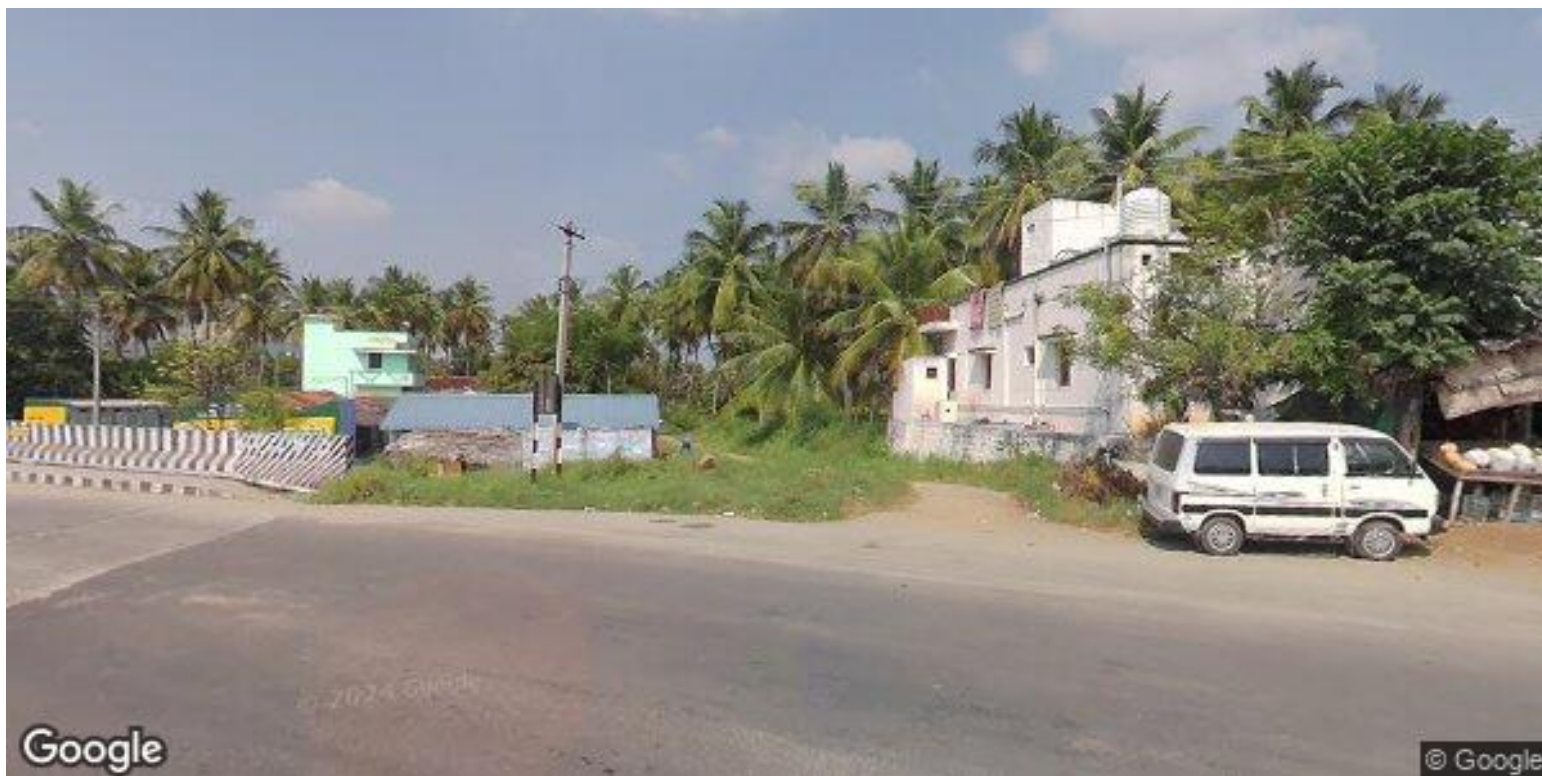
**Coordinates:** 11.44898, 77.87410

**Risk Type:** Turn

**Risk Level:** Medium

**Speed Limit:** 30 KM/Hr

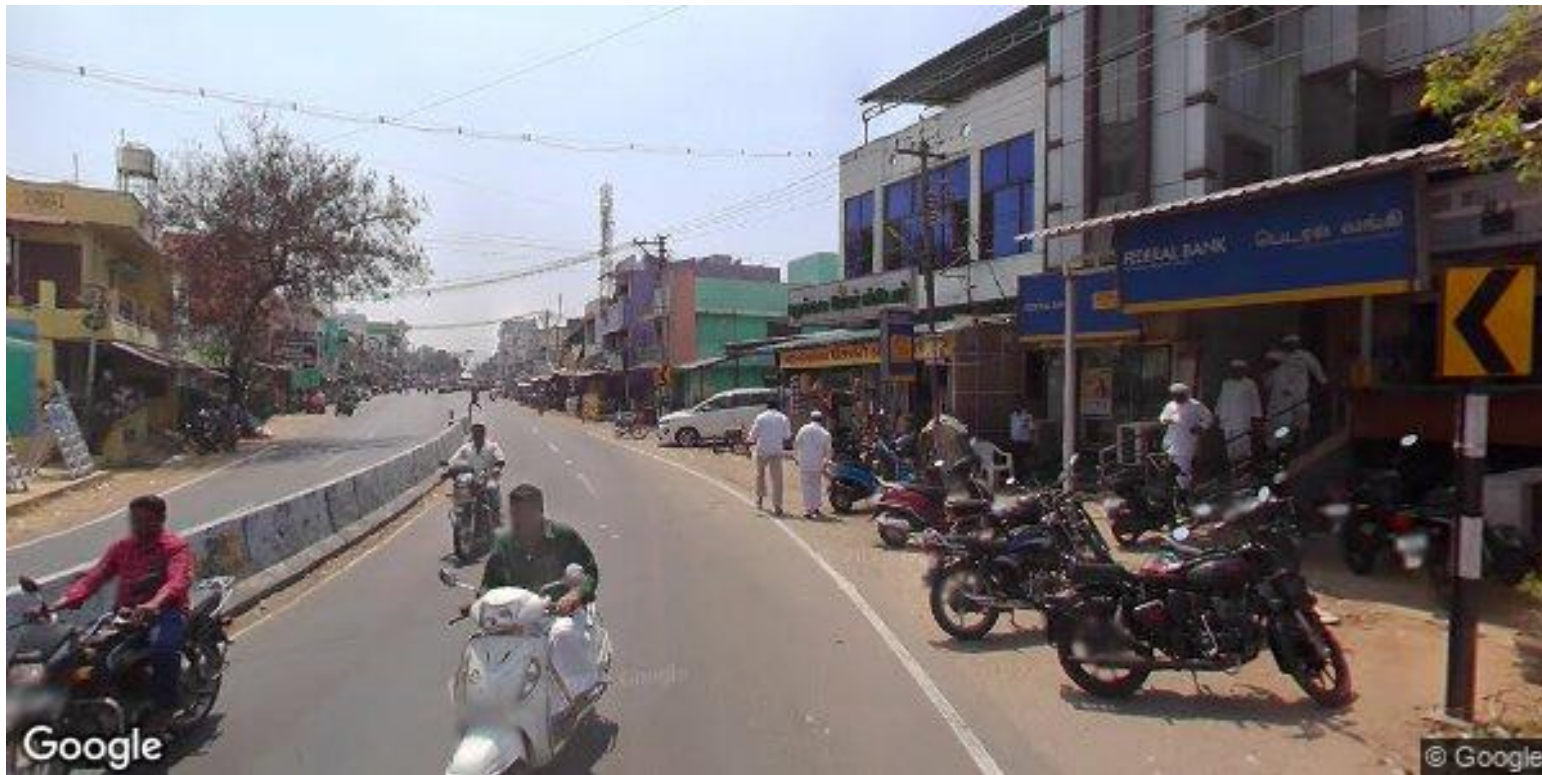
**Coordinates:** 11.43769, 77.67810

**Risk Type:** Turn

**Risk Level:** Medium

**Speed Limit:** 30 KM/Hr

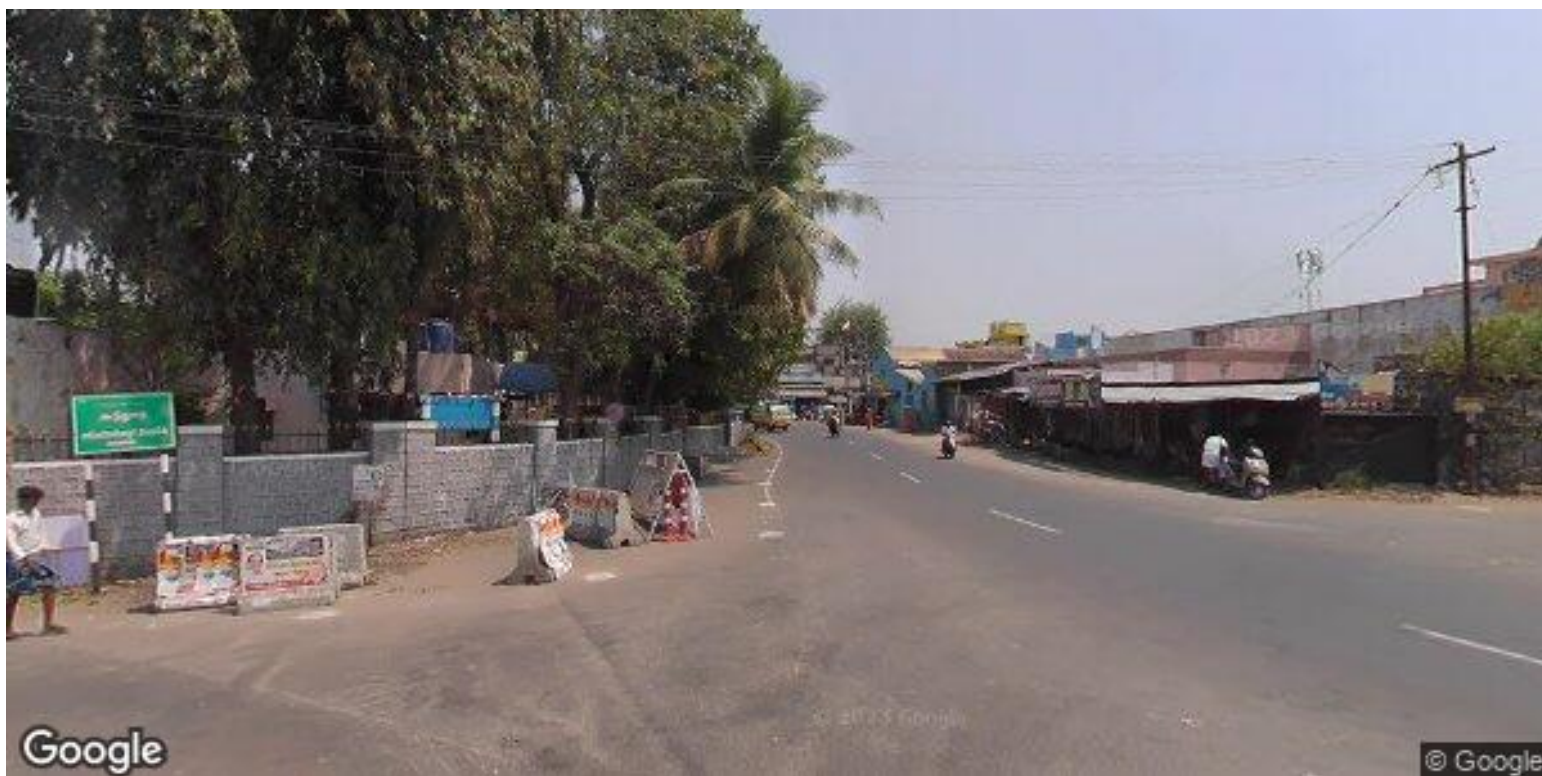
**Coordinates:** 11.43863, 77.68223

**Risk Type:** Turn

**Risk Level:** High

**Speed Limit:** 15 KM/Hr

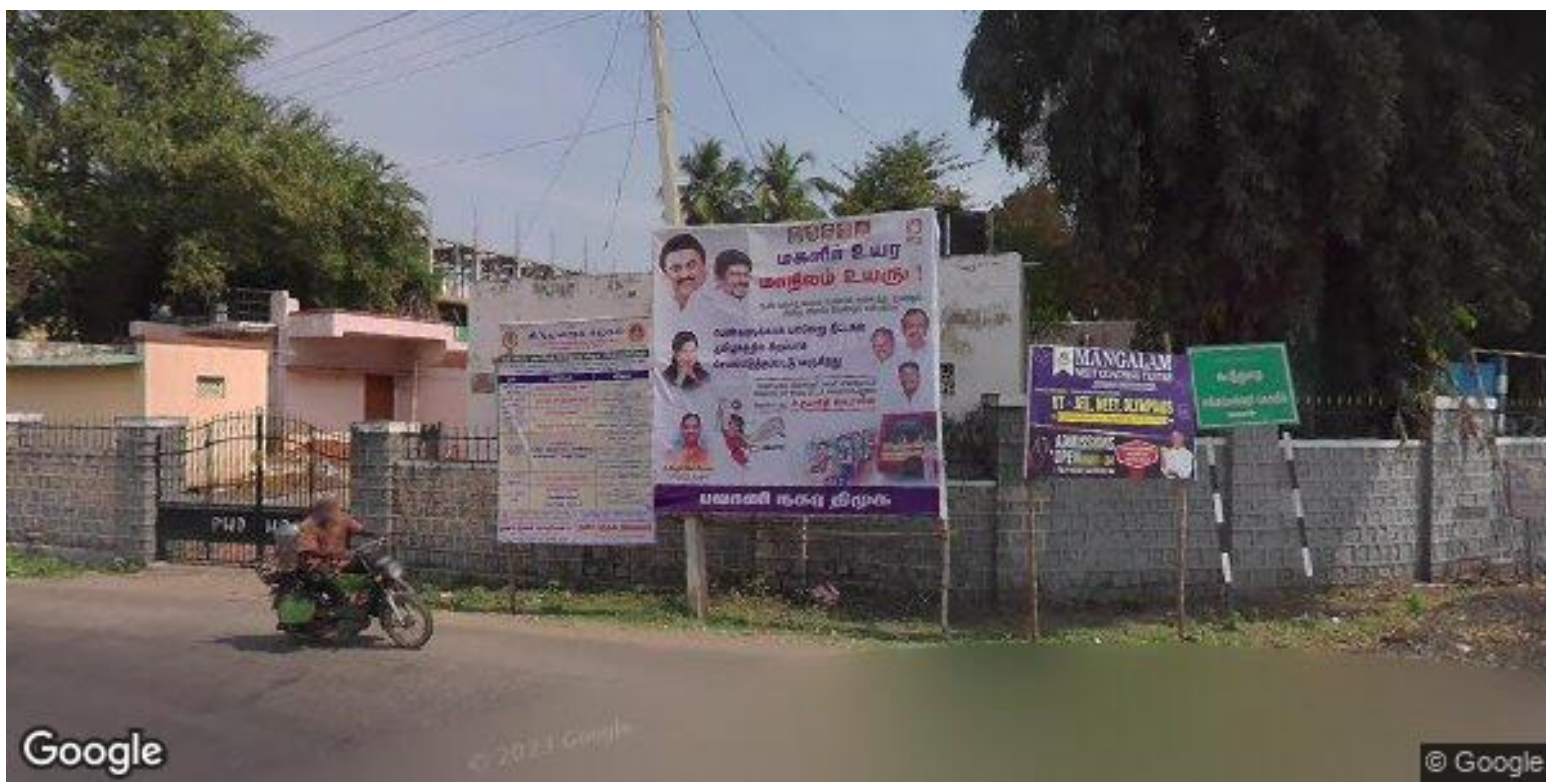
**Coordinates:** 11.43871, 77.68228

**Risk Type:** Turn

**Risk Level:** Medium

**Speed Limit:** 30 KM/Hr

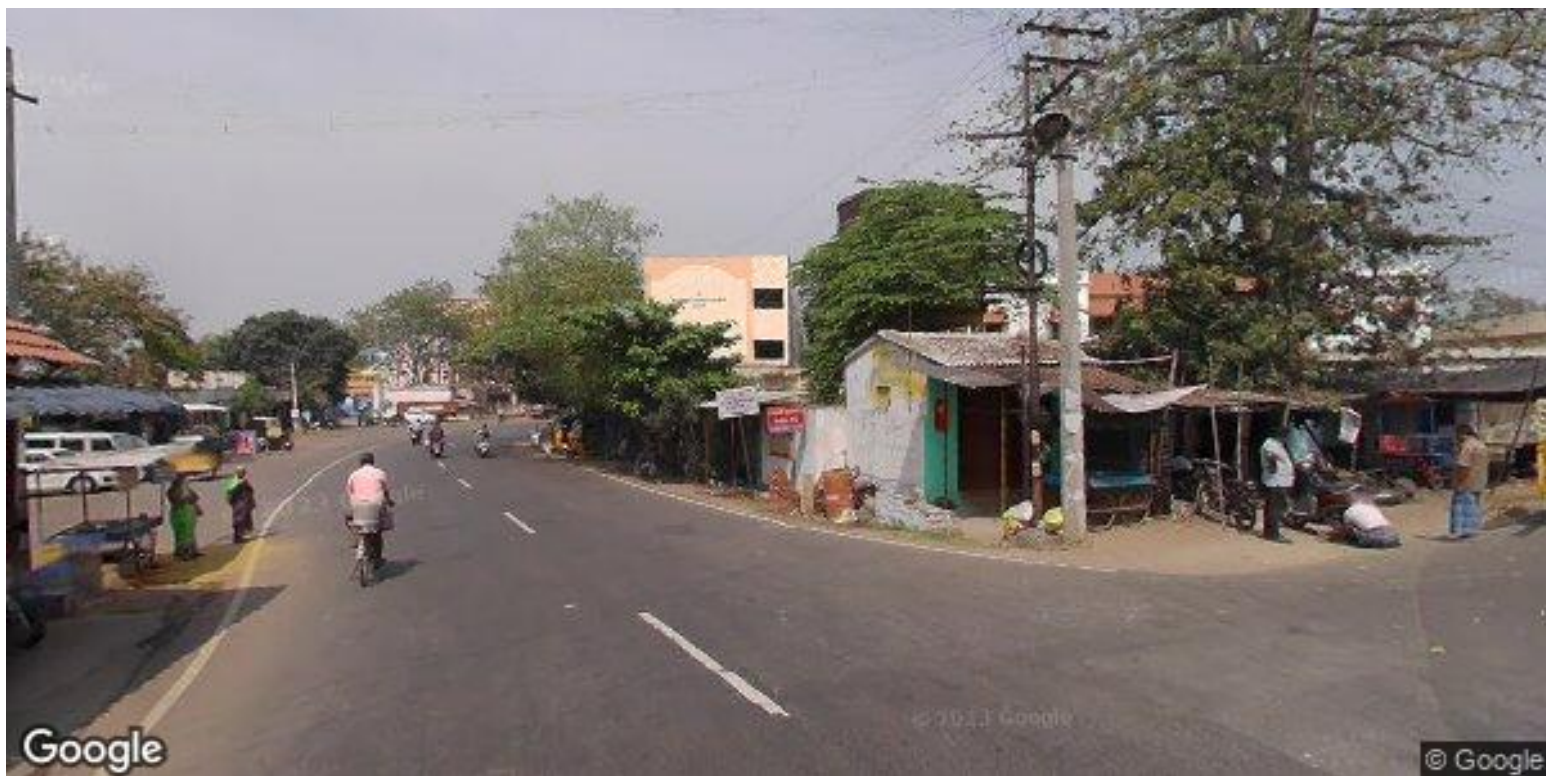
**Coordinates:** 11.43965, 77.68224

**Risk Type:** Turn

**Risk Level:** Medium

**Speed Limit:** 30 KM/Hr

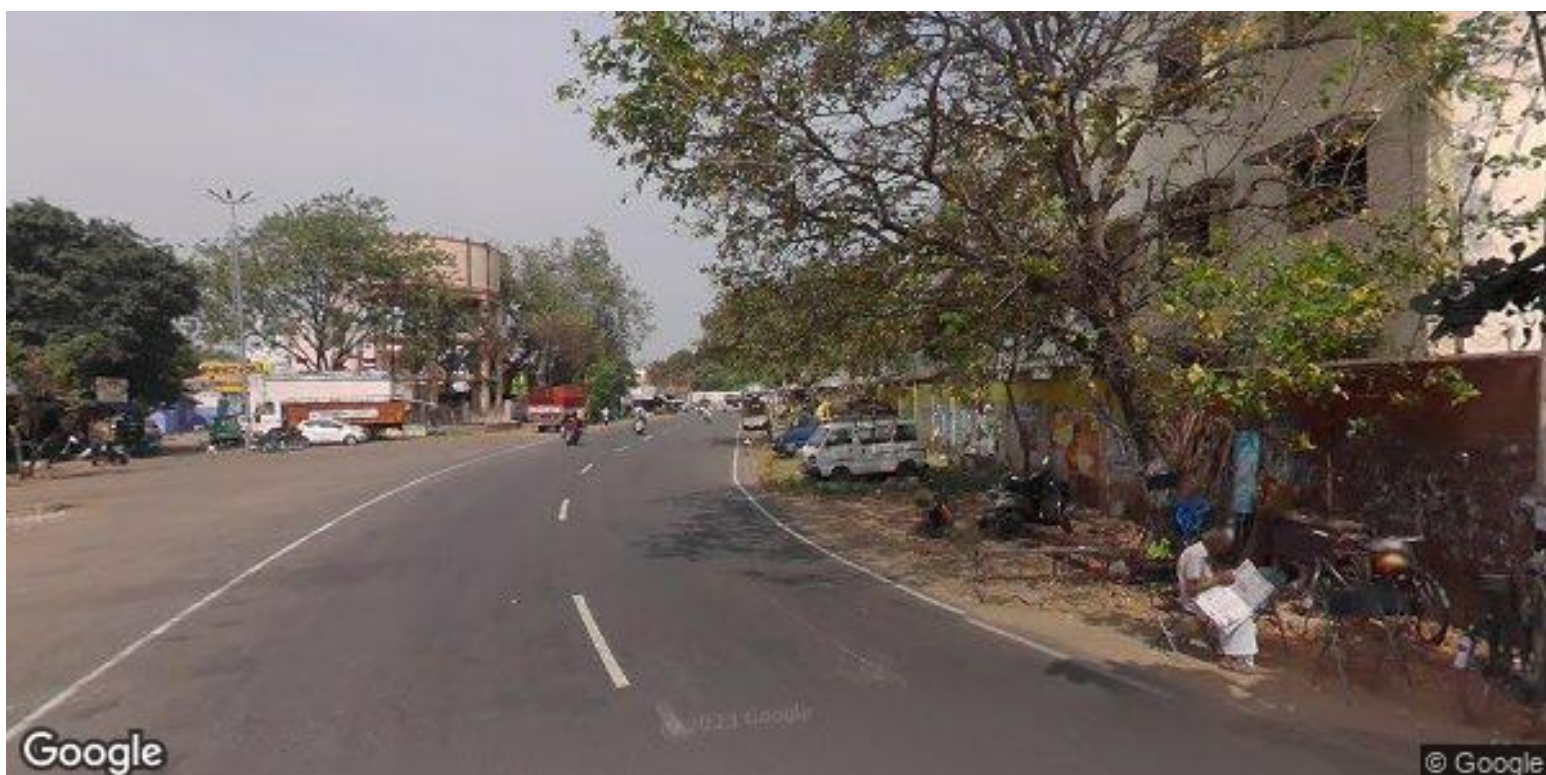
**Coordinates:** 11.43997, 77.68198

**Risk Type:** Turn

**Risk Level:** Medium

**Speed Limit:** 30 KM/Hr

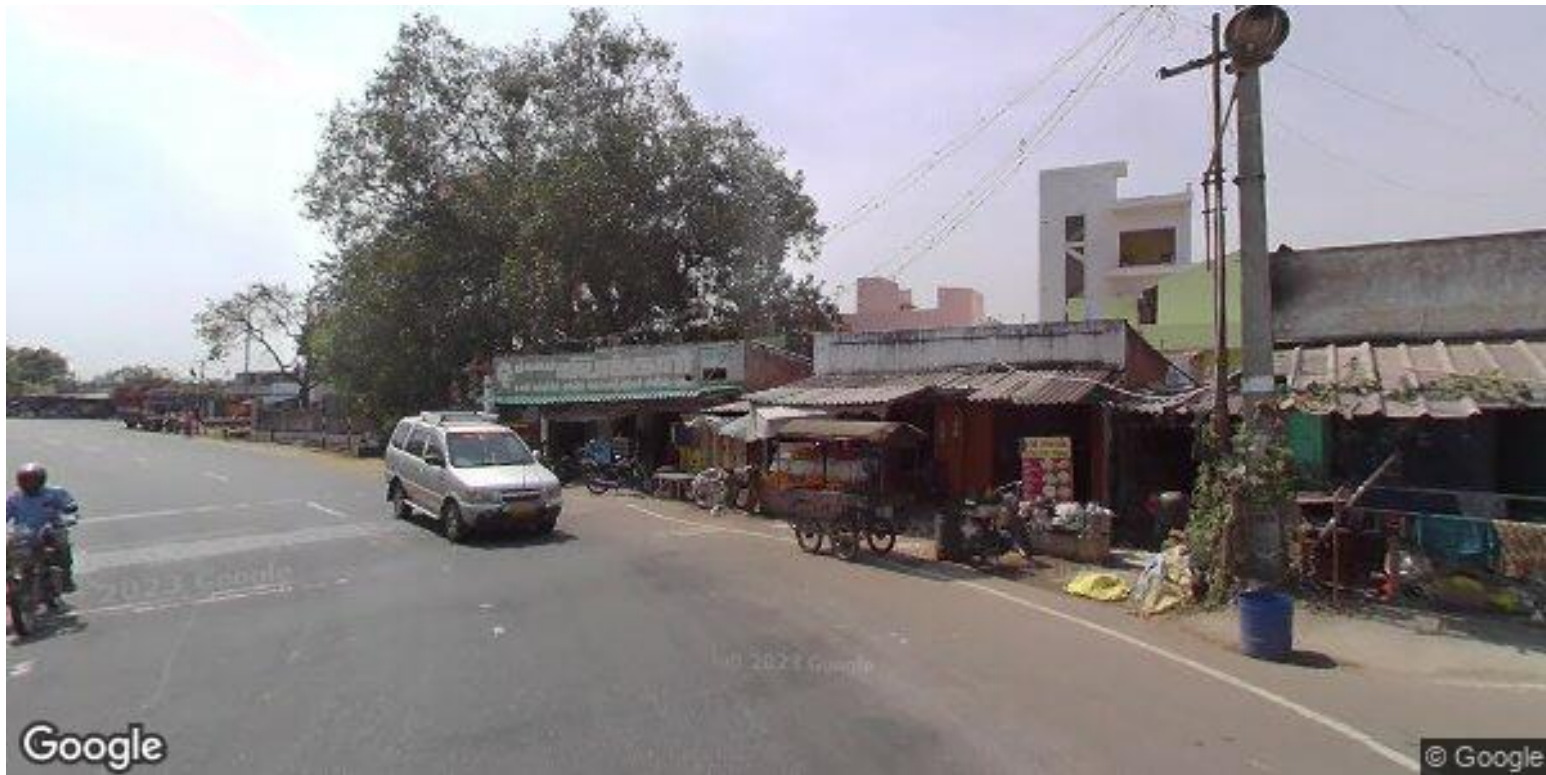
**Coordinates:** 11.44105, 77.68187

**Risk Type:** Turn

**Risk Level:** High

**Speed Limit:** 15 KM/Hr

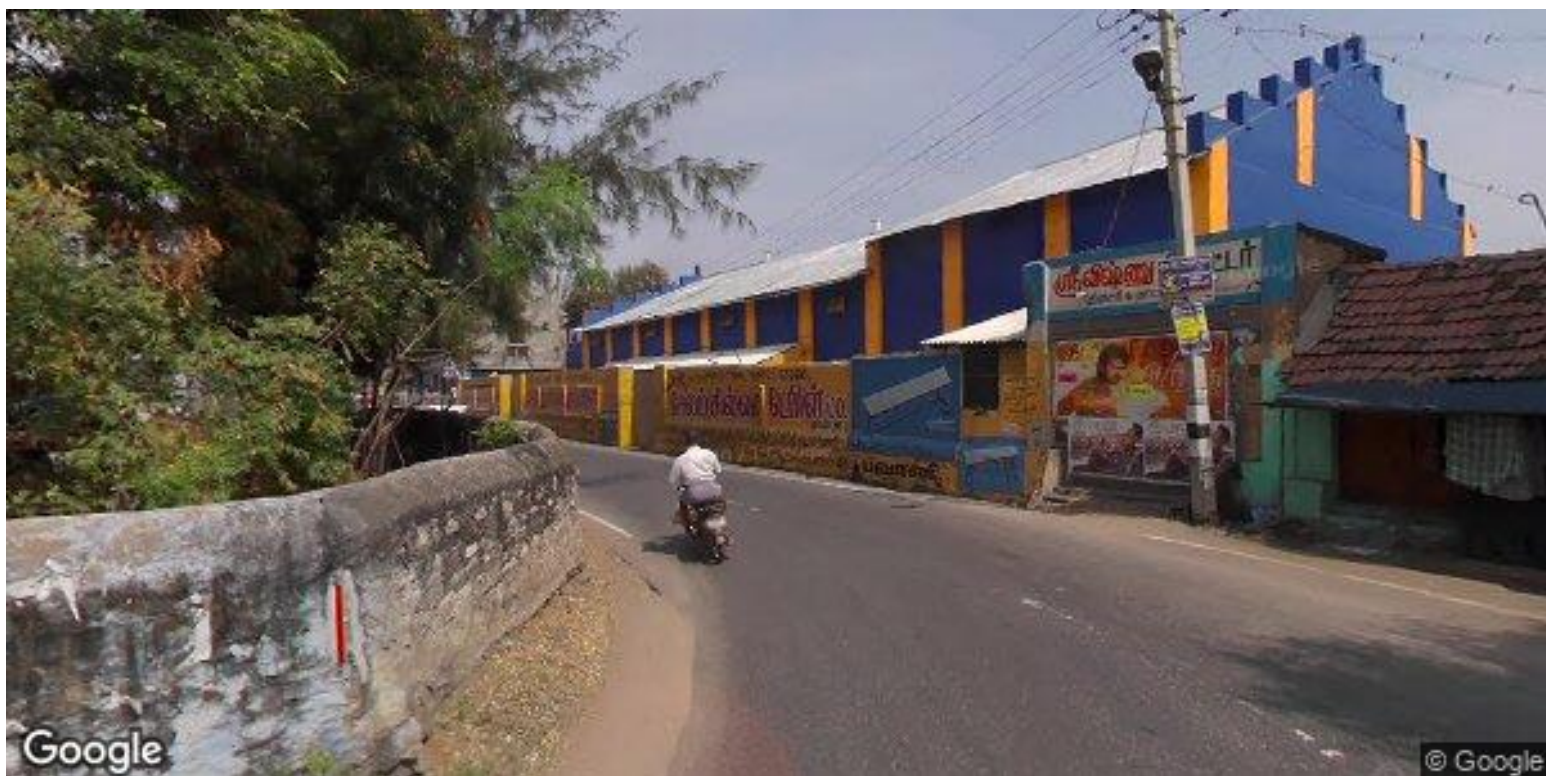
**Coordinates:** 11.44119, 77.68217

**Risk Type:** Turn

**Risk Level:** High

**Speed Limit:** 15 KM/Hr

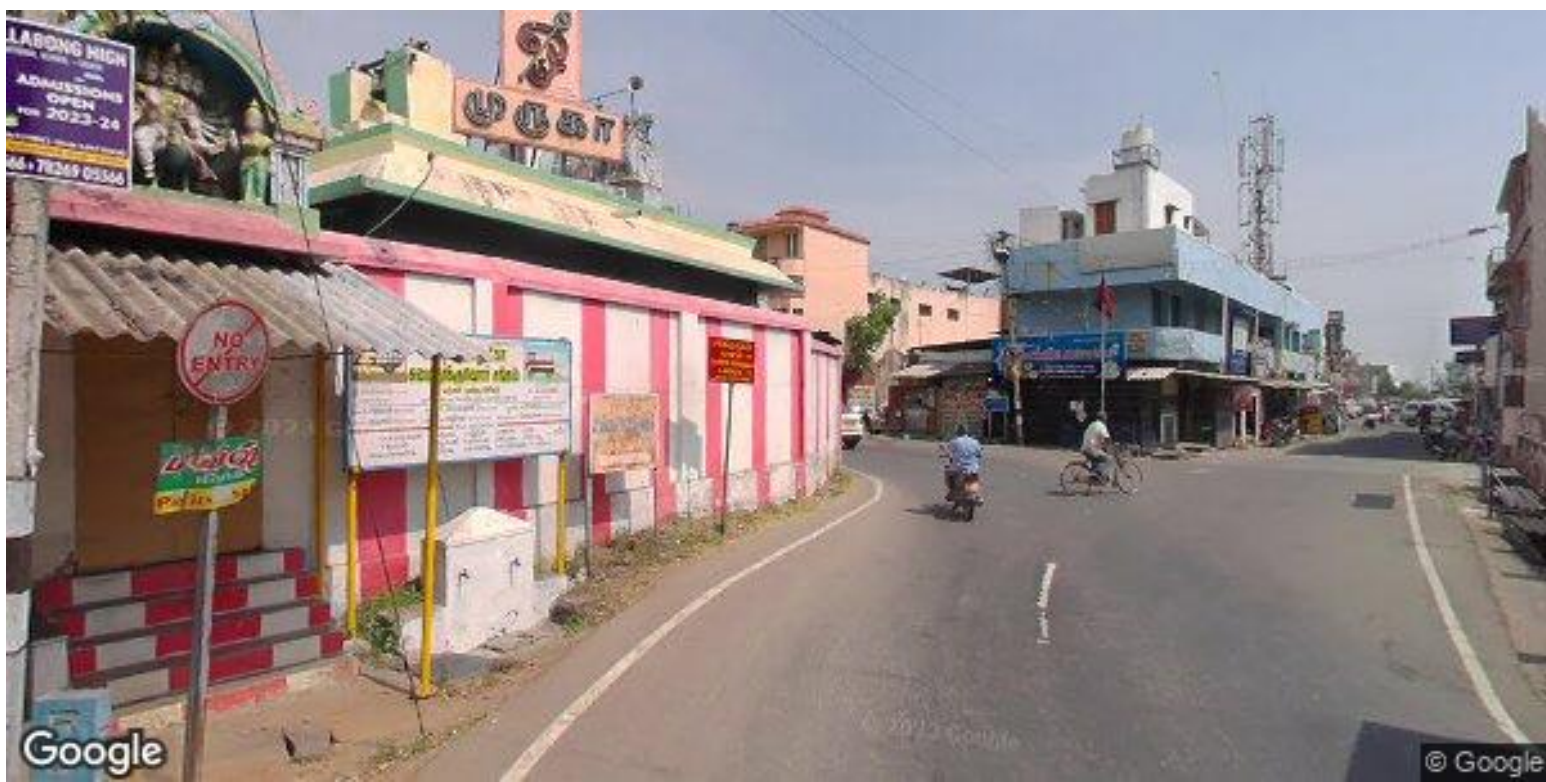
**Coordinates:** 11.44295, 77.68261

**Risk Type:** Turn

**Risk Level:** Medium

**Speed Limit:** 30 KM/Hr

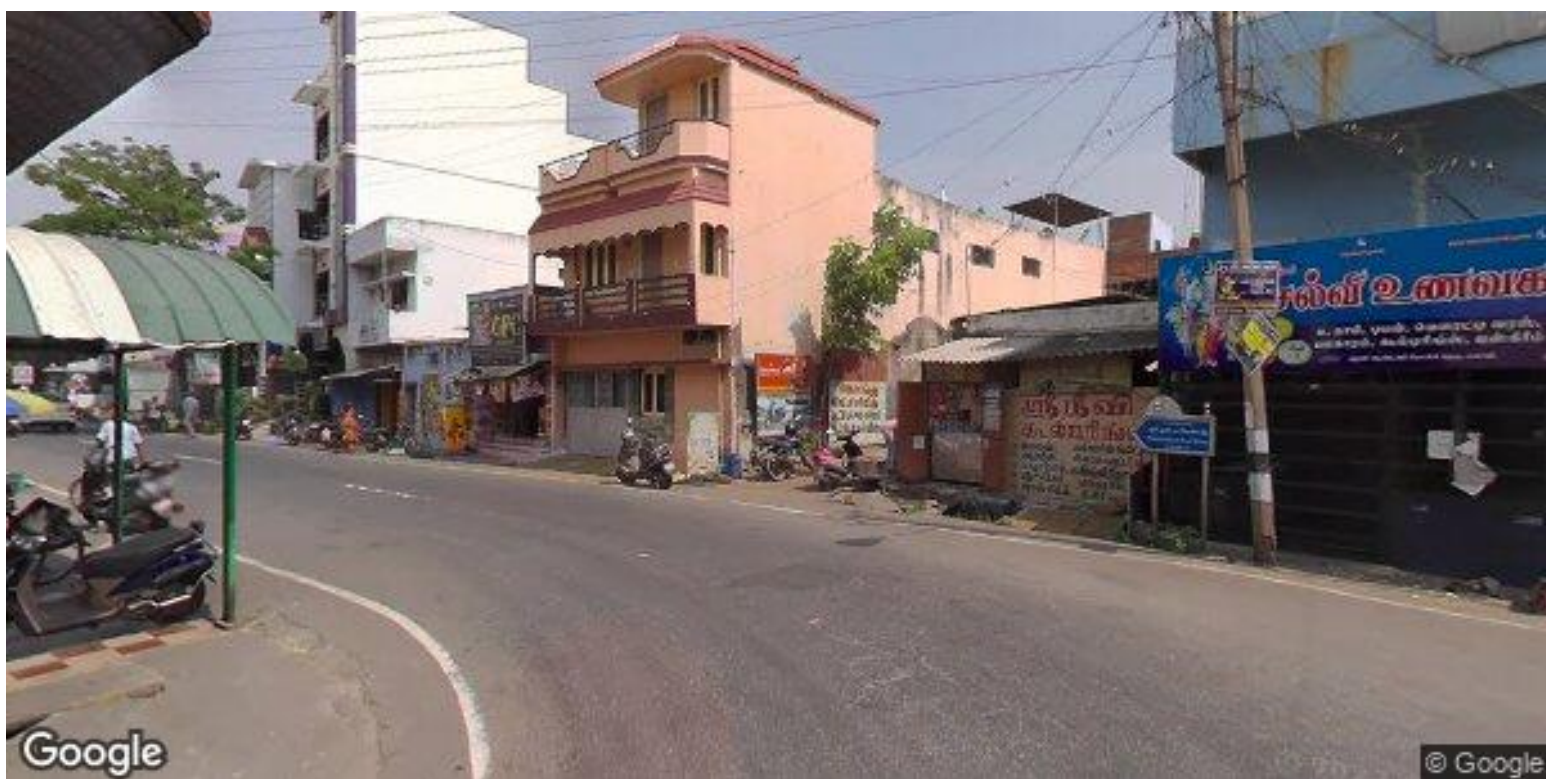
**Coordinates:** 11.44300, 77.68275

**Risk Type:** Turn

**Risk Level:** High

**Speed Limit:** 15 KM/Hr

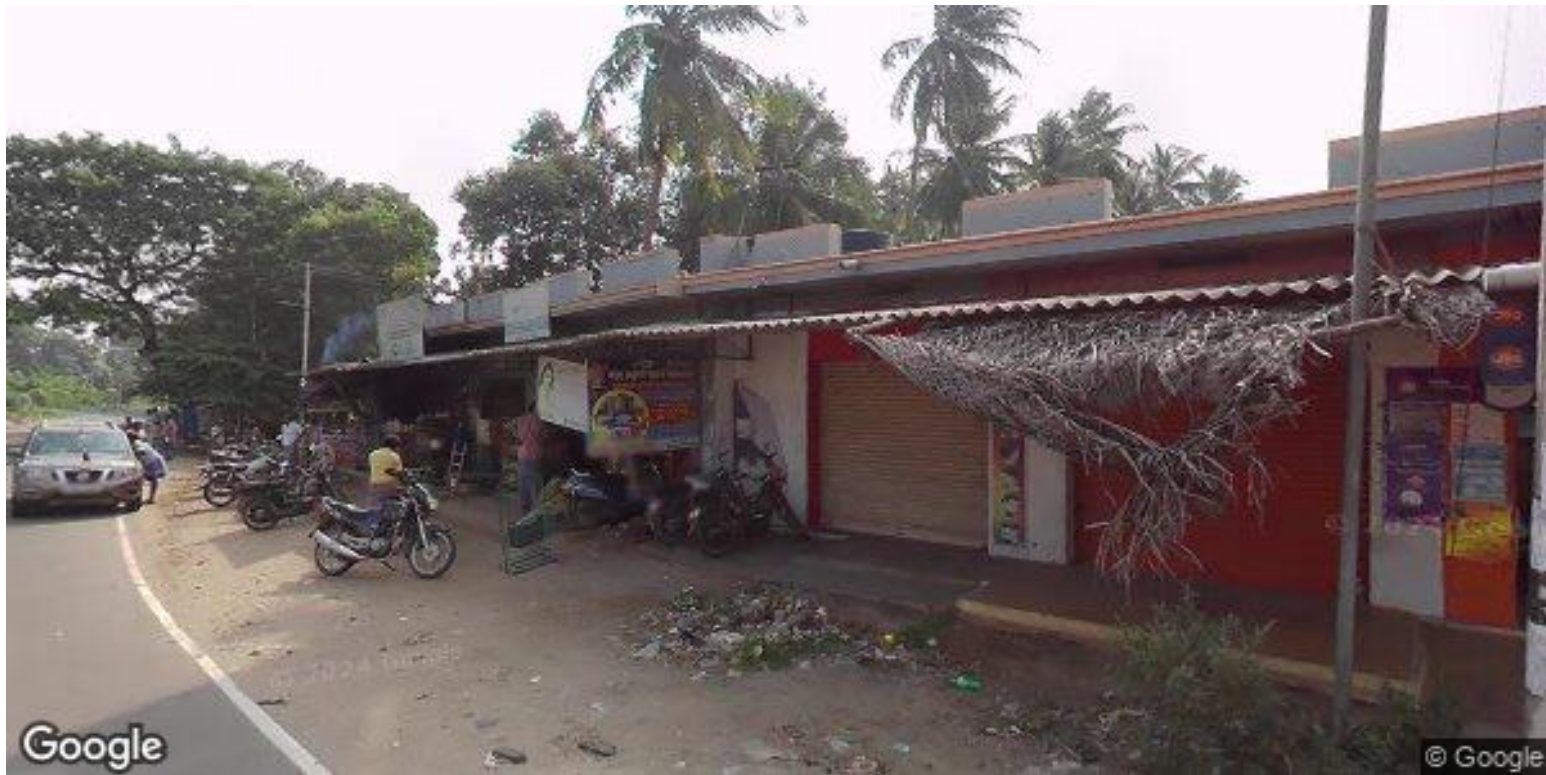
**Coordinates:** 11.52420, 77.52412

**Risk Type:** Blind Spot

**Risk Level:** Blind Spot

**Speed Limit:** 10 KM/Hr
